STATE OF NORTH CAROLINA
DEPARTMENT OF TRANSPORTATION

ROY COOPER
GOVERNOR

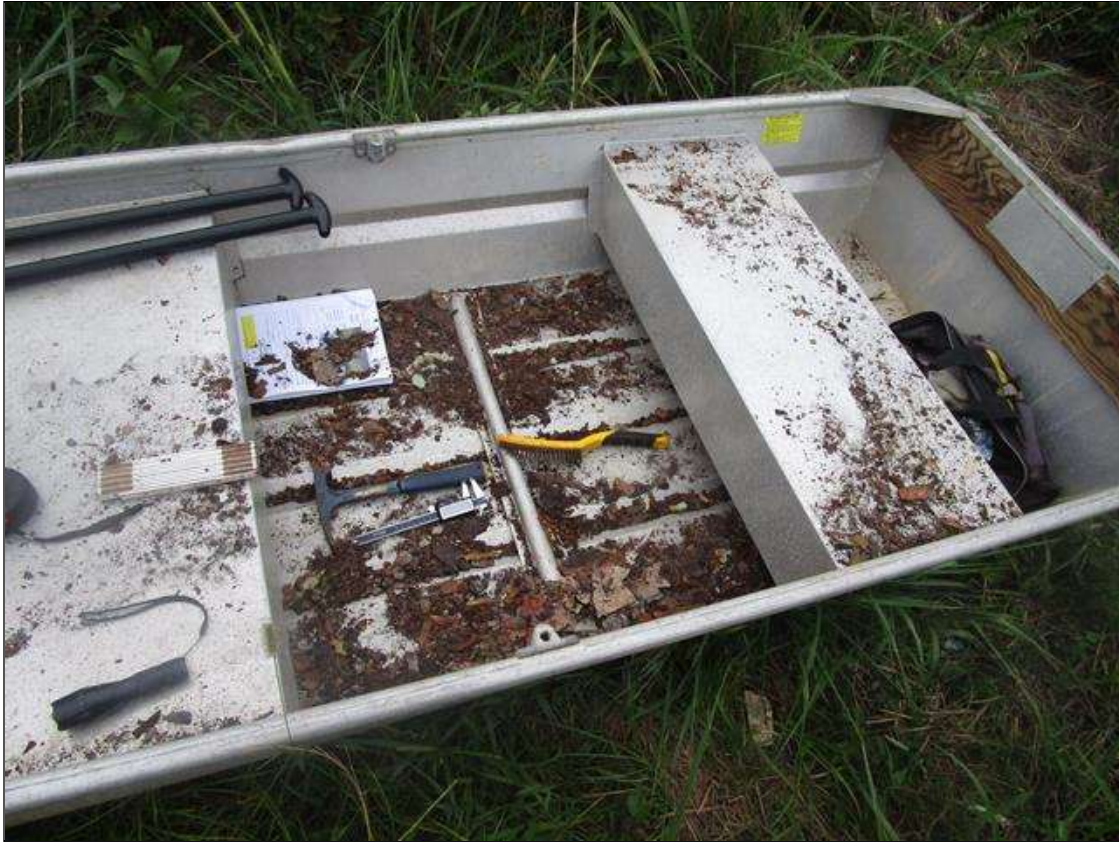
INSPECTION BOAT WITH CORRODED STEEL REMOVED FROM BEAMS

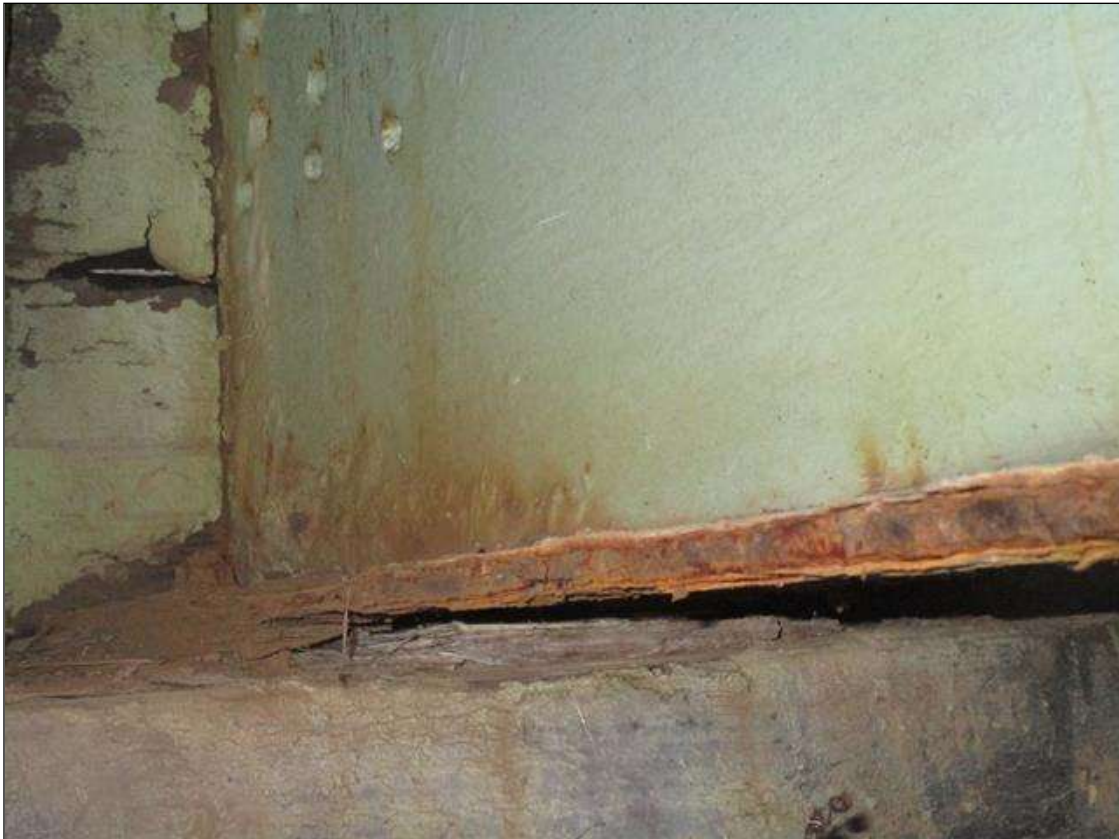
Span 5 Beam 4: SPAN 6, AT END BENT 2, 2FT AREA OF SECTION LOSS DOWN TO 3/16IN REMAINING IN BOTTOM FLANGE, PAR

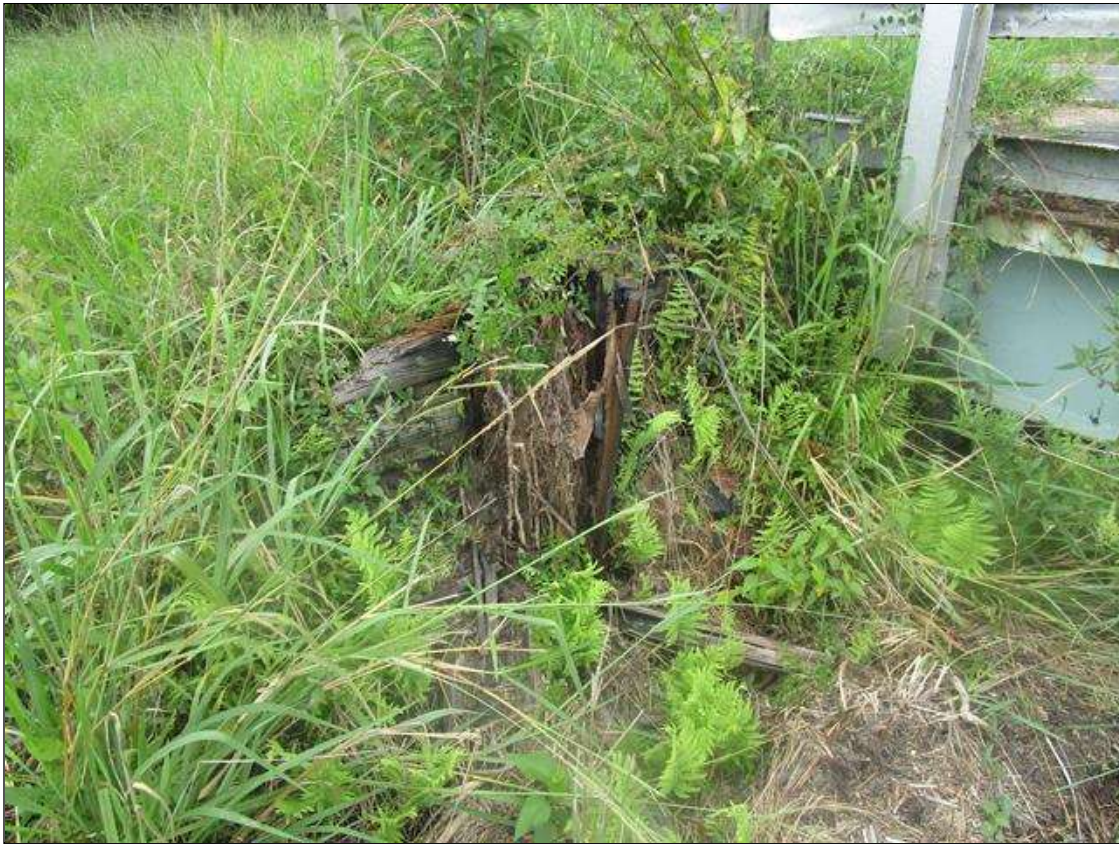
END BENT 1 RIGHT SIDE, 100% DECAY IN ABUTMENT PILE, PAR

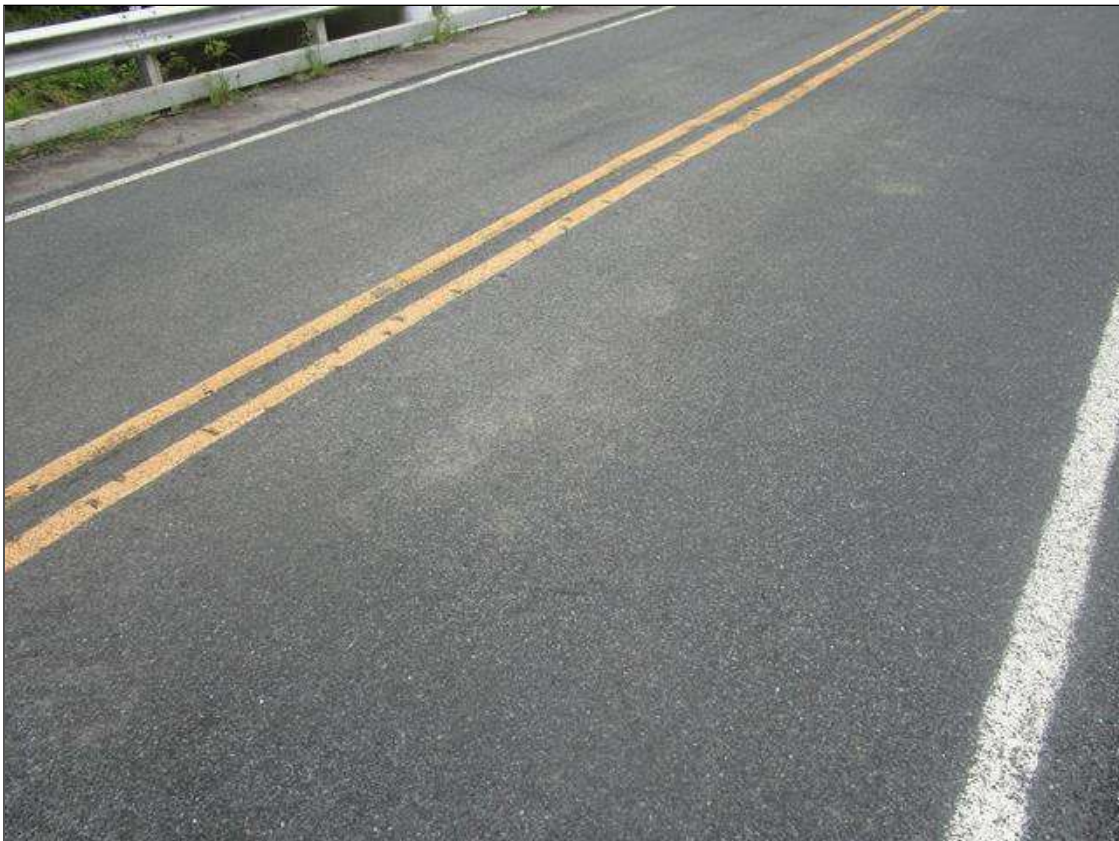
SPAN 1 WEARING SURFACE

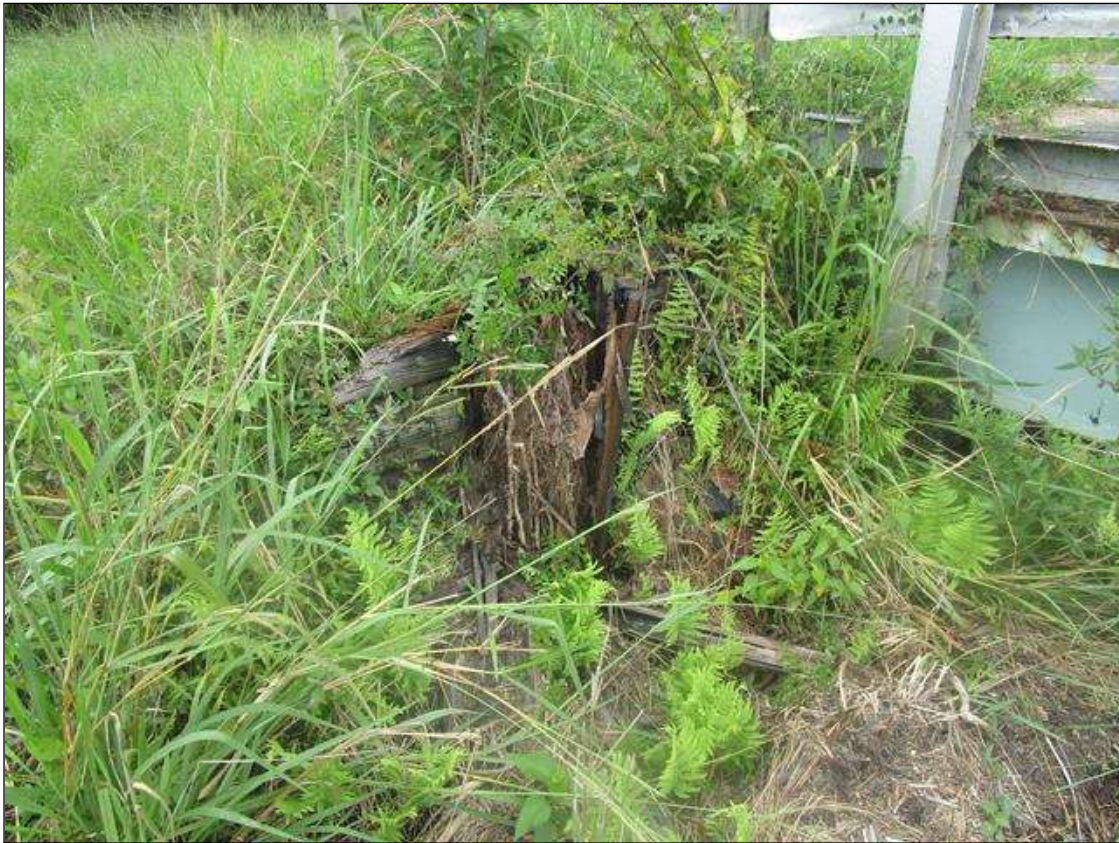
END BENT 1 ABUTMENT: END BENT 1 RIGHT SIDE, 100% DECAY IN ABUTMENT PILE, PAR
