# UNDERWATER BRIDGE INSPECTION REPORT

INSPECTION TYPE 4 Year Underwater Inspection BRIDGE NO. 660028 COUNTY ONSLOW

ROUTE NC210

OVER INTRACOASTAL WATE

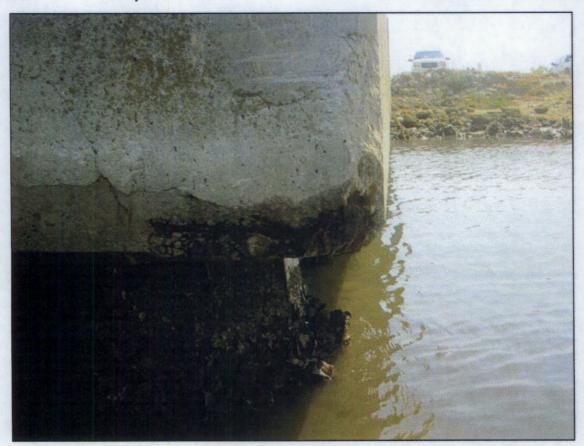
BENT 4 NORTHWEST CORNER SPALL ON FOOTING

MMS Code	Description of Function	Unit	Quantity	Remarks	Est. Cost
3348	Maintain Concrete Substructure Components	LF	1000	SPALLED FOOTINGS AND VERTICAL CRACKS AS NOTED IN CRACK SHEETS

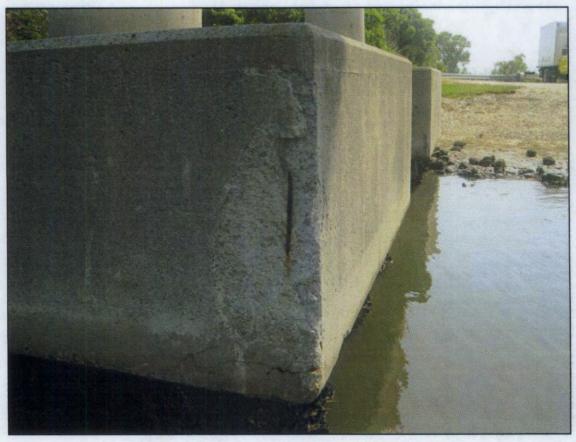
BENT 5 NORTHWEST CORNER SPALL ON FOOTING

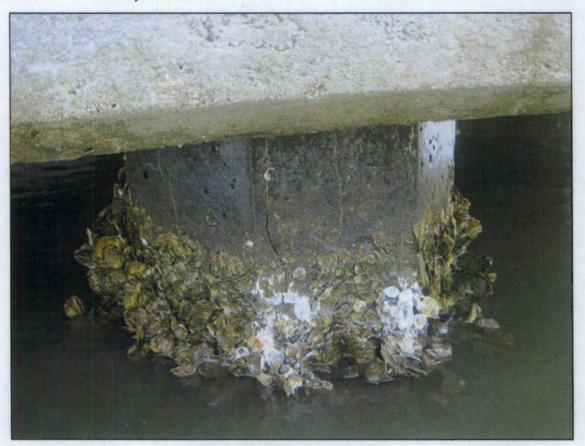
BENT 6 P-2 F-3 H/L - 1/16" CRACK

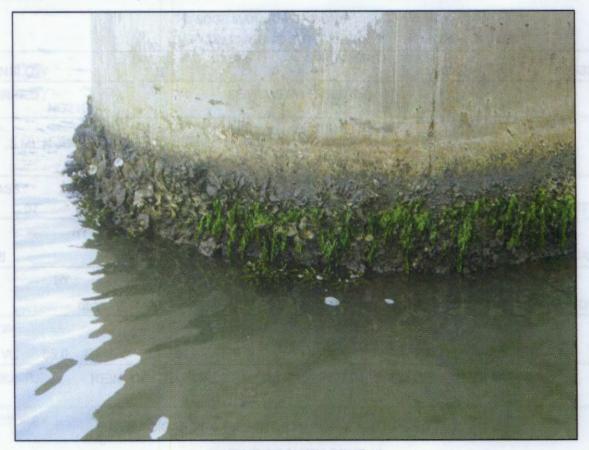
MARINE GROWTH BENT 13

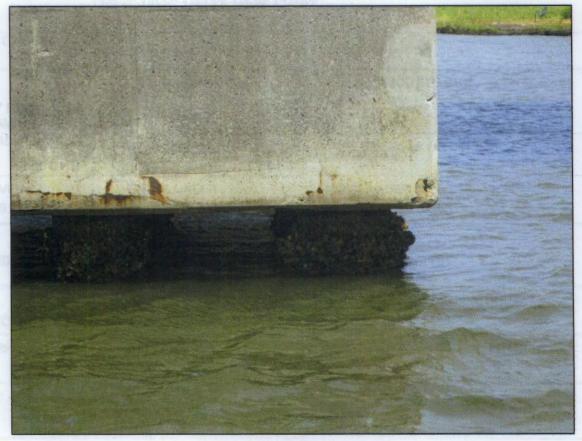
MARINE GROWTH ON PILES

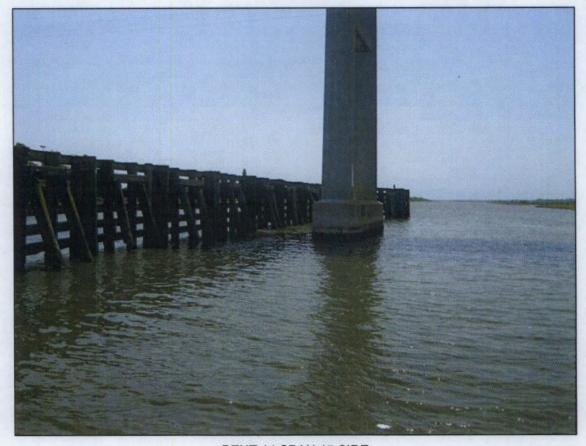
BENT 14 SPAN 15 SIDE

Itaan Na	0 1	
Item No.	Grade	
36b	F	CONCRETE COLUMNS BENTS 13 AND 14 ARE FOOTED BENTS ON SILLS WITH COLUMNS HAVING RANDOM HAIRLINE CRACKS AND SMALL SHALLOW SPALLS THROUGHOUT.
36e	F	FOOTINGS AND SILLS RANDOM CRACKS TO 1/16" EXTEND OUT AND UP THE SIDES. THE FOOTINGS HAVE HONEYCOMB AREAS ON CORNERS AND ON THE UNDERSIDE. AREAS OF COARSE AGGREGATE EXPOSED WITH HAIRLINE TO 1/16" CRACKS.
		BENT 13
		WEST FACE CRACKS TO 1/16" X FULL HEIGHT. LOCATED 12.8' AND 4.3' FROM THE EAST END. EAST FACE
		CRACKS TO 1/16" X FULL HEIGHT. LOCATED 12.5' AND 20.3' FROM THE EAST END.
		BENT 14 WEST FACE
		SPALL 16" X 2" X 1.5" PENETRATION. LOCATED 7.3' FROM THE SOUTH END. SPALL 4 X 3" X 1.5" PENETRATION. LOCATED 12' FROM THE SOUTH END. SPALL 14" X 16" X 1 PENETRATION. LOCATED 13.5' FROM THE NORTH END. EAST FACE
		AREA OF CONCRETE LAITANCE 18" X 1" PENETRATION AT THE TOP OF THE FOOTING NORTHWEST CORNER.
		NORTH FACE 2 SPALLS 3" X 1.5" X 1" PENETRATION AT THE NORTHWEST CORNER.

BOTH FOOTINGS HAVE RANDOM VOIDS AT JUNCTION OF FOOTING AND SILLS DUE TO CONCRETE CRUMBLING AWAY. 8" HIGH MAX. X 2' PROBE MAX.  BENTS 13 AND 14 SILLS HAVE NUMEROUS CRACKS RANGING FROM 1" TO 7" WIDE WITH PROBES FROM 1" TO 8". SILLS ALSO HAVE AREAS OF CONCRETE LAITANCE AND SPALLS.  FOOTINGS AT BENT 13 AND 14 HAVE SEVERAL CRACKS AND SPALLS.
38	F	CONCRETE FOUNDATION PILES  NUMEROUS PILES HAVE HAIRLINE TO 1/32" CRACKS WITH EFFLO.  IN THE TIDAL ZONE. RANDOM PILES CRACKED TO 1/8".  REFER TO CRACK SHEETS.
41	G	DRIFT NO PROBLEMS NOTED
45a	G	WATERWAY NO PROBLEMS NOTED.
45b	G	CHANNEL ALIGNMENT NO PROBLEMS NOTED.

BI	COUR SENT 13										
rade Si Bi											
F SO BI											
BI											
BI N 3	NW- 0.0' SW- 1.5' NE- 2.2' SE- 3.8' SENT 14 NW- 5.4' SW- 1.2' NE- 5.0' SE- 0.0' IORTHWES	E PILES	EXPOSI	ED FOR						ONG ACRO	oss
	N 3 N E	BENT 14 NW- 5.4' SW- 1.2' NE- 5.0' SE- 0.0' NORTHWES 3 CONCRET NORTH SIDE	BENT 14 NW- 5.4' SW- 1.2' NE- 5.0' SE- 0.0' NORTHWEST CORN 3 CONCRETE PILES NORTH SIDE X 9' LO	BENT 14 NW- 5.4' SW- 1.2' NE- 5.0' SE- 0.0' NORTHWEST CORNER BEN 3 CONCRETE PILES EXPOS NORTH SIDE X 9' LONG ACF	BENT 14 NW- 5.4' SW- 1.2' NE- 5.0' SE- 0.0' NORTHWEST CORNER BENT 14 3 CONCRETE PILES EXPOSED FOR NORTH SIDE X 9' LONG ACROSS WI	BENT 14 NW- 5.4' SW- 1.2' NE- 5.0' SE- 0.0' NORTHWEST CORNER BENT 14 3 CONCRETE PILES EXPOSED FOR 2.5'. SCO NORTH SIDE X 9' LONG ACROSS WEST SIDE.	BENT 14 NW- 5.4' SW- 1.2' NE- 5.0' SE- 0.0' NORTHWEST CORNER BENT 14 3 CONCRETE PILES EXPOSED FOR 2.5'. SCOUR 5.4' NORTH SIDE X 9' LONG ACROSS WEST SIDE. (SEE SEED)	BENT 14 NW- 5.4' SW- 1.2' NE- 5.0' SE- 0.0' NORTHWEST CORNER BENT 14 3 CONCRETE PILES EXPOSED FOR 2.5'. SCOUR 5.4' VER' NORTH SIDE X 9' LONG ACROSS WEST SIDE.(SEE SCOUR	BENT 14 NW- 5.4' SW- 1.2' NE- 5.0' SE- 0.0' NORTHWEST CORNER BENT 14 3 CONCRETE PILES EXPOSED FOR 2.5'. SCOUR 5.4' VERTICAL NORTH SIDE X 9' LONG ACROSS WEST SIDE.(SEE SCOUR PRO FIELD SCOUR EVALUATION	BENT 14 NW- 5.4' SW- 1.2' NE- 5.0' SE- 0.0' NORTHWEST CORNER BENT 14 3 CONCRETE PILES EXPOSED FOR 2.5'. SCOUR 5.4' VERTICAL X 9' LO NORTH SIDE X 9' LONG ACROSS WEST SIDE.(SEE SCOUR PROFILE) FIELD SCOUR EVALUATION	BENT 14 NW- 5.4' SW- 1.2' NE- 5.0' SE- 0.0' NORTHWEST CORNER BENT 14 3 CONCRETE PILES EXPOSED FOR 2.5'. SCOUR 5.4' VERTICAL X 9' LONG ACRO NORTH SIDE X 9' LONG ACROSS WEST SIDE.(SEE SCOUR PROFILE)
