# BRIDGE INSPECTION REPORT

INSPECTION TYPE:	Routine Inspection
COUNTY PENDER	BRIDGE NUMBER 700117 INSPECTION CYCLE 2 YRS
ROUTE SR1520	ACROSS HOLLY SHELTER CREEK M.P. 0
LOCATION 3.0MI.S.JCT.NC50	
SUPERSTRUCTURE TIMBER FLOOR/TIM	BER JOISTS
SUBSTRUCTURE E.BTS&BTS:TIMBER	CAPS/TIMBER PILES;TIM.CRUTCH BTS.
SPANS 1@9';1@8'3;2@8'8;1@8'6;1@8'	
LONGITUDE 77° 43' 49.5"	LATITUDE 34° 38' 26.0"
PRESENT CONDITION FAIR	INVENTORY RATING
INSPECTION DATE 10/22/2010	OPERATING HS-01
PRESENT POSTING Not Posted	Not Posted PROPOSED POSTING N.P.
	8-LD ANALYSIS DATE 11-15-10
POSTING LETTER DATE	SUFFICIENCY RATING
OTHER SIGNS PRESENT 4 DELINEATO	DRS.

BRIDGE NO. 700117

OVER HOLLY SHELTER CREEK

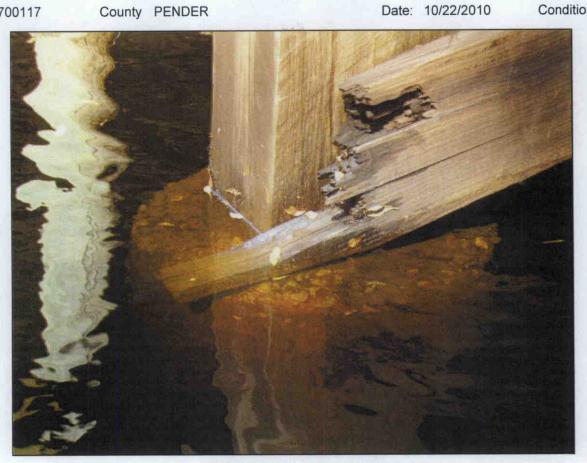
PILE 1 AT BENT 2 ENCASED IN CONCRETE

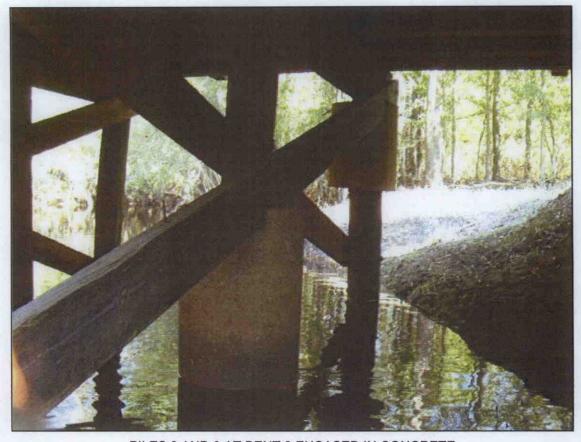
PILES 2 AND 3 AT BENT 2 ENCASED IN CONCRETE

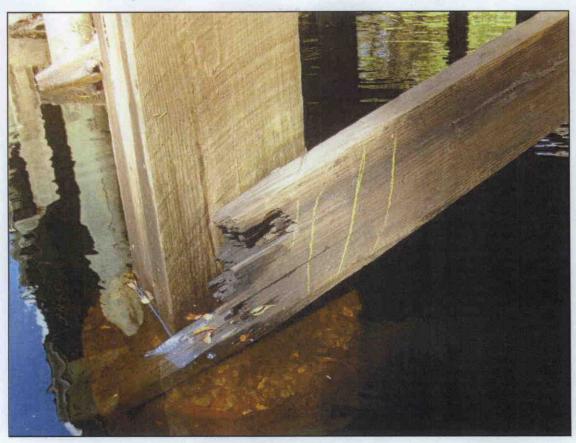
CROSSBRACE AT AT BENT 2 SPAN 2 SIDE DECAYED AT PILE 1, 2' LONG.

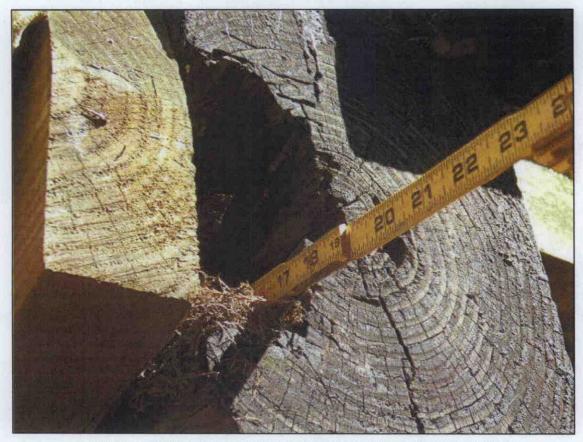
WEST END OF BENT 2 CAP DECAYED 4" WIDE X 6" HIGH X 17" LONG

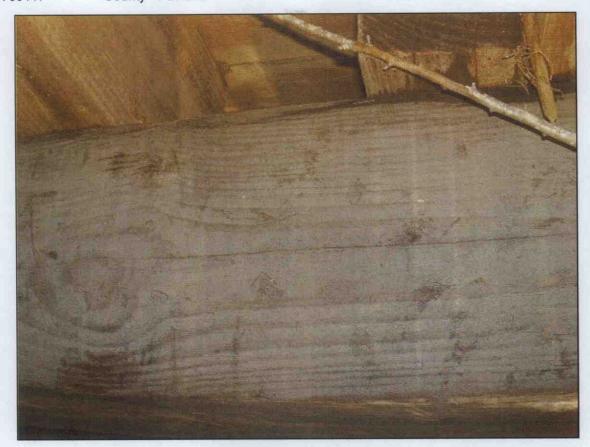
LONGITUDINAL CRACKING ALONG CAPS UP TO 1/16" WIDE

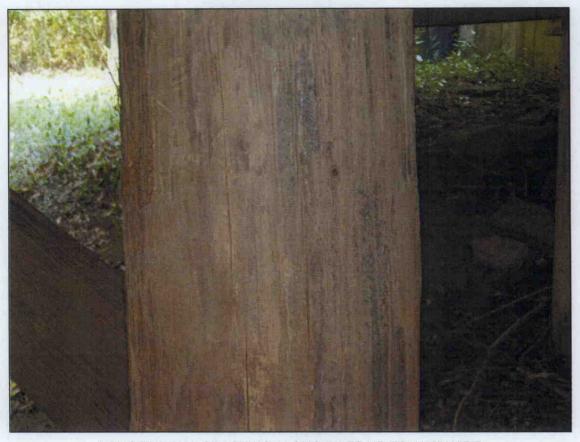
LONGITUDINAL CRACKING ALONG PILES UP TO 1/16" WIDE

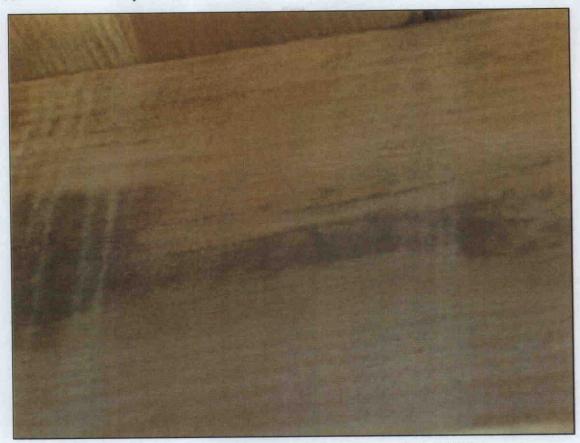
LONGITUDINAL CRACKING ALONG JOIST UP TO 1/16" WIDE

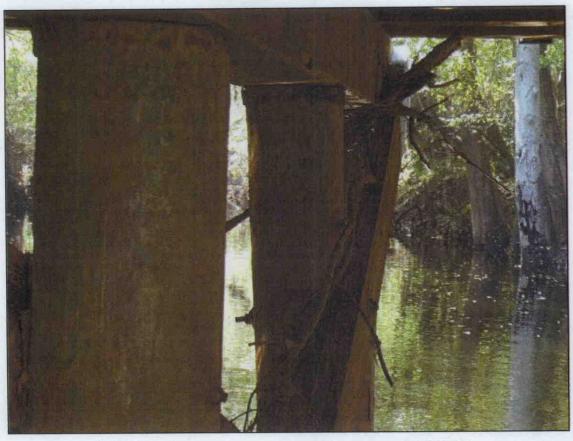
SMALL DRIFT COLLECTING AT BENT 3 SPAN 4 SIDE 3" DIA.

MMS Code	Description of Function	Unit	Quantity	Remarks	Est. Cost
3366	Drift and Debris Removal	HR	30	SMALL DRIFT COLLECTING AT BENT 3 SPAN 4 SIDE 3" DIA. DRIFT COLLECTING AT PILES 1 AND 2 OF BENT 4 UP TO 5" DIA. DRIFT COLLECTING AT BENT 6 UP TO 5" DIA.

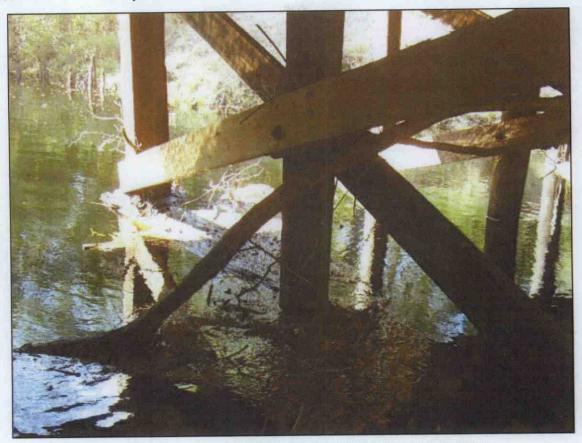
DRIFT COLLECTING AT PILES 1 AND 2 OF BENT 4 UP TO 5" DIA.

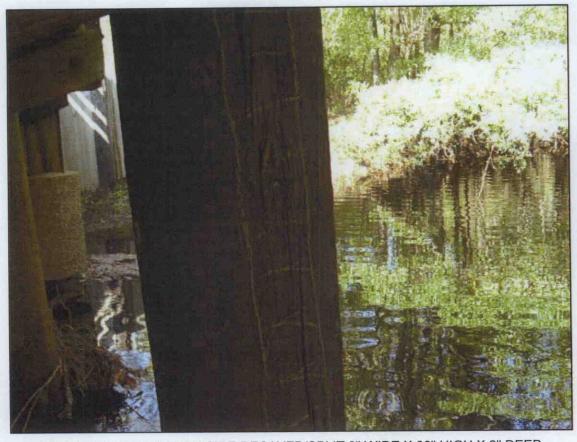
PILE 3 AT BENT 4 SOUTH SIDE DECAYED/SPLIT 3" WIDE X 30" HIGH X 2" DEEP

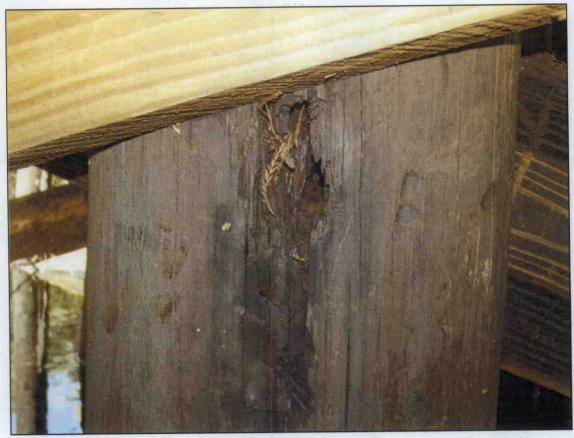
PILE 2 AT BENT 4 DECAYED AT BOLT HOLE 1" WIDE X 4" HIGH X 10" DEEP

MMS Code	Description of Function	Unit	Quantity	Remarks	Est. Cost
2816	Asphalt Surface Repair or Replacement	SY	3	SOUTH APPROACH ASPHALT WEARING SURFACE CRACKED AND SETTLED 1". SETTLED AREA AT CENTERLINE OF SOUTH APPROACH 2' WIDE X 16" LONG X 3" DEEP. NORTH APPROACH ASPHALT WEARING SURFACE SETTLED UP TO 2".	
3304	Maintain/Replace Timber Superstructure Components	LF	2	JOIST 1 IN SPAN 1 OVER BENT 1 3/16" GAP BETWEEN JOIST AND CAP, JOIST 2 SIMILAR.	
3344	Repair / Replace Timber Substructure Components	LF	20	WEST END OF BENT 2 CAP DECAYED 4" WIDE X 6" HIGH X 17" LONG. EAST END OF BENT 2 CAP DECAYED AREAS UP TO 14" LONG X 3" DIA.	
3344	Repair / Replace Timber Substructure Components	LF	75	CROSSBRACE AT AT BENT 2 SPAN 2 SIDE DECAYED AT PILE 1, 2' LONG. CROSSBRACE AT AT BENT 2 SPAN 2 SIDE DECAYED AT PILE 1, 2' LONG.	
				PILE 3 AT BENT 4 SOUTH SIDE DECAYED/SPLIT 3" WIDE X 30" HIGH X 2" DEEP PILE 2 AT BENT 4 DECAYED AT BOLT HOLE 1" WIDE X 4" HIGH X 10" DEEP CROSSBRACE AT BENT 4 SPAN 5 SIDE DECAYED 2' LONG

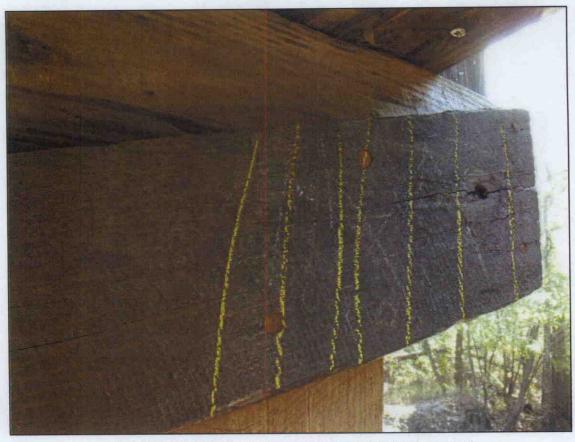
CROSSBRACE AT BENT 4 SPAN 5 SIDE DECAYED 2' LONG

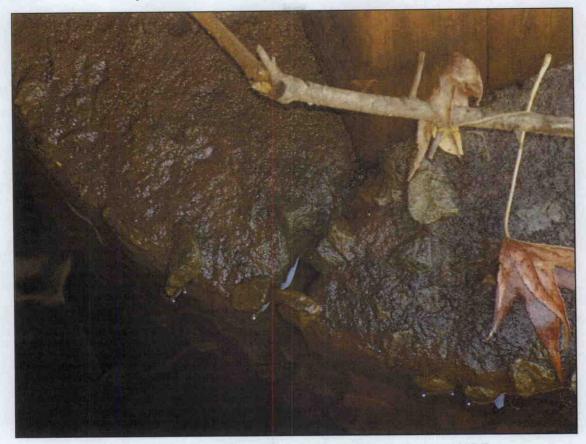
PILE 1 ENCASEMENT AT BENT 4 CRACKED UP TO 1/2" WIDE

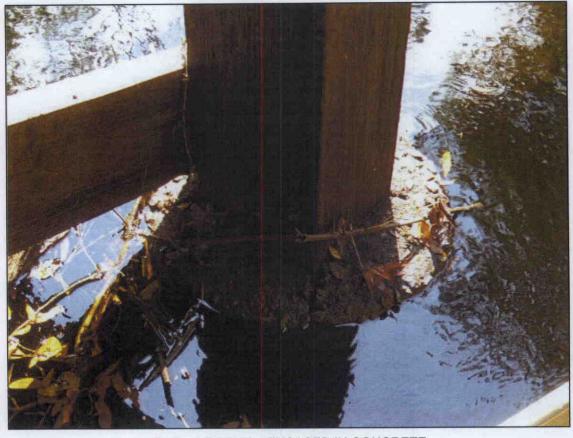
PILE 1 AT BENT 4 ENCASED IN CONCRETE

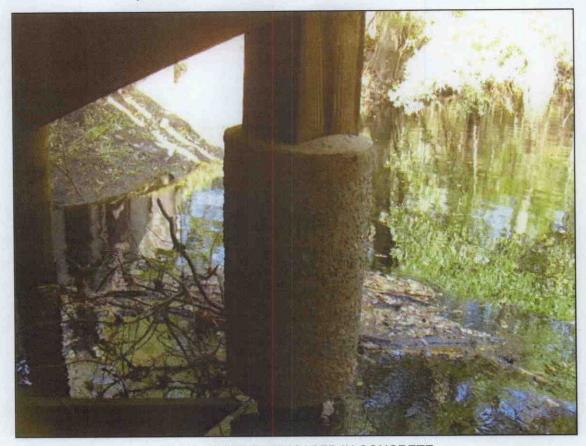
PILE 3 AT BENT 6 ENCASED IN CONCRETE

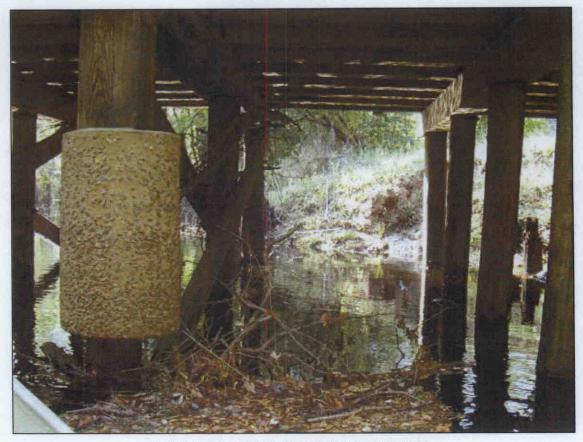
DRIFT COLLECTING AT BENT 6 UP TO 5" DIA.

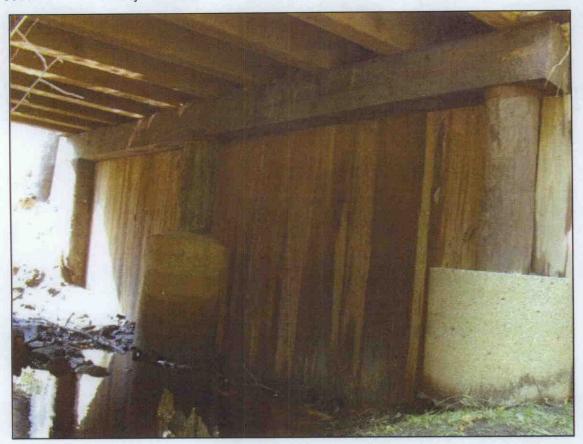
SHEET PILE BOARDS AT BULKHEAD AND WINGWALLS

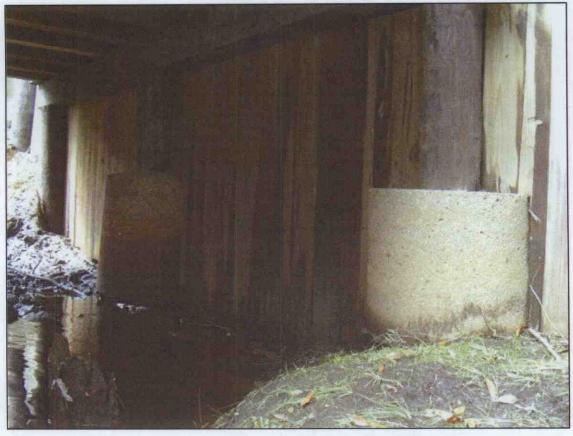
PILES 2 AND 3 AT END BENT 2 ENCASED IN CONCRETE

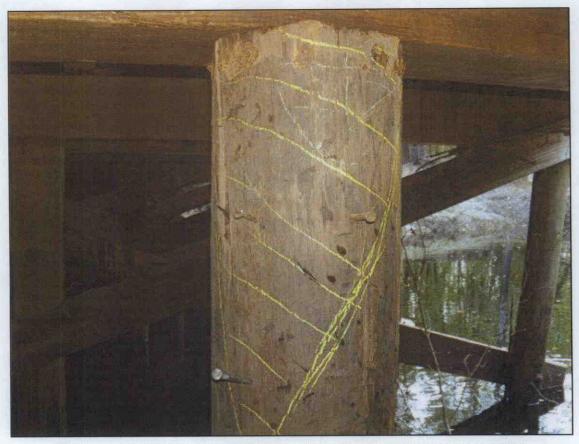
PILE 2 AT BENT 6 NORTH SIDE DECAYED 10" WIDE X 20" HIGH X 3" DEEP

PILE 2 AT BENT 6 NORTH SIDE DECAYED 10" WIDE X 20" HIGH X 3" DEEP	
3346	Repair / Maintain Timber Wings & Blkhds	SF	25	NORTHEAST TURNPILE AND WING PILE HOLLOW SOUTHWEST WINGPILE DECAYED AND HOLLOW. SIGNS OF BULKHEAD LEAKAGE ALONG TOP OF END BENT CAPS.

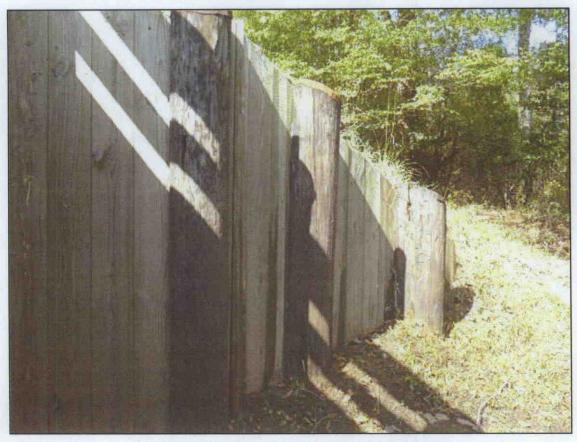
NORTHEAST TURNPILE AND WING PILE HOLLOW

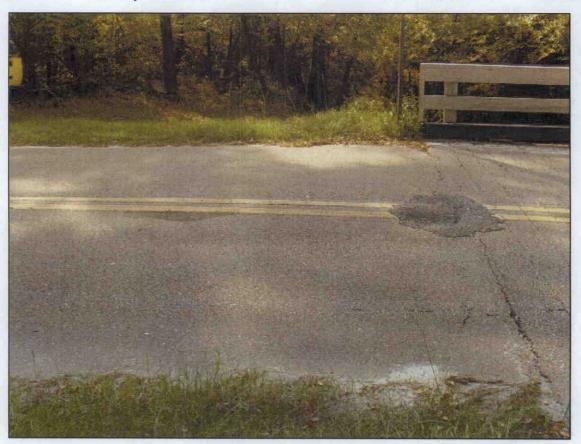
SOUTH APPROACH ASPHALT WEARING SURFACE CRACKED AND SETTLED 1"

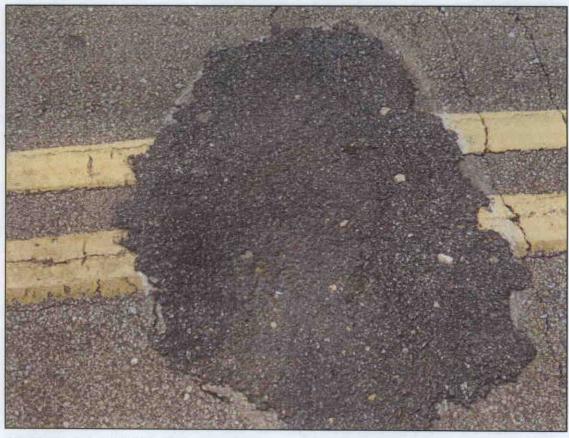
SETTLED AREA AT CENTERLINE OF SOUTH APPROACH 2' WIDE X 16" LONG X 3" DEEP

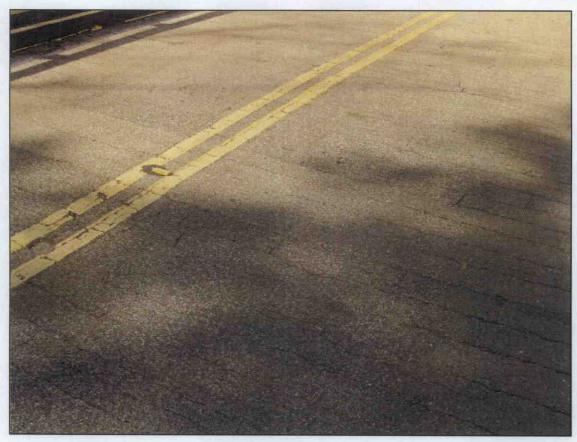
LONGITUDINAL CRACKING/TRANSVERSE CRACKING IN ASPHALT WEARING SURFACE IN ALL SPANS

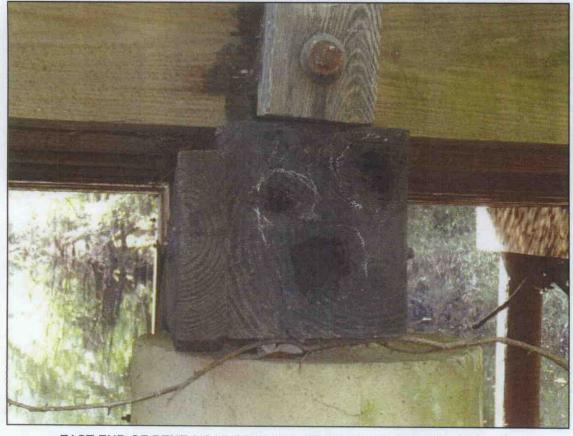
EAST END OF BENT 2 CAP DECAYED AREAS UP TO 14" LONG X 3" DIA.

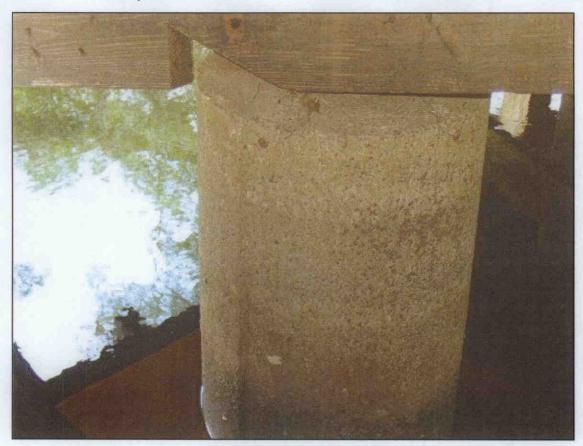
PILE 2 AT BENT 2 ENCASEMENT CRACKED

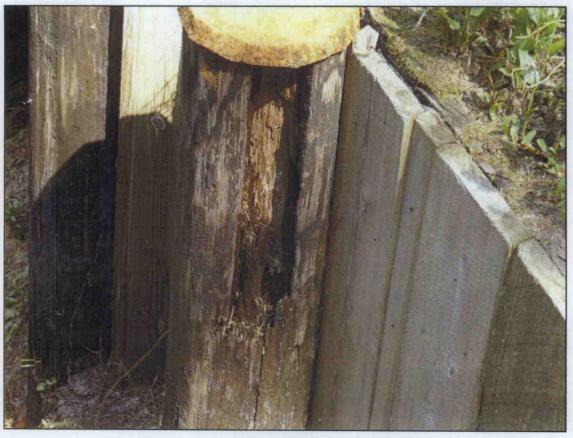
SOUTHWEST WINGPILE DECAYED AND HOLLOW

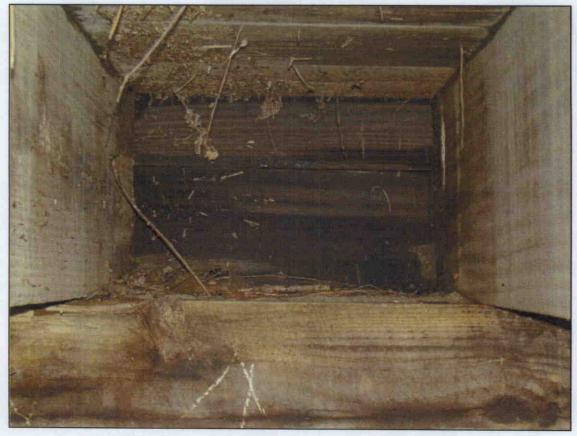
SIGNS OF BULKHEAD LEAKAGE ALONG TOP OF END BENT CAPS

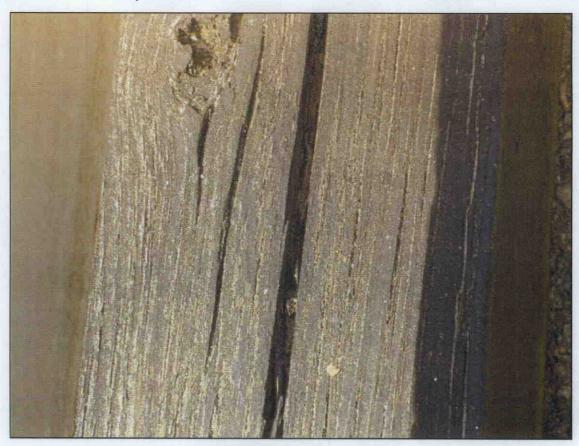
LONGITUDINAL CRACKING IN WHEEL GUARDS UP TO 1/4" WIDE

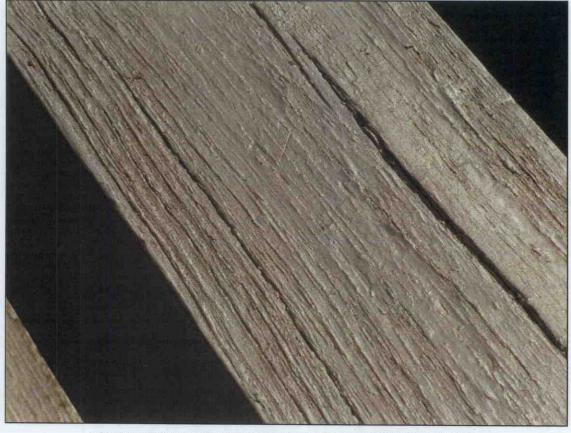
LONGITUDINAL CRACKING IN RAIL BOARDS UP TO 1/8" WIDE

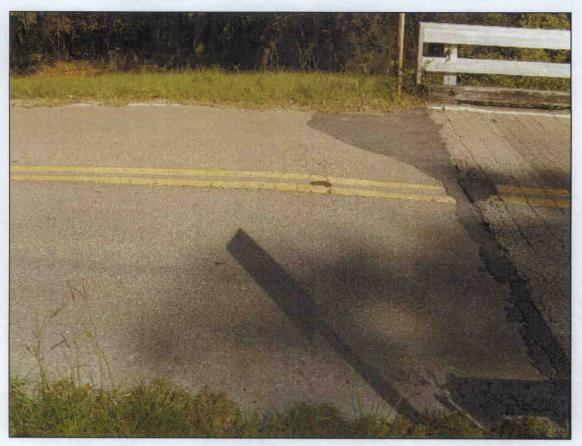
NORTH APPROACH ASPHALT WEARING SURFACE SETTLED UP TO 2"

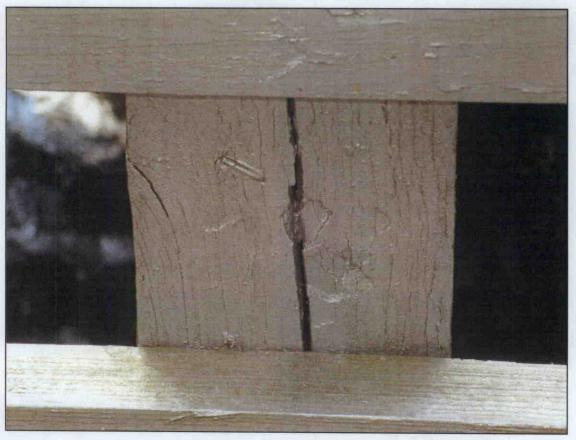
LONGITUDINAL CRACKING ALONG RAIL POST'S UP TO 3/16" WIDE
