NC DEPARTMENT OF TRANSPORTATION
DIVISION OF HIGHWAYS
STRUCTURE MANAGEMENT UNIT

ATTENTION: **PRIORITY MAINTENANCE ISSUED**

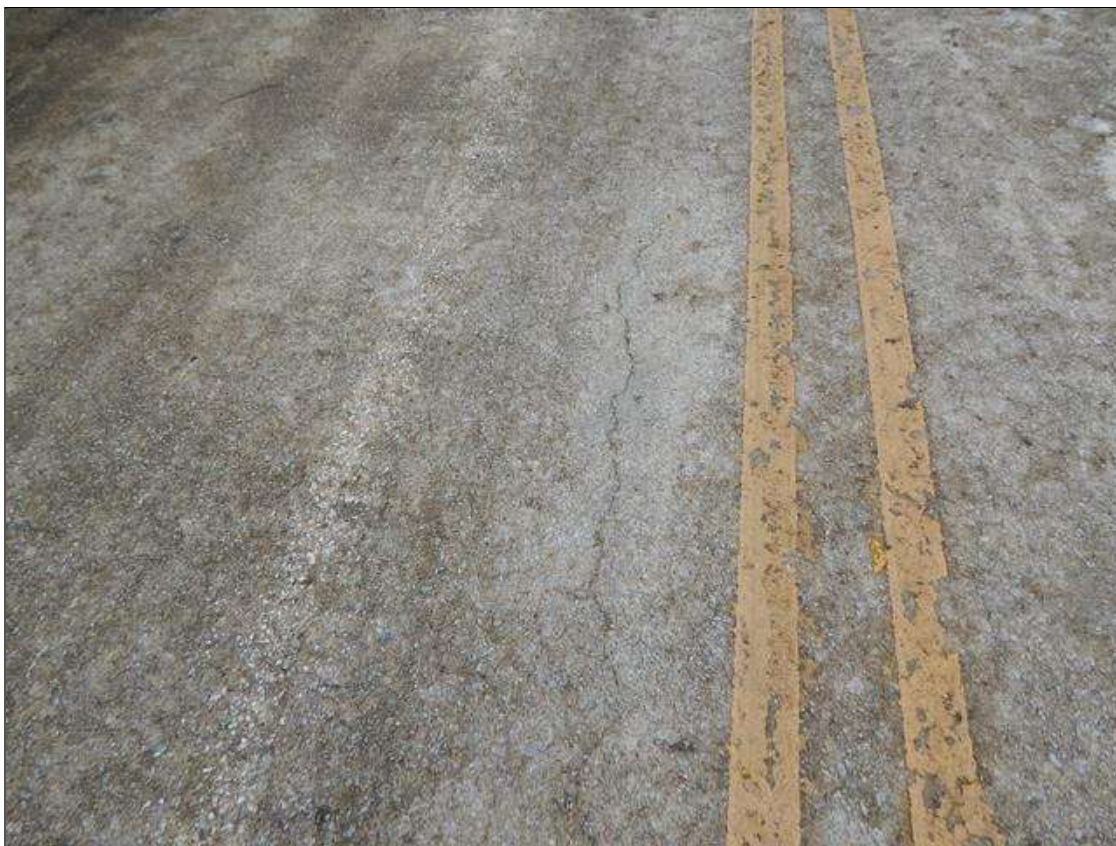
LONGITUDINAL CRACK IN TOP OF DECK OVER SPAN 2

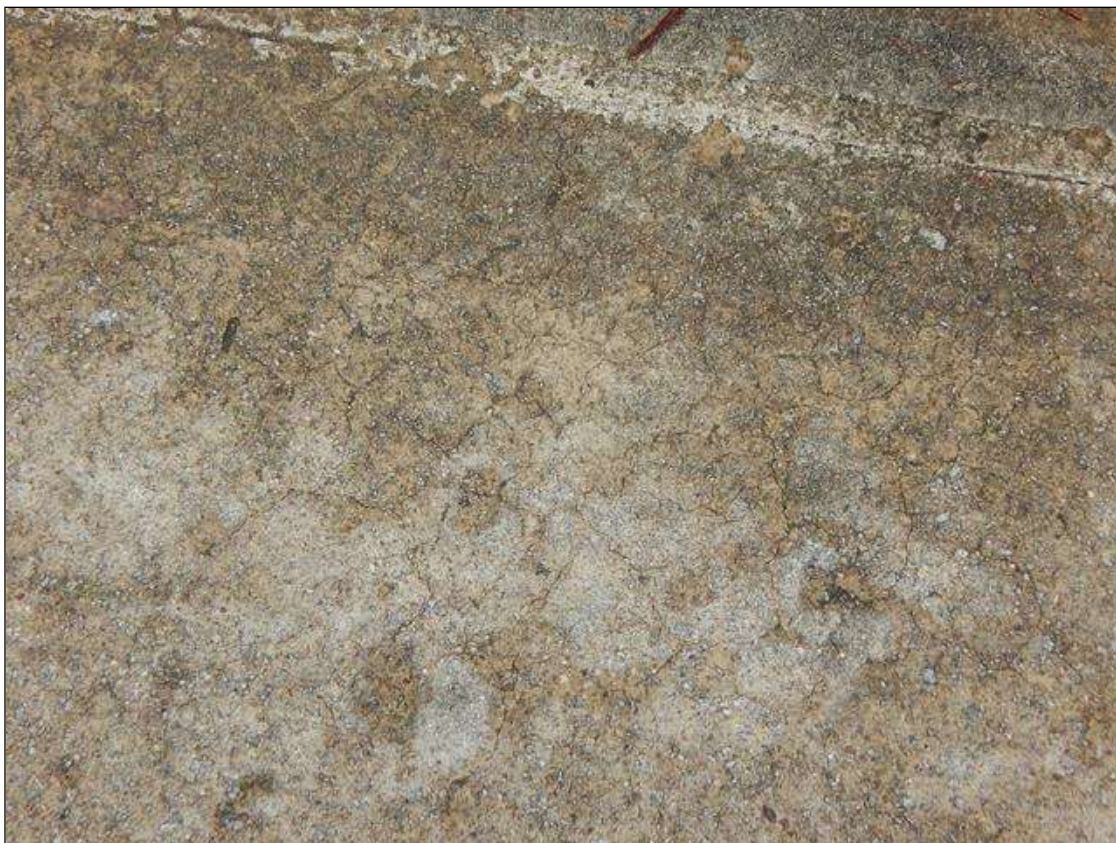
MAP CRACKING IN TOP OF DECK SPAN 2 (SIMILAR IN TOP OF DECK SPAN 1)

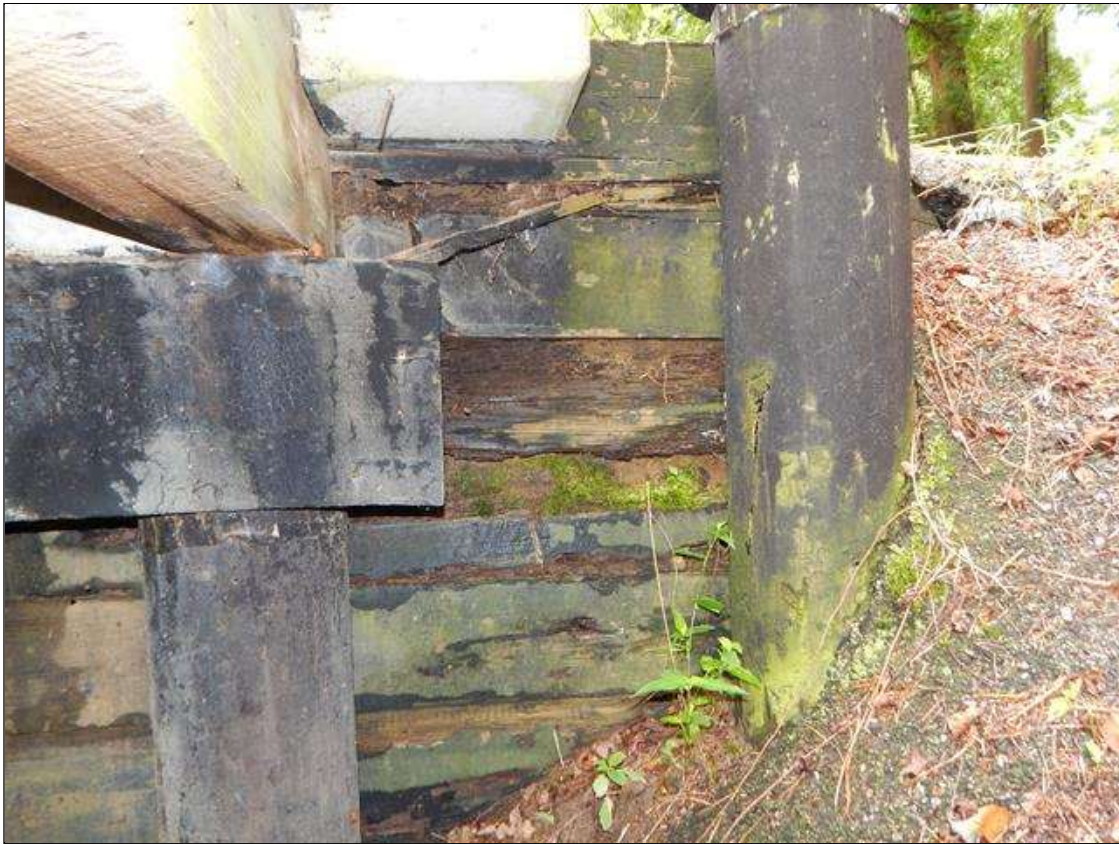
DECAY ON THE LEFT END BACKWALL AT END BENT 1

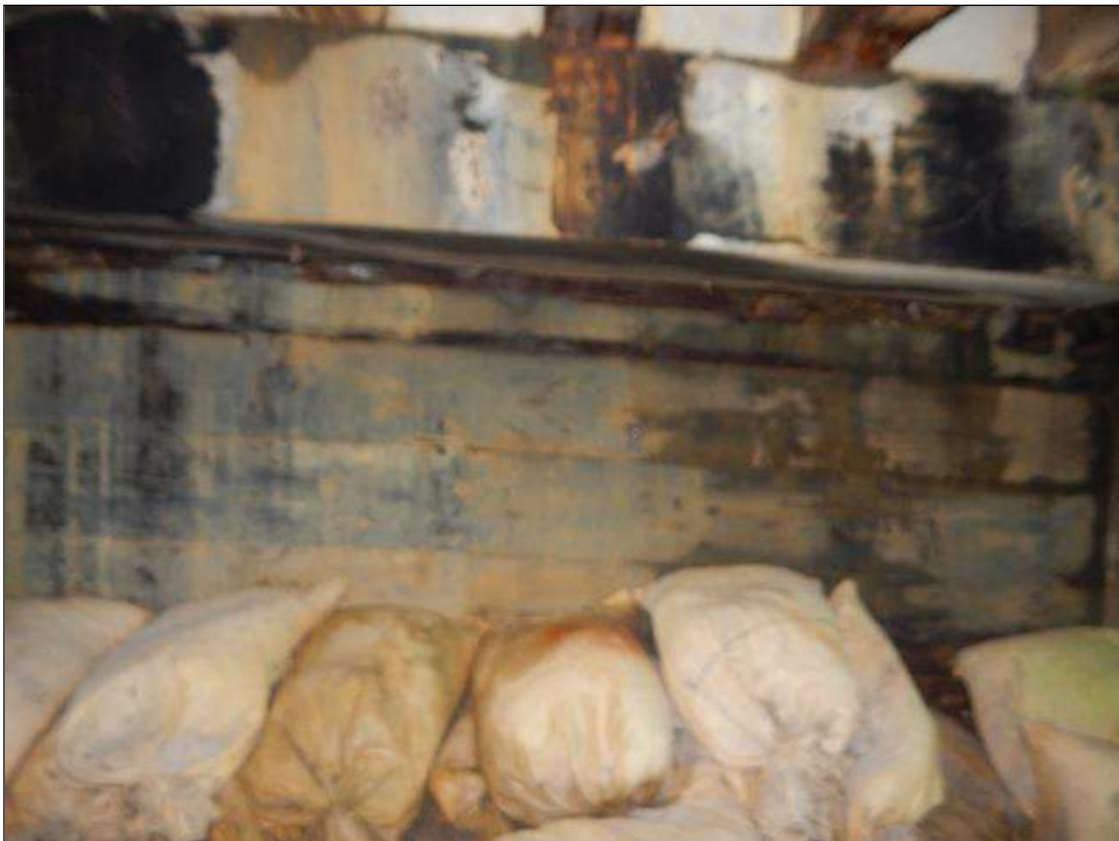
DECAY ON END BENT 1 BACKWALL BETWEEN PILE 1 AND PILE 2

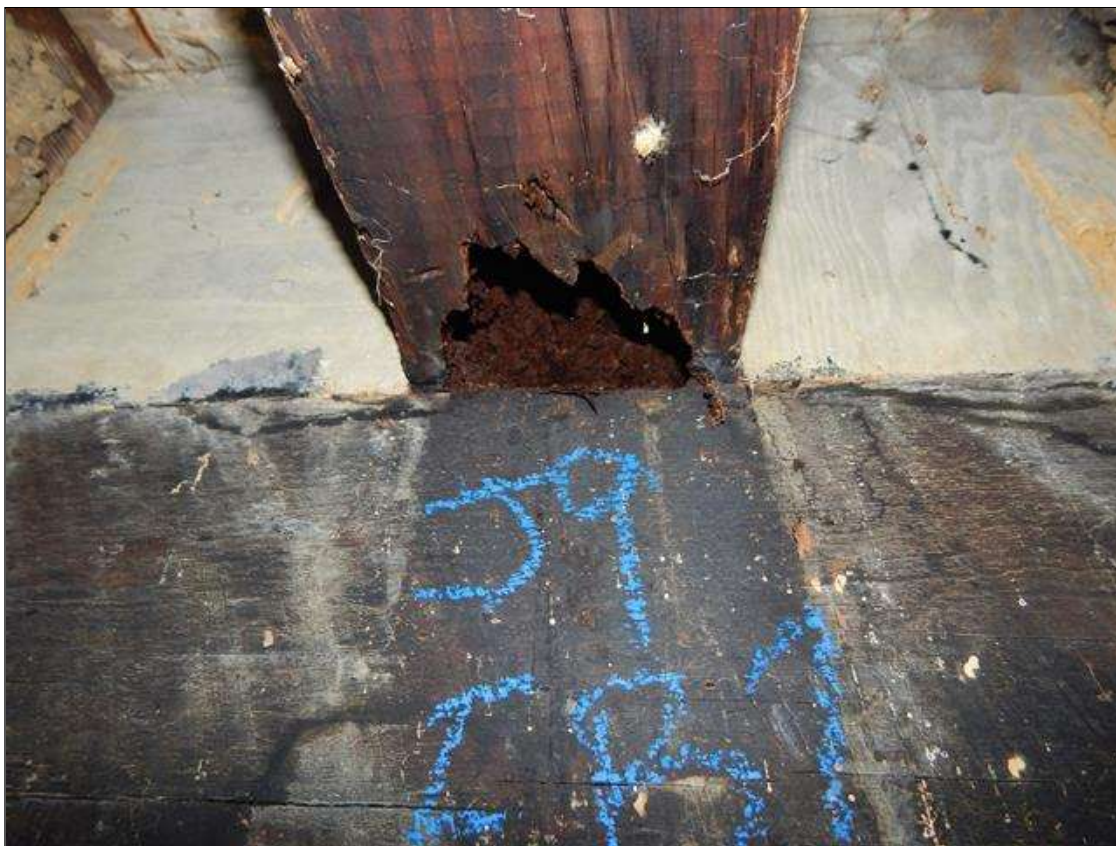
DECAY ON BEAM 9 IN SPAN 1

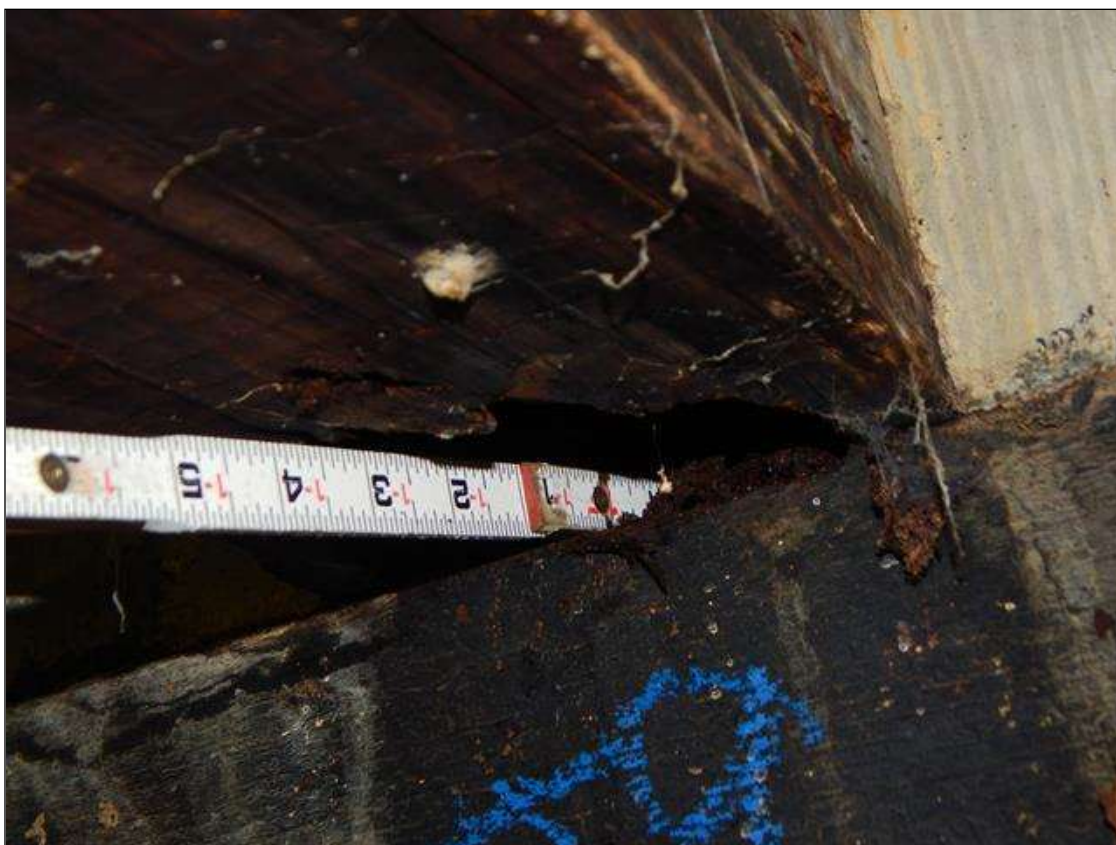
DECAY ON BEAM 9 IN SPAN 1

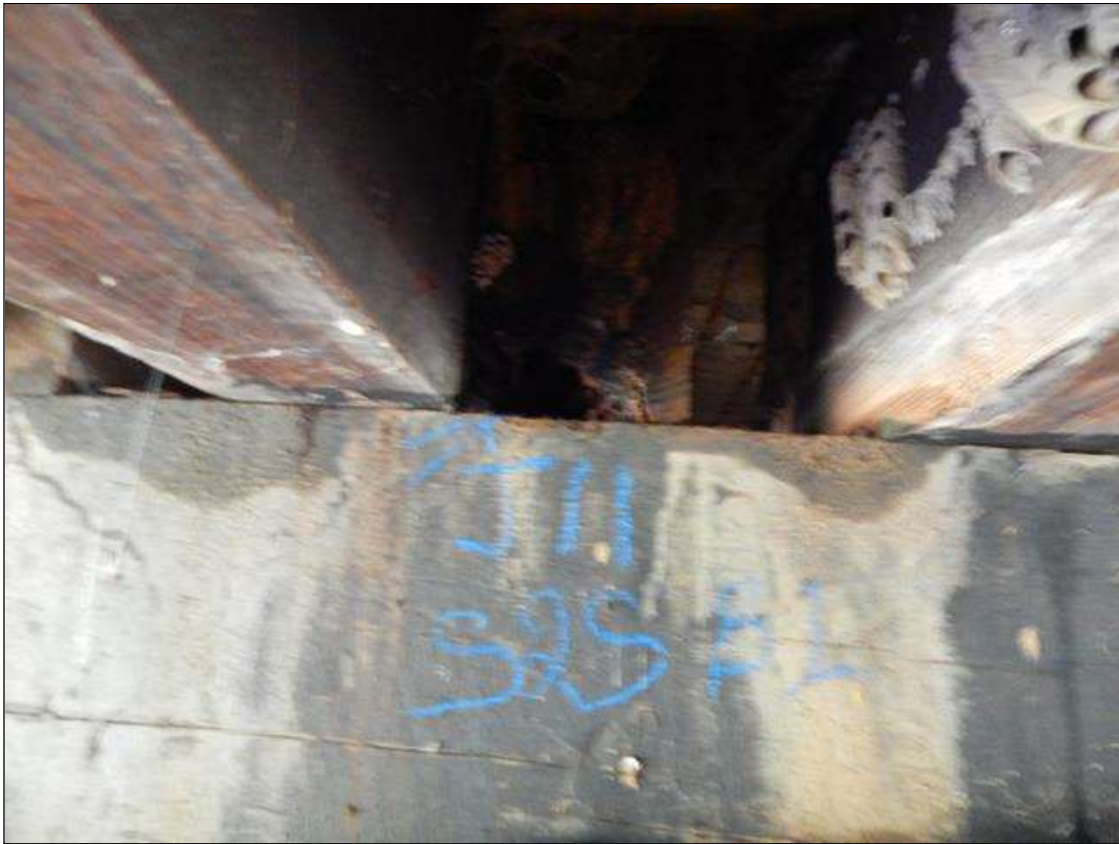
DECAY ON THE RIGHT END OF BEAM 11 IN SPAN 1

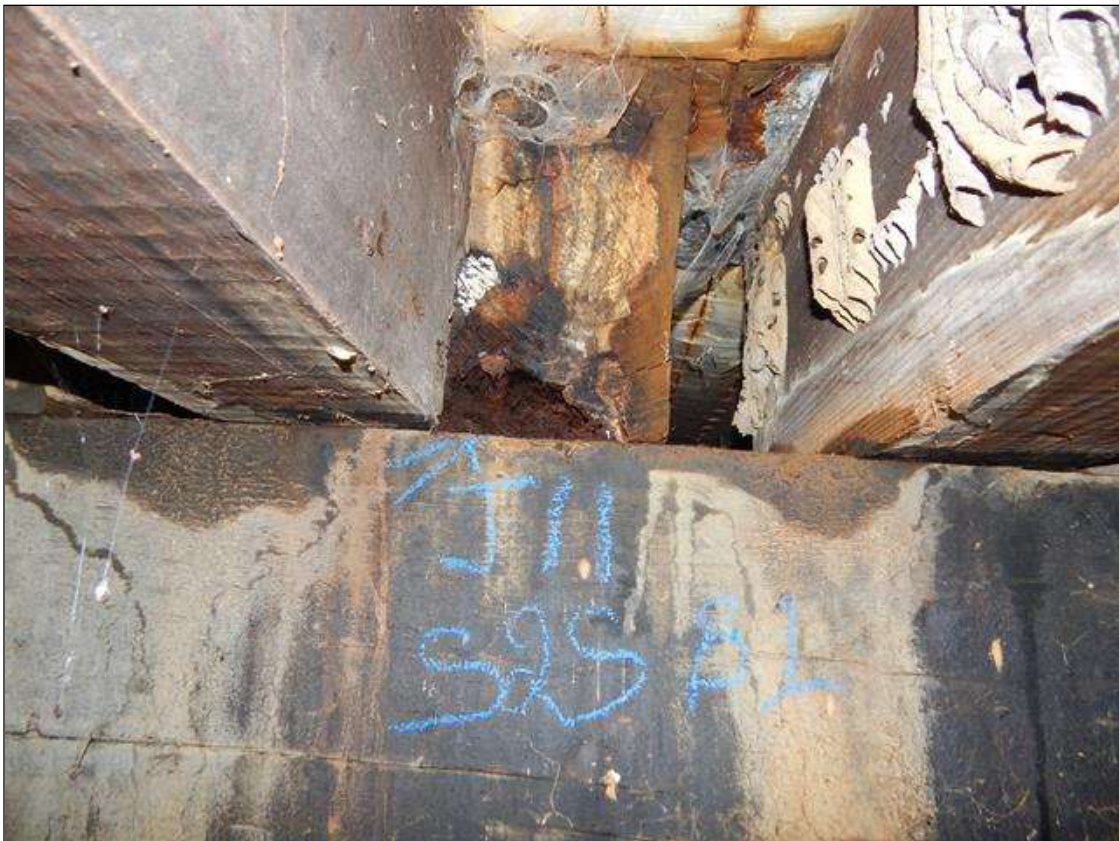
DECAY ON RIGHT END OF BEAM 11 IN SPAN 1

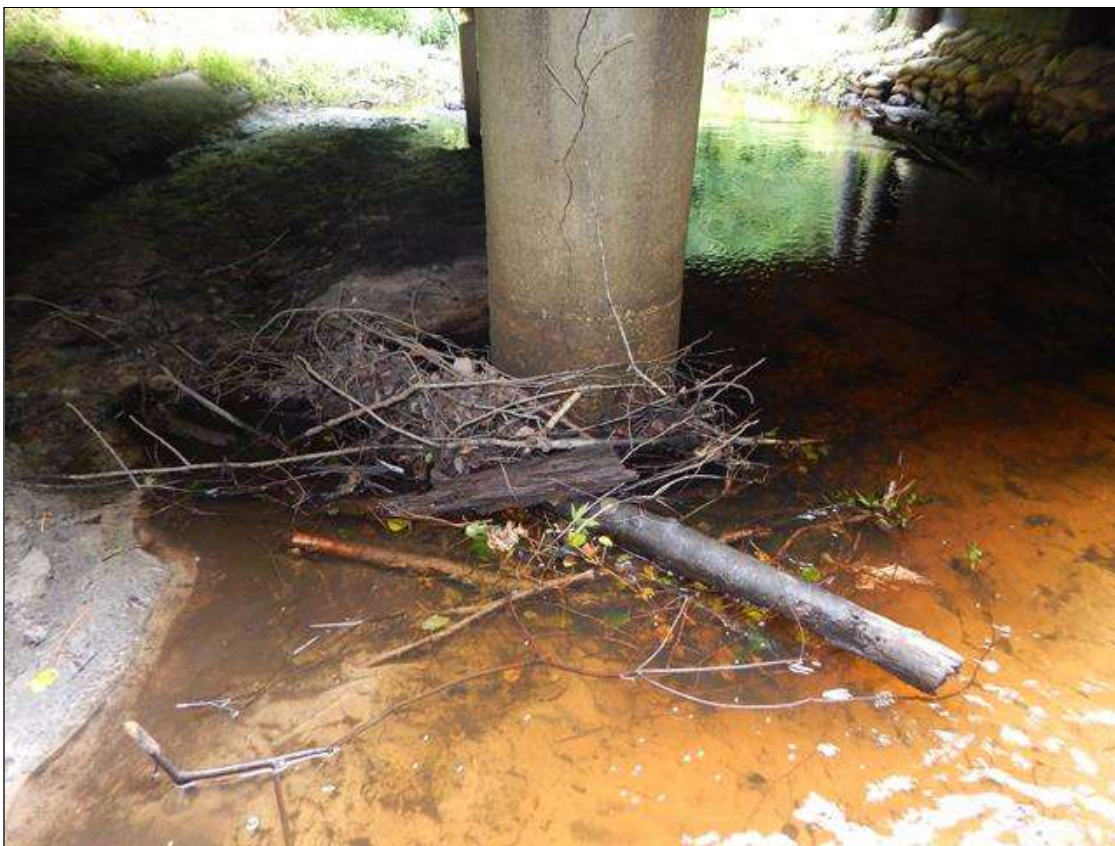
DRIFT AT PILE 1, WEST SIDE

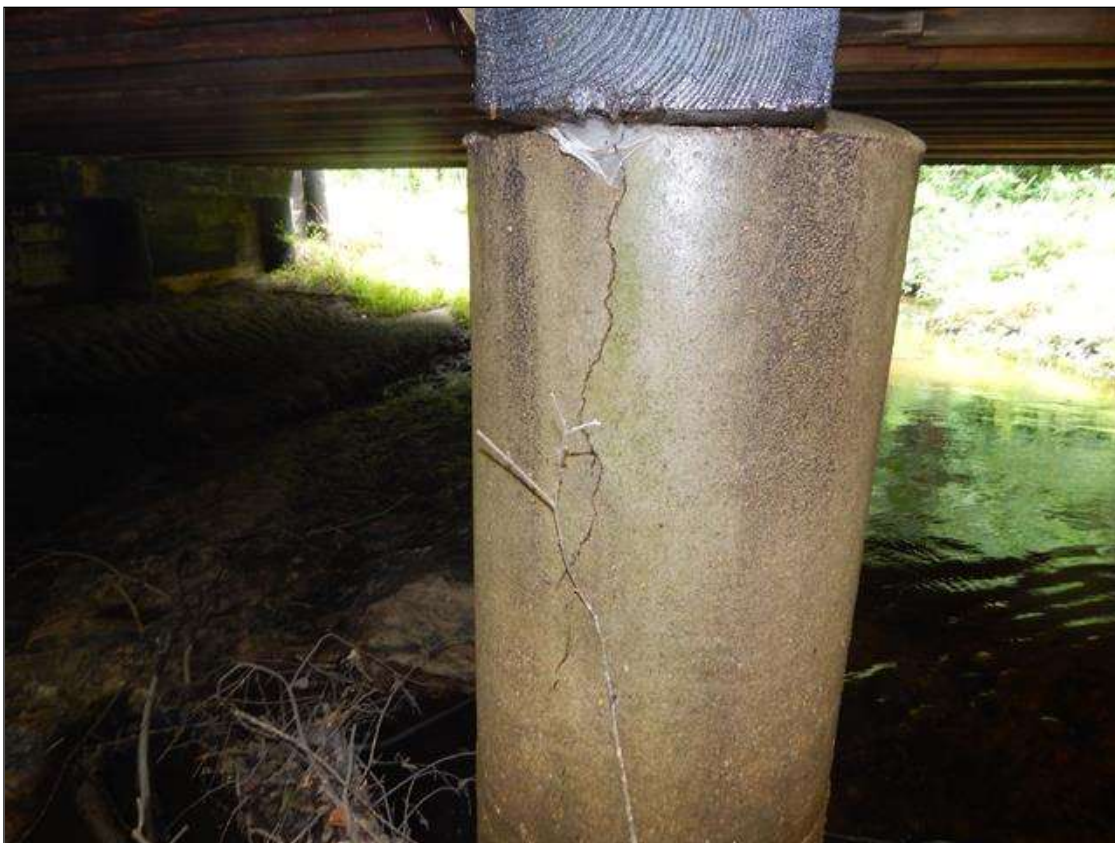
VERTICAL CRACK IN COLLAR OF PILE 1 ON BENT 1

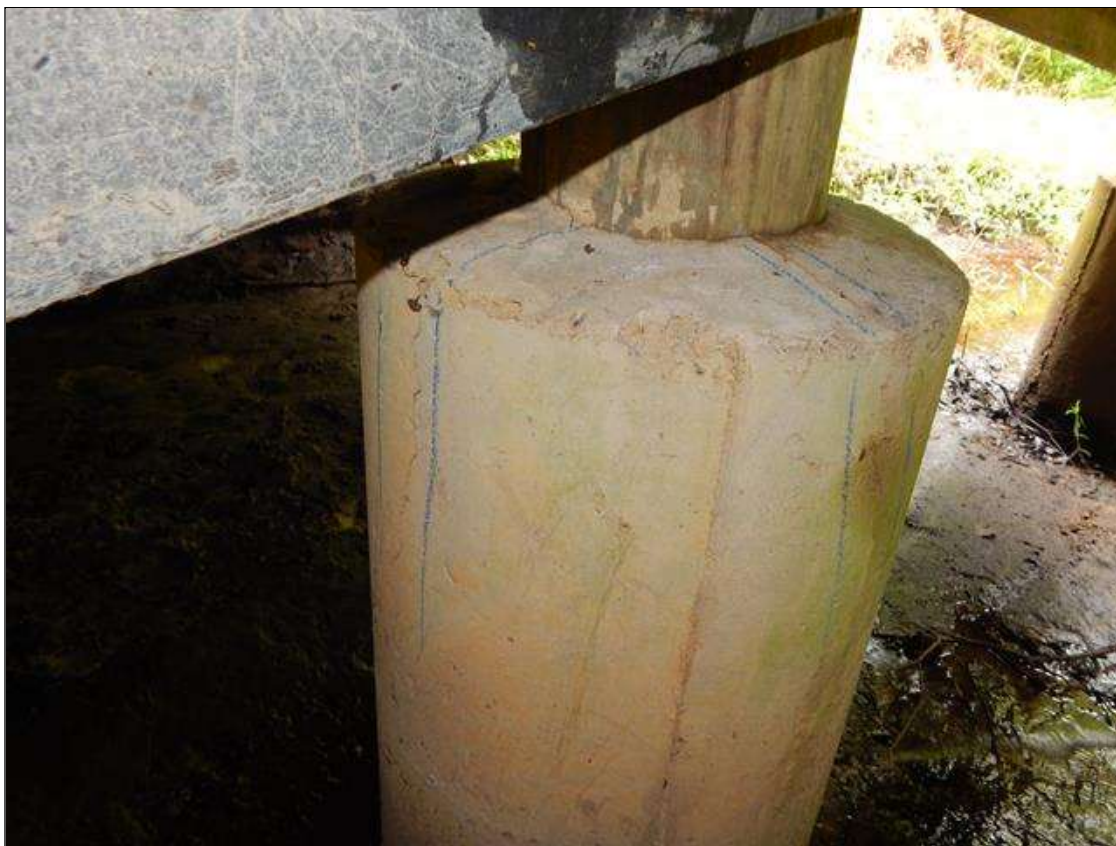
VERTICAL CRACK IN THE COLLAR OF PILE 3 ON BENT 1

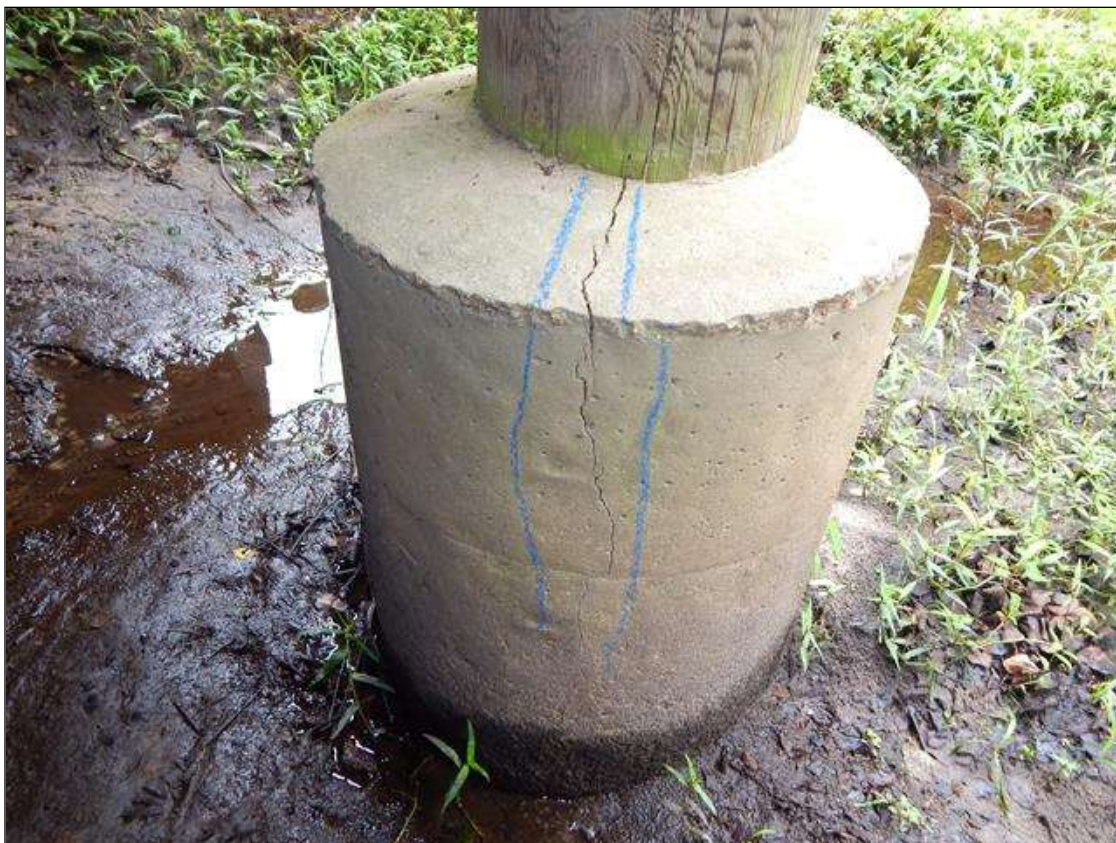
VERTICAL CRACK IN THE COLLAR OF PILE 4 ON BENT 1

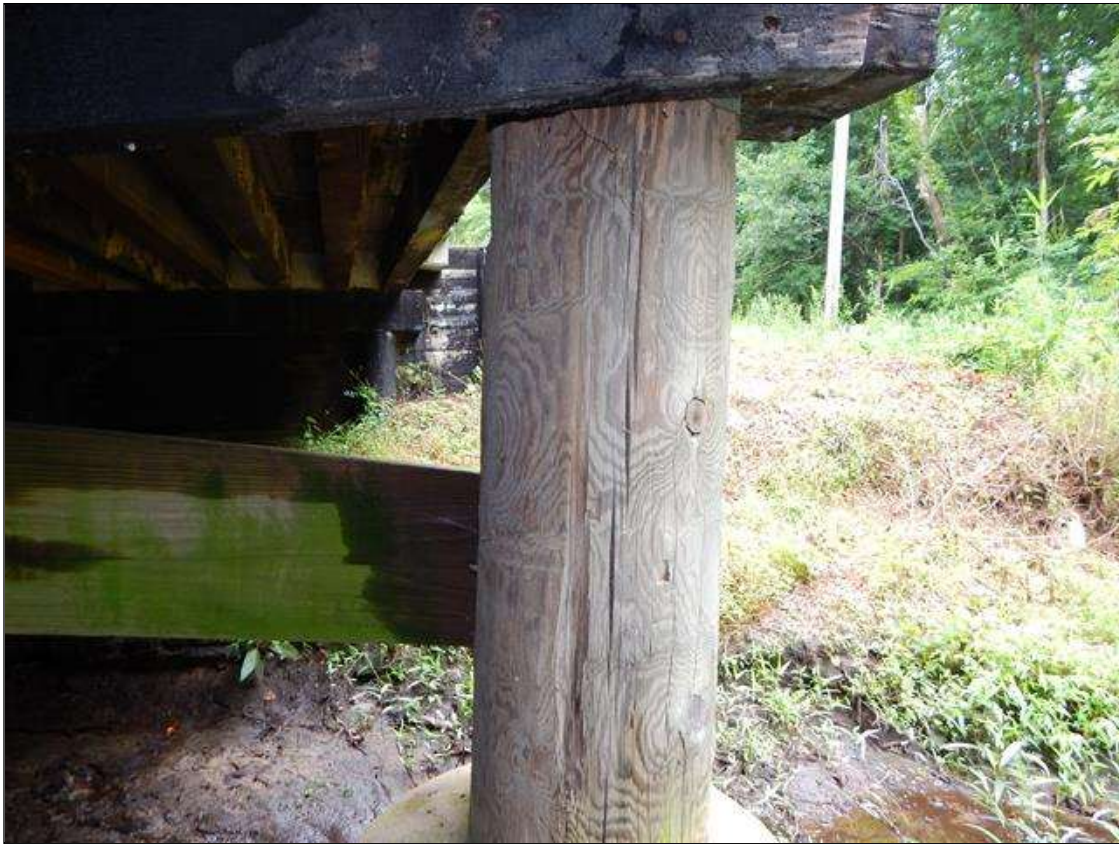
VERTICAL CRACKING IN PILE 4 ON BENT 1

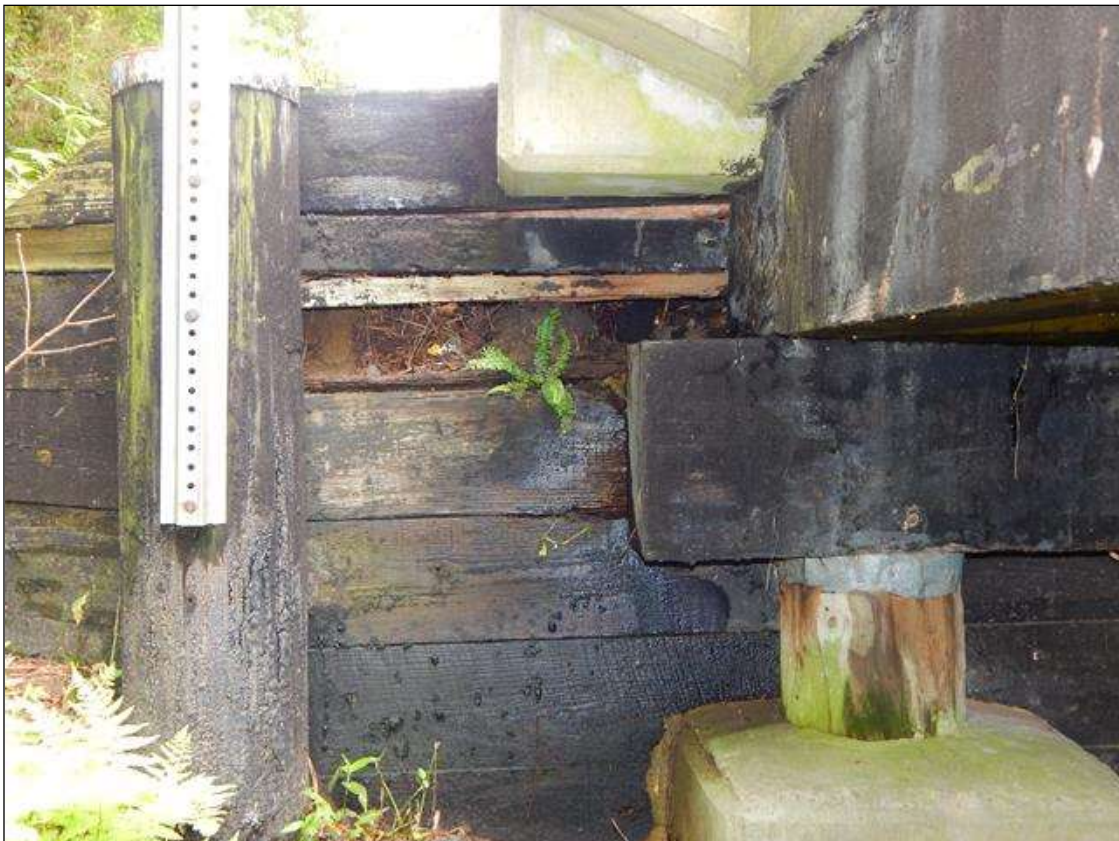
DECAYED BULKHEAD BOARD ON THE LEFT END OF END BENT 2

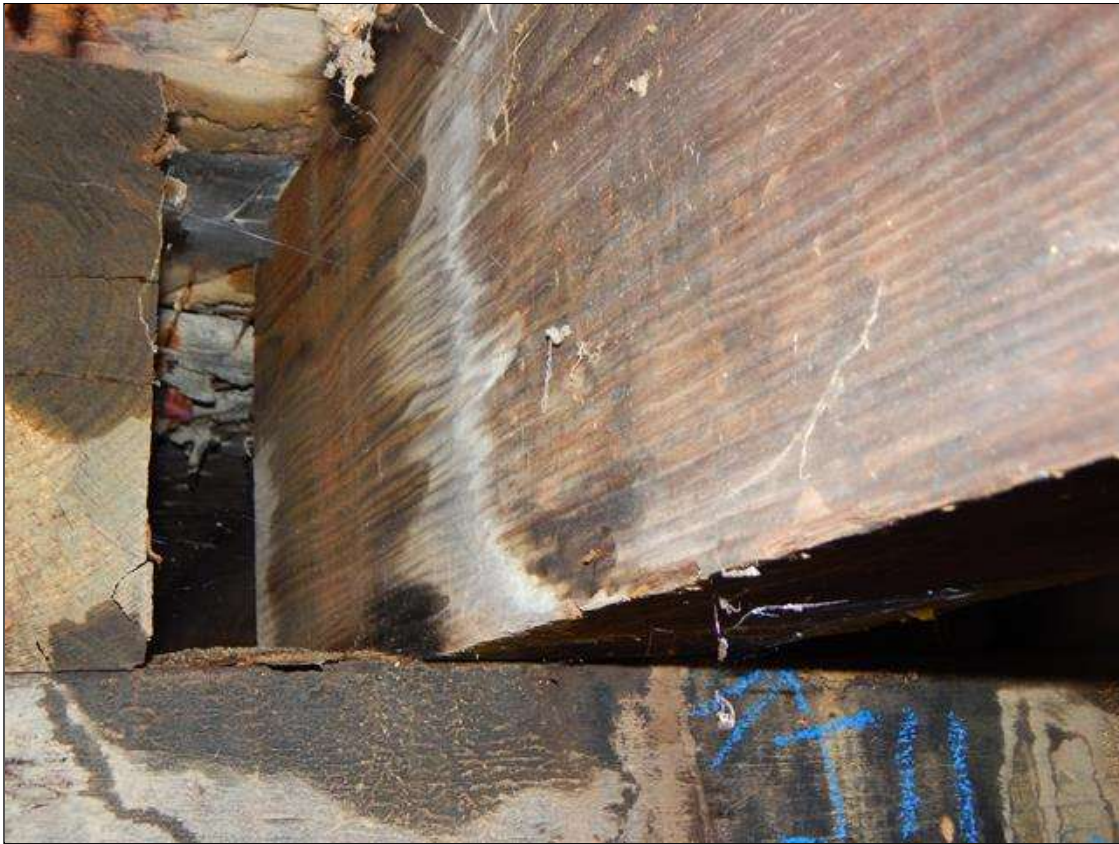
WET AND DISCOLORED END OF JOIST OVER BENT 1, SPAN 2 SIDE (SIMILAR THROUGHOUT)

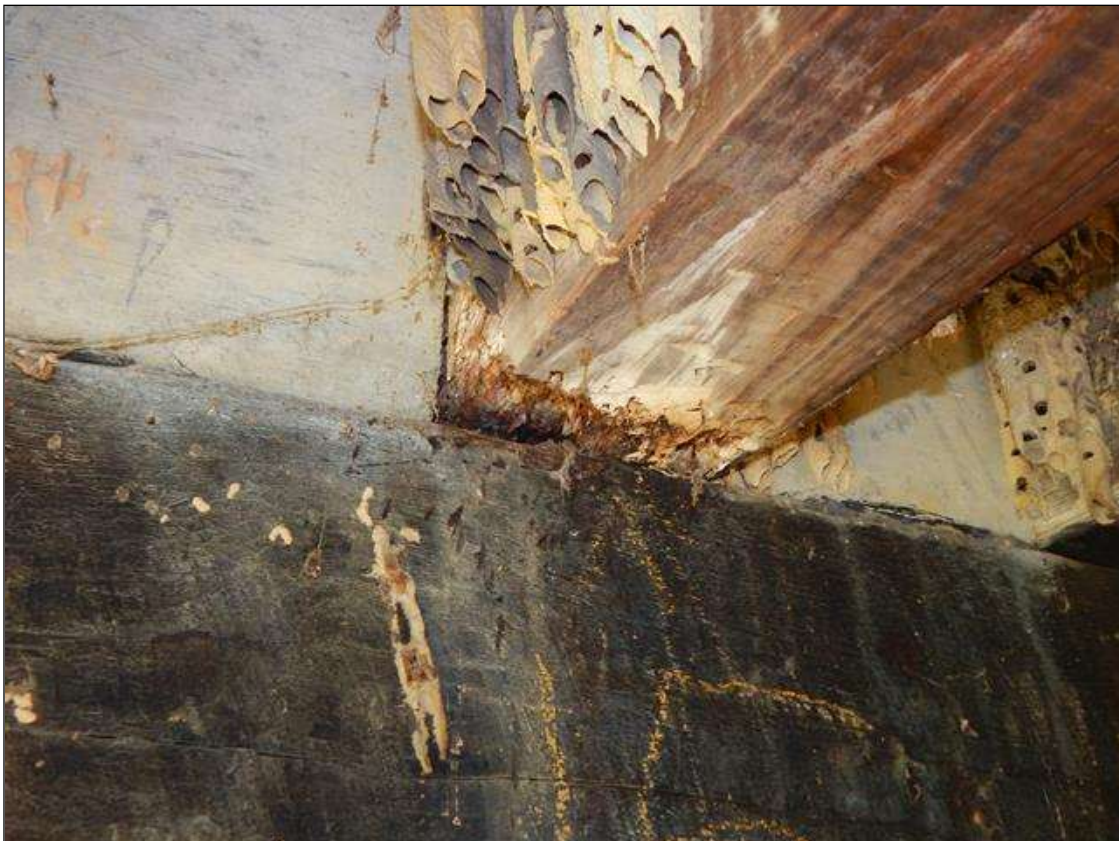
DECAY ON BOTTOM EDGE OF BEAM 15 AT END BENT 1

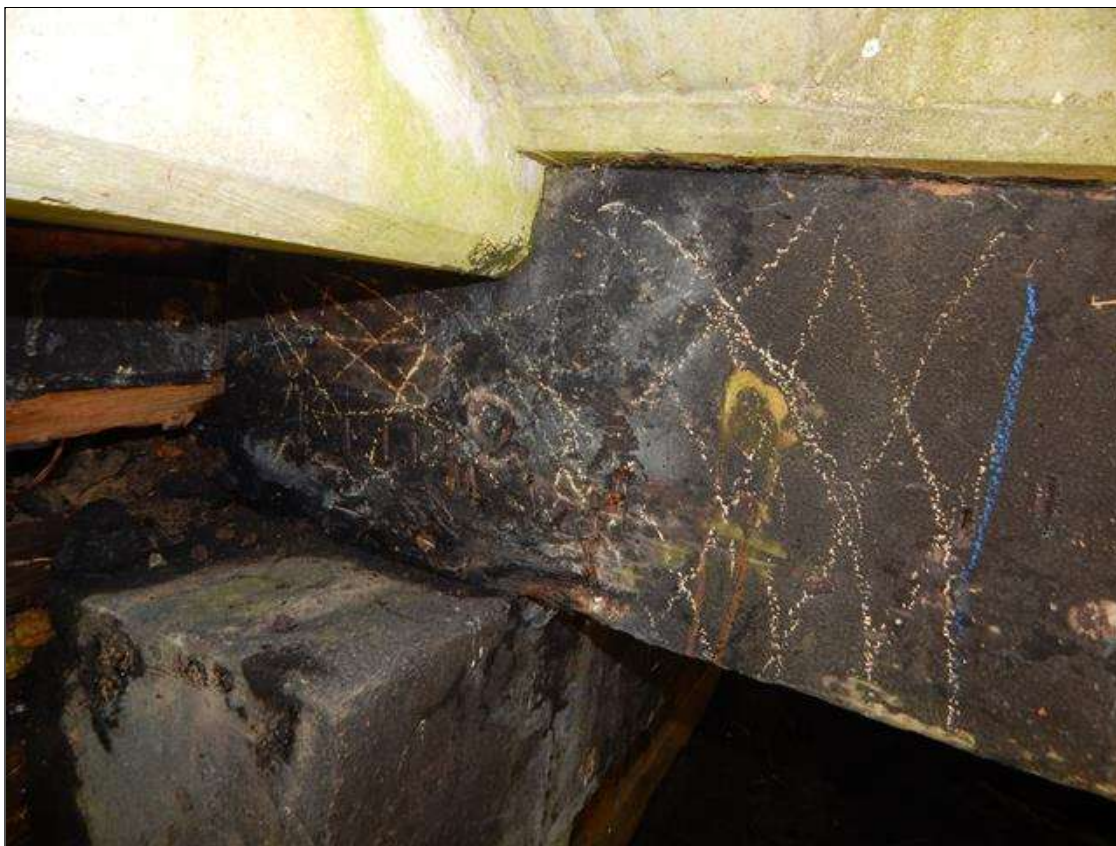
DELAMINATION ON THE LEFT SIDE OF BEAM 1 ON END BENT 2

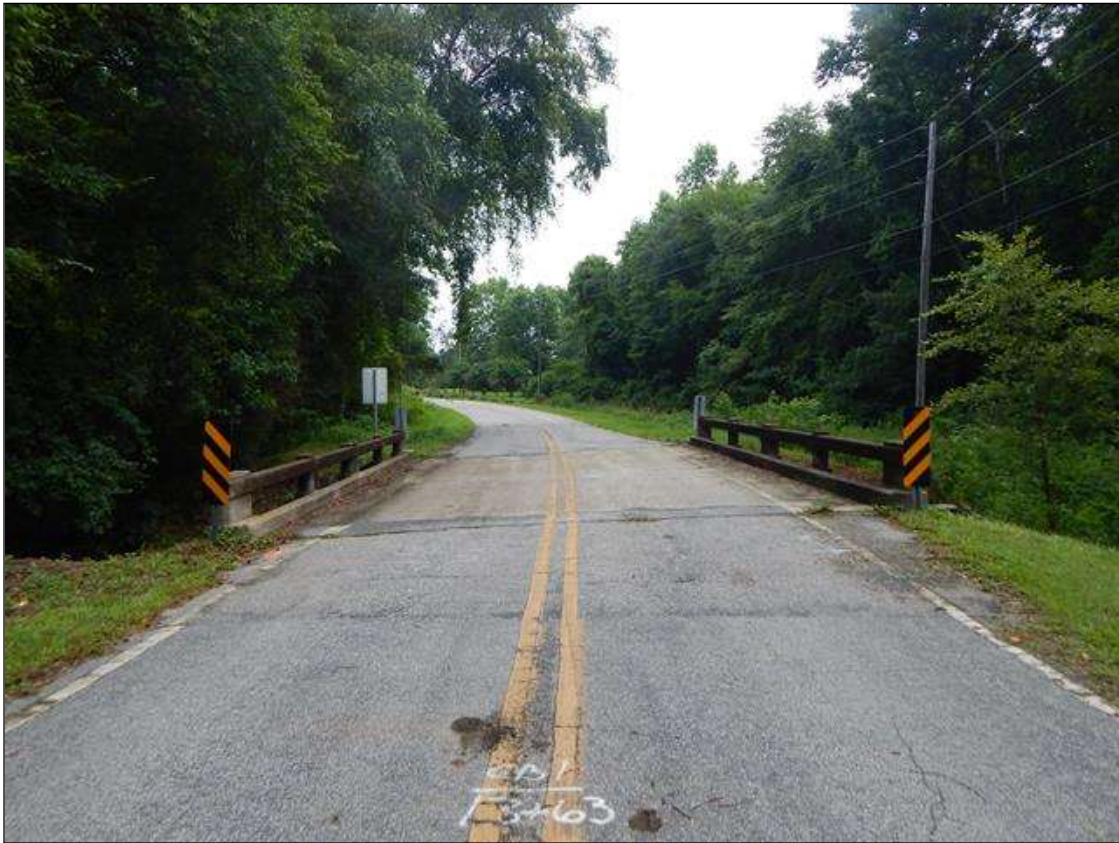
MISSING POSTING SIGN SOUTH END
