NC DEPARTMENT OF TRANSPORTATION
 DIVISION OF HIGHWAYS
 STRUCTURE MANAGEMENT UNIT

Structure Safety Report

Routine Element Inspection

COUNTY: NASH STRUCTURE NUMBER: 630062 FREQUENCY: 24 MONTHS

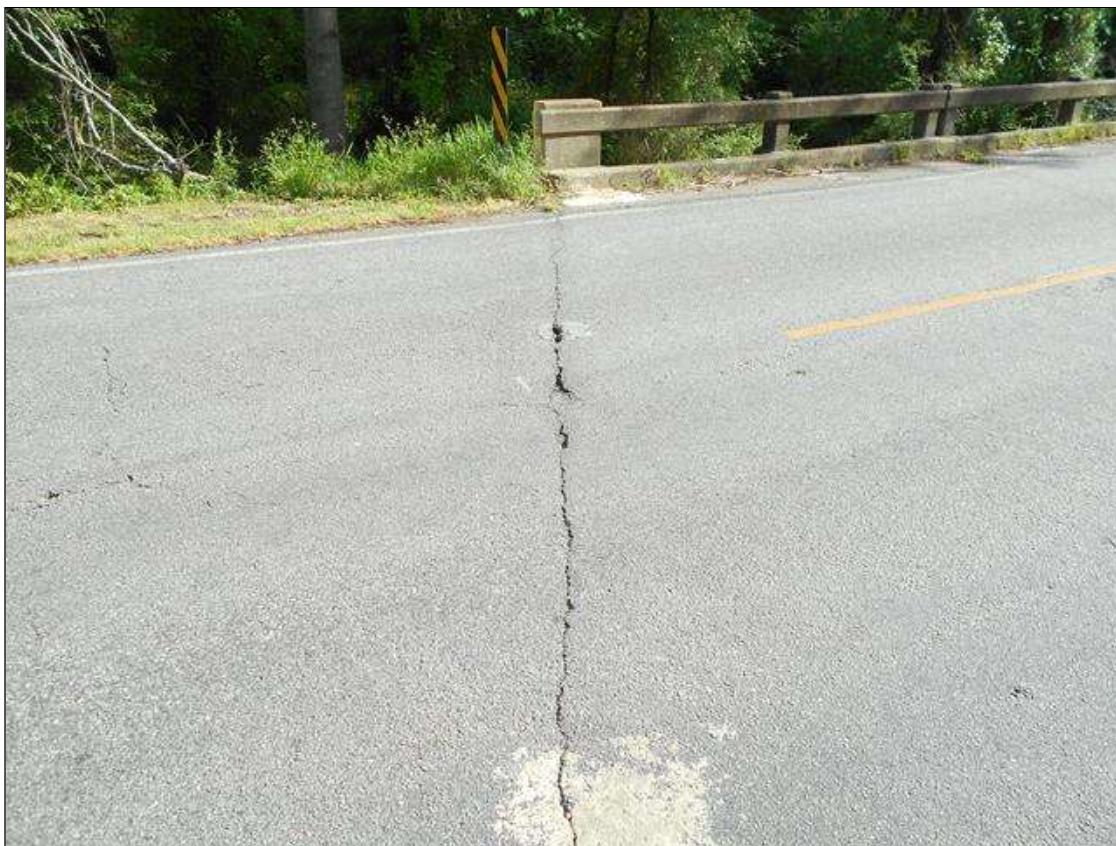
TRANSVERSE CRACK IN ASPHALT WEARING SURFACE OVER END BENT 1

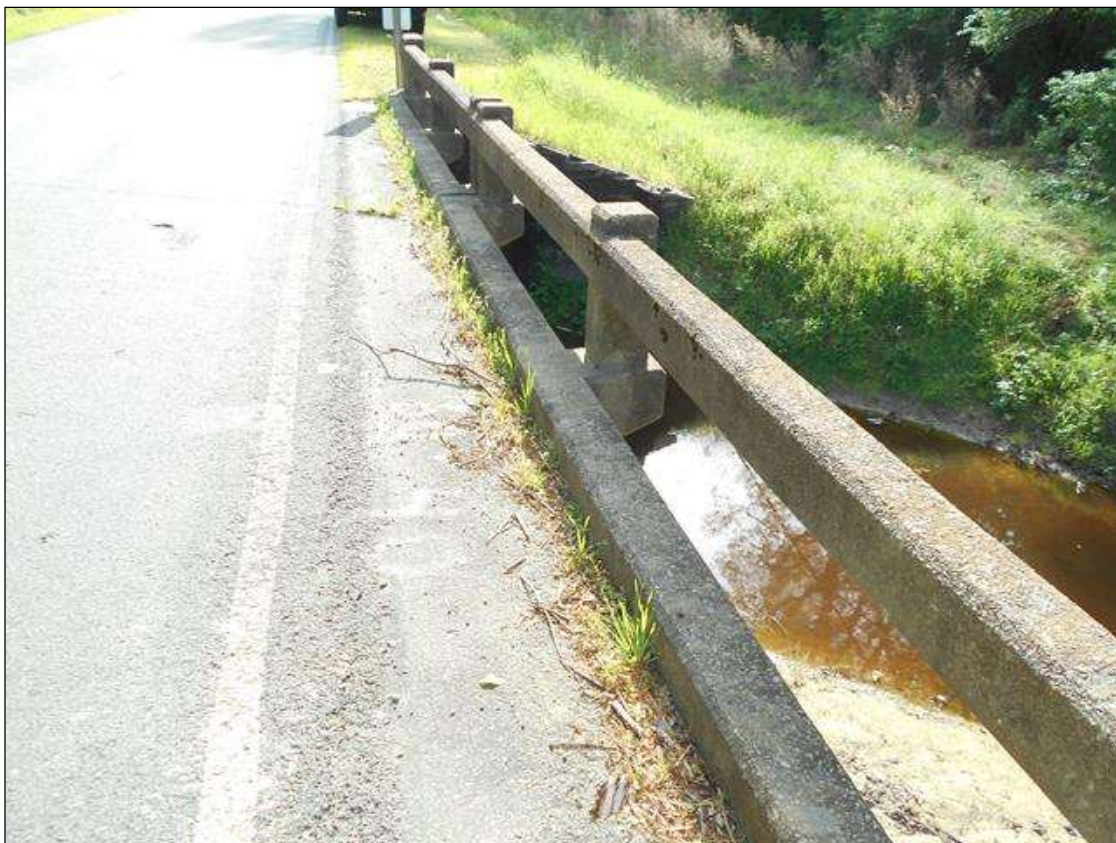
Item	Deck Debris	Grade F	Maint Code 3376	Qty. 72
Details	VEGETATION AND DIRT ALONG CURBS RESTRICT WATER RUNOFF TO DRAINS			
Item	Drainage System	Grade F	Maint Code 3332	Qty. 0
Details	VEGETATION AND DIRT ALONG CURBS RESTRICT WATER RUNOFF TO DRAINS. SEE DECK DEBRIS.

DIRT AND DEBRIS AND VEGETATION ALONG RIGHT SIDE WHEELGUARD (LEFT SIDE SIMILAR)

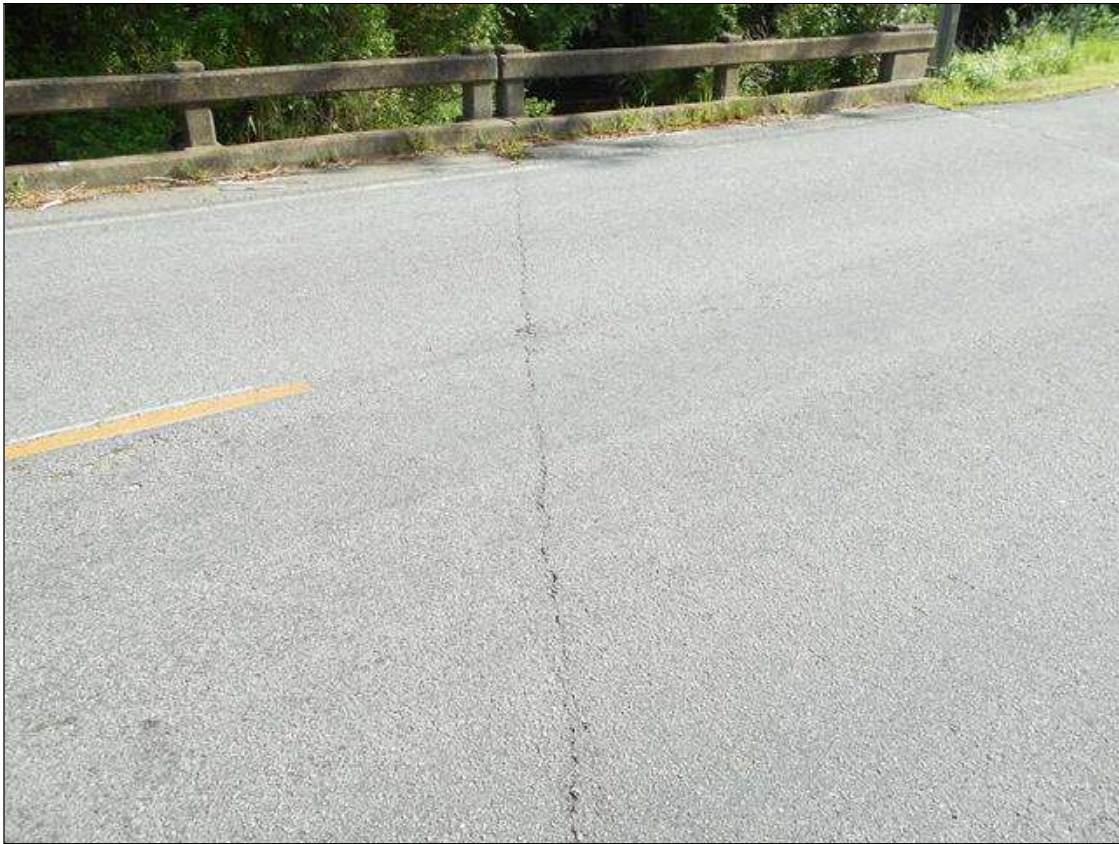
TRANSVERSE CRACK IN ASPHALT WEARING SURFACE OVER INTERIOR BENT 1

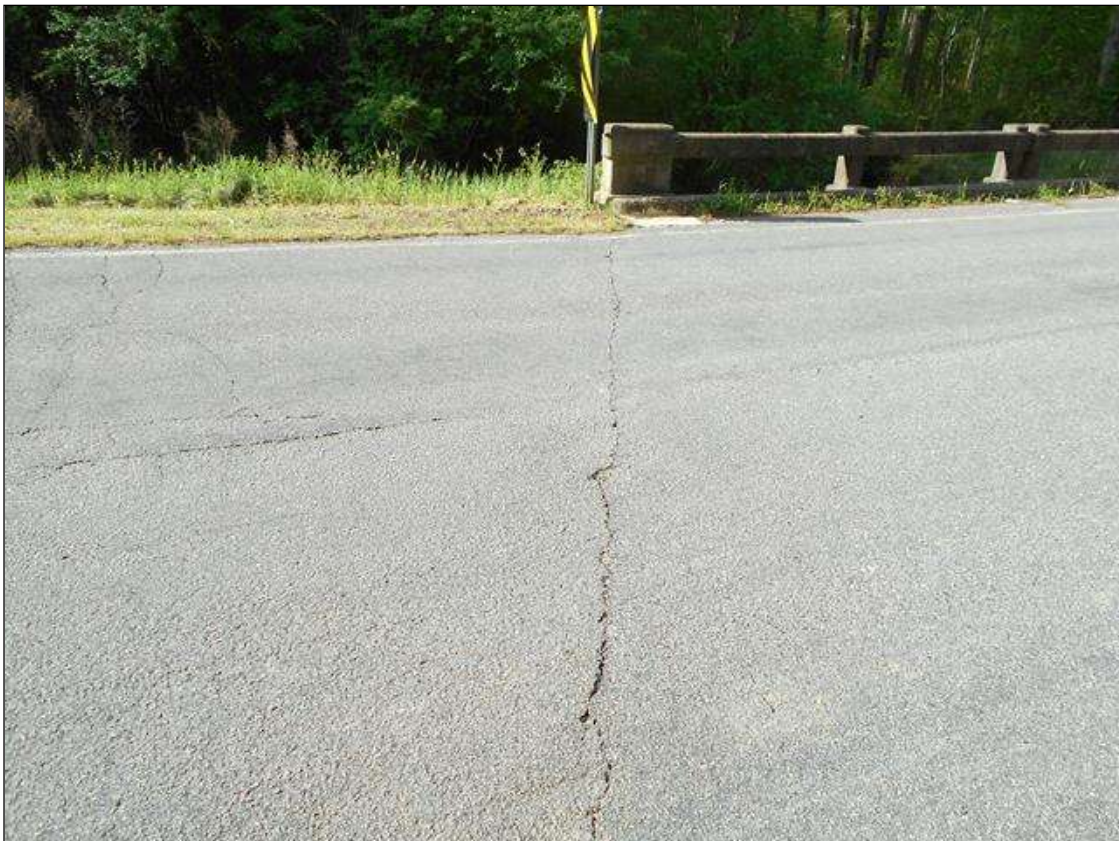
TRANSVERSE CRACK IN ASPHALT WEARING SURFACE OVER END BENT 2

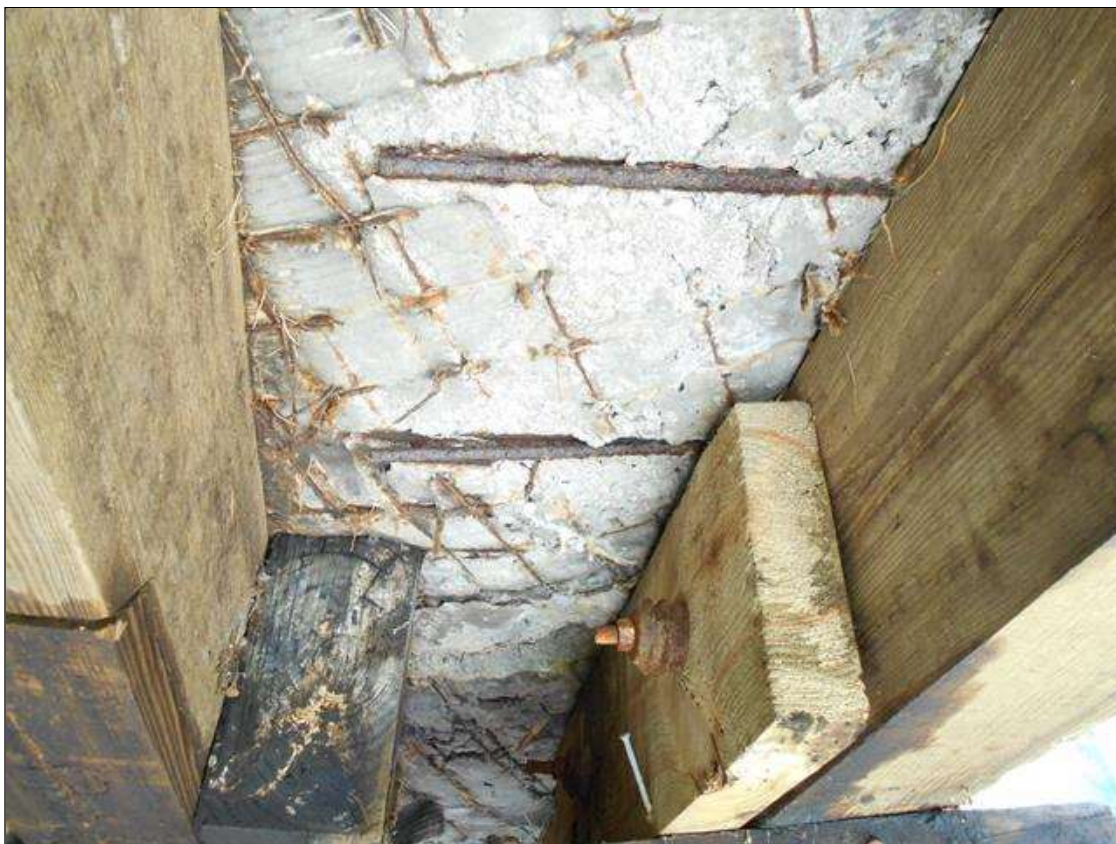
Span 1 Deck: 1 Square Feet of Delamination/Spall: Delaminated. Spall 1 in. or less deep or 6 in. or less in diameter.
SPALL IN BOTTOM OF DECK OVER INTERIOR BENT 1 BAY 18.

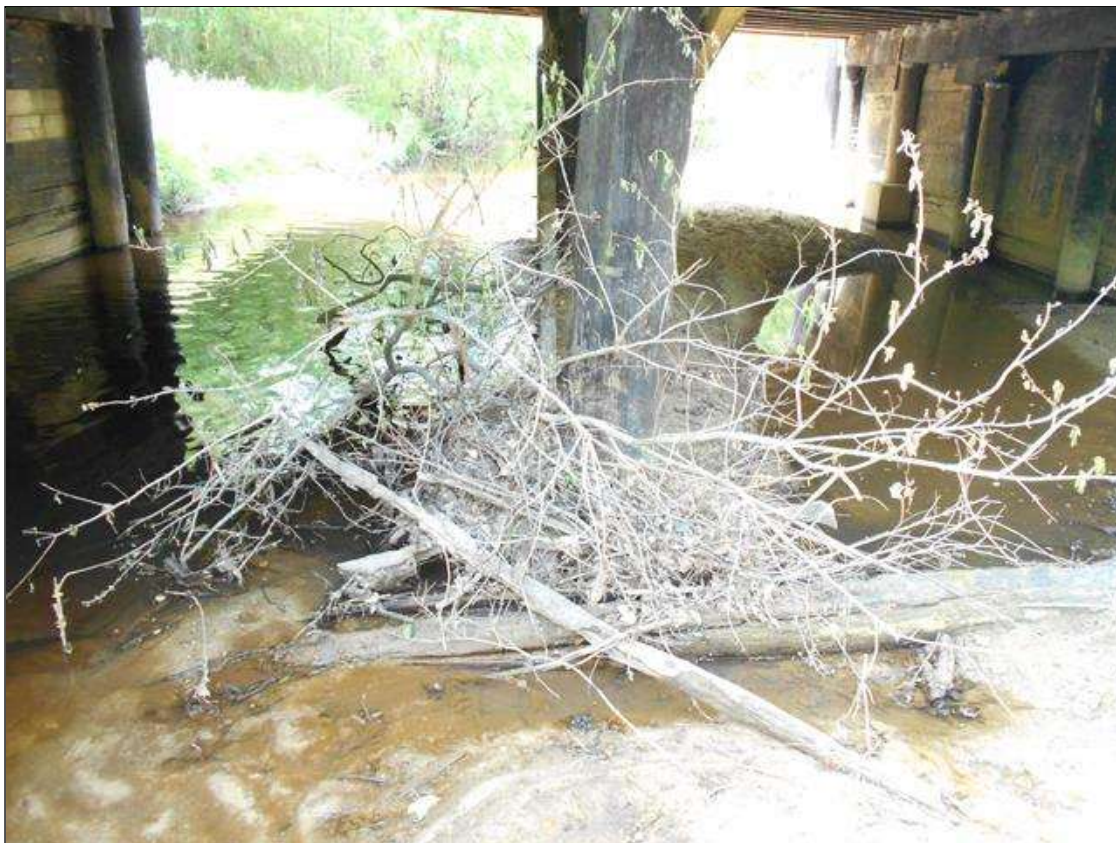
Item	Slope Protection	Grade F	Maint Code 3352	Qty. 0
Details	UNPROTECTED SLOPES			
Item	Drift	Grade F	Maint Code 3366	Qty. 2
Details	DRIFT ON THE NORTH SIDE OF INTERIOR BENT 1.

DRIFT AROUND BASE OF INTERIOR BENT 1

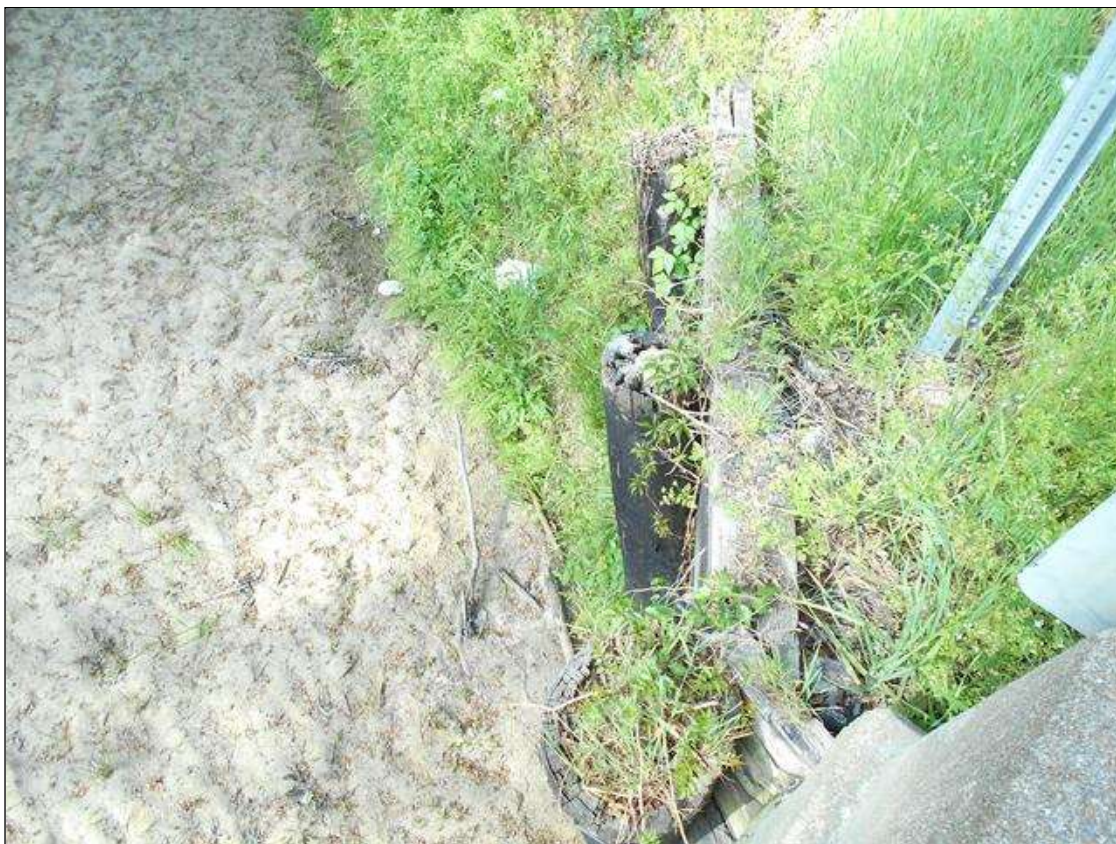
Item	Scour	Grade F	Maint Code	Qty. 0
Details	2 FT. DEEP BED SCOUR AT THE FACE ON END BENT 2 FOOTING			
Item	Wingwalls	Grade P	Maint Code 3350	Qty. 100
Details	WINGWALLS IN POOR CONDITION . DECAYED WINGWALL PILES AND BOARDS WITH EXPOSED FILL AT END BENT 1 AND 2.

DECAY IN WINGWALL PILES @ SOUTH WEST CORNER WINGWALL WITH VEGETATION IN TOPS

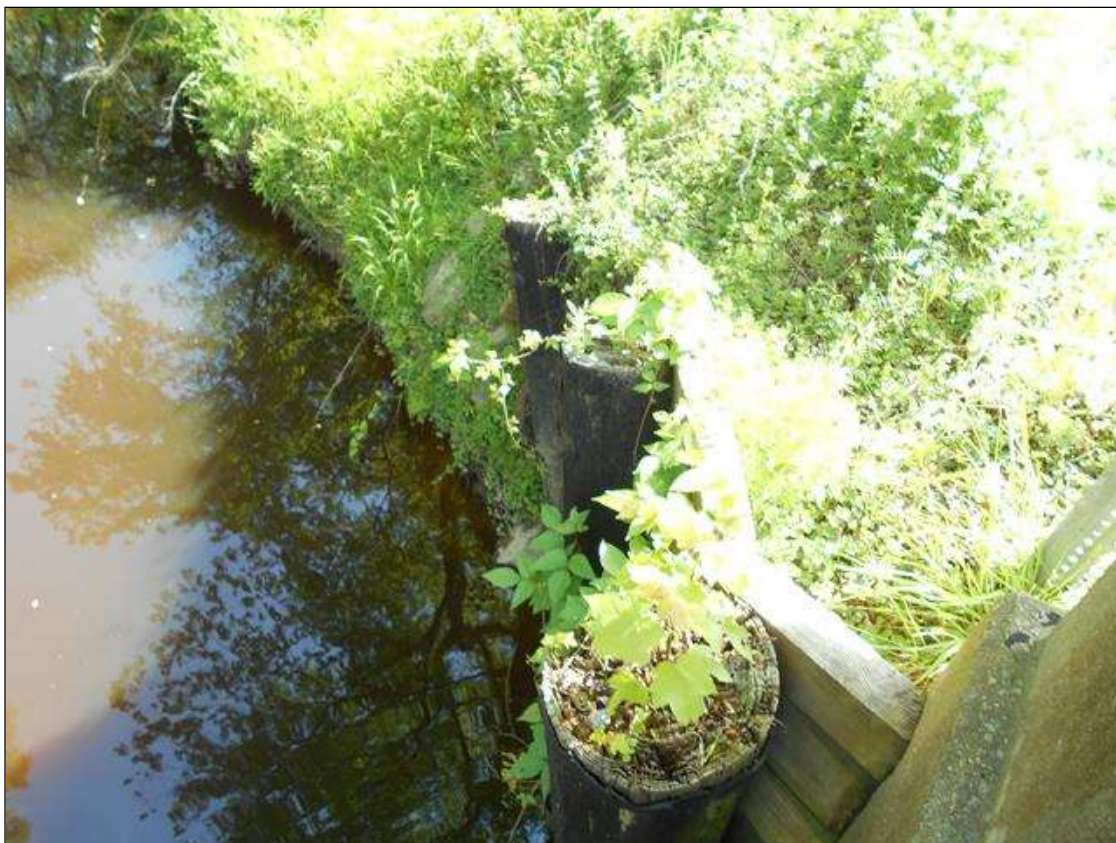
DECAY IN WINGWALL PILES @ NORTH EAST CORNER WINGWALL WITH VEGETATION IN TOPS

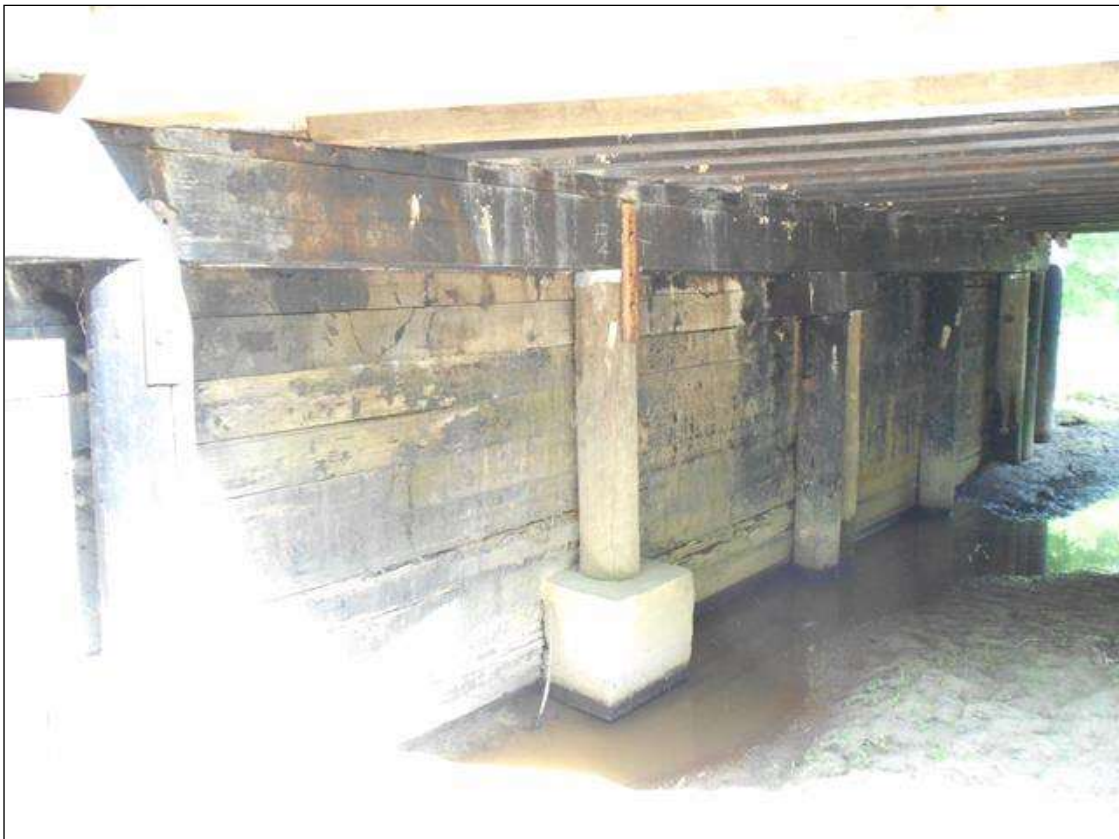
END BENT 1

Piles 1 & 3 @ E. Bent 1 have been supplemented. Piles 4 & 5 @ E. Bent 1 have been encased with concrete.

Item	Substructure - Item 60	Grade 5	Maint Code	Qty. 0
Details	SUBSTRUCTURE IS IN FAIR CONDITION . RANDOM SURFACE SOFTNESS AND DELAMINATION IN CAPS AND PILES . REPAIR PILES AT END BENTS 1 AND 2. CROSSBRACING REPAIRED.

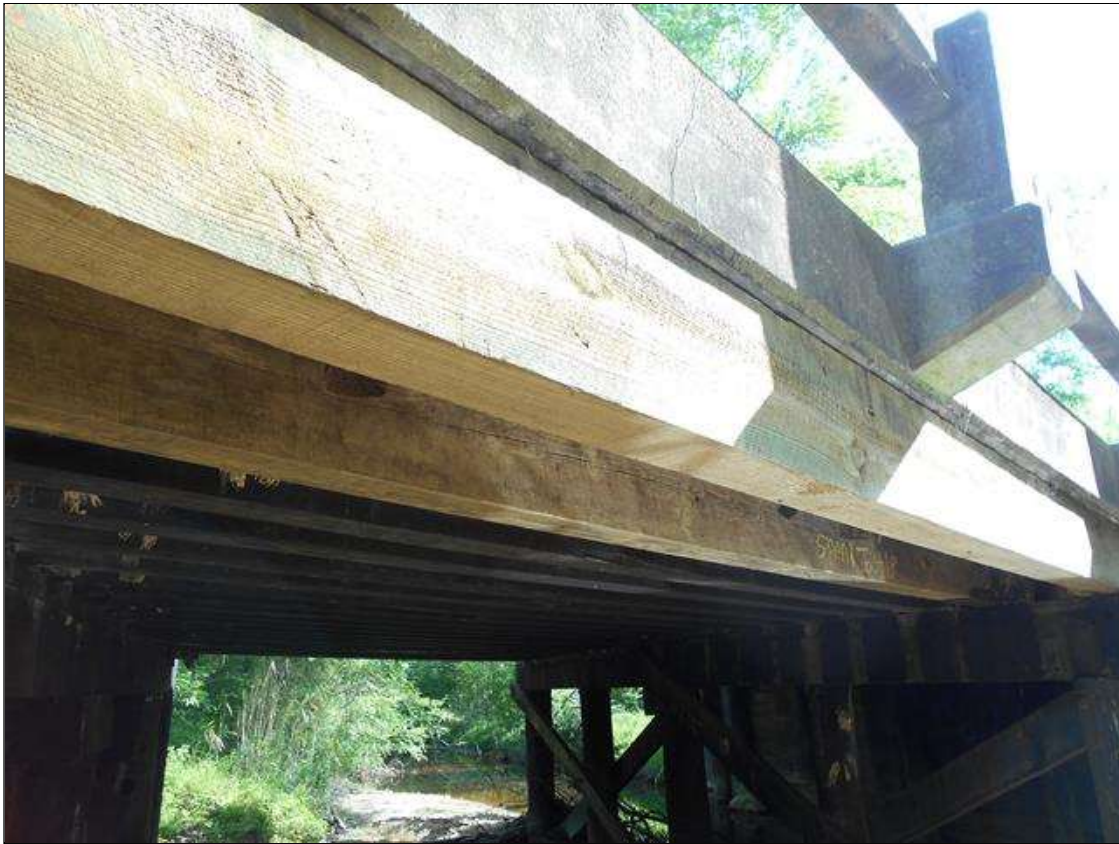
REPLACED JOIST 18 AND 19 SPAN 1 (JOIST 19 IN SPAN 2)

Joist 1, 18 and 19 are repair/ replacements.

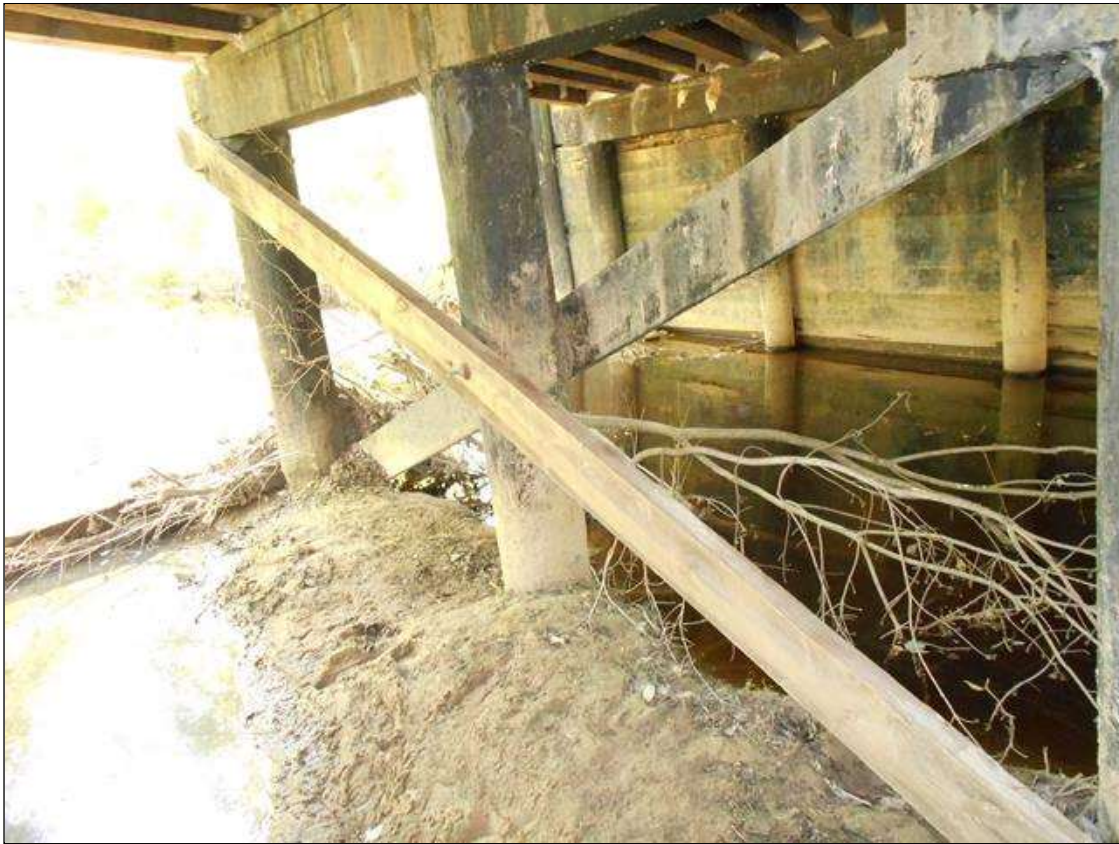
REPLACED CROSS BRACING @ INTERIOR BENT 1 SPAN 1 SIDE

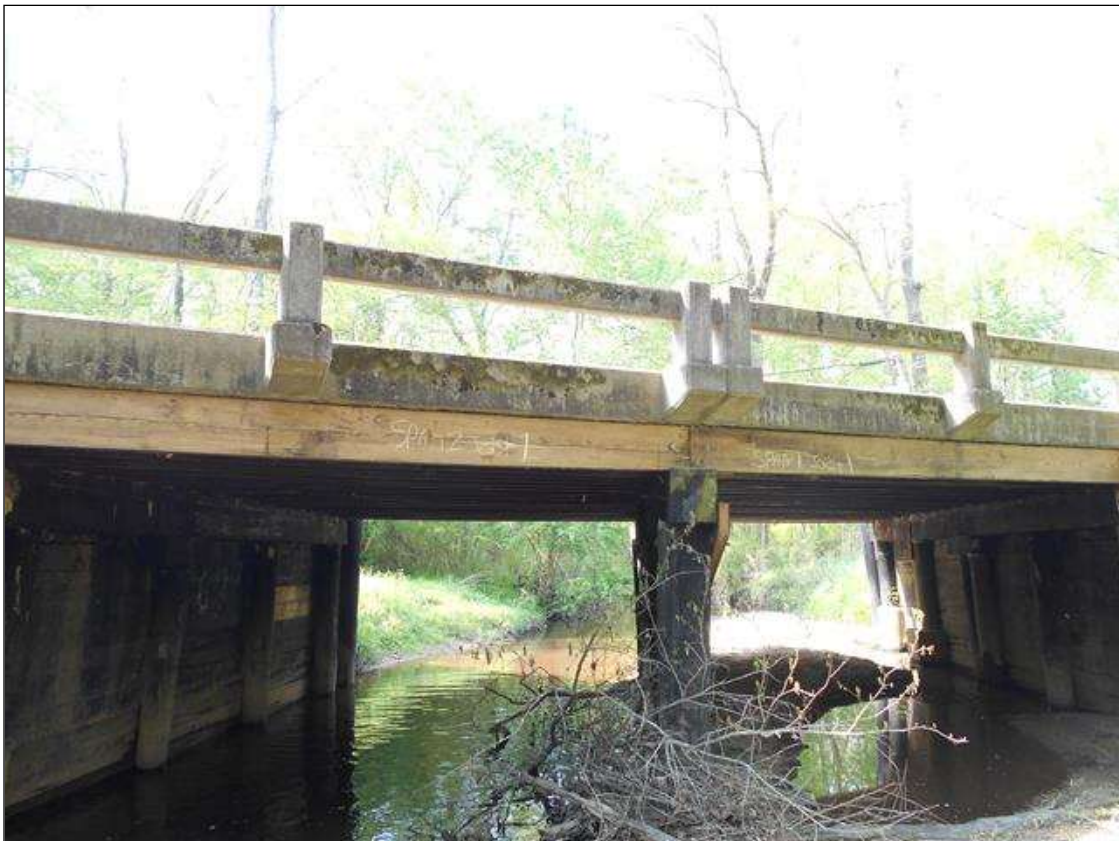
REPLACED JOIST 1 IN SPAN 1 AND SPAN 2

Joist 1 and 19 are repair / replacements.
