NC DEPARTMENT OF TRANSPORTATION
 DIVISION OF HIGHWAYS
 STRUCTURE MANAGEMENT UNIT

Structure Safety Report

Routine Element Inspection

COUNTY: JOHNSTON STRUCTURE NUMBER: 500239 FREQUENCY: 24 MONTHS

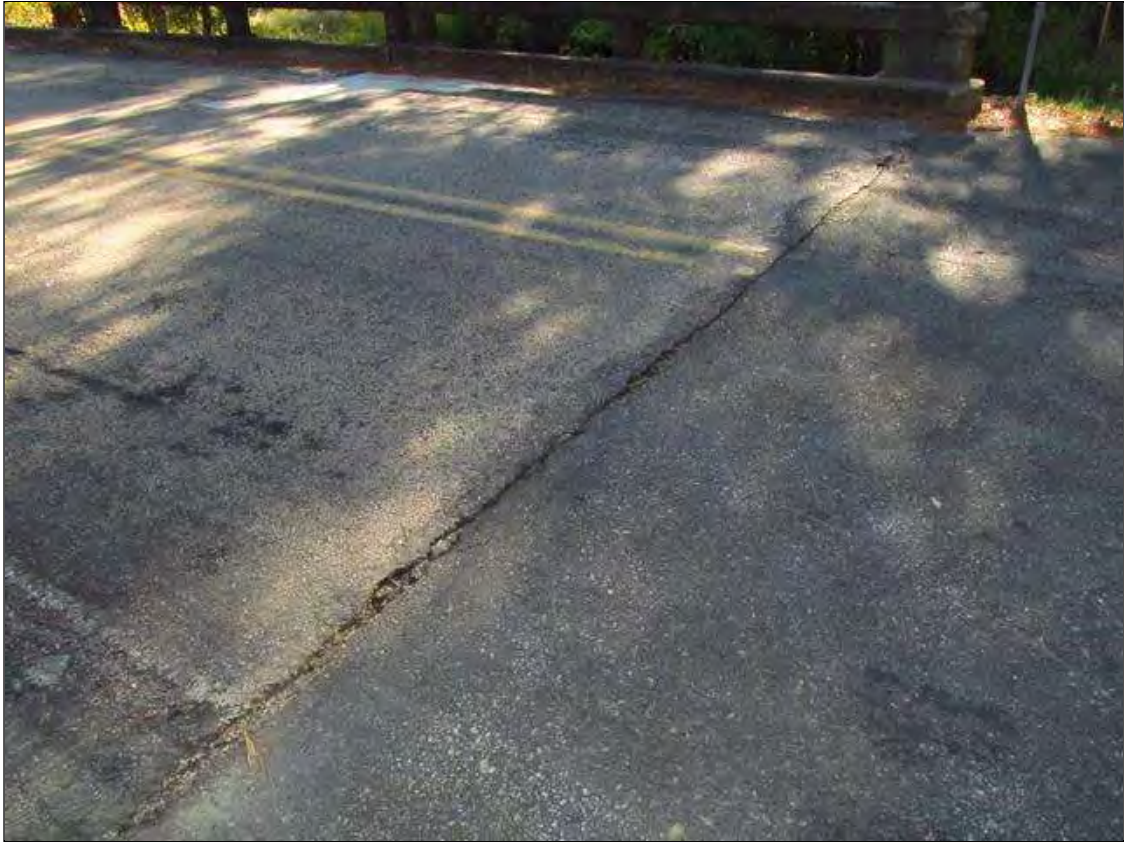
24 Square Feet of Cracking over End Bent 1 (Wearing Surface): Width of more than 0.05 in. or spacing of less than 1.0 ft.

Transverse cracking in Wearing surface over End Bent 1

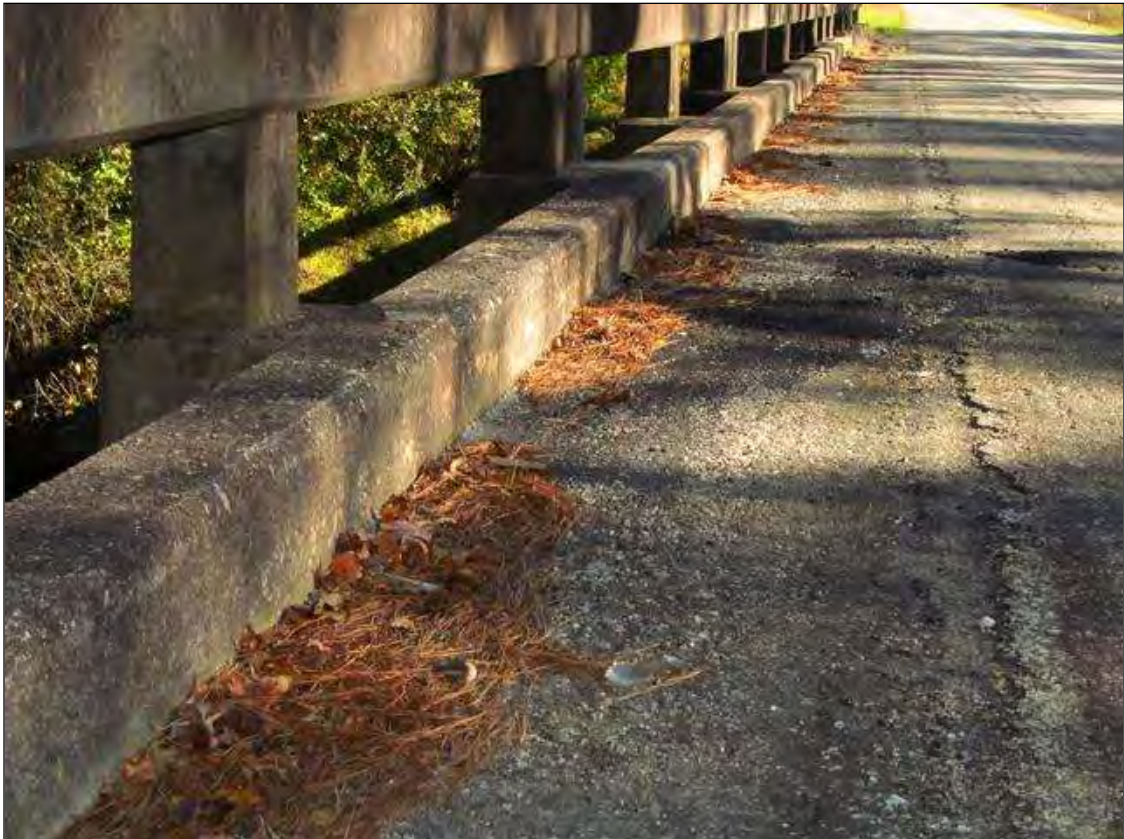
Dirt and debris along curblines

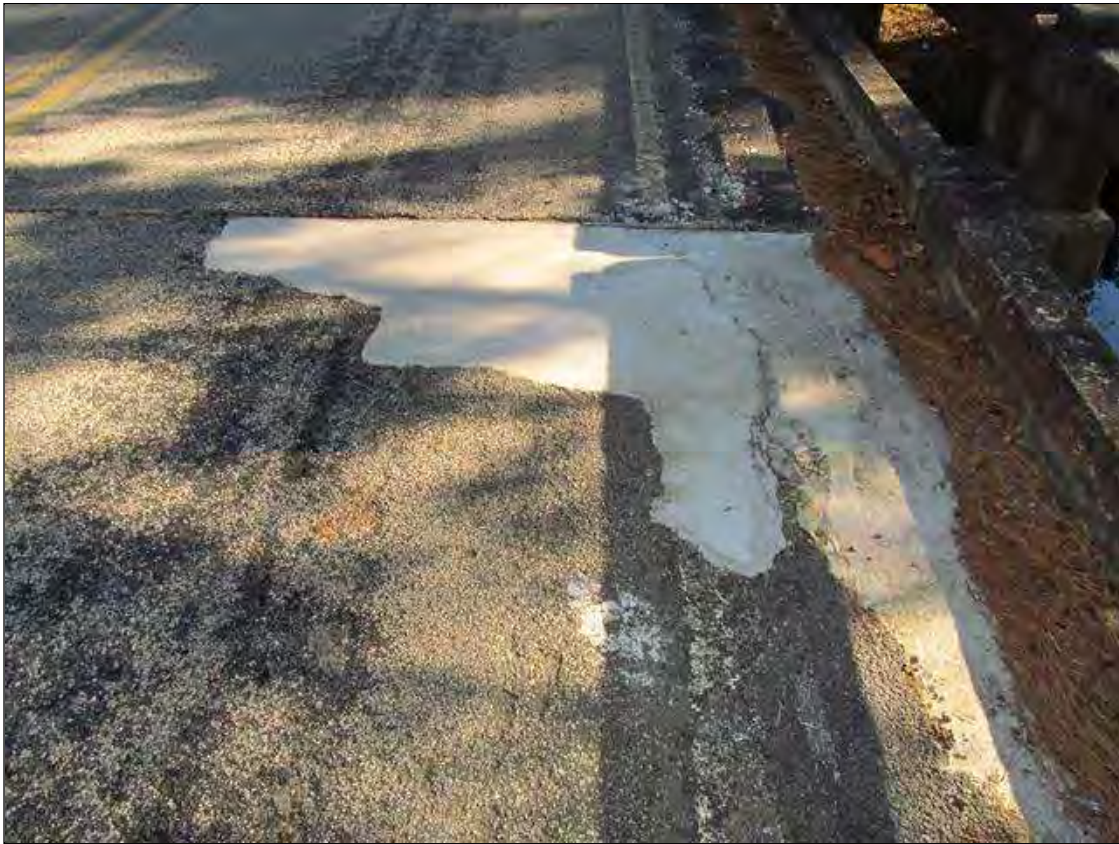
Concrete patch in the Northbound lane and shoulder of Span 1

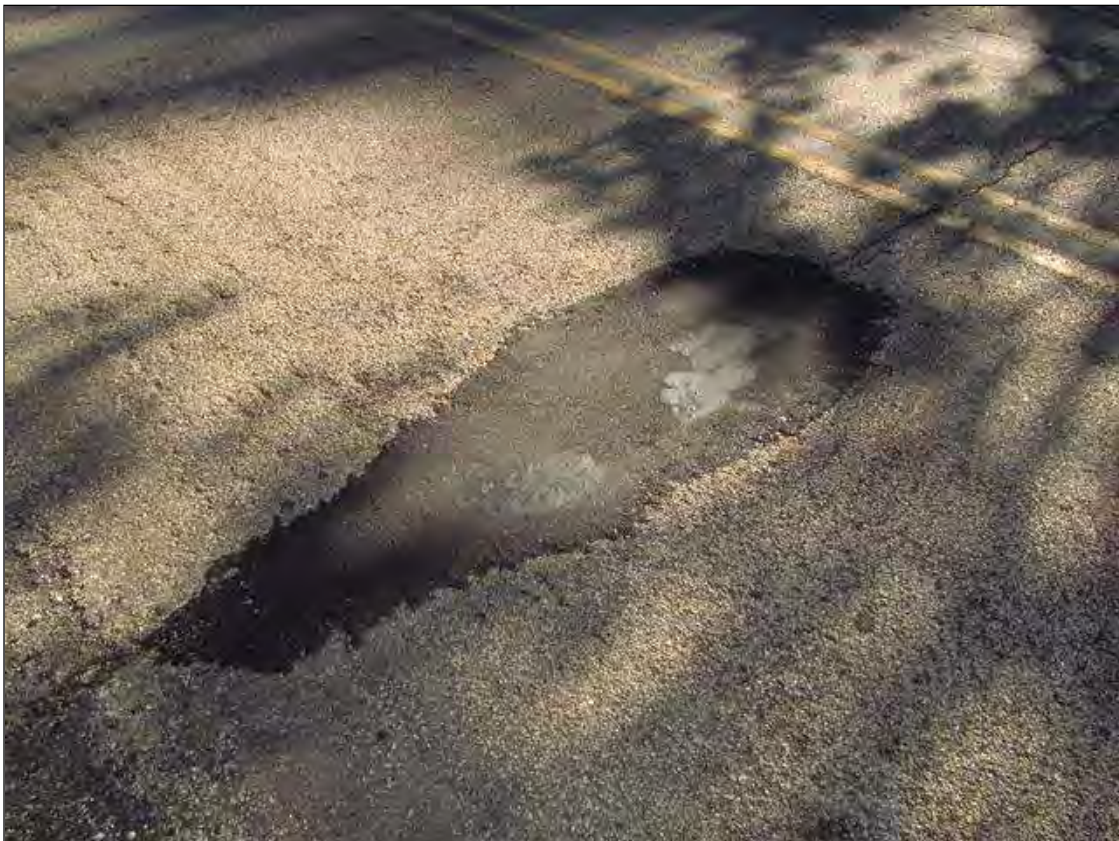
Asphalt patch in the Southbound lane over Bent 1

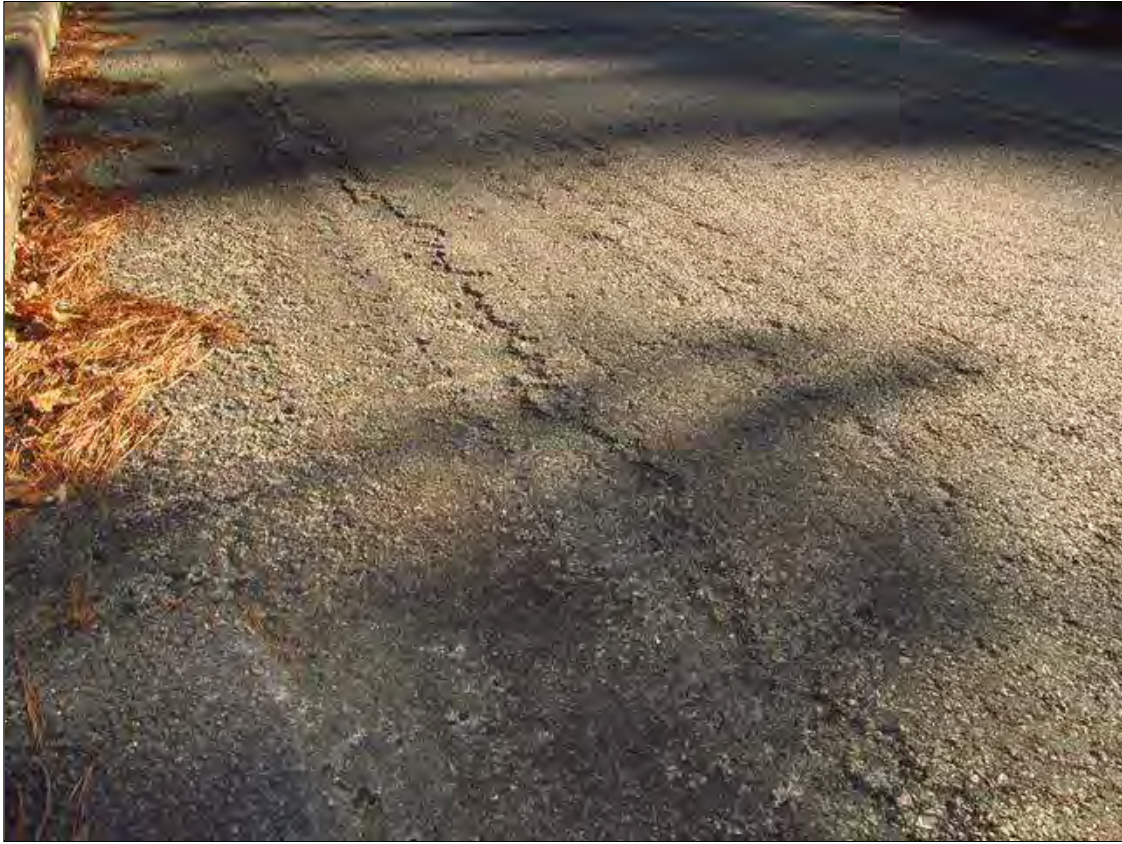
Longitudinal bands of deterioration in Span 1 Asphalt wearing surface - All spans similar

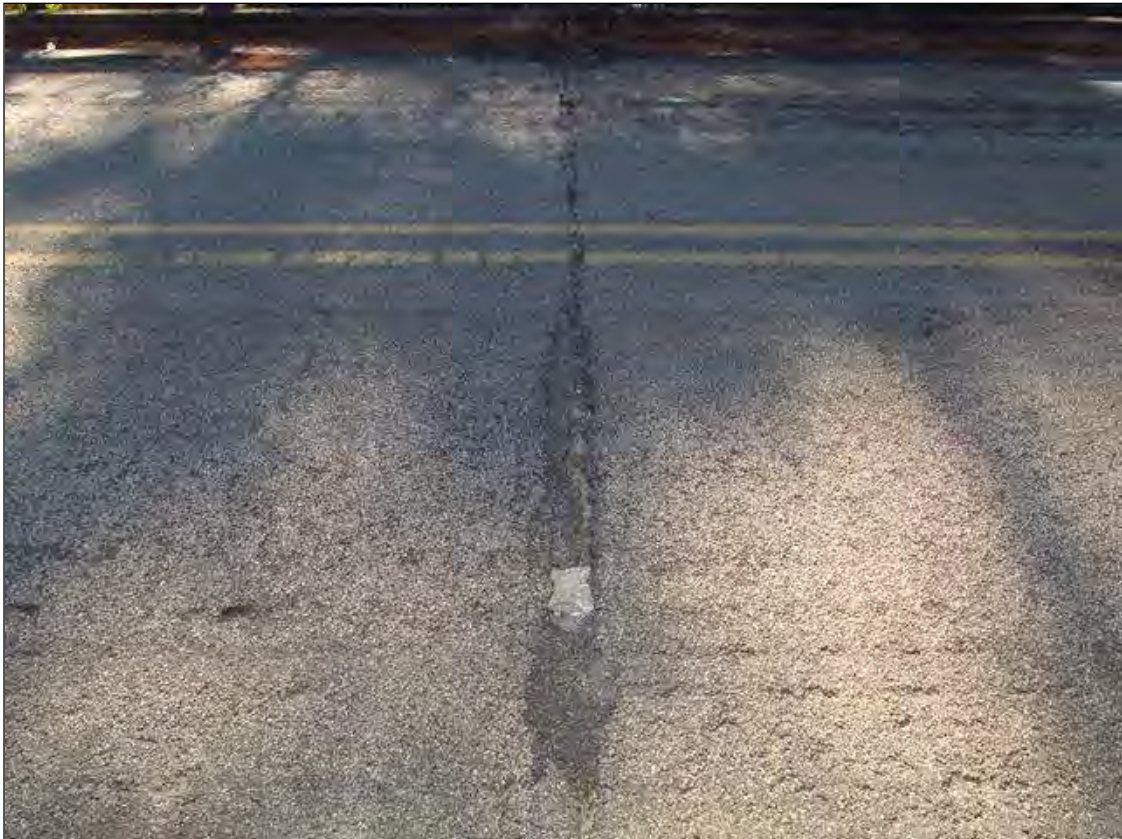
Cracking and separation in Asphalt wearing surface over Bent 2 - similar condition at other bents

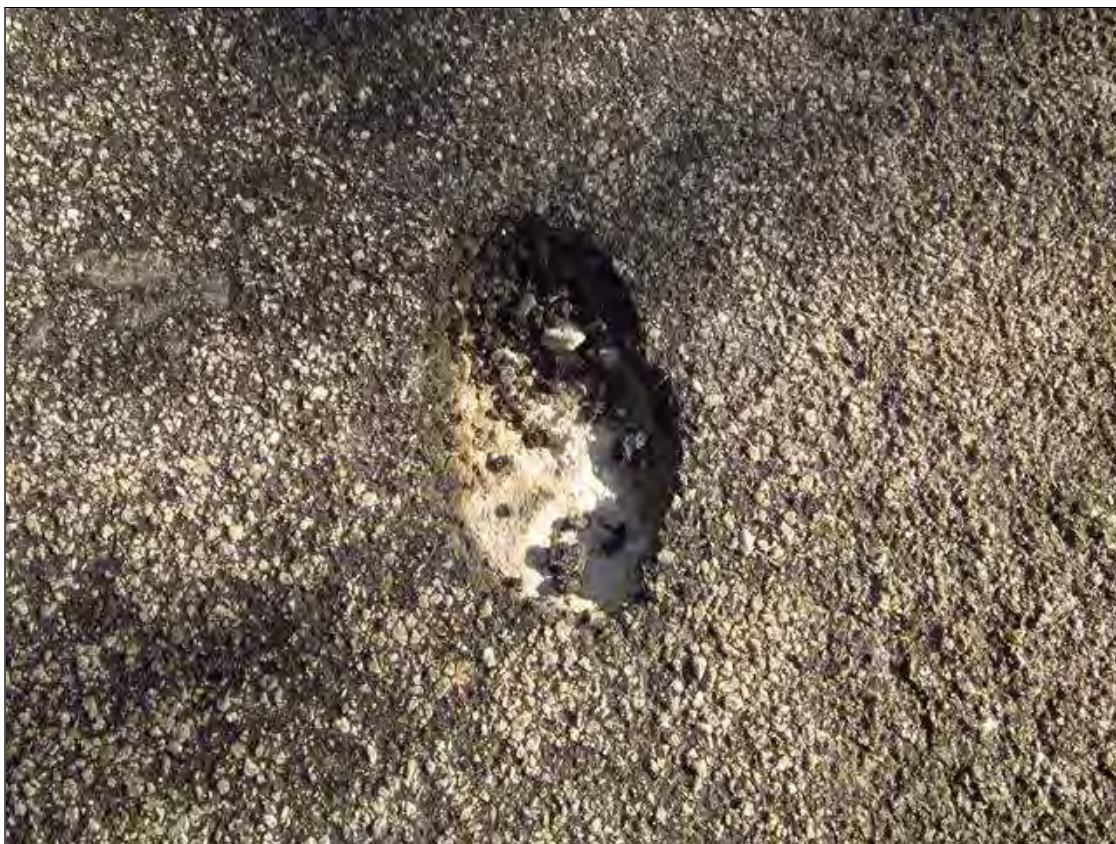
10" Diameter x 1.5" deep void pothole in the Northbound lane of Span 4

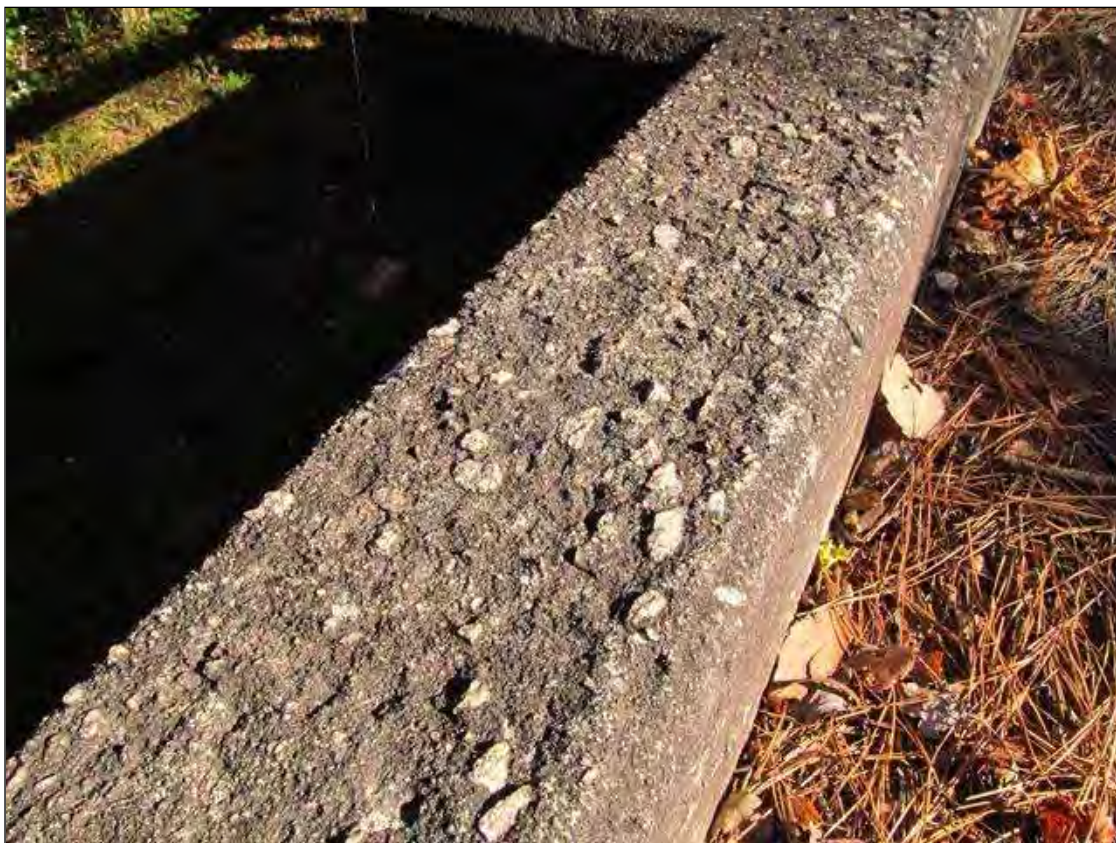
23 Square Feet of Abrasion/Wear along deck curbs (PSC/RC): Abrasion or wearing has exposed coarse aggregate but the aggregate remains secure in the concrete.

Abrasion with Coarse aggregate exposed along deck curbs

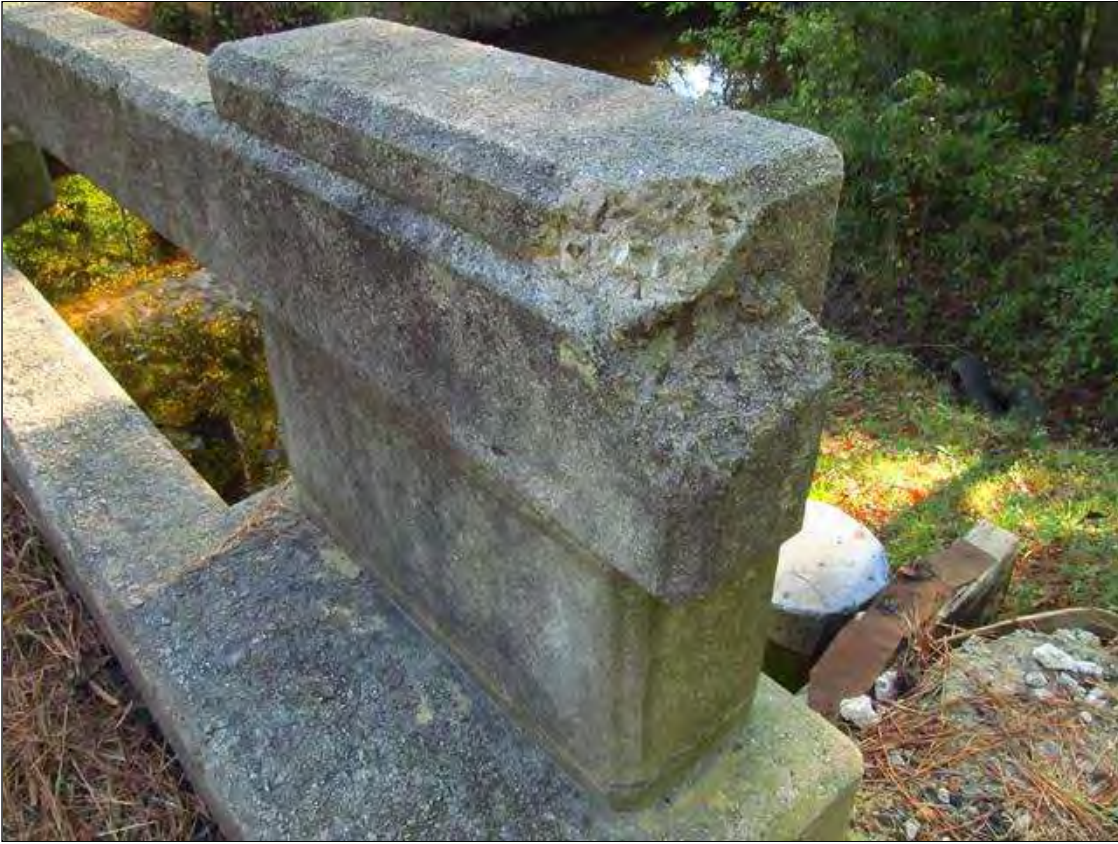
1 Foot of Spalling in the end post at End Bent 1: Spall greater than 1 in. deep or greater than 6 in. diameter.

Right guardrail endpost at End Bent 1 spalled

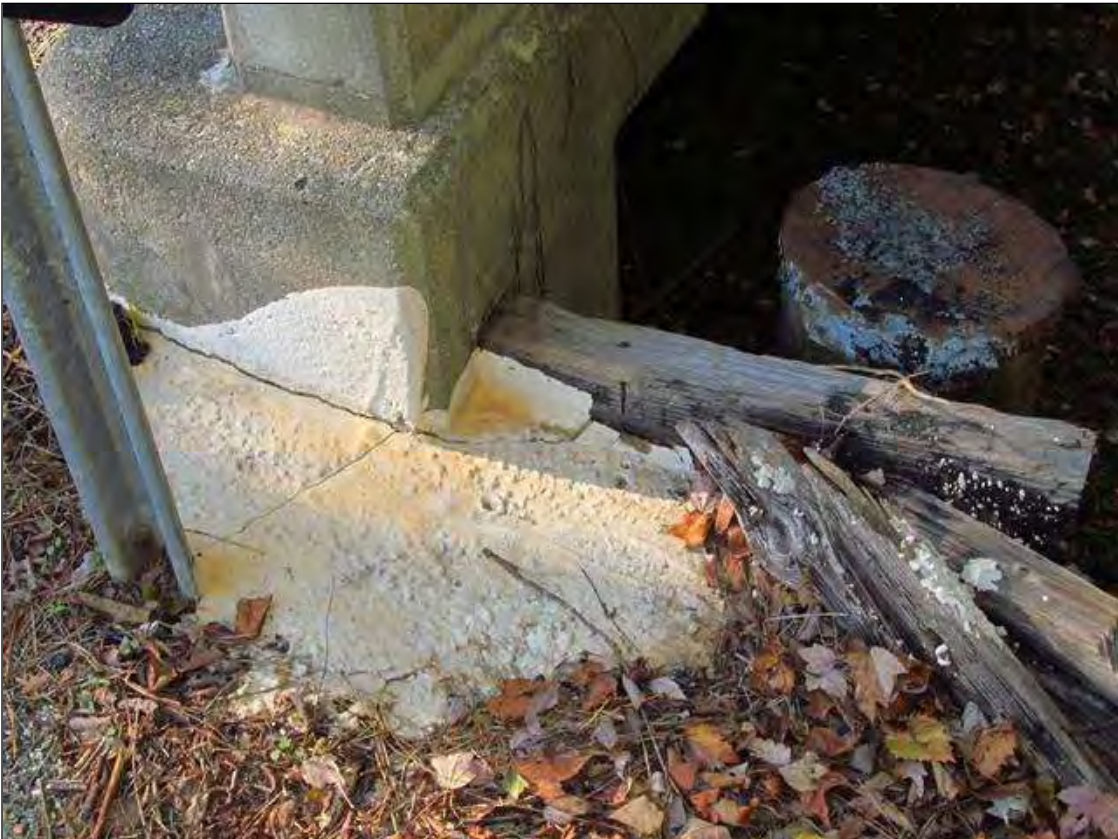
Grout Repair at the Left side of End Bent 2

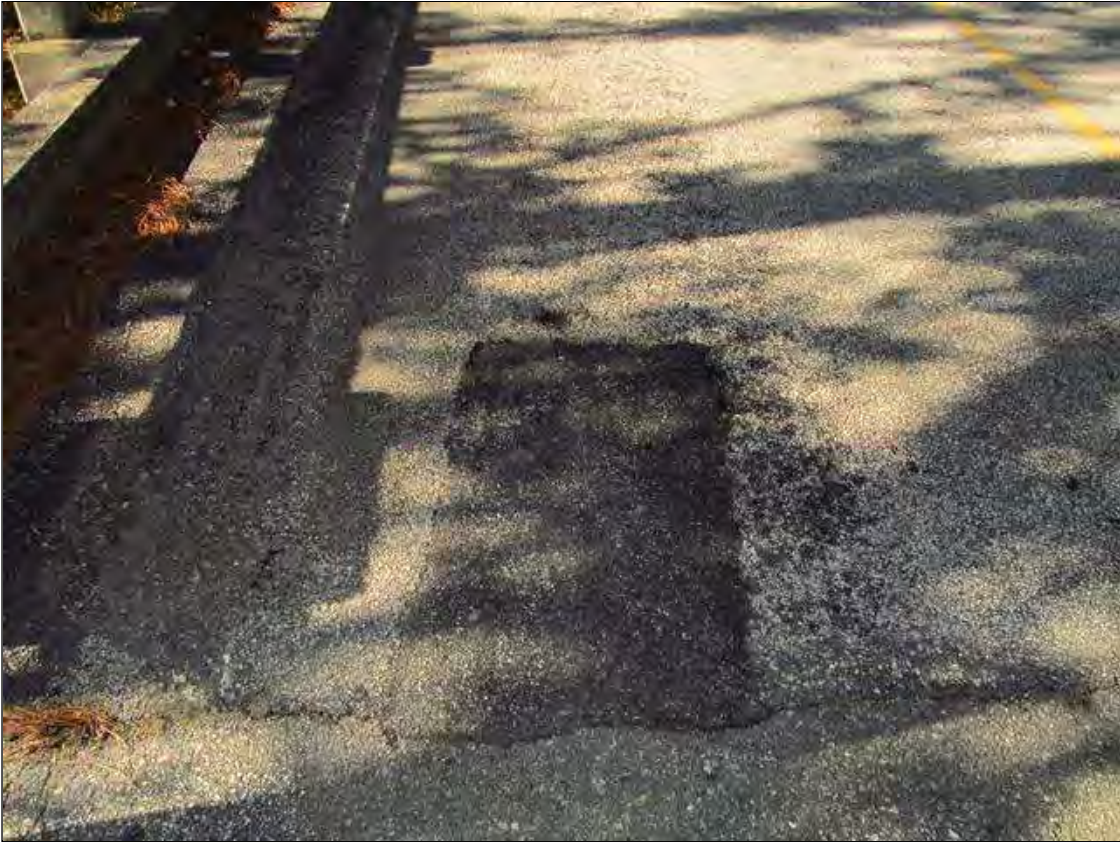
Asphalt patch in the Northbound lane at End Bent 2

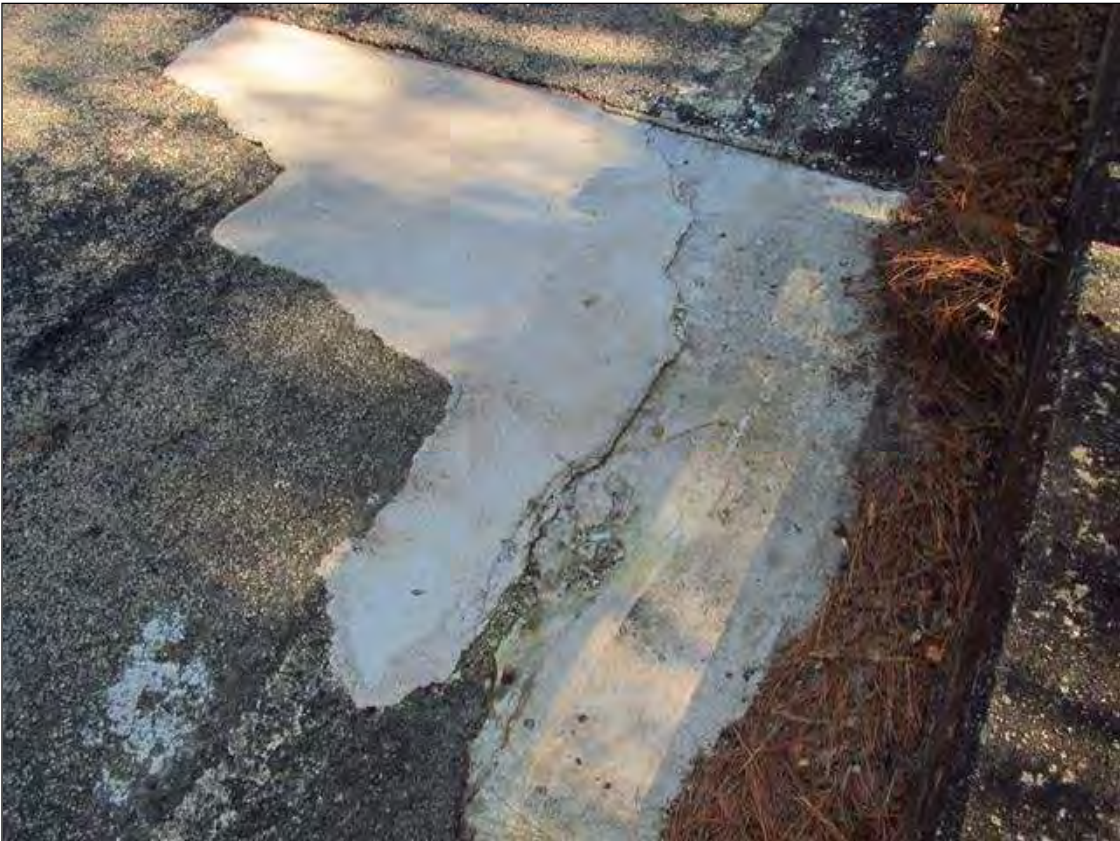
Concrete patch cracked and uneven in the Northbound lane of Span 1

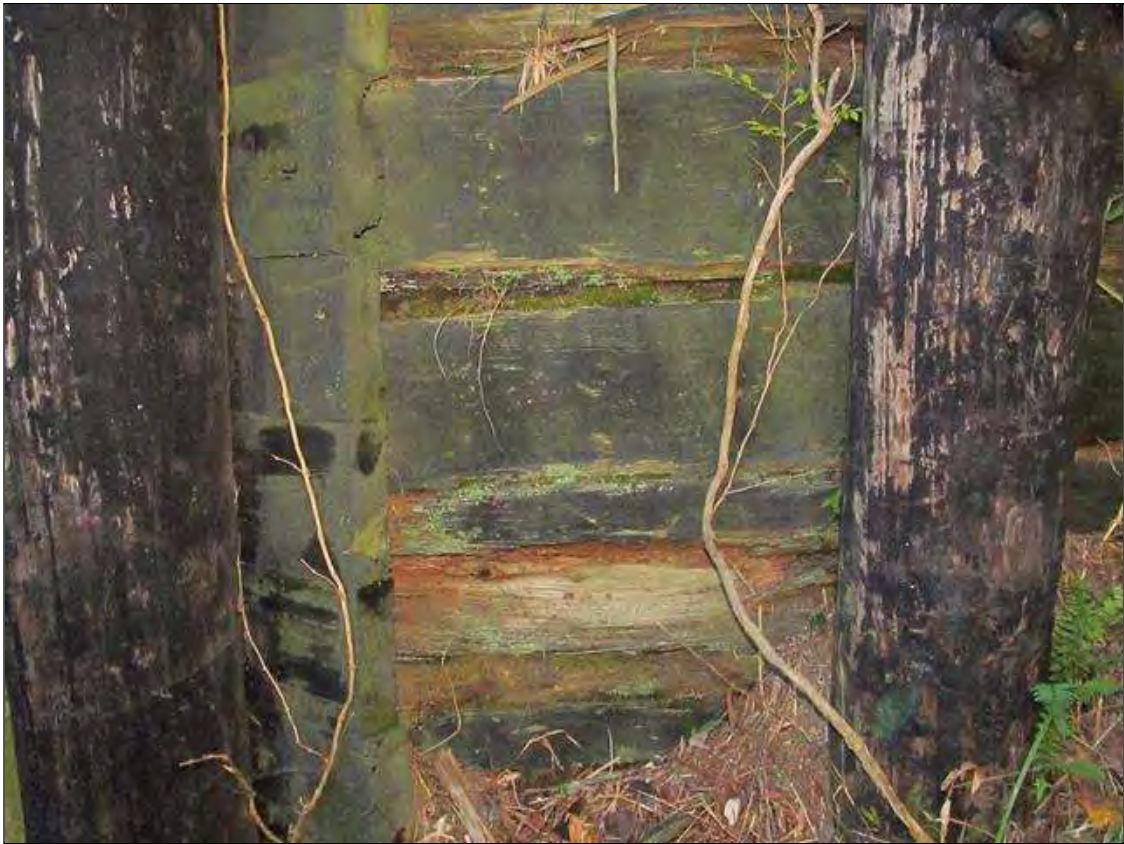
Decay and separation in the Left side Wingwall boards at End Bent 1

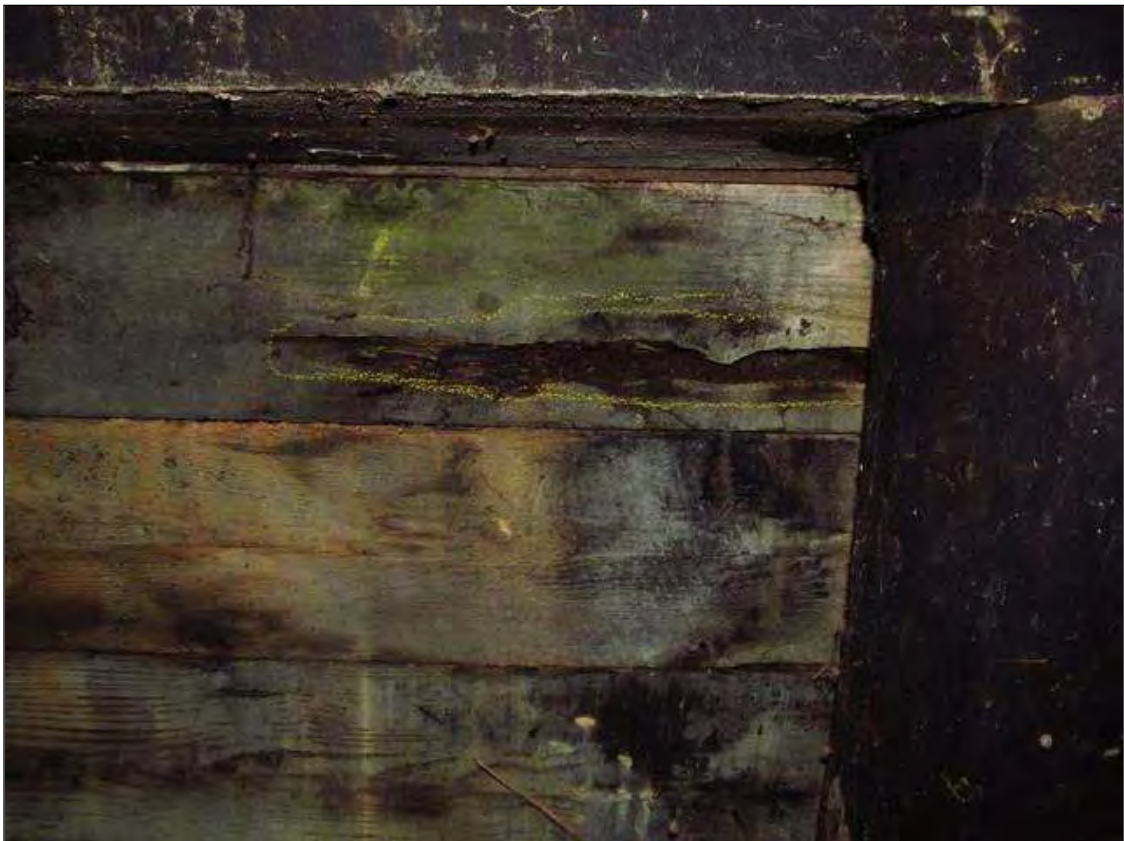
Rot areas of decay in Bulkhead boards at End Bent 1

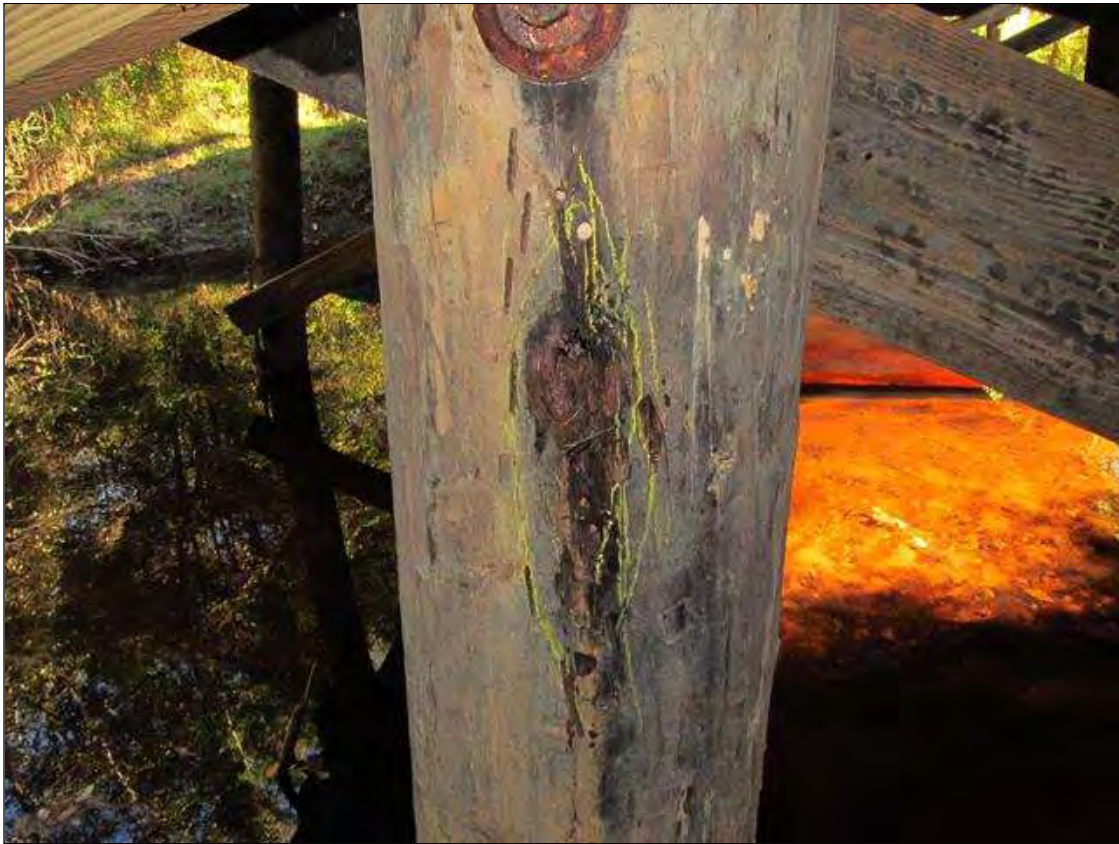
Decay in Span 1 side of Pile 2 at Bent 1

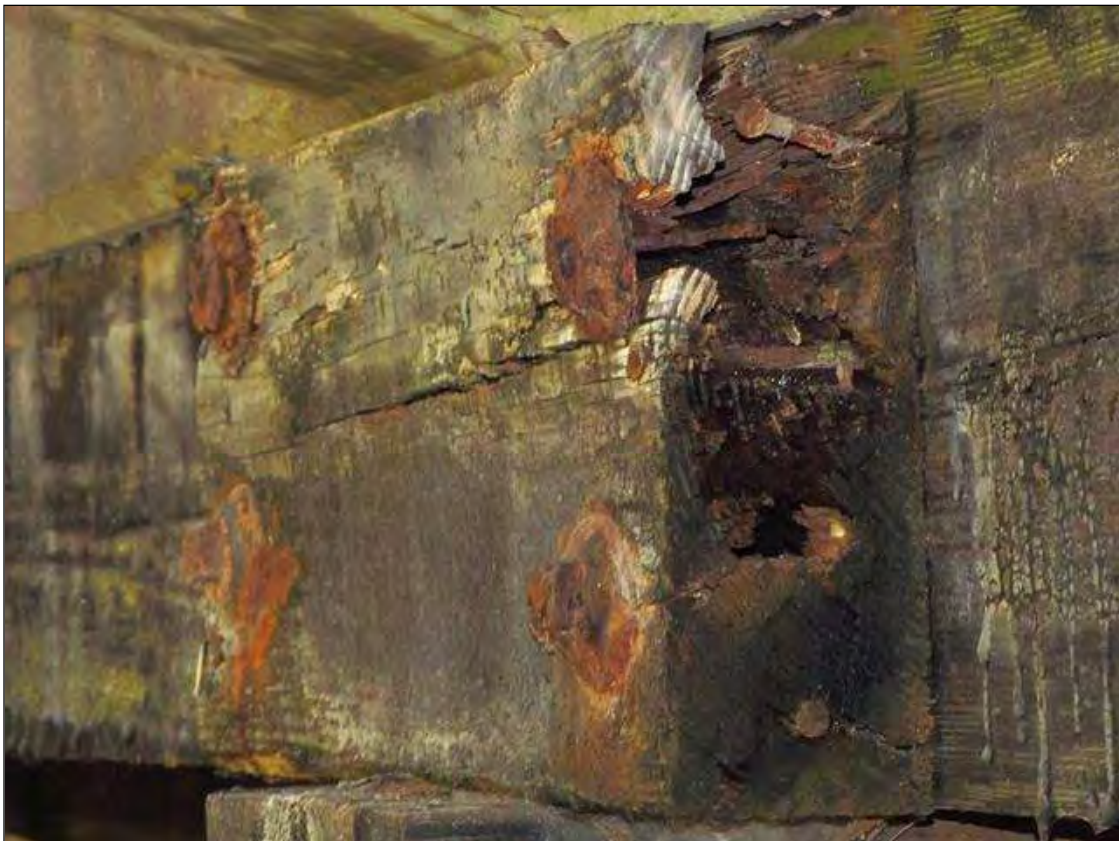
The splice block is decayed through at bent 1.

Decay in the Left side splice block at Bent 1 - Others similar

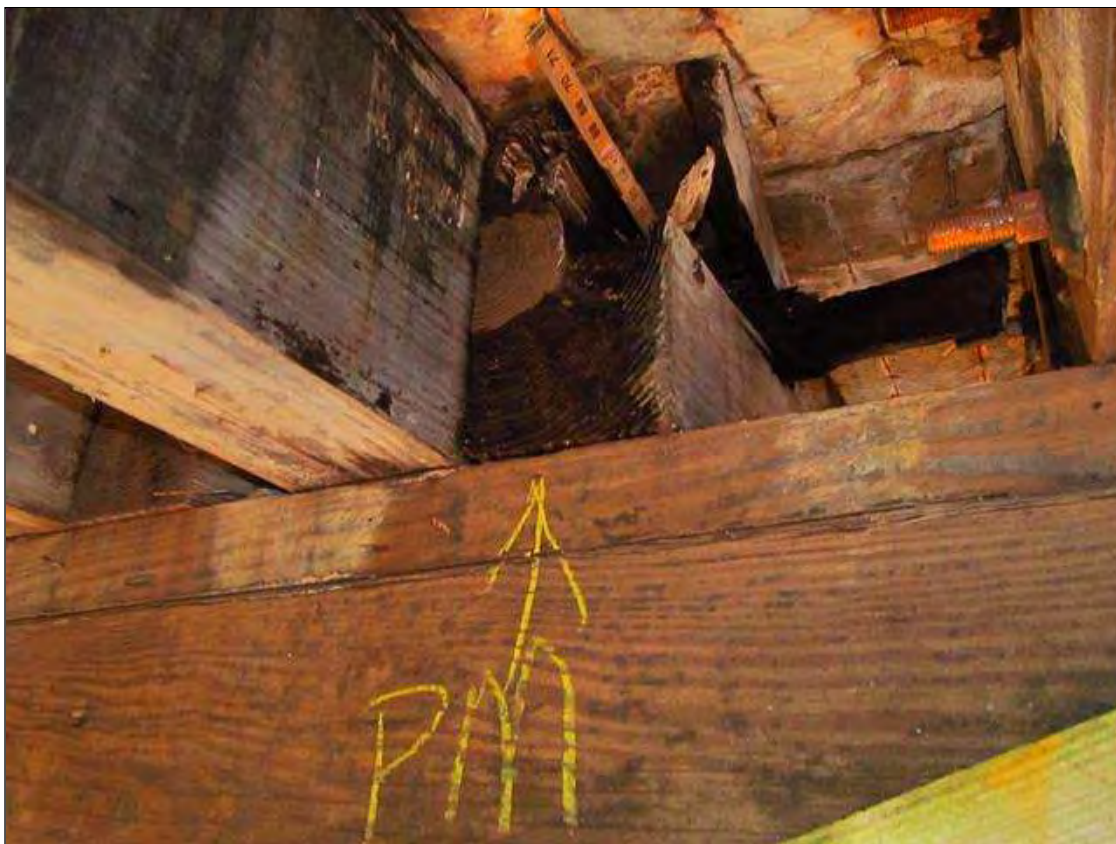
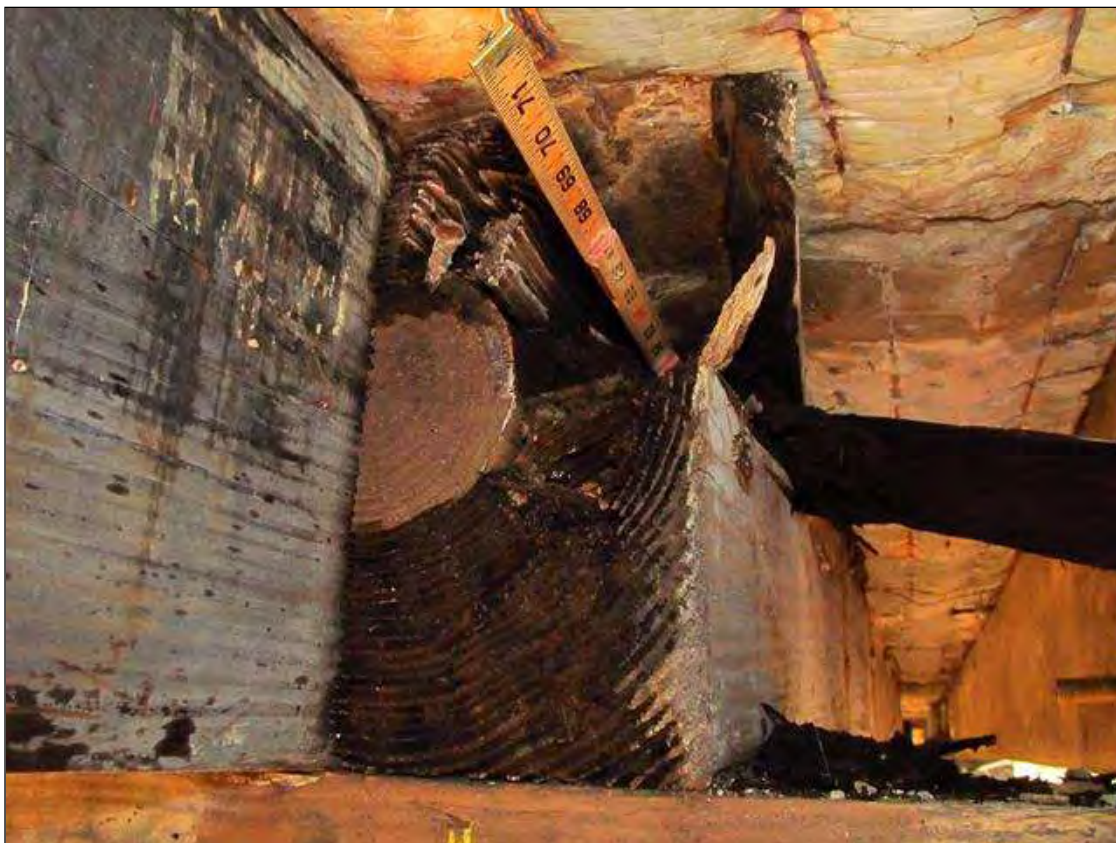
6 Feet of Decay/ decay 6 in high x 6 in wide x 5.5 ft long in top of joist at bent 4. priority maintenance issued

Decay in the end of Joist 18 in Span 5 over Bent 4 - Priority maintenance issued

MMS Code	MMS Description	Quantity
3304	Maintain/Replace Timber Superstructure Components	6 LF
Location:		
Beams and Girders	Bent/Span No. 5	JOIST #18 IN SPAN 5 OVER BENT 4
Priority Level	Status	
Priority Maintenance	Division Maintenance Work In Process	
Submitted Date:	Submitted By:	Assisted By:
10/21/2015	W.C. MAY	W.T. WILKINSON
Details		
Joist 18 span 5 at bent 4 is decayed 5 in wide x 6 in high x 5.5 feet long in the top portion of the joist.

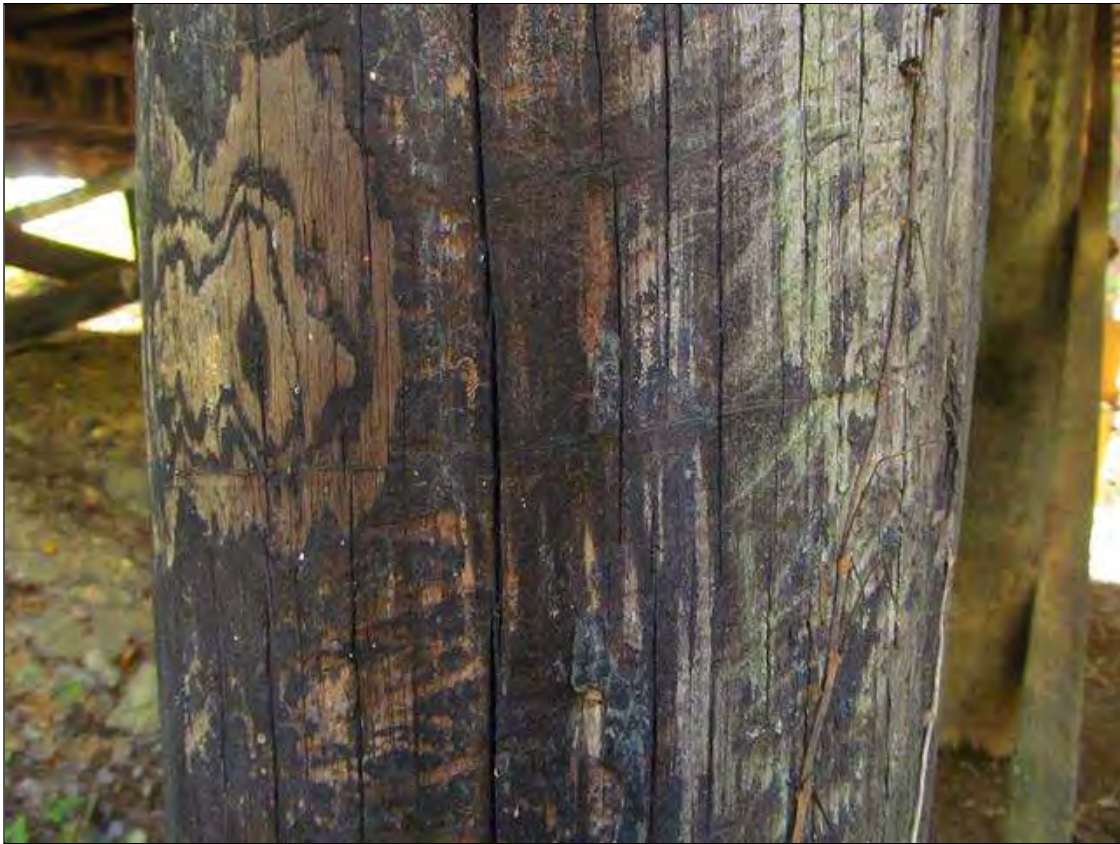
Random vertical checking throughout all timber piles

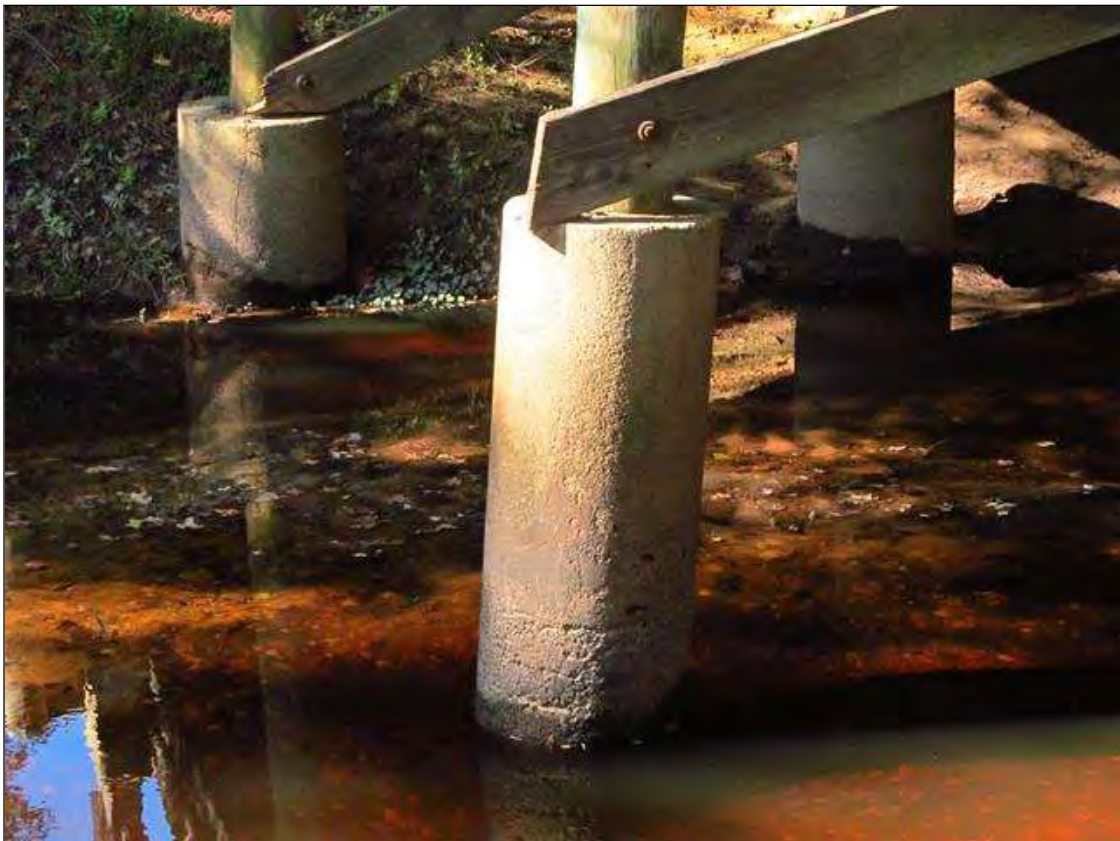
Temporary pile repairs throughout structure

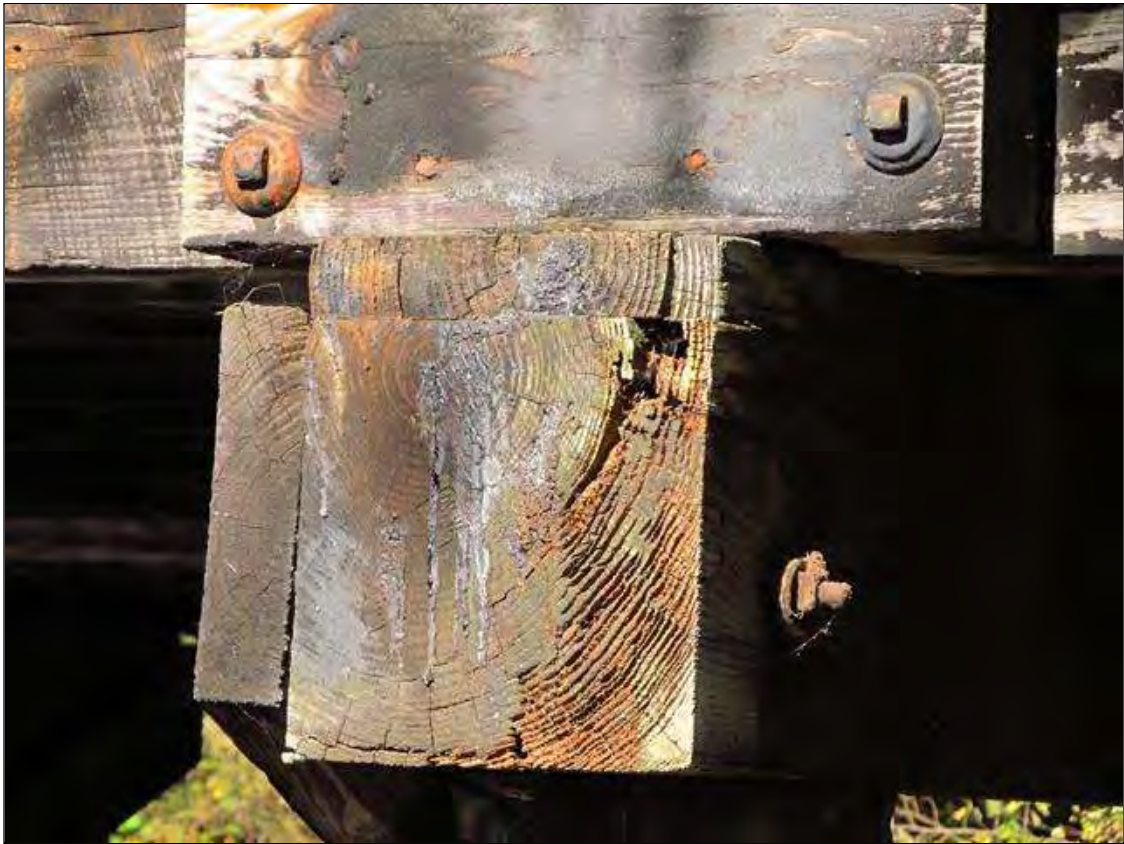
Decay in right End of cap at Bent 3

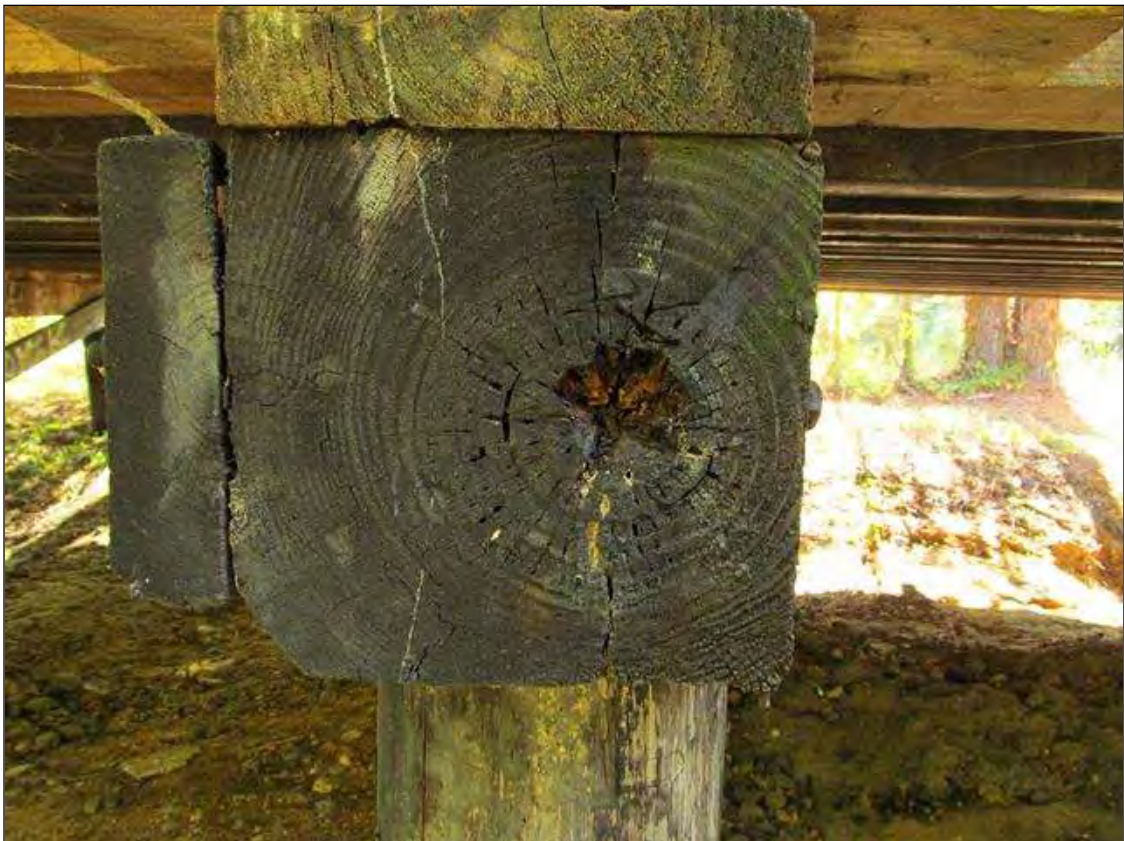
Decay in left End of cap at Bent 5

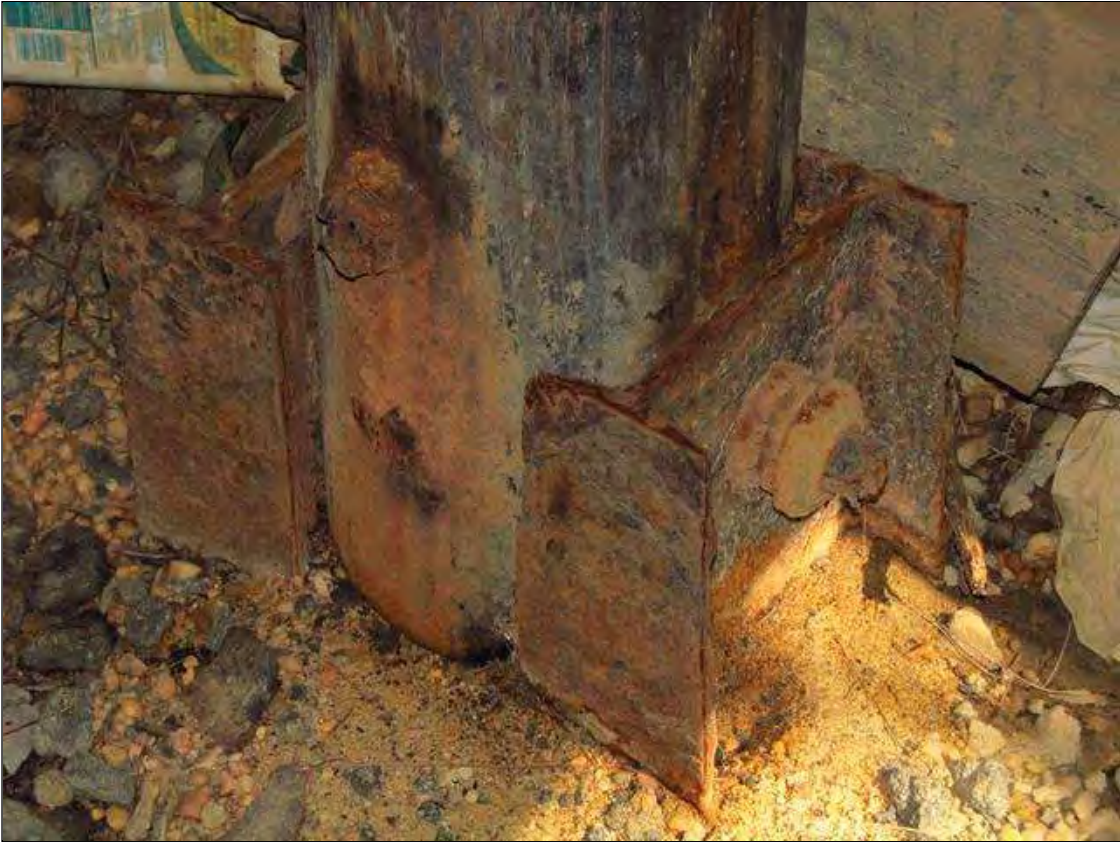
Temporary repair for Pile 3 at Bent 5

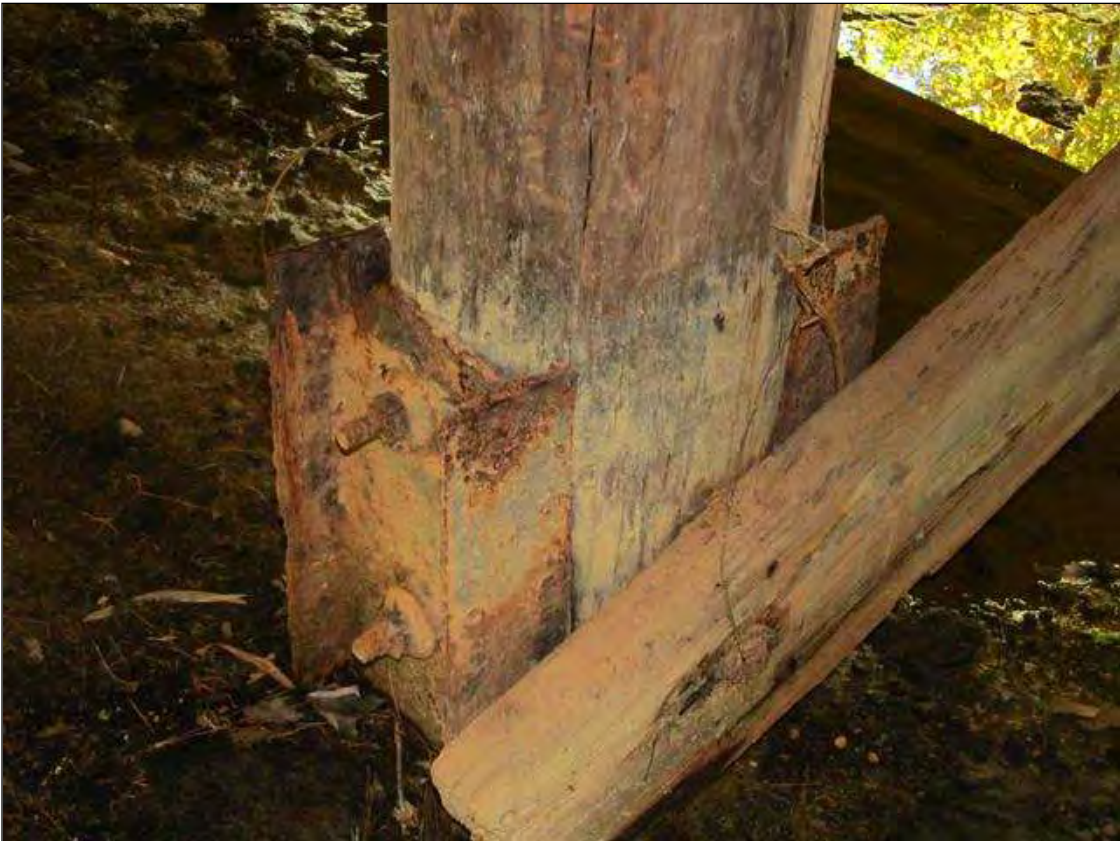
Temporary Repair for Pile 2 at Bent 6
