NC DEPARTMENT OF TRANSPORTATION
 DIVISION OF HIGHWAYS
 STRUCTURE MANAGEMENT UNIT

Structure Safety Report

Routine Element Inspection

COUNTY: JOHNSTON STRUCTURE NUMBER: 500239 FREQUENCY: 24 MONTHS

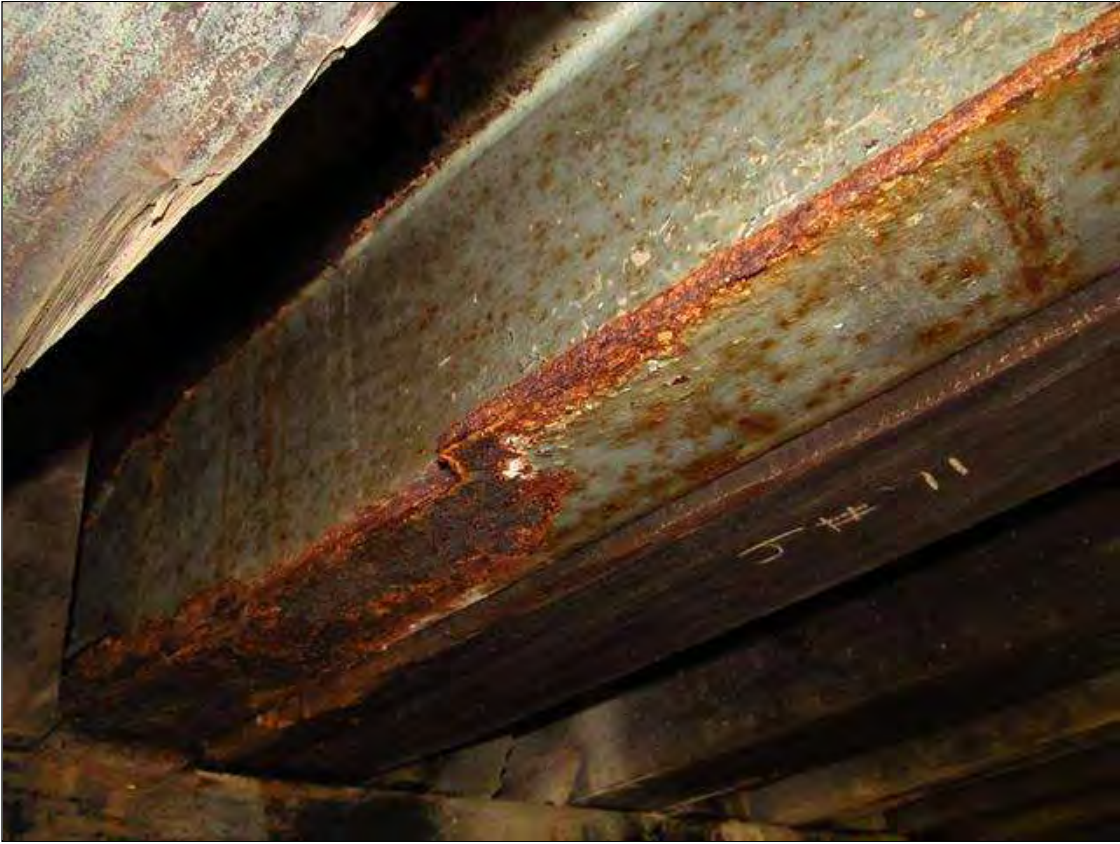
Section loss in the Bottom flange of beam 12 in Span 6 over Bent 5

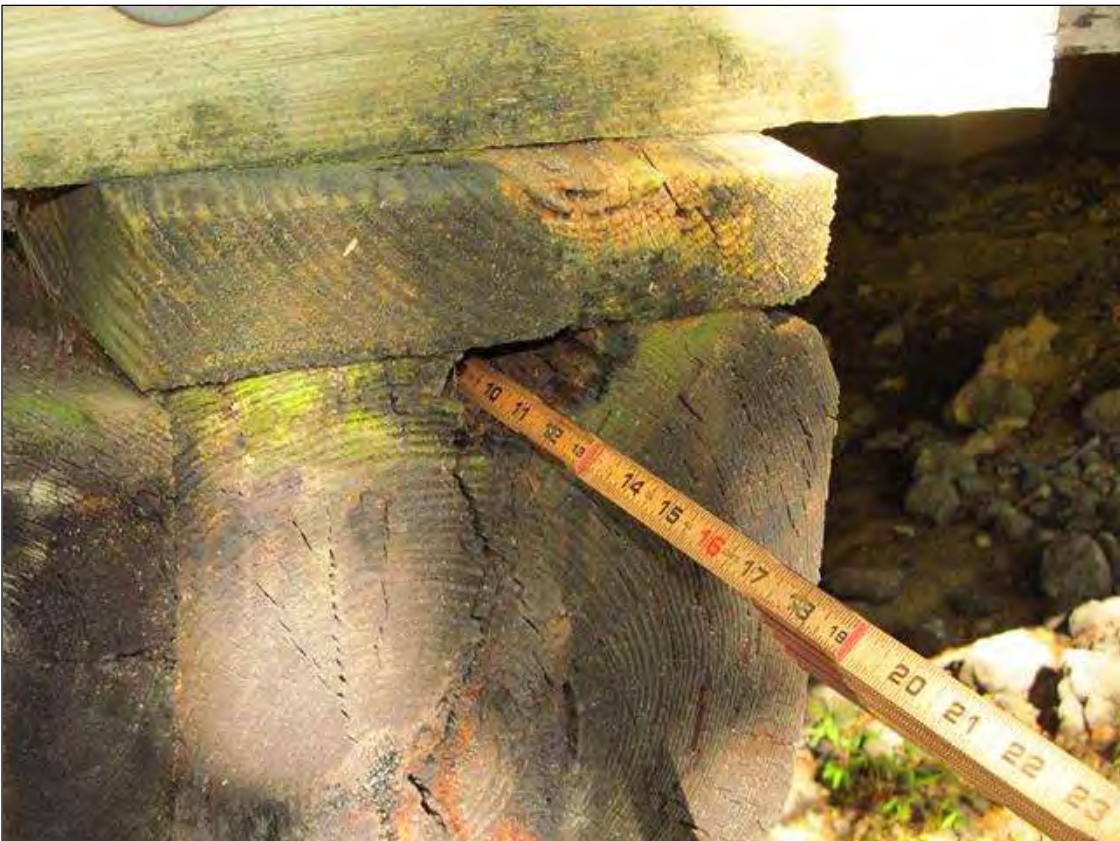
Decay in right End of cap at Bent 7

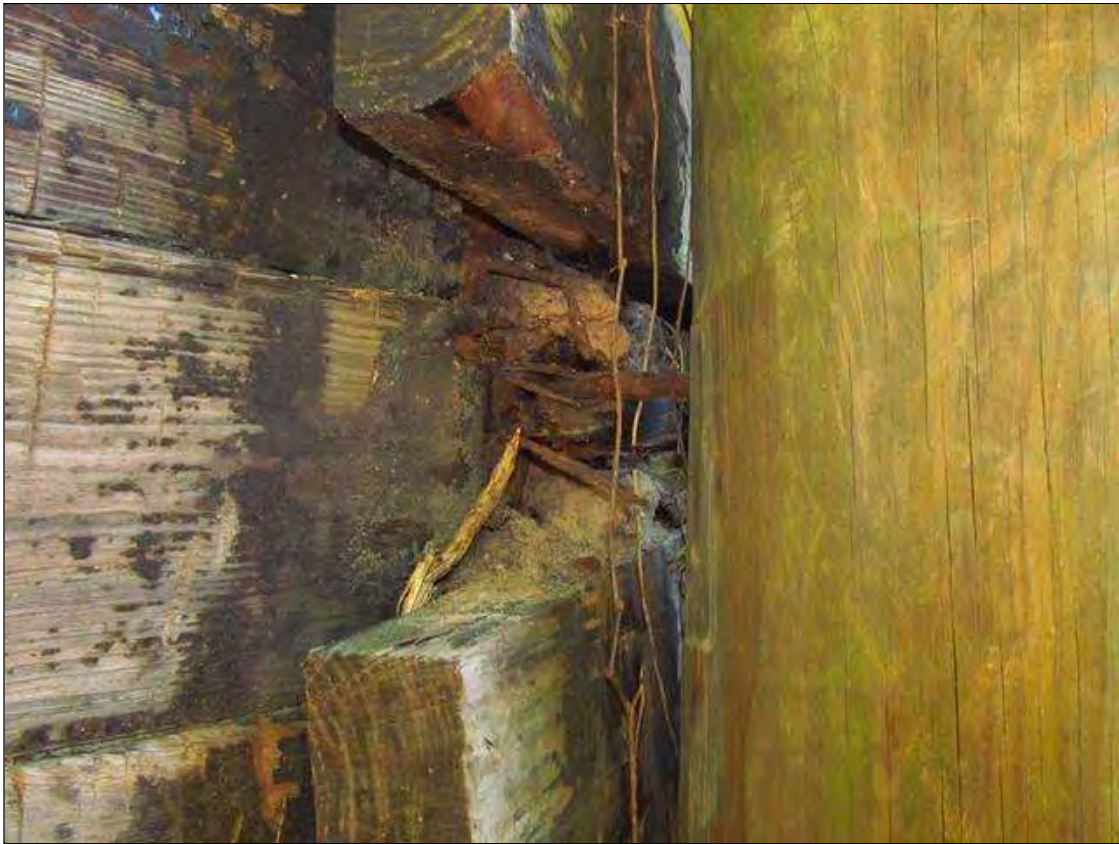
2nd Bulkhead board from top at End Bent 2 decayed and missing from the left end to left end of cap

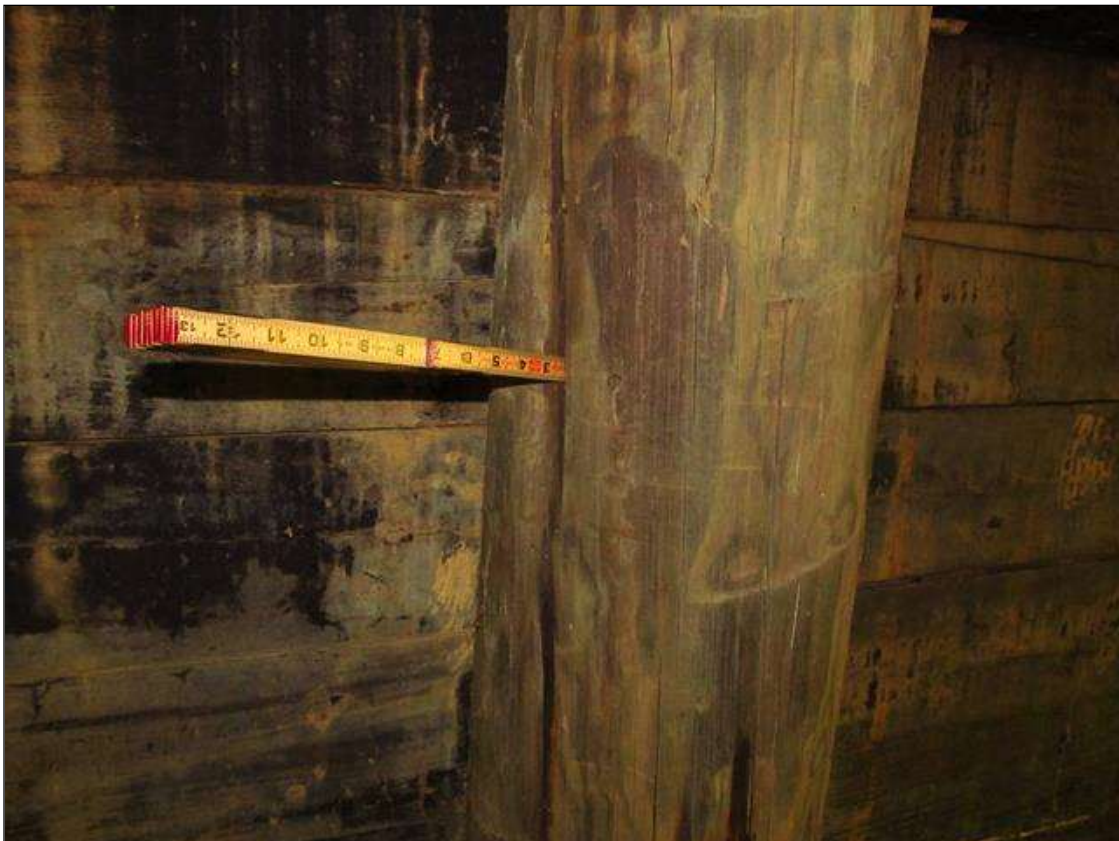
2-1/4" deep vertical check in Pile 2 at End Bent 2

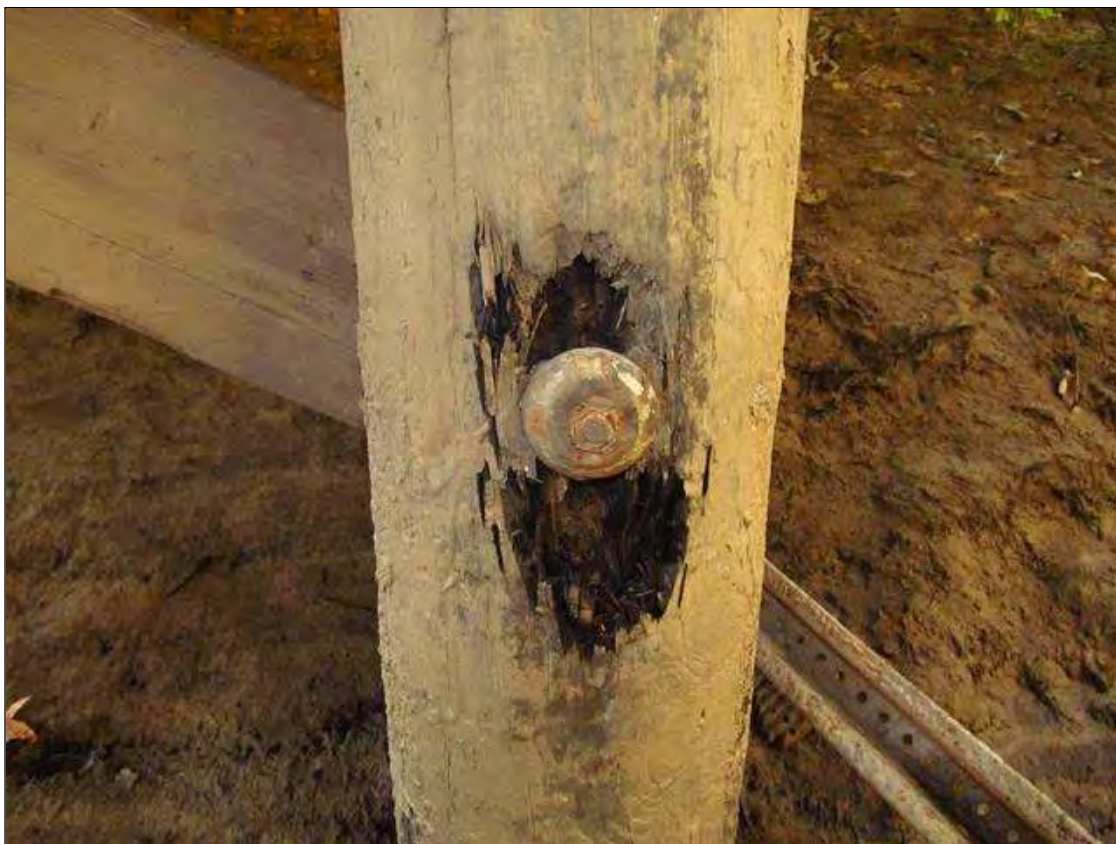
Decay in Span 2 side of Pile 2 at Bent 1 lower crossbrace connection - Pile 1 at Bent 2 similar

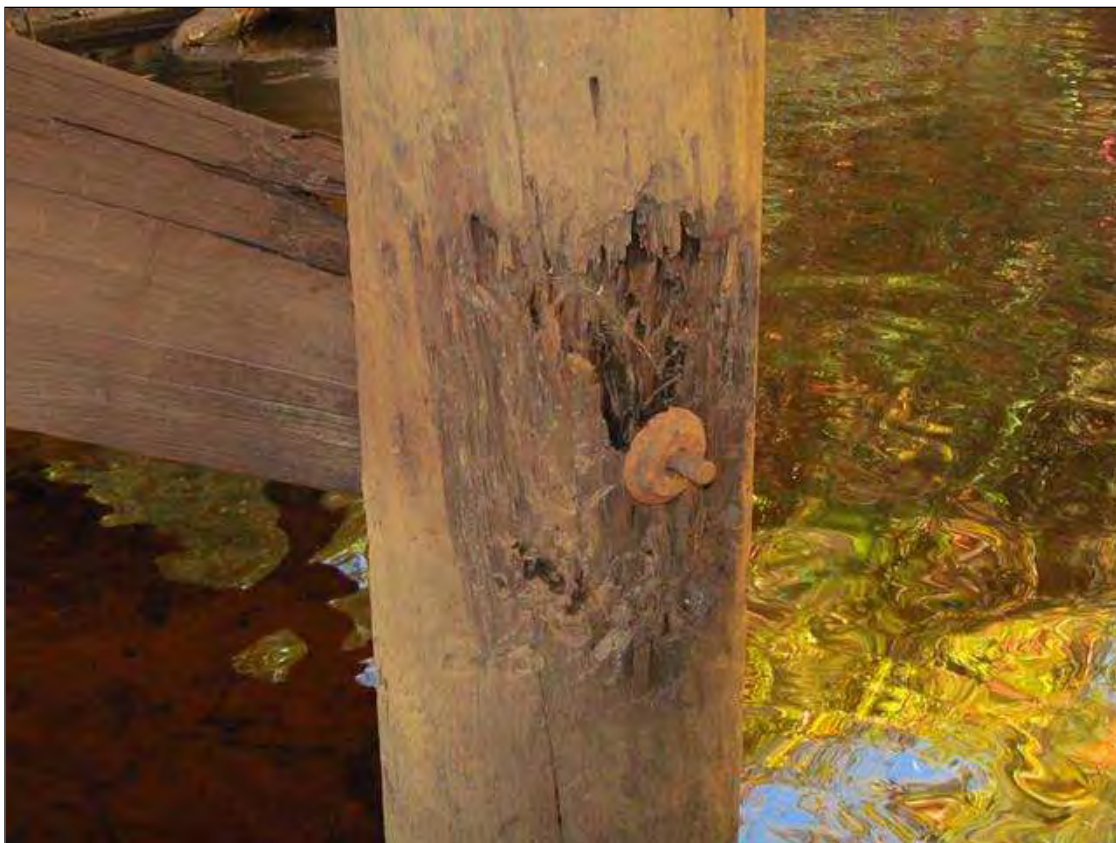
Decay in Span 3 side of Pile 2 at Bent 2 lower crossbrace connection

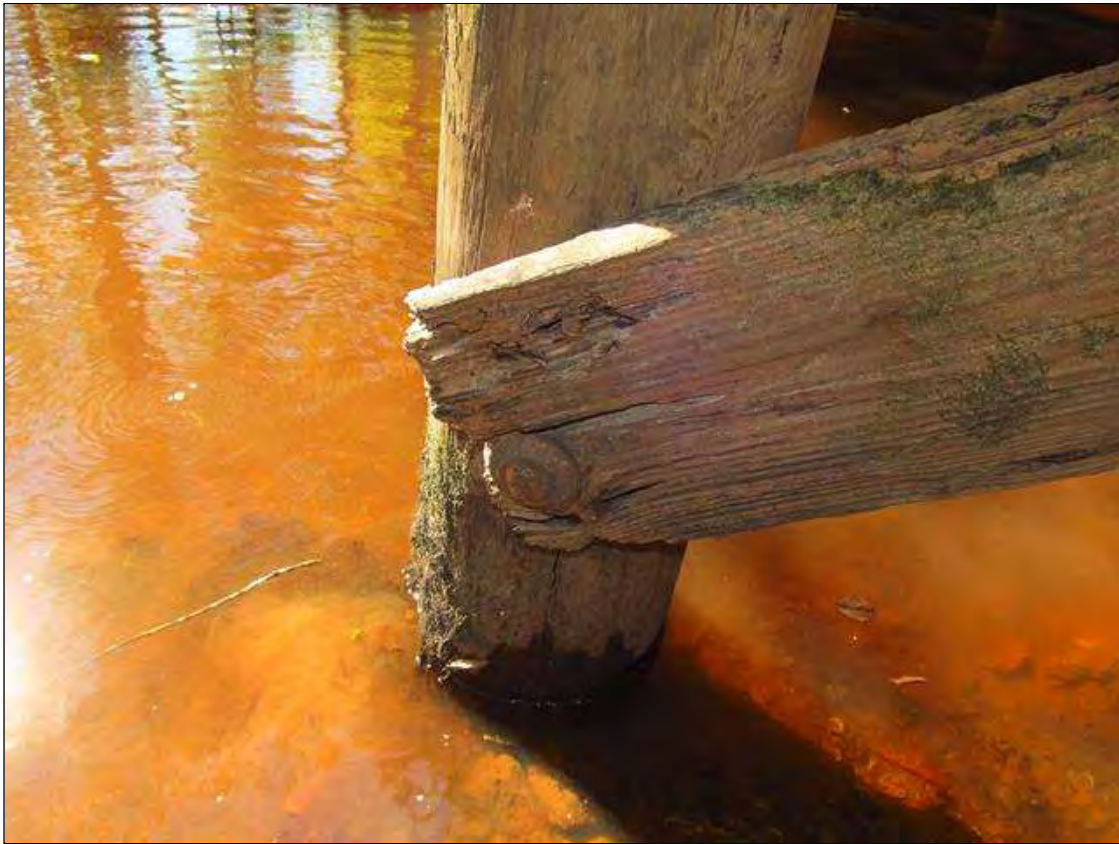
Decay in end of lower crossbrace for Pile 4 at Bent 3 span 4 side

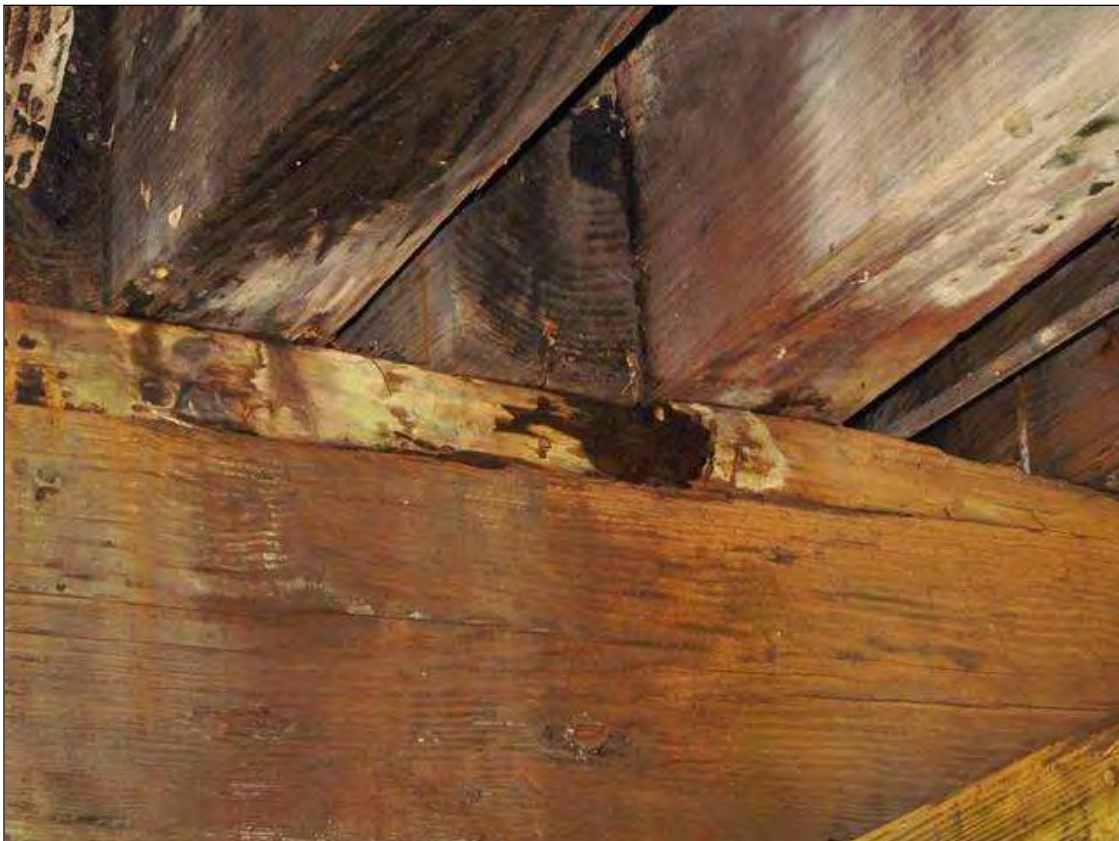
Decay in Bent 3 crownstrip span 4 side at Joist 2

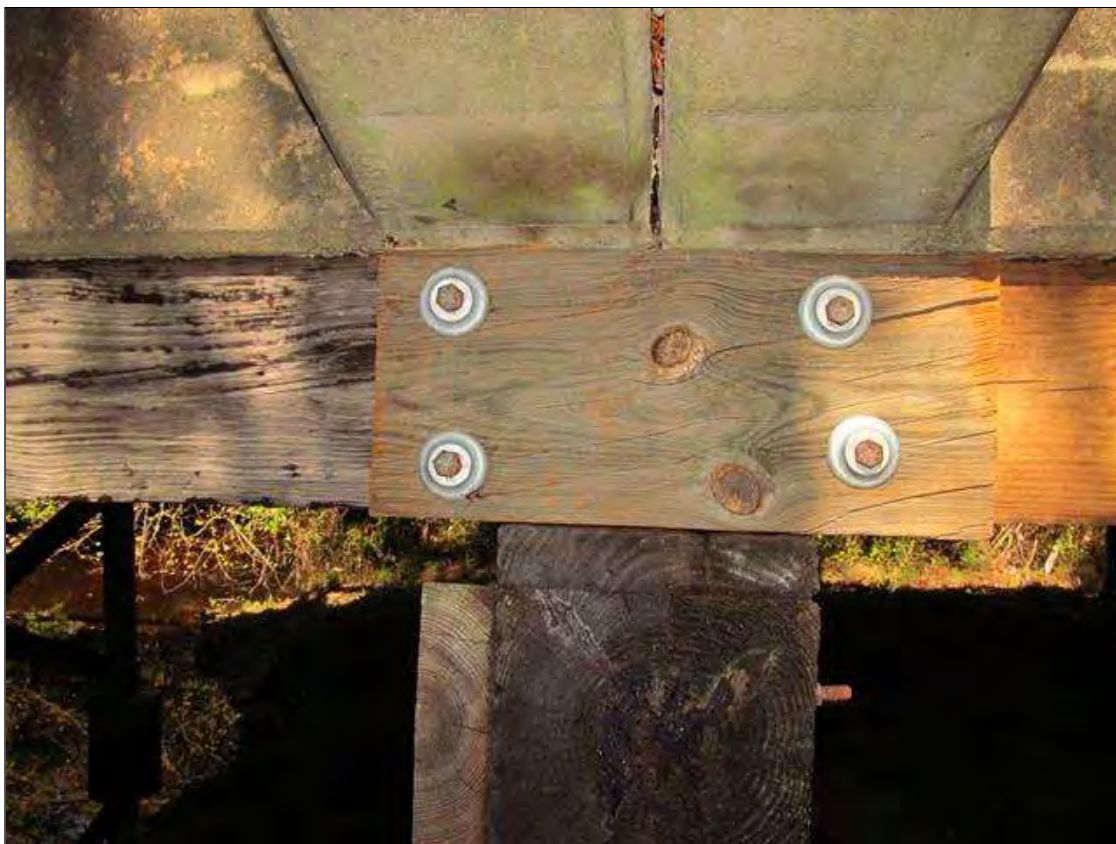
New splice block has been added at the Right side of Bent 4 - Others similar

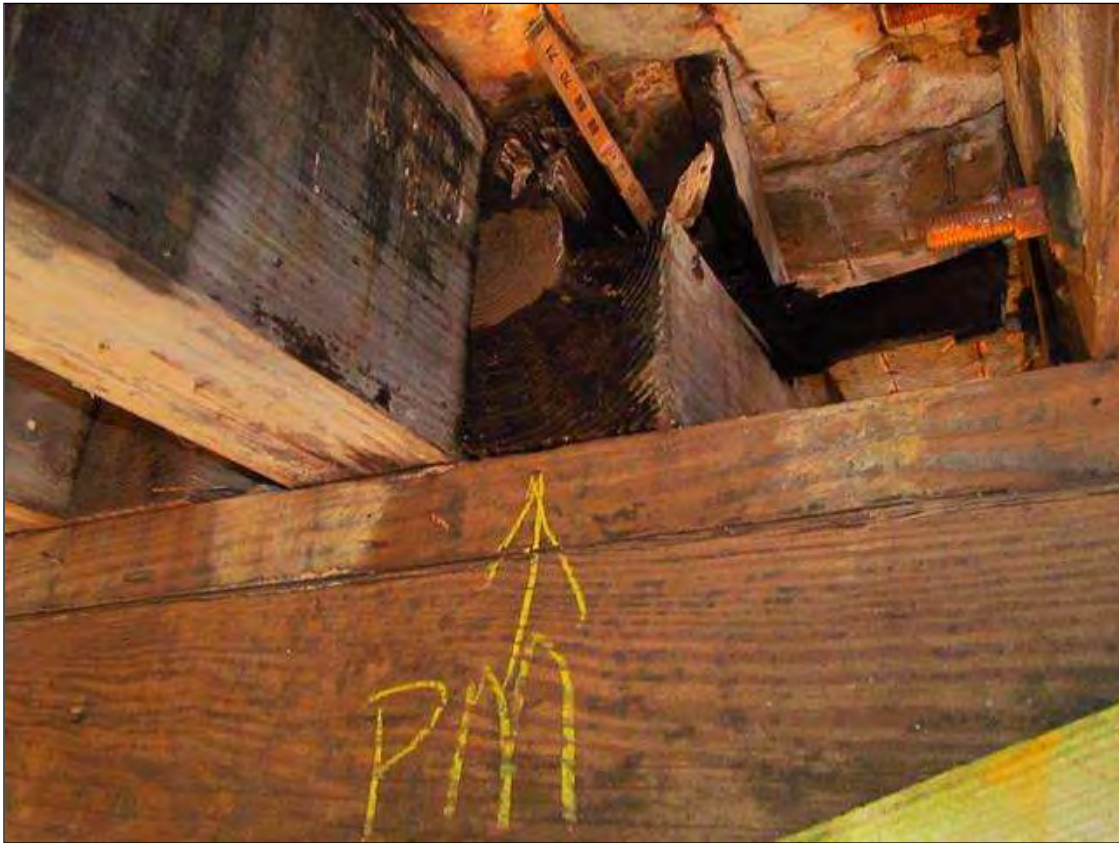
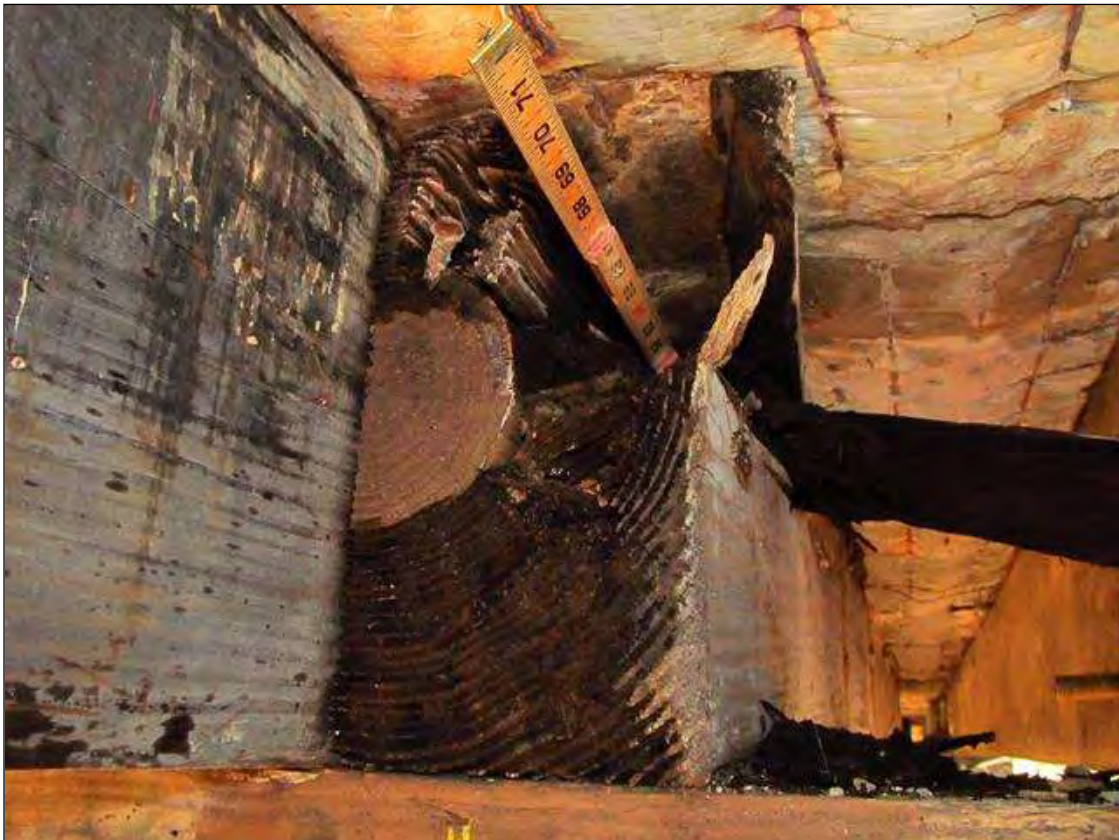
5.5 FT. DEEP DECAY IN THE END OF JOIST 18 IN SPAN 5 OVER BENT 4

MMS Code	MMS Description	Quantity
3304	Maintain/Replace Timber Superstructure Components	6 LF
Location:		
Beams and Girders	Bent/Span No. 5	JOIST #18 IN SPAN 5 OVER BENT 4
Priority Level	Status	
Priority Maintenance	Division Maintenance Work In Process	
Submitted Date:	Submitted By:	Assisted By:
10/21/2015	W.C. MAY	W.T. WILKINSON
Details		
Joist 18 span 5 at bent 4 is decayed 5 in wide x 6 in high x 5.5 feet long in the top portion of the joist.
