NC DEPARTMENT OF TRANSPORTATION
 DIVISION OF HIGHWAYS
 STRUCTURE MANAGEMENT UNIT

Structure Safety Report

2 Year Complete Topside and Underwater Element Inspection

COUNTY: WILSON STRUCTURE NUMBER: 970143 FREQUENCY: 24 MONTHS

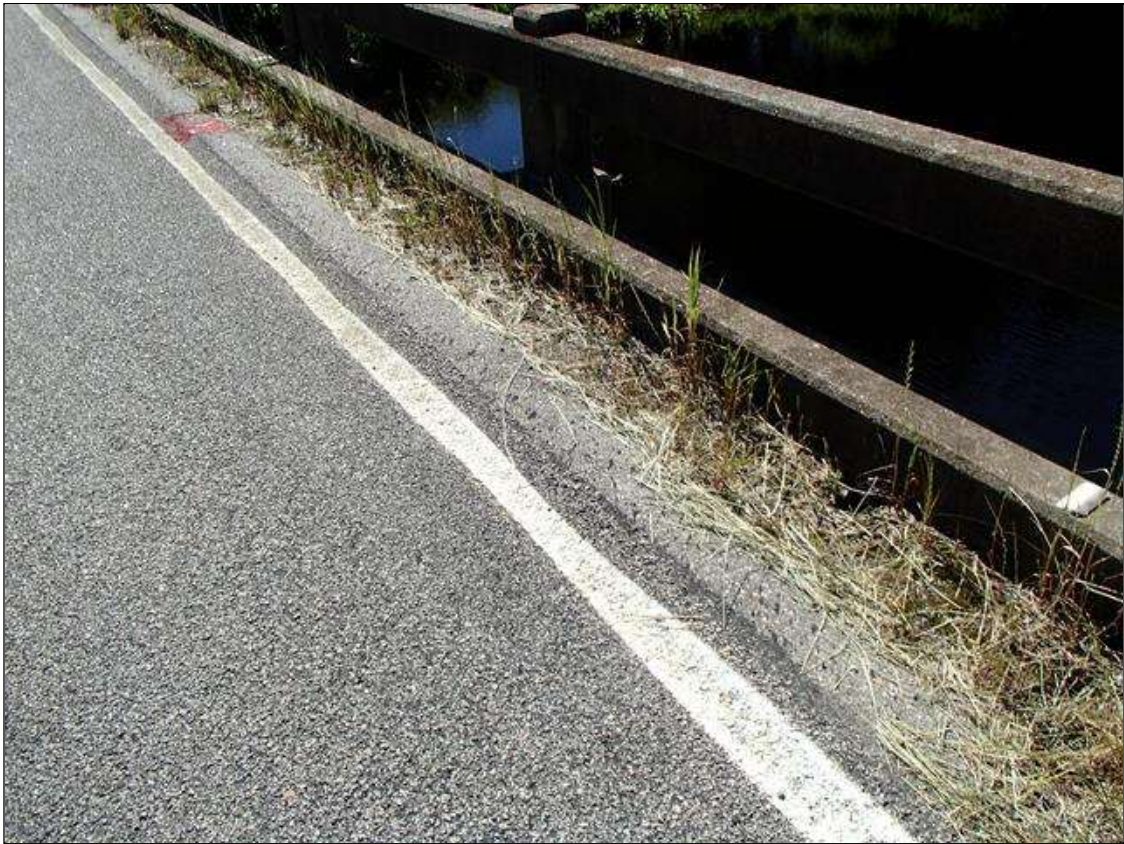
DECK DEBRIS

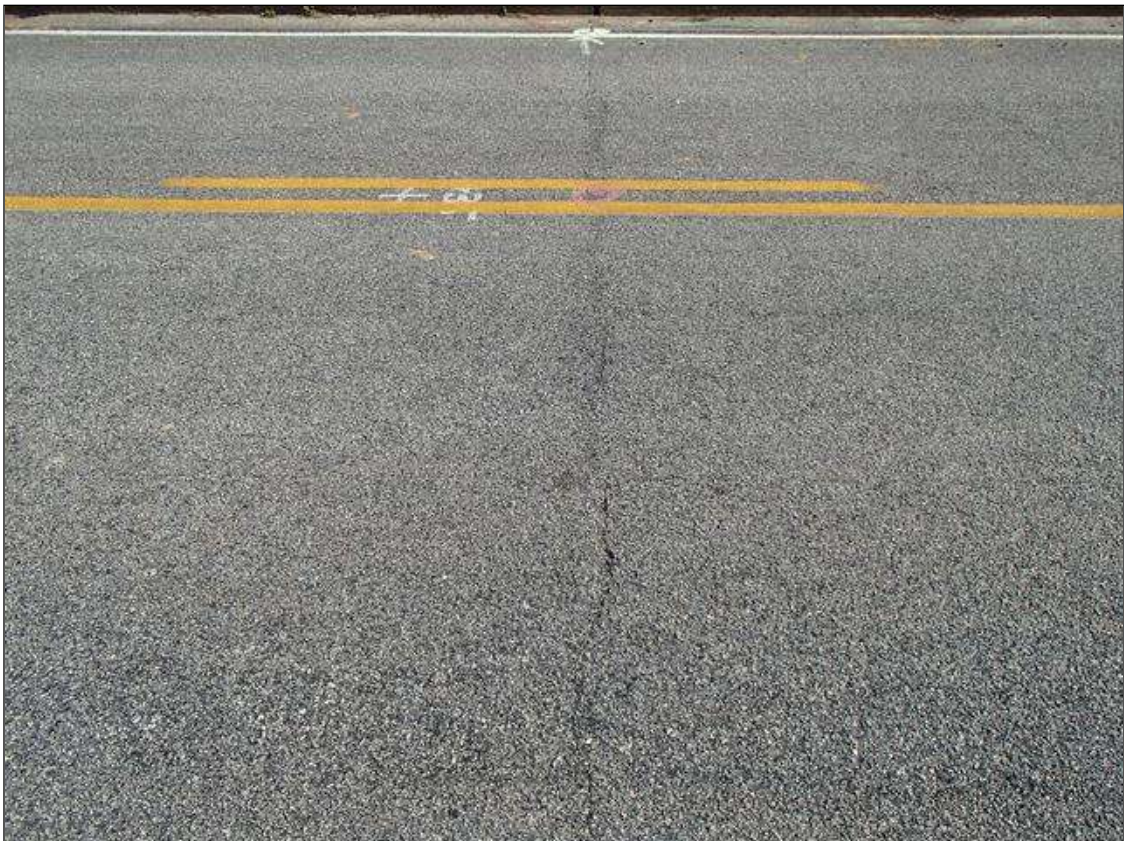
Element Number	Defect Type	Defect Description	CS	CS Qty	Maint Qty
510	Crack (Wearing Surface)	Hairline crack in aws over bent 1	2	24	24 Square Feet

HAIRLINE CRACK IN AWS OVER BENT 1

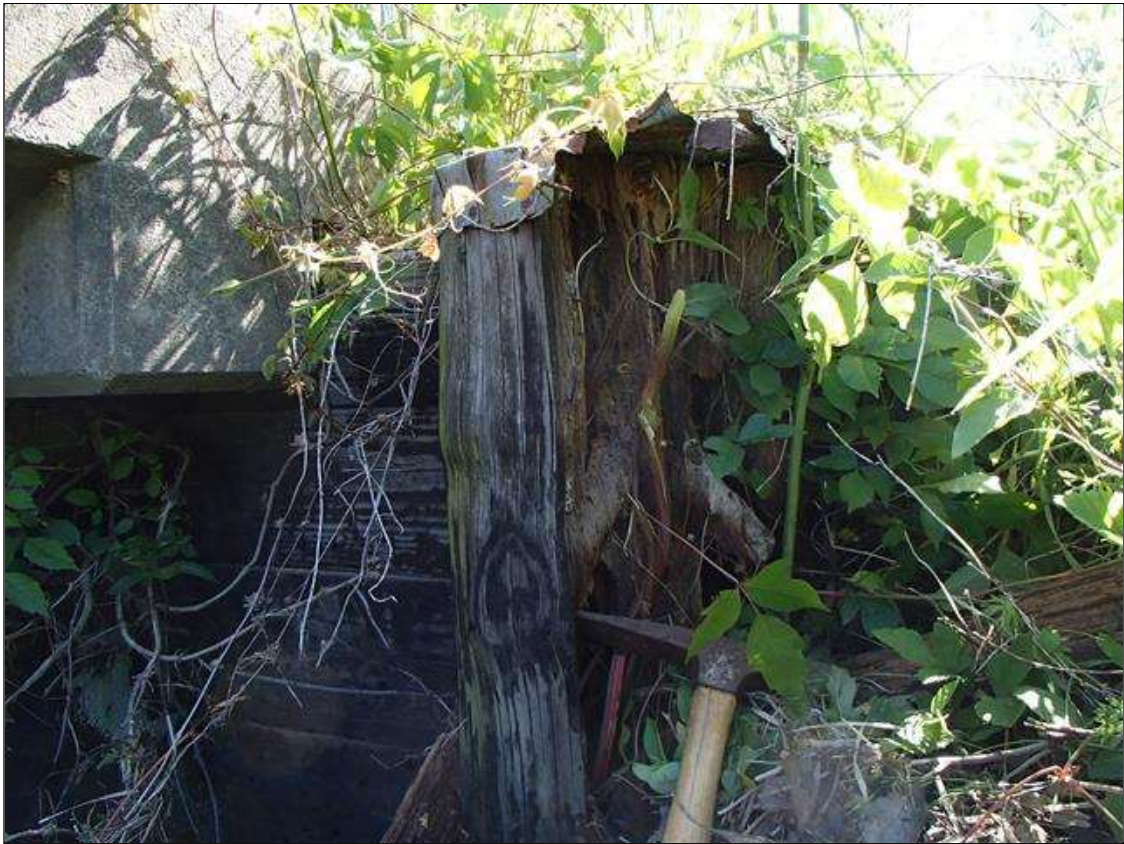
Details 100% decay on wingwall retention piles. south east retention pile and south west retention pile 100% decayed.

SOUTH EAST RETAINING PILE 100% DECAY

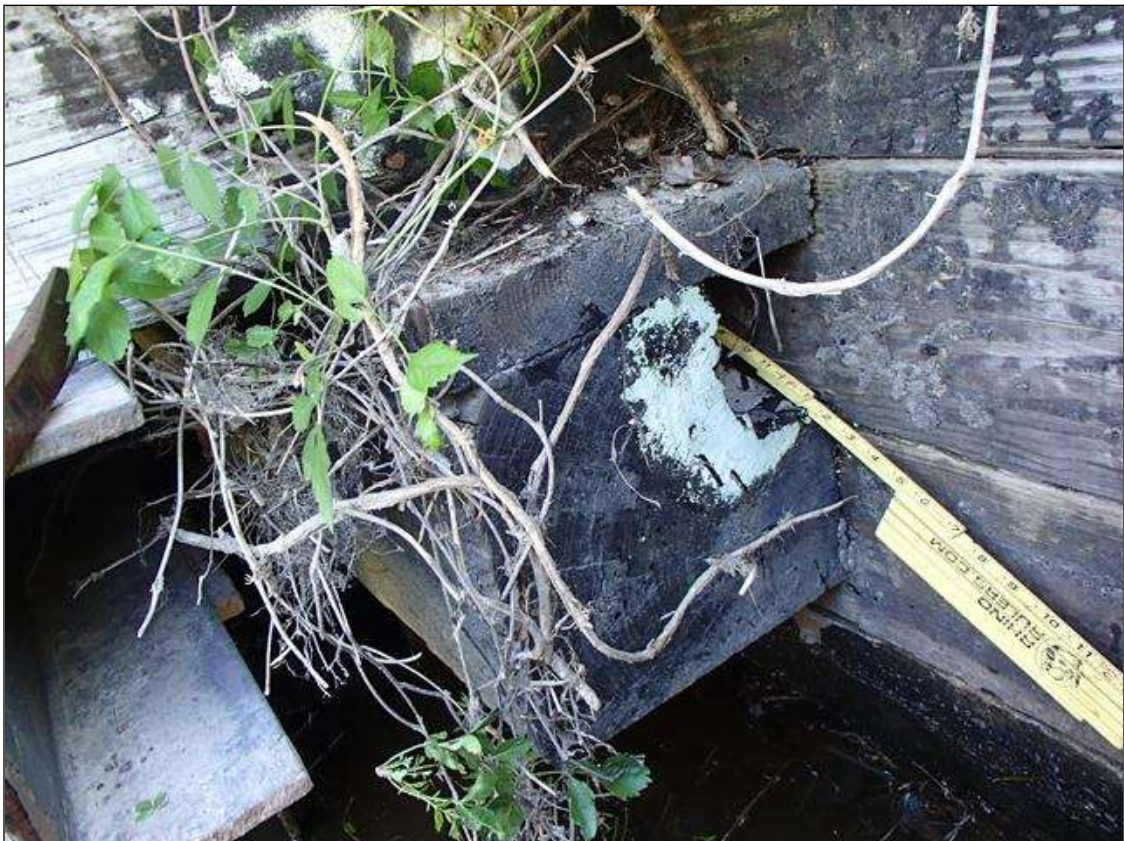
Element Number	Defect Type	Defect Description	CS	CS Qty	Maint Qty
235	Decay/Section Loss	Left end of cap decayed 4" deep x 5" wide x 5" long	4	1	1 Feet
235	Decay/Section Loss	Right end of cap decayed 1' deep x 6" wide x 6" long	4	1	1 Feet
235	Check/Shake	Checks to 1/8"	2	24	24 Feet

END BENT 2 RIGHT END OF CAP DECAY (BEYOND CRUTCH BENT)

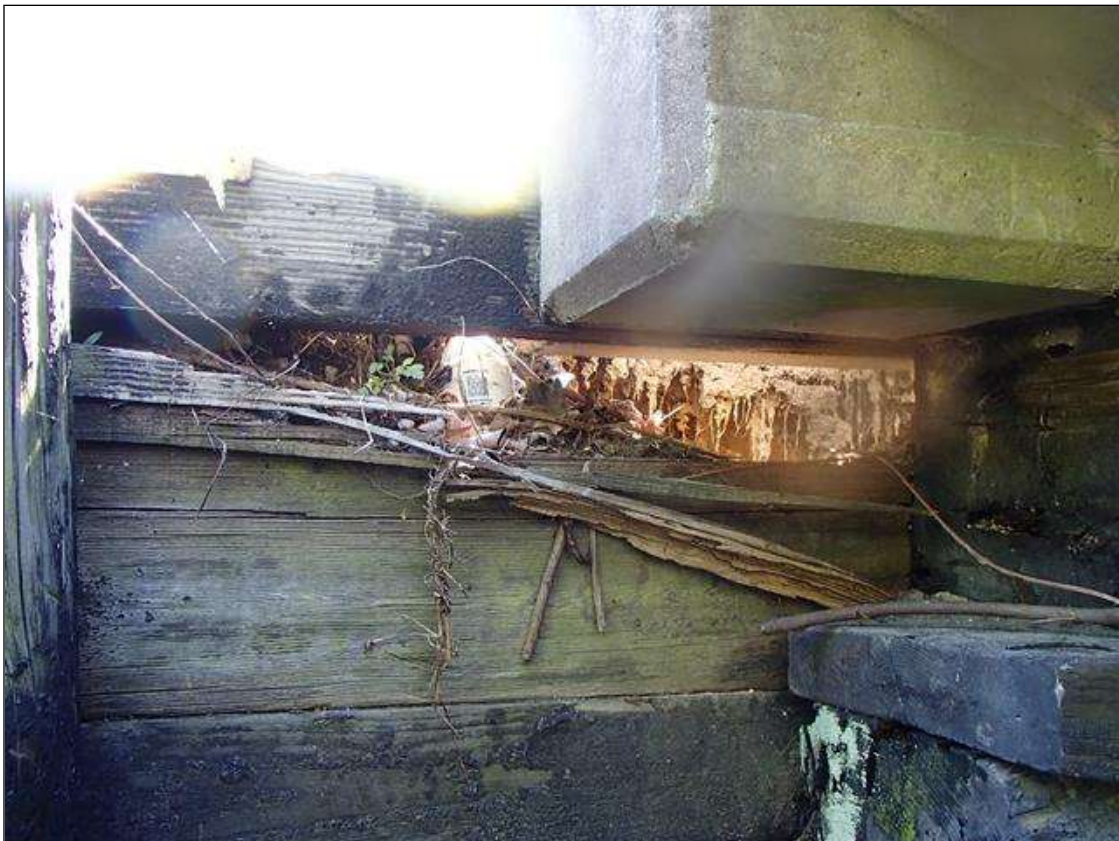
Element Number	Element Name	Total Qty	CS1 Qty	CS2 Qty	CS3 Qty	CS4 Qty
216	Decay/Section Loss	Bulkhead board 1 near north east retention pile - 3'long x 5" high missing	4	3	3	3 Feet
216	Scour	Undermining under bulkhead board #8 and losing fill.	4	3	3	3 Feet
216	Check/Shake	Checks to 1/8"	2	20	20	20 Feet

BULKHEAD BOARD 1 LEFT AT END BENT 2 MISSING 3'

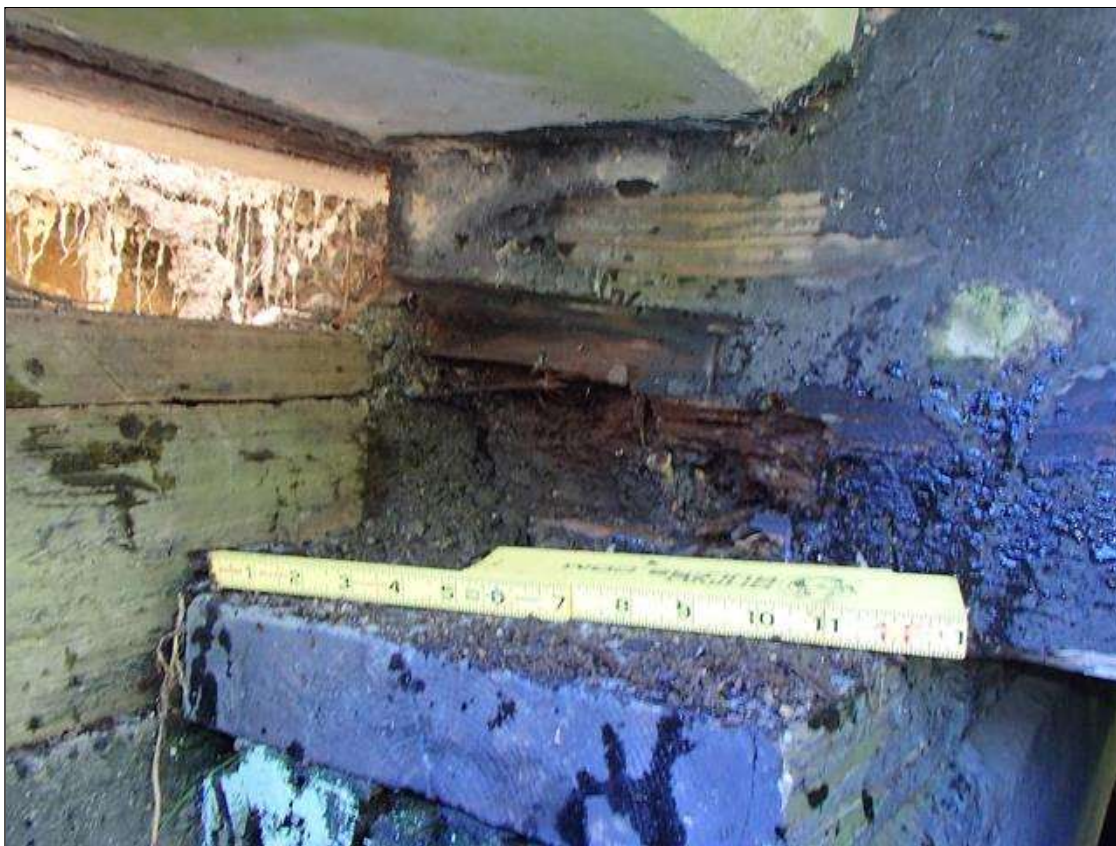
Element Number	Defect Type	Defect Description	CS	CS Qty	Maint Qty
111	Decay/Section Loss	Decayed up to 5" deep x 1' long x 5" high at end bent 2 beyond crutch bent.	4	1	1 Feet
111	Check/Shake	Checks to 1/8"	2	17	17 Feet

BEAM 1 AT END BENT 2 DECAYED (BEYOND CRUTCH BENT)

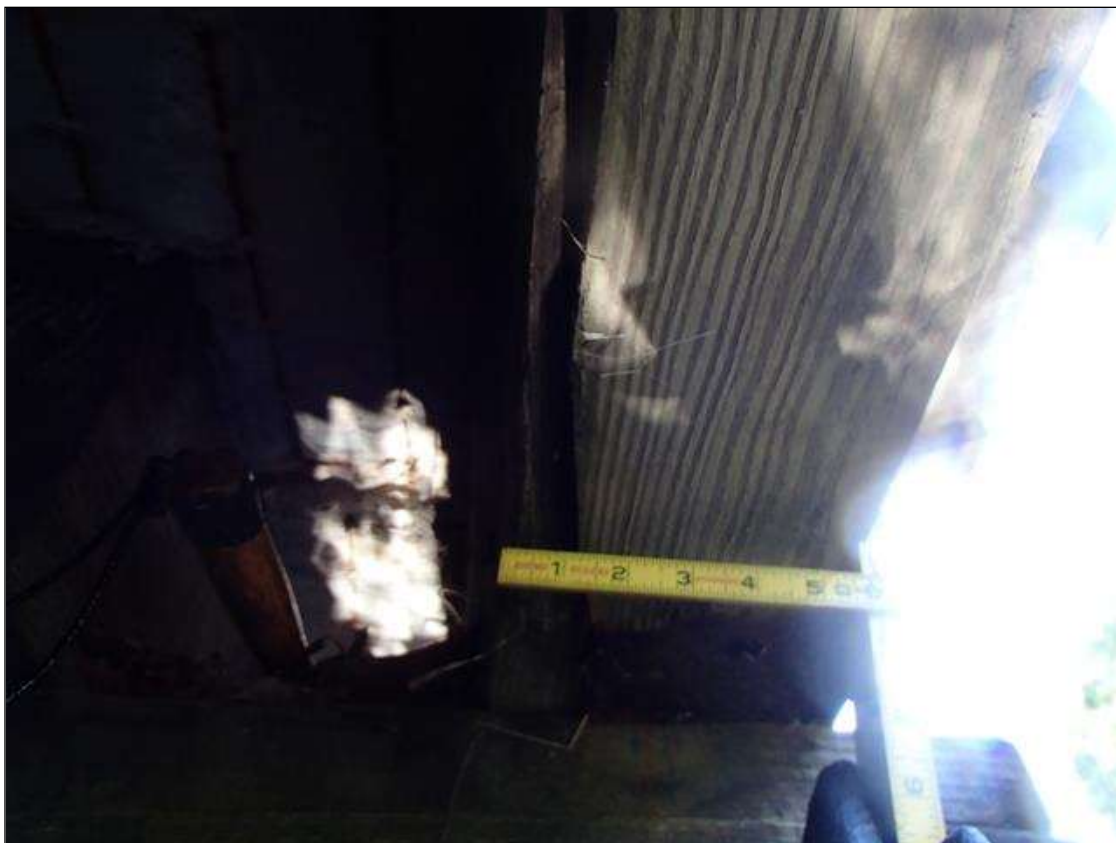
Element Number	Defect Type	Defect Description	CS	CS Qty	Maint Qty
111	Split/Delamination (Timber)	1" wide split over bent 1 - 2' long	3	2	2 Feet
111	Check/Shake	Checks to 1/8"	2	7	7 Feet
111	Damage	Beam rotated inward 1.5" midspan to bent 1	2	9	9 Feet

BEAM 19 SPAN 1 - 1" WIDE SPLIT OVER BENT 1 - 2' LONG

ATTENTION: **P.M. issued for split beam 19, span 1. Sinkhole at N.E. bridge rail.**

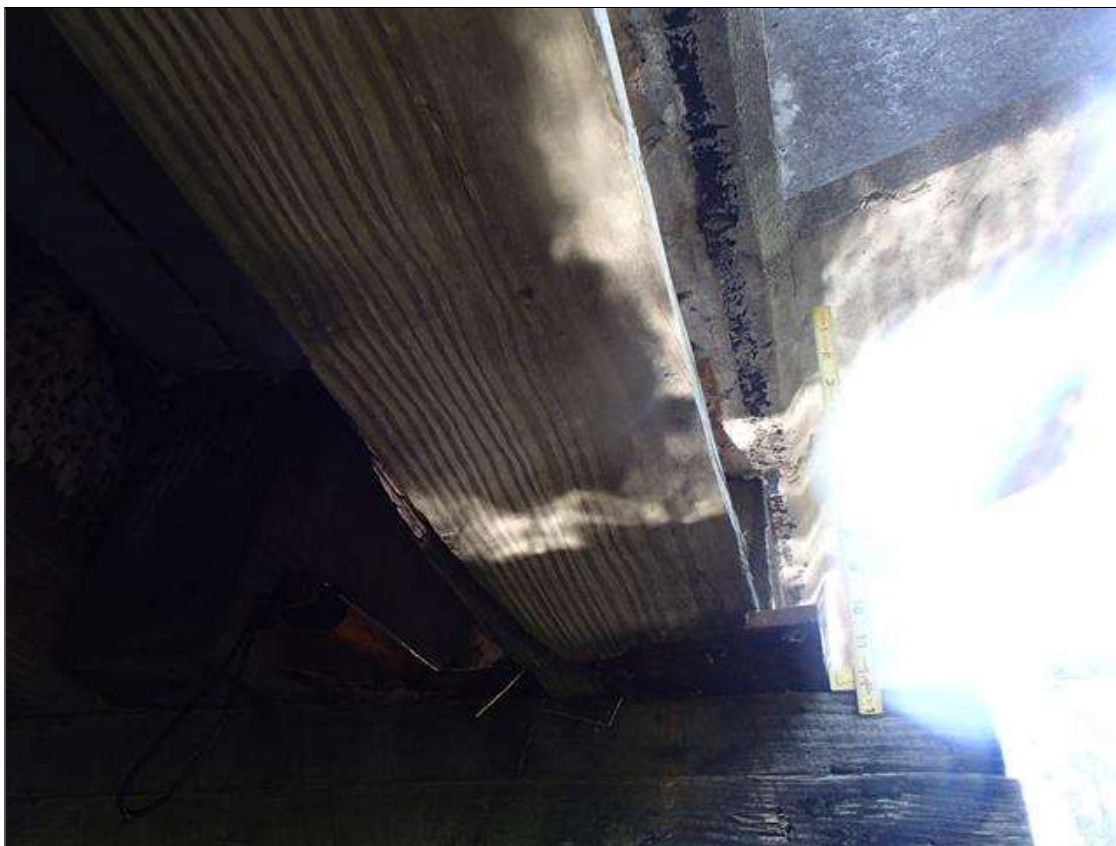
BEAM 19 SPAN 1 ROTATED INWARD 1.5" MIDSPAN BENT 1

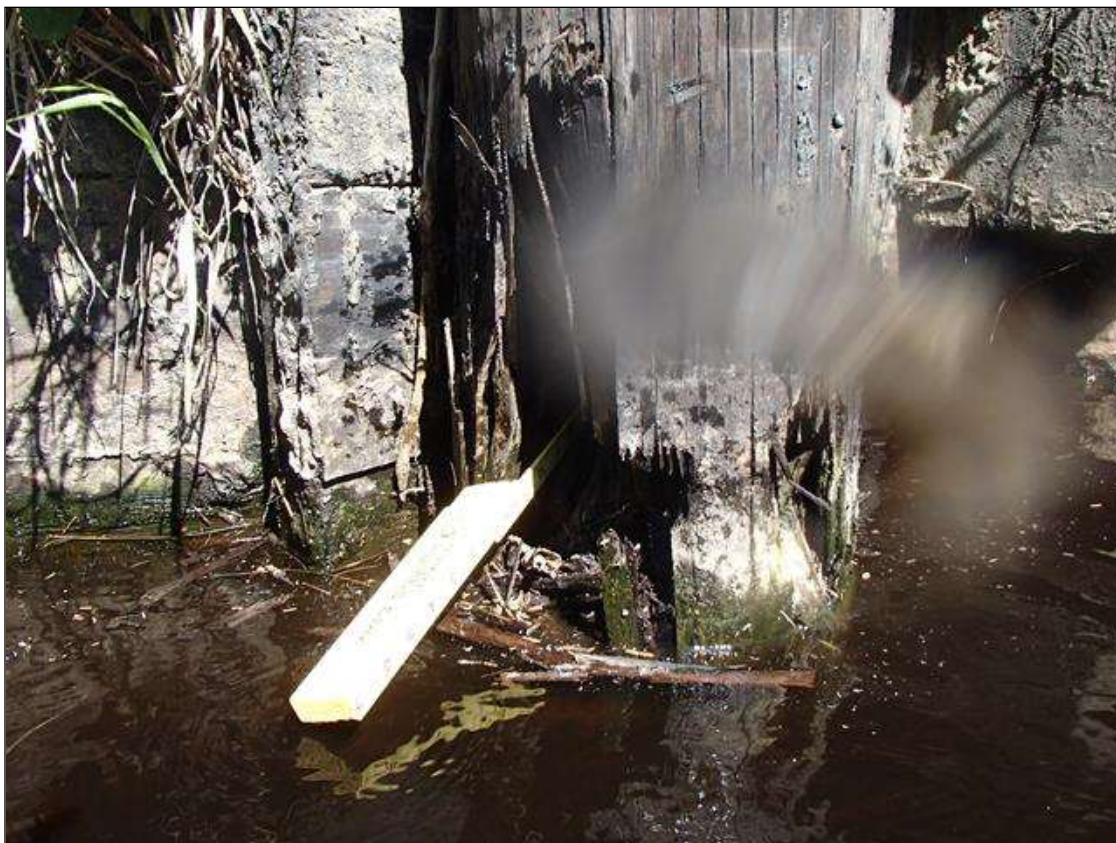
SOUTH WEST RETAINING PILE 100% DECAYED

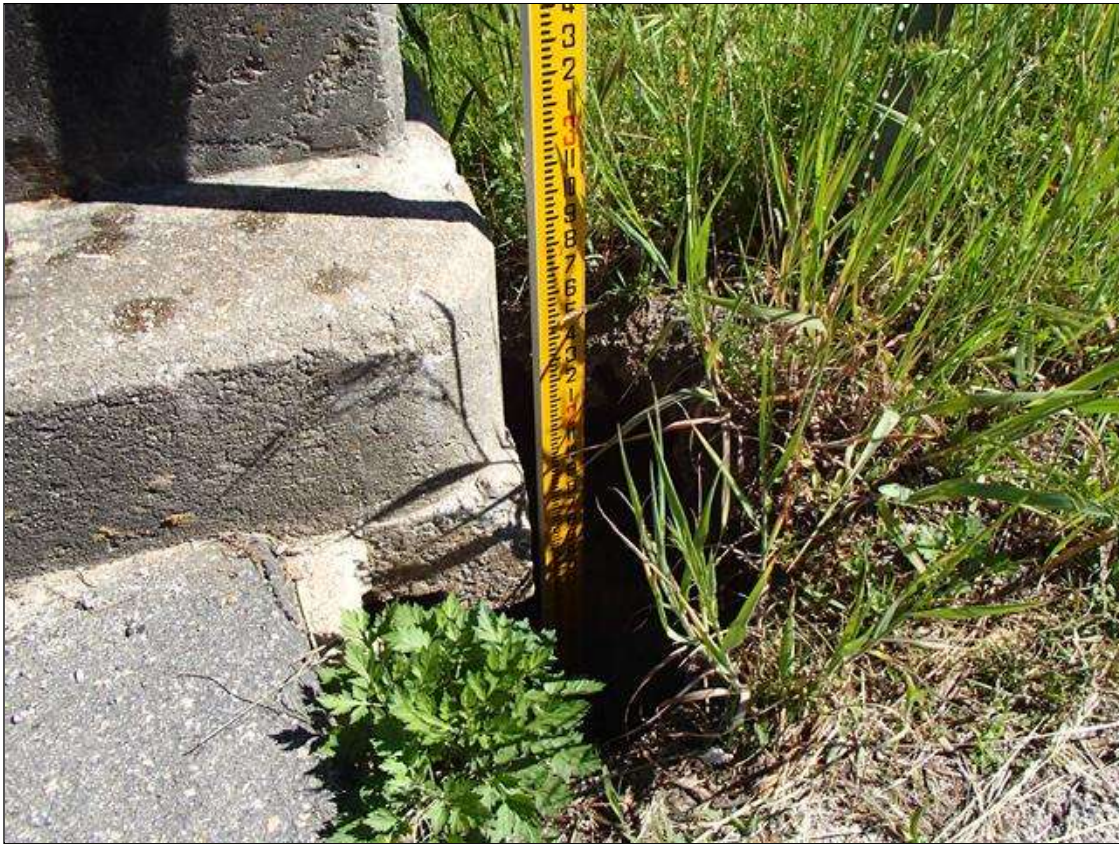
SINKHOLE NEAR NORTH EAST CORNER DOWN TO BULKHEAD BOARD #8

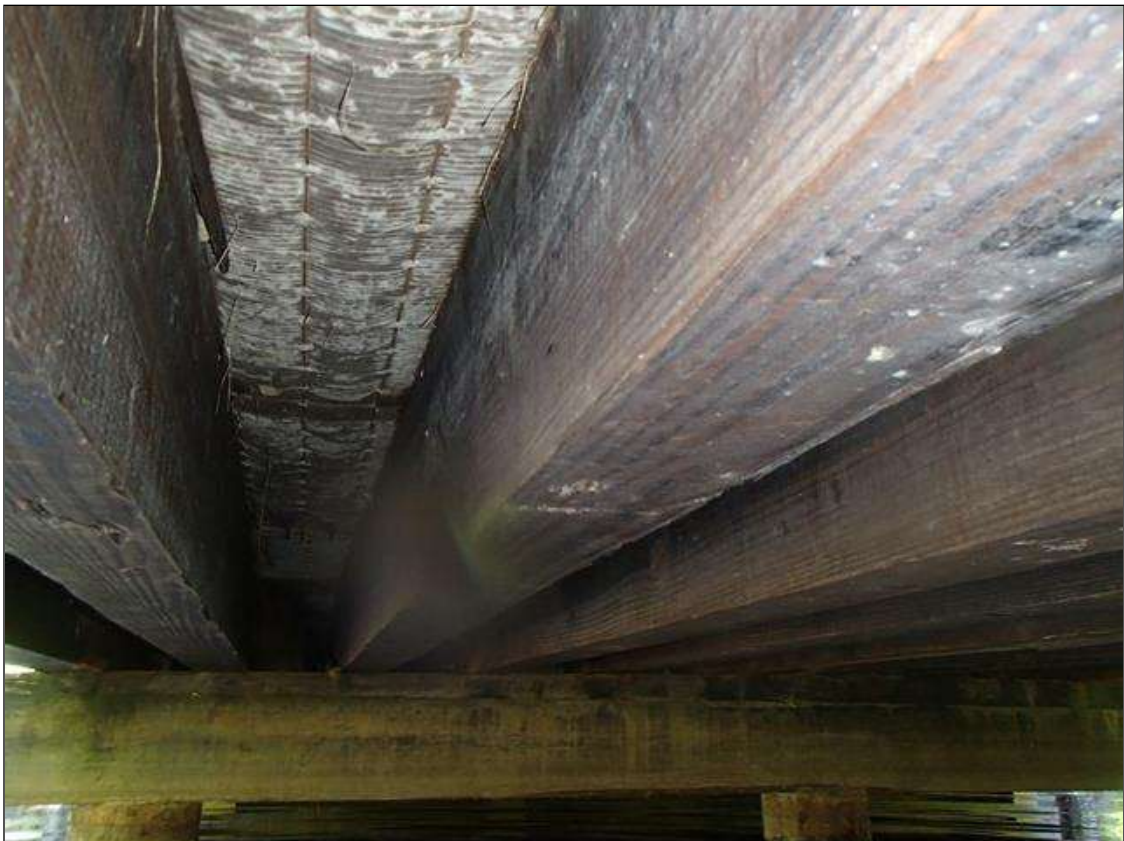
Element Number	Defect Type	Defect Description	CS	CS Qty	Maint Qty
111	Check/Shake	Checks to 1/8"	2	18	18 Feet

BEAM 3 SPAN 1 SHOWING CHECKS, TYPICAL
