NC DEPARTMENT OF TRANSPORTATION
 DIVISION OF HIGHWAYS
 BRIDGE MANAGEMENT UNIT

BRIDGE INSPECTION REPORT

COUNTY NASH BRIDGE NUMBER 630187 INSPECTION CYCLE 0 YRS
 ROUTE SR1001 ACROSS LITTLE SAPONY CREEK M.P. 0

INSPECTION DATE 08/06/2014 PRESENT CONDITION FAIR

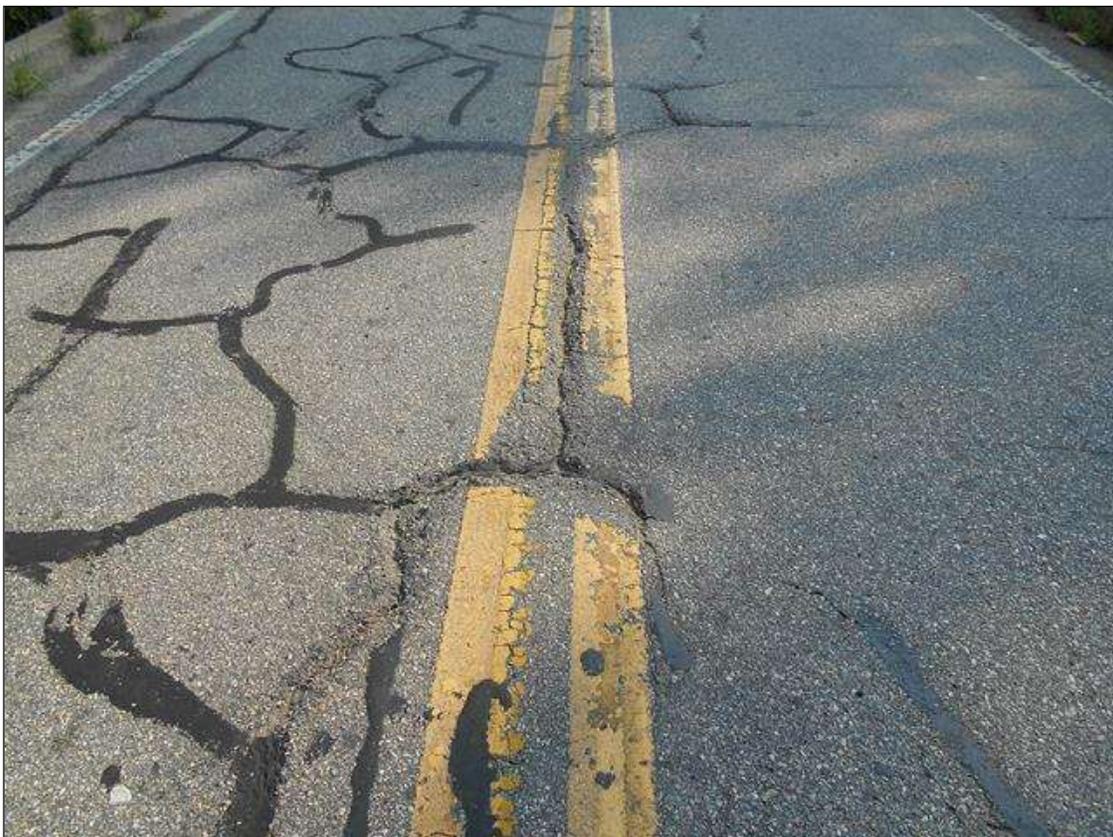
Item No.	Grade		
1	F	CRACKING IN ASPHALT WEARING SURFACE ALONG CENTERLINE.	
2a	F	UNDERSIDE DECK SPALLING UP TO 3/4" DEEP WITH REBAR EXPOSED MIDSPAN BAY 1. SIMILAR NEAR ABUTMENT 1 END BAY1 AND AT BAY 10. UNDERSIDE DECK BAY 4 MAP CRACKING WITH DISCOLORATION AT MIDSPAN. SIMILAR AT BAYS 6, 7 AND 8. REPAIR FORM IN PLACE AT BAY 8 ABUTMENT 1 END. UNDERSIDE OF DECK HAS FINE MAP CRACKING WITH DELAMINATION SCATTERED AND HONEYCOMB IN SPOTS.	
4	G	BOTH CURBS HAVE SCATTERED AREAS OF MAP CRACKING AND SURFACE SCALING.	
7	F	DECK DEBRIS ALONG RIGHT SIDE. SIMILAR AT LEFT SIDE.	
10	F	BEAM 10 TOP RIGHT FLANGE HAS LOSS OF SECTION 1/4" WITH 3/16" SECTION REMAINING 4' LONG AT MIDSPAN. BEAM 11 TOP FLANGE HAS LOSS OF SECTION 1/4" WITH 1/8" SECTION REMAINING FULL LENGTH OF SPAN. BEAM 10 ABUTMENT 2 END HAS LOSS OF SECTION 3/8" WITH 3/8" SECTION REMAINING IN BOTTOM FLANGE, FULL WIDTH ALONG CAP ENTRY AREA BEAM 11 ABUTMENT 1 END HAS LOSS OF SECTION 1/8" WITH 1/4" REMAINING FULL WIDTH OF BOTTOM FLANGE ALONG BEAM / CAP ENTRY AREA. HOLES IN WEBS. SEE SKETCHES. DEAD LOAD DEFLECTION IN BEAMS WITH PITTING IN BOTTOM FLANGES NEAR BEARINGS.

CRACKING IN ASPHALT WEARING SURFACE ALONG CENTERLINE.

3314	Maintain Steel Superstructure Components	LF	1	BEAM 11 ABUTMENT 1 END HAS LOSS OF SECTION 1/8" WITH 1/4" REMAINING FULL WIDTH OF BOTTOM FLANGE ALONG BEAM / CAP ENTRY AREA.	
2816	Asphalt Surface Repair or Replacement	SY	115	CRACKING IN ASPHALT WEARING SURFACE ALONG CENTERLINE.	
3326	Maintain Concrete Deck	SF	1035	DECK SPALLING UP TO 3/4" DEEP WITH REBAR EXPOSED MIDSPAN BAY 1. SIMILAR NEAR ABUTMENT 1 END BAY1 AND AT BAY 10.

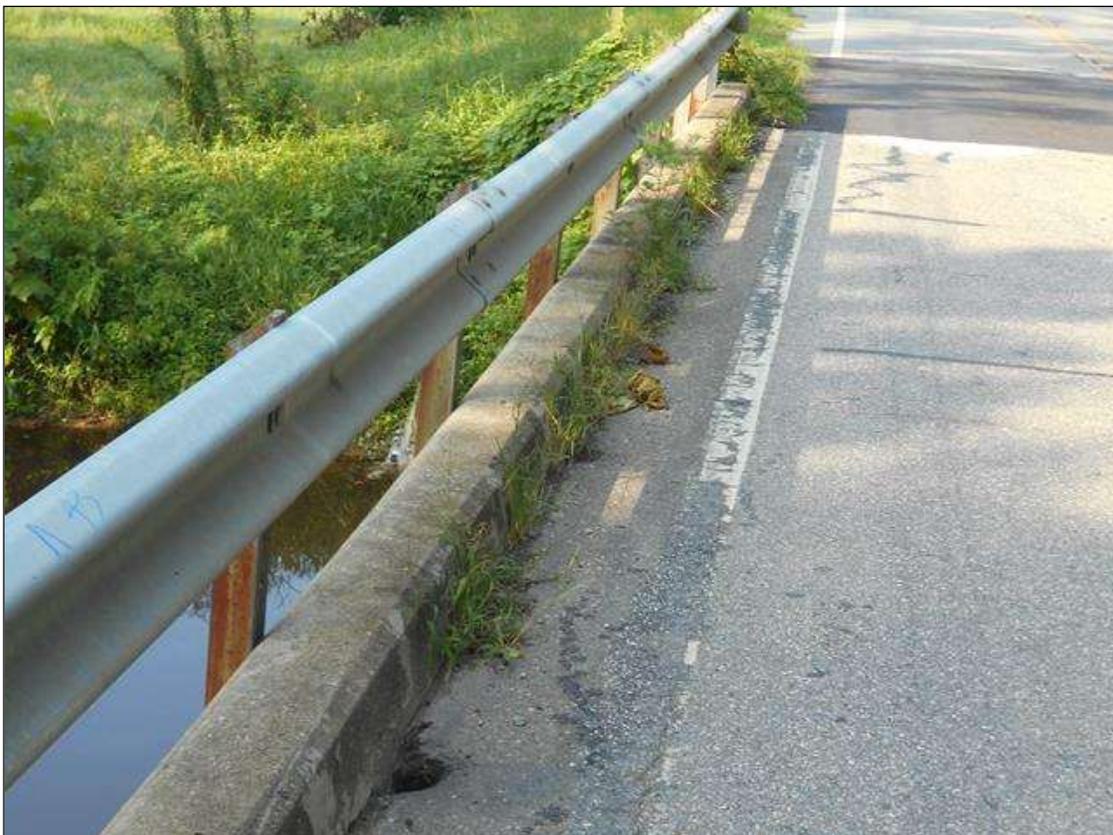
DECK DEBRIS ALONG RIGHT SIDE. SIMILAR AT LEFT SIDE.

3342	Clean and Paint Structural Steel	SF	2376	PAINT SCALING AT BEAMS 2 AND 3. SIMILAR AT EACH BEAM.	
3376	Clean/Wash Bridge Decks	SF	270	DECK DEBRIS ALONG RIGHT SIDE. SIMILAR AT LEFT SIDE.

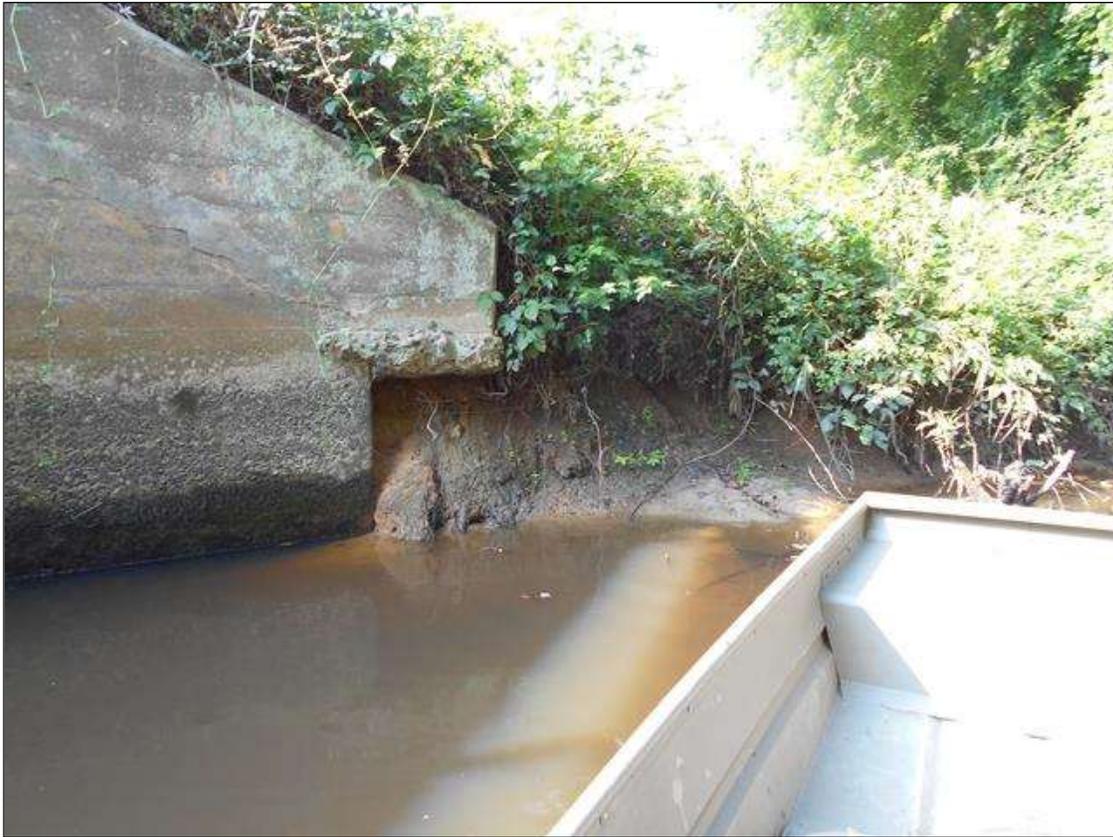
BANK SCOUR UP TO 2' DEEP ALONG SOUTHWEST CORNER.

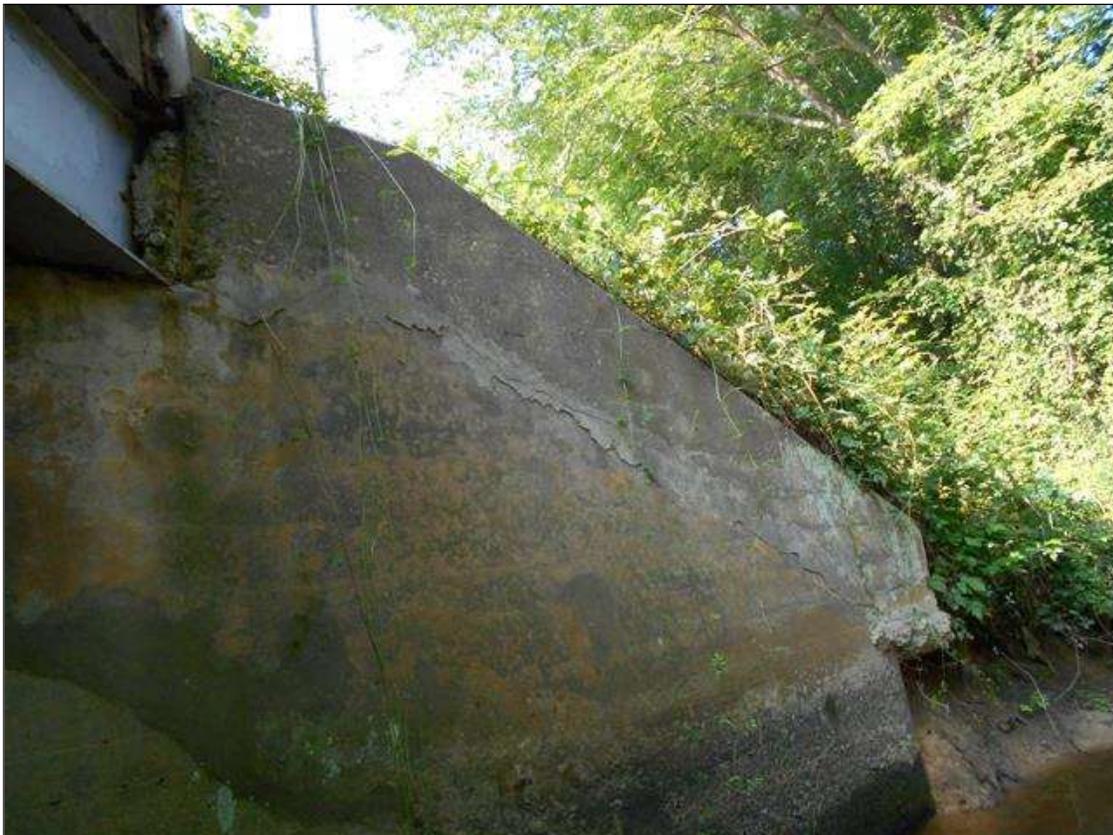
CRACKING ALONG PATCH AT SOUTHWEST WINGWALL

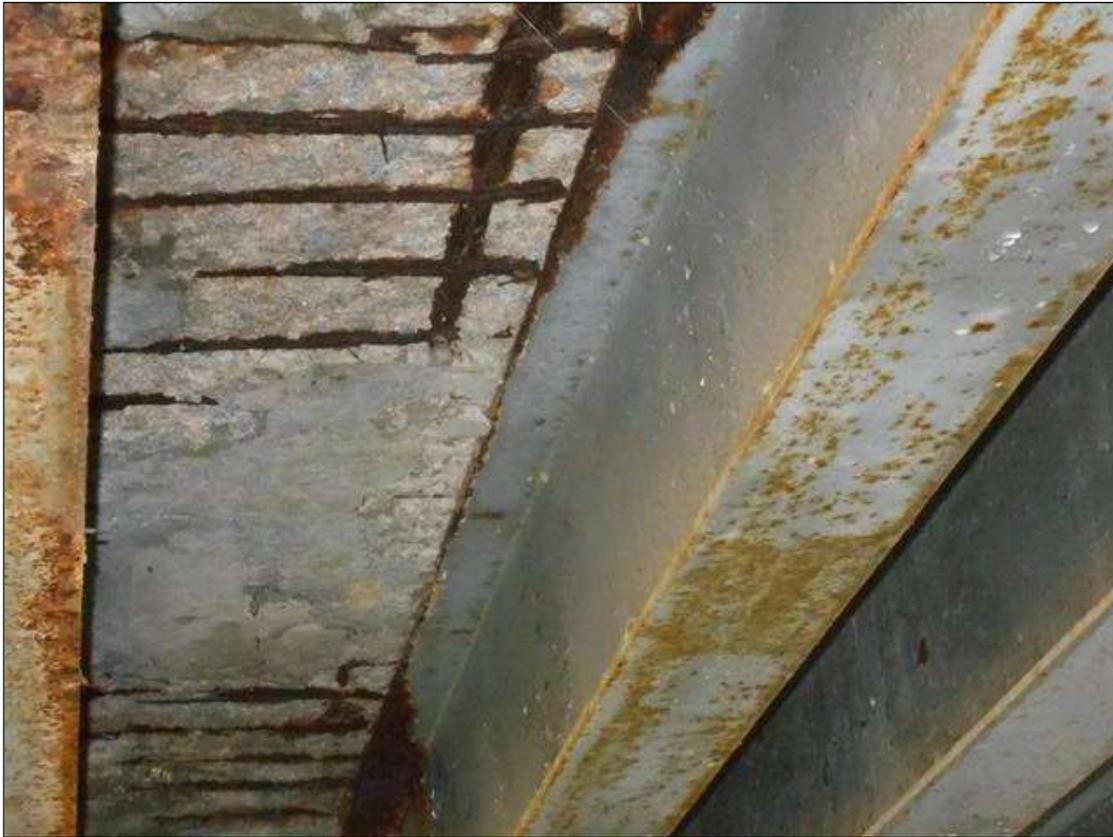
DECK SPALLING UP TO 3/4" DEEP WITH REBAR EXPOSED MIDSPAN BAY 1. SIMILAR NEAR ABUTMENT 1 END BAY1 AND AT BAY 10.

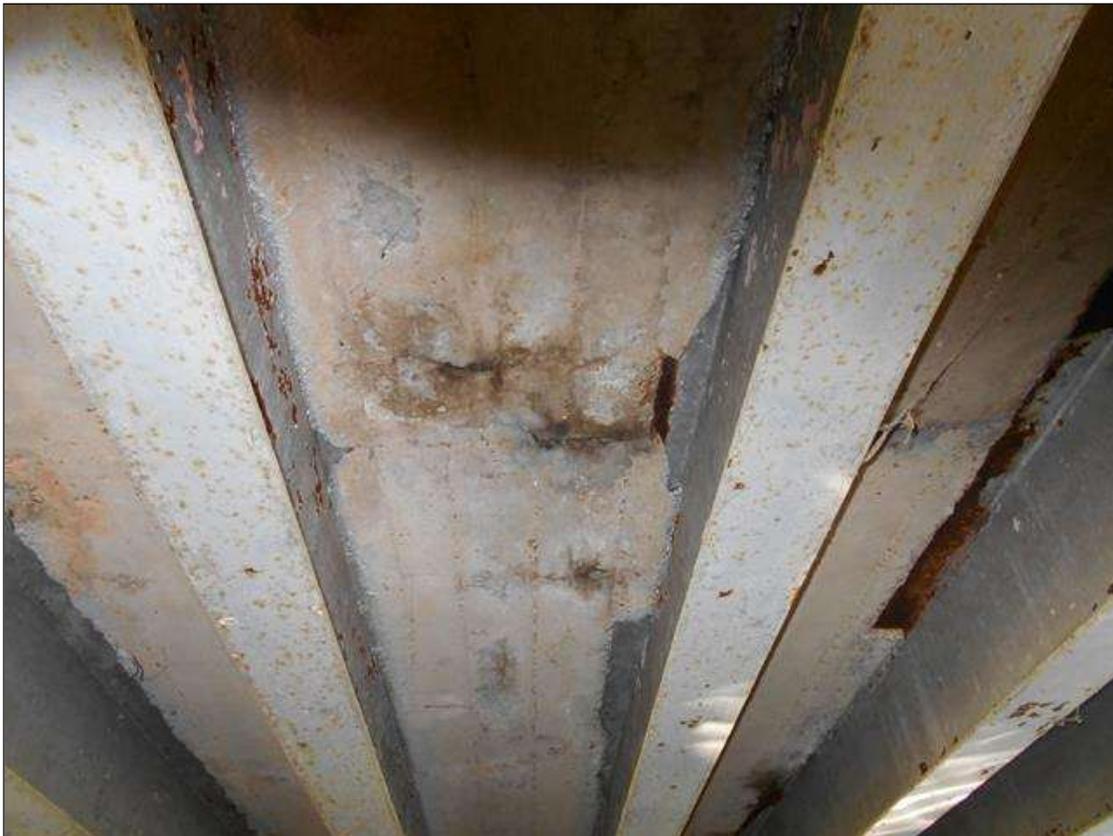
DECK BAY 4 MAP CRACKING WITH DISCOLORATION AT MIDSPAN. SIMILAR AT BAYS 6, 7 AND 8.

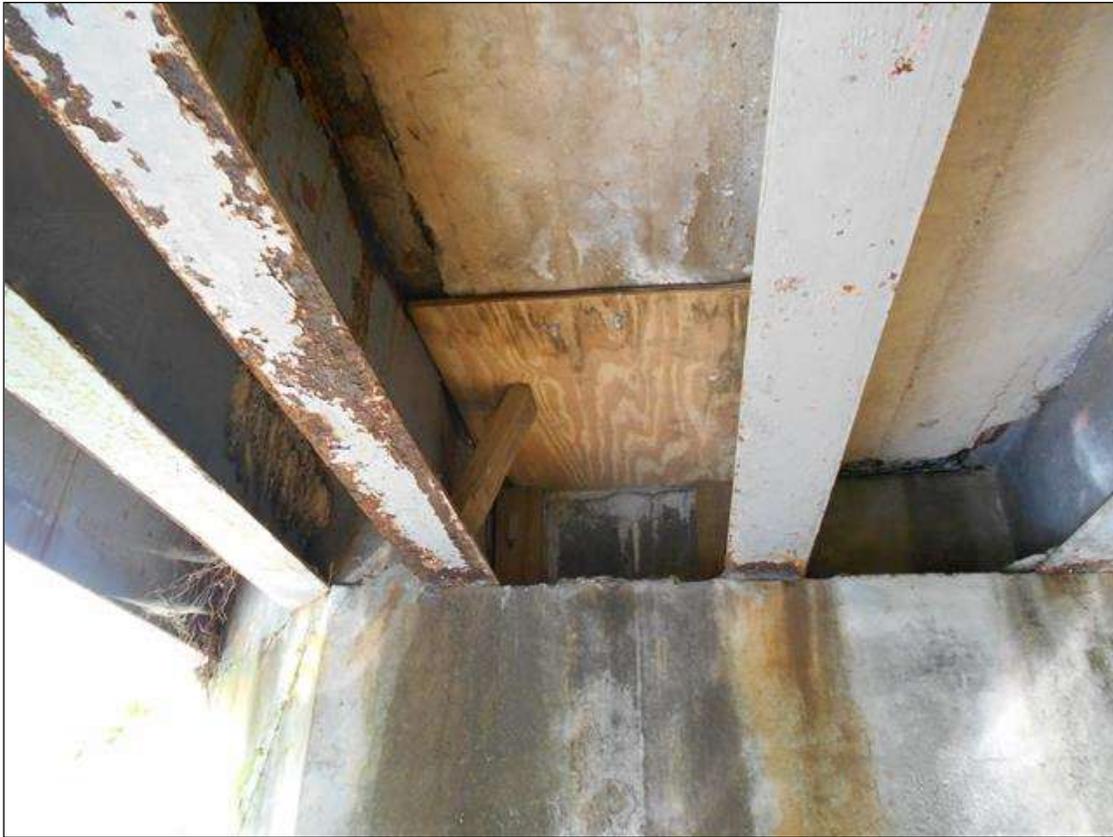
REPAIR FORM IN PLACE AT BAY 8 ABUTMENT 1 END.

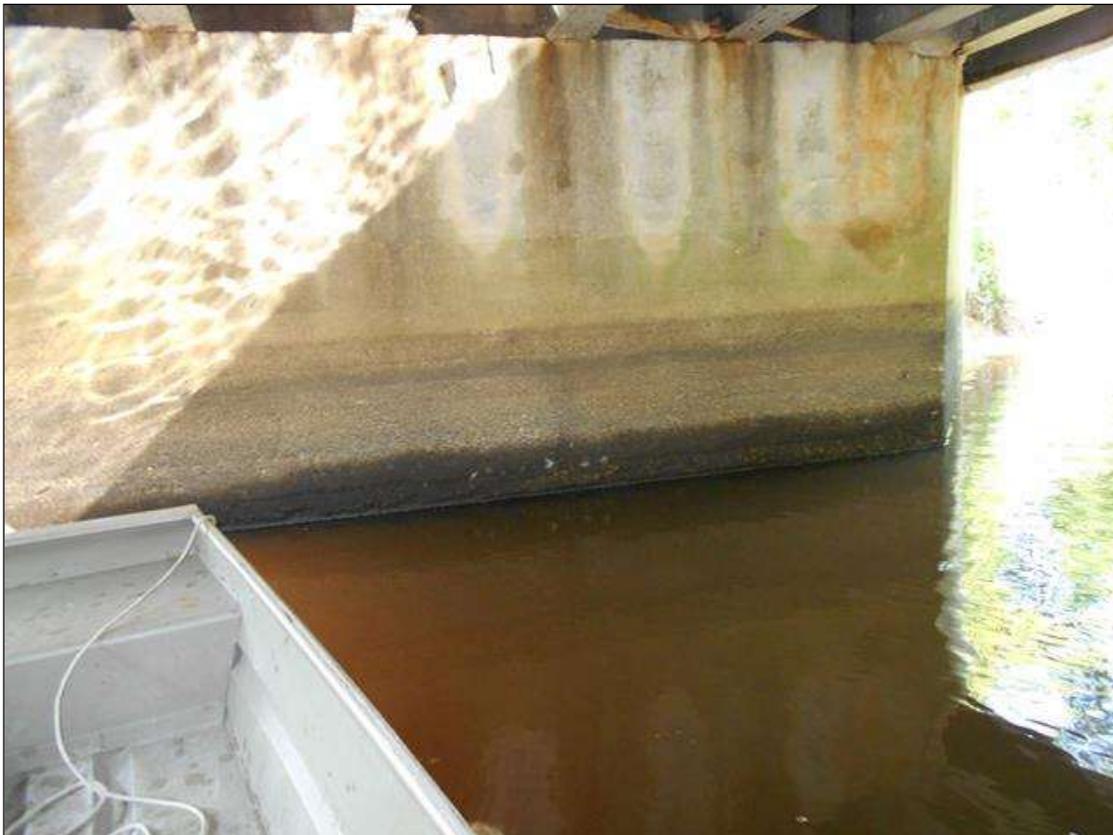
Item No.	Grade		
36b	F	ABUTMENT 1 BREASTWALL HAS COARSE AGGREGATE EXPOSED ALONG BOTTOM 3' TO WATERLINE. SIMILAR AT ABUTMENT 2 BREASTWALL. ABUTMENT 1 BREASTWALL HAS VERTICAL HAIRLINE CRACKING UNDER BEAM 5. ABUTMENT 2 BREASTWALL VERTICAL CRACKING UP TO 1/8" OPEN UNDER BEAM 3. ABUTMENT 2 BREASTWALL HAS VERTICAL CRACKING HAIRLINE TO 1/16" OPEN UNDER BEAM 9. ABUTMENT 2 HAS DIAGONAL CRACKING UP TO 1/16" OPEN AT WINGWALL JOINT UP TO BEAM 11.	
36d	G	CRACKING ALONG PATCH AT SOUTHWEST WINGWALL NORTHEAST WINGWALL HORIZONTAL HAIRLINE CRACKING ALONG CONSTRUCTION POUR JOINT.	
36e	F	NOT VISIBLE	
45c	F	BANK SCOUR UP TO 2' DEEP ALONG SOUTHWEST CORNER.	
50	G	RECENT REPAIR ALONG SOUTH APPROACH. RECENT REPAIR ALONG NORTH APPROACH.	
61	YES	BEAMS 10 AND 11	
62	YES	SV 18 TTST 22

ABUTMENT 1 BREASTWALL HAS COARSE AGGREGATE EXPOSED ALONG BOTTOM 3' TO WATERLINE.
SIMILAR AT ABUTMENT 2 BREASTWALL.

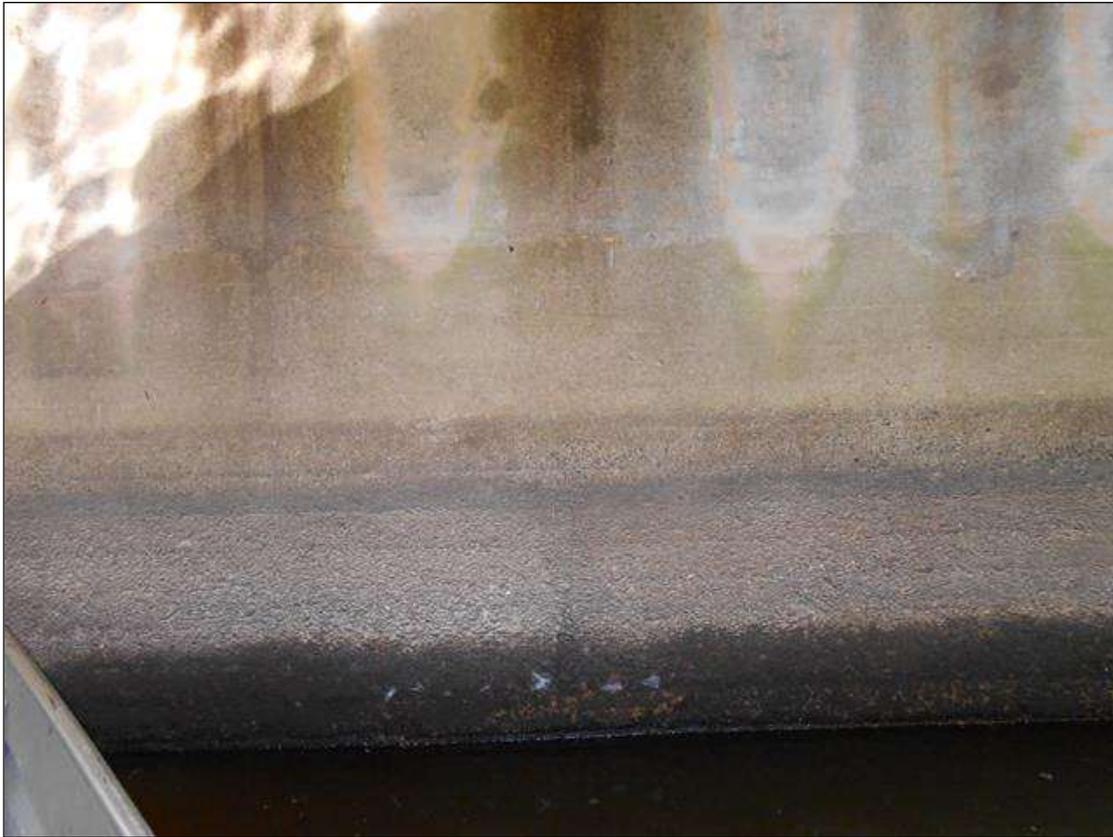
ABUTMENT 1 BREASTWALL HAS VERTICAL HAIRLINE CRACKING UNDER BEAM 5.

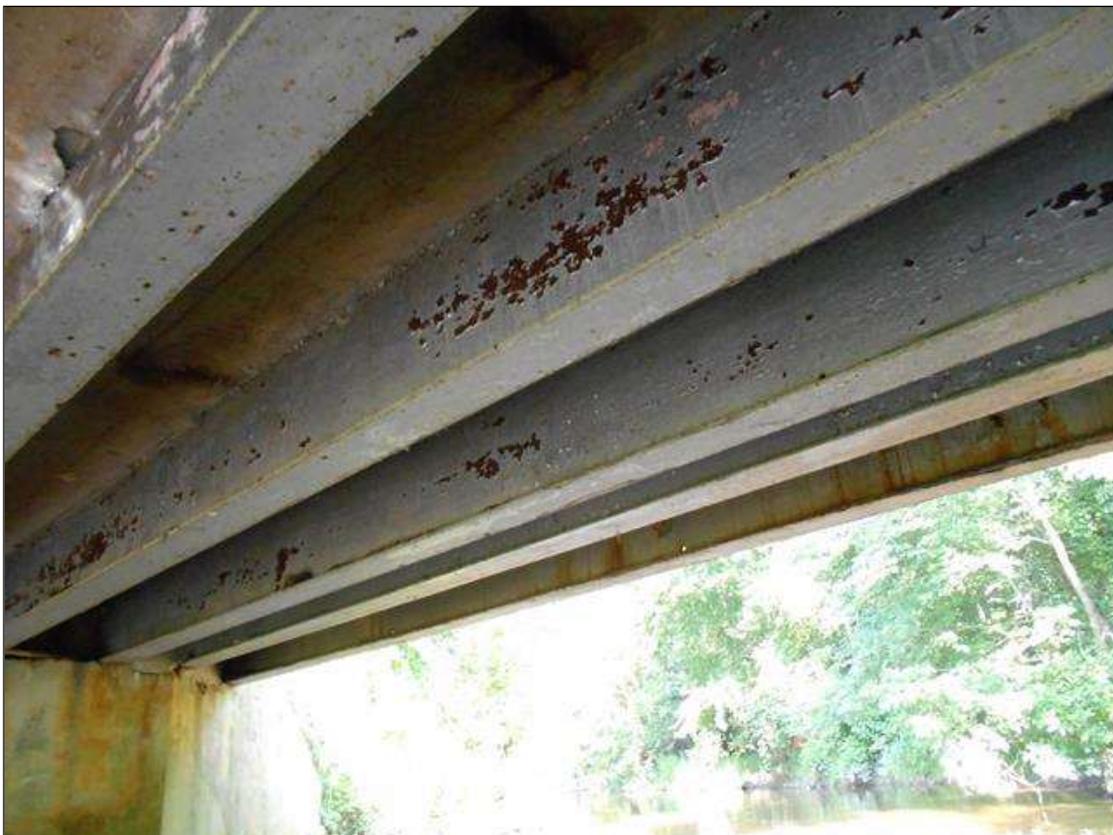
10A	NO	NO CURVED GIRDERS.	
16	F	WATER RUNOFF RESTRICTED BY DECK DEBRIS . SEE ITEM 7.	
52	F	PAINT SCALING AT BEAMS 2 AND 3. SIMILAR AT EACH BEAM.	
36a	F	ABUTMENT 2 CAP SPALLING 6' WIDE X 5" HIGH X 2" DEEP WITH REBAR EXPOSED UNDER BEAMS 10 AND 11. BOTH HAVE SCATTERED AREAS OF MAP CRACKS AND SURFACE SCALING ON FACE. ABUTMENT 1 HAS A SPALL 5 IN. WIDE X 7 IN. HIGH X 1 1/2 IN. DEEP UNDER BEAM 2.

PAINT SCALING AT BEAMS 2 AND 3. SIMILAR AT EACH BEAM.

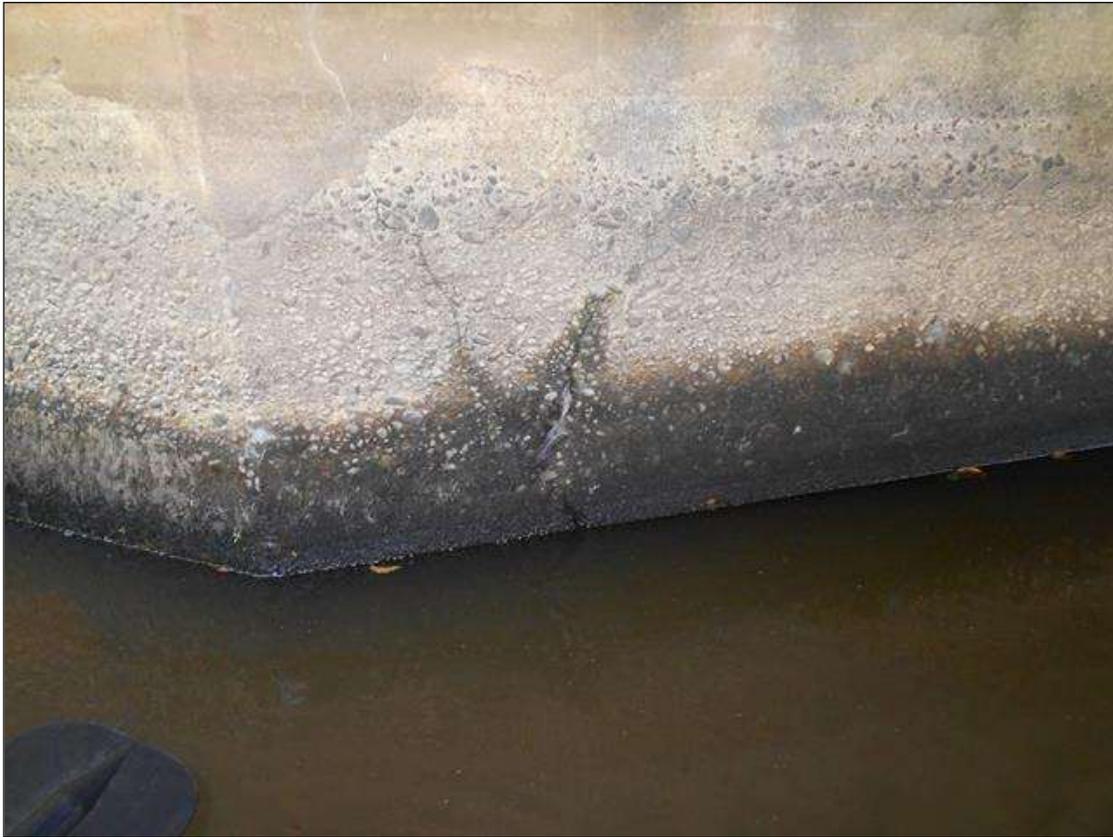
ABUTMENT 2 BREASTWALL VERTICAL CRACKING UP TO 1/8" OPEN UNDER BEAM 3.

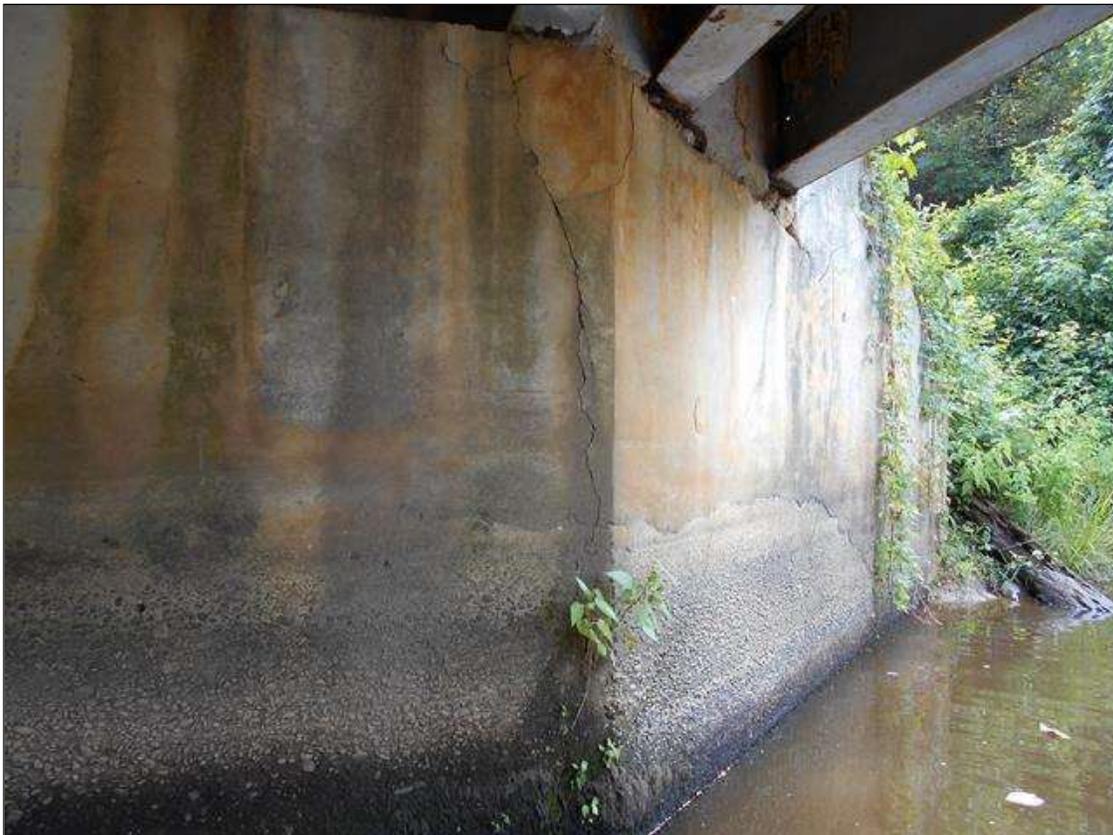
ABUTMENT 2 BREASTWALL HAS VERTICAL CRACKING HAIRLINE TO 1/16" OPEN UNDER BEAM 9.

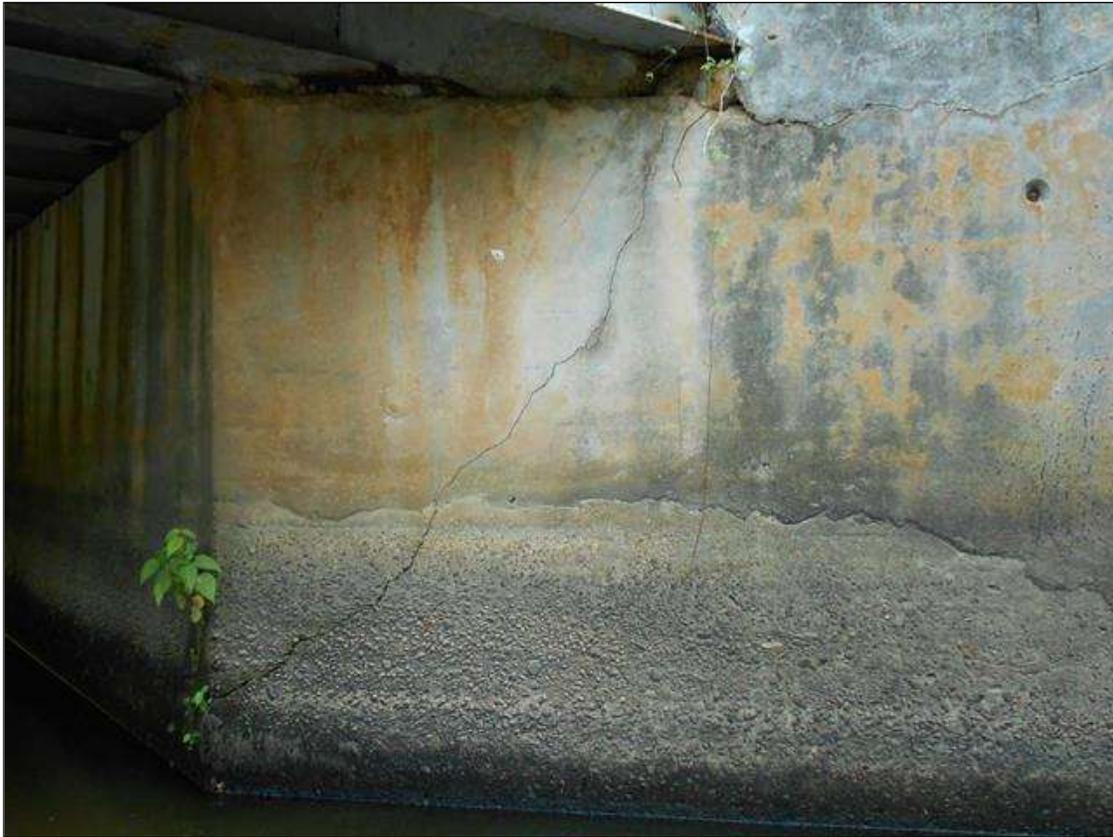
ABUTMENT 2 HAS DIAGONAL CRACKING UP TO 1/16" OPEN AT WINGWALL JOINT UP TO BEAM 11.

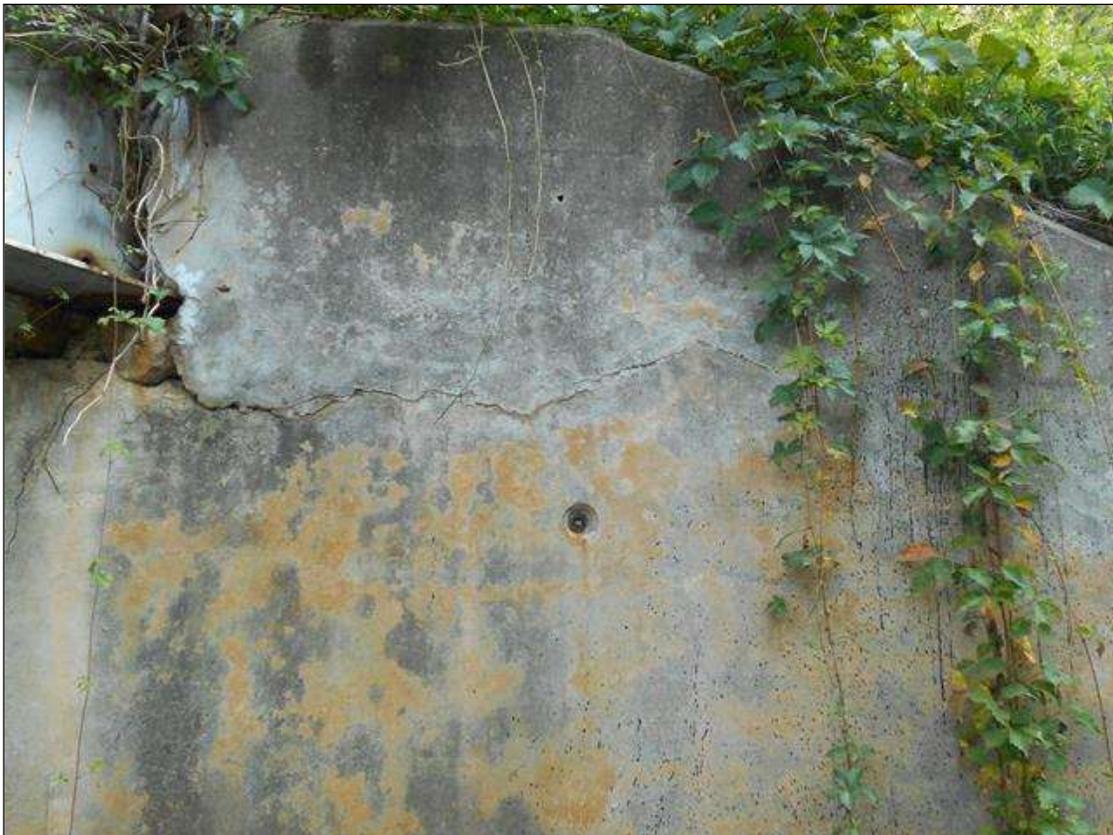
NORTHEAST WINGWALL HORIZONTAL HAIRLINE CRACKING ALONG CONSTRUCTION POUR JOINT.

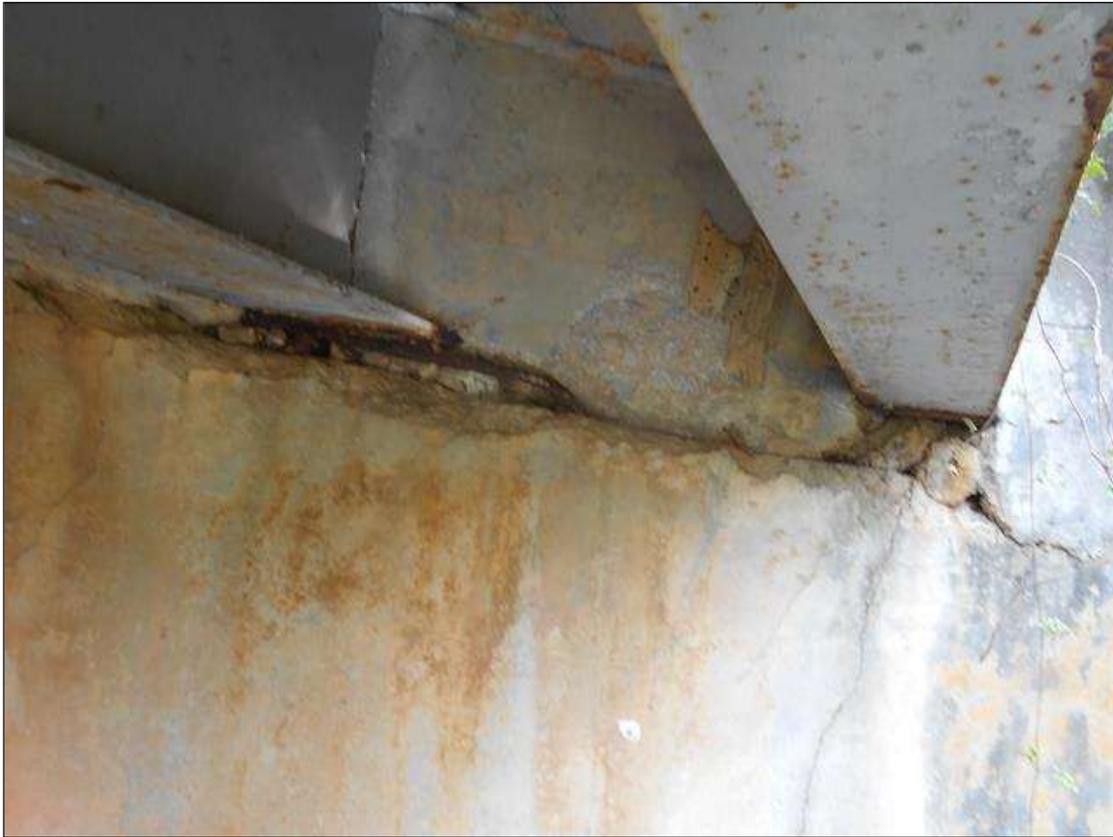
ABUTMENT 2 CAP SPALLING 6' WIDE X 5" HIGH X 2" DEEP WITH REBAR EXPOSED UNDER BEAMS 10 AND 11.

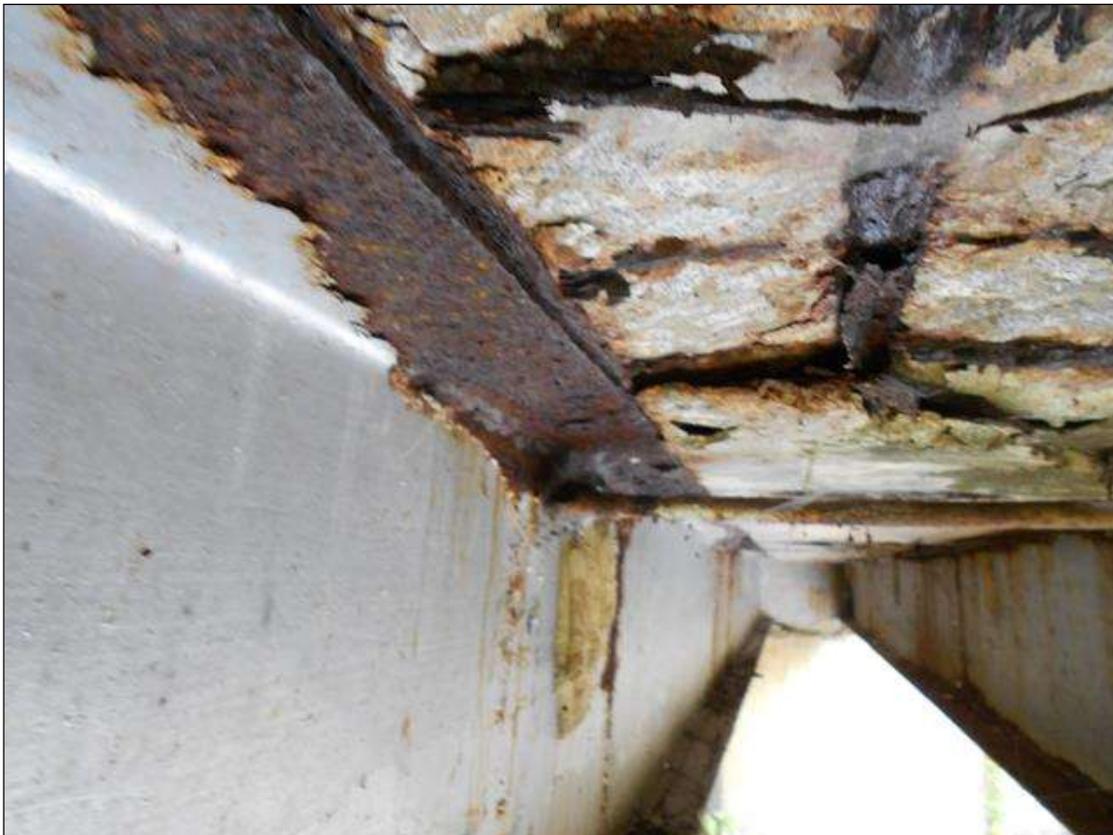
BEAM 10 TOP RIGHT FLANGE HAS LOSS OF SECTION 1/4" WITH 3/16" SECTION REMAINING 4' LONG AT MIDSPAN.

3314	Maintain Steel Superstructure Components	LF	4	BEAM 10 TOP RIGHT FLANGE HAS LOSS OF SECTION 1/4" WITH 3/16" SECTION REMAINING 4' LONG AT MIDSPAN.

MMS Code	MMS Description	Quantity
3314	Maintain Steel Superstructure Components	4 LF
Location:		
Beams and Girders		Bent/Span No. 1 BEAM 10
Priority Level	Status	
Priority Maintenance	Division Bridge Maintenance Notification Received	
Submitted Date:	Submitted By:	Assisted By:
08/07/2014	H.W. HICKS, JR.	T.L. GOINS
Details		
BEAM 10 TOP RIGHT FLANGE HAS LOSS OF SECTION 1/4" WITH 3/16" SECTION REMAINING 4' LONG AT MIDSPAN.

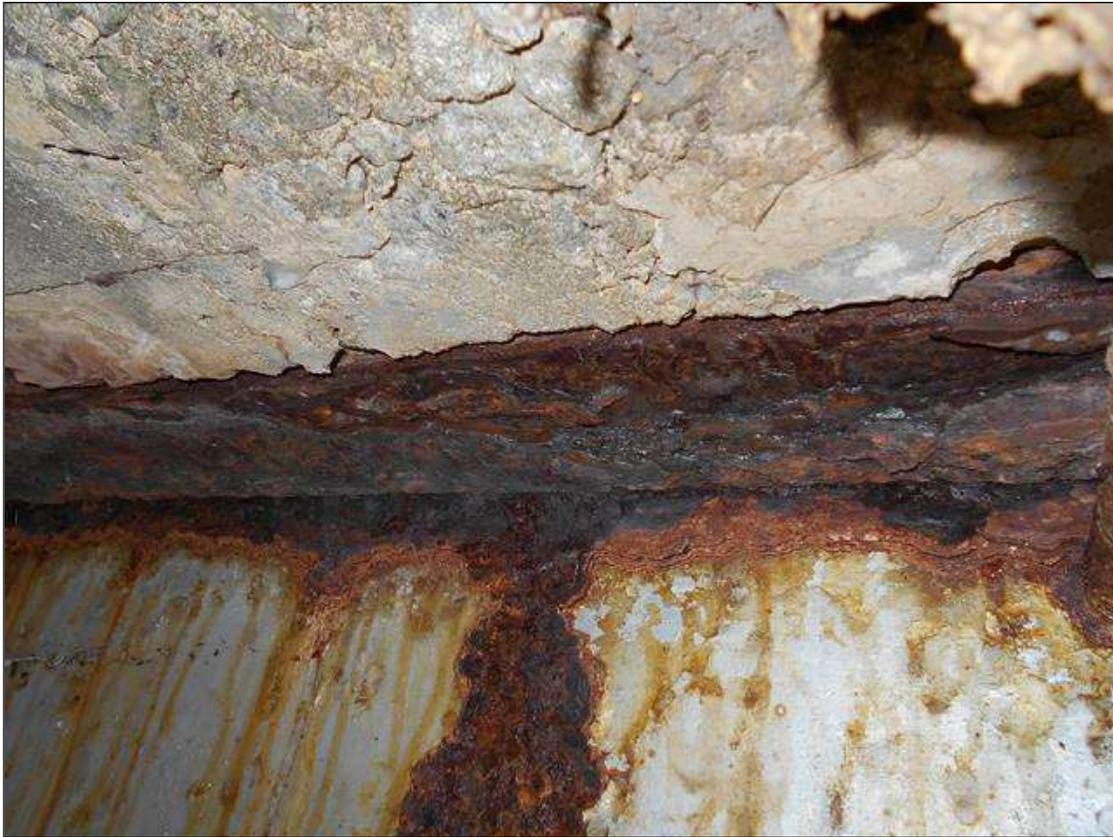
BEAM 11 TOP FLANGE HAS LOSS OF SECTION 1/4" WITH 1/8" SECTION REMAINING FULL LENGTH OF SPAN.

3314	Maintain Steel Superstructure Components	LF	45	BEAM 11 TOP FLANGE HAS LOSS OF SECTION 1/4" WITH 1/8" SECTION REMAINING FULL LENGTH OF SPAN.

MMS Code	MMS Description	Quantity
3314	Maintain Steel Superstructure Components	45 LF
Location:		
Beams and Girders		Bent/Span No. 1 11
Priority Level	Status	
Priority Maintenance	Division Bridge Maintenance Notification Received	
Submitted Date:	Submitted By:	Assisted By:
08/07/2014	H.W. HICKS, JR.	T.L. GOINS
Details		
BEAM 11 TOP FLANGE HAS LOSS OF SECTION 1/4" WITH 1/8" SECTION REMAINING FULL LENGTH OF SPAN.

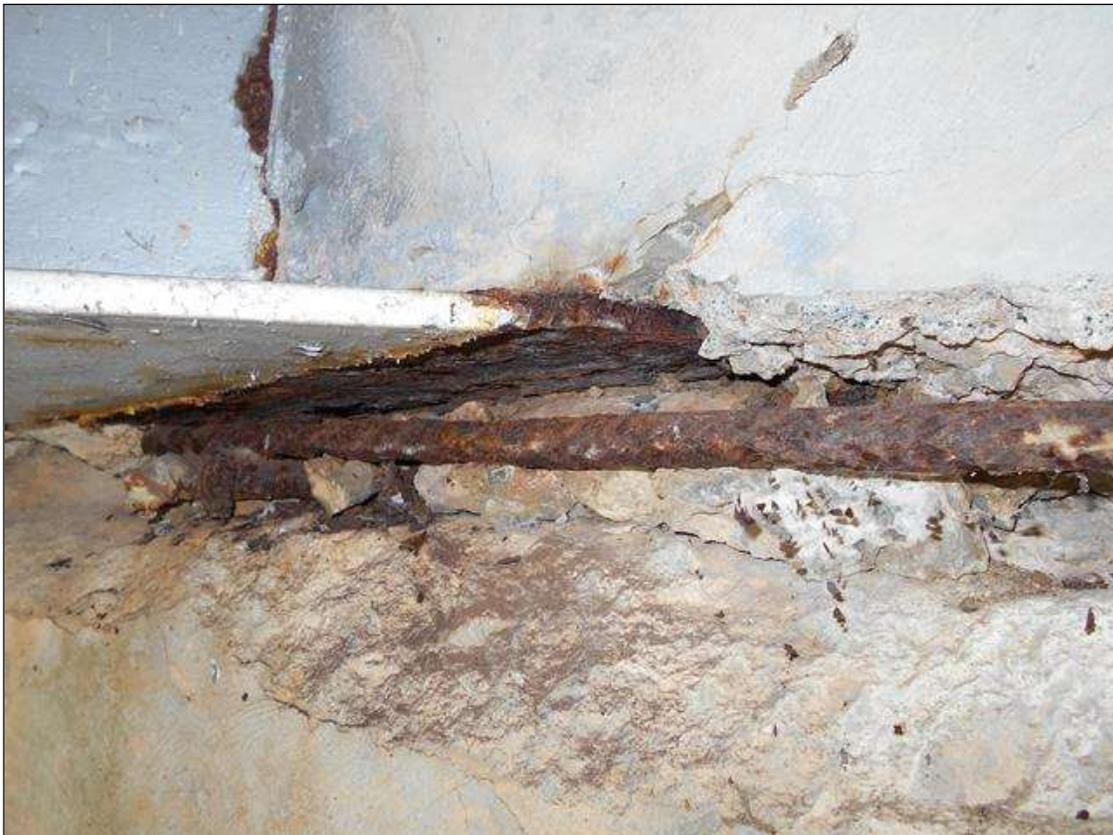
BEAM 10 ABUTMENT 2 END HAS LOSS OF SECTION 3/8" WITH 3/8" SECTION REMAINING IN BOTTOM FLANGE, FULL WIDTH ALONG CAP ENTRY AREA

3314	Maintain Steel Superstructure Components	LF	1	BEAM 10 ABUTMENT 2 END HAS LOSS OF SECTION 3/8" WITH 3/8" SECTION REMAINING IN BOTTOM FLANGE, FULL WIDTH ALONG CAP ENTRY AREA

MMS Code	MMS Description	Quantity
3314	Maintain Steel Superstructure Components	1 LF
Location:		
Beams and Girders		Bent/Span No. 1 10
Priority Level	Status	
Priority Maintenance	Division Bridge Maintenance Notification Received	
Submitted Date:	Submitted By:	Assisted By:
08/07/2014	H.W. HICKS, JR.	T.L. GOINS
Details		
BEAM 10 ABUTMENT 2 END HAS LOSS OF SECTION 3/8" WITH 3/8" SECTION REMAINING IN BOTTOM FLANGE, FULL WIDTH ALONG CAP ENTRY AREA

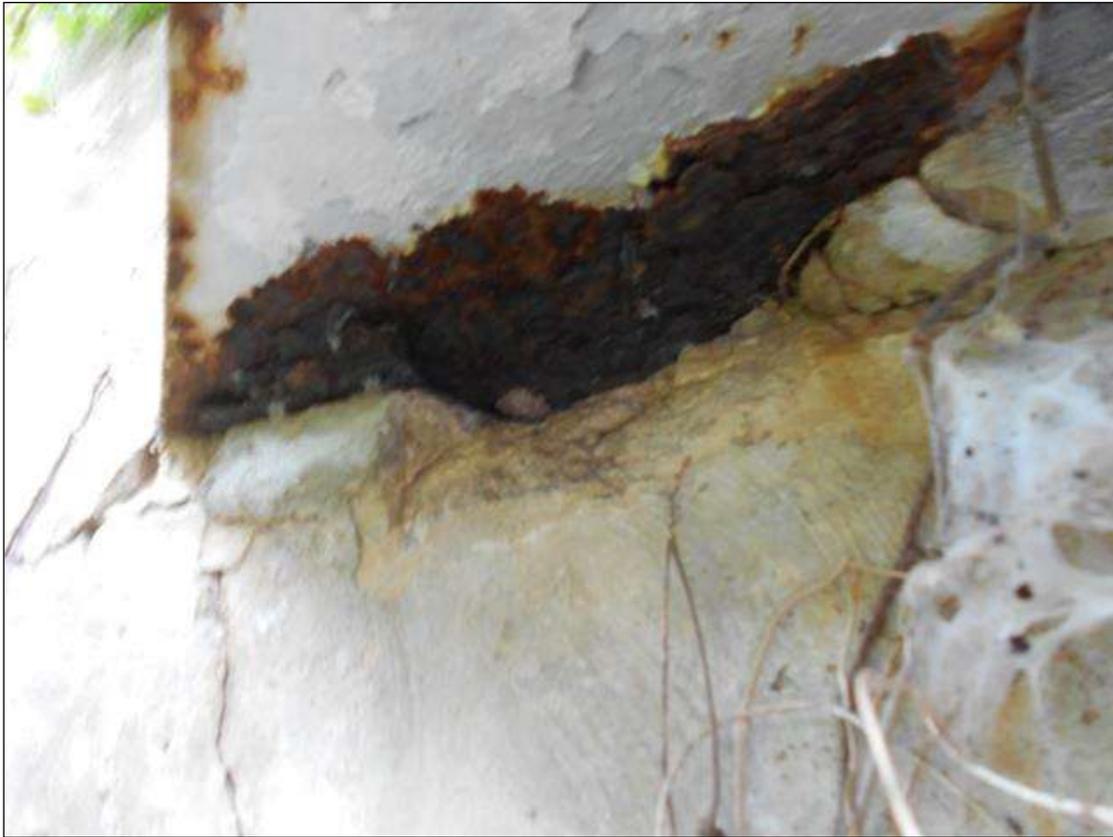
BEAM 11 ABUTMENT 1 END HAS LOSS OF SECTION 1/8" WITH 1/4" REMAINING FULL WIDTH OF BOTTOM FLANGE ALONG BEAM / CAP ENTRY AREA.

MMS Code	MMS Description	Quantity
3314	Maintain Steel Superstructure Components	1 LF
Location:		
Beams and Girders		Bent/Span No. 1 11
Priority Level	Status	
Priority Maintenance	Division Bridge Maintenance Notification Received	
Submitted Date:	Submitted By:	Assisted By:
08/07/2014	H.W. HICKS, JR.	T.L. GOINS
Details		
BEAM 11 ABUTMENT 1 END HAS LOSS OF SECTION 1/8" WITH 1/4" REMAINING FULL WIDTH OF BOTTOM FLANGE ALONG BEAM / CAP ENTRY AREA.

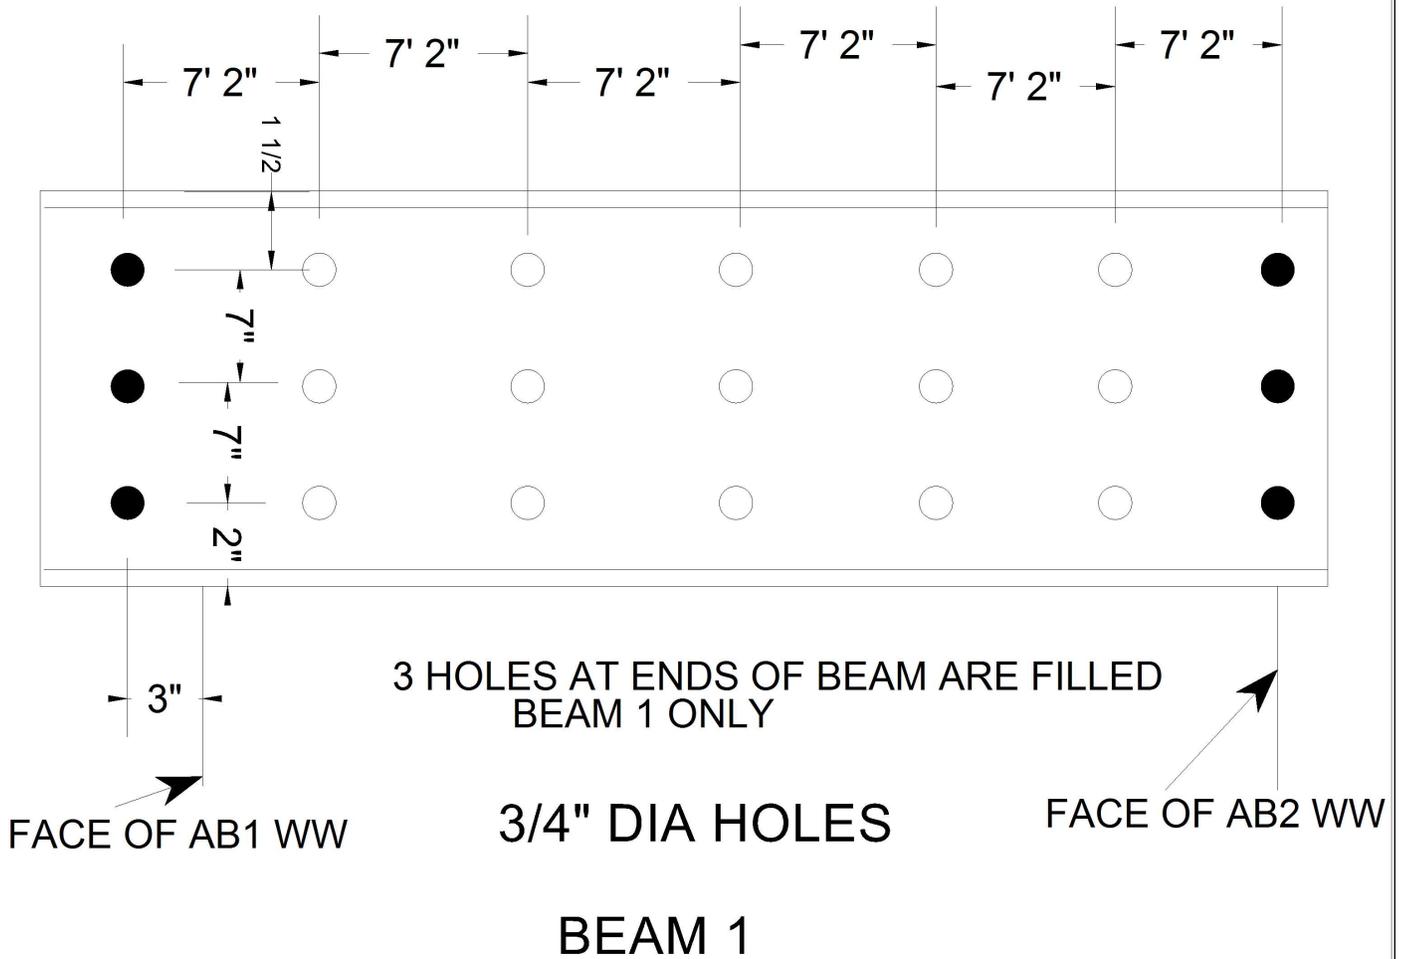
HOLES IN BEAMS

HOLES IN BEAM 1

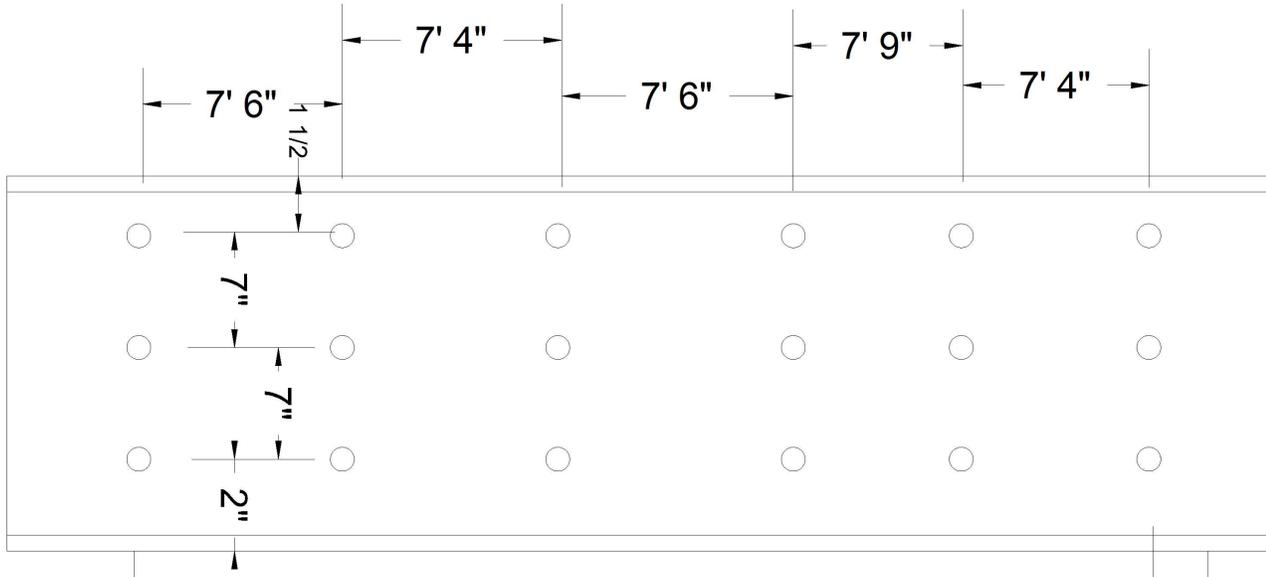
Title HOLES IN BEAMS 3		Description HOLES IN BEAM 9	
Bridge No: 630187	Drawn By: WCM	Date: 08/17/10	File Name: S0026002382

3/4 " DIA HOLES
