IMPACT DAMAGE REPORT. GRADES FOR BEAMS AND DIAPHRAGMS IN SPAN 2 ONLY.

BRIDGE INSPECTION REPORT

INSPECTION TYPE: Damage Inspection Report

COUNTY SCOTLAND BRIDGE NUMBER 820026 INSPECTION CYCLE 0 YRS
 ROUTE NC79 ACROSS US74 M.P. 0

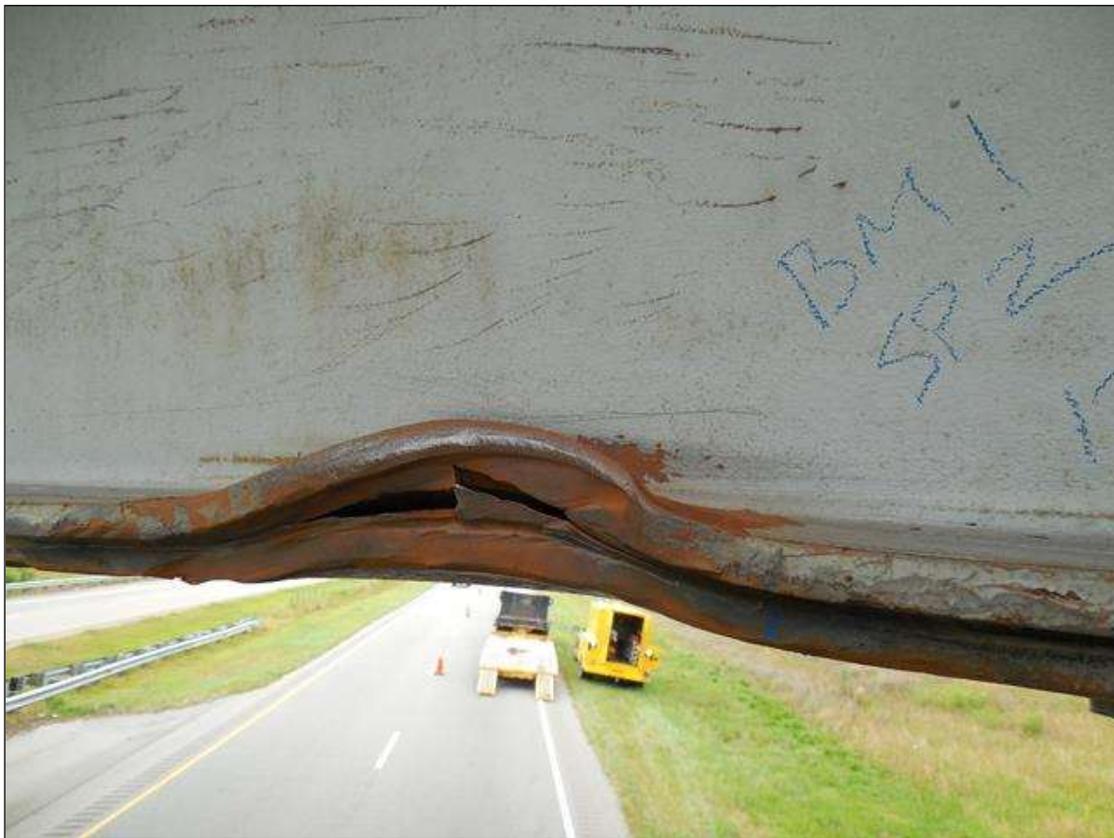
IMPACT DAMAGE ON BEAM 1 IN SPAN 2, IMPACT POINT AT 17'-10" FROM BENT 1.

3314	Maintain Steel Superstructure Components	LF	17	BEAM 1 IN SPAN 2, AT POINT OF IMPACT, BOTTOM FLANGE BENT UPWARD 3" WITH TEAR IN WELD TO COVER PLATE, CRACK IS 14- 1/2"LONG X 1/2"WIDE. BEAM IS BENT ALONG A 16'- 4" LENGHT OF BEAM. CENTER OF IMPACT AREA IS 17'- 10" OUT FROM BENT 1.

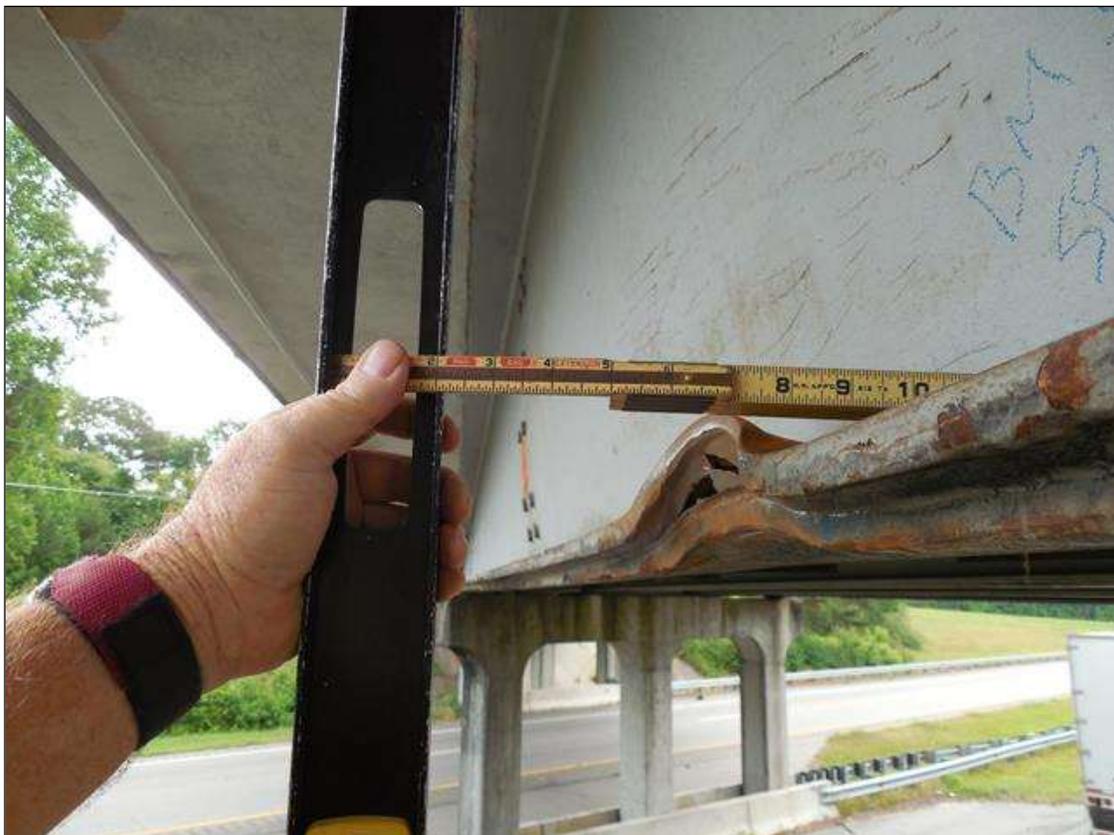
BEAM BENT OUT OF PLUMB 7-1/2" AT POINT OF IMPACT

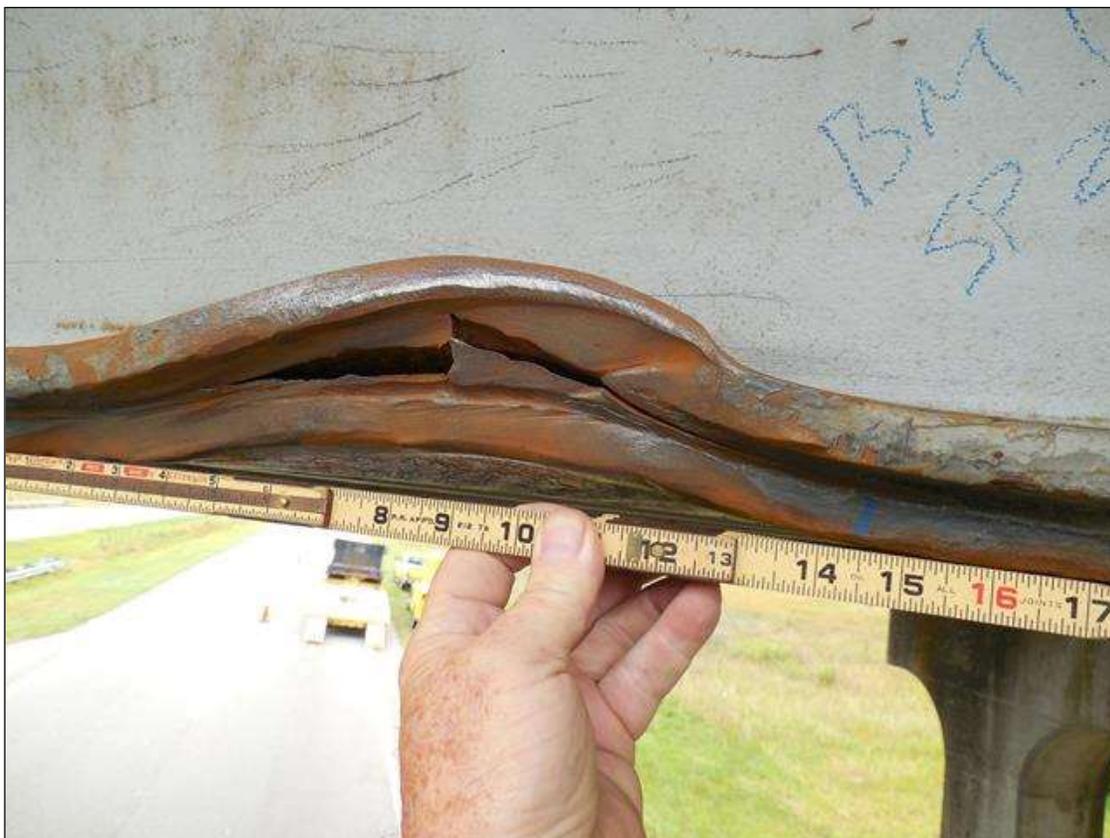
BOTTOM COVER PLATE CRACKED ALONG BOTTOM FLANGE AT POINT OF IMPACT, 14-1/2"LONG X 1/2"WIDE

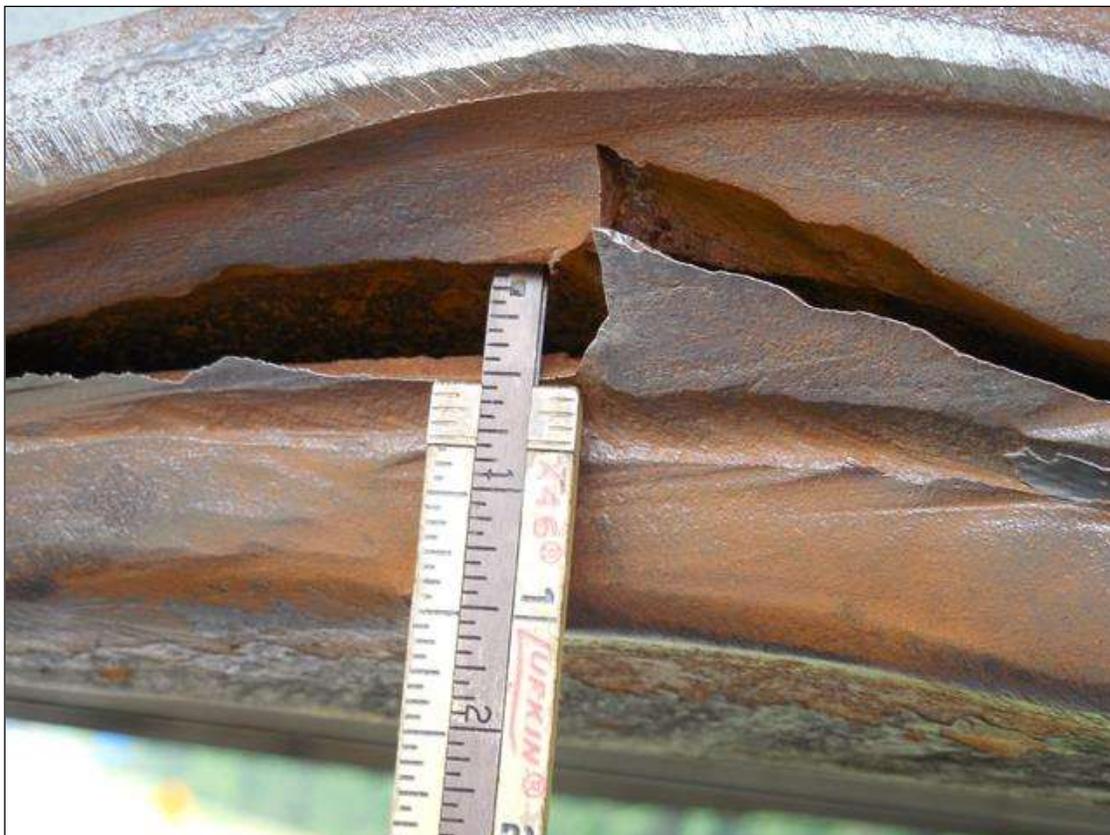
BOTTOM FLANGE CRACK IS 1/2" WIDE AT IMPACT AND BENT UPWARD 3"

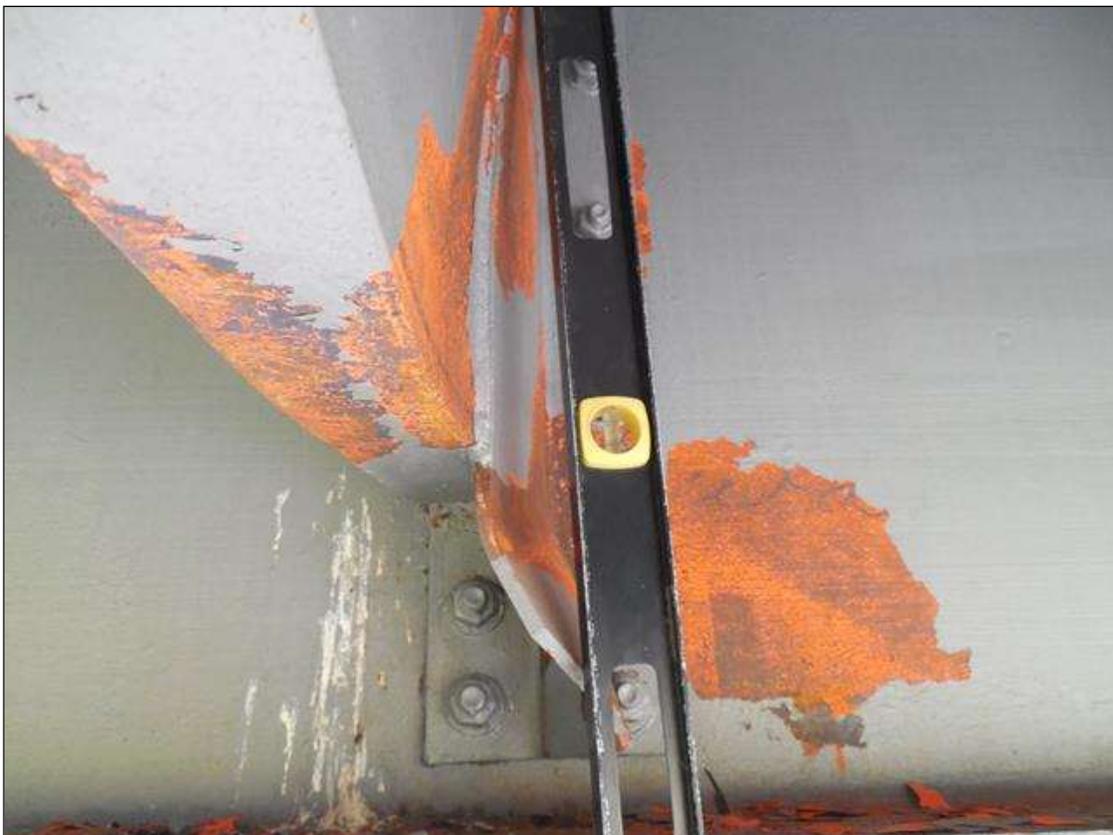
INTERIOR DIAPHRAGM HAS BUCKLED AND BENT AT FIRST DIAPHRAGM. AT 1/4 POINT.

3314	Maintain Steel Superstructure Components	LF	3	INTERIOR DIAPHRAGM AT FIRST 1/4 POINT NEAR IMPACT. DIAPHRAGM BENT WITH CONNECTION BRACKET BENT

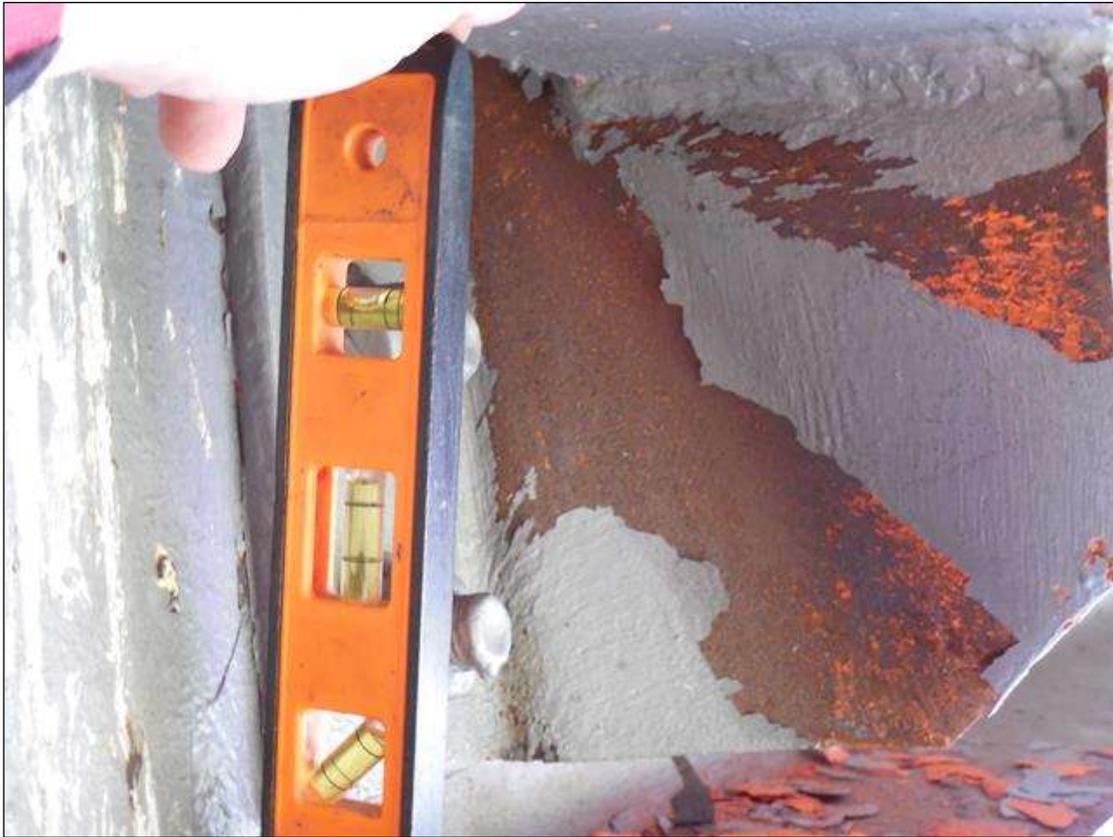
DIAPHRAGM CONNECTION TO INSIDE FACE OF WEB BENT.

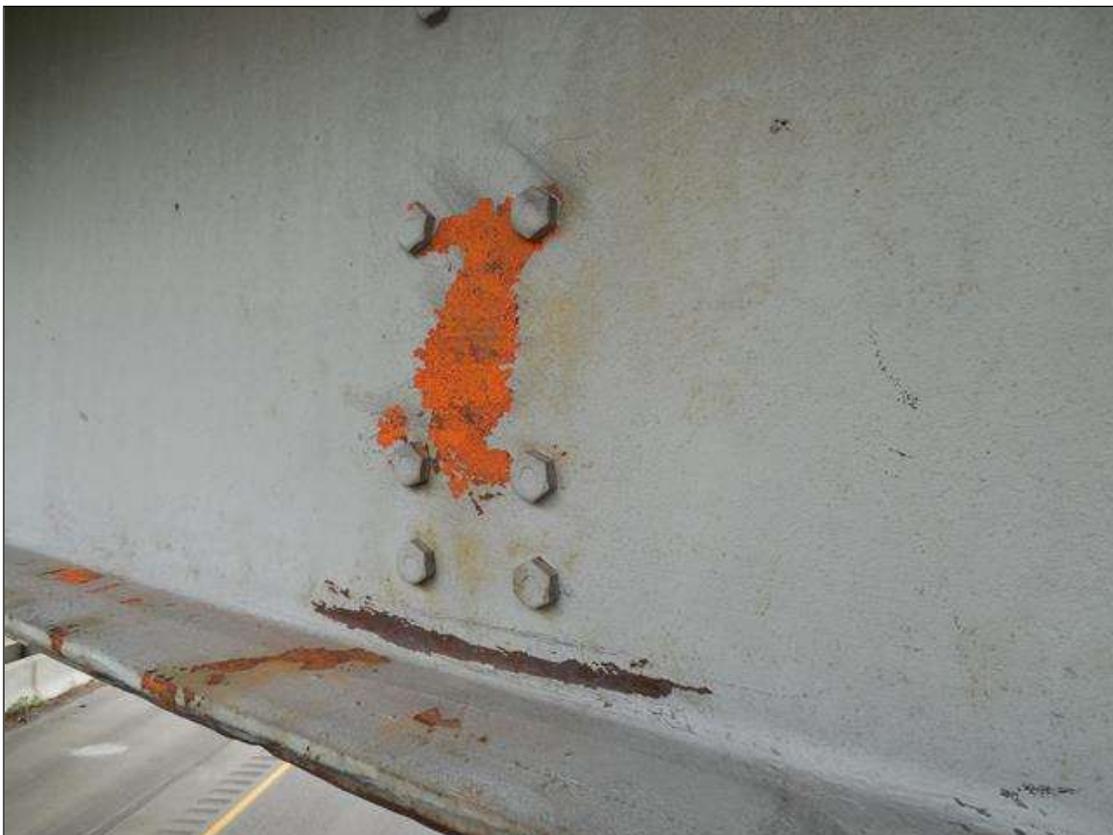
ANOTHER PHOTO OF OUTSIDE FACE AT FIRST DIAPHRAGM

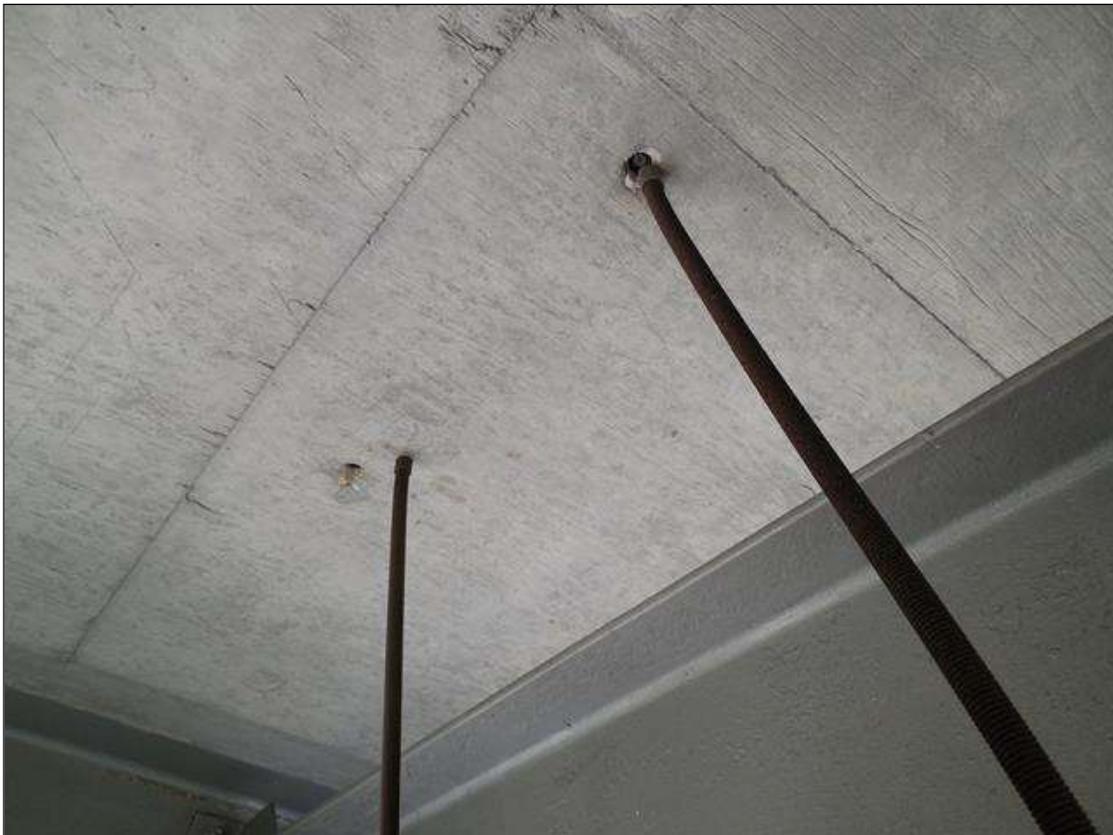
UTILITY HANGERS BROKEN AT IMPACT AREA, BRACKETS HANGING IN BAY 1, OTHER BENT.

3314	Maintain Steel Superstructure Components	LF	6	UTILITY HANGERS BROKEN AT IMPACT AREA, BRACKETS HANGING IN BAY 1, OTHER BENT.

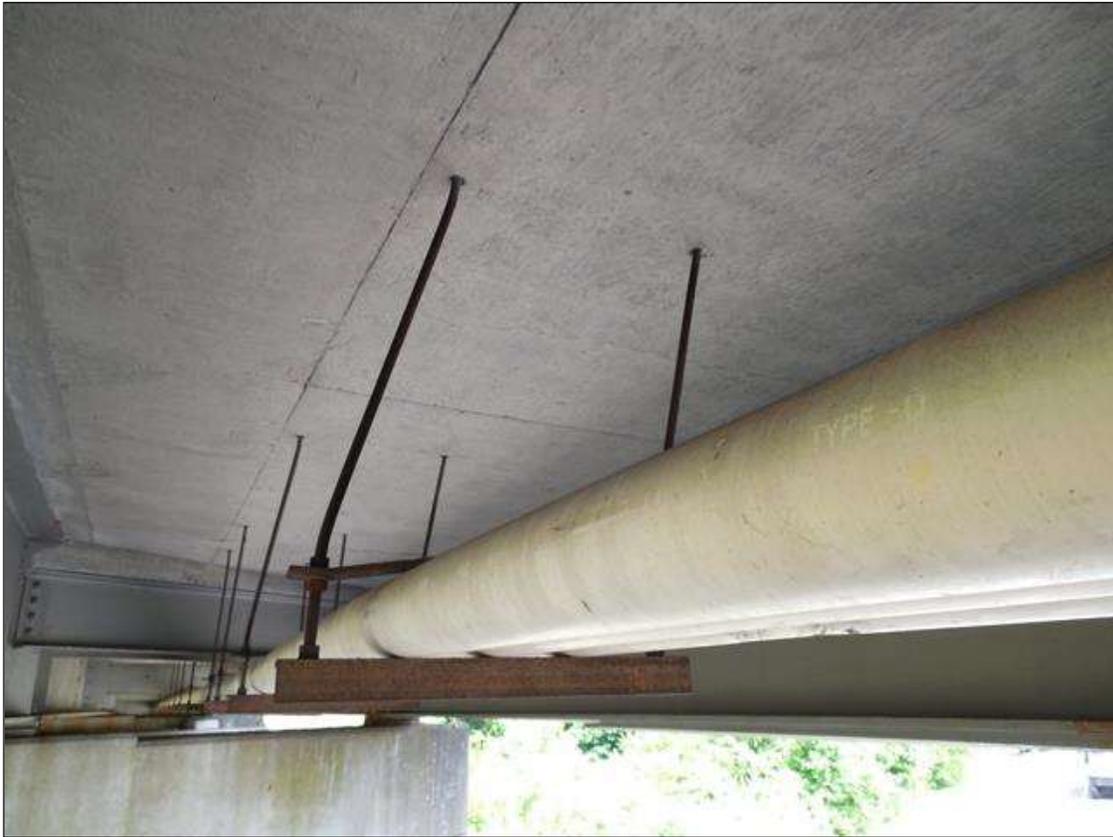
OTHER BRACKETS BENT

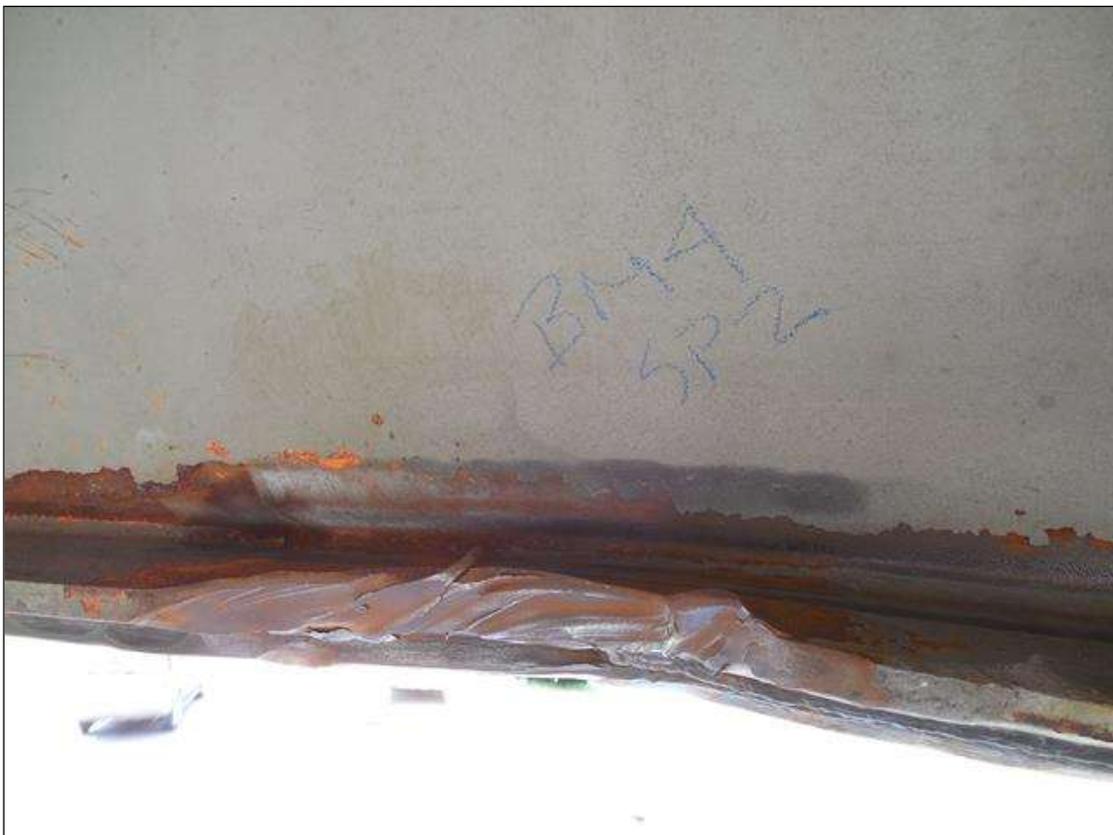
BEAM 4 POINT OF IMPACT, 19'-10" FROM BENT 1.

3314	Maintain Steel Superstructure Components	LF	32	BEAM 4 POINT OF IMPACT, 19'-10"FROM BENT 1, BEAM IS BENT OUT OF PLUMB 6", BOTTOM FLANGE IS BENT ALONG 32' OF BEAM LENGTH. BOTTOM FLANGE IS BENT UPWARD 1" AT IMPACT AREA. INTERIOR DIAPHRAGM IN BAY 3 AT BEAM 4, MISSING 8 BOLTS

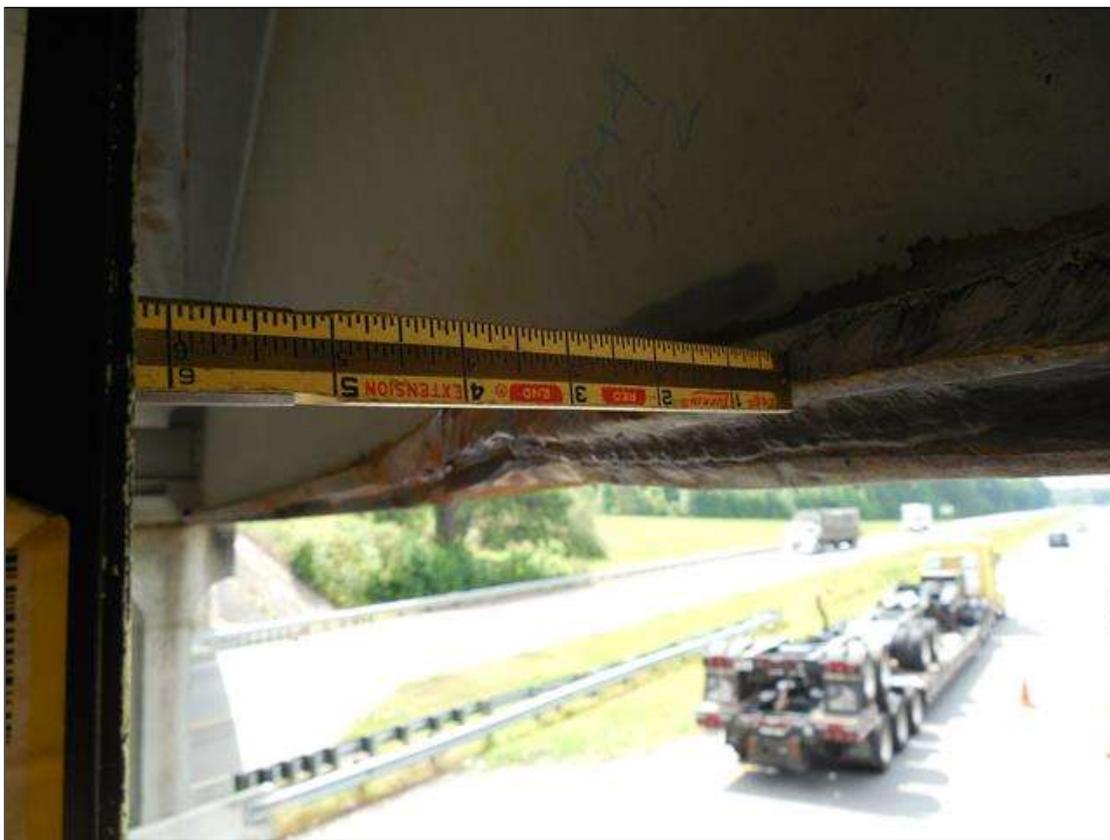
BEAM 4 IN SPAN 2 BENT OUT OF PLUMB 6", BOTTOM FLANGE IS BENT ALONG 32' OF BEAM LENGTH.

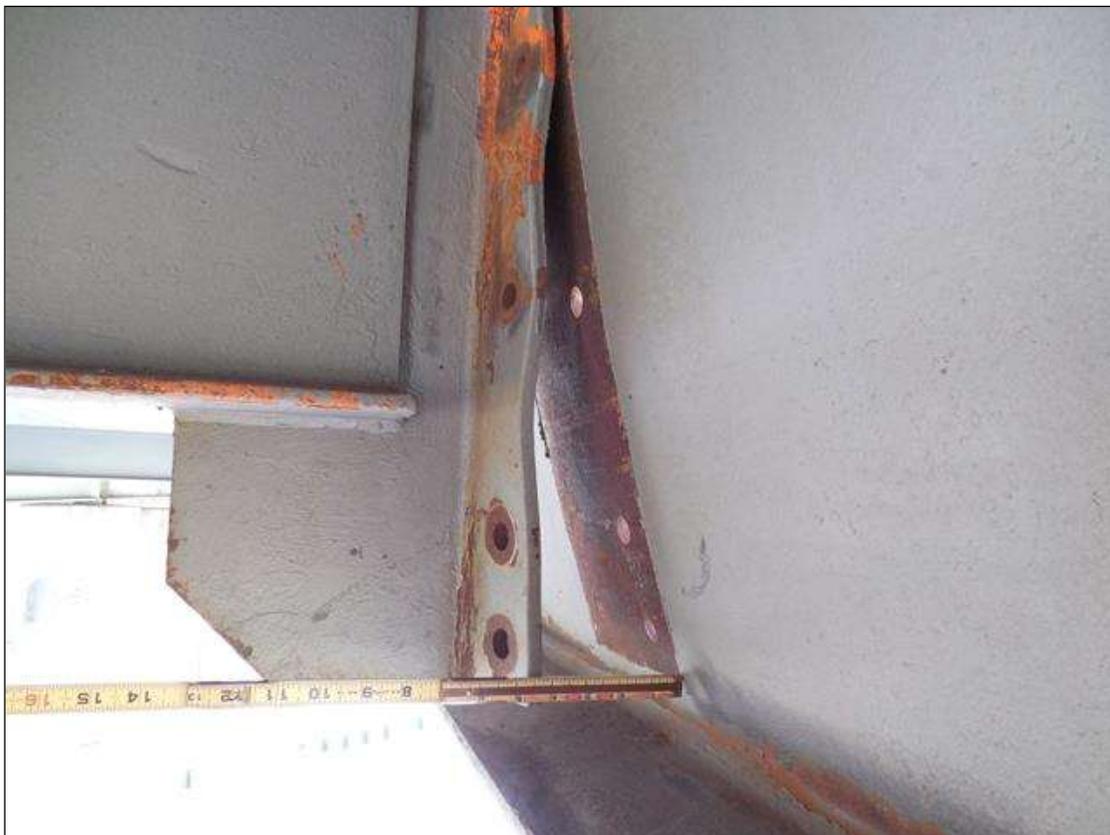
INTERIOR DIAPHRAGM IN BAY 3 AT BEAM 4, MISSING 8 BOLTS

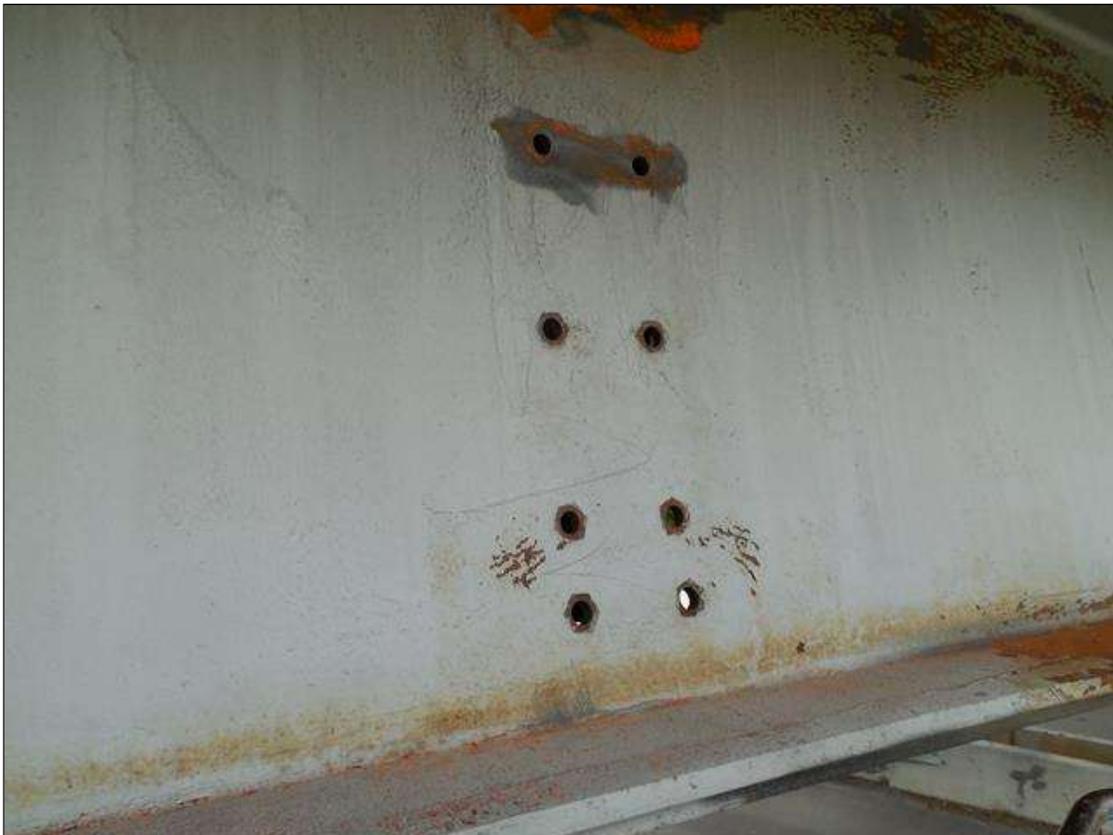
OUTSIDE FACE OF BEAM 4 AT INTERIOR DIAPHRAGM, BOLTS SHEARED OFF.

3314	Maintain Steel Superstructure Components	LF	3	OUTSIDE FACE OF BEAM 4 AT INTERIOR DIAPHRAGM, 8 BOLTS SHEARED OFF.

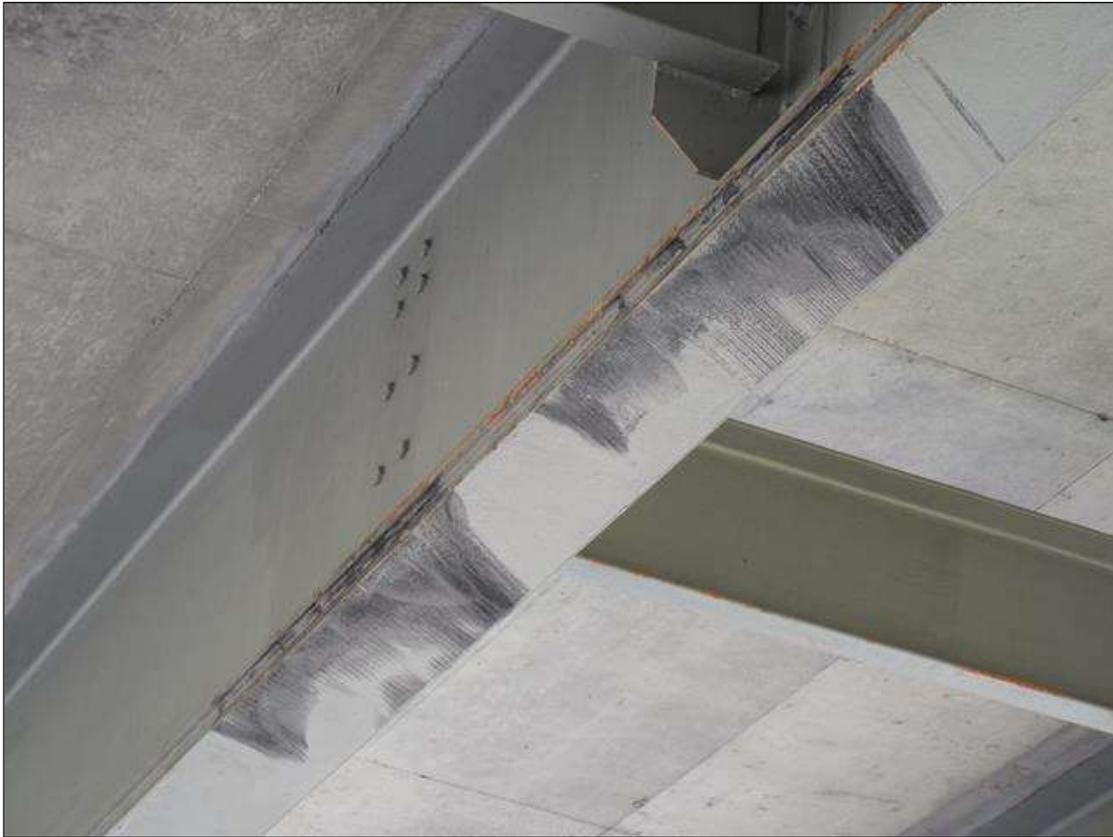
SCRAPES ALONG BOTTOM FLANGES ON BEAM 3
