STATE OF NORTH CAROLINA
DEPARTMENT OF TRANSPORTATION

MEMORANDUM TO: J. VICTOR BARBOUR, PE
STATE DESIGN SERVICES ENGINEER

FROM: C. L. JONES, P. E.
STATE MATERIALS ENGINEER

SUBJECT: Wood Guardrail Posts & Offset Blocks

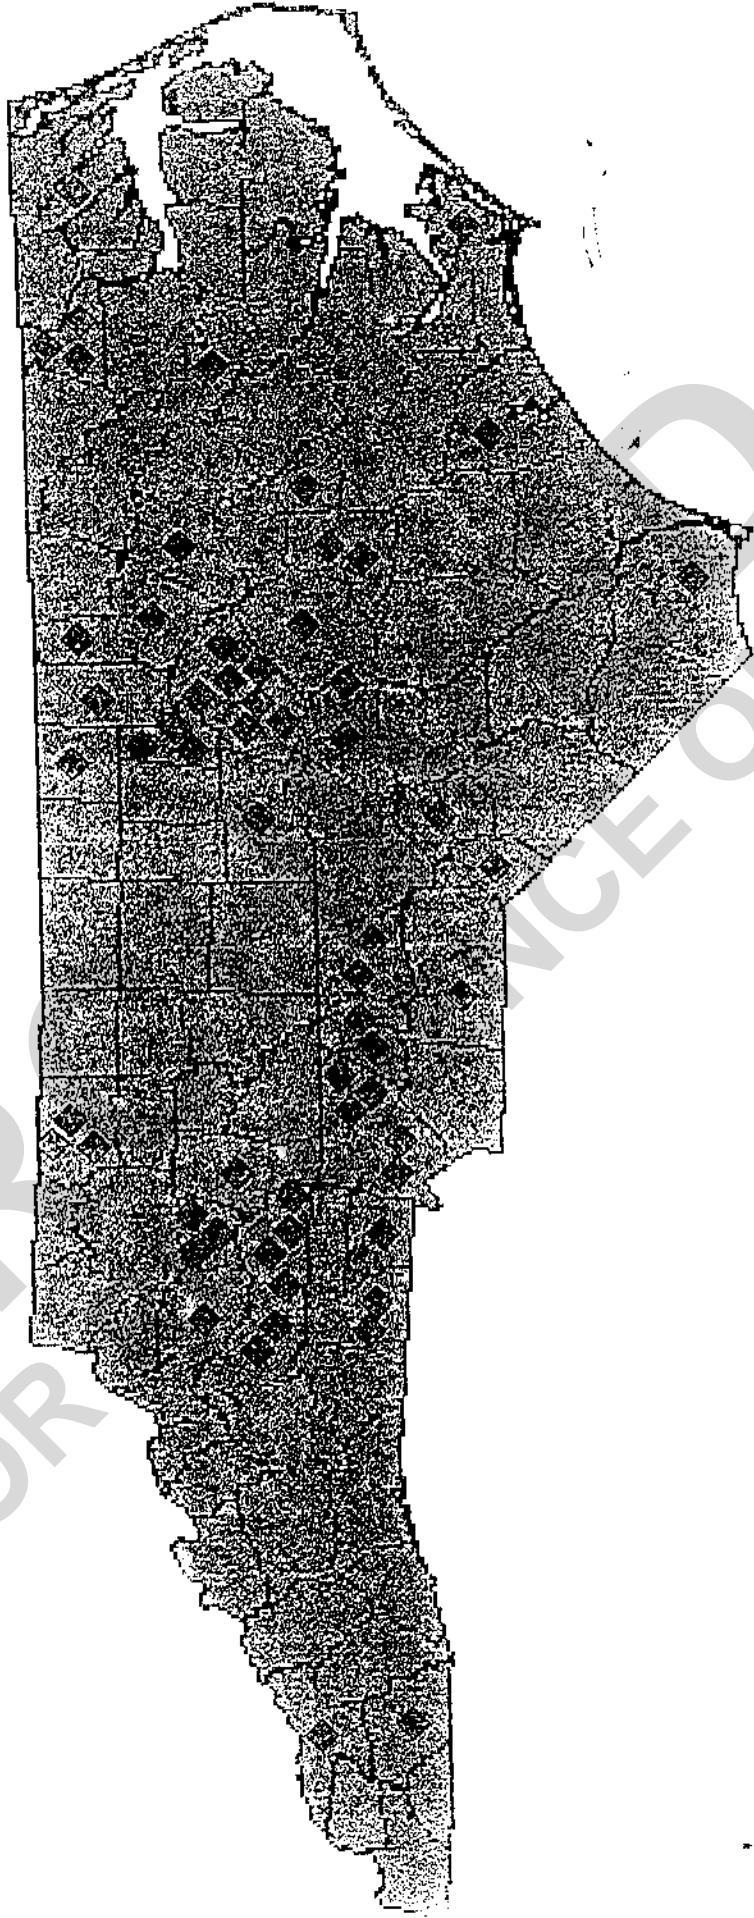
LOCATIONS WITH SEVERE DAMAGE

Based upon this information, the Materials and Tests Unit evaluated 110 different guardrail locations in 61 counties throughout the state. We were surprised to find that 65 of these locations (59%) exhibited major distress. Severe insect damage was observed at 35 locations (32% of the total). The other damaged locations were either severely cracked or checked, rotten or broken. Twenty-one of the locations exhibiting severe damage were less than 20 years old.

We are continuing to gather information, but based upon the investigation so far, we recommend that the use of wood guardrail posts and offset blocks be discontinued. I have a presentation showing the extent of the damage that could be shown at the next guardrail committee meeting if desired.
