# STRUCTURE BULLETIN

## NCDOT Construction Unit

1. Current Issues: Cored Slab Rotation During Tensioning
2. Repair of Galvanizing
3. Curing Compound

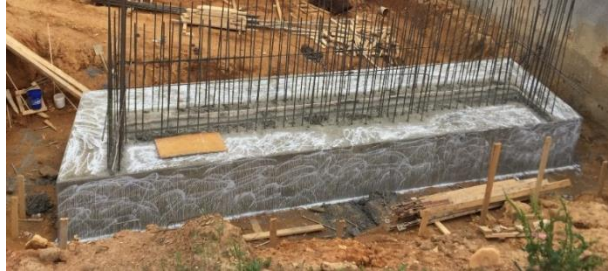
should look like a painted wall. The coverage rate seen in the picture above is far too common on many of our structural members. This will not keep moisture from evaporating from within the concrete. So clean those nozzles, completely coat the concrete surface, check the application rate, leave the supersoakers for the kids, and let's not let the Roadway folks show us up.

reactions will be slowed and the concrete will not perform as intended. This is why we cure our concrete. [Article 420-15](#) lists various approved methods of curing concrete for different applications. Today we will discuss curing compounds. [Article 420-15\(C\)](#) should be reviewed in detail, but it should be noted that the required rate of application is **one gallon per 150 square feet**. At this rate, it
