# STRUCTURE BULLETIN

## NCDOT Construction Unit

### Current Issues: Payment for PPC overlays

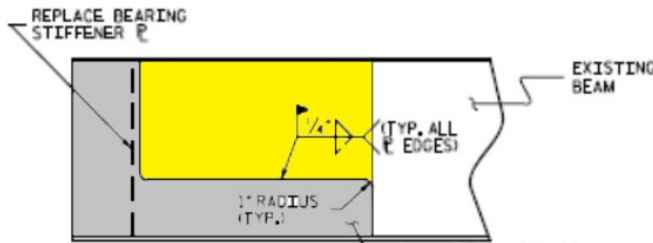
**Question:** Can the contractor change the shape of a steel girder repair?

**Answer:** Sometimes. The "L" shaped repairs shown above in grey are common in girder repairs. While this shape may capture the area needing repair it may involve cutting sections with two or sometimes three radii. Some contractors will ask to square up the repair to eliminate these radii, resulting in a repair area of both the grey and yellow above. While it costs them more in material it the savings in time and fit up is worth it to them. This is allowable with the approval of the engineer. Just remember we only pay for the pounds of material in the original repair area (grey) and not the addition (yellow).
