STRUCTURE BULLETIN

NCDOT Construction Unit

Current Issues: Bridge Deck Finish

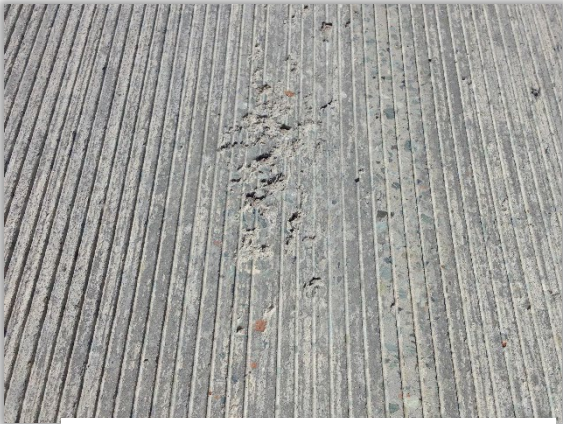
PITTED DECK SURFACE

Have you ever poured a bridge deck and thought everything went well, only to see a pitted surface texture on the top of the deck when the burlap and plastic is eventually pulled off?

There are a lot of factors that affect the finish of a bridge deck, including proper inspection. Shadows, glare, angle, lack of light, and distance can impact your ability to properly inspect the surface texture of a bridge deck during the pour, especially if only inspected from the leading edge of the pour. To truly see how the screed is finishing, it is critical to inspect the deck finishing from all angles, including leading edge of pour, left and right overhangs, and behind the pour. The Contractor should have 2 work bridges that can also be used if need be. Identifying the problem is the first step. On the following page are some troubleshooting tips provided by Terex Bidwell, to help resolve some common finishing problems if they occur. Although it is the Contractor's responsibility and their means and methods, your knowledge could help point them on the right path for correcting the poor finish. Timely corrective action is key to a good deck!

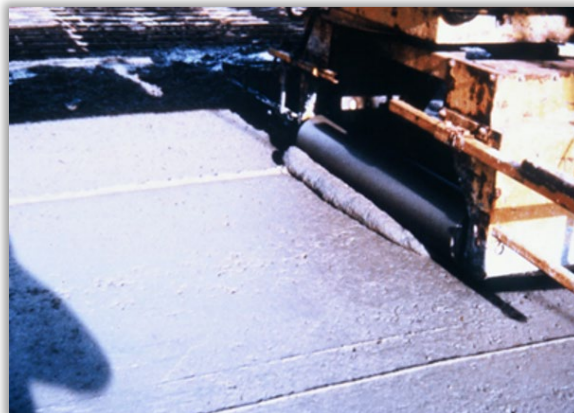
TOO MUCH CONCRETE ON DRUMS

Symptom	Cause	Remedy
Open or pitted surface left by the rollers (rollers are plowing concrete)	Paving rollers are carrying too much concrete (the roll of concrete on the side of the rollers is too large)	Adjust the augers lower to leave a golf ball size roll at the front edge of the leading roller.
	Concrete may be placed too far ahead of the machine. Concrete may be drying out.	Limit concrete placement to within a maximum of 10' ahead of the paving machine.
Open or pitted surface left by the rollers (no concrete on side of the leading roller)	Augers are set too low and are removing too much concrete (paving rollers carrying no concrete roll)	Raise augers to leave a golf ball size of concrete at the front end of the leading roller.
Roll of concrete coming off the rear of paving rollers (rollers are leaving a ridge in the slab)	This condition may exist if the rear of the paving rollers is too low.	Raise the rear of the paving rollers by raising the back legs of the screed until the excess roll or ridge disappears. Normally, the rear of the paving rollers should be 1/8" to 3/16" higher than the front of the leading edge of the paving rollers. Note: The augers may need to be readjusted at this time.
