Investigation of Primary Causes of Fatigue Cracking in Asphalt Pavement in North Carolina

NCDOT Project 2010-01

FHWA/NC/2010-01

March 2015

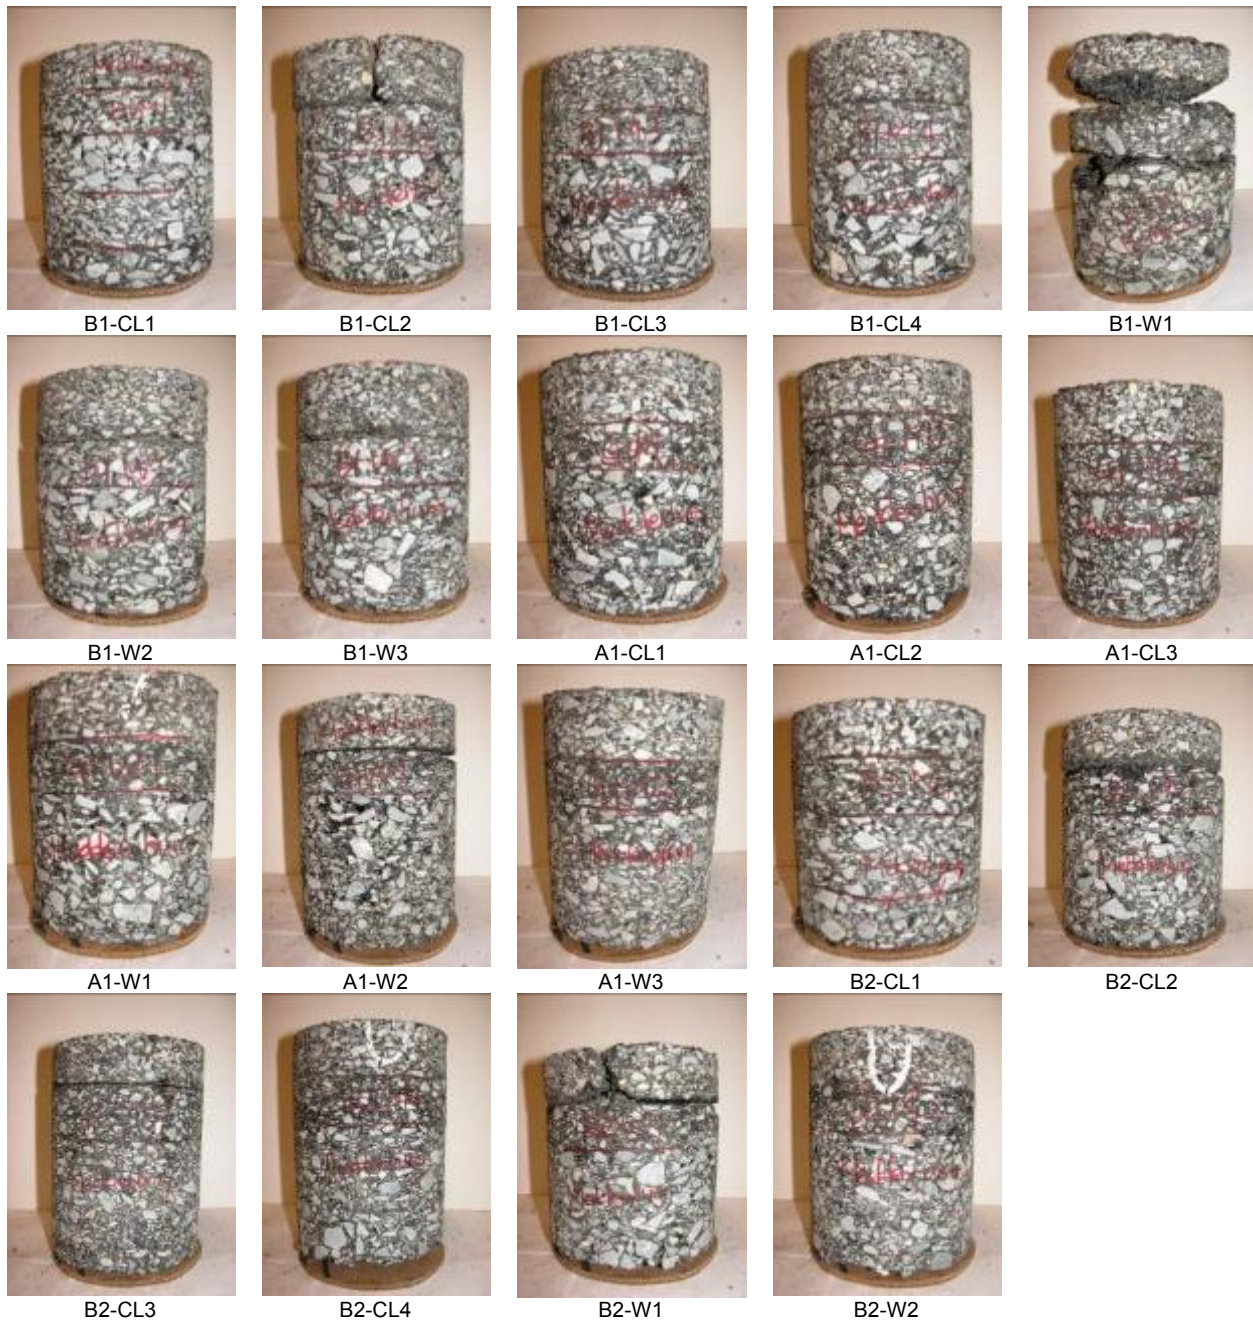
Figure B.9 Cores taken from NC-24, Charlotte, Mecklenburg County

B2M1	1 1/4	1 3/8	3 1/4	Cracked/	Cracks on top surface connected to 1 vertical crack on 1st layer
B2M2	1 5/8	1 3/8	4	Delamination/Intact	Delamination between 1st & 2nd layers
B2M3	1 1/2	1 3/4	4 1/4	Delamination/Intact	Delamination between 1st & 2nd layers
B2M4	1 5/8	1 3/8	4 1/2	Cracked	Cracks on surface connected to 1 vertical crack on 1st layer
B2W1	1 3/8	1 1/4	3 3/8	Cracked	Delamination and horizontal crack at/near bottom of top layer (1st layer)
B2W2	1 3/8	1 3/8	4	Cracked	Cracks on surface connected to 1 vertical crack on 1st layer

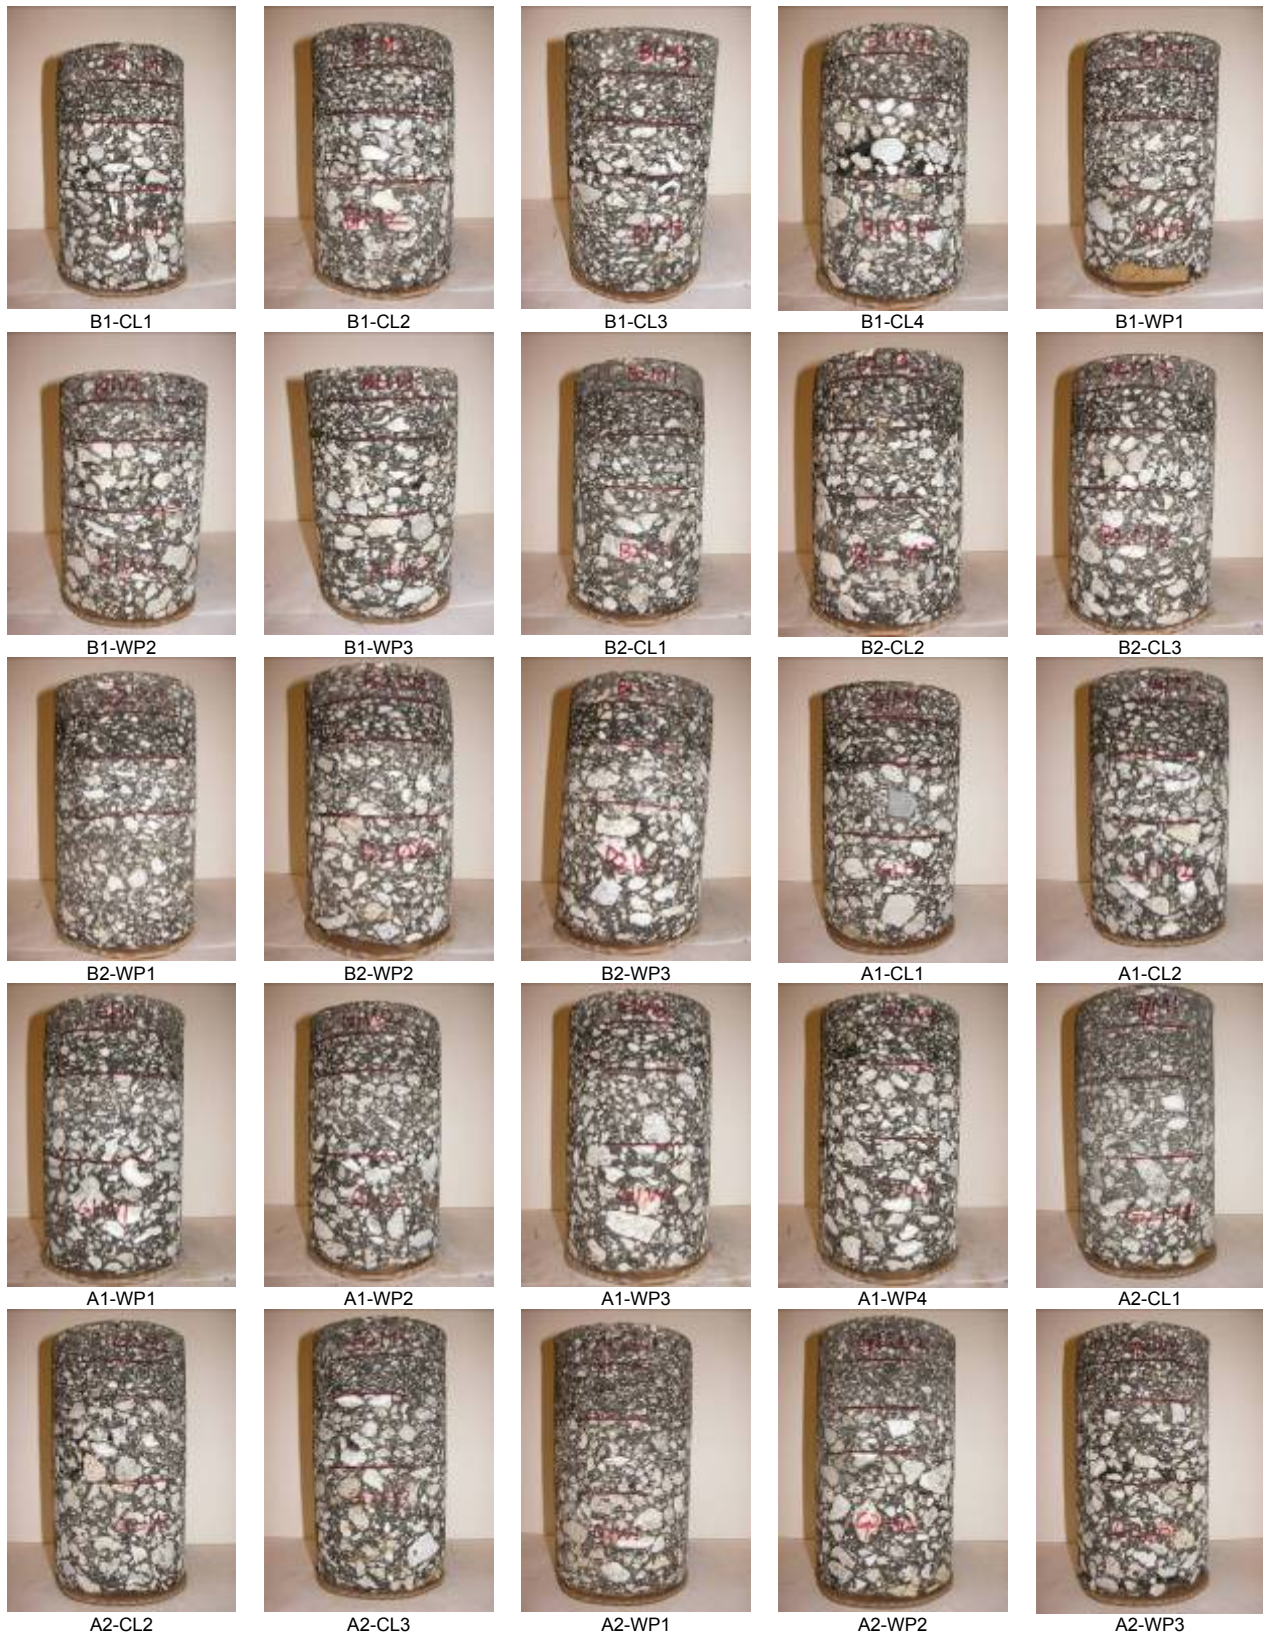
Figure B.13 Cores taken from US-17 (Ocean Highway) NB, Supply, Brunswick County

A1-WP4	1 1/8	1 3/4	2 3/4	4 3/4	10 3/8	Intact	
A1-CL1	1 1/4	1 1/2	2 1/4	4	9	Intact	
A1-CL2	1 1/8	1 7/8	2 1/4	4 1/8	9 3/8	Intact	
A2-WP1	1 3/4	1 7/8	2 5/8	4	10 1/4	Intact	
A2-WP2	1 1/2	1 5/8	1 1/2	5	9 5/8	Intact	
A2-WP3	1 3/8	1 3/8	3	4 1/8	9 7/8	Intact	
A2-CL1	1 3/8	1 3/4	2 3/4	4	9 7/8	Intact	
A2-CL2	1 1/2	1 1/4	3	4 1/4	10	Intact	
A2-CL3	1 3/4	1 3/4	2 1/2	5	11	Intact

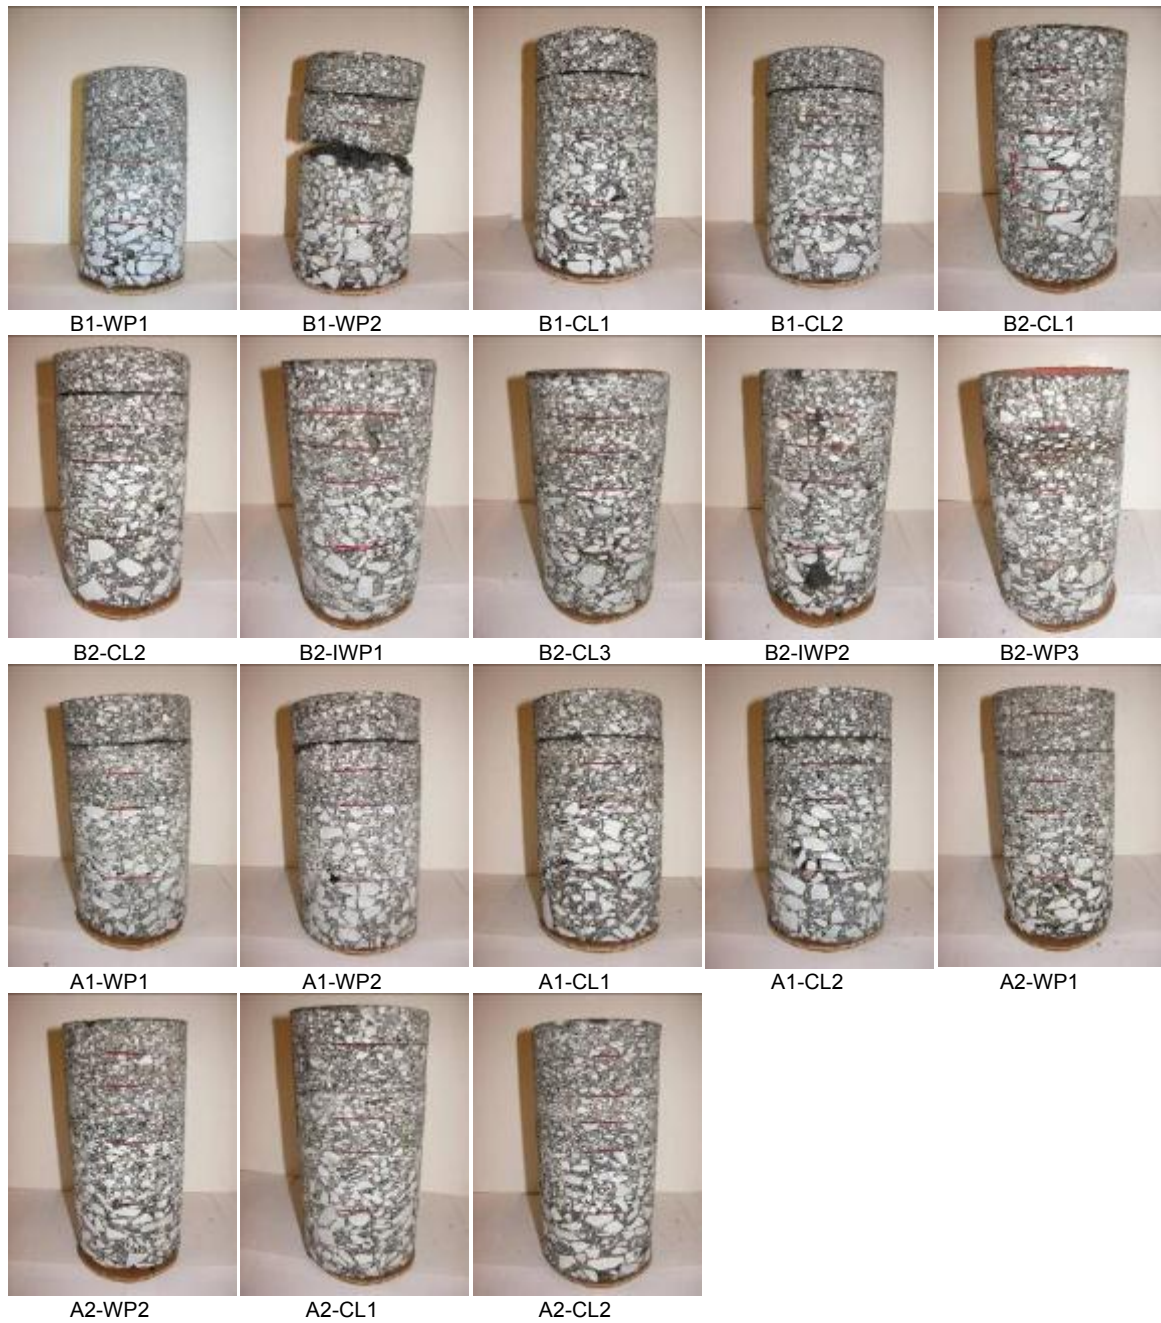
Figure B.24 Cored field samples taken from US-70 EB near Selma, Johnston County

Photographs of all the pavement cores are shown in Figure B.24, and a summary of each is given in Table B.7. B2-IWP1 (1st inner wheel path in 2nd bad region in the section), B2-IWP2 and B2-WP3 (3rd outer wheel paths in 2nd bad region in the section) are of primary interest because these cores show vertical cracks connected to cracks on top of the core. These cores can be regarded as exhibiting either top-down cracking or a trace of bottom-up cracking that has spread diagonally through the pavement thickness. Photographs and crack mapping data will be used to try to clarify whether the observed cracking is in fact top-down cracking or a reflection of nearby bottom-up cracking.

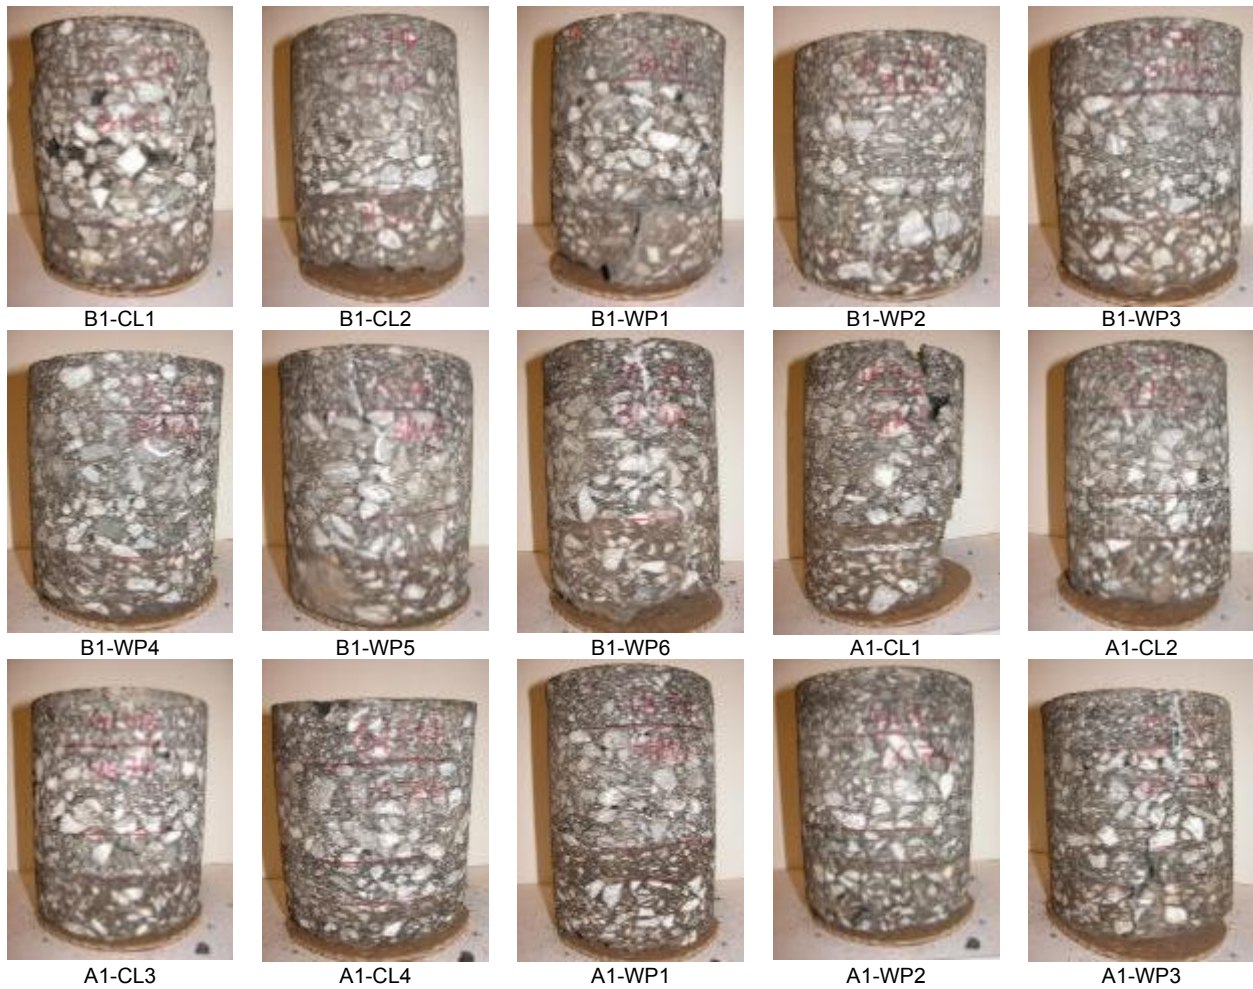
Figure B.30 Cores taken from US-74, Bryson City, Swain County

A1-CL1	1 1/2	2 2/3	1 1/8	2 1/2	Broken	2 vertical macrocracks from top to bottom; partial delamination in the surface of sublayers in 4th layer
A1-CL2	1 7/8	2 3/8	1 1/4	1 3/4	Intact	Sound condition
A1-CL3	1 1/2	2 1/4	1 1/4	1 7/8	Intact	Sound condition
A1-CL4	1 3/8	2 3/8	1 1/4	1 1/4	Intact	Sound condition, but hairline crack on top surface
A1-WP1	1 3/4	3 3/8	1	2	Intact	Sound condition
A1-WP2	1 3/4	2 1/2	7/8	2	Intact	Sound condition
A1-WP3	1 1/2	2 3/8	1	1 3/8	Cracked	3 vertical macrocracks from top to bottom; horizontal crack in 4th layer

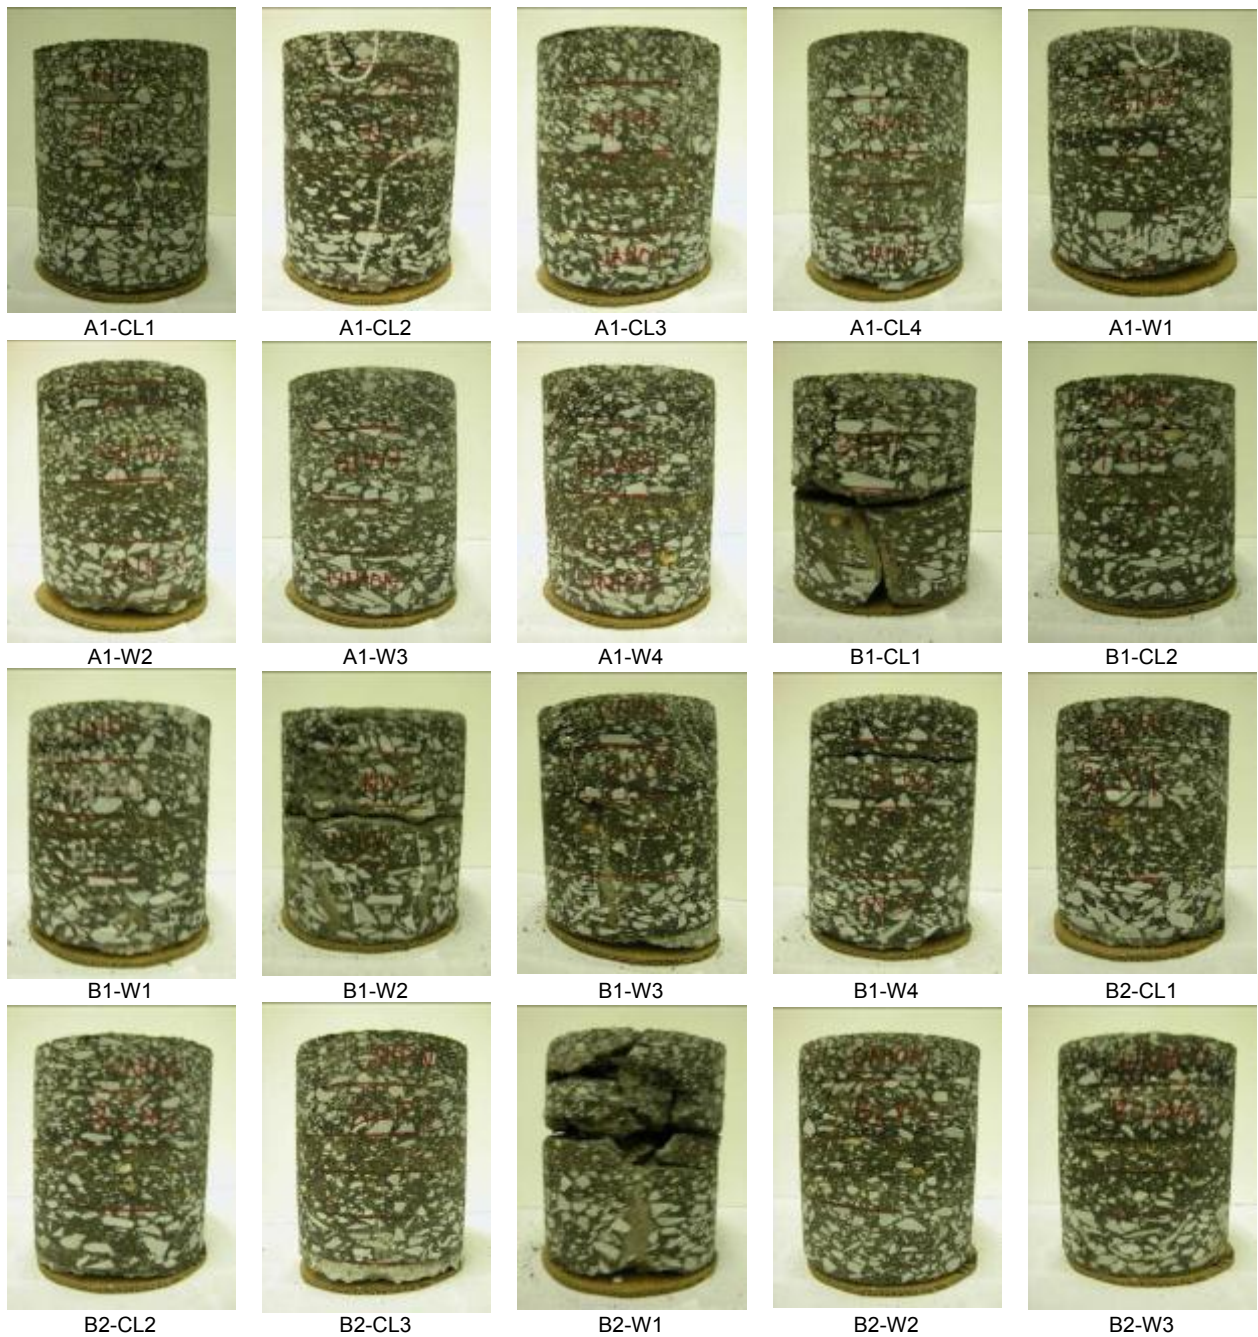
Figure B.35 Cores taken from US-601, Monroe, Union County

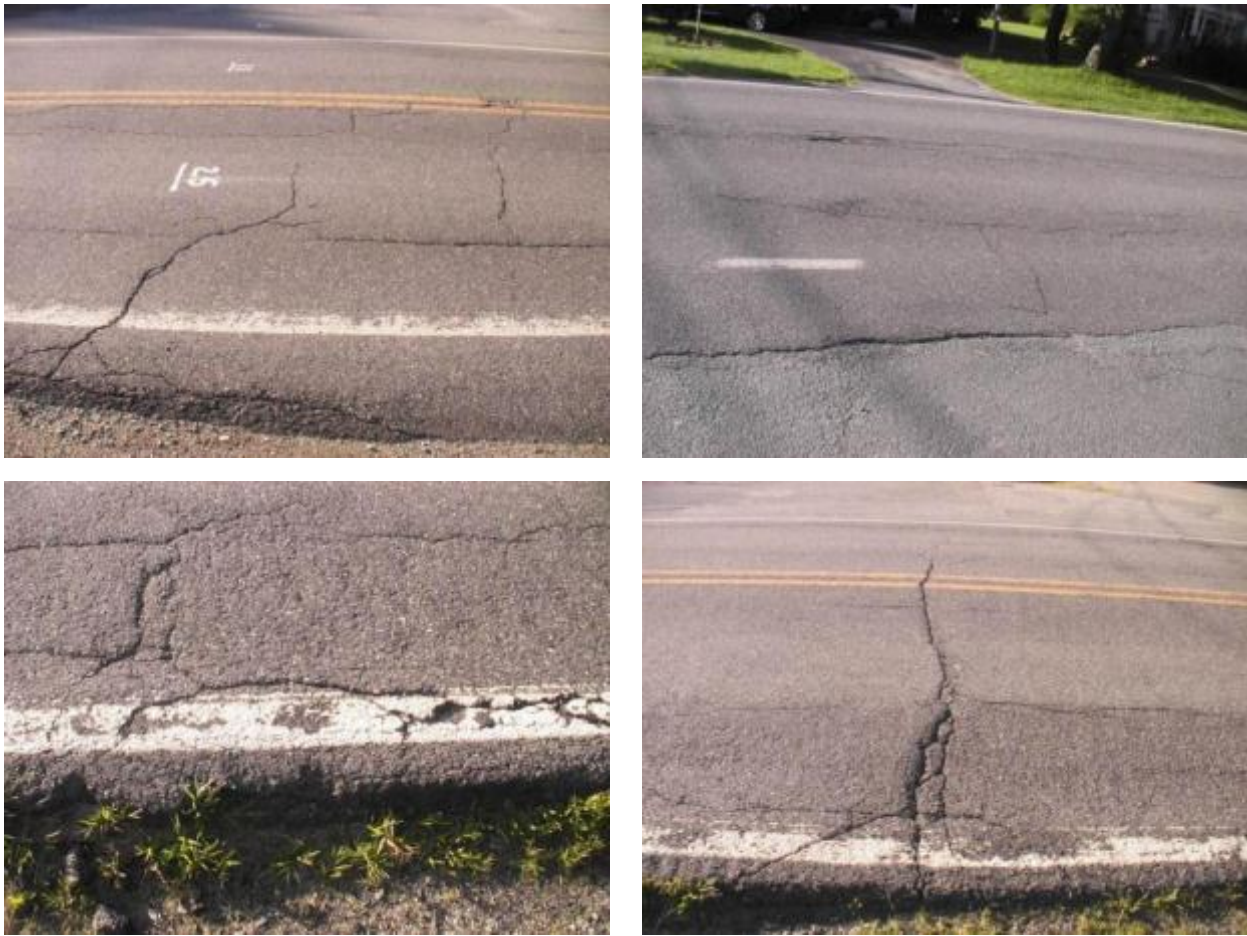
Figure B.48 Photographs of cracking patterns on NC-194, Banner Elk, Avery County

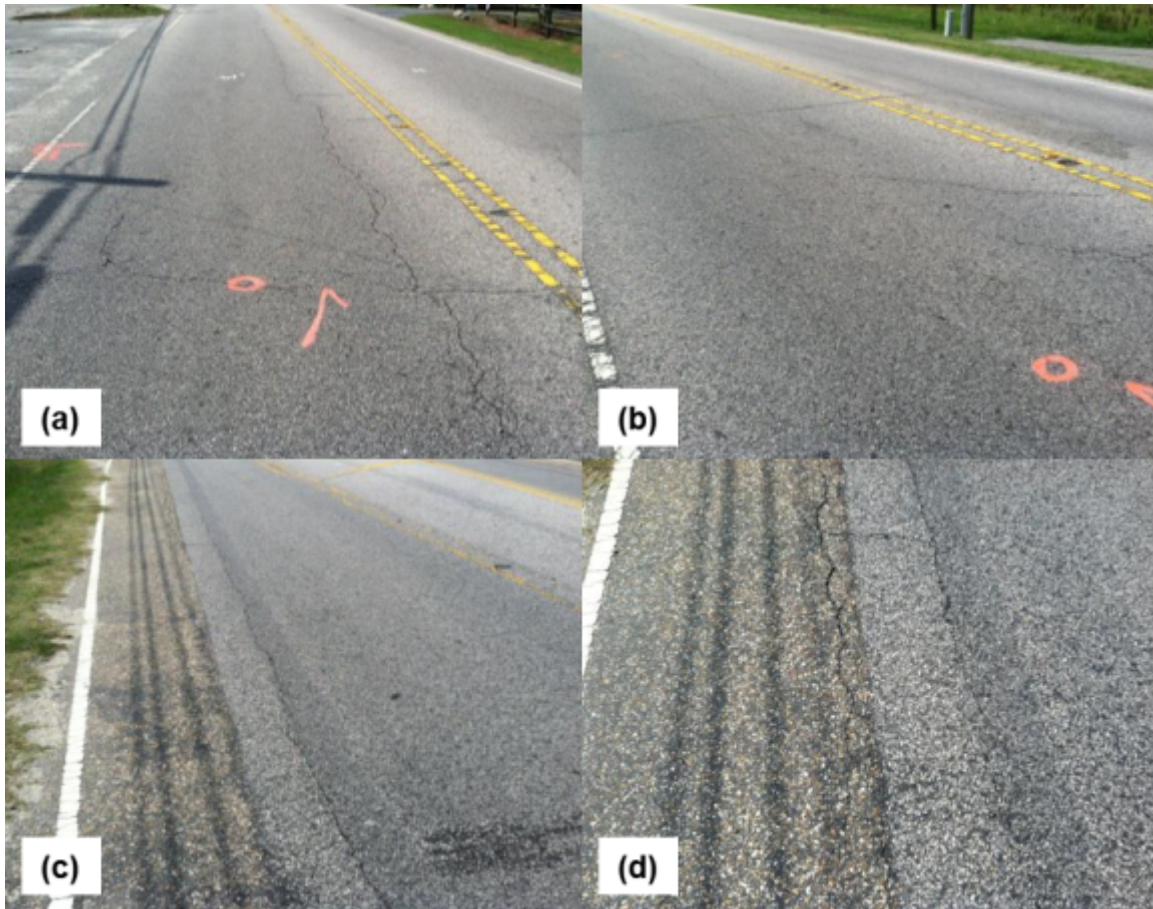
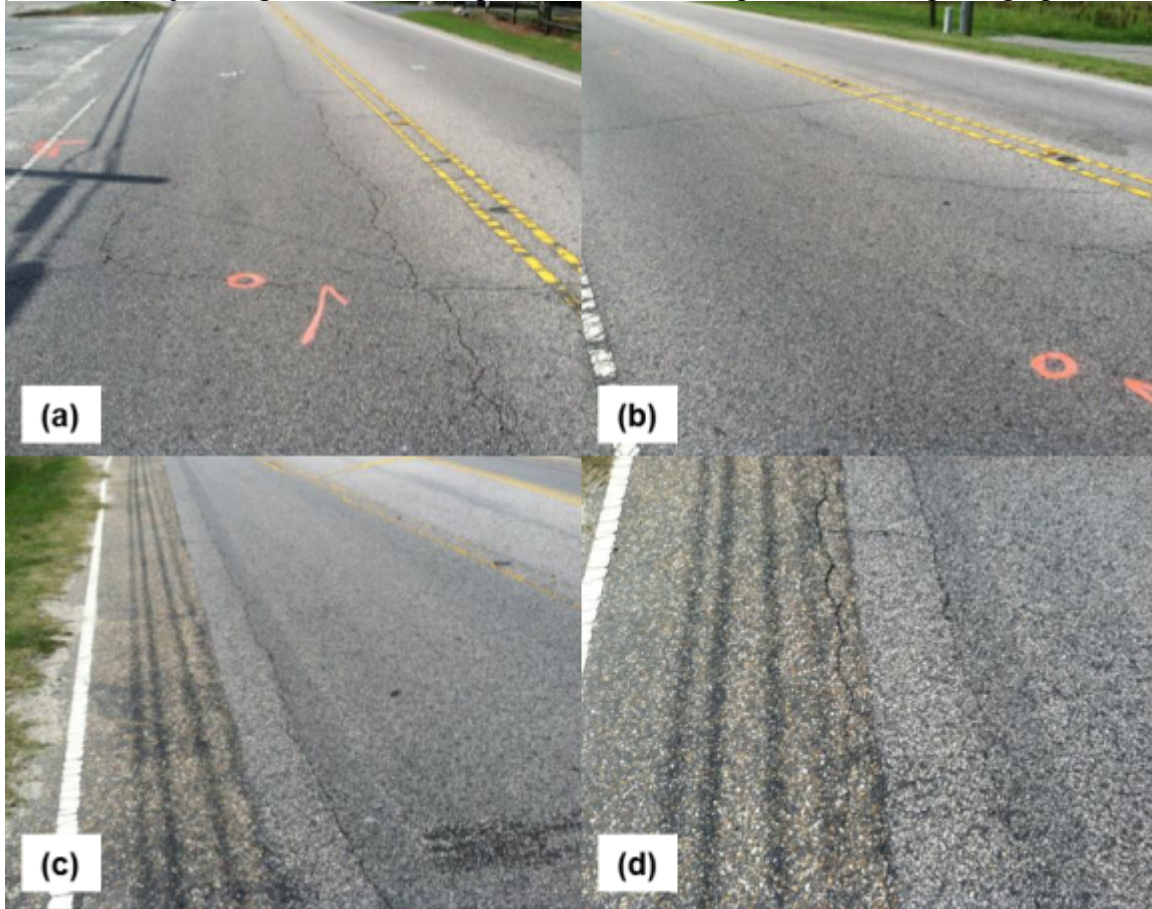
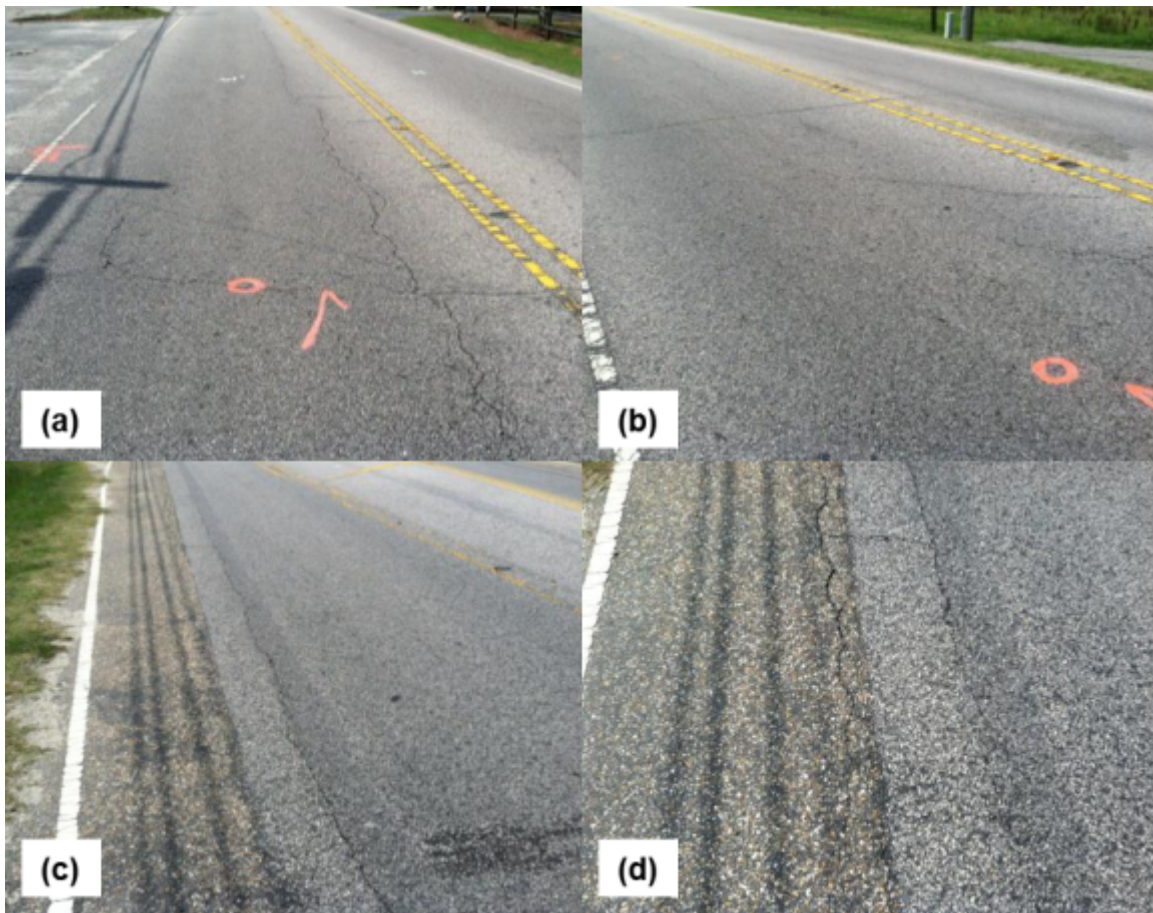
Figure B.81(a) and (b) show major longitudinal cracking in the inner wheel-path area for both of the two different condition regions (*bad and good*). The southbound lane (opposite direction

Figure B.81(c) and (d) were taken where the good condition region begins. In the good condition region, longitudinal cracking can be observed in both the inner and outer wheel-path areas, but no outer longitudinal cracking is observed in the bad condition region. Usually, longitudinal cracking is observed more in the outer wheel-path area; but, this site is not representative of a commonly observed case.

Figure B.81 Photographs of representative cracking patterns on NC-55, Angier, Harnett County: (a) *bad* condition location, (b) *good* condition location, (c) at the beginning of the *good* condition region, and (d) magnified view of photograph of (c)
