Final Report

**EVALUATION OF STREAM CROSSING CULVERTS TO ASSESS  
IMPACTS ON STREAM MORPHOLOGY AND AQUATIC PASSAGE-Part  
II**

Daniel E. Line and James D. Blackwell

September 25, 2013

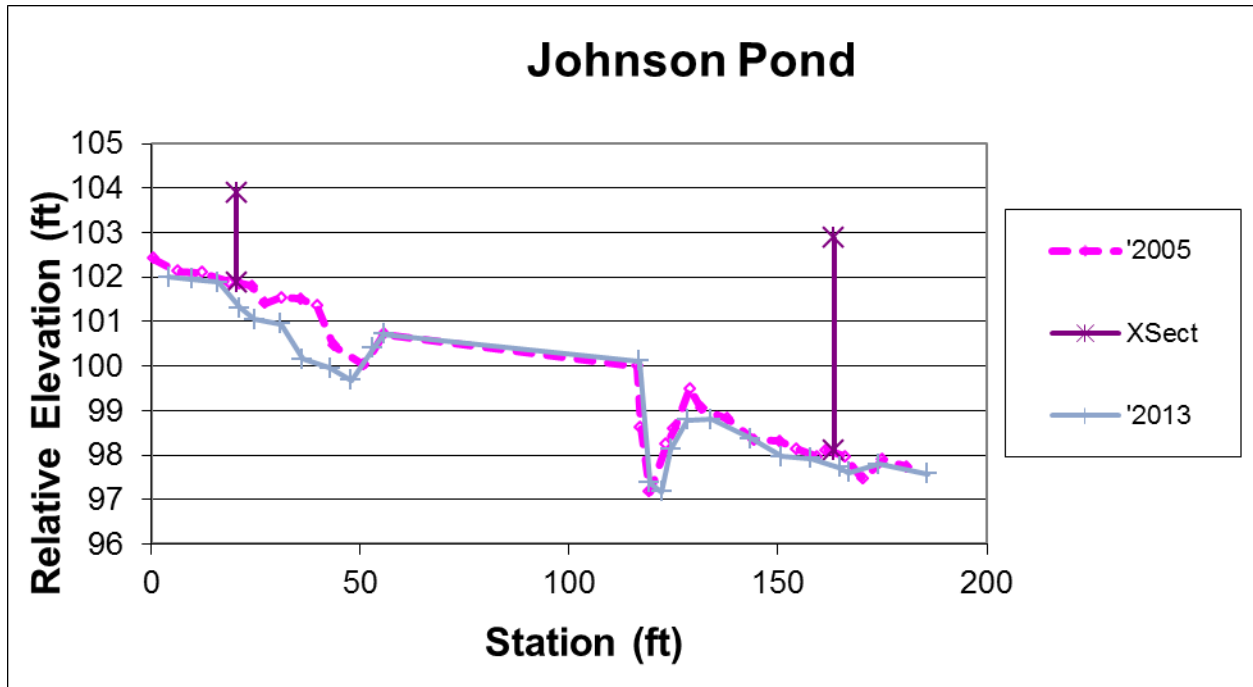
Figure 2. Longitudinal survey data for the Johnson Pond culvert.

The longitudinal profile for the thalweg of the stream channel and culvert at Johnson Pond is shown in figure 2. The slope of the culvert was considerably less than that of the upstream channel section and slightly greater than the downstream channel section (Table 2). Comparing the 2005 and 2013 survey data shows that the first 20-30ft of the stream channel upstream of the culvert has downcut ~0.5-1.0ft during the period. A possible reason for the downcutting is that there was a log across the channel ~10ft upstream of the culvert which would cause an overflow and scour hole dynamic during higher flows (figure 3). The scouring worked long enough to undermine the log and then the stream channel eroded to below the log (figure 3). This situation may have been started or helped by lowering the invert of the new culvert as in order to install a larger diameter culvert (from 36 to 66 in.) the invert was lowered ~1.5ft. Evidence for this is that the channel was over the top of the log in a 2004 photo, but in the 2005 photo after the new culvert was installed, the log was almost totally exposed. The downcutting appears to have migrated upstream ~30ft over the 8 years, but it is unknown when this occurred, if it would have

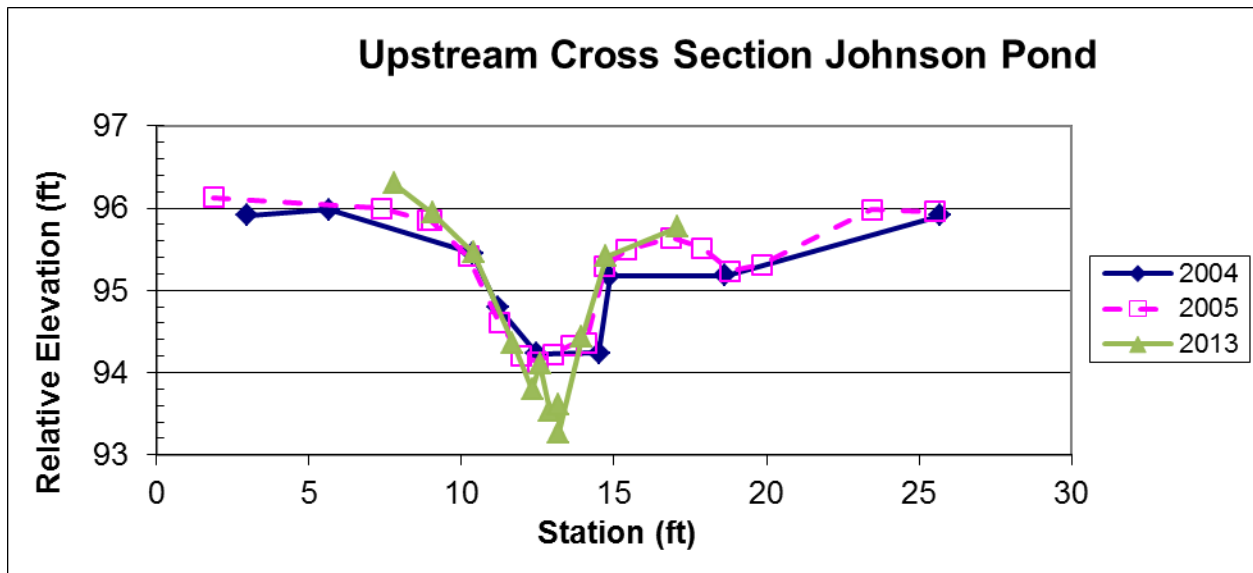
Figure 4. Upstream cross section for Johnson Pond.

Survey data of the upstream cross sections are shown in figure 4. As shown, the 2013 survey data indicates the channel has downcut about 1ft since 2005. The fact that there were many roots, fallen tree limbs across the channel, roots, and detritus in the channel (figure 3) may indicate that changes in the stream channel survey could have been caused by decay and/or movement of these stream stabilizing factors. Survey data from the downstream cross section (figure 5) document little change from 2005 to 2013 thereby confirming the longitudinal data, which also showed little change. The small differences in the surveys are likely the result of uncertainty in survey measurements.

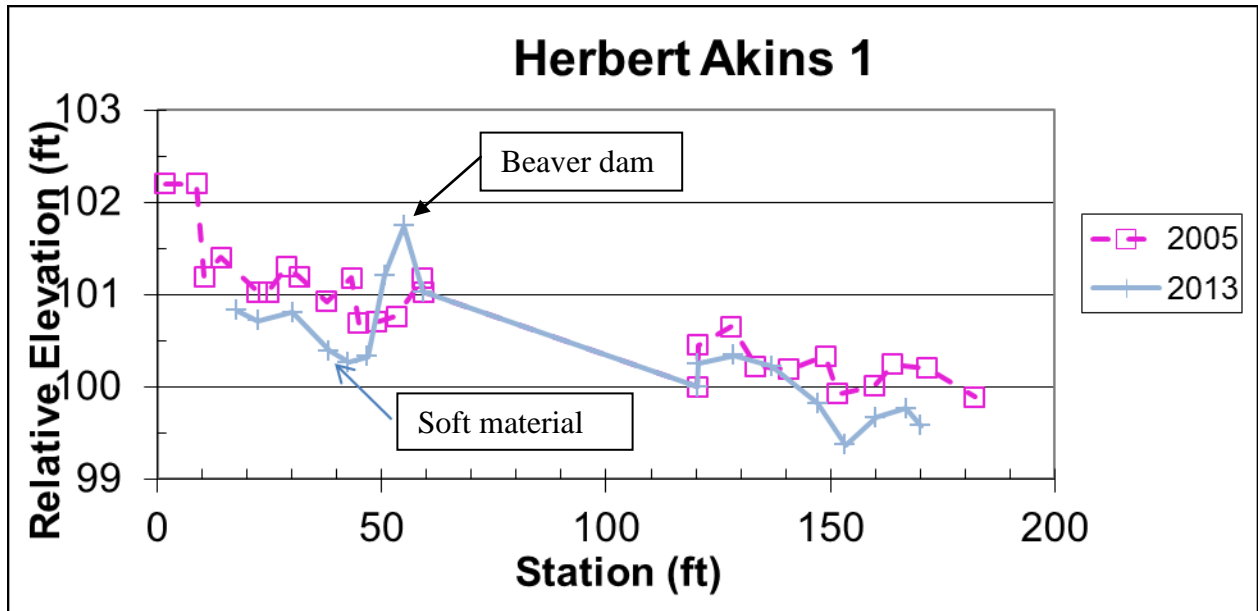
Figure 6. Longitudinal survey data for the Herbert Akins1 stream and culvert.

The longitudinal profile for the thalweg of the stream channel and the culvert is shown in figure 6. Although the inlet of the culvert could not be surveyed due to the beaverdam, it appears from the figure that the slope of the culvert is greater than that of the stream channel, which suggests an embedded culvert outlet and in fact this was the case (figure 7). Comparing the 2005 and 2013 survey data shows that the stream channel upstream of the culvert has downcut ~0.2-0.5ft during the period. It is difficult to explain why a stream with a low slope would downcut to a level 0.5-0.8 ft below the elevation of the culvert invert. A possible explanation for this is that there was an error in one of the surveys or that prior to the beaverdam (figure 7) vegetation increased the elevation of the channel and after the vegetation died due to standing water the channel material consolidated thereby dropping the elevation of the channel. Soft depositional material was observed in the upstream channel, which makes determining an accurate channel height difficult. The invert of the larger culvert installed in 2005 (72 vs 60 in.) was likely at a lower elevation than the previous one, but the upstream invert was still at a higher elevation than

the bottom of the channel; thus the culvert should have provided grade control. Downstream of the culvert, the stream channel also downcut ~0.5ft over the last 30ft of the profile. This downcutting may not have been a natural occurrence as it appears that a combination of soil and #57 stone were dumped along one bank at some point during the period and there was rip rap observed in the channel in 2005. In addition, a large tree fell across the channel which likely changed the hydraulics of flow in the surveyed reach. The fact that the survey indicates that the stream channel upstream and downstream downcut would seem to provide strong evidence of stream instability caused by the new culvert, but there are so many confounding factors including the build-out in the watershed changing peak discharge that this cannot be stated with a high degree of confidence.

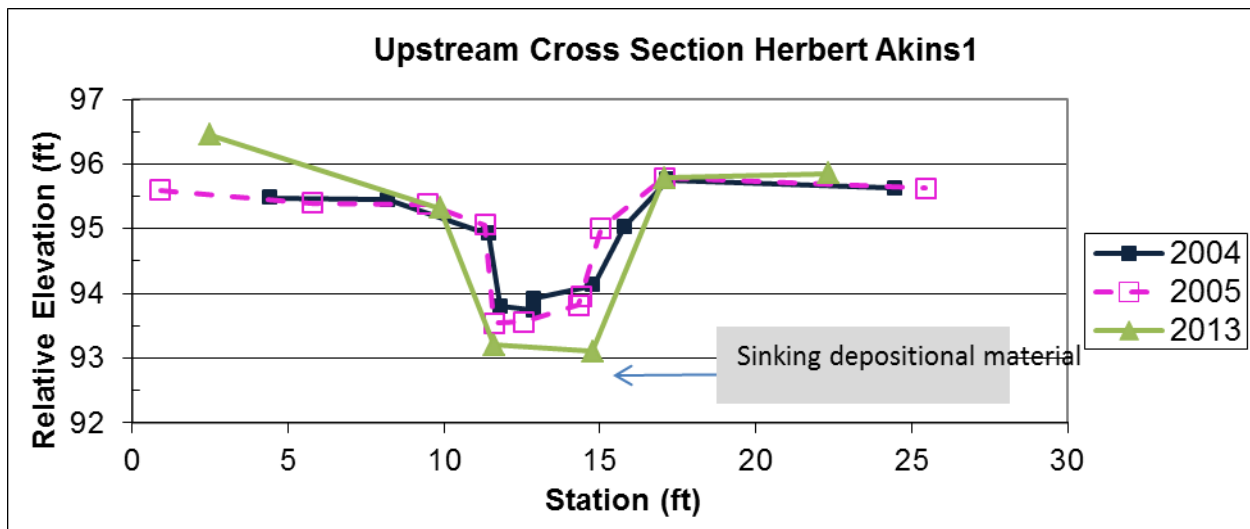
Figure 8. Upstream cross section at Herbert Akins1.

Survey data of the upstream cross sections are shown in figure 8. The 2013 survey was conducted about 4ft upstream from the 2005 survey. As shown, the 2013 survey data indicates the channel has downcut and widened about 0.5-0.7ft since 2005, but this may be explained by the difference in longitudinal location. It was often difficult to repeat the 2005 survey as it was not well-documented. Survey data from the downstream cross section (figure 9) could not be obtained at the same location because of a fallen tree, so it was conducted 8ft downstream; however, the cross sections from 2005 and 2013 are similar indicating little change.

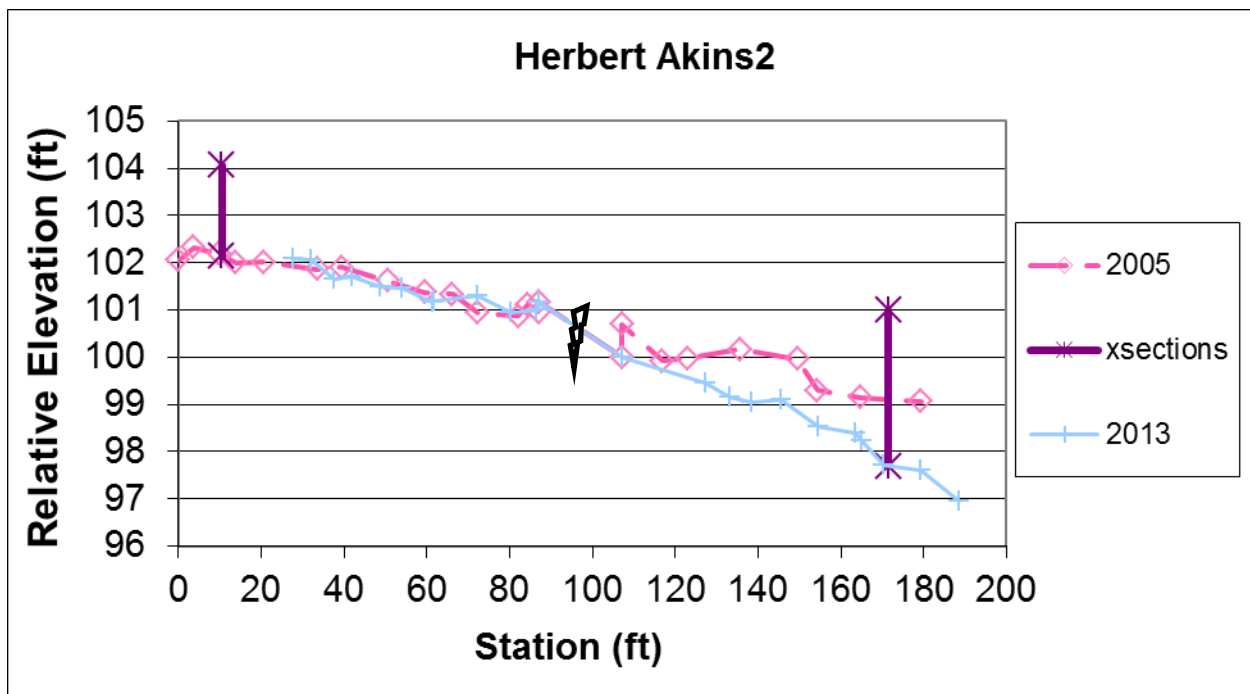
Figure 10. Longitudinal survey data for the Herbert Akins2 stream and culvert.

The longitudinal profile for the thalweg of the stream channel and culvert is shown in figure 10. The slope of the culvert (longer than shown in figure 10 to fit better) was about the same as the upstream stream section, but was much less than the downstream section (Table 2). Survey data from 2005 showed that the outlet was embedded which was indicated on the profile by the stream channel being higher than the downstream invert of the culvert. Comparing the 2005 and 2013 survey data shows that the stream channel upstream of the culvert remained about the same during the period. Downstream of the culvert, the stream channel has downcut ~0.5 to 1ft. This downcutting may not have been a natural occurrence as it appears that there was a

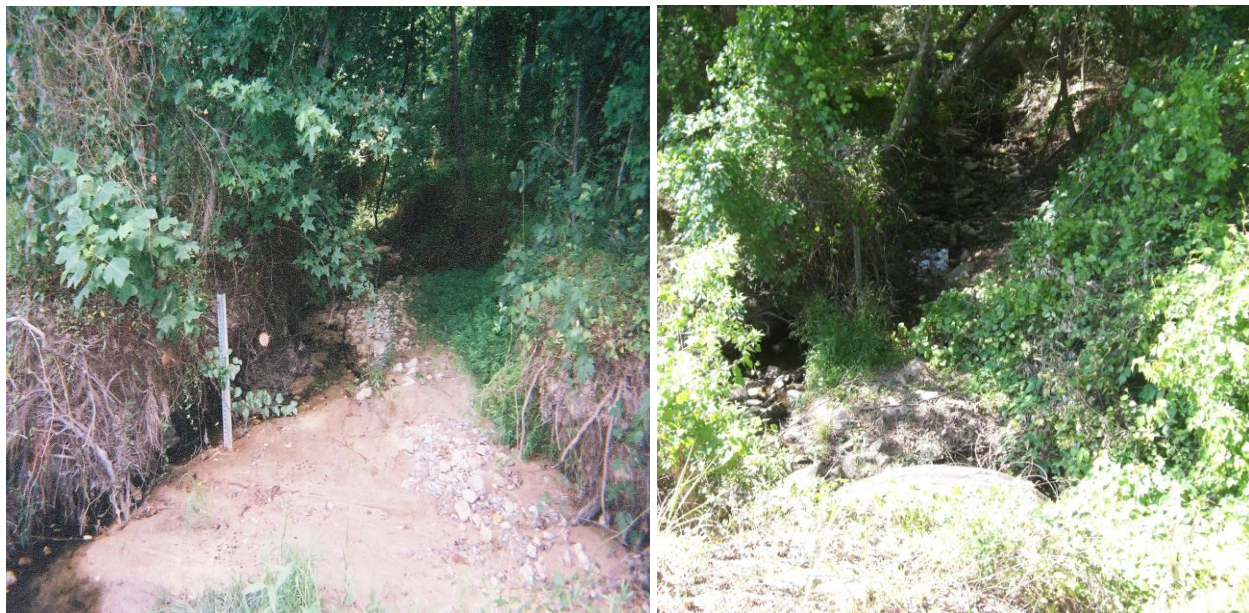
considerable amount of relatively new sediment deposition in the channel at the time of the 2005 survey (figure 11), which was removed by the time of the 2013 survey (figure 11). Excess sediment originating from the development in the contributing watershed likely raised the streambed in 2005 and then was removed via normal stream sediment dynamics by 2013. The build-out in the watershed could have been the reason for the channel downcutting more than 50ft downstream from the culvert also. Increased peak flows following build-out has been shown to cause instability/downcutting of stream channels.

Figure 11. Channel downstream of culvert in 2005 (left) and 2012 (right) at Herbert Akins2.

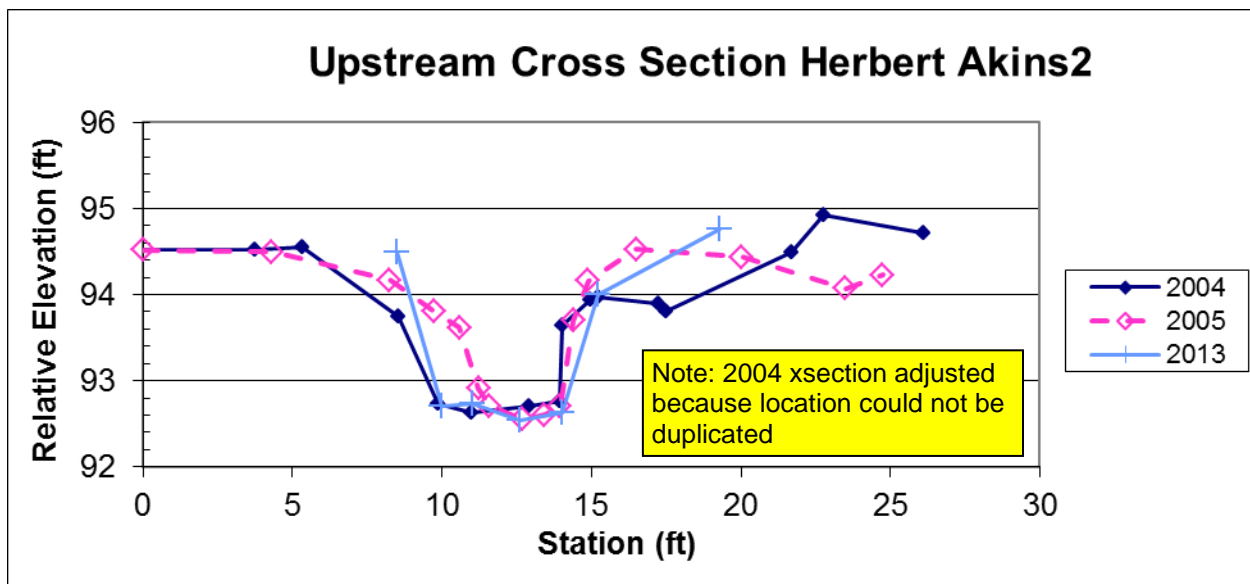
Figure 12. Upstream cross section at Herbert Akins2.

Survey data of the upstream cross sections are shown in figure 12. The 2013 survey was conducted about 30ft downstream (as best we can determine) from the 2005 survey; thus, the comparison is likely inexact, but as shown the elevation of the bottom of the channel is similar for both years. It was often difficult to repeat the 2005 survey as it was not well-documented. Like the longitudinal profile, survey data from the downstream cross section (figure 13) showed that the stream had downcut from 2005 to 2013. However, it appears that significant widening did not occur.

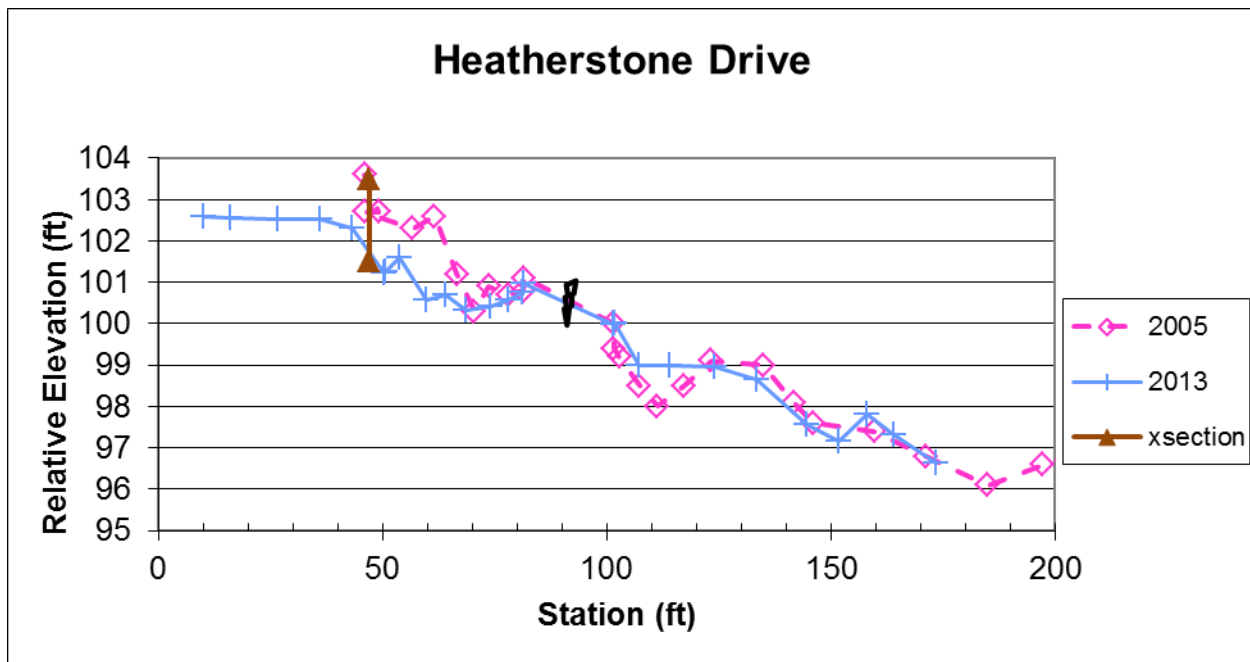
Figure 14. Longitudinal profile of stream at Heatherstone.

The longitudinal profile for the thalweg of the stream channel and culvert is shown in figure 14. The slope of the culvert (shortened in figure 14 to fit better) was slightly less than half both the upstream and downstream stream channel sections (Table 2). Comparing the 2005 and 2013 survey data shows that the stream channel upstream of the culvert eroded/downcut during the period; however, there were likely problems with the 2005 survey. The very steep section of channel from station 60 to 70 seems very unlikely for such a small stream unless there was a rock outcrop and this was not found in 2013. Downstream of the culvert, the stream channel was similar during the period, except for some filling-in of the scour hole at the end of the culvert and minor stream dynamics or survey uncertainty. These data indicated a stable channel.

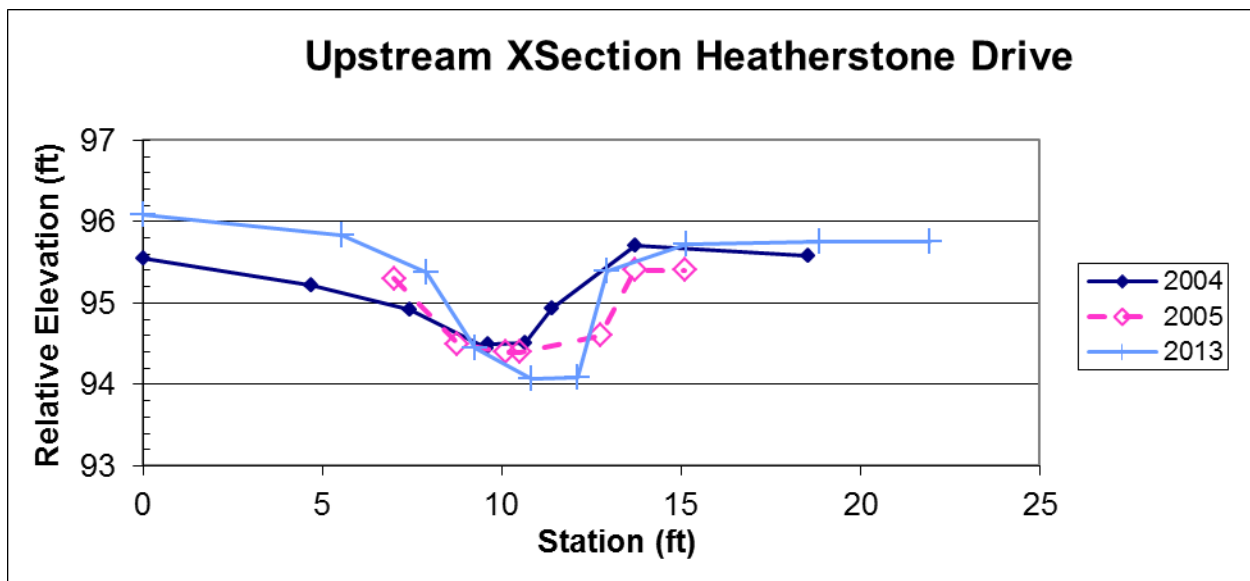
Figure 15. Upstream cross section data at Heatherstone site.

Survey data of the upstream cross sections are shown in figure 15. Comparison between survey data is not possible due to the likely problems with the 2005 survey. In 2005 the downstream cross section survey was conducted ~147ft downstream of the culvert, which was likely outside the influence of the culvert. In 2013 the cross section survey was conducted 55ft from the culvert. As shown in figure 16 the surveys are still similar indicating, like the longitudinal profile survey, that there was little change in the stream channel from 2005 to 2103.

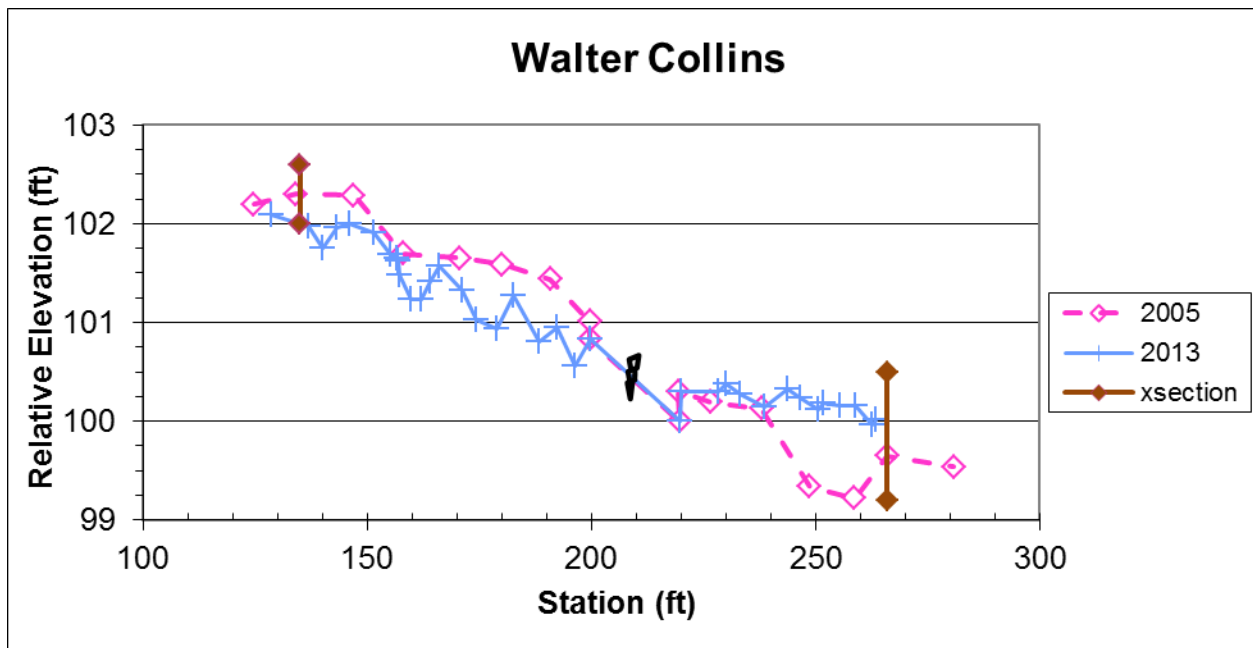
Figure 17. Longitudinal profile of stream at Walter Collins site.

The longitudinal profile for the thalweg of the stream channel and culvert is shown in figure 17. The slope of the culvert (shortened in figure 17 to fit better) was slightly greater than the upstream stream section and much greater than the downstream section (Table 2). Comparing the 2005 and 2013 survey data shows that the stream channel upstream of the culvert downcut during the period; however, the raw data from the 2005 survey (not in figure 17) were not consistent with known points and the 2013 survey was made difficult due to the dense vegetation (figure 18) and soft material in the channel. These factors combine to make comparisons between the data suspect. If the tops of the 2013 survey data are used the downcutting is relatively small (<0.25 ft) for most of the upstream section. Downstream of the culvert, the stream channel was similar for the first 20 ft then the data shows that a hole was filled in sometime between 2005 and 2013. Runoff from a side channel entered the stream near here which likely carried the sediment that filled in the hole.

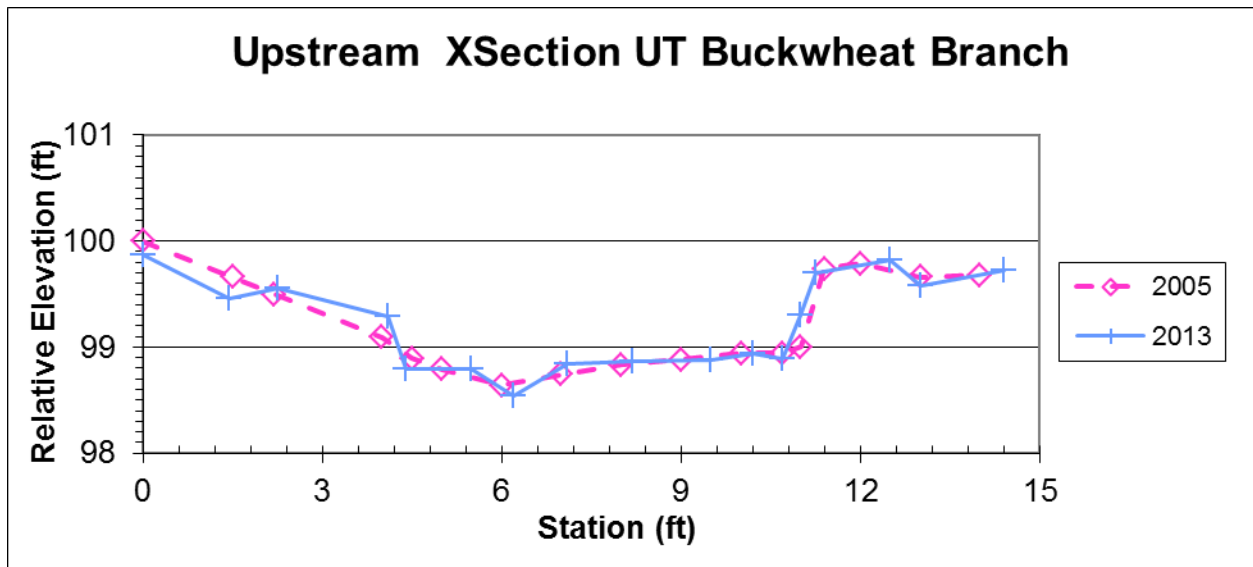
Figure 25. Upstream cross section for the UT Buckwheat Branch site.

The 2005 and 2013 surveys of the upstream cross section are shown in figure 25. As shown, the cross sections are similar indicating a stable channel. Comparing the downstream cross section survey data (figure 26) similarly shows little change indicating a stable cross section. The relatively small differences were likely caused by survey uncertainty and/or differences in cross section location or orientation (whether perpendicular to the channel or not).

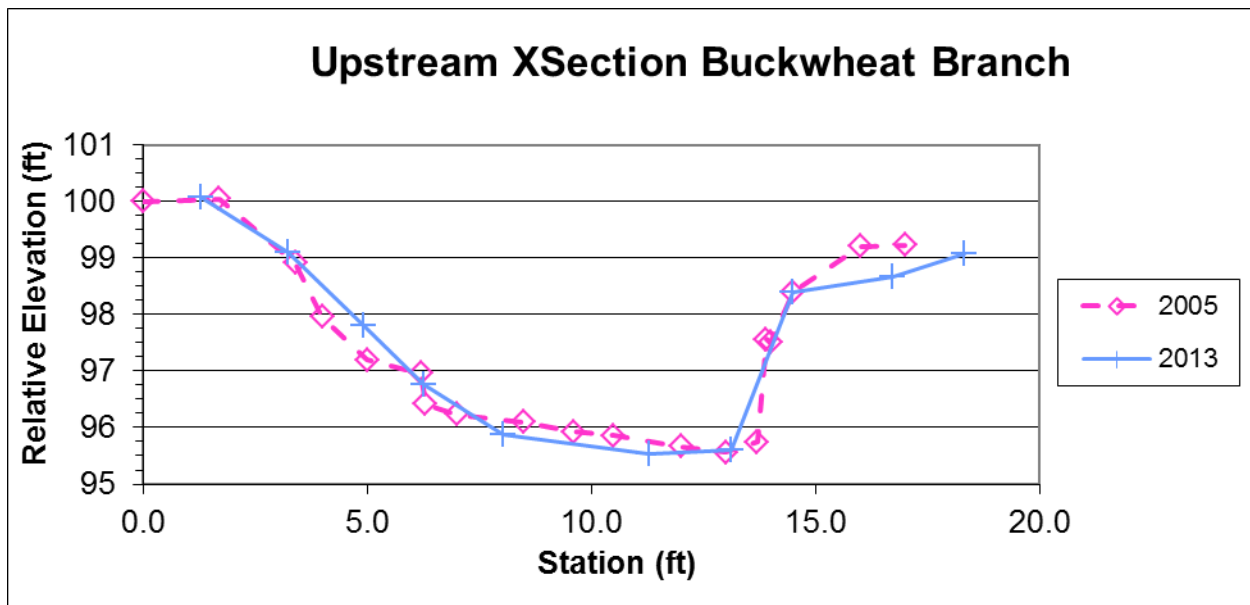
Figure 28. Upstream cross section on stream at Buckwheat Branch site.

The 2005 and 2013 surveys of the upstream cross section are shown in figure 28. As shown, the cross sections are similar indicating a stable channel. The relatively small differences were likely caused by survey uncertainty and/or differences in cross section location or orientation (whether perpendicular to the channel or not). The downstream cross section could not be compared due to an error in the 2005 data.

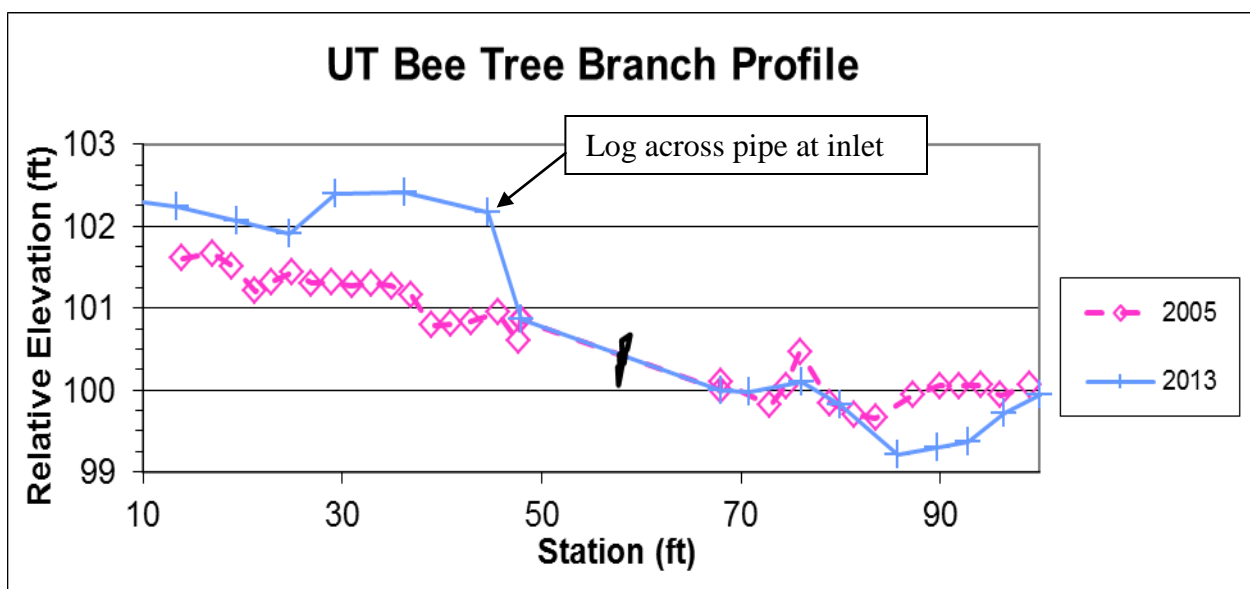
Figure 32. Longitudinal profile of stream at UT Bee Tree Branch site.

The longitudinal profile for the thalweg of the stream channel and the road culvert is shown in figure 32. The slope of the culvert (shortened to fit better) was slightly greater than both the upstream and downstream stream channel sections (Table 2). Comparing the 2005 and 2013 survey data shows that stream channel upstream of the culvert aggraded 0.5-0.8 ft. This was likely due to the log across the upstream end of the culvert creating backwater in the upstream channel area which caused sediment deposition. Downstream of the culvert the channel downcut to create a pool from about the 84 to 100 ft station. The reason for the pool created in this section was unknown, but may be related to the deposition of sediment upstream, which would create water with an artificially low amount of suspended sediment compared to the water's sediment transport capacity. Thus, it is unclear if the channel has been stable during the period due to the changing stream dynamics caused by the log across the culvert inlet.

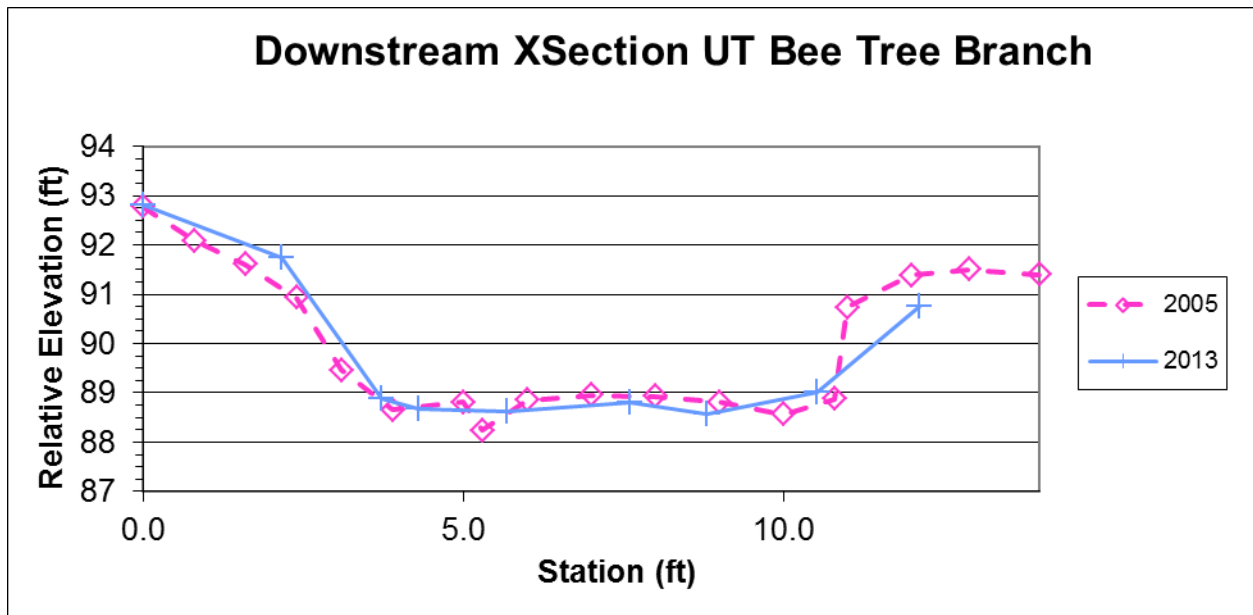
Figure 33. Downstream cross section for stream at UT Bee Tree Branch site.

The survey of the upstream cross section is not shown due to the backwater from the log creating sediment deposition, which was atypical for culverts. The 2005 and 2013 surveys of the downstream cross section are shown in figure 33. As shown, the cross sections are similar indicating a stable channel. The relatively small differences were likely caused by survey uncertainty and/or differences in cross section location or orientation (whether perpendicular to the channel or not).

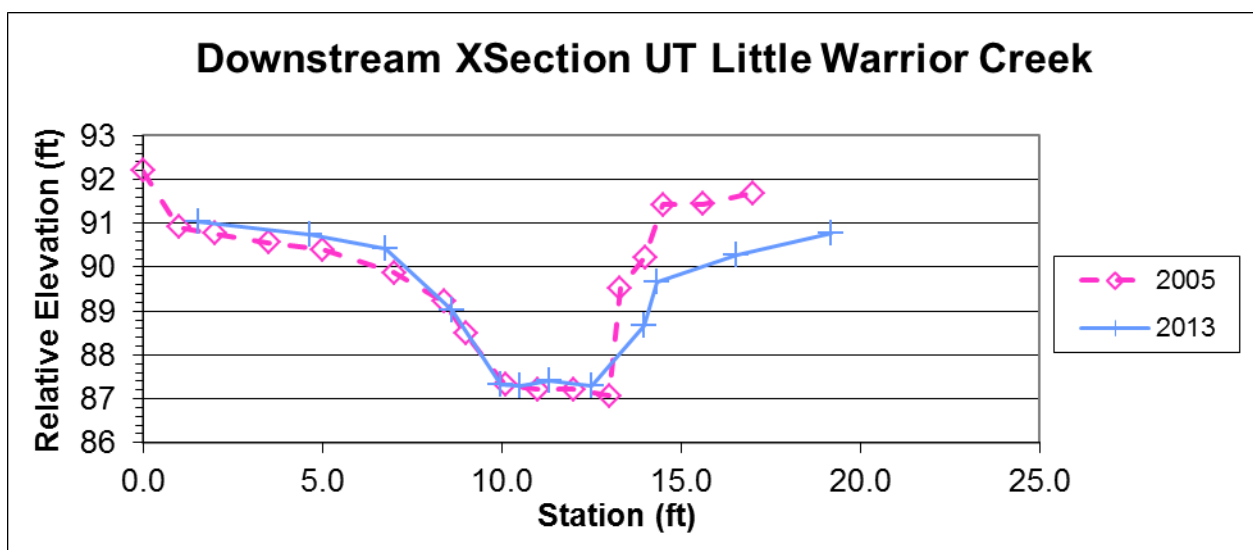
Figure 36. Downstream cross section for stream at UT Little Warrior Creek site.

The survey of the upstream cross section is not shown due to the likely error in the 2005 survey data. The 2005 and 2013 surveys of the downstream cross section are shown in figure 36. As shown, the cross sections are similar indicating a stable channel. The relatively small differences were likely caused by survey uncertainty and/or differences in cross section location or orientation (whether perpendicular to the channel or not).
