# Retaining Wall Inventory and Assessment System

**NCDOT Project 2014-10**

**FHWA/NC/2014-10**

**September 2015**

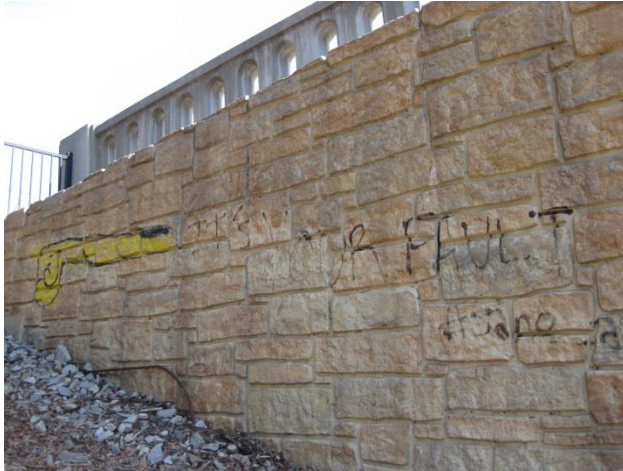
**Figure 3. Graffiti on south side MSE abutment**

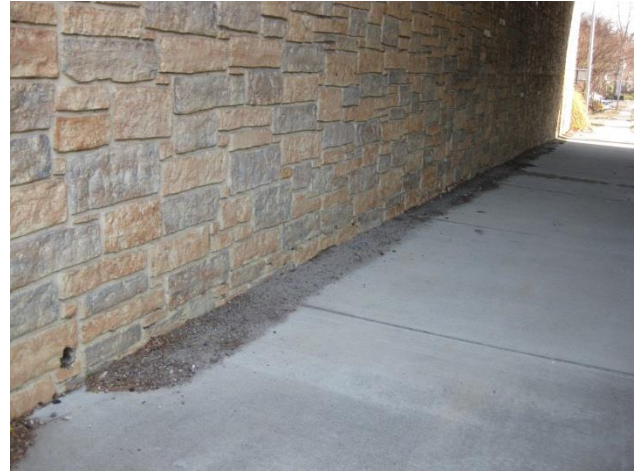
**Figure 5. Minor erosion on south side MSE abutment**

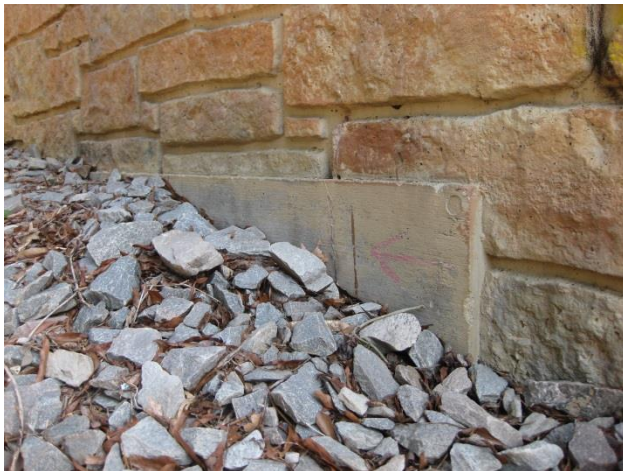
**Figure 4. Exposed footing on south side MSE abutment**

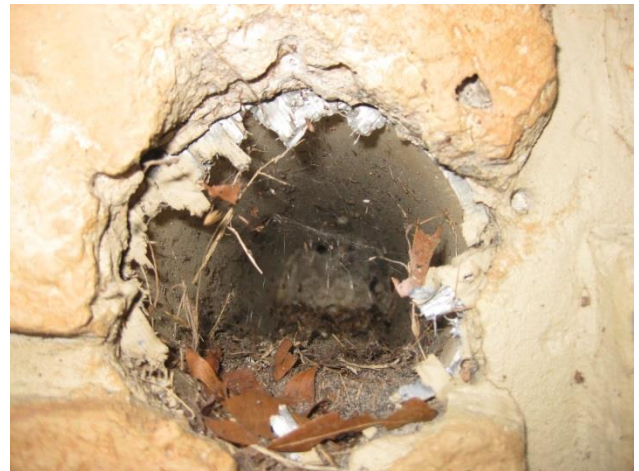
**Figure 6. Weep hole on south side MSE abutment**

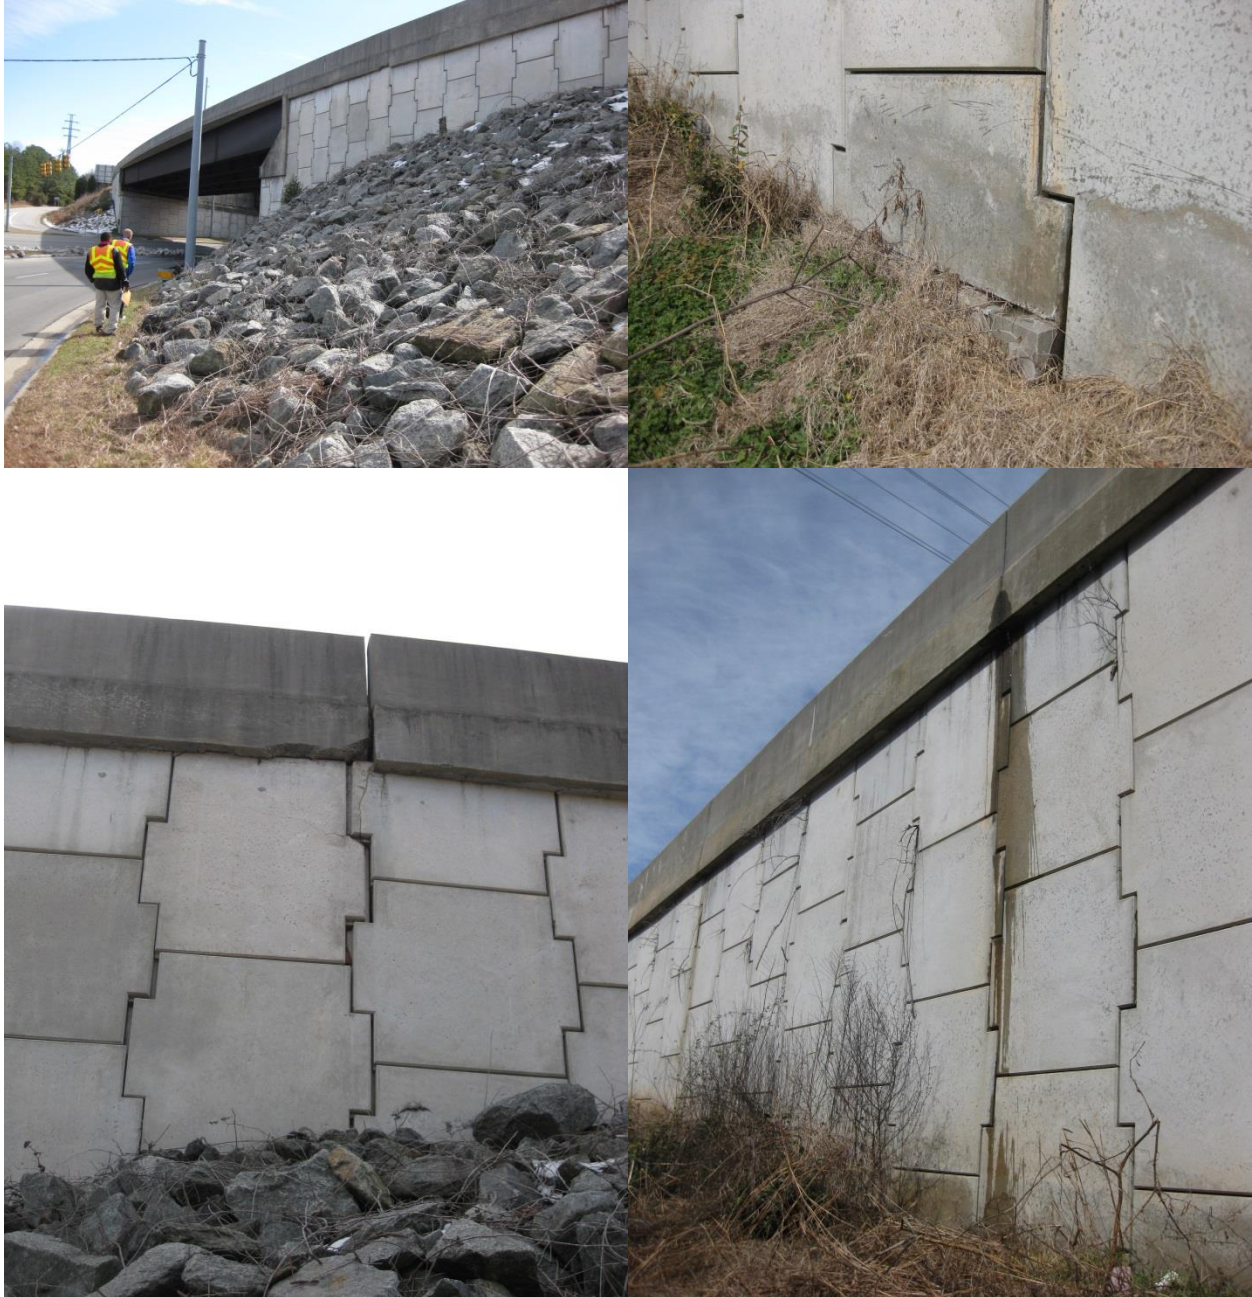
**Figure 3. MSE Wall on NC 147 (Durham, NC) with damaged panels, sign of erosion, exposed foundation, and improper drainage**

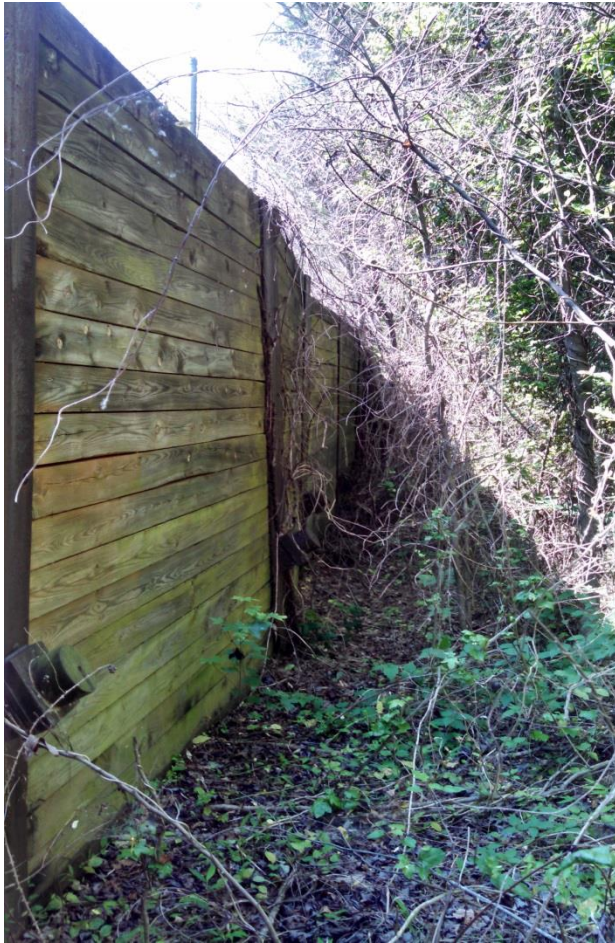
**Figure 1: Trees and overgrown vegetation in close proximity of the wall.**

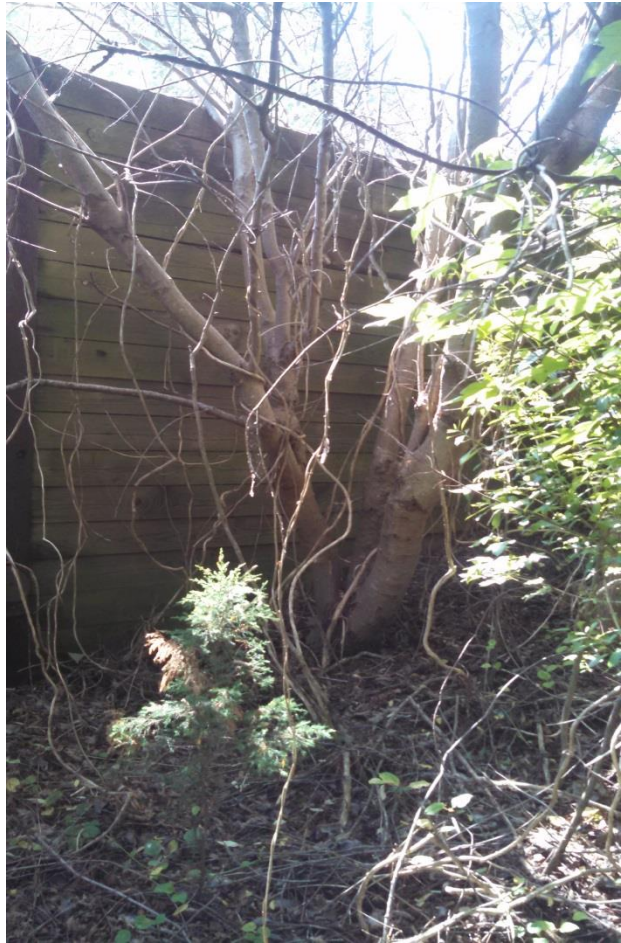
**Figure 2: Weathered timber lagging more pronounced at the base of the wall.**

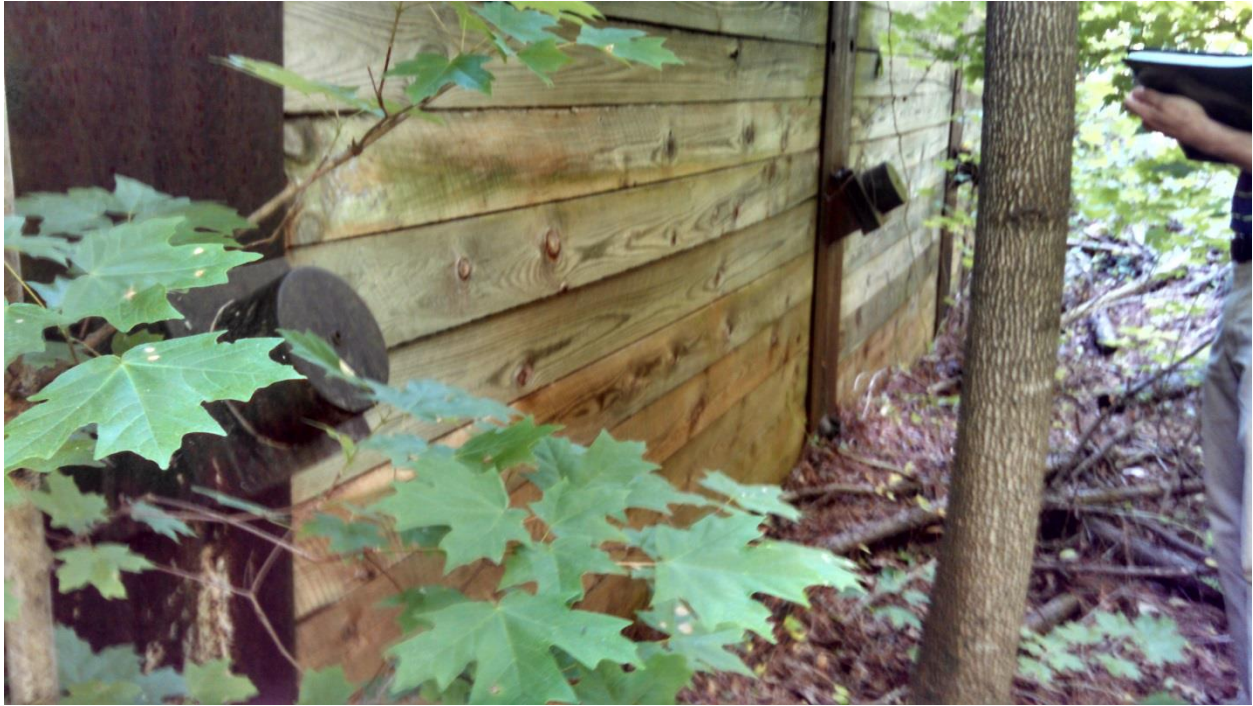
**Figure 4: Pronounce bulge in one specific section of the wall and rusty H-piles.**

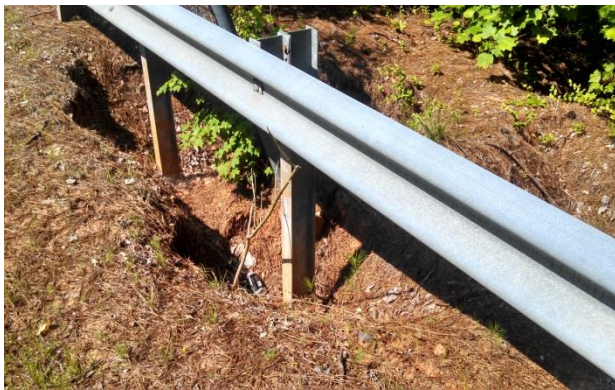
**Figure 5: Evidence of an impending slope failure at the end of the wall.**

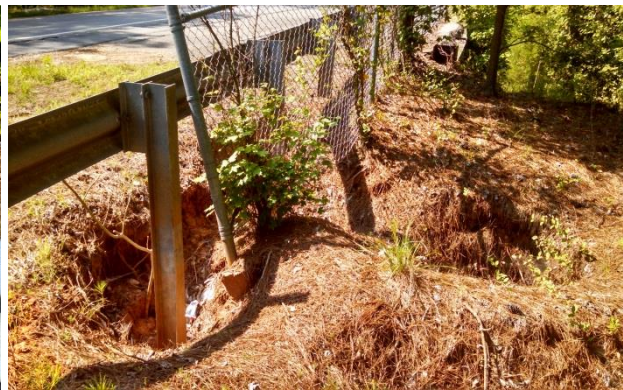
**Figure 6: Displaced chain link fencing at the end of the wall.**

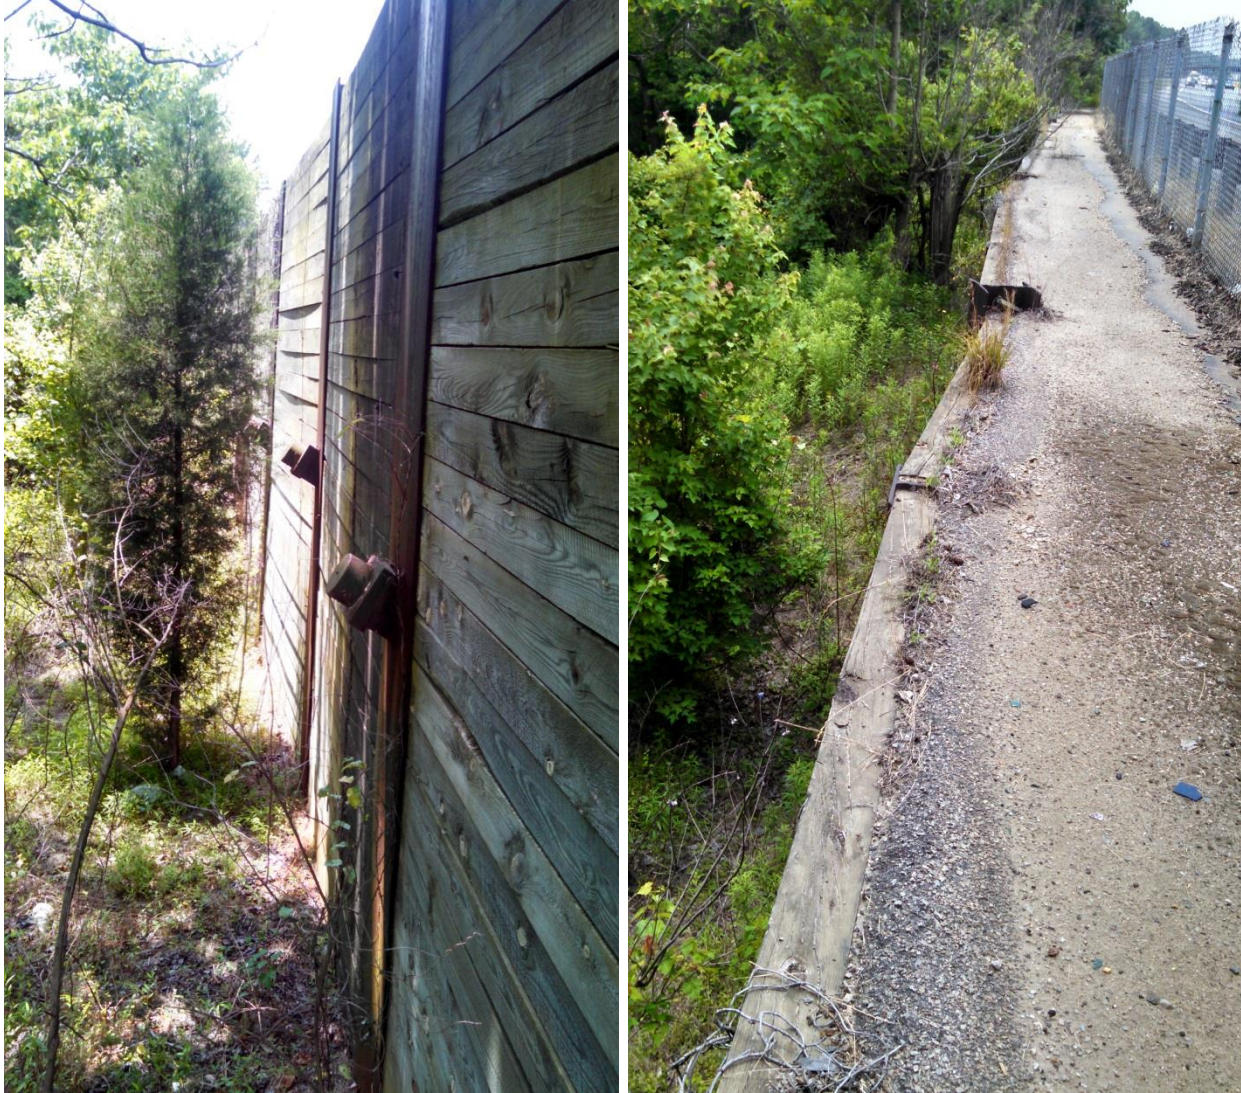
**Figure 1: Evidence of some deflection in the wall and timber lagging units that are bulging outwards.**

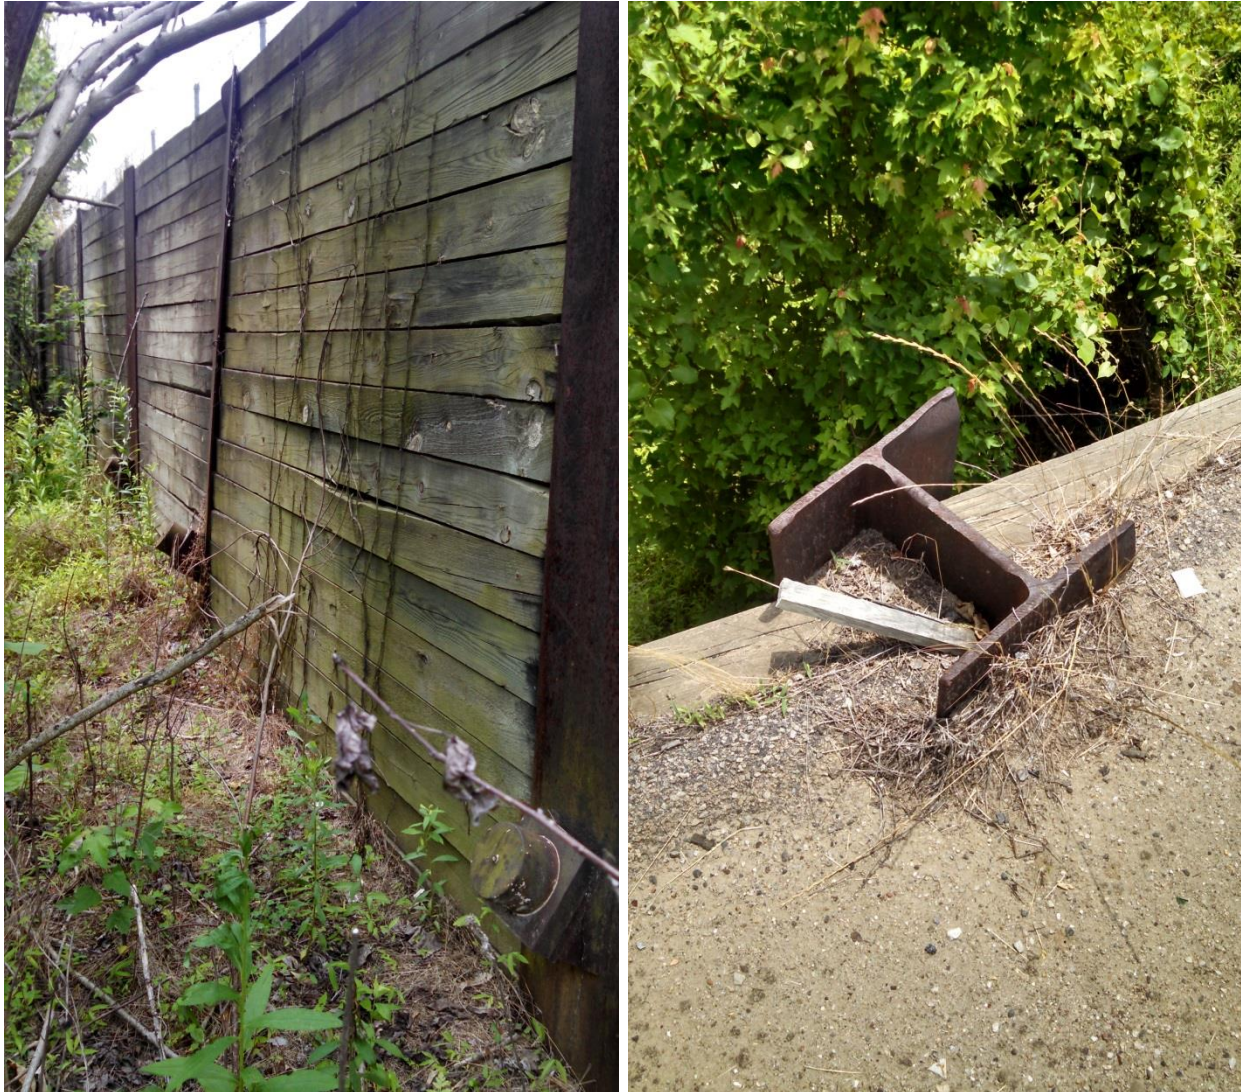
**Figure 2: Severely rusted H-Piles and several that are rotated (this likely occurred during construction).**

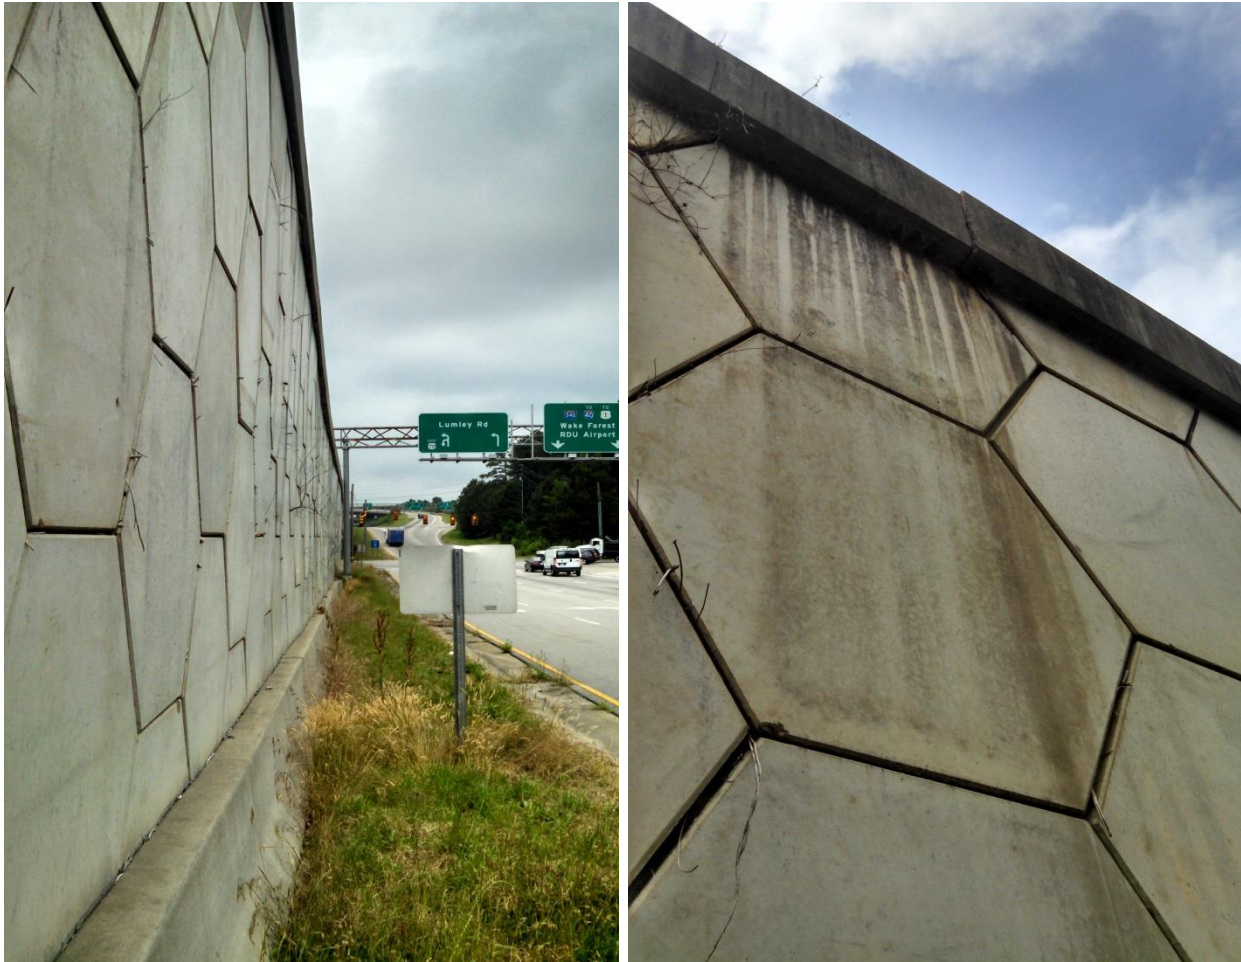
**Figure 3: Evidence of some deflection in the wall on the left side of the south bridge abutment.**

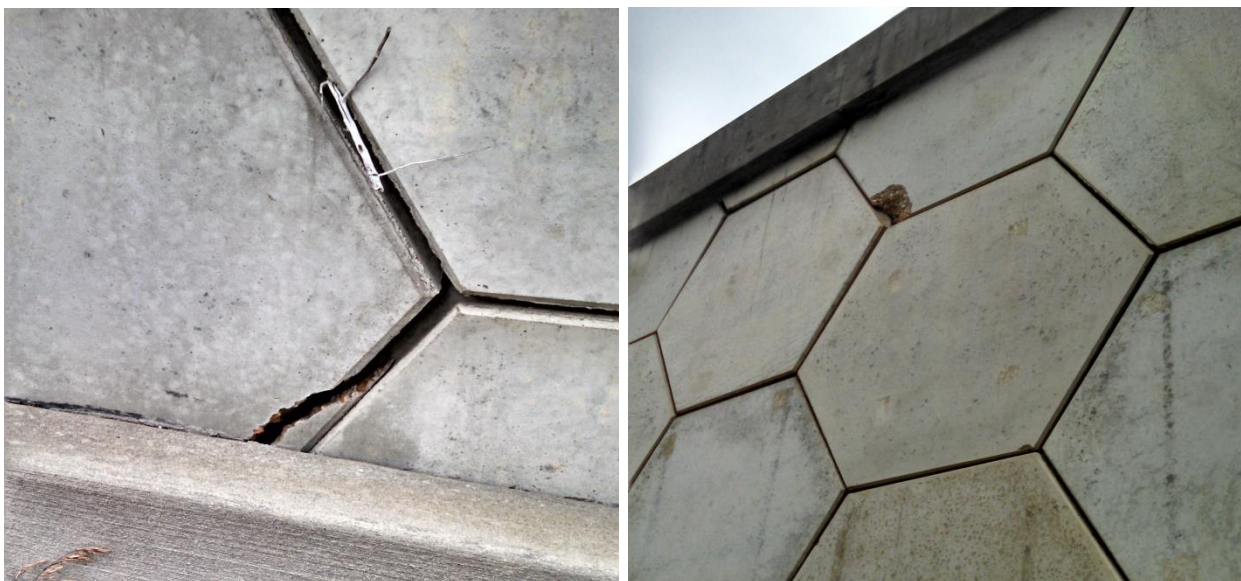
**Figure 4: Chipped and cracked MSE panels.**

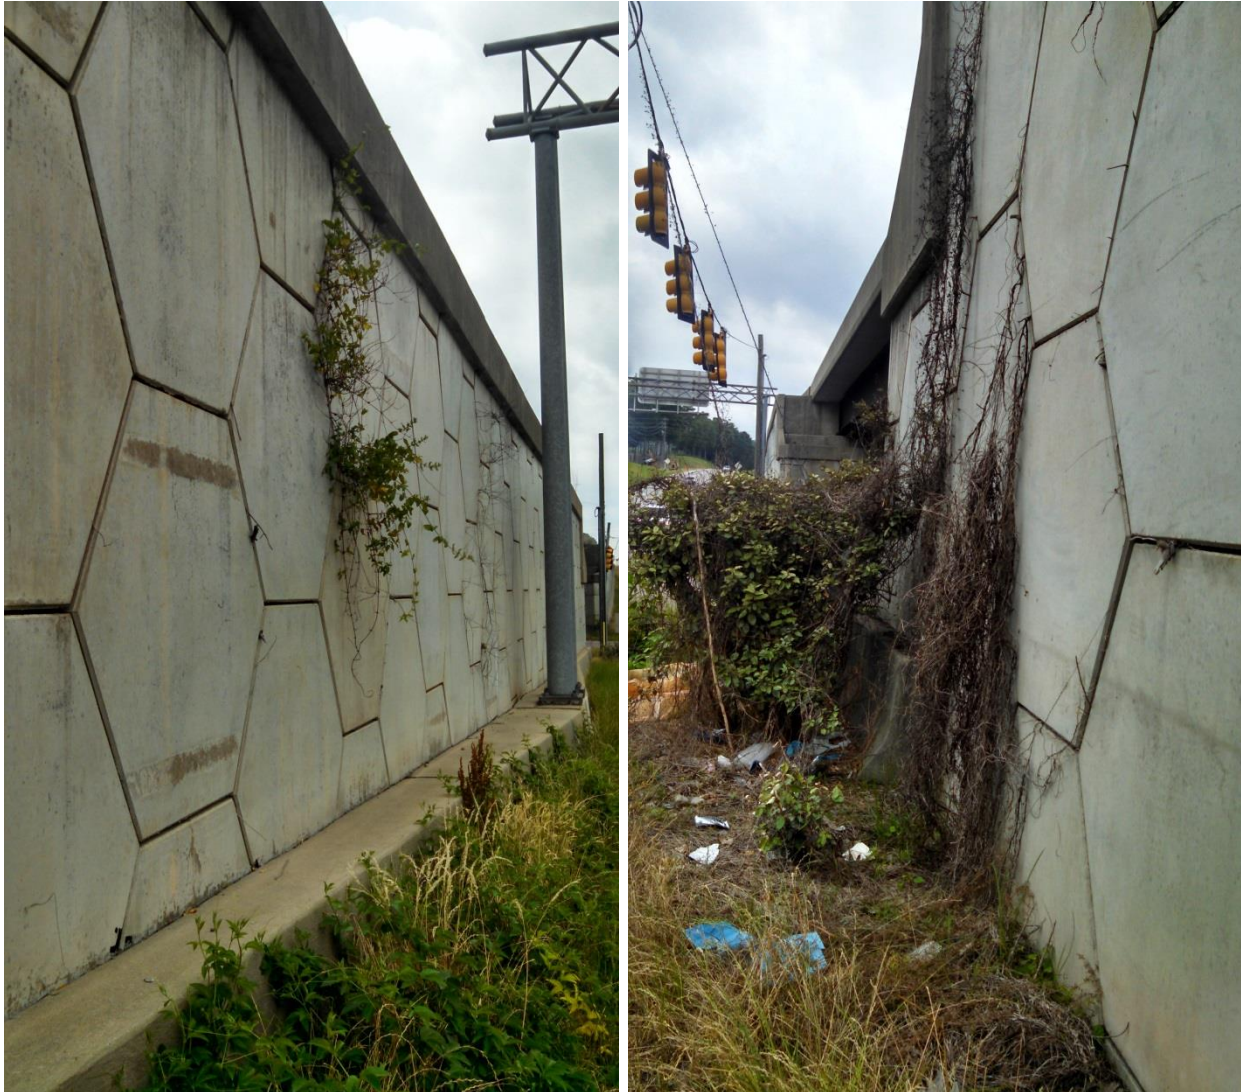
**Figure 5: Several roots penetrating the facing of the wall.**

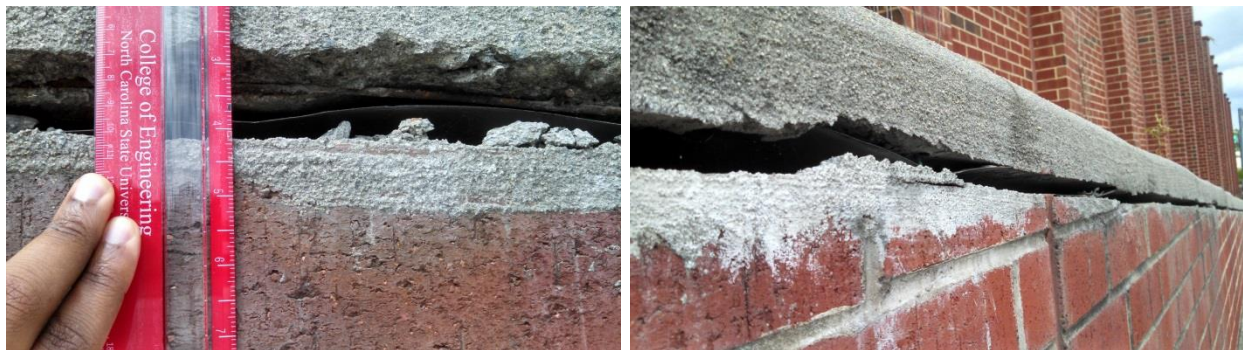
**Figure 1. East wing wall showing a 1.5 inch gap that has developed between the wall top feature and top of the wall.**

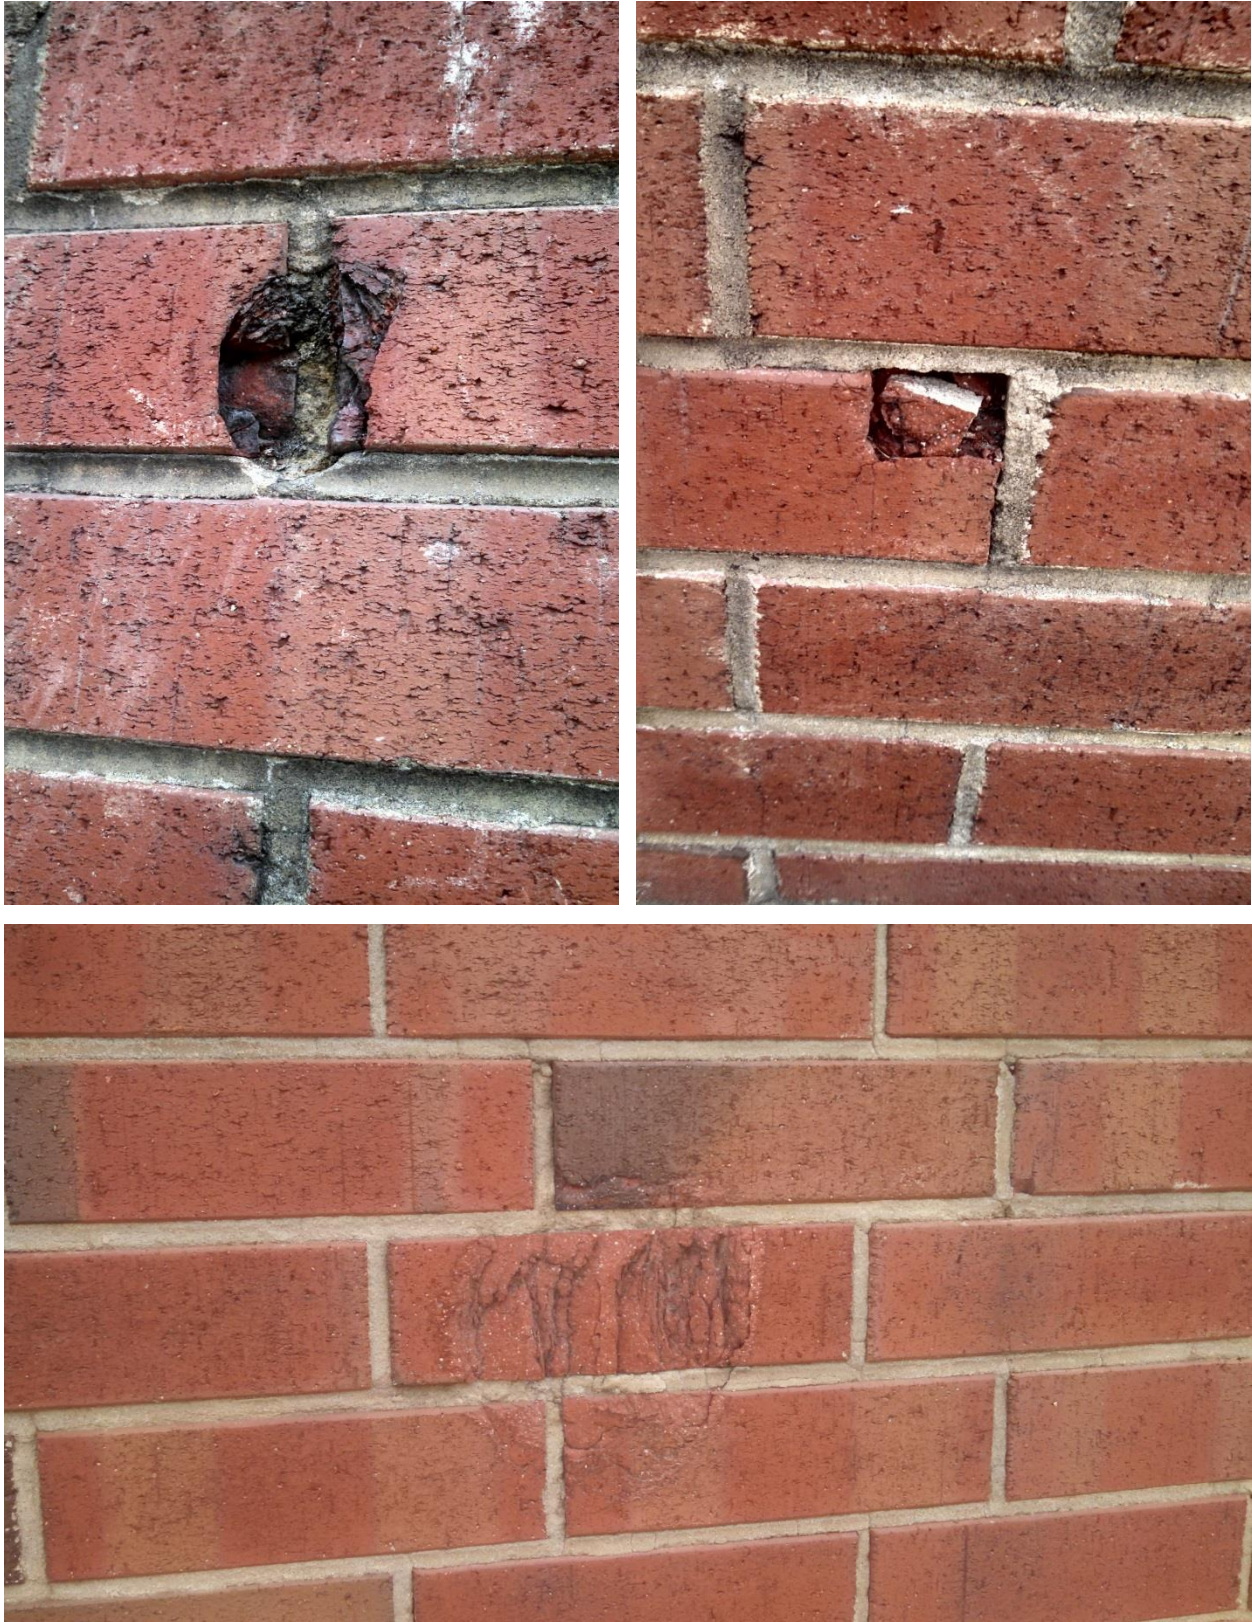
**Figure 2. West wing wall showing signs of spalling.**

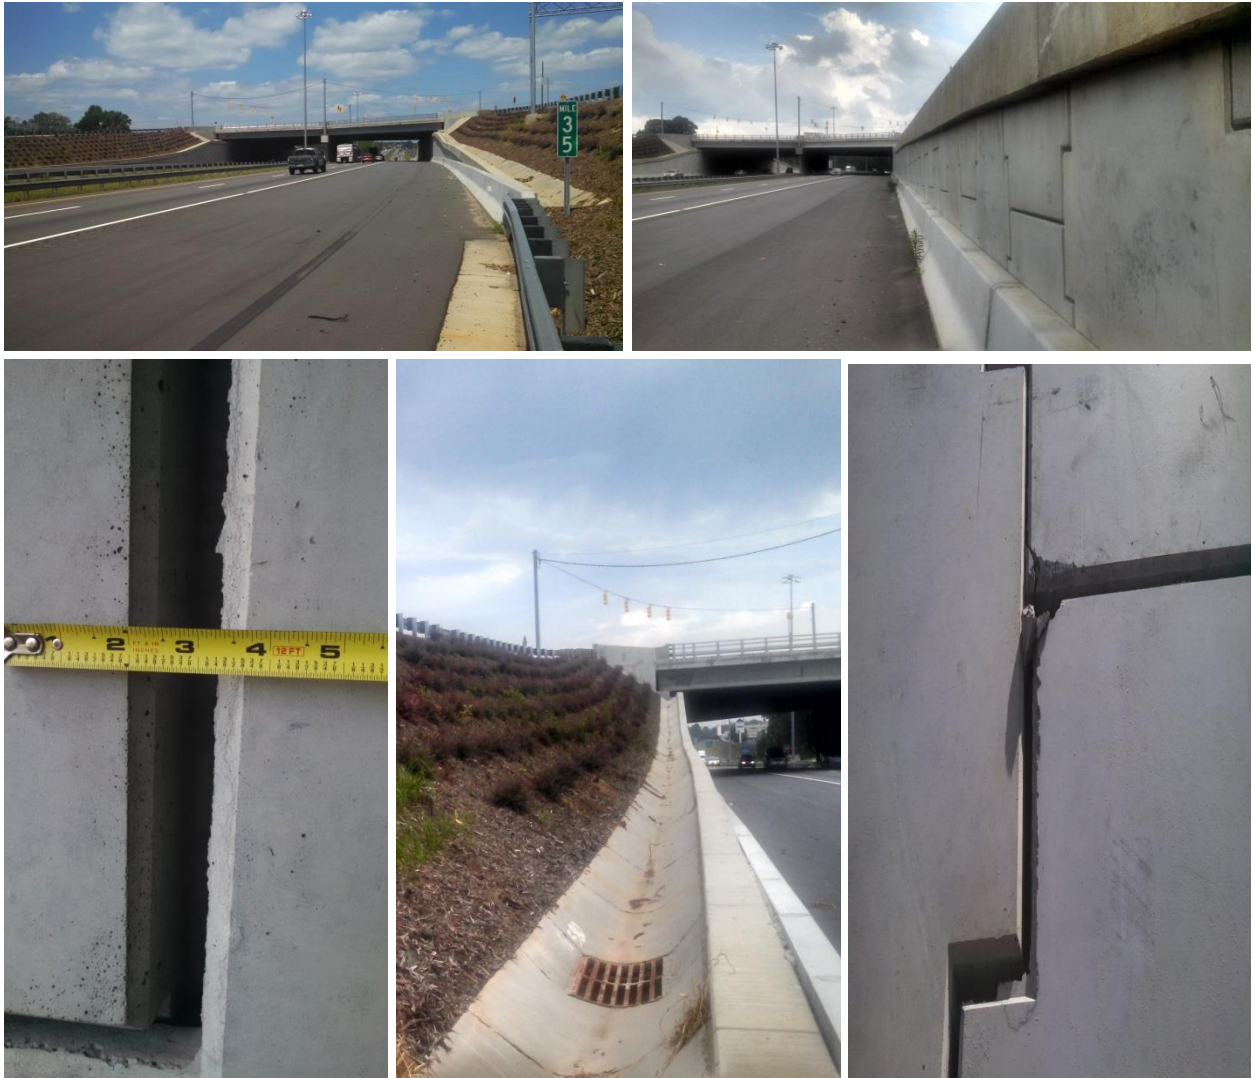
**Figure 1. MSE Walls on I-77 ( Mooresville, NC) under SR-1100 (Brawley School Road).**

A few joints between panels are too wide or narrow and a few chipped panels were identified. External drainage is in good condition.

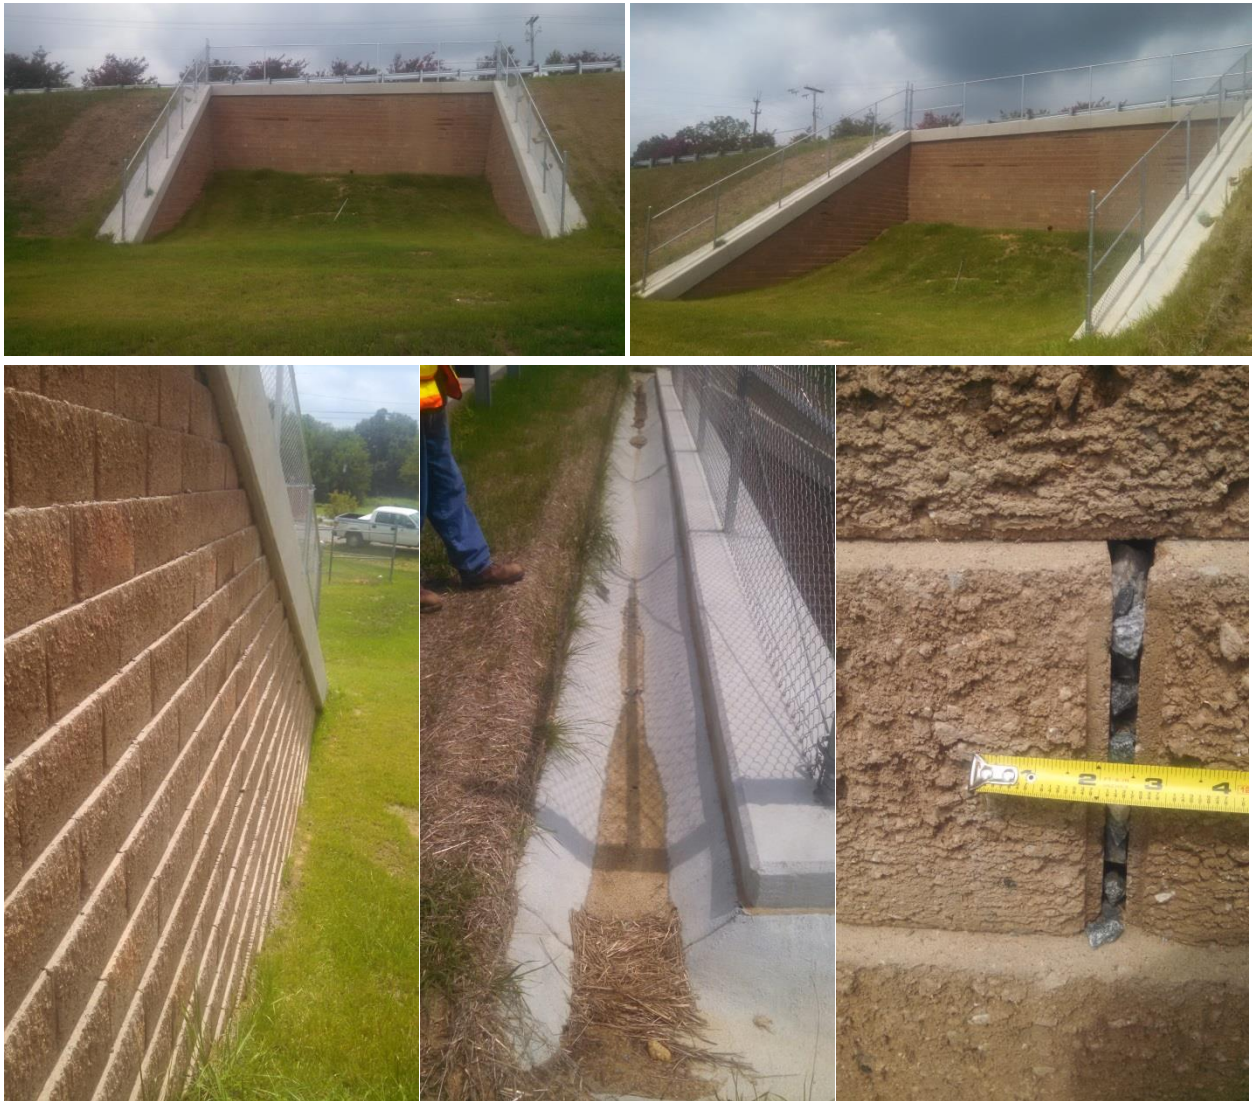
**Figure 2. MSE Segmental Retaining Wall near 380 Corban Avenue SW (Concord, NC).**

A collection of mud and debris is present in the top corners of the concrete ditch and a few joints between SRW units are too wide.

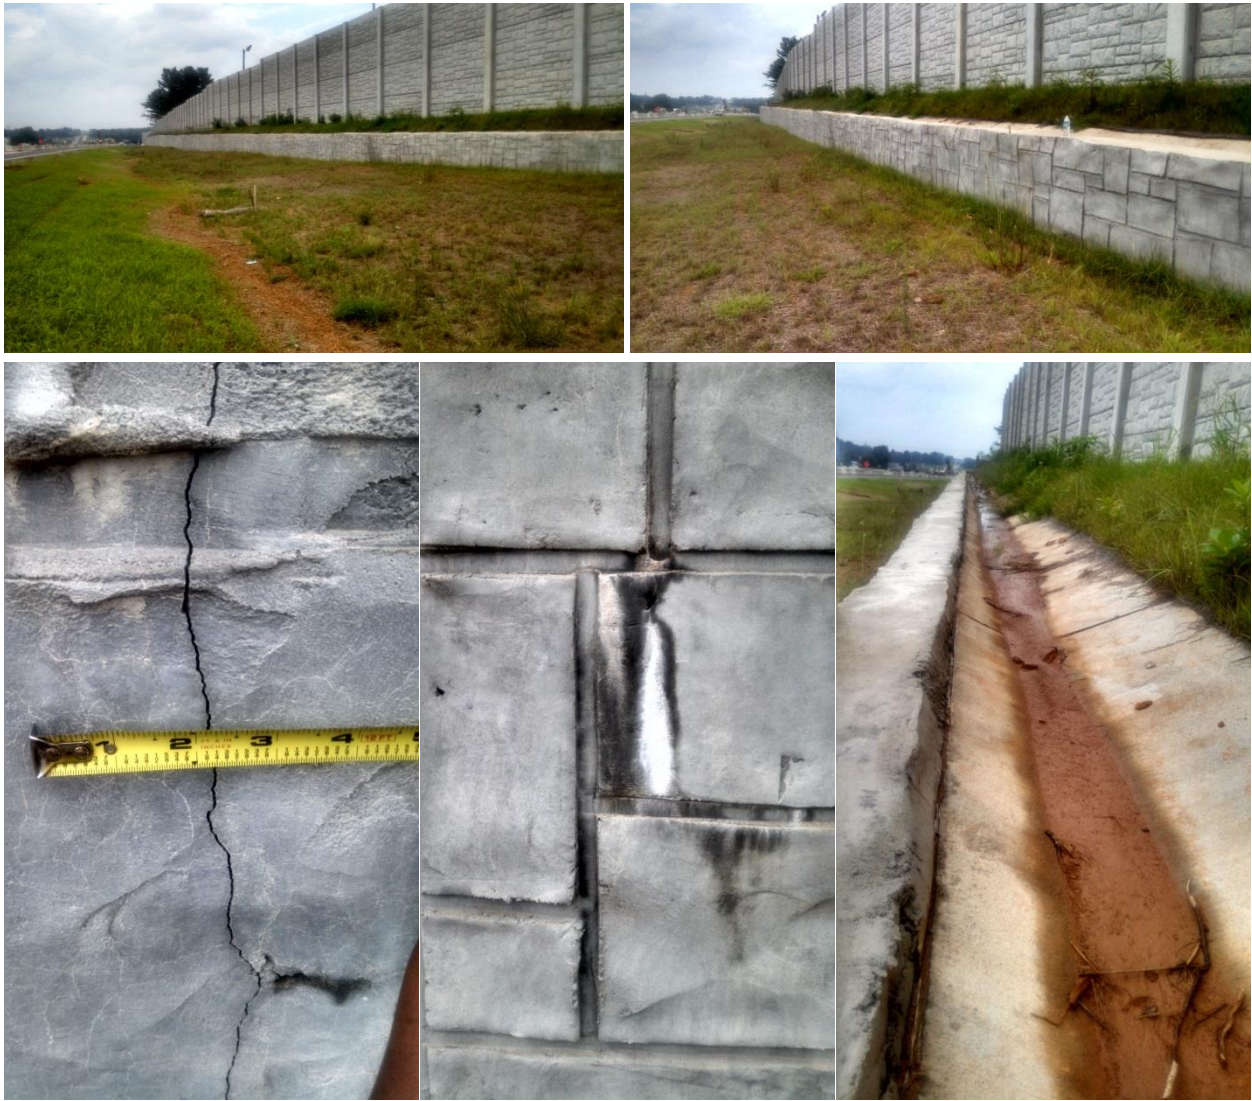
**Figure 3. Soil Nail Wall on EB I-40 between Radio Road and US-21 (Statesville, NC).**

Several cracks about 1/16" wide were identified. Efflorescence staining is present on the wall facing and a collection of mud and debris is present in the concrete ditch along the top of the wall.

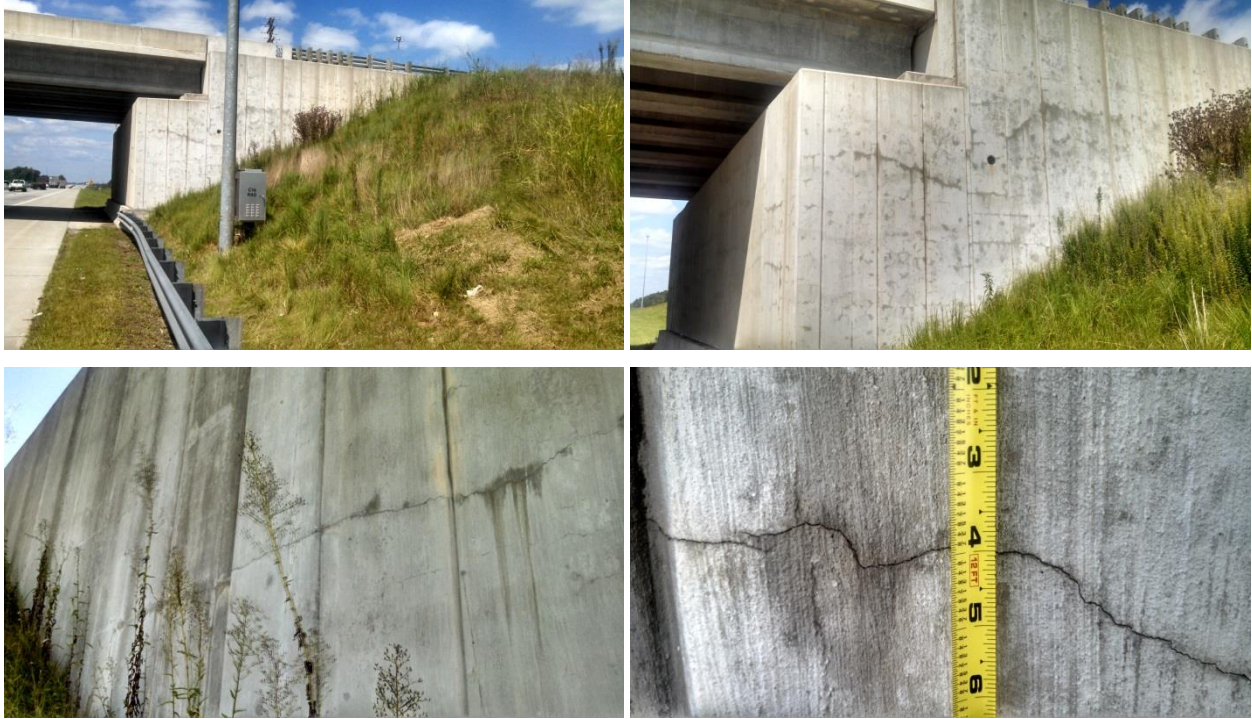
**Figure 4. Anchored Wall with a timber lagging facing and a cast-in-place concrete veneer on I-85 (Salisbury, NC) under SR-2120 (Long Ferry Road).**

Several hair line cracks on the concrete facing were identified. One transverse crack is about 11 feet long.

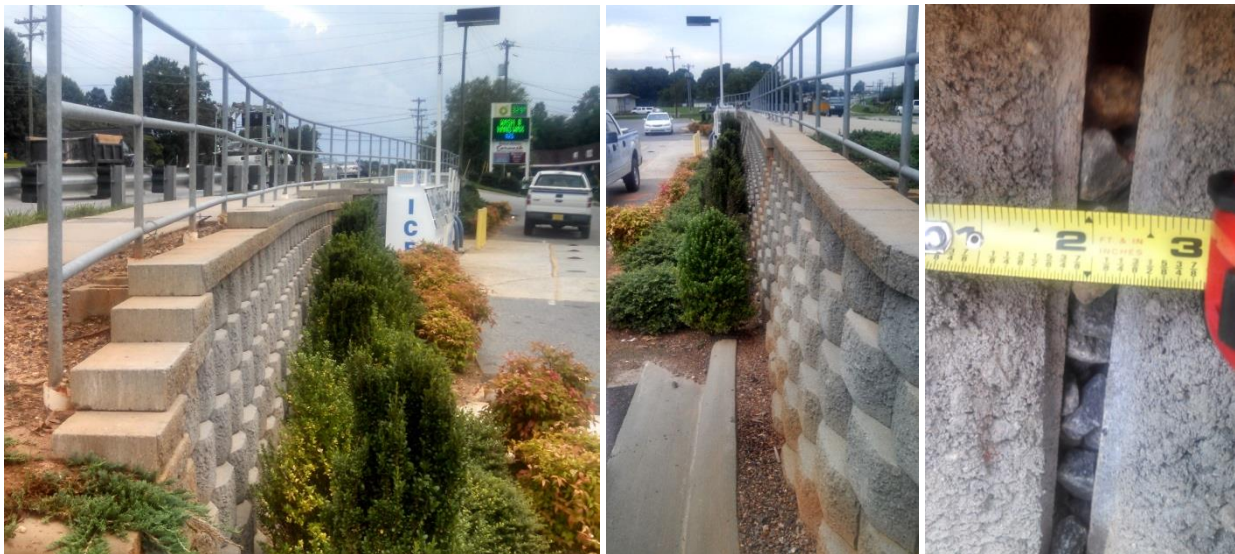
**Figure 5. Gravity Segmental Retaining Wall near 798 Brawley School Road ( Mooresville, NC).**

Joints between SWR units are too wide.

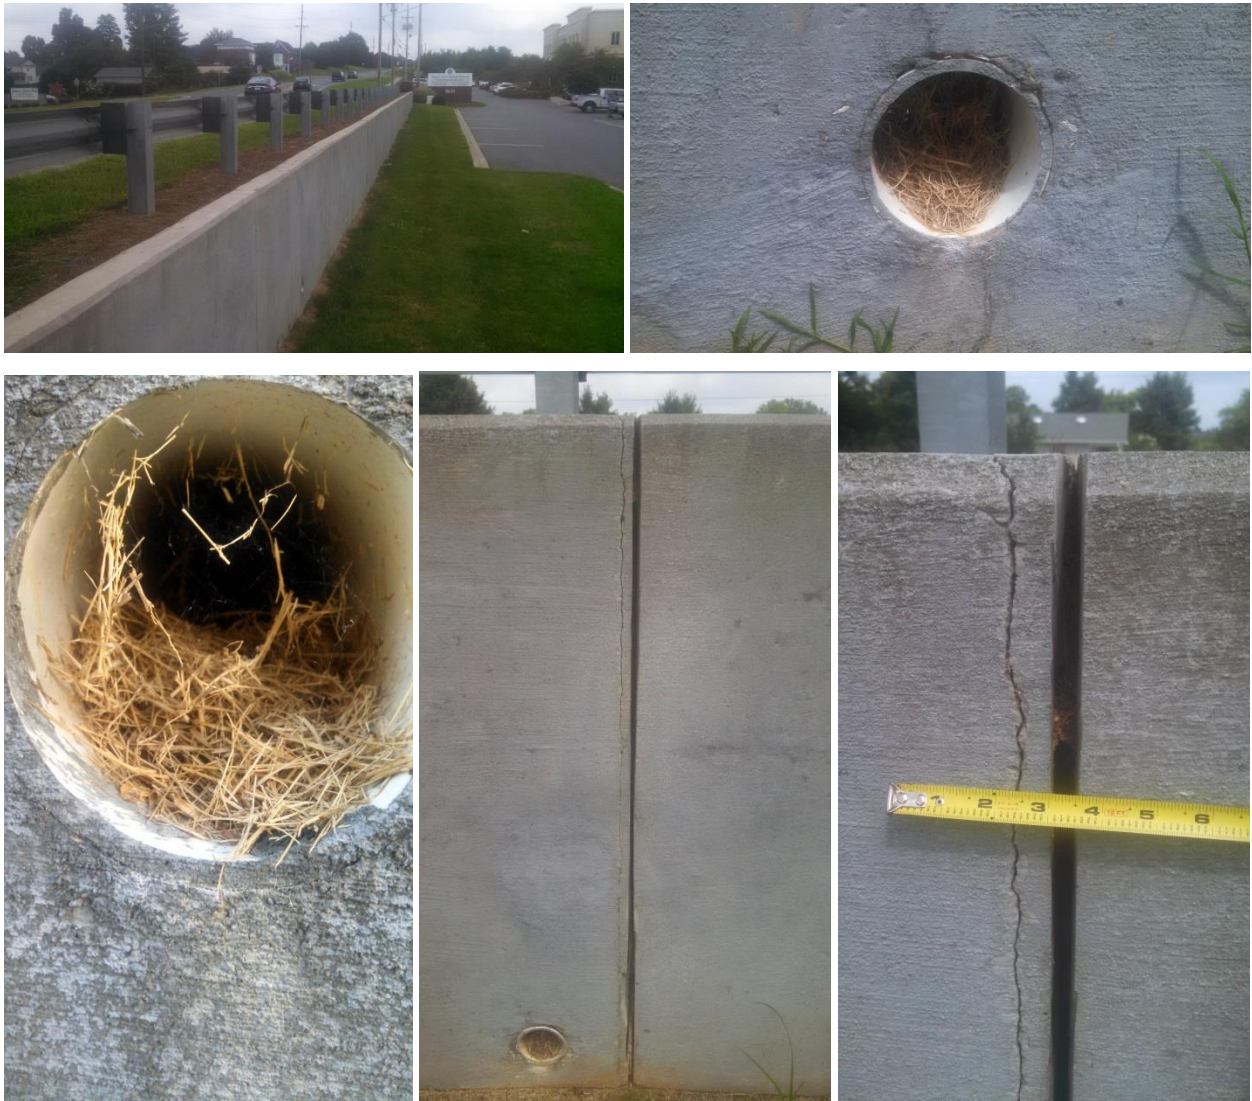
**Figure 6. Gravity Wall with a cast-in-place concrete facing near 5771 Poplar Tent Road (Concord, NC).**

Several weep holes are full of grass and debris and one vertical crack is present that is about 1/16" wide and 1" inch away from the expansion joint.

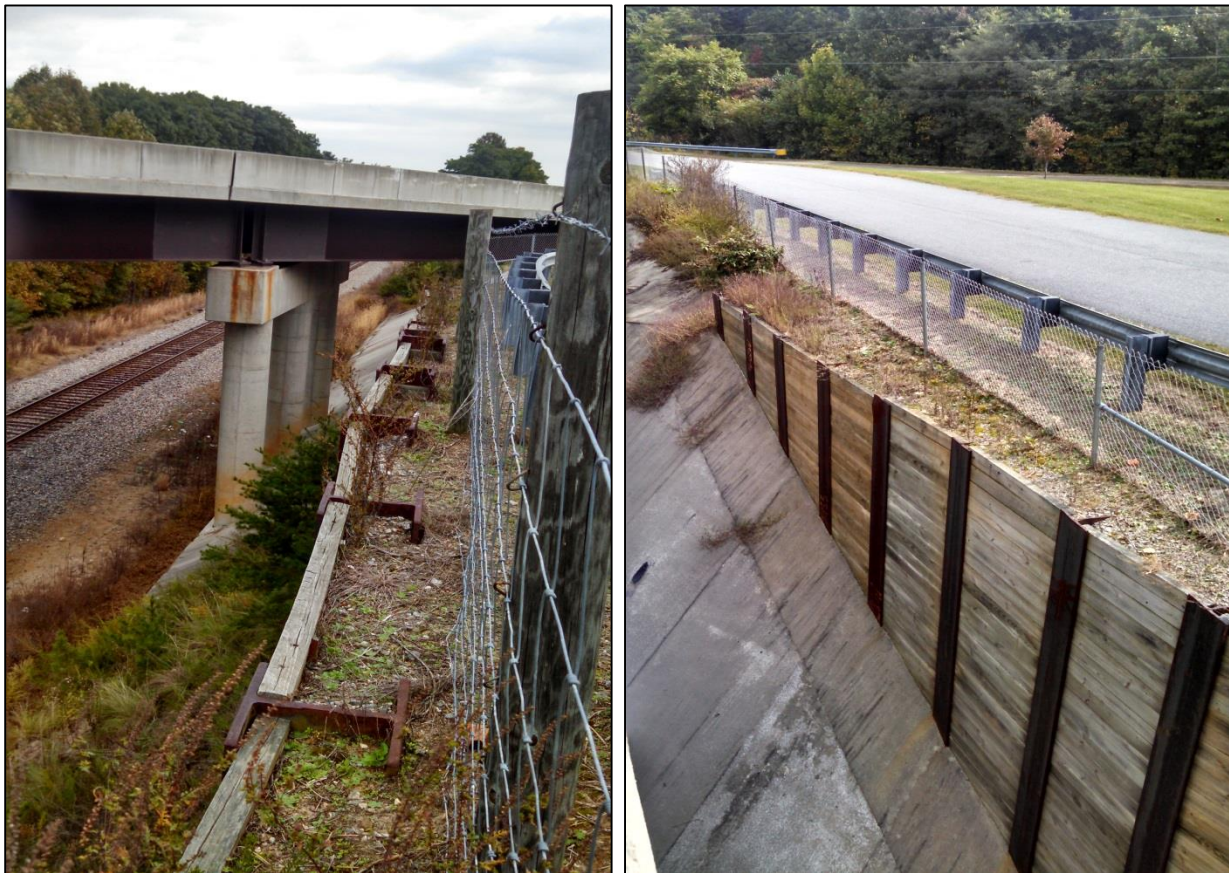
**Figure 1: Several misaligned H-Piles along the *Cantilever Wall*.**
