# Retaining Wall Inventory and Assessment System

**NCDOT Project 2014-10**

**FHWA/NC/2014-10**

**September 2015**

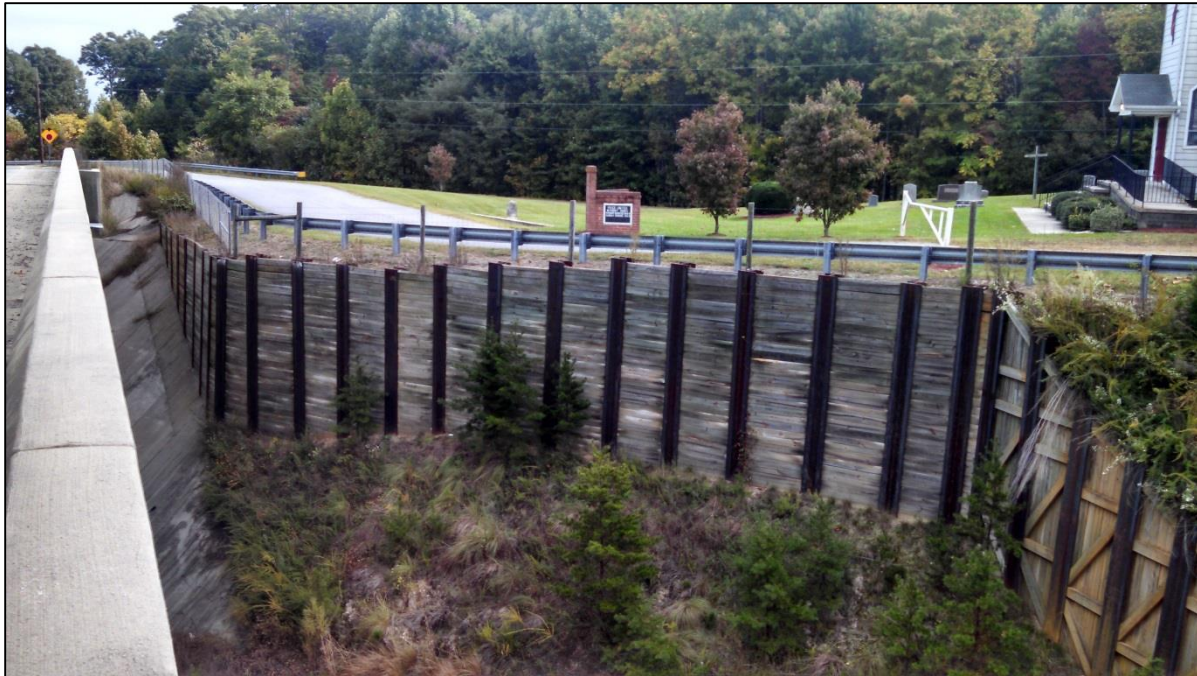
**Figure 2: Weathered timber concentrated near the center of the *Cantilever Wall*.**

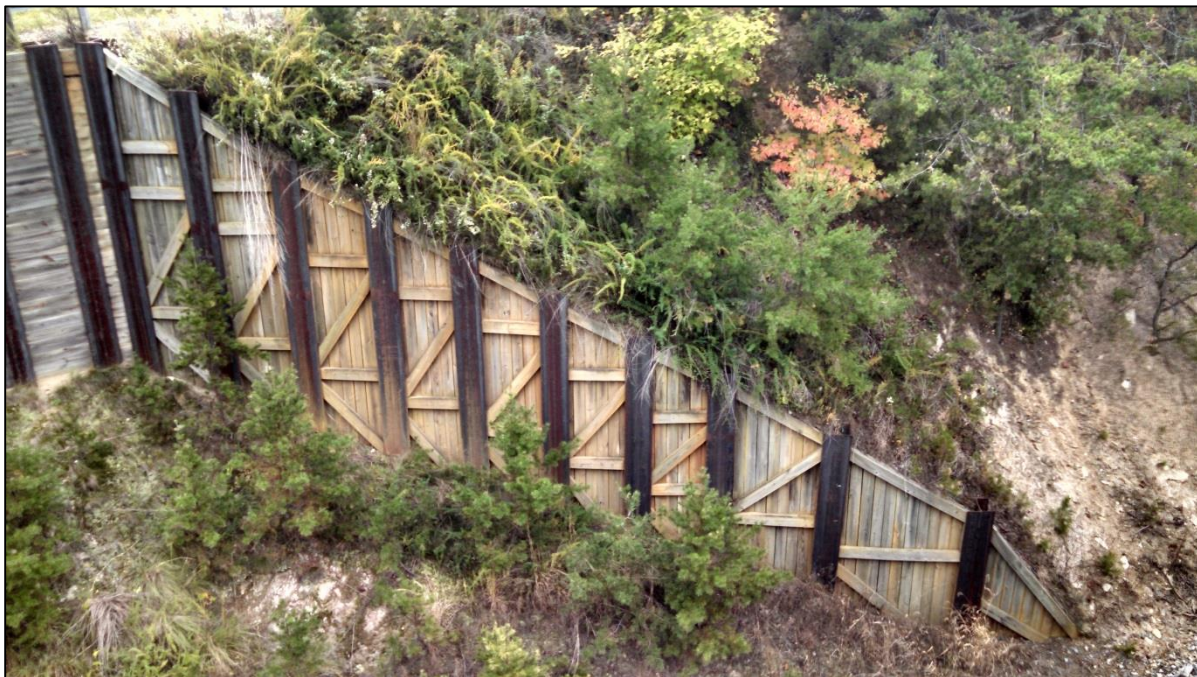
**Figure 3: Improper installation of timber lagging units on the right wing of the *Cantilever Wall*.**

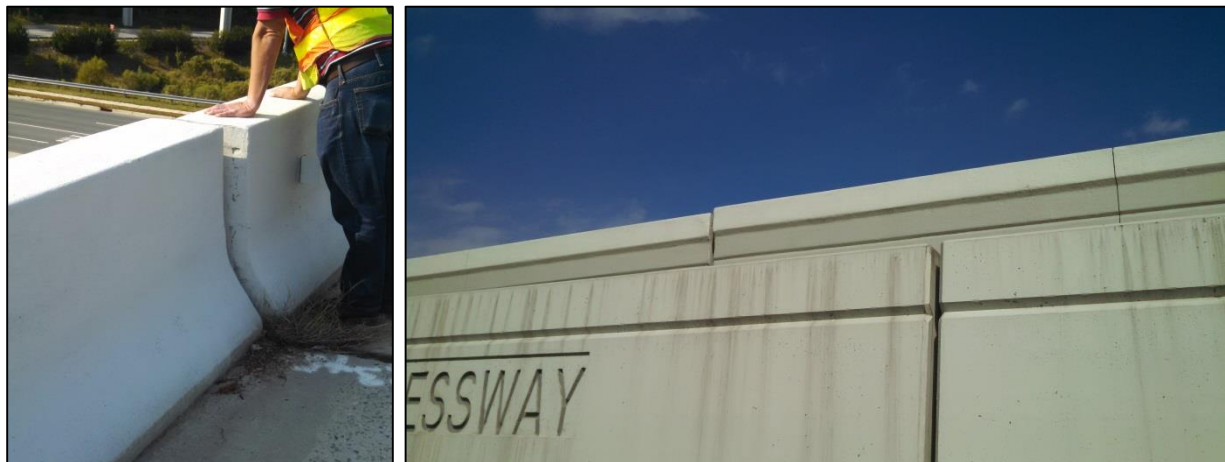
**Figure 4: Displaced concrete barrier rail and evidence of deflection in the right approach wall.**

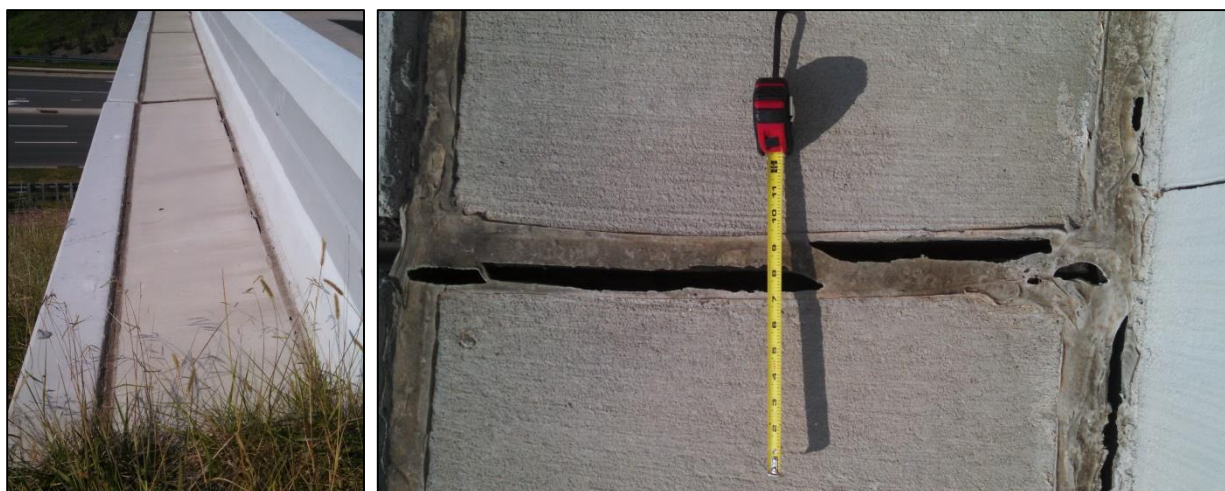
**Figure 5: Evidence of settlement near the end of the right approach wall exposing a 2” gap in one of the control joints.**

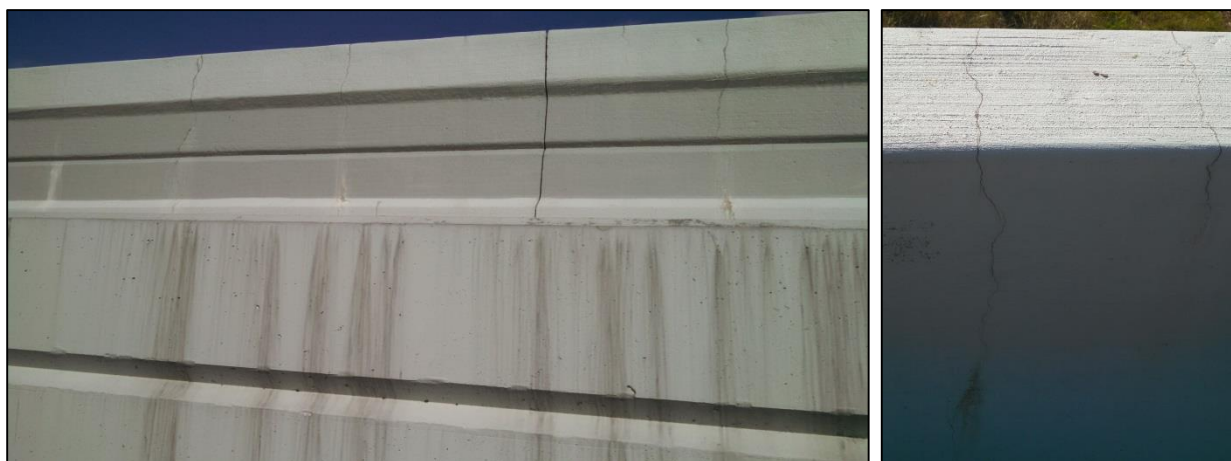
**Figure 6: Several vertical cracks in the concrete barrier rail right approach wall.**

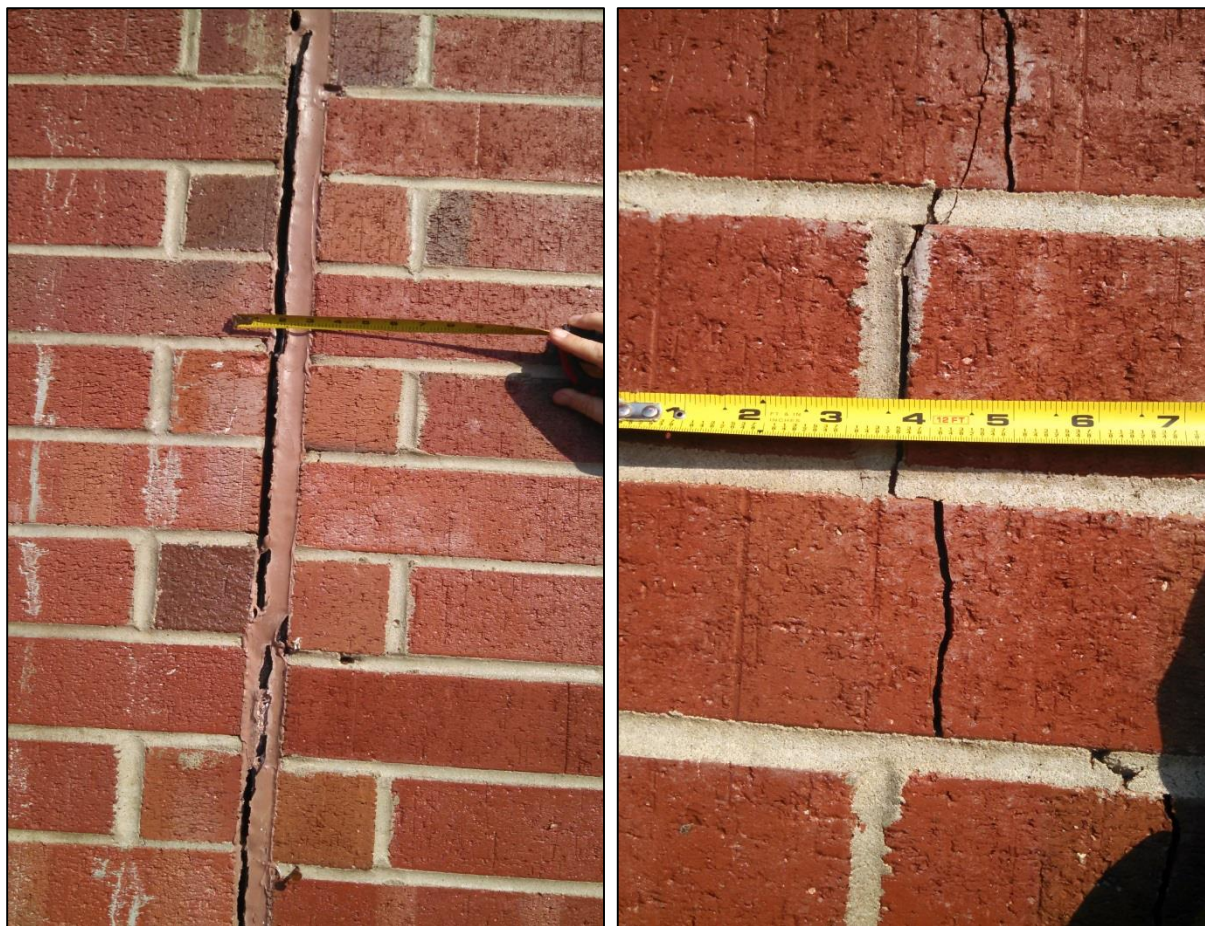
**Figure 7: Vertical cracks about  $\frac{1}{4}$ " wide and separation of the expansion joint exposing an additional  $\frac{1}{2}$ " gap on the of the right approach wall.**

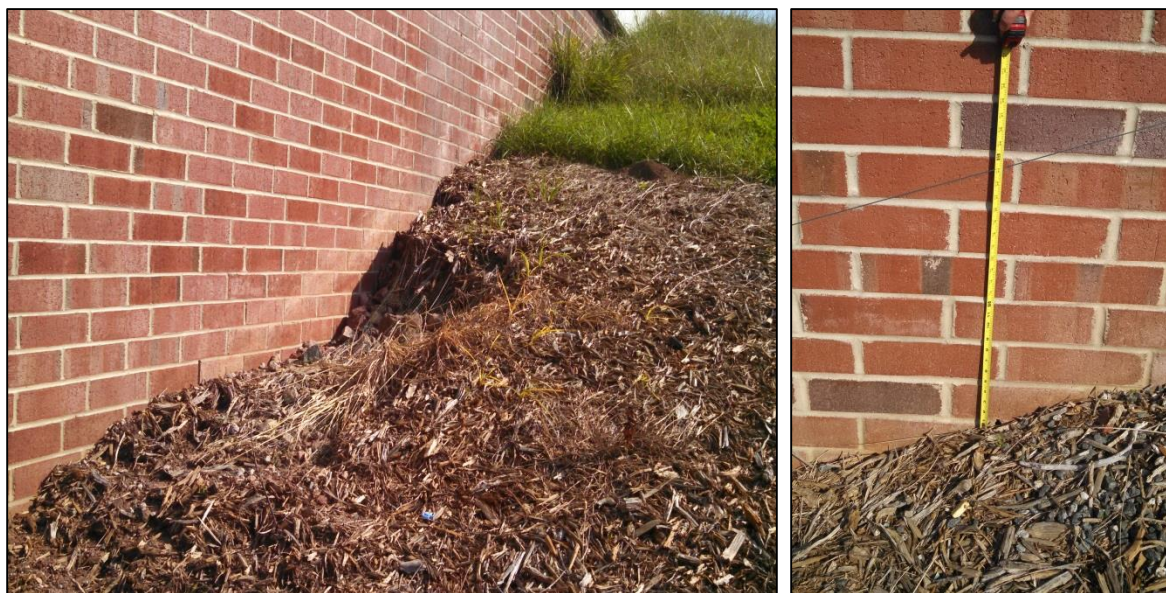
**Figure 8: There is some evidence of earth movement along the right approach wall. The earth material is also significantly lower (about 2 feet) than specified.**

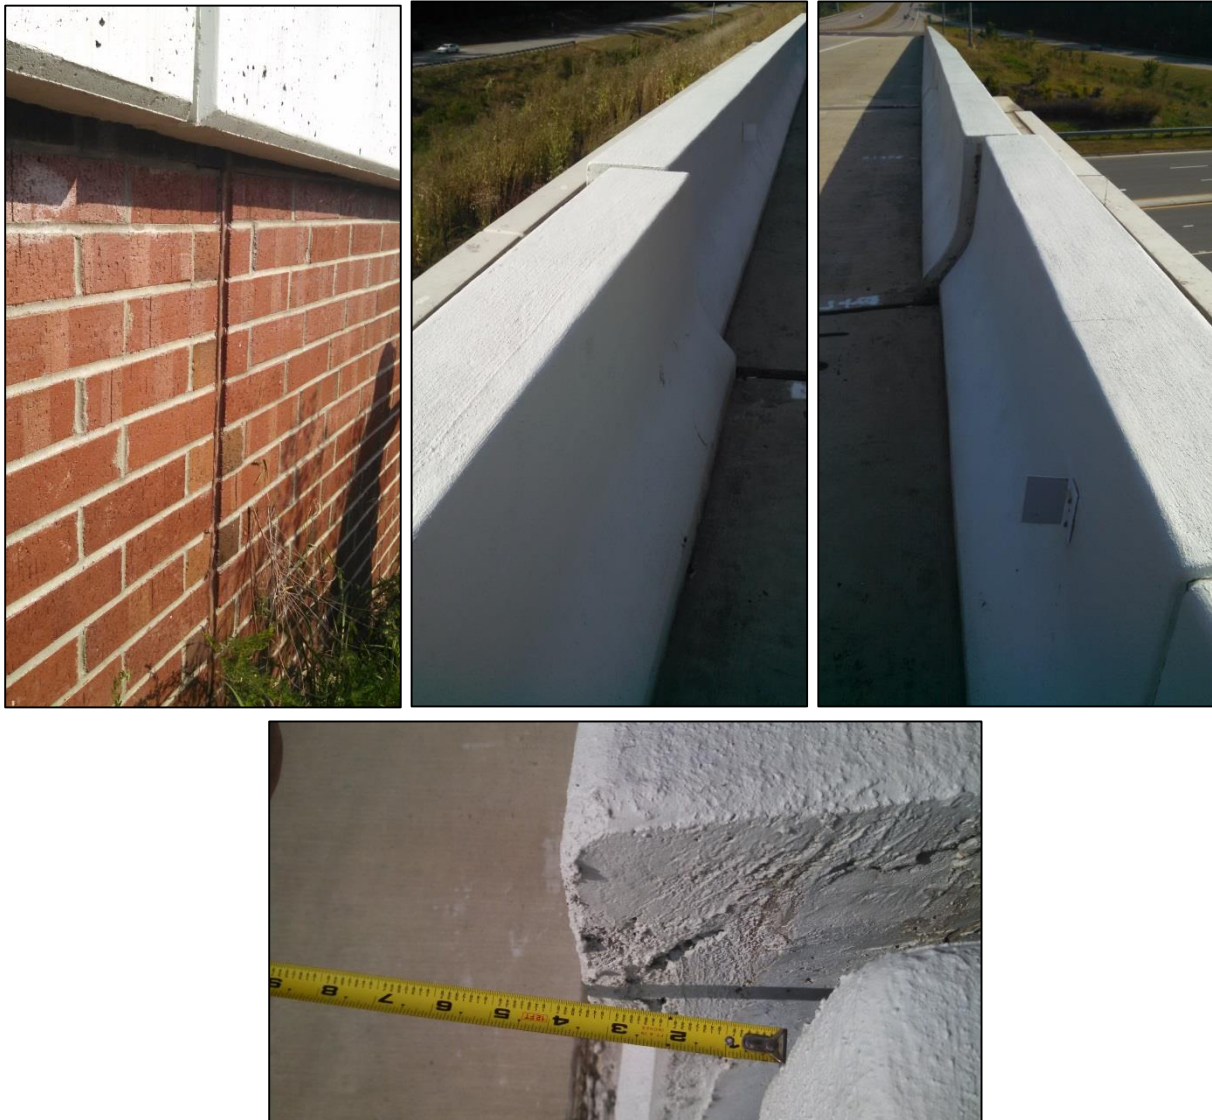
**Figure 9: Evidence of deflection in the left approach wall. The concrete barrier rail has displaced about 3.5”.**

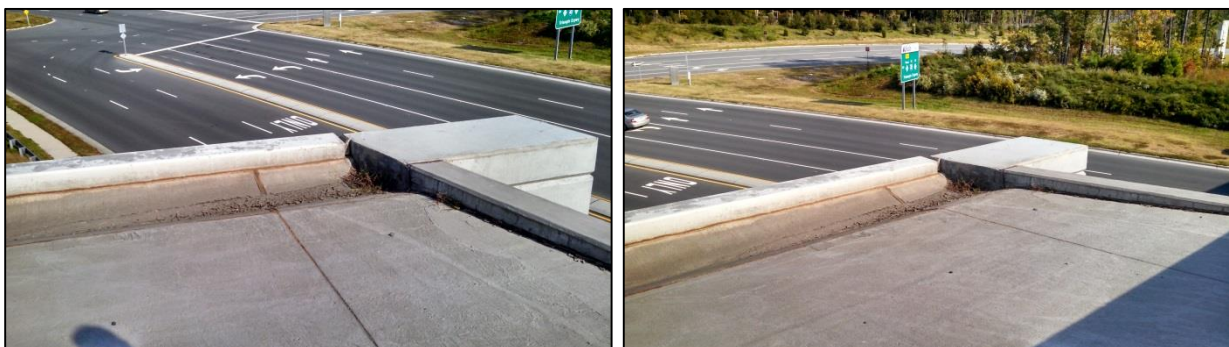
**Figure 10: Outlet at the end of the draining channel along the left approach wall is full of debris and no longer serving its intended function.**

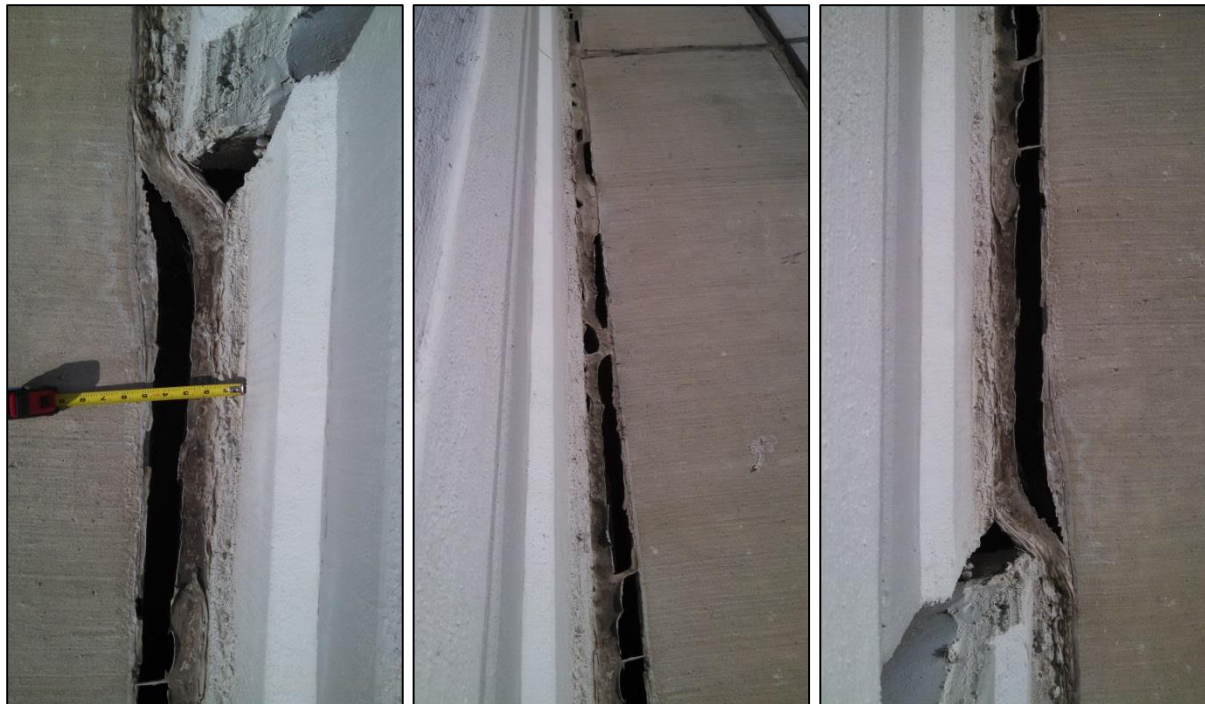
**Figure 11: Evidence of settlement near the end of the left approach wall. The concrete parapet has displaced exposing a 4.5" gap between the concrete barrier rail and the concrete section behind the parapet.**
