Assessment of Deteriorated Cored Slabs Bridges No.: 150035 and 150039

**Department of Civil, Construction, and Environmental
Engineering
North Carolina State University**

**FHWA/NC/2014-35
February 2016**

Prepared for:
North Carolina Department of Transportation
Research and Development Unit

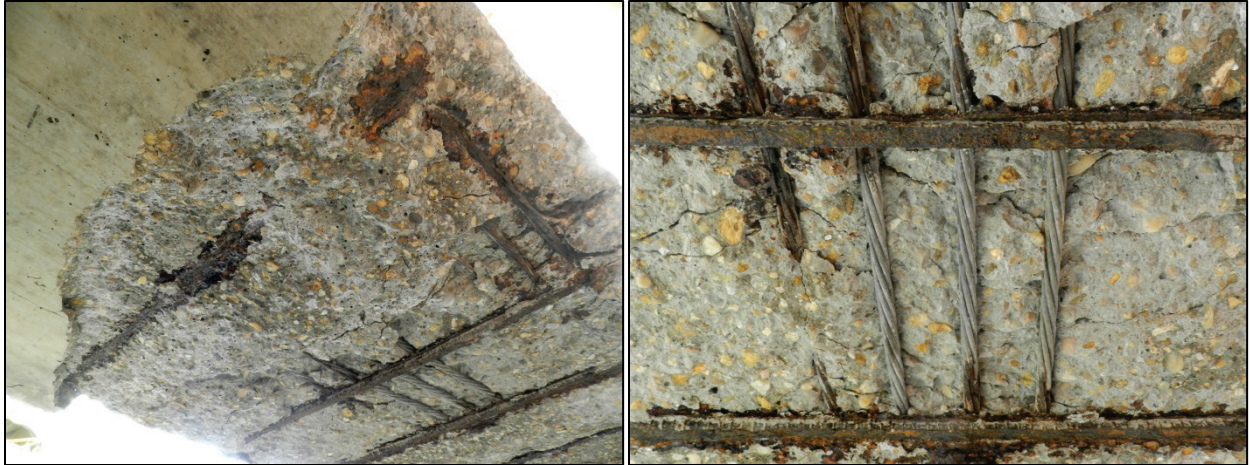
Figure 4.12 - Ward Creek - Span 1 - Slab 13, soffit at failed region

Examination of the slab after testing revealed the failure region, 17 to 20 ft, was a region of audible delamination. Stirrups showed significant section loss (~50%), with 6 of 11 bottom strands rusty, pitted, and significantly damaged. All strands above the bottom layer were in good condition. Photos of the failed region are shown in Figure 4.12 to Figure 4.14.

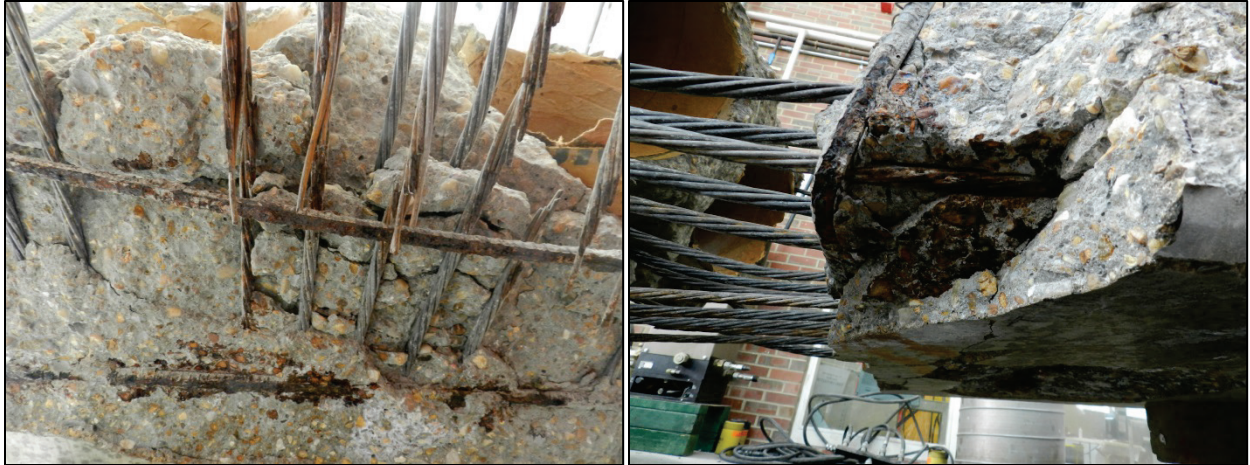
Figure 4.16 - Ward Creek - Span 1 - Slab 14, strands at failed region

The failure region, 17 to 21 ft, was a region with a single spall with rust stains surrounded by audible delamination. Stirrups showed some corrosion, with 5 of 11 bottom strands displaying some pitting near the stirrups, and minor rusting of 4 additional strands. All strands above the bottom layer were in good condition. Photos of the failed region are shown in Figure 4.16 and Figure 4.17.

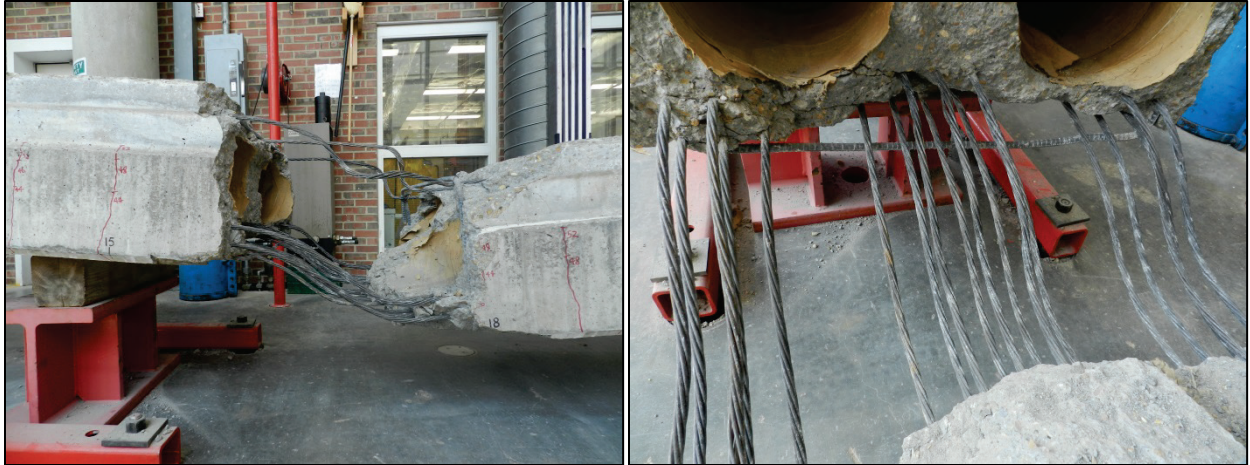
Figure 4.19 - Ward Creek - Span 4 - Slab 5, overview of failed region

The failure region, 16 to 18 ft, was a region with no visible deterioration. All strands were in good condition, with only typical light surface rust on some strands. Photos of the failure region are shown in Figure 4.19. Figure 4.20 shows a closer view of a typical group of strands.

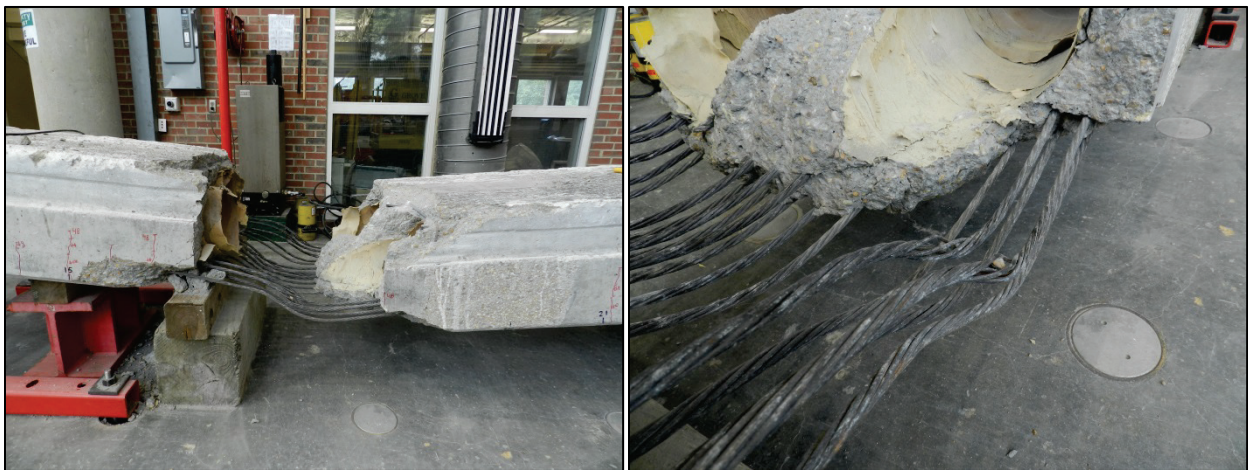
Figure 4.23 - Ward Creek - Span 4 - Slab 6, failed region

The failure region, 16 to 19 ft, contained no visible deterioration. All strands were in very good condition, with only faint discoloration. Photos of the failure region are shown in Figure 4.23.

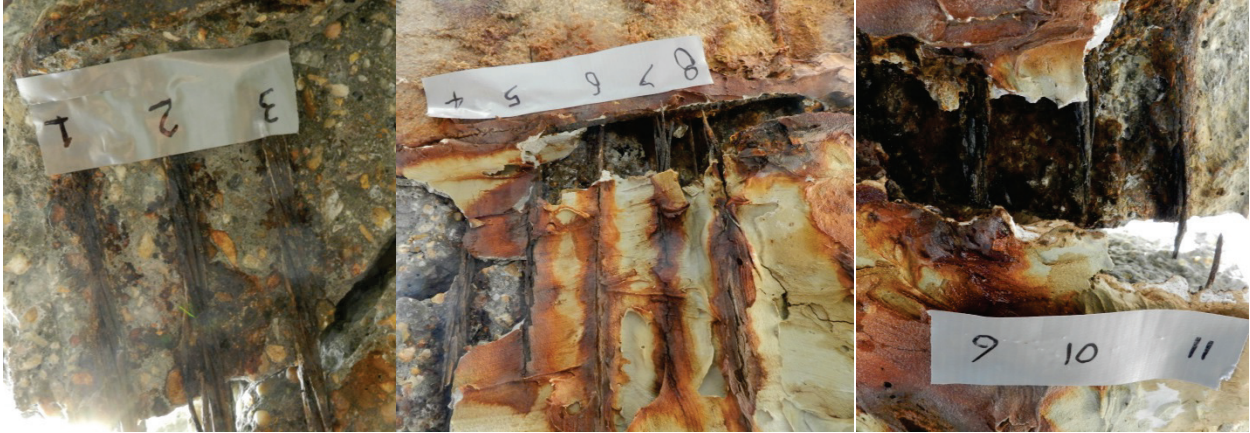
Figure 4.28 - Ward Creek - Span 9 - Slab 7, bottom layer of strands at failure plane after testing

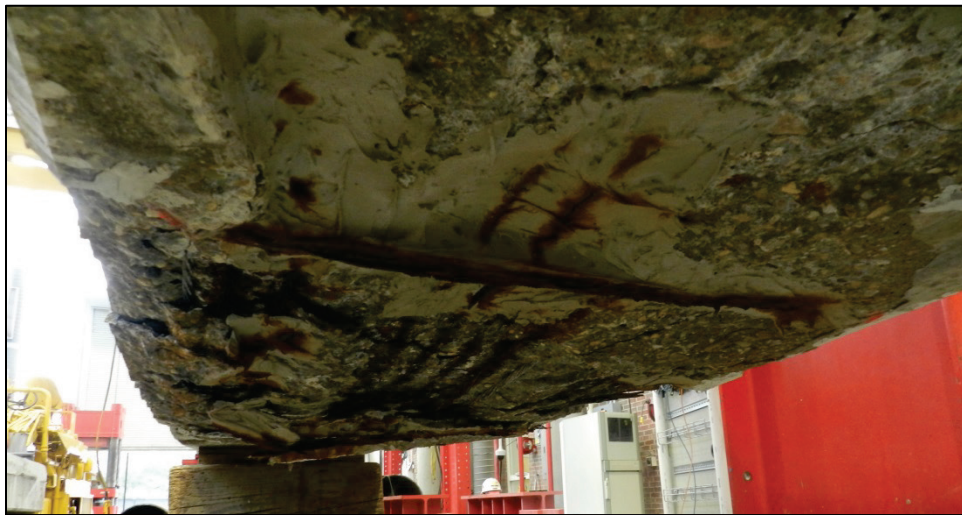
Figure 4.32 - Oyster Creek - Span 1 - Slab 13, slab soffit after failure

The failure region, 20 to 23 ft, contained extensive patching with pronounced longitudinal rust stains, visually similar to Ward Creek – Span 9 – Slab 7 discussed in Section 4.3.6. Nine of eleven bottom strands were either completely corroded or had approximately one wire out of seven left, while the two remaining strands had moderate rusting and pitting. All strands above the bottom layer were in good condition, with only surface rust or light surface rust. A photo of the failure region is shown in Figure 4.32, showing some patching material spalled off during testing while other patching material remained bonded to the concrete above.

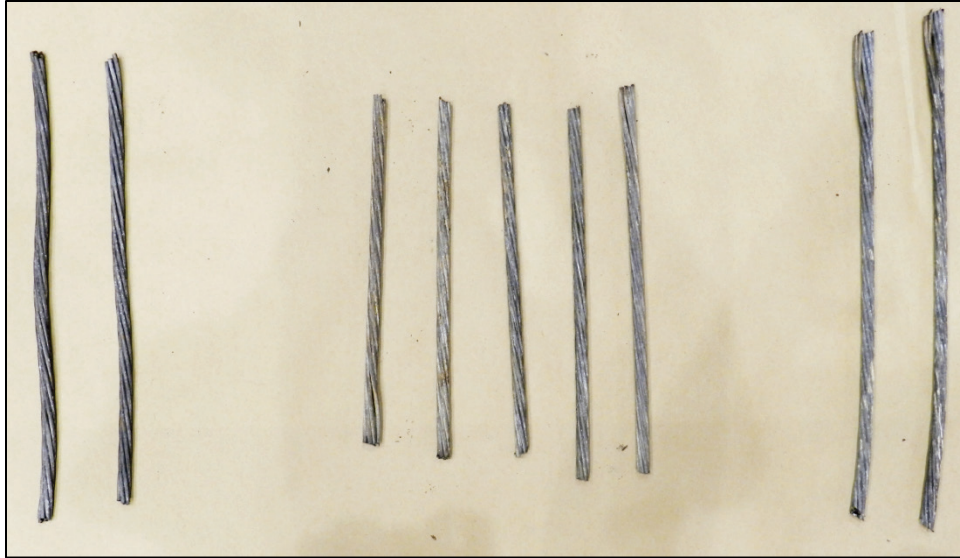
Figure 4.37 - Oyster Creek - Span 1 - Slab 14, second layer strands from failed region

Figure 4.37 shows pieces of prestressing strands cut from the second layer of strands in this slab. Their condition is typical of almost all strands above the bottom layer.

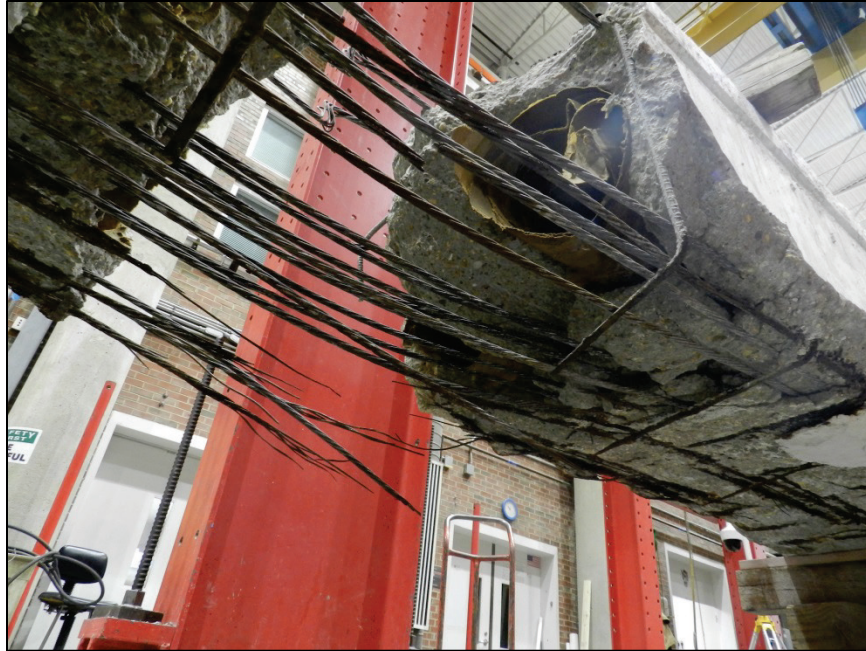
Figure 4.44 - Oyster Creek - Span 8 - Slab 12, soffit after testing, formerly covered by icolastic patch

The failure region, 19 to 22 ft, was visually a single large, clearly delaminated icolastic patch, with no visible deterioration. Five of eleven bottom strands were fully corroded, with remaining bottom strands heavily corroded and ruptured during testing. One strand in the second layer was heavily rusted and pitted, and effectively completely lost, while one other strand in the second layer displayed significant pitting on all 7 wires. All other strands above the first layer were in very good condition. Photos of the failure region are shown in Figure 4.44 and Figure 4.45.

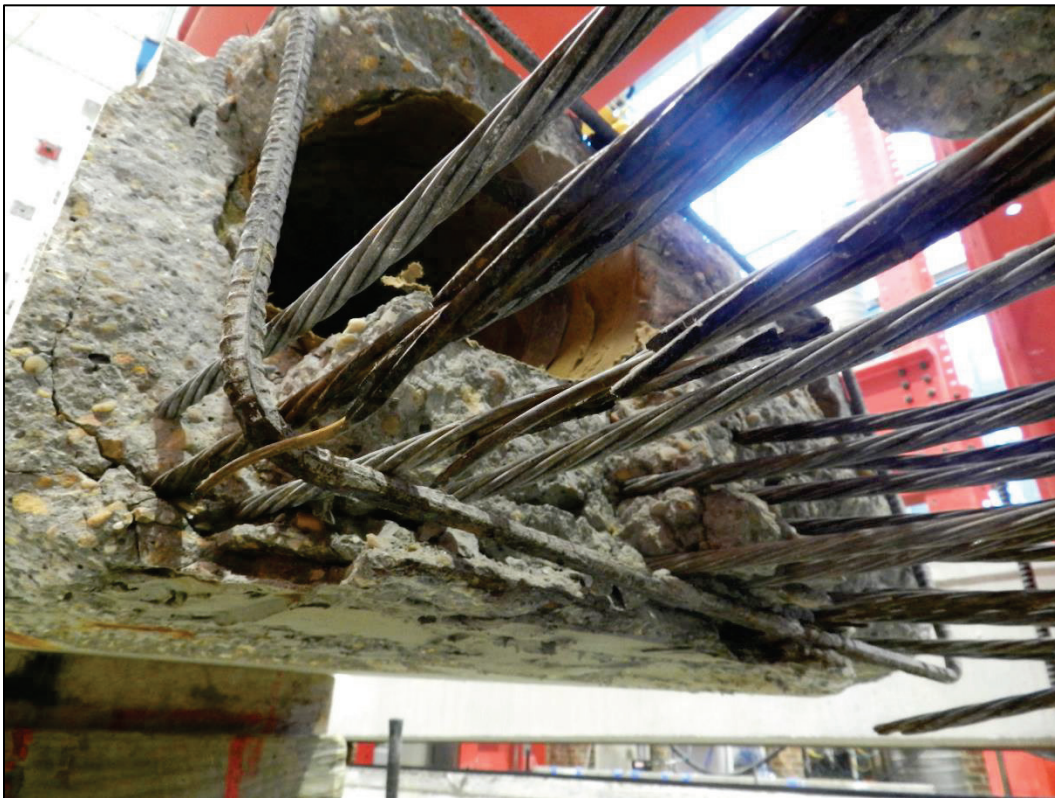
Figure 4.47 - Oyster Creek - Span 8 - Slab 13, moderate rust and pitting of ruptured corner strand

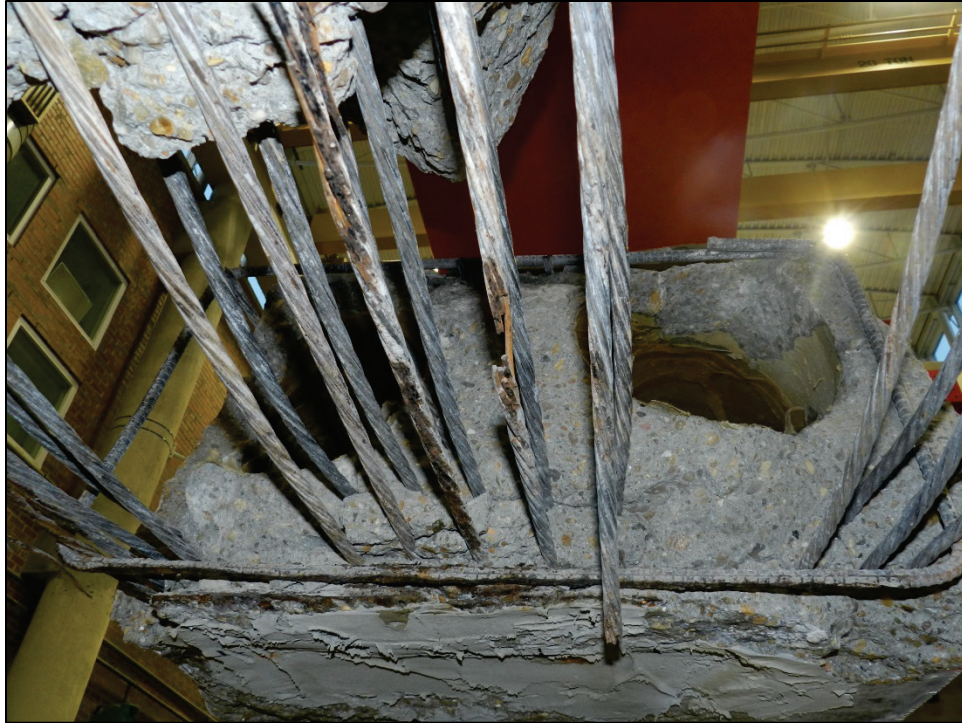
Figure 4.48 - Oyster Creek - Span 8 - Slab 13, rust and pitting of strands above (removed) stirrup location

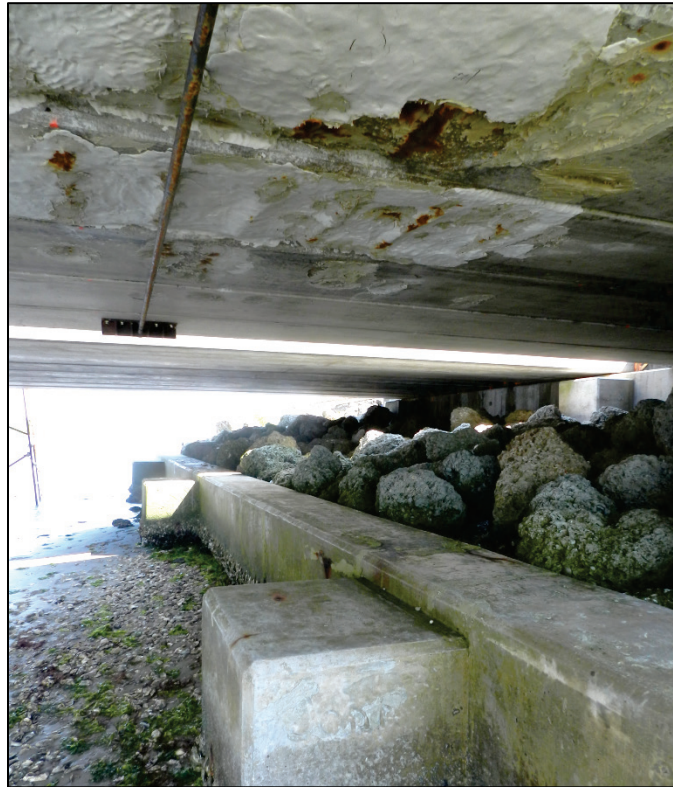
Figure 5.1 - Deterioration of slabs above retaining wall blocks

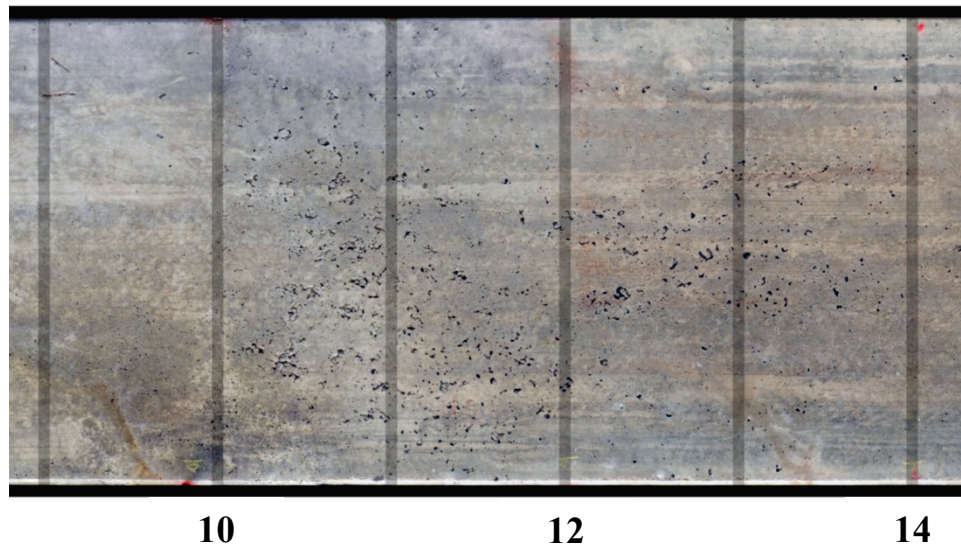
Figure 5.6 – Honeycombing, Oyster Creek - Span 2 - Slab 5, 9 - 14 ft

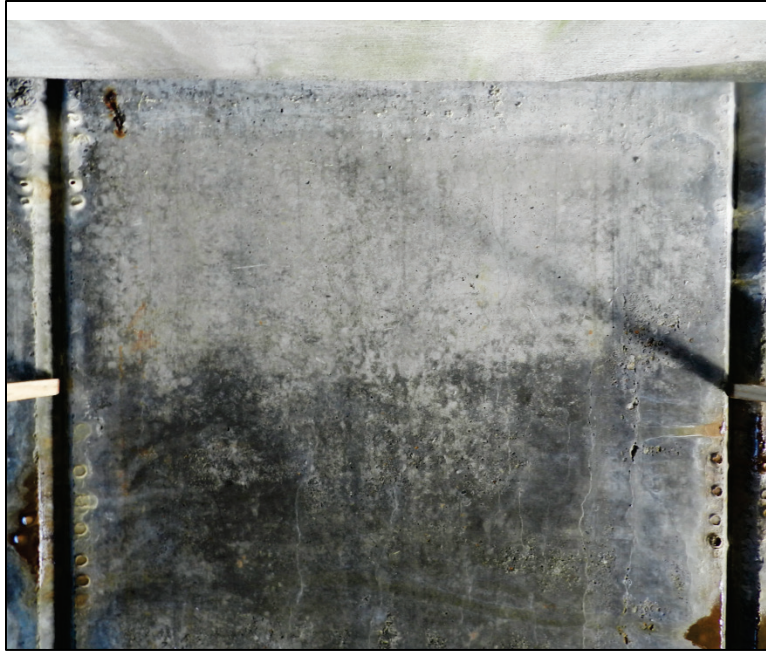
Figure 5.7 – Hairline cracks, Ward Creek - Span 9 - Slab 7, 3 ft

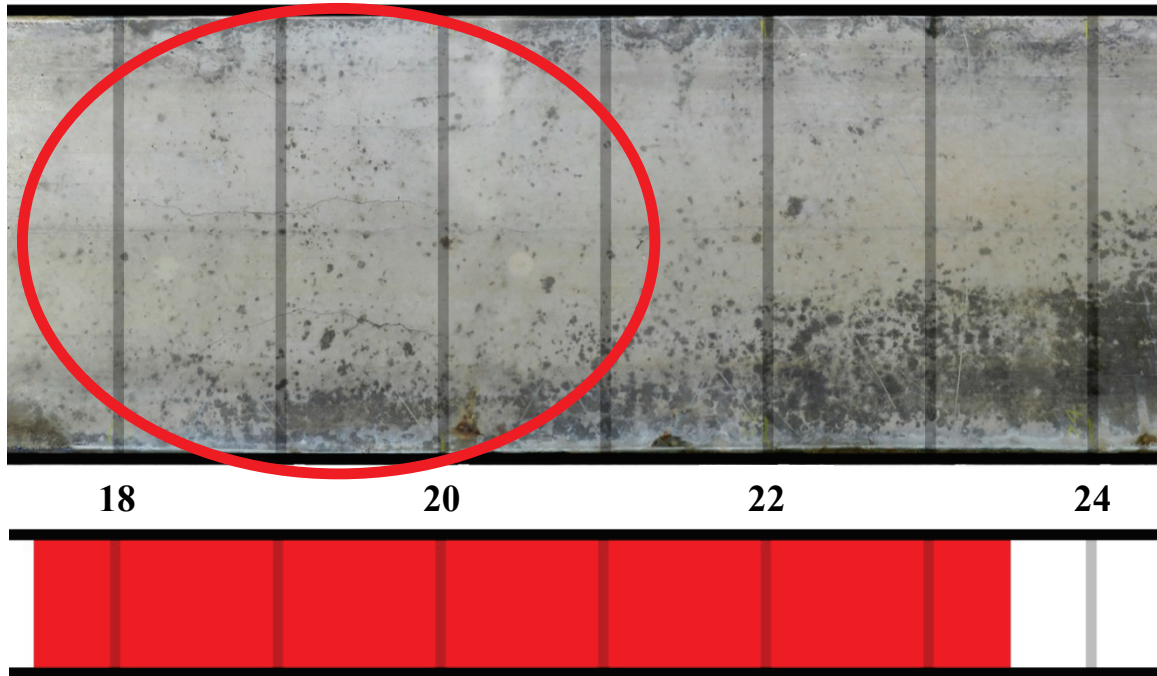
Figure 5.35 - Delaminated region, Ward Creek - Span 1 - Slab 13

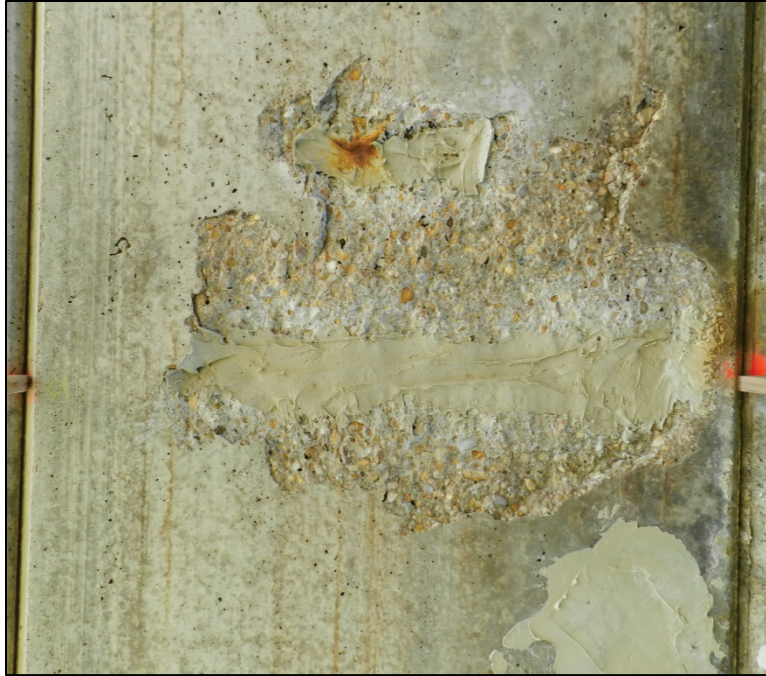
Figure 5.38 - Small patches, Oyster Creek - Span 2 - Slab 4 at 10 ft

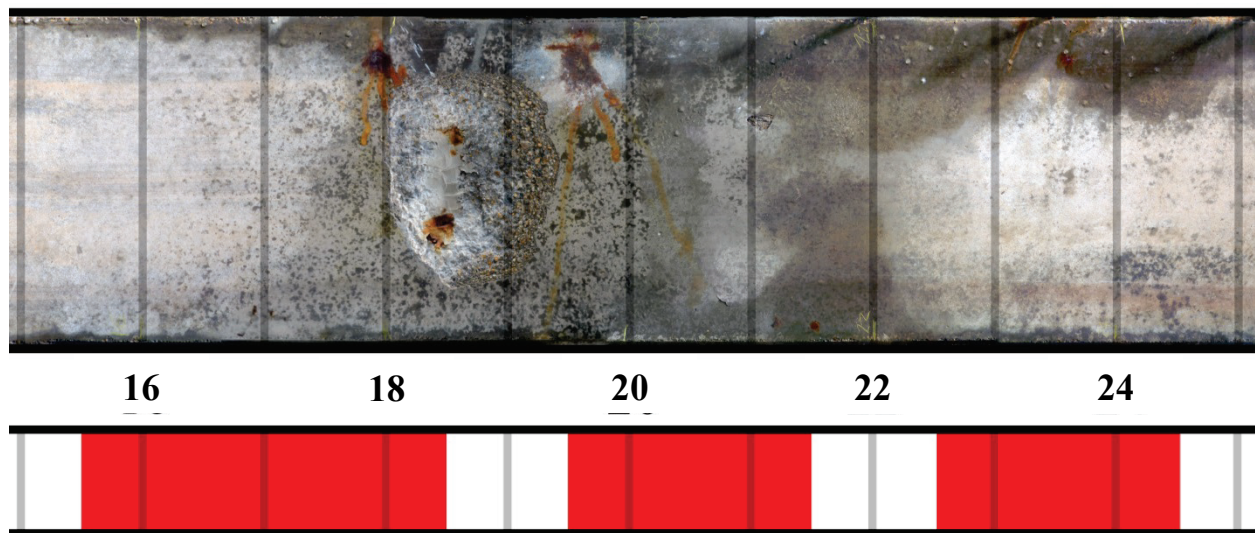
Figure 5.44 - Deteriorated region, Ward Creek - Span 1 - Slab 14
