Improved Approaches to Environmental Compliance During Highway Construction

**NCDOT Project 2019-05
FHWA/NC/2019-05
April 2021**

North Carolina Department of Transportation

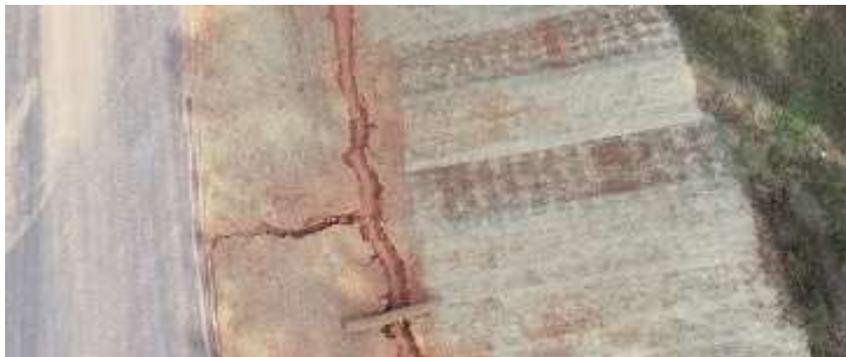
Figure 2.2 Example of a wattle failure with undercutting and ditch erosion at the NC 42 site.

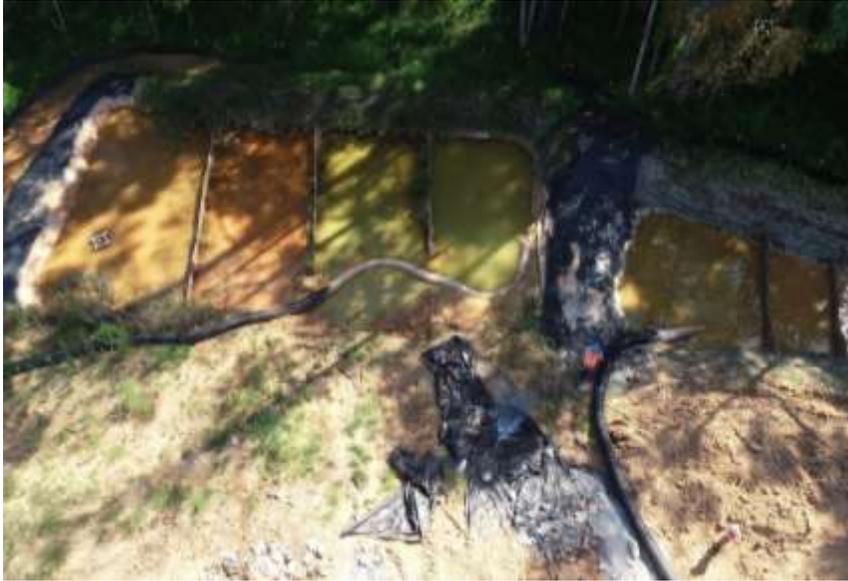
Figure 2.3 Example of baffle failure due to placement of a slope drain on top of the baffle.

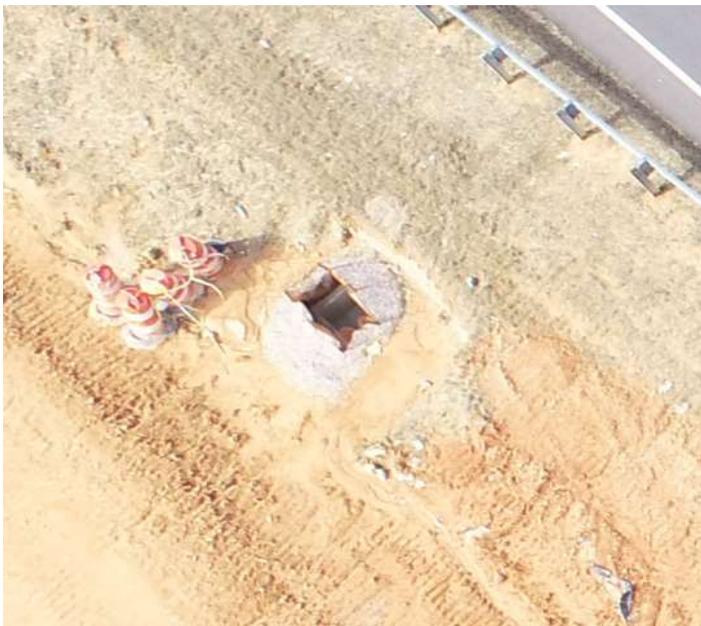
Figure 2.4 Example of heavy sediment deposition on one side of a Type C Rock Inlet Protection device.

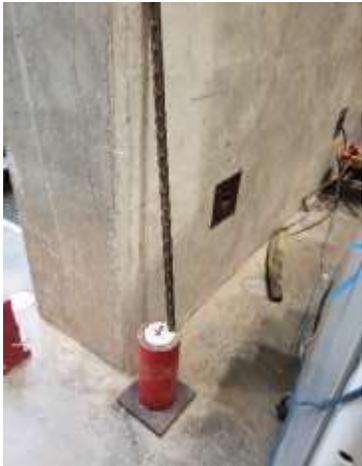
<p style="text-align: center;">Style S1 Fracture at Post Base (Note post separated from base)</p>

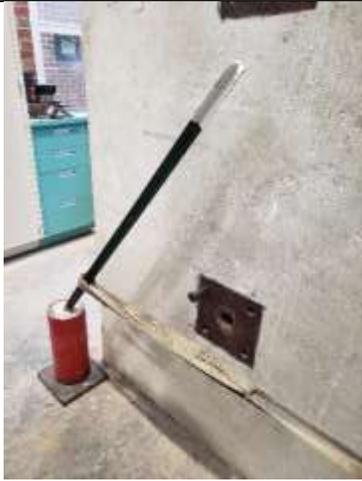
<p style="text-align: center;">Style S2 Yielding at post base with local buckling of the cross-section.</p>

- Of potential concern is specimen S2-1, an NCDOT rated post. While the average behavior of group S2 achieved the calculated target load, specimen S2-1 failed to reach this target and is a significantly low outlier. A specification for steel posts that measures only post weight per foot creates the possibility for significant variability in performance because variability in key material properties such as metal yield strength will not be

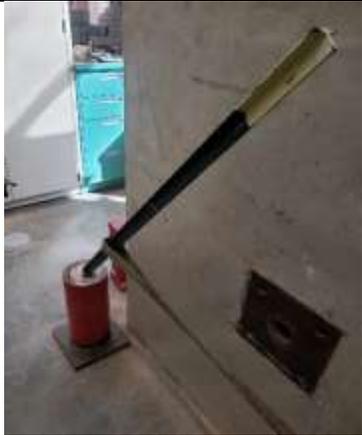
<p style="text-align: center;">Style S3 Yielding at post base with local buckling of the cross-section.</p>

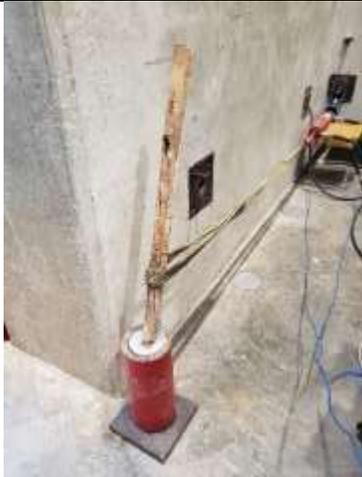
<p style="text-align: center;">Style W1 Bending and Fracture at Post Base</p>

- SYP silt fence post cross section sizes could be significantly smaller if less than 2' of ponded water were considered. For example, if only a 1' depth of water needs to be retained, then a Select Structural SYP post of approximately 1.2" square would easily be acceptable using an 8' post spacing. If only 6" of water needs to be retained, then a SYP post only 5/8" square would do the job, still at an 8' spacing. It is noted that a 5/8" square cross-section is likely smaller than what could easily be produced and installed for this application, so a larger cross-section would probably be selected for practical reasons.
