Improving Resilience of Transportation Infrastructure to Hurricane Damage

NCDOT Project 2021-08
FHWA/NC/2021-08
September 2023

B. Shane Underwood, Ph.D.
Brina Montoya, Ph.D..
Department of Civil, Construction, and
Environmental Engineering
North Carolina State University

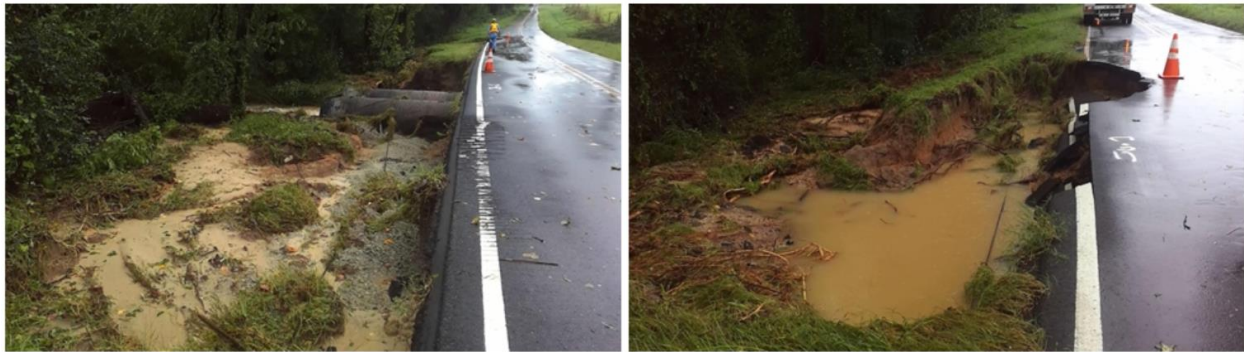
Figure 28. Photos of damage after Hurricane Florence in Site 53-4-MF.

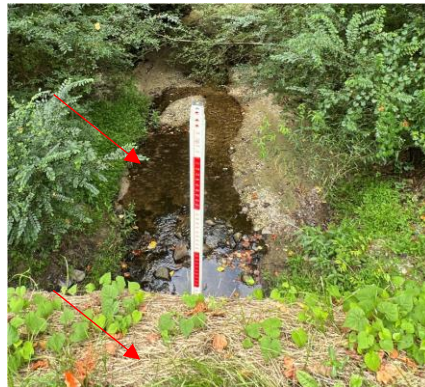
Figure 29. Current photo of Site 53-4-MF.

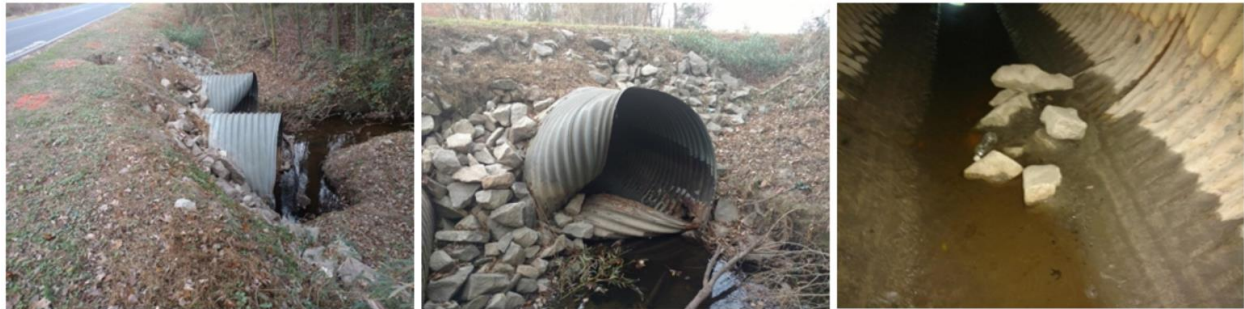
Pre – Matthew Structure	2 @ 84" CMP
Post – Matthew Proposed Structure	Alt 1: 2 @ 112"x75" CMPA w/HW. Alt 2: 1 @ 13'-11" x 8'-5" AASPPA (requested by Div.)
Post – Matthew Actual Structure	1 @ 171" x 115" CMPA w/HW
Costs after Matthew	\$421,593

Figure 30. Photos of damage after Hurricane Matthew in Site 95-3-M.

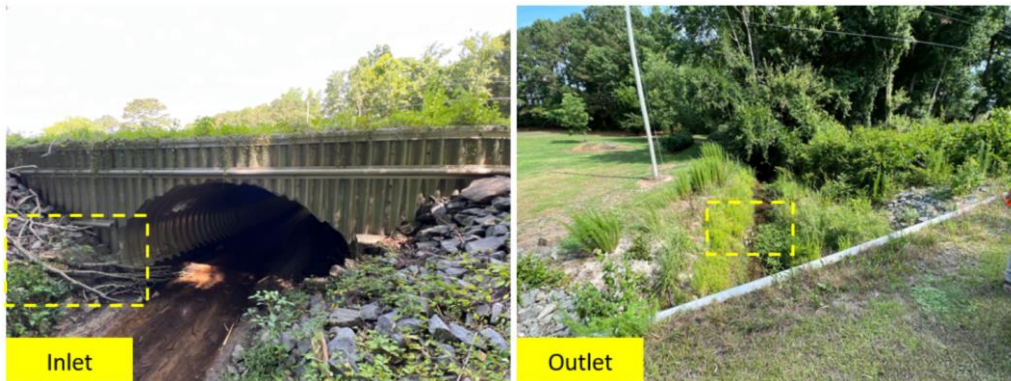
Figure 31. Current photos of Site 95-3-M.
