Natural Hazards Vulnerability Assessment of the NCDOT Ferry Division Assets

NCDOT Research Project 2023-14

July 9, 2024

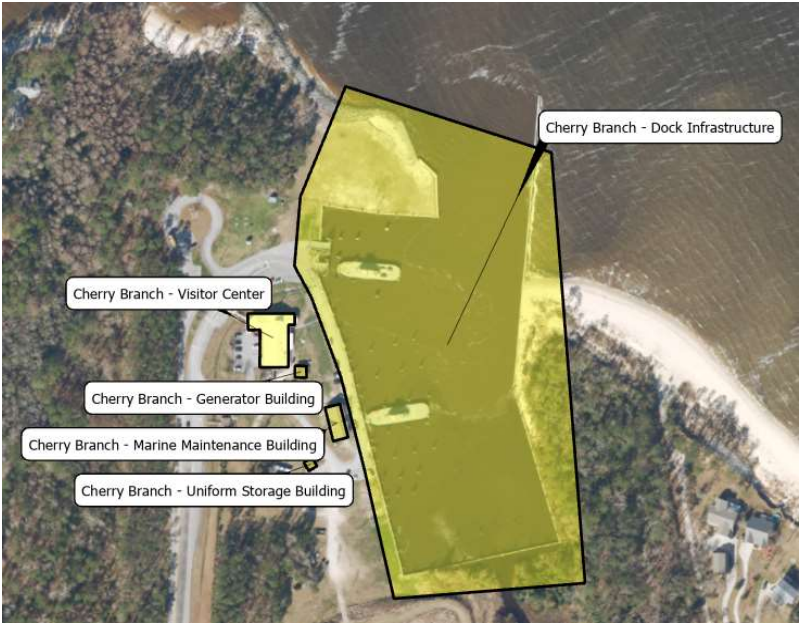
ASSET AREA

One of the staff members named either Mike or Mark walked us around and told us about the property and its damage. He said that there had been a lot of storm-related damage and erosion over time. He also said that during extreme storms and flooding, the ferry station becomes flooded and causes mechanical issues/damages that need to be repaired every time this occurs

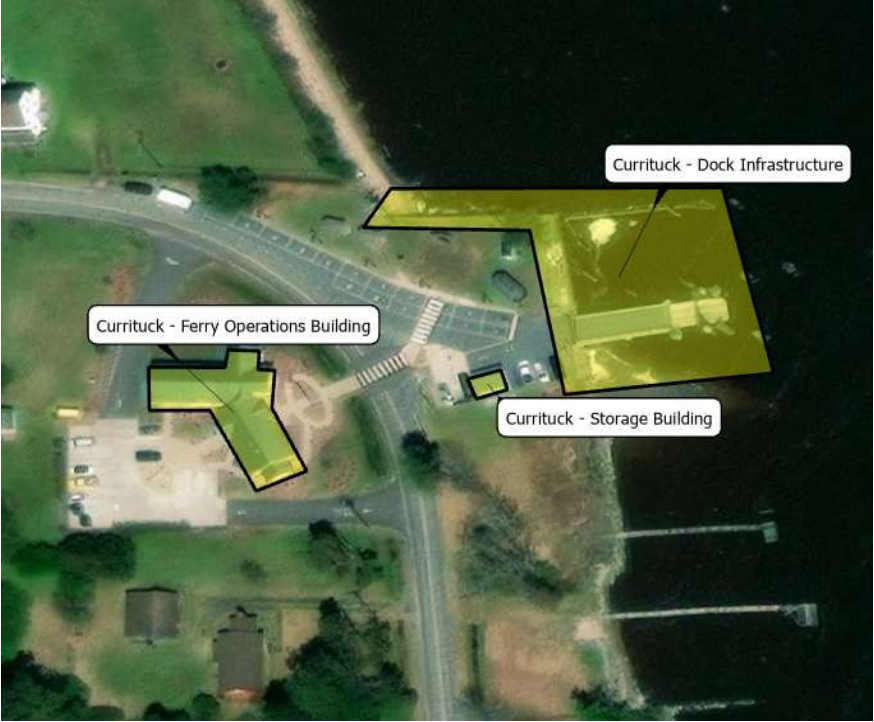
Asset Area	Asset Name	Asset No.	Photo(s)	Measurement	Comments
1	Cu	Currituck Ferry Operations Building	027-010-010	Cu1 - Cu9	N/A	No visual damage to the structure.
2	Cu	Storage Building	027-010-009	Cu10 - Cu16	N/A	Minor damage to the storage building due to the old wooden structure (small cracks at door)
3	Cu	Currituck - Dock Infrastructure	Cur-Dock	Cu17 - Cu33	N/A	No visual damage to the structure, but improper fencing found near the dock.
4						
5

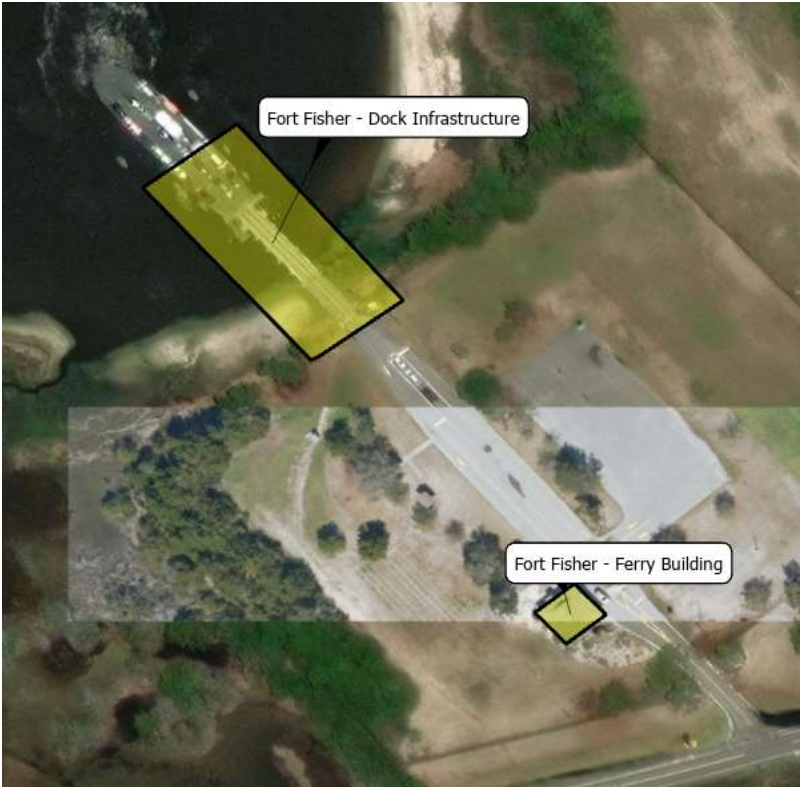
ASSET AREA

No visible water damage anywhere, lack of rising tides

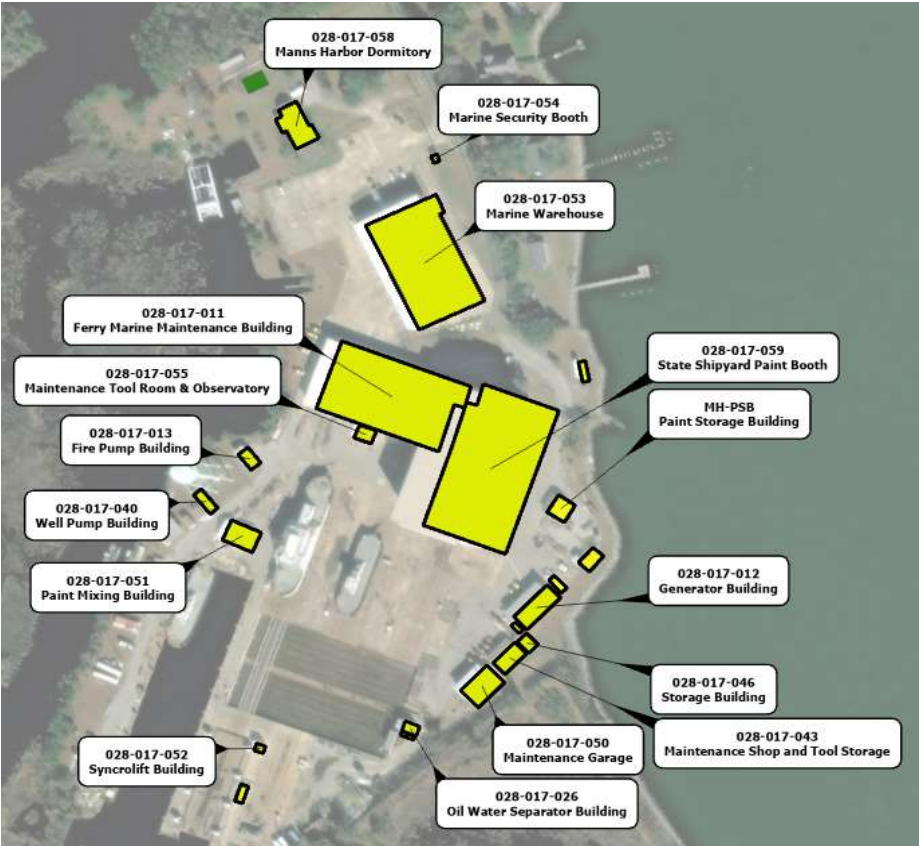
Description	Lat	Long	Photo(s)	Measurement	Comments
1	Propane	35.872°N	75.753°W	Ma-AST1	1'	Tank above 1'; but many components below
2	Oxygen	35.871°N	75.753°W	Ma-AST2	2'	Platformed
3	Diesel	35.871°N	75.753°W	Ma-AST3	2'	Boxed by Concrete

4	Gen Bldg	35.871°N	75.754°W	Ma-AST4	0'	Lifeted but components lower
5	Used Oil	35.870°N	75.754°W	Ma-AST5	2'	Boxed by Concrete
6	Diesel	35.870°N	75.755°W	Ma-AST6	0'	Large Tank at grade

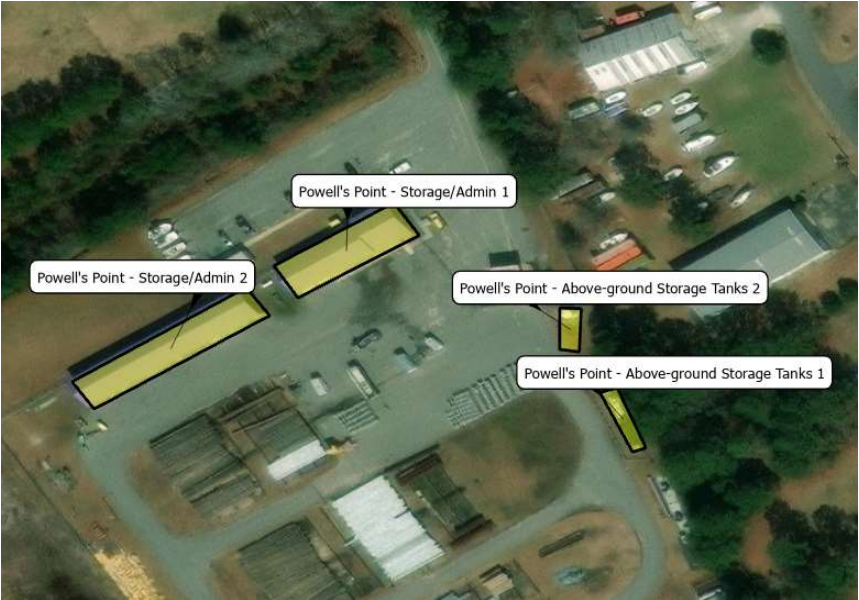
ASSET AREA

Many photos of surrounding areas and damage we noticed. We were unable to get into the area behind the fence so we took photos of what we could.
