**NCDOT Project SP 2007-2
March 2011**

***Hollow Core Beam Bridge #20
over Broad Creek on SR 1124 in
Carteret County, North Carolina***

Review of Hollow Core Beam Bridge #20 over Broad Creek

March 11, 2011

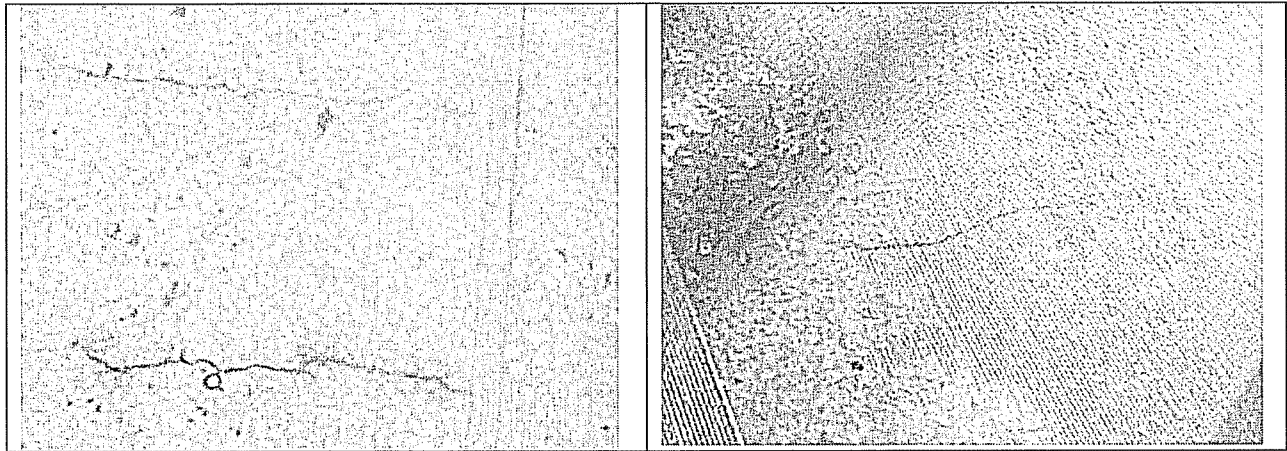
Figure 2 Examples of Transverse Cracks

Inspection of the bridge highlighted the inconsistent nature of the occurrence of these cracks, transverse to the longitudinal beam dimension. In general, there did not appear to be identifiable patterns based on exterior issues such as placement of the beam, traffic load, grinding pattern or other factors. For example, a slab displaying this issue would be next to a slab with no indication of cracks. Figure 2 is a close up picture depicting a transverse crack in a precast deck slab. As seen in the picture, this crack occurs only in one slab and cracks are not evident in the adjacent slabs. This picture was taken in January and the cracks may well appear smaller in the summer. Nevertheless, it is important in the long term to identify the source of this phenomenon since it does not appear to be related to the grinding process.

There are a number of possible root causes which could explain the beam by beam occurrence of these cracks. Figure 3 provides information from a publication from the Prestressed Concrete Institute (PCI, 1983) and indicates a range of potential causes for the beam by beam occurrence of these cracks. The highest potential areas involve:

- The individual manufacturing process: It is possible that aspects of production of these beams relate to the formation of these cracks on an individual beam basis. Causes may relate to variation and quality control in the original manufacturing / fabrication steps, including shrinkage due to mix issues, curing / heat issues, and excessive top fiber tension, among others.
- Mishandling of the beams: This issues examines cantilever loading by misplacement of dunnage, and related activities which would result in an excessive cantilever condition.

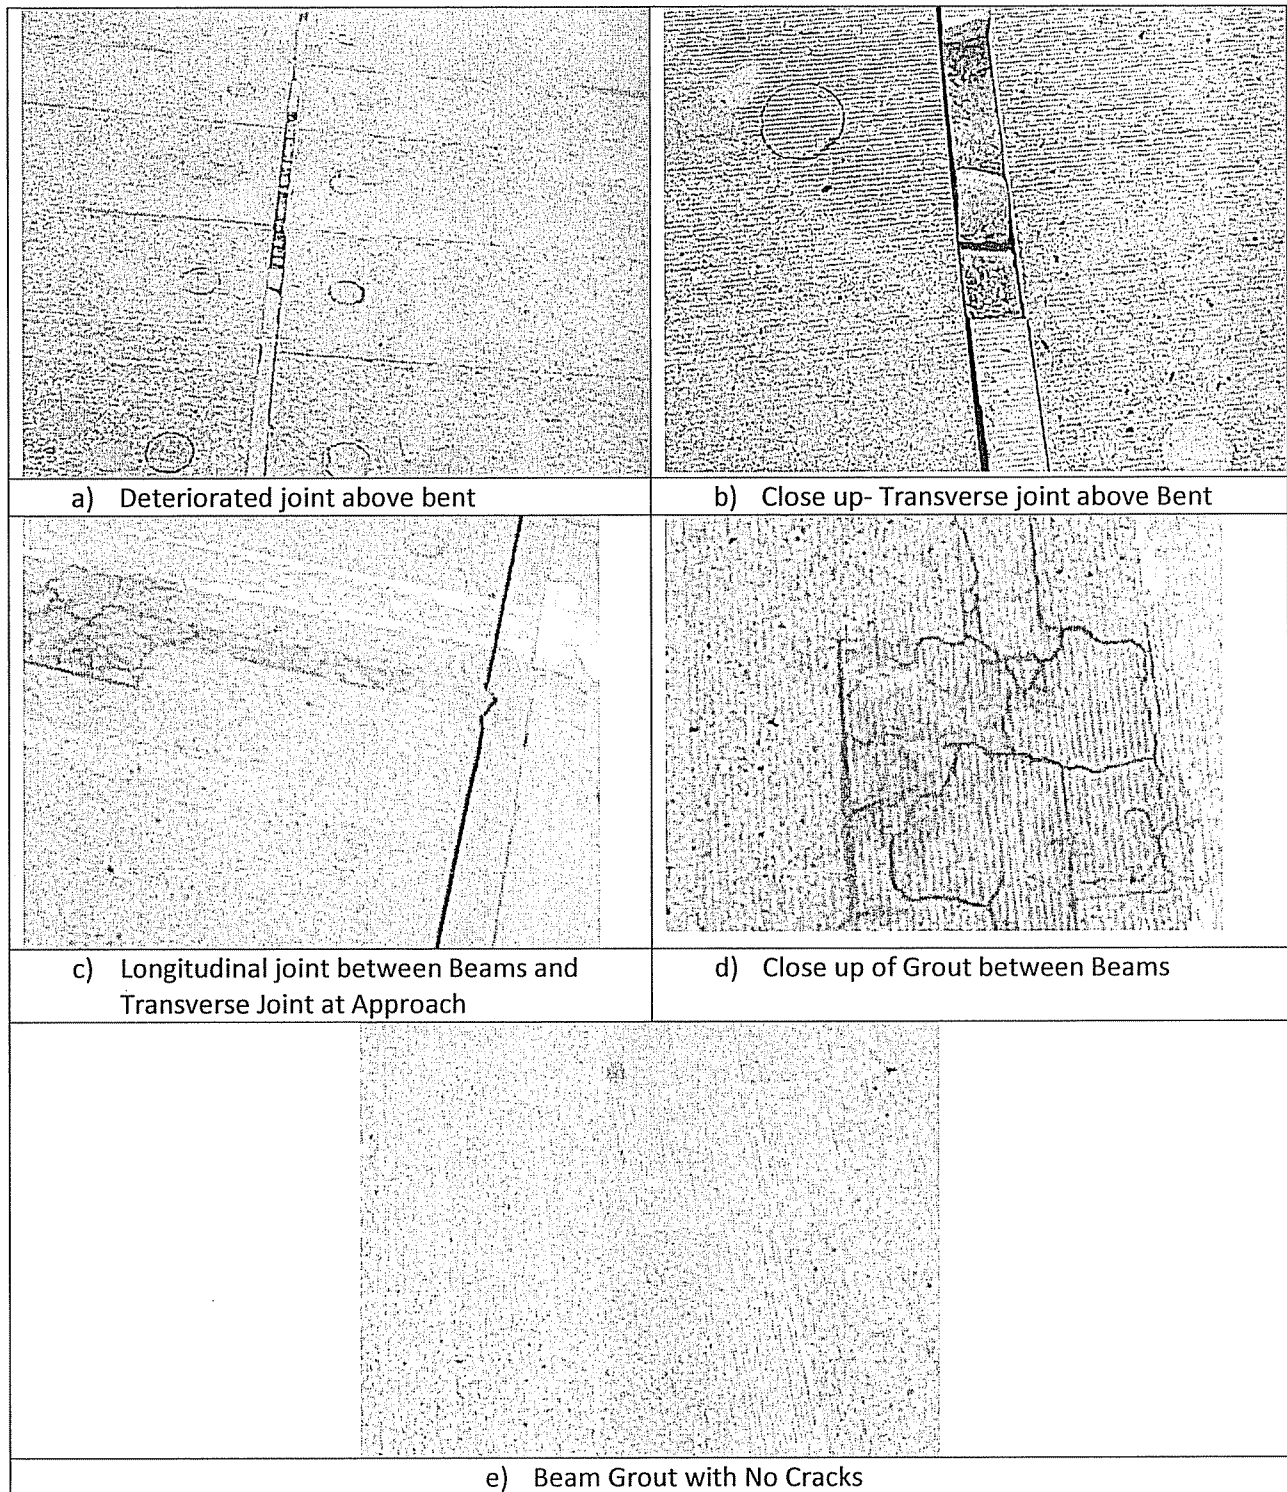
Figure 4 Grout Pictures

Issues are evident related to performance of the grout used both for filling voids longitudinally between beams and at the transitions between the approach and over the pile caps. Once again, the performance of grout was inconsistent.

- Figure 4 (a) and (b) show issues with the transverse joints between the beam slabs.
- Figure 4 (c) and (d) show issues with the transverse joint where the approach meets the beam slab and also with a longitudinal joint between beams.
- Figure 4 (e) shows a similar joint to 4(d) with no cracking evident.

The inconsistency of the cracking in the longitudinal joints between beams may indicate an issue with mix or material consistency. As far as the transverse joints, root cause issues appear to relate to joint design, material specification or both.

A second area of concern involves visible and serious failure of grout used for a variety of voids. Both longitudinal and transverse grout joints showed evidence of failure. Design of these joints, material consistency, application quality, and the value of eliminating an overlay should be investigated relative to this issue.

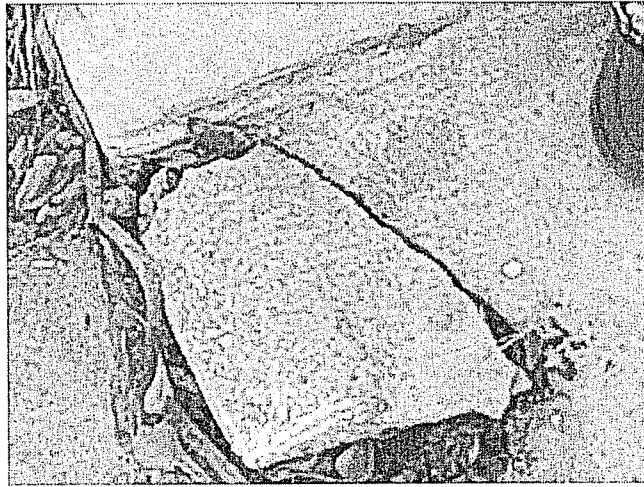
Figure 5 Concrete Spalling

Figure 5 illustrates a final issue observed during the site visit and relates to the potential implications of the late delivery of materials. The figure shows a concrete spall on the bridge shoulder. Delays in slab delivery forced the contractor to pour this segment early, before the approach was installed. The height ended up above the approach and it appears the grinding process may have produced a hairline crack which eventually resulted in this spall. Once again this highlights the importance of component availability to assure appropriate sequencing of tasks.
