APPENDIX E:
BRIDGE INSPECTION REPORT —
THREE RIVERS BRIDGE

THE BRITE BRIDGES:
Bridging Resources for Infrastructure and Thriving
Economies Project

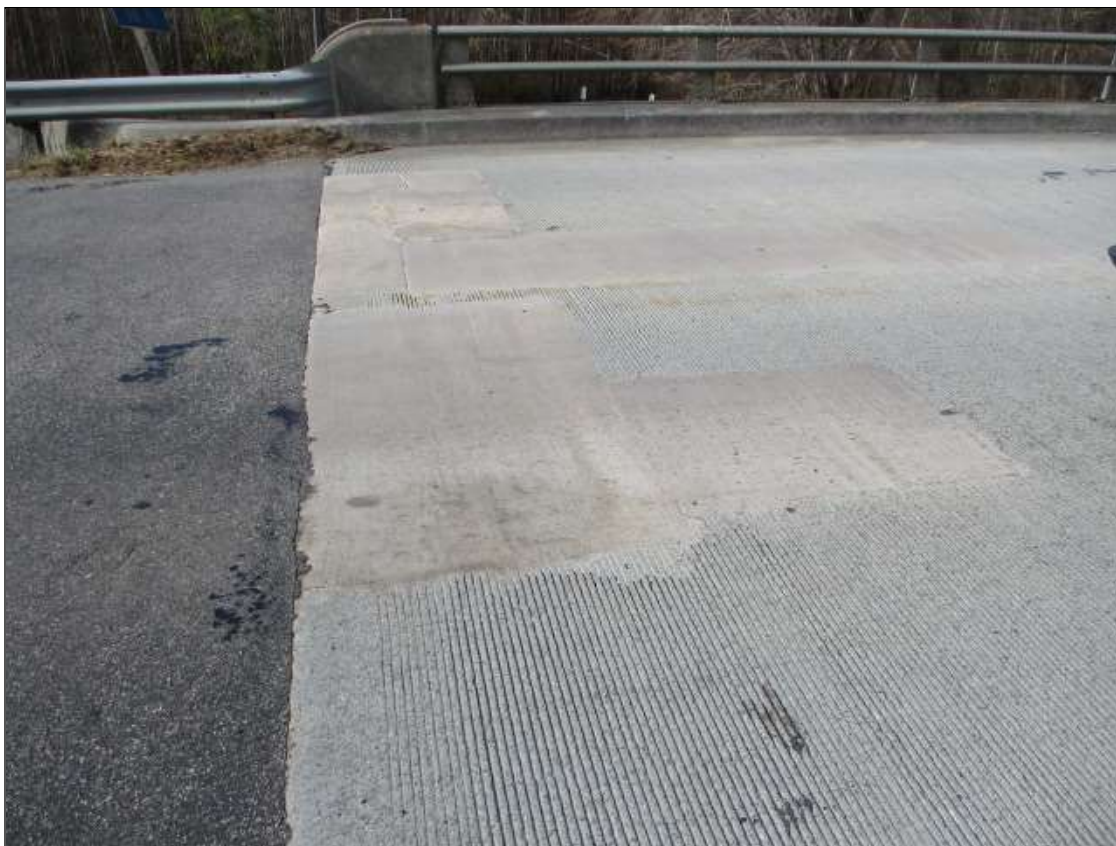
Span 1 Deck: throughout both lanes, multiple sound patches [up to 6ft x up to 8ft]

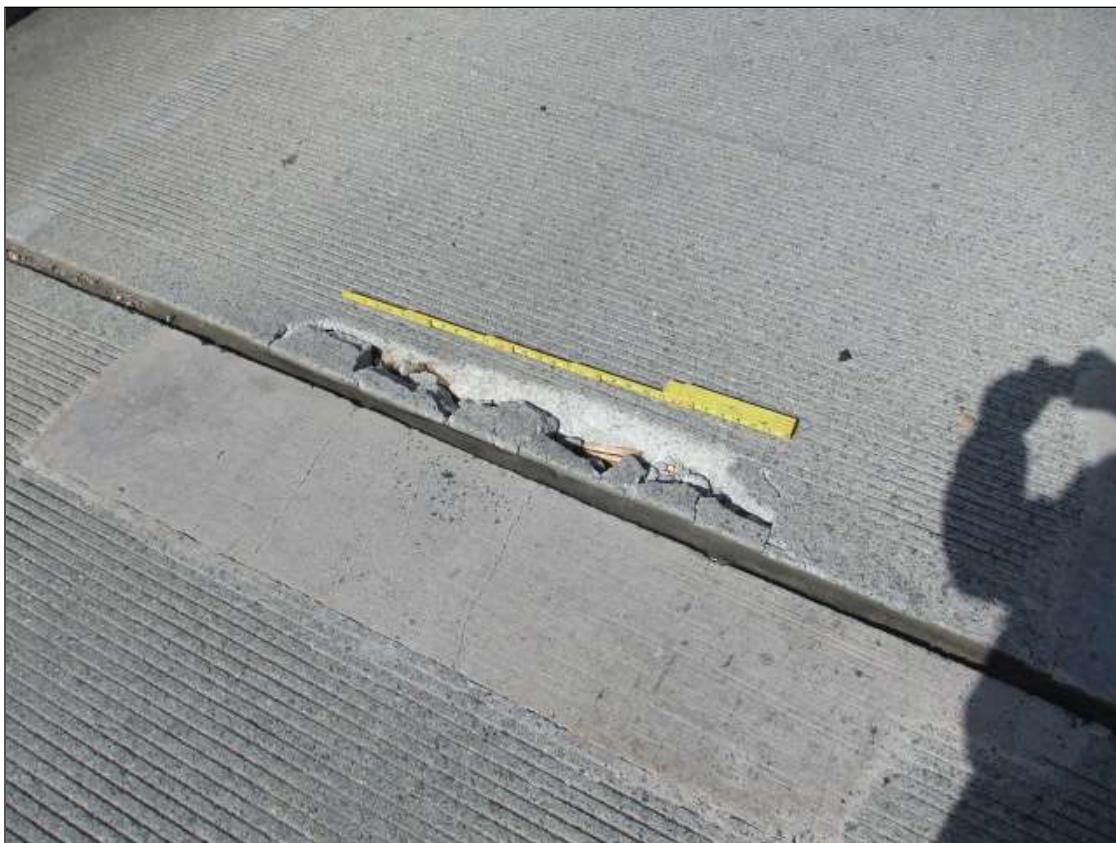
Span 13 Deck: PAR: 3' WIDE X 6" LONG X 3" DEEP SPALL WITH EXPOSED REBAR IN SOUTH BOUND LANE AT BENT 12 JOINT

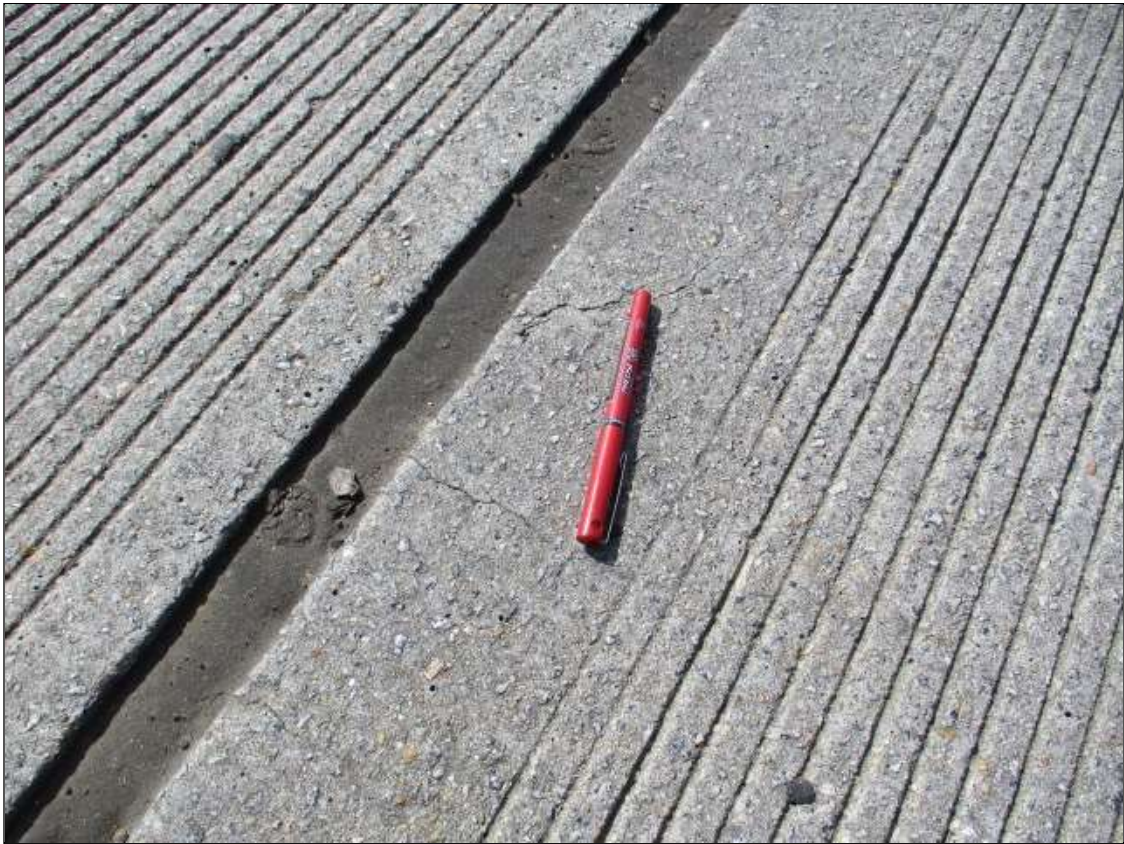
Span 15 Deck: 1/32" LONGITUDINAL CRACKING ALONG JOINTS

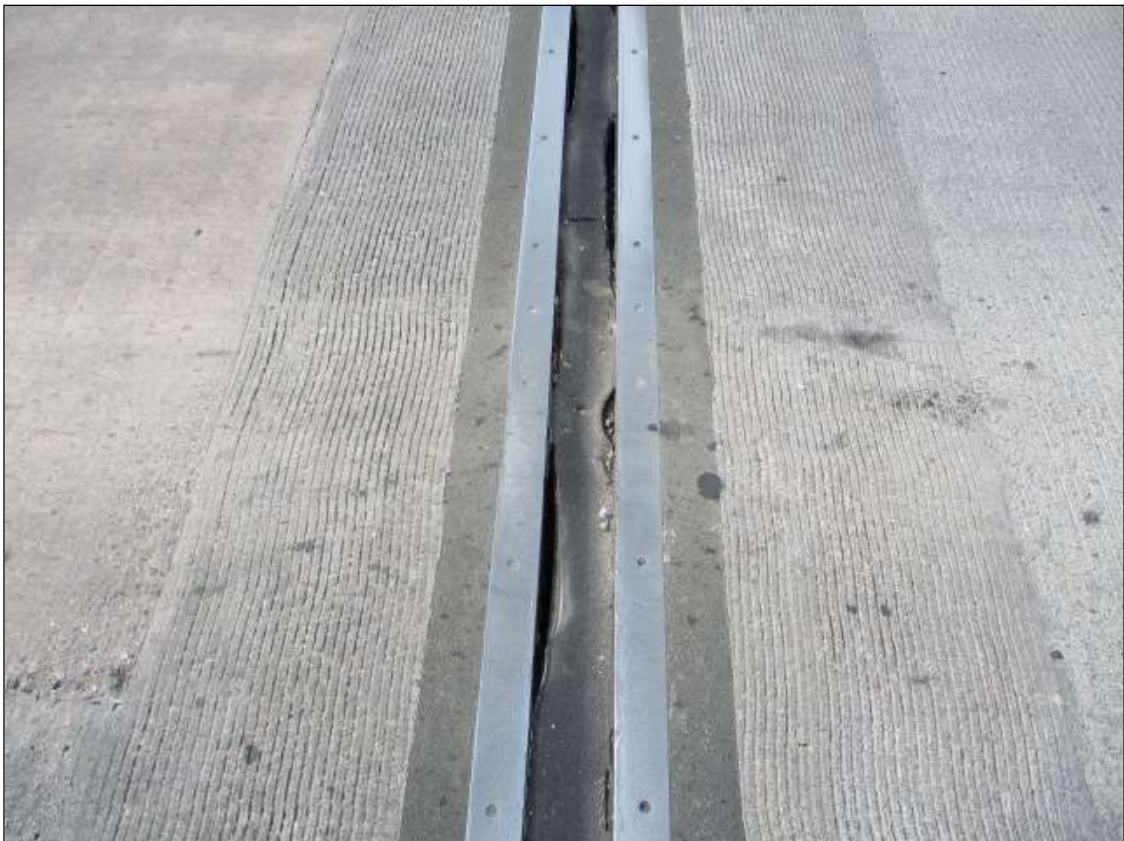
Span 17 Expansion Joint over Bent 16: along joint, loss of seal adhesion [20ft x full depth]

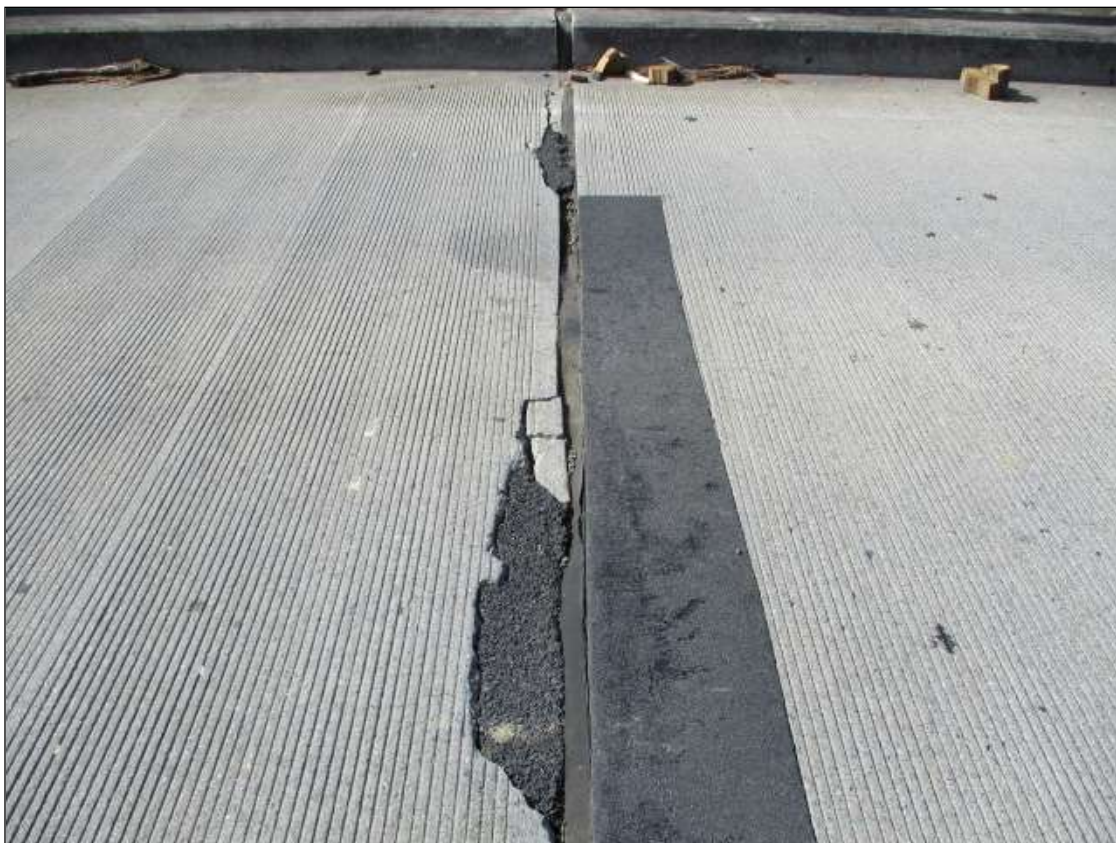
Span 26 Deck: in left shoulder AND IN SOUTH BOUND LANE at bent 26, 2 spalls [4ft x 4in x up to 2in deep]

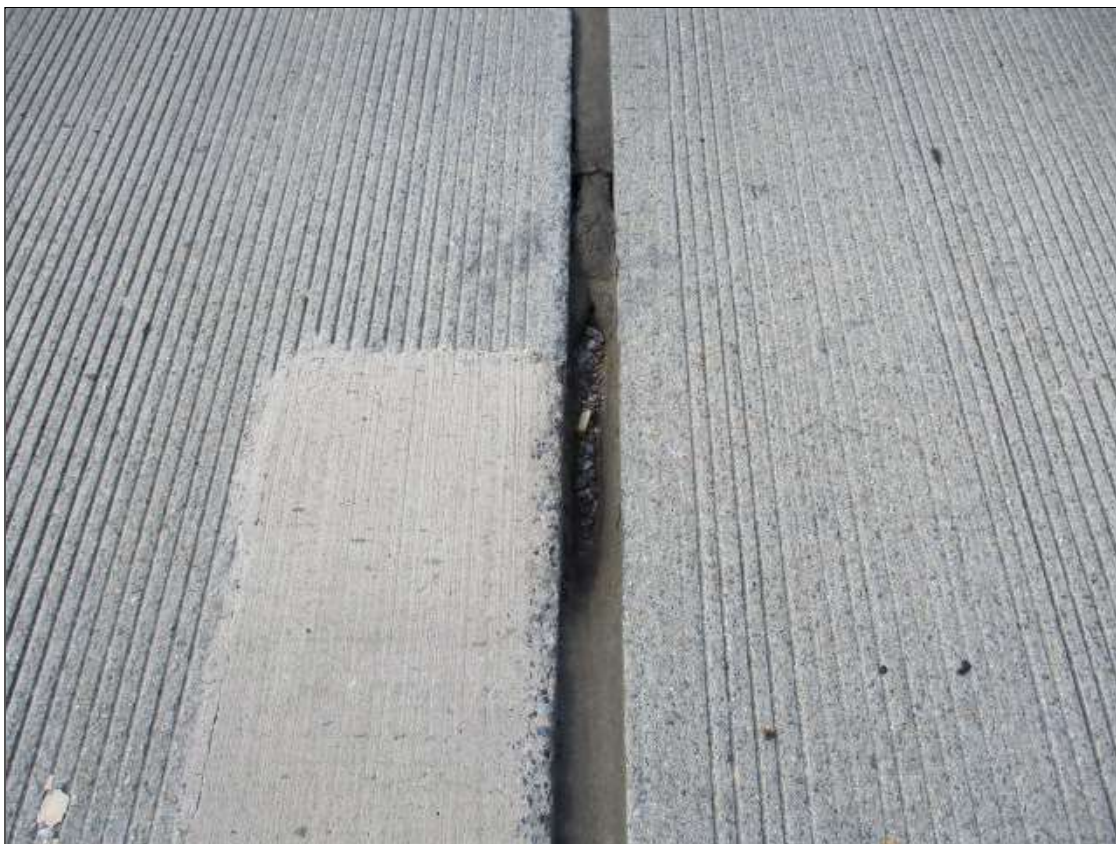
Span 34 Expansion Joint over Bent 33: At centerline, adhesion failure [1ft x full depth]

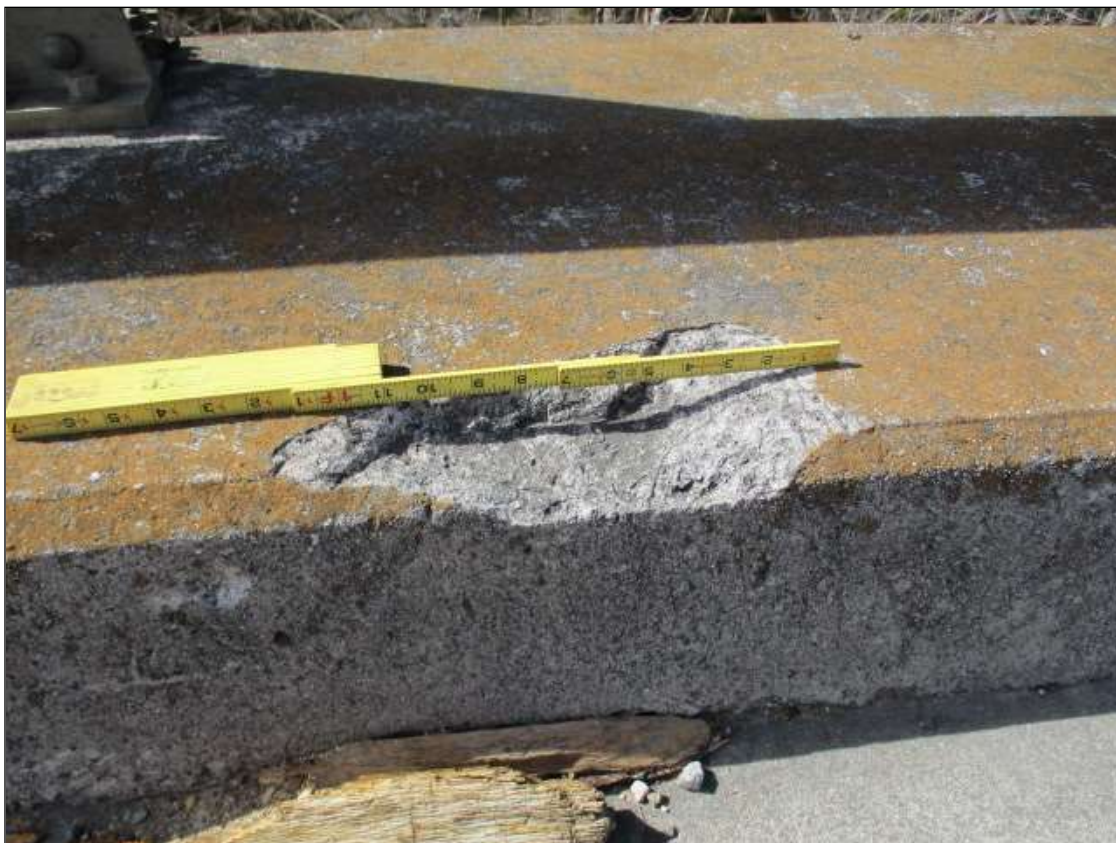
Span 36 Left Bridge Rail: 12" LONG X 6" WIDE X 1" TALL SPALL ON LEFT CURB AT 5' FROM BENT 35

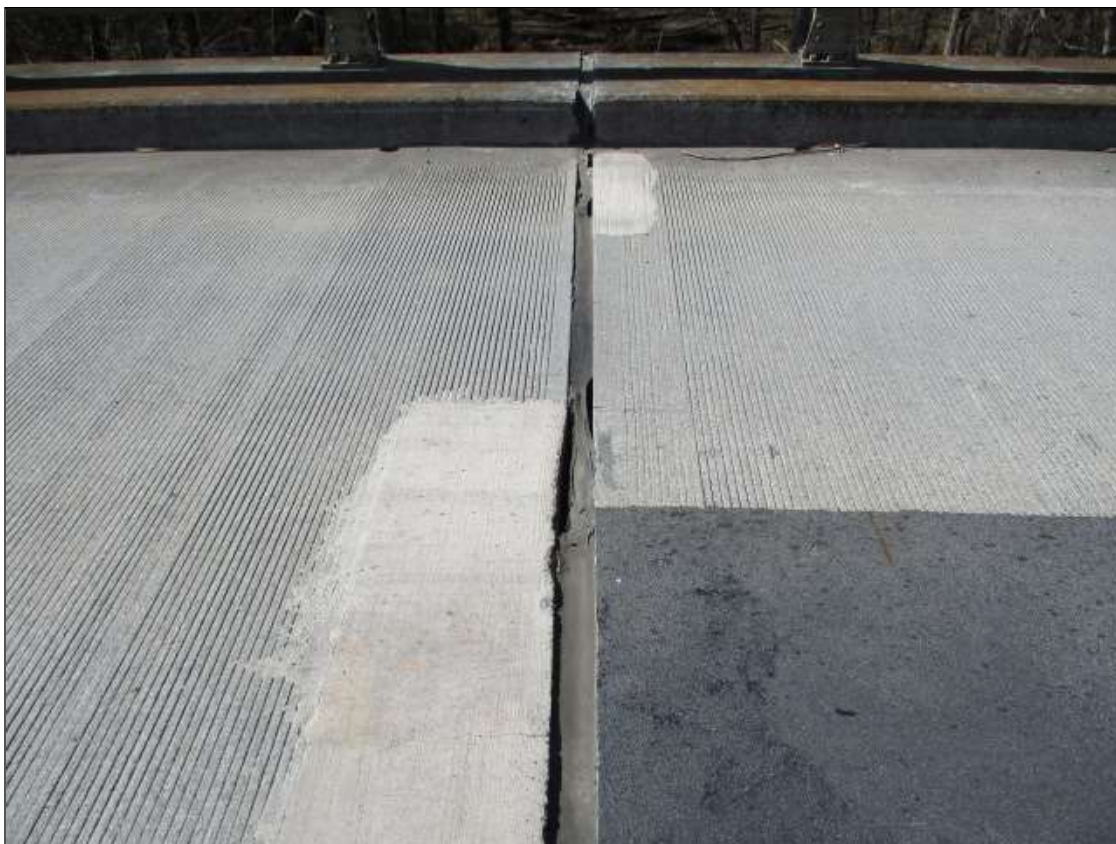
Span 39 Expansion Joint over Bent 38: in left lane, loss of seal adhesion [up to 3ft x full depth]

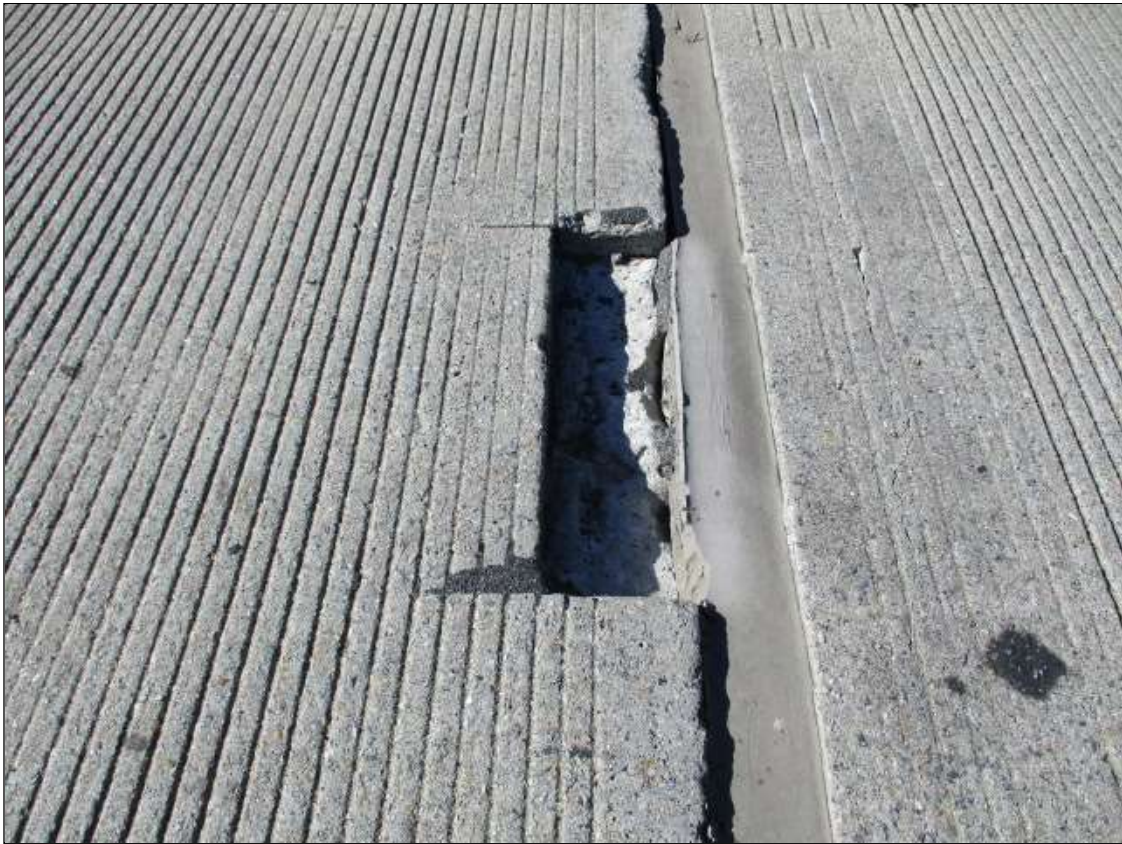
Span 74 Deck: 15" WIDE X 3" LONG X 2" DEEP SPALL IN LEFT LANE AT BENT 74

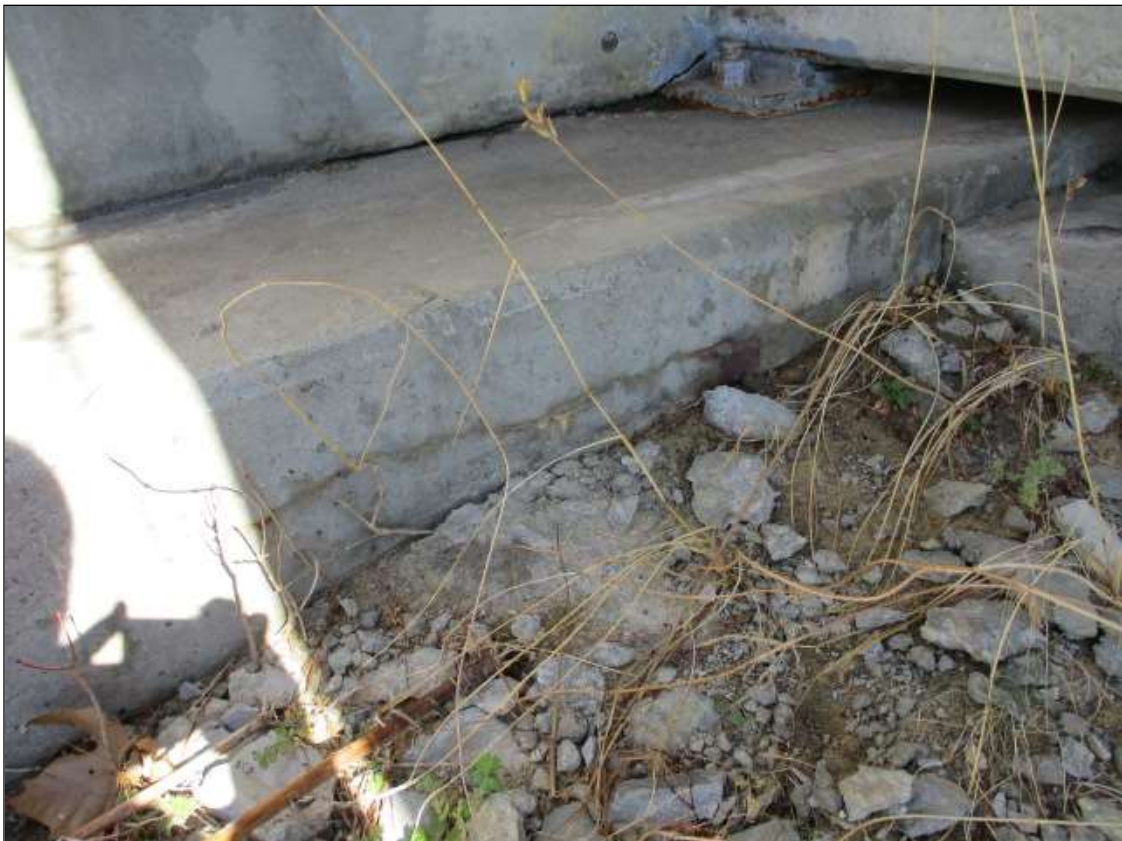
End Bent 2 End Bent 2 Cap: 1/16" HORIZONTAL CRACKING UNDER LEFT OVERHANG

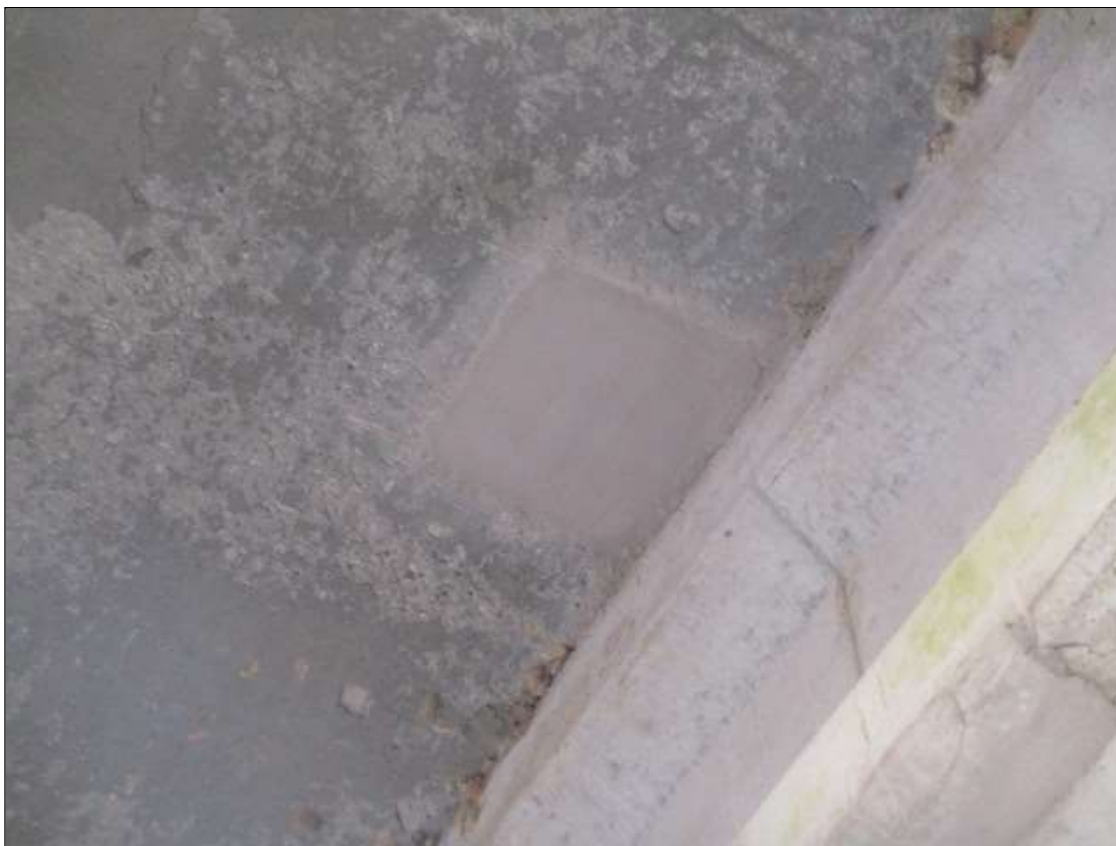
Span 1 Deck: 12" X 12" NEW REPAIR TO UNDERSIDE IN BAY 1 AT 25' FROM END BENT 1 ADJACENT TO GIRDEF
2

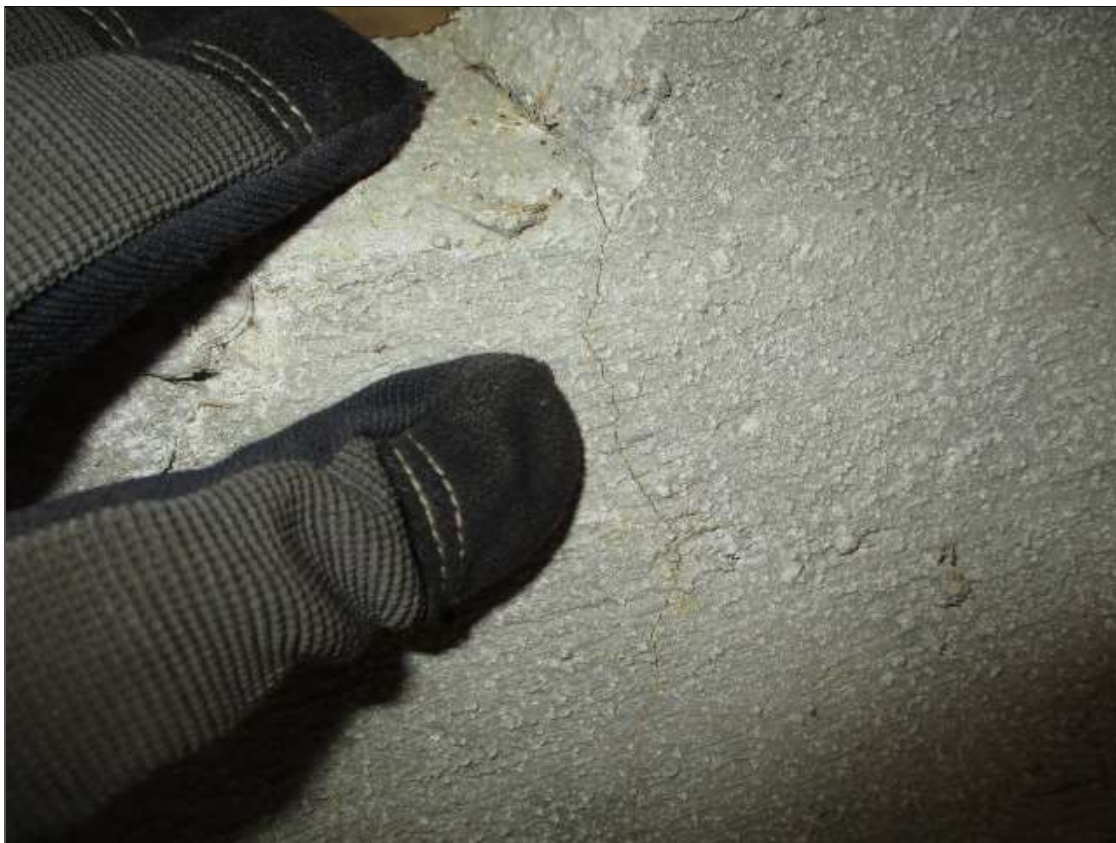
Bent 1 Cap 1: 1/32" VERTICAL CRACKING ON CAP

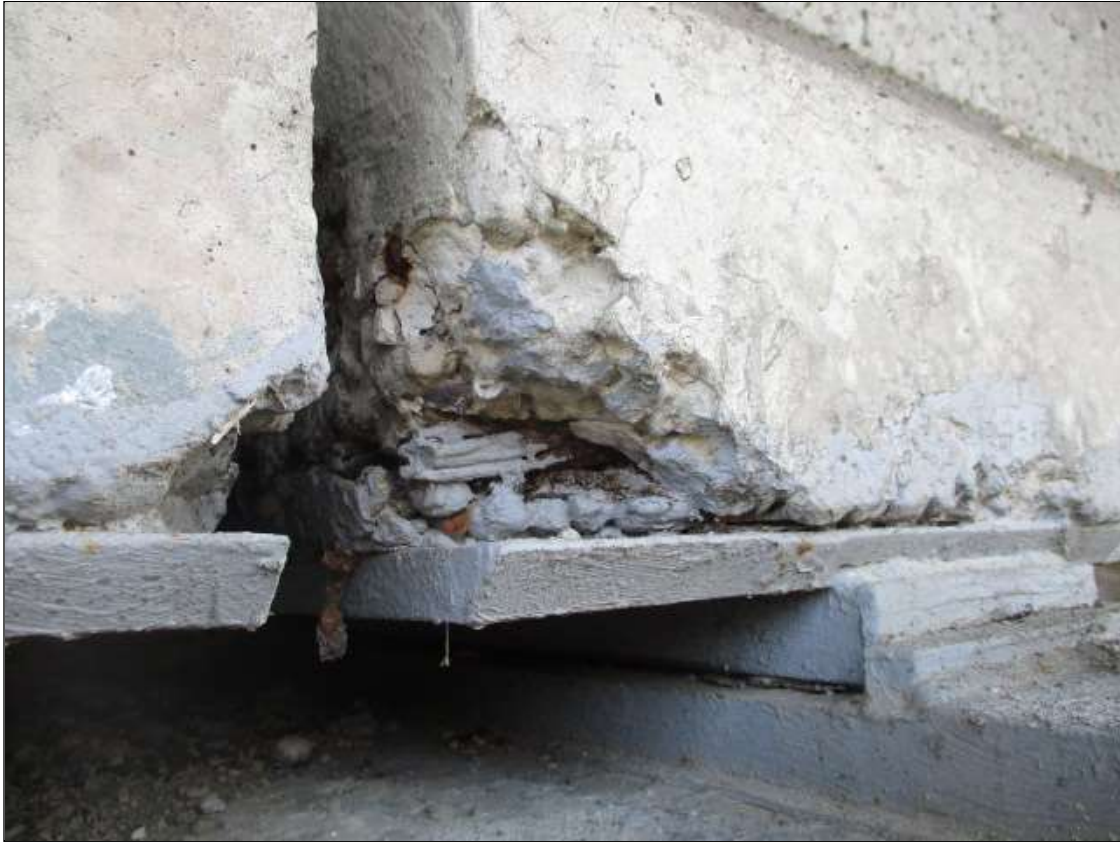
Span 1 Beam 1: West face of bottom flange at bent 1, spall [4in x 3.5in x up to 2in deep] with [1] exposed strand [no section loss]

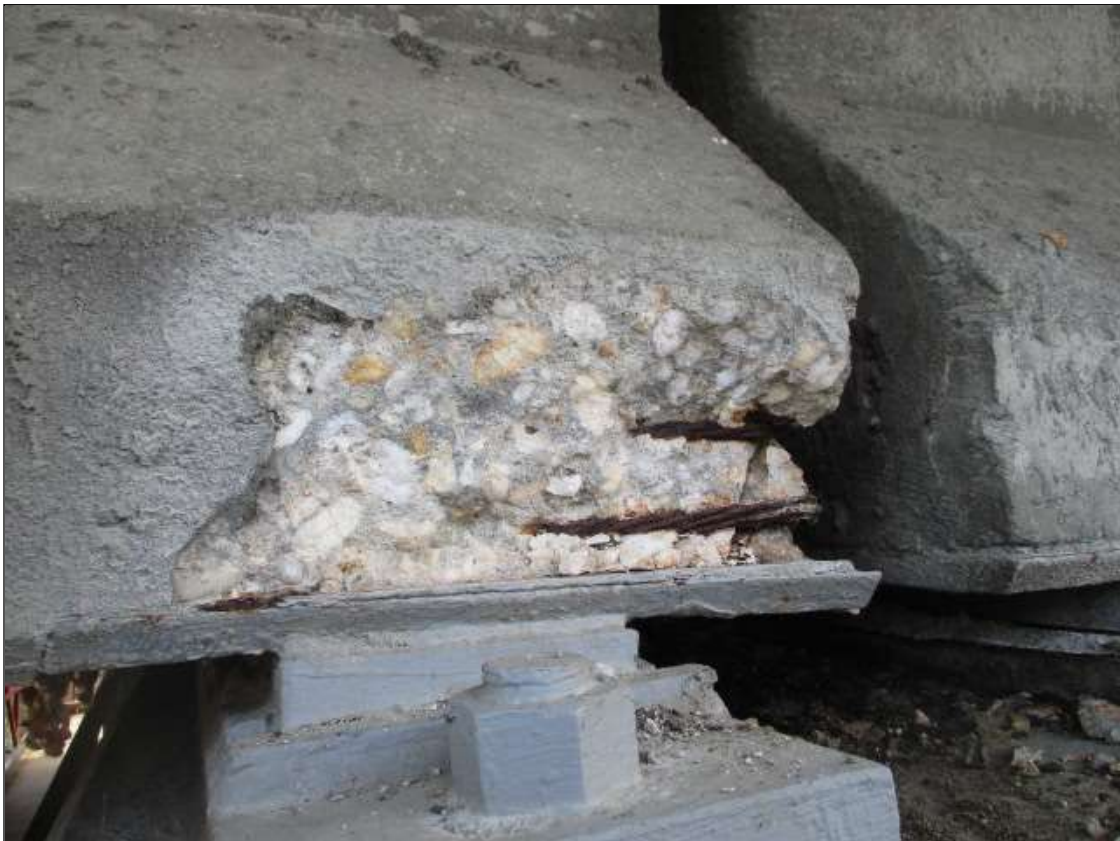
Span 3 Beam 1: [PAR] bottom left flange at bent 2, spall [12in x 8in x 3in deep] with [2] two exposed rusted stirrup [up to 1/16in section loss]

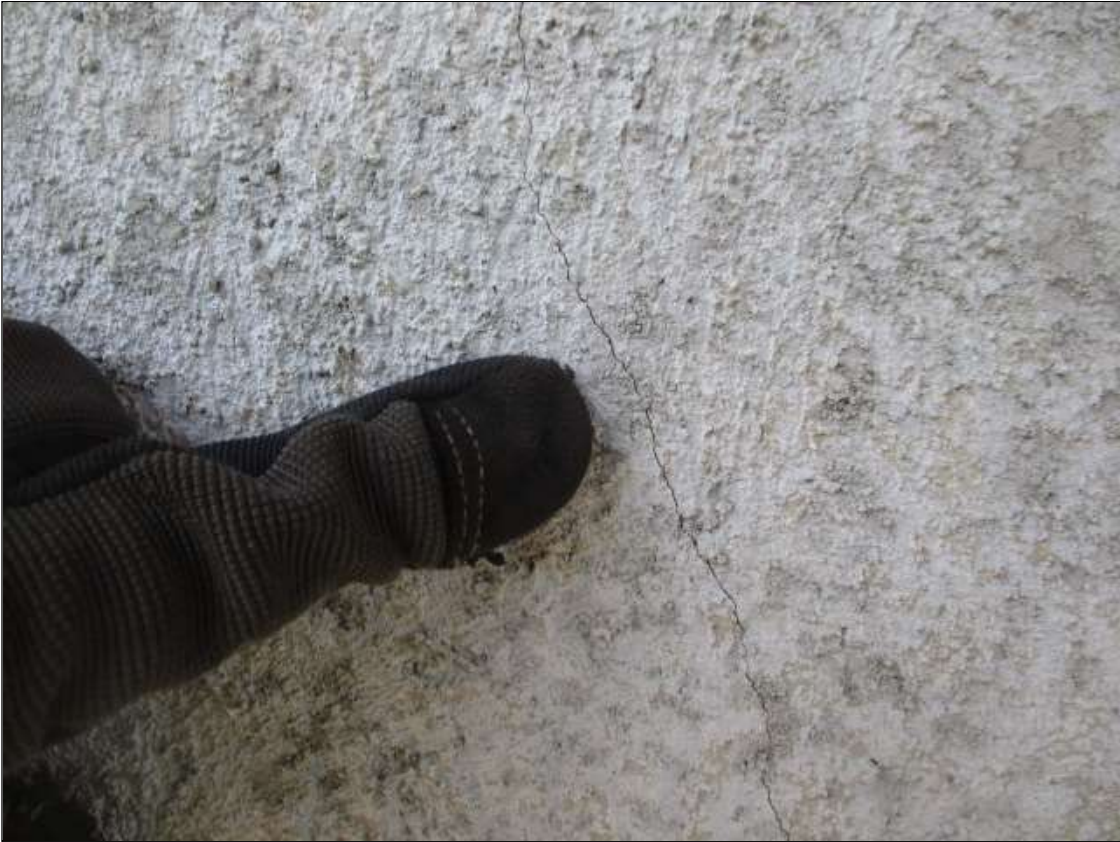
Bent 2 Pile 2: along East face, sound patch [up to 6ft x up to full width] WITH 1/32" VERTICAL CRACKING

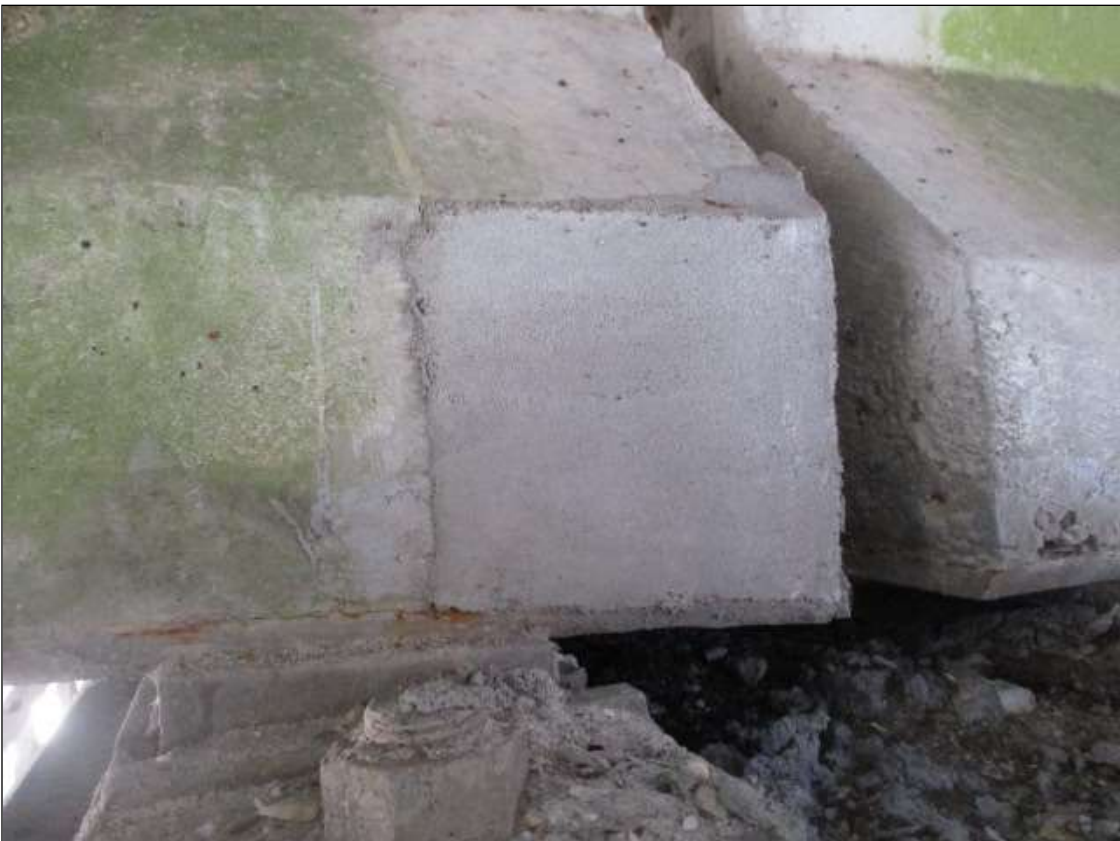
Span 4 Beam 2: 8" LONG X 8" TALL NEW PATCH ON BOTTOM LEFT FLANGE AT BENT 3

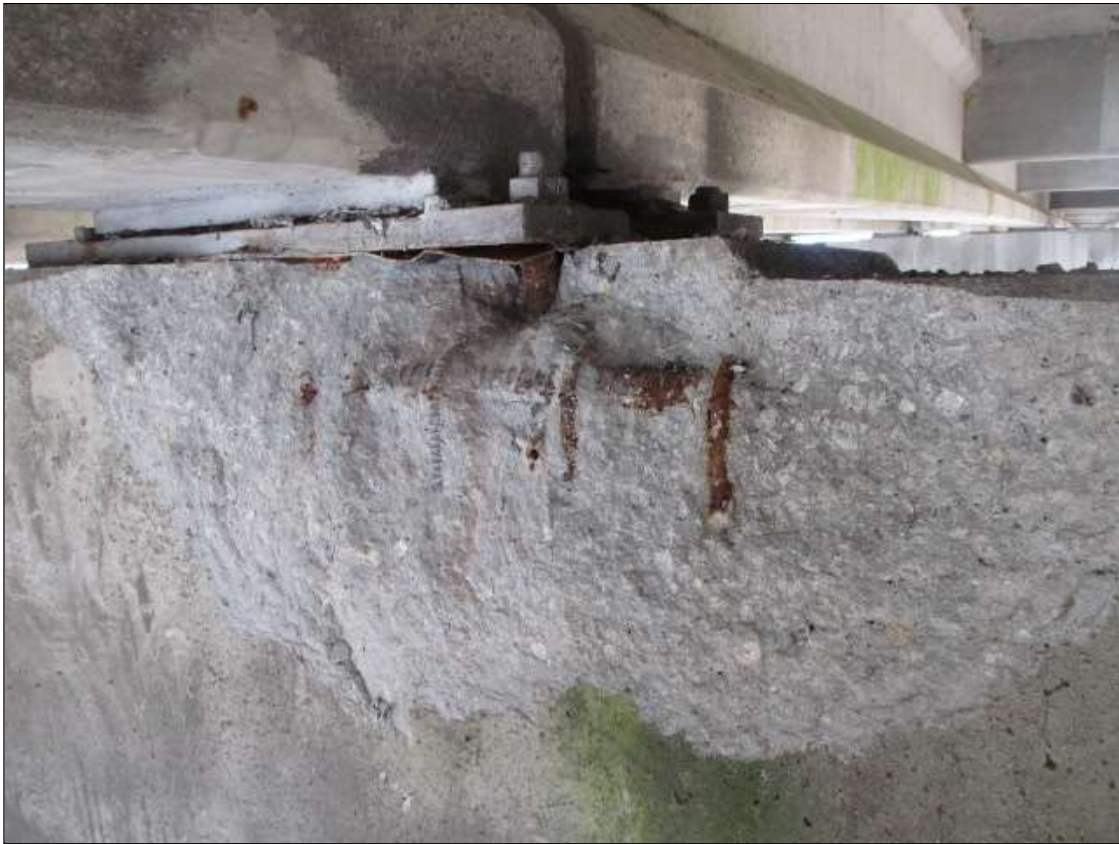
Bent 6 Cap 1: PAR: 4' LONG X 2' TALL X 10" DEEP SPALL WITH EXPOSED REBAR ON SOUTH FACE UNDER GIRDER 3 WITH 18" LONG X 6" DEEP TRIANGULAR AREA OF LOSS OF BEARING

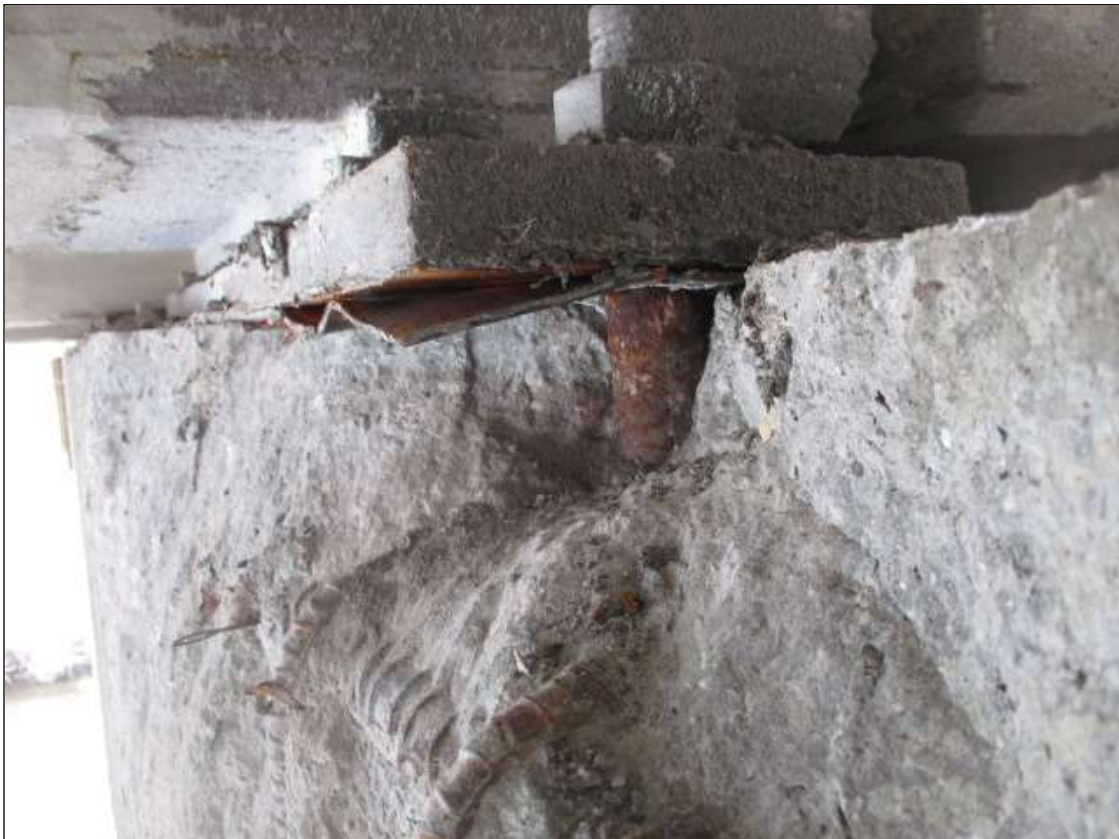
Span 6 Beam 3 Far Bearing: PAR: 18" WIDE X 6" DEEP TRIANGULAR AREA OF LOSS OF BEARING AT BENT 6 CAP DUE TO LARGE SPALL ON SOUTH FACE OF CAP

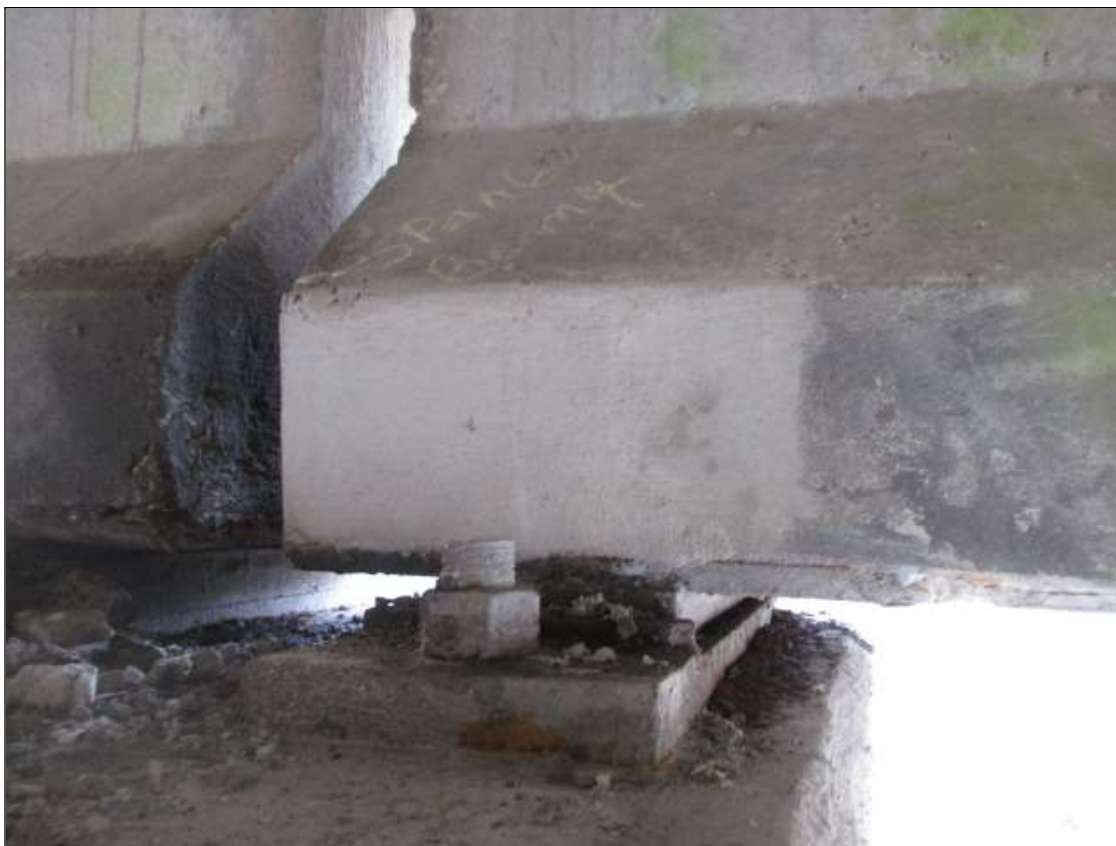
Span 6 Beam 4: 10" LONG X 8" TALL NEW PATCH ON BOTTOM LEFT FLANGE AT BENT 6

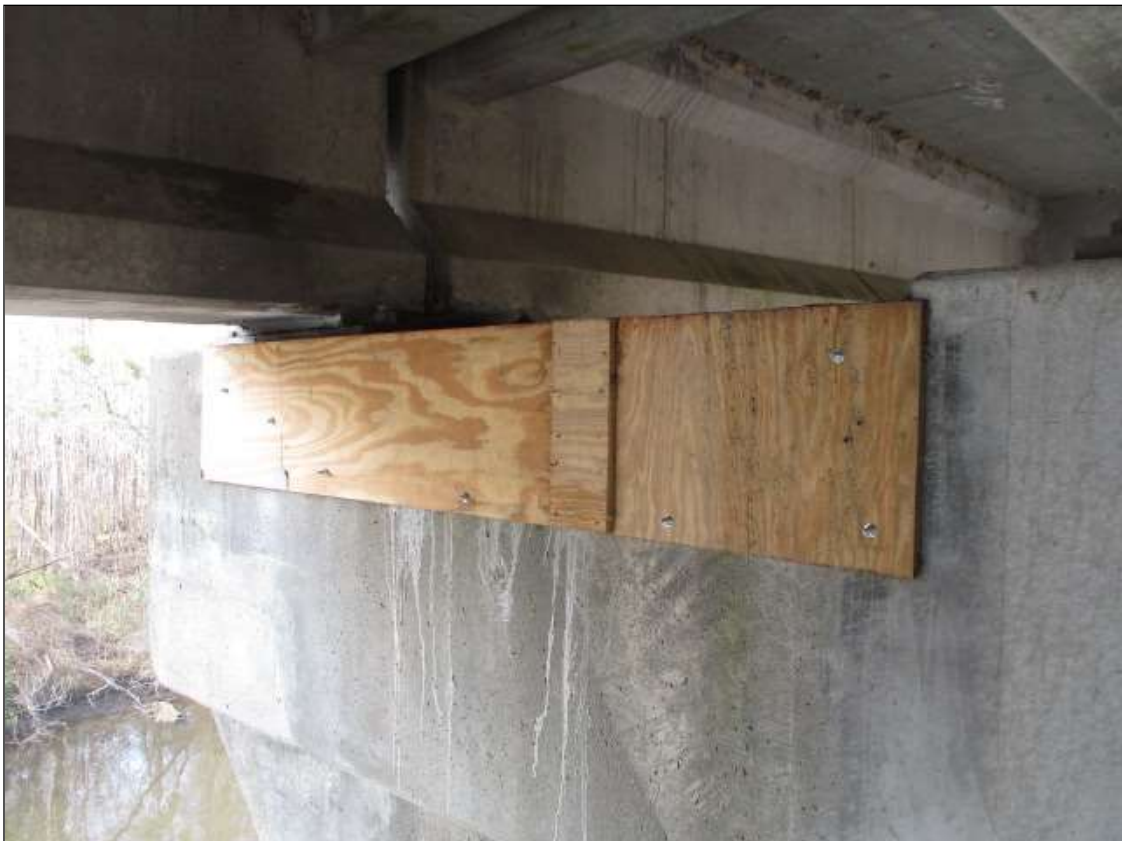
Bent 6 Cap 1: 6' LONG X 12" TALL NEW REPAIR TO SOUTH FACE UNDER BAY 1

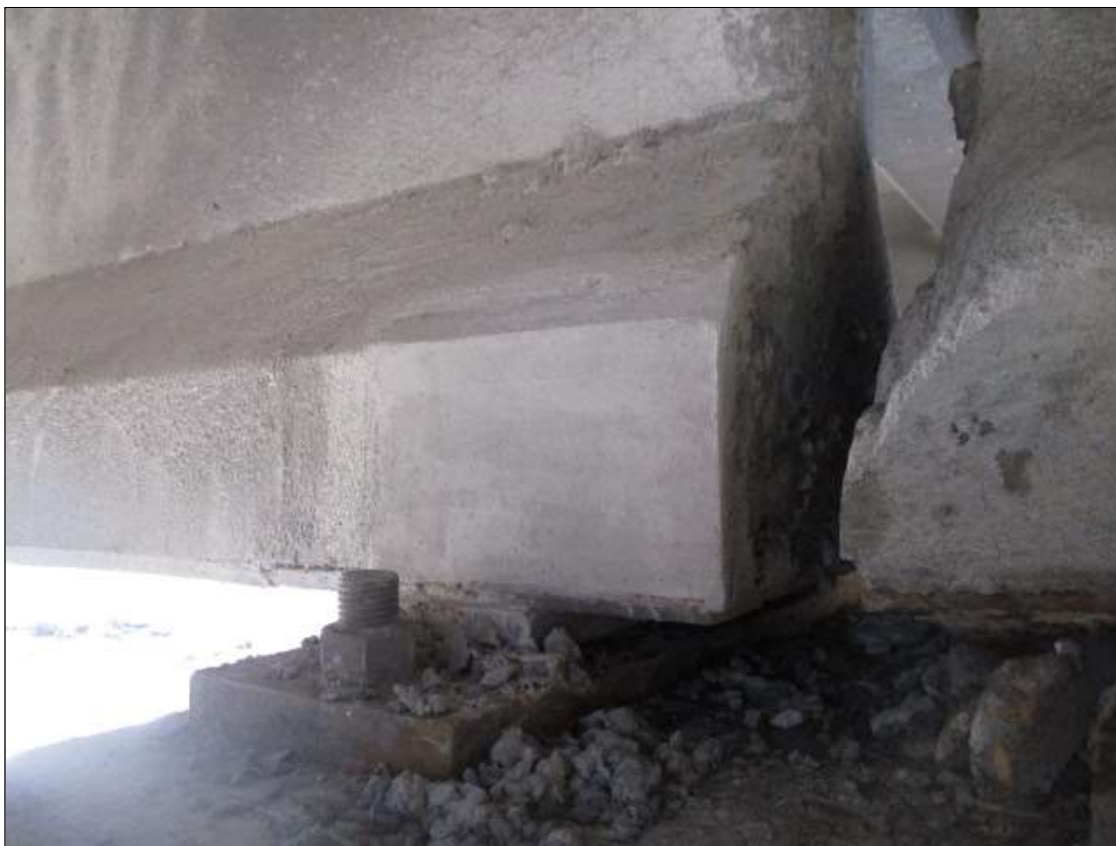
Span 7 Beam 3: 10" LONG X 10" TALL NEW PATCH ON BOTTOM RIGHT FLANGE AT BENT 7

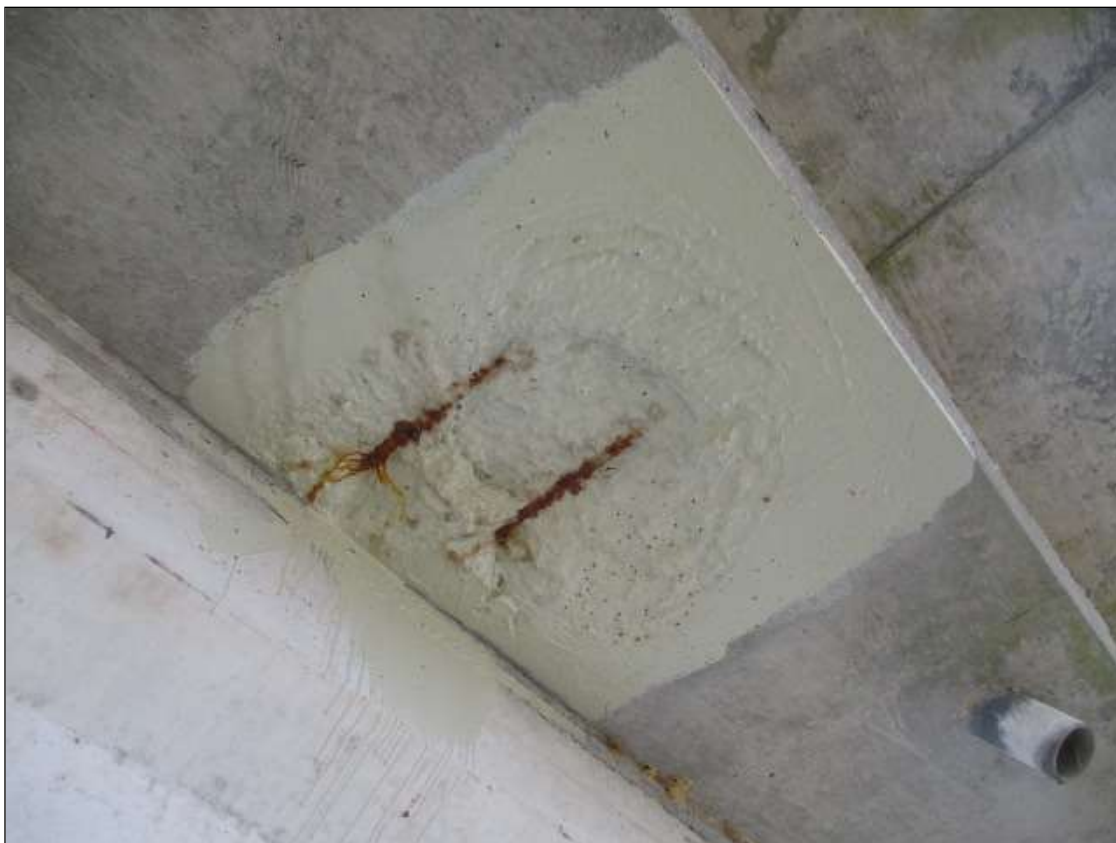
Span 11 Deck: underside of right overhang, spall/failed patch [18in diameter x 2in deep] with exposed rusted reinforcing [up to 10% section loss]

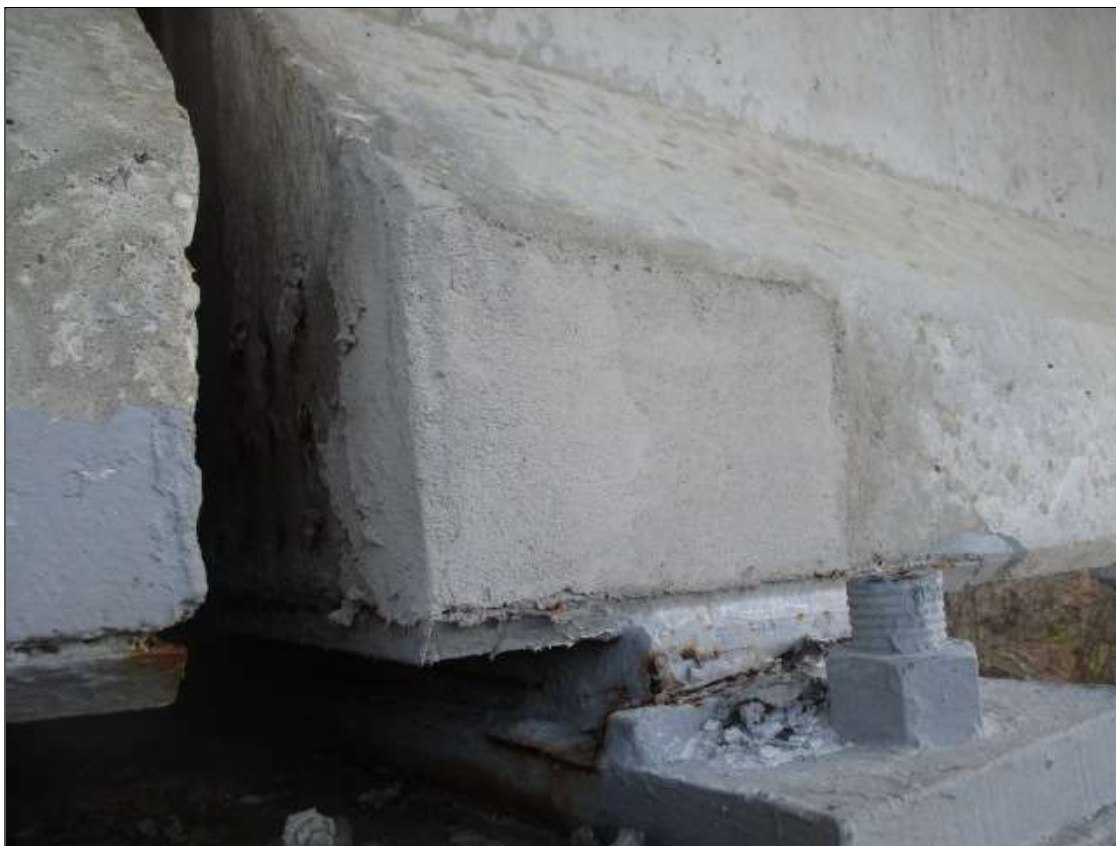
Span 10 Beam 1: 10" LONG X 8" TALL NEW PATCH ON BOTTOM LEFT FLANGE AT BENT 10

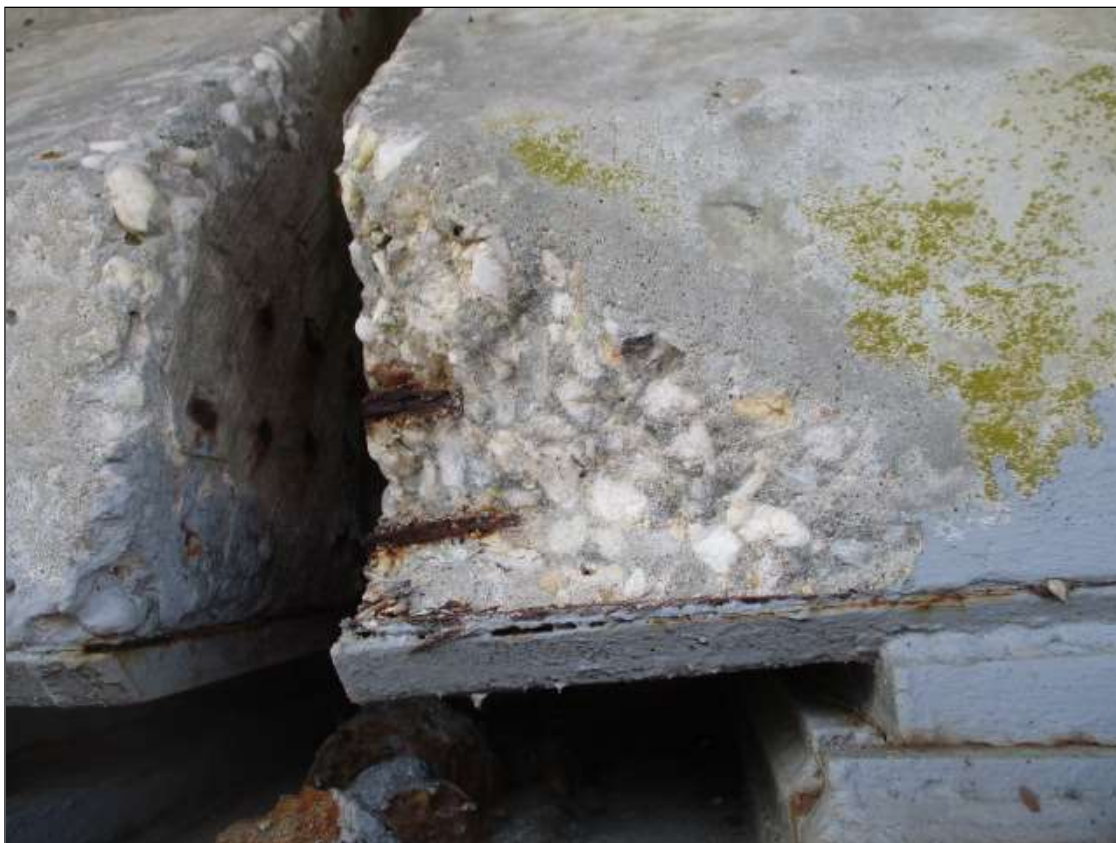
Span 11 Beam 4: East face of bottom flange at bent 10, SPALL [8in x 8in] WITH EXPOSED REBAR WITH NO SECTION LOSS
