APPENDIX E:
BRIDGE INSPECTION REPORT —
THREE RIVERS BRIDGE

THE BRITE BRIDGES:
Bridging Resources for Infrastructure and Thriving
Economies Project

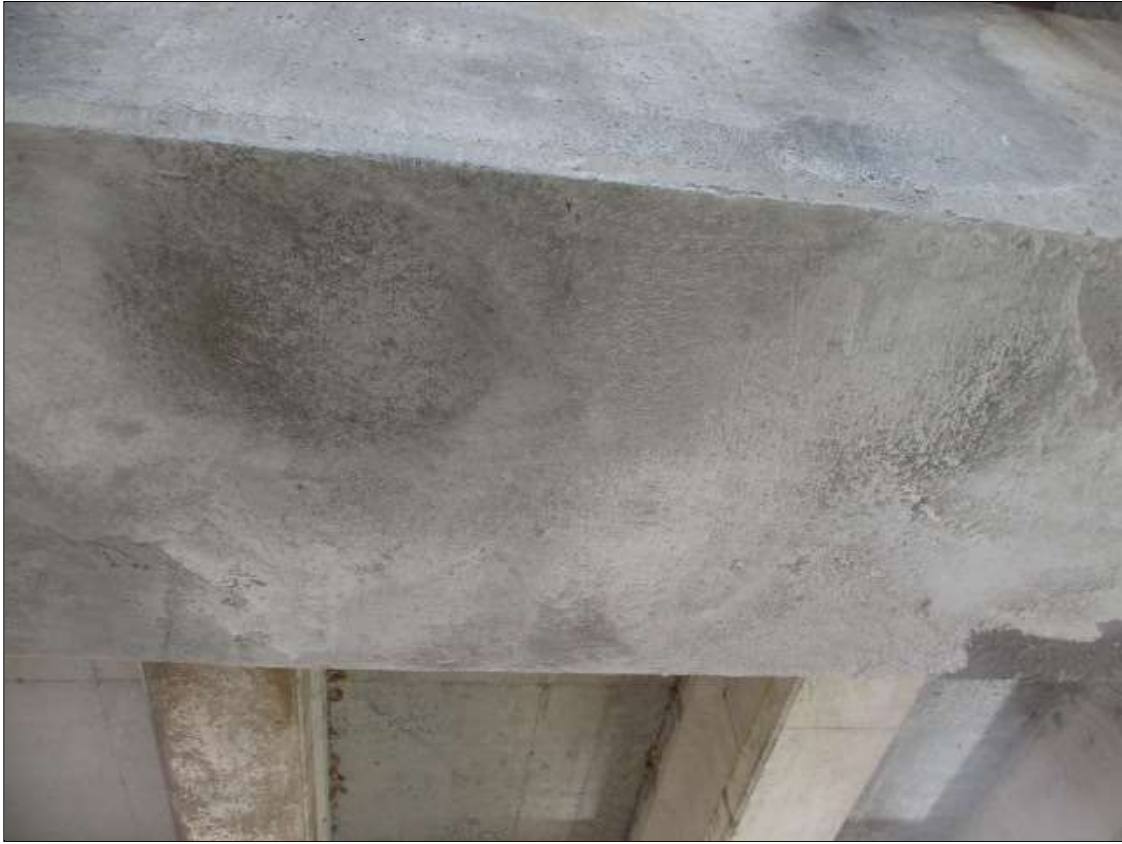
Bent 10 Cap 1: 5' LONG X FULL WIDTH NEW REPAIR TO UNDERSIDE OF CAP

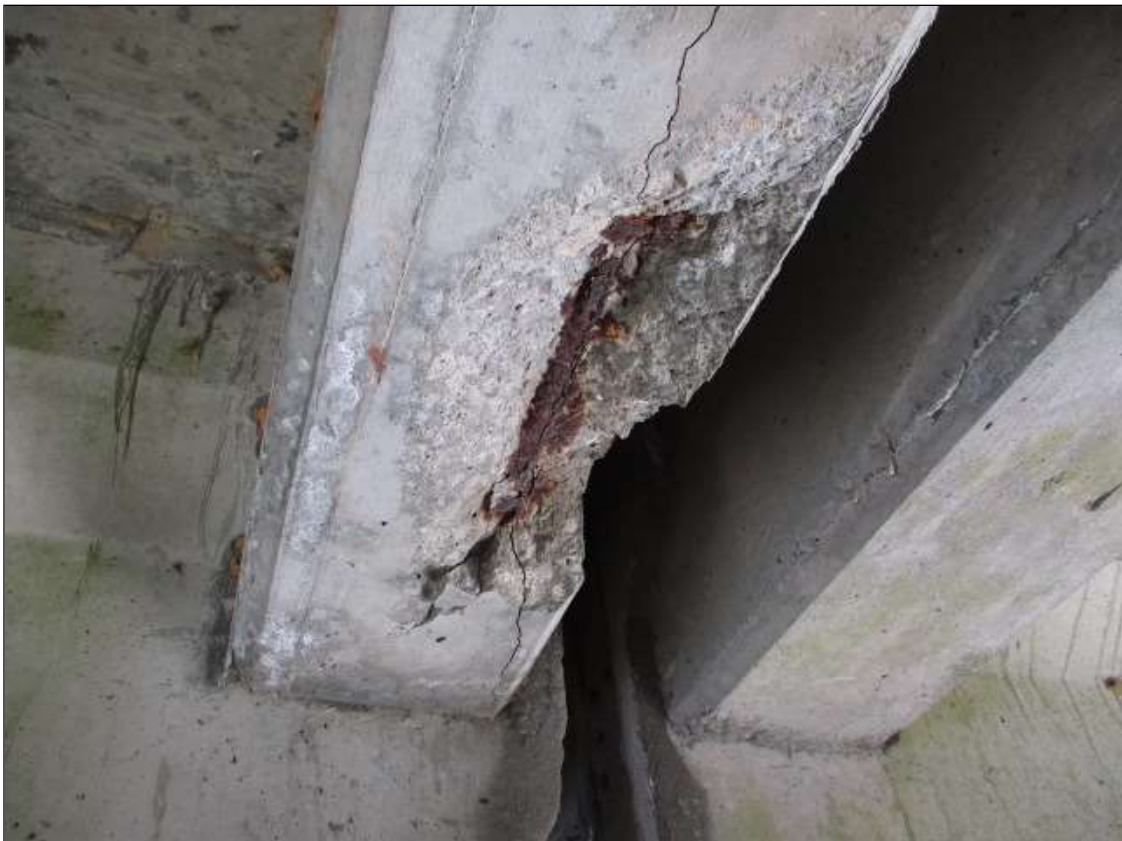
Span 13 Deck: 18" LONG X 6" X TALL X 6" WIDE SPALL WITH EXPOSED REBAR IN BAY 1 DIAPHRAGM AT BENT

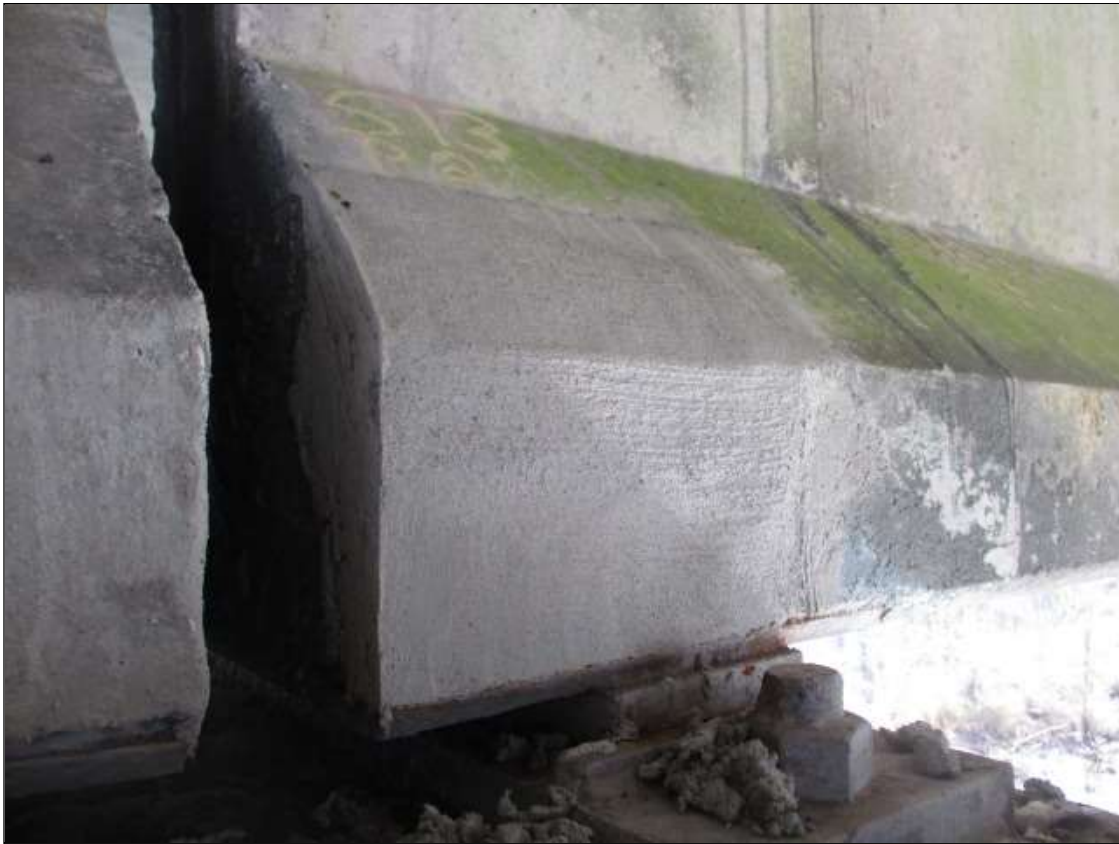
Span 13 Beam 2: 10" LONG X 18" TALL NEW PATCH ON BOTTOM LEFT FLANGE AT BENT 13

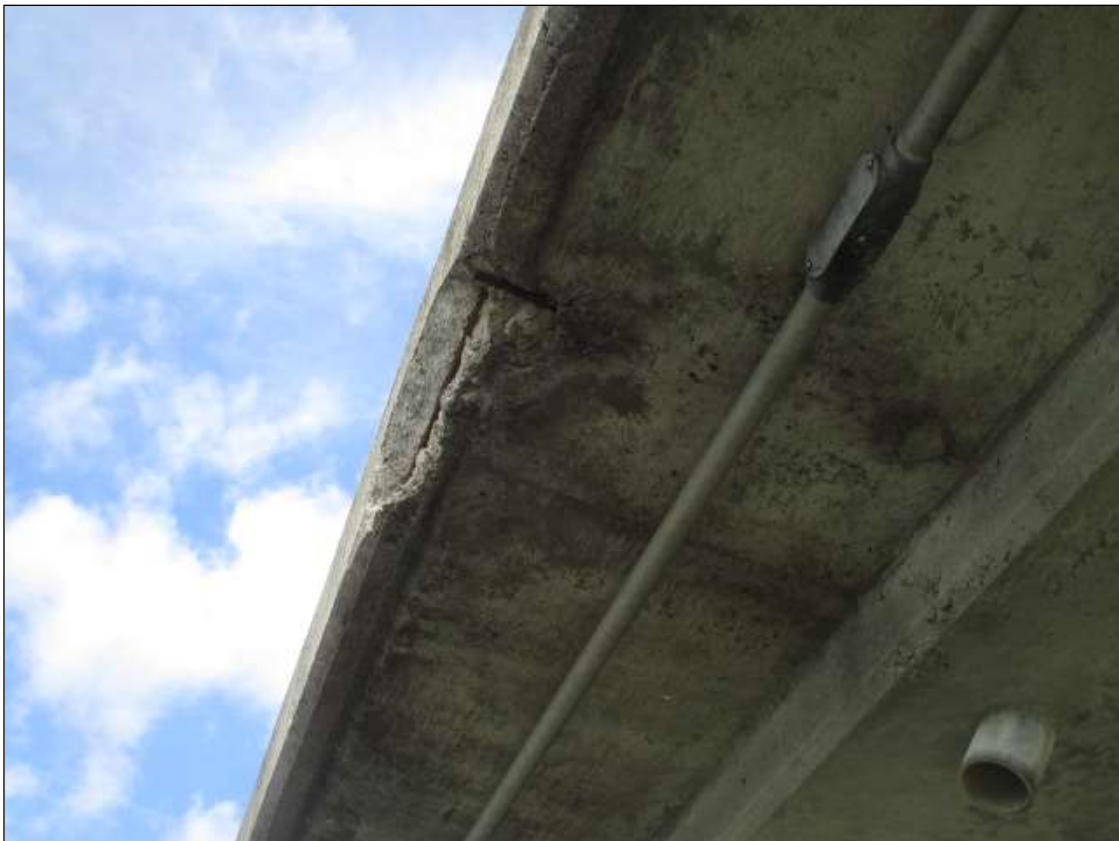
Span 15 Deck: SPAN 15 BOTTOM OF LEFT OVERHANG HAS A SPALLED AREA WITH REBAR EXPOSED. LOCATED 8' FROM BENT 14. AREA IS: 8" x 18" x 1 1/2" DEEP.

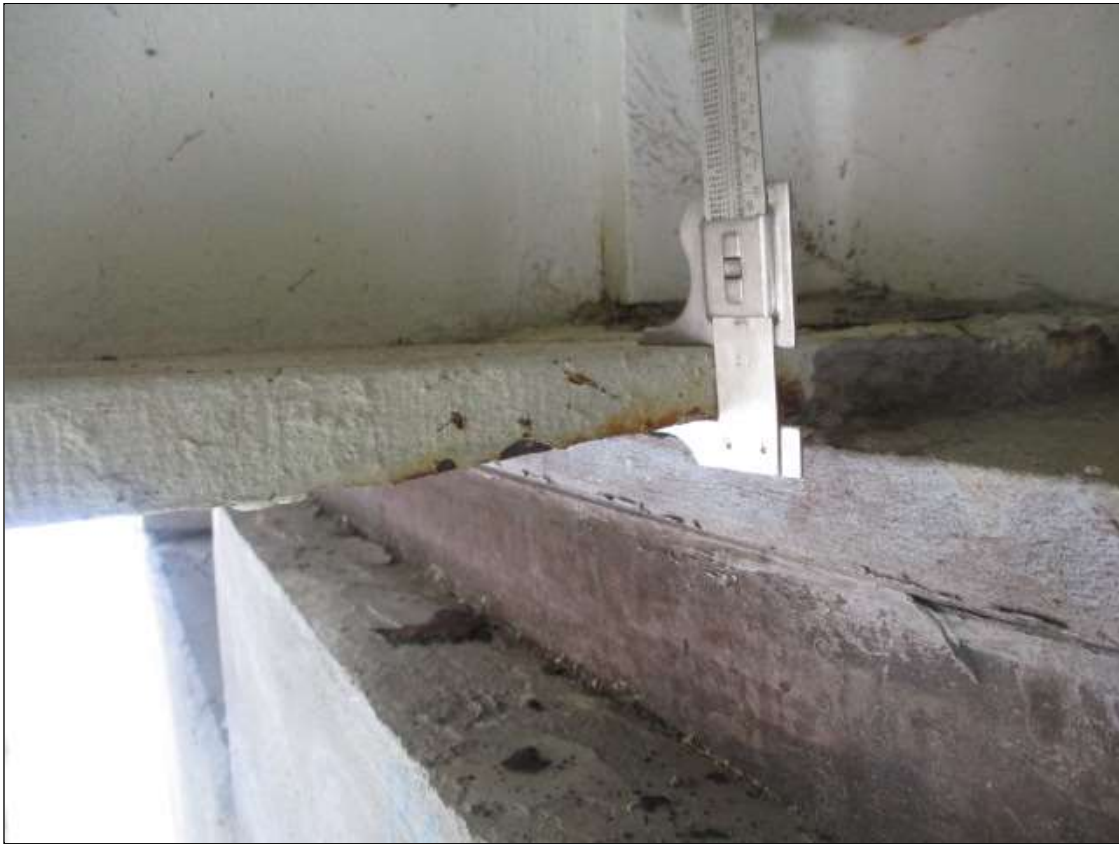
Span 17 Beam 3: PAR: bottom left flange at bent 16, active corrosion with section loss [5in x in x 3/4in avg rem]

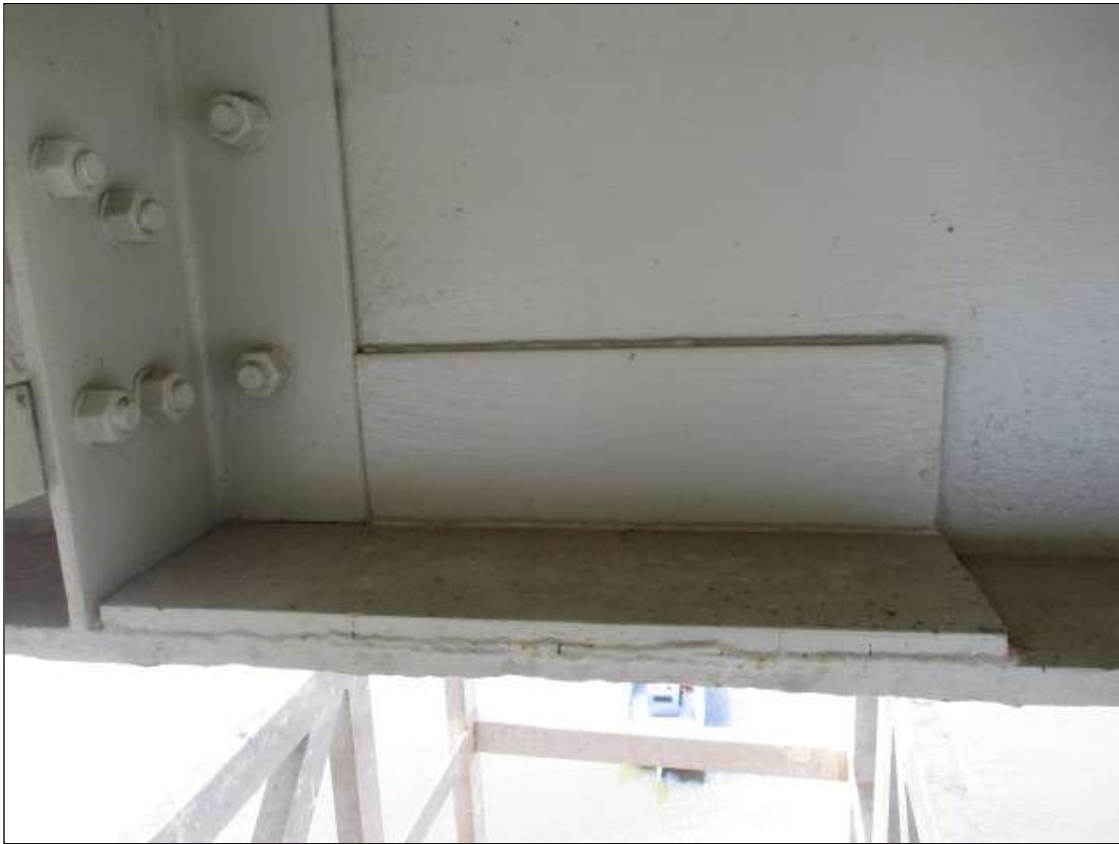
Span 17 Beam 1: SPAN 17 BEAM 1 RIGHT BOTTOM FLANGE AT 3RD CROSS BRACE. HAS A AREA OF SECTION LOSS WITH 5/8" REMAINING. AREA IS: FROM EDGE BACK 7" x 19". Arrested section loss with repair plate in place.

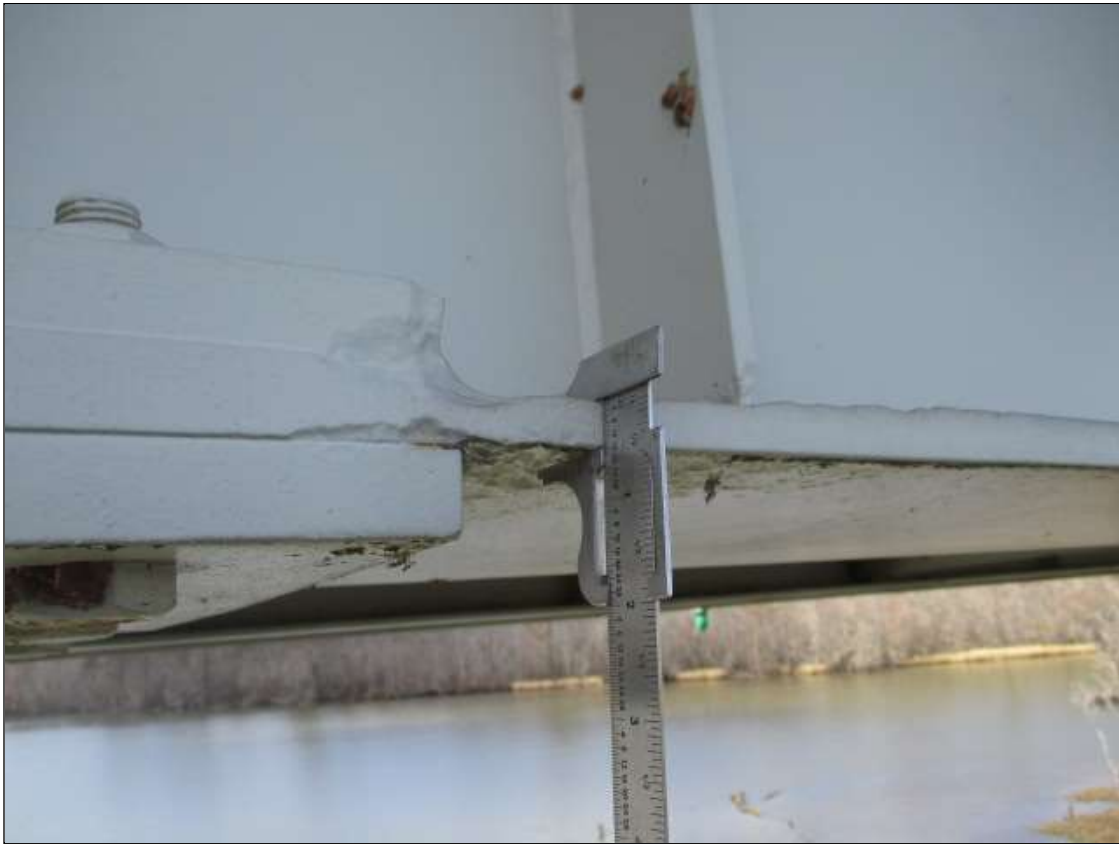
Span 17 Beam 4: PAR: 1/2" REMAINING ON BOTTOM RIGHT FLANGE FOR 3" WIDE X 3" LONG ON NORTH SIDE OF SPLICE NUMBER 1 IN SPAN 18

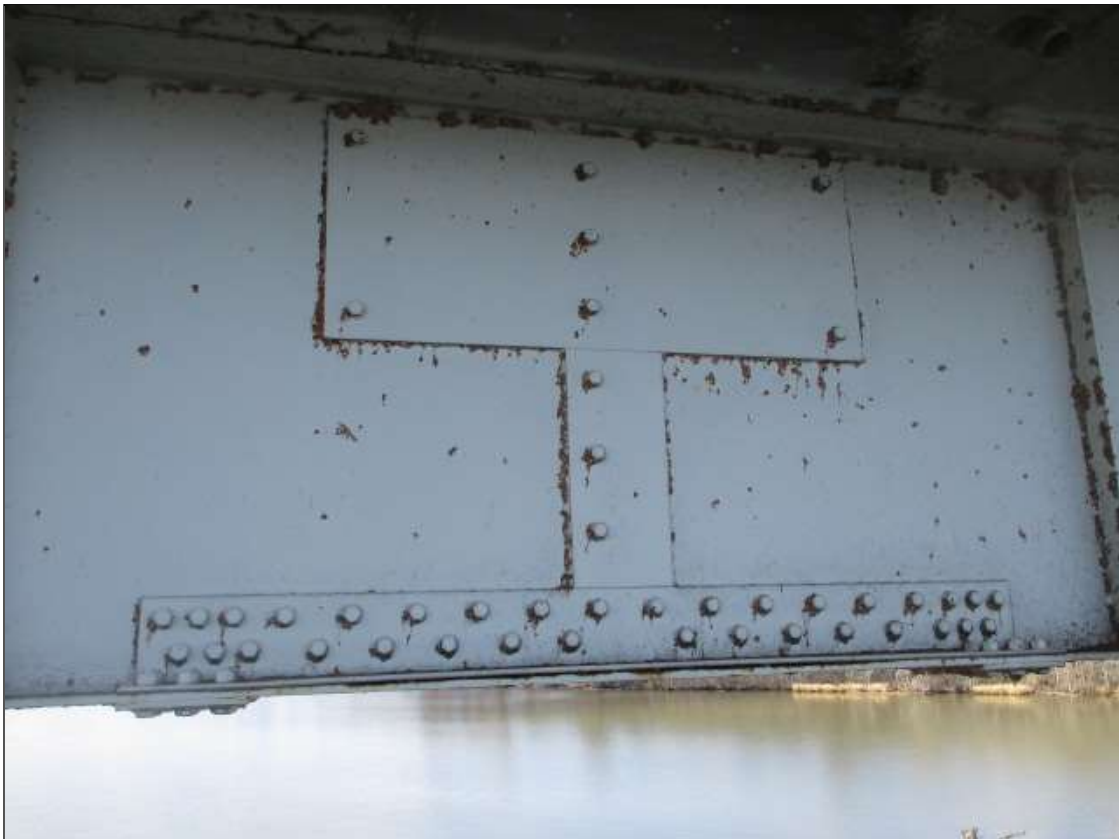
5' LONG X FULL WIDTH REPAIR TO BOTTOM FLANGE AND FULL HEIGHT X UP TO 3' LONG REPAIR TO WEB OF GIRDER 4 SPAN 18 BETWEEN SPLICES

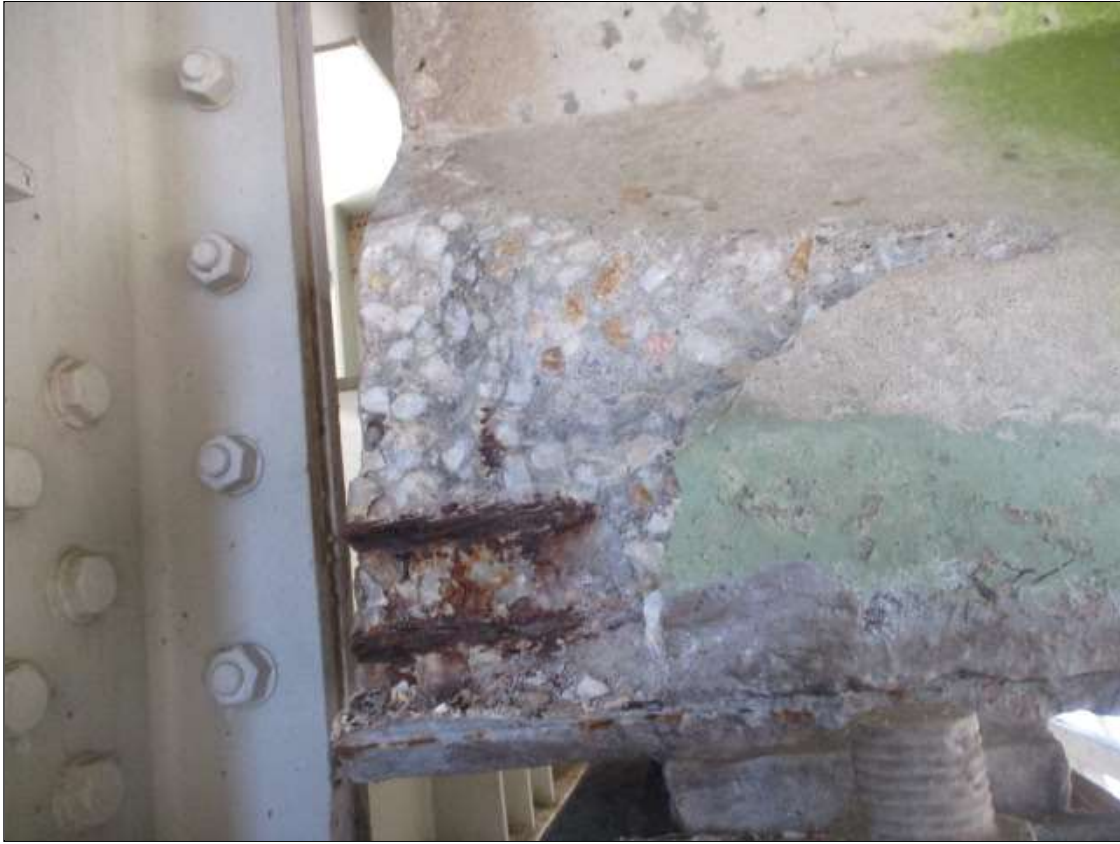
Span 20 Beam 3: PAR: SPAN 20 BEAM 3 RIGHT BOTTOM FLANGE OVER BENT 19. HAS A SPALL WITH EXPOSED STRANDS 12" LONG X 8" TALL X 3" DEEP

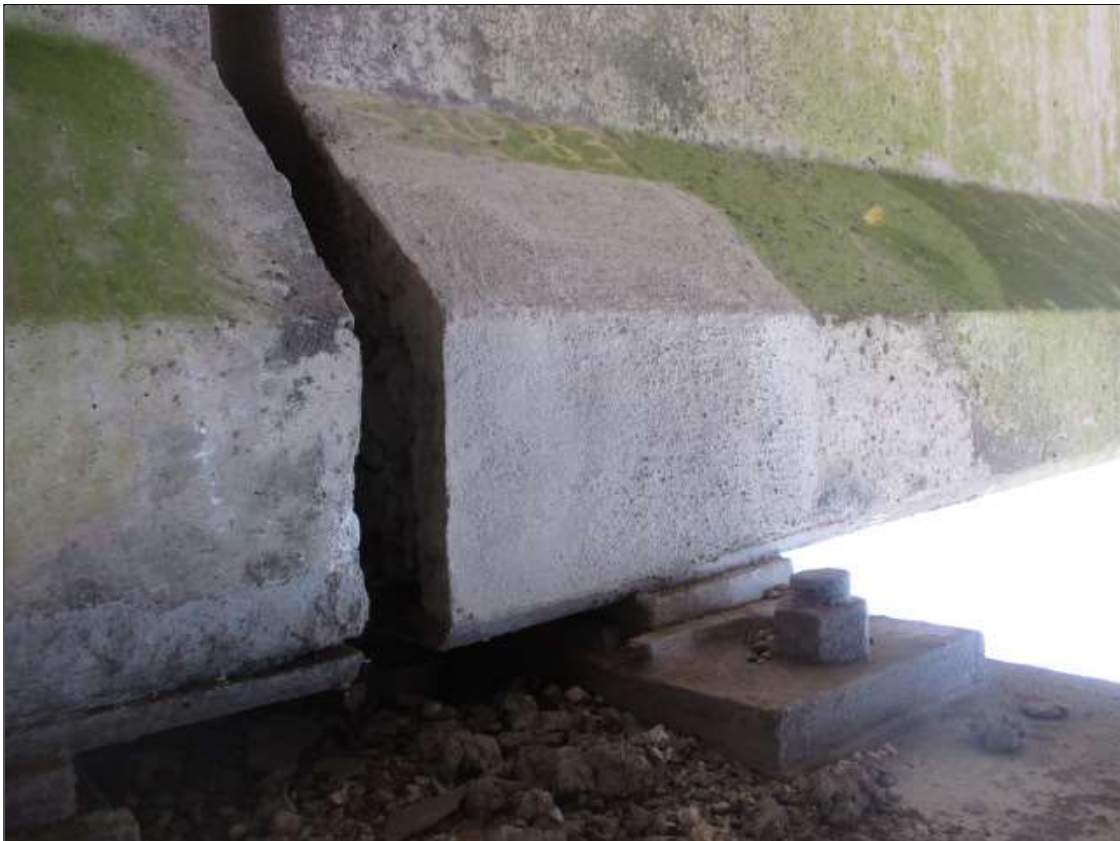
Span 21 Beam 3: 8" LONG X 18" TALL NEW REPAIR TO BOTTOM LEFT FLANGE AT BENT 21

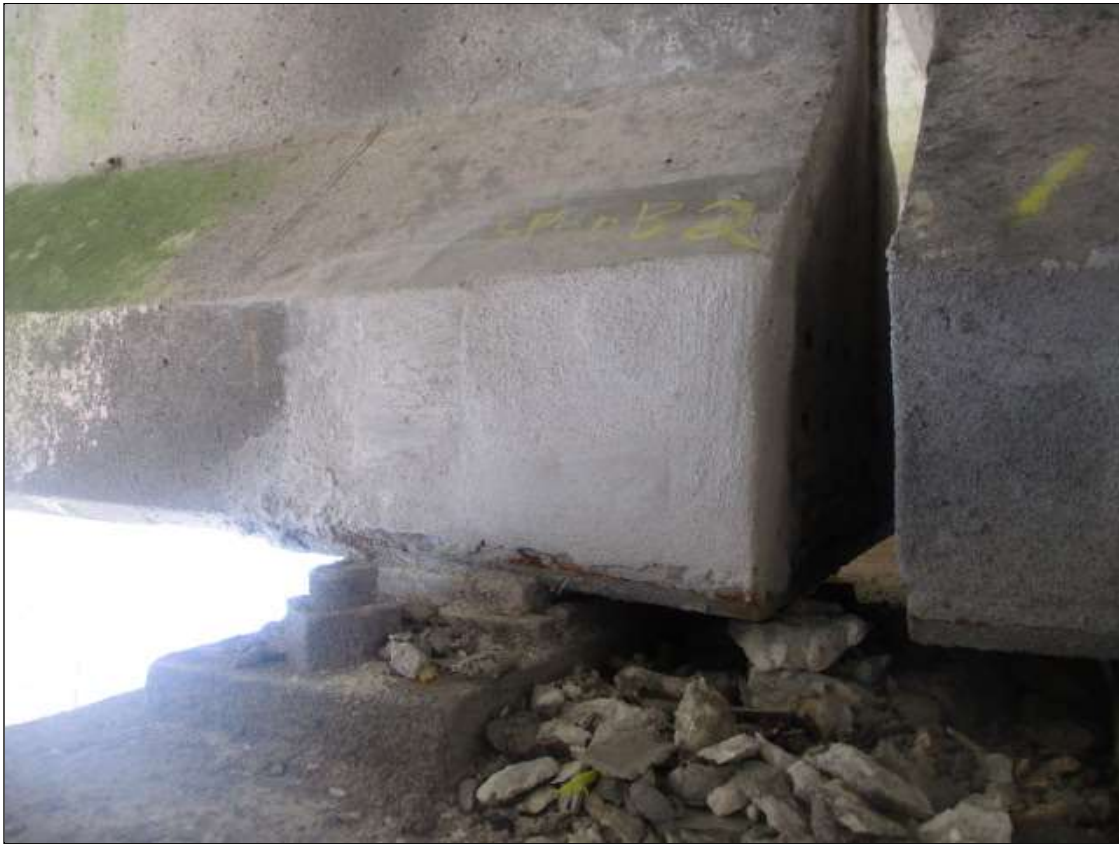
Span 21 Beam 2: 8" LONG X 18" TALL NEW REPAIR TO BOTTOM RIGHT FLANGE AT BENT 21

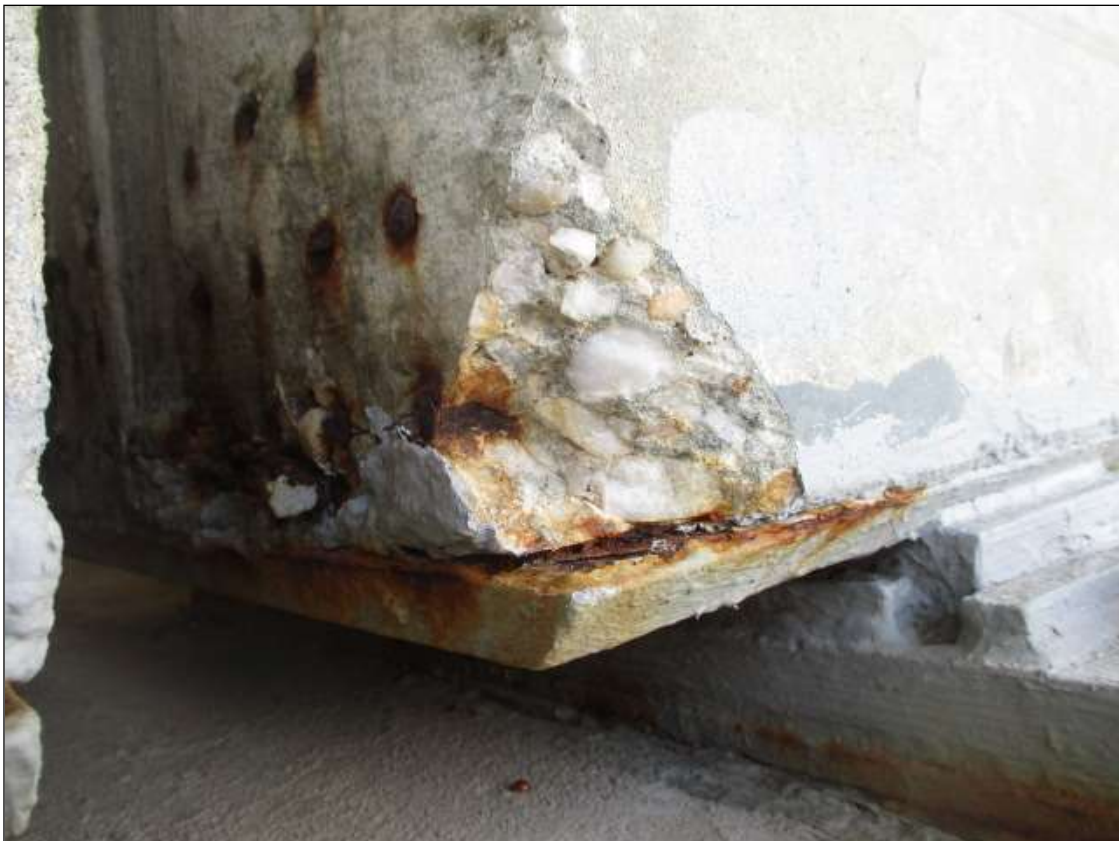
Span 23 Beam 1: West face of bottom flange at bent 23, spall [4in x 4in x 2in deep] with [1] one exposed rusted strand [no section loss]

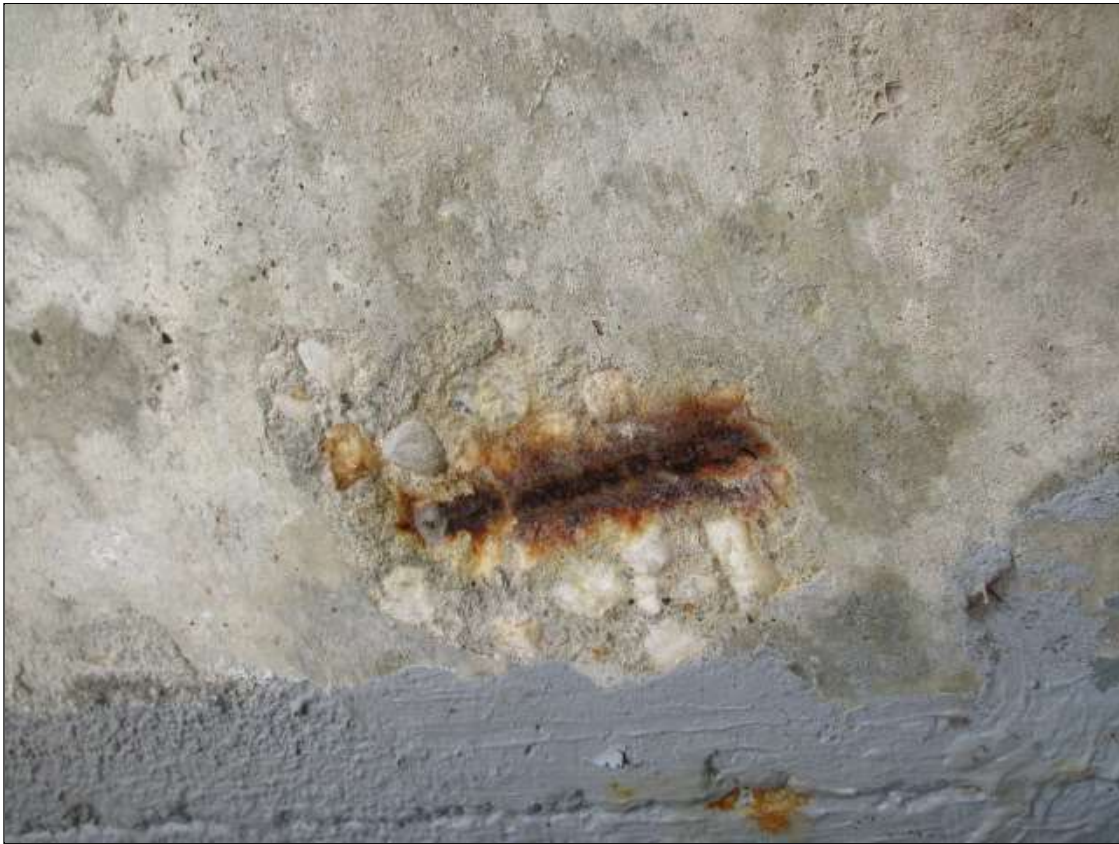
Span 23 Beam 3: underside of bottom flange at bent 23, spall [4in x 2in x 1in deep] with exposed rusted reinforcing [up to 10% section loss]

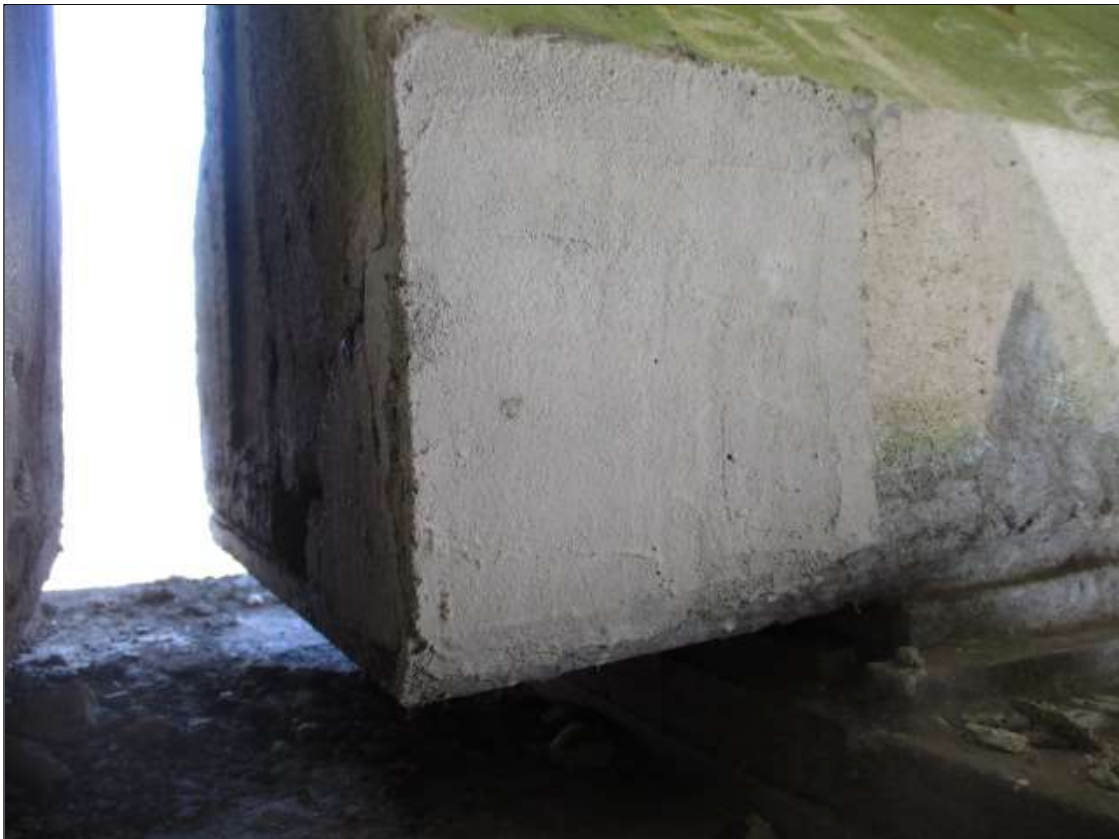
Span 24 Beam 4: 8" LONG X 8" TALL NEW REPAIR TO BOTTOM LEFT FLANGE AT BENT 24

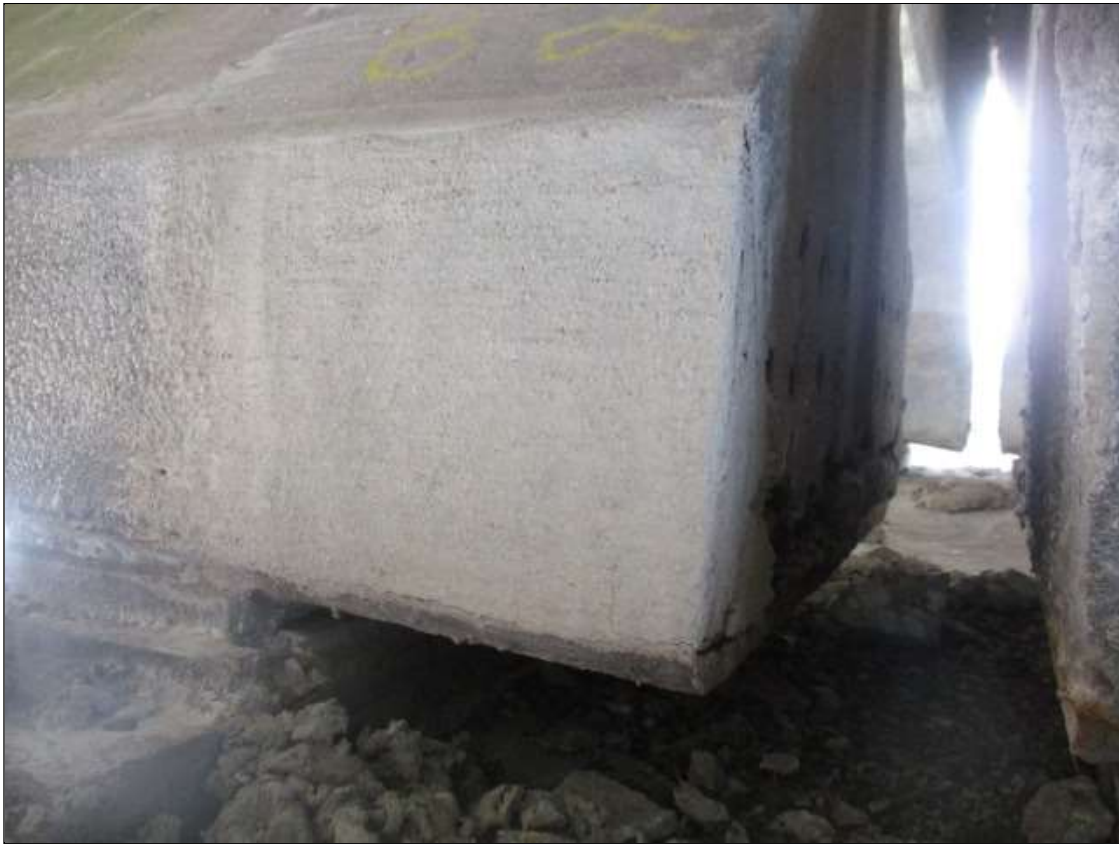
Span 24 Beam 2: 10" LONG X 10" TALL NEW REPAIR TO BOTTOM RIGHT FLANGE AT BENT 24

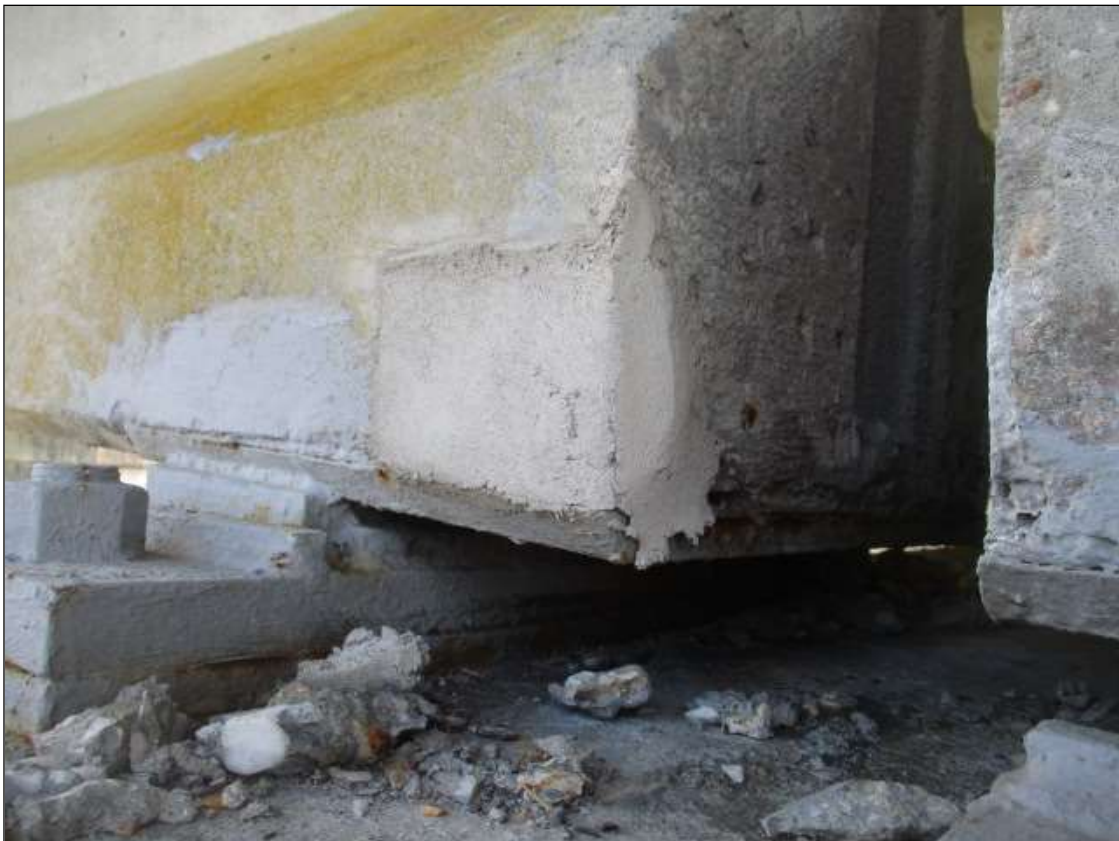
Span 25 Beam 4: 6" LONG X 6" TALL NEW REPAIR TO BOTTOM RIGHT FLANGE AT BENT 25

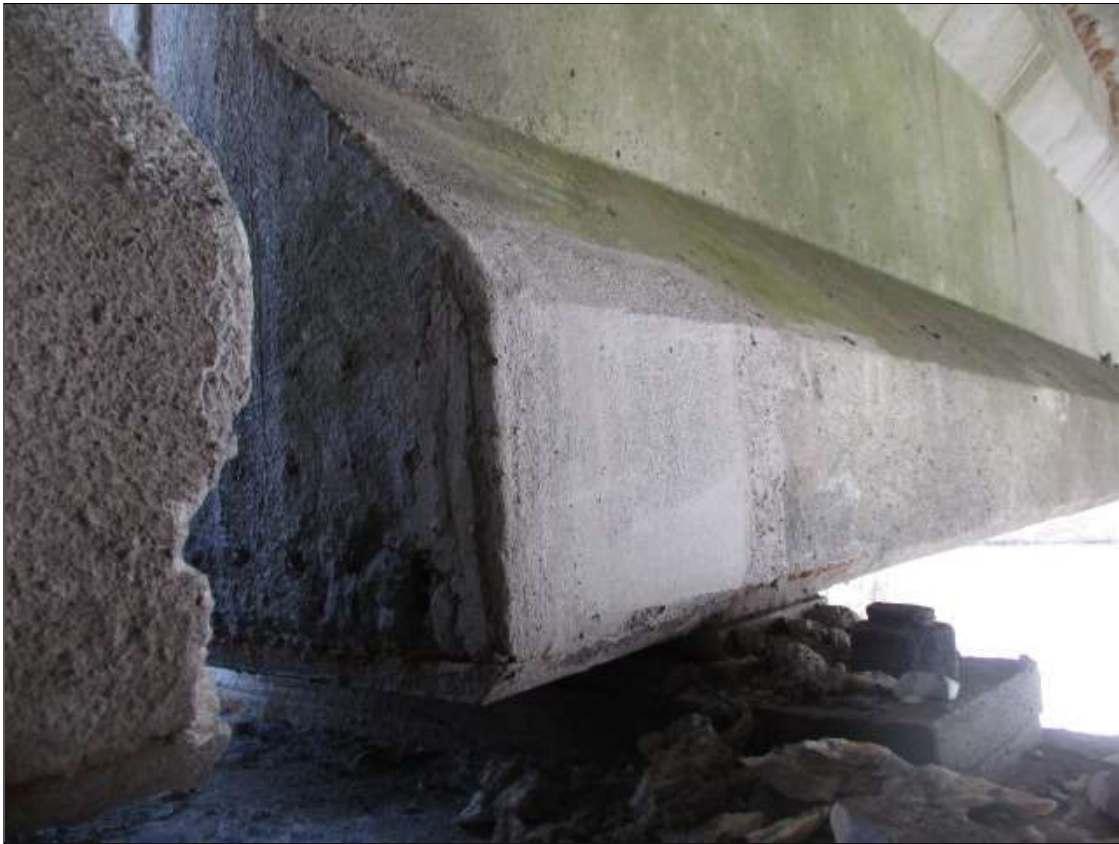
Span 25 Beam 4: 10" LONG X 10" TALL NEW REPAIR TO BOTTOM LEFT FLANGE AT BENT 25

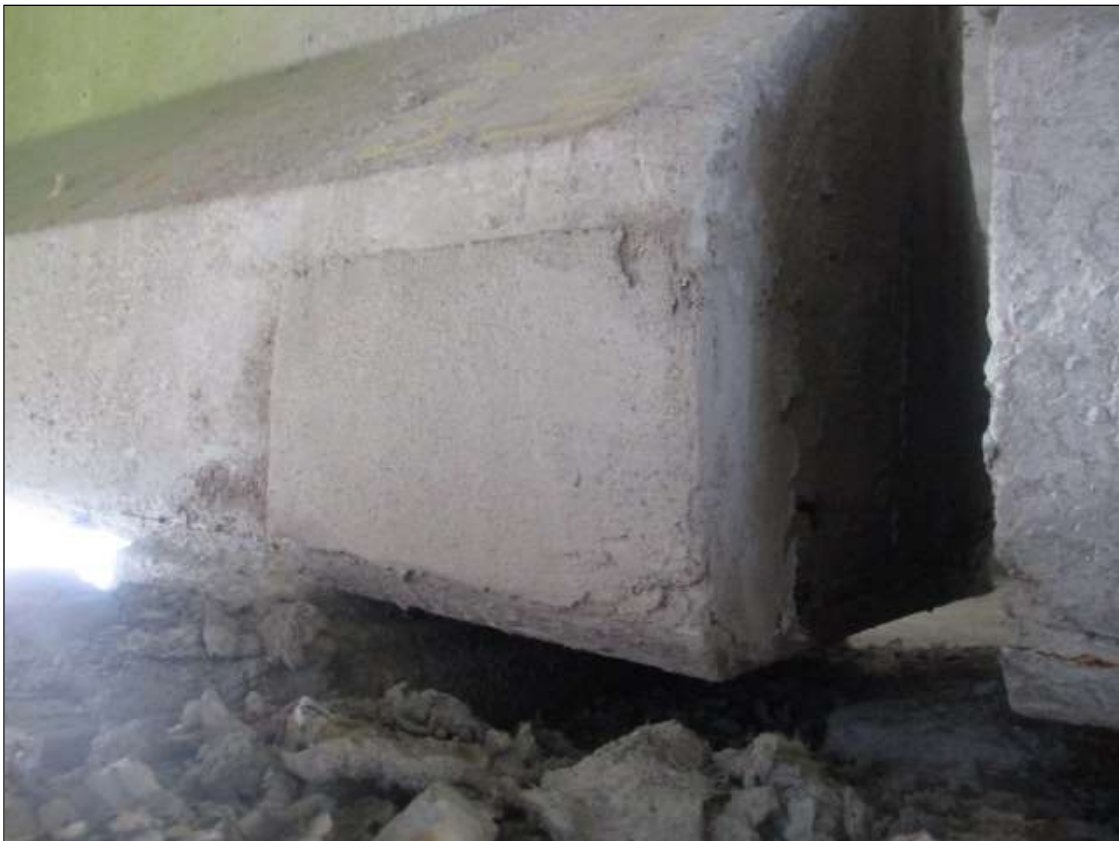
Span 25 Beam 3: 10" LONG X 8" TALL NEW REPAIR TO BOTTOM RIGHT FLANGE AT BENT 25

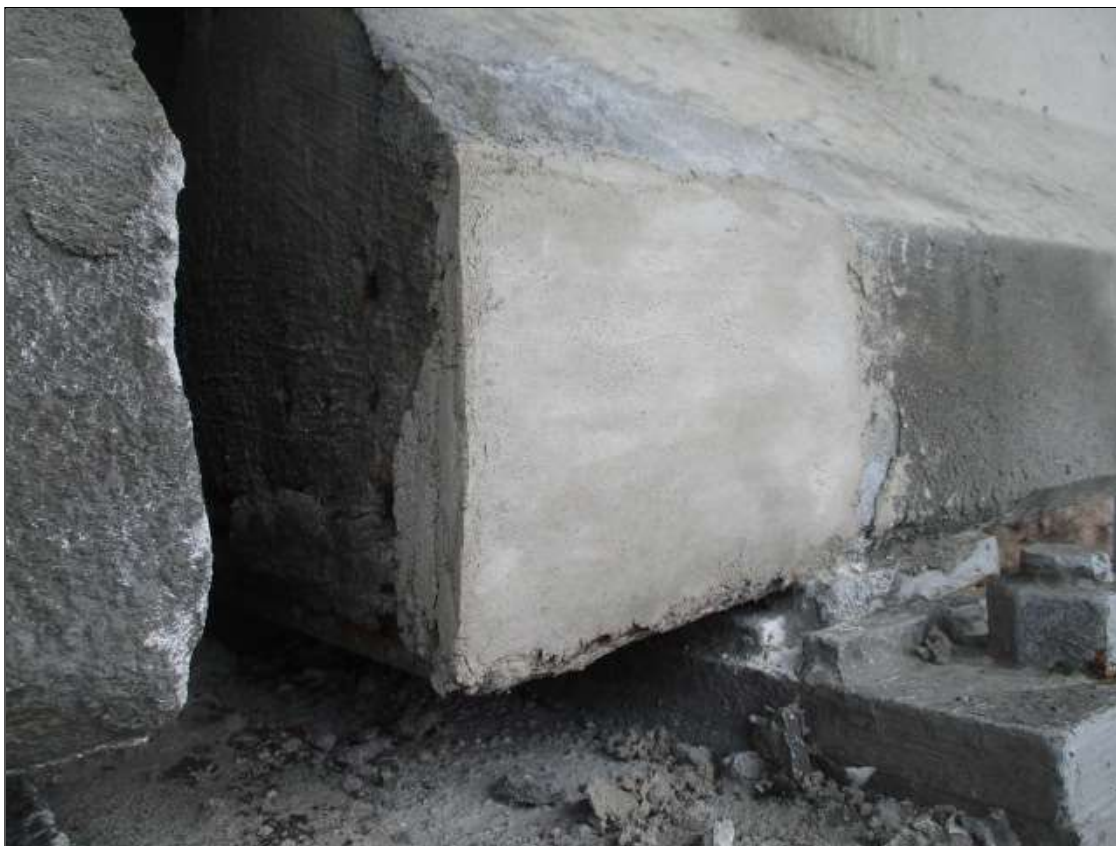
Span 25 Beam 1: 10" LONG X 10" TALL NEW REPAIR TO BOTTOM LEFT FLANGE AT BENT 25

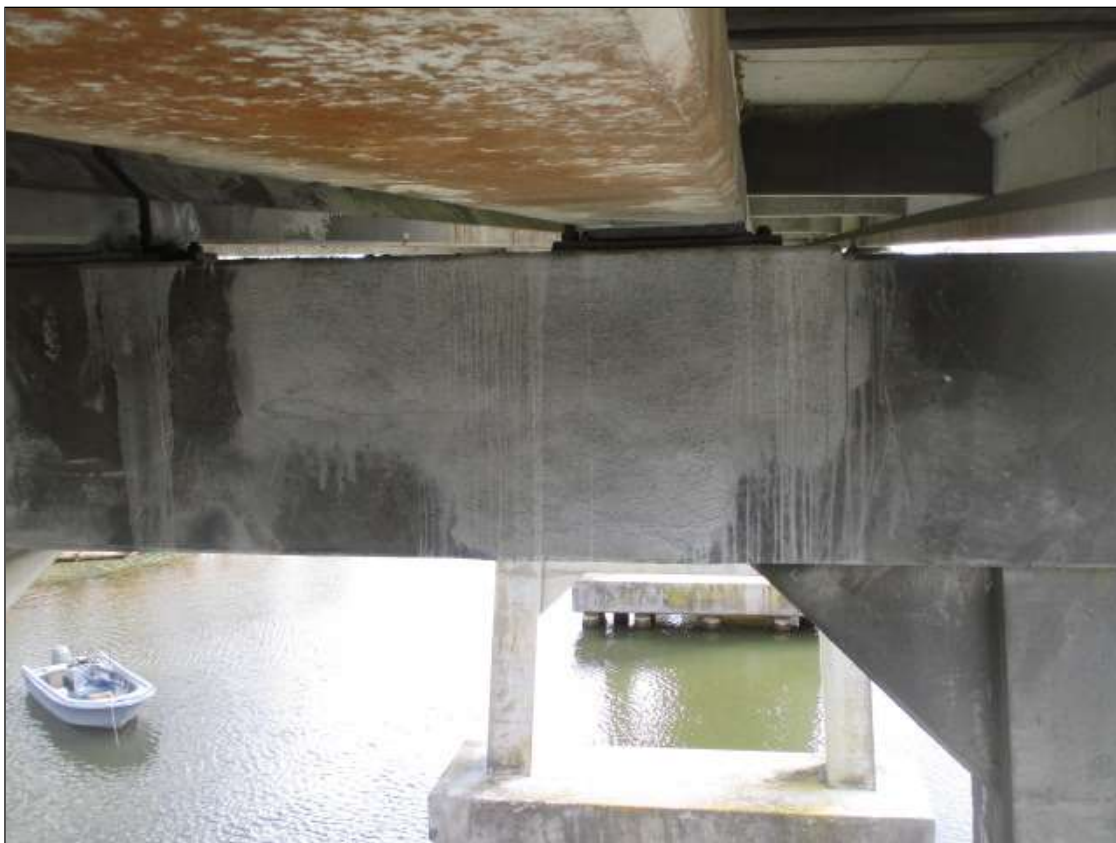
Bent 27 Cap 1: 11' X FULL HEIGHT NEW REPAIR ON NORTH FACE OF BENT 27 CAP UNDER GIRDER 2 AND BAY

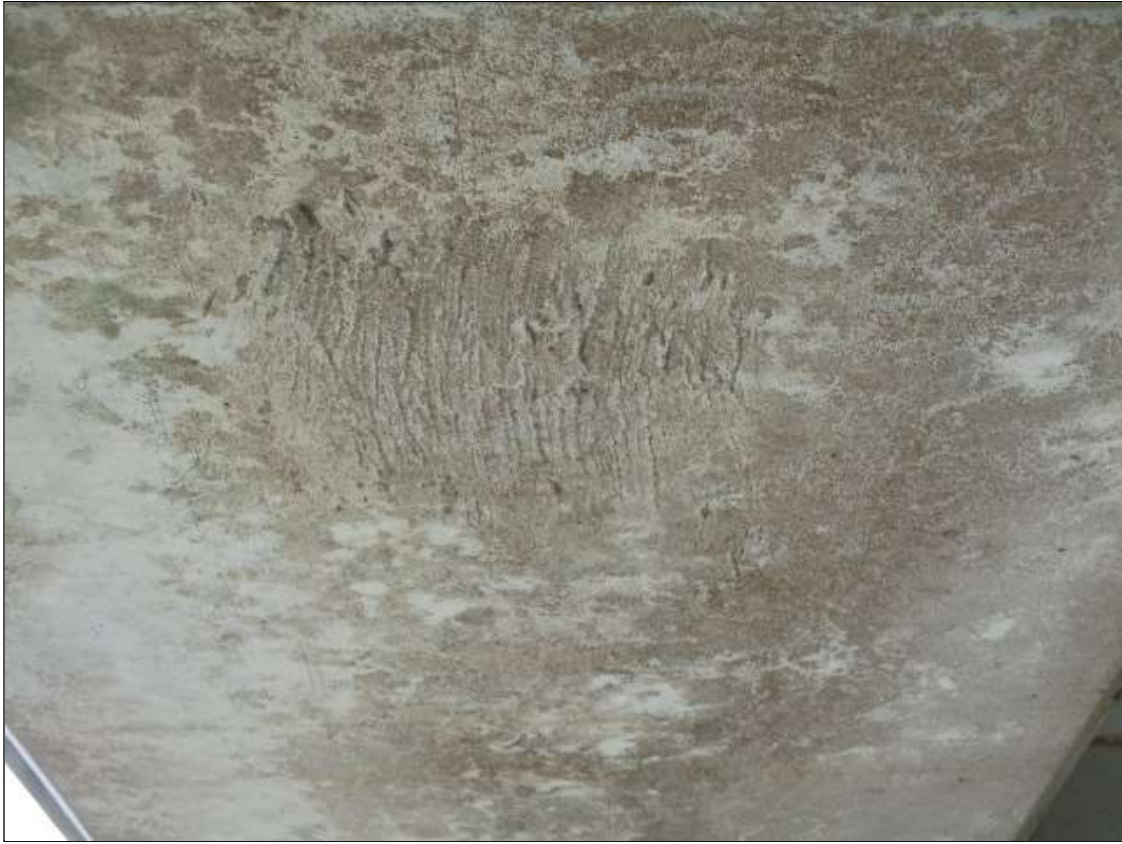
Span 28 Beam 1: 8" LONG X 8" WIDE NEW REPAIR TO UNDERSIDE OF BOTTOM FLANGE AT 8' FROM BENT 27

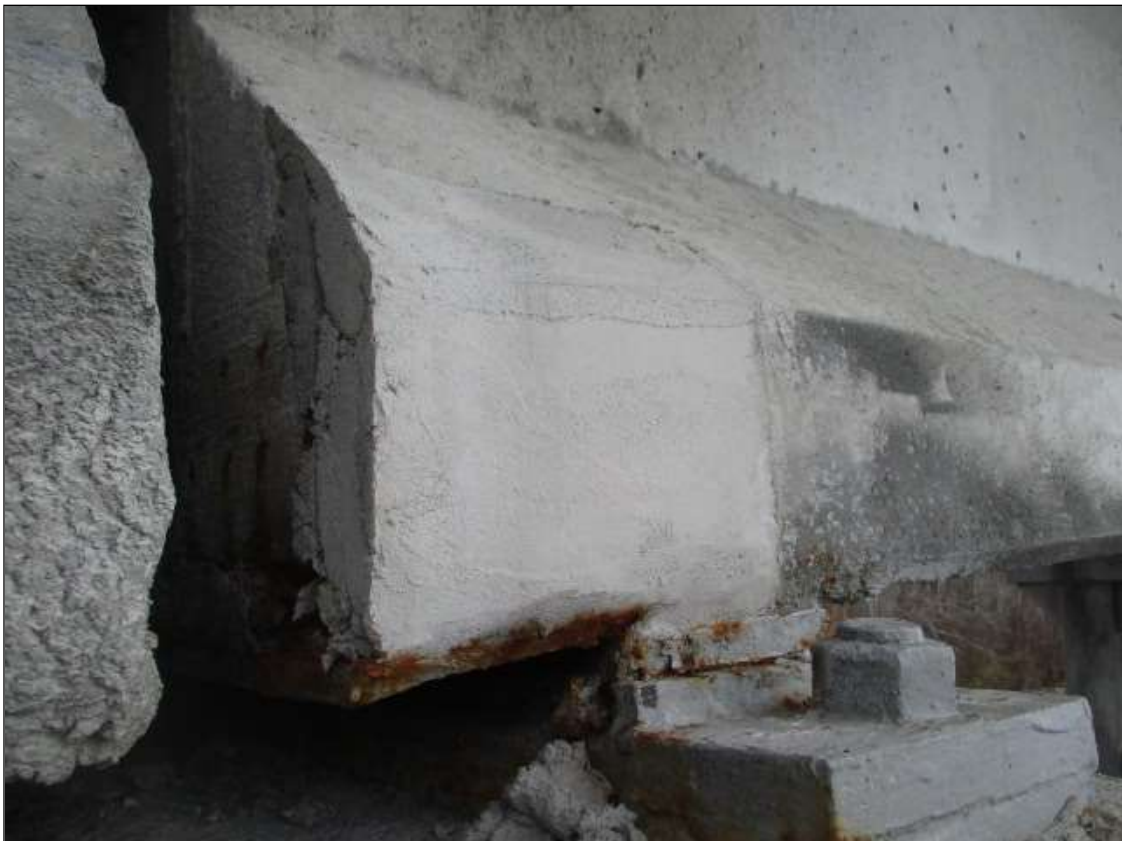
Span 28 Beam 1: 10" LONG X 10" TALL NEW REPAIR TO BOTTOM LEFT FLANGE AT BENT 28

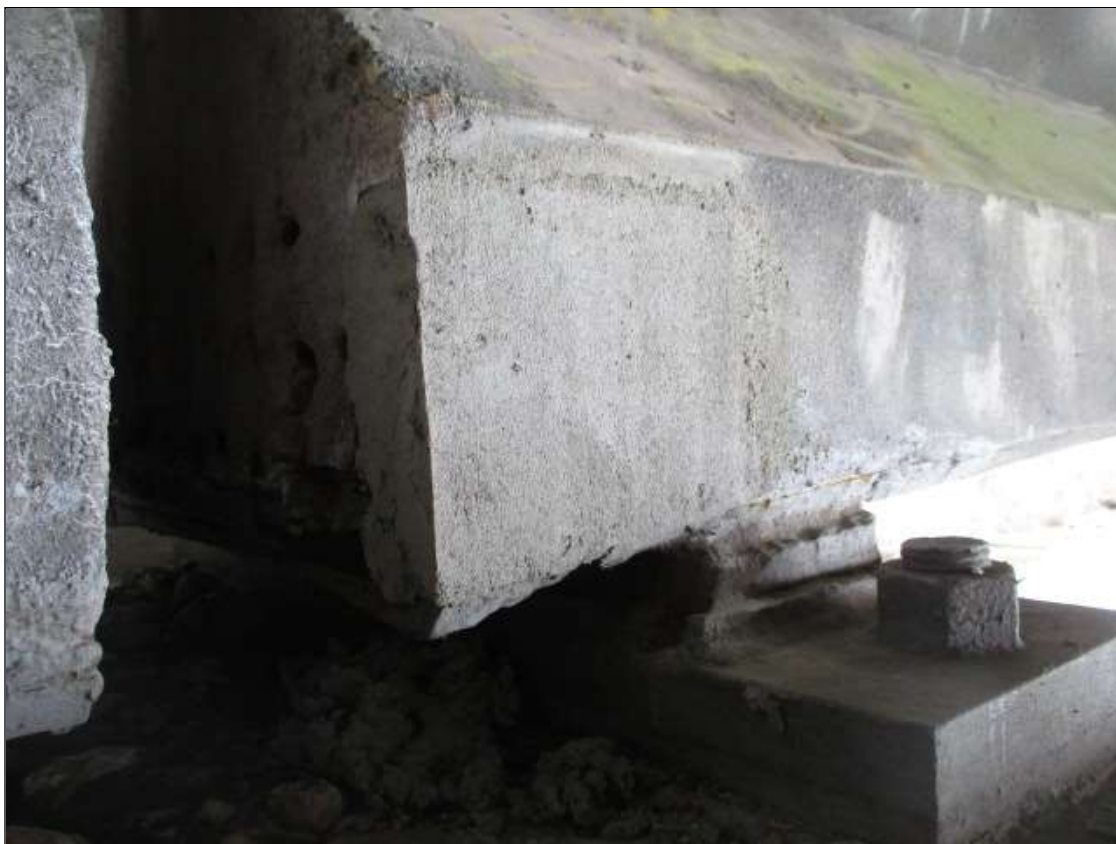
Span 28 Beam 3: 8" LONG X 8" TALL NEW REPAIR TO BOTTOM LEFT FLANGE AT BENT 28

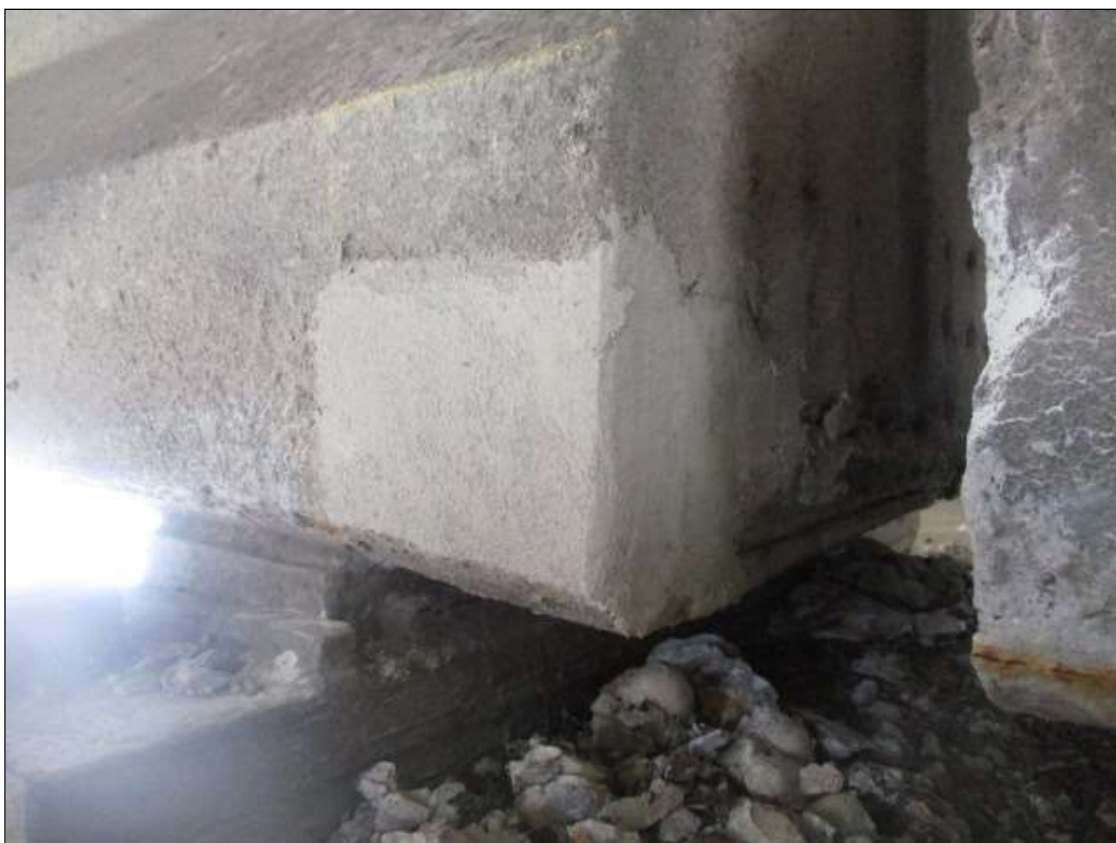
Span 28 Beam 3: 6" LONG X 4" TALL NEW REPAIR TO BOTTOM RIGHT FLANGE AT BENT 28
