APPENDIX E:
BRIDGE INSPECTION REPORT —
THREE RIVERS BRIDGE

THE BRITE BRIDGES:
Bridging Resources for Infrastructure and Thriving
Economies Project

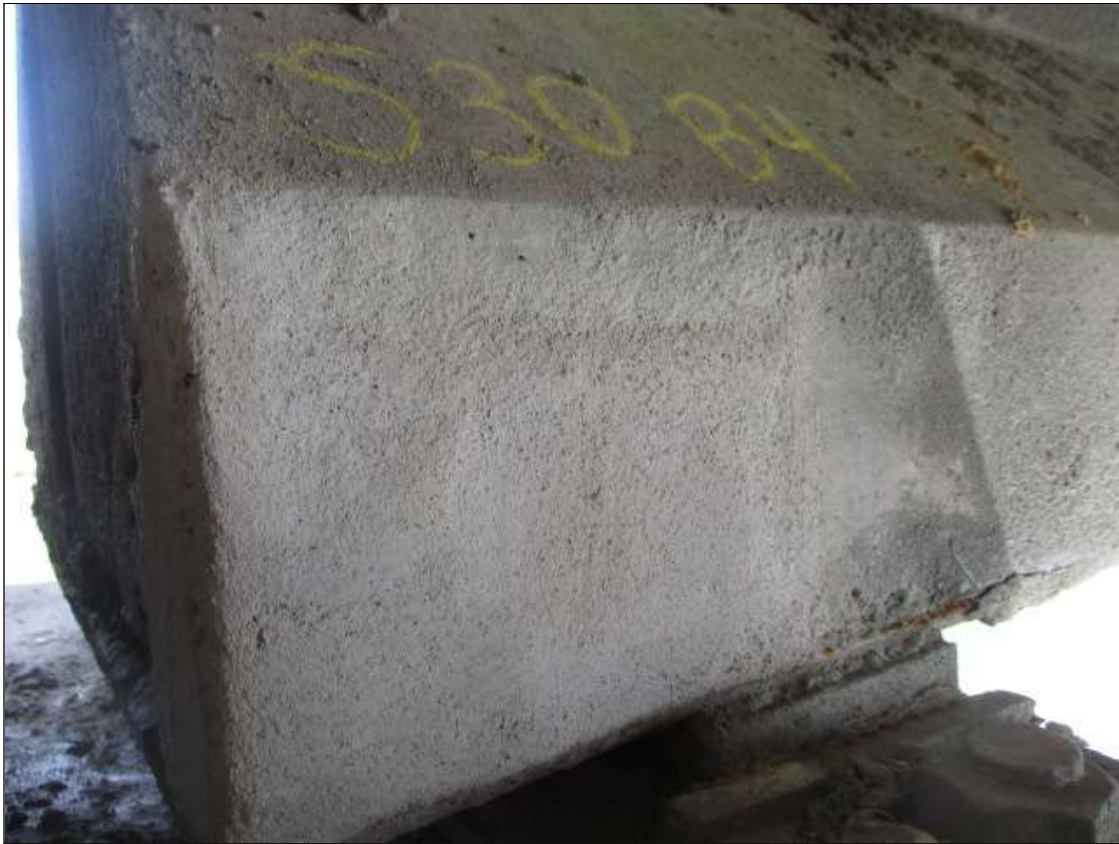
Span 30 Beam 4: 8" LONG X 8" TALL NEW REPAIR TO BOTTOM LEFT FLANGE AT BENT 30

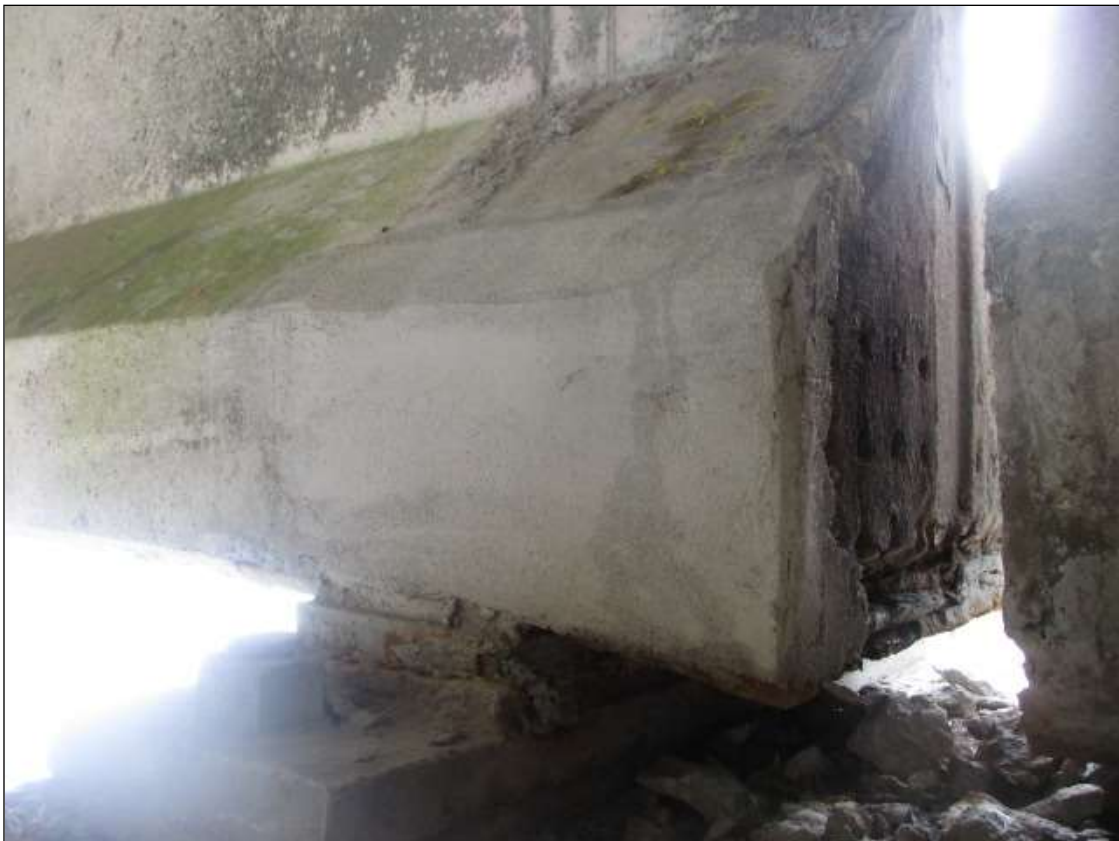
Span 32 Beam 1: 18" LONG X 12" TALL NEW REPAIR TO BOTTOM RIGHT FLANGE AT BENT 32

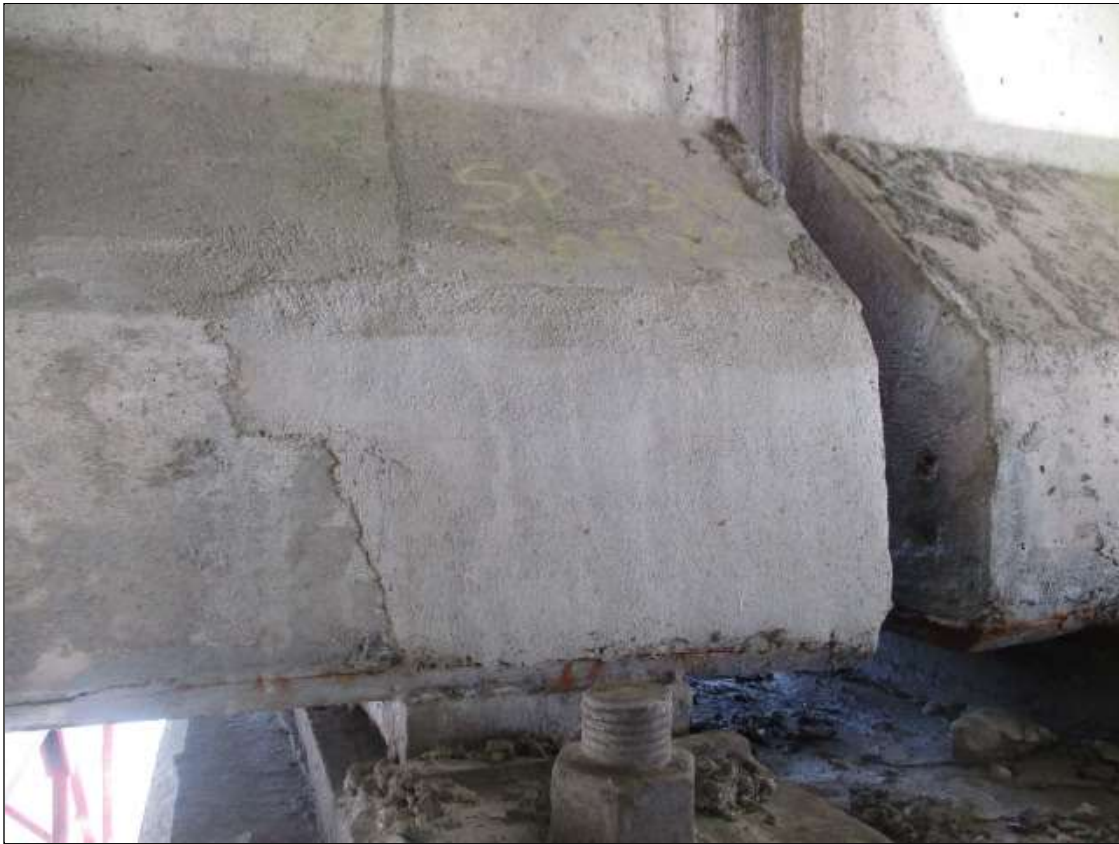
Span 33 Beam 4: 12" LONG X 10" TALL NEW REPAIR TO BOTTOM LEFT FLANGE AT BENT 32

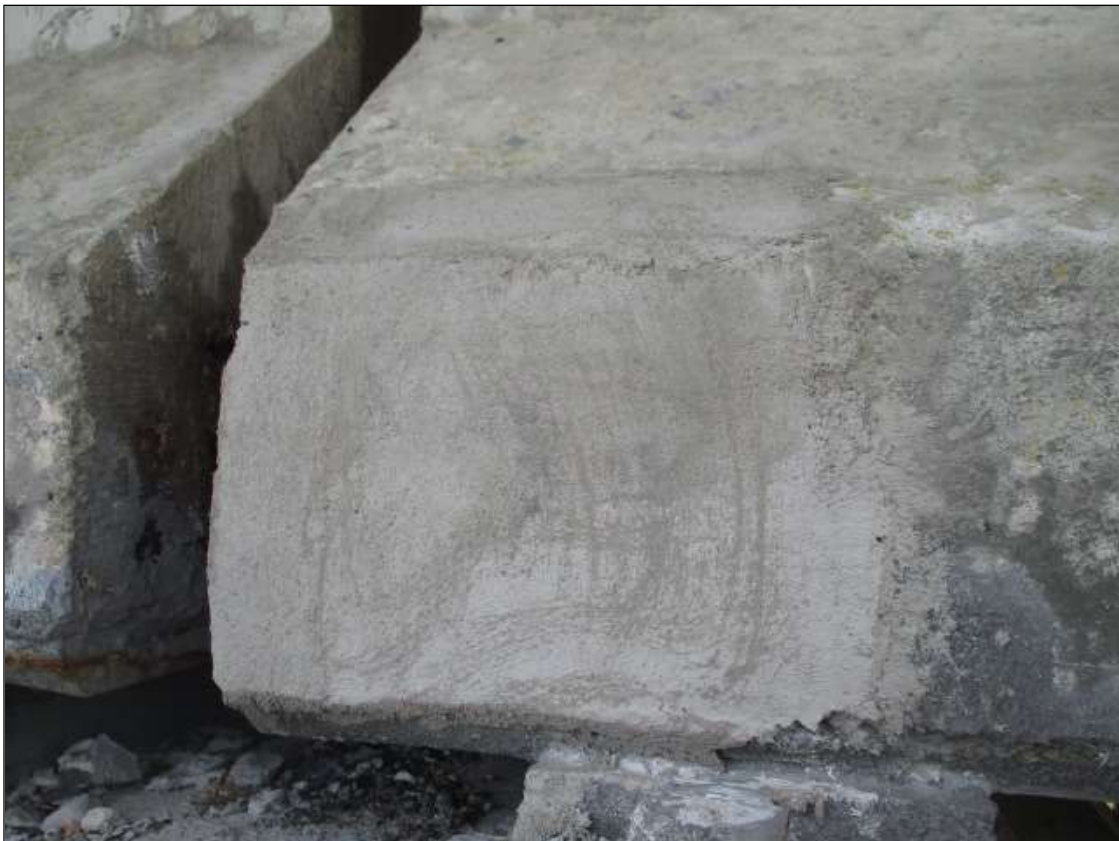
Span 33 Beam 4: 10" LONG X 10" TALL NEW REPAIR TO BOTTOM RIGHT FLANGE AT BENT 32

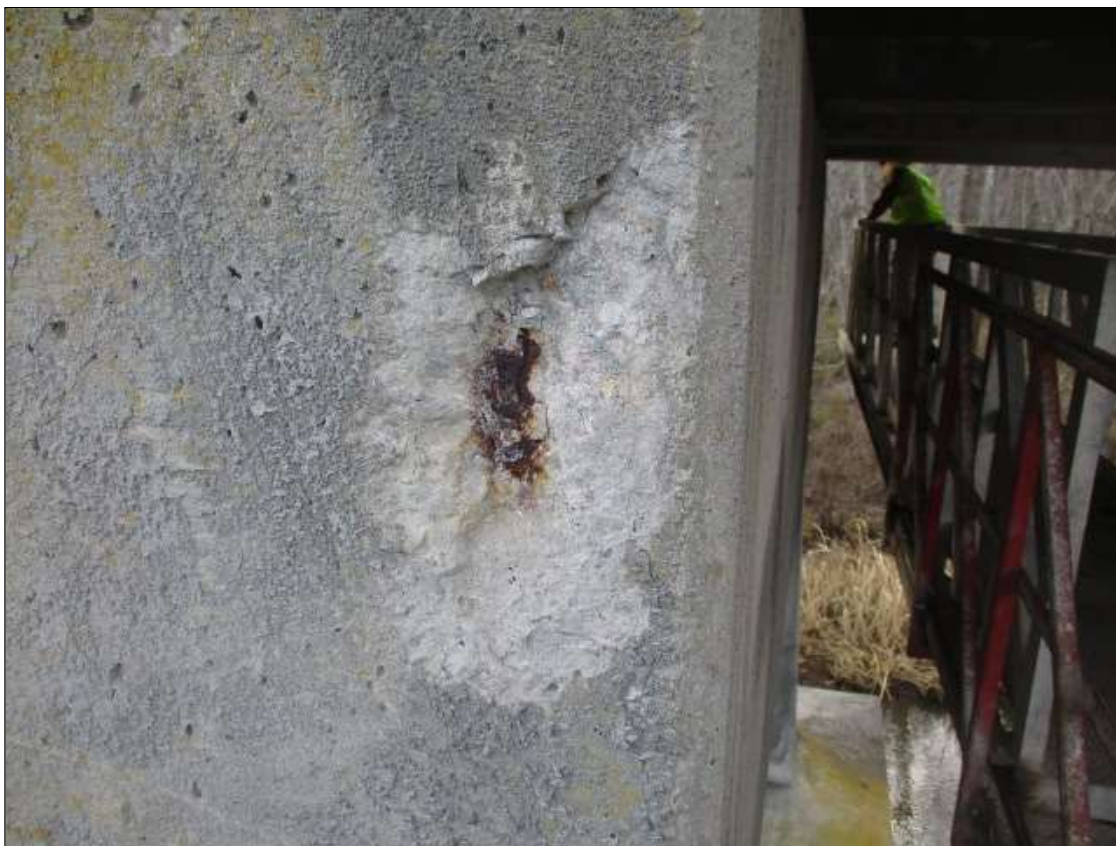
Bent 33 Cap 1: at East end of cap, spall [5in x 9in x up to 1in deep] with [1] one exposed rusted reinforcing [no section loss]

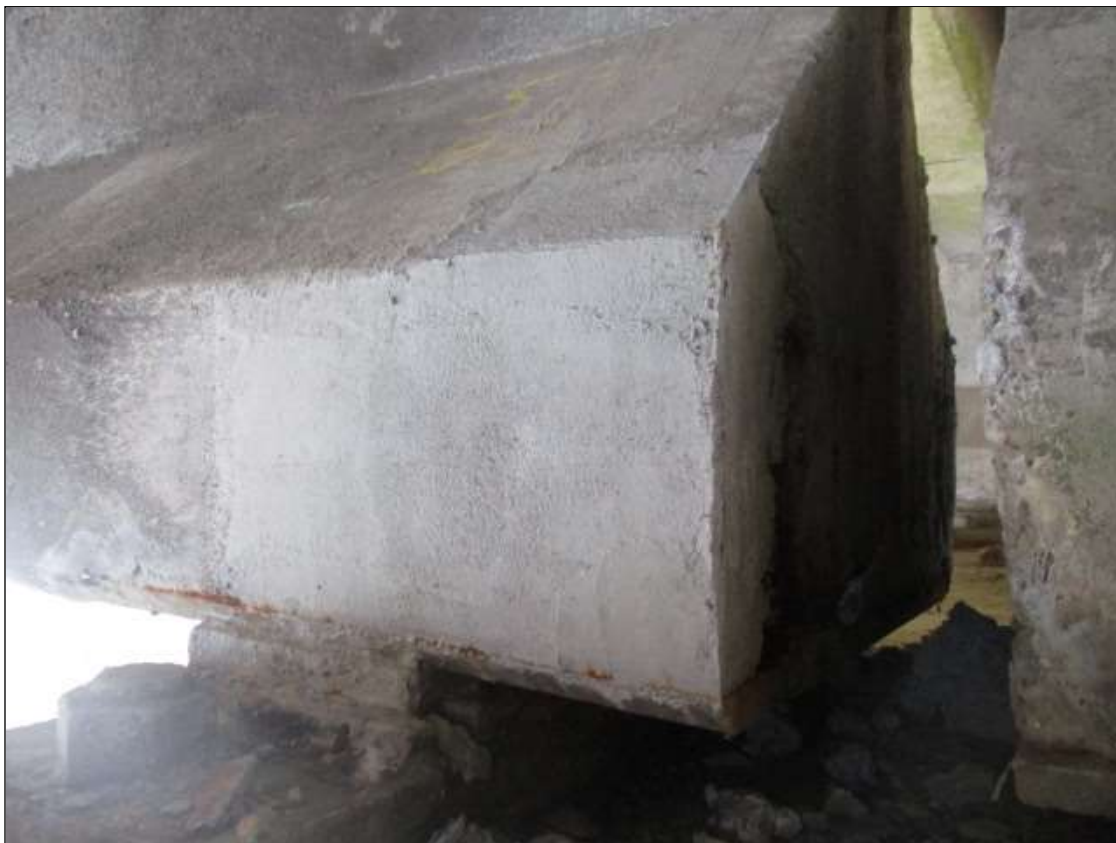
Span 34 Beam 3: 12" LONG X 10" TALL NEW REPAIR TO BOTTOM RIGHT FLANGE AT BENT 34

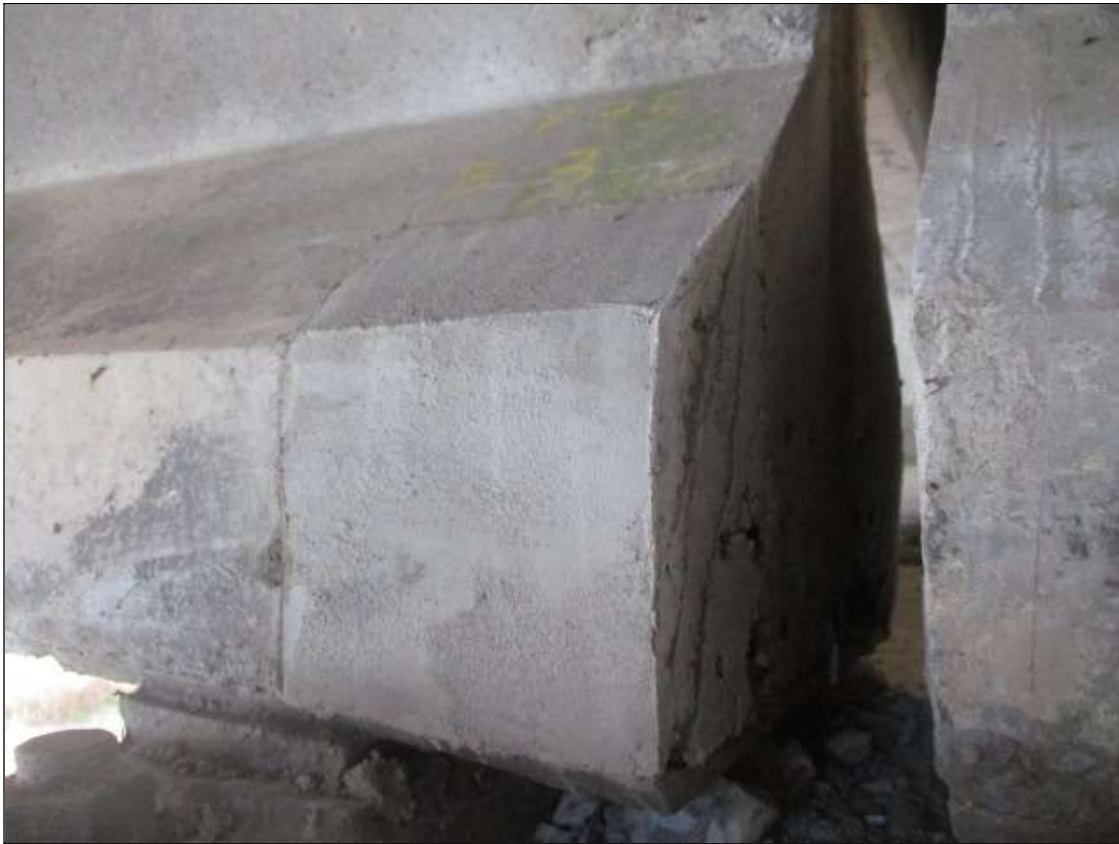
Span 35 Beam 3: 8" LONG X 12" TALL NEW REPAIR TO BOTTOM RIGHT FLANGE AT BENT 35

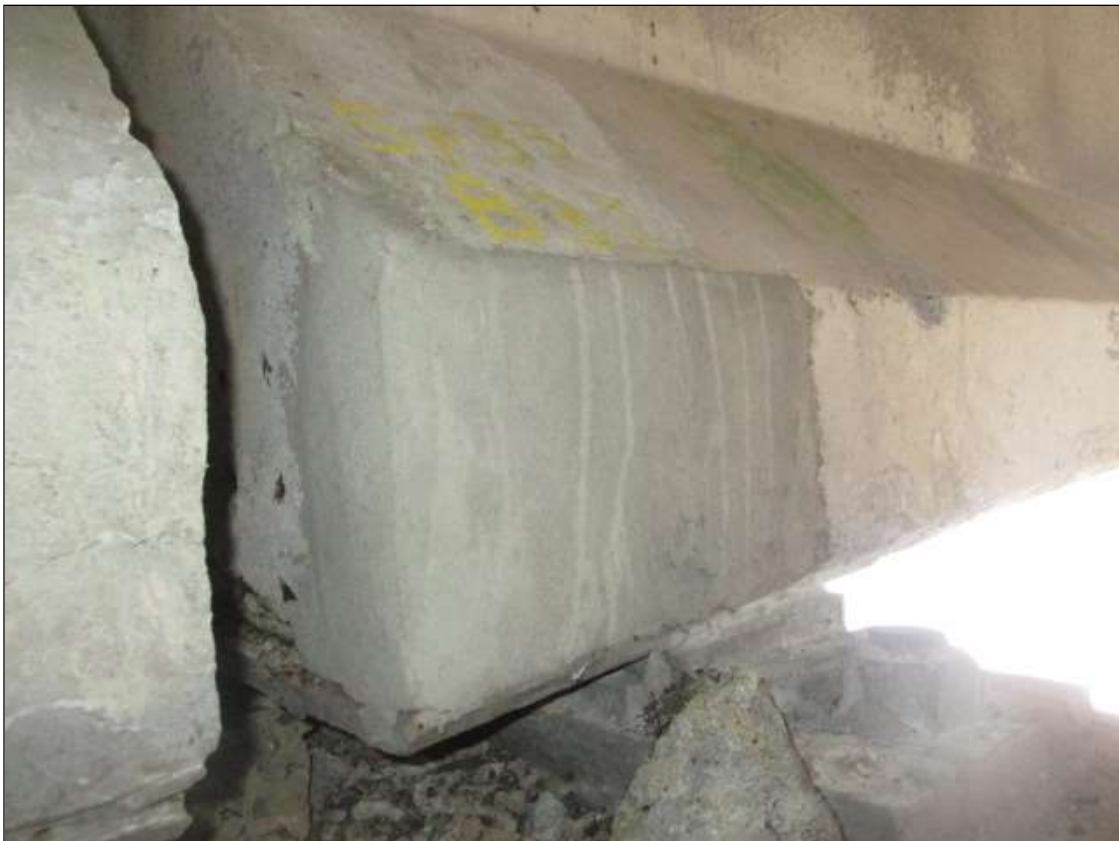
Span 35 Beam 3: 12" LONG X 8" TALL NEW REPAIR TO BOTTOM LEFT FLANGE AT BENT 35

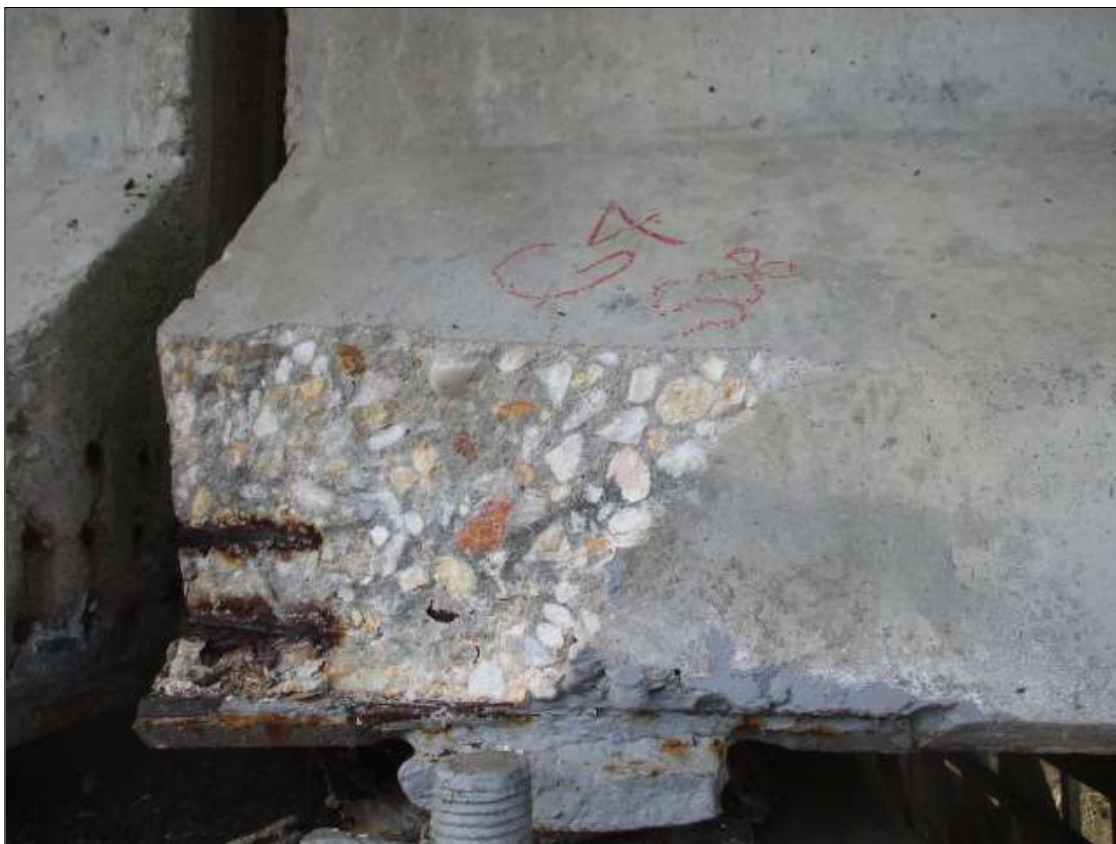
Span 38 Beam 4: PAR: 12" LONG X 8" TALL X 3" DEEP SPALL WITH EXPOSED STRANDS WITH SOME SECTION LOSS ON BOTTOM RIGHT FLANGE AT BENT 37

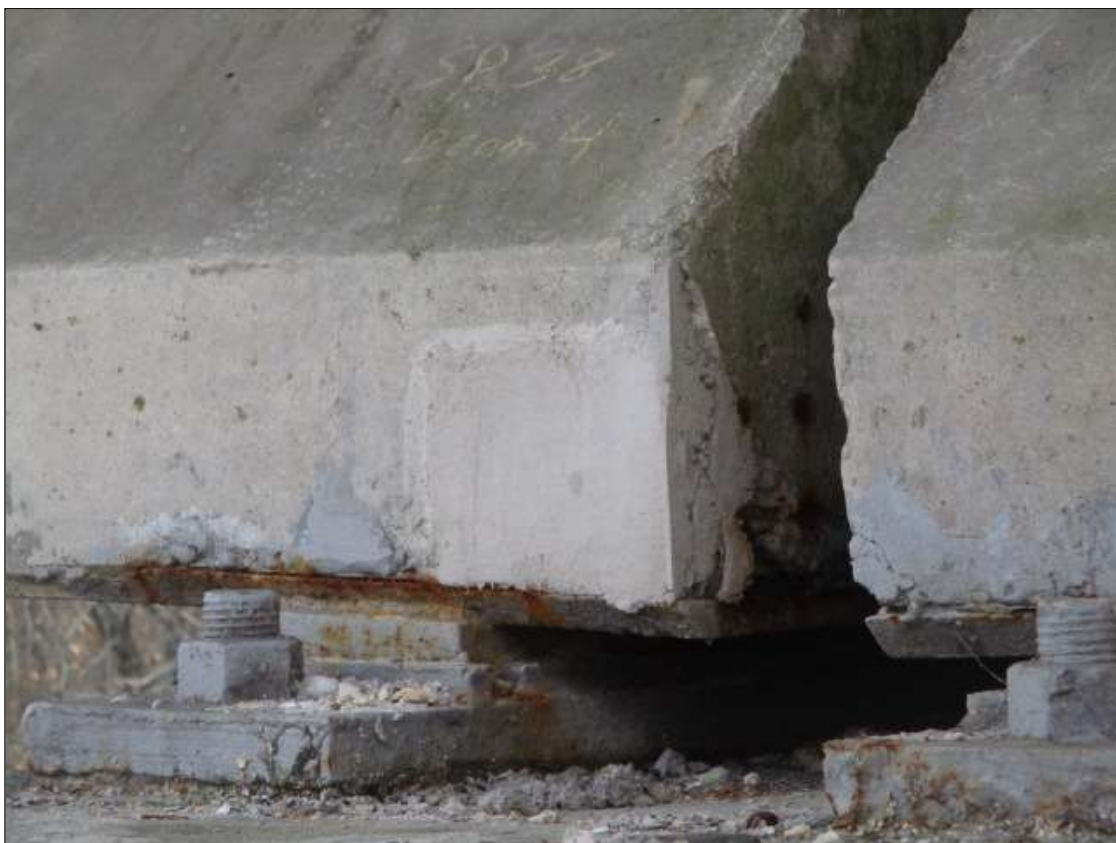
Span 38 Beam 4: 6" LONG X 6" TALL NEW REPAIR TO BOTTOM RIGHT FLANGE AT BENT 38

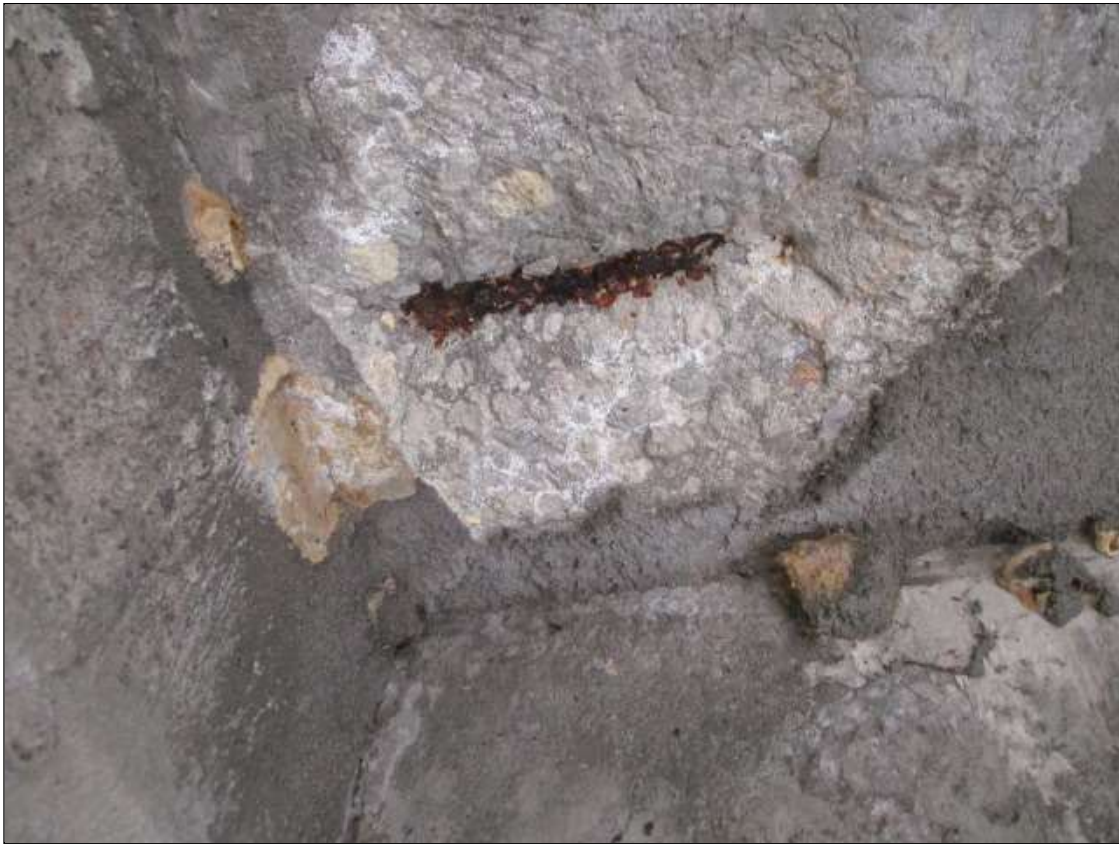
Span 41 Deck: 12" DIAMETER X 1" DEEP SPALL WITH EXPOSED REBAR IN UNDERSIDE OF BAY 1 AT BENT 40

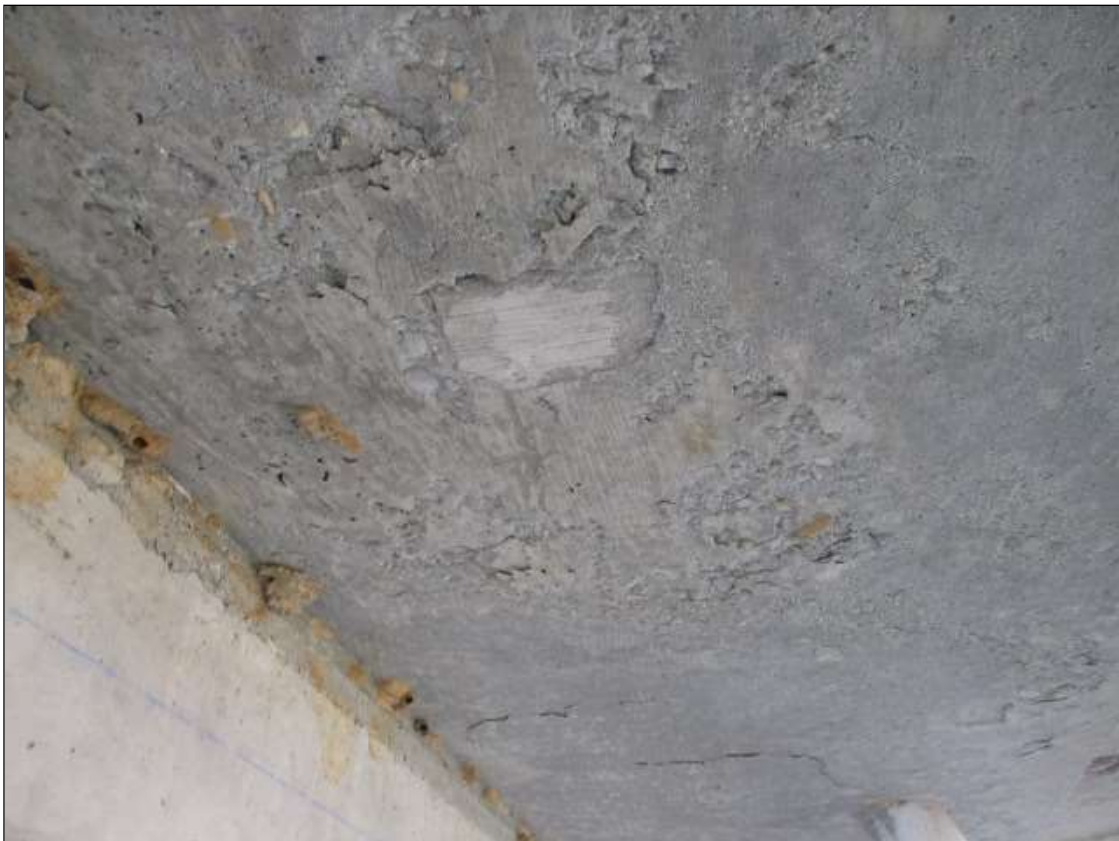
Span 42 Deck: AREA OF POORLY CONSOLIDATED CONCRETE IN RIGHT OVERHANG

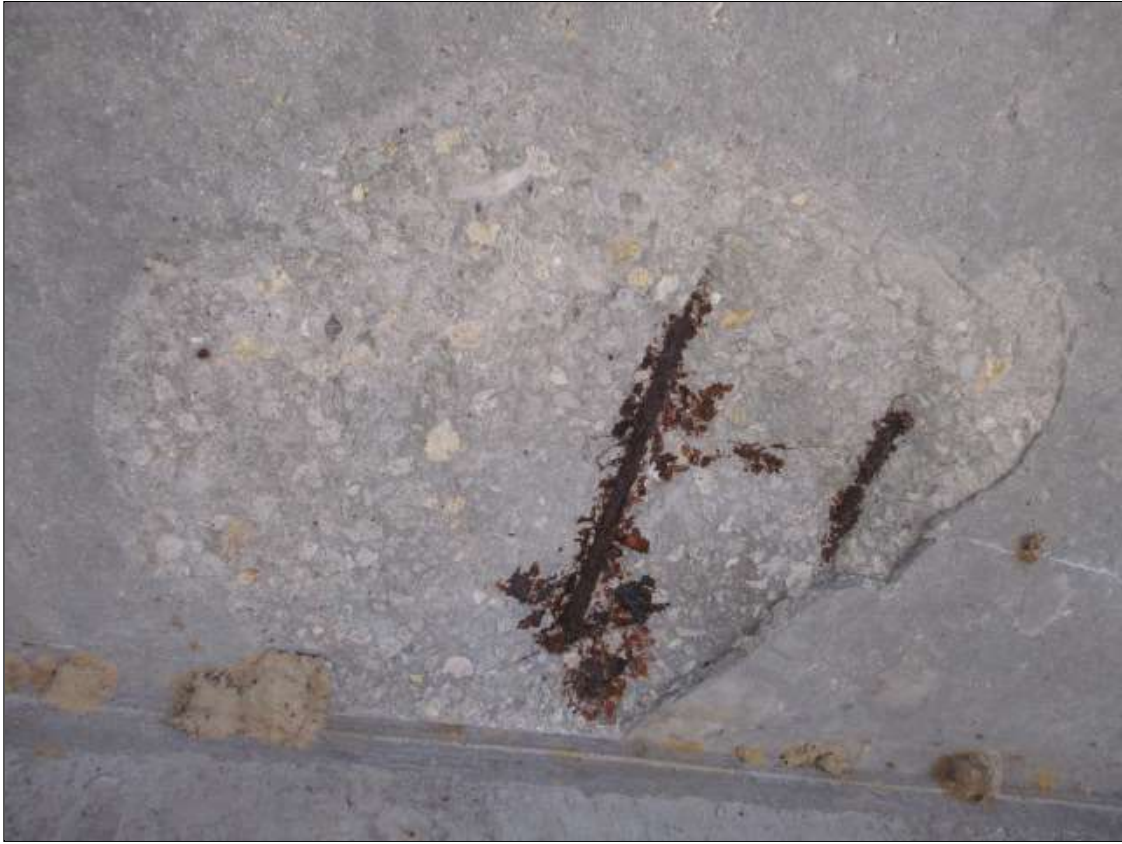
Span 42 Deck: PAR: 30" DIAMETER X 2" DEEP SPALL WITH EXPOSED REBAR WITH SECTION LOSS IN BAY 1 AT 12' FROM BENT 41

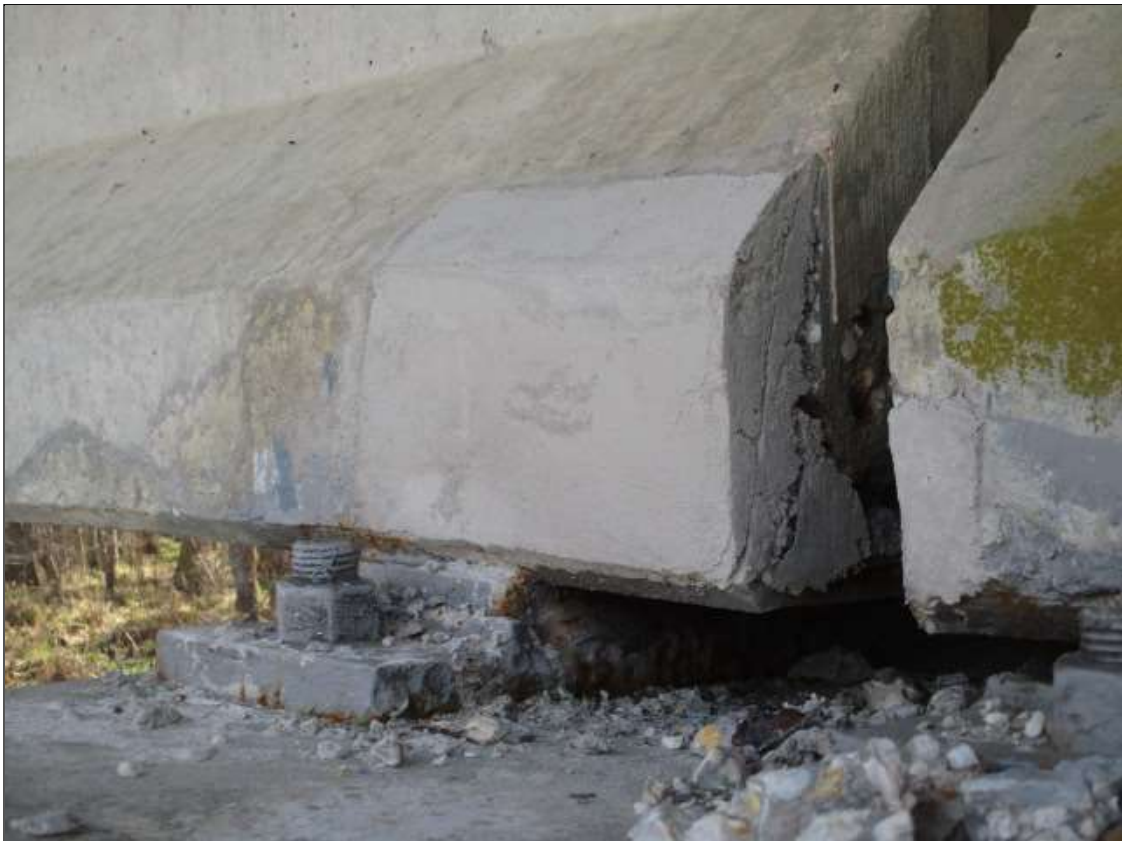
Span 43 Beam 4: 12" LONG X 10" TALL NEW REPAIR TO BOTTOM RIGHT FLANGE AT BENT 43

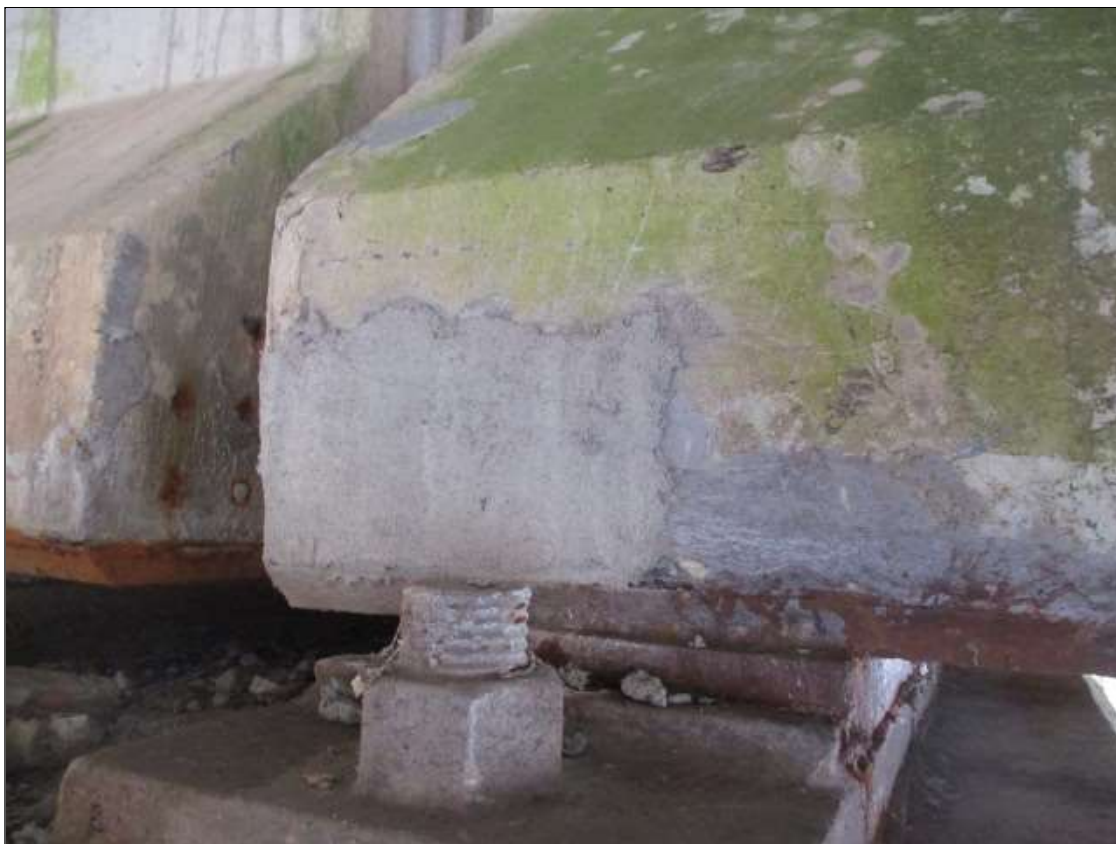
Span 44 Beam 3: 6" LONG X 4" TALL NEW REPAIR TO BOTTOM RIGHT FLANGE AT BENT 43

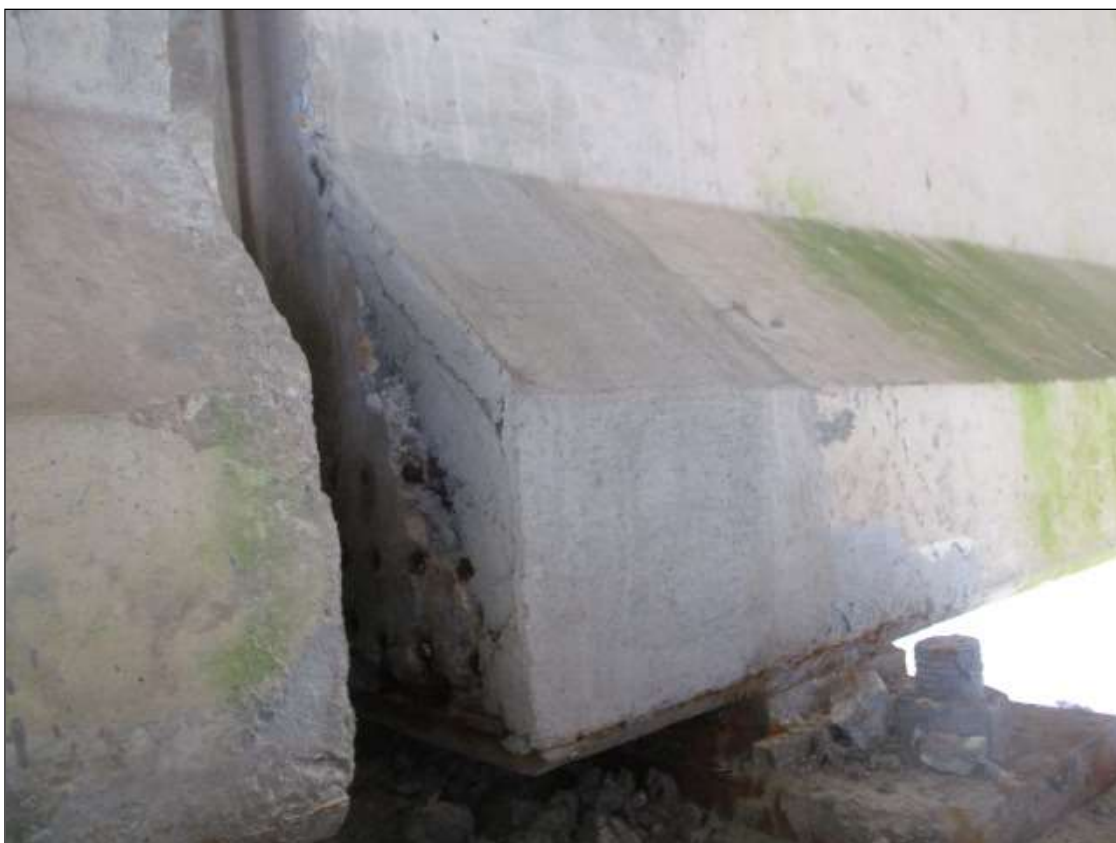
Span 43 Beam 2: 10" LONG X 18" TALL NEW REPAIR TO BOTTOM LEFT FLANGE AT BENT 43

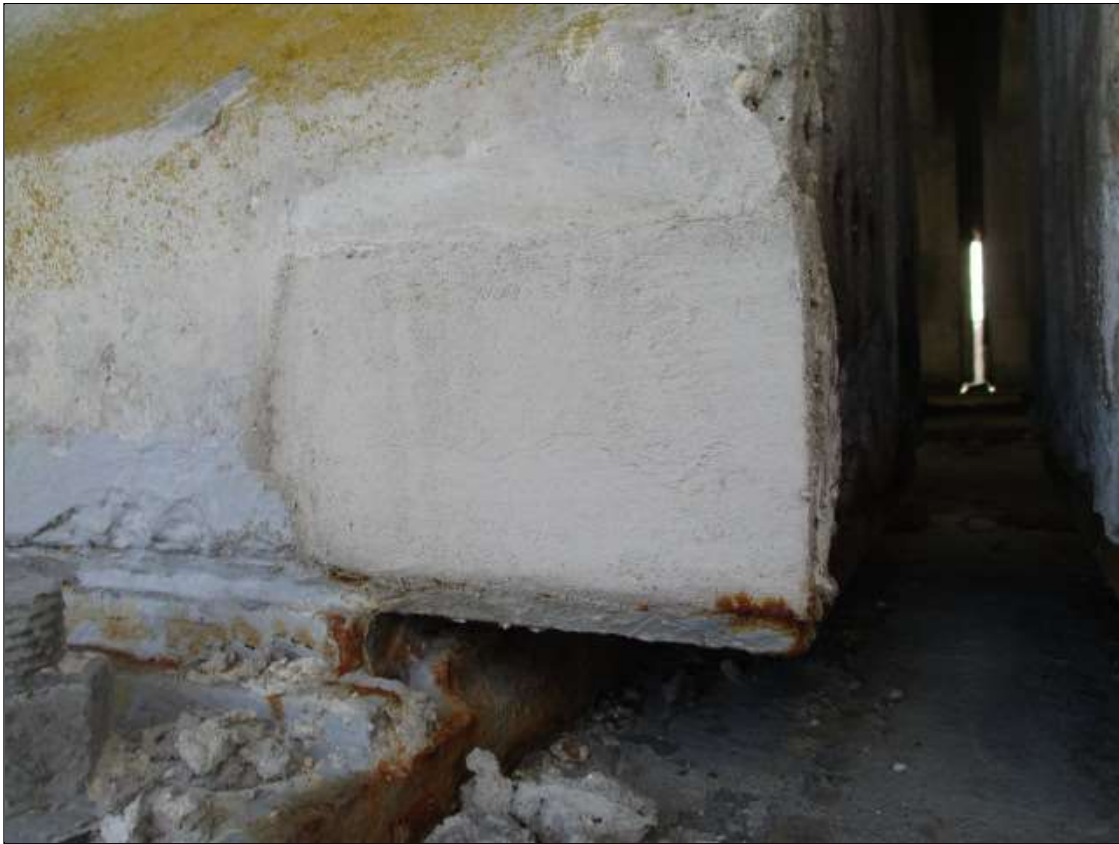
Span 45 Beam 4: 6" LONG X 4" TALL NEW REPAIR TO BOTTOM RIGHT FLANGE AT BENT 45

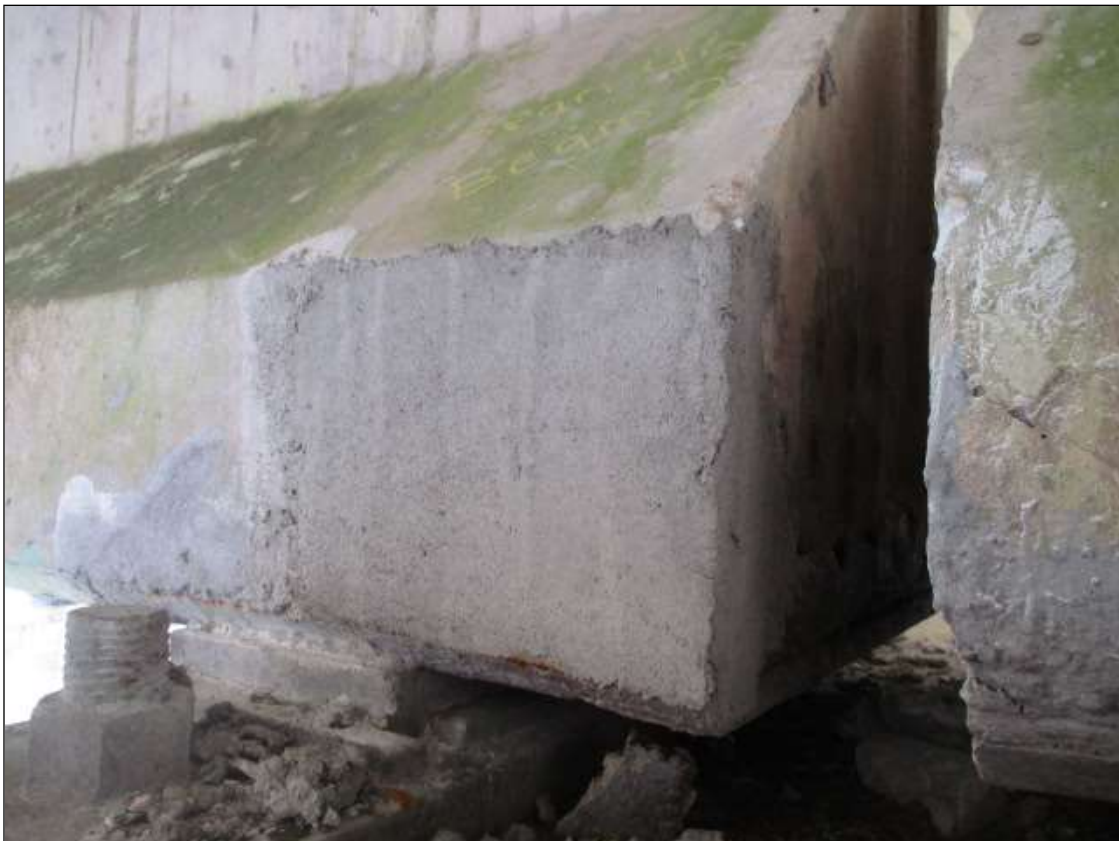
Span 45 Beam 2: 10" LONG X 10" TALL NEW REPAIR TO BOTTOM RIGHT FLANGE AT BENT 45

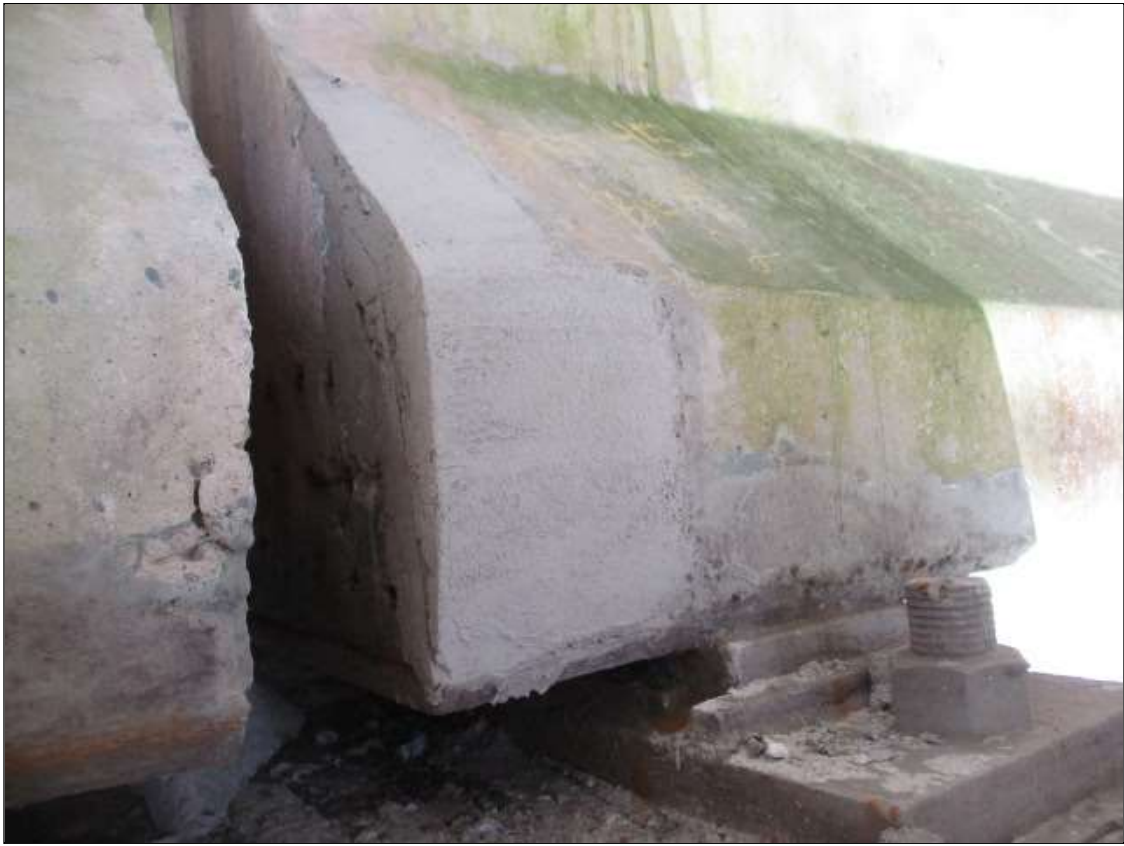
Span 45 Beam 2: 6" LONG X 12" TALL NEW REPAIR TO BOTTOM LEFT FLANGE AT BENT 45

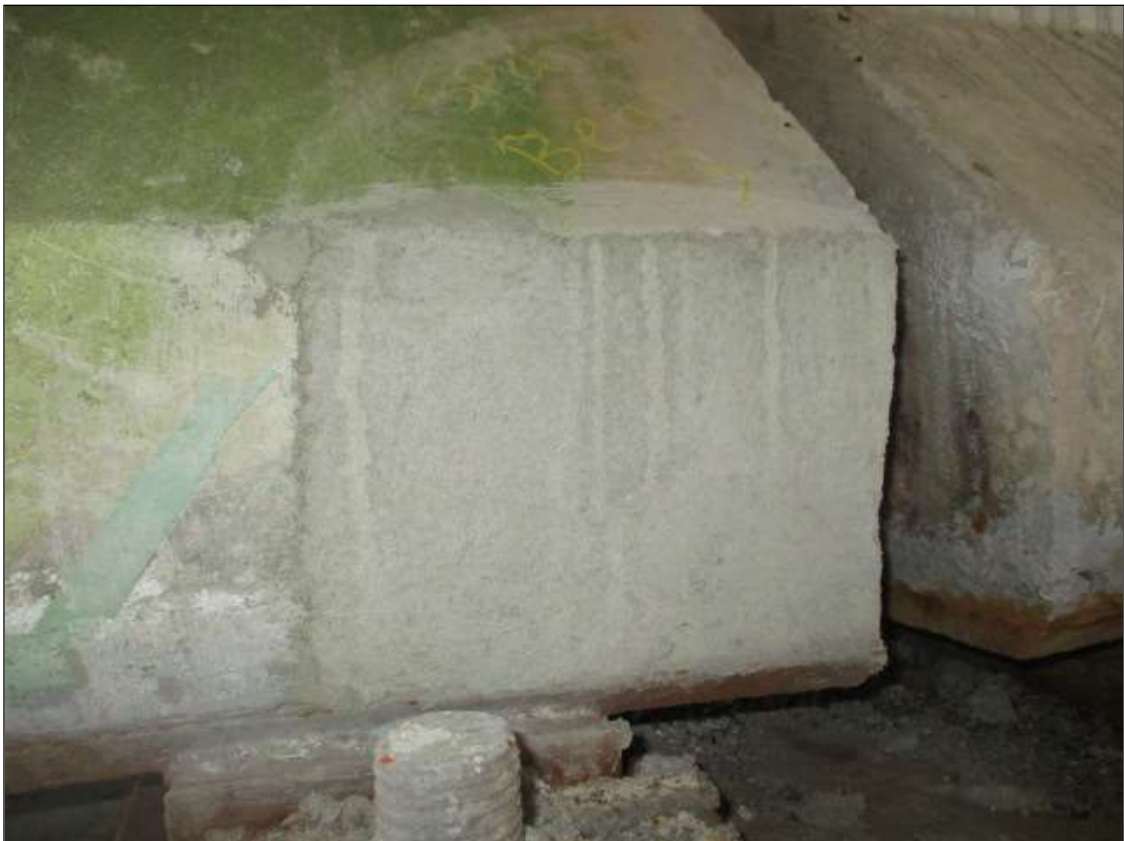
Span 46 Beam 3: 10" LONG X 10" TALL NEW REPAIR TO BOTTOM LEFT FLANGE AT BENT 45

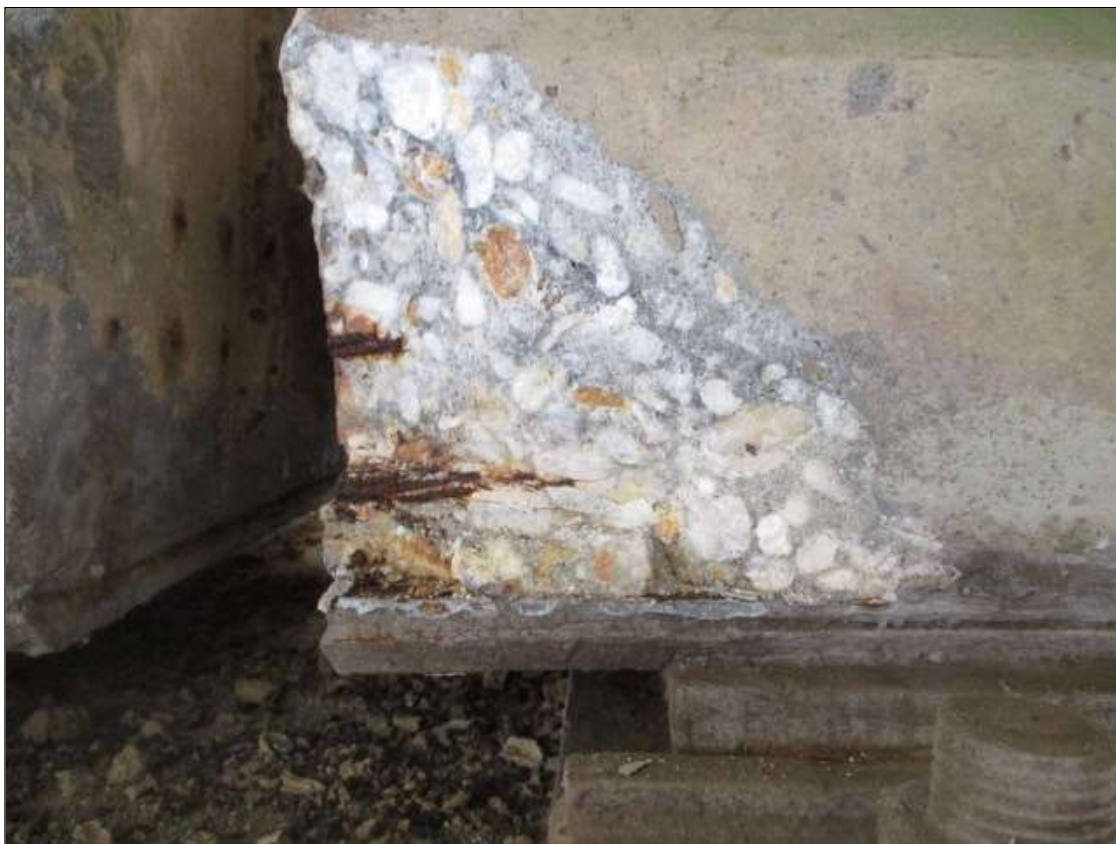
Span 47 Beam 2: PAR: 8" LONG X 8" TALL X 3" DEEP SPALL WITH EXPOSED STRANDS WITH SECTION LOSS ON BOTTOM RIGHT FLANGE AT BENT 46

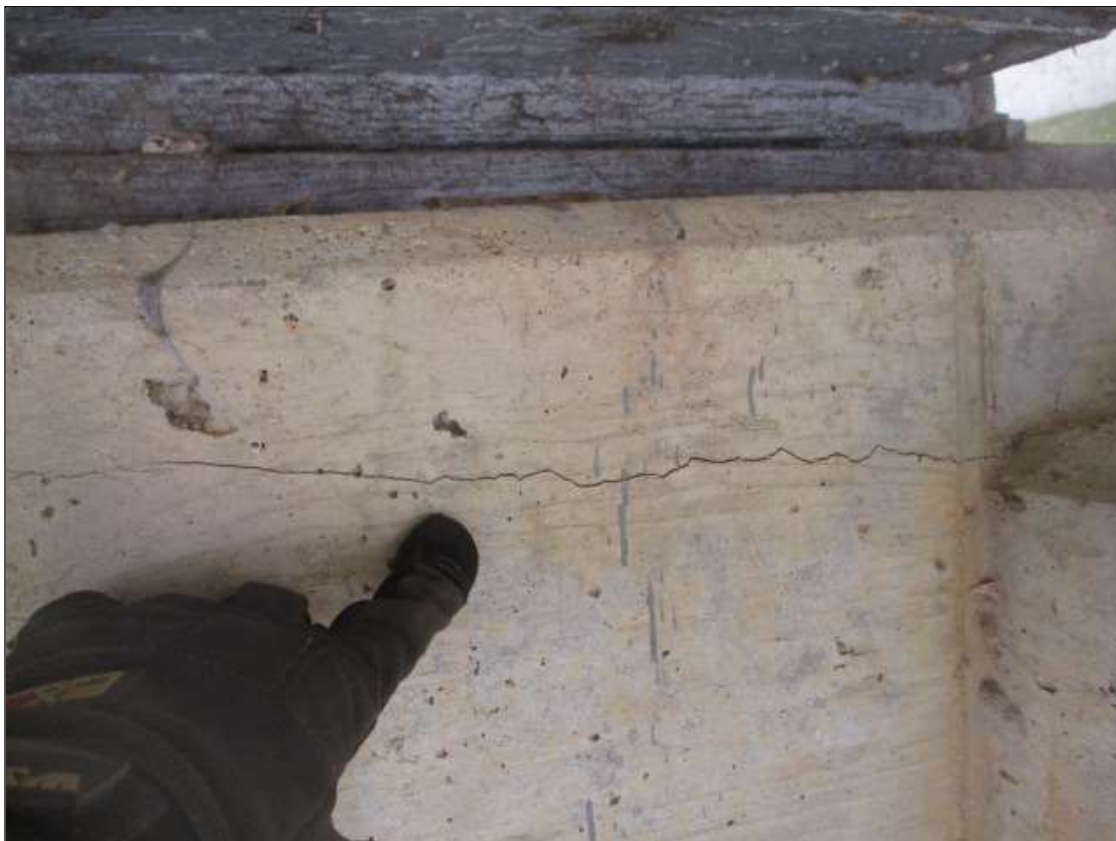
Bent 47 Cap 1: 1/8" HORIZONTAL CRACKING ON NORTH FACE UNDER GIRDER 2

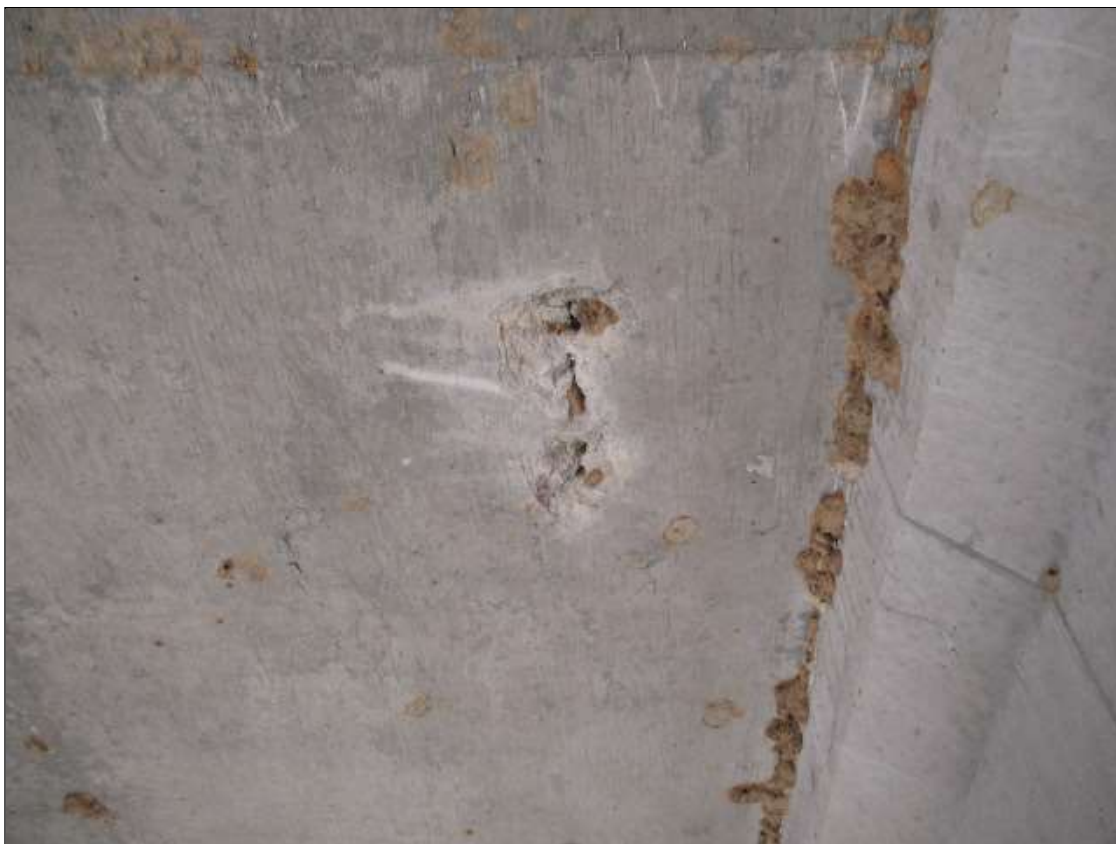
Span 49 Deck: 12" LONG X 6" WIDE X 1" DEEP SPALL IN BAY 2 AT 30' FROM BENT 48

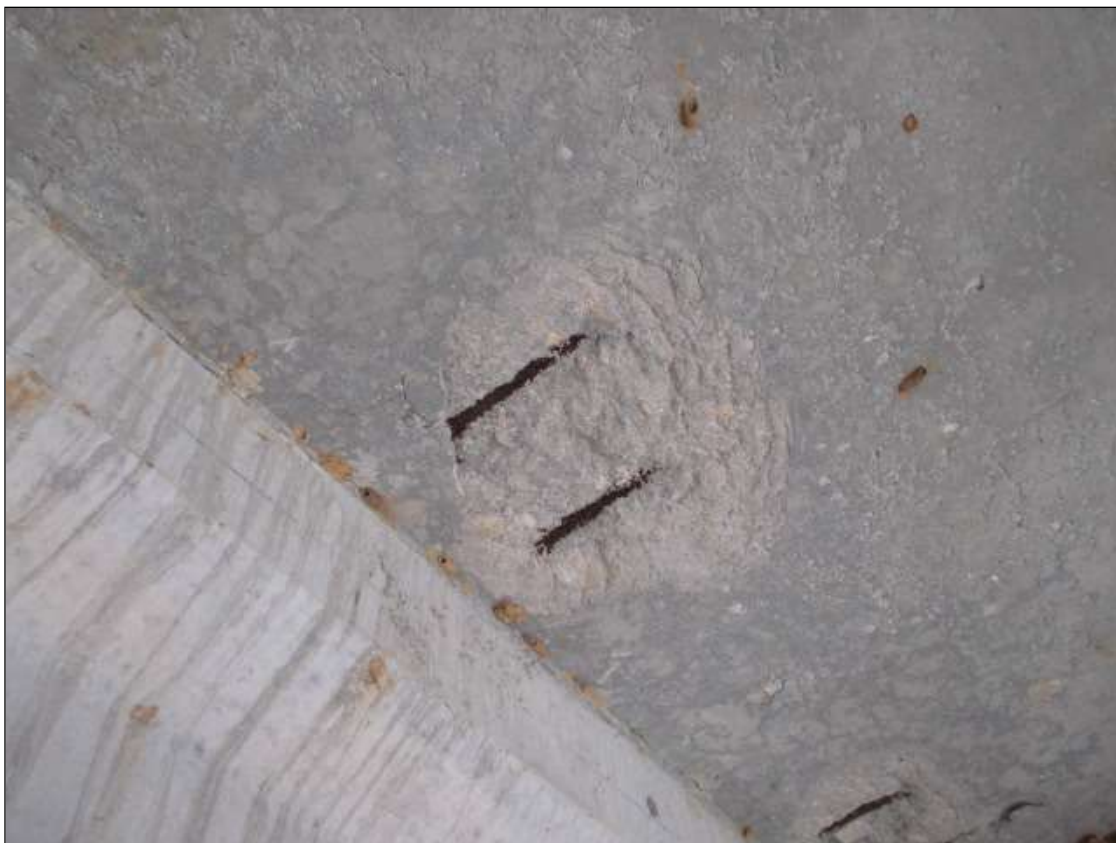
Span 49 Deck: 18" DIAMETER X 1" DEEP SPALL WITH EXPOSED REBAR WITH NO SECTION LOSS IN BAY 3 AT 4' NORTH OF 1ST INTERMEDIATE DIAPHRAGM
