APPENDIX E:
BRIDGE INSPECTION REPORT —
THREE RIVERS BRIDGE

THE BRITE BRIDGES:
Bridging Resources for Infrastructure and Thriving
Economies Project

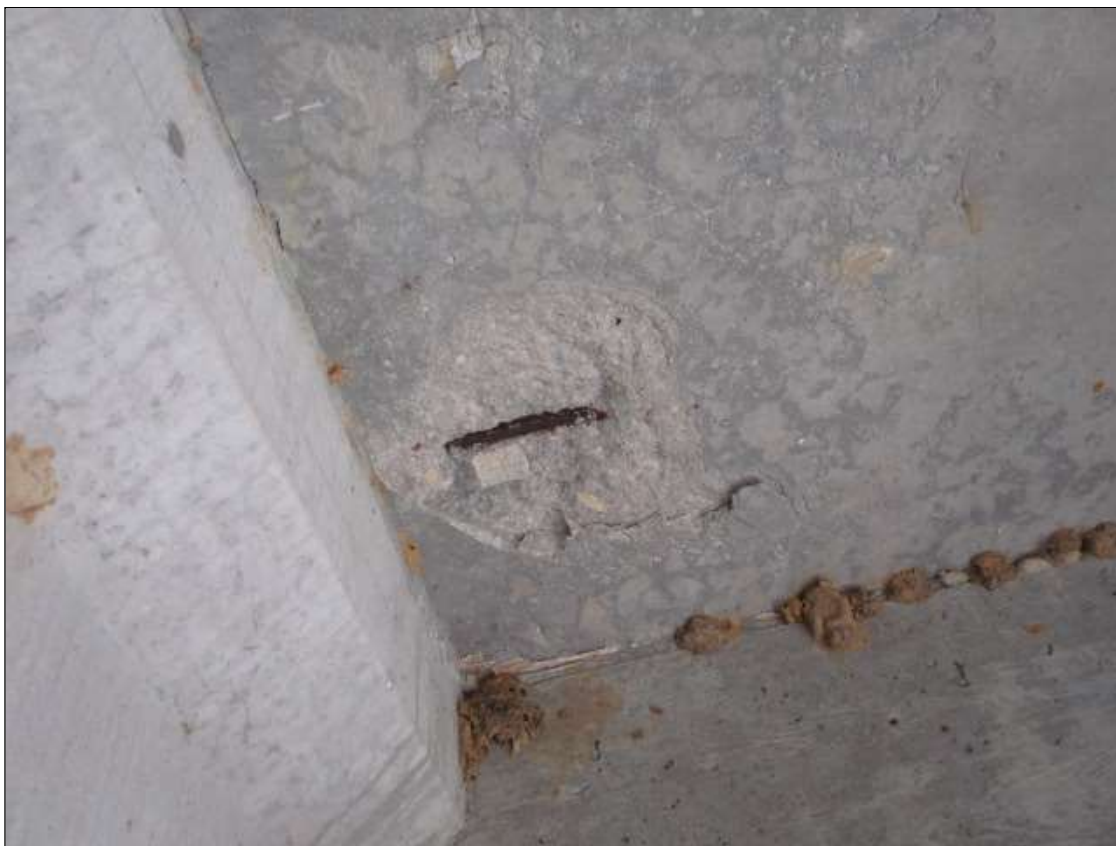
Span 49 Deck: 12" DIAMETER X 1" DEEP SPALL WITH EXPOSED REBAR WITH NO SECTION LOSS IN BAY 3 AT THE 1ST INTERMEDIATE DIAPHRAGM

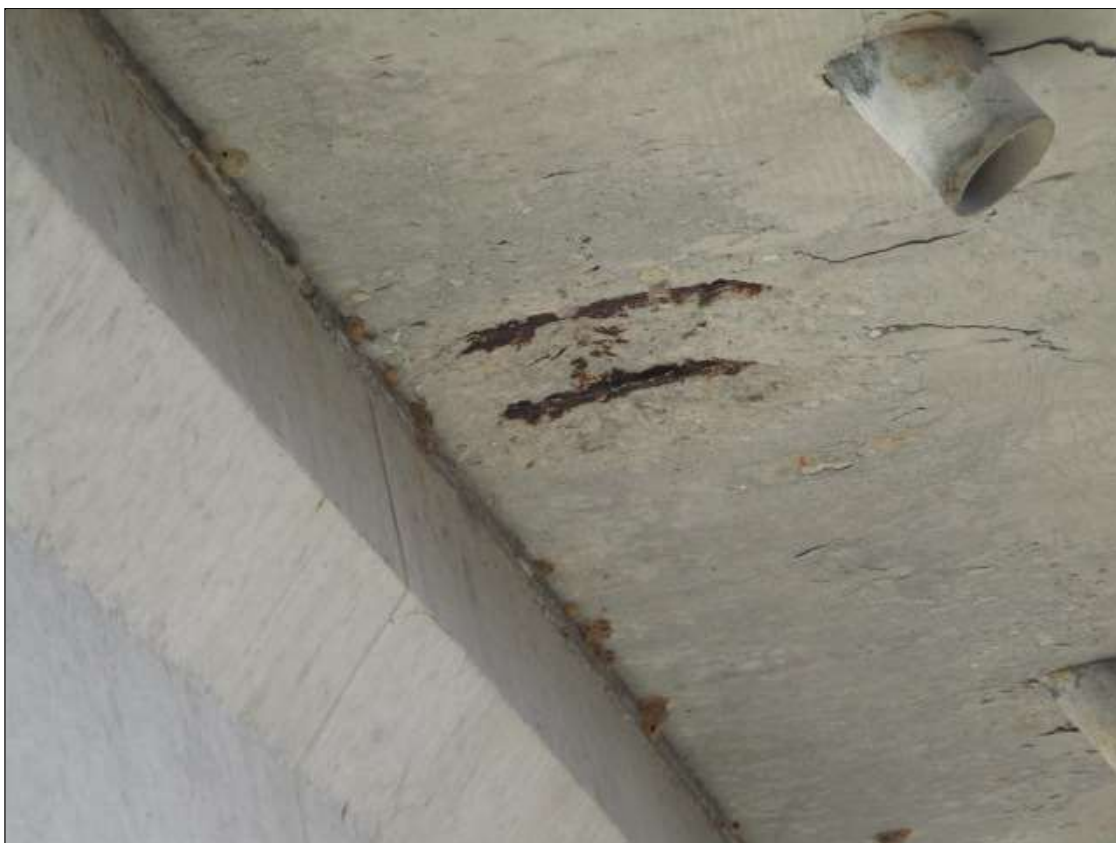
Span 49 Deck: underside of left overhang at 10' from bent 49, spall [18in diameter x 2in deep] with exposed rusted reinforcing [no section loss]

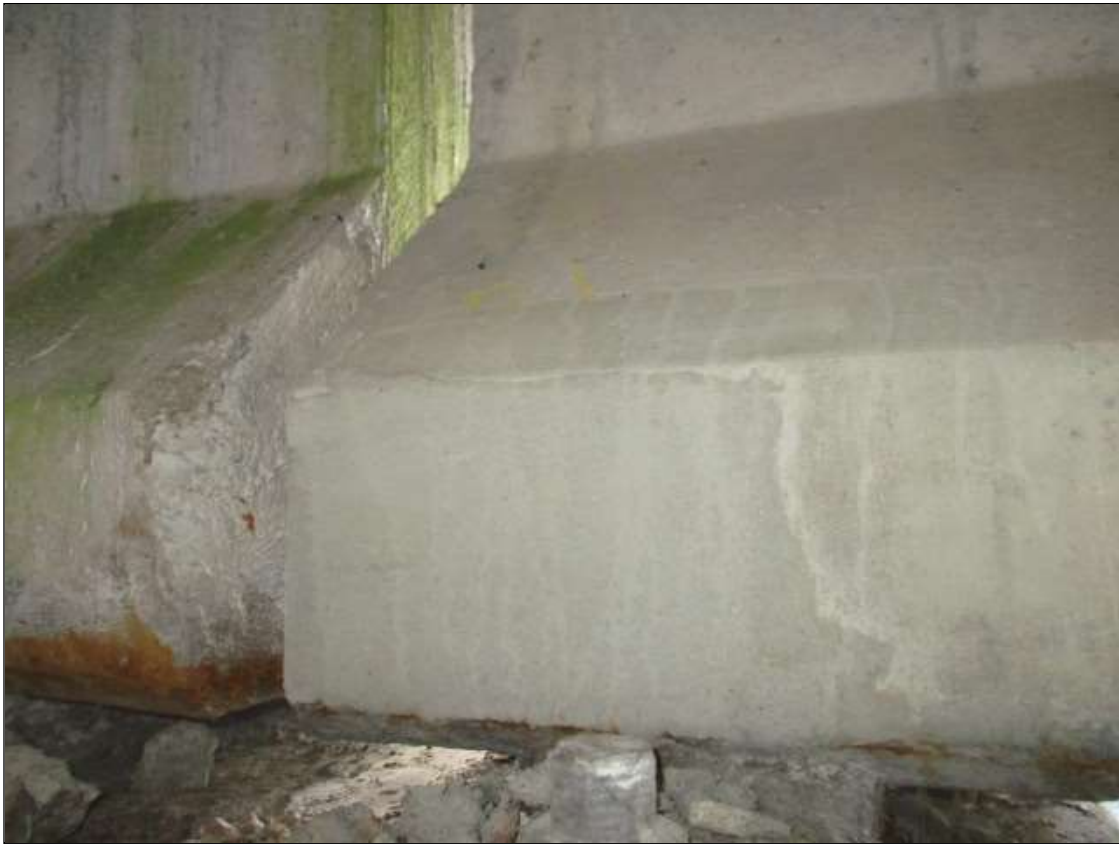
Span 51 Beam 1: 10" LONG X 8" TALL NEW REPAIR TO BOTTOM RIGHT FLANGE AT BENT 50

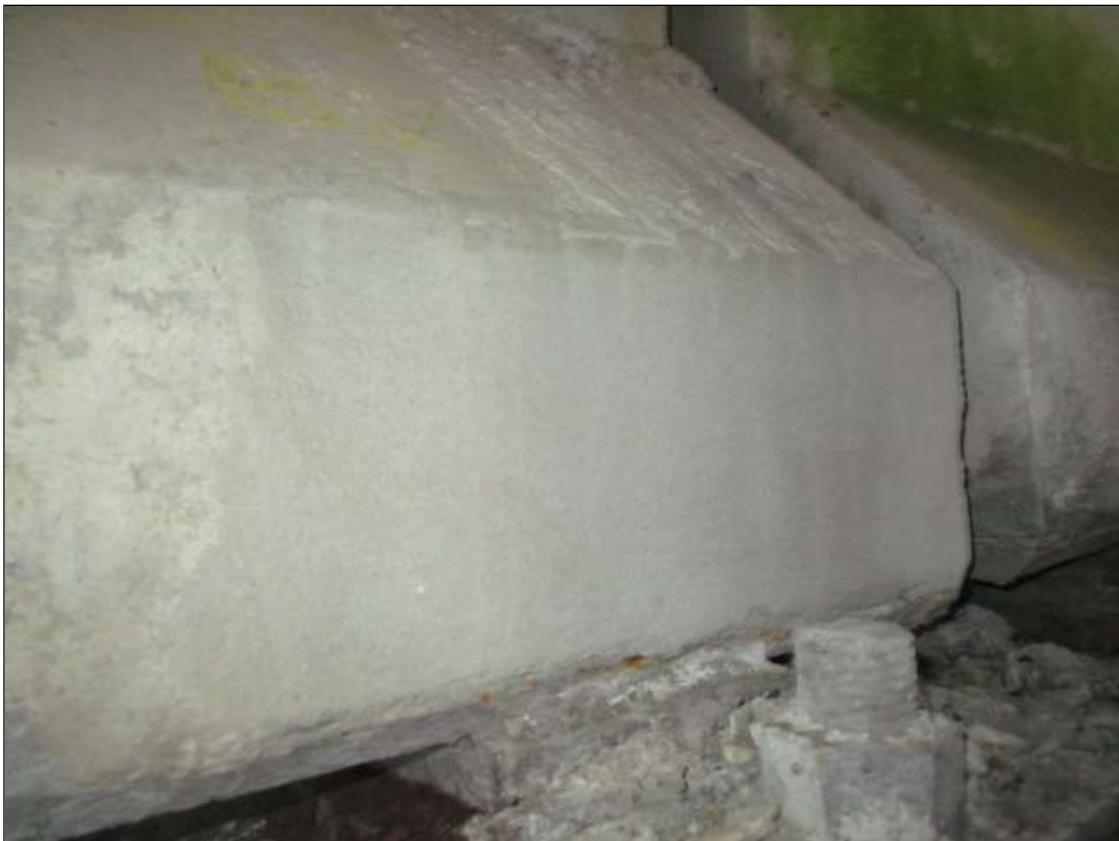
Span 51 Beam 2: 12" LONG X 8" TALL NEW REPAIR TO BOTTOM LEFT FLANGE AT BENT 50

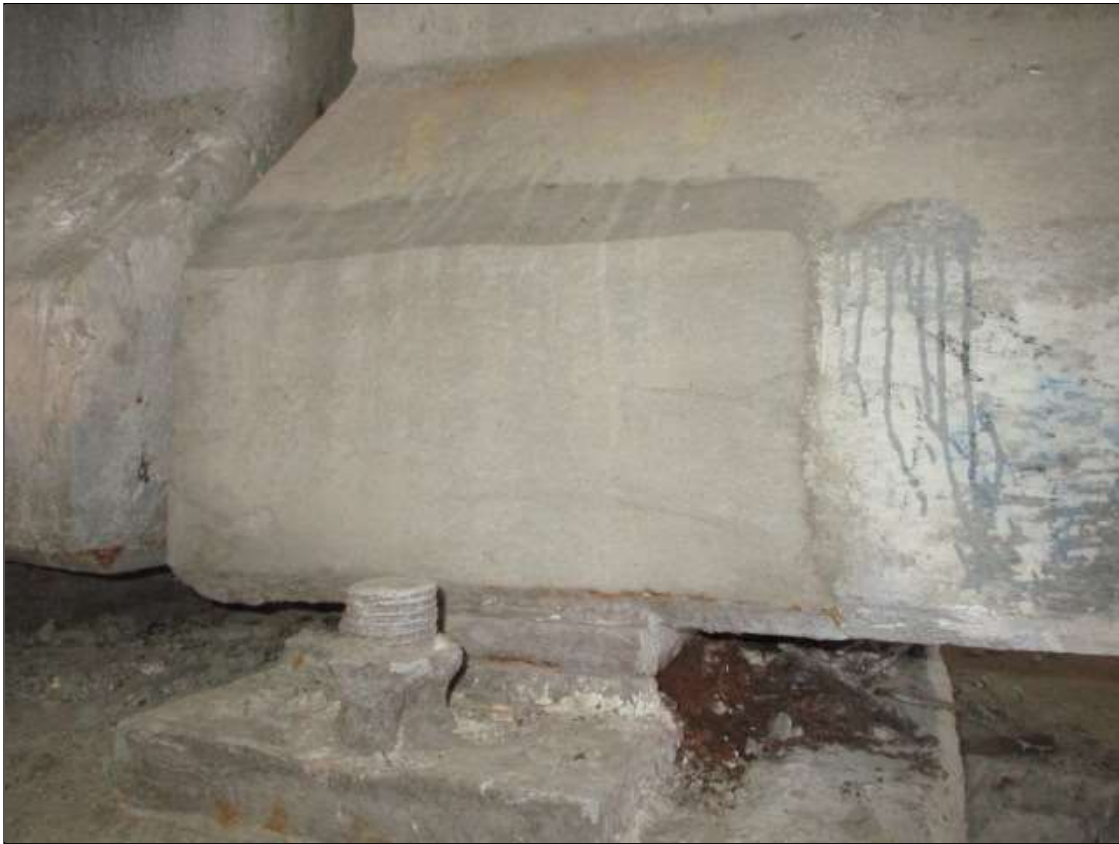
Span 51 Beam 2: 12" LONG X 10" TALL NEW REPAIR TO BOTTOM RIGHT FLANGE AT BENT 50

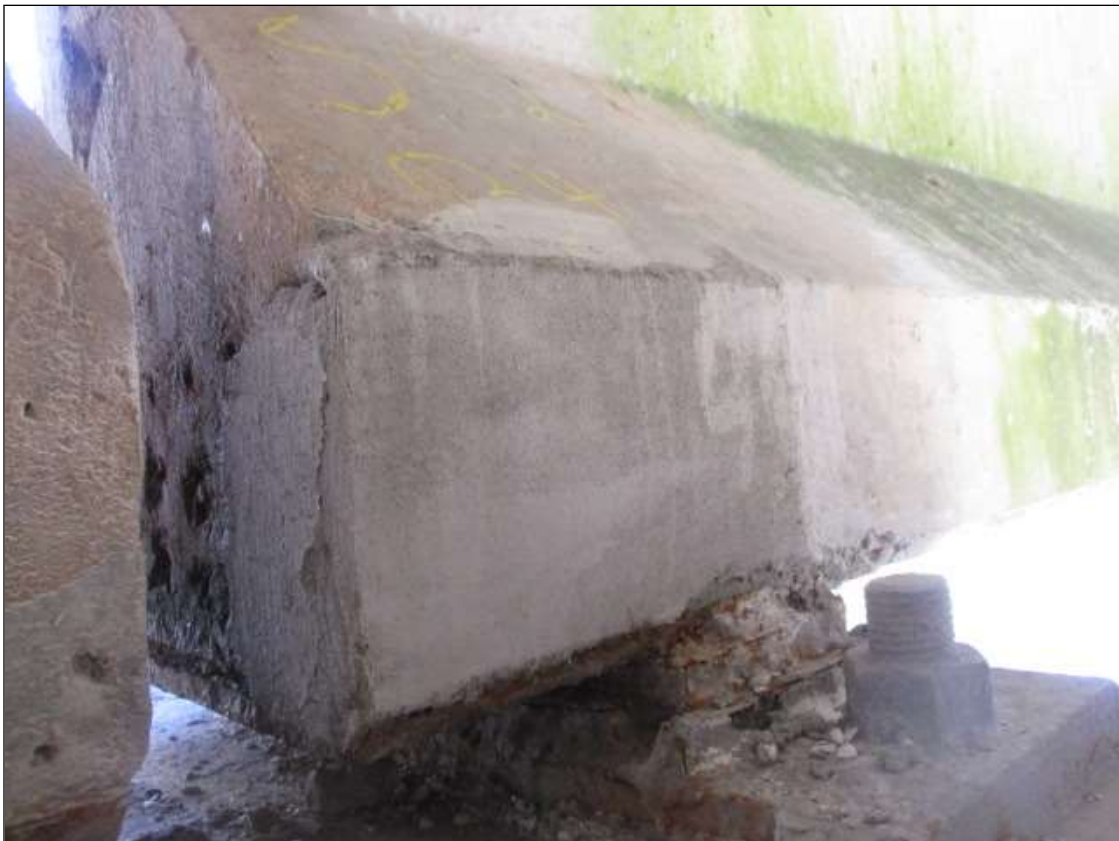
Span 52 Beam 4: 10" LONG X 8" TALL NEW REPAIR TO BOTTOM LEFT FLANGE AT BENT 52

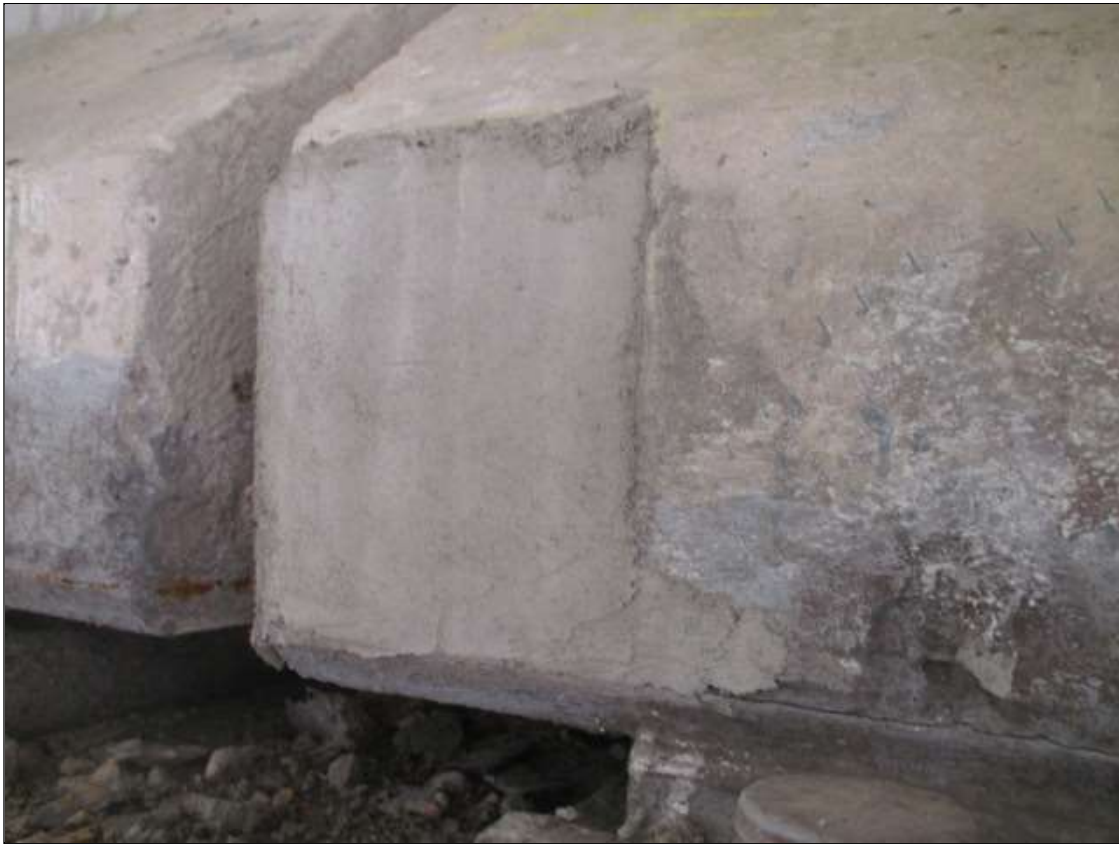
Span 53 Beam 2: 6" LONG X 8" TALL NEW REPAIR TO BOTTOM RIGHT FLANGE AT BENT 52

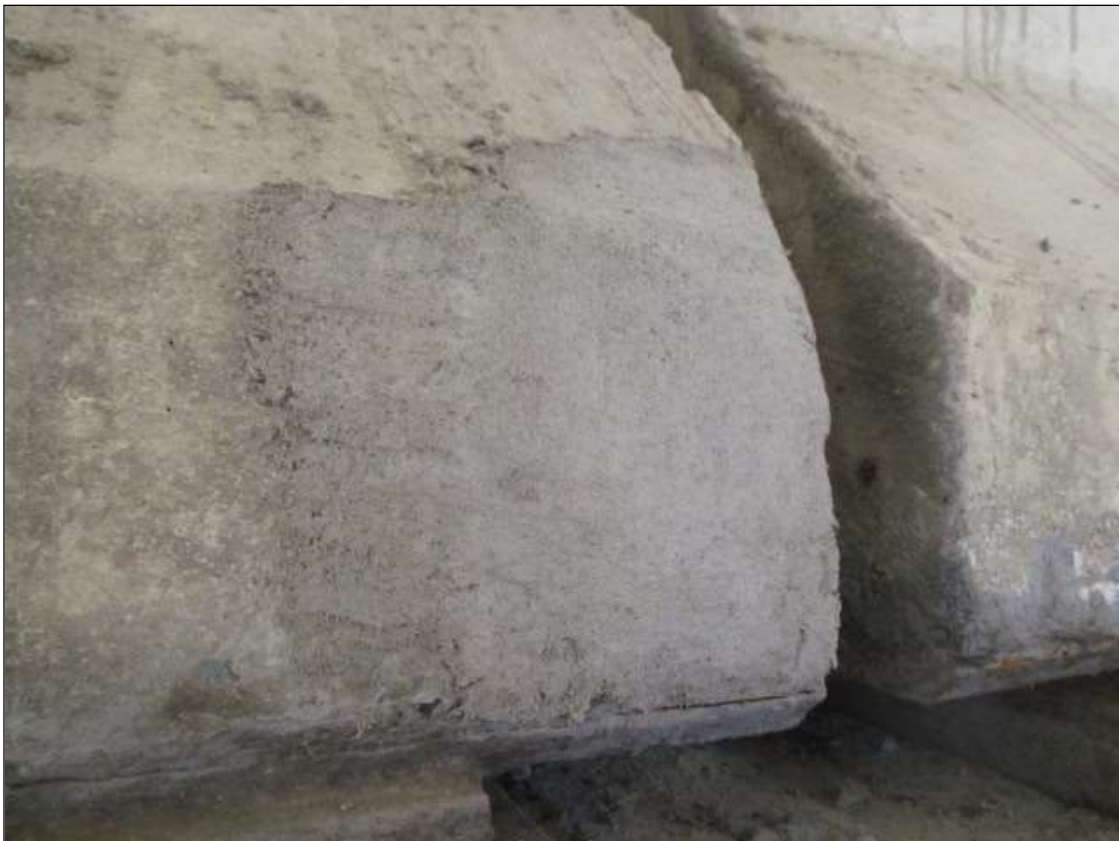
Span 53 Beam 2: SPAN 53 BEAM 2 LEFT BOTTOM FLANGE OVER BENT 52. sound patch [8in x 10in]

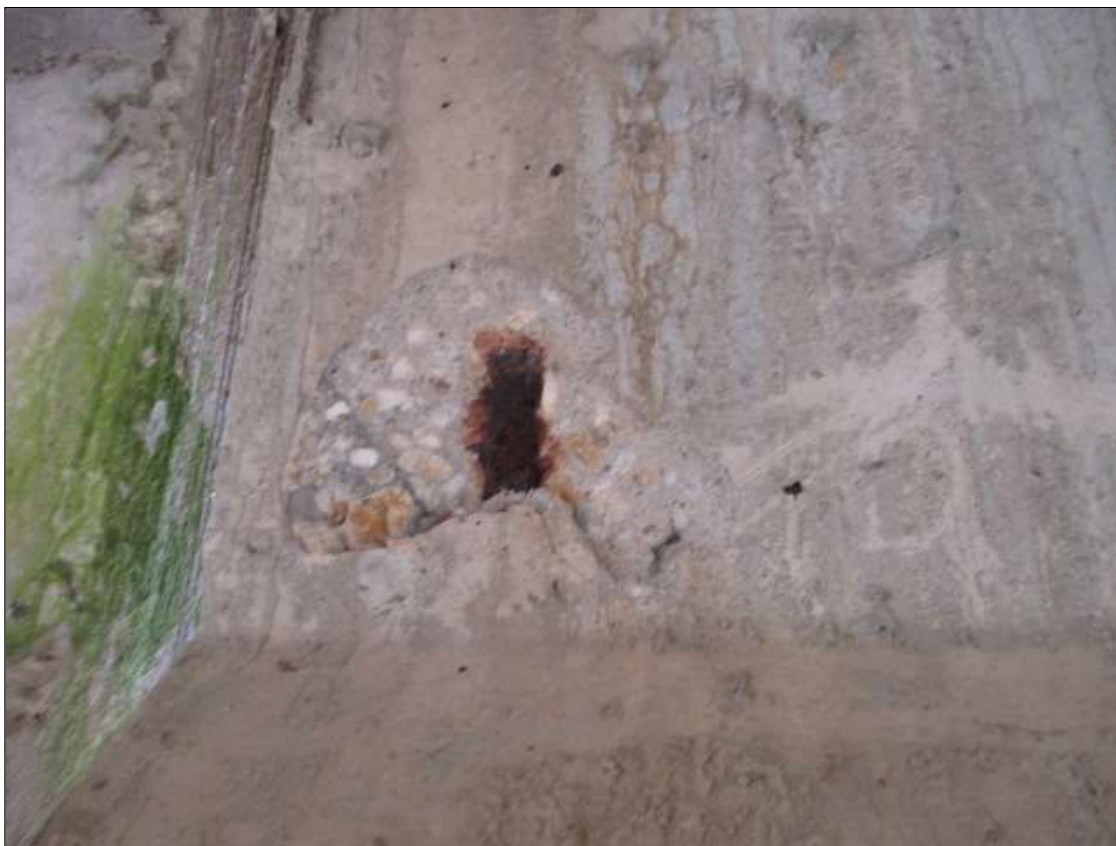
Span 53 Beam 1: SPAN 53 BEAM 1 RIGHT WEB OVER BENT 52. HAS A CRACK/SPALL AND DELAMINATED AREA WITH 1 REBAR VISIBLE. AREA IS: 4" x 5" x 1/2" DEEP. No section loss noted.

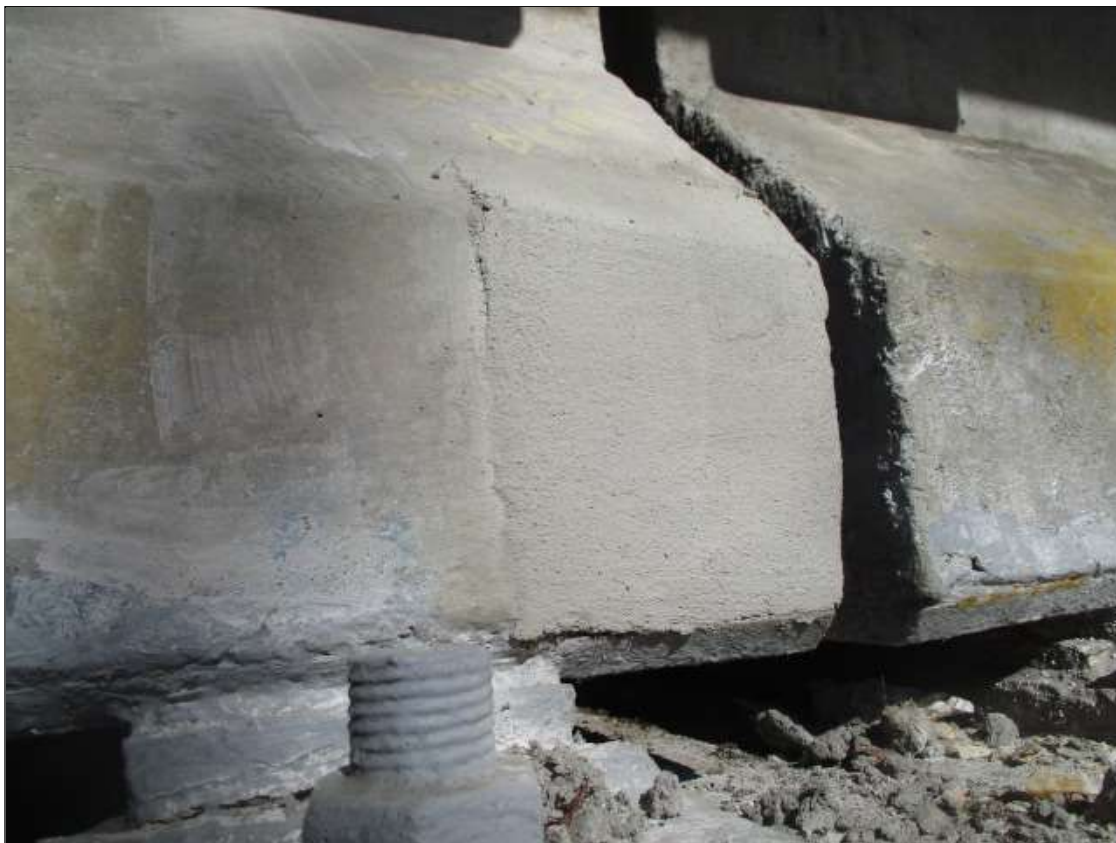
Span 53 Beam 1: 8" LONG X 10" TALL NEW REPAIR TO BOTTOM LEFT FLANGE AT BENT 52

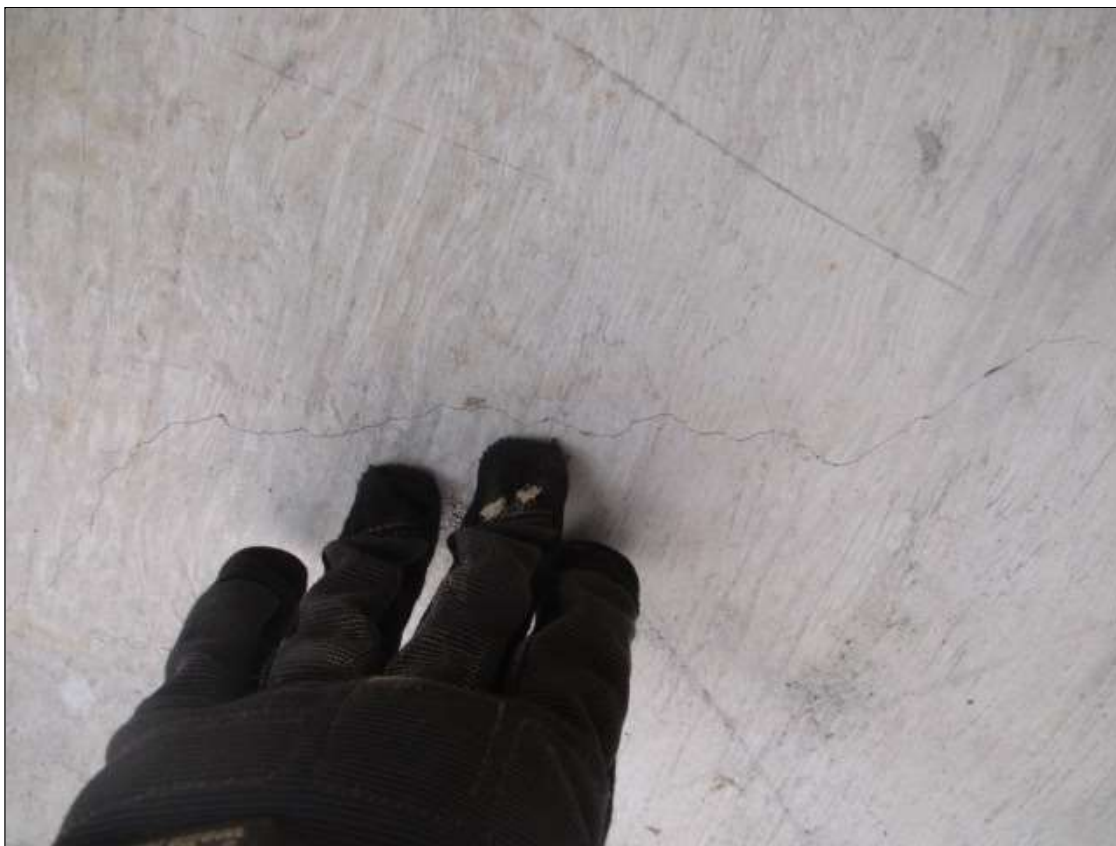
Span 53 Deck: SPAN 53 BOTTOM OF DECK HAS SCATTERED MAP CRACKING.

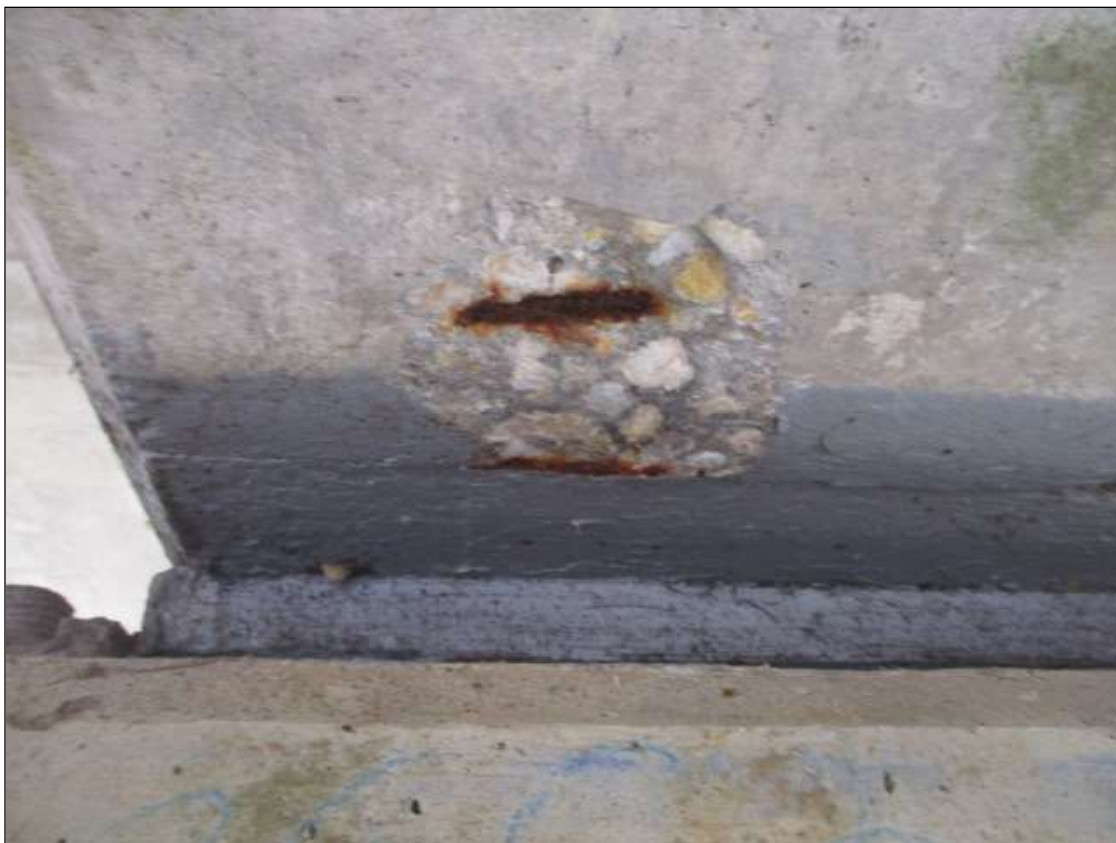
Span 53 Beam 2: underside of bottom flange at near end, spall [4in x 4in x 1/2in deep] with exposed stirrup [no section loss noted]

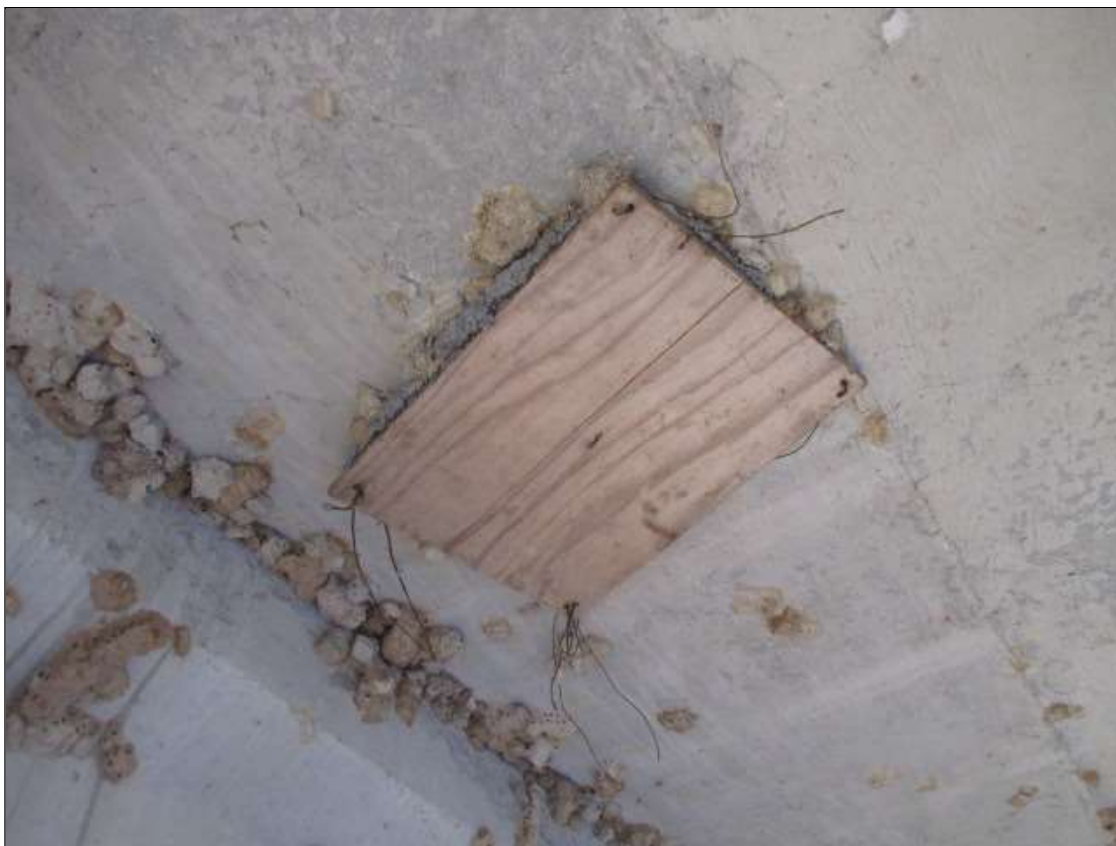
Span 54 Deck: 2' X 2' PATCHED AREA IN BAY 3 AT 30' FROM BENT 53

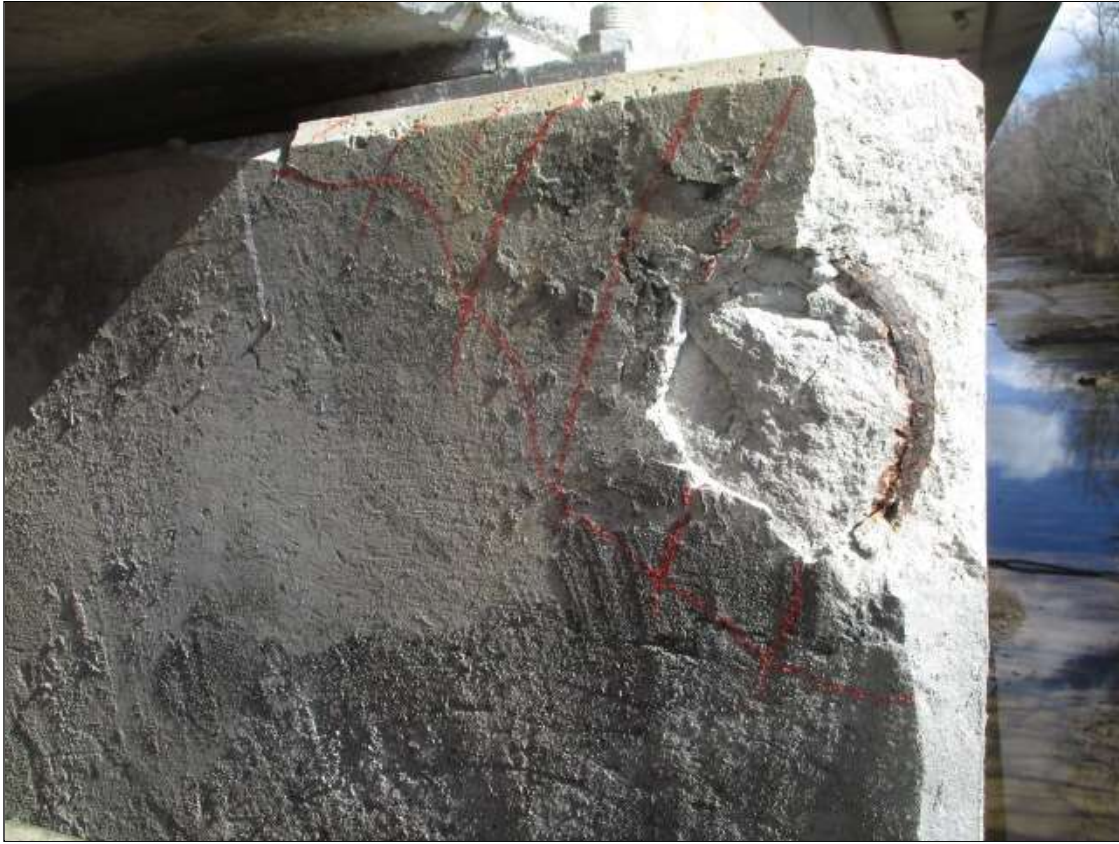
Bent 55 Cap 1: BENT 55 CAP TOP AND NORTH FACE UNDER GIRDER 1. HAS A SPALLED AND DELAMINATED AREA. AREA IS: FROM TOP EDGE BACK 6", FROM TOP EDGE DOWN 10" x 24", TOTAL AREA IS 2.5' LONG X 24" DELAMINATION WITH UP TO 8" DEEP SPALLING WITH EXPOSED REBAR

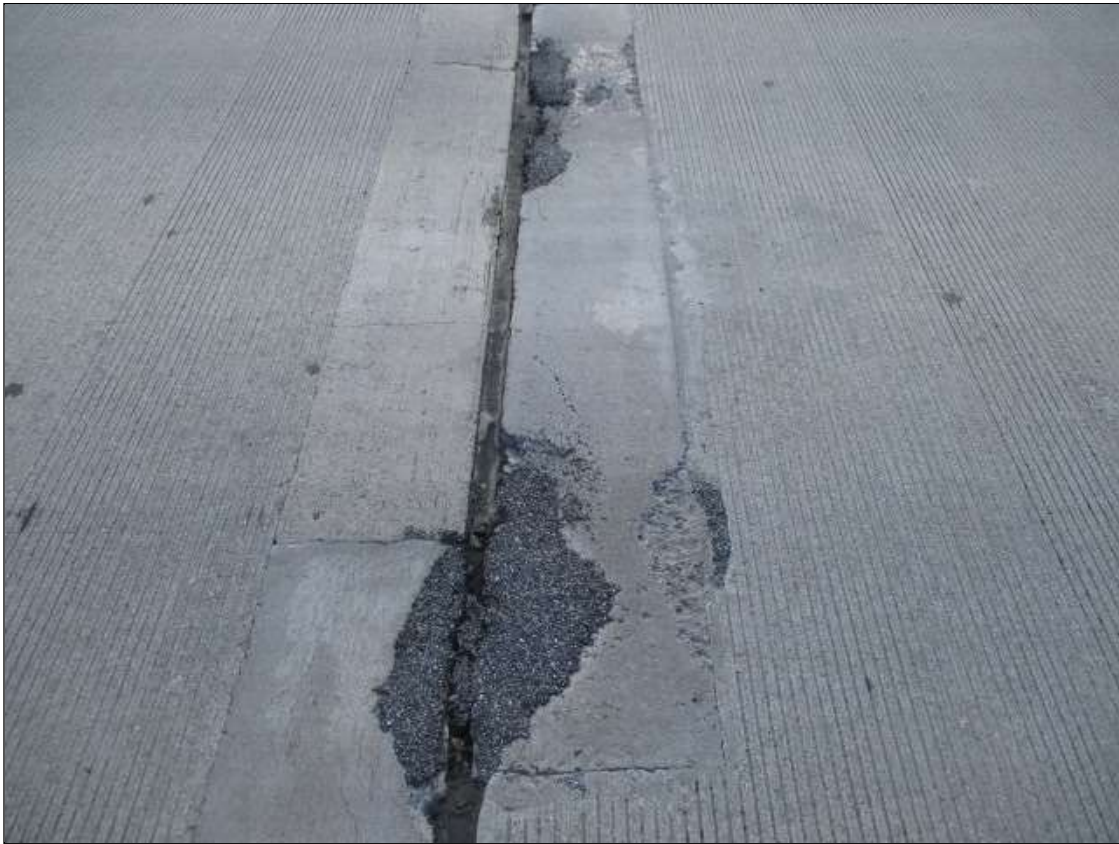
Span 59 Deck: 8' WIDE X 1' LONG CONCRETE AND ASPHALT PATCHED AREA IN NORTH BOUND LANE AT BENT 58

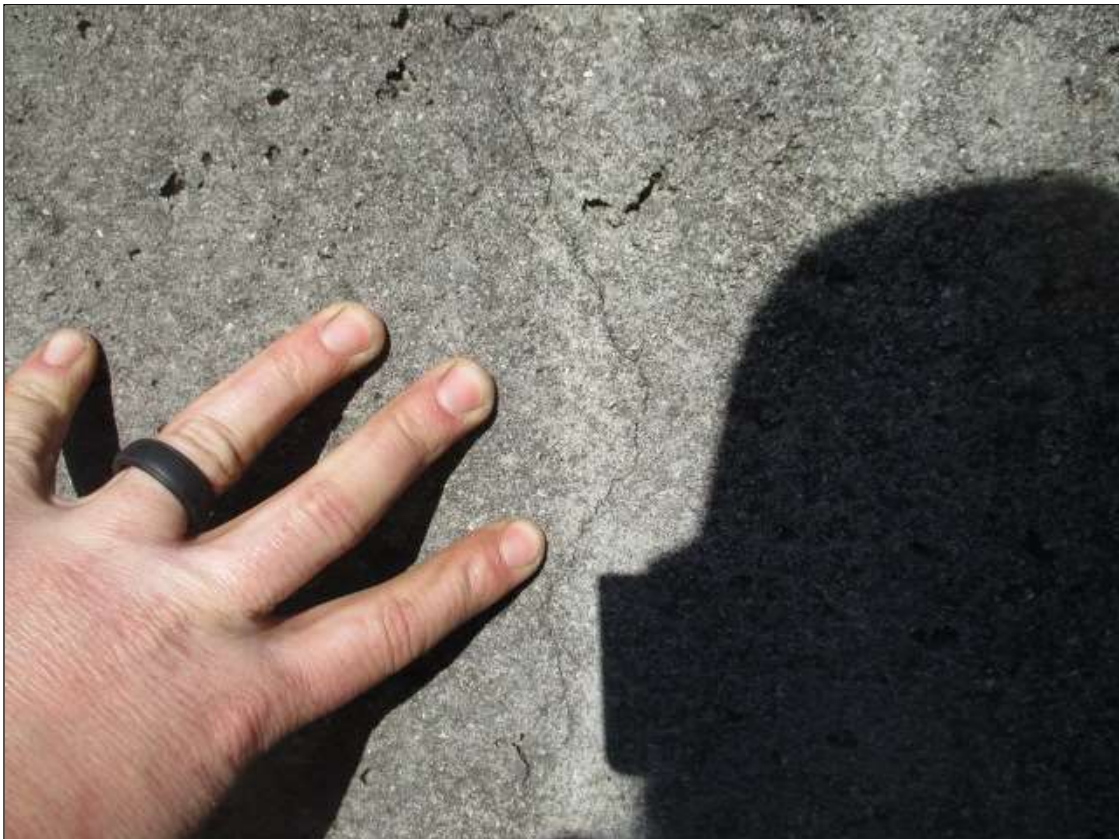
Bent 4 Footing: 1/32" VERTICAL CRACKING ALONG ALL FACES

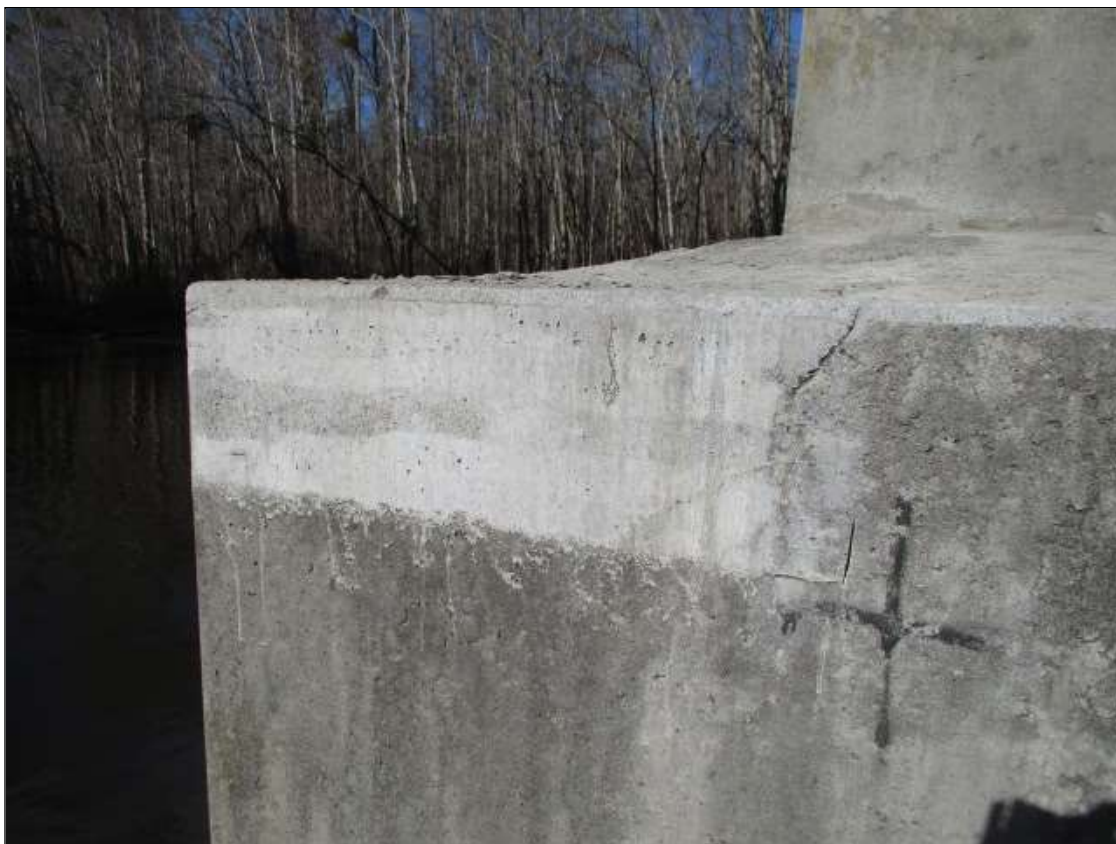
Bent 4 Footing: Northwest and Southwest corners, multiple sound patches [up to 3ft x 1ft]

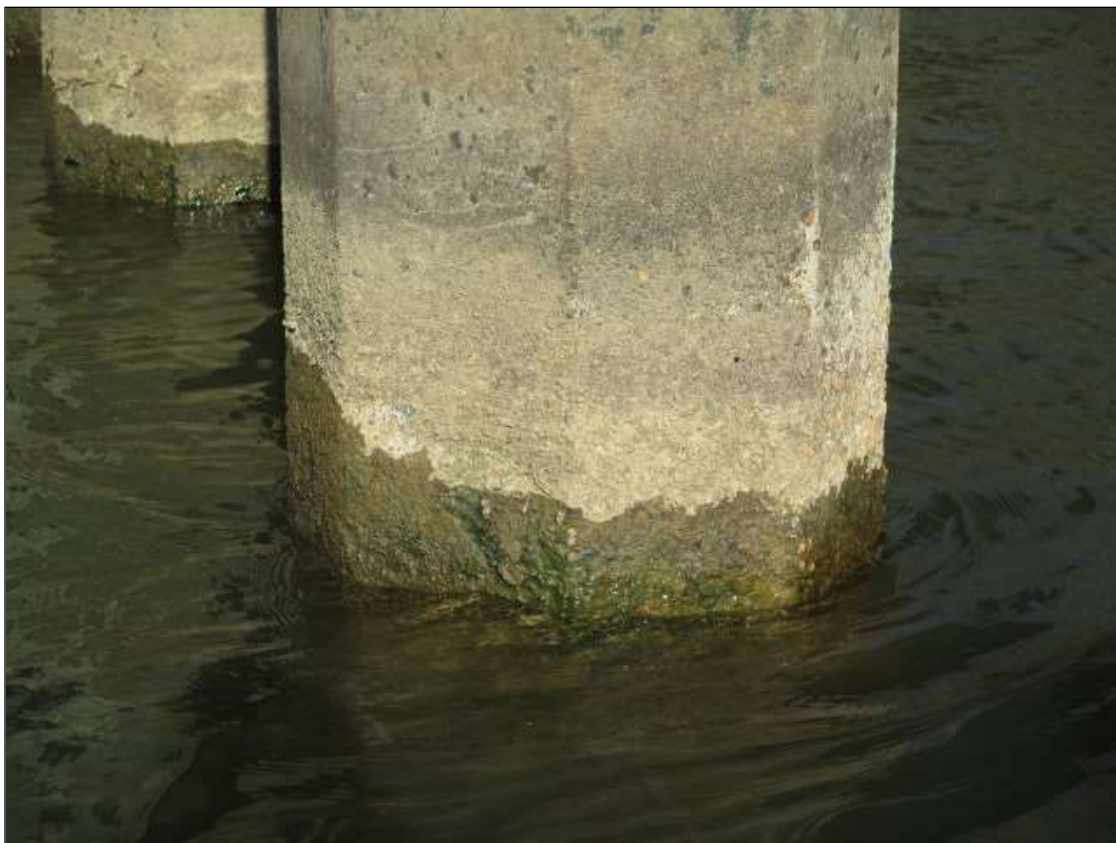
Bent 59 Pile 1: U/W INSPECTION, SCALING 1/2-1" DEEP WITH LOOSE AGGREGATE X 360° FROM WATERLINE DOWN 4'.

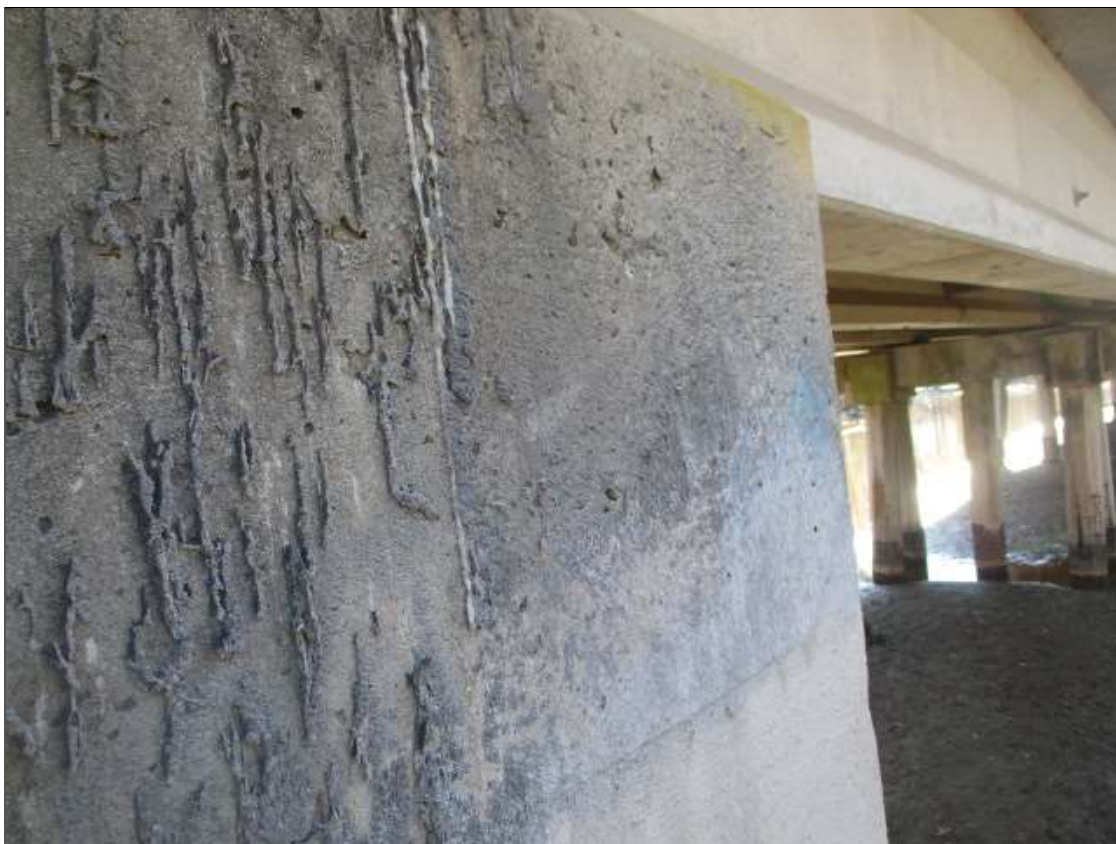
Bent 51 Cap 1: 18" WIDE X 18" TALL NEW REPAIR ON WEST FACE OF CAP

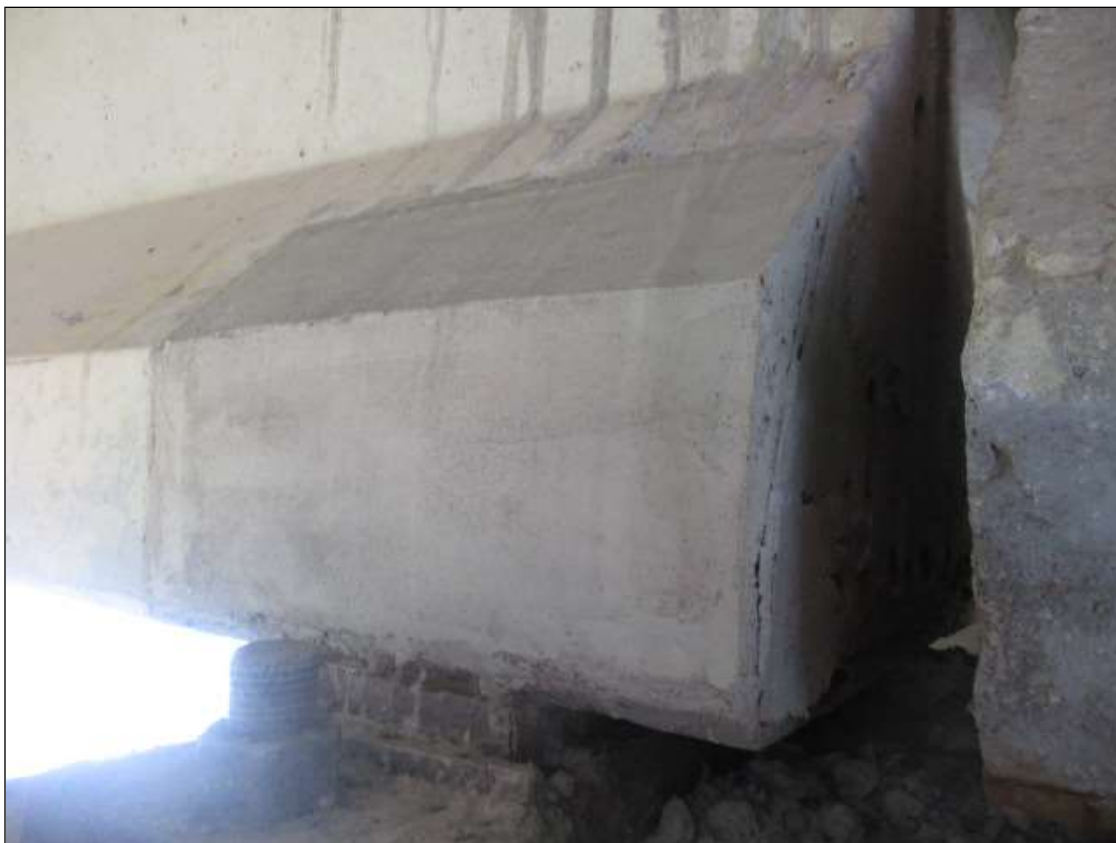
Span 61 Beam 3: 18" LONG X 12" TALL NEW REPAIR TO BOTTOM RIGHT FLANGE AT BENT 61

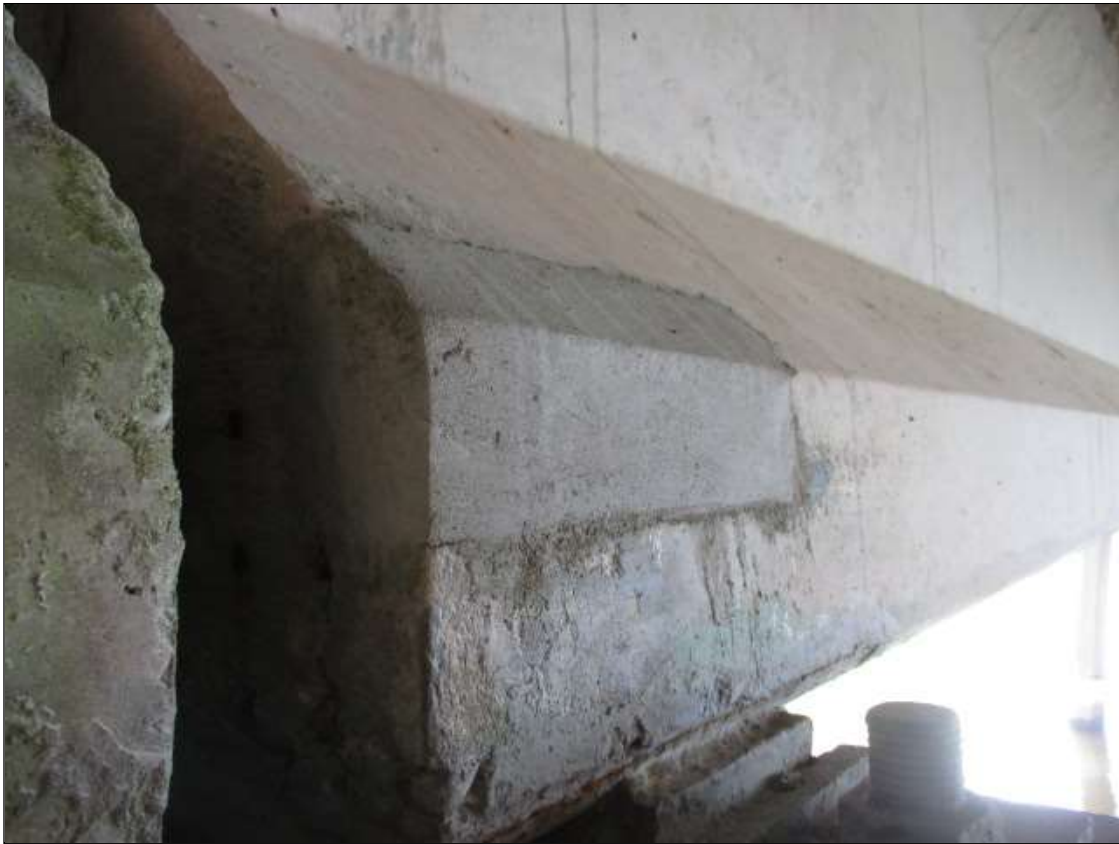
Span 61 Beam 3: 10" LONG X 4" TALL NEW REPAIR TO BOTTOM LEFT FLANGE AT BENT 61

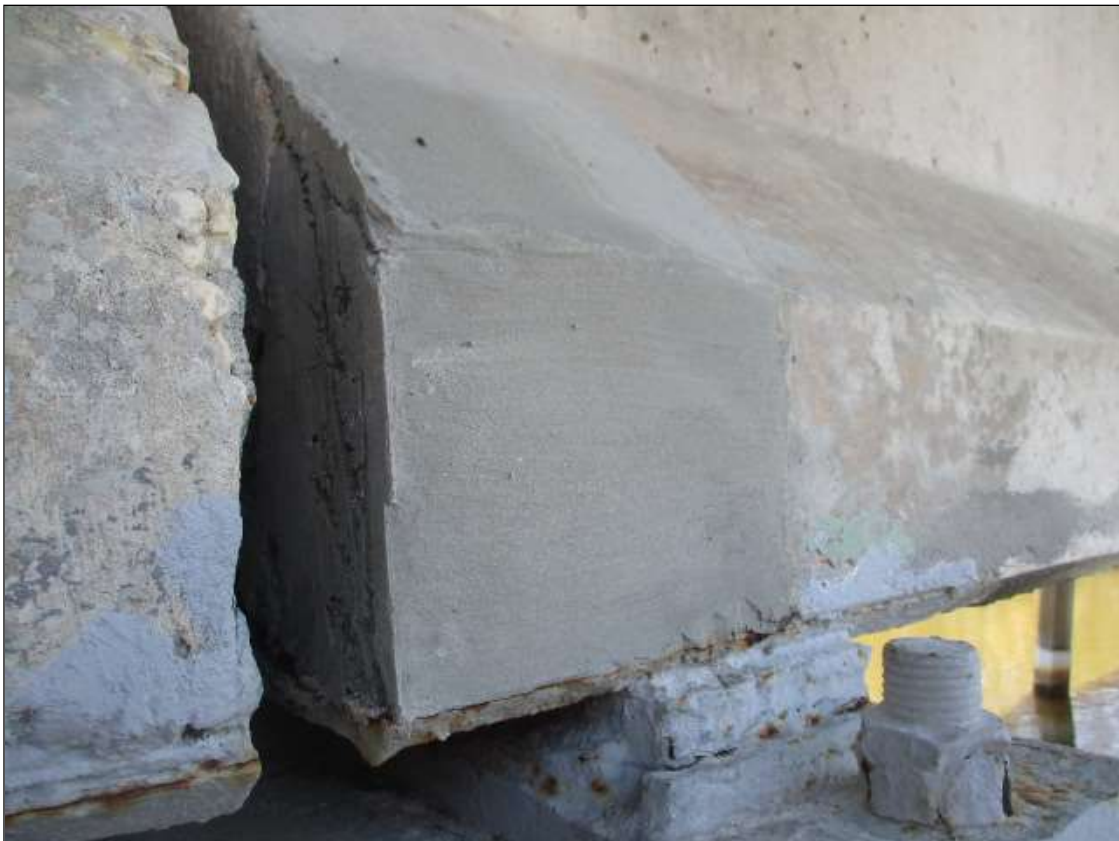
Span 61 Beam 1: SPAN 61 BEAM 1 LEFT BOTTOM FLANGE OVER BENT 61. sound patch [10in x 11in]

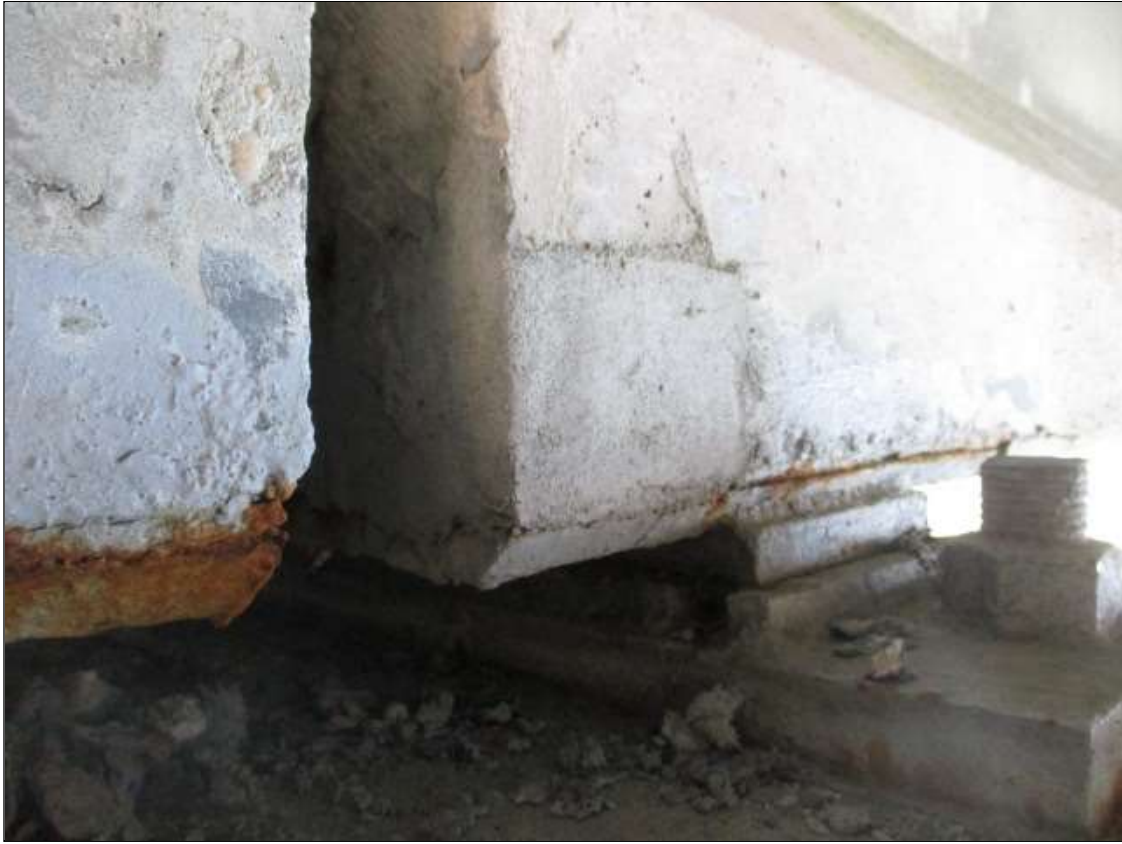
Span 61 Beam 2: 4" LONG X 4" TALL NEW REPAIR TO BOTTOM LEFT FLANGE AT BENT 61

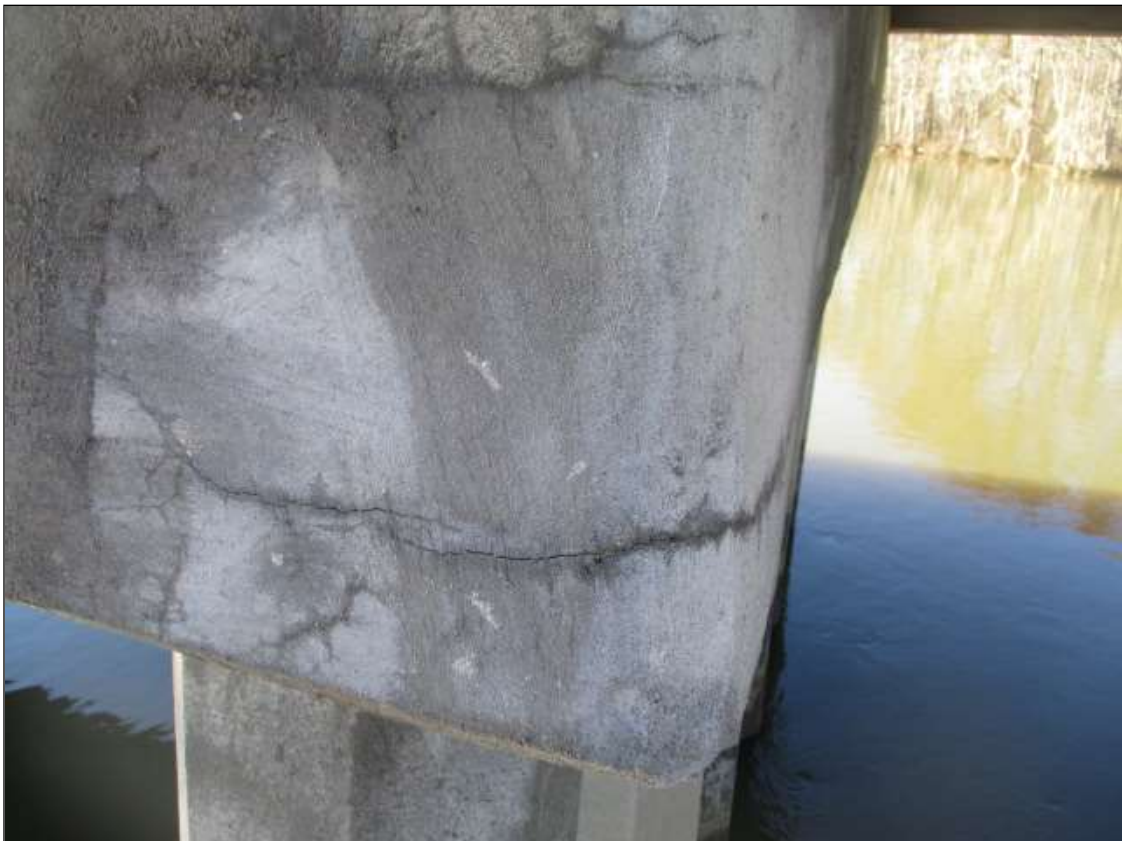
Bent 61 Cap 1: 1/32" HORIZONTAL CRACKING IN PATCHED AREA ON NORTHEAST CORNER
