APPENDIX E:
BRIDGE INSPECTION REPORT —
THREE RIVERS BRIDGE

THE BRITE BRIDGES:
Bridging Resources for Infrastructure and Thriving
Economies Project

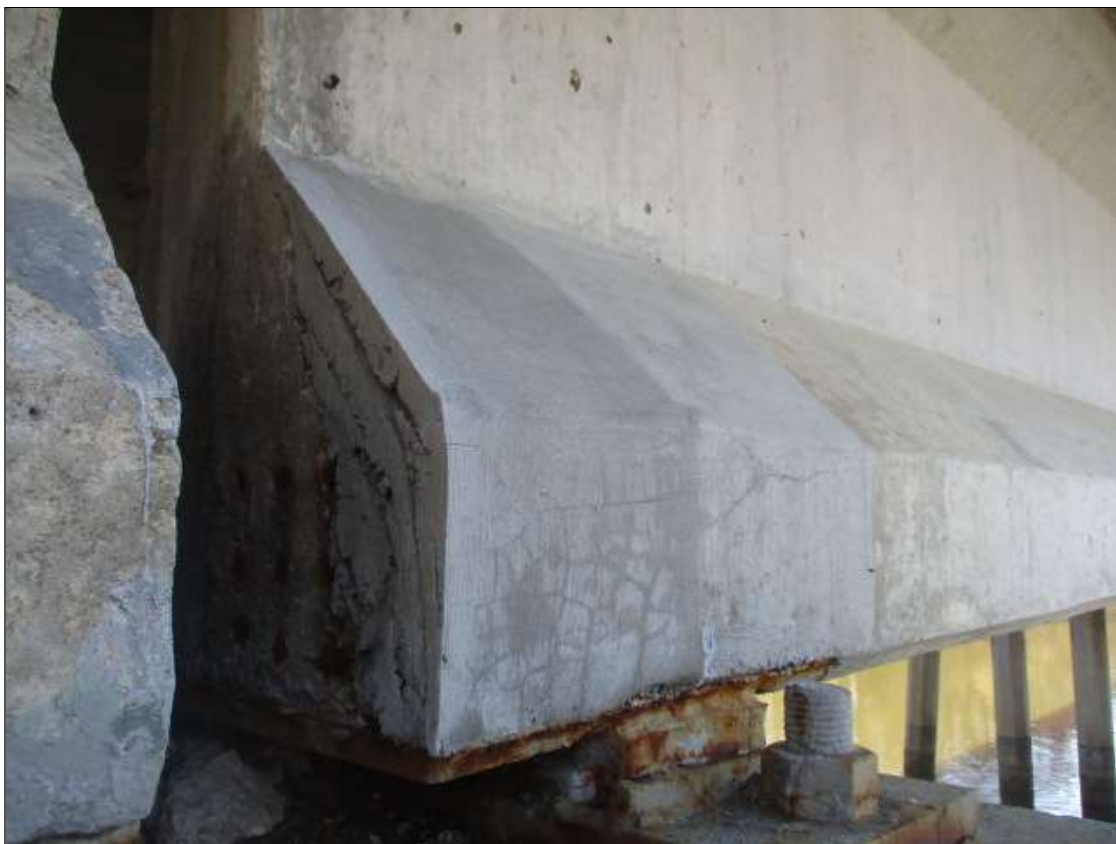
Span 62 Beam 1: SPAN 62 BEAM 1 LEFT BOTTOM FLANGE OVER BENT 62. sound patch [14in x 23in]

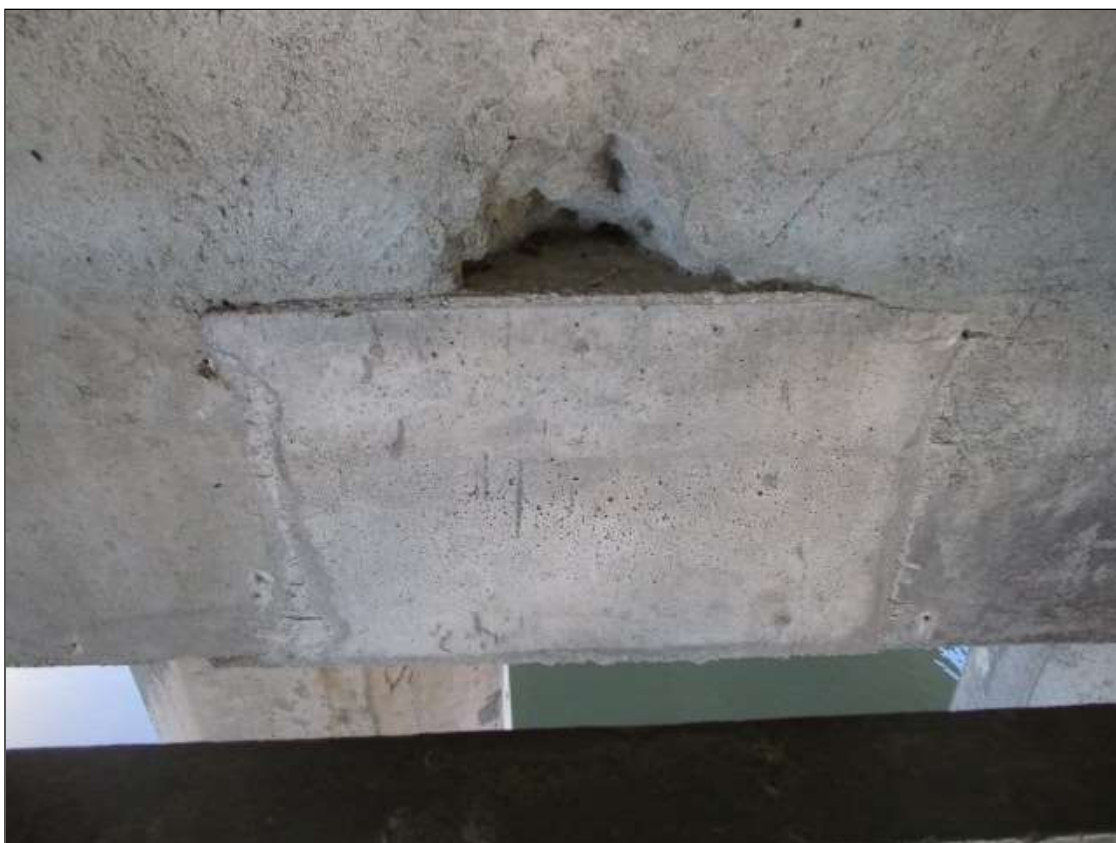
Bent 63 Cap 1: BENT 63 CAP NORTH FACE BAY 2. HAS A SPALLED AREA. AREA IS: 5" x 10" x 4" DEEP.

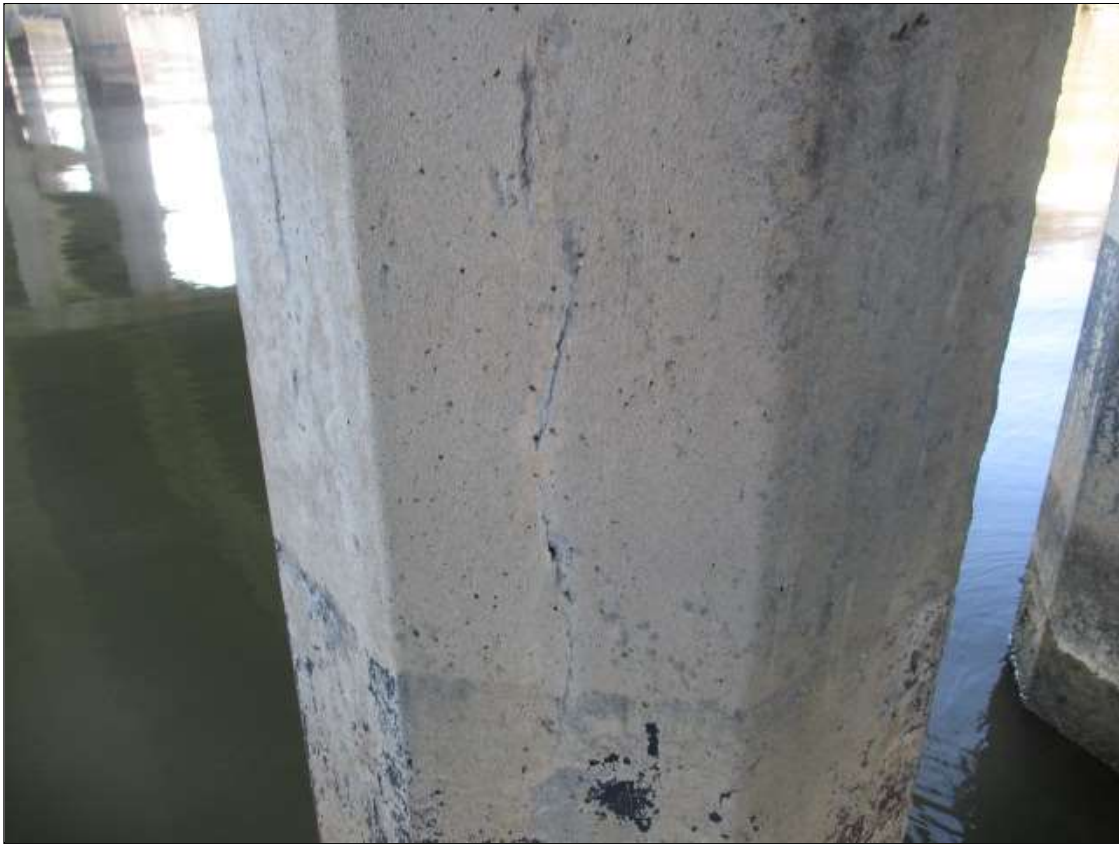
Bent 63 Pile 4: 1/64" VERTICAL CRACKING ON ALL FACES

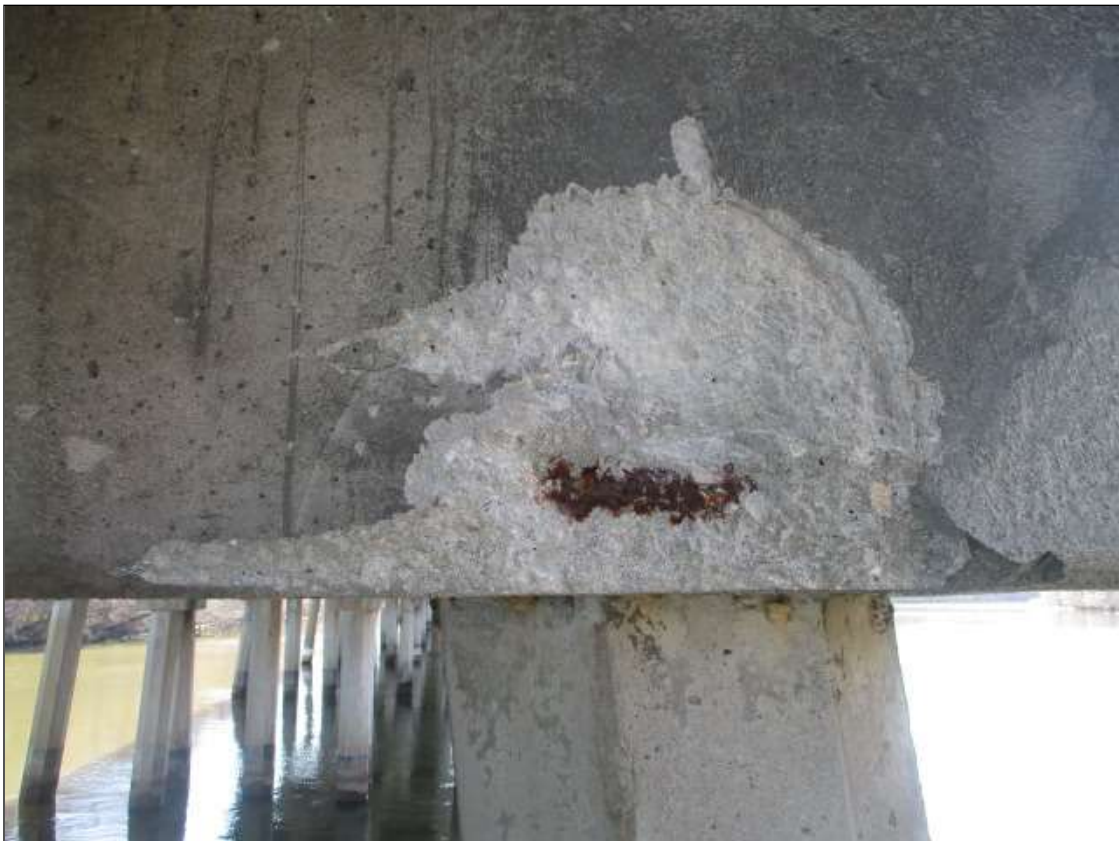
Bent 63 Cap 1: 30" LONG X 18" TALL X 2" DEEP SPALL WITH EXPOSED REBAR WITH NO SECTION LOSS ON NORTH FACE UNDER GIRDER 1

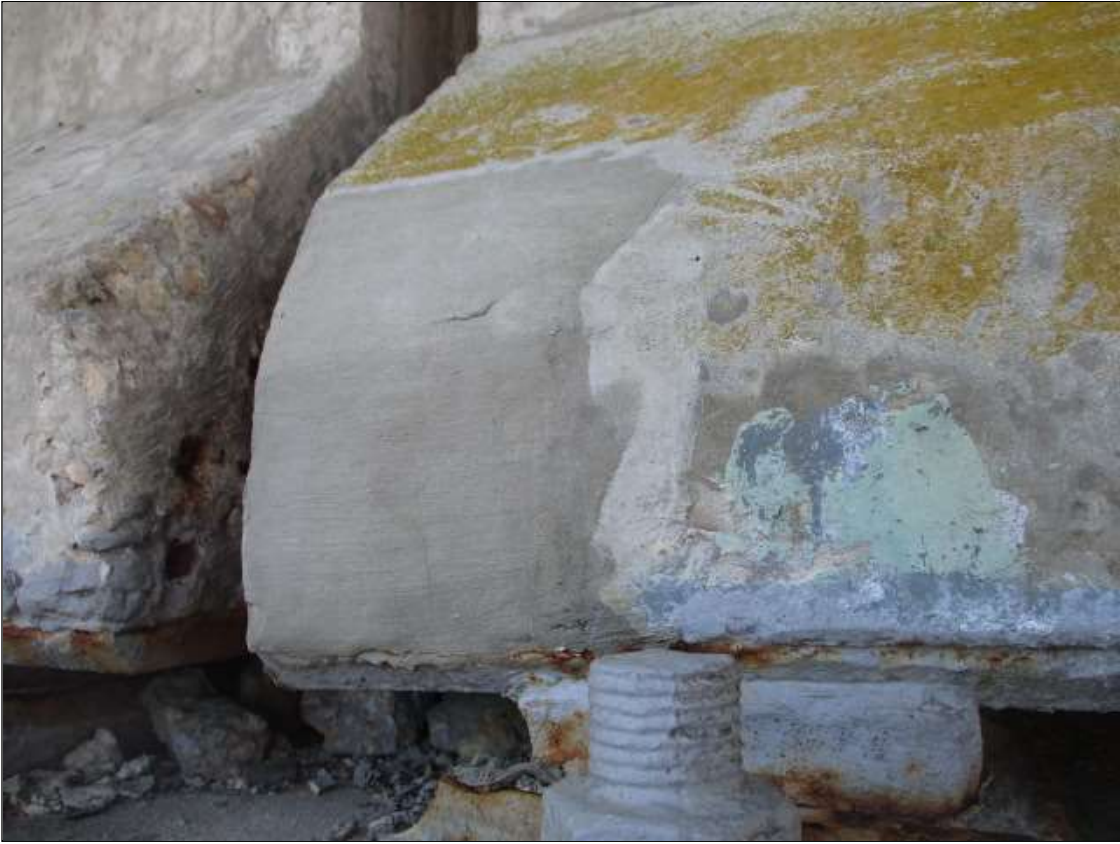
Span 66 Beam 4: SPAN 66 BEAM 4 RIGHT BOTTOM FLANGE OVER BENT 65. sound patch [8in x 8in]

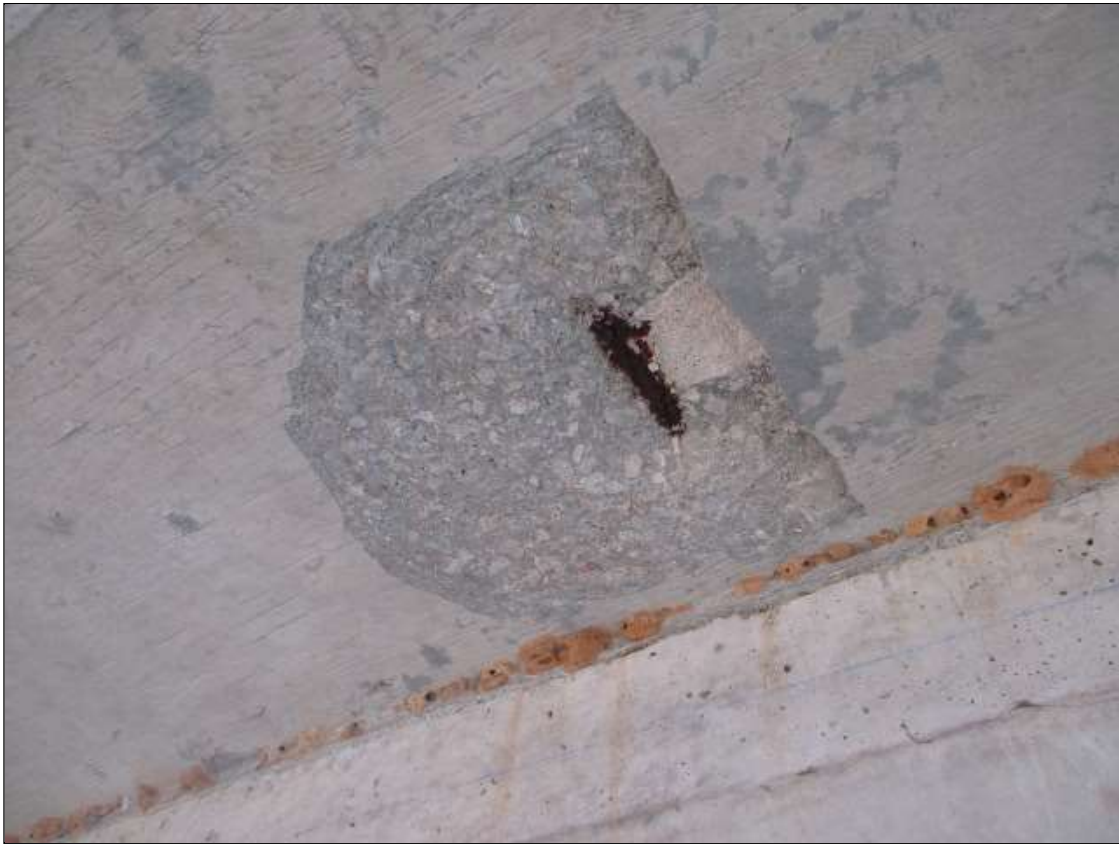
Span 68 Deck: 18" DIAMETER X 1/2" DEEP SPALL WITH EXPOSED REBAR WITH NO SECTION LOSS IN LEFT OVERHANG AT 5' FROM BENT 67

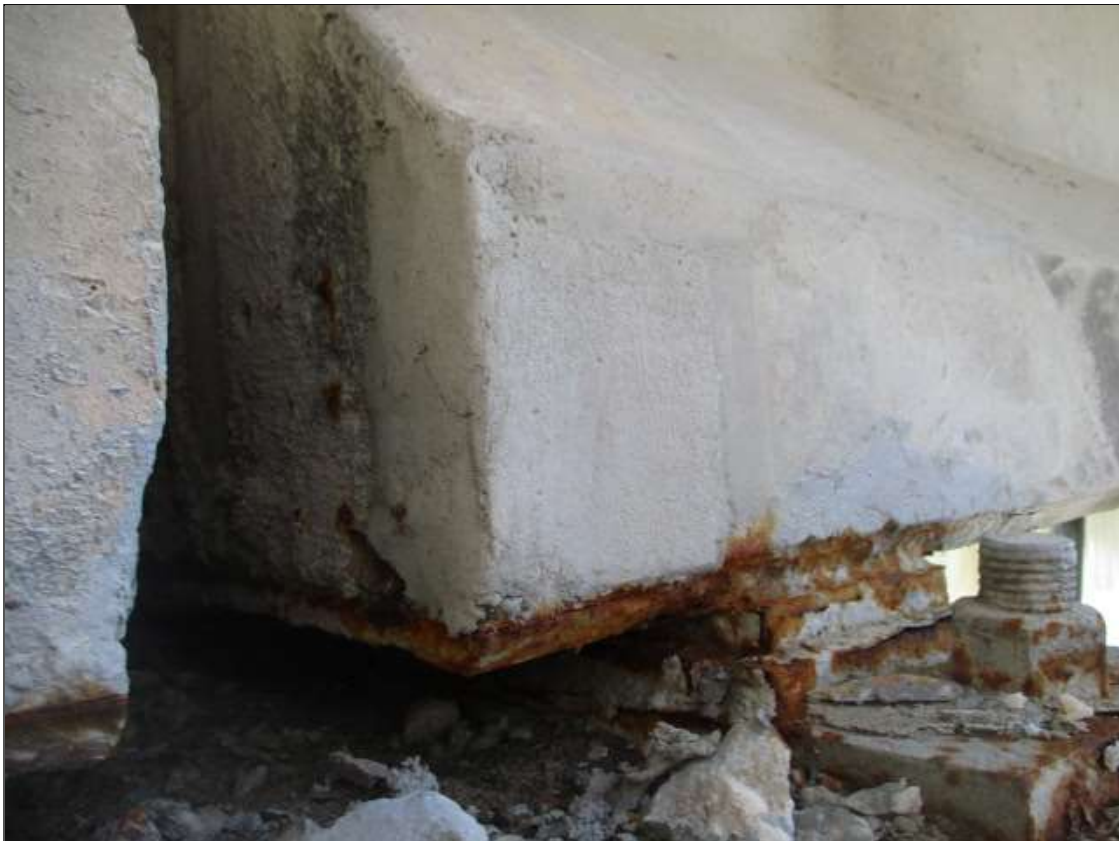
Span 69 Beam 1: 6" LONG X 6" TALL NEW REPAIR TO BOTTOM LEFT FLANGE AT BENT 69

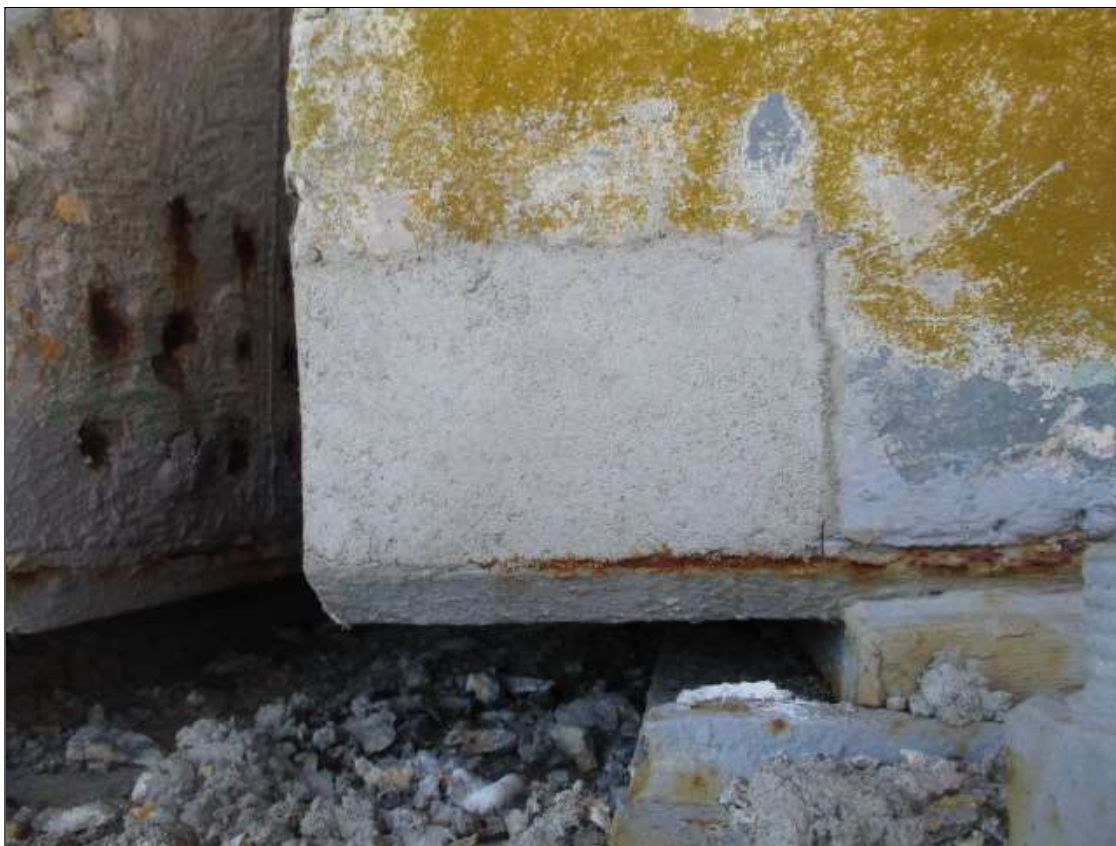
Span 70 Beam 4: 6" LONG X 4" TALL NEW REPAIR TO BOTTOM RIGHT FLANGE AT BENT 69

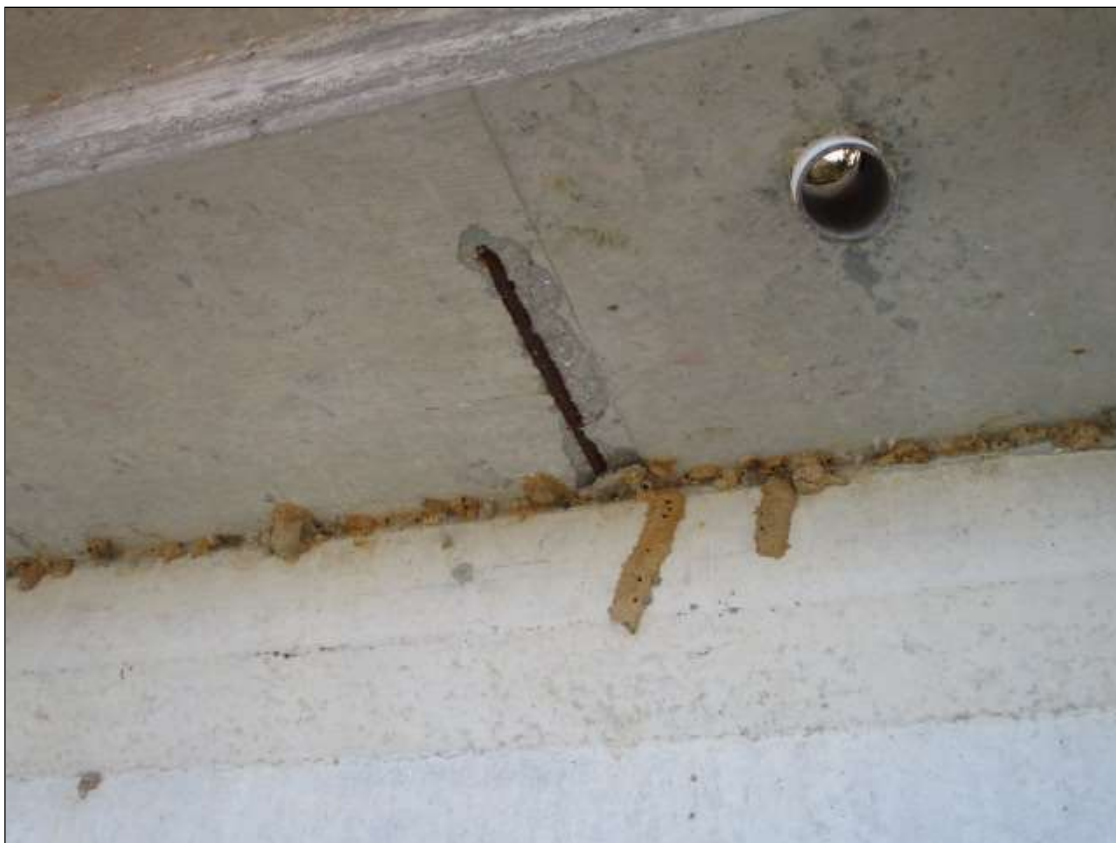
Span 69 Deck: 18" WIDE X 3" LONG X 1/2" DEEP SPALL WITH EXPOSED REBAR WITH NO SECTION LOSS IN RIGHT OVERHANG AT 10' FROM BENT 69

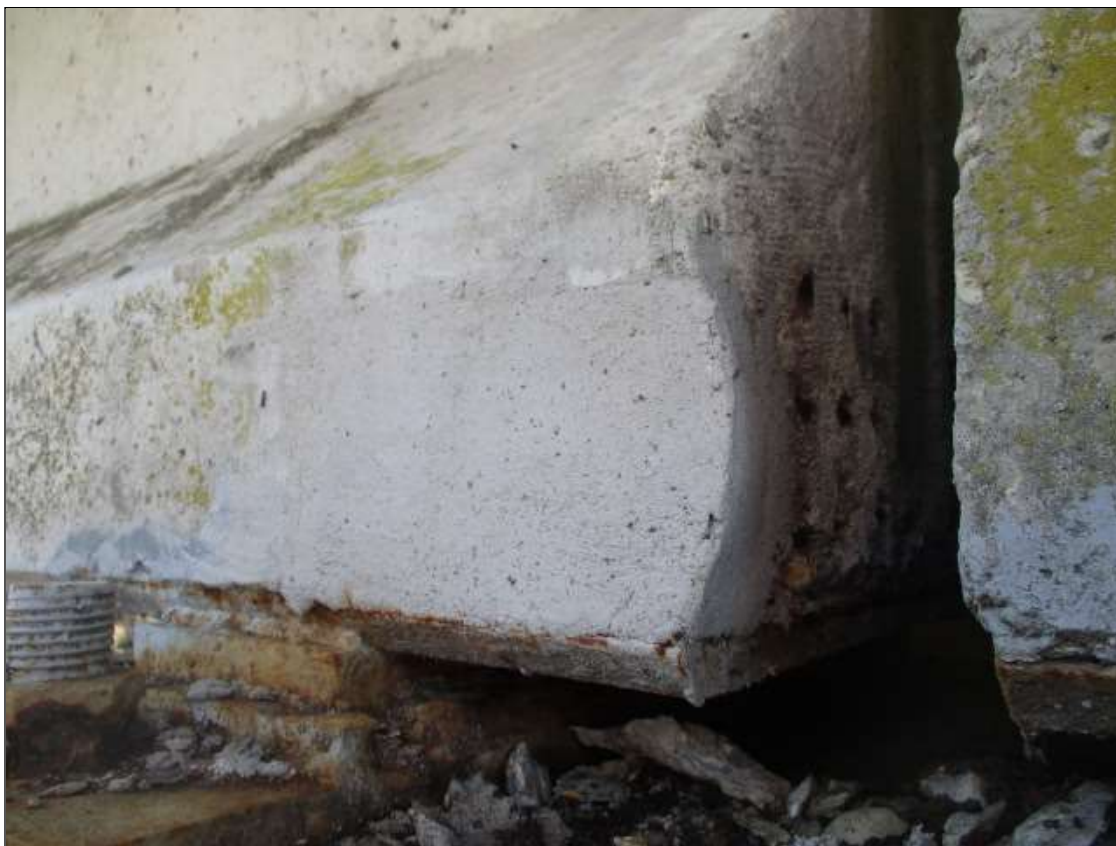
Span 75 Beam 4: 8" LONG X 6" TALL NEW REPAIR TO BOTTOM RIGHT FLANGE AT BENT 75

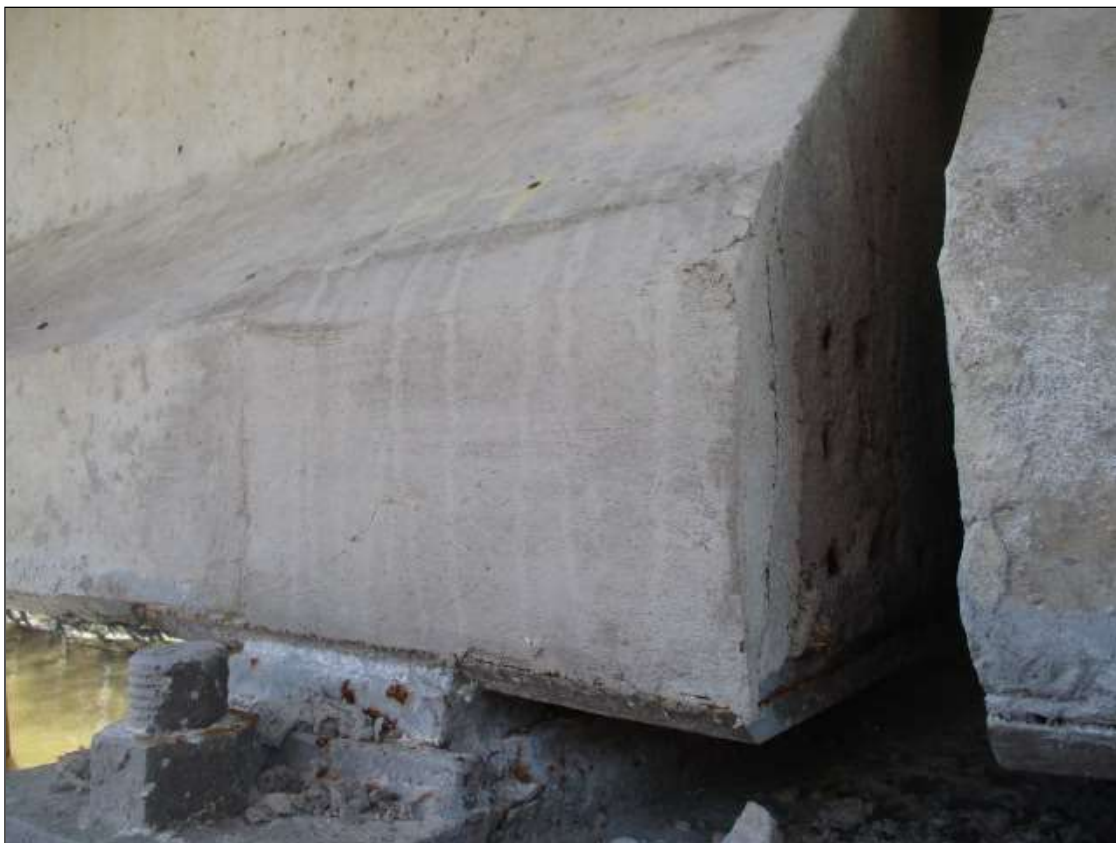
Span 76 Beam 4: 12" LONG X 10" TALL NEW REPAIR TO BOTTOM RIGHT FLANGE AT BENT 76

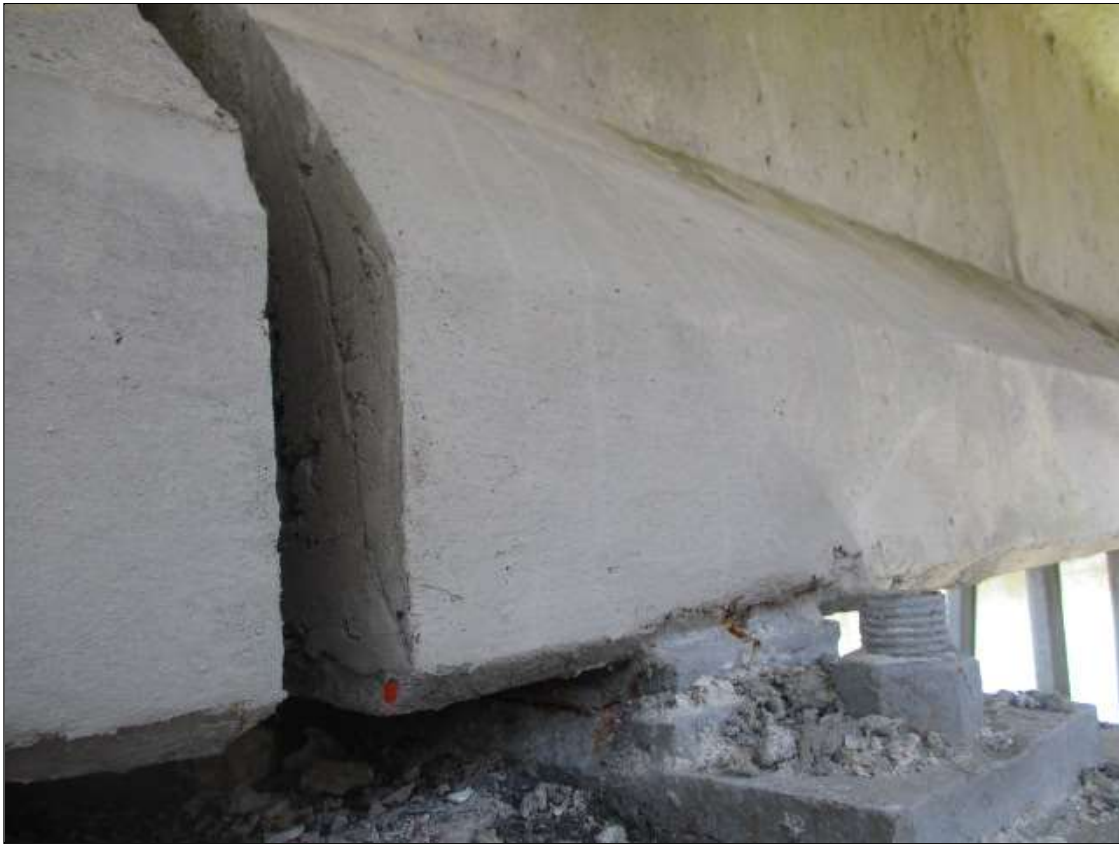
Span 76 Beam 1: 24" LONG X 18" TALL NEW REPAIR TO BOTTOM LEFT FLANGE AT BENT 76

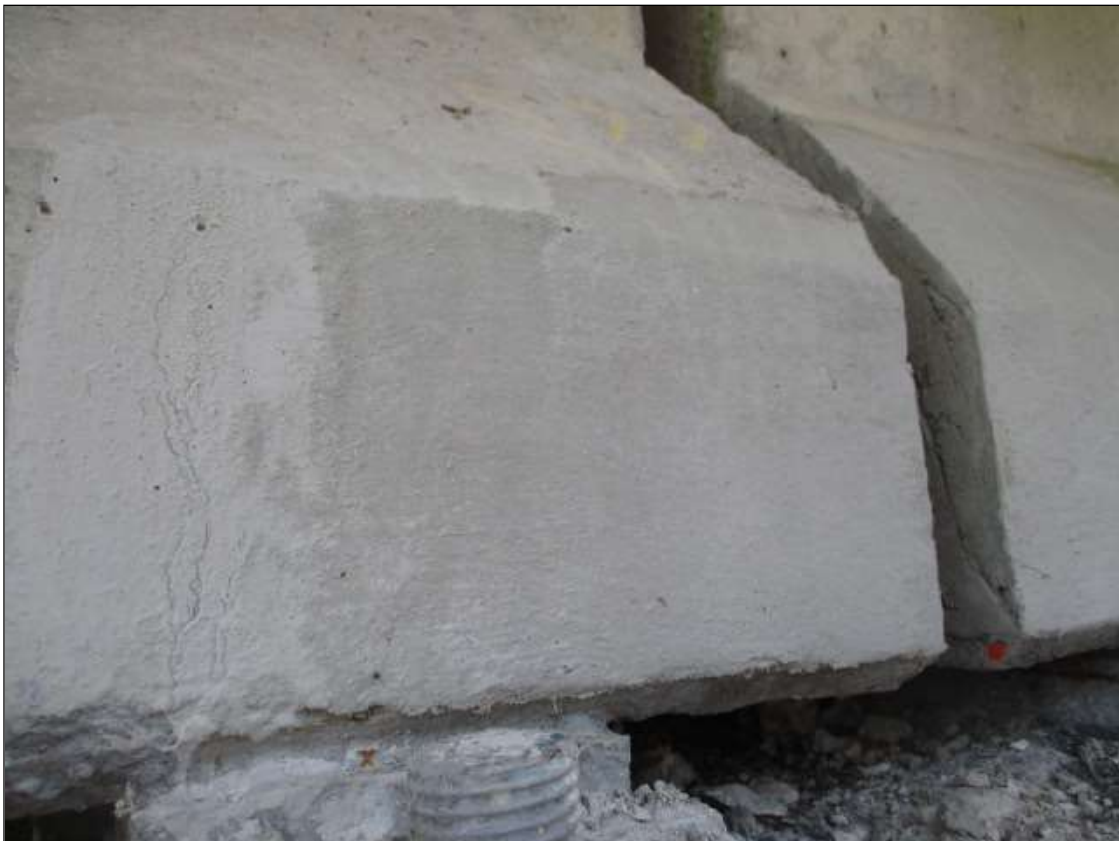
Span 77 Beam 1: 10" LONG X 10" TALL NEW REPAIR TO BOTTOM LEFT FLANGE AT BENT 76

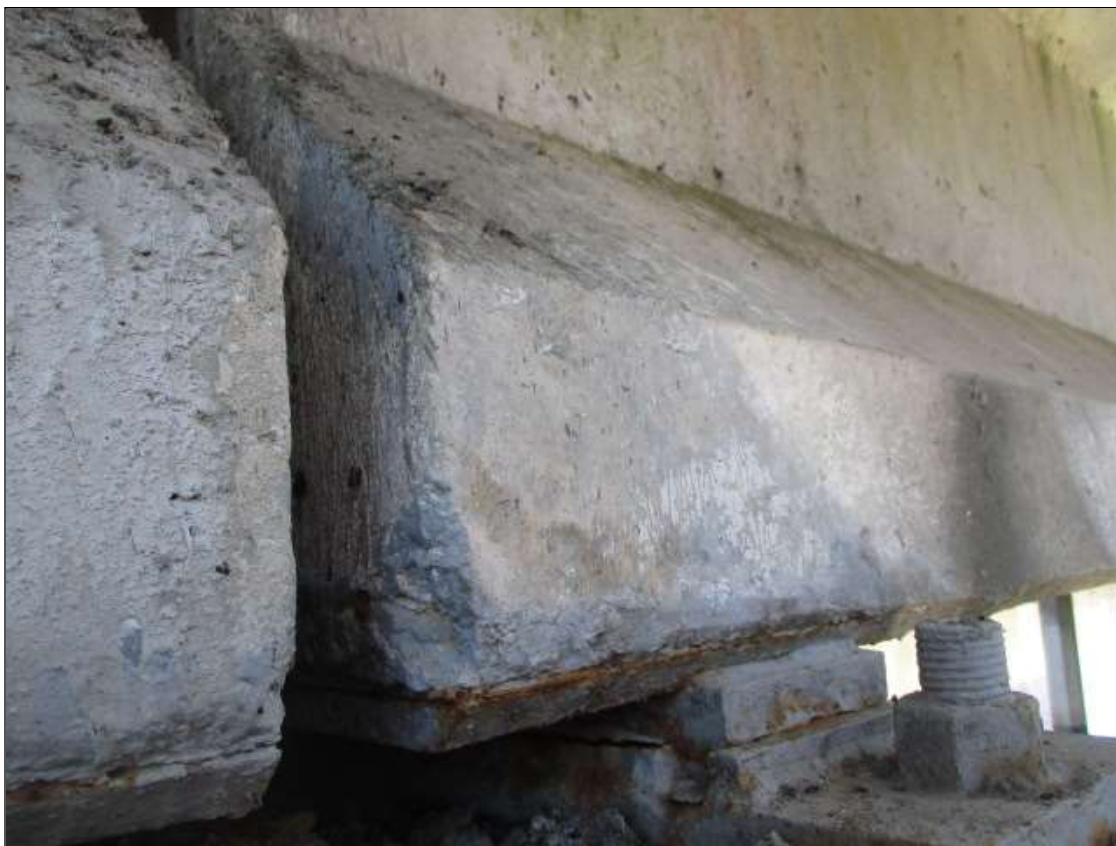
NO SPALL ON BOTTOM LEFT FLANGE OF GIRDER 1 SPAN 77 AT BENT 77 (REPAIR AT BENT 76)

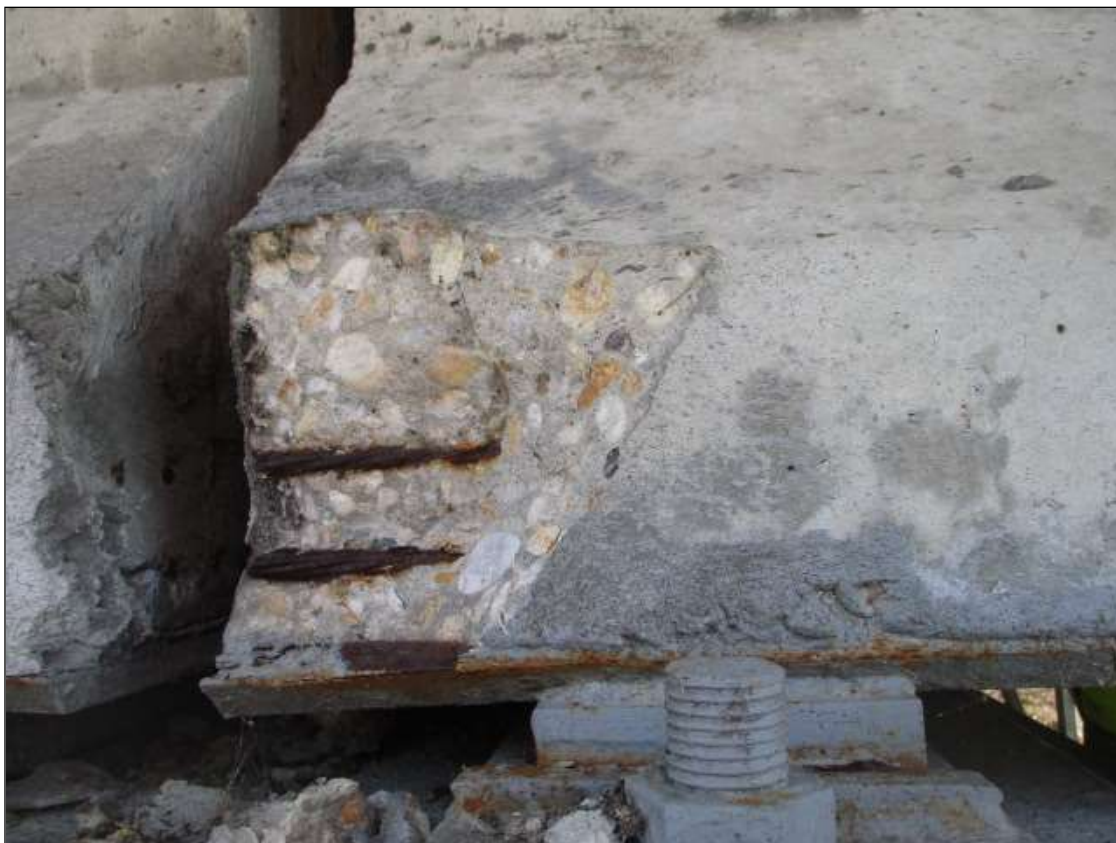
Span 78 Beam 4: bottom right flange at bent 77, spall [8in x 8in x 2in] with [2] two exposed rusted strands [no section loss]

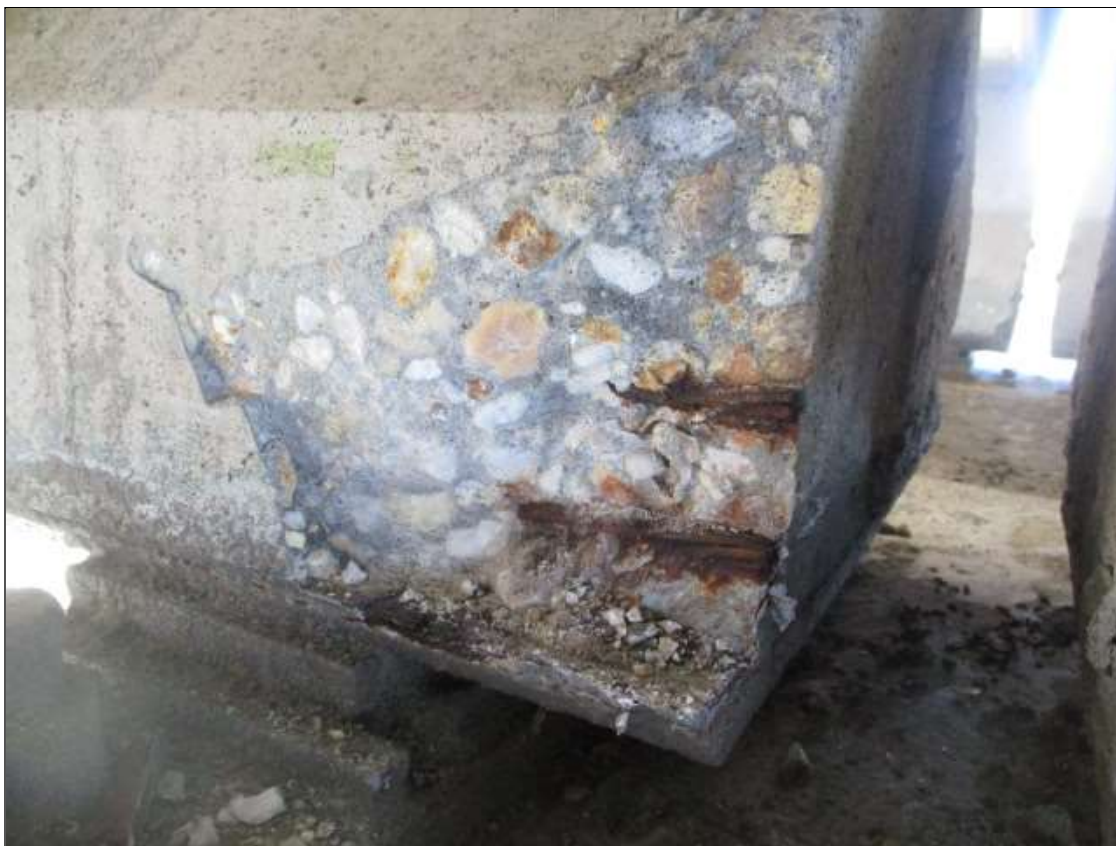
Span 80 Beam 2: SPAN 80 BEAM 2 RIGHT BOTTOM FLANGE OVER BENT 80. HAS A SPALL. AREA IS: 7" x 9" x 2" DEEP.

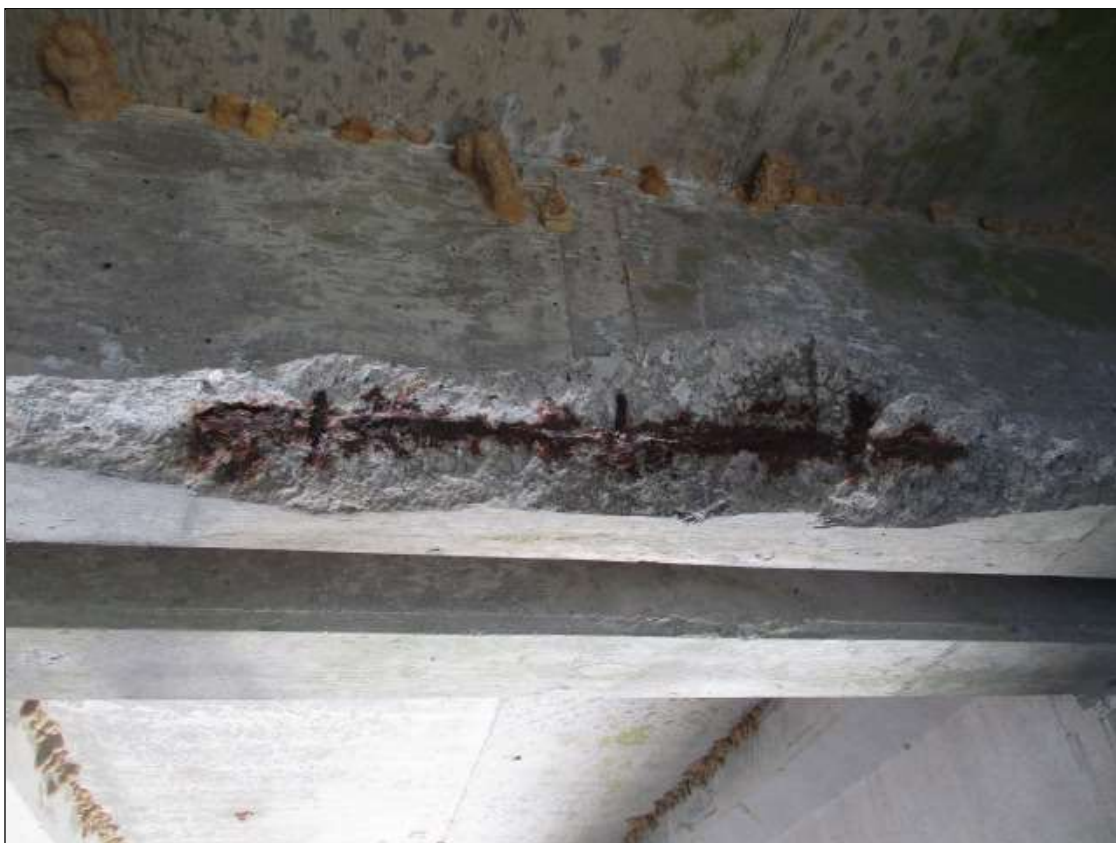
Span 82 Deck: 5' WIDE X 12" TALL X 6" DEEP SPALL WITH EXPOSED REBAR WITH NO SECTION LOSS IN BAY DIAPHRAGM OVER BENT 81

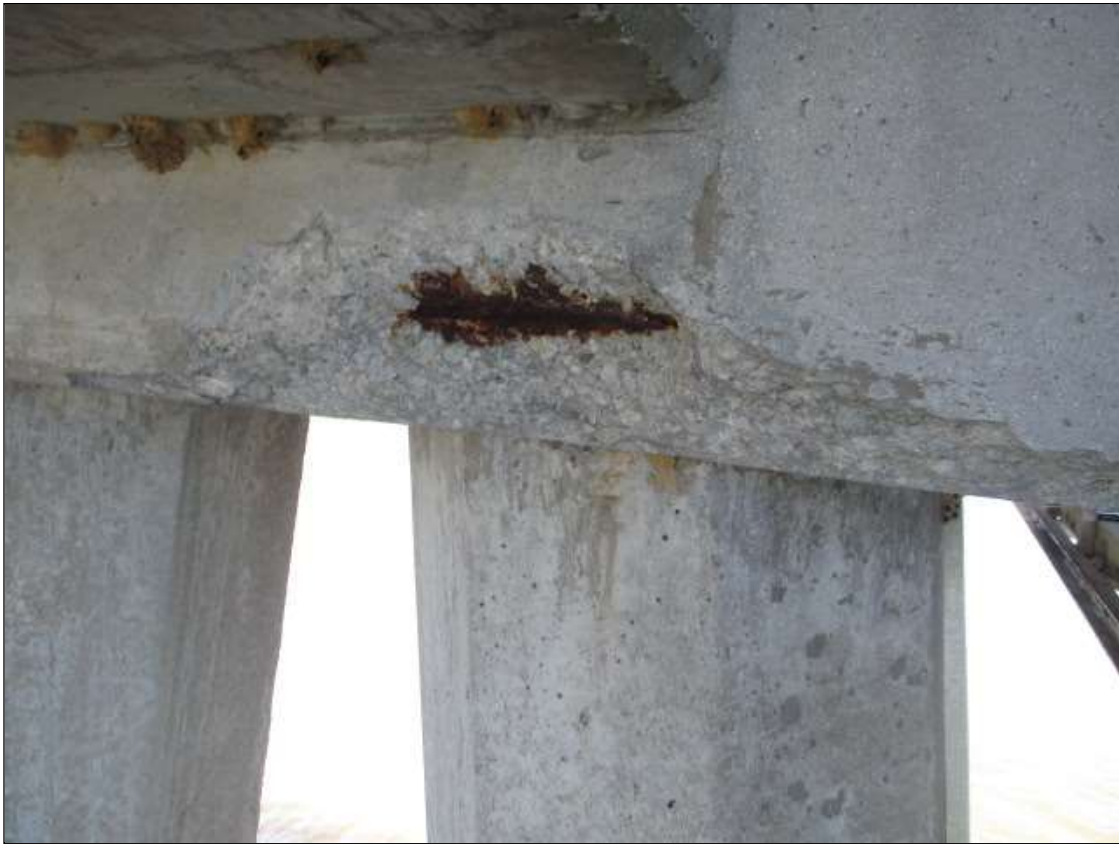
Bent 82 Cap 1: across East face, spall [32in x 4in x 3in deep] with exposed rusted reinforcing [up to 10% section loss] OVER PILES 5 AND 6

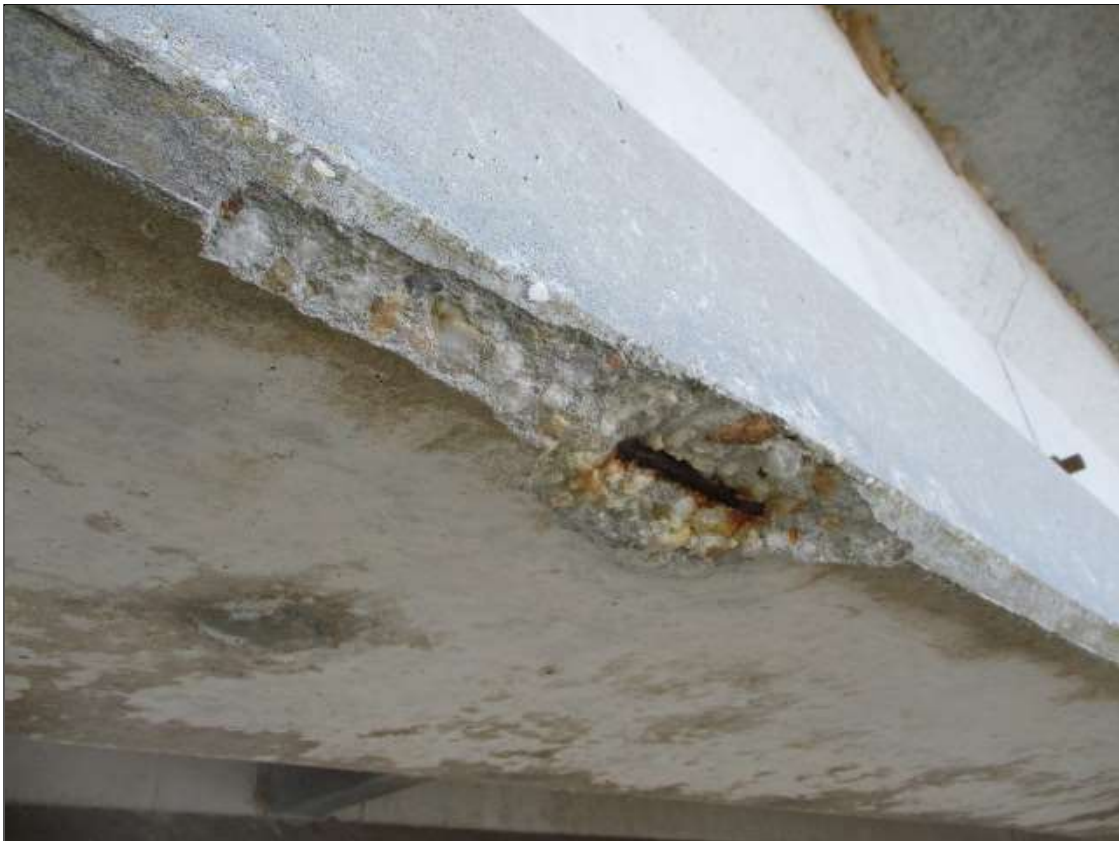
Span 85 Beam 4: SPAN 85 RIGHT BOTTOM EDGE OF BEAM 4. HAS A SPALLED AREA WITH 1 CABLE VISIBLE. LOCATED 24' FROM BENT 85. AREA IS: 5" x 16" x 1" DEEP.

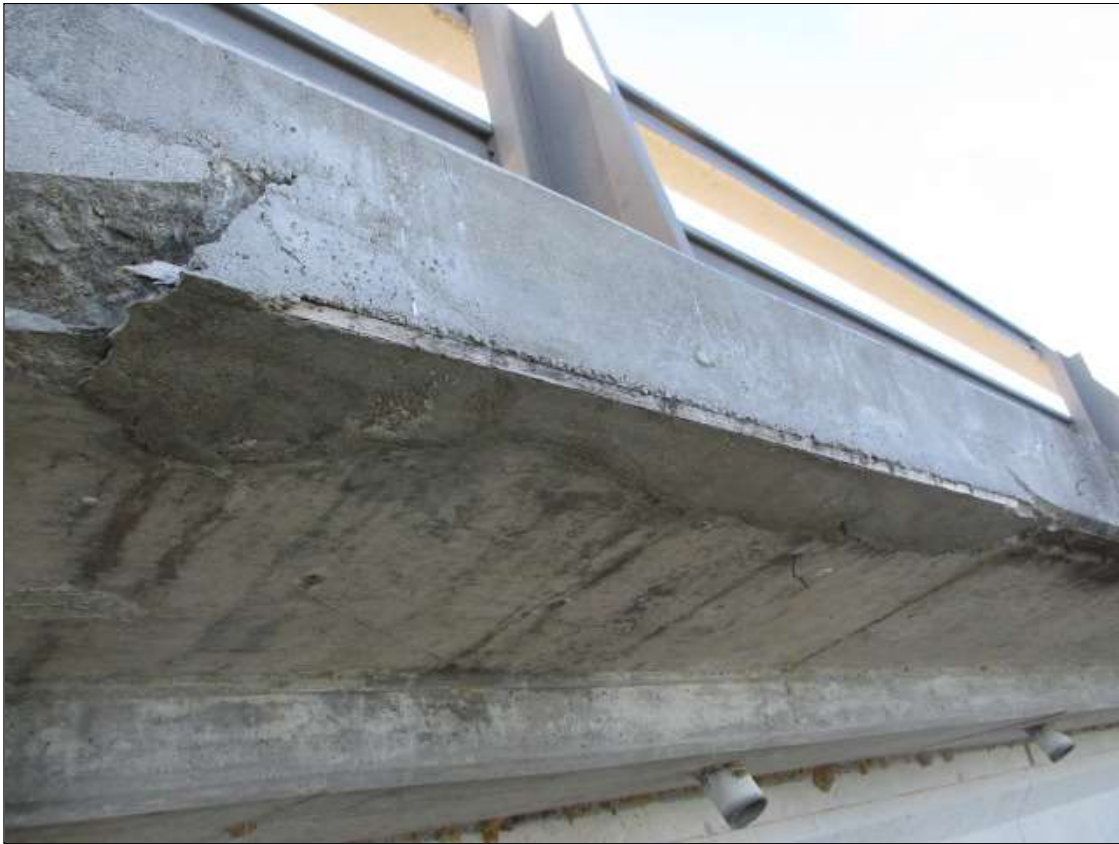
Span 85 Deck: 4' LONG X 8" TALL X 8" WIDE DELAMINATED PATCH IN RIGHT OVERHANG 15' FROM BENT 84

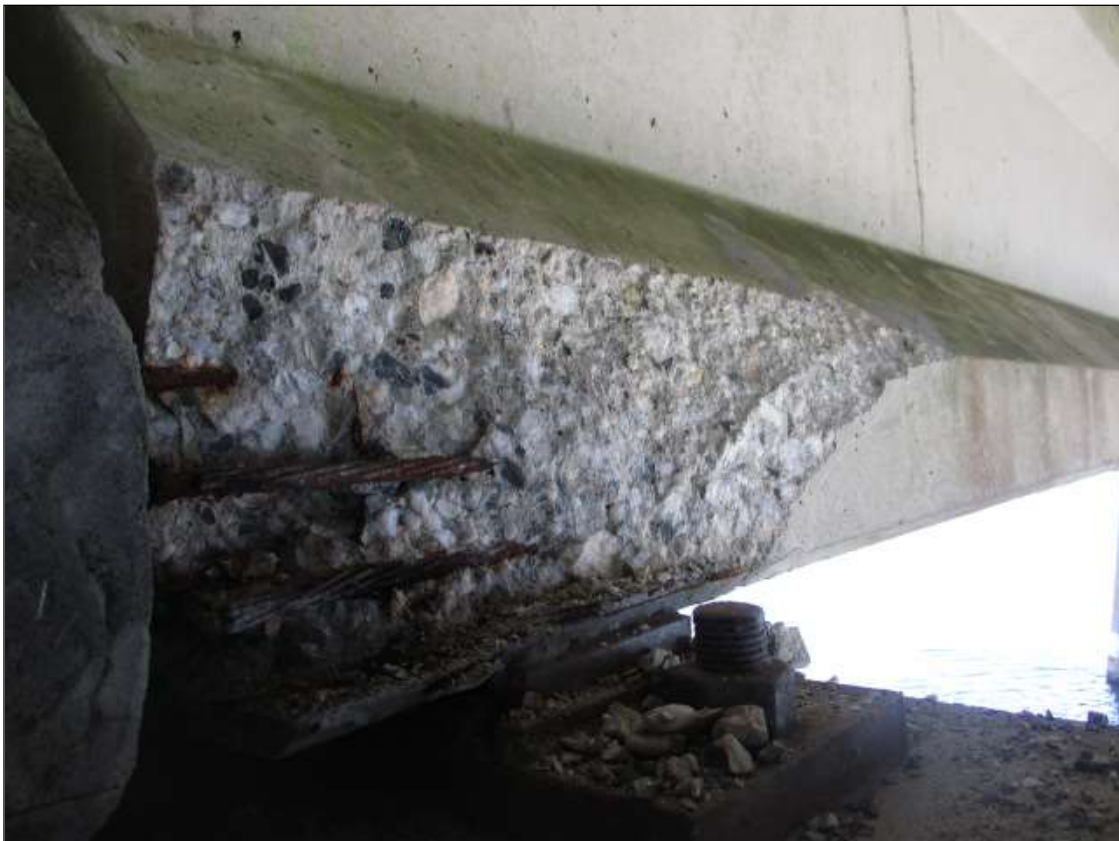
Span 88 Beam 3: PAR: 3' LONG X 10" TALL X 3" DEEP SPALL WITH EXPOSED STRANDS WITH SECTION LOSS ON BOTTOM LEFT FLANGE AT BENT 88

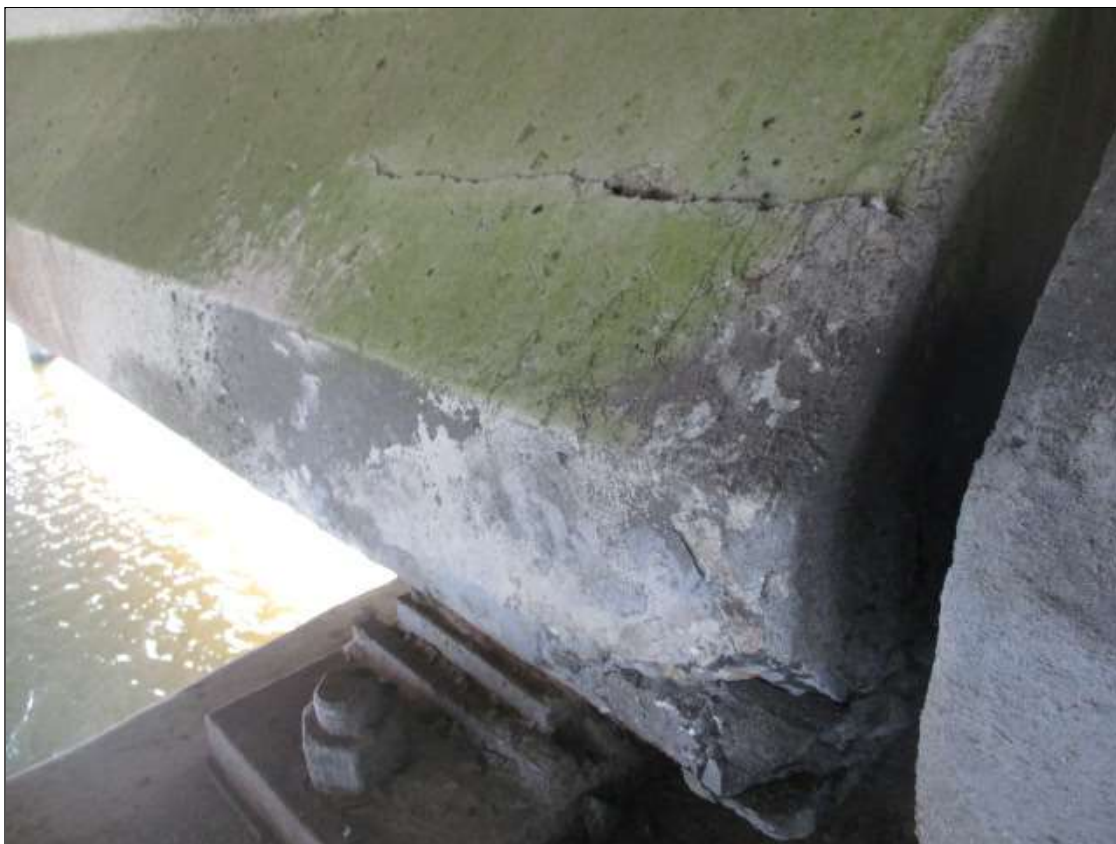
Span 88 Beam 3: SPAN 88 BEAM 3 RIGHT BOTTOM FLANGE OVER BENT 88. DELAMINATED AREA THAT IS 2' LONG X 18" TALL

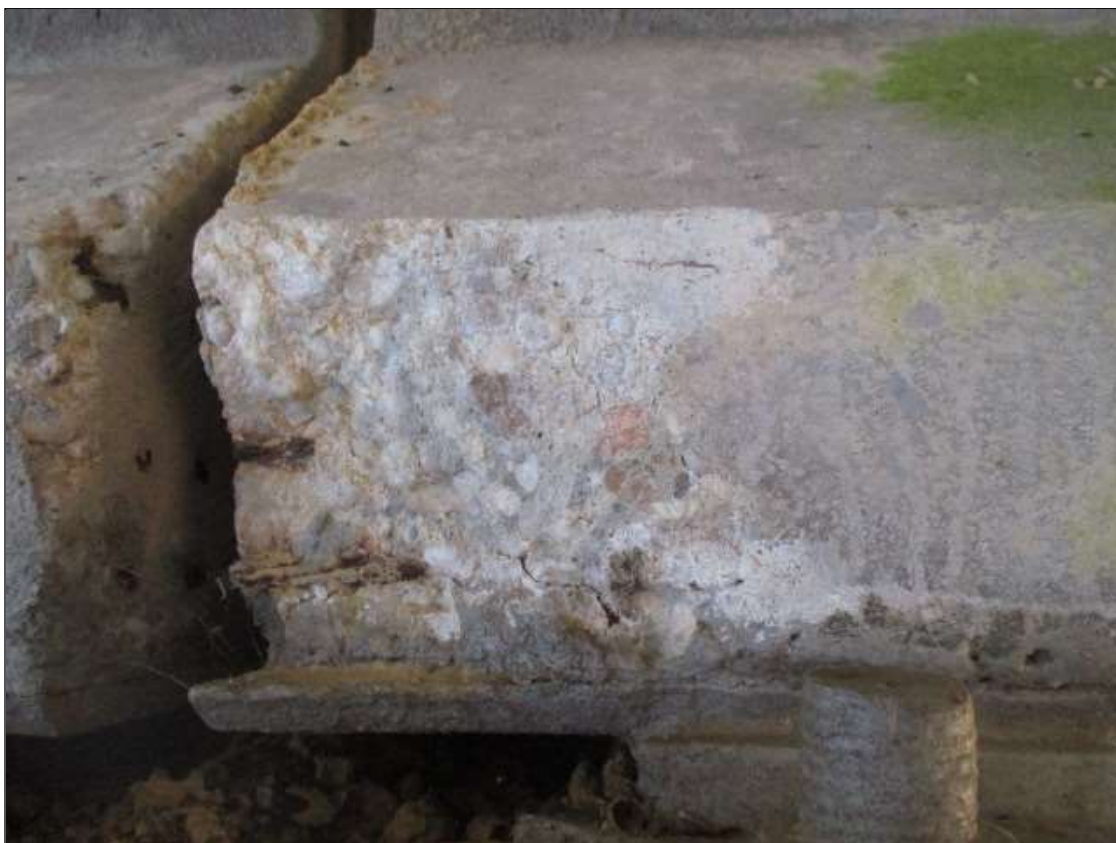
Span 95 Beam 2: 10" LONG X 10" TALL X 2" DEEP SPALL WITH 2 EXPOSED STRANDS WITH NO SECTION LOSS ON BOTTOM RIGHT FLANGE AT BENT 94

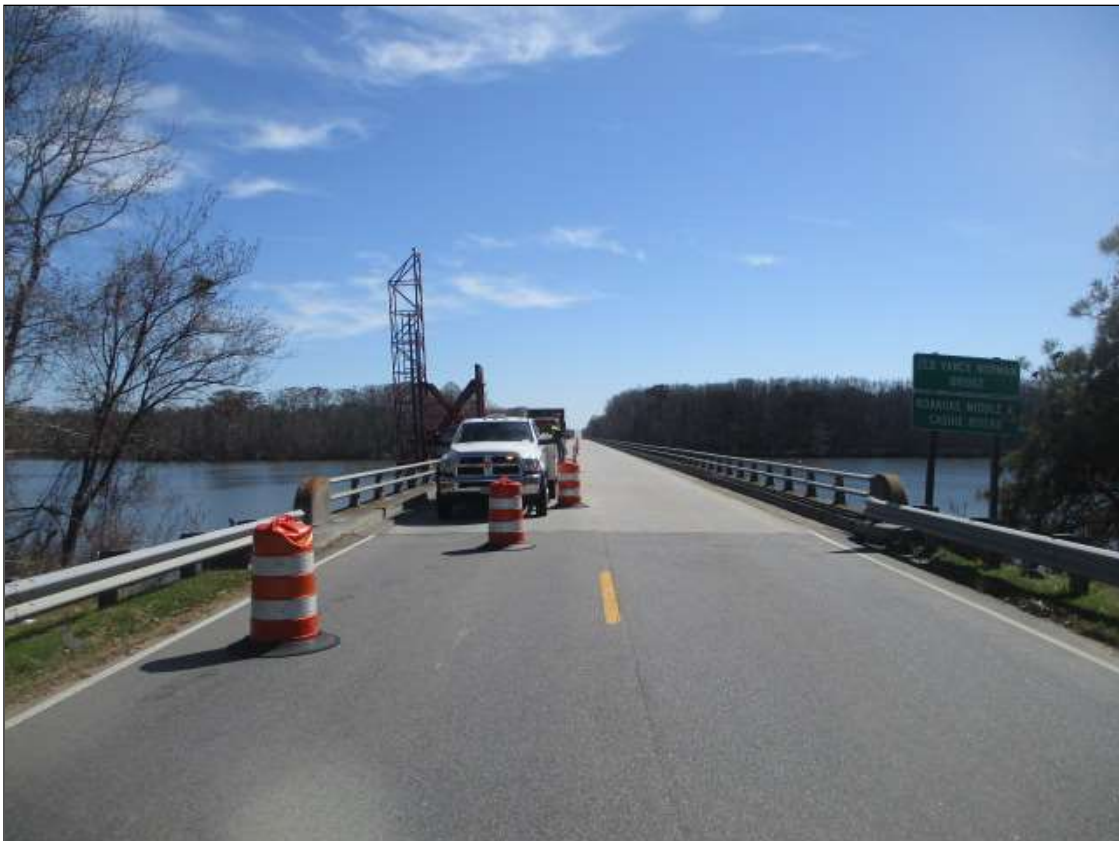
GAUGING STATION ON BENT 93 BETWEEN PILES 5/6 AND 7
