APPENDIX E:
BRIDGE INSPECTION REPORT —
THREE RIVERS BRIDGE

THE BRITE BRIDGES:
Bridging Resources for Infrastructure and Thriving
Economies Project

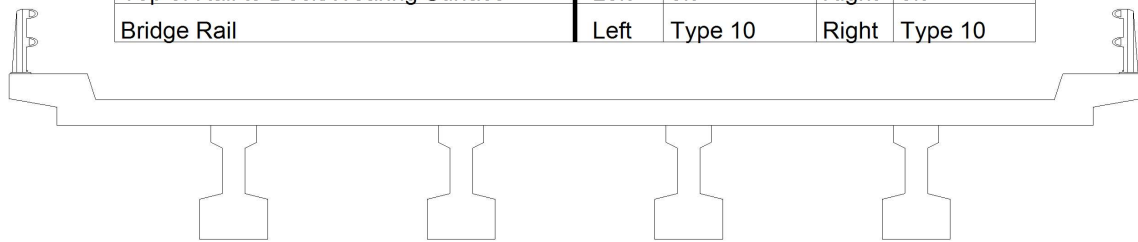
Measurements for Span #	1	Similar Spans: 1-16 and 20-95	
Deck Thickness	0.75ft	Left Overhang	4.85in
Top of Rail to Bottom of Beam	7.5ft	Right Overhang	4.85in

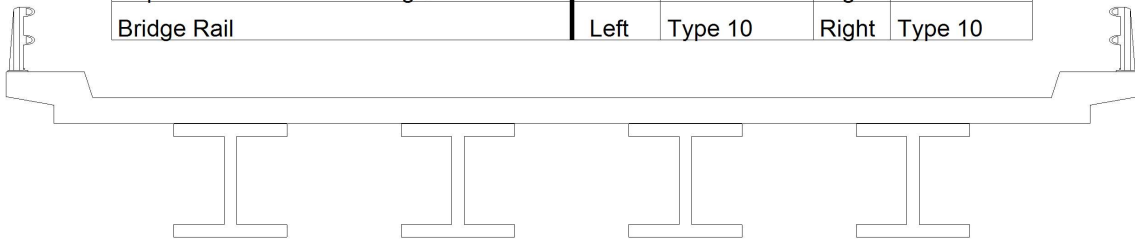
Measurements for Span #	17	Similar Spans: 18 and 19	
Deck Thickness	0.75ft	Left Overhang	4.85ft
Top of Rail to Bottom of Beam	7.5ft	Right Overhang	4.85ft

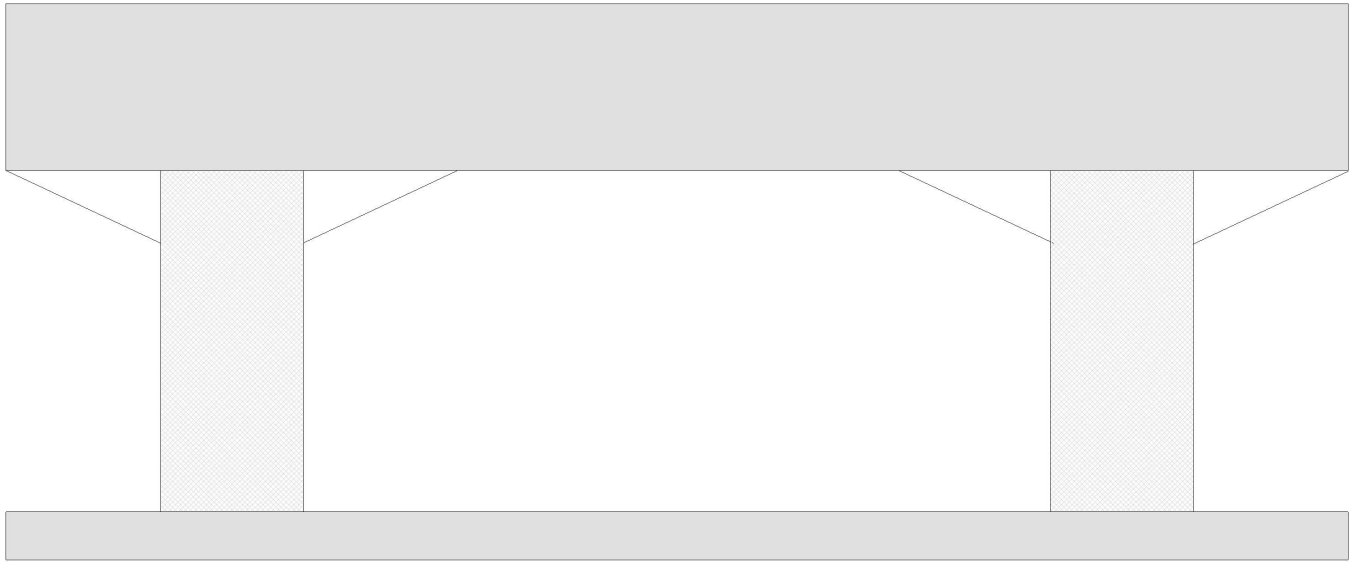
Cap Information			Material Cast-in-Place Concrete							
Length	Width	Height	Left Overhang	Right Overhang	Left Beam to End of Cap.	Right Beam to End of Cap.				
28.167 ft.	3.000 ft.	3.500 ft.	4.750 ft.	4.750 ft.	2.080 ft.	2.080 ft.				
Subcap Information			Material							
Length	Width	Height	Left Overhang	Right Overhang	Left Pile to Splice.					
Sill Information			Material							
Length	Width	Height								
31.000 ft.	9.000 ft.	4.250 ft.								
Pile #	Material	Spacing	Width/Dia.	Height	Length	Orientation	Driven?	Replacement?	Removed?	Collar?
1	Concrete	18.67 ft.	3 ft.			Vertical	No	No	No	No
2	Concrete		3 ft.			Vertical	No	No	No	No
Bent/Abutment #: 1			Similar Bents: 2-6 and 29-34

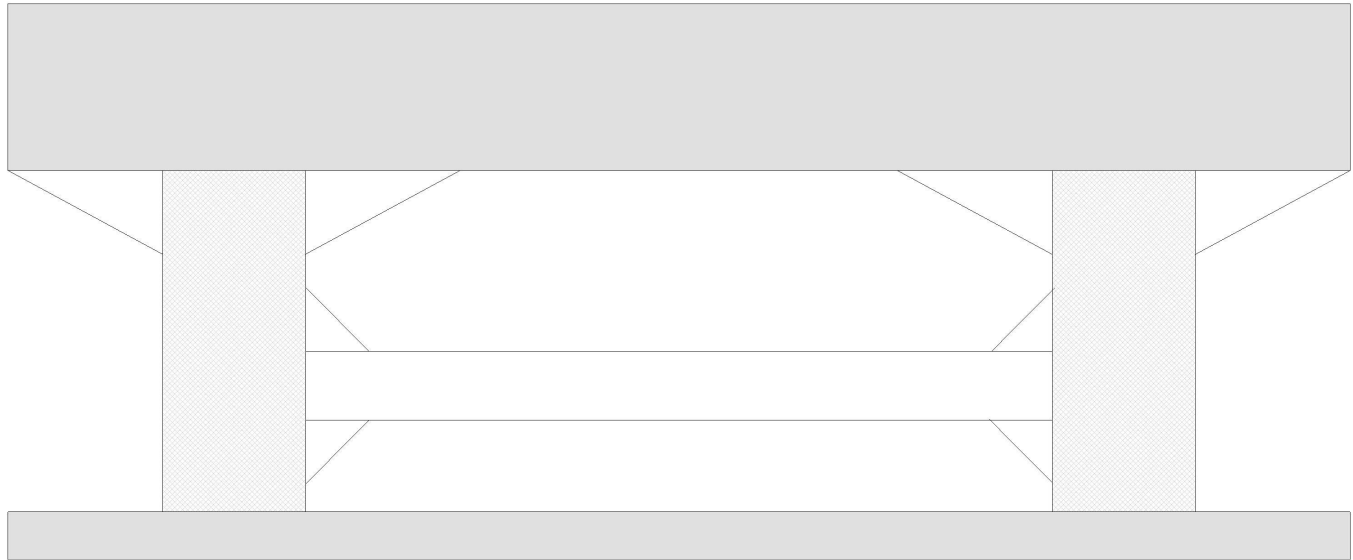
Cap Information			Material Cast-in-Place Concrete							
Length	Width	Height	Left Overhang	Right Overhang	Left Beam to End of Cap.	Right Beam to End of Cap.				
28.170 ft.	3.000 ft.	3.500 ft.	4.750 ft.	4.750 ft.	2.080 ft.	2.080 ft.				
Subcap Information			Material							
Length	Width	Height	Left Overhang	Right Overhang	Left Pile to Splice.					
Sill Information			Material							
Length	Width	Height								
32.000 ft.	10.000 ft.	4.250 ft.								
Pile #	Material	Spacing	Width/Dia.	Height	Length	Orientation	Driven?	Replacement?	Removed?	Collar?
1	Concrete	18.67 ft.	3 ft.			Vertical	No	No	No	No
2	Concrete		3 ft.			Vertical	No	No	No	No
Bent/Abutment #: 7			Similar Bents:

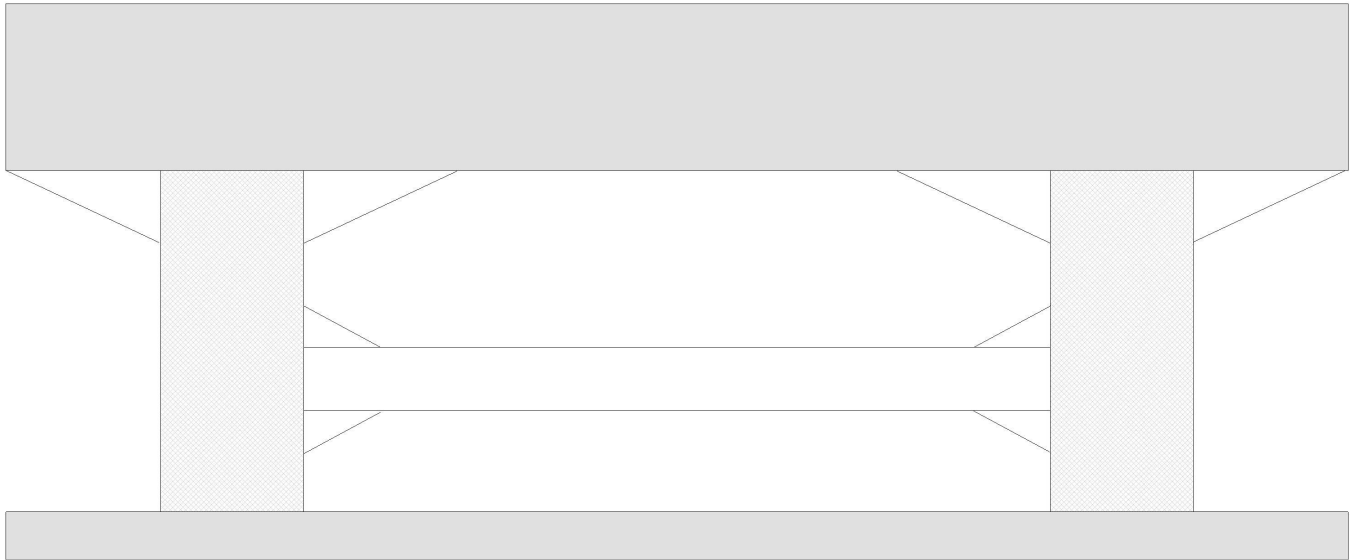
Cap Information			Material Cast-in-Place Concrete							
Length	Width	Height	Left Overhang	Right Overhang	Left Beam to End of Cap.	Right Beam to End of Cap.				
28.170 ft.	3.000 ft.	3.500 ft.	4.750 ft.	4.750 ft.	2.080 ft.	2.080 ft.				
Subcap Information			Material							
Length	Width	Height	Left Overhang	Right Overhang	Left Pile to Splice.					
Sill Information			Material							
Length	Width	Height								
33.000 ft.	11.000 ft.	4.250 ft.								
Pile #	Material	Spacing	Width/Dia.	Height	Length	Orientation	Driven?	Replacement?	Removed?	Collar?
1	Concrete	18.67 ft.	3 ft.			Vertical	No	No	No	No
2	Concrete		3 ft.			Vertical	No	No	No	No
Bent/Abutment #: 16			Similar Bents: 19

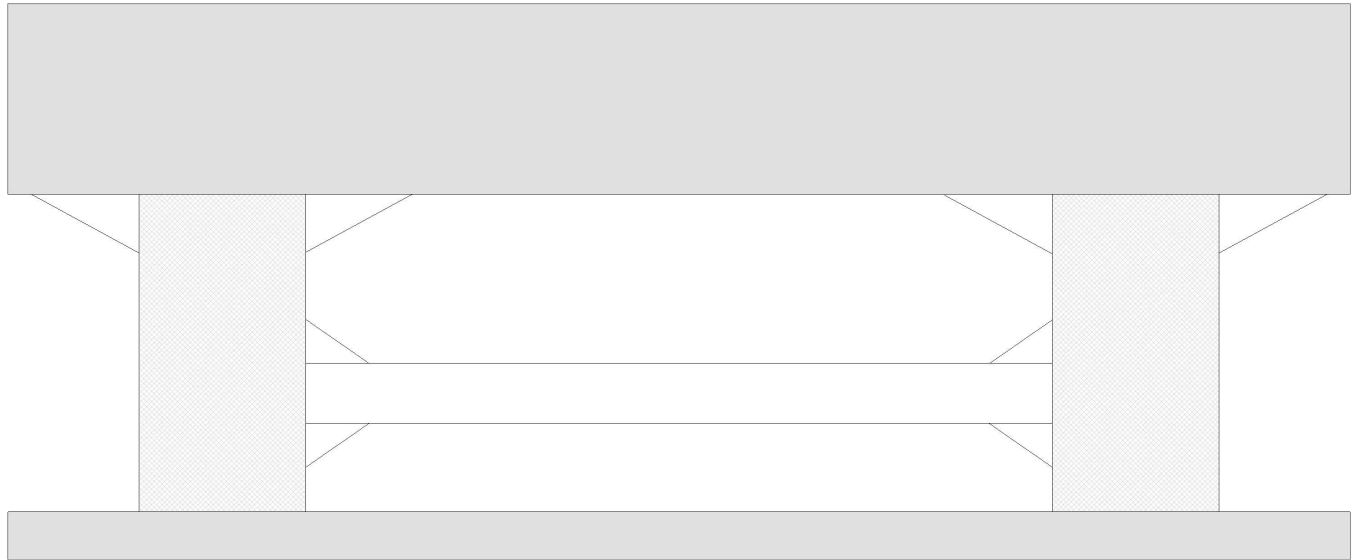
Cap Information			Material Cast-in-Place Concrete							
Length	Width	Height	Left Overhang	Right Overhang	Left Beam to End of Cap.	Right Beam to End of Cap.				
28.170 ft.	4.000 ft.	4.000 ft.	4.500 ft.	4.500 ft.	2.080 ft.	2.080 ft.				
Subcap Information			Material							
Length	Width	Height	Left Overhang	Right Overhang	Left Pile to Splice.					
Sill Information			Material							
Length	Width	Height								
33.000 ft.	15.000 ft.	4.500 ft.								
Pile #	Material	Spacing	Width/Dia.	Height	Length	Orientation	Driven?	Replacement?	Removed?	Collar?
1	Concrete	19.17 ft.	3.5 ft.			Vertical	No	No	No	No
2	Concrete		3.5 ft.			Vertical	No	No	No	No
Bent/Abutment #: 17			Similar Bents: 18

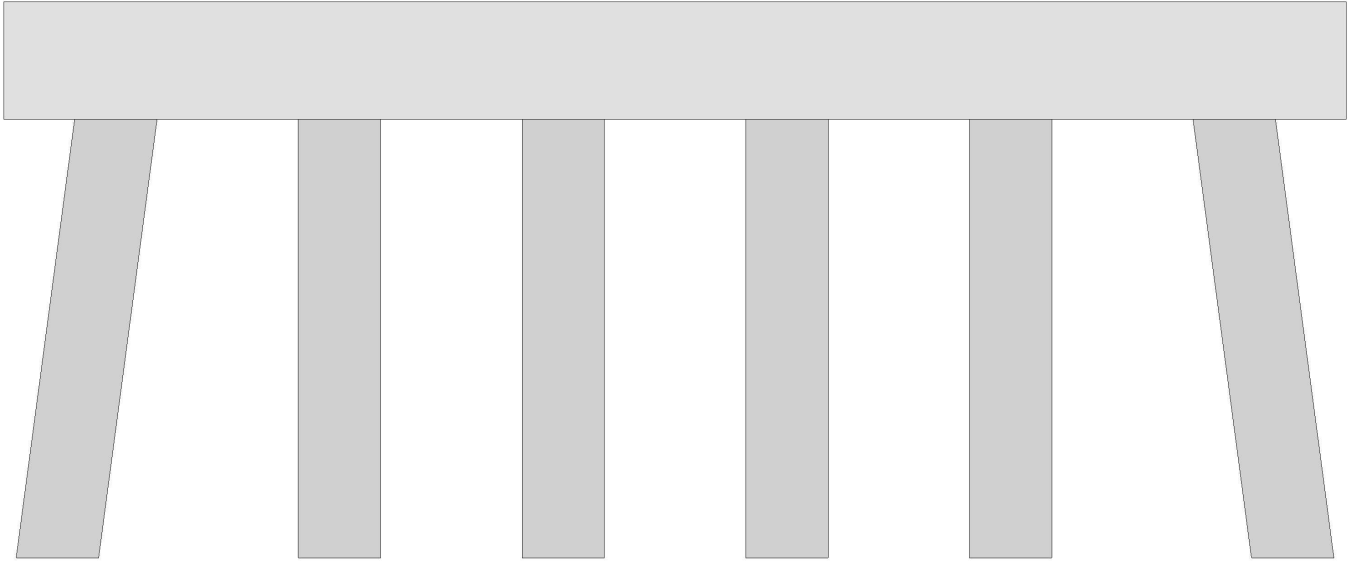
Cap Information			Material Cast-in-Place Concrete							
Length	Width	Height	Left Overhang	Right Overhang	Left Beam to End of Cap.	Right Beam to End of Cap.

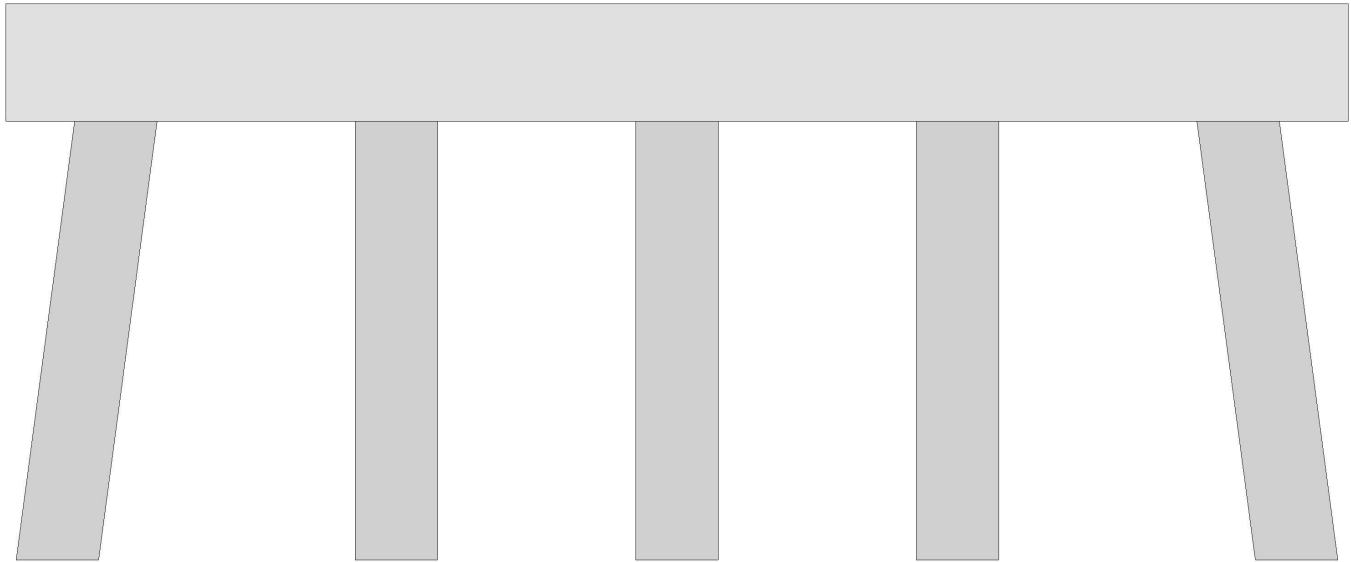
Cap Information			Material Cast-in-Place Concrete							
Length	Width	Height	Left Overhang	Right Overhang	Left Beam to End of Cap.	Right Beam to End of Cap.				
28.500 ft.	3.250 ft.	2.500 ft.	2.333 ft.	2.333 ft.	2.250 ft.	2.250 ft.				
Subcap Information			Material							
Length	Width	Height	Left Overhang	Right Overhang	Left Pile to Splice.					
Sill Information			Material							
Length	Width	Height								
Pile #	Material	Spacing	Width/Dia.	Height	Length	Orientation	Driven?	Replacement?	Removed?	Collar?
1	Concrete	5.958 ft.	1.75 ft.			Battered	Yes	No	No	No
2	Concrete	5.958 ft.	1.75 ft.			A-Frame	Yes	No	No	No
3	Concrete	5.958 ft.	1.75 ft.			Vertical	Yes	No	No	No
4	Concrete	5.958 ft.	1.75 ft.			A-Frame	Yes	No	No	No
5	Concrete		1.75 ft.			Battered	Yes	No	No	No
Bent/Abutment #: 38			Similar Bents: 42, 46, 50, 54, 58, 62, 66, 70, 74, 78, 82, 86, 89

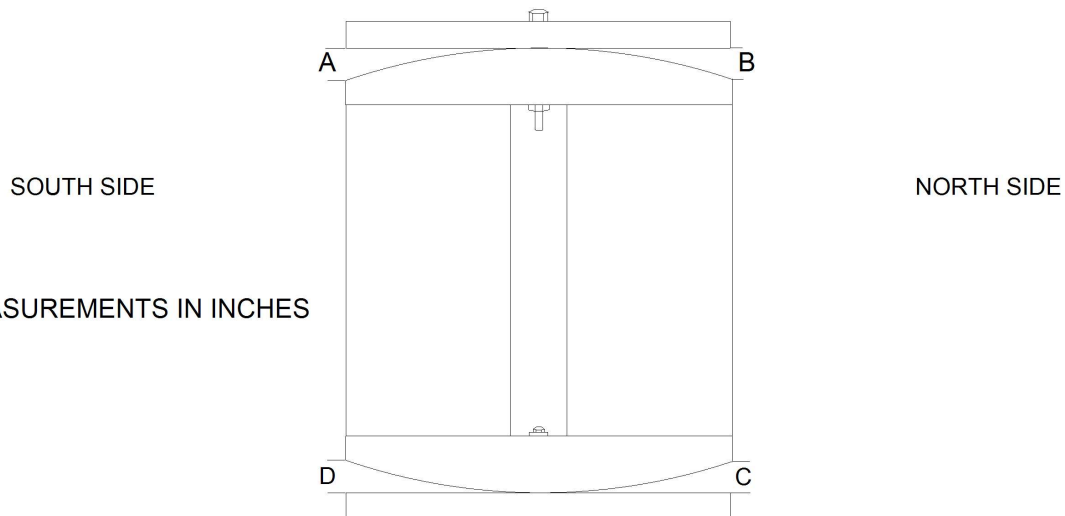
MEASUREMENT TAKEN WITH AN AIR TEMPERATURE OF 67 DEGREES FARENHEIT.
BENT 16

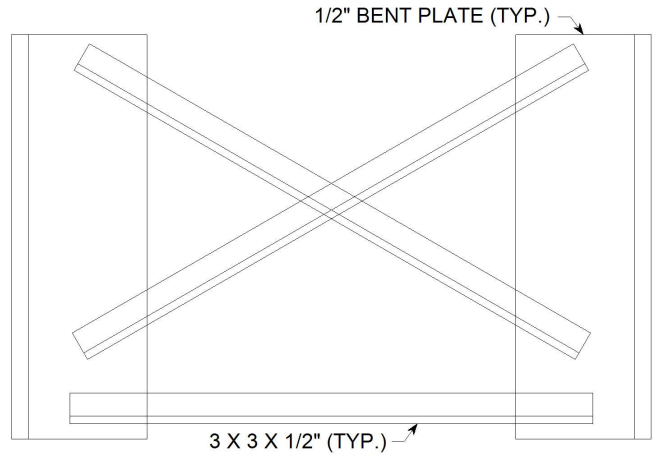
INTERMEDIATE DIAPHRAGM REPAIR
SPANS 17, 18 AND 19 AT MID-SPAN

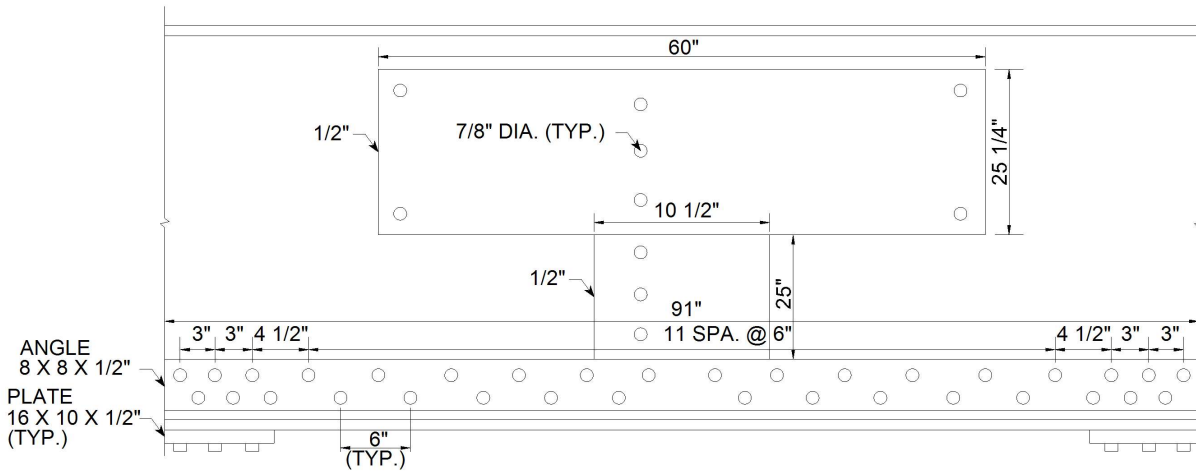
GIRDER 4 SPAN 18 AT MID-SPAN (EAST FACE)

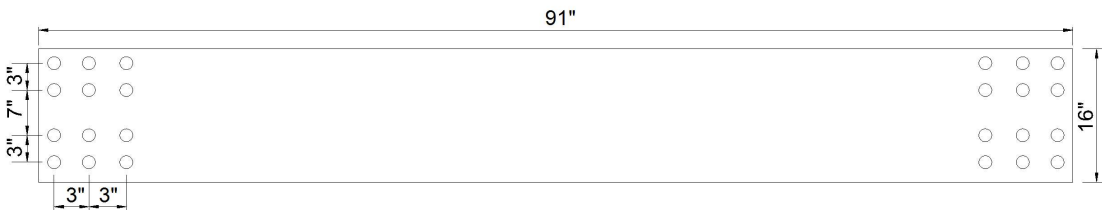
GIRDER 4 SPAN 18 AT MID-SPAN (BOTTOM FLANGE)

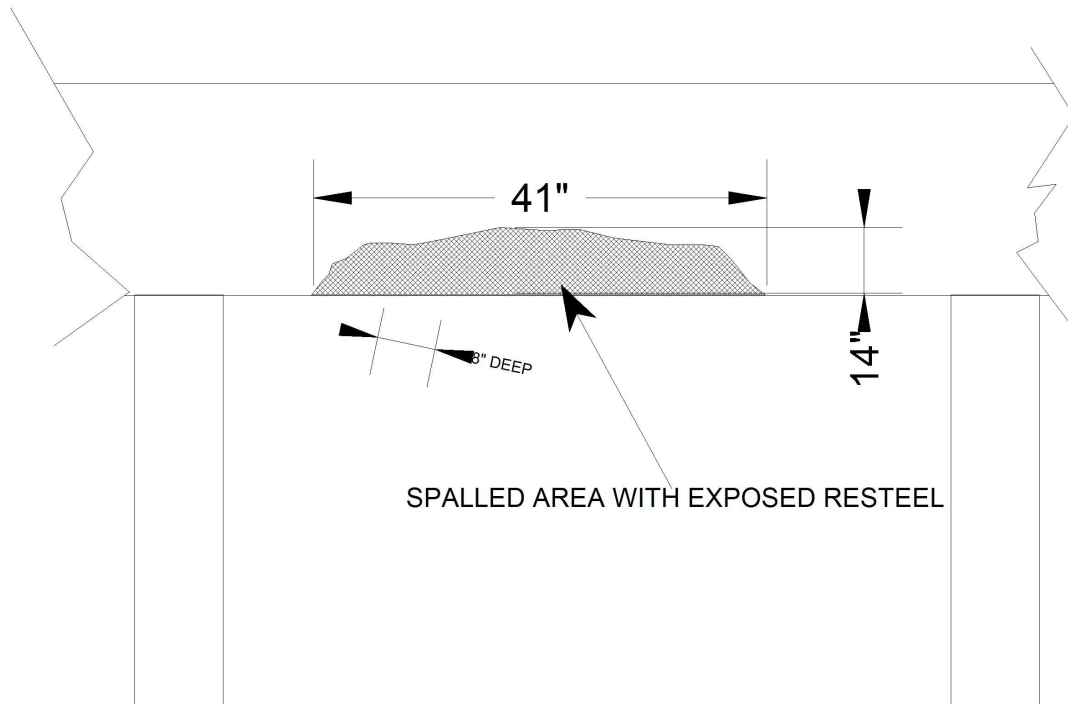
AREA PREVIOUSLY REPAIRED

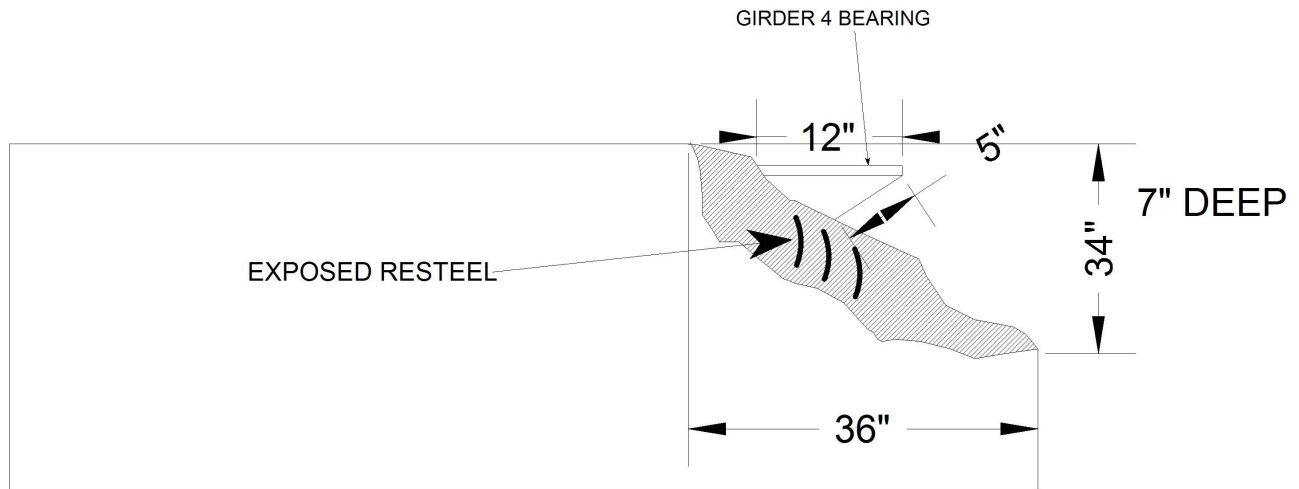
CRACKED, SPALLED, AND DELAMINATED AREA WITH RESTEEL EXPOSED IN RIGHT END (SOUTHEAST CORNER) OF BENT 24 CAP. AREA IS 30" LONG, 24" TALL, AND 8" DEEP AND EXTENDS 5" UNDER SOUTHEAST CORNER OF BEARING AT GIRDER 4 OR 12" ON SPAN 24 SIDE.

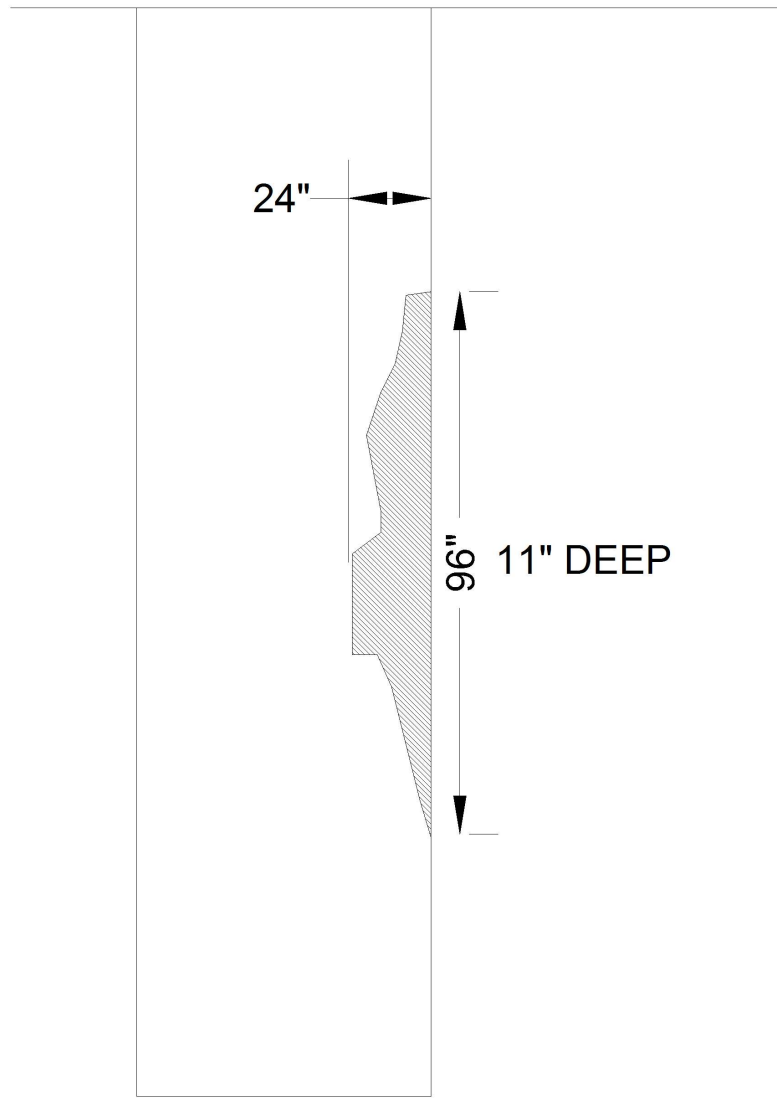
AREA PREVIOUSLY REPAIRED

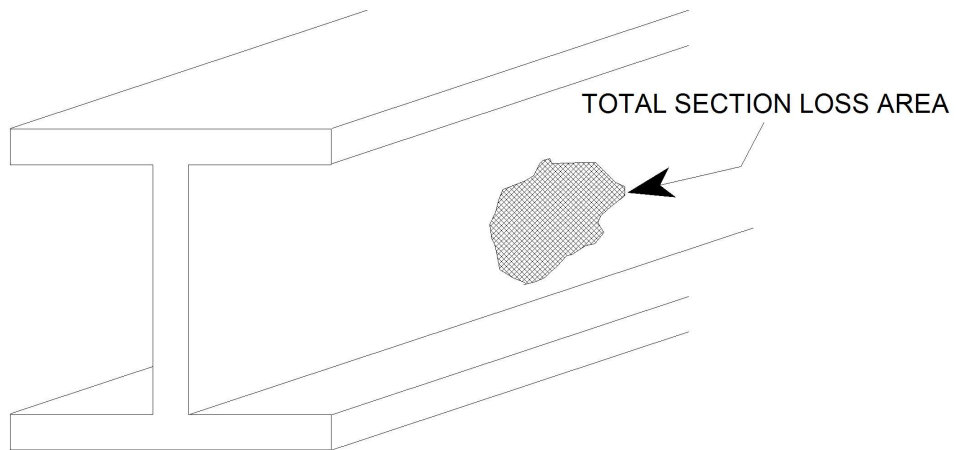
AREAS PREVIOUSLY REPAIRED

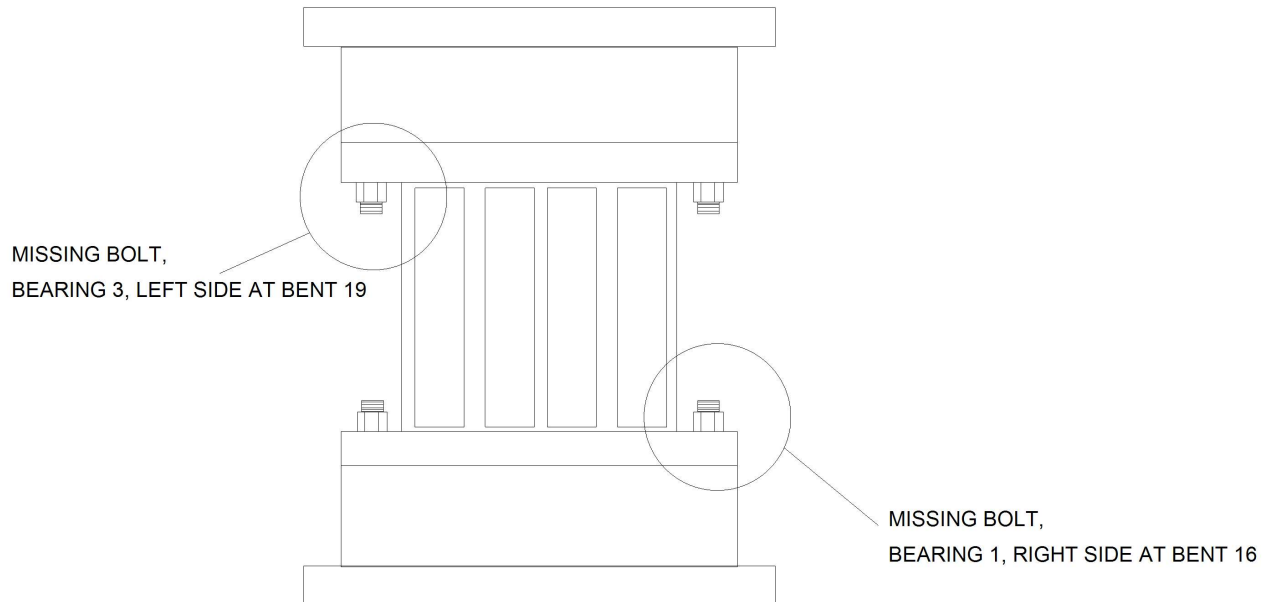
ROCKER BEARINGS HAVE BEEN REPLACED WITH CONCRETE RISER AND ELASTOMERIC PAD

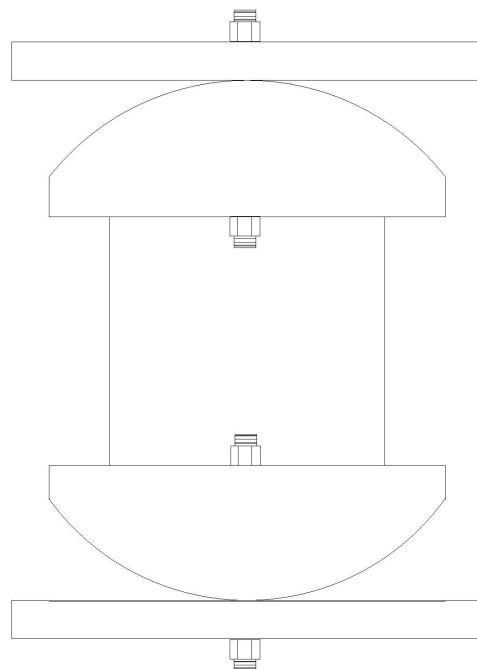
VERIFIED BY TSE 5/23/18

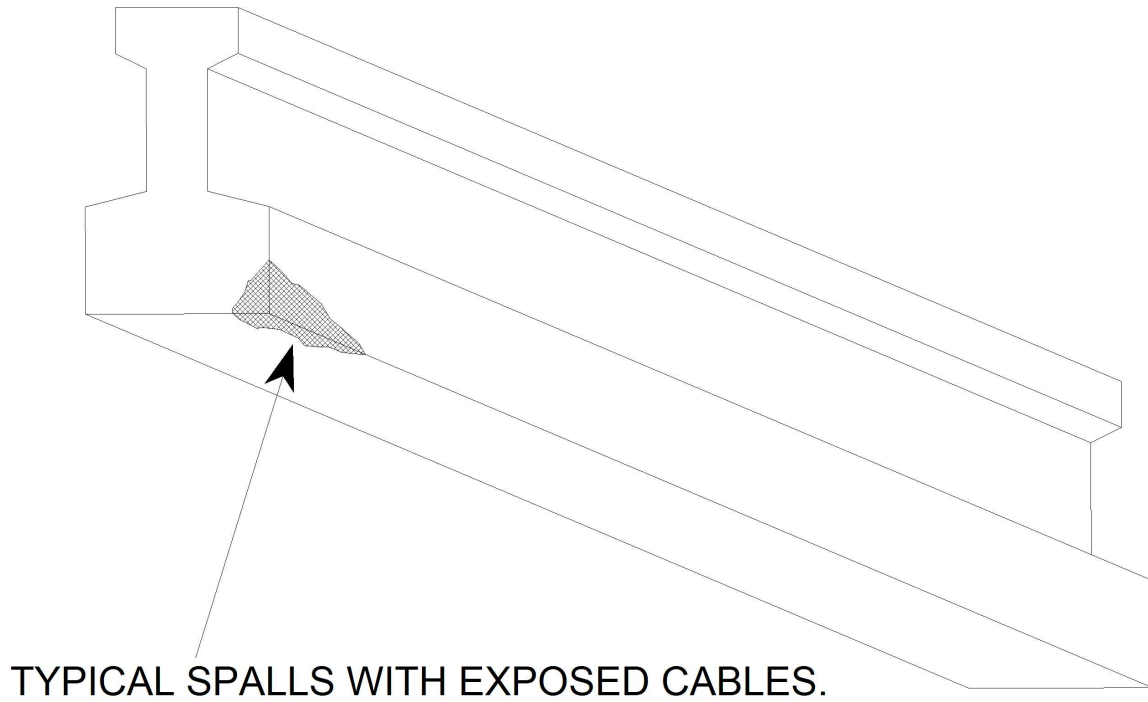
MOST AREAS PREVIOUSLY REPAIRED, SEE RECORD AND SUMMARY FOR CURRENT CONDITIONS
