NC DEPARTMENT OF TRANSPORTATION
DIVISION OF HIGHWAYS
STRUCTURE MANAGEMENT UNIT

Structure Safety Report

Routine Element Inspection - Contract

DIVISION: 3 COUNTY: NEW HANOVER STRUCTURE NUMBER: 640013 FREQUENCY: 24 MONTHS

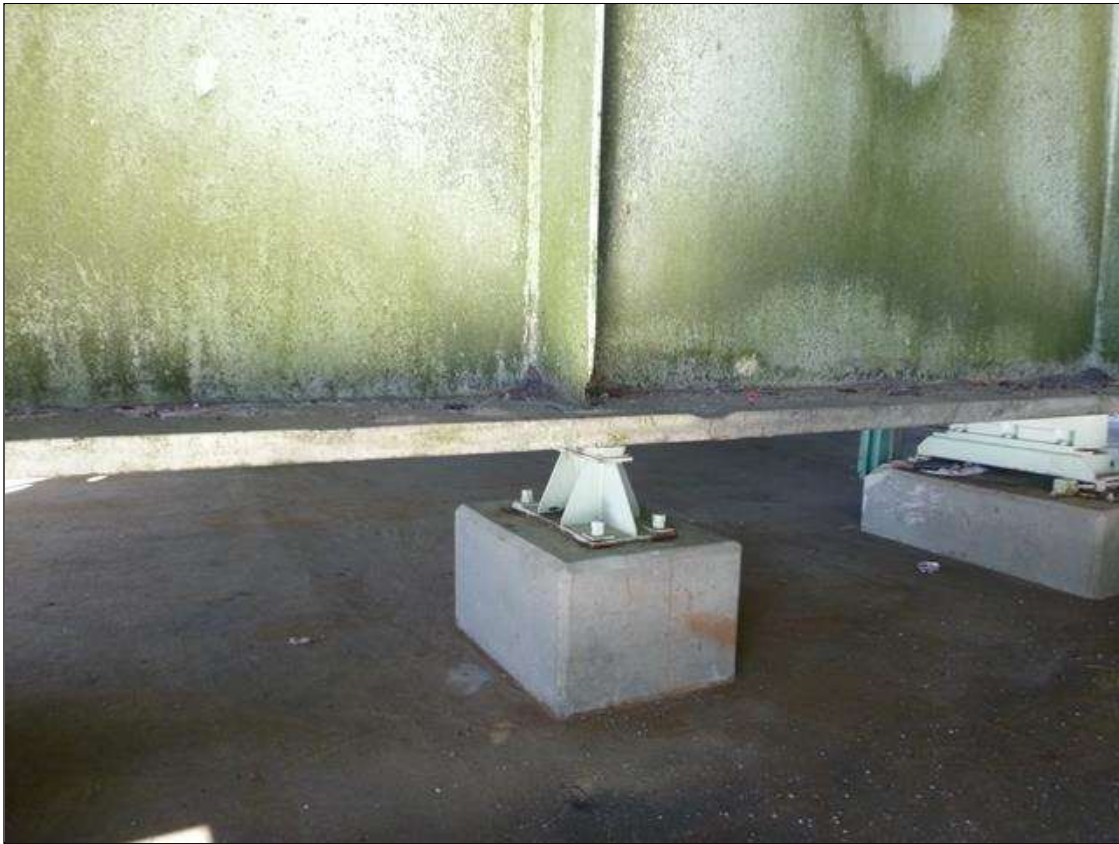
Span 18 Lift Span Floor Beam 0: PITTED AREAS UP TO 3/8" DEEP SCATTERED ALONG BOTH SIDES OF BOTTOM FLANGE AND STIFFENERS- CLEANED AND PAINTED.

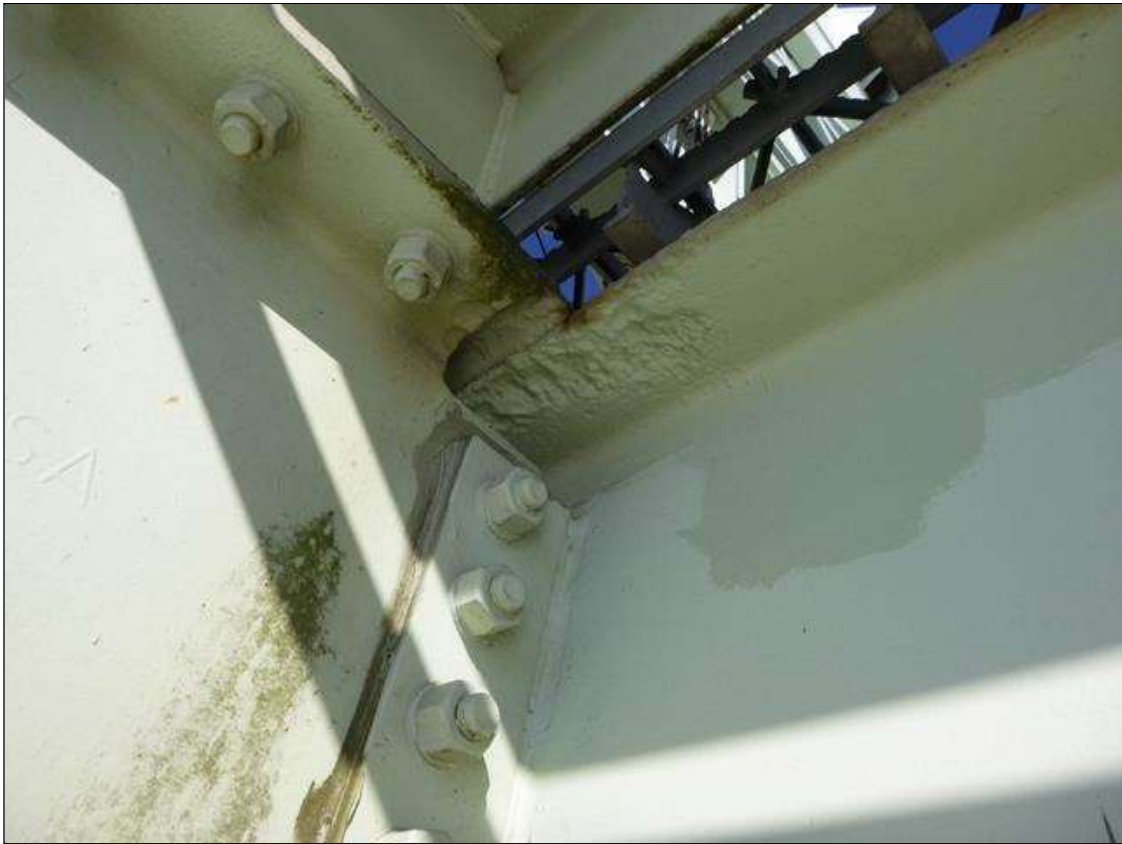
Span 18 Lift Span Stringer 14: BETWEEN FB's 0-1 - AREAS ALONG EDGES OF TOP FLANGE UP TO 8" LONG x 2" WIDE / 5/16" REMAINING - CLEANED AND PAINTED

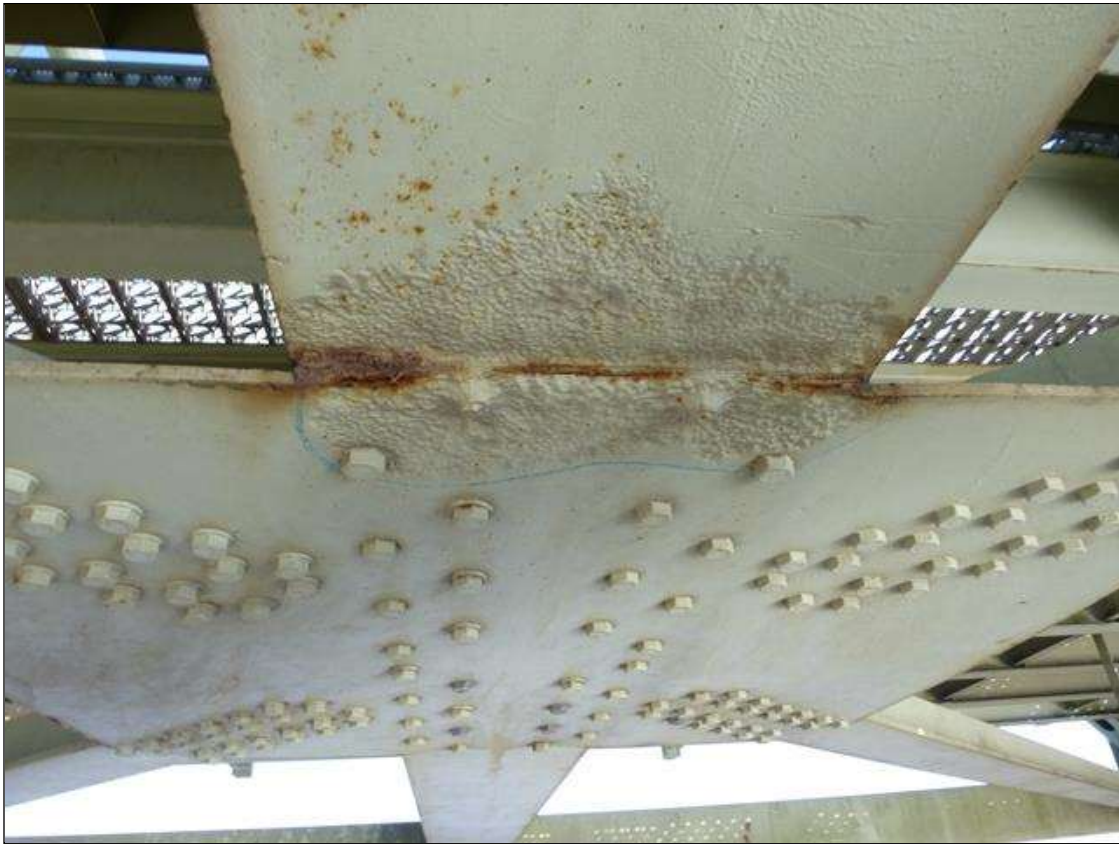
CENTER BOTTOM LATERAL GUSSET - SOUTH SIDE - UP TO 1/2" PACK RUST BETWEEN GUSSET AND BOTTOM FLANGE ON EAST AND WEST SIDES - 10"L x 4" AREA OF GUSSET AT BOTTOM FLANGE REDUCED TO 3/8" - 60% LOSS TO (2) FASTENERS.

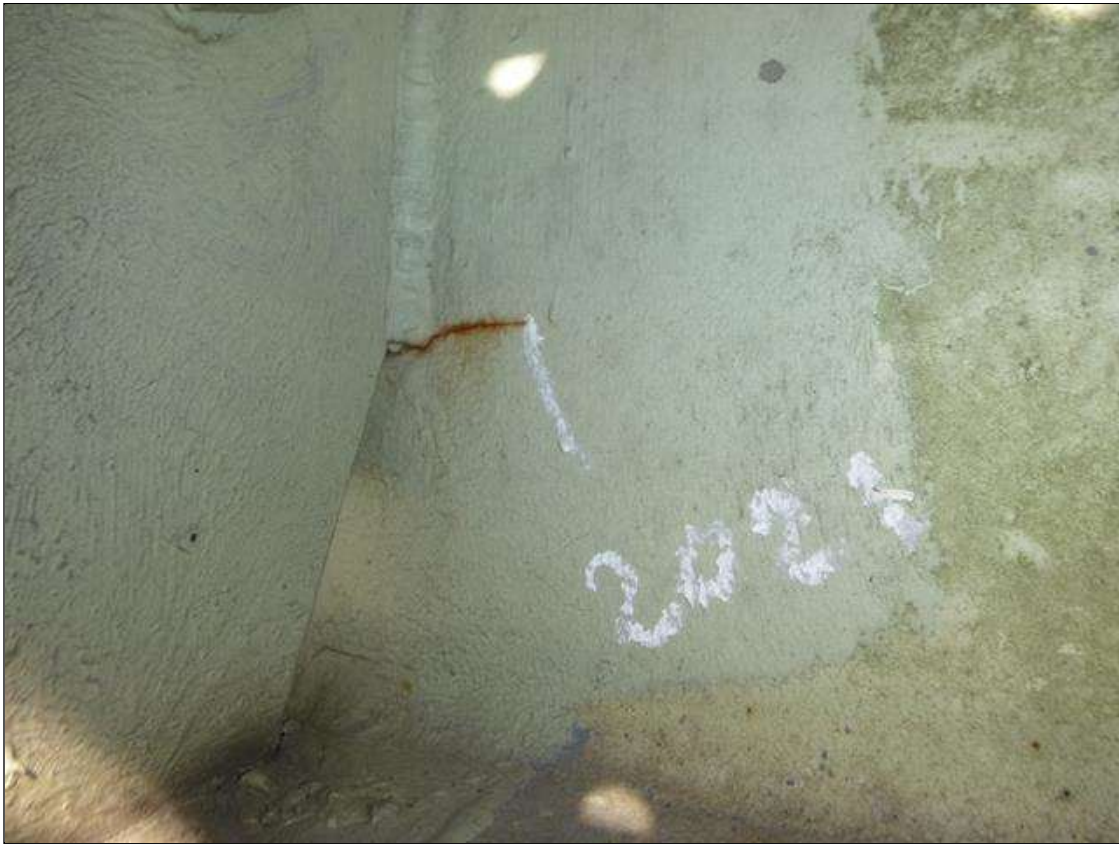
Span 18 Lift Span Stringer 13: (PAR) BETWEEN FB's 2-3 - 1 1/4" LONG CRACK IN WEB ACROSS BOTTOM OF WELD AT DIAPHRAGM CONNECTION ON SOUTH SIDE.

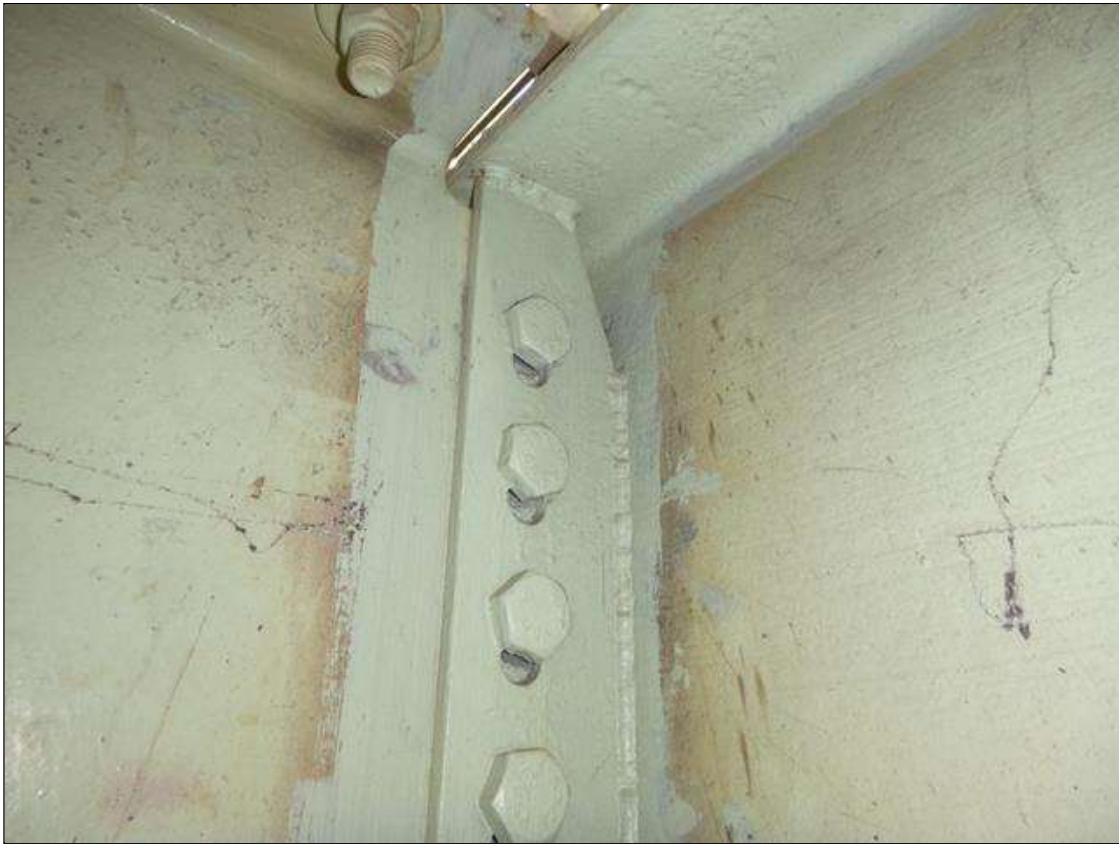
Span 18 Lift Span Stringer 8: REPAIR OBSERVED IN 2020 INSP: CRACK NOT VISIBLE, AREA HAS BEEN PAINTED OVER. 2018 REPORT HAD BETWEEN FB's 3-4 - 1/2" LONG CRACK IN WEB ACROSS TOP OF WELD AT DIAPHRAGM CONNECTION ON NORTH SIDE.

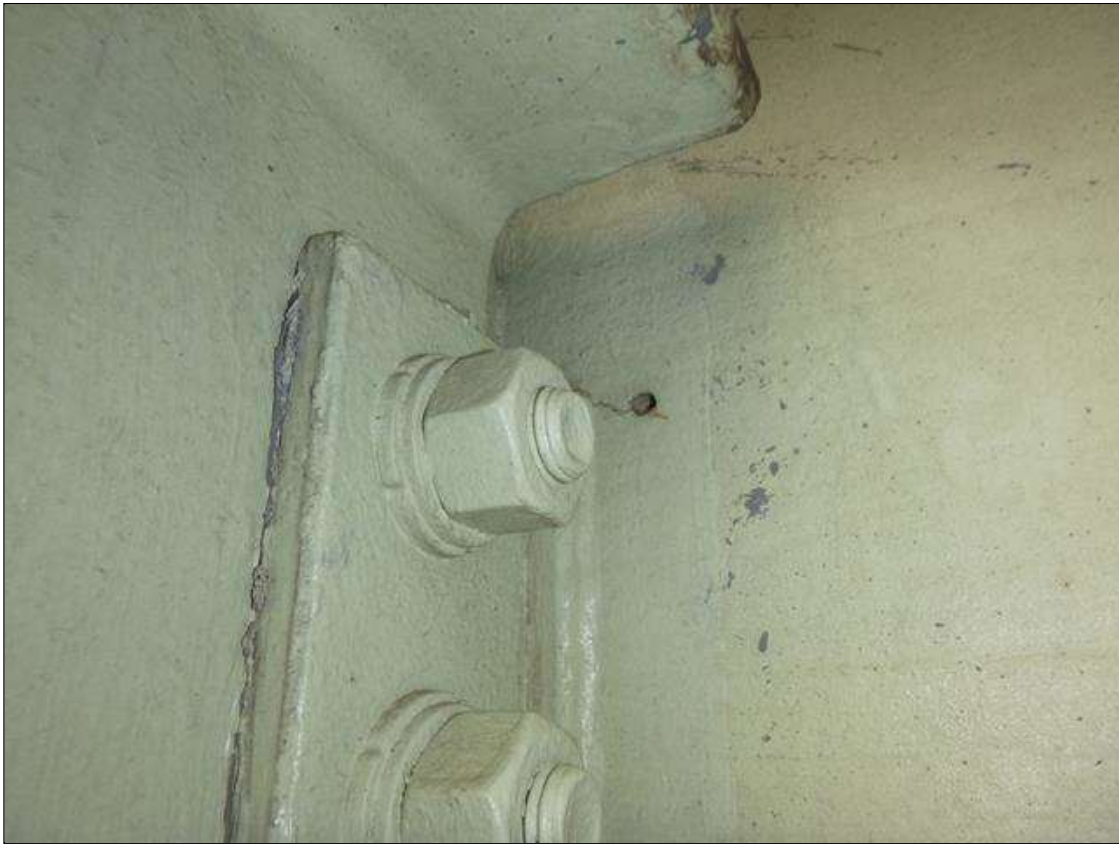
Span 18 Lift Span Stringer 11: OBSERVED IN 2020 INSP.; AREA HAS BEEN PAINTED OVER, NO CHANGE, PROPAGATED CRACK STILL VISIBLE. PAR ISSUED. 2018 REPORT HAD BETWEEN FB's 3-4 - CRACKS PROPAGATED UP TO 3/16" PAST EAST AND WEST ARREST HOLES AT TOP OF DIAPHRAGM CONNECTION - PAR ISSUED

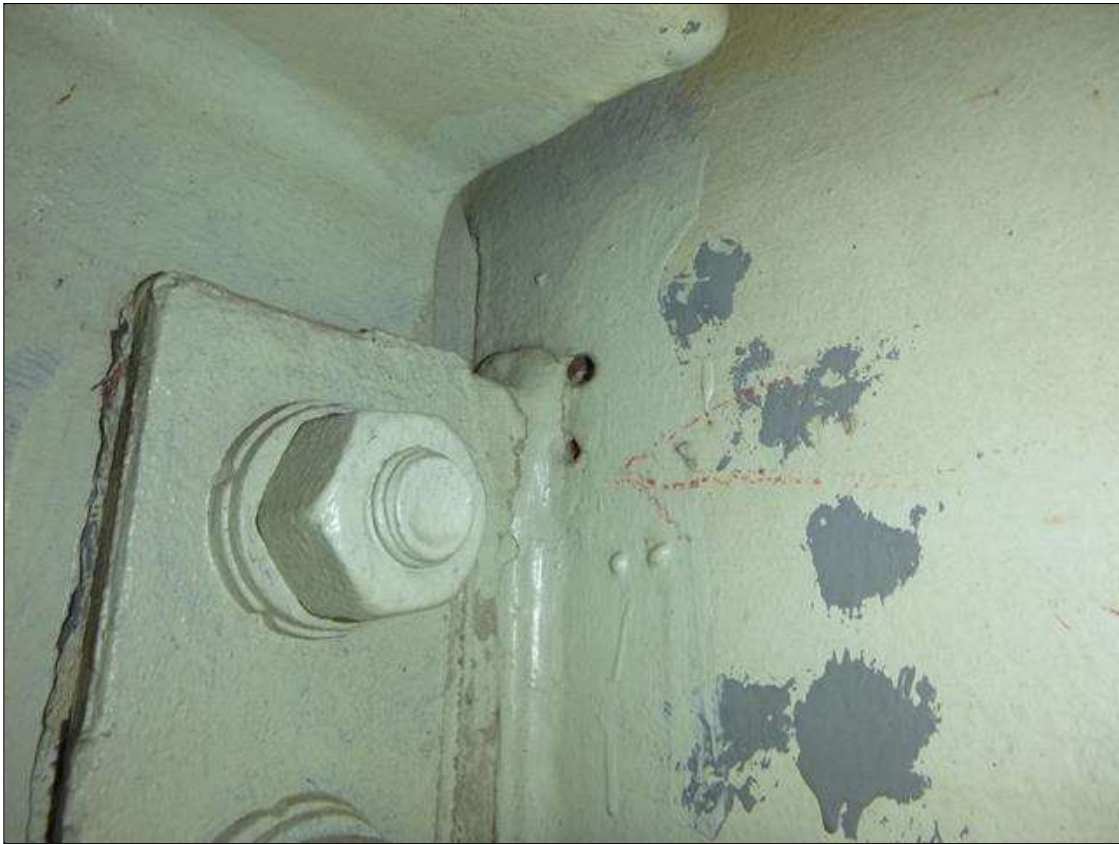
Span 18 Lift Span Stringer 11: BETWEEN FB's 4-5 - CRACK PROPAGATED 3/16" PAST ARREST HOLE AT TOP OF DIAPHRAGM CONNECTION - PROMPT ACTION REQUEST

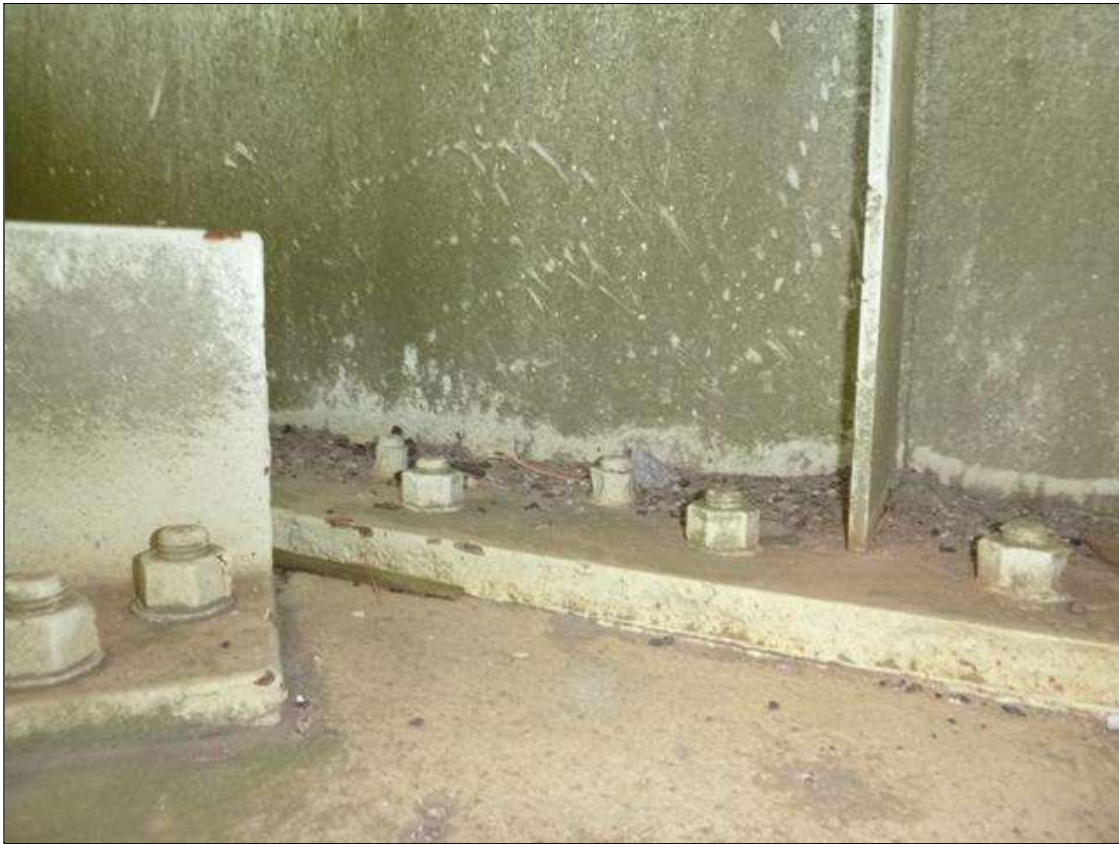
Span 18 Lift Span Floor Beam 5: 50-80% LOSS TO (5) CENTER BOTTOM LATERAL GUSSET FASTENERS AT BOTTOM FLANGE ON WEST SIDE

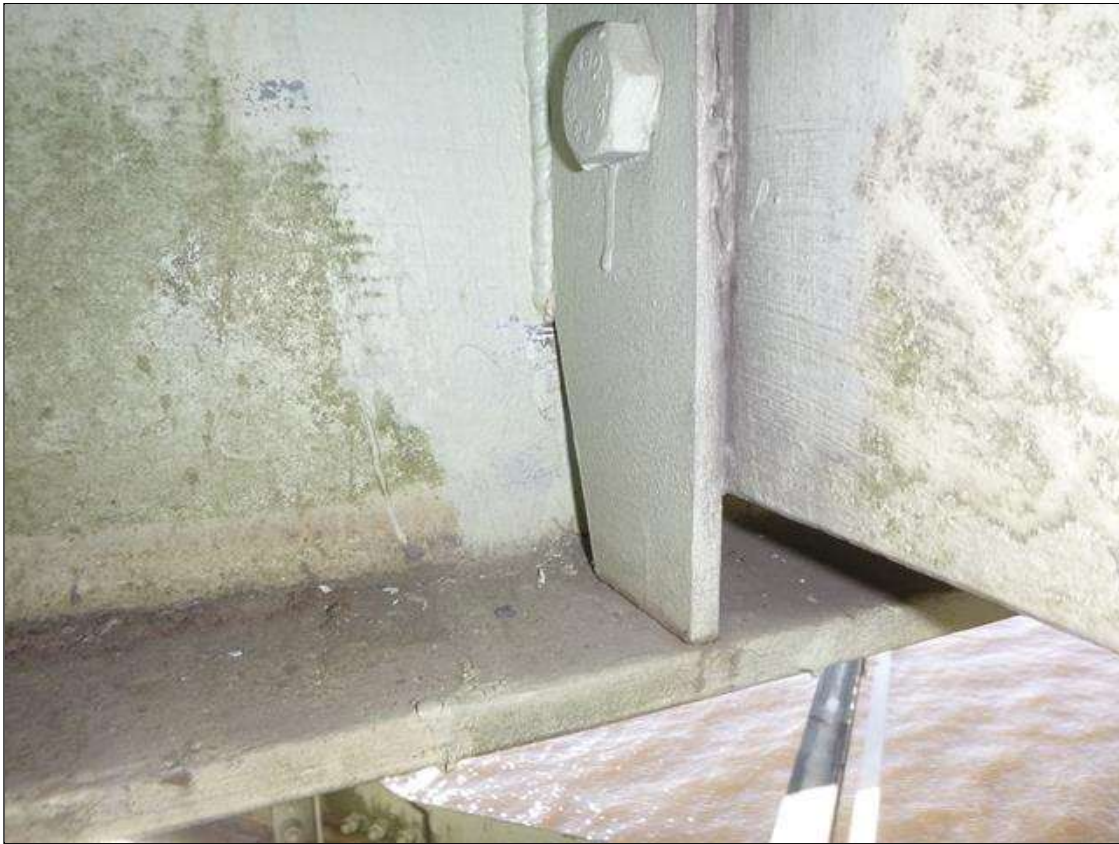
Span 18 Lift Span Stringer 10: REPAIR OBSERVED IN 2021 INSP: CRACK NOT VISIBLE AREA HAS BEEN PAINTED OVER. 2020 REPORT BETWEEN FB's 5-6 - 1-1/2" LONG CRACK IN DIAPHRAGM CONNECTION WELD AT BOTTOM ON NORTH SIDE.

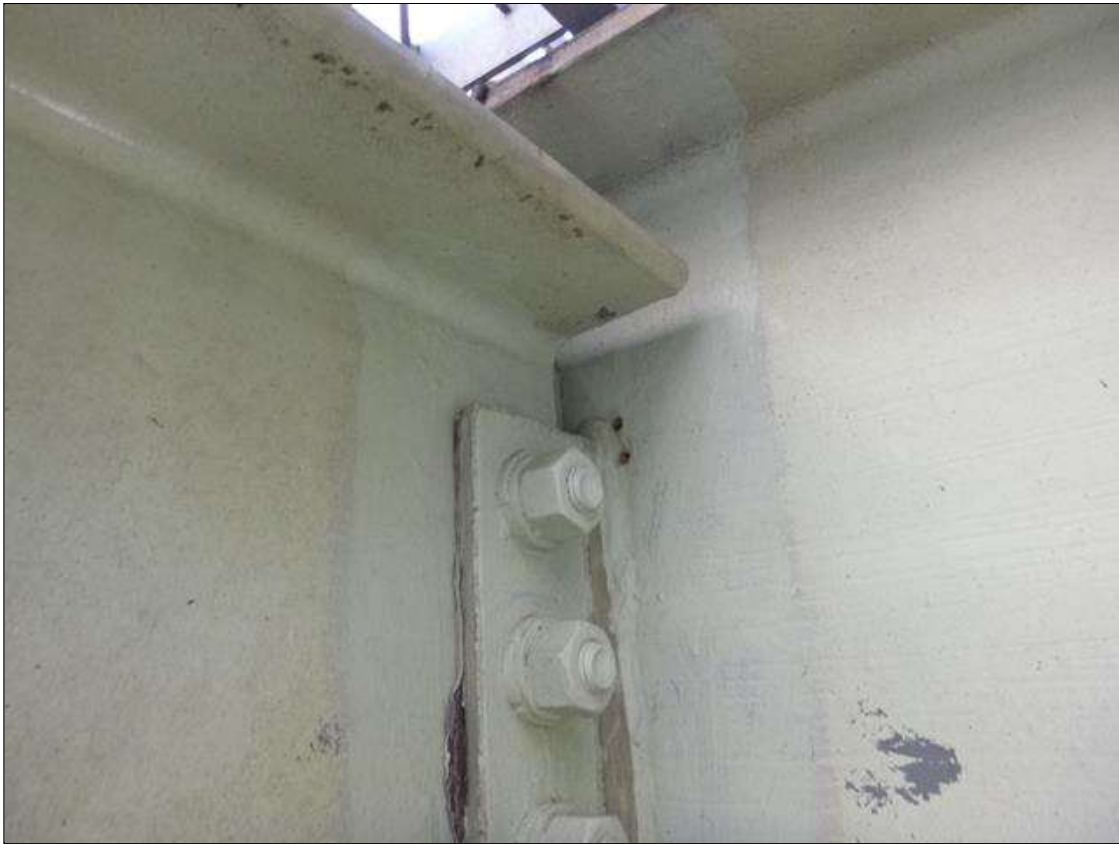
Span 18 Lift Span Stringer 11: BETWEEN FB's 5-6 - ARRESTED CRACK IN WEB AT TOP OF DIAPHRAGM CONNECTION

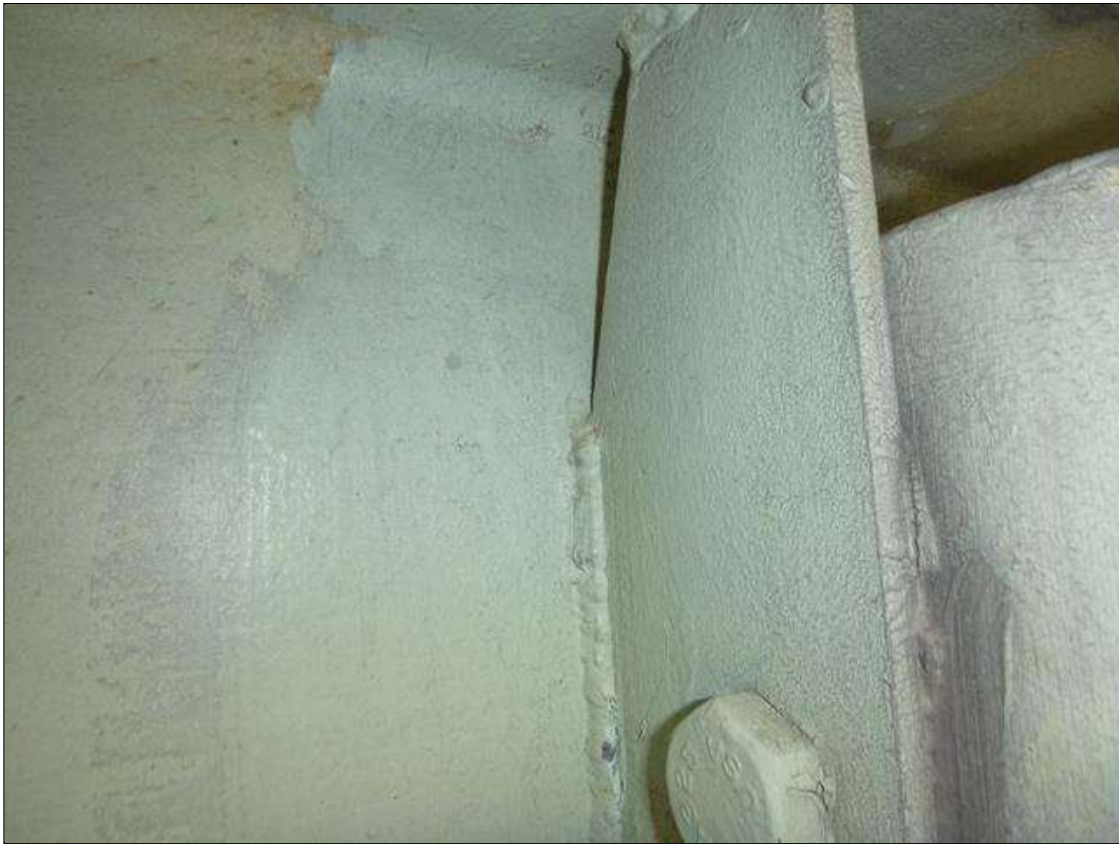
Span 18 Lift Span Stringer 10: REPAIR OBSERVED IN 2021 INSP: CRACK NOT VISIBLE AREA HAS BEEN PAINTED OVER. 2020 REPORT BETWEEN FB's 5-6 - 1" LONG CRACK IN WEB ACROSS TOP OF WELD AT DIAPHRAGM CONNECTION

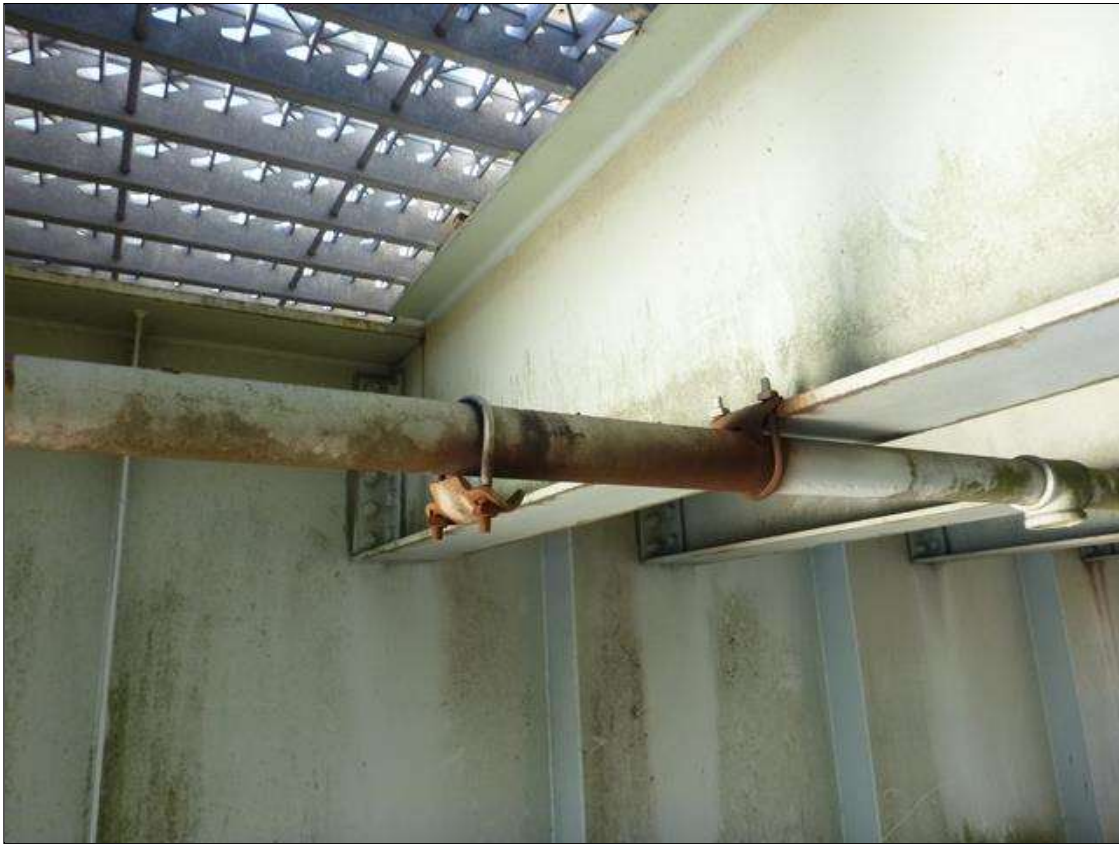
BETWEEN FLOOR BEAMS 6 AND 7 THERE ARE 5 OF 9 UTILITY BRACKETS DISCONNECTED..

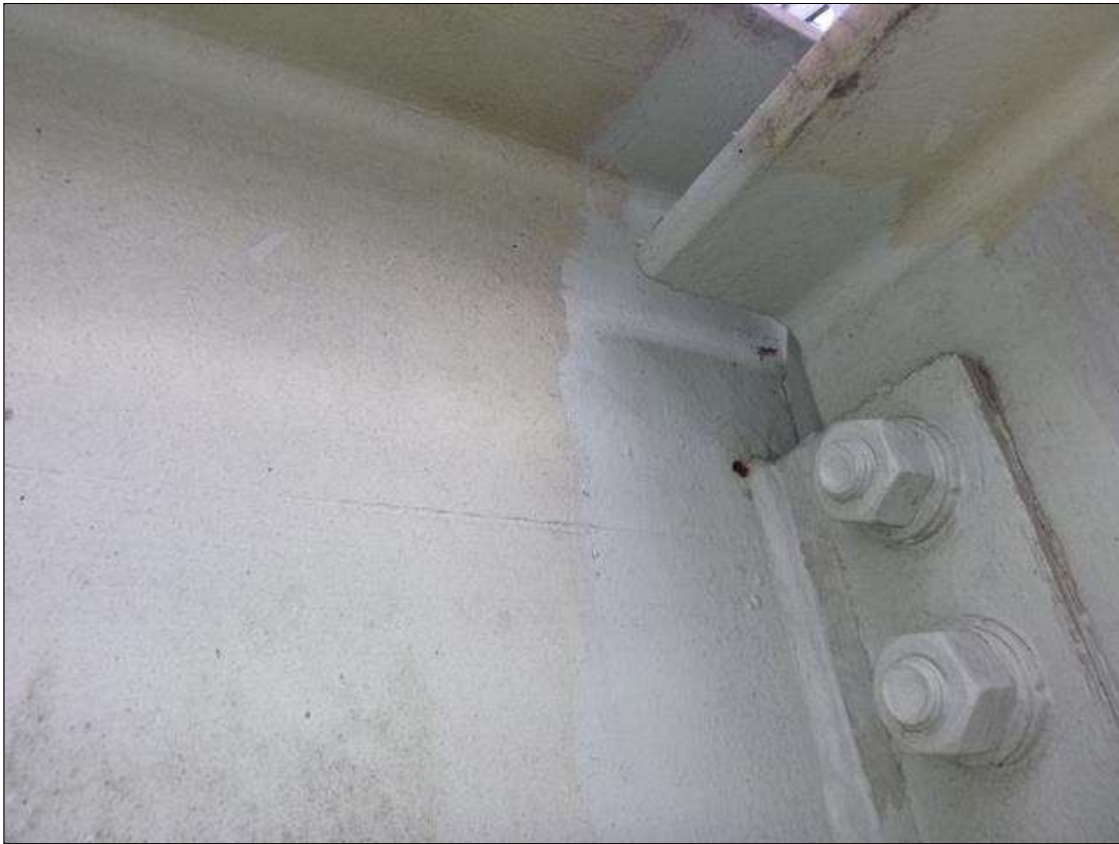
Span 18 Lift Span Stringer 11: OBSERVED IN 2020 INSP: CRACK NOT VISIBLE, AREA HAS BEEN PAINTED OVER.
2018 REPORT HAD BETWEEN FB's 6-7 - CRACK PROPAGATED 3/16" PAST ARREST HOLE AT TOP OF
DIAPHRAGM CONNECTION

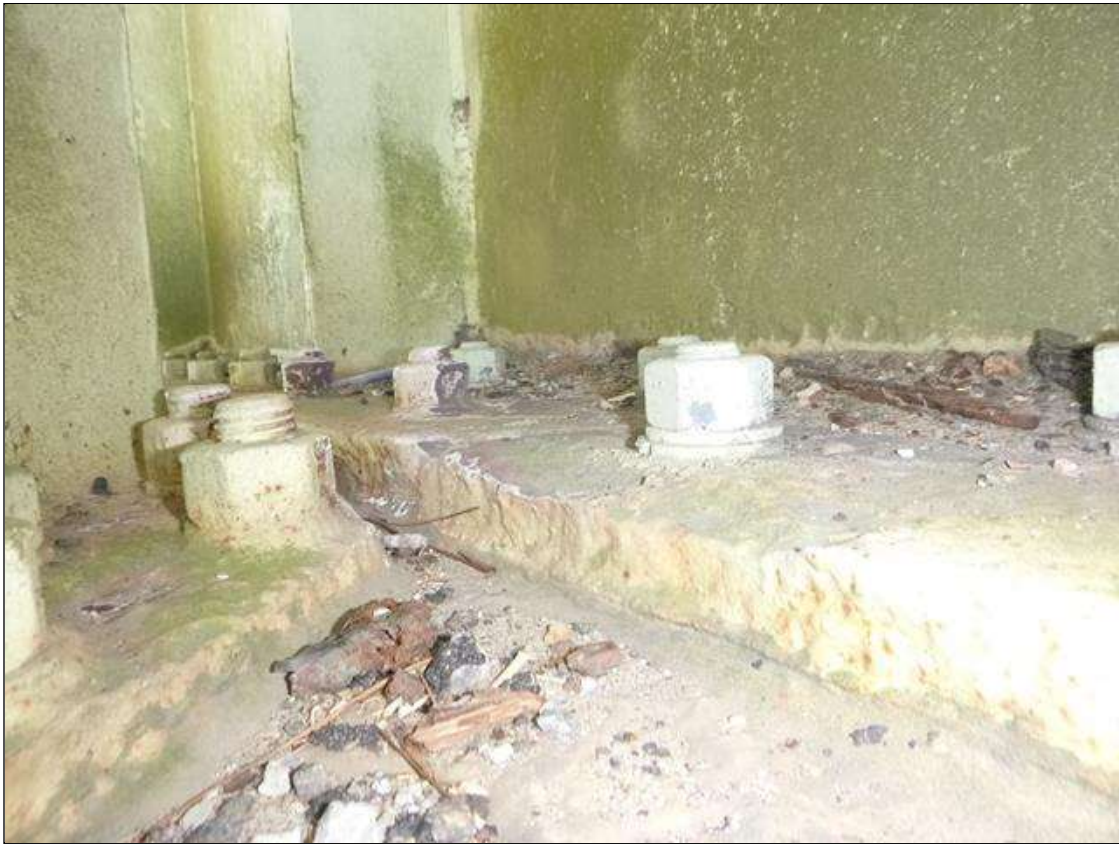
Span 18 Lift Span Floor Beam 7: SPAN 18 CENTER BOTTOM LATERAL GUSSET AT FB 7: PITTED AREA ON TOP AT THE NORTHEAST CORNER, 7" X 7" X 1/4" DEEP, CLEANED AND PAINTED.

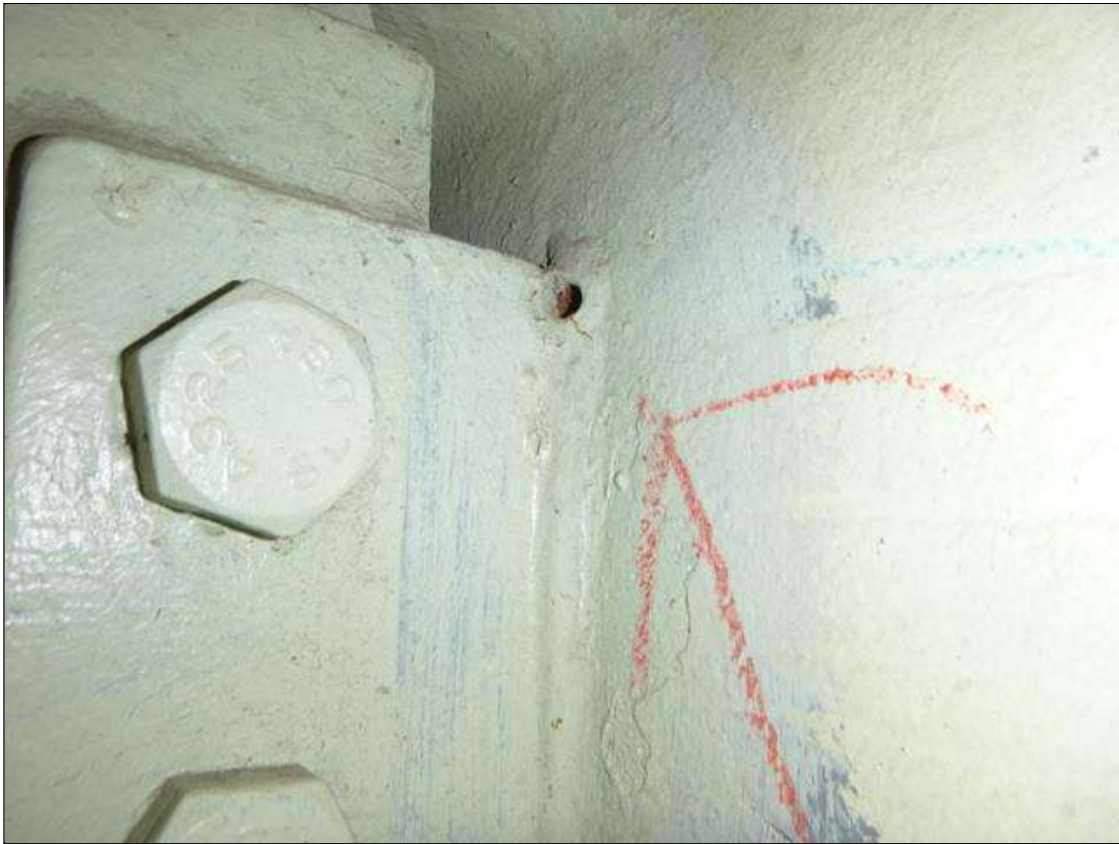
Span 18 Lift Span Stringer 8: BETWEEN FB's 7-8 - (2) CRACKS PROPAGATED 3/16" PAST ARREST HOLE AT TOP OF DIAPHRAGM CONNECTION - PROMPT ACTION REQUEST

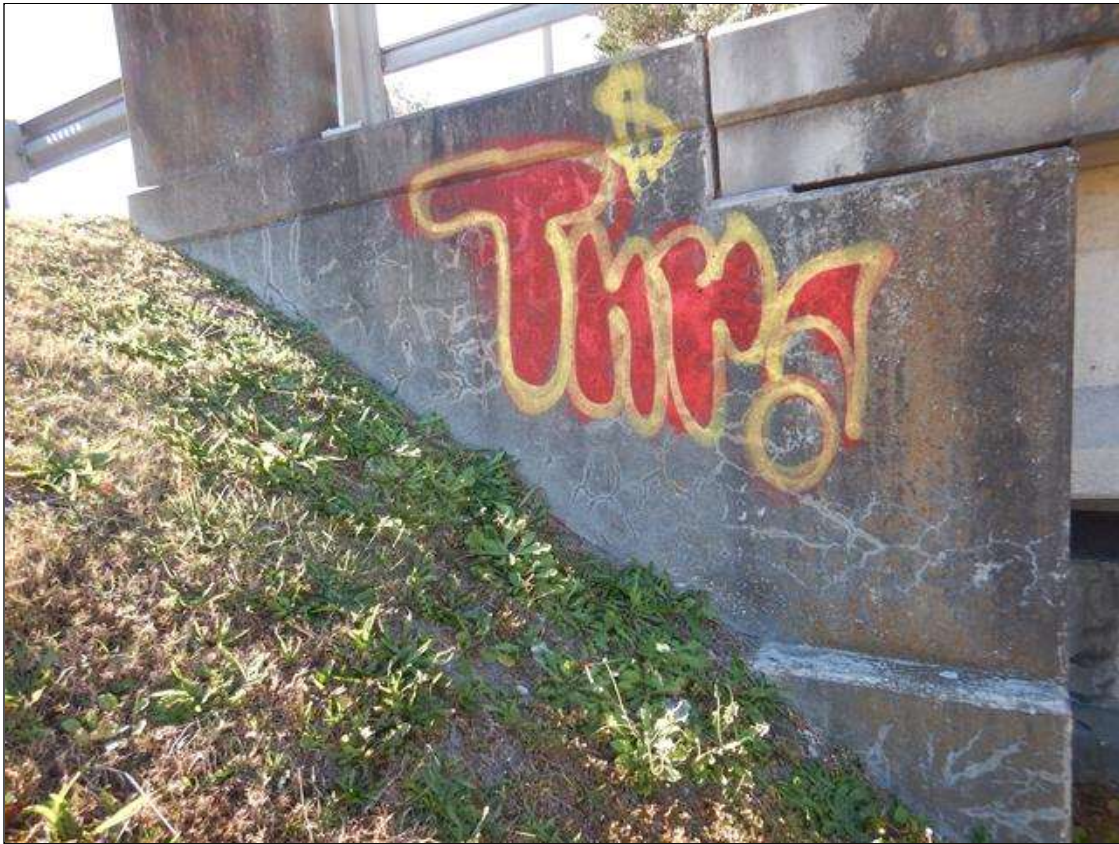
Ramp End Bent Abutment: area of hairline map cracking on the left side of ramp bridge abutment, 10 FOOT. long with EFFLORESCENCE.

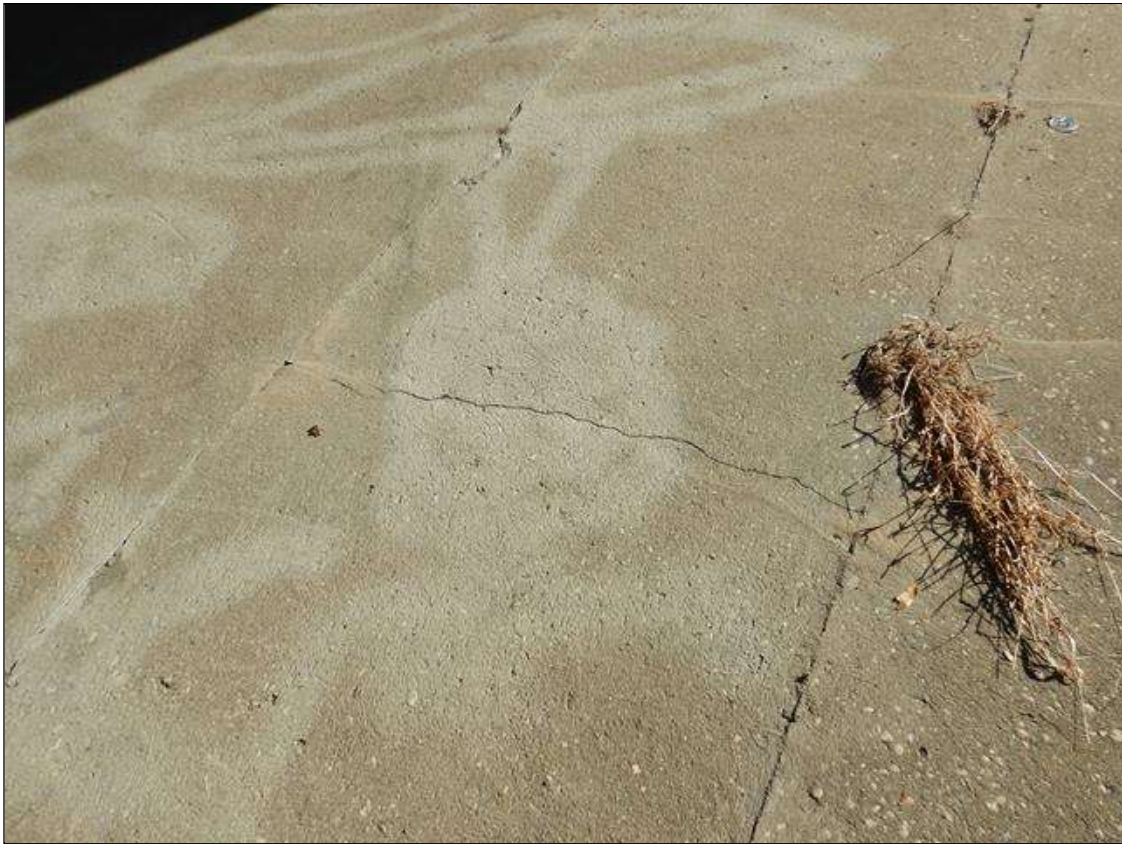
AT ABUTMENT 2, RIGHT SIDE OF THE CONCRETE SLOPE PROTECTION ON THE SLOPE, TWO AREAS OF HORIZONTAL CRACKING TO 1/8" WIDE [APPROXIMATELY 8' TOTAL]

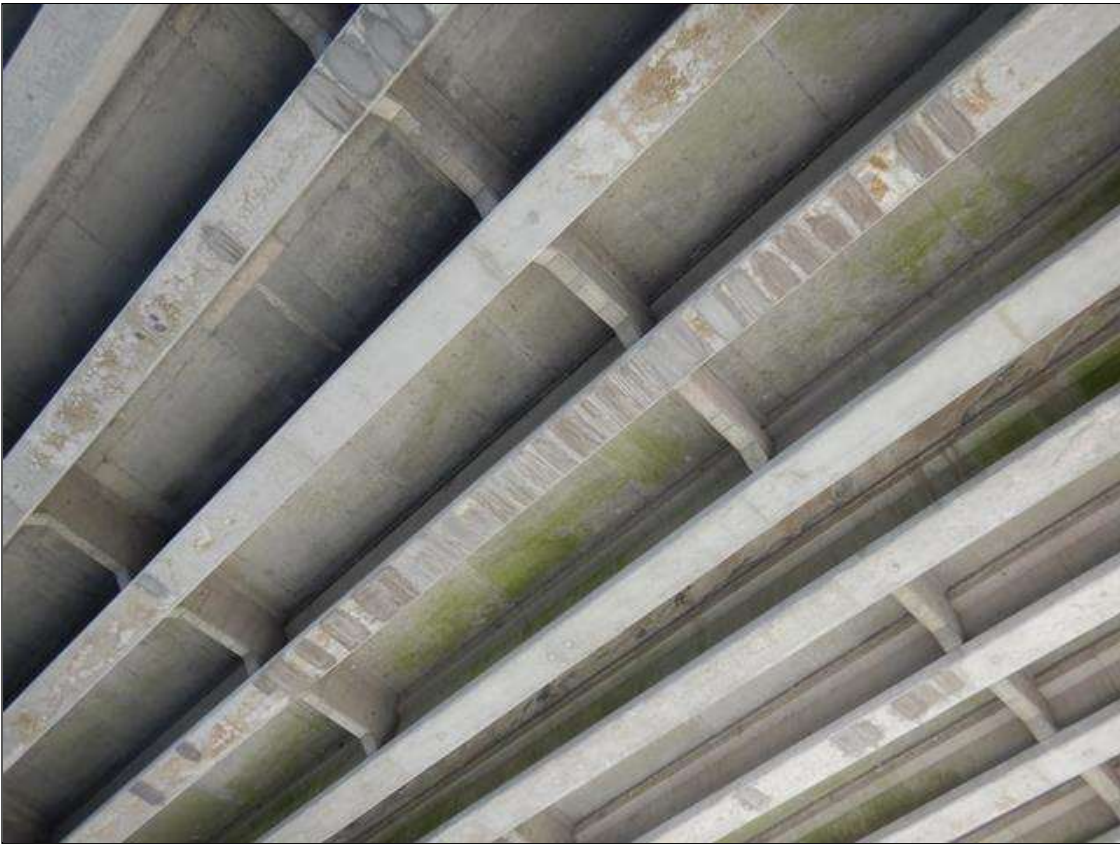
Span 27 Beam 6: [NEW REPAIR-PATCHING] FORMERLY --> (x23) spalls with exposed rebar on the bottom face up to (18" x 5" x 1/2")

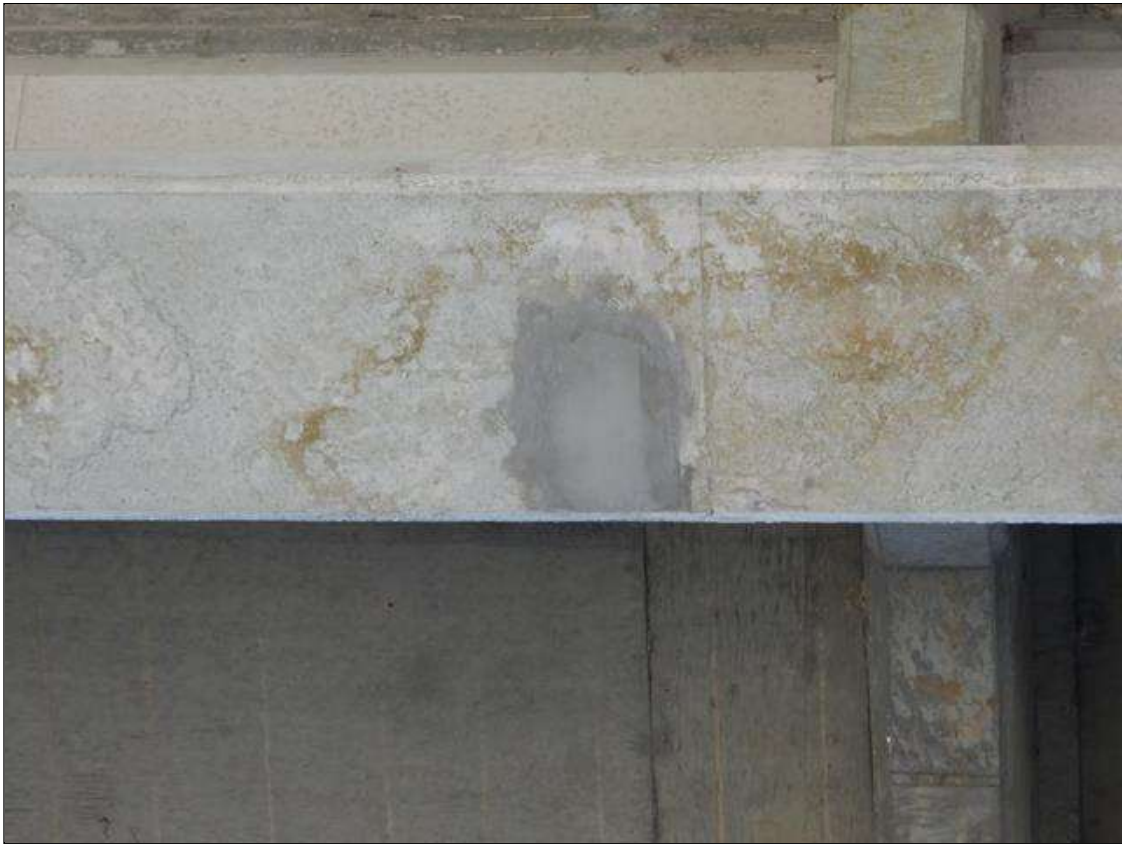
Span 27 Beam 5: [NEW REPAIR-PATCHING] FORMERLY --> spall with exposed rebar on the bottom face at 23ft from Bent 25 (7" x 5" x 1/2")

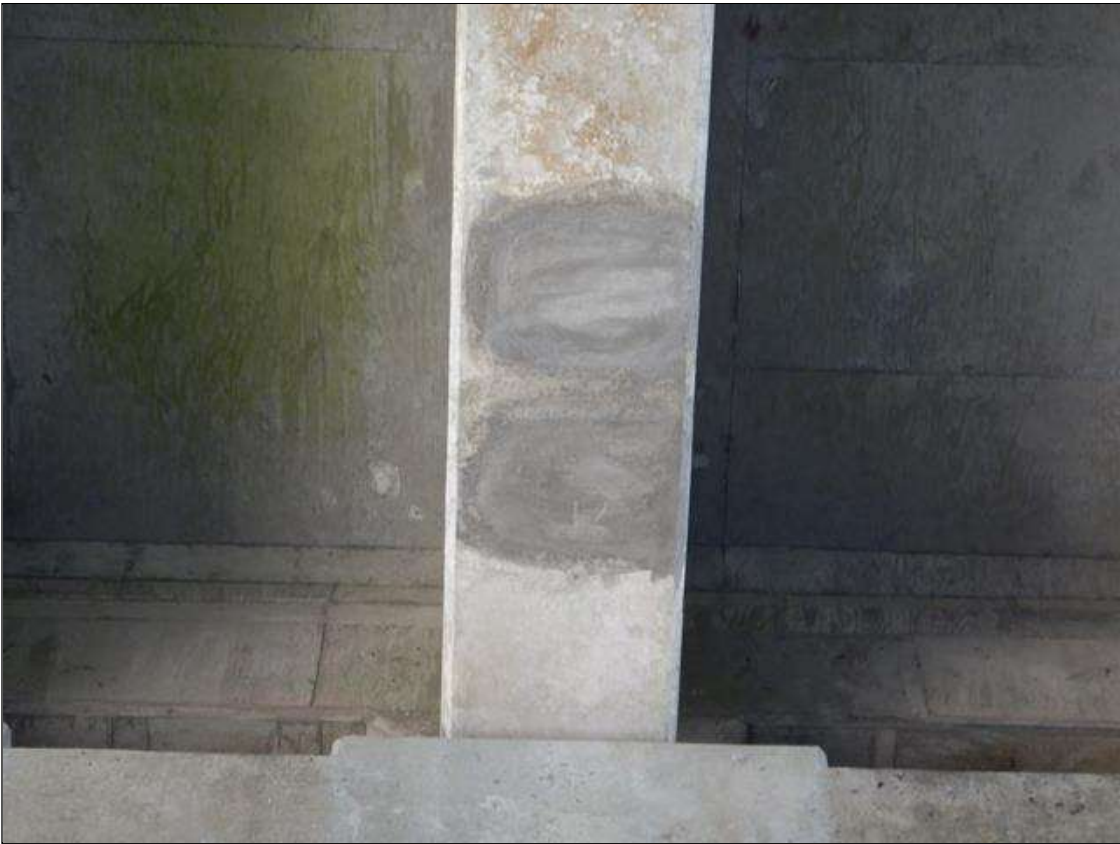
Span 28 Beam 5: [NEW REPAIR-PATCHING] FORMERLY --> (x2) spalls with exposed rebar on the bottom face at bent 25 up to (7" x 7" x 1/2")

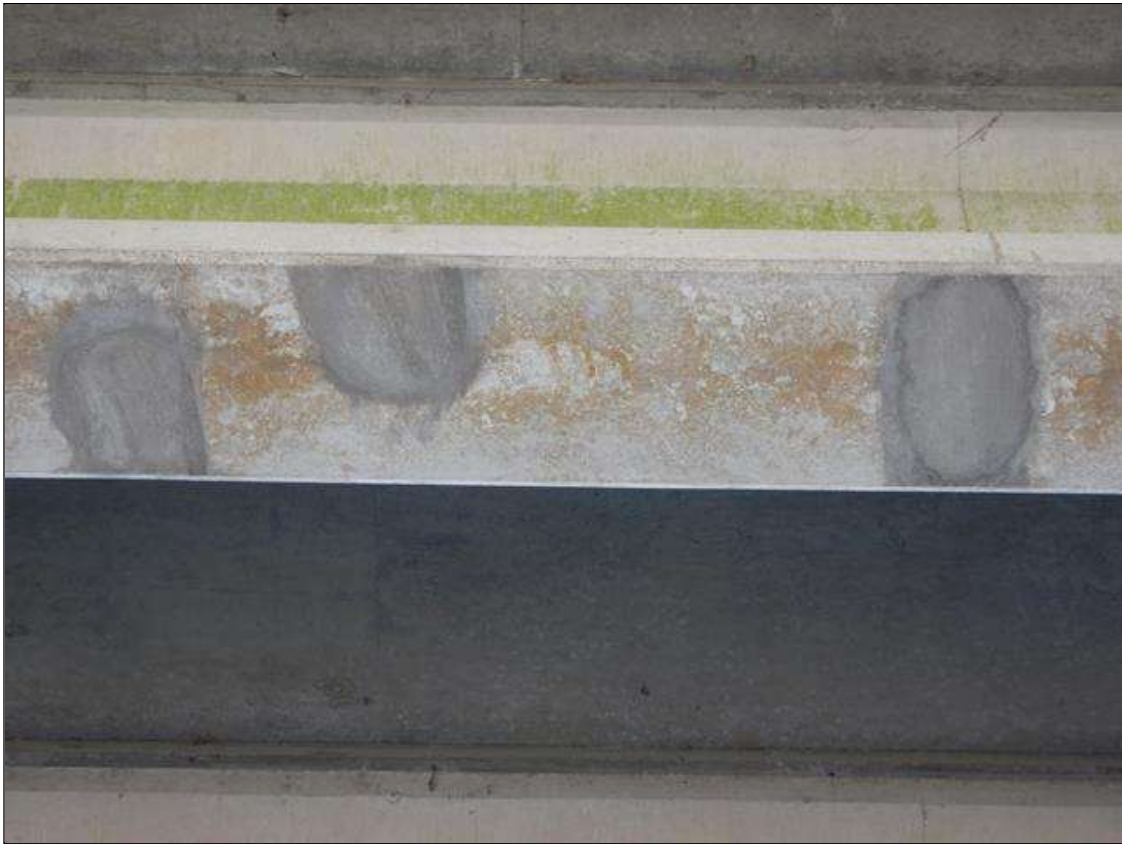
Span 28 Beam 5: [NEW REPAIR-PATCHING] FORMERLY --> (x3) spalls with exposed rebar on the bottom face starting at 22.5ft from Bent 26 up to (6" x 4" x 1/2")

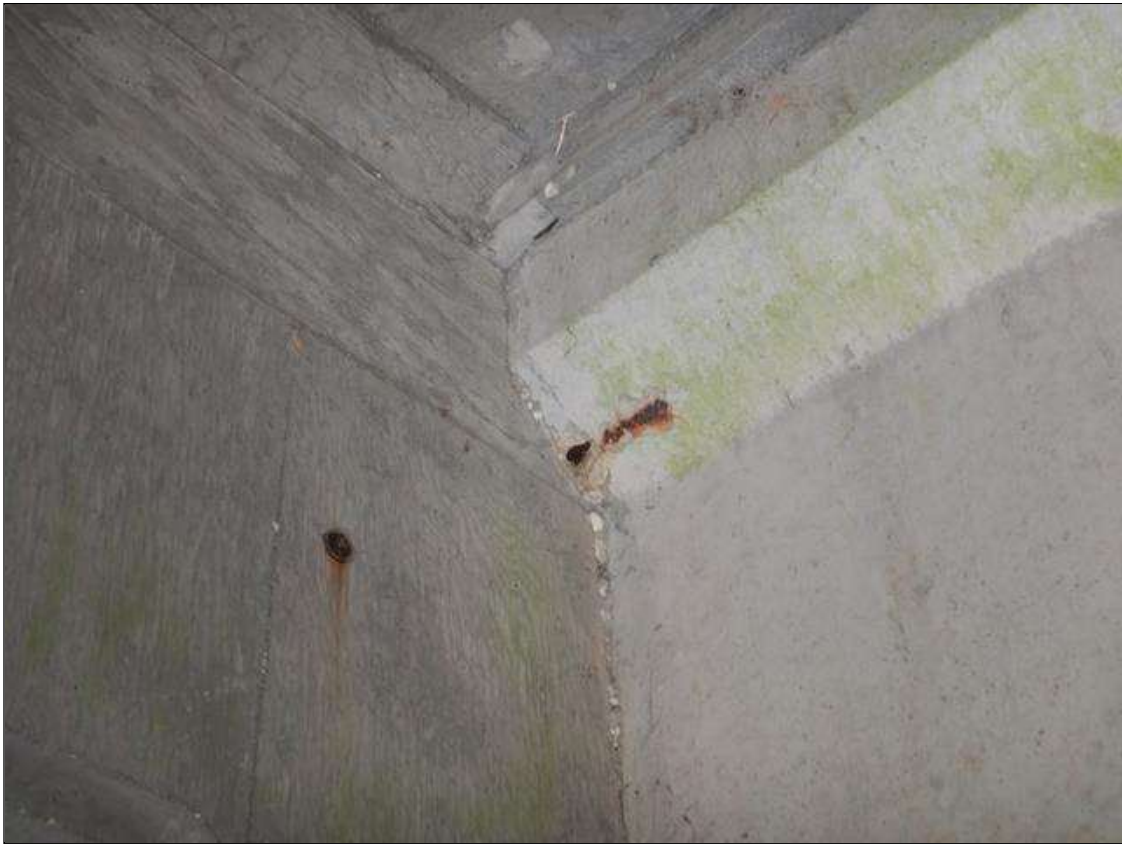
Span 28 Beam 8: [PROMPT ACTION REQUEST] spall with exposed rebar on the top right flange at bent 25 (5" x 1 1/2" x 1/4")

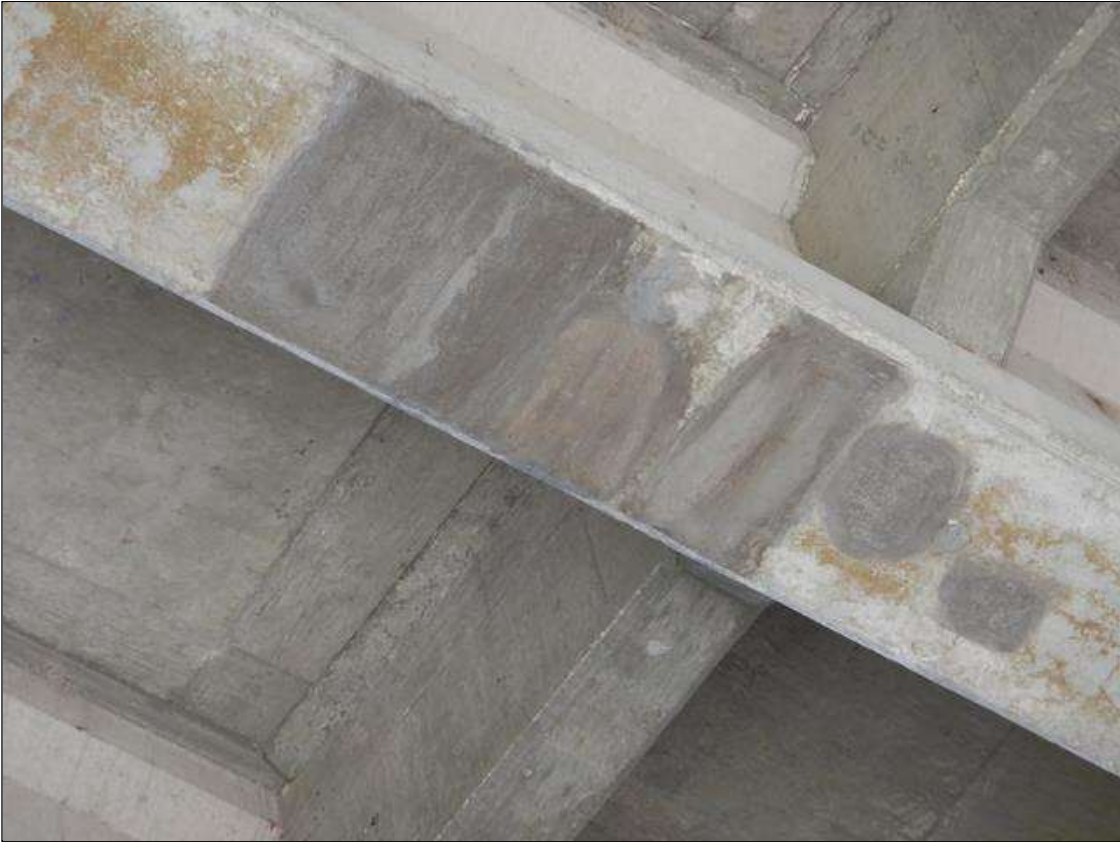
Span 28 Beam 9: [NEW REPAIR-PATCHING] FORMERLY --> multiple spalls with exposed rebar and sound patches on the bottom face up to (13" x 6" x 1/2")
