NC DEPARTMENT OF TRANSPORTATION
DIVISION OF HIGHWAYS
STRUCTURE MANAGEMENT UNIT

Structure Safety Report

Routine Element Inspection - Contract

DIVISION: 3 COUNTY: NEW HANOVER STRUCTURE NUMBER: 640013 FREQUENCY: 24 MONTHS

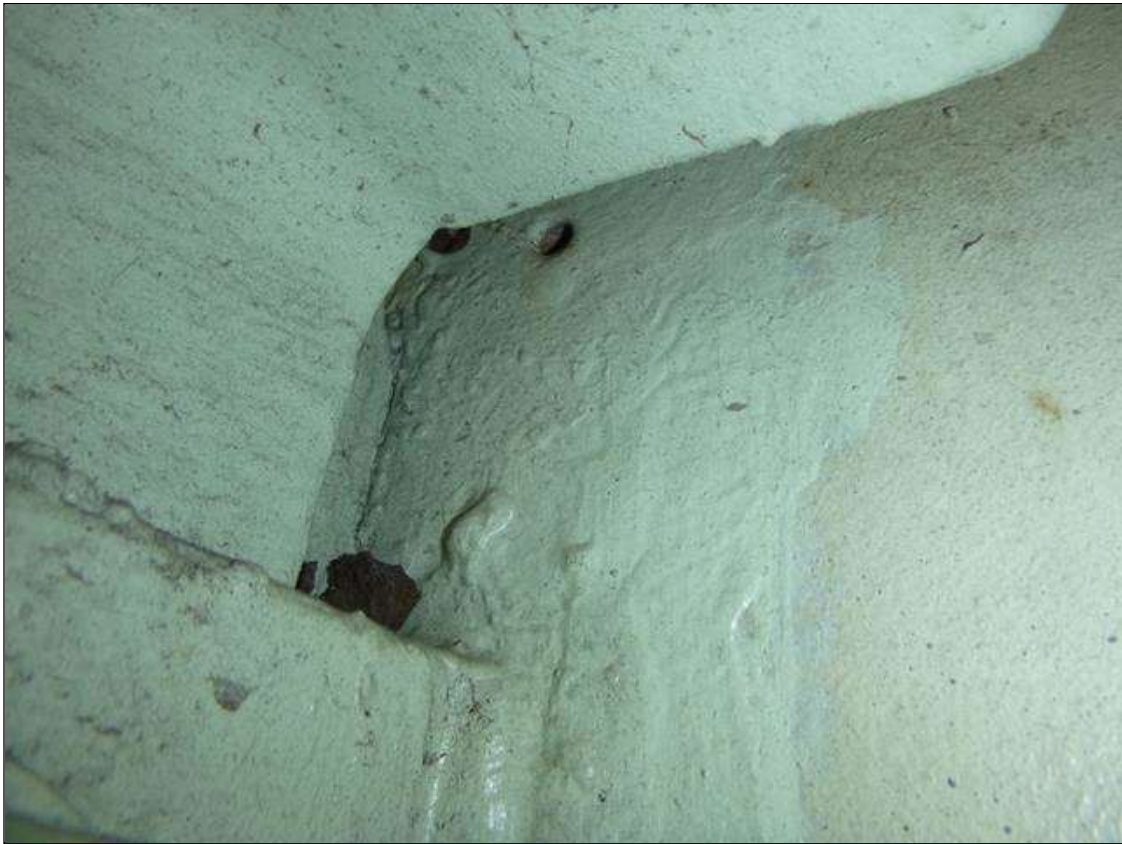
Span 18 Lift Span Stringer 8: BETWEEN FB's 11-12 - CRACK PROPAGATED 1/4" PAST EAST ARREST HOLE AT TOP OF DIAPHRAGM CONNECTION – PROMPT ACTION REQUEST

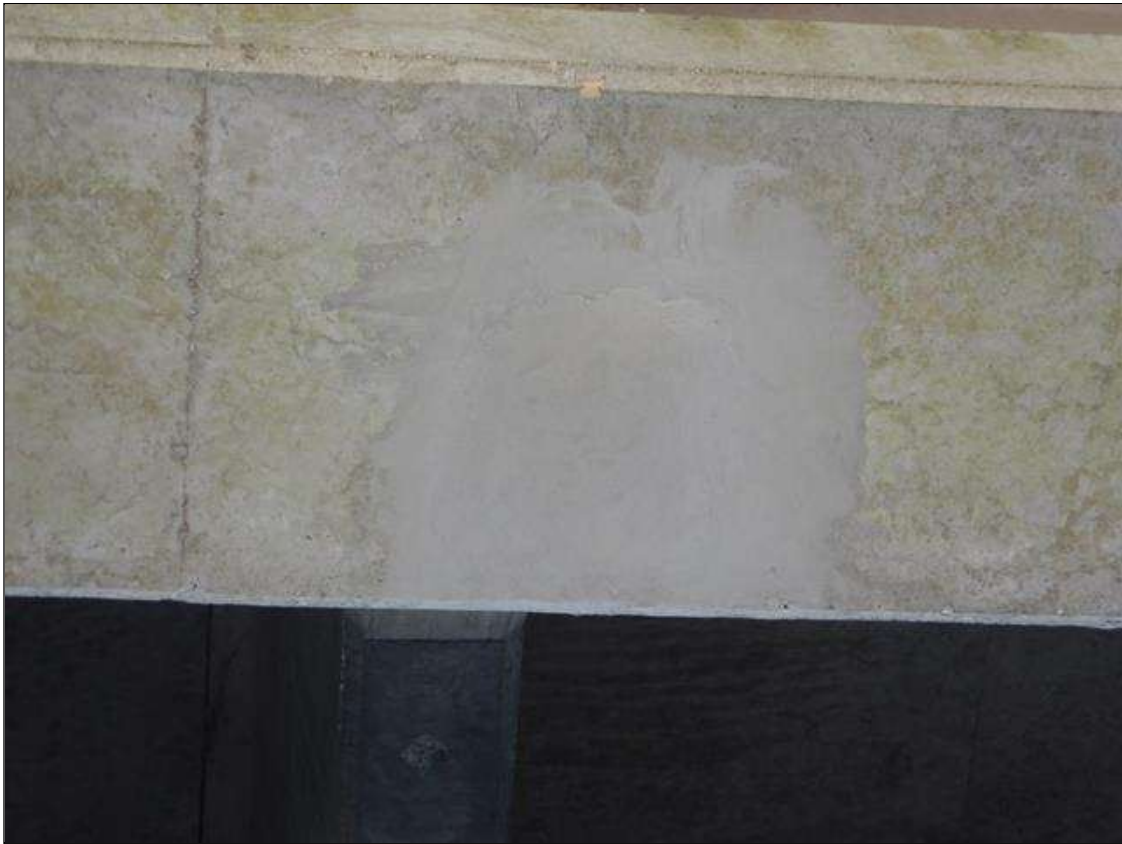
Span 30 Beam 4: [NEW REPAIR-PATCHING] FORMERLY --> (x4) spalls with exposed rebar on the bottom face at mid span up to (10" x 9" x 1/4")

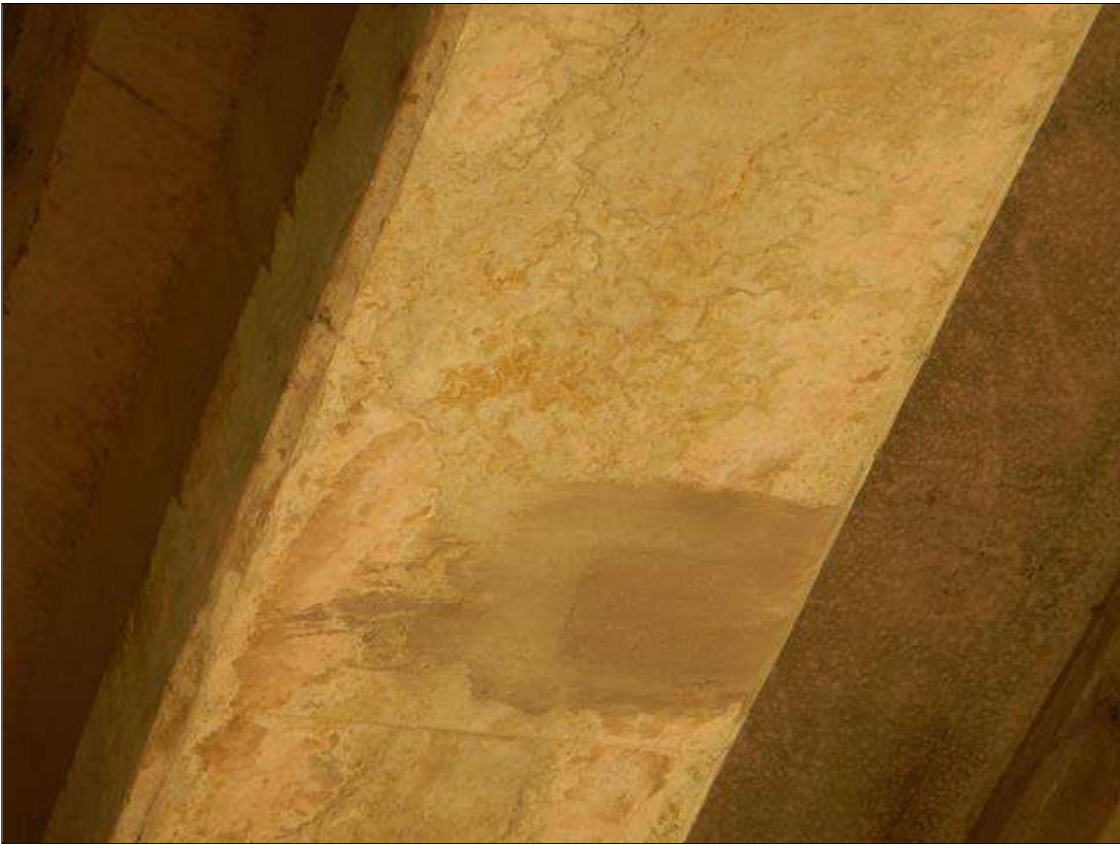
Span 30 Beam 9: [NEW REPAIR-PATCHING] FORMERLY --> DELAMINATION on the bottom face at 7ft from bent 28
(6" x 6")

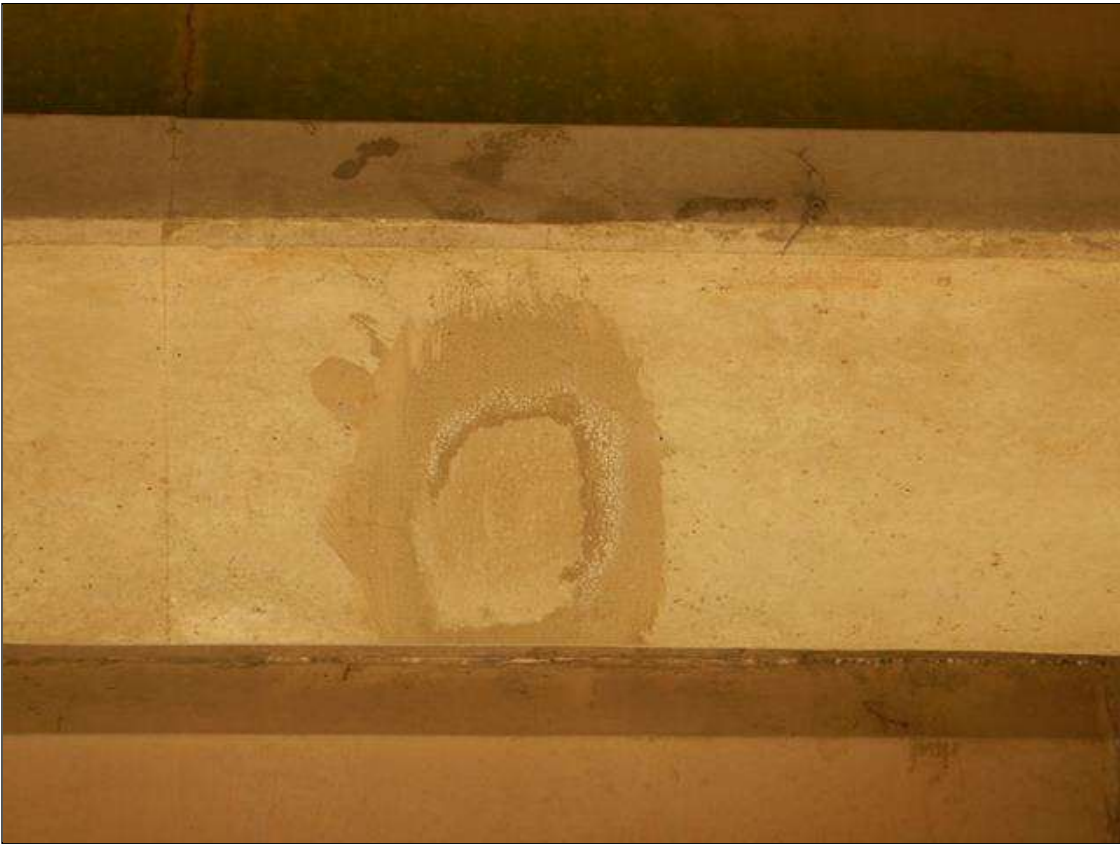
Span 30 Beam 10: [NEW REPAIR-PATCHING] FORMERLY --> (x3) spalls with exposed rebar on the bottom face at 20ft from bent 28 up to (10" x 3" x 1/4")

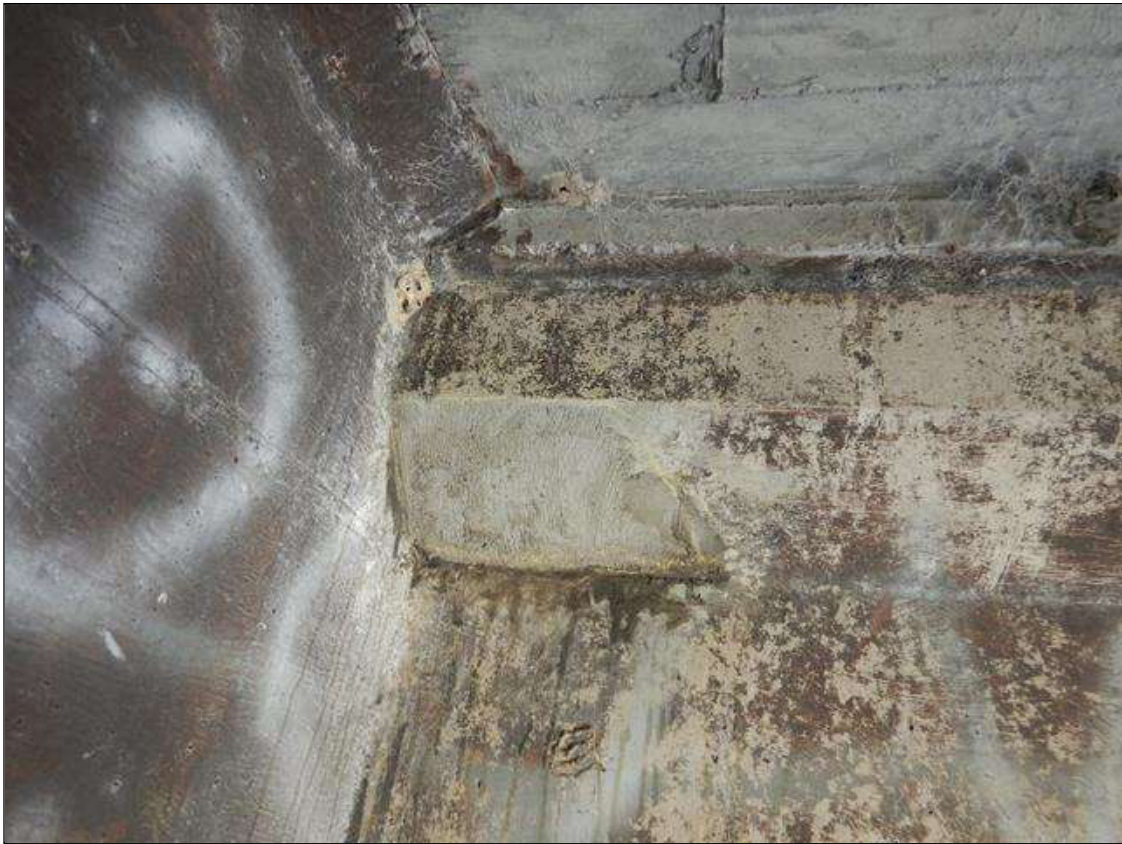
Span 35 - Ramp Span Beam 2: [NEW REPAIR-PATCHING] FORMERLY --> spall with exposed rebar in the top left flange at Ramp End Bent (7" x 1 1/2" x 1/4")

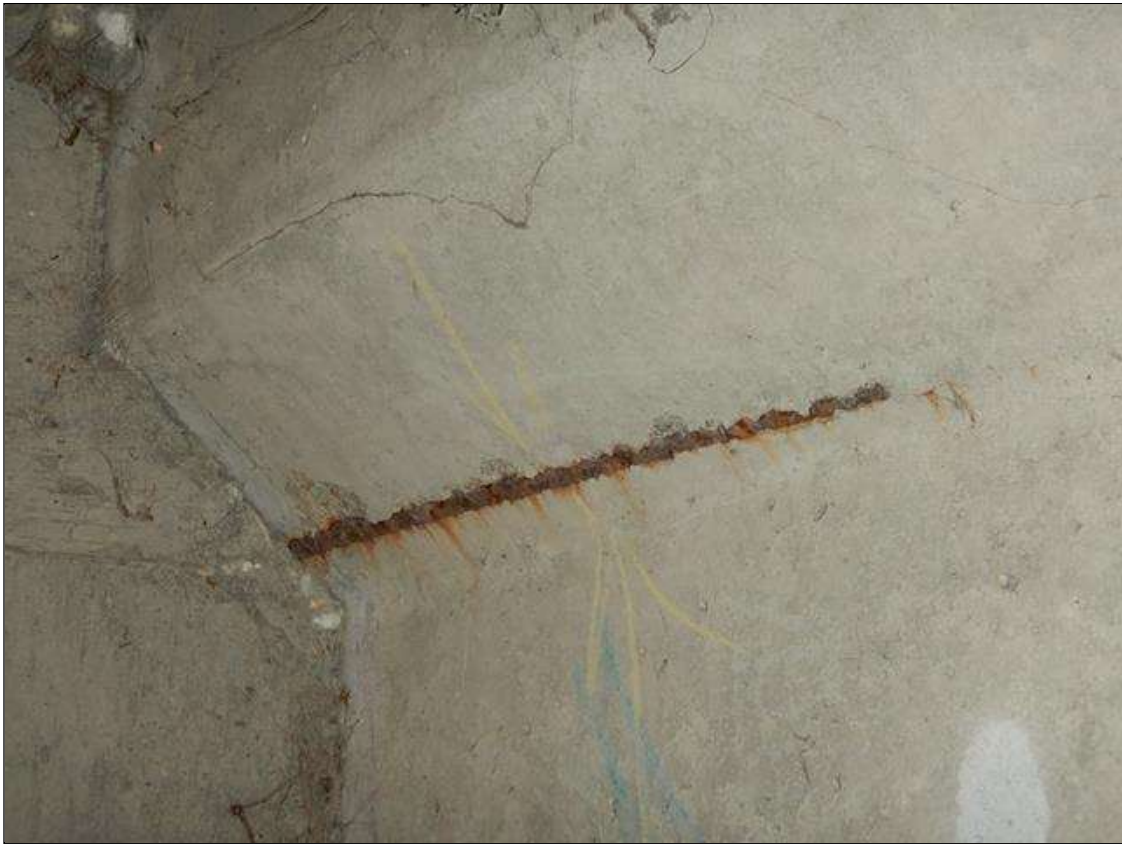
Span 35 - Ramp Span Beam 5: [PROMPT ACTION REQUEST] spall with exposed steel on the top left flange at the Ramp End Bent (13" x 1" x 1/4")

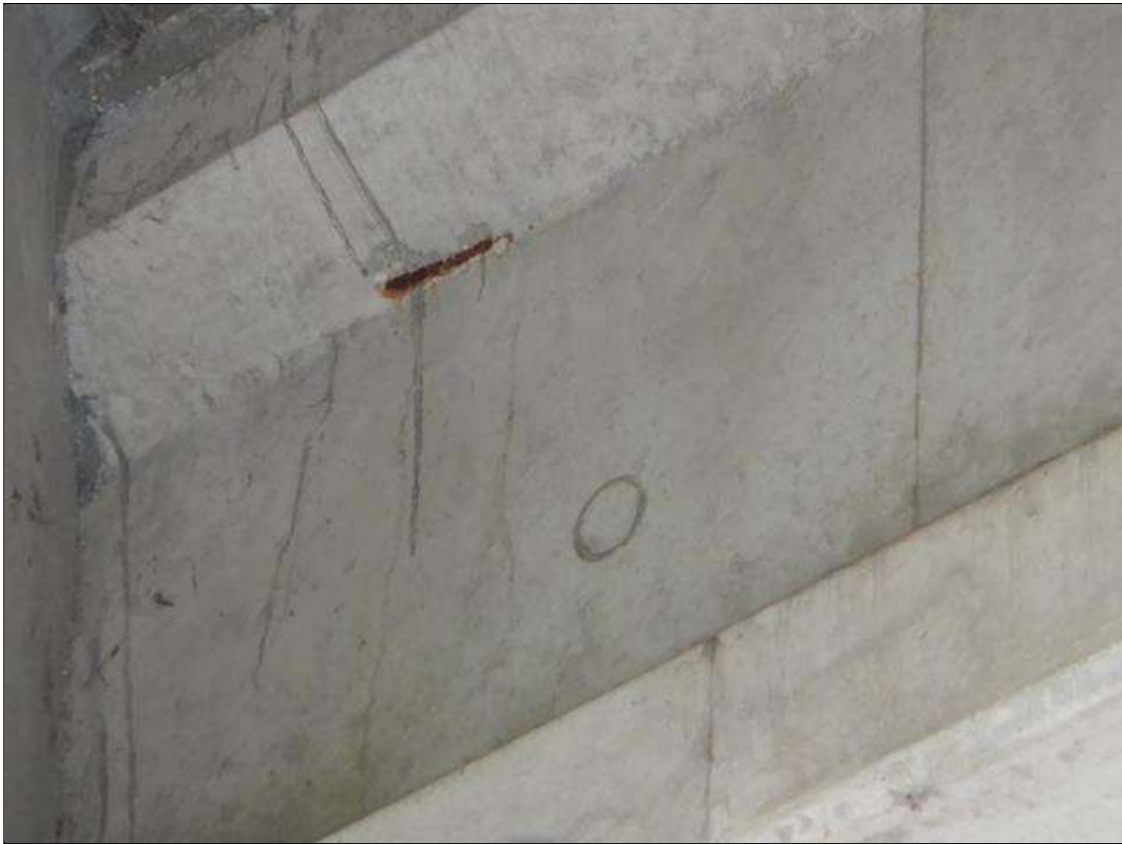
Span 32 Beam 10: [PROMPT ACTION REQUEST] spall with exposed rebar on the top right flange at 3ft from Bent 29
(4" x 1 1/2" x 1/8")

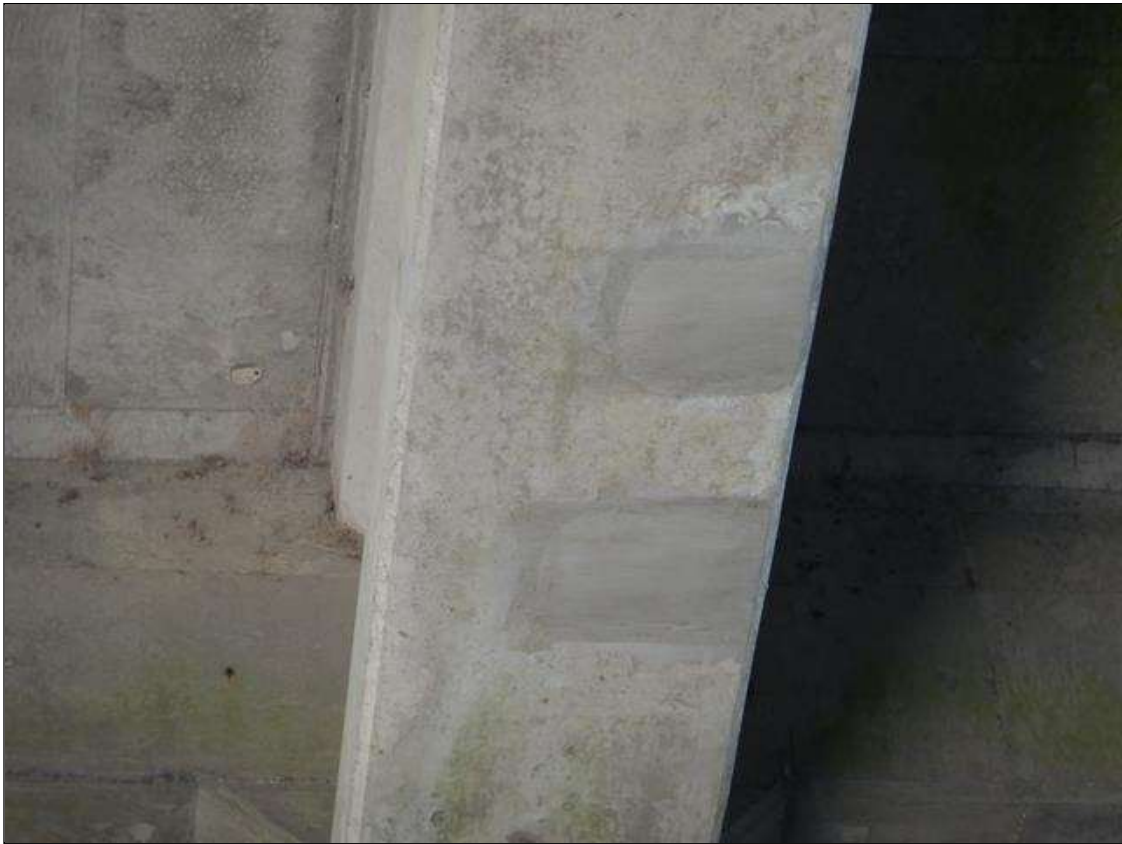
Span 29 Beam 5: [NEW REPAIR-PATCHING] FORMERLY --> (x2) spalls with exposed rebar on the bottom face at 3ft from Bent 26 up to (9" x 4")

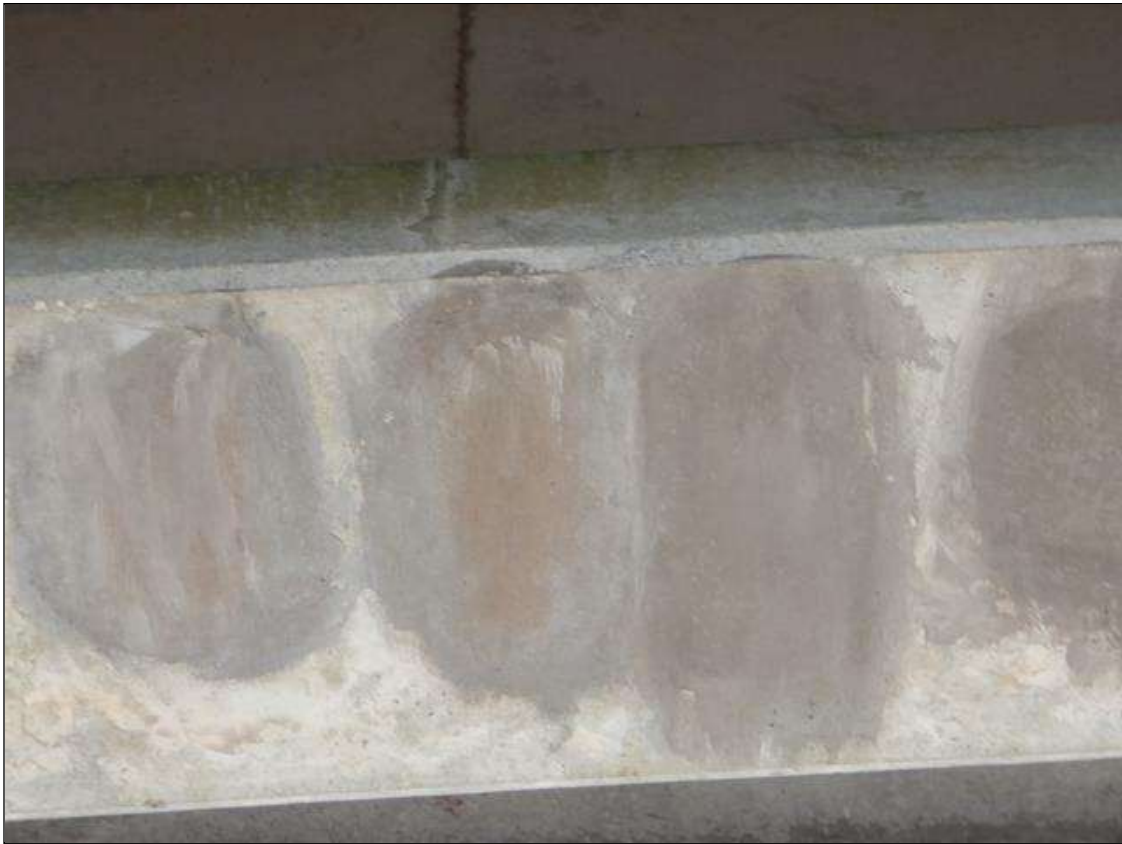
Span 29 Beam 7: [NEW REPAIR-PATCHING] FORMERLY --> spall with exposed rebar on the bottom face at 22ft from bent 27 (5" x 4" x 1/2")

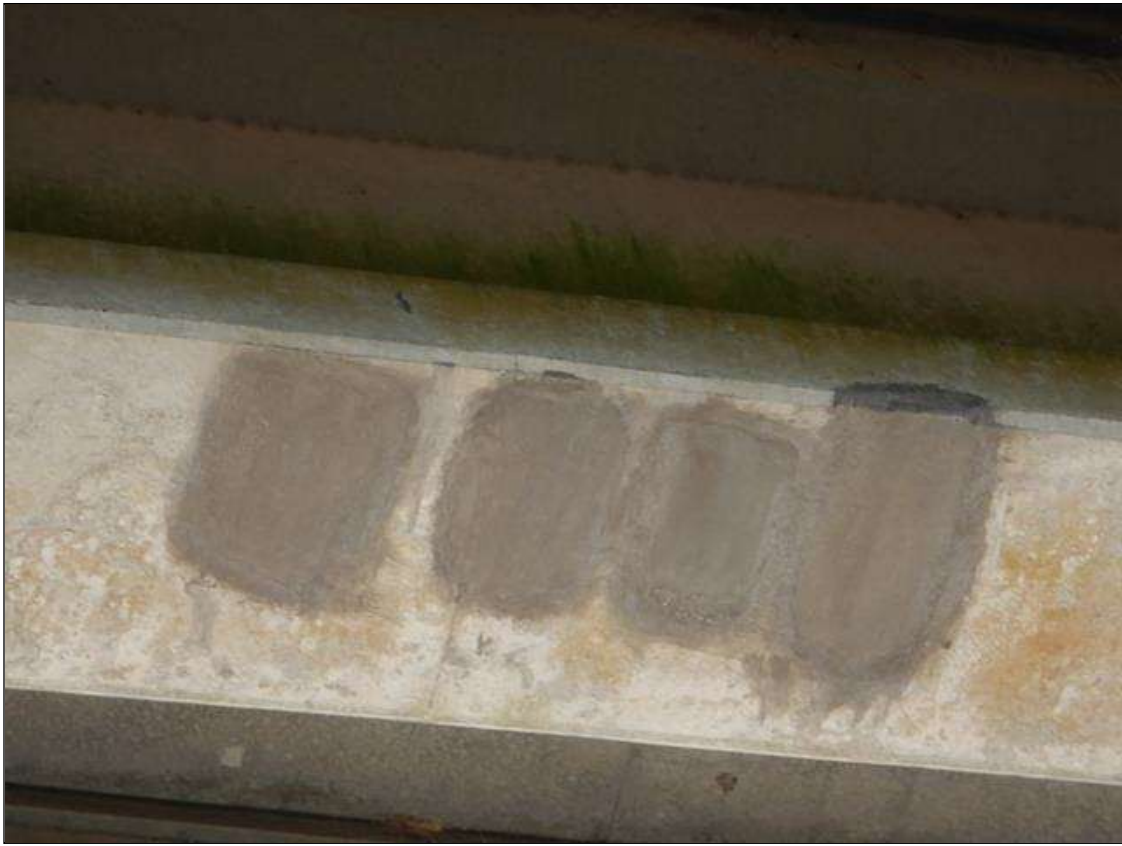
Span 29 Beam 7: [NEW REPAIR-PATCHING] FORMERLY --> (x4) spalls with exposed rebar on the bottom face at 26ft from Bent 27 up to (13" x 7" x 1/2")

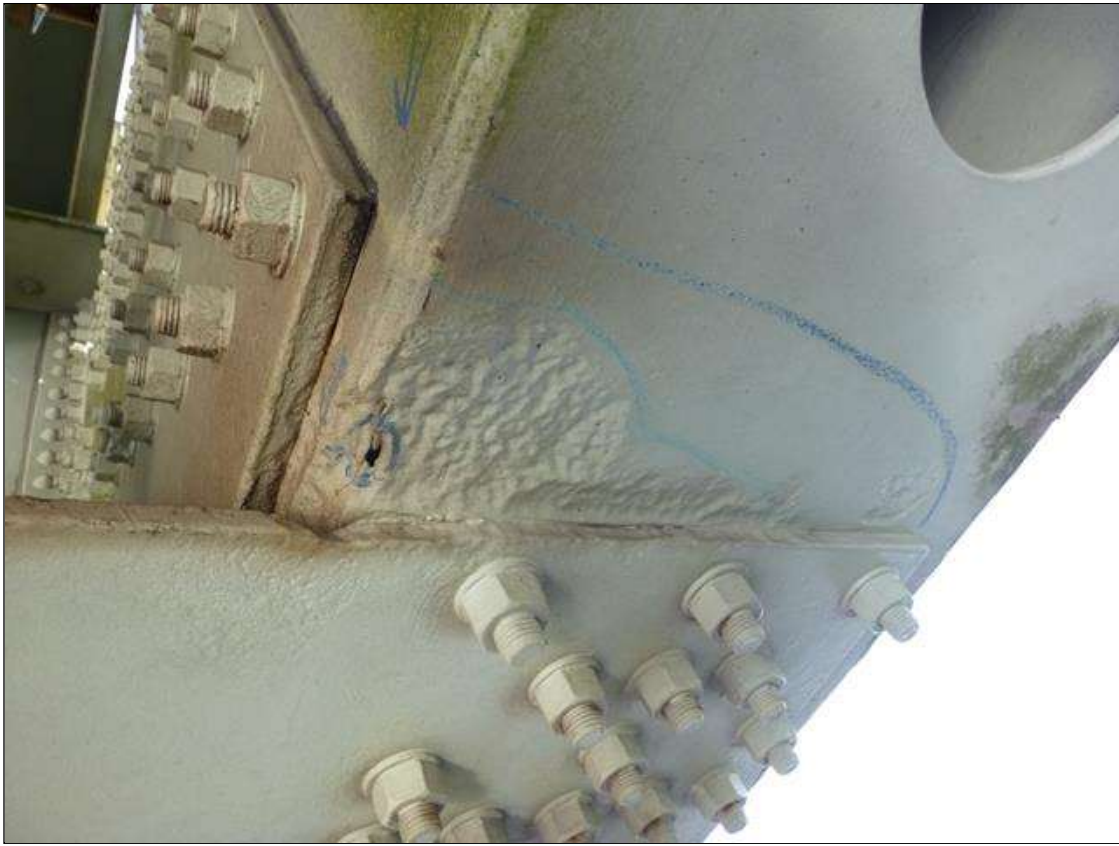
Span 18 Lift Span L10L11 NORTH: OBSERVED IN 2020 INSP: BOTTOM OF CHORD AT L10 - 4"LONG x 12"WIDE PITTED AREA UP TO 1/4"DEEP (APPROX. 3/16" REMAINING SECTION) WIDE/ 1-1/2"LONG x 3/16"WIDE HOLE AND 1-1/2"LONG CRACK PROPAGATING FROM WEST SIDE OF HOLE, PAR ISSUED.

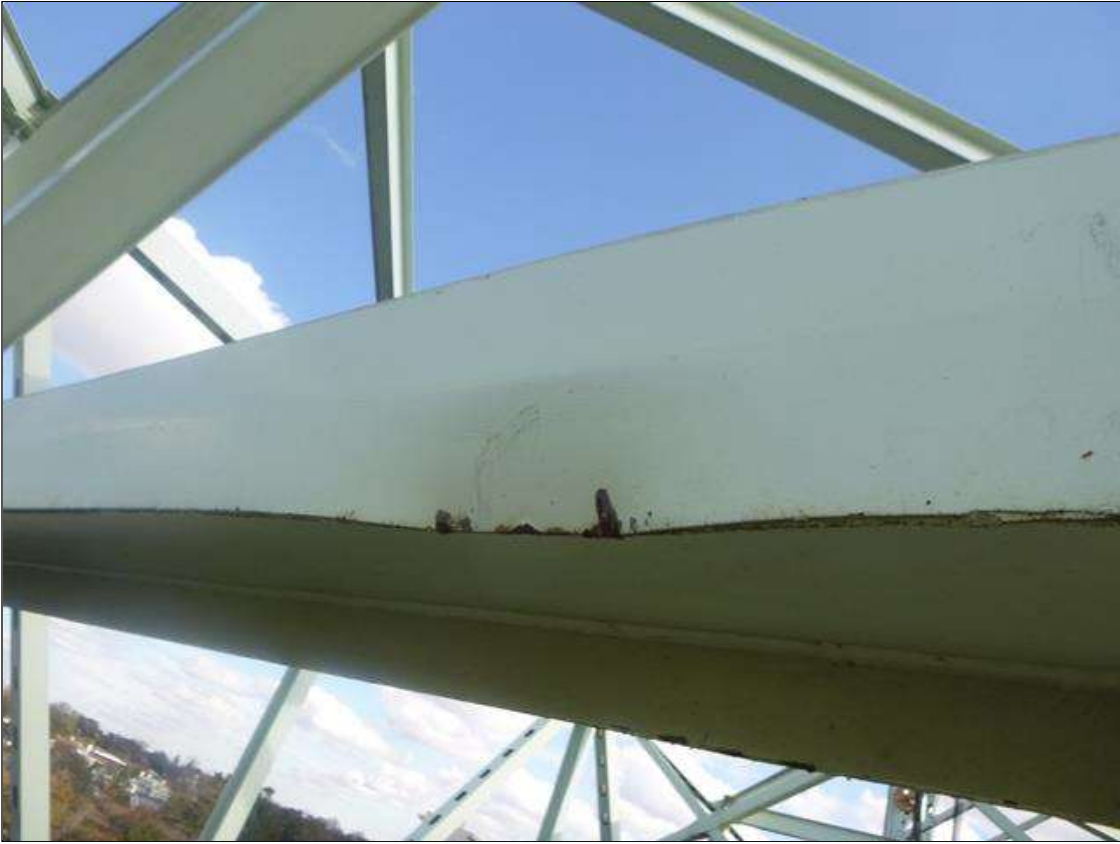
Span 18 Lift Span LB7: IMPACT DAMAGE 20" WIDE X 1-1/2" DEFORMATION IN WEST FLANGE OVER RIGHT EAST BOUND LANE.

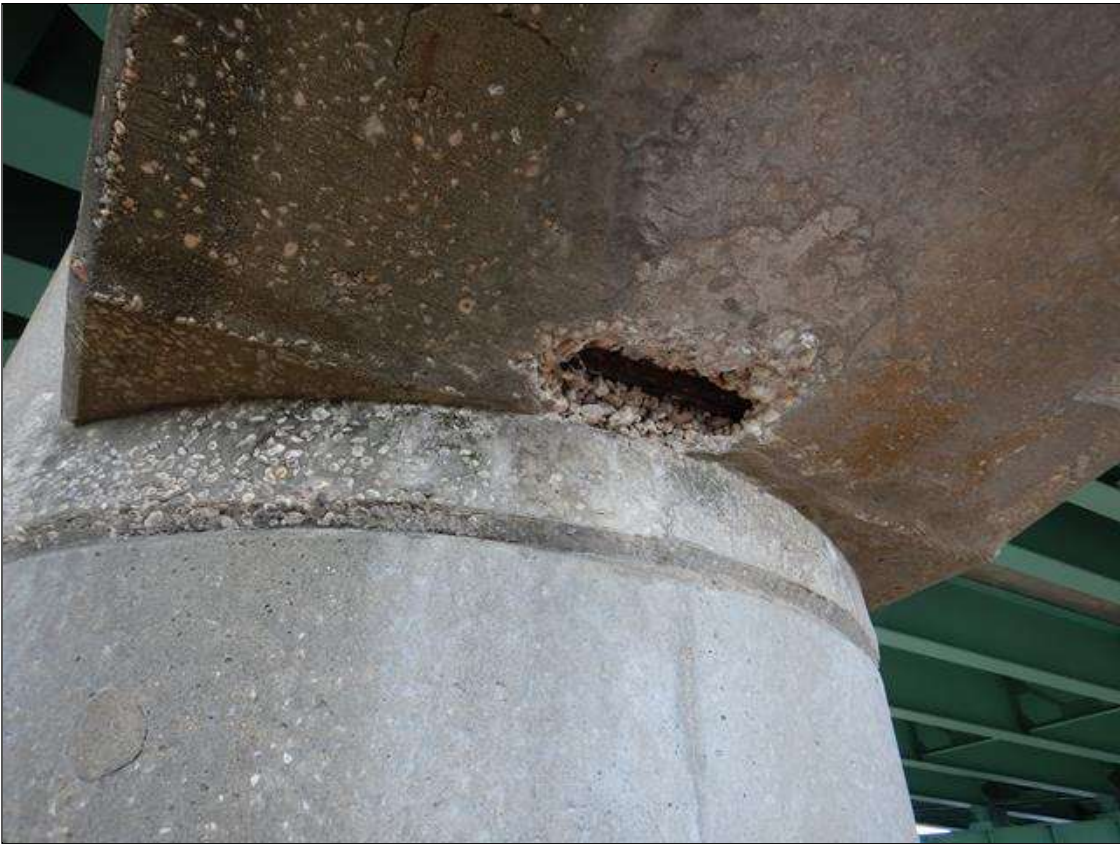
Bent 21 Cap 2: RIGHT SIDE OF COLUMN 3, BOTTOM OF CAP, SPALLING WITH EXPOSED REBAR [1' LONG X 6" WIDE X 2" DEEP] WITH LAYERED RUST ON THE REBAR

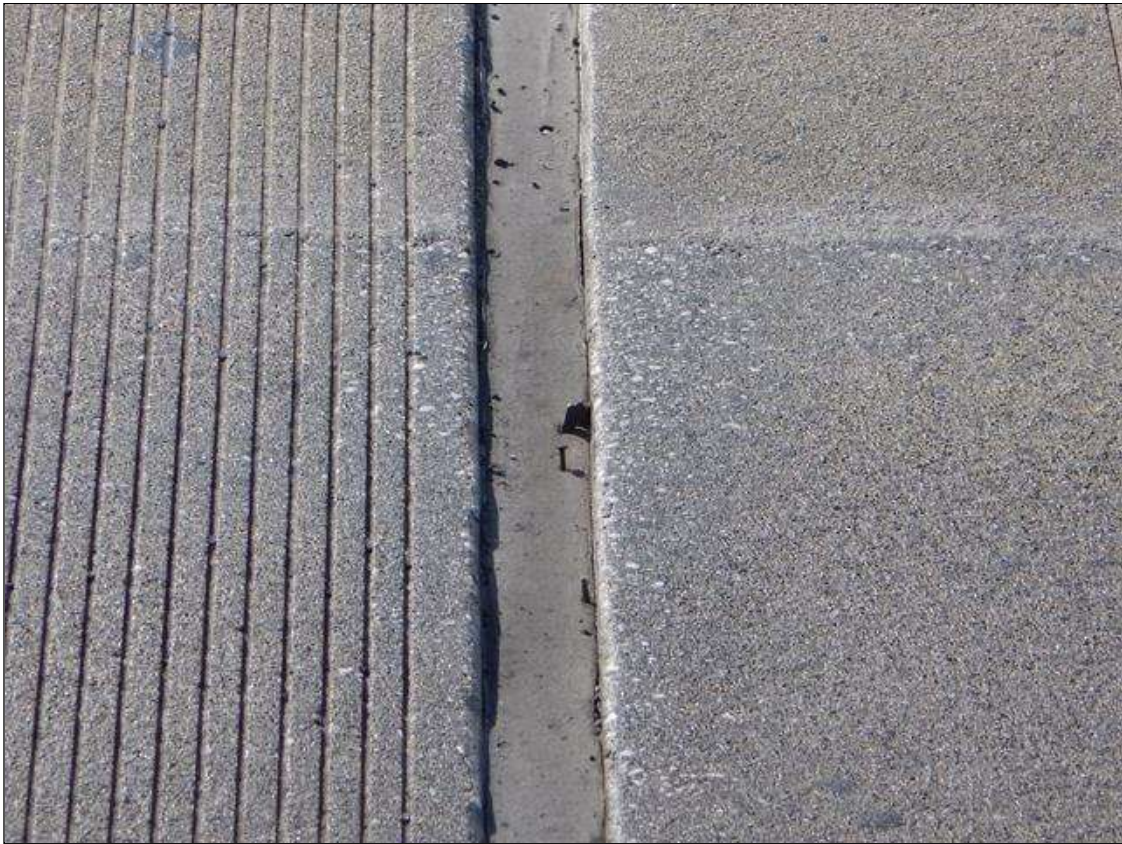
Span 4 Joint at Bent 3: SCATTERED ALONG THE LENGTH, PUNCTURES UP TO 1" DIAMETER IN THE LEFT LANES AND SCATTERED LOSS OF ADHESION IN THE RIGHT.

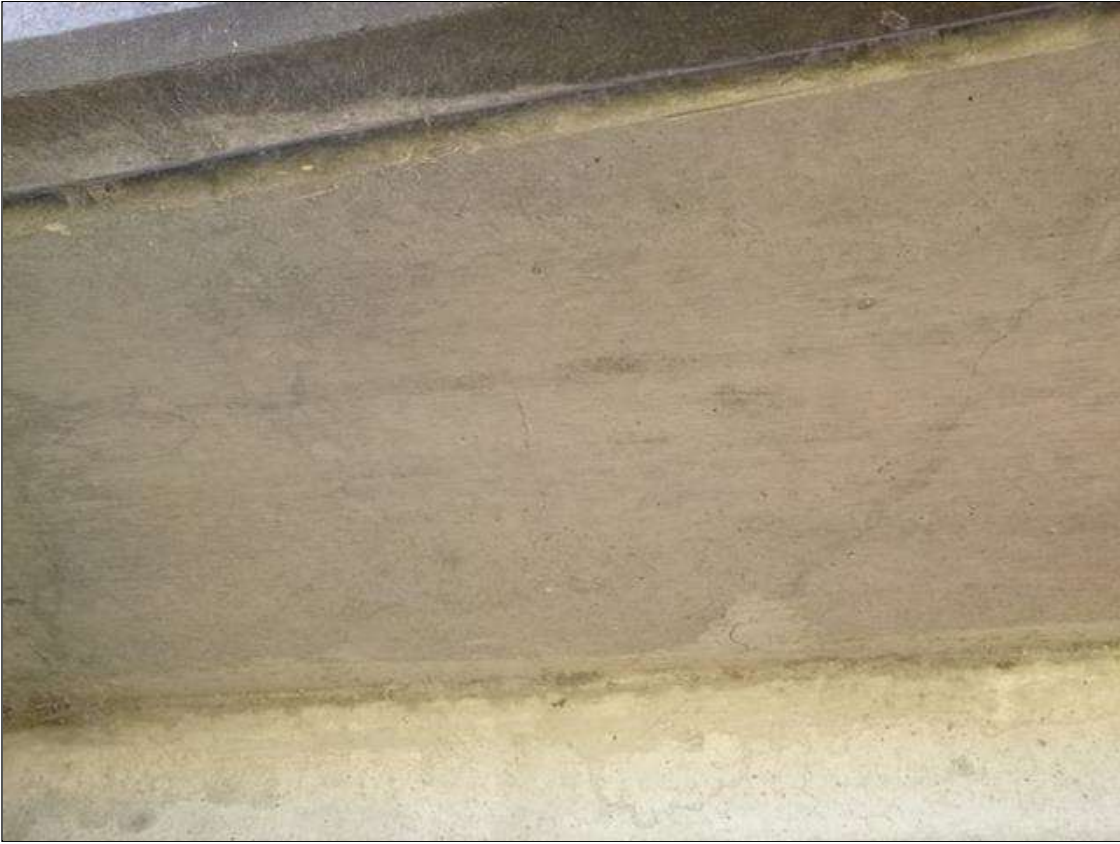
Span 35 - Ramp Span Deck: [NEW REPAIR - PATCHING] FORMERLY --> spall with exposed rebar on the left overhang at Ramp End Bent (20" x 24" x 6")

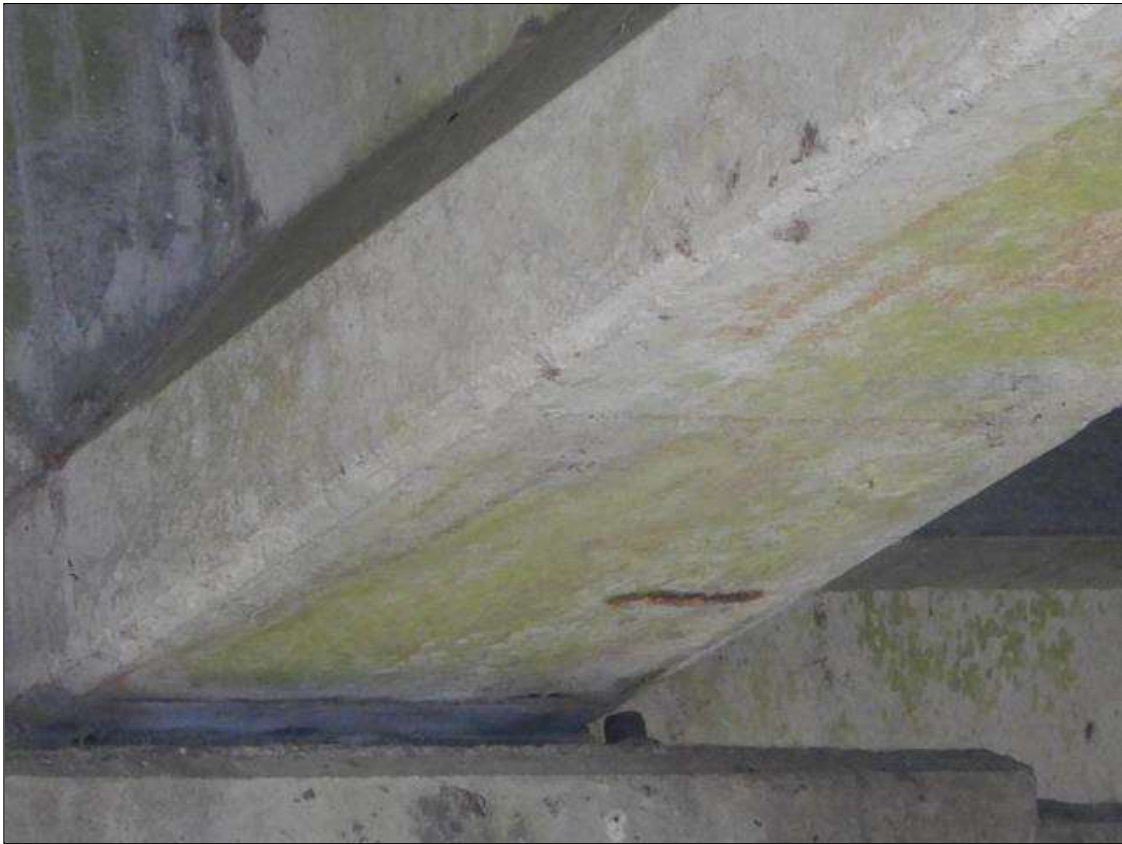
Span 2 Beam 2: [PROMPT ACTION REQUEST] 14" section of 2 areas of exposed rebar in the bottom face at bent 2 up to (6" x 2")

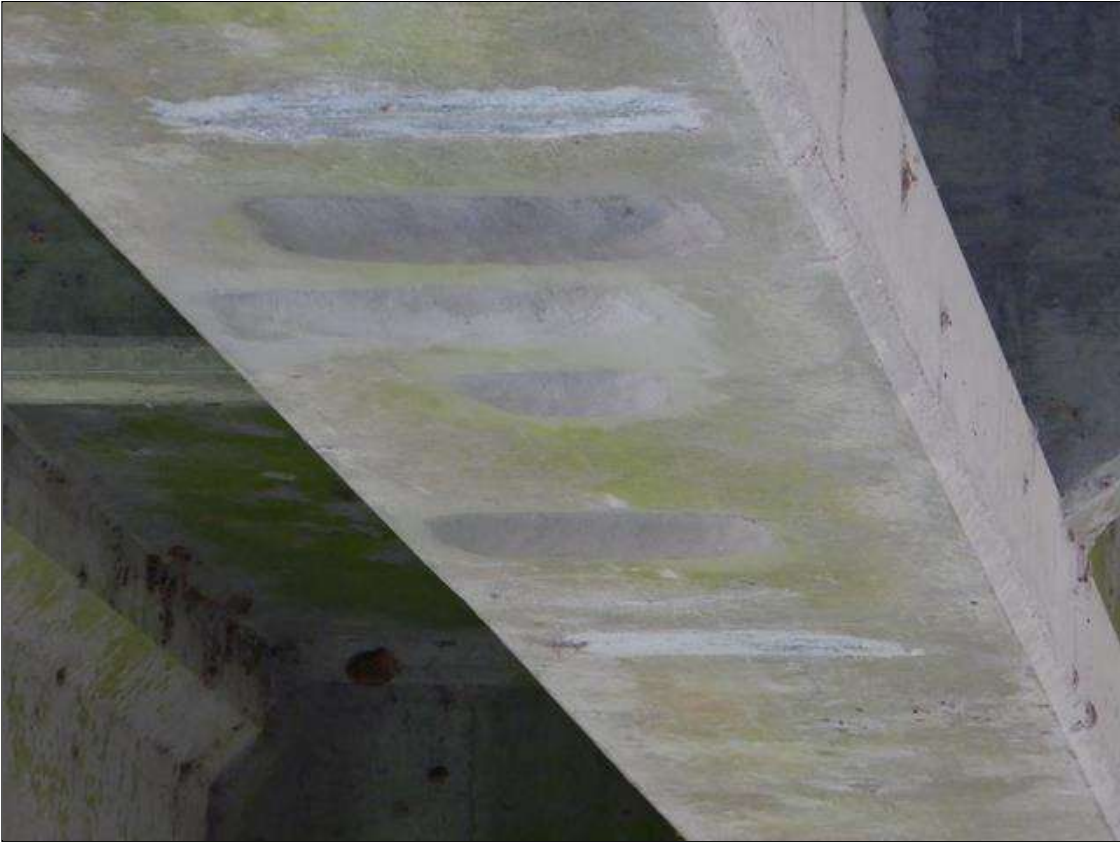
Span 3 Beam 2: [NEW REPAIR - PATCHING] FORMERLY --> (x4) spalls with exposed rebar on the bottom face starting at 24ft from bent 2 up to (8" x 3" x 1/2")

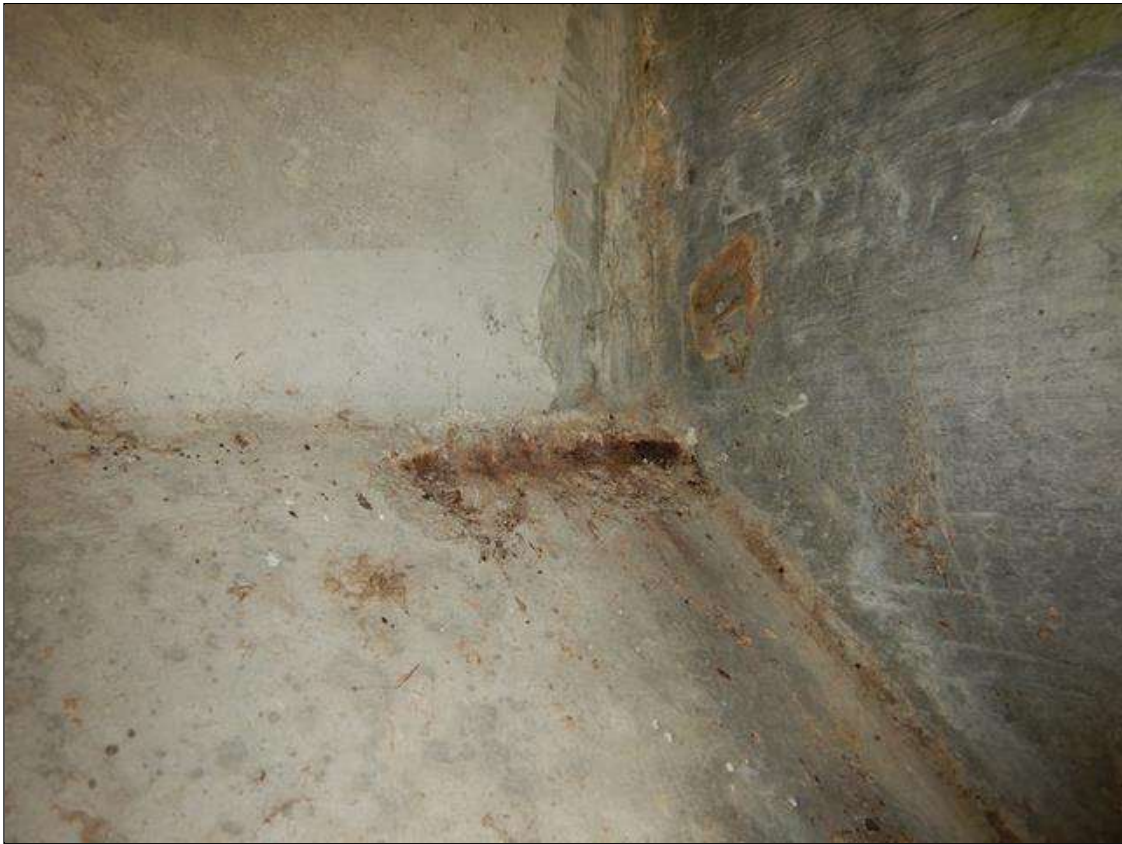
Span 3 Beam 5: [PROMPT ACTION REQUEST] (6" x 2" x 1/4") spall with exposed rebar in the bottom right chamfer at bent 3

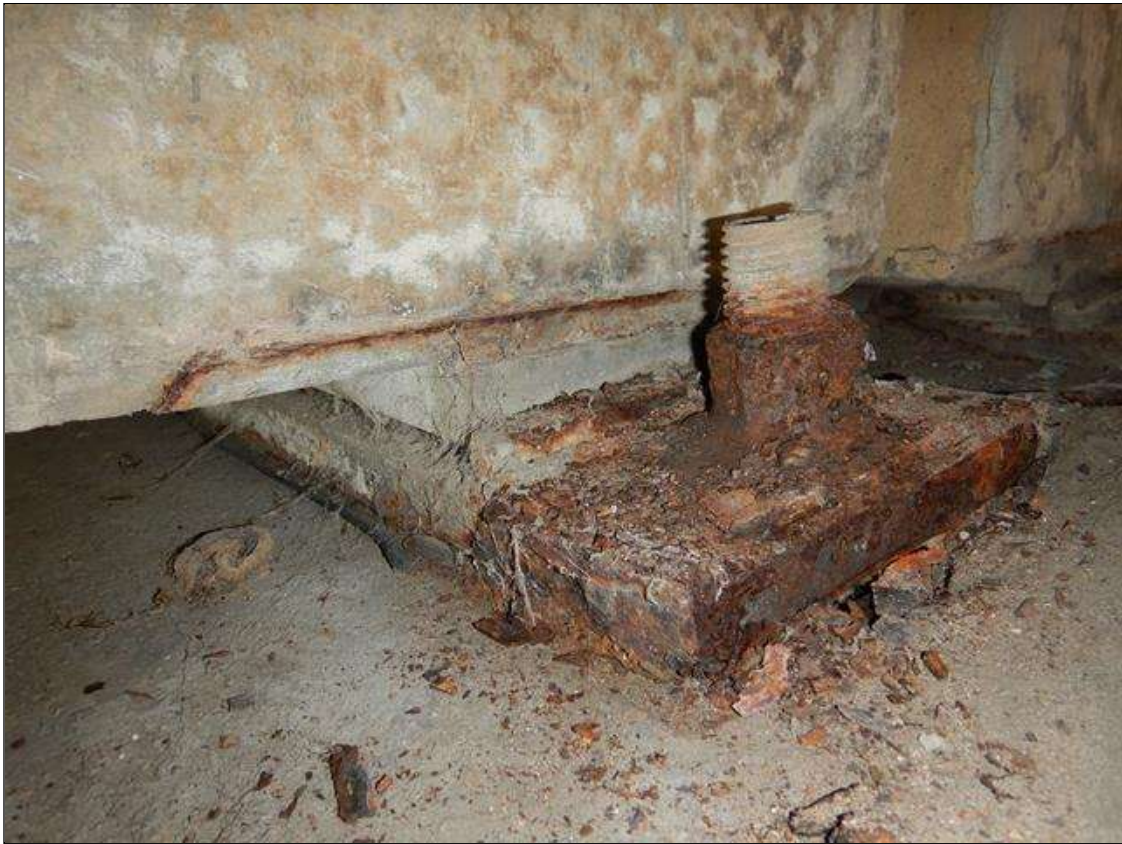
Span 3 Beam 5 - Beam 5 Near Bearing: LEFT ANCHOR NUT HAS CORROSION WITH APPROXIMATELY 50% SECTION LOSS

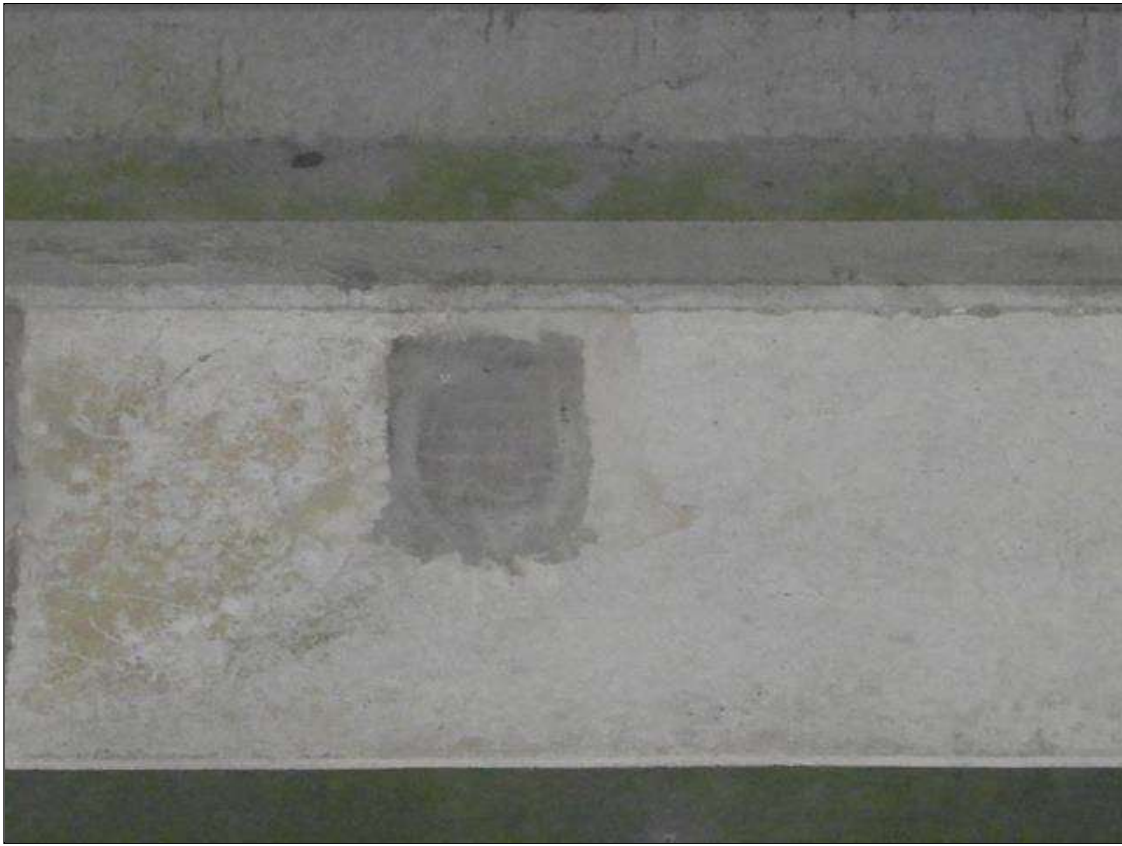
Span 5 Beam 2: [NEW REPAIR - PATCHING] FORMERLY --> (8" x 4" x 1/2") spall with exposed rebar on the bottom face at 14ft from bent 4

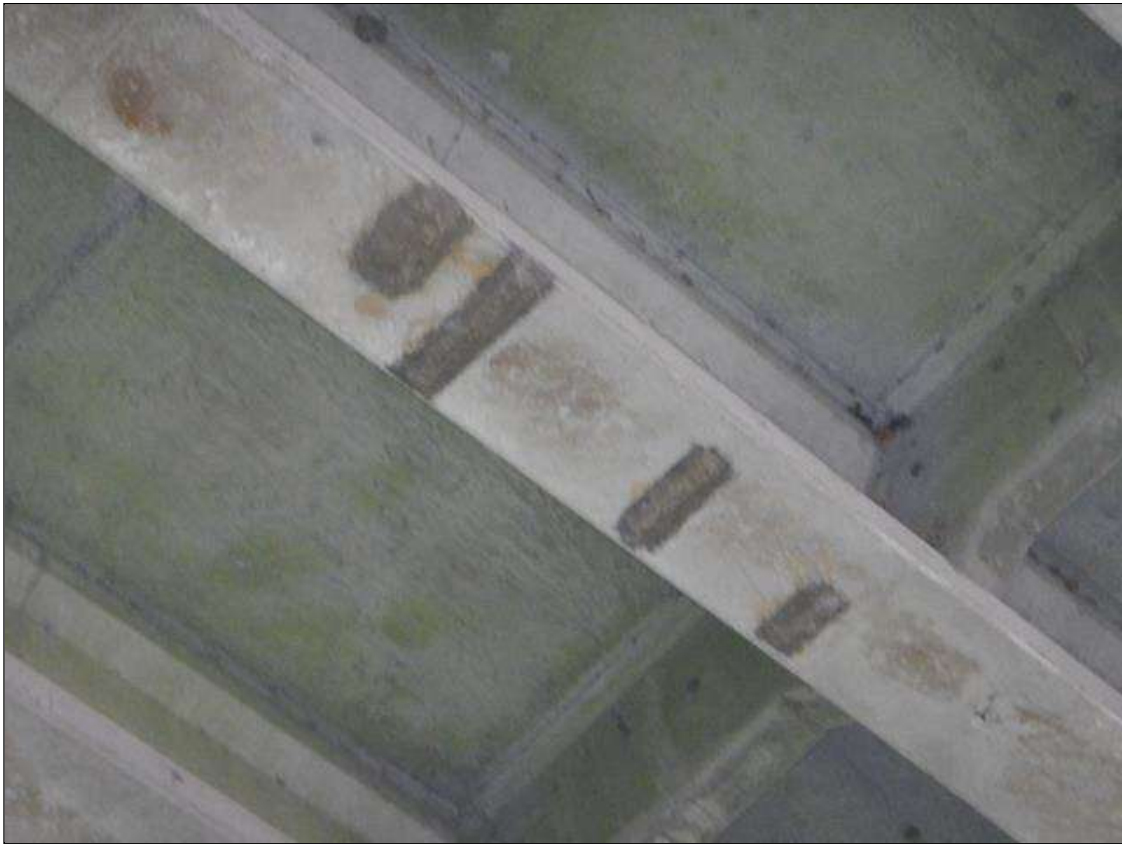
Span 6 Beam 2: [NEW REPAIR - PATCHING] FORMERLY --> (x4) spalls with exposed rebar on the bottom face starting at 22ft from bent 5 up to (16" x 5" x 1/2")

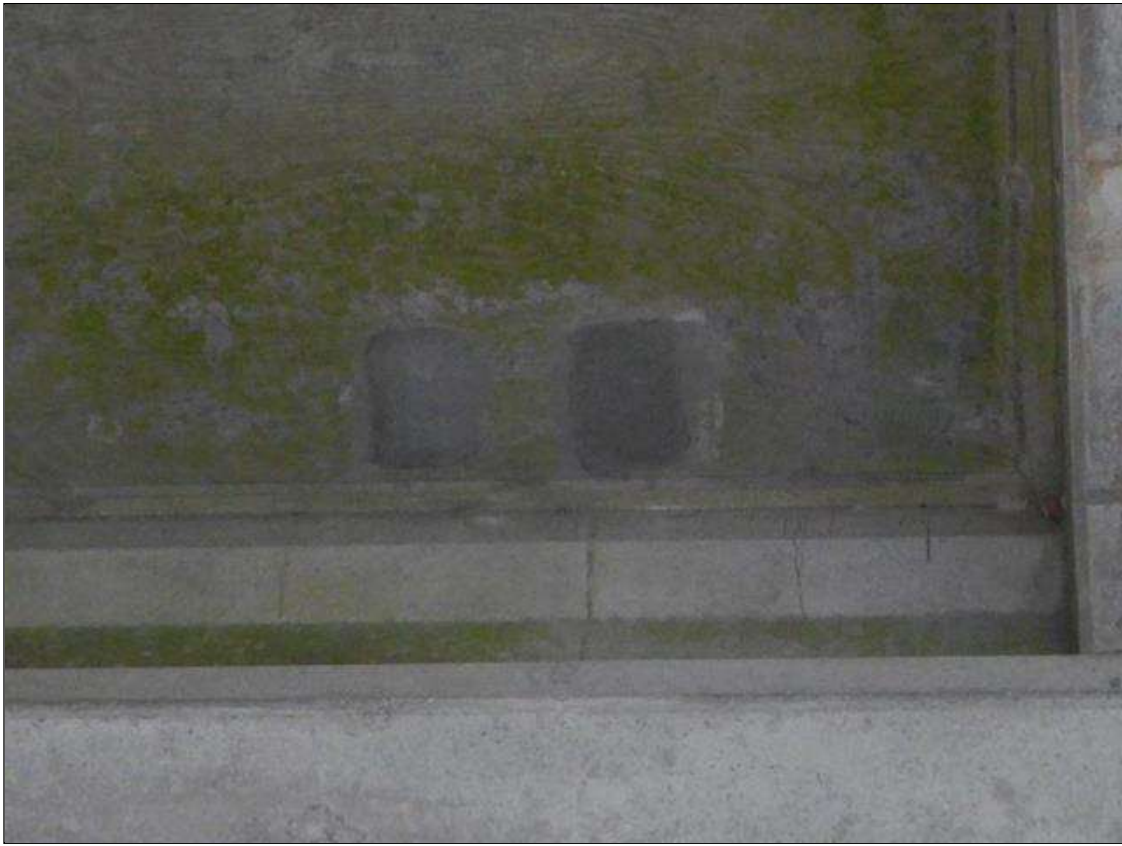
Span 8 Deck: [NEW REPAIR - PATCHING] FORMERLY --> (20" x 9") area of (x2) spalls with exposed rebar on the deck bottom in bay 4, 15.5ft from bent 8 up to (9" x 4" x 1/2')

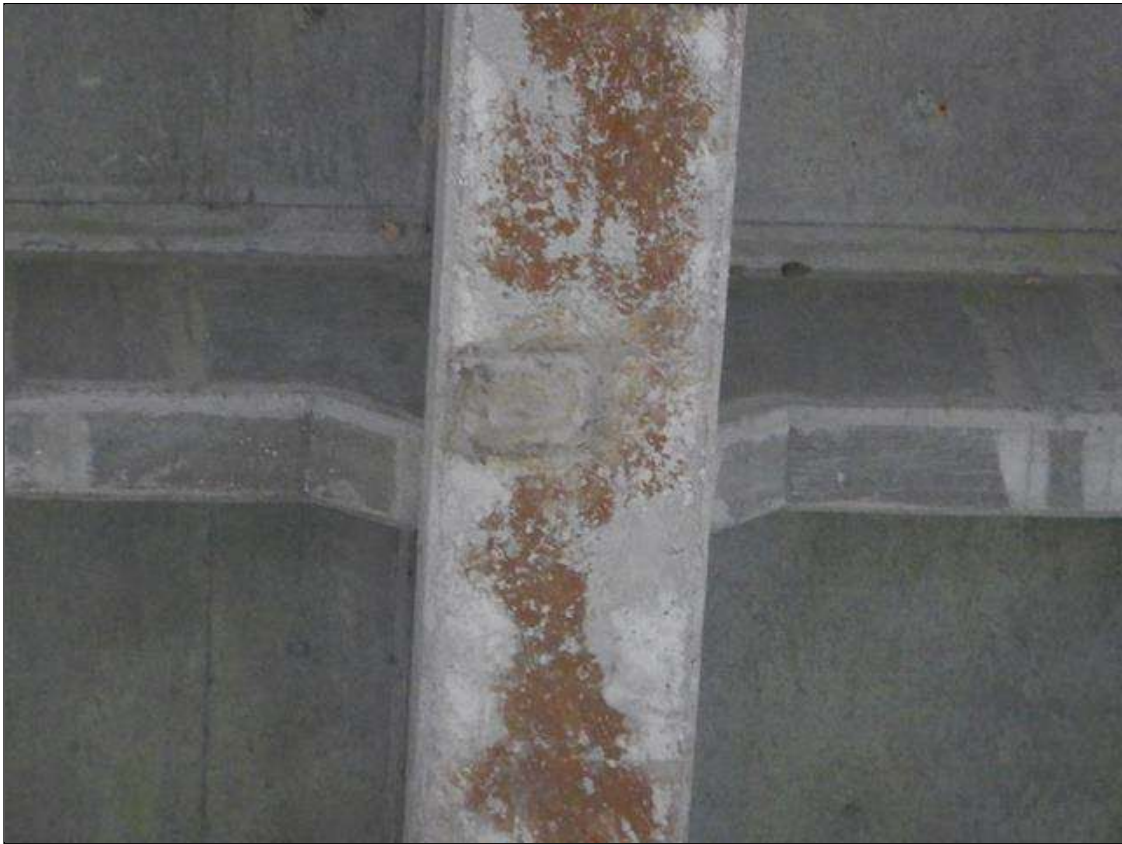
Span 8 Beam 2: [NEW REPAIR - PATCHING] FORMERLY --> (8" x 5" x 1/2") spall with exposed rebar on the bottom face at 28ft from bent 8
