NC DEPARTMENT OF TRANSPORTATION
DIVISION OF HIGHWAYS
STRUCTURE MANAGEMENT UNIT

Structure Safety Report

Routine Element Inspection - Contract

DIVISION: 3 COUNTY: NEW HANOVER STRUCTURE NUMBER: 640013 FREQUENCY: 24 MONTHS

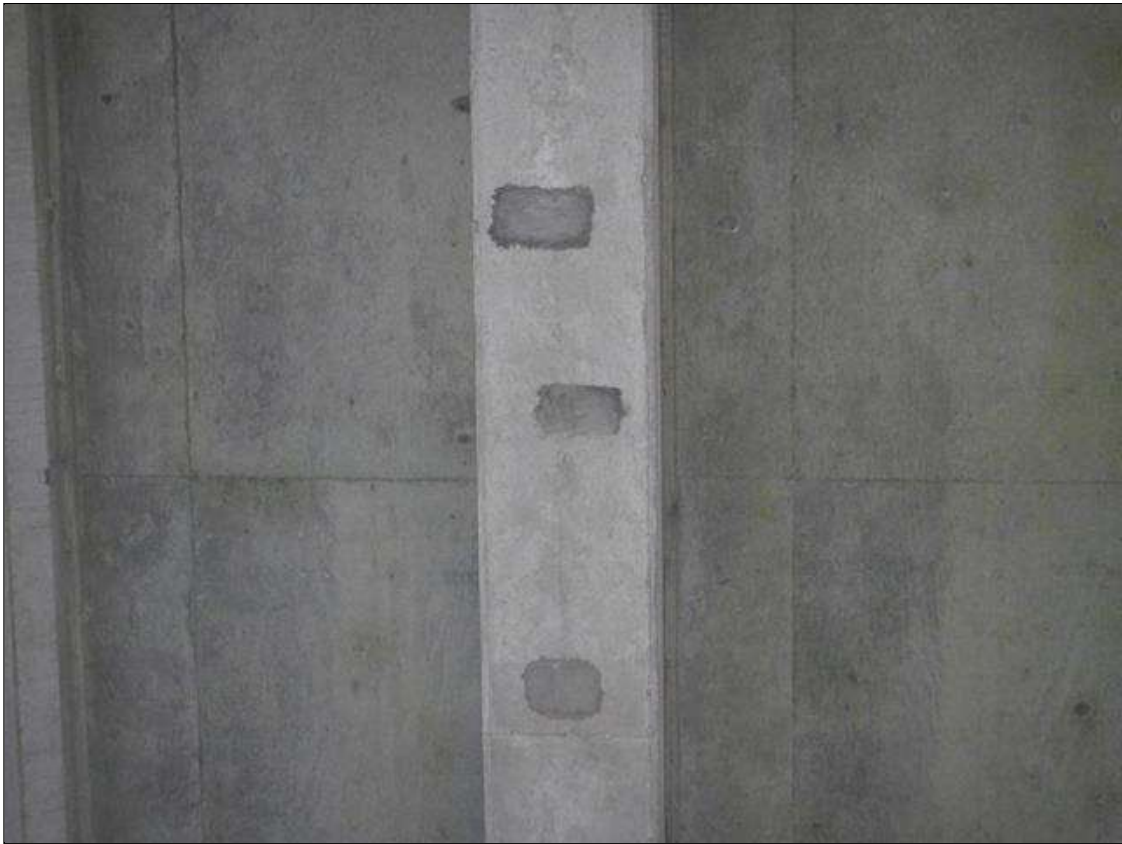
Span 8 Beam 2: [NEW REPAIR - PATCHING] FORMERLY --> (x3) spalls (6" x 3" x 1/2"), (5" x 5" x 1/2") and (6" x 4" x 1/4") with exposed rebar on the bottom face at 26ft, 23ft and 16ft from bent 8 respectively

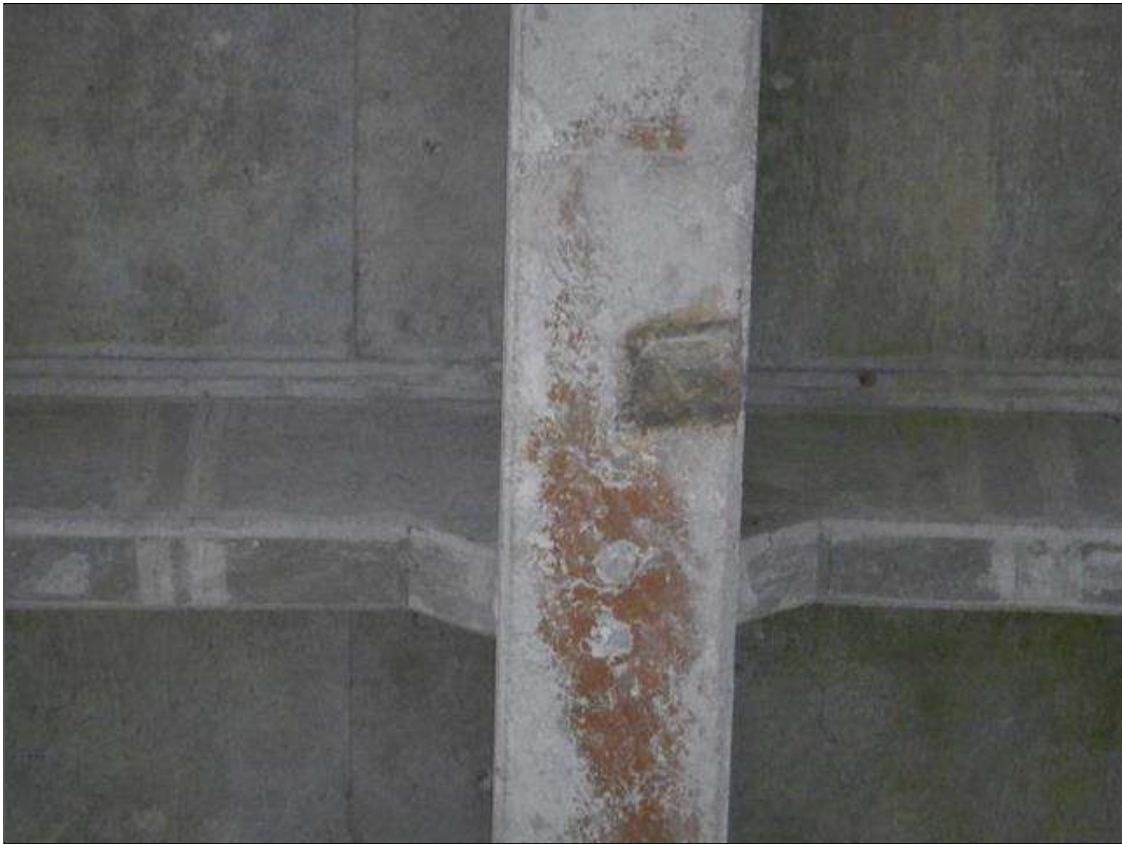
Span 8 Beam 6: [NEW REPAIR - PATCHING] FORMERLY --> (7" x 4" x 1/2") spall with exposed rebar on the bottom face at 20ft from bent 7

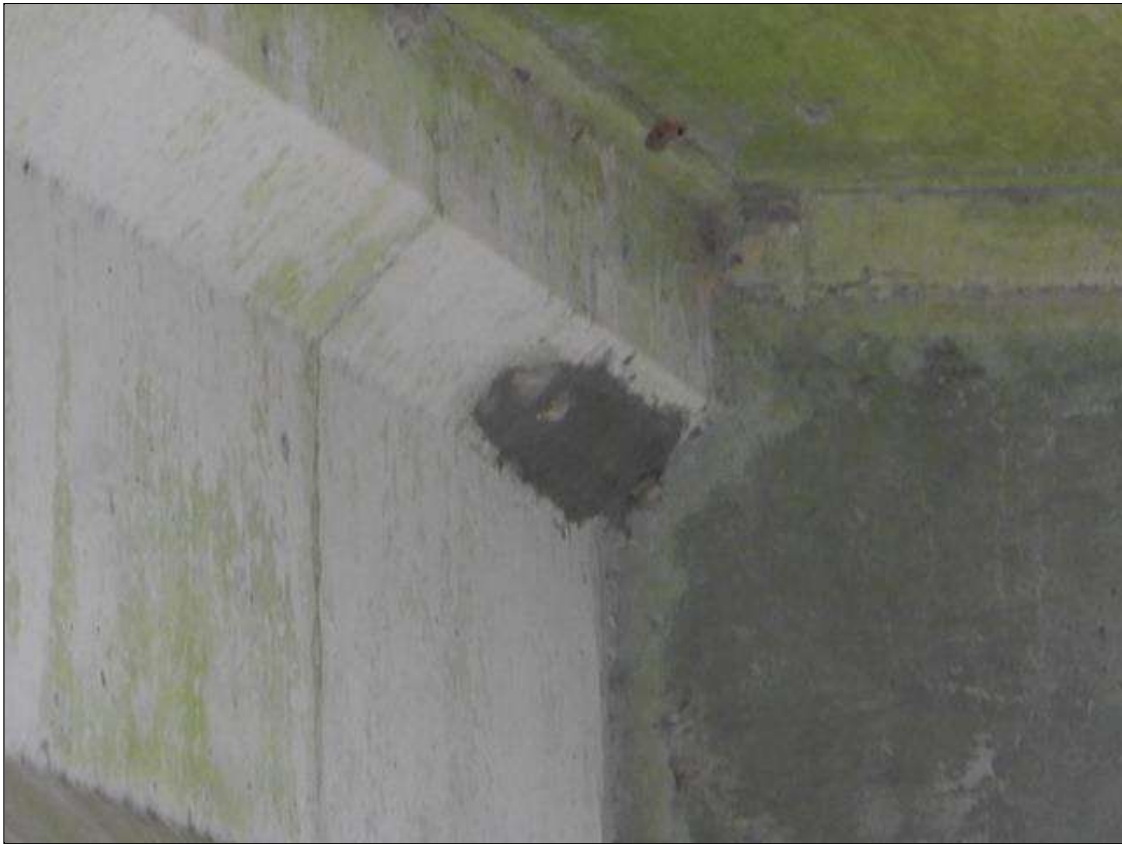
Span 9 Beam 7: [NEW REPAIR - PATCHING] FORMERLY --> (x2) spalls with exposed rebar on the top left chamfer at bent 8 up to (10" x 4" x 1/4")

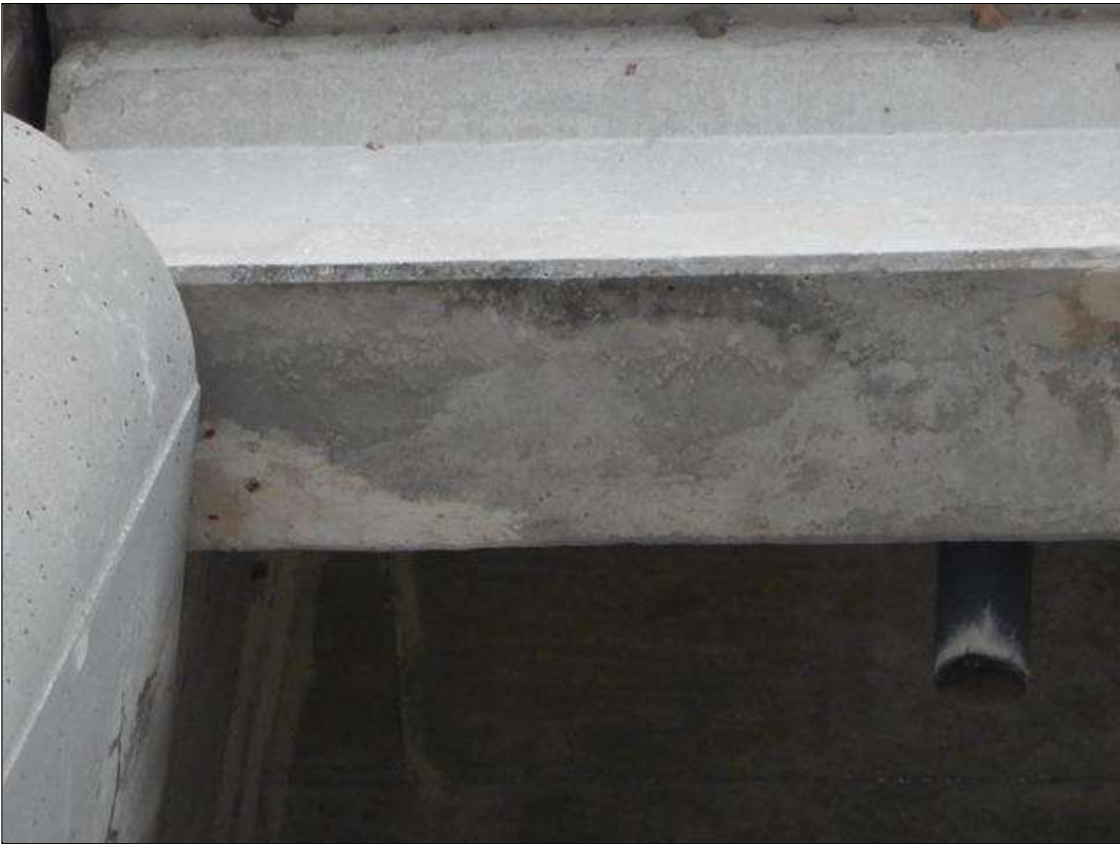
Span 9 Beam 9: [NEW REPAIR - PATCHING] FORMERLY --> (20" x 20") area of failed repair, DELAMINATION and up to 0.025" longitudinal cracking on the bottom face at 4ft from bent 8

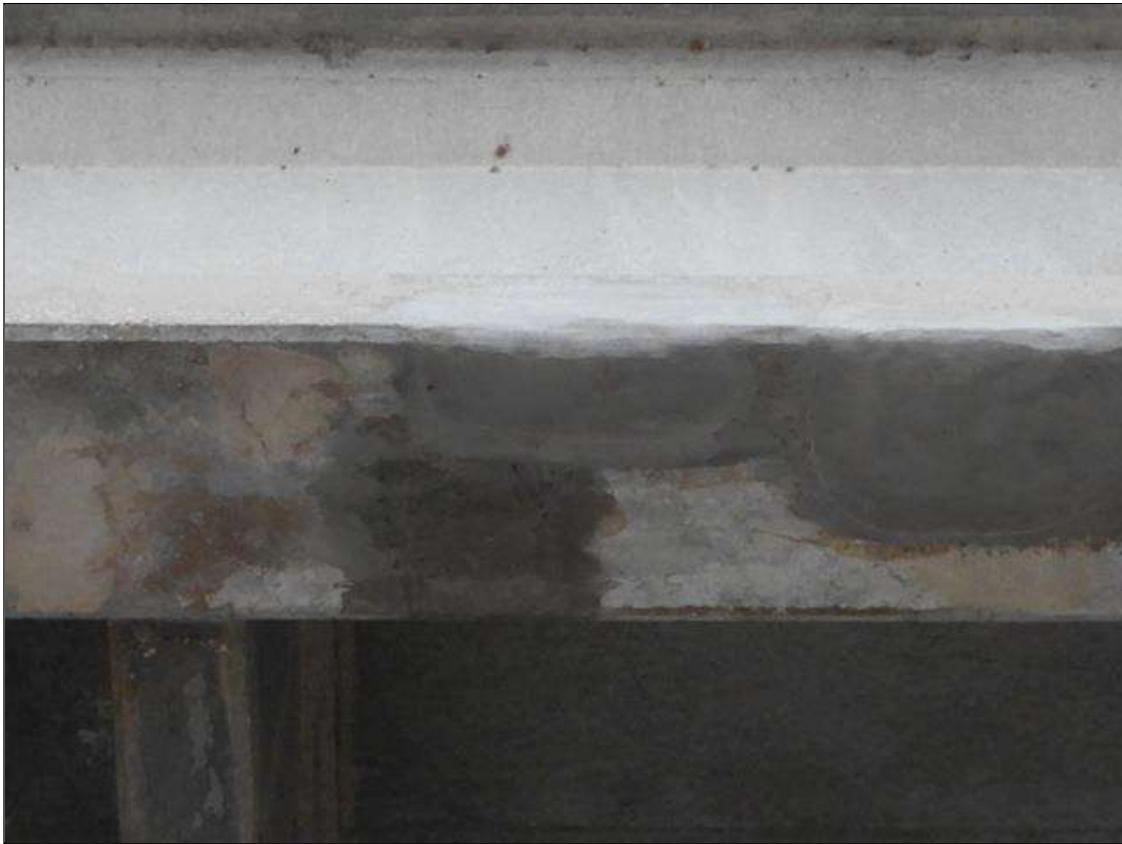
Span 9 Beam 9: [NEW REPAIR - PATCHING] FORMERLY --> PRIORITY MAINTENANCE - spall with exposed strands on the bottom face at 14ft from bent 9 (18" x 7" x 2"), strand exposed for (10") long

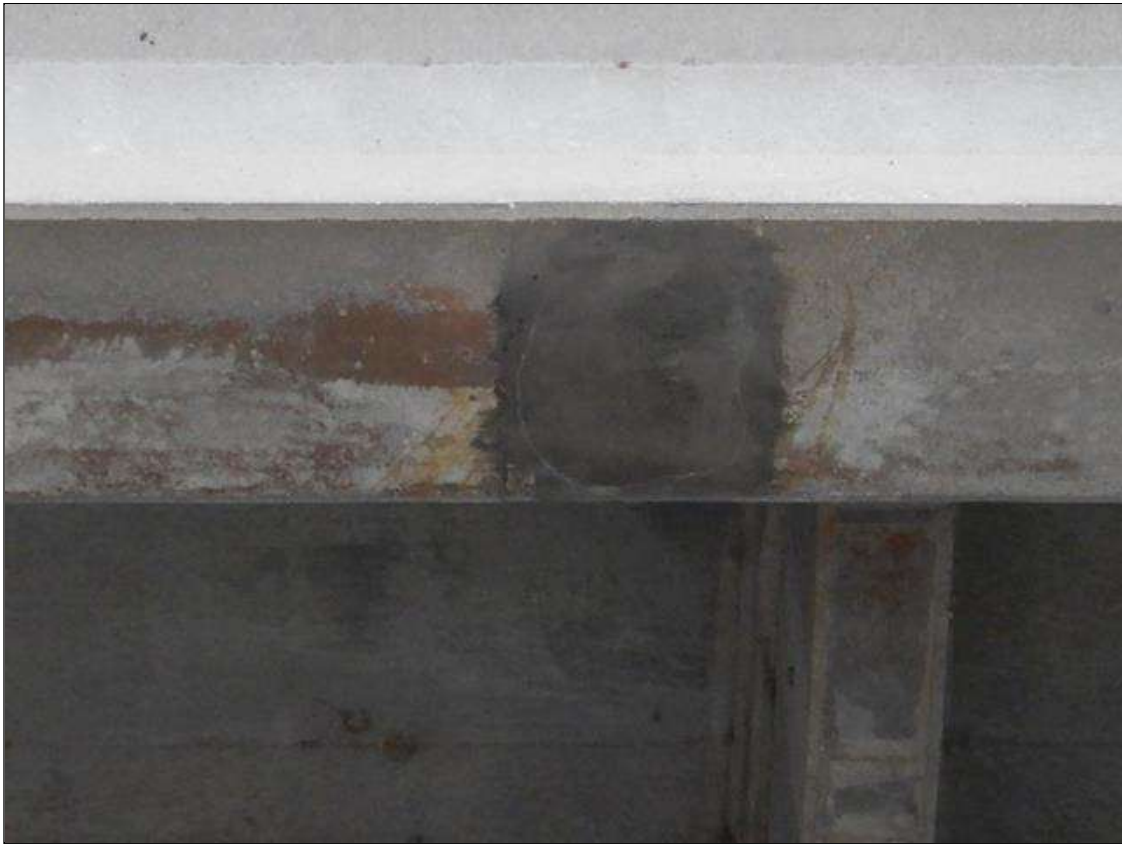
Span 9 Beam 9: [NEW REPAIR - PATCHING] FORMERLY --> PRIORITY MAINTENANCE - spall with exposed strands on the bottom face at 16ft from bent 8 (16" x 13" x 1 1/2"), (x2) strands exposed for (4") long

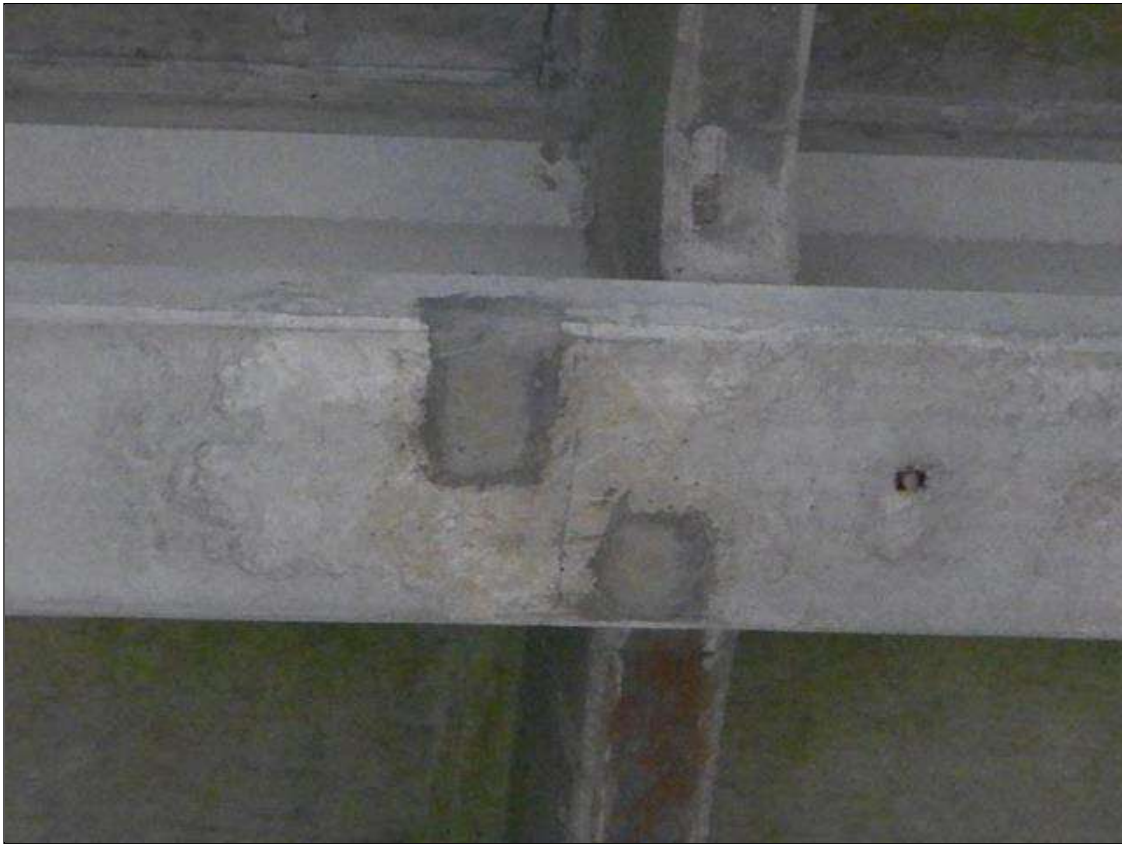
Span 10 Beam 5: [NEW REPAIR - PATCHING] FORMERLY --> (2 1/2" x 1/2") spall with exposed rebar in the bottom face at 22ft from bent 10

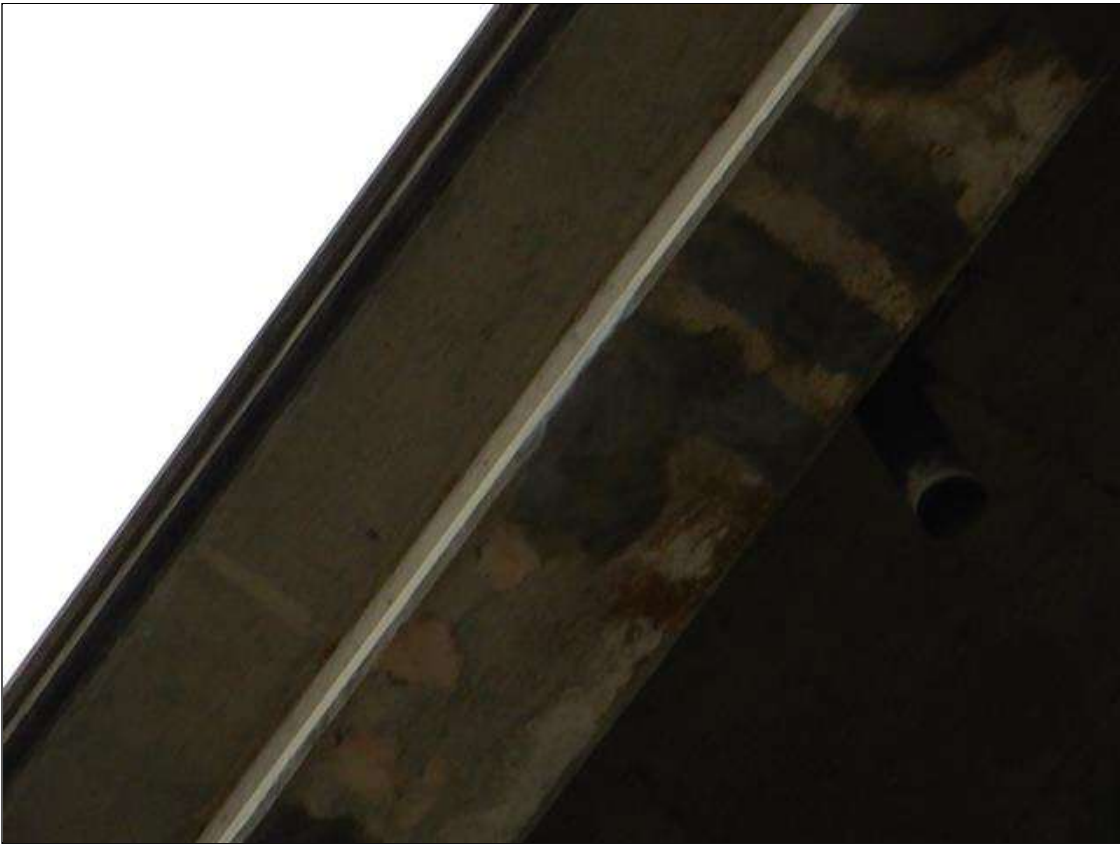
Span 10 Beam 9: [NEW REPAIR - PATCHING] FORMERLY --> (x4) spoalls with exposed rebar on the bottom face at 14ft from bent 9 up to (9" x 2" x 1/4")

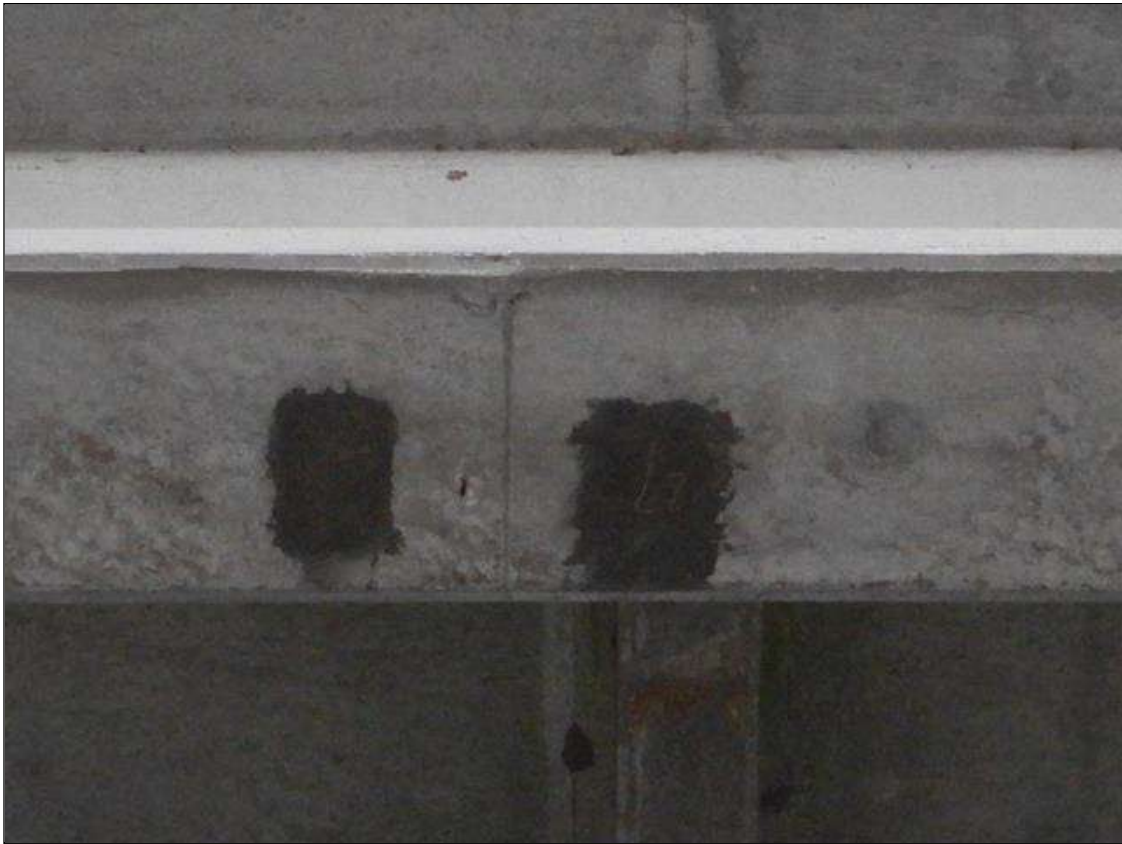
Span 10 Beam 9: [NEW REPAIR - PATCHING] FORMERLY --> (4" x 4" x 1/4") spall with exposed rebar on the bottom face at 11ft from bent 10

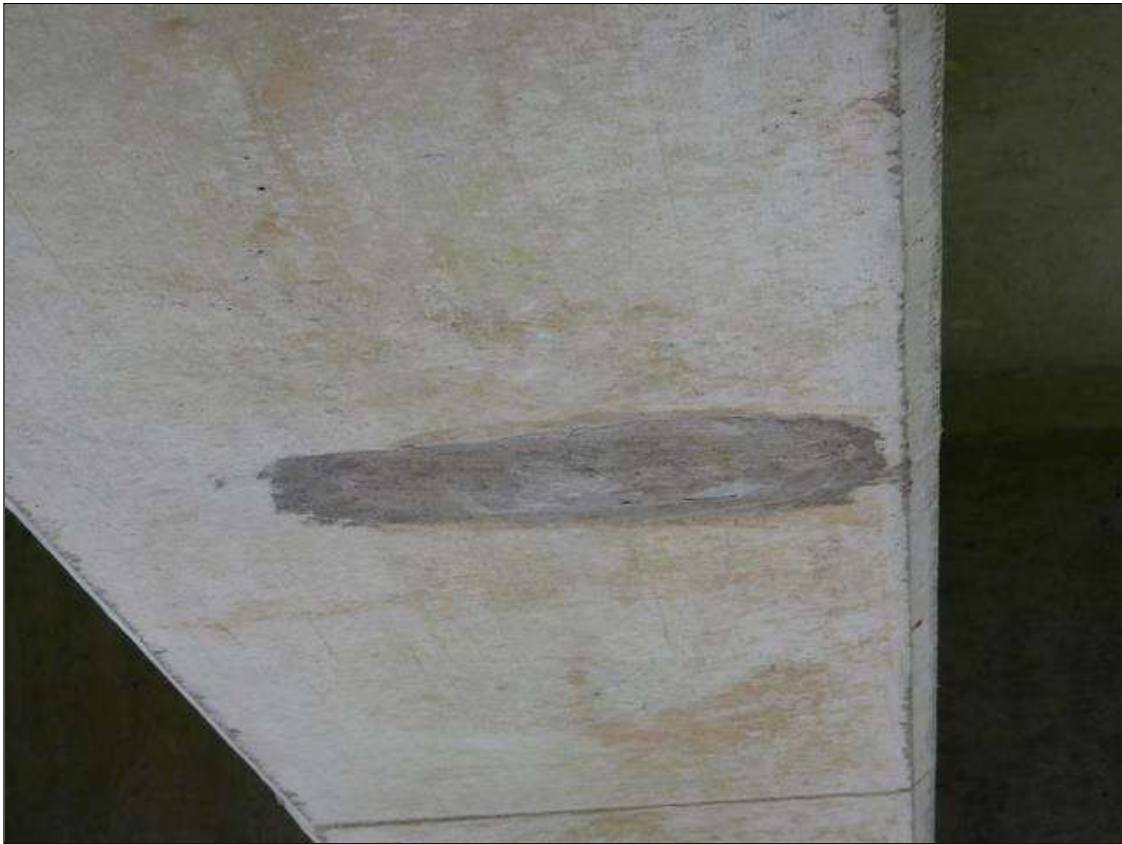
Span 11 Beam 4: [NEW REPAIR - PATCHING] FORMERLY --> (7" x 6" x 1/2") spall with exposed rebar on the bottom face at 27ft from bent 11

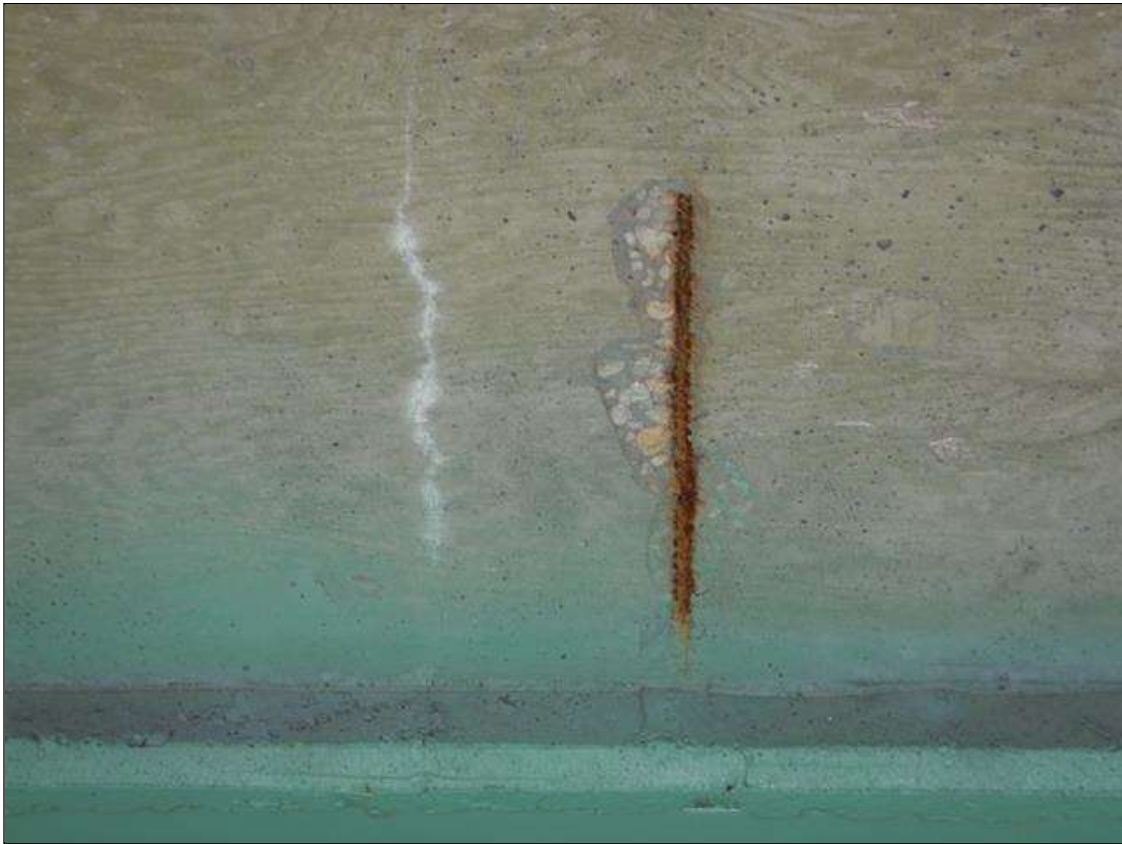
Span 14 Deck: spall with exposed rebar in bay 7 at 6ft from bent 13 (18" x 4" x 1/4")

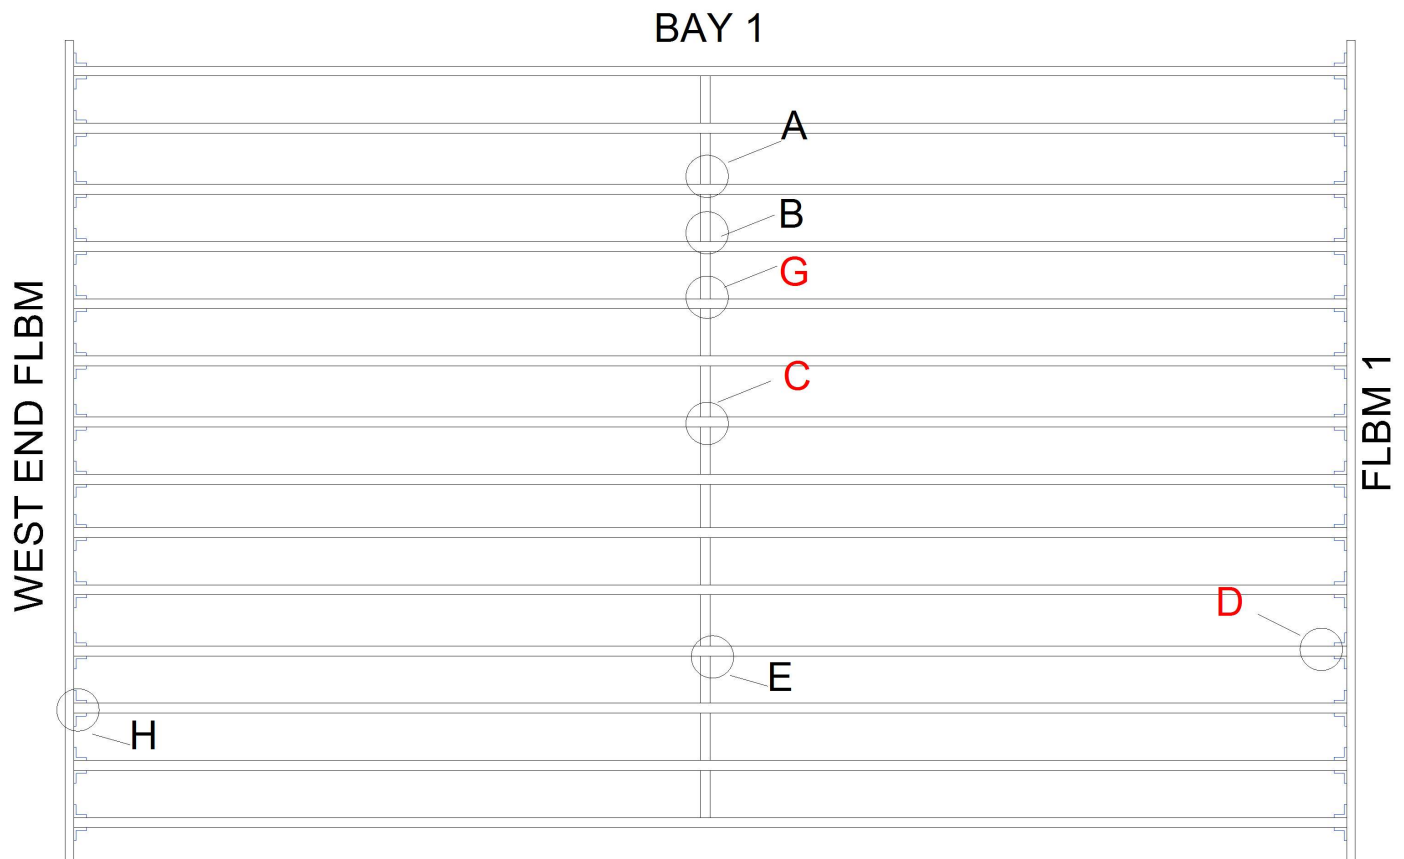
- A. CRACKED DIA CONN WELD NORTH SIDE OF STR3 PROPIGATING 1 1/2" INTO WEB OF STR 3 REPAIRED
- B. CRACKED DIA CONN WELD NORTH SIDE OF STR4 PROPIGATING 1 1/2" INTO WEB OF STR 4 REPAIRED
- C. CRACKED DIA CONN WELD AT STR7 - PROP. 1/8" PAST EAST ARREST HOLE
- D. HOLE 3/4"X1/4" IN STR11@WEST FLBM1 CONN.
- E. 2 11/16" CRACK AT TOP DIAPH. CONNECTION WELD AT SOUTH SIDE STR 11 REPAIRED
- G. 1" CRACK AT TOP DIAPH. CONNECTION WELD AT NORTH SIDE STR 5 - PROP. 1/8" PAST ARREST HOLE
- H. 1" CRACK IN COPING OF STRINGER 12 REPAIRED

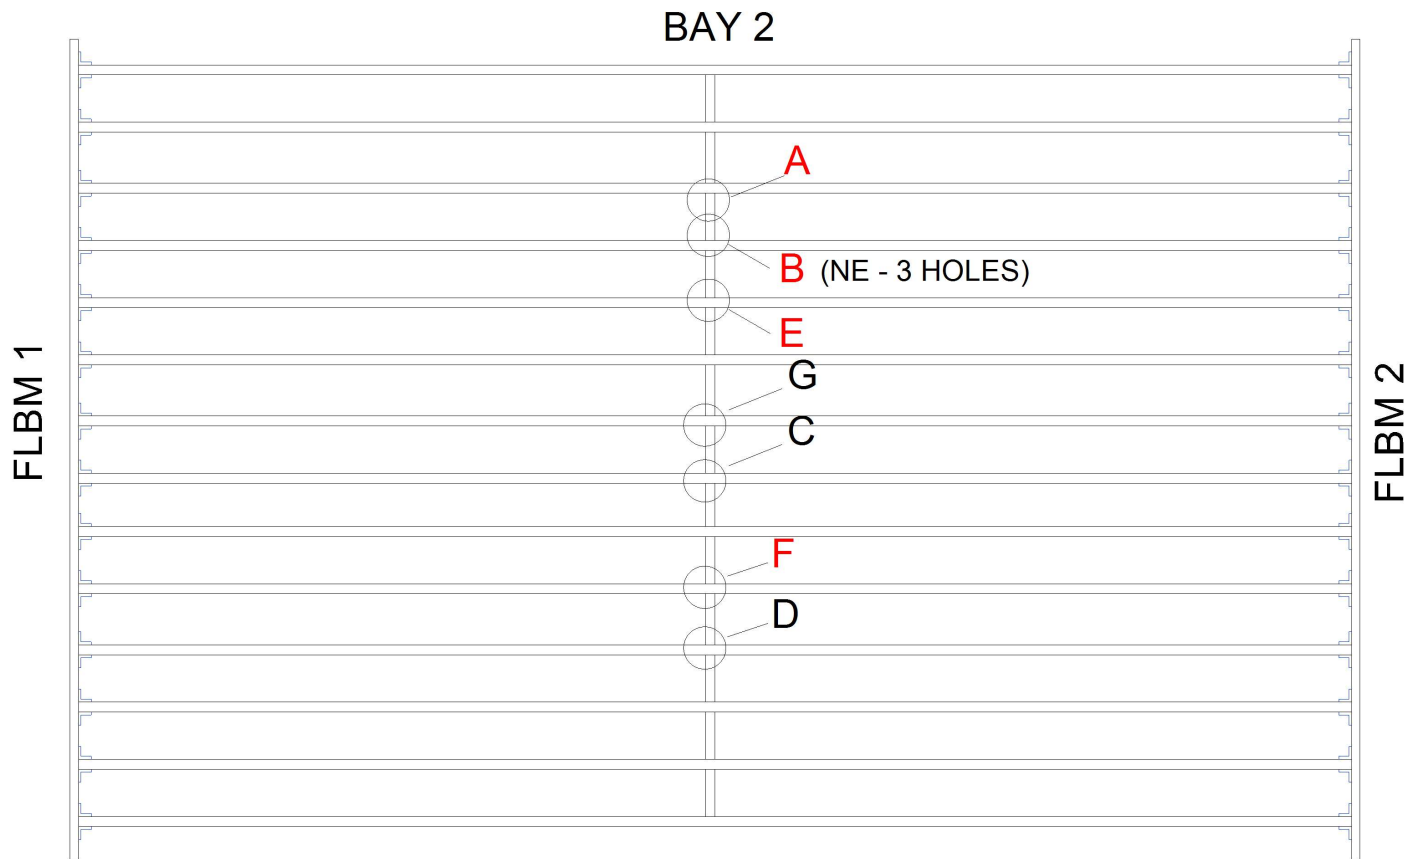
- A. CRACKED DIAPHRAGM CONN TO SOUTH SIDE OF STR3 1/4" - PROP. 1" PAST ARREST HOLE
- B. CRACKED DIAPHRAGM CONN TO STR4 1/2" - PROP. 1/2" AT WEST ARREST HOLE
- C. CRACKED DIAPHRAGM CONN TO SOUTH SIDE OF STR7 1/4" REPAIRED
- D. CRACK IN DIAPH. AT SOUTH SIDE OF STR 1 REPAIRED
- E. CRACK IN WEB AT DIAPH. CONN. AT STR5 2"
- F. CRACK IN WEB AT TOP OF DIAPH. CONN. AT STR 10 1-3/4"
- G. ARRESTED CRACK IN WEB AT TOP OF DIAPH. CONN. AT STR8

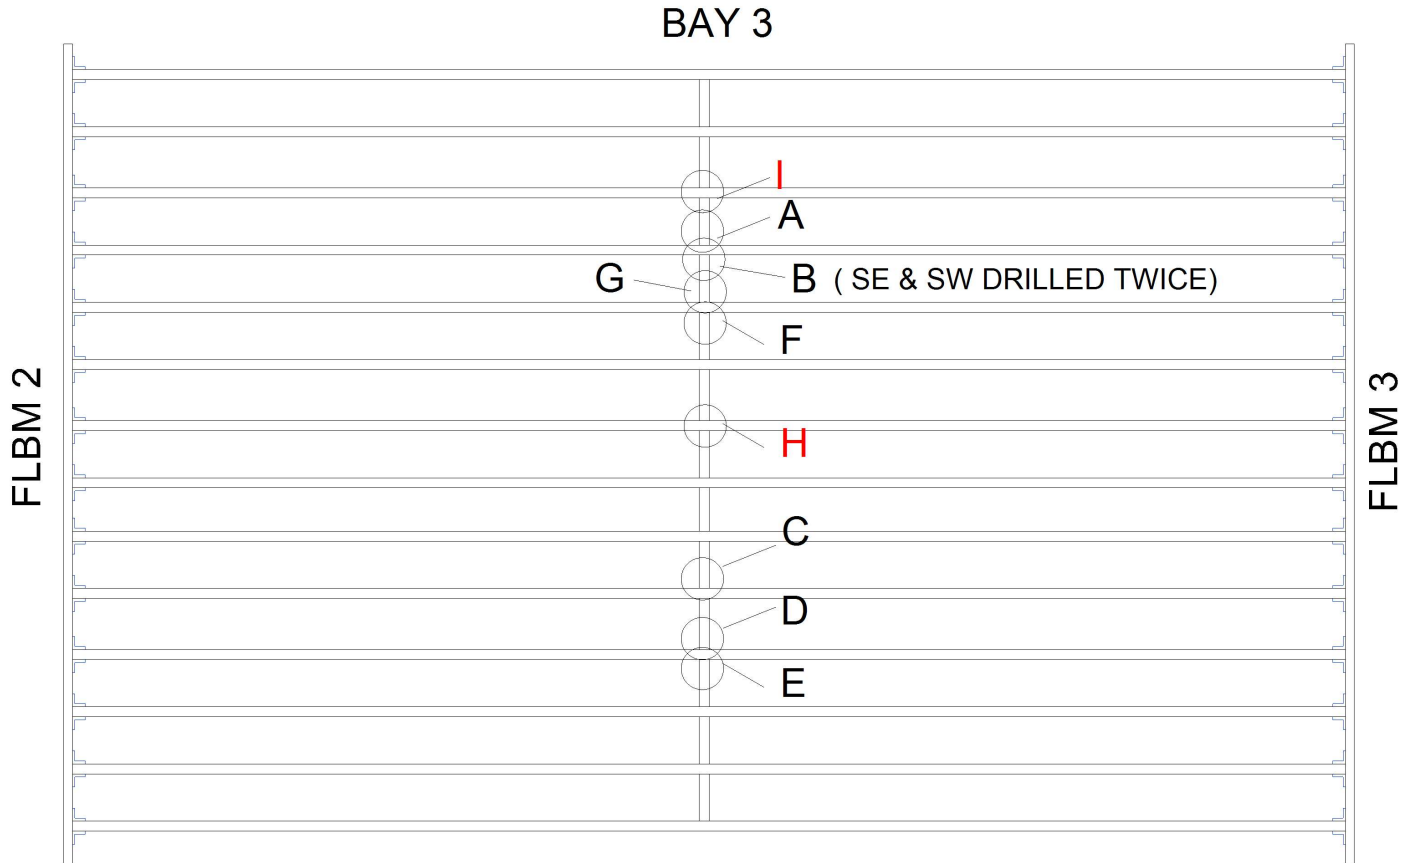
- A. CRACKED WEB AT DIAPHRAGM CONN IN NORTH SIDE OF STR4 1/2"REPAIRED
- B. CRACKED WEB AT DIAPHRAGM CONN IN SOUTH SIDE OF STR4 1/2"REPAIRED
- C. CRACKED DIAPHRAGM CONN TO NORTH SIDE OF STR10 HL REPAIRED
- D. CRACKED WEB AT DIAPHRAGM CONN TO NORTH SIDE OF STR11 3"REPAIRED
- E. CRACKED WEB AT DIAPHRAGM CONN TO SOUTH SIDE OF STR11 3"REPAIRED
- F. 1 5/8" CRACK AT TOP DIAPH. CONN. WELD AT SOUTH SIDE STR 5REPAIRED
- G. 1" CRACK AT TOP DIAPH. CONN. WELD AT NORTH SIDE STR 5REPAIRED
- H. 1/2" CRACK IN WELD AT TOP DIAPH. CONN. WELD AT SOUTH SIDE STR 7
- I. 1/2" CRACK IN WEB AT TOP DIAPH. CONN. BOTH SIDES STR 3

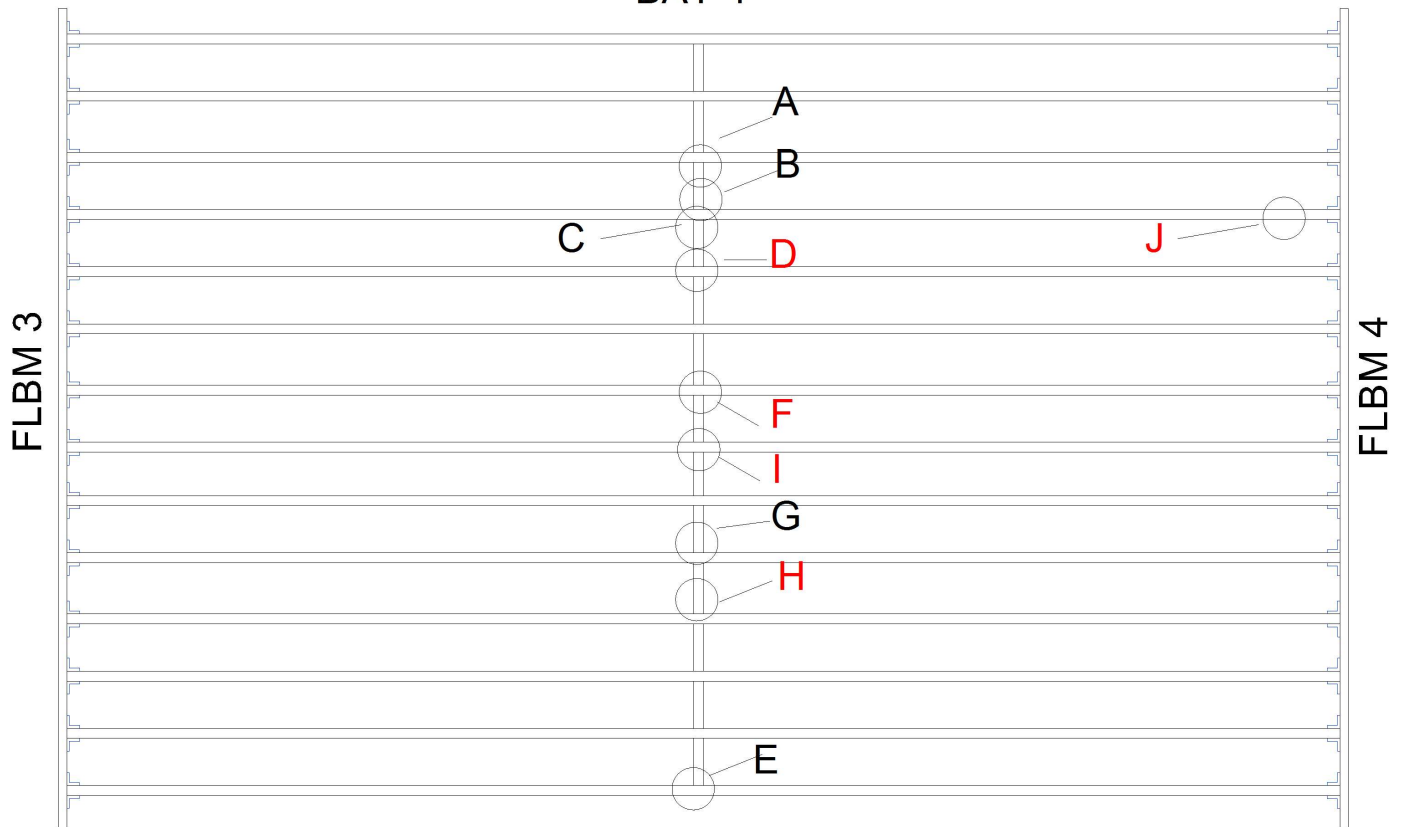
BAY 4

- A. CRACKED DIAPHRAGM CONN TO SOUTH SIDE OF STR3 REPAIRED
- B. CRACKED DIAPHRAGM CONN TO NORTH SIDE OF STR4 REPAIRED
- C. CRACKED DIAPHRAGM CONN TO SOUTH SIDE OF STR4 REPAIRED
CRACK PROPAGATED 5/16" PAST OLD REPAIR HOLE AT SE. STR.4 REPAIRED
- D. CRACKED DIAPHRAGM CONN TO NORTH SIDE OF STR5 - (2) TOTAL PROP. ~1/8" PAST ARREST HOLES
- E. IMCOMPLETE WELD AT BASE OF DIA. CONN. ON NORTH SIDE STR 14
- F. CRACKED DIAPHRAGM CONN TO SOUTH SIDE OF STR7 - PROP. 3/8" PAST ARREST HOLE
- G. CRACKED DIAPHRAGM CONN TO NORTH SIDE OF STR10 HL REPAIRED
- H. CRACK IN WEB ABOVE DIAP CONN AT STR11 HL - (2) TOTAL PROP. ~3/16" PAST ARREST HOLES
- I. CRACK IN WEB ABOVE DIAPH. CONN. AT STR8 1/2"
- J. (2) 1/2" HOLES ON NORTH SIDE OF TOP FLANGE AT 3' FROM FB4

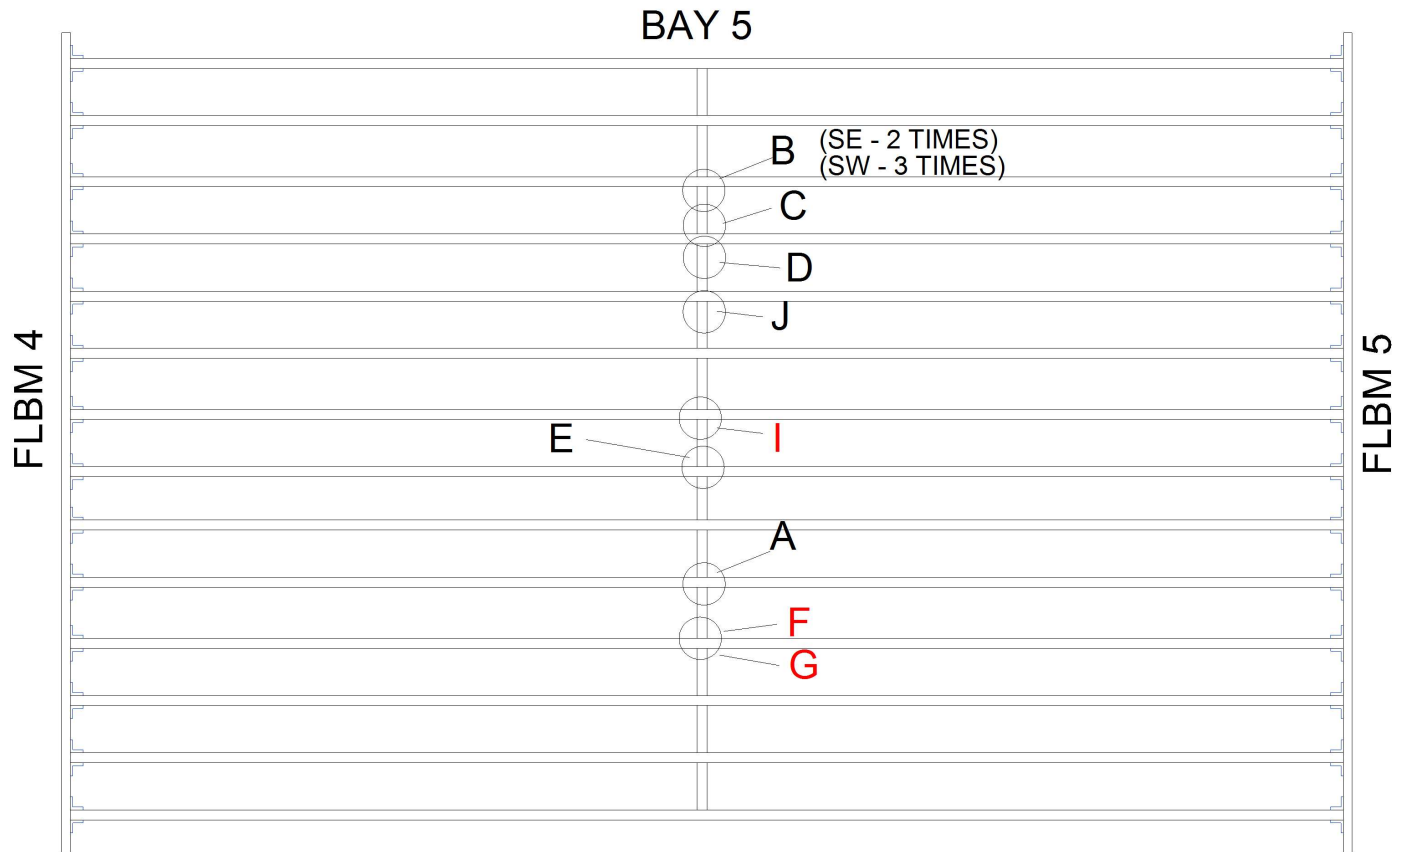
- A. CRACKED WEB AT DIAPHRAGM CONN IN SOUTH SIDE OF STR10 1/2" REPAIRED
- B. CRACKED WEB AT DIAPHRAGM CONN IN SOUTH SIDE OF STR3 1/2" REPAIRED
- C. CRACKED WEB AT DIAPHRAGM CONN IN NORTH SIDE OF STR4 1/2' REPAIRED
- D. CRACKED WEB AT DIAPHRAGM CONN IN SOUTH SIDE OF STR4 1/2" REPAIRED
- E. CRACKED WEB AT DIAPHRAGM CONN IN SOUTH SIDE OF STR8 1 1/2" REPAIRED
- F. CRACKED WEB AT DIAPHRAGM CONN AT STR11 2" - PROP. 3/16" PAST ARREST HOLE
- G. 4" CRACK IN WELD AT BOTTOM OF DIAPH. CONN. ON N SIDE AT STR11
- I. 1 1/4" CRACK AT TOP DIAPH. CONN. STR 7 - PROP. 1/4" PAST EAST ARREST HOLE, AND 5/16" PAST WEST
- J. 2" CRACK AT TOP DIAPH. CONN. WELD AT SOUTH SIDE STR 5 REPAIRED

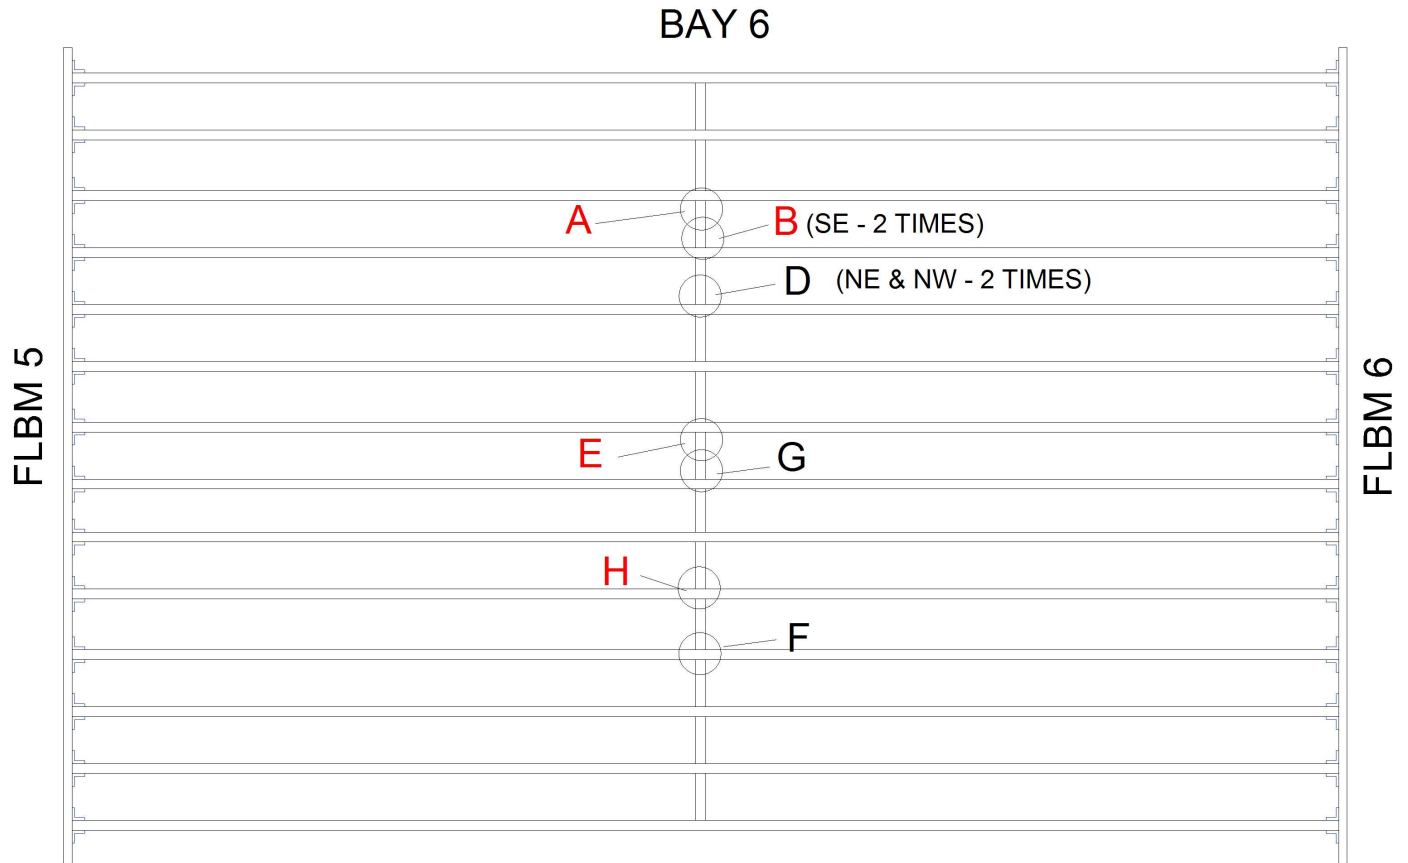
- A. CRACK IN WEB ABOVE WELD AT DIAPHRAGM CONN AT STR3 - 1-1/2"
- B. CRACK IN WEB ABOVE WELD AT DIAPHRAGM CONN AT STR4 - PROP. 3/16" PAST ARREST HOLE
- D. CRACKED ABOVE WELD AT DIAPHRAGM CONN IN NORTH SIDE OF STR5 REPAIRED
- E. CRACK IN WEB ABOVE WELD AT DIAPH. CONN. ON STR7 - PROP. UP TO 1" ON E & W SIDES OF ARST. HOLE
- F. CRACKED WEB AT DIAPHRAGM CONN IN NORTH SIDE OF STR11 1" HL REPAIRED
- G. 1 1/4" CRACK IN TOP DIAPH. CONN. WELD AT NORTH SIDE STR 8 REPAIRED
- H. CRACKS IN WELD AT BOTTOM OF DIAPH. CONN. AT STR10 UP TO 1-1/2"L - (1) ON N SIDE, (1) ON S SIDE

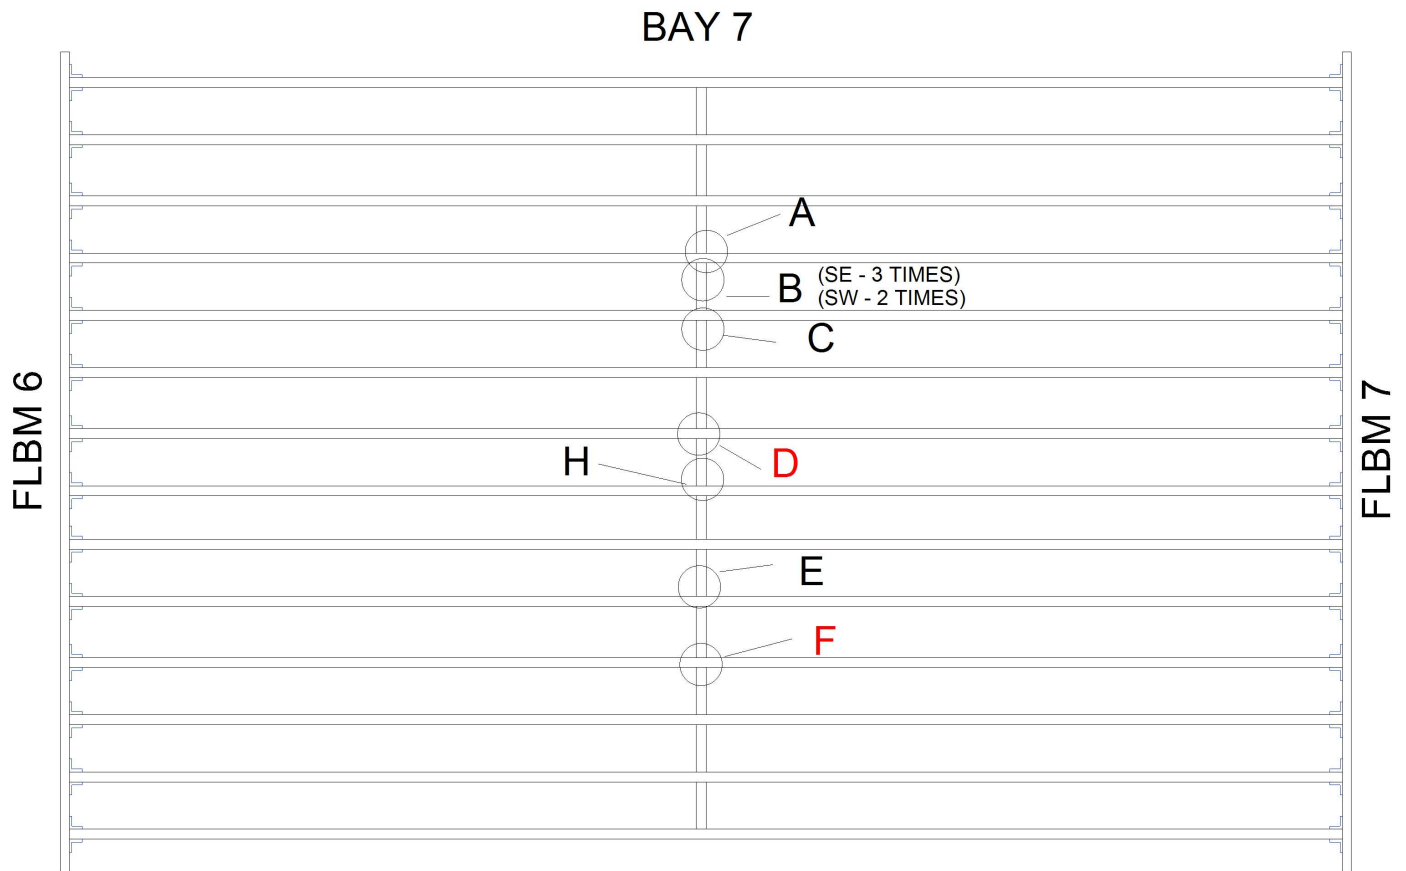
- A. CRACKED ABOVE WELD AT DIAPHRAGM CONN IN NORTH SIDE OF STR4 2" REPAIRED
- B. CRACKED ABOVE WELD AT DIAPHRAGM CONN IN SOUTH SIDE OF STR4 1" REPAIRED
- C. CRACKED IN DIAPHRAGM CONN AT SOUTH SIDE OF STR5 1/2" REPAIRED
- D. CRACKED ABOVE WELD AT DIAPHRAGM CONN IN STR7 1" - (4) TOTAL PROP. 1/4" PAST ARREST HOLE**
- E. CRACKED ABOVE WELD AT DIAPHRAGM CONN IN NORTH SIDE OF STR10 1/2" REPAIRED
- F. CRACKED WEB AT DIAPHRAGM CONN IN NORTH SIDE OF STR11 1" HL - PROP. 3/16" PAST ARREST HOLE**
- H. 1-3/4" CRACK AT TOP DIA. CONN. WELD N.SIDE STR.8 REPAIRED

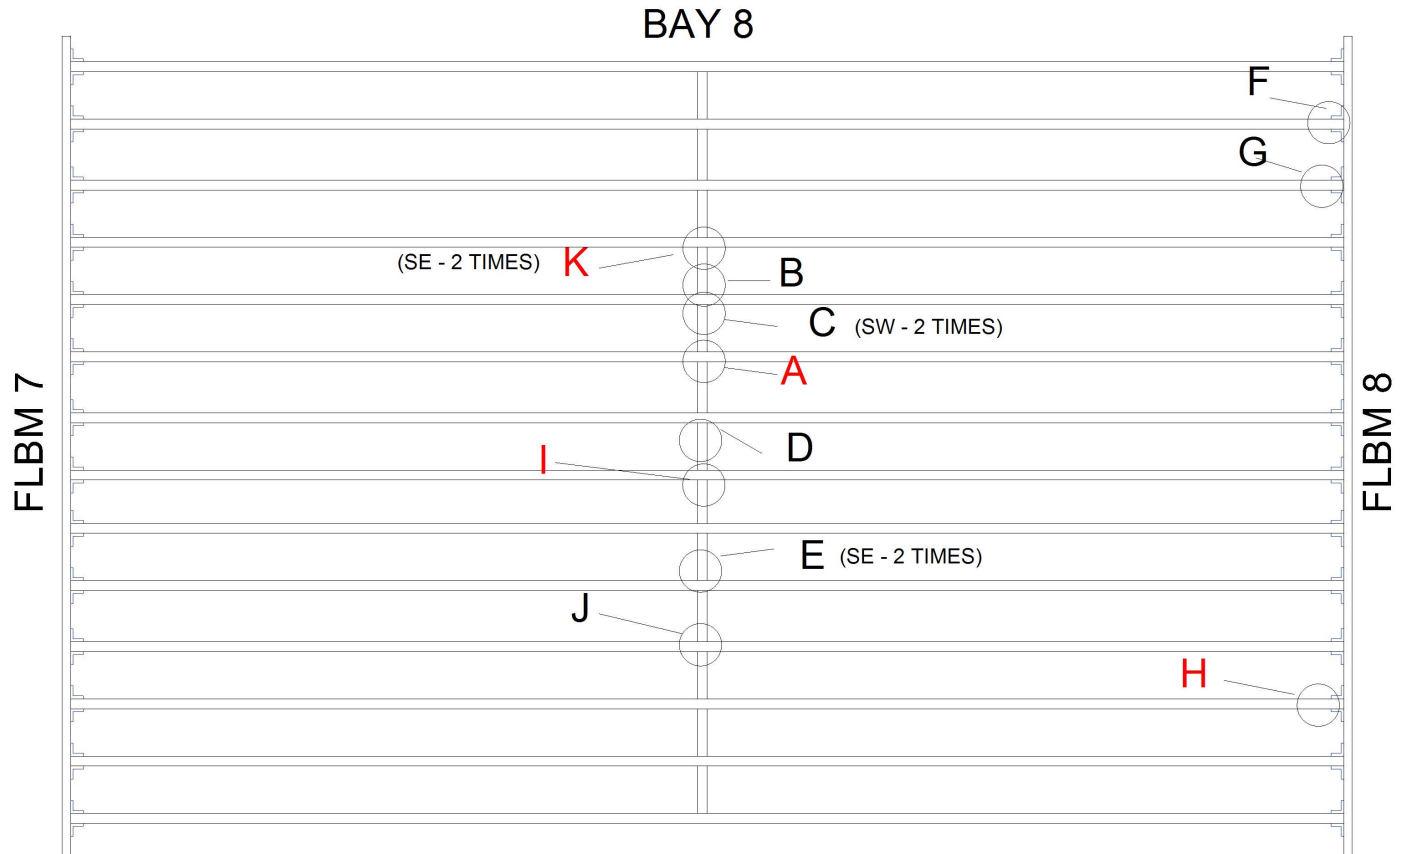
- A. (2) CRACKS AT TOP OF DIAPH. CONN - (1) IN WELD (1) IN WEB, & (1) IN BRACKET AT BOTTOM - ALL 1" TO 1-1/2"L
- B. CRACKED IN DIAPHRAGM CONN AT NORTH SIDE OF STR5 1/2"REPAIRED
- C. CRACKED IN DIAPHRAGM CONN AT SOUTH SIDE OF STR5 3/4"REPAIRED
- D. CRACKED ABOVE WELD AT DIAPHRAGM CONN IN SOUTH SIDE OF STR7 1/2"REPAIRED
- E. CRACKED ABOVE WELD AT DIAPHRAGM CONN IN NORTH SIDE OF STR10 3/4"REPAIRED
- F. 2"DIAMETER HOLE IN WEB OF STR2 AT CONN WITH FLBM 8REPAIRED
- G. 1/2"DIAMETER HOLE IN WEB OF STR3 AT CONN WITH FLBM 8REPAIRED
- H. ~1" DIAMETER HOLE IN WEB OF STR12 AT CONN WITH FLBM 8
- I. 1 5/8" CRACK AT TOP DIAPH. CONN. WELD AT STR 8 - (2) PROP. 3/16"
- J. CRACK HAD PROPAGATED 3/4" PAST REPAIR HOLE AT NE SIDE STR 11 REPAIRED
- K. CRACK PROP. PAST ARREST HOLE AT TOP OF DIAP. CONN 1/4"
