NC DEPARTMENT OF TRANSPORTATION
DIVISION OF HIGHWAYS
STRUCTURE MANAGEMENT UNIT

Structure Safety Report

Routine Element Inspection - Contract

DIVISION: 3 COUNTY: NEW HANOVER STRUCTURE NUMBER: 640013 FREQUENCY: 24 MONTHS

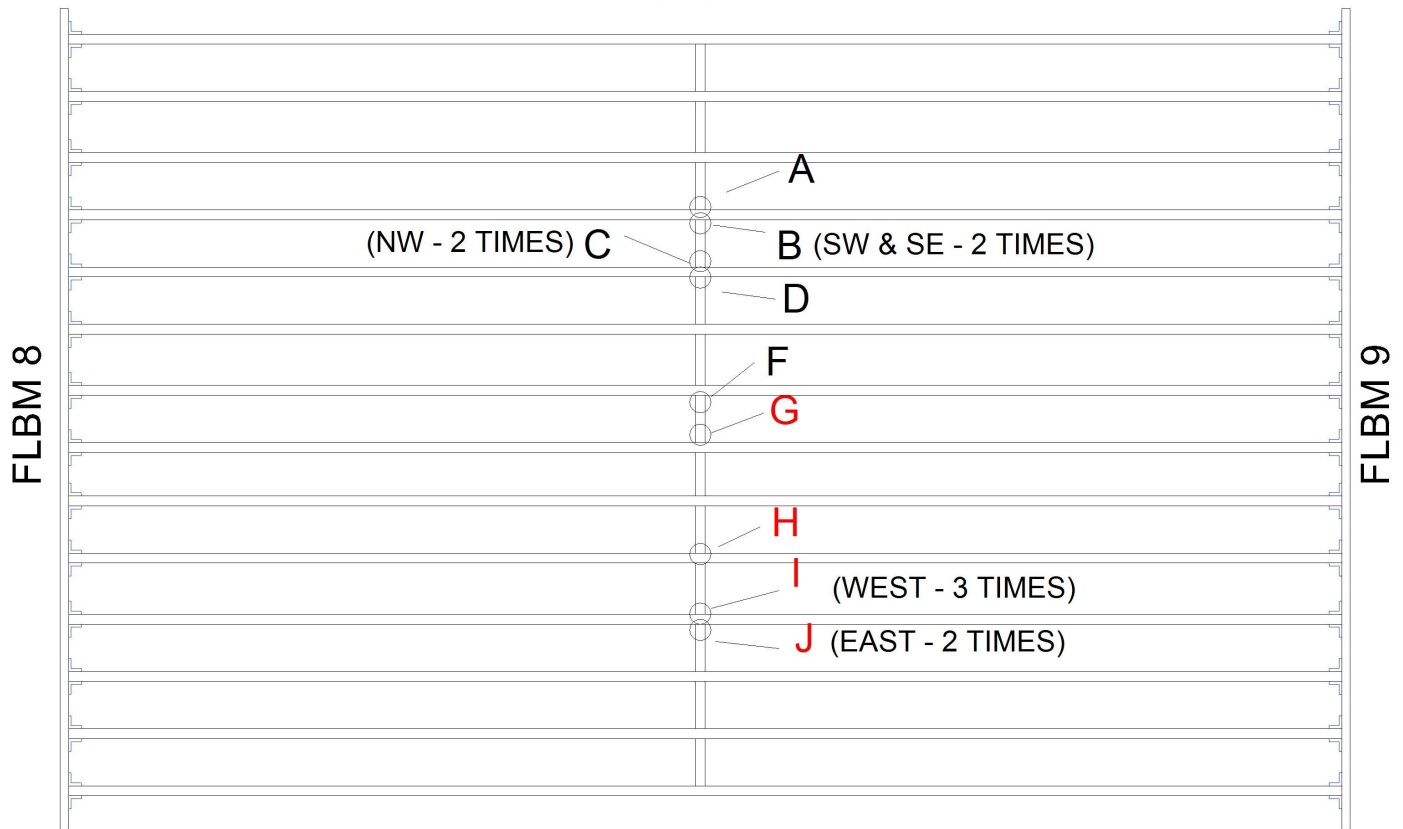
BAY 9

- A. CRACKED ABOVE WELD AT DIAPHRAGM CONN IN NORTH SIDE OF STR4 2" REPAIRED
- B. CRACKED ABOVE WELD AT DIAPHRAGM CONN IN SOUTH SIDE OF STR4 2" REPAIRED
- C. CRACKED IN DIAPHRAGM CONN AT NORTH SIDE OF STR5 3/4" REPAIRED
- D. CRACKED IN DIAPHRAGM CONN AT SOUTH SIDE OF STR5 1/2" REPAIRED
- F. CRACKED IN DIAPHRAGM CONN AT SOUTH SIDE OF STR7 1/2" REPAIRED
- G. CRACKED AT DIAPHRAGM CONN AT STR8 - (1) 1" IN WEB, (2) 3/4" IN WELD
- H. CRACKED IN DIAPHRAGM CONN AT NORTH SIDE OF STR10 - PROP. TOTAL OF (3) ~1/8" PAST ARREST HOLES
- I. CRACKED AT DIAPHRAGM CONN IN NORTH SIDE OF STR11 2" - PROP. ~1/4" PAST ARREST HOLE
- J. CRACKED AT DIAPHRAGM CONN IN SOUTH SIDE OF STR11 2" - PROP. ~1/4" PAST ARREST HOLE

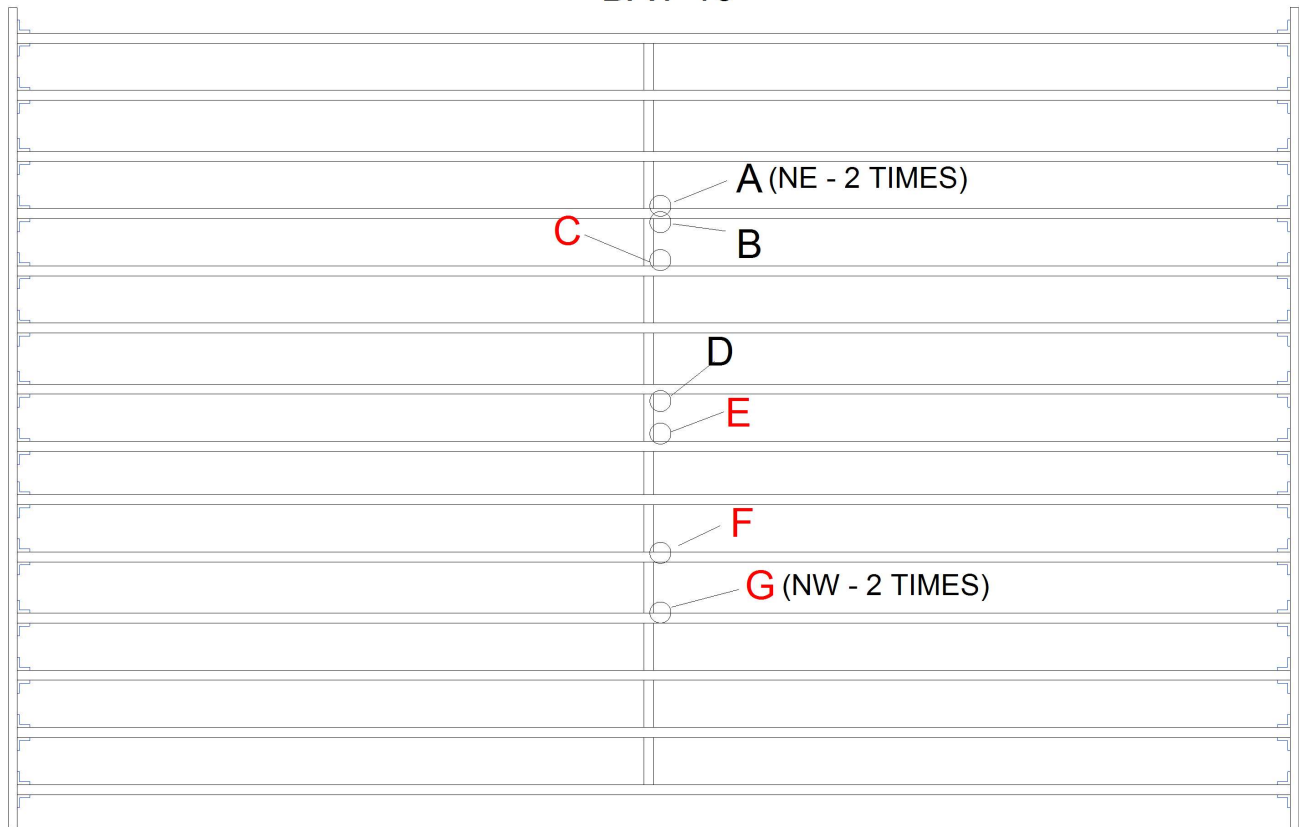
- A. CRACKED ABOVE WELD AT DIAPHRAGM CONN IN NORTH SIDE OF STR4 2" REPAIRED
- B. CRACKED ABOVE WELD AT DIAPHRAGM CONN IN SOUTH SIDE OF STR4 2" REPAIRED
- C. CRACKED ABOVE WELD AT DIAPHRAGM CONN IN NORTH SIDE OF STR5 - PROP. 1/2" PAST ARREST HOLE
- D. CRACKED ABOVE WELD AT DIAPHRAGM CONN IN SOUTH SIDE OF STR7 HL REPAIRED
- E. CRACKED ABOVE WELD AT DIAPHRAGM CONN IN NORTH SIDE OF STR8 HL - PROP. 1/4" PAST ARREST HOLE
- F. CRACKED ABOVE WELD AT DIAPHRAGM CONN IN NORTH SIDE OF STR10 HL - PROP. 1/4" PAST ARREST HOLE
- G. CRACKED ABOVE WELD AT DIAPHRAGM CONN IN NORTH SIDE OF STR11 HL - (3) PROP. ~1/2" PAST ARREST HOLE

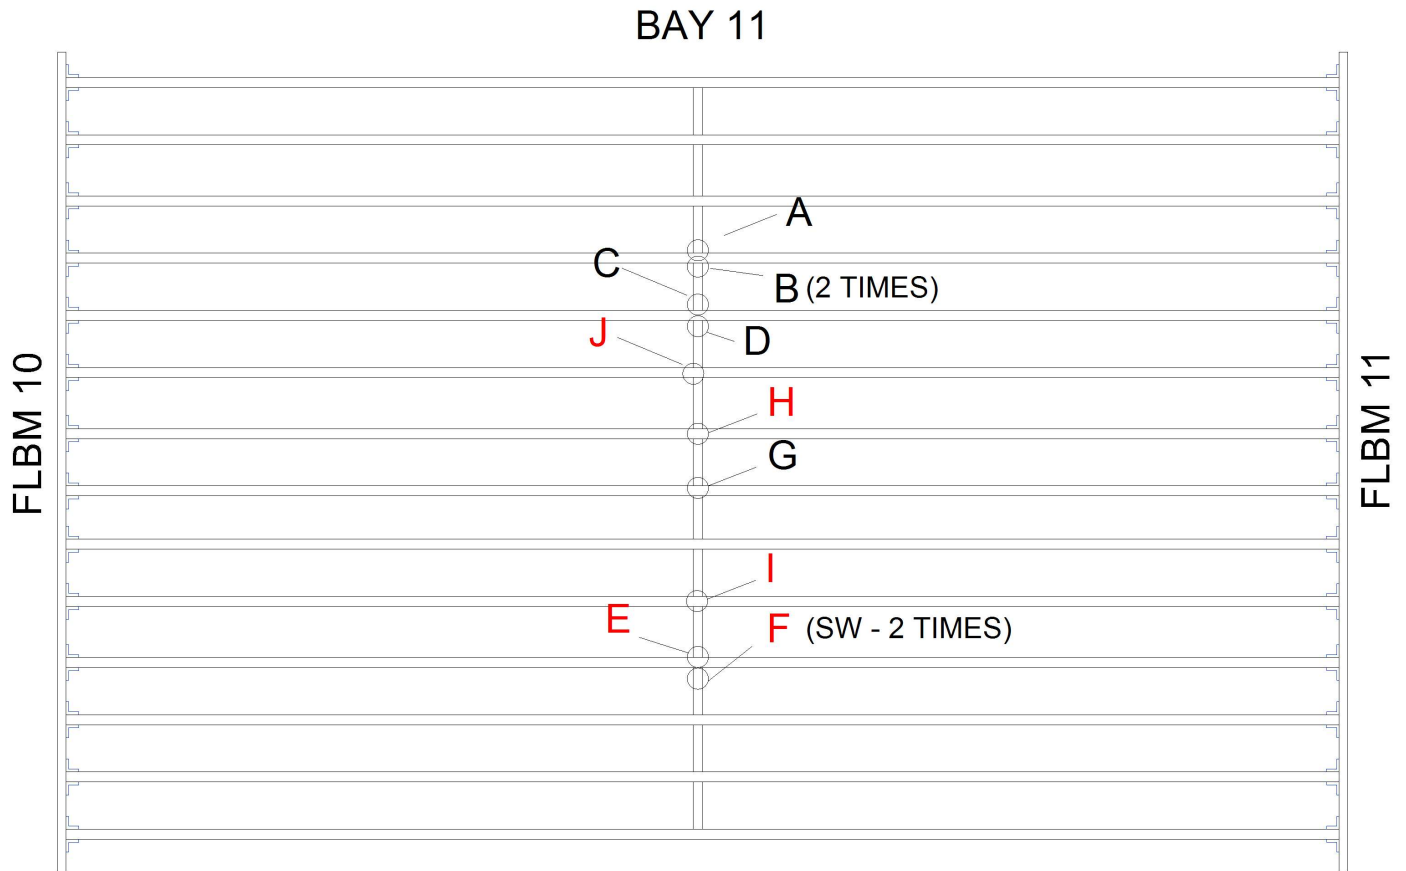
- A. CRACKED ABOVE WELD AT DIAPHRAGM CONN IN NORTH SIDE OF STR4 2" REPAIRED
- B. CRACKED ABOVE WELD AT DIAPHRAGM CONN IN SOUTH SIDE OF STR4 2" REPAIRED
- C. CRACKED ABOVE WELD AT DIAPHRAGM CONN IN NORTH SIDE OF STR5 1" REPAIRED
- D. CRACKED ABOVE WELD AT DIAPHRAGM CONN IN SOUTH SIDE OF STR5 1/2" REPAIRED
- E. CRACK IN WELD AT DIAPHRAGM CONN AT NORTH SIDE OF STR11 2" - PROPAGATED 1/8" PAST ARREST HOLE
- F. CRACK IN WELD AT DIAPHRAGM CONN AT SOUTH SIDE OF STR11 5/16" - (5) TOTAL ~1/8" CRACKS PROPAGATING PAST ARREST HOLES.
- G. 1 5/8" CRACK AT TOP DIAPH. CONN. WELD AT NORTH SIDE STR.8 REPAIRED
- H. CRACK AT TOP DIAPH. CONN. WELD AT STR7 5/16"
- I. CRACK AT TOP DIAPH. CONN. WEB AT STR10 1-1/4"
- J. CRACK AT TOP DIAPH. CONN. WEB AT STR6 3/4"

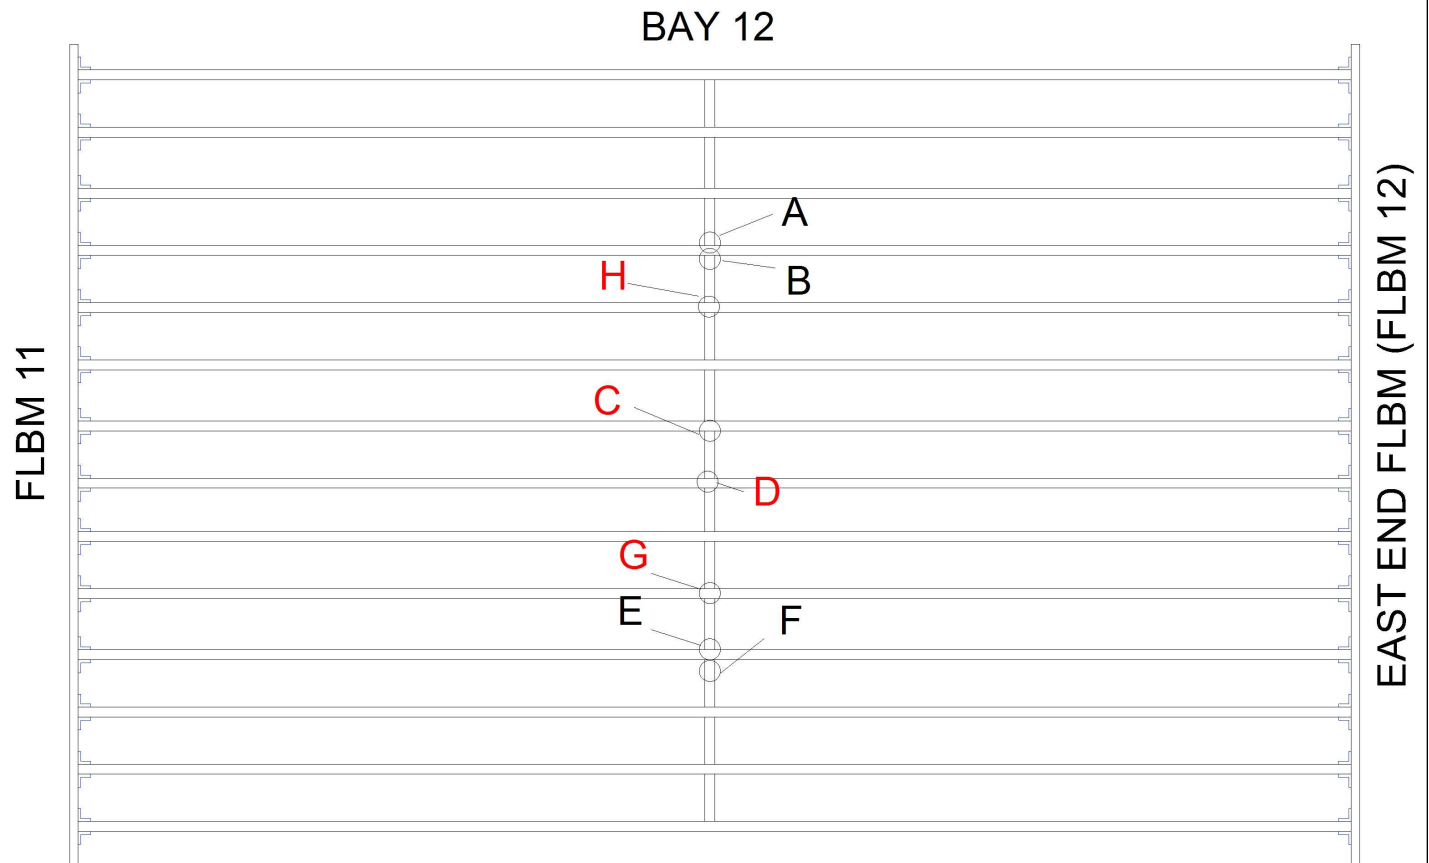
- A. CRACKED ABOVE WELD AT DIAPHRAGM CONN IN NORTH SIDE OF STR4 1" REPAIRED
- B. CRACKED ABOVE WELD AT DIAPHRAGM CONN IN SOUTH SIDE OF STR4 1" REPAIRED
- C. CRACKED IN WELD AT DIAPHRAGM CONN AT SOUTH SIDE OF STR7 PROP. 1/8"
- D. CRACKED IN WELD AT DIAPHRAGM CONN AT NORTH SIDE OF STR8 PROP. ~1/4"
- E. CRACKED IN WELD AT DIAPHRAGM CONN AT NORTH SIDE OF STR11 HL REPAIRED
- F. CRACKED IN WELD AT DIAPHRAGM CONN AT SOUTH SIDE OF STR11 HL REPAIRED
- G. CRACK IN WELD AT DIAPHRAGM CONN AT STR10 1"
- H. CRACK ABOVE WELD AT DIAPHRAGM CONN AT STR5 1-1/2"
