NC DEPARTMENT OF TRANSPORTATION  
DIVISION OF HIGHWAYS  
STRUCTURE MANAGEMENT UNIT

## Structure Safety Report

### Routine Element Inspection - Contract

STRUCTURE NUMBER: 500082 SAP STRUCTURE NO: 0510082 FHWA STRUCTURE NO: 000000001010082  
DIVISION: 4 COUNTY: JOHNSTON INSPECTION DATE: 04/16/2024 FREQUENCY: 24 MONTHS  
FACILITY CARRIED: I95N MILE POST: 90.5  
LOCATION: 0.8 MI N JCT US70/US301  
FEATURE INTERSECTED: BLACK CREEK  
LATITUDE: 35° 27' 58.66" LONGITUDE: 78° 22' 50.4"  
SUPERSTRUCTURE: RC DECK ON I-BEAMS  
SUBSTRUCTURE: EBTS;RC CAP H-PILES;INT.BTS.RCP&BEAM  
SPANS: 4 SPANS. SEE SPAN PROFILE SHEET FOR SPAN DETAILS  
☐ FRACTURE CRITICAL ☐ TEMPORARY SHORING ☐ SCOUR CRITICAL ☐ SCOUR PLAN OF ACTION  
GRADES: (Inspector/NBI Coding) DECK 6 / 6 SUPERSTRUCTURE 7 / 7 SUBSTRUCTURE 6 / 6 CULVERT N / N  
POSTED SV: Not Posted POSTED TTST: Not Posted  
OTHER SIGNS PRESENT: 2- DELINEATORS

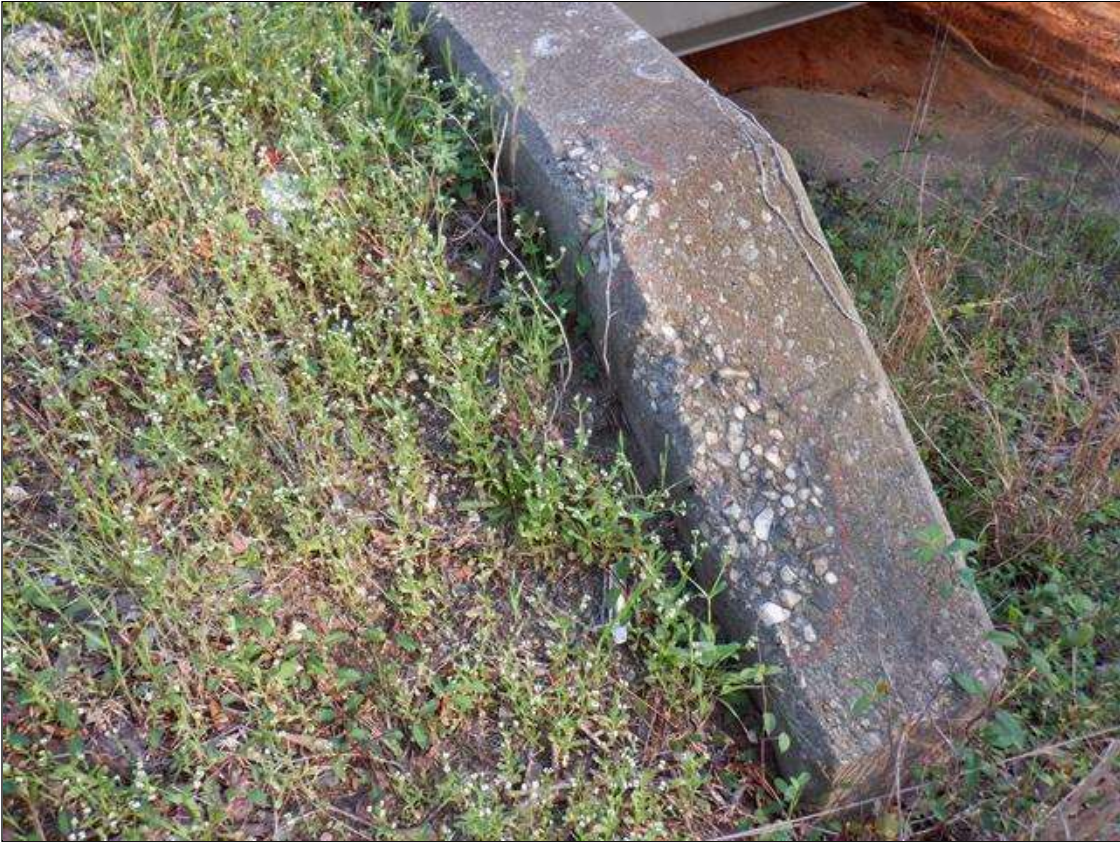
WINGWALL: 2- UP TO 18 INCHES X 5 INCHES X 3 INCHES SPALLS IN TOP OF SOUTHEAST WINGWALL.

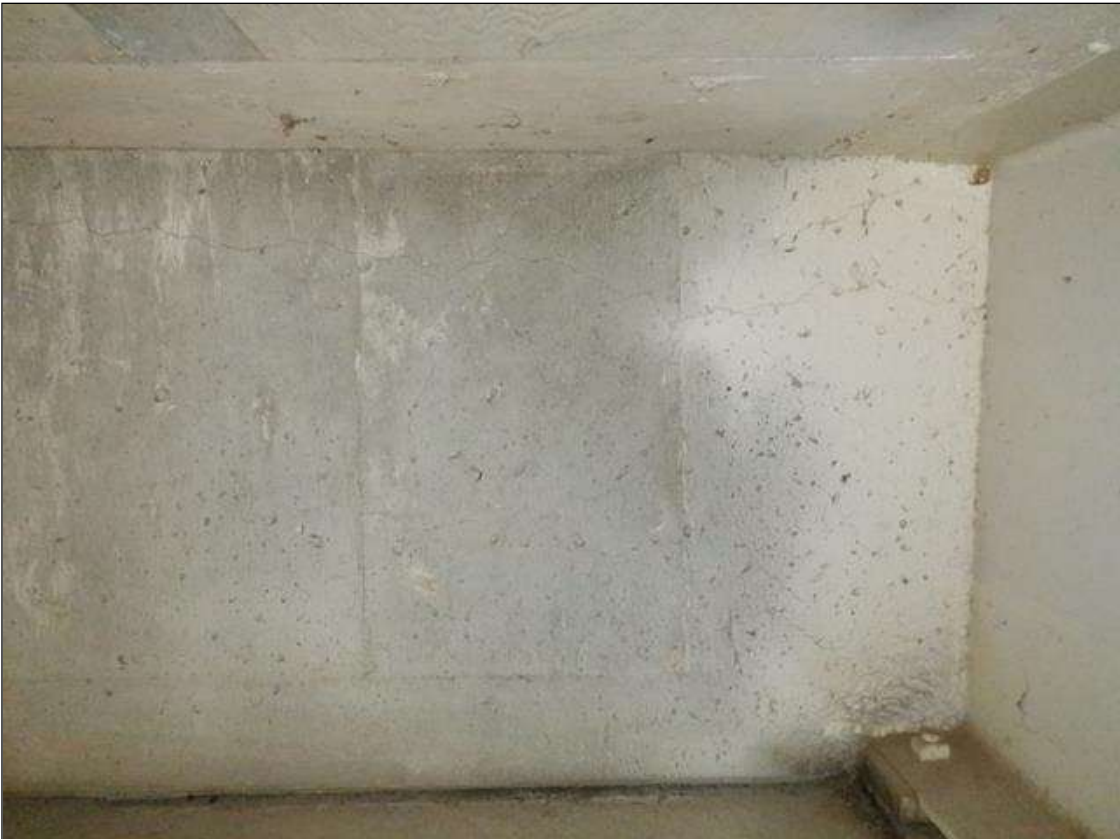
| Element Number | Defect Type | Defect Description | CS | CS Qty | Maint Qty |
|---|---|---|---|---|---|
| <input checked="" type="checkbox"/> 215 | Cracking (RC and Other) | 32 FEET OF UP TO 1/32 INCHES HORIZONTAL AND VERTICAL CRACKS, SOME WITH EFFLORESCENCE. | 2 | 32 | Feet |

End Bent 1 Abutment: 32 FEET OF UP TO 1/32 INCHES HORIZONTAL AND VERTICAL CRACKS, SOME WITH EFFLORESCENCE. (PHOTO TAKEN IN BAY 2)

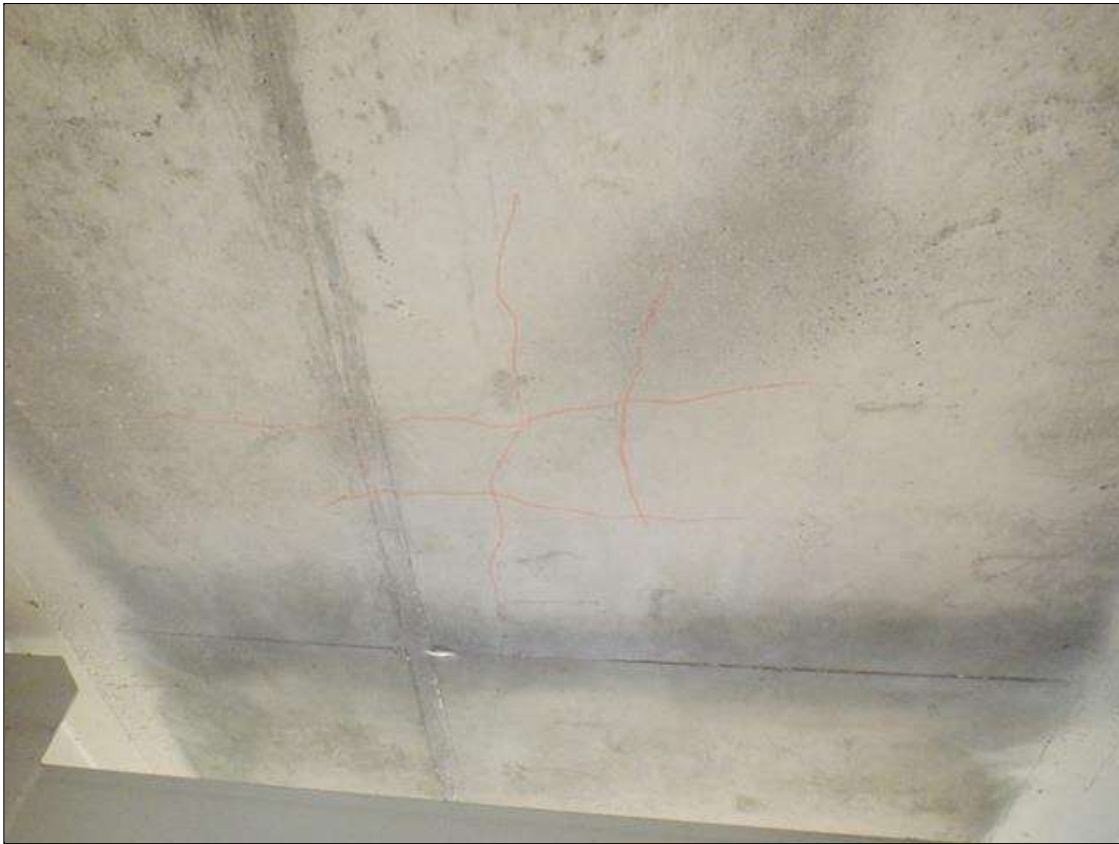
| Element Number | Defect Type | Defect Description | CS | CS Qty | Maint Qty |
|---|---|---|---|---|---|
| <input checked="" type="checkbox"/> 12 | Cracking (RC and Other) | 750 SQUARE FEET OF UP TO 1/32 INCHES MAP CRACKING AT RANDOM THROUGHOUT UNDERSIDE. | 2 | 750 | 750 Square Feet |

Span 1 Deck: 750 SQUARE FEET OF UP TO 1/32 INCHES MAP CRACKING AT RANDOM THROUGHOUT UNDERSIDE. (PHOTO TAKEN IN BAY 1)

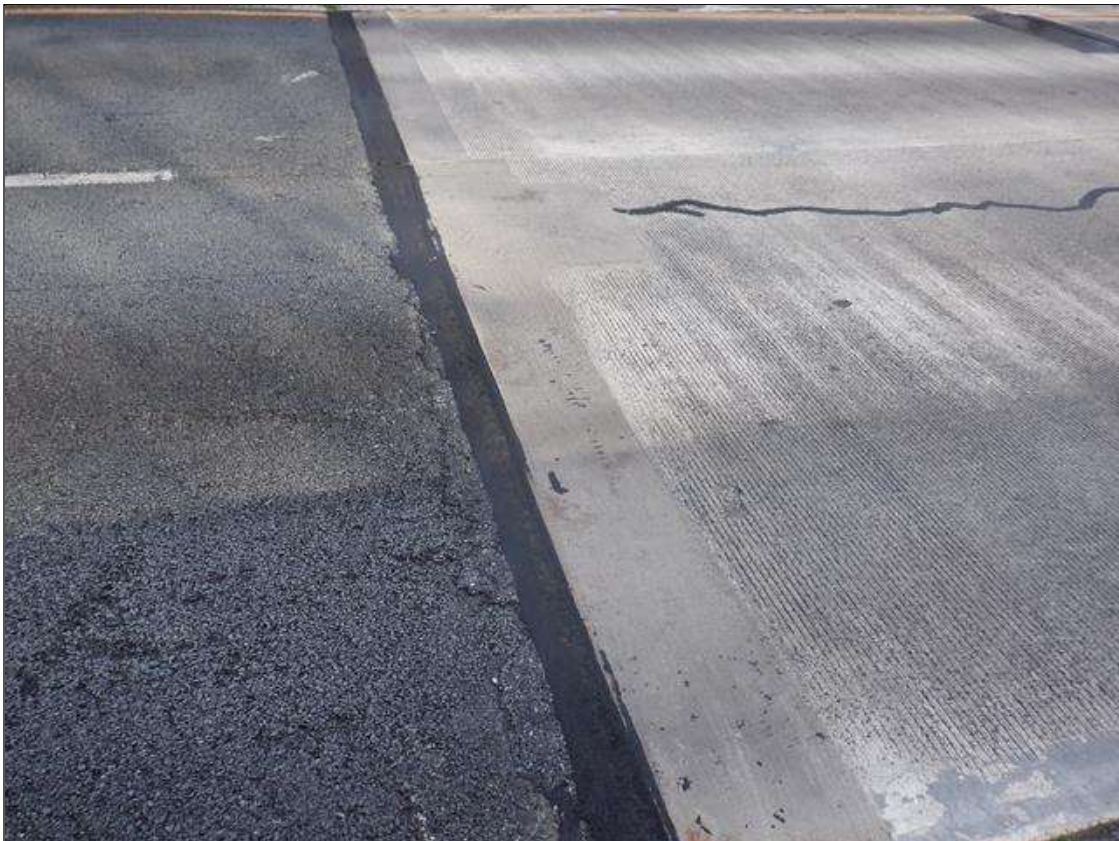
Approach 1 : FULL WIDTH X UP TO 3 FEET PATCHED AREA IN SOUTH END.

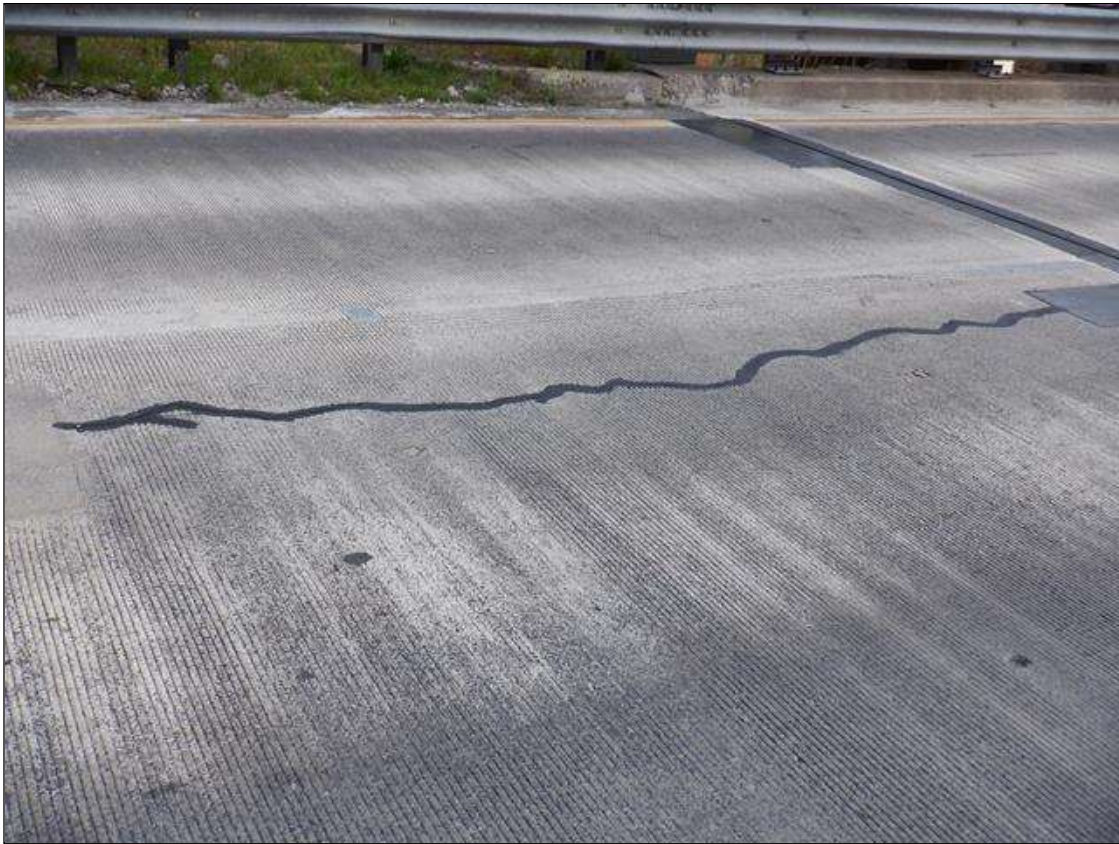
Approach 1 : 15 FEET SEALED LONGITUDINAL CRACK NEAR CENTERLINE

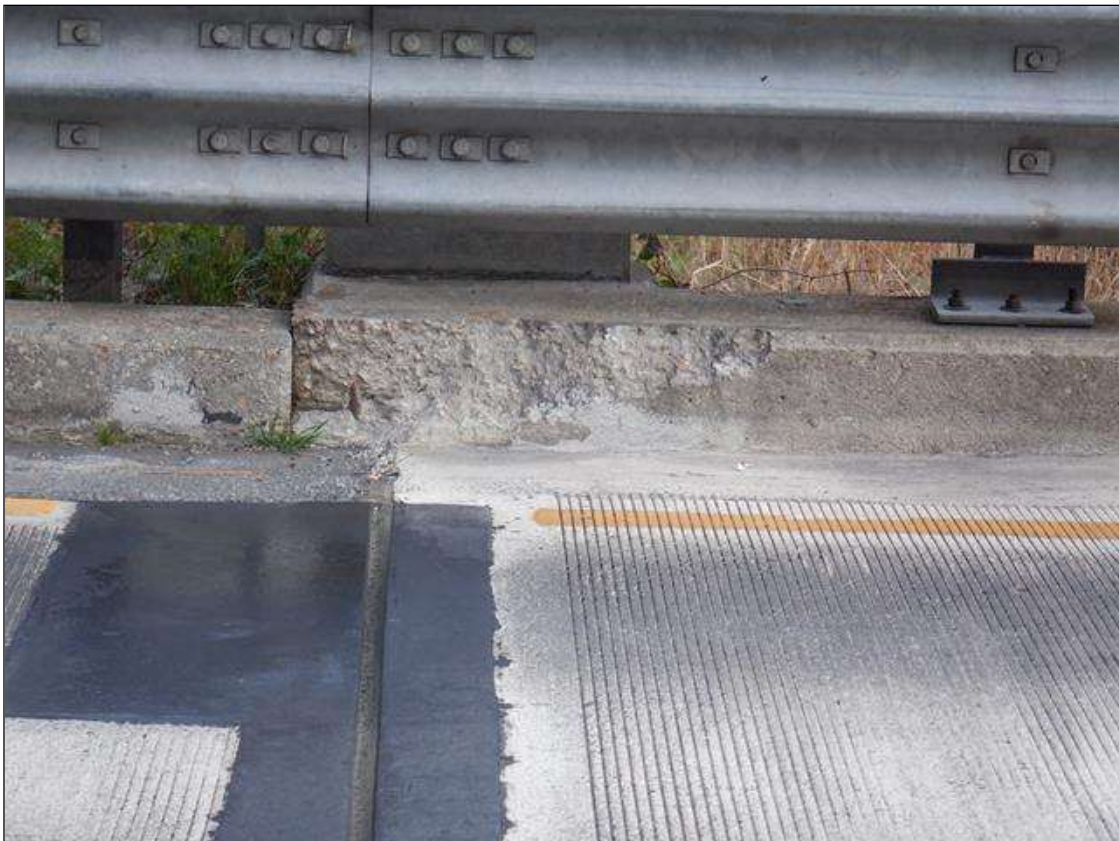
| Element Number | Defect Type | Defect Description | CS | CS Qty | Maint Qty |
|---|---|---|---|---|---|
| ✓ 331 | Delamination/Spall | 35 INCHES X UP TO 9 INCHES X 2 INCHES SPALL WITH EXPOSED REBAR IN CURB AT END BENT 1. | 3 | 3 | 3 Feet |

Span 1 Left Concrete Rail: 35 INCHES X UP TO 9 INCHES X 2 INCHES SPALL WITH EXPOSED REBAR IN CURB AT END BENT 1.

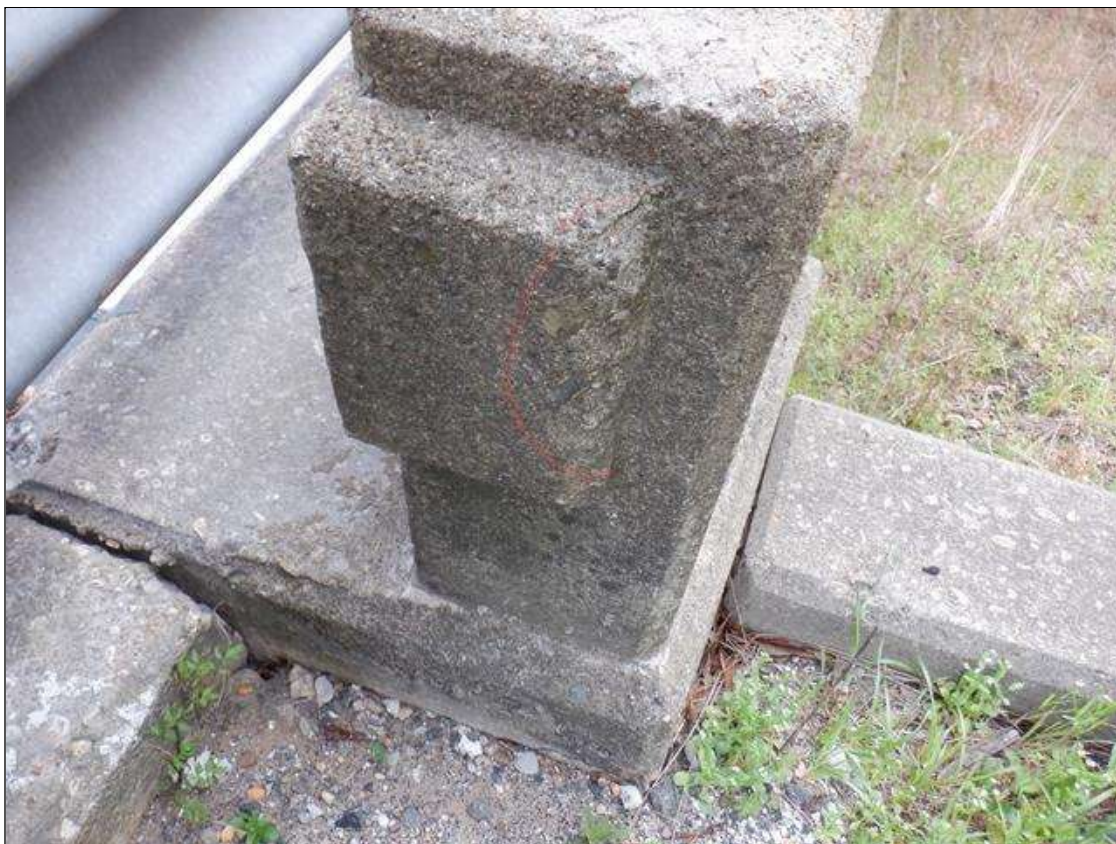
| Element Number | Defect Type | Defect Description | CS | CS Qty | Maint Qty |
|---|---|---|---|---|---|
| <input checked="" type="checkbox"/> 331 | Delamination/Spall | 2 INCHES X UP TO 3 INCHES X 1/2 INCHES SPALL ON END POST AT END BENT 1. | 2 | 1 | 1 Feet |

Span 1 Right Concrete Rail: 2 INCHES X UP TO 3 INCHES X 1/2 INCHES SPALL ON END POST AT END BENT 1.

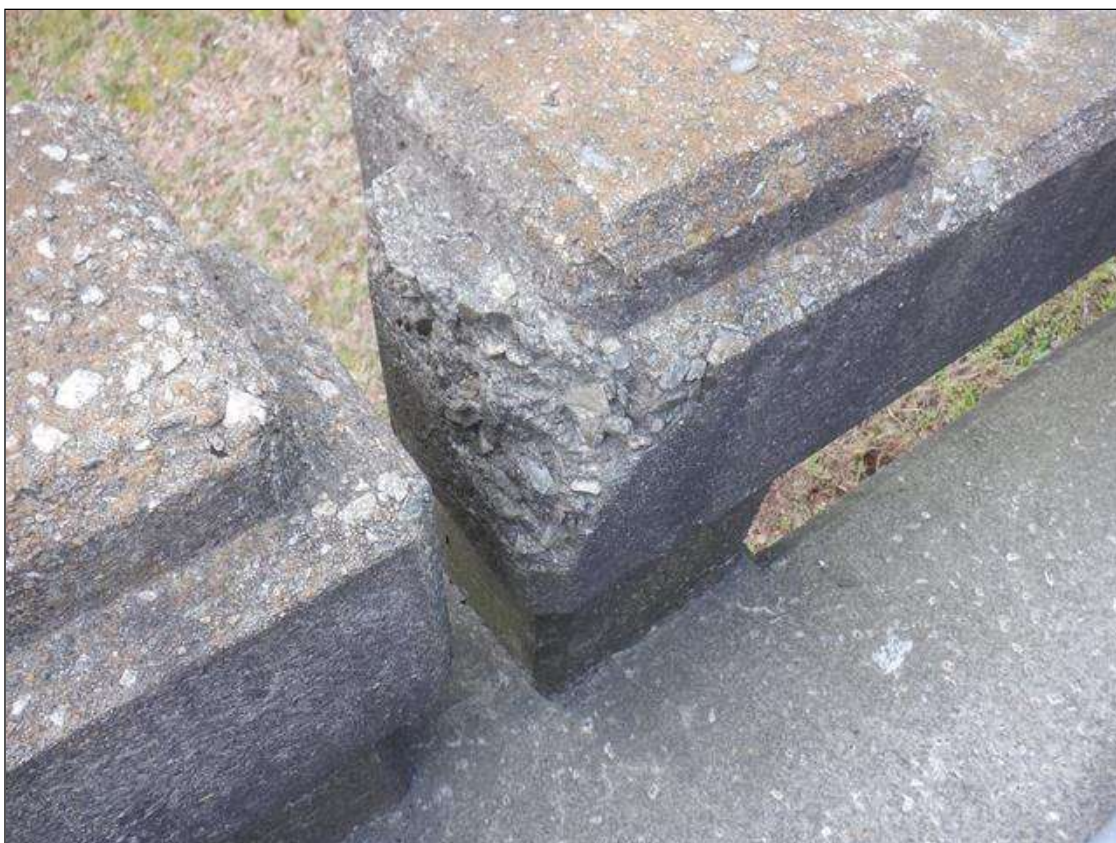
| Element Number | Defect Type | Defect Description | CS | CS Qty | Maint Qty |
|---|---|---|---|---|---|
| <input checked="" type="checkbox"/> 331 | Delamination/Spall | 4 INCHES X 7 INCHES X UP TO 6 INCHES SPALL AT POST 2. | 3 | 1 | 1 Feet |

Span 1 Right Concrete Rail: 4 INCHES X 7 INCHES X UP TO 6 INCHES SPALL AT POST 2.

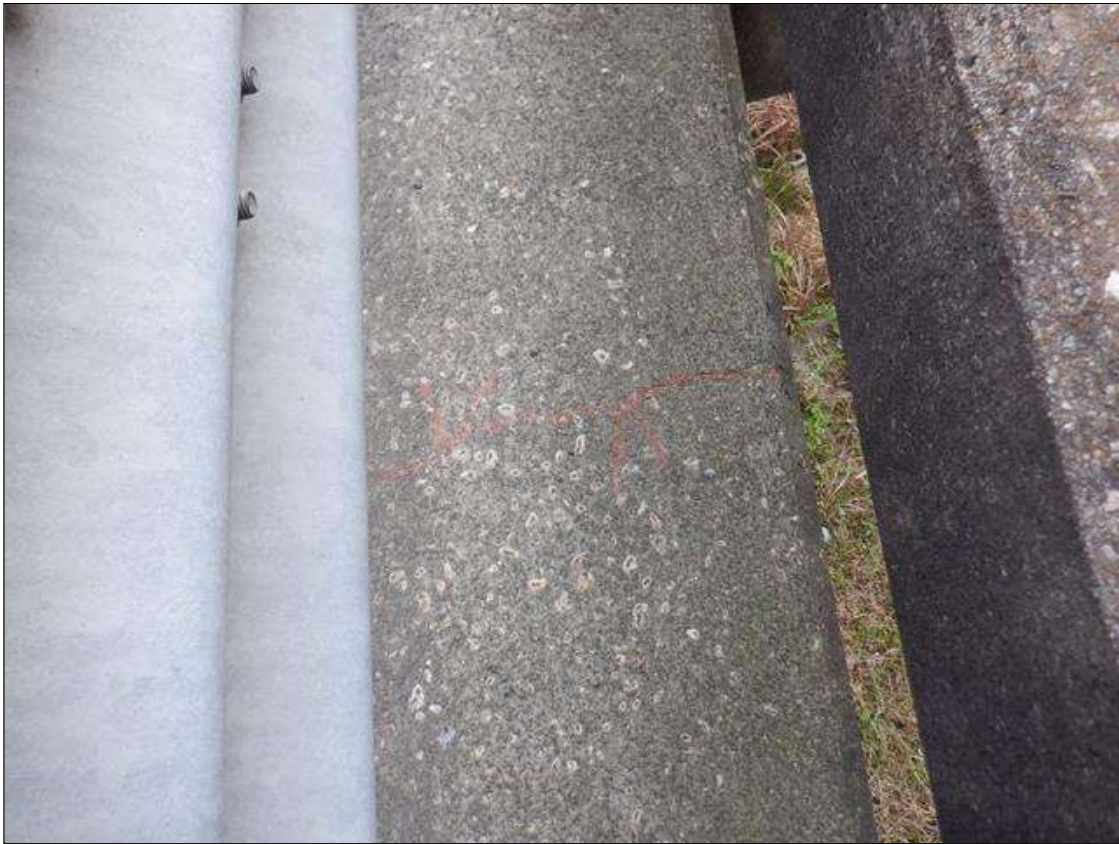
| Element Number | Defect Type | Defect Description | CS | CS Qty | Maint Qty |
|---|---|---|---|---|---|
| <input checked="" type="checkbox"/> 331 | Cracking (RC and Other) | (6) UP TO 1/64 INCHES TRANSVERSE AND WRAPAROUND CRACKS AT RANDOM THROUGHOUT CURB AND RAIL. | 2 | 6 | Feet |

Span 1 Right Concrete Rail: (6) UP TO 1/64 INCHES TRANSVERSE AND WRAPAROUND CRACKS AT RANDOM THROUGHOUT CURB AND RAIL.

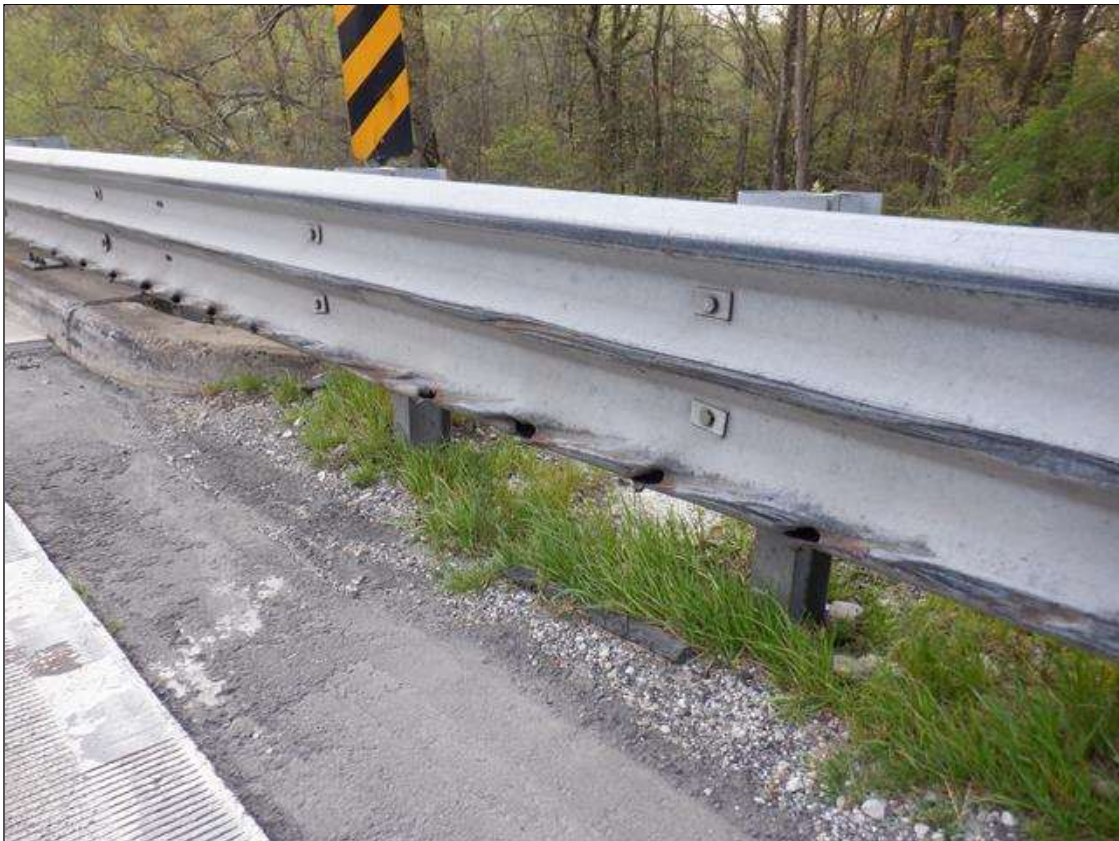
| Priority Level | Defect Type | Quantity | Defect Description |
|---|---|---|---|
| 2 | | 15 | (PAR) 15 FEET OF IMPACT DAMAGE WITH 11- UP TO 4 INCHES X 2 INCHES GOUGES IN SOUTHEAST GUARDRAIL AT END BENT 1. |

General Comments and Misc. Items: (PAR) 15 FEET OF IMPACT DAMAGE WITH 11- UP TO 4 INCHES X 2 INCHES GOUGES IN SOUTHEAST GUARDRAIL AT END BENT 1.

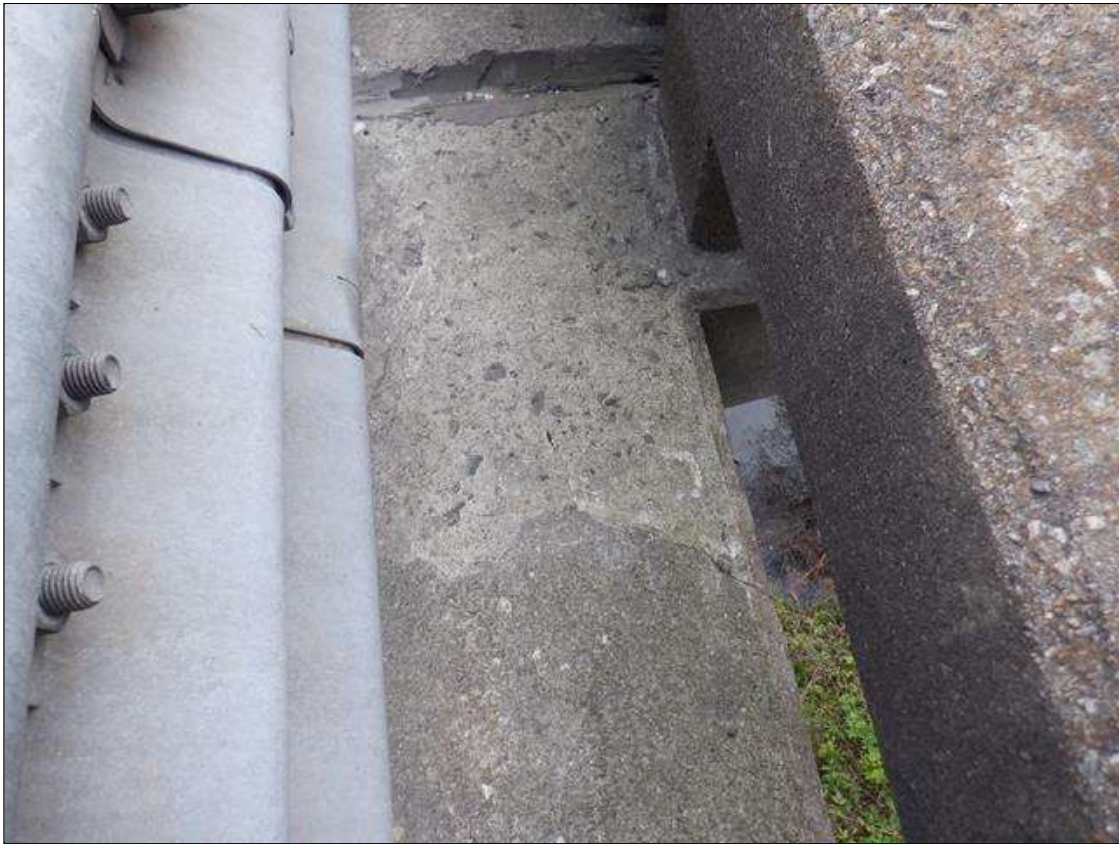
| Element Number | Defect Type | Defect Description | CS | CS Qty | Maint Qty |
|---|---|---|---|---|---|
| <input checked="" type="checkbox"/> 331 | Patched Area | 2 FEET X UP TO 2 FEET CRACKED PATCHED AREA WITH UP TO 1/32 INCHES CRACKING IN CURB AT BENT 1. | 3 | 2 | 2 Square Feet |

Span 1 Right Concrete Rail: 2 FEET X UP TO 2 FEET CRACKED PATCHED AREA WITH UP TO 1/32 INCHES CRACKING IN CURB AT BENT 1.

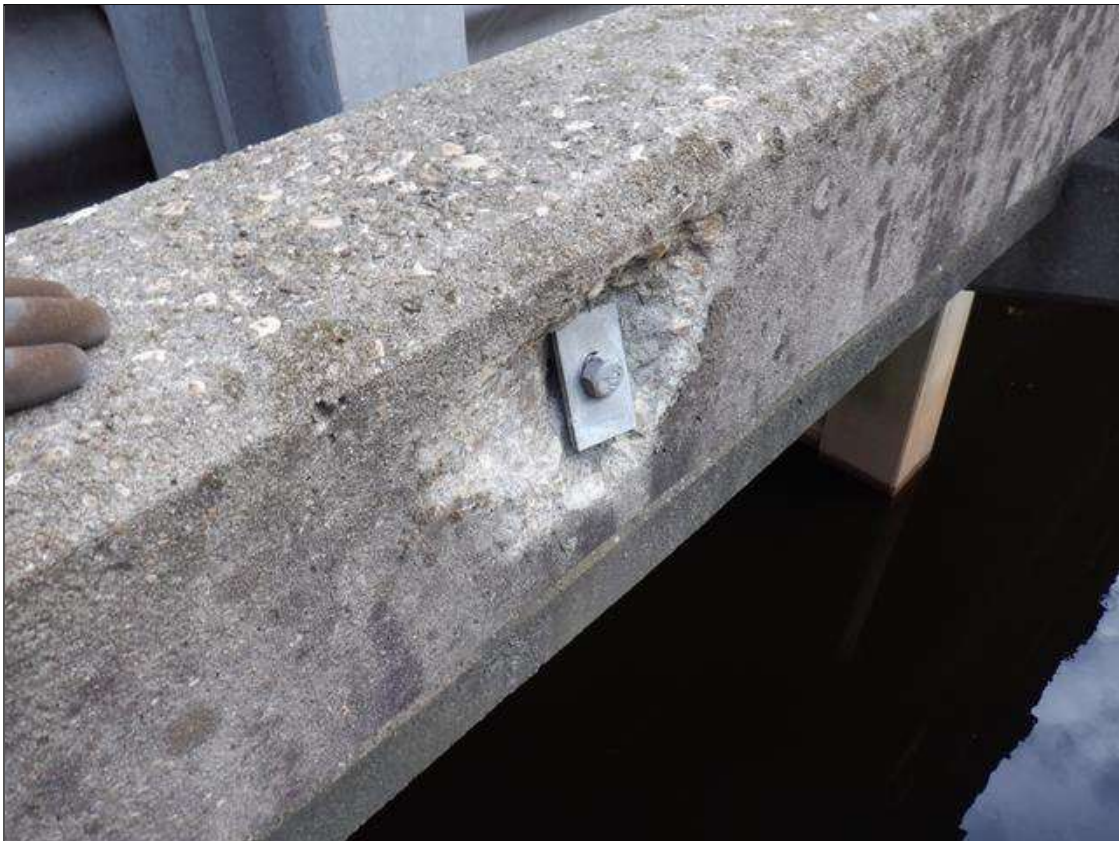
| Element Number | Defect Type | Defect Description | CS | CS Qty | Maint Qty | |
|---|---|---|---|---|---|---|
| <input checked="" type="checkbox"/> 331 | Delamination/Spall | 9 INCHES X UP TO 9 INCHES X 1 INCHES SPALL IN OUTSIDE FACE AT MIDSPAN. | 3 | 1 | 1 | Feet |

Span 2 Right Concrete Rail: 9 INCHES X UP TO 9 INCHES X 1 INCHES SPALL IN OUTSIDE FACE AT MIDSPAN.

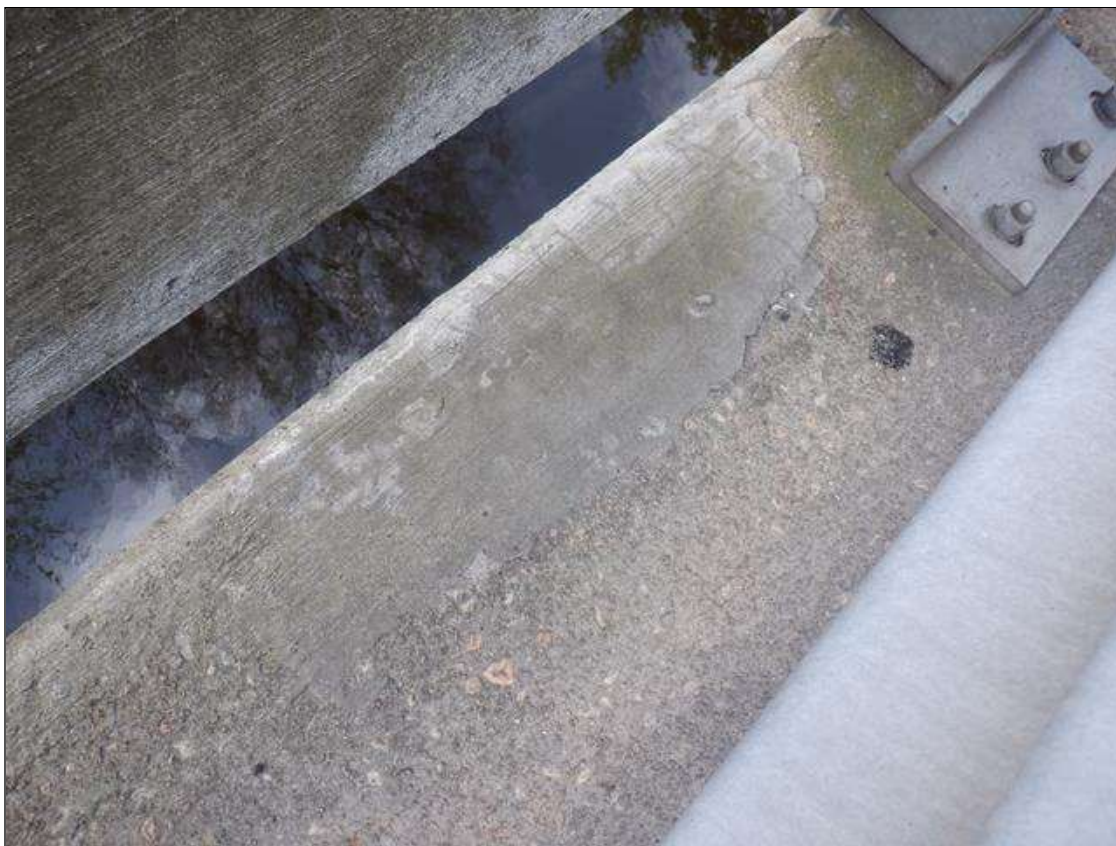
| Element Number | Defect Type | Defect Description | CS | CS Qty | Maint Qty | |
|---|---|---|---|---|---|---|
| <input checked="" type="checkbox"/> 331 | Patched Area | 36 INCHES X UP TO 9 INCHES CRACKED PATCHED AREA WITH UP TO 1/64 INCHES CRACKING IN CURB NEAR BENT 2. | 3 | 3 | 3 | Square Feet |

Span 2 Right Concrete Rail: 36 INCHES X UP TO 9 INCHES CRACKED PATCHED AREA WITH UP TO 1/64 INCHES CRACKING IN CURB NEAR BENT 2.

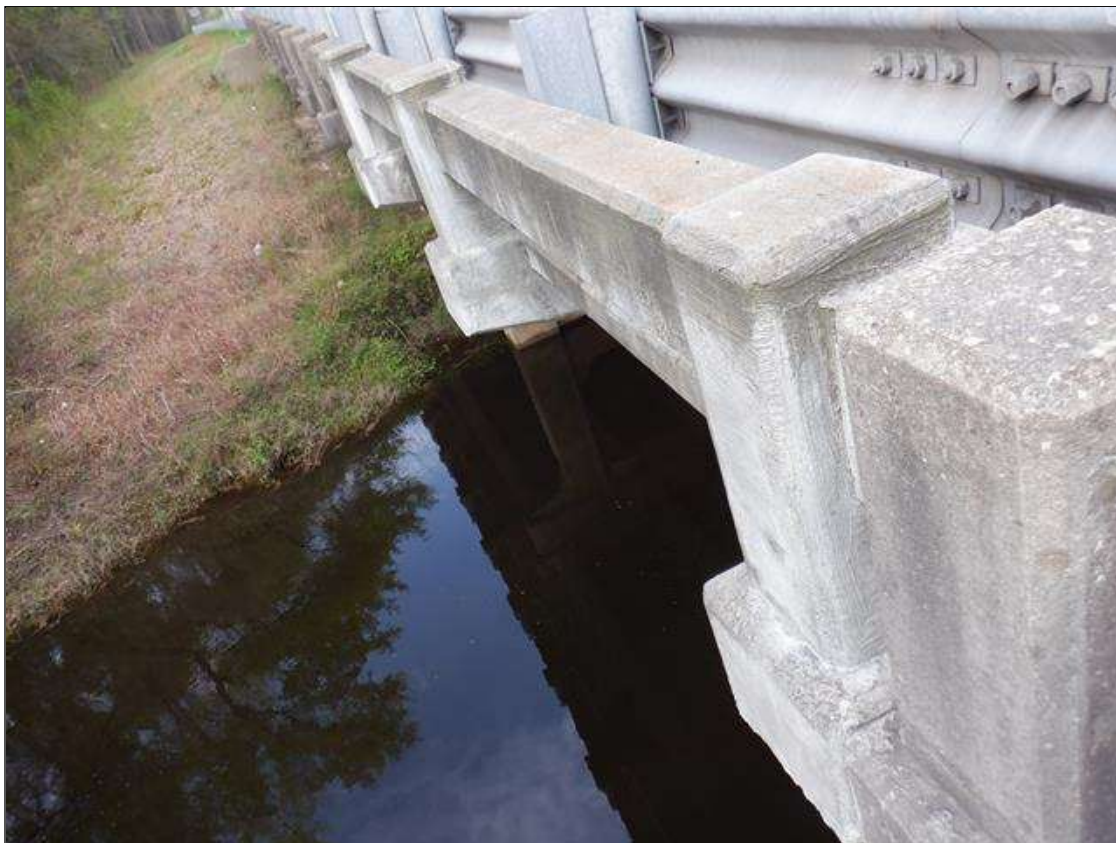
| <input checked="" type="checkbox"/> | <b>331</b> | Patched Area | 16 FEET OF REPAIRED SECTION OF CONCRETE RAIL AT BENT 2. | 2 | 13 | Square Feet |

Span 2 Right Concrete Rail: 16 FEET OF REPAIRED SECTION OF CONCRETE RAIL AT BENT 2.

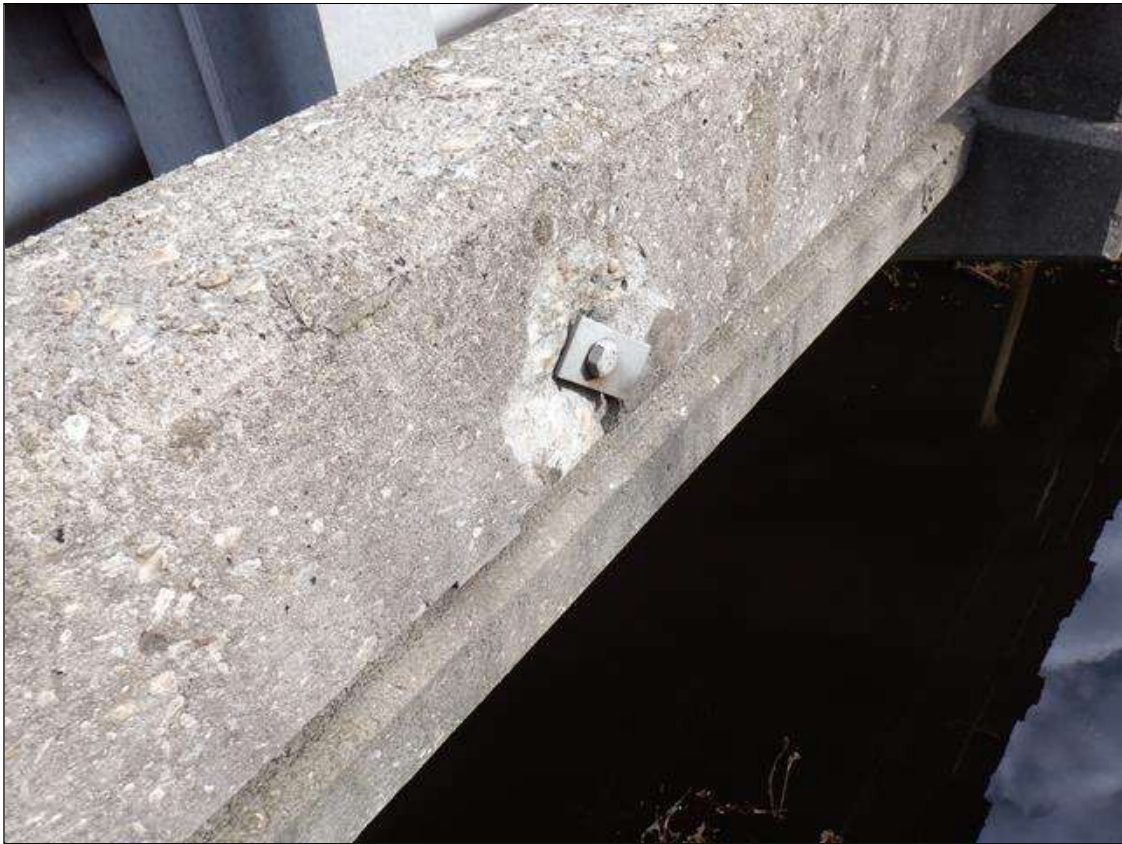
| Element Number | Defect Type | Defect Description | CS | CS Qty | Maint Qty |
|---|---|---|---|---|---|
| <input checked="" type="checkbox"/> | <b>331</b> | Delamination/Spall (3) UP TO 9 INCHES X 9 INCHES X 1 INCHES SPALLS IN OUTSIDE FACE. | 3 | 3 | 3 Feet |

Span 3 Right Concrete Rail: (3) UP TO 9 INCHES X 9 INCHES X 1 INCHES SPALLS IN OUTSIDE FACE. (PHOTO TAKEN NEAR BENT 2)

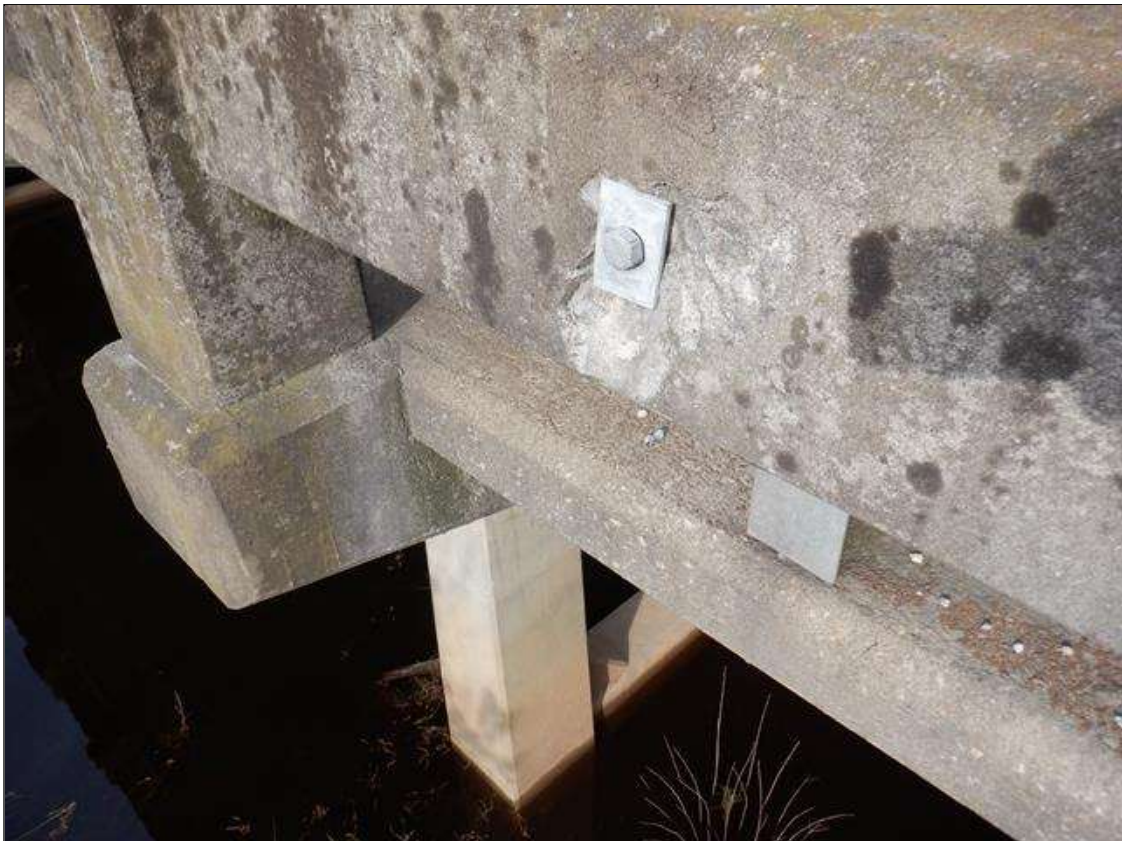
| Element Number | Defect Type | Defect Description | CS | CS Qty | Maint Qty |
|---|---|---|---|---|---|
| <input checked="" type="checkbox"/> 331 | Delamination/Spall | 5- UP TO 7 INCHES X 6 INCHES X 1 INCHES SPALLS IN OUTSIDE FACE OF RAIL. | 3 | 5 | 5 Feet |

Span 4 Right Concrete Rail: 5- UP TO 7 INCHES X 6 INCHES X 1 INCHES SPALLS IN OUTSIDE FACE OF RAIL. (PHOTO TAKEN NEAR MIDSPAN)

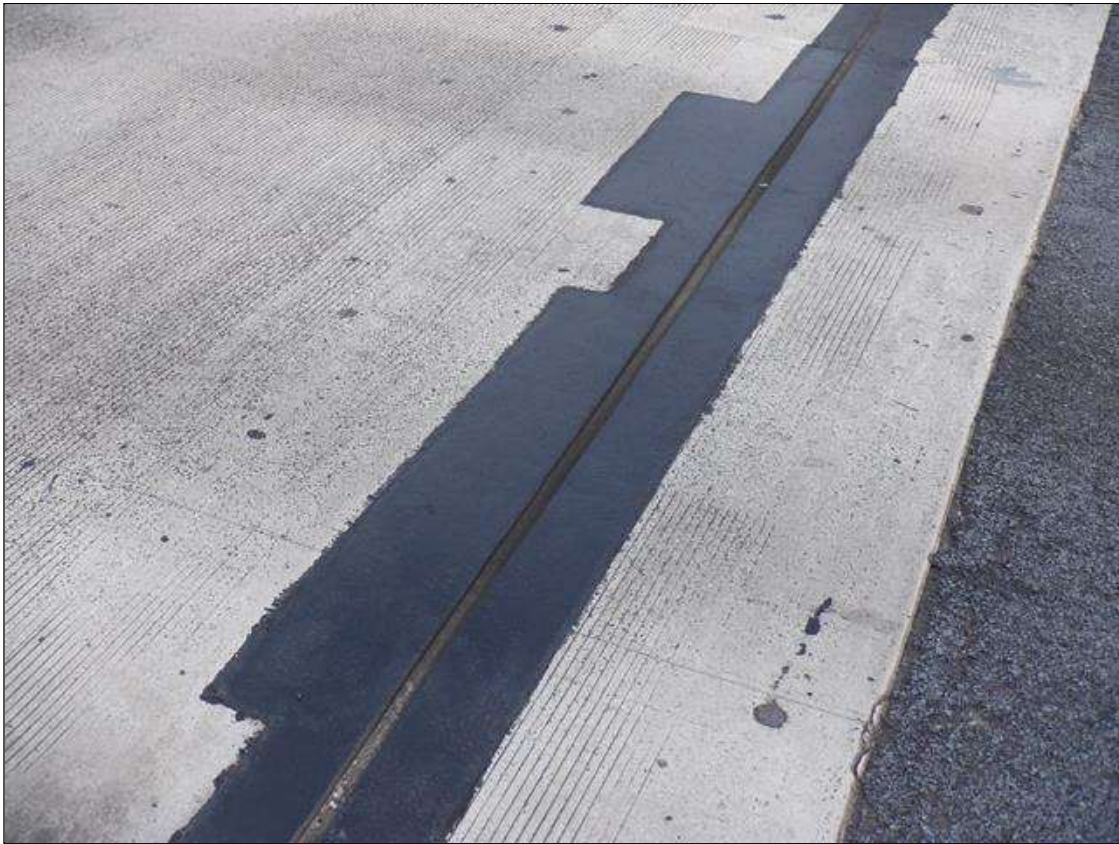
Span 4 Expansion Joint at End Bent 2: 2- UP TO 7 FEET X 18 INCHES PATCHED AREAS ALONG SOUTH EDGE IN EAST LANE.

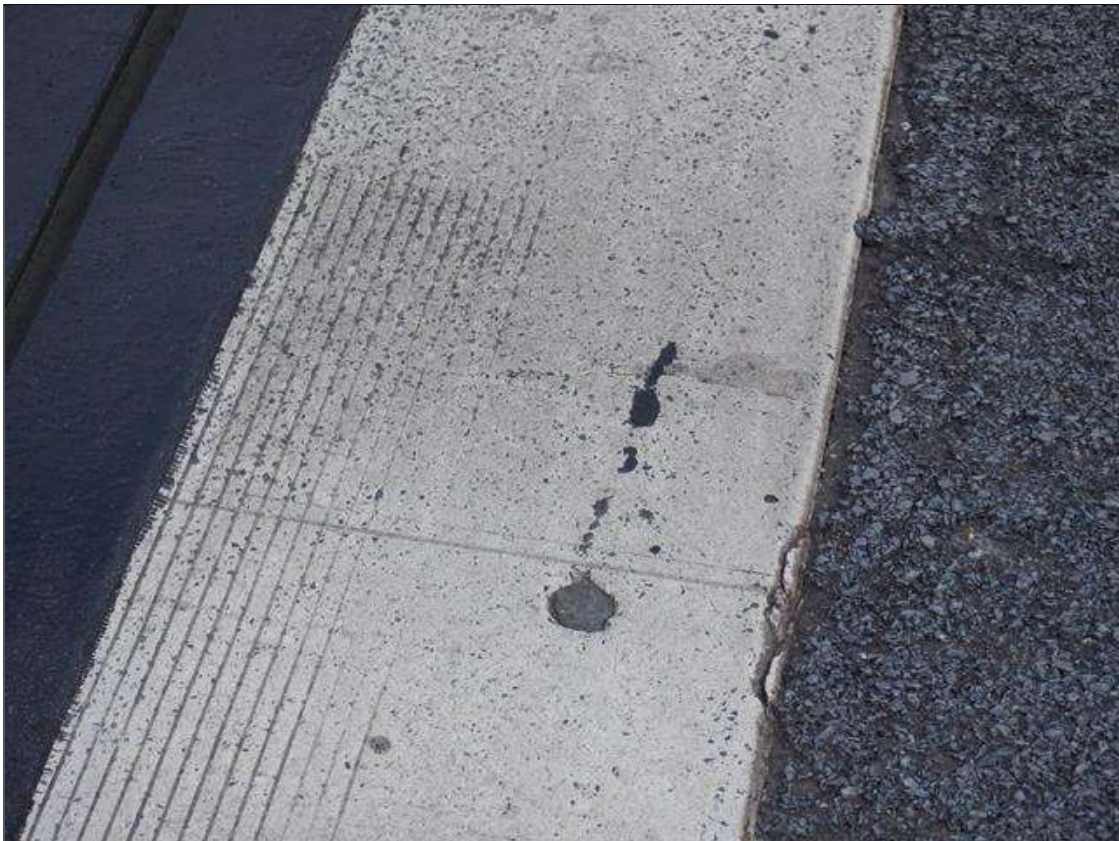
Approach 2 : 18 INCHES X UP TO 1/4 INCHES LONGITUDINAL CRACK IN EAST LANE

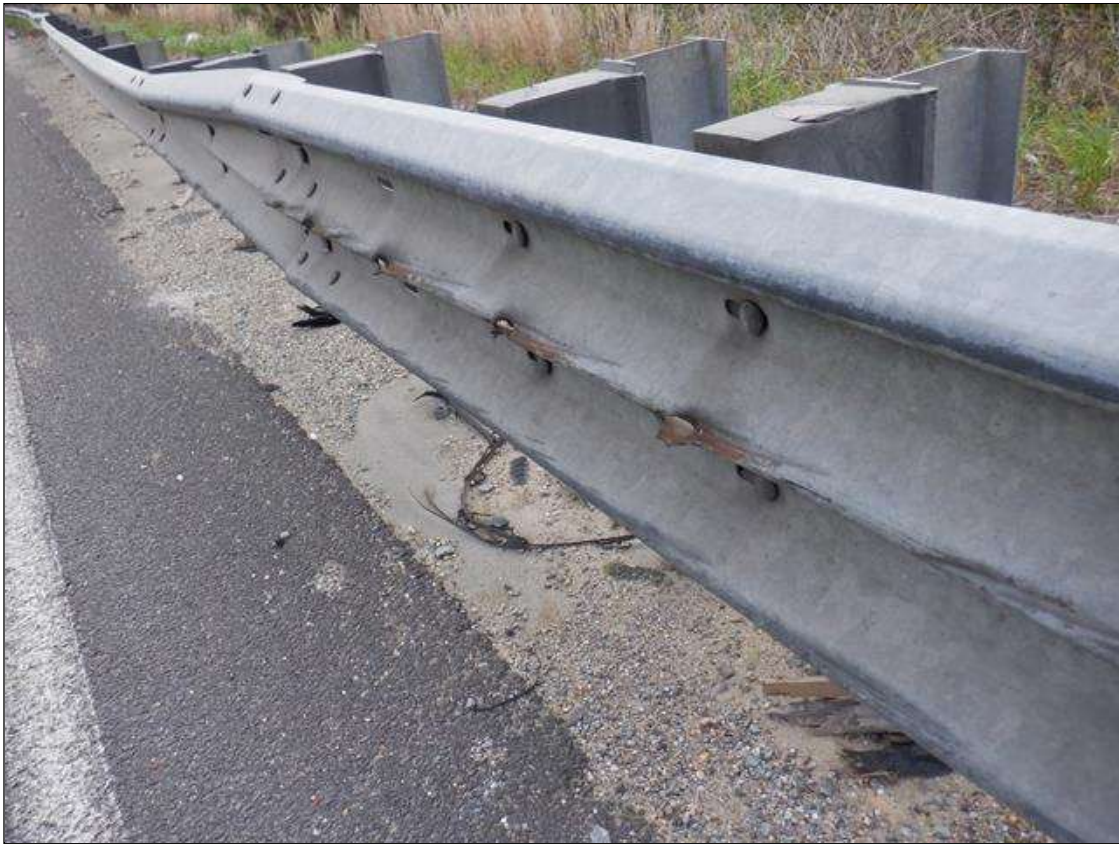
| Priority Level | Defect Type | Quantity | Defect Description |
|---|---|---|---|
| 2 | | 15 | (PAR) 15 FEET OF IMPACT DAMAGE WITH 4- UP TO 3 INCHES X 1 INCHES GOUGES IN NORTHEAST GUARDRAIL, 50 FEET FROM END BENT 2. |

General Comments and Misc. Items: (PAR) 15 FEET OF IMPACT DAMAGE WITH 4- UP TO 3 INCHES X 1 INCHES GOUGES IN NORTHEAST GUARDRAIL, 50 FEET FROM END BENT 2.

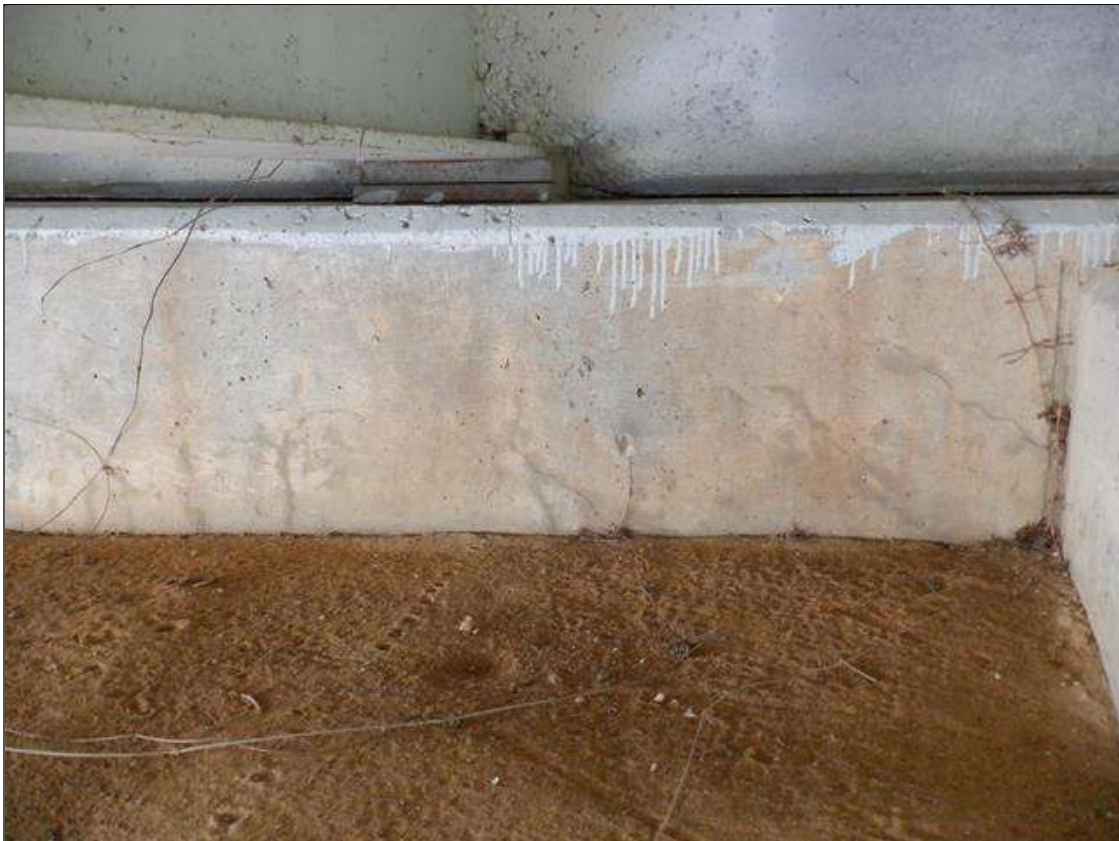
| Element Number | Defect Type | Defect Description | CS | CS Qty | Maint Qty |
|---|---|---|---|---|---|
| <input checked="" type="checkbox"/> 234 | Cracking (RC and Other) | 12 FEET X UP TO 2 FEET AREA OF UP TO 1/32 INCHES MAP CRACKING, BEGINNING AT WEST END. | 2 | 12 | Feet |

End Bent 2 Cap 1: 12 FEET X UP TO 2 FEET AREA OF UP TO 1/32 INCHES MAP CRACKING, BEGINNING AT WEST END.

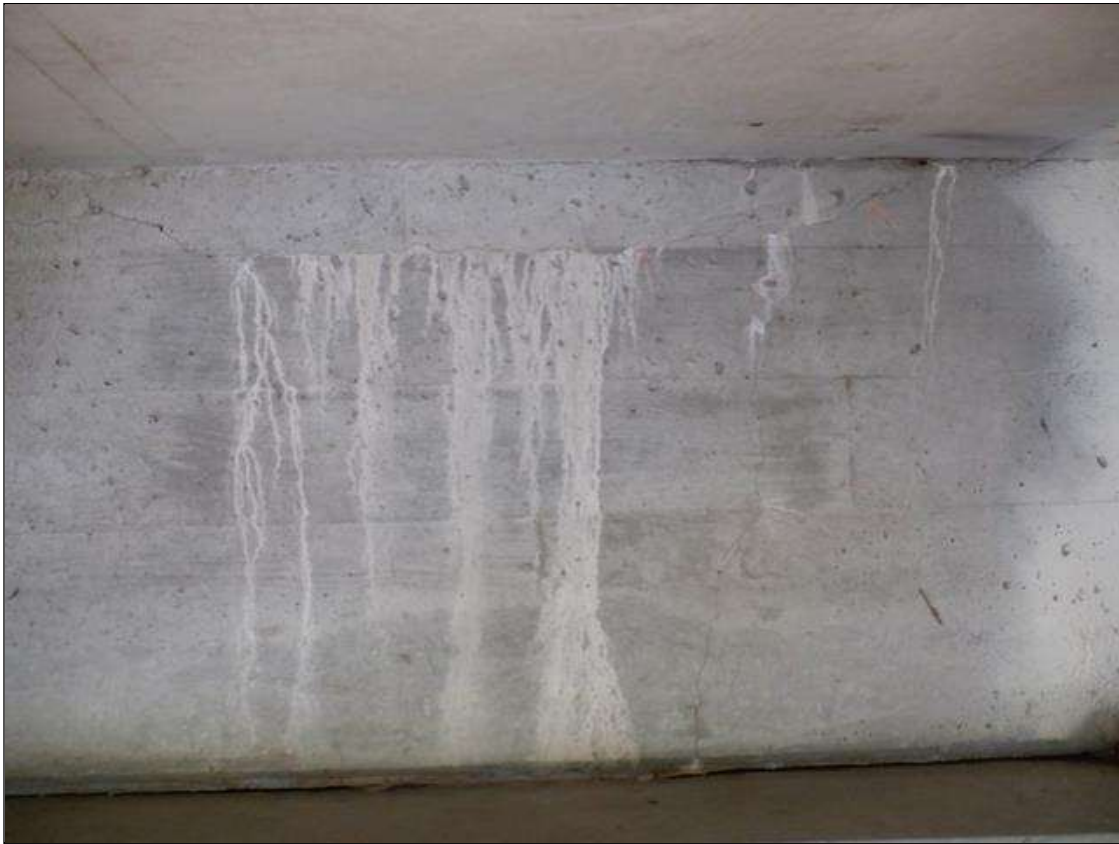
| Element Number | Defect Type | Defect Description | CS | CS Qty | Maint Qty |
|---|---|---|---|---|---|
| <input checked="" type="checkbox"/> 215 | Cracking (RC and Other) | 24 SQUARE FEET OF UP TO 1/8 INCHES HORIZONTAL AND VERTICAL CRACKS, SOME WITH EFFLORESCENCE, IN ALL BAYS. | 3 | 24 | 24 Feet |

End Bent 2 Abutment: 24 SQUARE FEET OF UP TO 1/8 INCHES HORIZONTAL AND VERTICAL CRACKS, SOME WITH EFFLORESCENCE, IN ALL BAYS. (PHOTO TAKEN IN BAY 2)

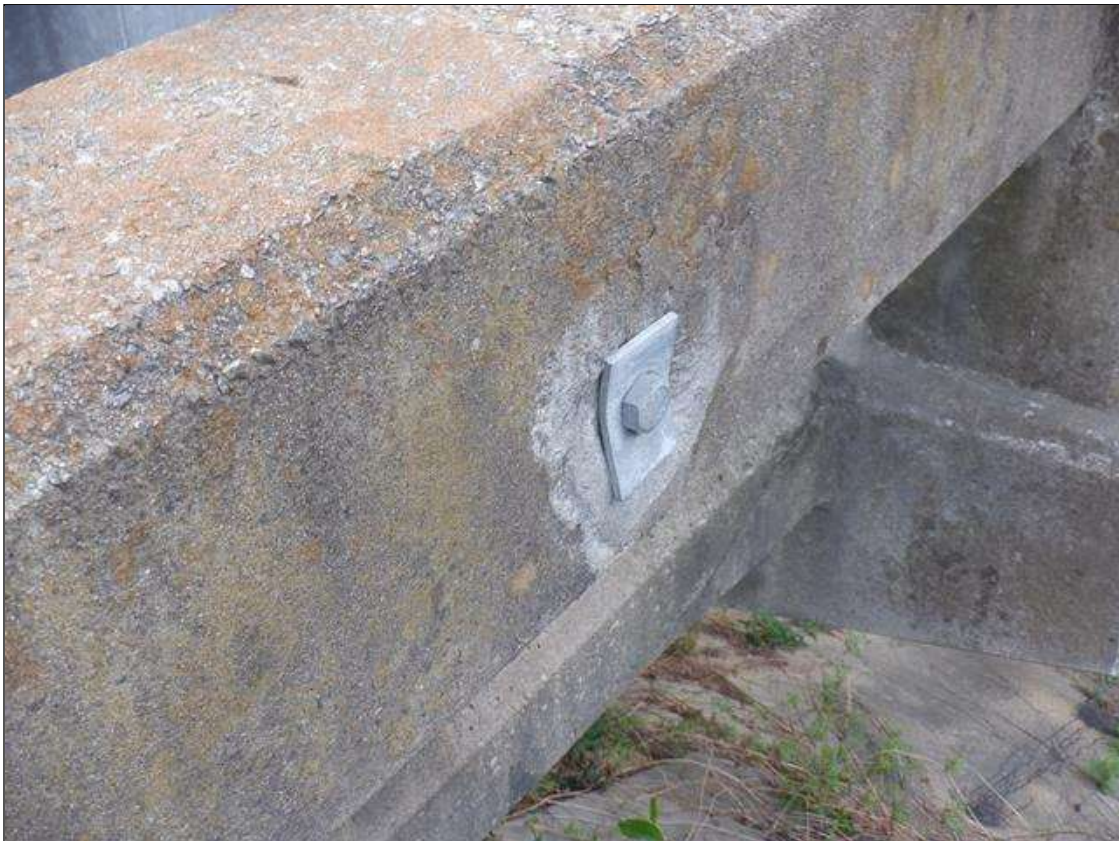
| Element Number | Defect Type | Defect Description | CS | CS Qty | Maint Qty |
|---|---|---|---|---|---|
| <input checked="" type="checkbox"/> | <b>331</b> | Delamination/Spall (2) UP TO 8 INCHES X 8 INCHES X 1 INCHES SPALLS IN OUTSIDE FACE OF RAIL. | 3 | 2 | 2 Feet |

Span 4 Left Concrete Rail: (2) UP TO 8 INCHES X 8 INCHES X 1 INCHES SPALLS IN OUTSIDE FACE OF RAIL. (PHOTO TAKEN NEAR END BENT 2)
