NC DEPARTMENT OF TRANSPORTATION  
DIVISION OF HIGHWAYS  
STRUCTURE MANAGEMENT UNIT

## Structure Safety Report

### Routine Element Inspection - Contract

STRUCTURE NUMBER: 500082 SAP STRUCTURE NO: 0510082 FHWA STRUCTURE NO: 000000001010082  
DIVISION: 4 COUNTY: JOHNSTON INSPECTION DATE: 04/16/2024 FREQUENCY: 24 MONTHS  
FACILITY CARRIED: I95N MILE POST: 90.5  
LOCATION: 0.8 MI N JCT US70/US301  
FEATURE INTERSECTED: BLACK CREEK  
LATITUDE: 35° 27' 58.66" LONGITUDE: 78° 22' 50.4"  
SUPERSTRUCTURE: RC DECK ON I-BEAMS  
SUBSTRUCTURE: EBTS;RC CAP H-PILES;INT.BTS.RCP&BEAM  
SPANS: 4 SPANS. SEE SPAN PROFILE SHEET FOR SPAN DETAILS  
☐ FRACTURE CRITICAL ☐ TEMPORARY SHORING ☐ SCOUR CRITICAL ☐ SCOUR PLAN OF ACTION  
GRADES: (Inspector/NBI Coding) DECK 6 / 6 SUPERSTRUCTURE 7 / 7 SUBSTRUCTURE 6 / 6 CULVERT N / N  
POSTED SV: Not Posted POSTED TTST: Not Posted  
OTHER SIGNS PRESENT: 2- DELINEATORS

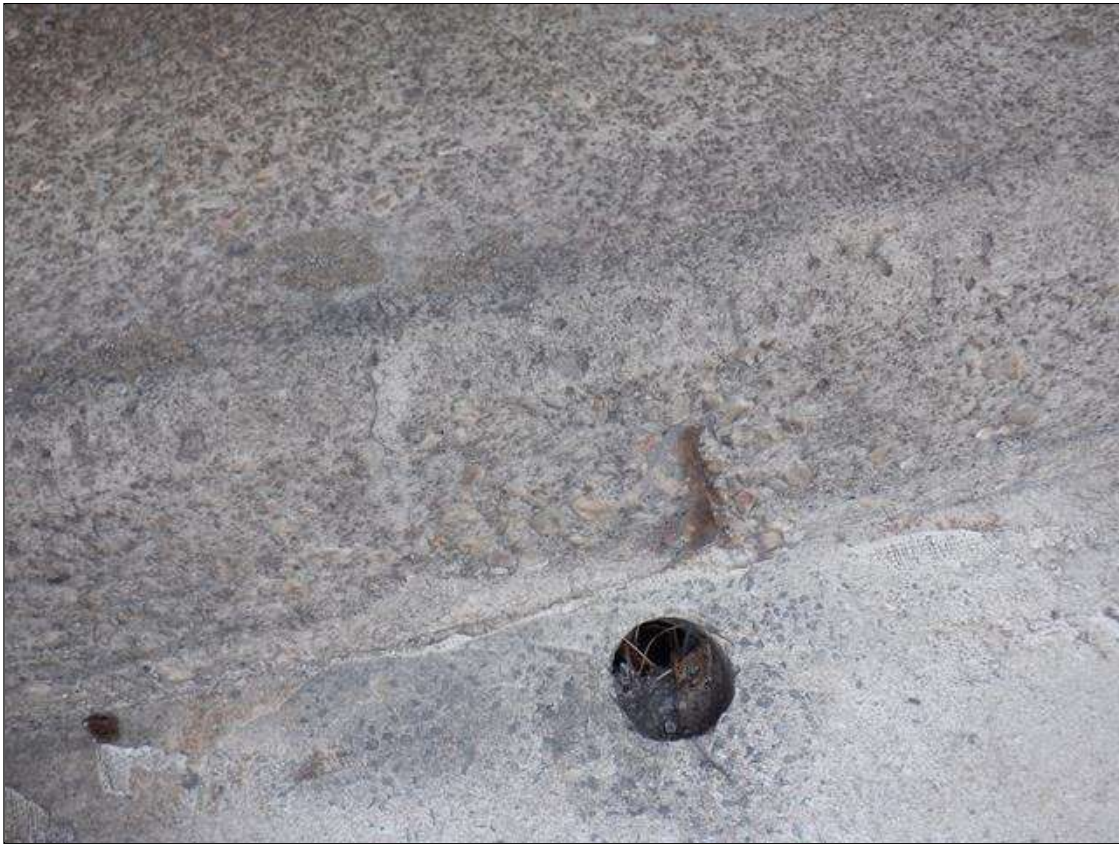
| <input checked="" type="checkbox"/> | <b>331</b> | Delamination/Spall | 2 INCHES X 6 INCHES X UP TO 1/2 INCHES SPALL WITH EXPOSED REINFORCING IN EAST FACE OF CURB, NEAR MIDSPAN. | 2 | 1 | 1 Feet |

Span 4 Left Concrete Rail: 2 INCHES X 6 INCHES X UP TO 1/2 INCHES SPALL WITH EXPOSED REINFORCING IN EAST FACE OF CURB, NEAR MIDSPAN.

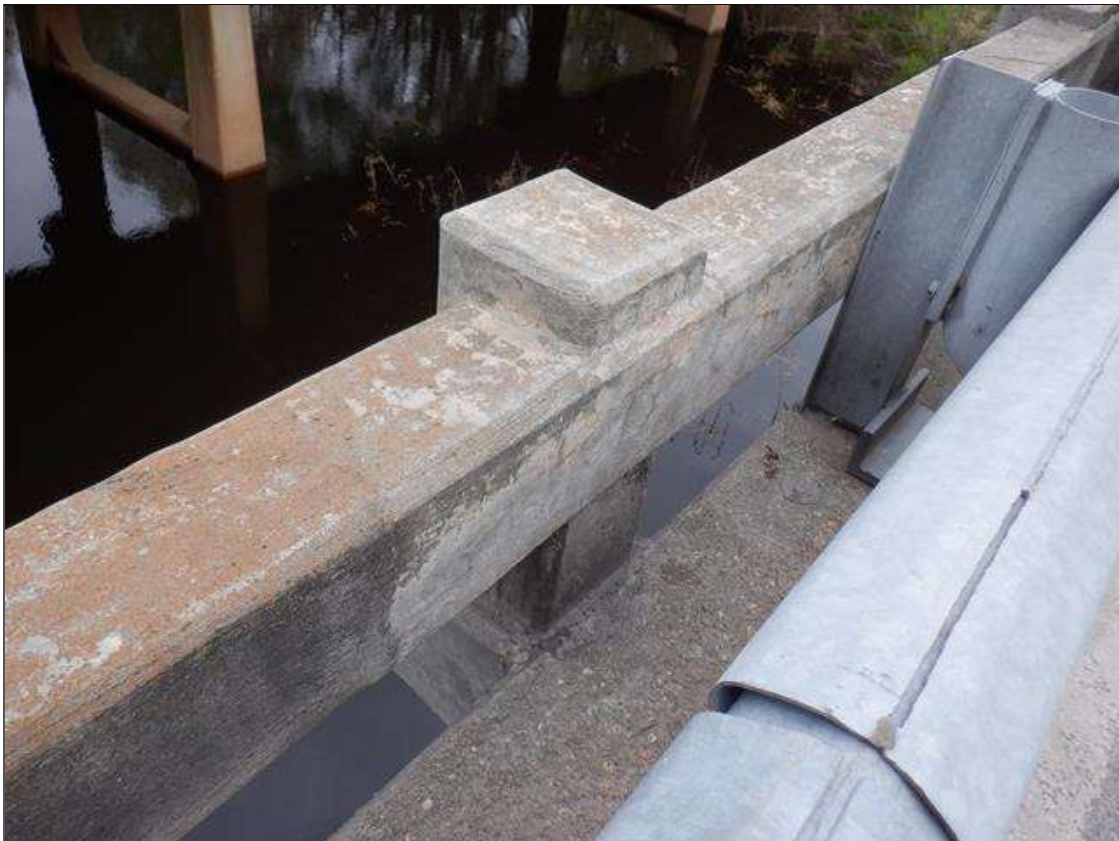
| Element Number | Defect Type | Defect Description | CS | CS Qty | Maint Qty | |
|---|---|---|---|---|---|---|
| <input checked="" type="checkbox"/> 331 | Patched Area | 10 FEET X 1 FEET X 1 FEET CRACKED PATCHED AREA WITH UP TO 1/64 INCHES CRACKING AT MIDSPAN. | 3 | 10 | 10 | Square Feet |

Span 2 Left Concrete Rail: 10 FEET X 1 FEET X 1 FEET CRACKED PATCHED AREA WITH UP TO 1/64 INCHES CRACKING AT MIDSPAN.

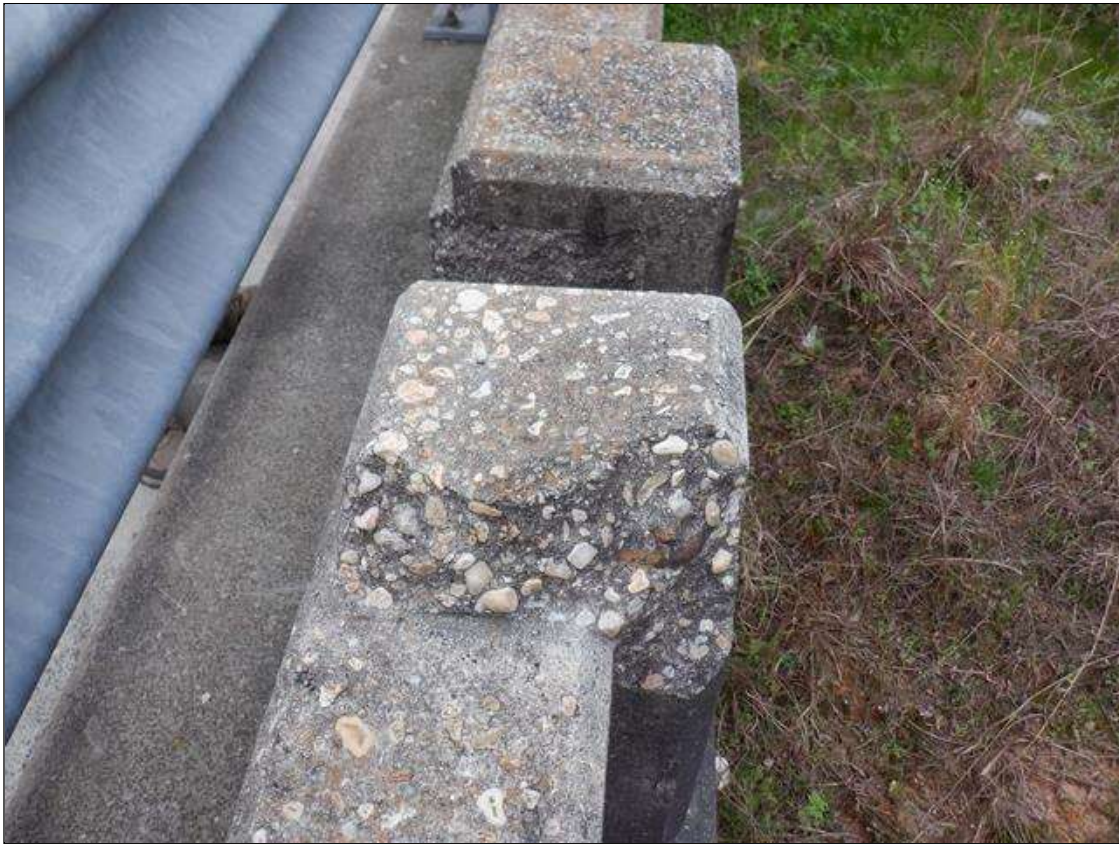
| Element Number | Defect Type | Defect Description | CS | CS Qty | Maint Qty |
|---|---|---|---|---|---|
| ✓ 331 | Delamination/Spall | 2- UP TO 4 INCHES X 10 INCHES X 7 INCHES SPALLS WITH EXPOSED REINFORCING IN TOP OF POSTS, 17 FEET FROM END BENT 1. | 3 | 2 | 2 Feet |

Span 1 Left Concrete Rail: 2- UP TO 4 INCHES X 10 INCHES X 7 INCHES SPALLS WITH EXPOSED REINFORCING IN TOP OF POSTS, 17 FEET FROM END BENT 1.

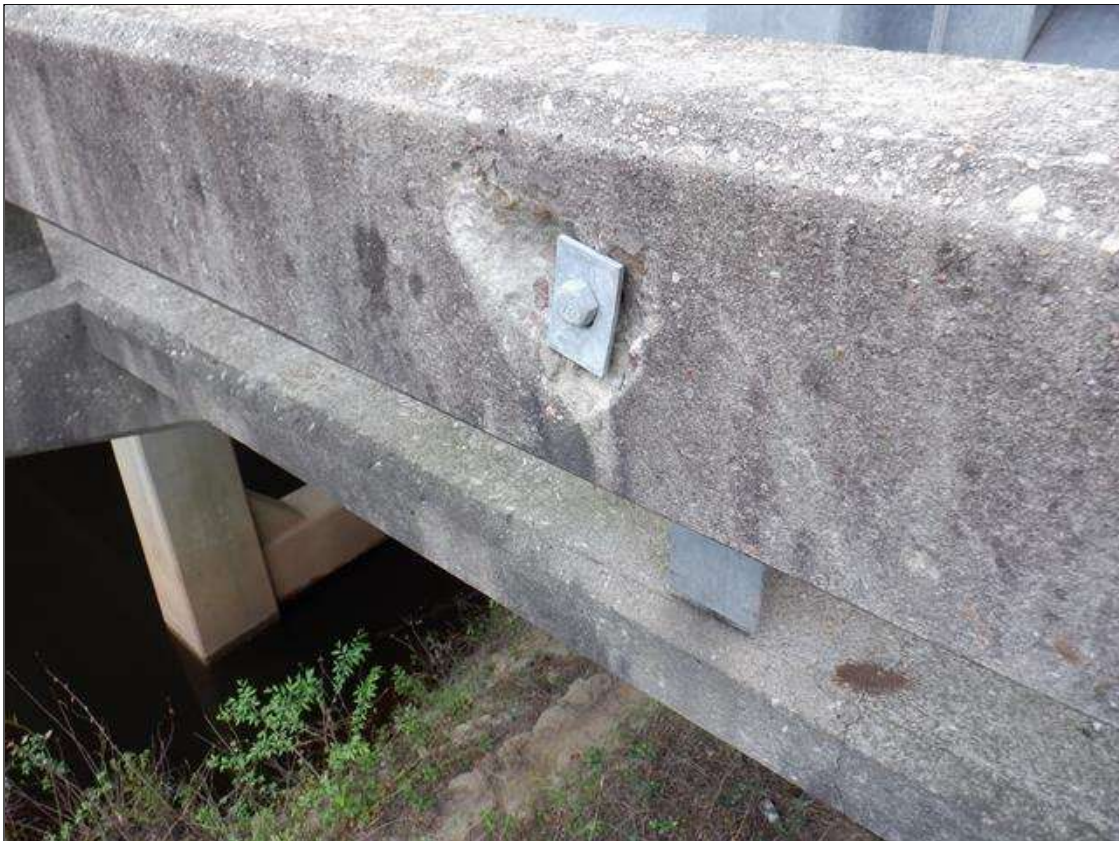
| Element Number | Defect Type | Defect Description | CS | CS Qty | Maint Qty |
|---|---|---|---|---|---|
| ✓ 331 | Delamination/Spall | (5) UP TO 7 INCHES X 9 INCHES X 1 INCHES SPALLS ON OUTSIDE FACE AT BOLT LOCATIONS. | 3 | 5 | 5 Feet |

Span 1 Left Concrete Rail: (5) UP TO 7 INCHES X 9 INCHES X 1 INCHES SPALLS ON OUTSIDE FACE AT BOLT LOCATIONS.

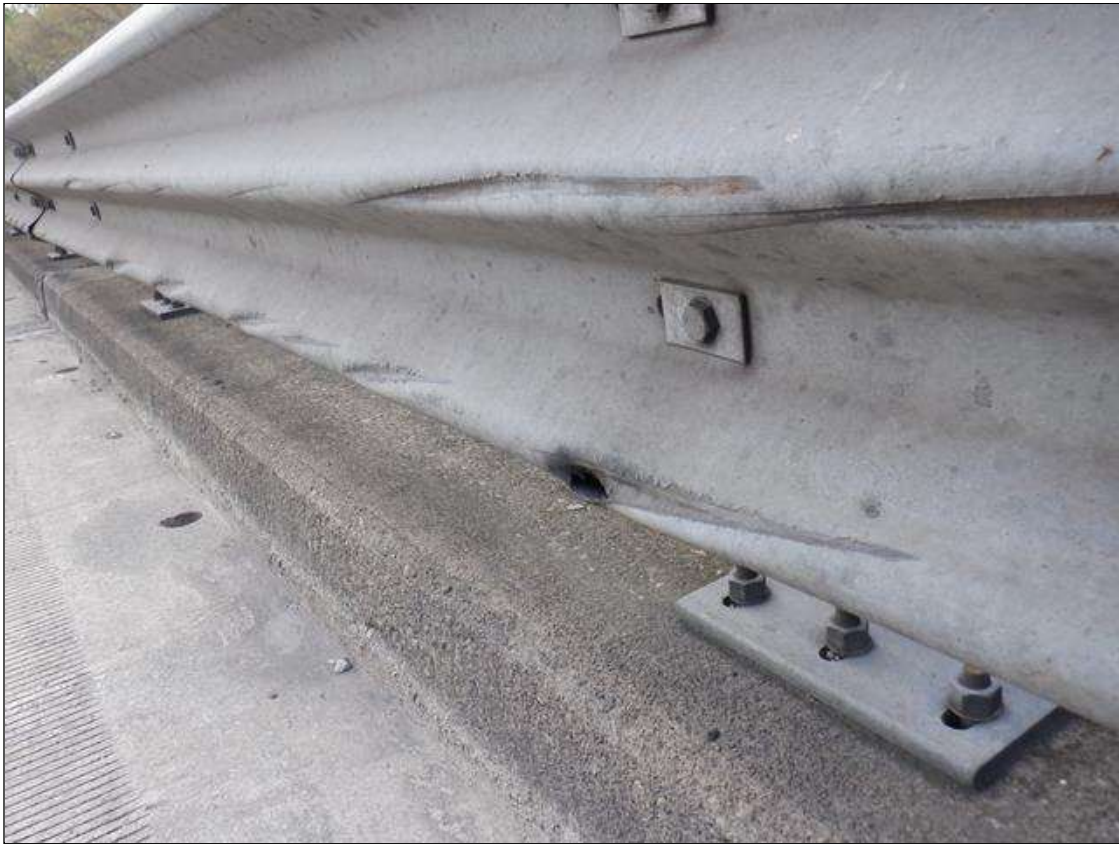
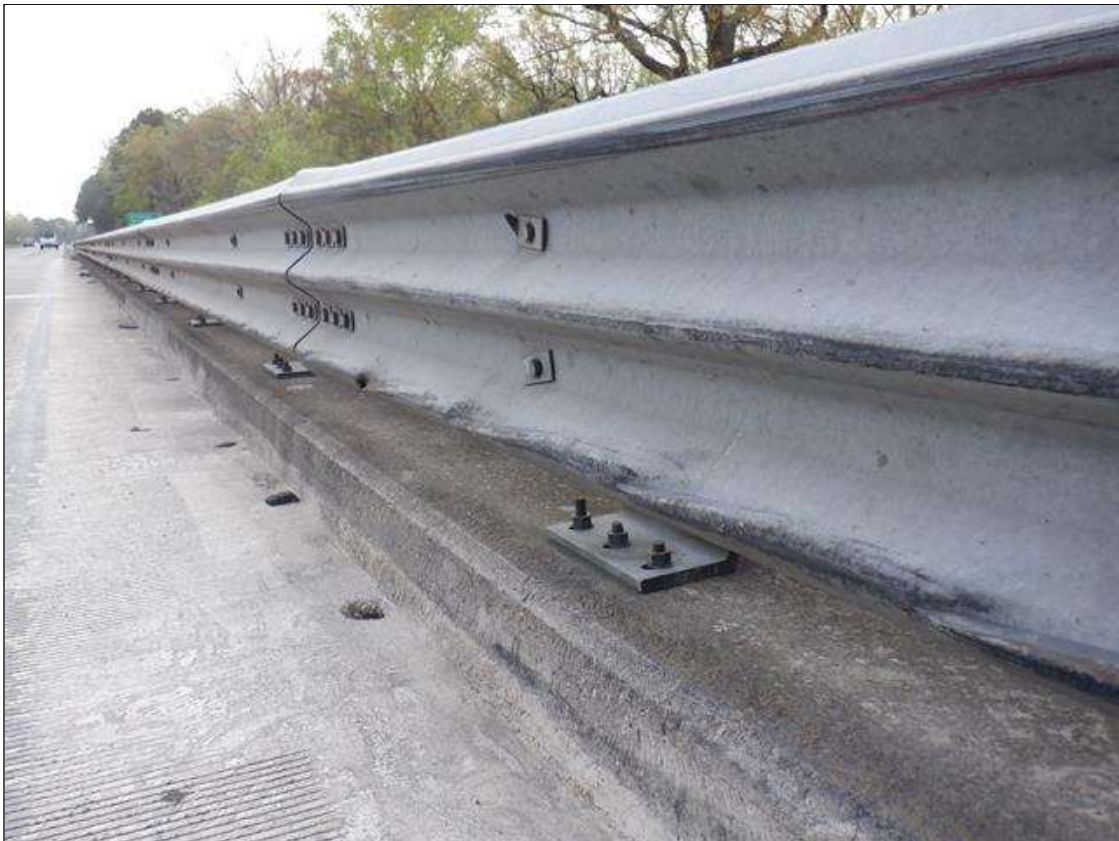
| Priority Level | Defect Type | Quantity | Defect Description |
|---|---|---|---|
| 2 | Distortion | 52 | Span 1 Right Metal Rail: (PAR) 52 FEET OF IMPACT DAMAGE WITH SCRAPES AND 4- UP TO 3 INCHES X 1.5 INCHES GOUGES. |

| Element Number | Defect Type | Defect Description | CS | CS Qty | Maint Qty |
|---|---|---|---|---|---|
| <input checked="" type="checkbox"/> 330 | Distortion | (PAR) 52 FEET OF IMPACT DAMAGE WITH SCRAPES AND 4- UP TO 3 INCHES X 1.5 INCHES GOUGES. | 3 | 52 | 52 Feet |

Span 1 Right Metal Rail: (PAR) 52 FEET OF IMPACT DAMAGE WITH SCRAPES AND 4- UP TO 3 INCHES X 1.5 INCHES GOUGES.

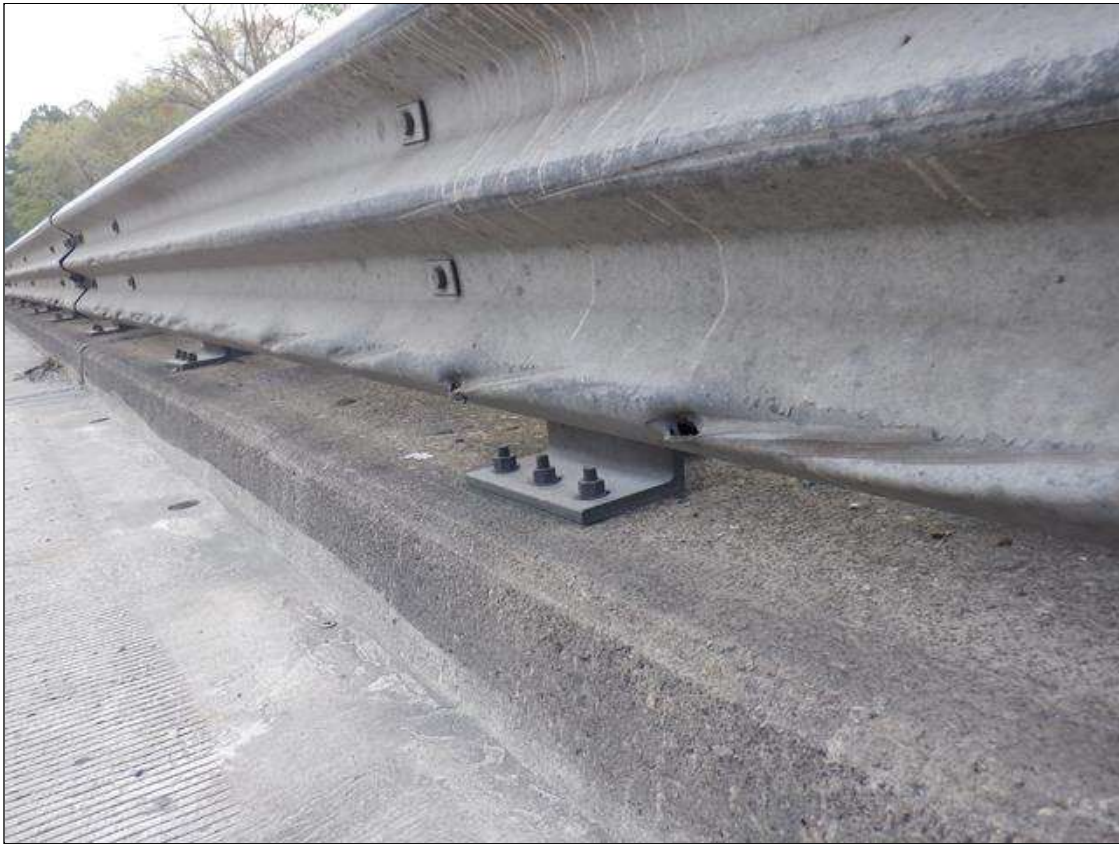
| Priority Level | Defect Type | Quantity | Defect Description |
|---|---|---|---|
| 2 | Distortion | 50 | Span 2 Right Metal Rail: (PAR) 50 FEET OF IMPACT DAMAGE WITH SCRAPES AND 4- UP TO 2 INCHES X 1 INCHES GOUGES. |

| Element Number | Defect Type | Defect Description | CS | CS Qty | Maint Qty |
|---|---|---|---|---|---|
| <input checked="" type="checkbox"/> | <b>330</b> | Distortion (PAR) 50 FEET OF IMPACT DAMAGE WITH SCRAPES AND 4- UP TO 2 INCHES X 1 INCHES GOUGES. | 3 | 50 | 50 Feet |

Span 2 Right Metal Rail: (PAR) 50 FEET OF IMPACT DAMAGE WITH SCRAPES AND 4- UP TO 2 INCHES X 1 INCHES GOUGES.

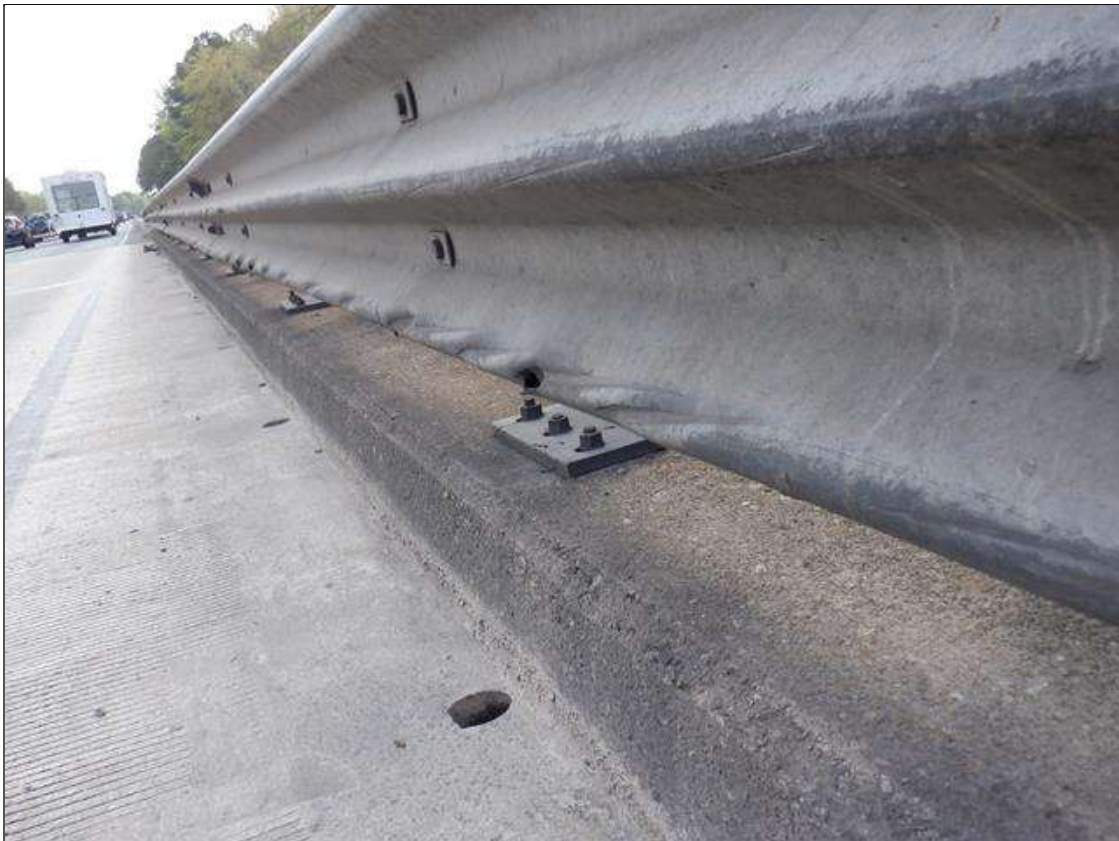
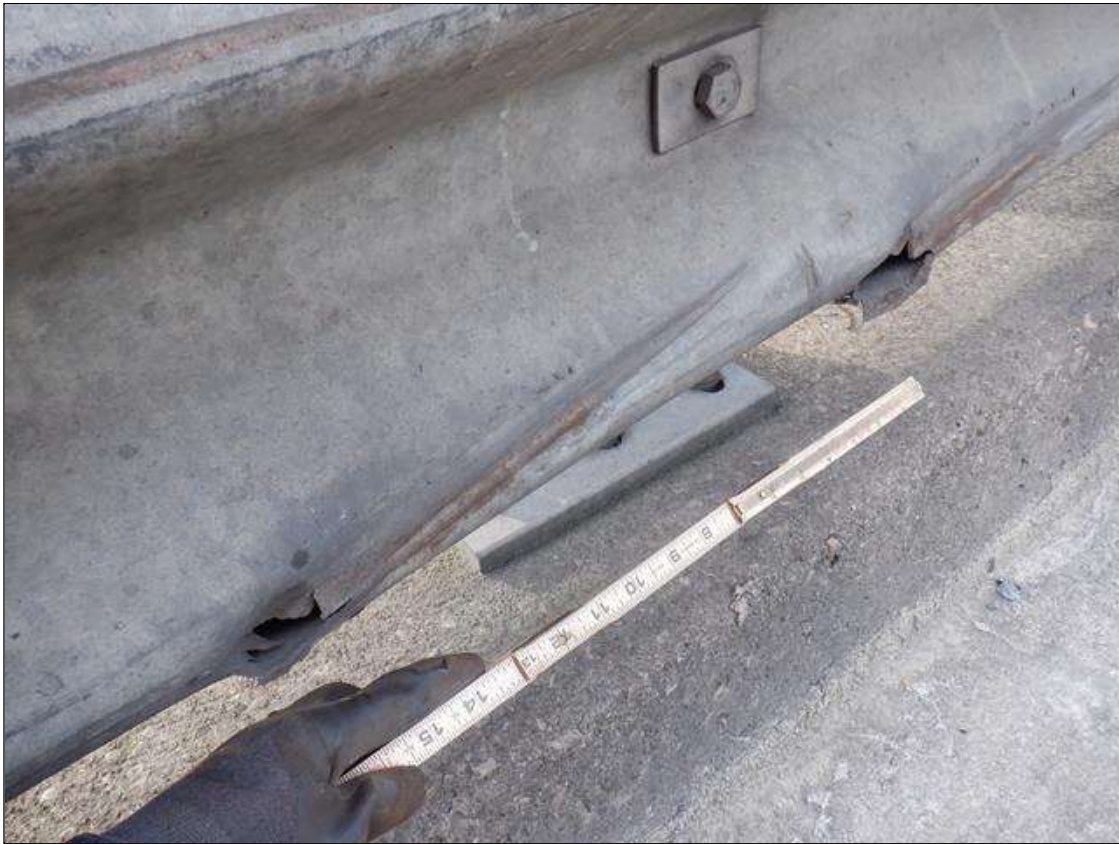
| Priority Level | Defect Type | Quantity | Defect Description |
|---|---|---|---|
| 2 | Distortion | 50 | Span 3 Right Metal Rail: (PAR) 50 FEET OF IMPACT DAMAGE WITH 8- UP TO 4 INCHES X 1.5 INCHES GOUGES. |

| Element Number | Defect Type | Defect Description | CS | CS Qty | Maint Qty |
|---|---|---|---|---|---|
| <input checked="" type="checkbox"/> | <b>330</b> | Distortion (PAR) 50 FEET OF IMPACT DAMAGE WITH 8- UP TO 4 INCHES X 1.5 INCHES GOUGES. | 3 | 50 | 50 Feet |

Span 3 Right Metal Rail: (PAR) 50 FEET OF IMPACT DAMAGE WITH 8- UP TO 4 INCHES X 1.5 INCHES GOUGES.

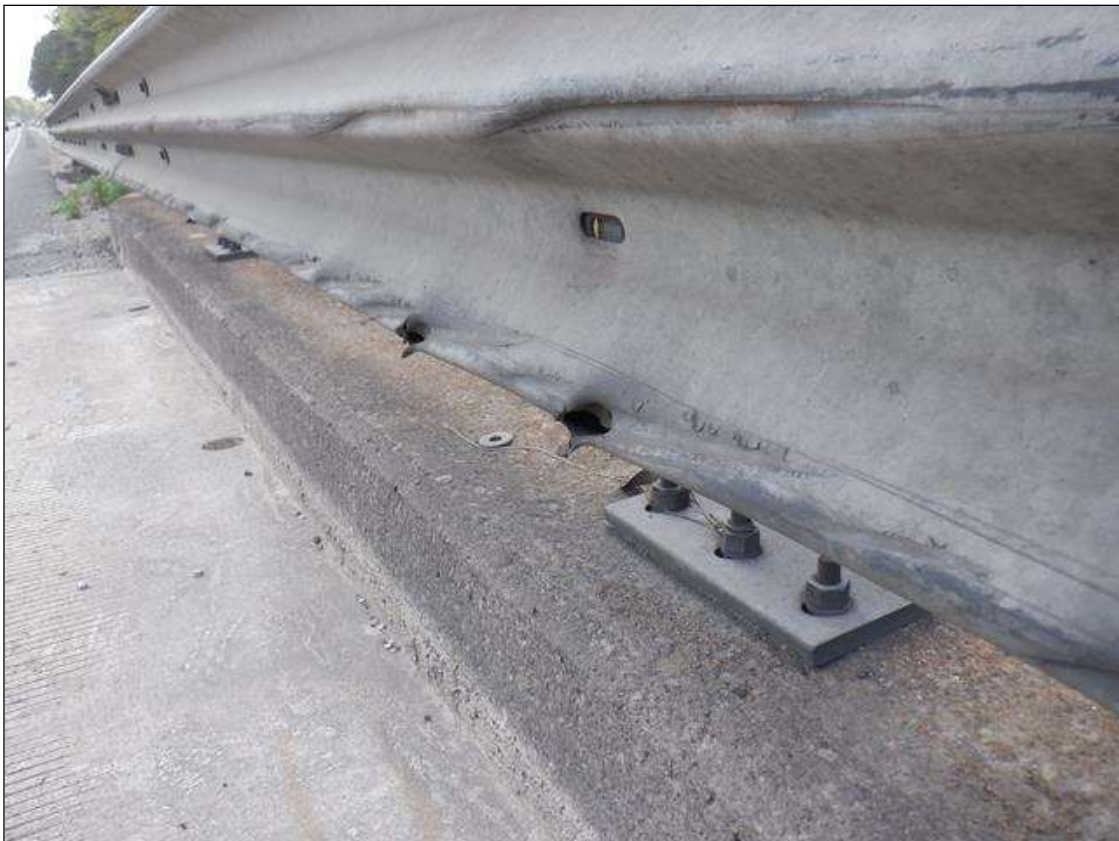
| Priority Level | Defect Type | Quantity | Defect Description |
|---|---|---|---|
| 2 | Distortion | 51 | Span 4 Right Metal Rail: (PAR) 51 FEET OF IMPACT DAMAGE WITH 5- UP TO 3 INCHES X 1 INCHES GOUGES. |

| Element Number | Defect Type | Defect Description | CS | CS Qty | Maint Qty |
|---|---|---|---|---|---|
| <input checked="" type="checkbox"/> 330 | Distortion | (PAR) 51 FEET OF IMPACT DAMAGE WITH 5- UP TO 3 INCHES X 1 INCHES GOUGES. | 3 | 51 | 51 Feet |

Span 4 Right Metal Rail: (PAR) 51 FEET OF IMPACT DAMAGE WITH 5- UP TO 3 INCHES X 1 INCHES GOUGES.

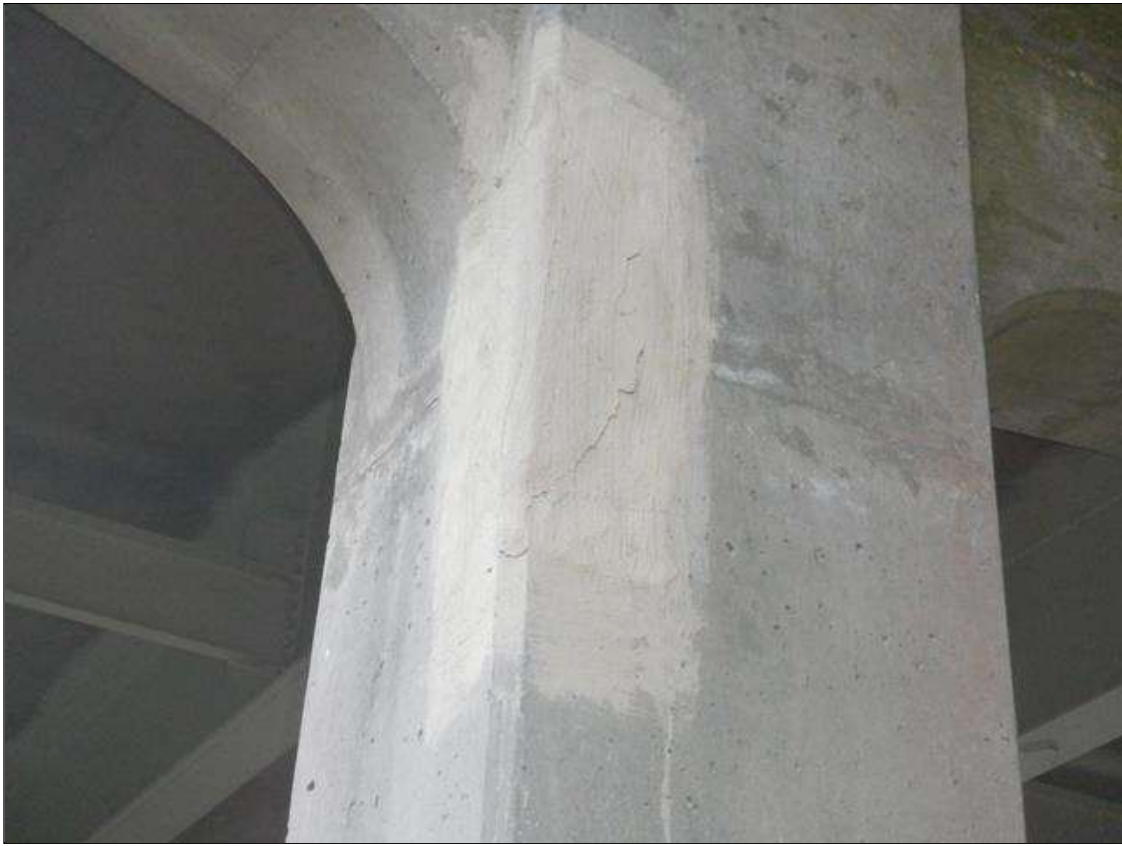
| Element Number | Defect Type | Defect Description | CS | CS Qty | Maint Qty |
|---|---|---|---|---|---|
| <input checked="" type="checkbox"/> 205 | Patched Area | 24 INCHES X UP TO 7 INCHES X 4 INCHES CRACKED AND DELAMINATED PATCHED AREA WITH UP TO 1/16 INCHES CRACKING IN SOUTH FACE, 2 FEET FROM BOTTOM OF CAP. | 3 | 1 | 2 Each |

Bent 3 Pile 1: 24 INCHES X UP TO 7 INCHES X 4 INCHES CRACKED AND DELAMINATED PATCHED AREA WITH UP TO 1/16 INCHES CRACKING IN SOUTH FACE, 2 FEET FROM BOTTOM OF CAP.

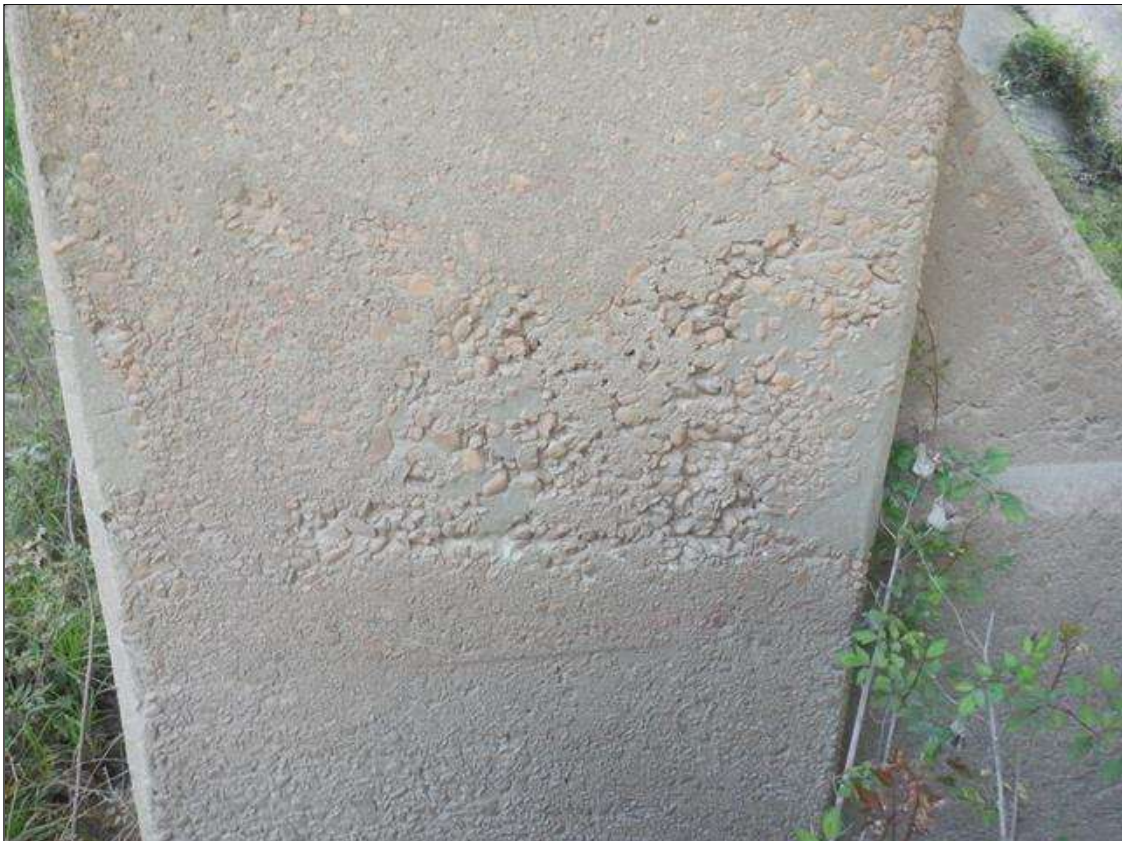
| <input checked="" type="checkbox"/> | <b>205</b> | Delamination/Spall | 15 INCHES X UP TO 19 INCHES AREA OF UP TO 1/2 INCHES HONEYCOMBING IN NORTH AND SOUTH FACES, AT STRUT HEIGHT. | 2 | 2 | Each |

Bent 3 Pile 1: 15 INCHES X UP TO 19 INCHES AREA OF UP TO 1/2 INCHES HONEYCOMBING IN NORTH AND SOUTH FACES, AT STRUT HEIGHT.

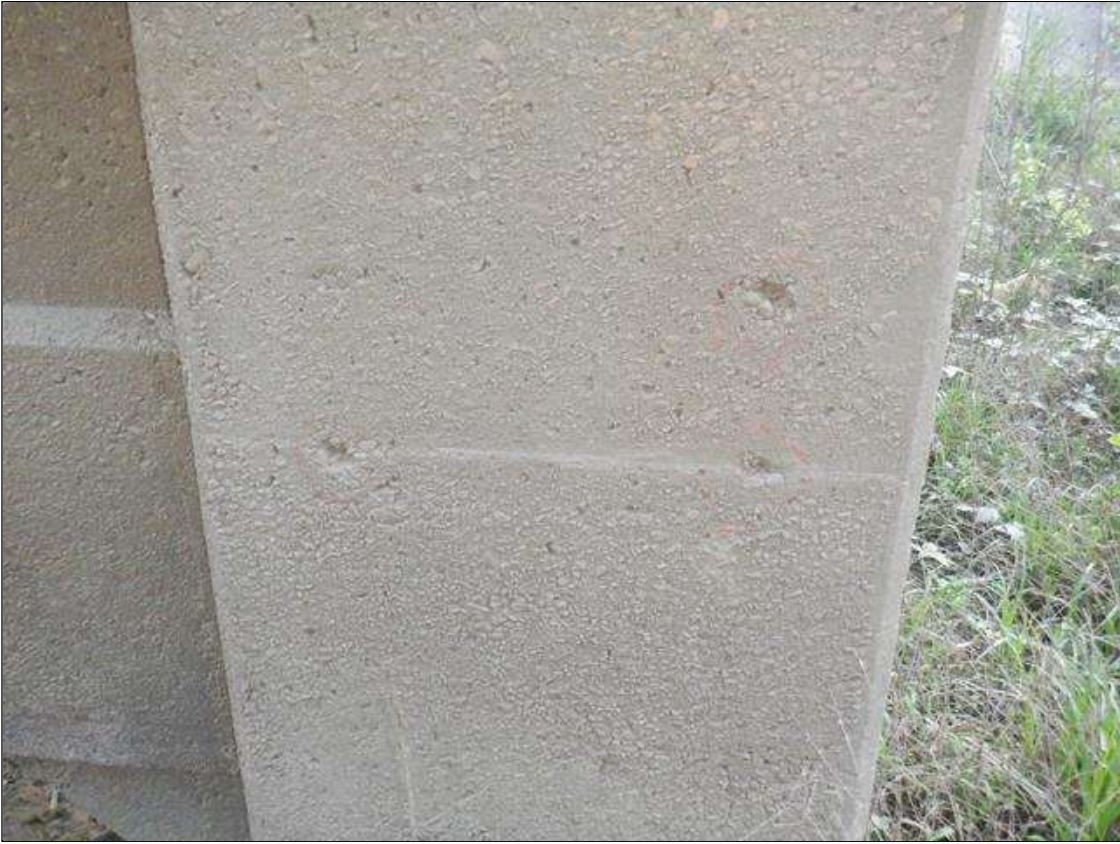
| Element Number | Defect Type | Defect Description | CS | CS Qty | Maint Qty | |
|---|---|---|---|---|---|---|
| <input checked="" type="checkbox"/> 205 | Delamination/Spall | (3) UP TO 2 INCHES X 2 INCHES X 1/2 INCHES SPALLS IN SOUTH FACE, 11 FEET FROM BOTTOM OF CAP. | 2 | 1 | 2 | Each |

Bent 3 Pile 2: (3) UP TO 2 INCHES X 2 INCHES X 1/2 INCHES SPALLS IN SOUTH FACE, 11 FEET FROM BOTTOM OF CAP.

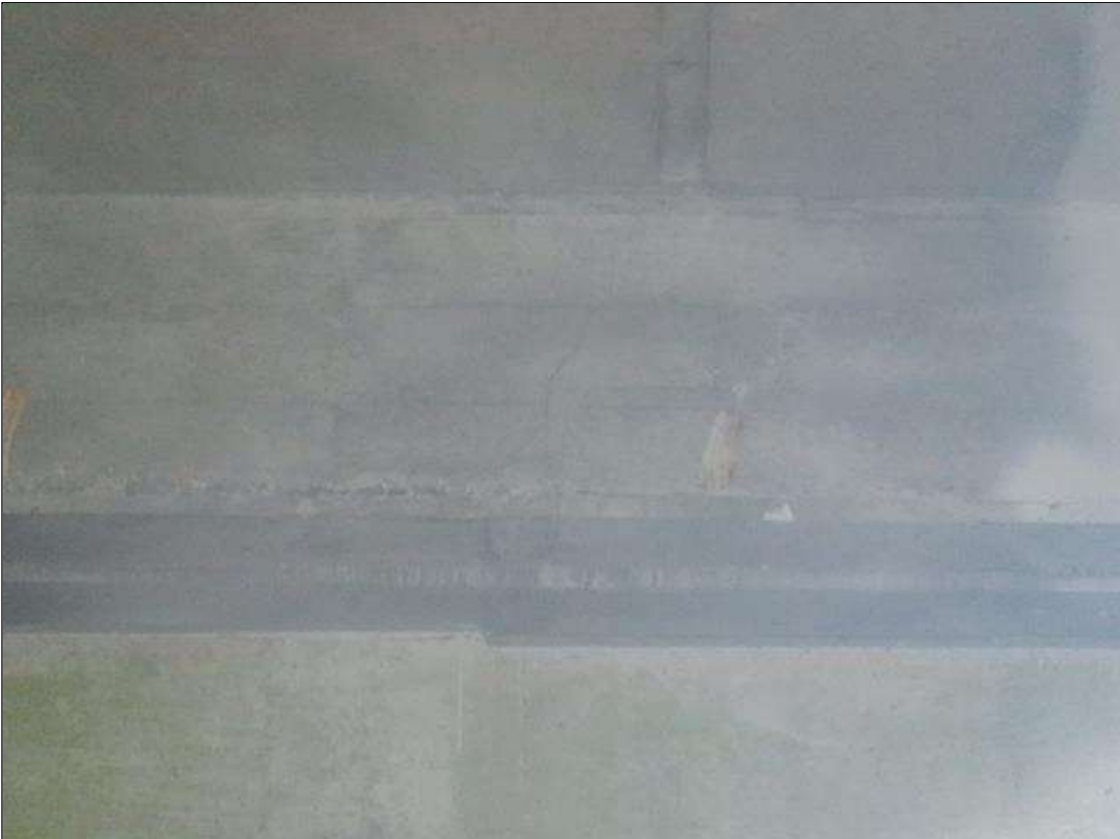
| Element Number | Defect Type | Defect Description | CS | CS Qty | Maint Qty |
|---|---|---|---|---|---|
| <input checked="" type="checkbox"/> | <b>12</b> | Cracking (RC and Other) 5- FULL HEIGHT X UP TO 1/32 INCHES VERTICAL CRACKS IN BENT 3 BAY 1 DIAPHRAGM. (BAYS 2 AND 3 SIMILAR) | 2 | | 15 Square Feet |

Span 4 Deck: 5- FULL HEIGHT X UP TO 1/32 INCHES VERTICAL CRACKS IN BENT 3 BAY 1 DIAPHRAGM. (BAYS 2 AND 3 SIMILAR)

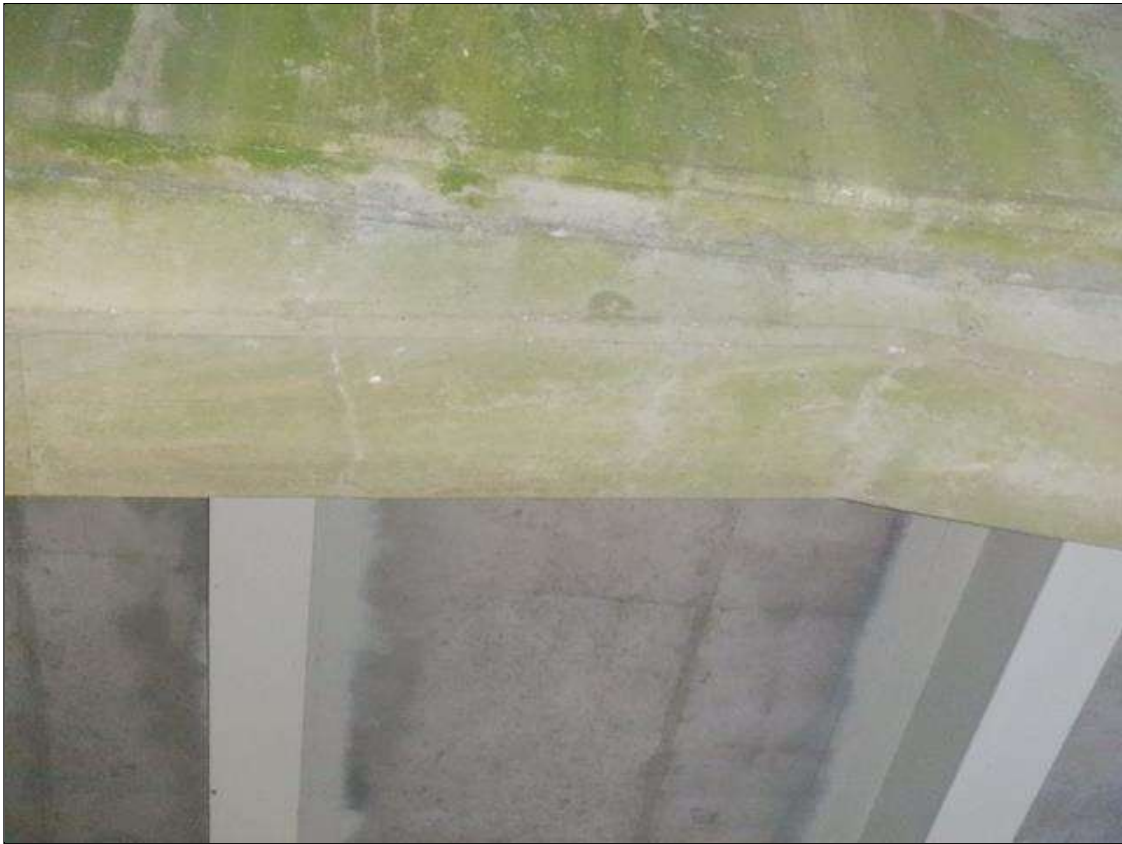
| Element Number | Defect Type | Defect Description | CS | CS Qty | Maint Qty |
|---|---|---|---|---|---|
| <input checked="" type="checkbox"/> 234 | Cracking (RC and Other) | (3) UP TO 20 INCHES X 1/64 INCHES TRANSVERSE CRACKS, SOME WITH EFFLORESCENCE, ON BOTTOM OF CORBEL BETWEEN COLUMNS 1 AND 2. | 2 | | Feet |

Bent 2 Cap 1: (3) UP TO 20 INCHES X 1/64 INCHES TRANSVERSE CRACKS, SOME WITH EFFLORESCENCE, ON BOTTOM OF CORBEL BETWEEN COLUMNS 1 AND 2.

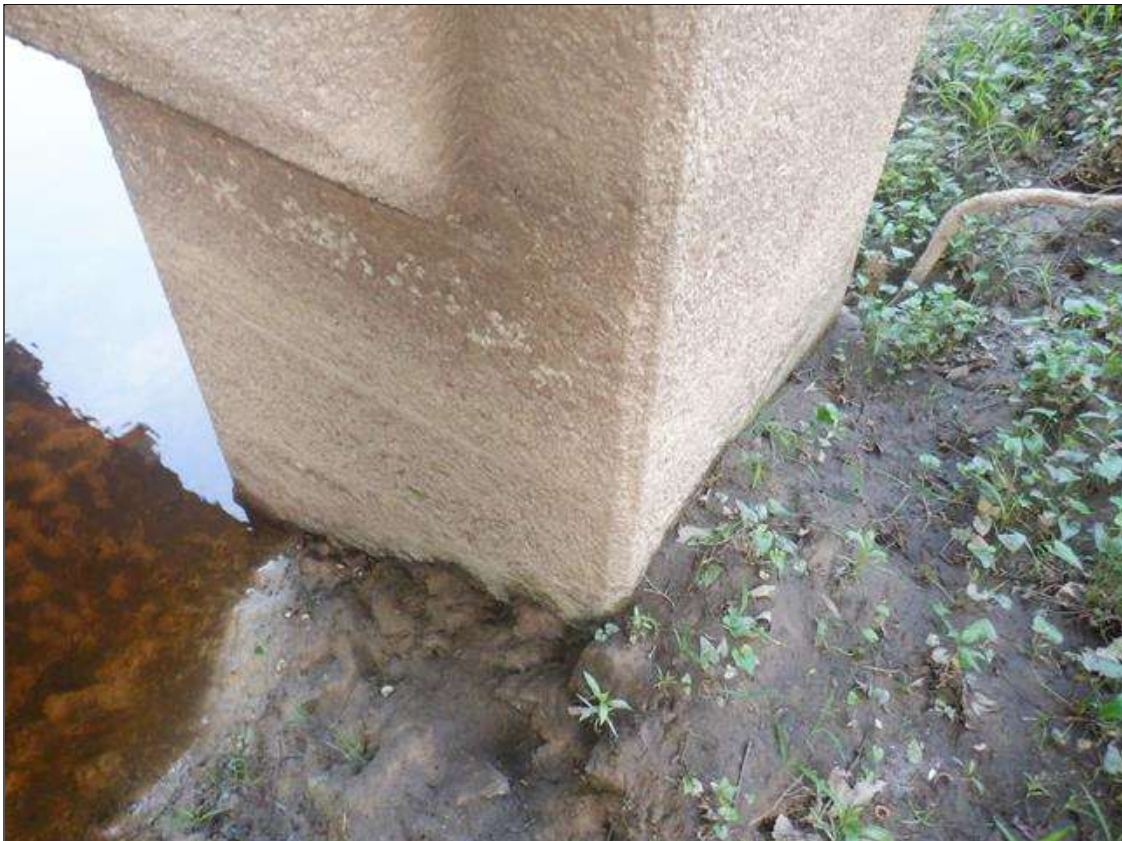
| Element Number | Defect Type | Defect Description | CS | CS Qty | Maint Qty |
|---|---|---|---|---|---|
| <input checked="" type="checkbox"/> 205 | Abrasion/Wear (PSC/RC) | 4 FEET ABRASION/WEAR WITH EXPOSED COARSE AGGREGATE, 12 FEET FROM BOTTOM OF CAP. | 2 | 1 | Each |

Bent 2 Pile 1: 4 FEET ABRASION/WEAR WITH EXPOSED COARSE AGGREGATE, 12 FEET FROM BOTTOM OF CAP.

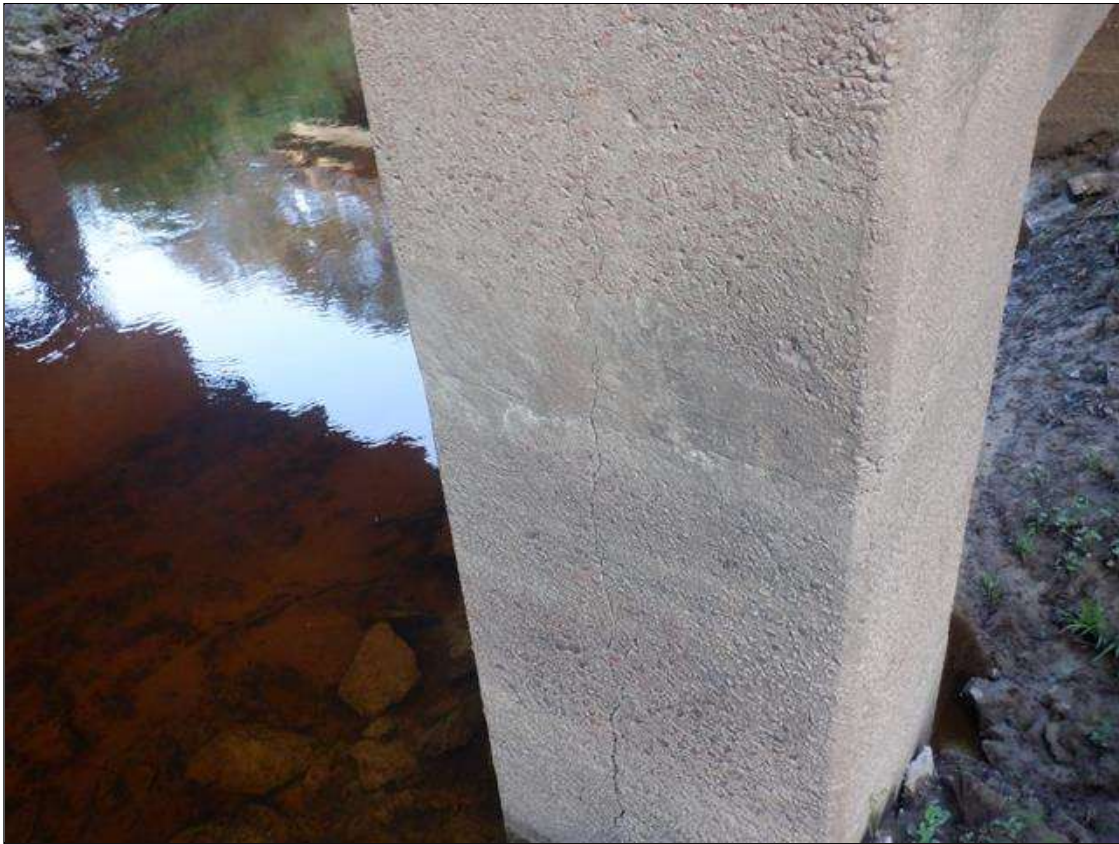
| Element Number | Defect Type | Defect Description | CS | CS Qty | Maint Qty |
|---|---|---|---|---|---|
| <input checked="" type="checkbox"/> 205 | Cracking (RC and Other) | 2- UP TO 6 FEET X 1/8 INCHES VERTICAL CRACKS ON NORTH AND EAST FACE, 13 FEET FROM BOTTOM OF CAP. | 3 | 1 | 8 Each |

Bent 2 Pile 2: 2- UP TO 6 FEET X 1/8 INCHES VERTICAL CRACKS ON NORTH AND EAST FACE, 13 FEET FROM BOTTOM OF CAP.
