NC DEPARTMENT OF TRANSPORTATION  
 DIVISION OF HIGHWAYS  
 STRUCTURE MANAGEMENT UNIT  
 COUNTY: JOHNSTON DIV: 4

ATTENTION:  PARS Submitted  Sign Notice Issued  
 sketches revised; new repairs

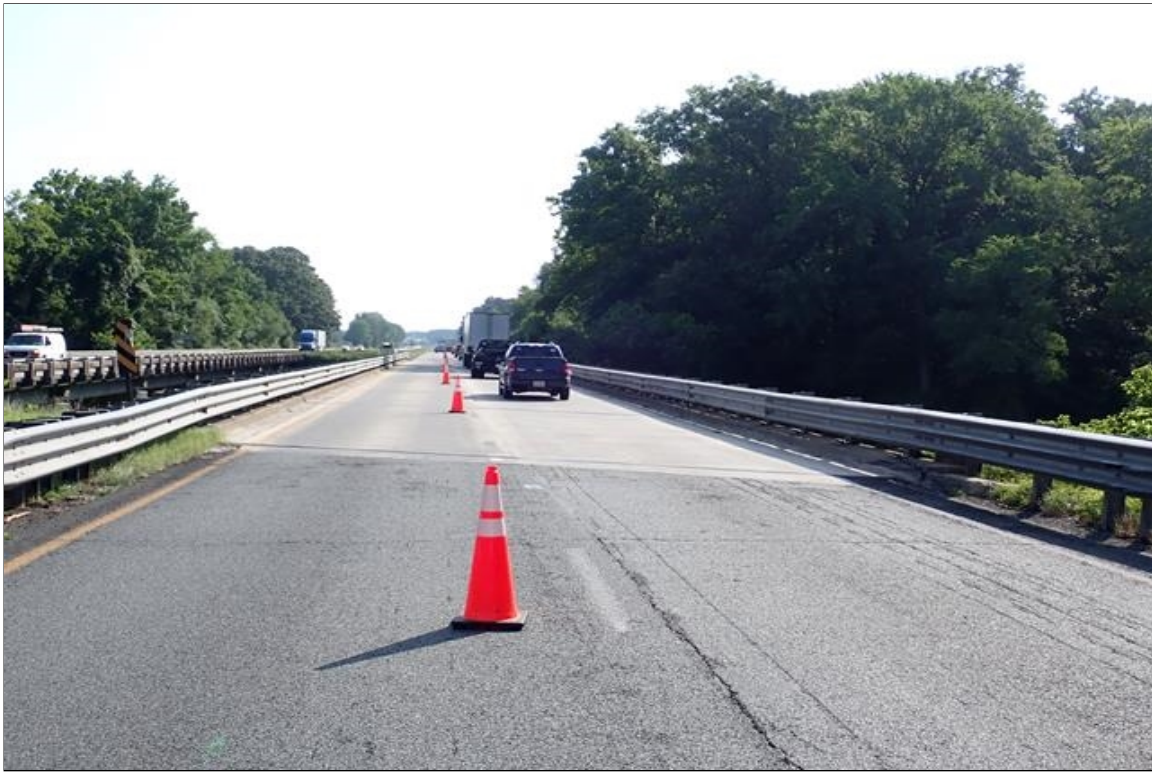
south approach looking north

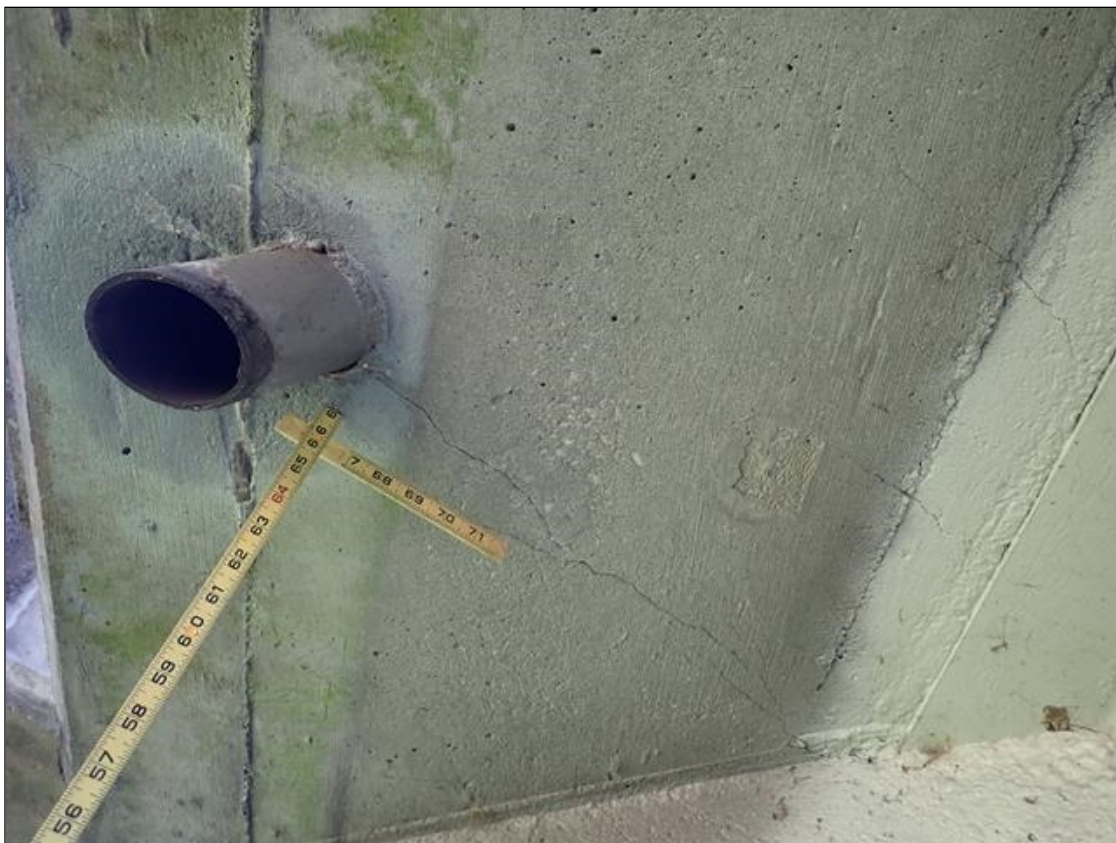
Span 1 Deck: UP TO 1/32 INCH WIDE TRANSVERSE CRACKS UNDER LEFT OVERHANG, SCATTERED.

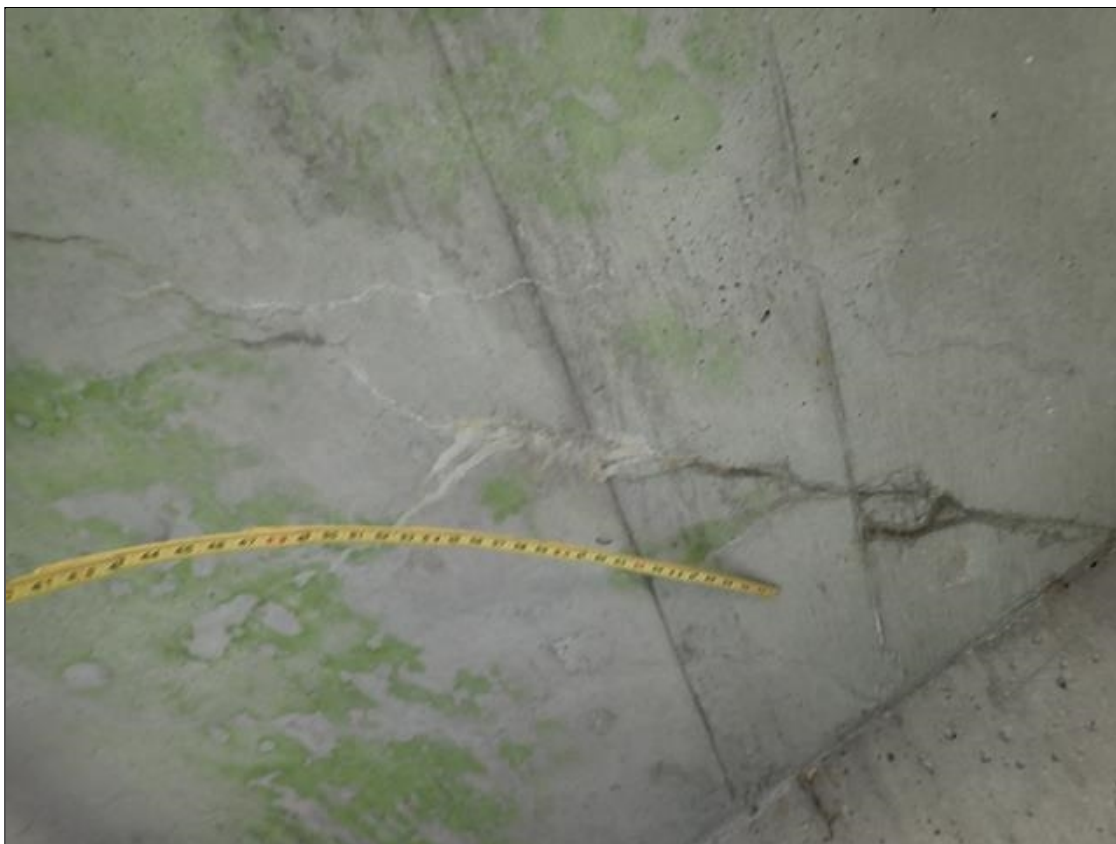
Span 1 Deck: UP TO 0.02 INCH WIDE TRANSVERSE CRACKS SOME WITH EFFLORESCENCE IN DECK UNDERSIDE IN BAY 1 BETWEEN INTERMEDIATE DIAPHRAGMS TYPICAL IN BAYS 2 AND 3.

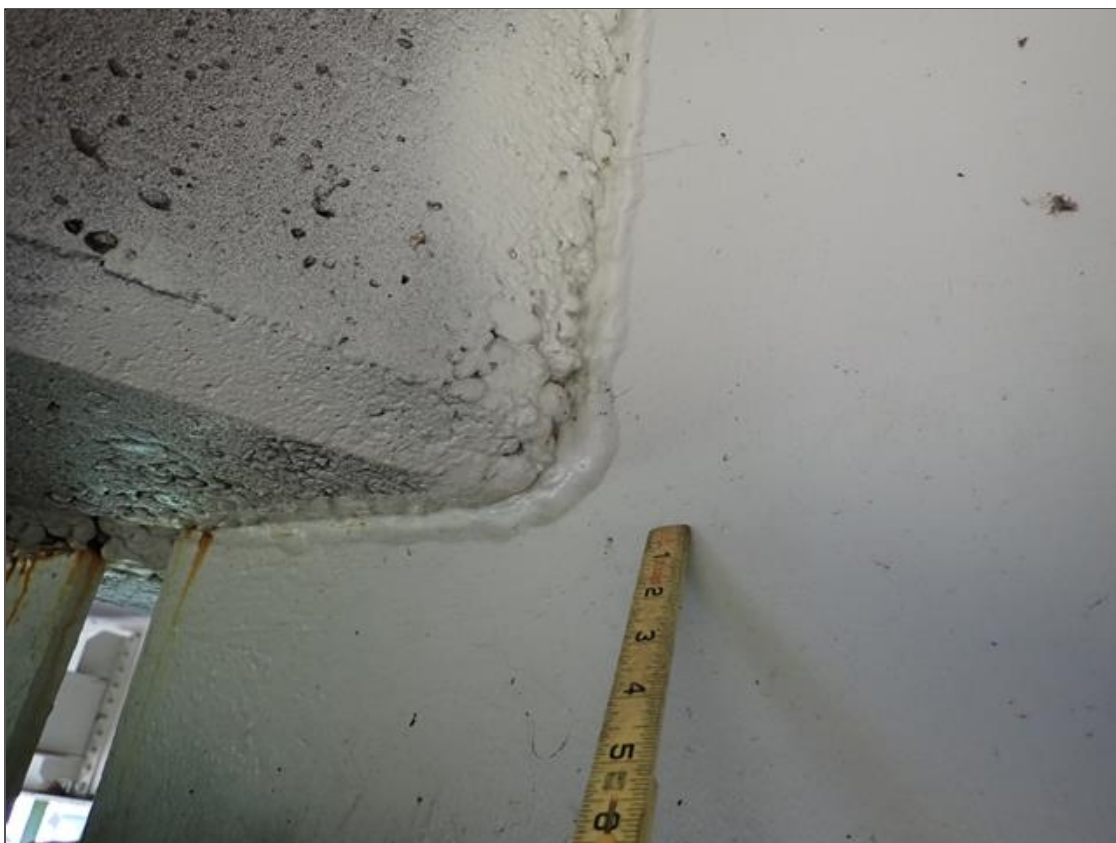
Span 5 Beam 2: (PAR) at bent 4, web adjacent to end diaphragm, painted over section loss (3/8 inch average remaining x 8 inch x 18 inch) with corrosion reactivating

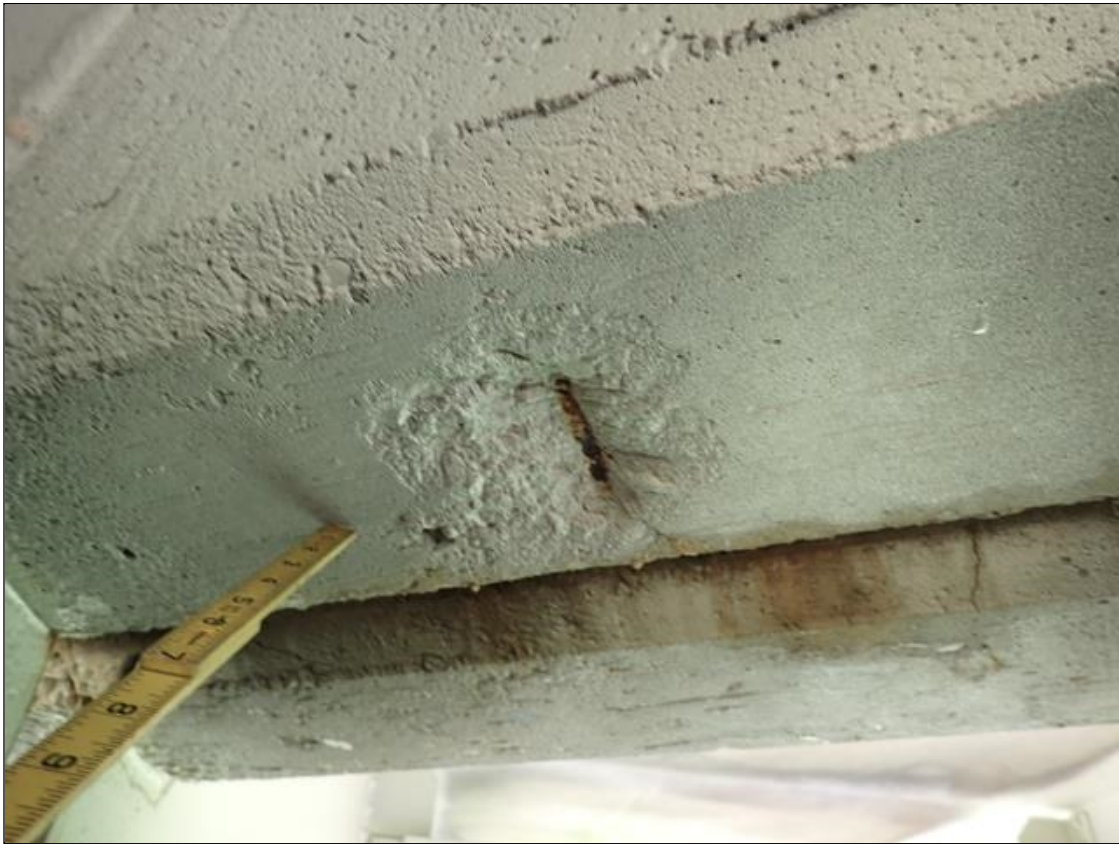
Span 5 Deck: span 5, bay 2 end diaphragm over bent 4, underside, spall (6 inch x 6 inch x 3/4 inch deep) with exposed rusted rebar

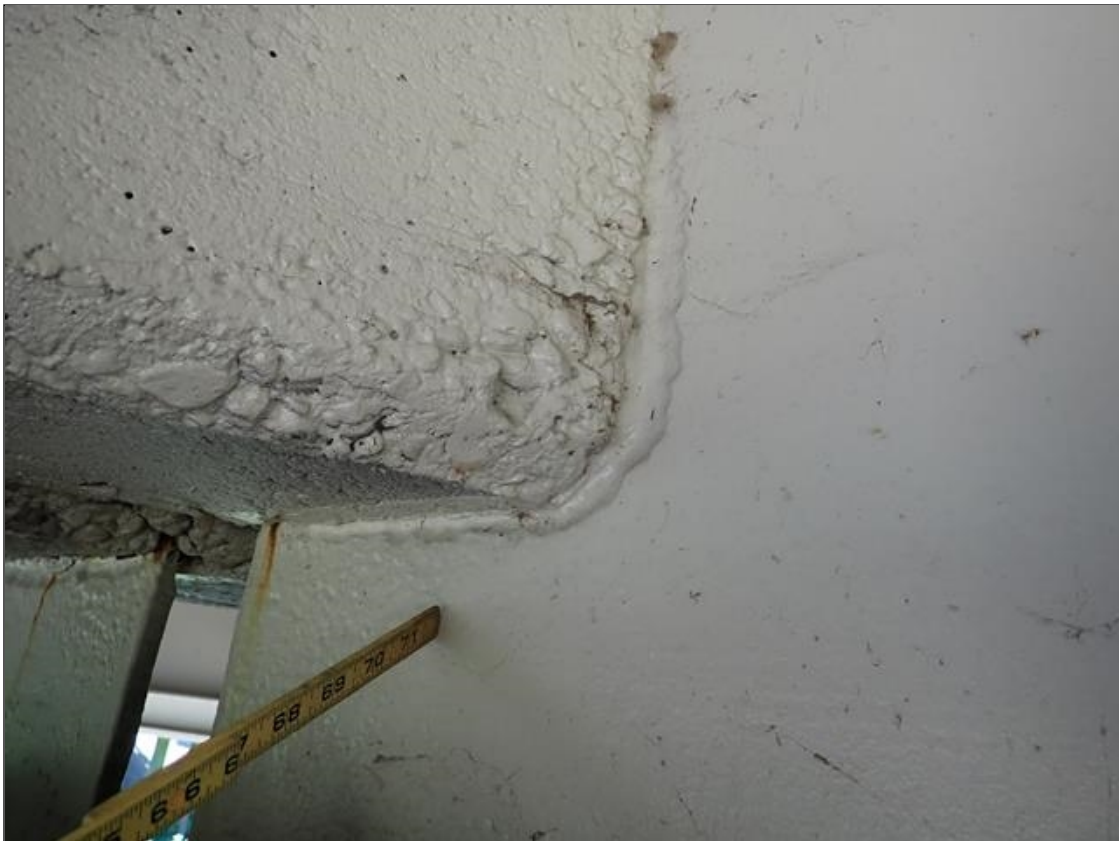
Span 5 Beam 3: (PAR) at bent 4, web adjacent to end diaphragm, painted over section loss (3/8 inch average remaining x 8 inch x 18 inch)

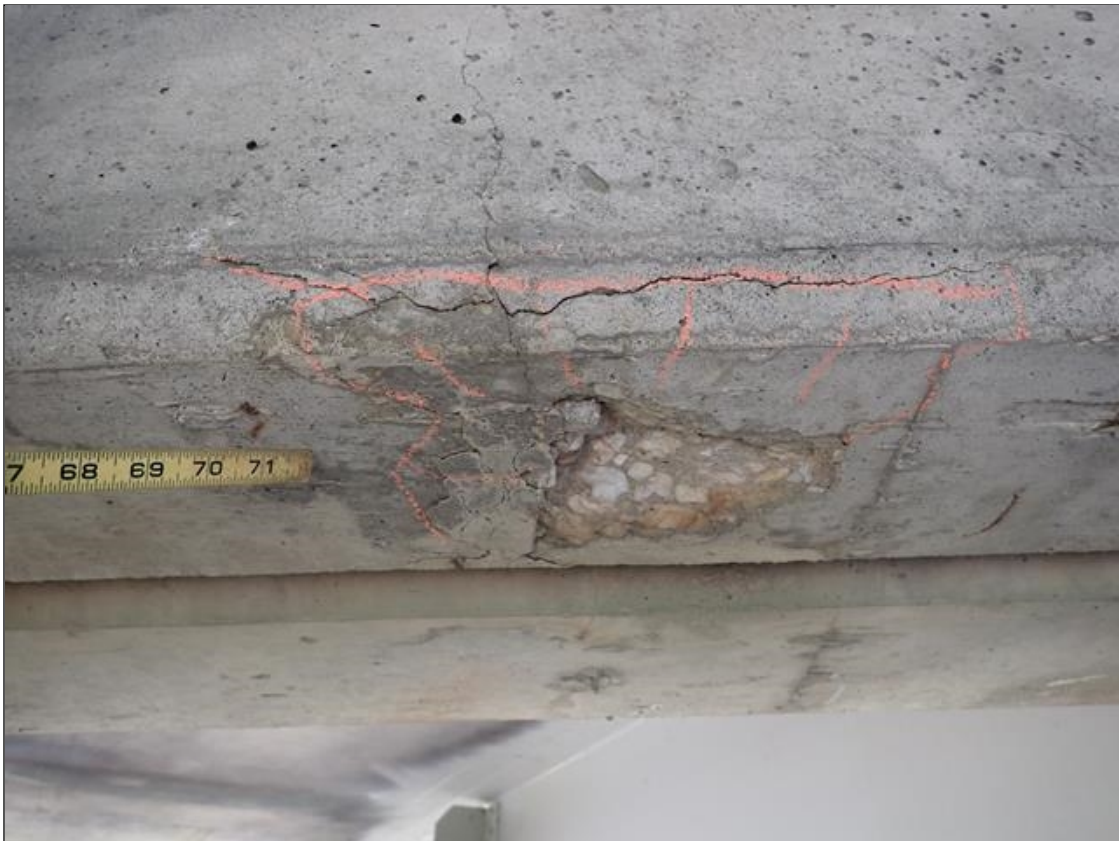
Span 5 Deck: 12 INCHES X 8 INCH X 3/4 INCH DEEP SPALL/DELMINATION IN INTERMEDIATE DIAPHRAGM IN BAY 2 ABOVE BENT 5.

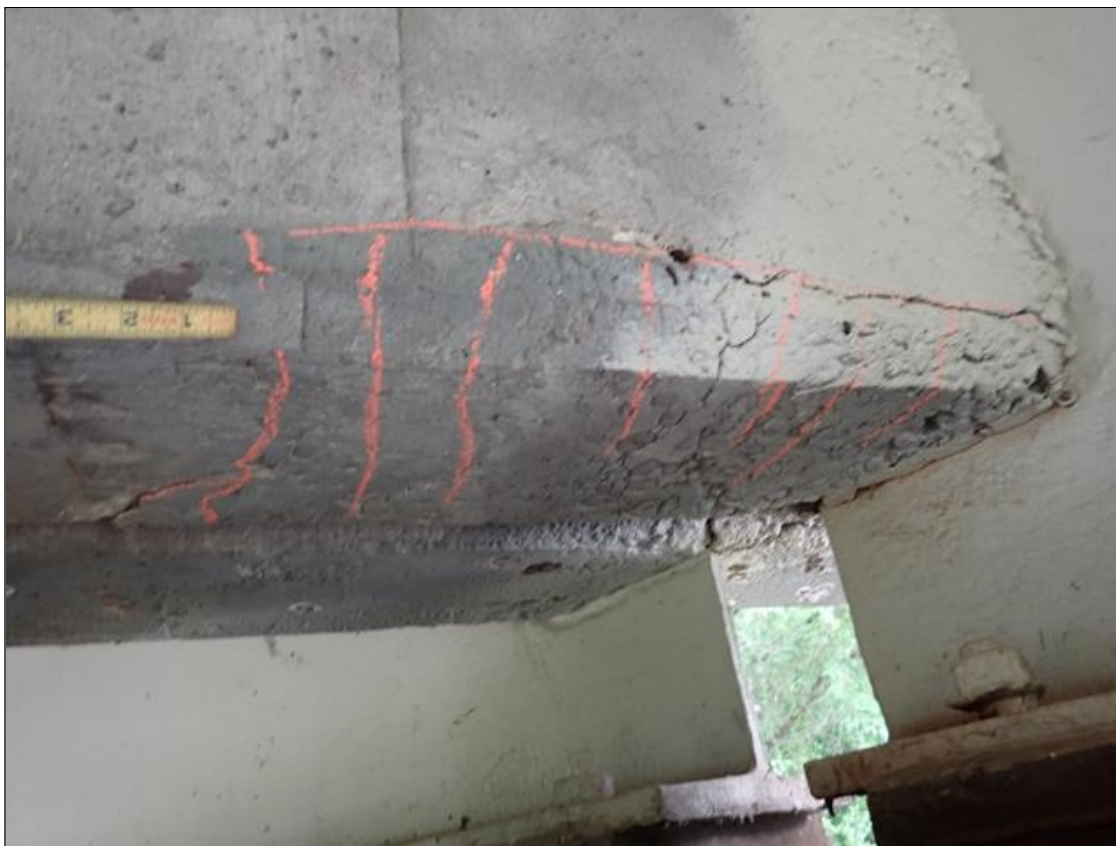
Span 5 Deck: bay 3 end diaphragm over bent 5, delamination (20 inch x 10 inch) with cracks (up to 1/16 inch)

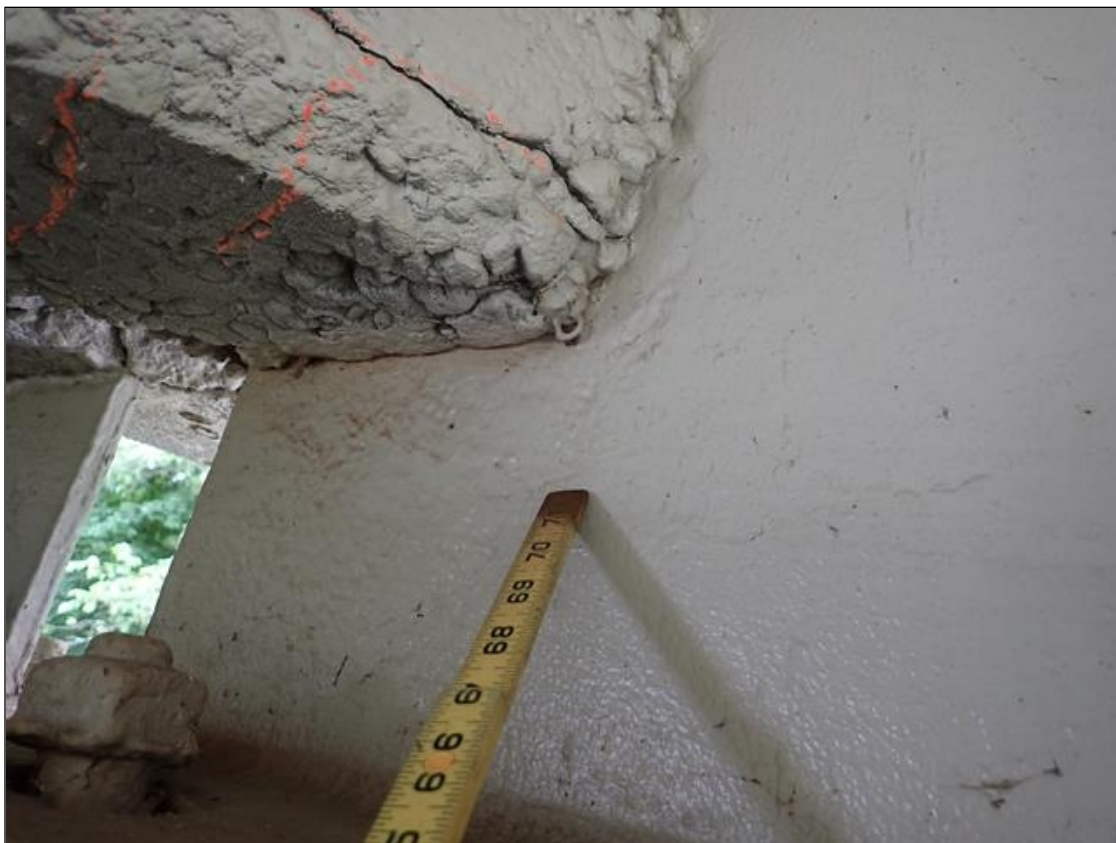
Span 5 Beam 4: at bent 5, painted over pitting (up to 1/16 inch deep x 8 inch x 10 inch)

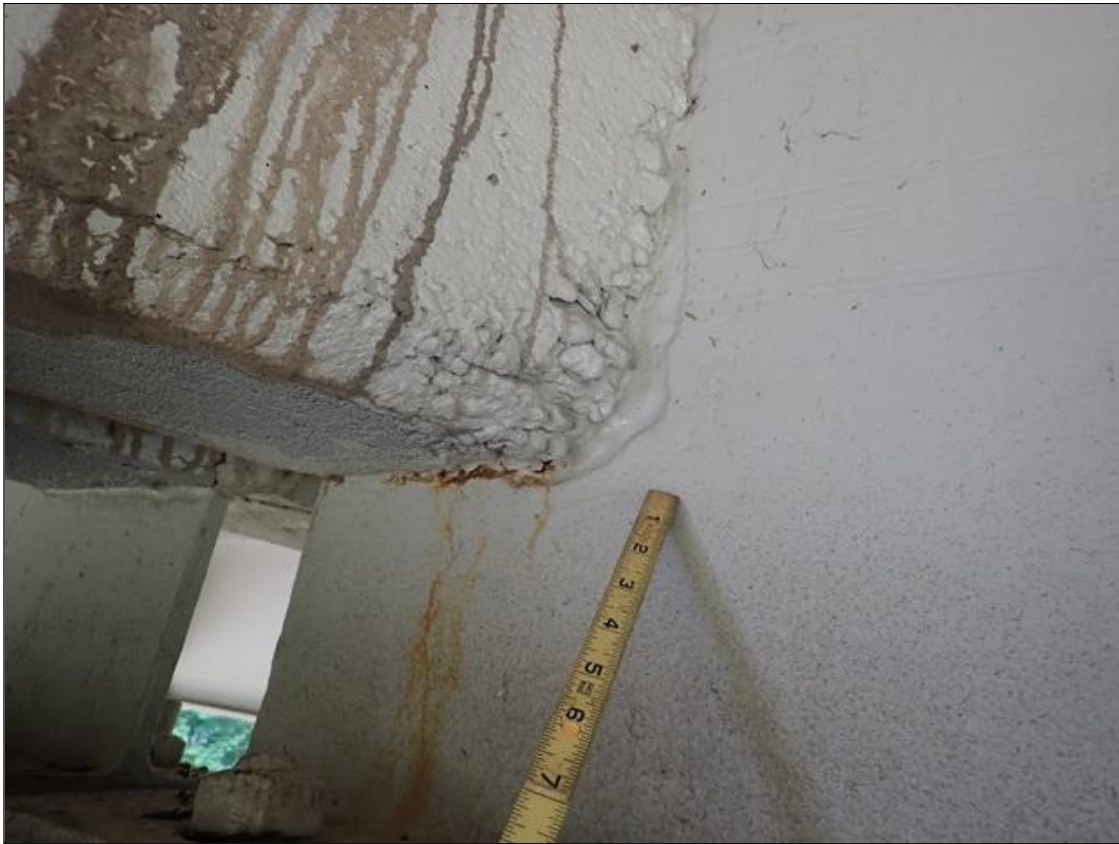
Span 5 Beam 3: (PAR) at bent 4, web adjacent to end diaphragm, painted over section loss (9/16 inch average remaining x 8 inch x 1 inch) with corrosion reactivating

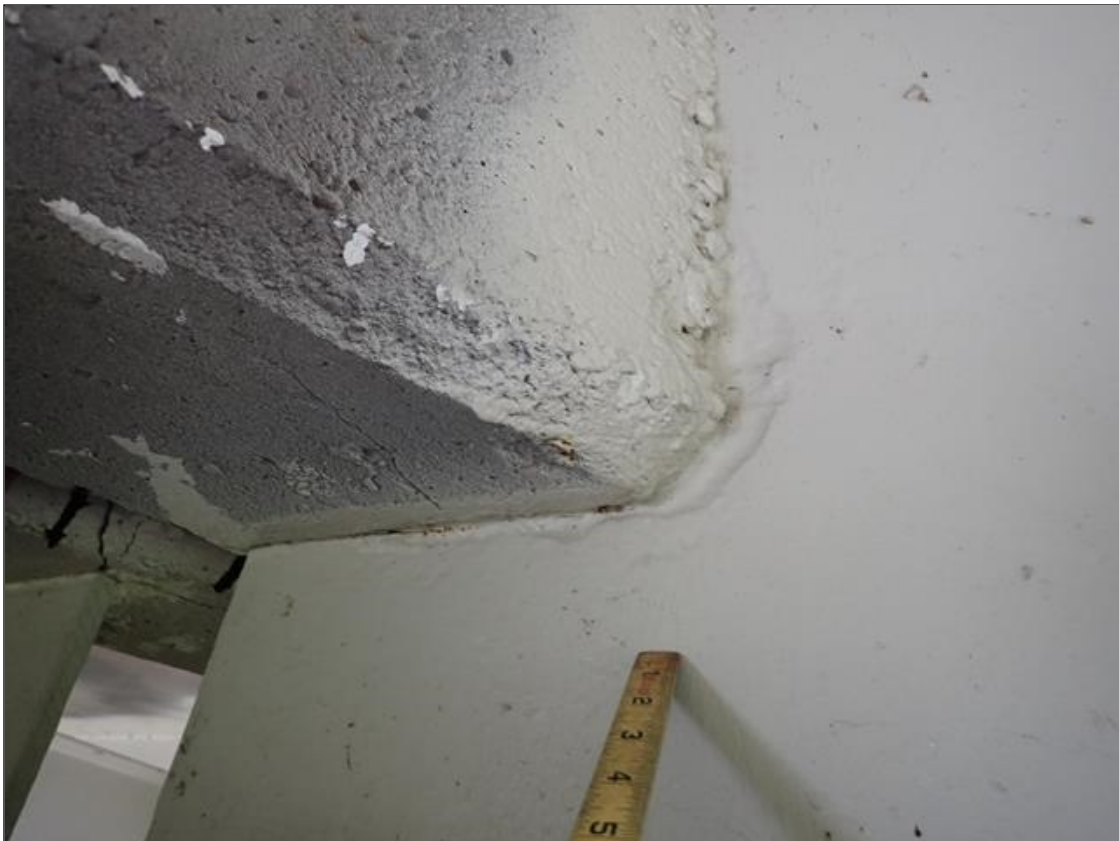
Span 5 Beam 2: (PAR) at bent 5, web adjacent to end diaphragm, painted over section loss (3/8 inch average remaining x 10 inch x 1 inch) with corrosion reactivating

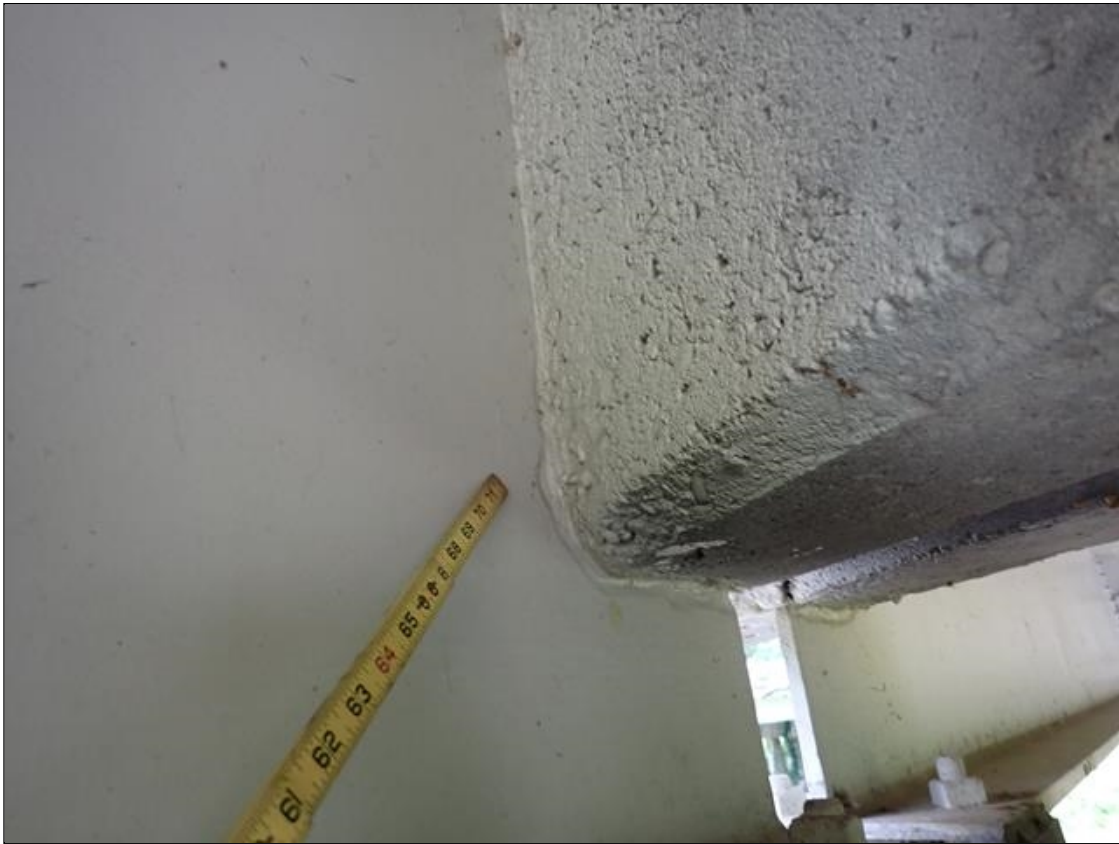
Span 5 Beam 1: (PAR) at bent 5, web adjacent to end diaphragm, painted over section loss (3/8 inch average remaining x 8 inch x 4 inch)

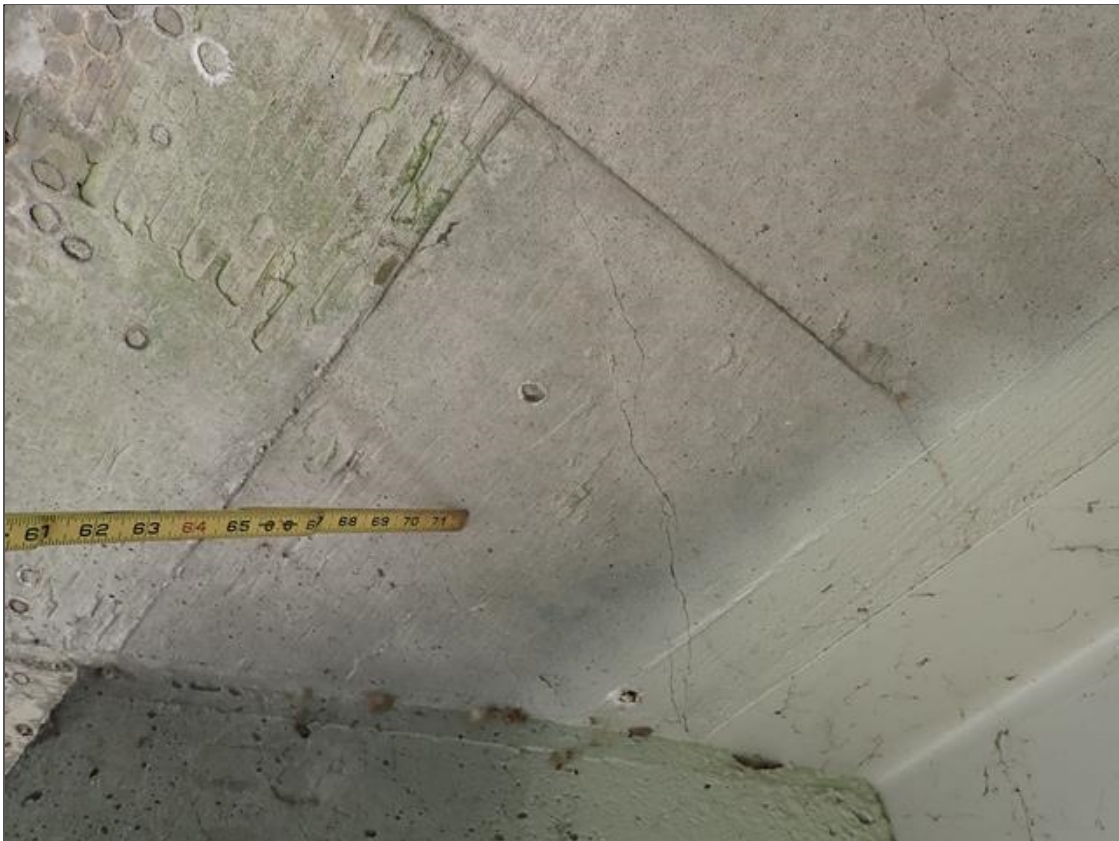
Span 6 Deck: UP TO 0.02 INCH WIDE X UP TO 3 FEET LONG TRANSVERSE CRACKS IN RIGHT OVERHANG. SIMILAR CRACKS IN LEFT OVERHANG.

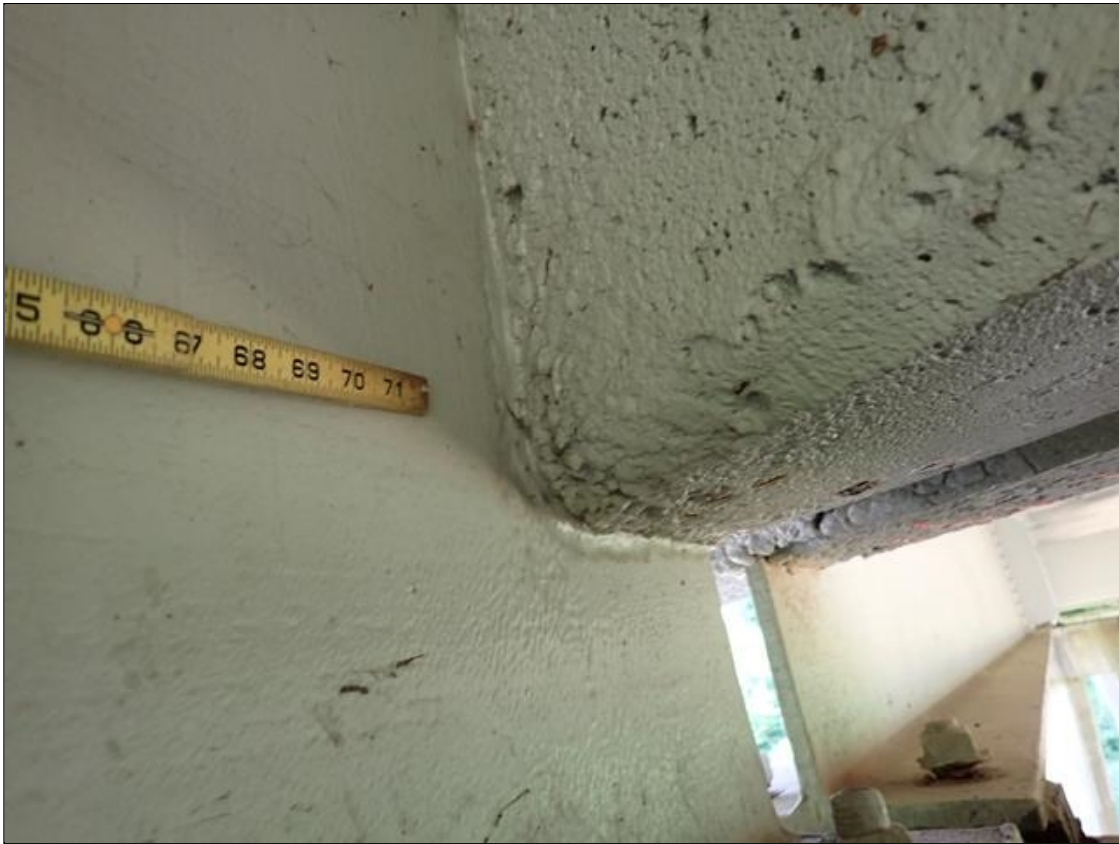
Span 6 Beam 4: at bent 5, web adjacent to end diaphragm, painted over section loss (9/16 inch average remaining x 8 inch x 8 inch)

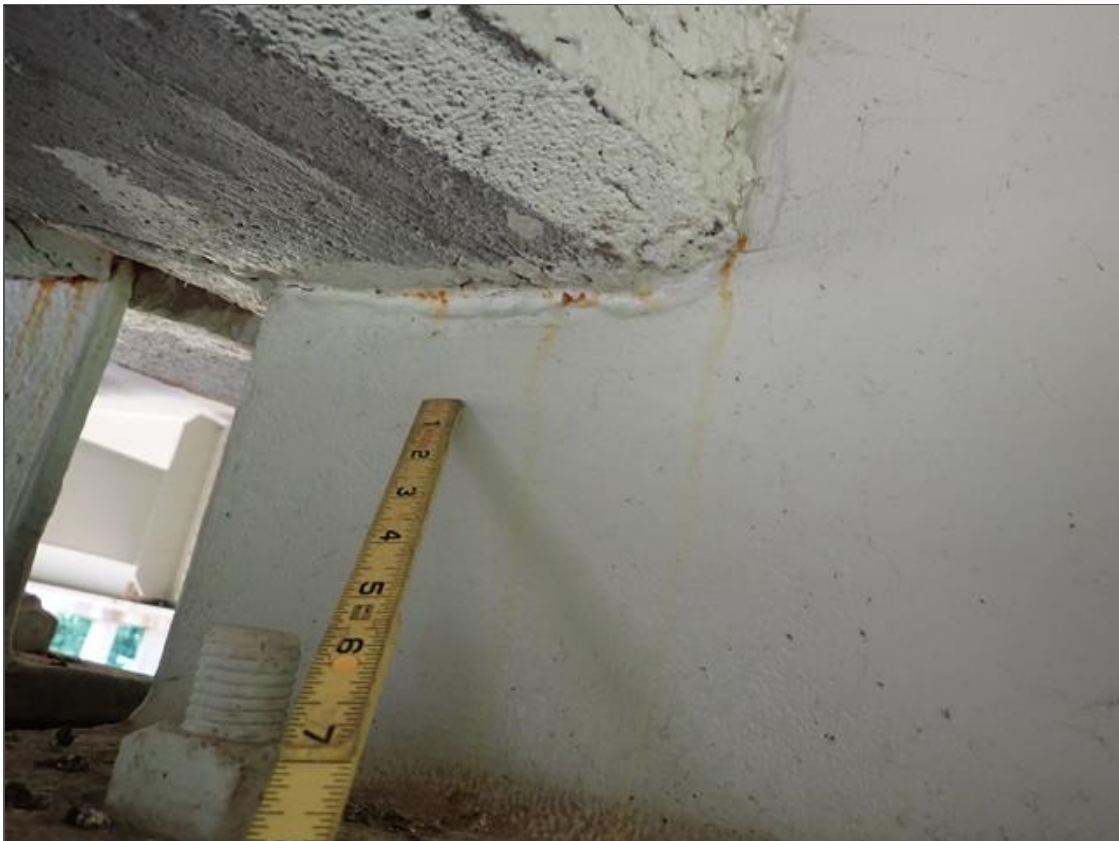
Span 6 Beam 3: at bent 5, web adjacent to end diaphragm, painted over section loss (9/16 inch average remaining x 8 inch x 8 inch) with corrosion reactivating

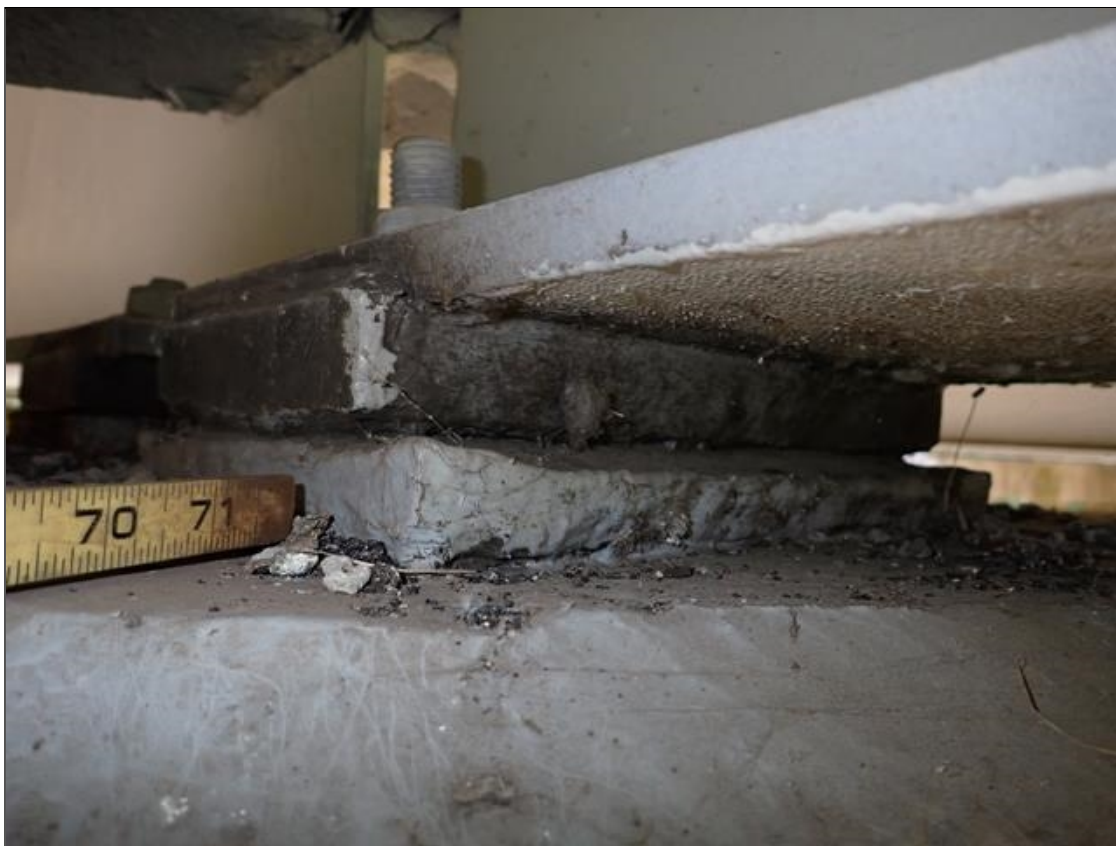
Span 6 Near Bearing 2 : painted over section loss (approximately 80 percent remaining)

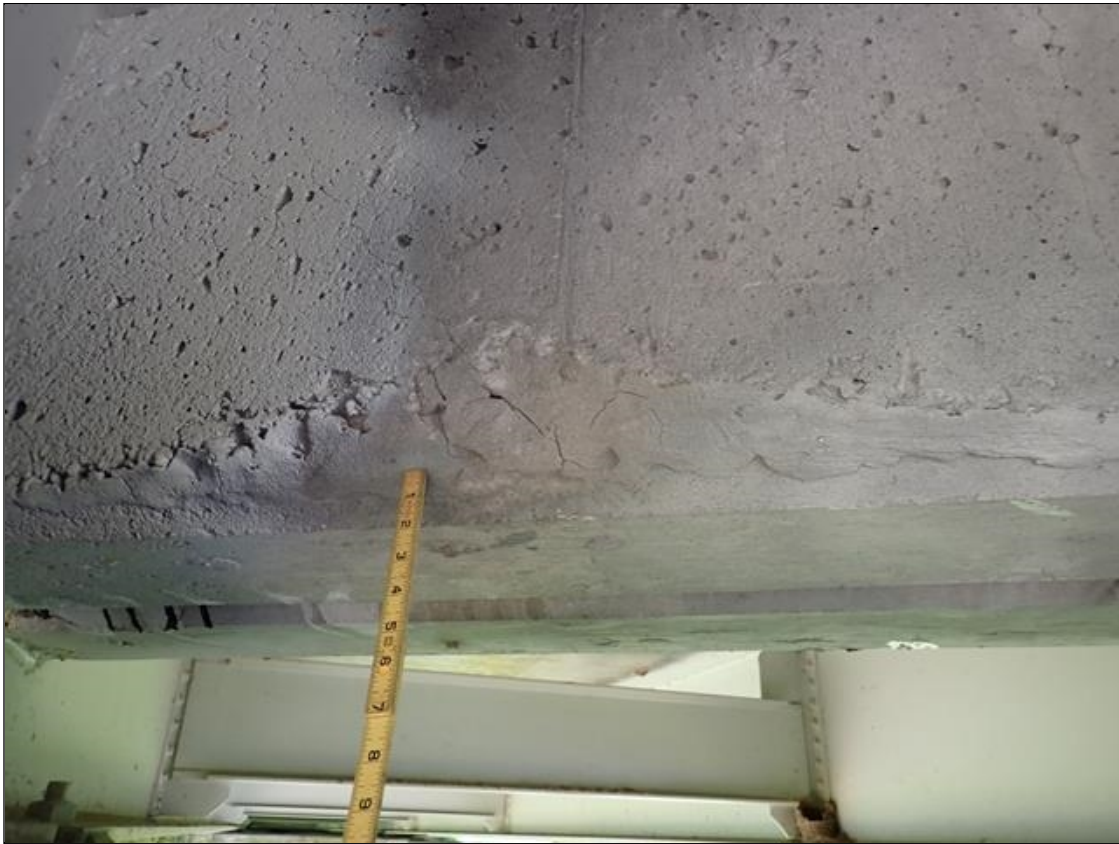
Span 6 Deck: 38 INCHES LONG X 1 FOOT HIGH UNSOUND CONCRETE PATCHED AREA WITH CRACKS (UP TO 1/32 INCH), BOTTOM OF BAY 2 END DIAPHRAGM, AT BENT 6.

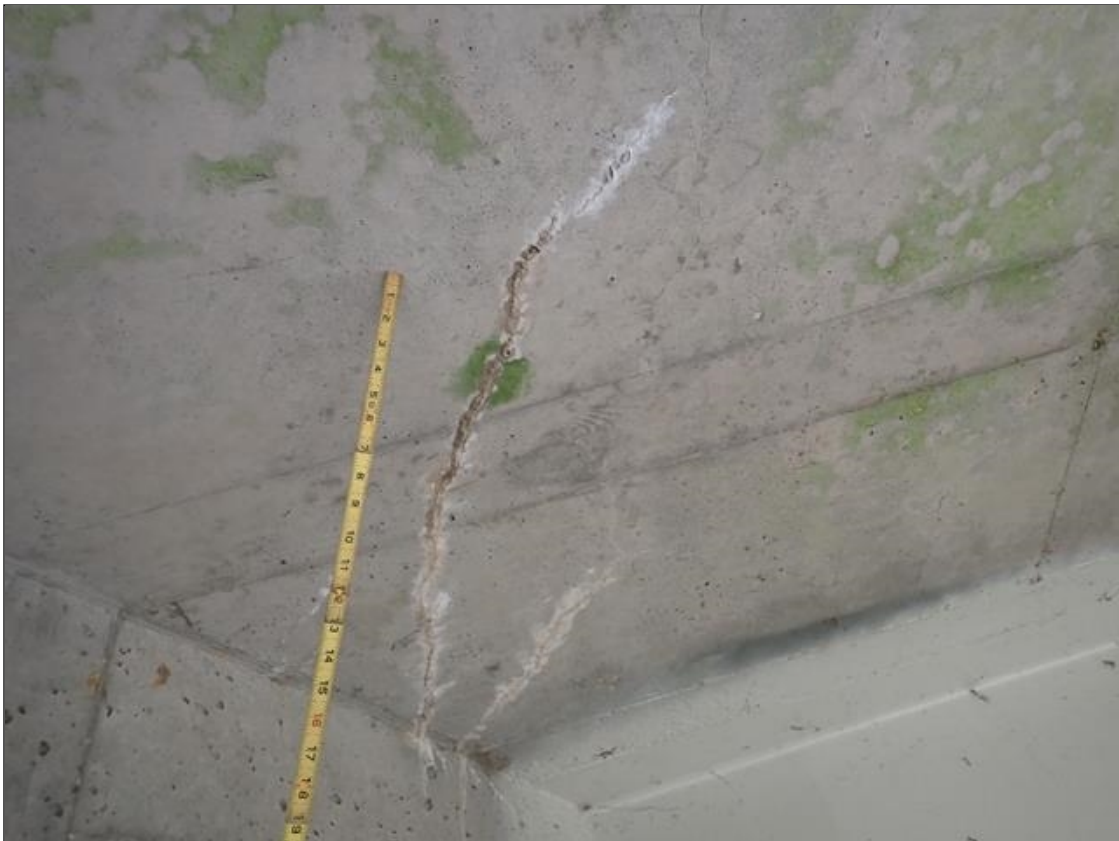
Span 6 Deck: UP TO 0.02 INCH WIDE RANDOM CRACKING SOME WITH EFFLORESCENCE IN DECK UNDERSIDE, SCATTERED THROUGHOUT.

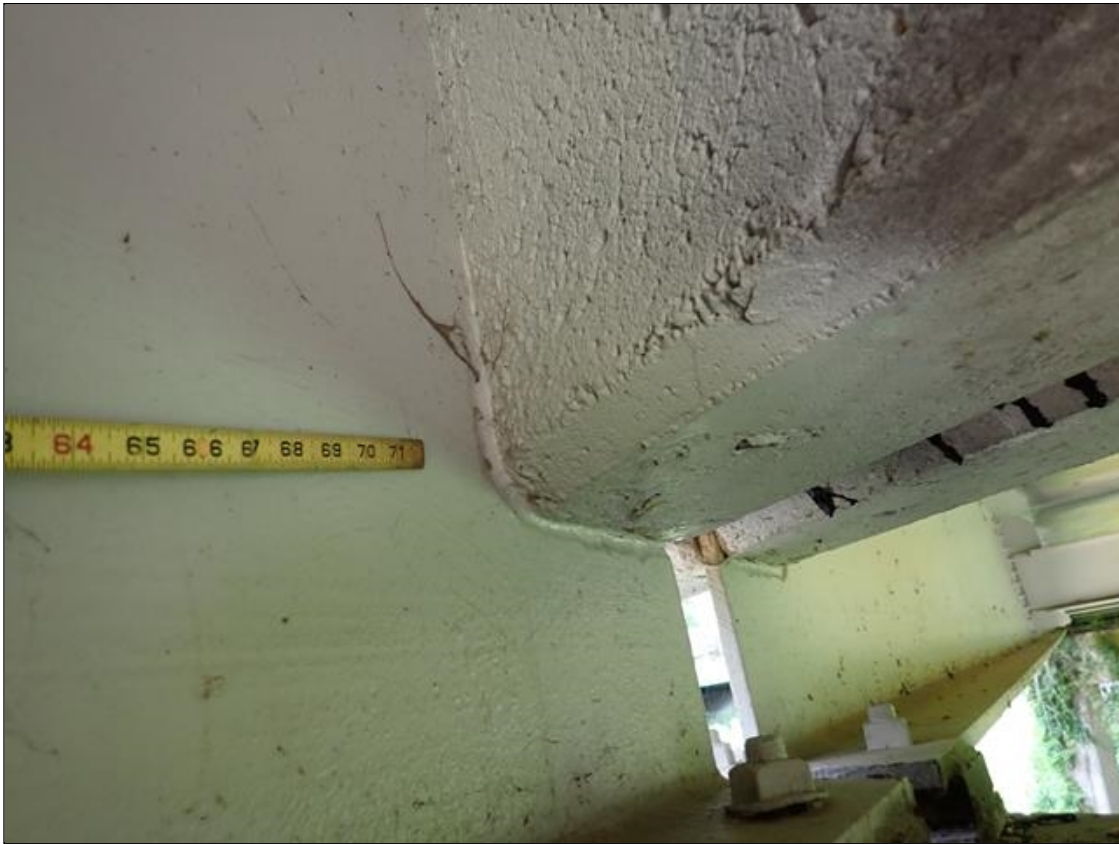
Span 6 Beam 1: (PAR) at bent 6, web adjacent to end diaphragm, painted over section loss (3/8 inch average remaining x 8 inch x 4 inch) with corrosion reactivating

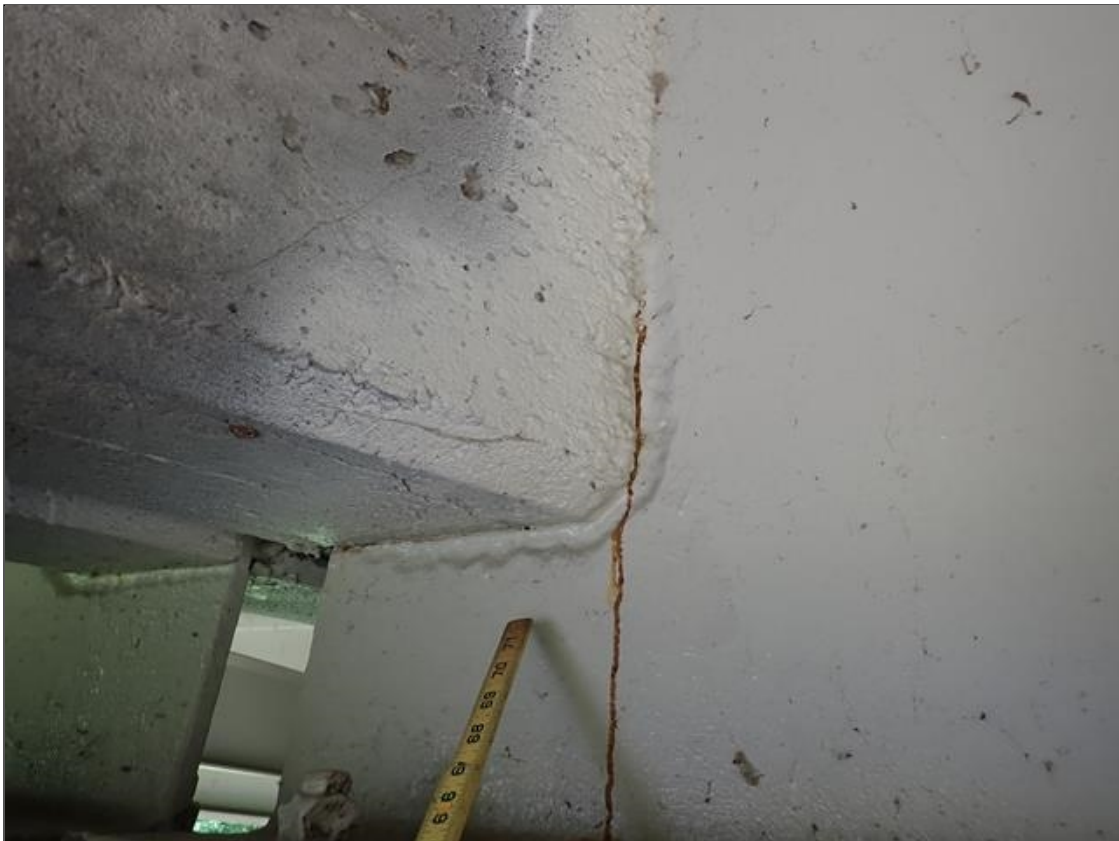
Span 6 Beam 2: (PAR) at bent 6, web adjacent to end diaphragm, painted over section loss (3/8 inch average remaining x 7 inch x 10 inch) with corrosion reactivating

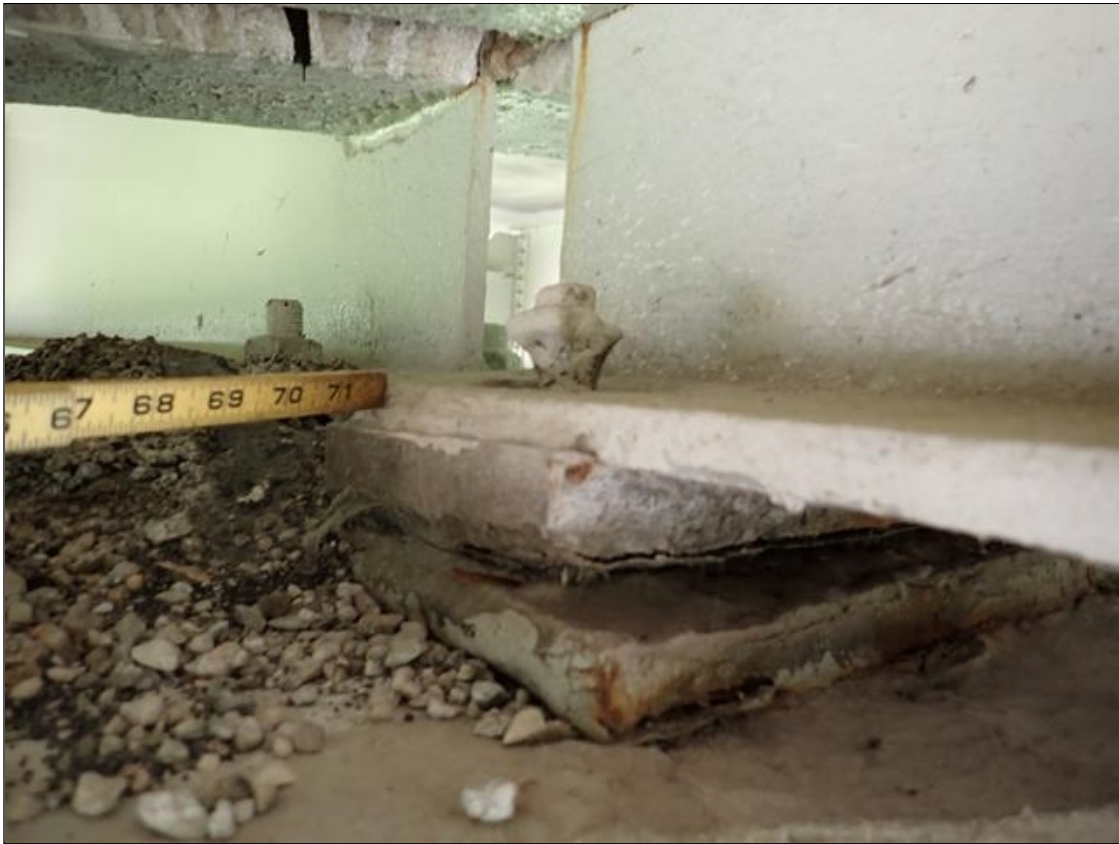
Span 6 Far Bearing 3: (PAR) LEFT ANCHOR BOLT HAS UP TO 80 PERCENT SECTION REMAINING AND ANCHOR BOLT NUT HAS UP TO 50 PERCENT SECTION REMAINING.

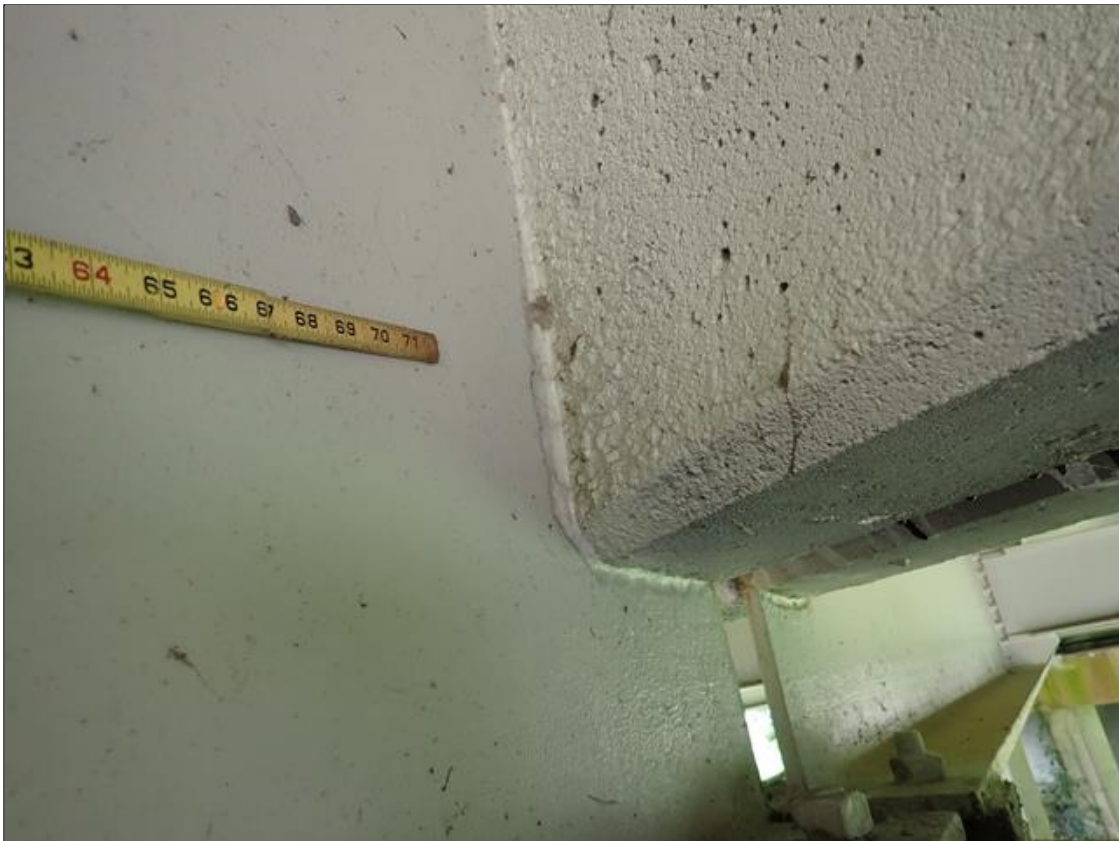
Span 6 Beam 3: (PAR) at bent 6, web adjacent to end diaphragm, painted over section loss (3/8 inch average remaining x 8 inch x 8 inch) with corrosion reactivating

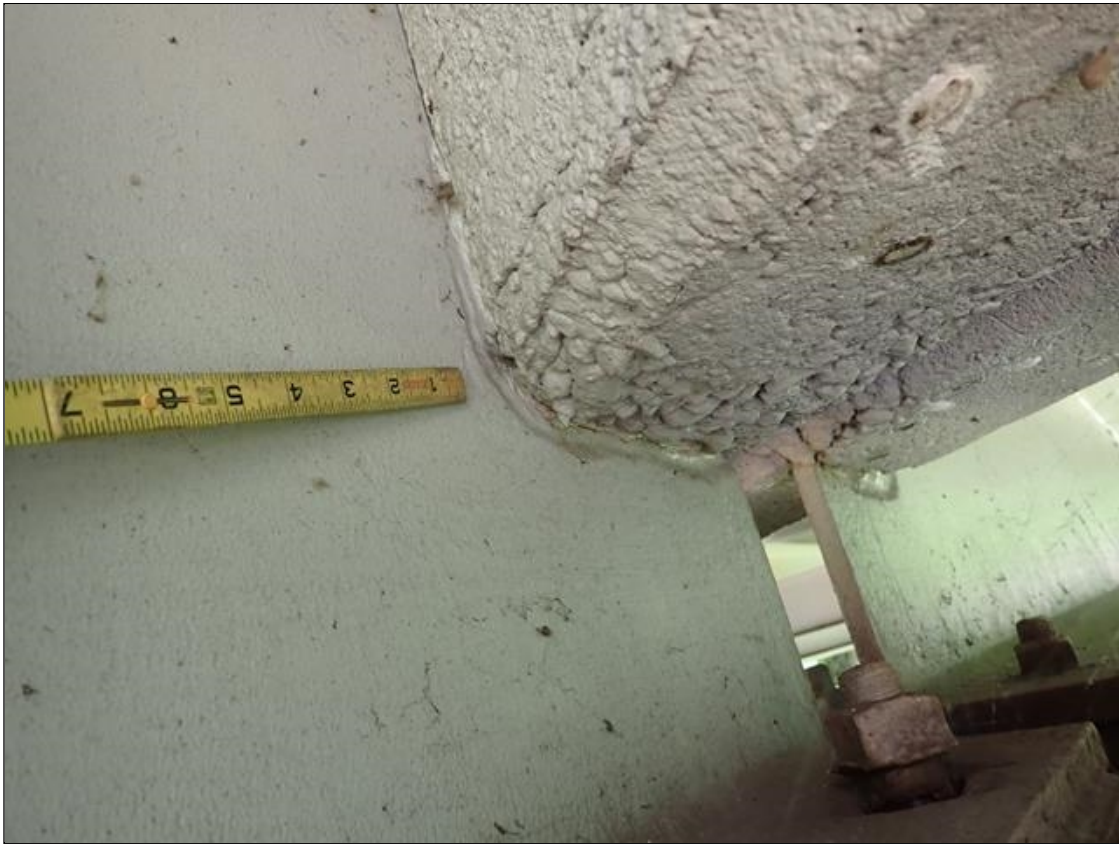
Span 6 Beam 4: (PAR) at bent 6, web adjacent to end diaphragm, painted over section loss (3/8 inch average remaining x 8 inch x 8 inch) with corrosion reactivating
