NC DEPARTMENT OF TRANSPORTATION  
 DIVISION OF HIGHWAYS  
 STRUCTURE MANAGEMENT UNIT  
 COUNTY: JOHNSTON DIV: 4

ATTENTION:  PARS Submitted  Sign Notice Issued  
 sketches revised; new repairs

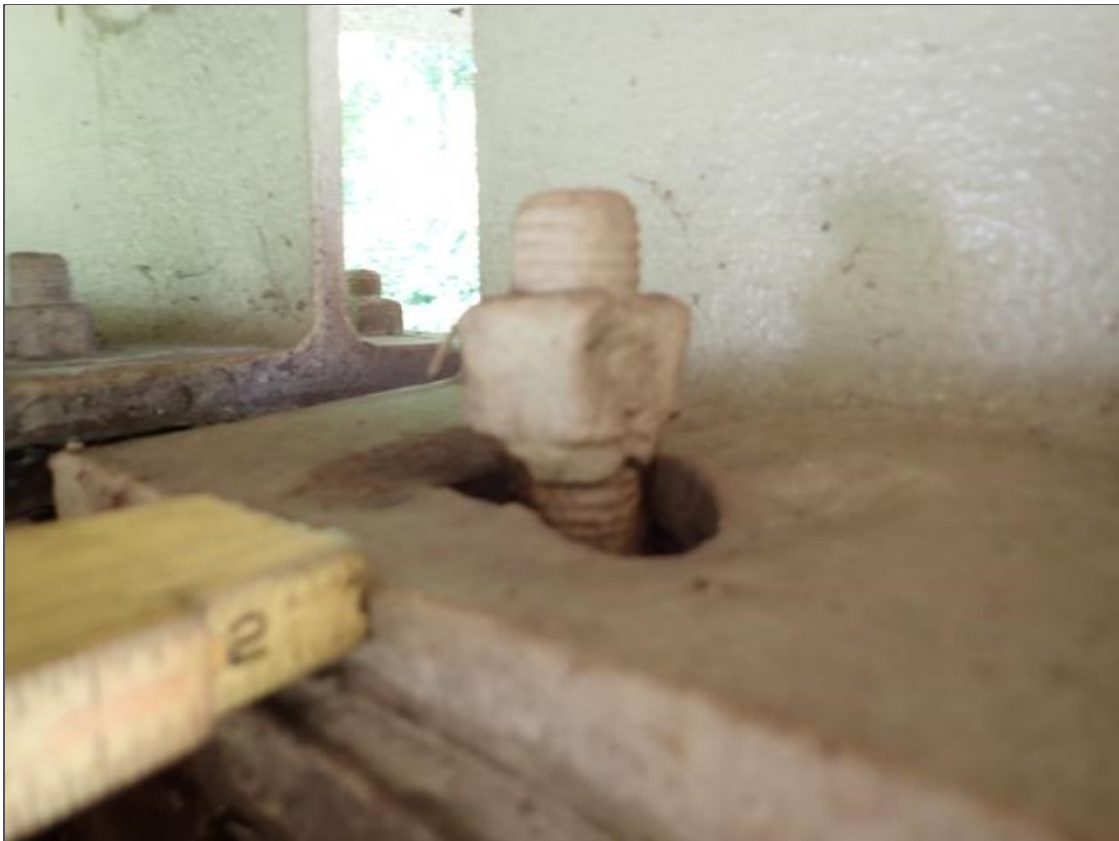
Span 6 Far Bearing 4: corrosion with section loss (approximately 80 percent remaining); left anchor bolt nut, painted over loss (approximately 80 percent remaining)

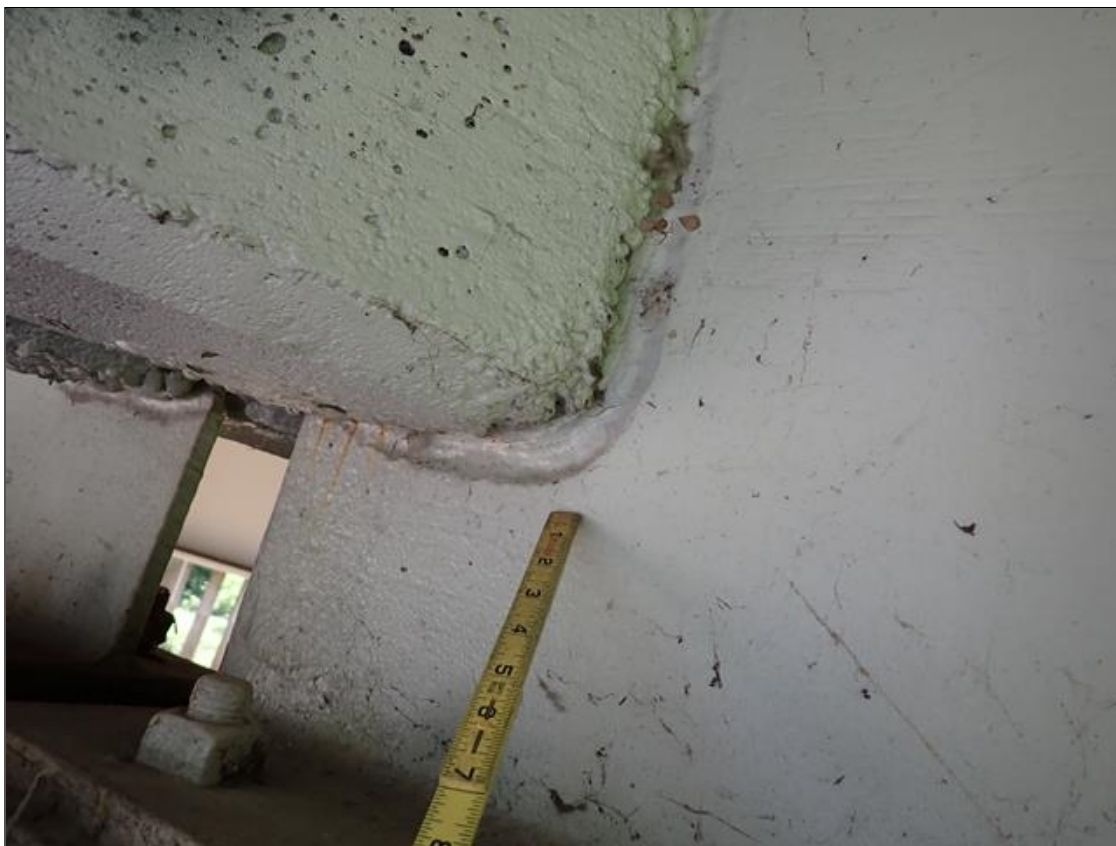
Span 7 Beam 4: (PAR) at bent 6, web adjacent to end diaphragm, painted over section loss (3/8 inch average remaining x 7 inch x 12 inch) with corrosion reactivating

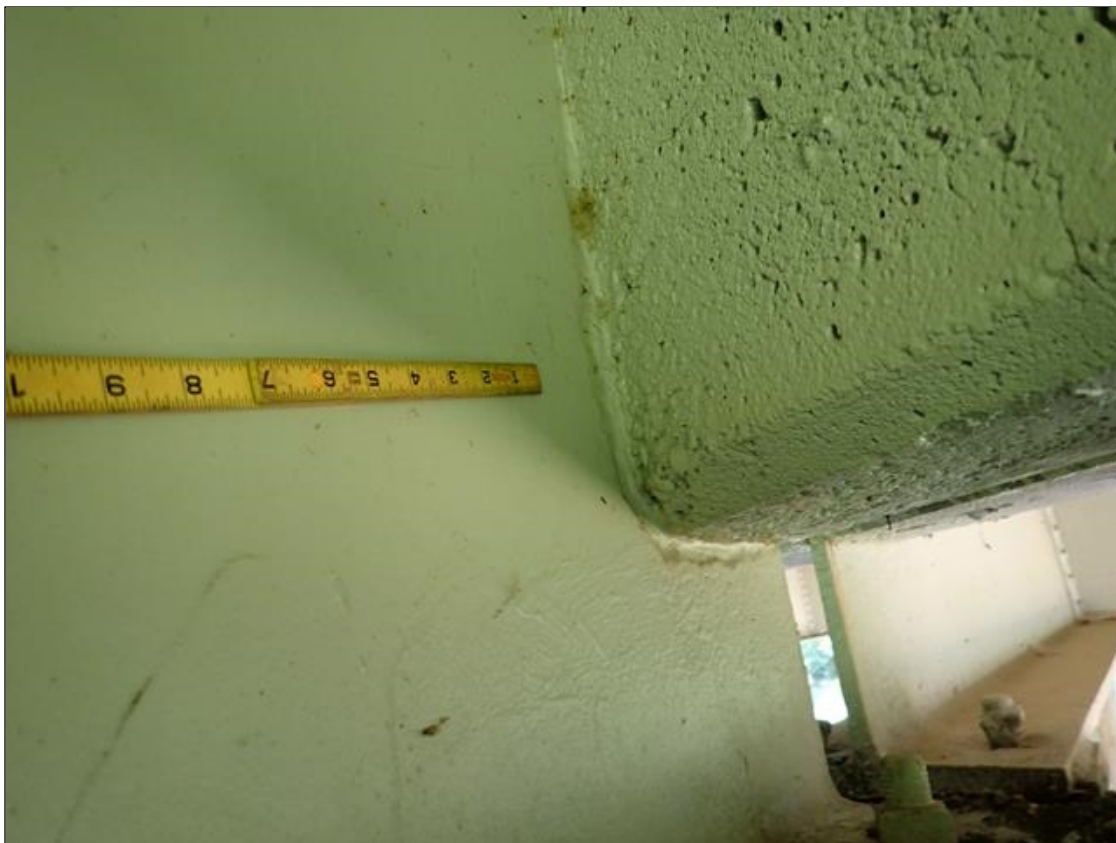
Span 7 Beam 3: (PAR) at bent 6, web adjacent to end diaphragm, painted over section loss (3/8 inch average remaining x 7 inch x 12 inch) with corrosion reactivating

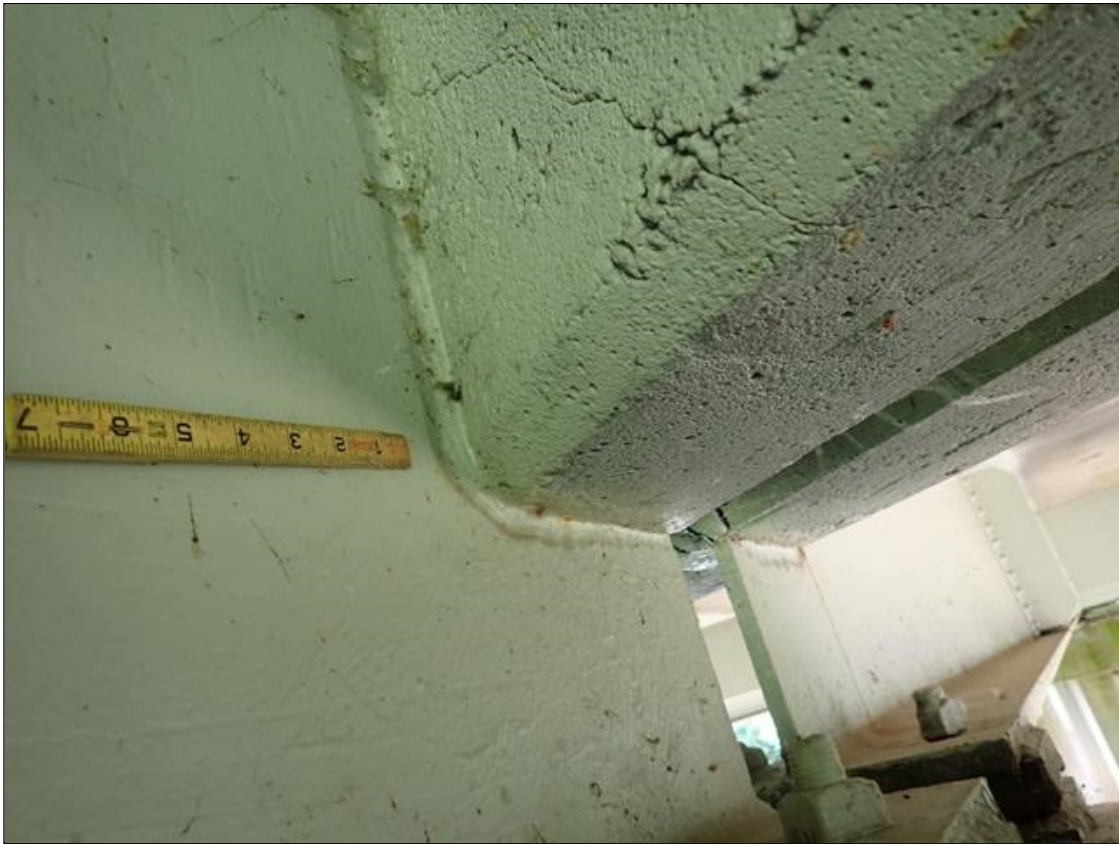
Span 7 Beam 2: (PAR) at bent 6, web adjacent to end diaphragm, painted over section loss (3/8 inch average remaining x 7 inch x 14 inch) with corrosion reactivating

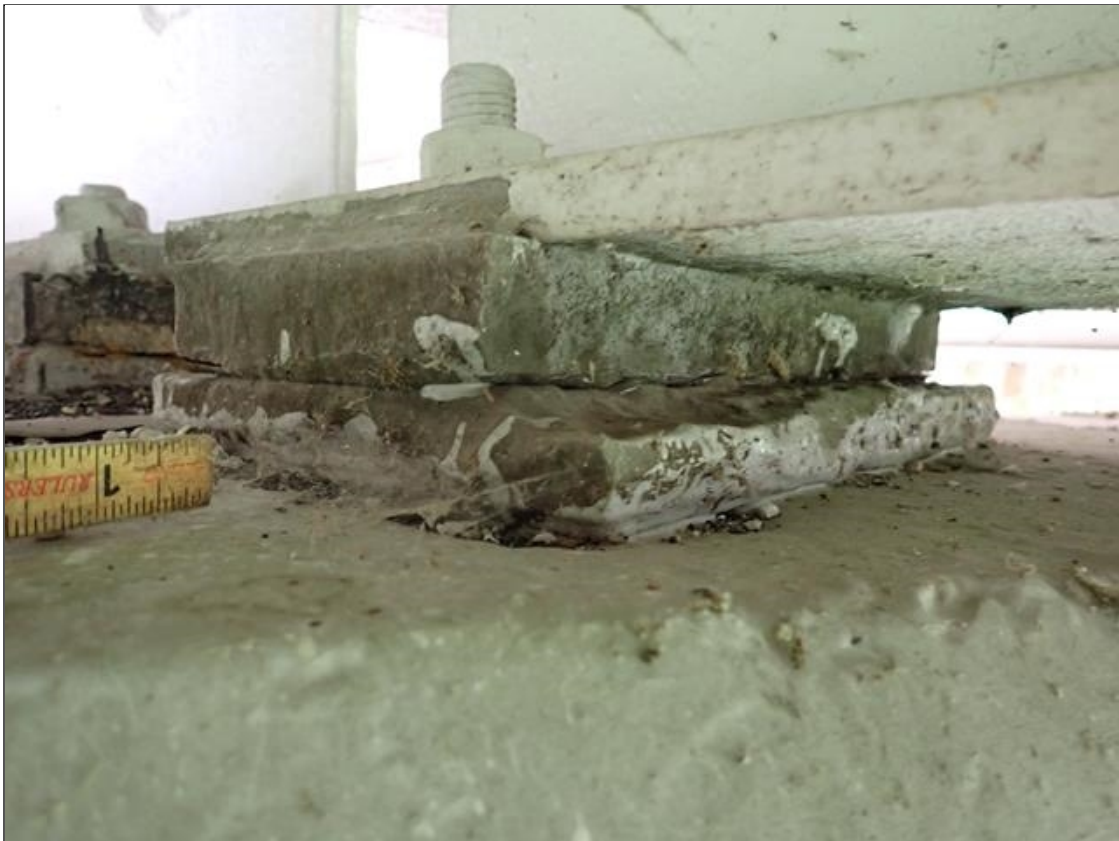
Span 7 Near Bearing 2: painted over section loss (approximately 85 percent remaining)

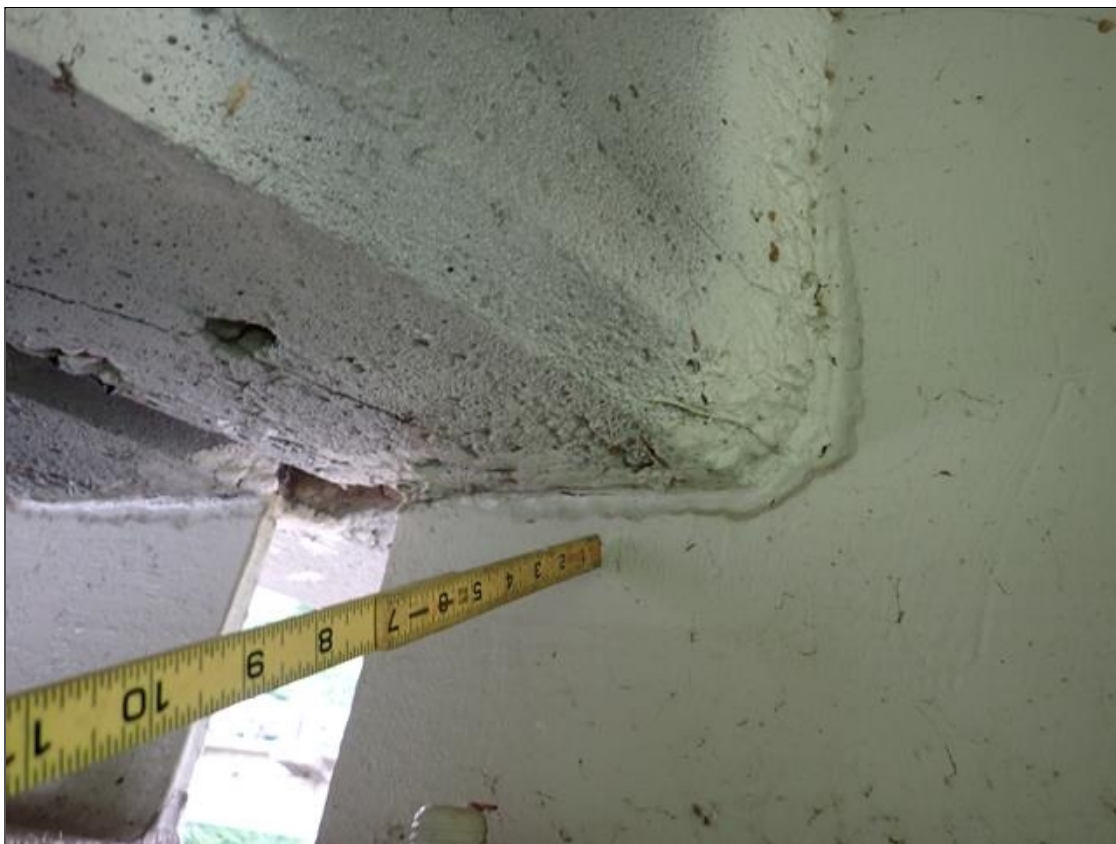
Span 7 Beam 1: (PAR) at bent 6, web adjacent to end diaphragm, painted over section loss (3/8 inch average remaining x 7 inch x 14 inch) with corrosion reactivating

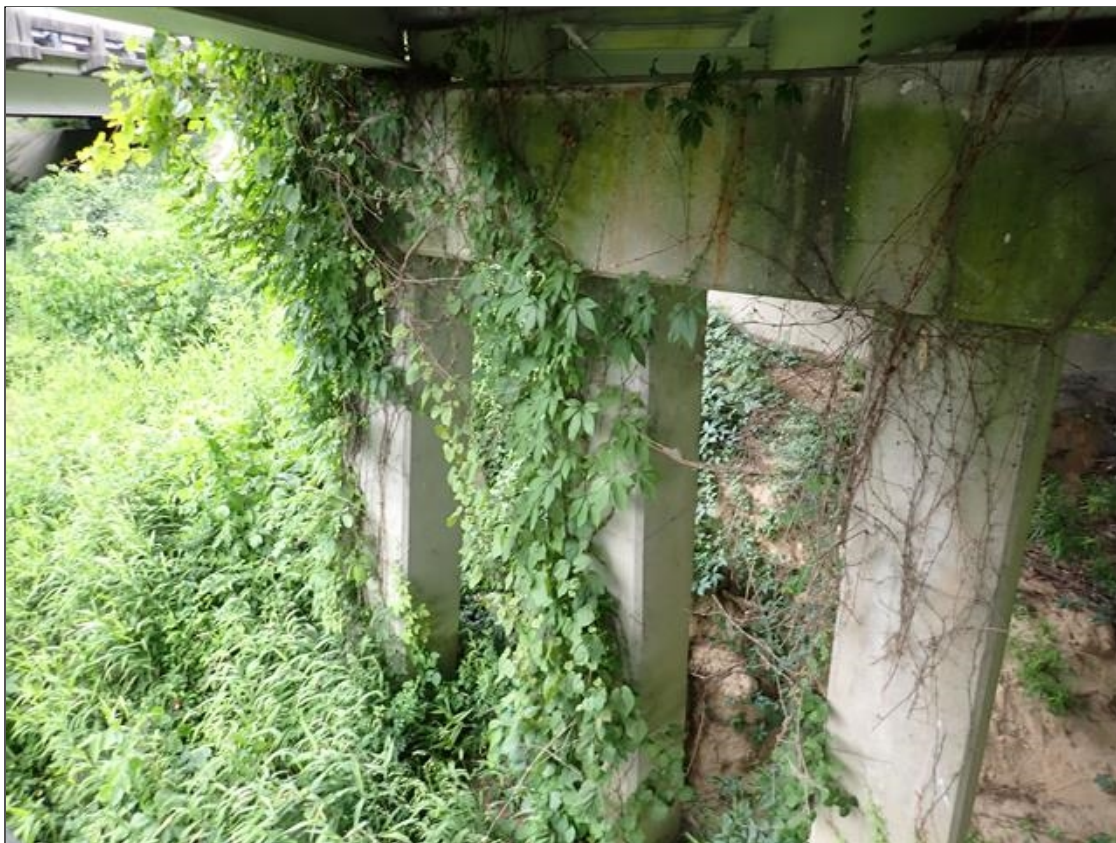
Bent 7 Pile 1: along pile, vegetation growth

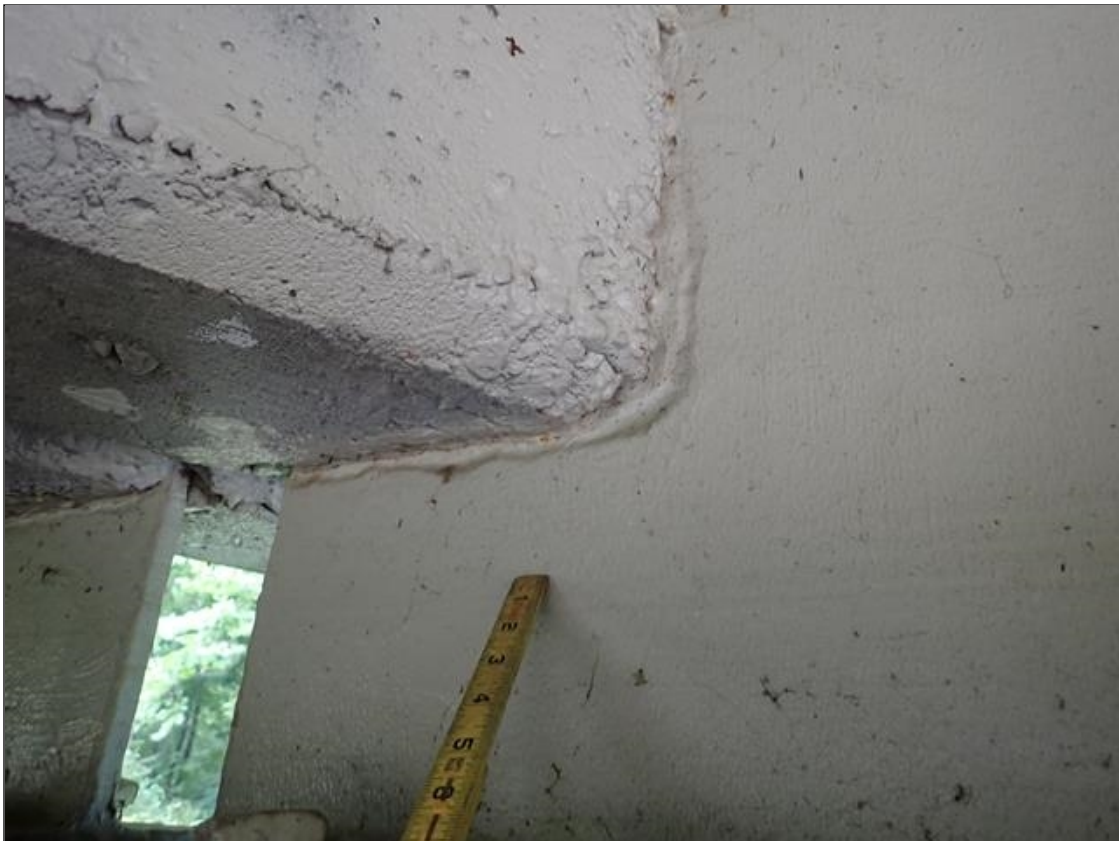
Span 7 Beam 4: (PAR) at bent 7, web adjacent to end diaphragm, painted over section loss (3/8 inch average remaining x 7 inch x 5 inch) with corrosion reactivating

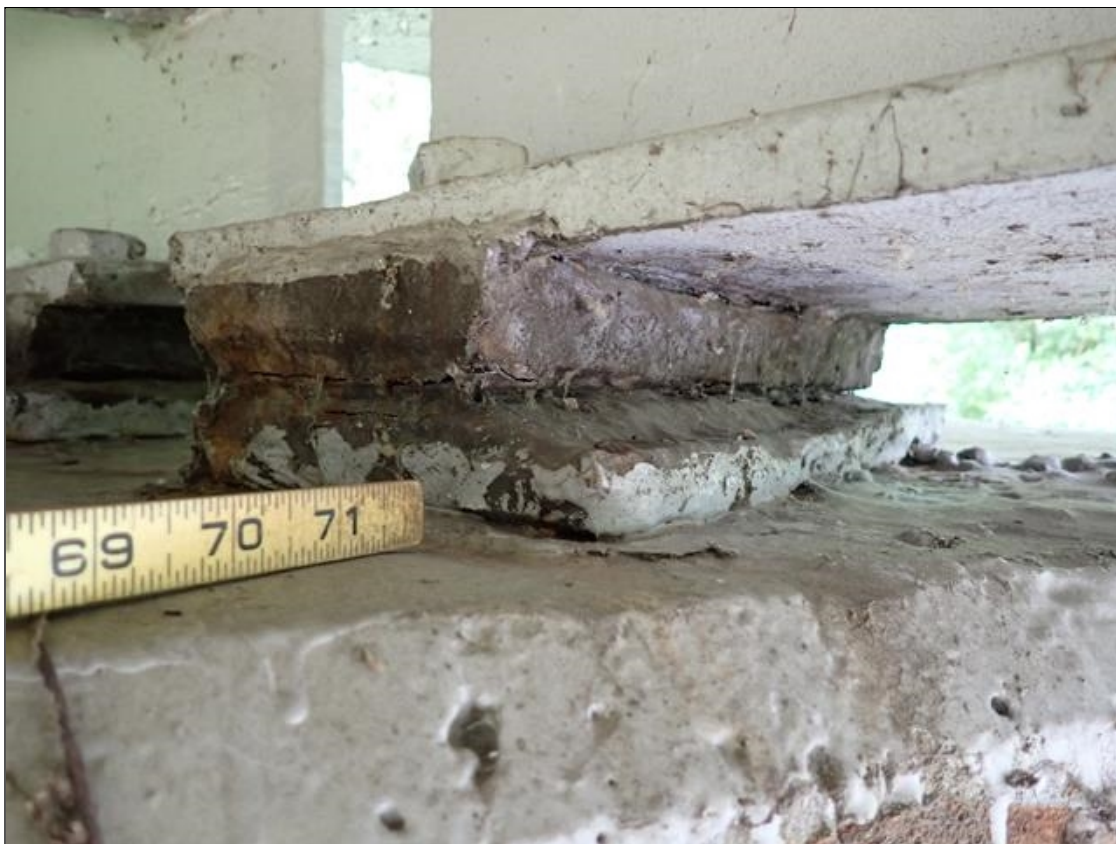
Span 7 Far Bearing 4: painted over section loss (approximately 80 percent remaining)

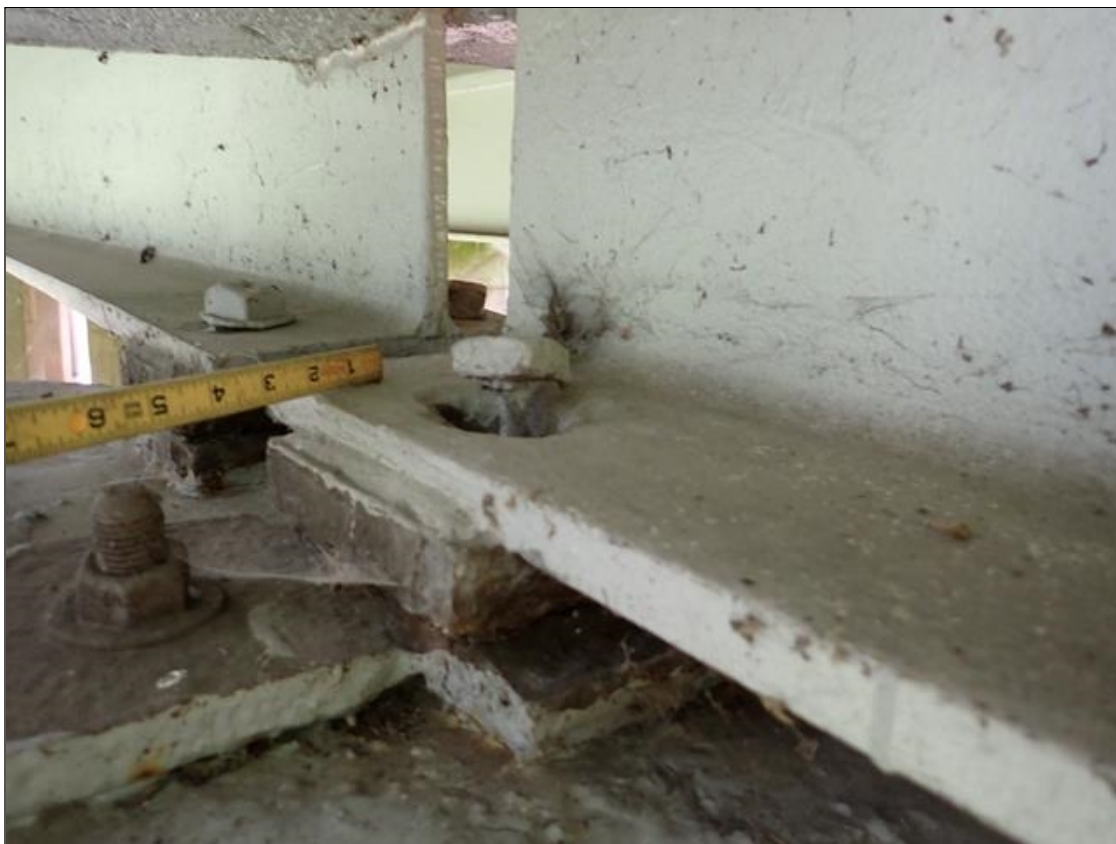
Span 8 Near Bearing 4: (PAR) right anchor bolt, painted over section loss (approximately 25 percent remaining); previous repair in place

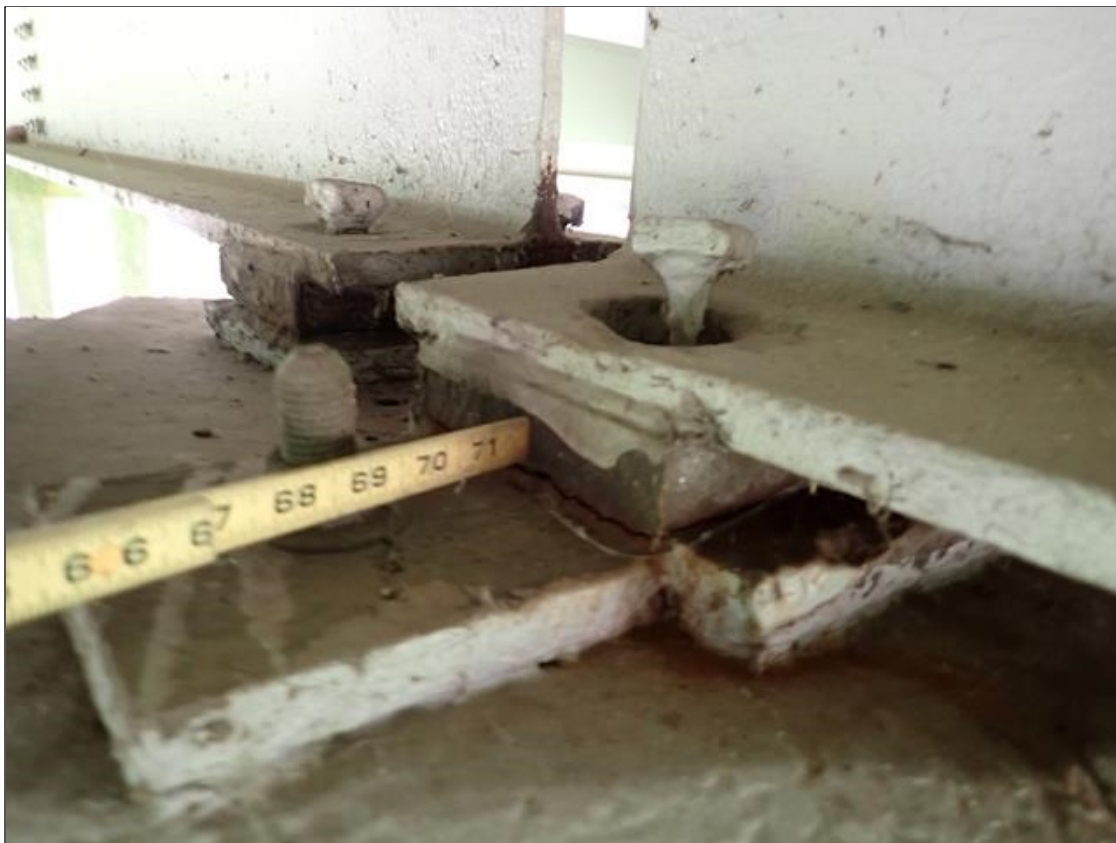
Span 8 Near Bearing 3: RIGHT ANCHOR BOLT, PAINTED OVER LOSS (APPROXIMATELY 50 PERCENT REMAINING); BEARING ASSEMBLY HAS WELDED REPAIR WITH NEW ANCHOR BOLT.

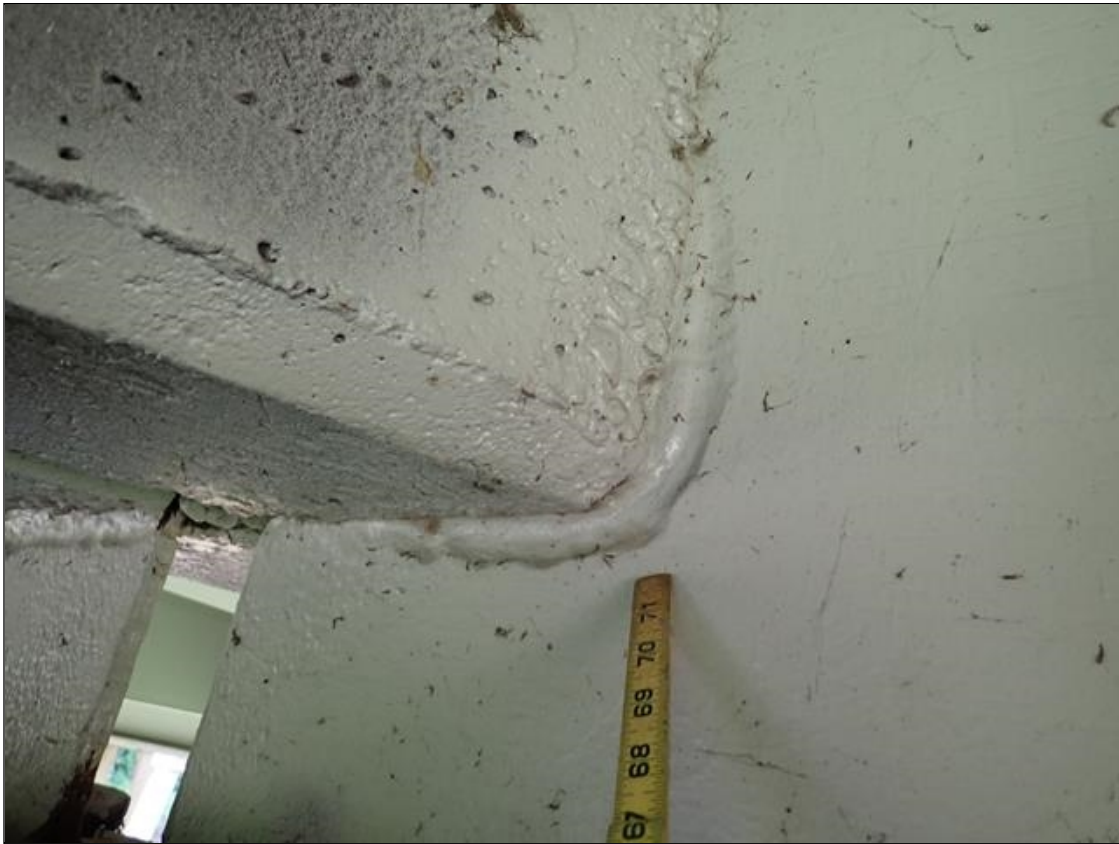
Span 8 Beam 3: (PAR) at bent 7, web adjacent to end diaphragm, painted over section loss (3/8 inch average remaining x 4 inch x 12 inch)

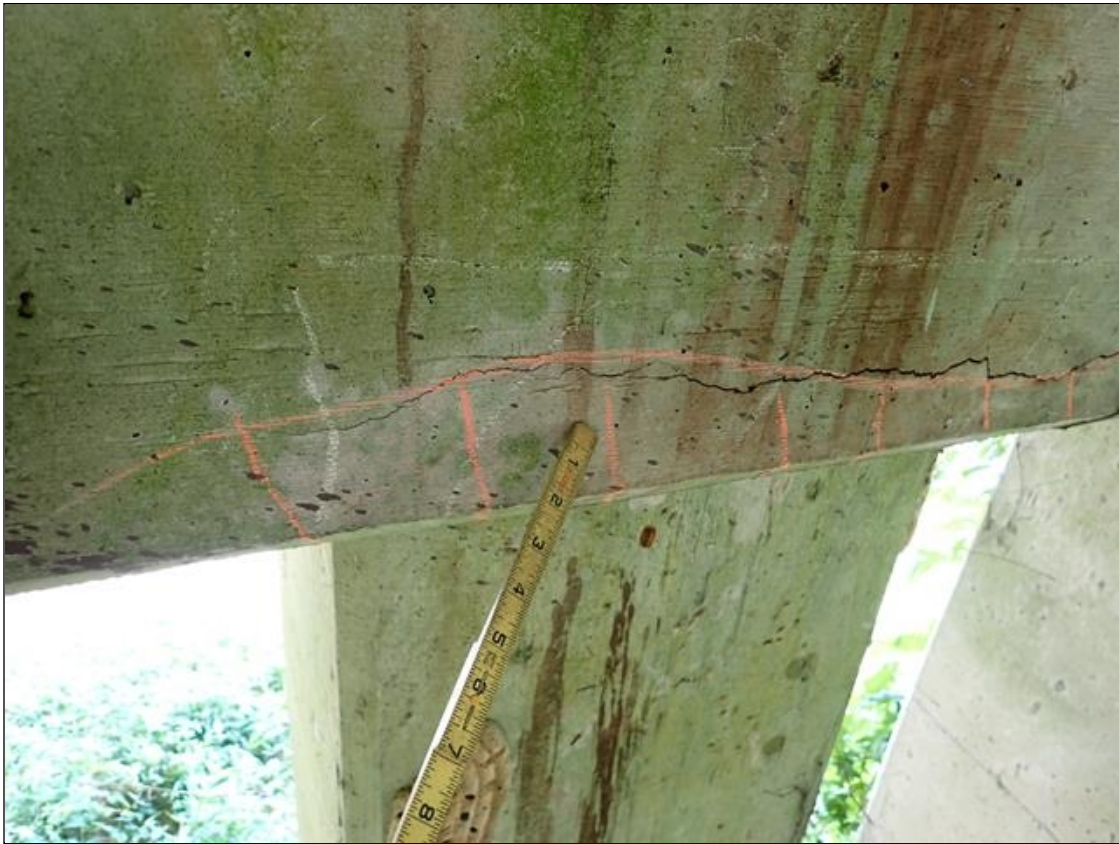
Bent 7 Cap 1: 3 FEET WIDE X 6 INCHES HIGH DELAMINATION WITH A 3 FEET LONG HORIZONTAL CRACK UP TO 1/16 INCH WIDE BOTTOM OF NORTH FACE, OVER PILE 3.

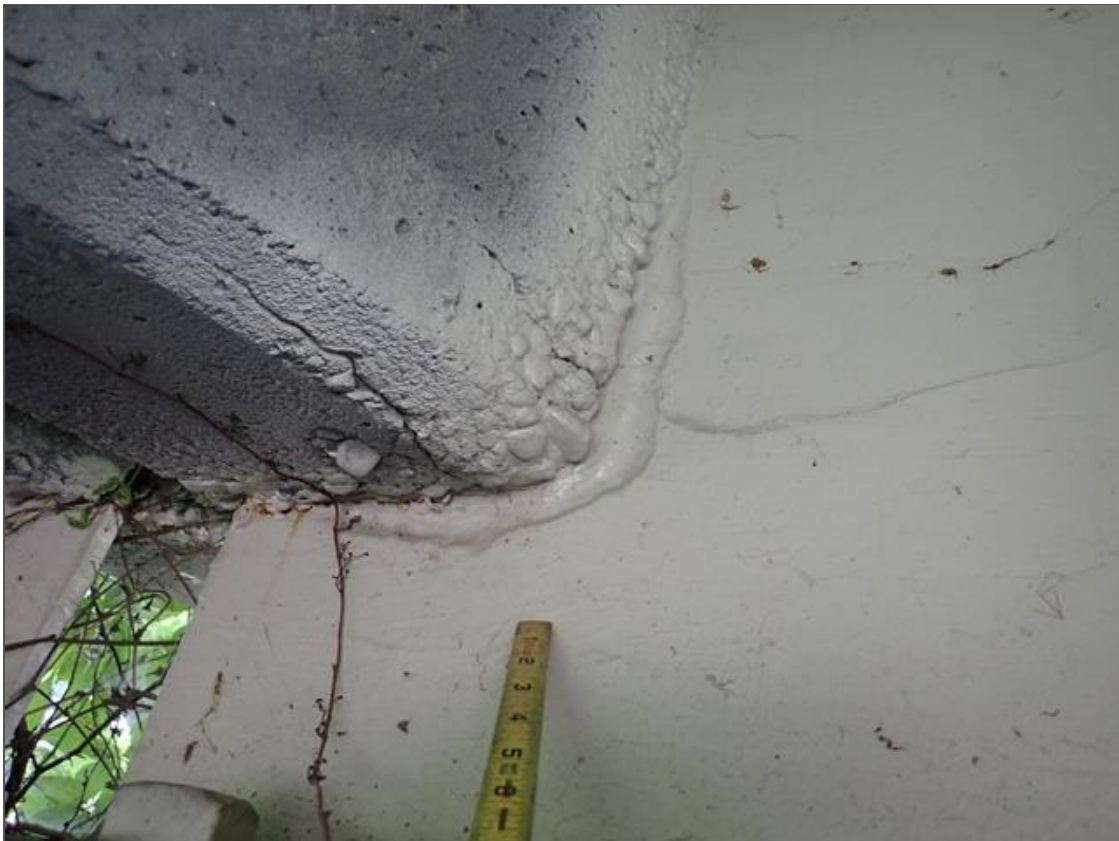
Span 8 Beam 1: (PAR) at bent 7, web adjacent to end diaphragm, painted over section loss (3/8 inch average remaining x 4 inch x 10 inch) with corrosion reactivating

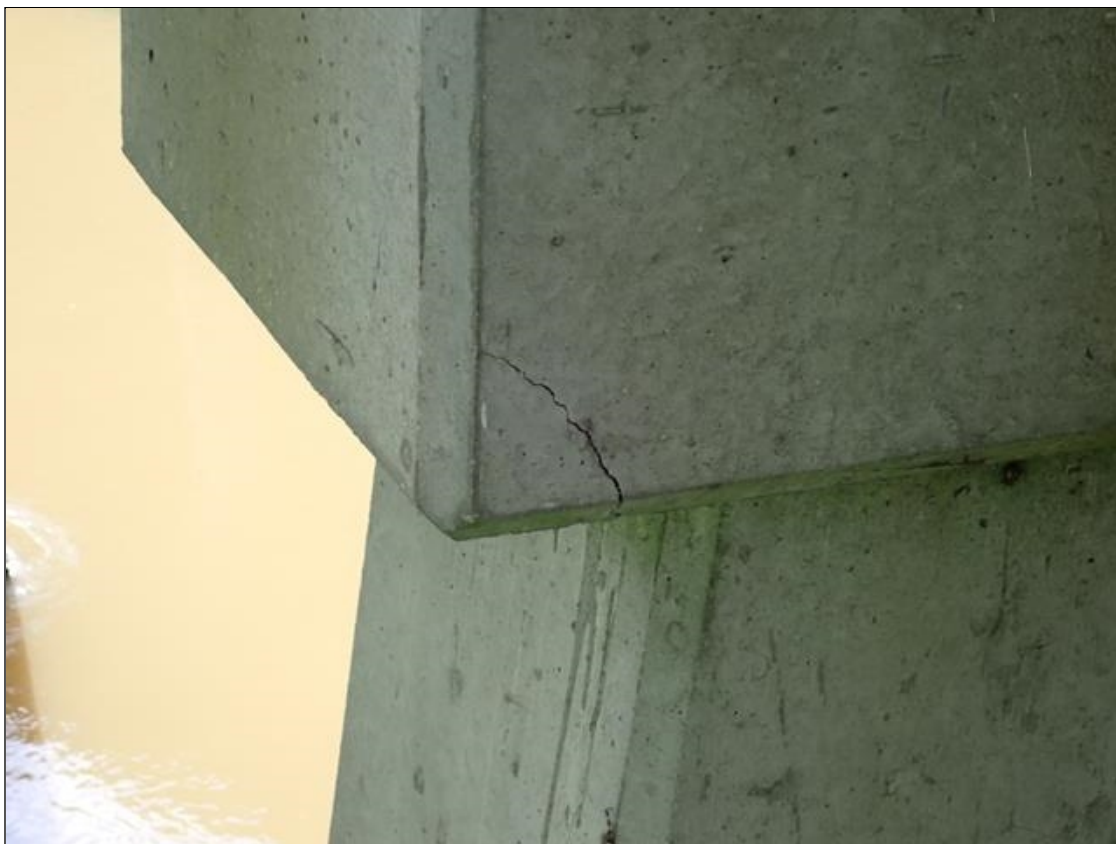
Bent 7 Cap 1: north face at east end, diagonal crack (1/16 inch x 6 inch)

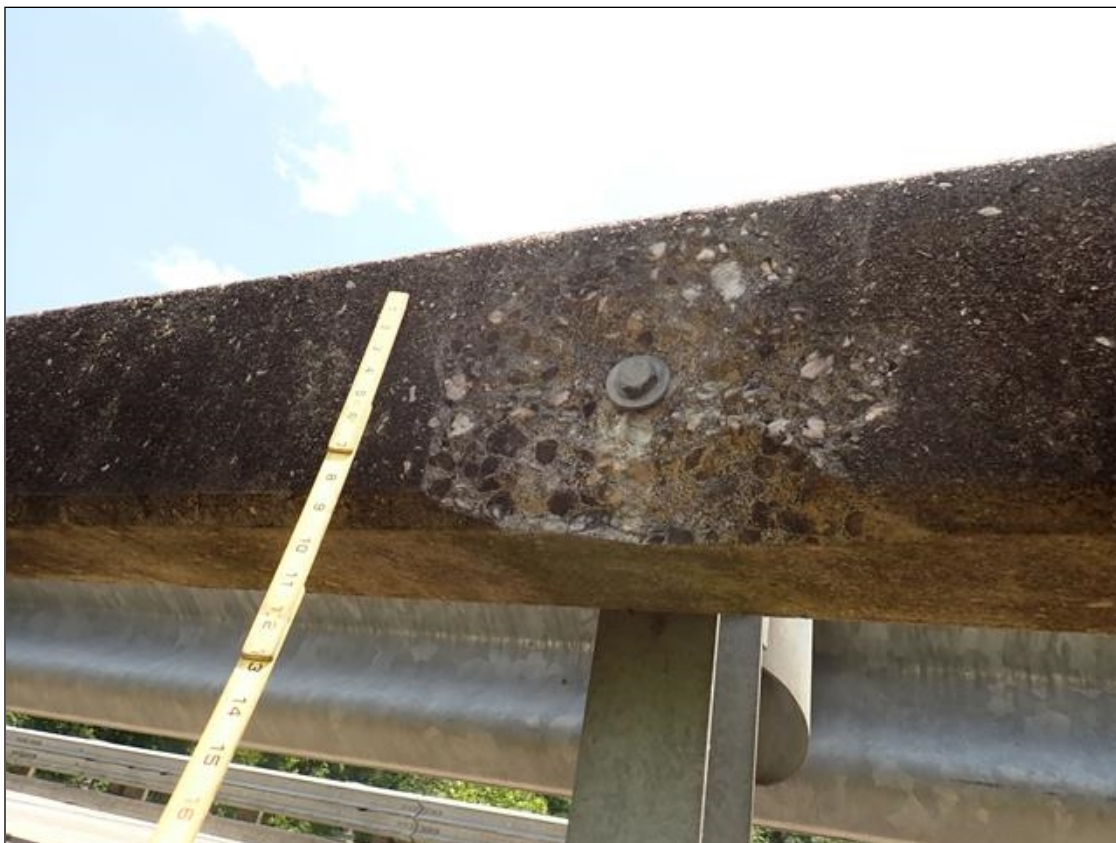
Span 1 Left Bridge Rail: UP TO 8 INCH X 12 INCH X 1.5 INCH DEEP SPALL IN EXTERIOR FACE AT ANCHOR BOLT CONNECTION. TYPICAL AT SEVERAL CONNECTIONS.

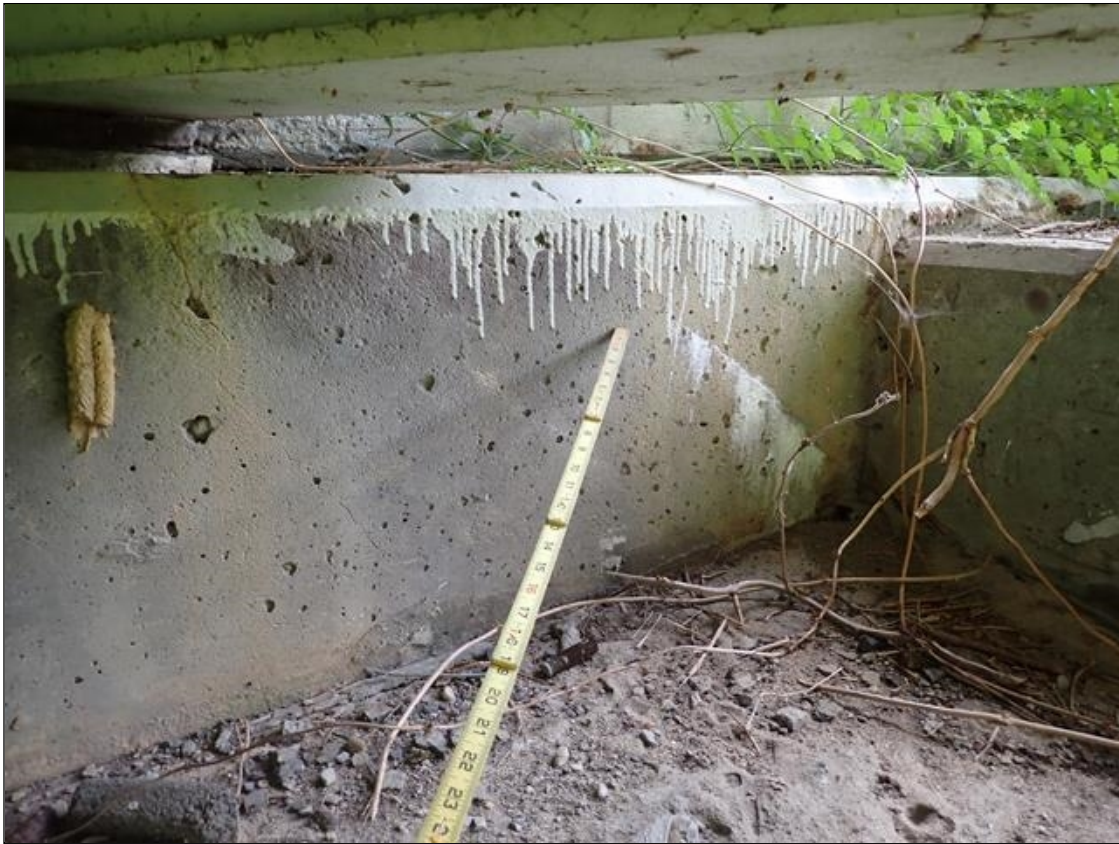
End Bent 1 Cap 1: FOUR (4) DIAGONAL X FULL HEIGHT HAIRLINE CRACKS SOME WITH EFFLORESCENCE IN FACE OF CAP BELOW BAY 1.

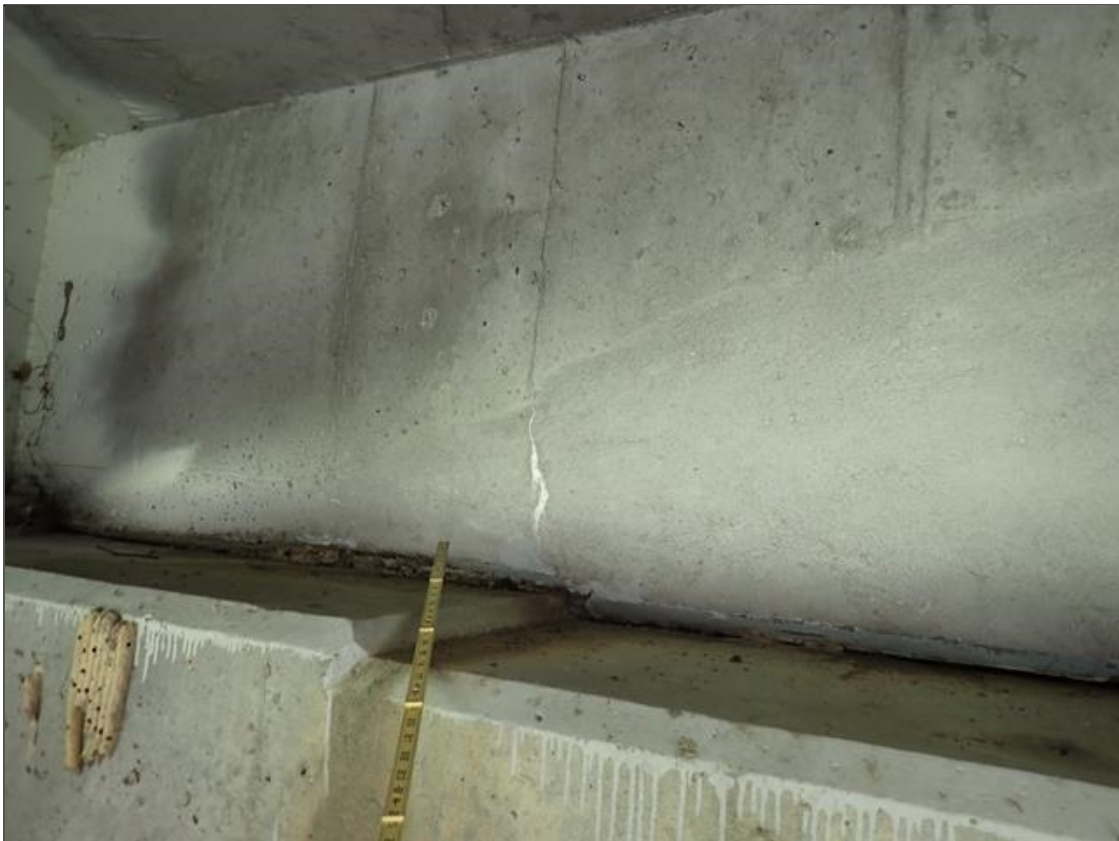
End Bent 1 Abutment: UP TO 3 FEET HIGH X HAIRLINE VERTICAL CRACK WITH EFFLORESCENCE IN BAYS 1 AND 2.

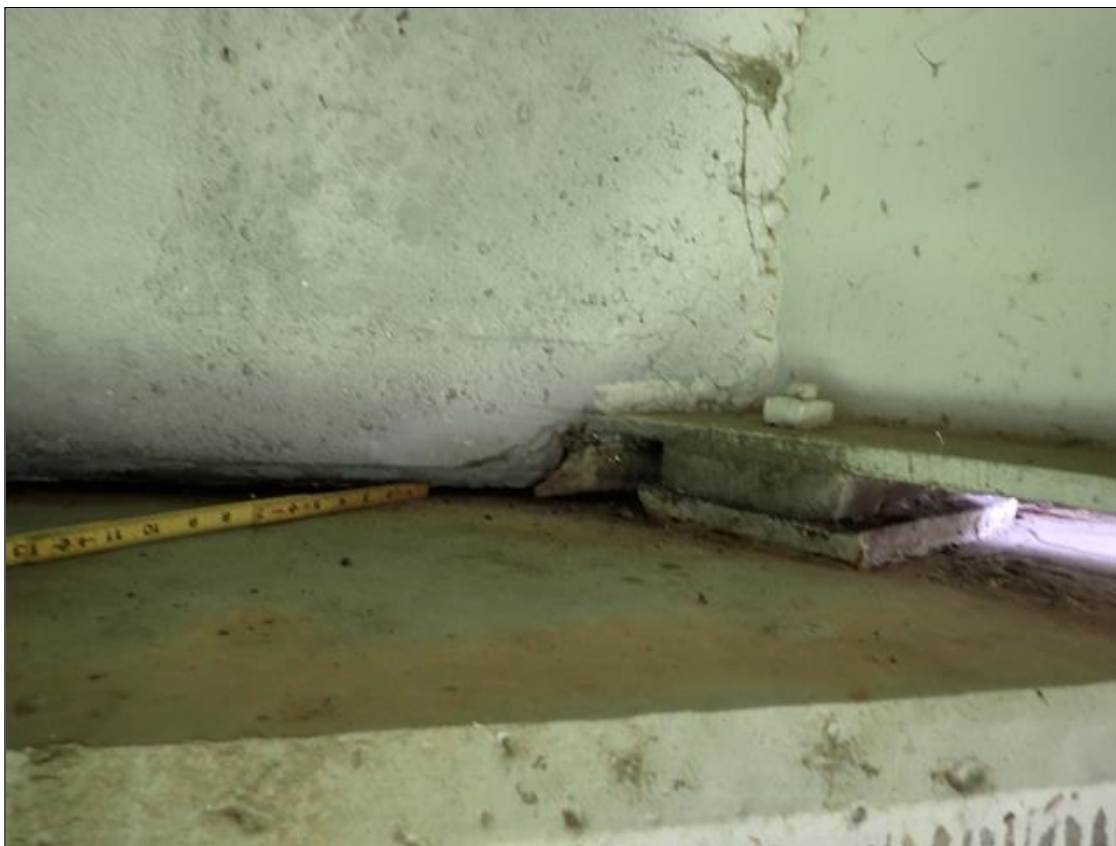
End Bent 1 Abutment: along abutment adjacent to bearings, spalls (up to 12 inch x 6 inch x 2 inch deep)

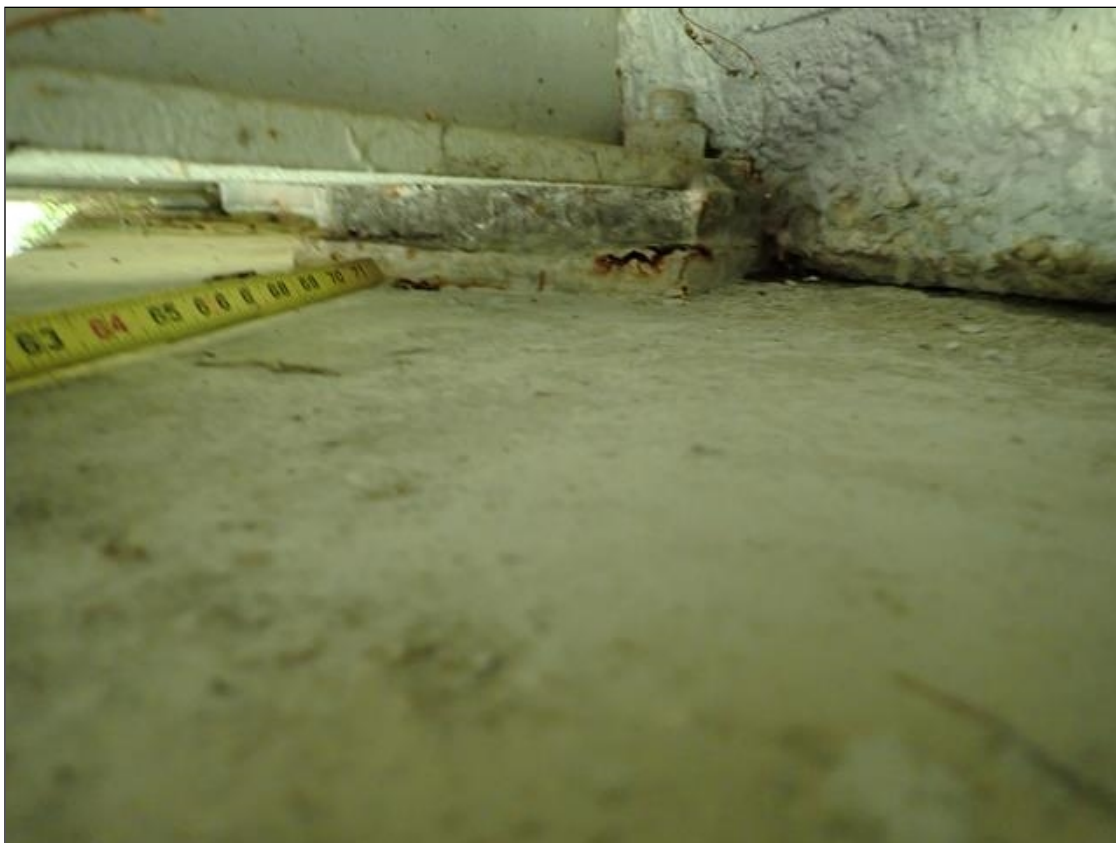
Span 1 Near Bearing 2: painted over section loss (approximately 80 percent remaining) with corrosion reactivating

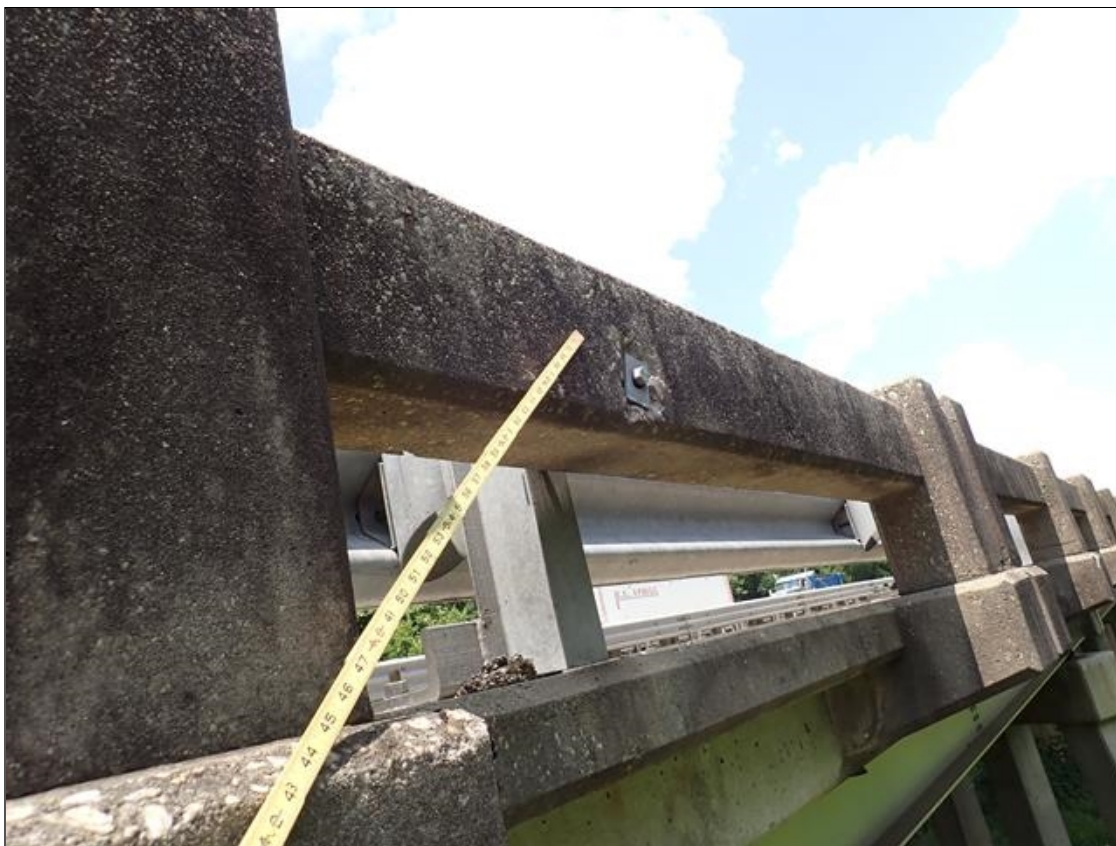
Span 1 Right Bridge Rail: UP TO 6 INCH DIAMETER X 1.5 INCH DEEP SPALL IN EXTERIOR FACE AT ANCHOR BOLT CONNECTION. TYPICAL AT SEVERAL CONNECTIONS.

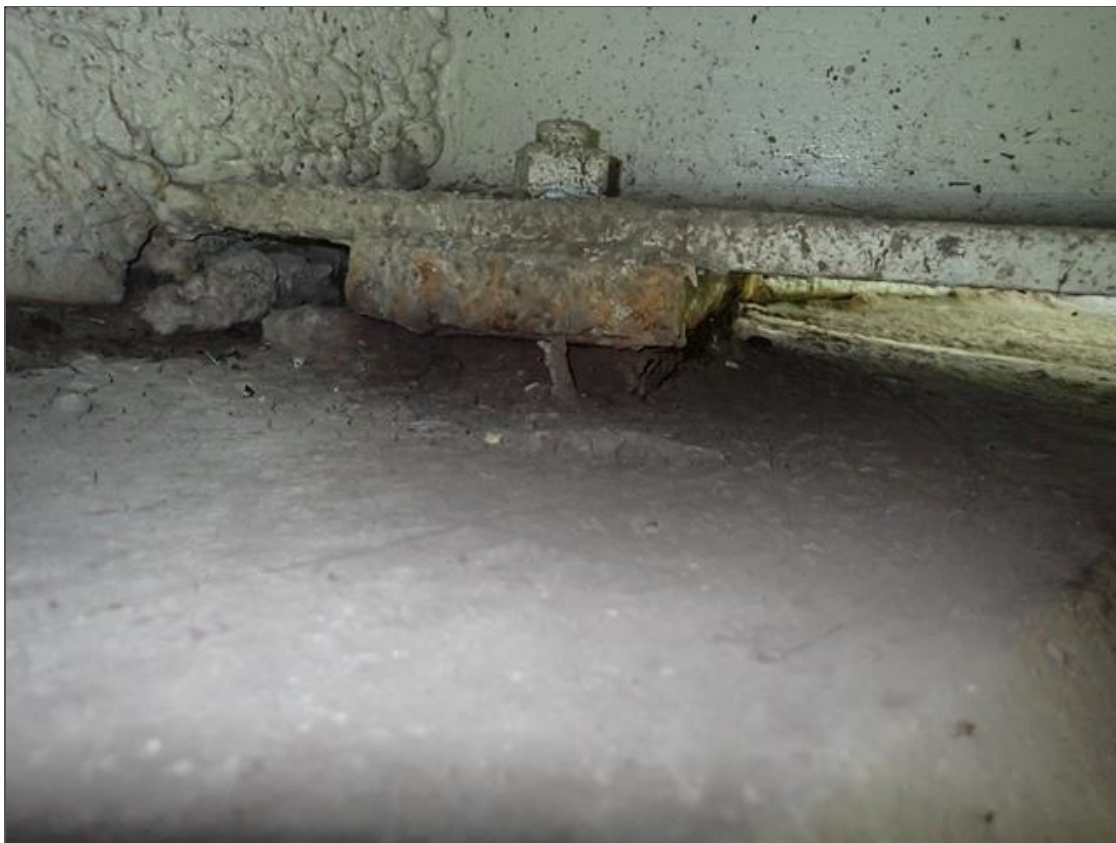
Span 8 Far Bearing 4: corrosion with section loss (approximately 80 percent remaining)

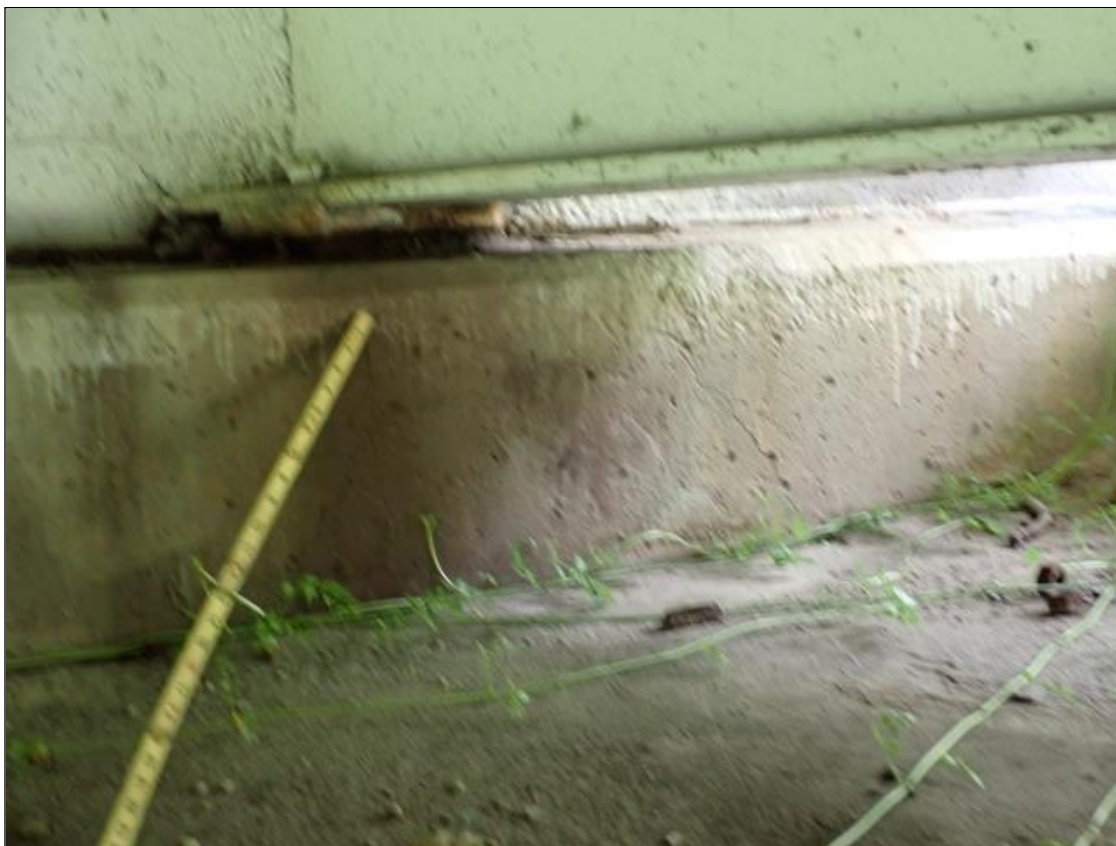
End Bent 2 Cap 1: 2 FEET HIGH X 1/32 INCH WIDE DIAGONAL CRACK UNDER BEAM 4.
