NC DEPARTMENT OF TRANSPORTATION  
 DIVISION OF HIGHWAYS  
 STRUCTURE MANAGEMENT UNIT  
 COUNTY: JOHNSTON DIV: 4

ATTENTION:  PARS Submitted  Sign Notice Issued  
 sketches revised; new repairs

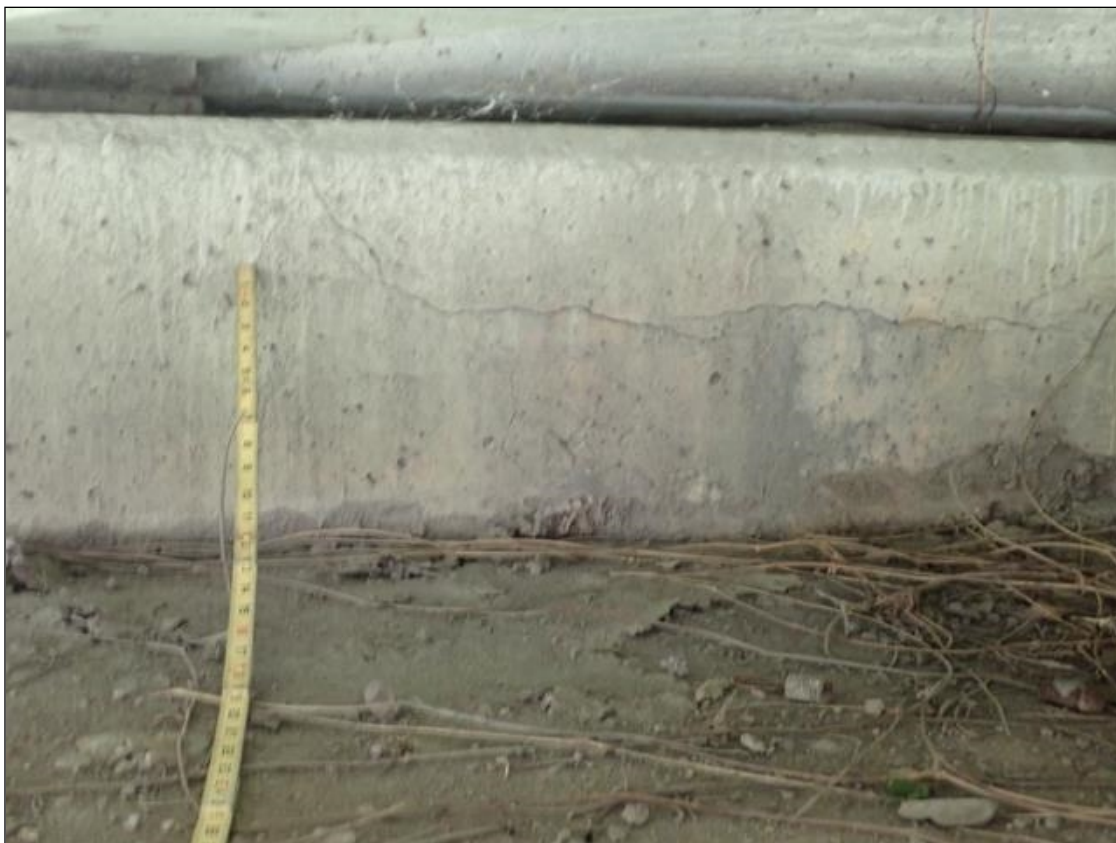
End Bent 2 Cap 1: UP TO 3 FEET LONG X 1/16 INCH WIDE HORIZONTAL CRACK, BELOW BEAM 2. TYPICAL AT BEAM 3.

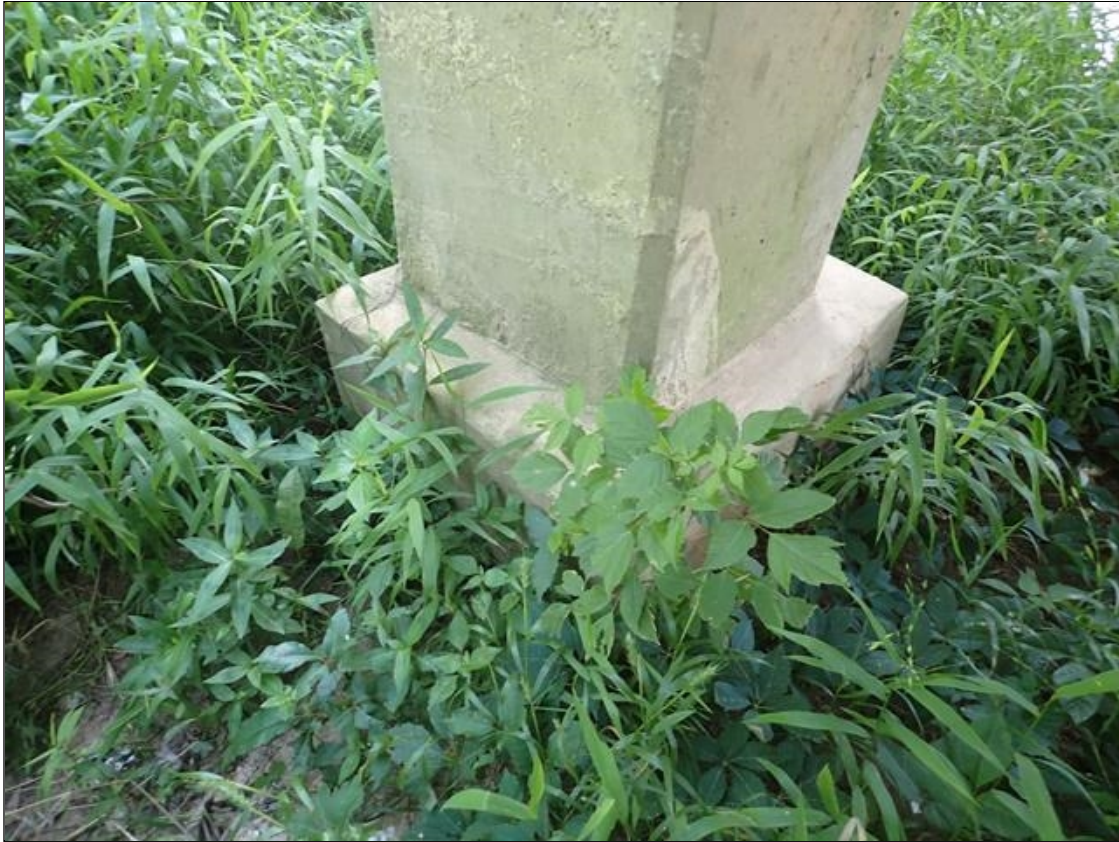
Bent 7 Pile 7: 15 INCHES WIDE X 10 INCHES HIGH AREA OF THE SOUTH FLANGE EXHIBITS SURFACE CORROSION WITH SECTION LOSS ON WEB AND FLANGES OF EXPOSED STEEL PILE AT GROUNDLINE. UP TO 0.50 INCH SECTION REMAINING. NORTH FLANGE AND THE WEB EXHIBIT SURFACE CORROSION WITH NO MEASUREABLE SECTION LOSS. CONCRETE REPAIR AT BASE OF PILE COVERS STEEL PILE.

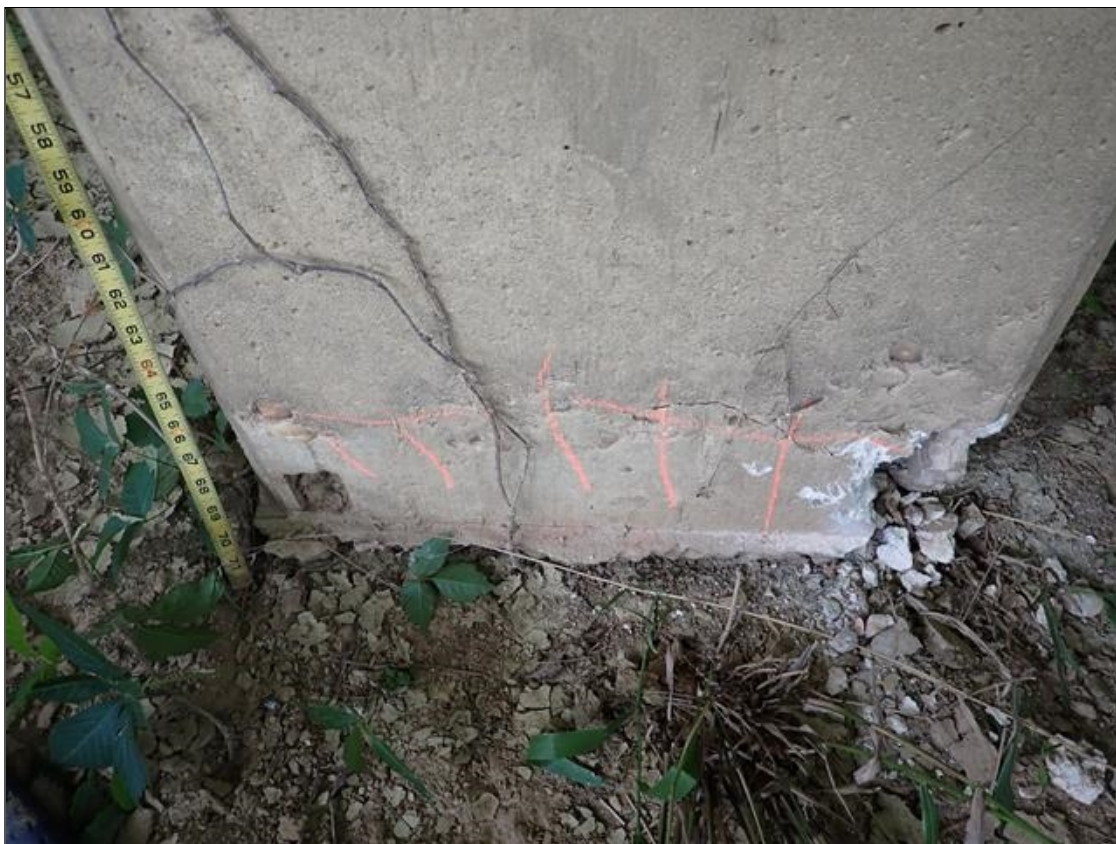
Bent 7 Pile 6: UP TO 3 INCHES HIGH OF THE STEEL PILE EXPOSED AT THE BOTTOM EXHIBITS SURFACE CORROSION WITH NO MEASUREABLE SECTION LOSS IN THE FLANGES AND WEB. CONCRETE REPAIR AT BASE OF PILE COVERS STEEL PILE; AT BASE, SOUTH FACE, DELAMINATION/SPALL (22 INCH X 6 INCH X 3 INCH DEEP)

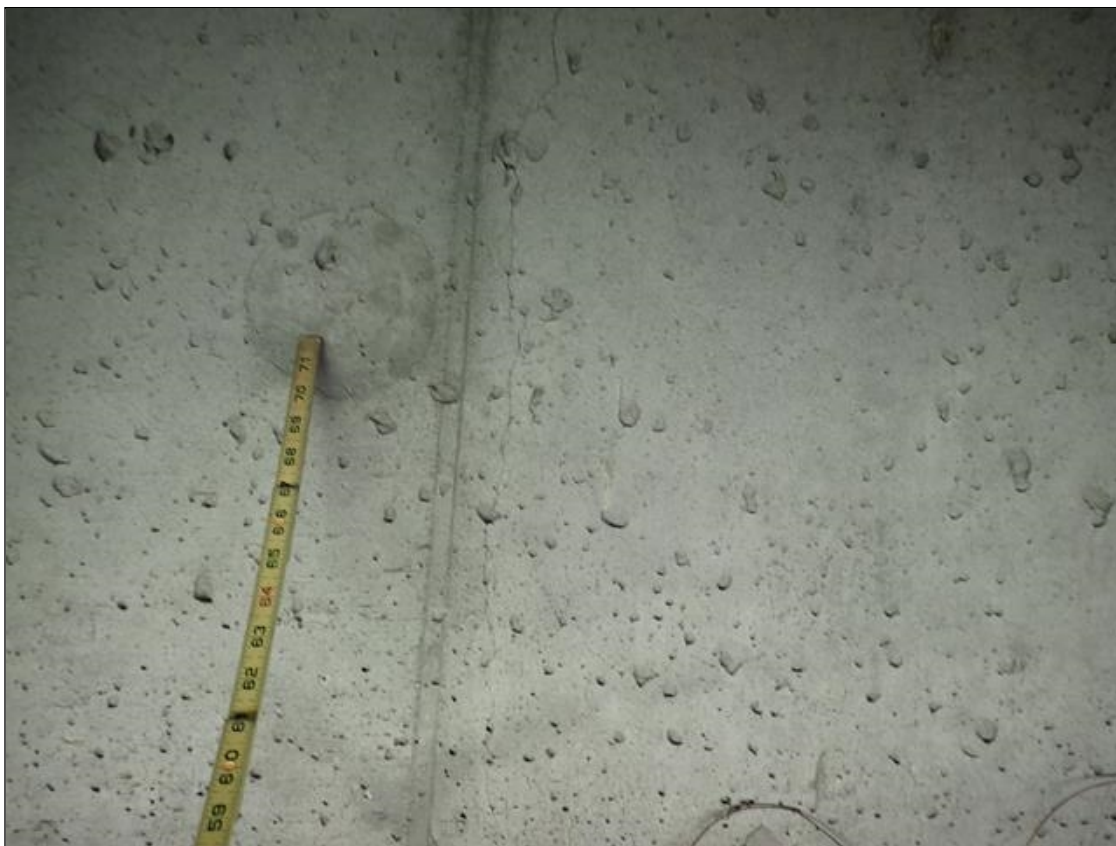
End Bent 2 Abutment: 4 FEET HIGH X UP TO 0.05 INCH WIDE VERTICAL AND HORIZONTAL CRACKS IN ALL BAYS

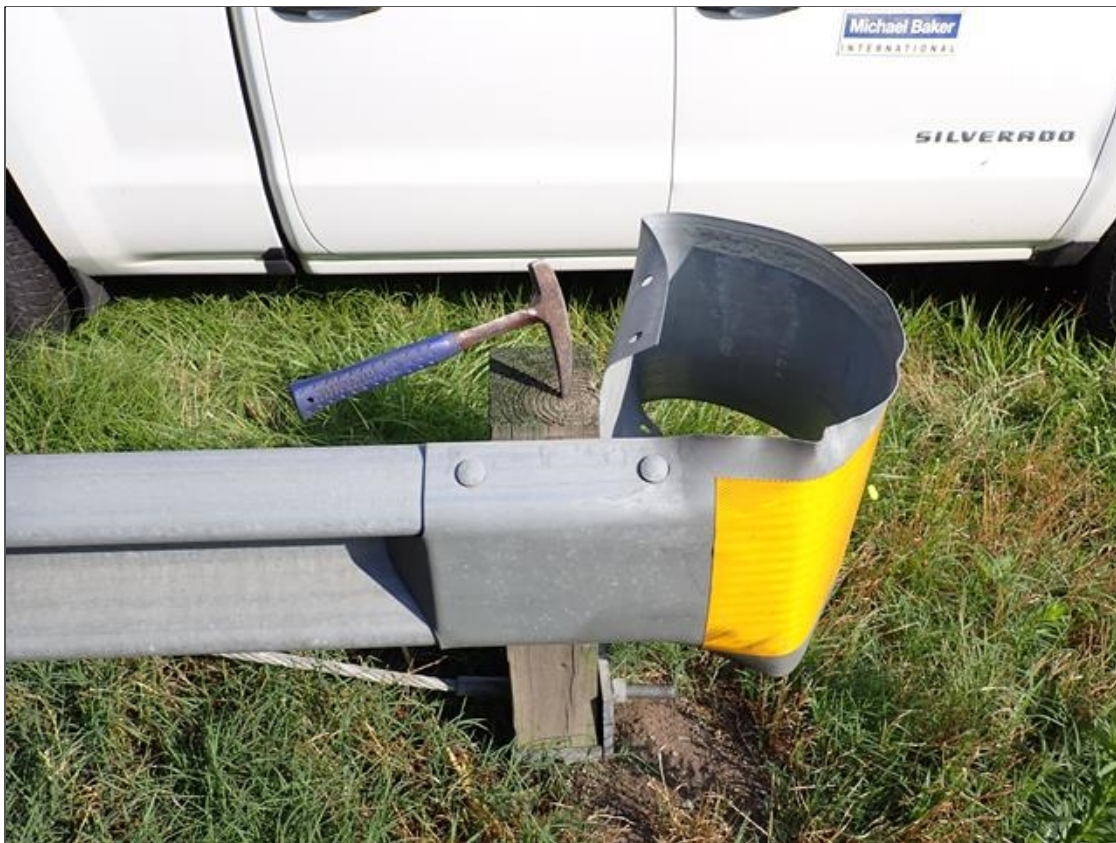
(PAR) northwest guardrail termination, impact damage

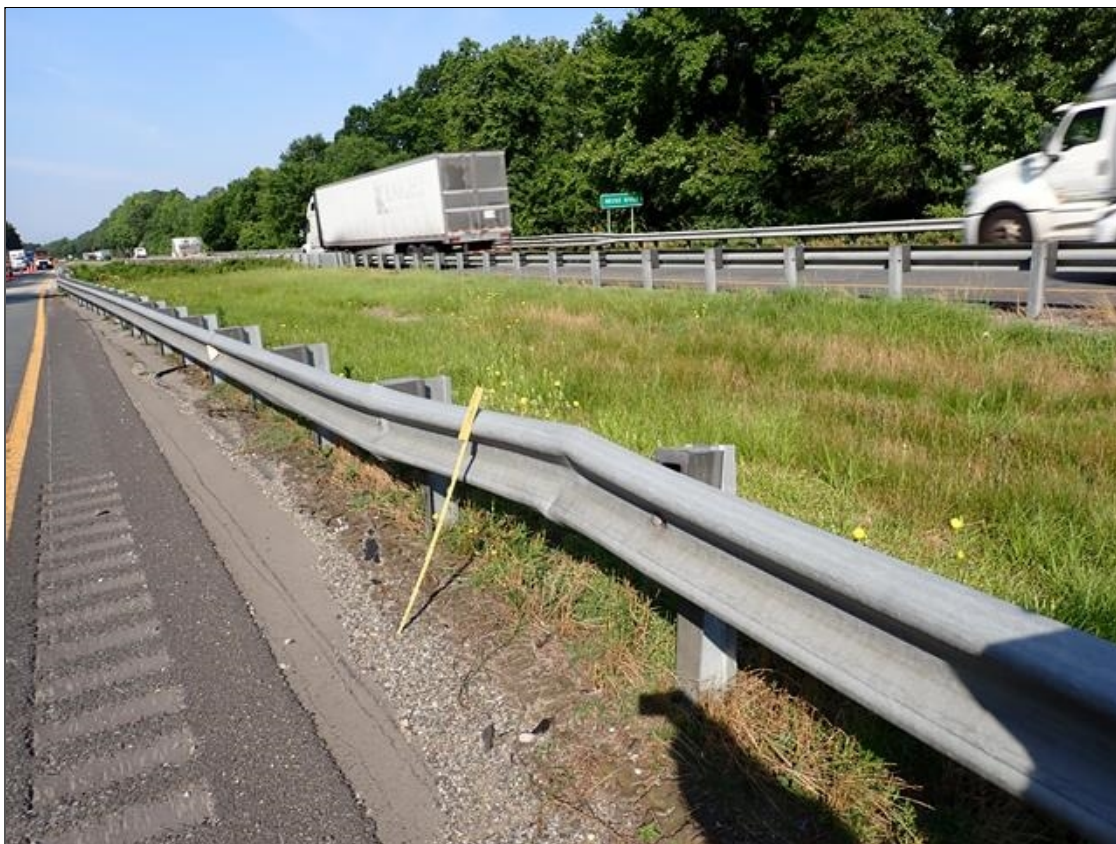
(PAR) northwest guardrail, approximately 60 foot from bridge, impact damage (10 foot)

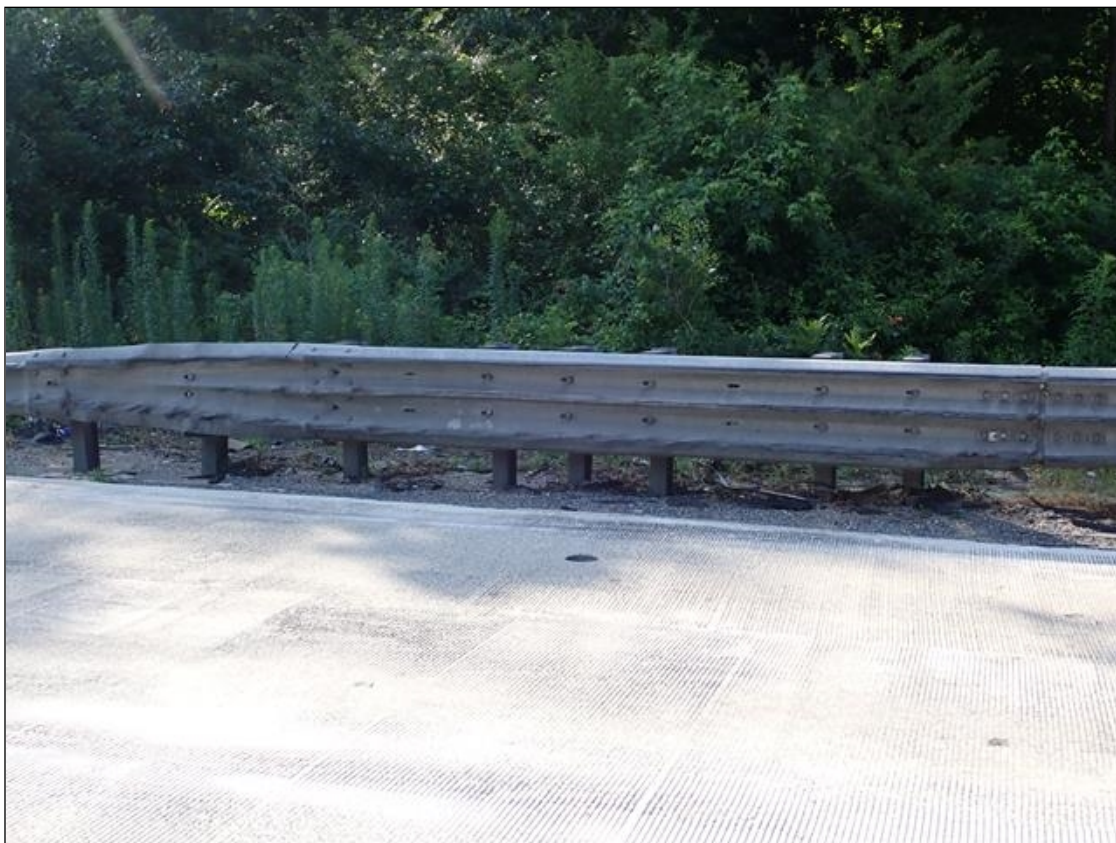
(PAR) northeast guardrail, starting at bridge, impact damage (50 foot)

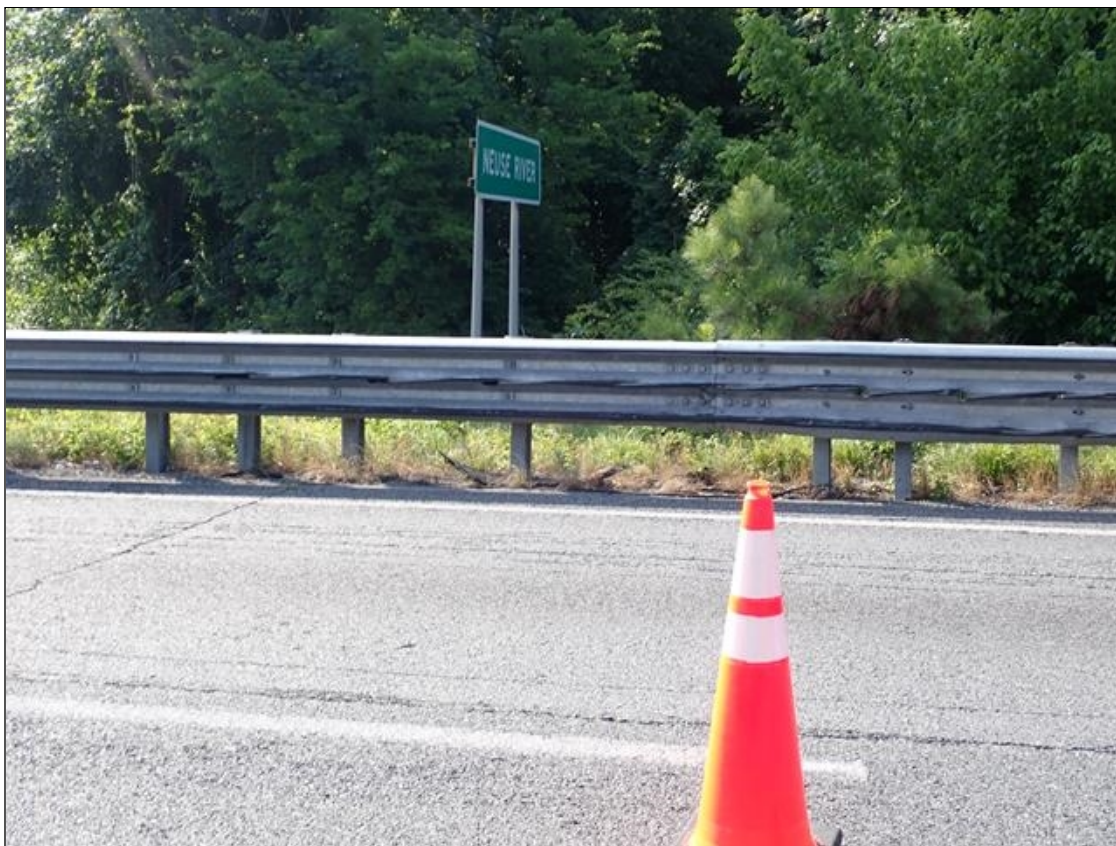
(PAR) southeast guardrail, starting at bridge, impact damage (30 foot)

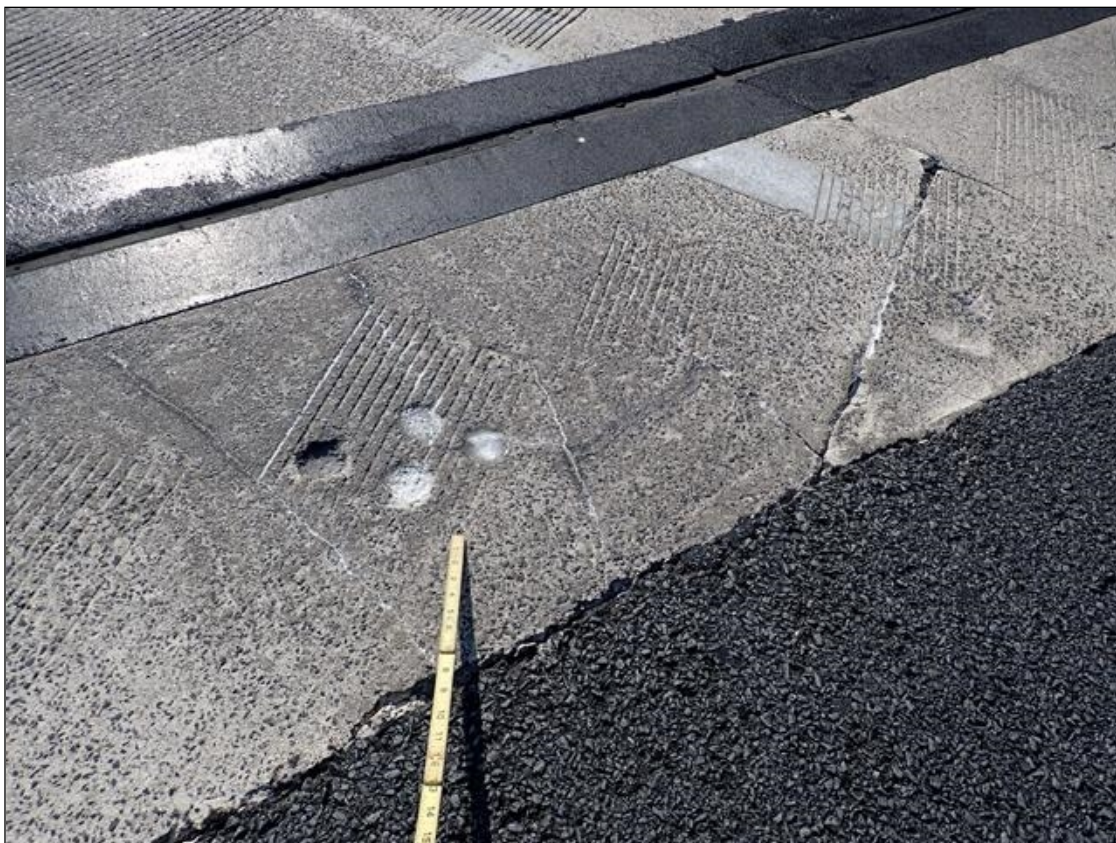
Approach 1: throughout slab, longitudinal and transverse cracks (up to 1/32 inch x 4 foot) some with efflorescence at random

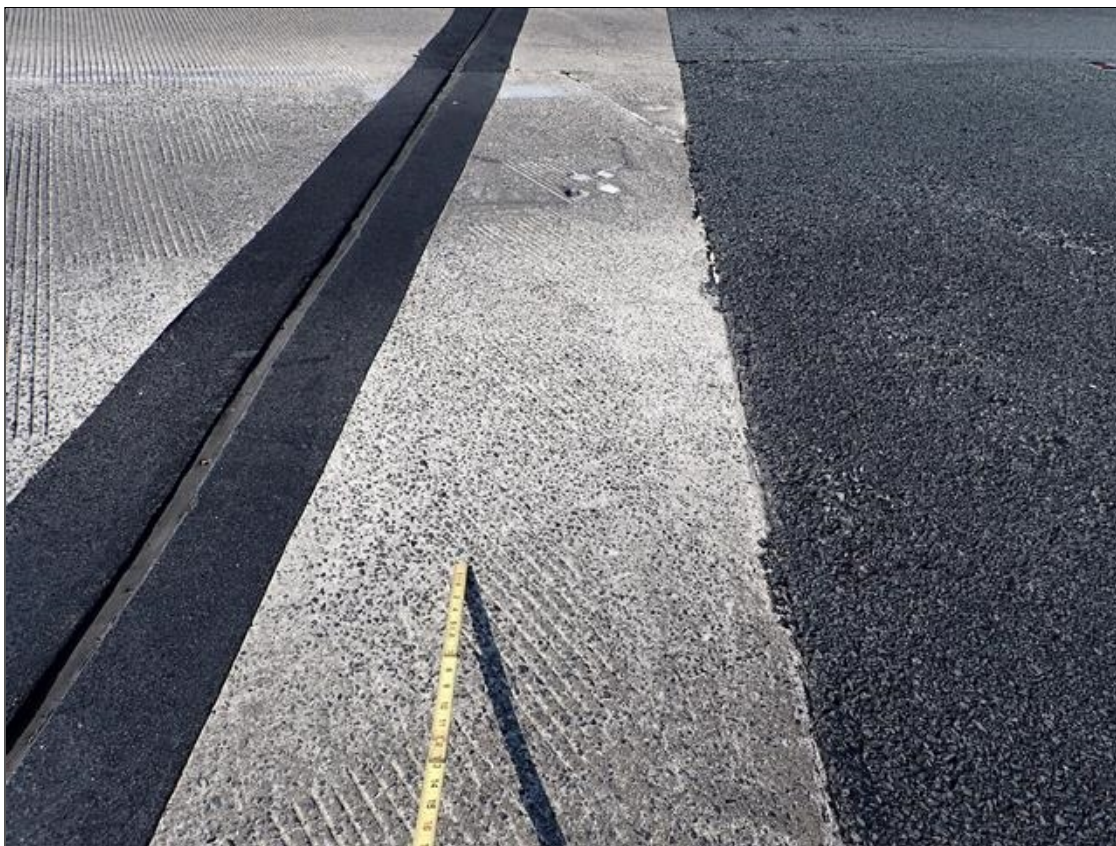
Approach 1: throughout slab, wear with secure aggregate at random

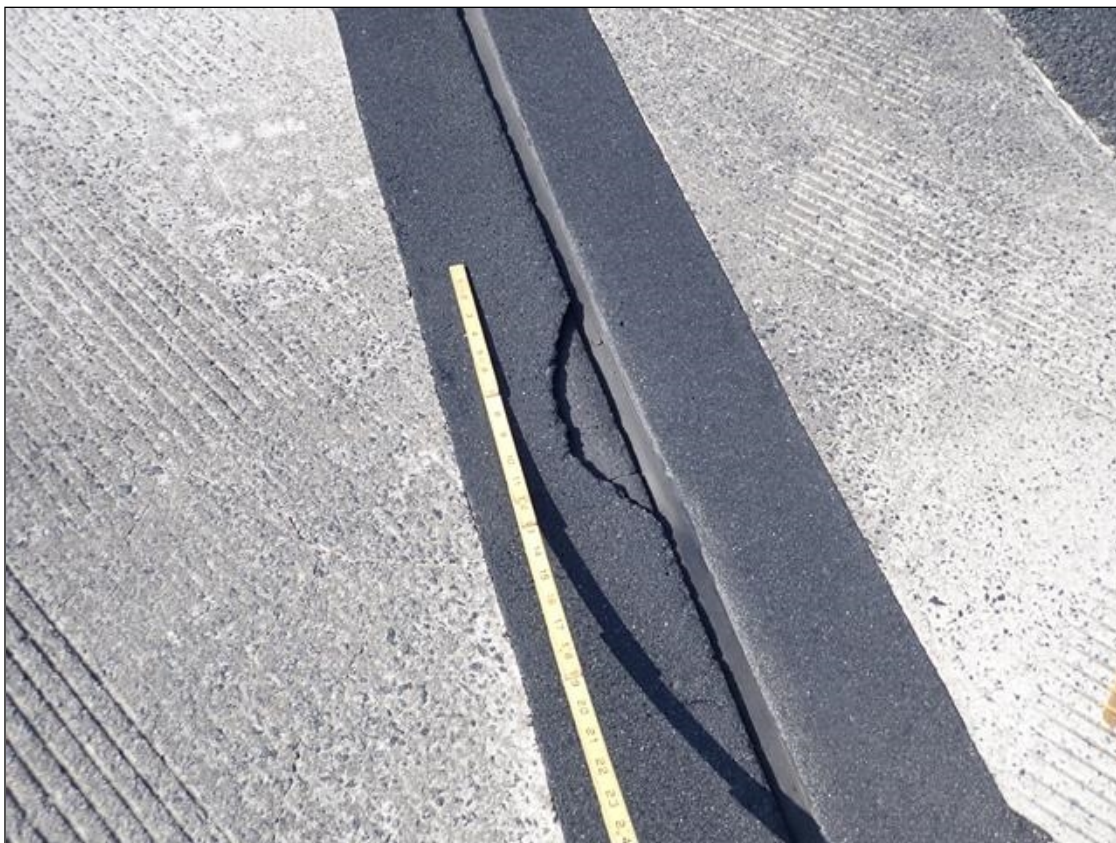
Span 1 End bent 1 Joint: span 1 side, in left travel lane near yellow line, spall/settlement (12 inch x 3 inch x 3/8 inch deep)

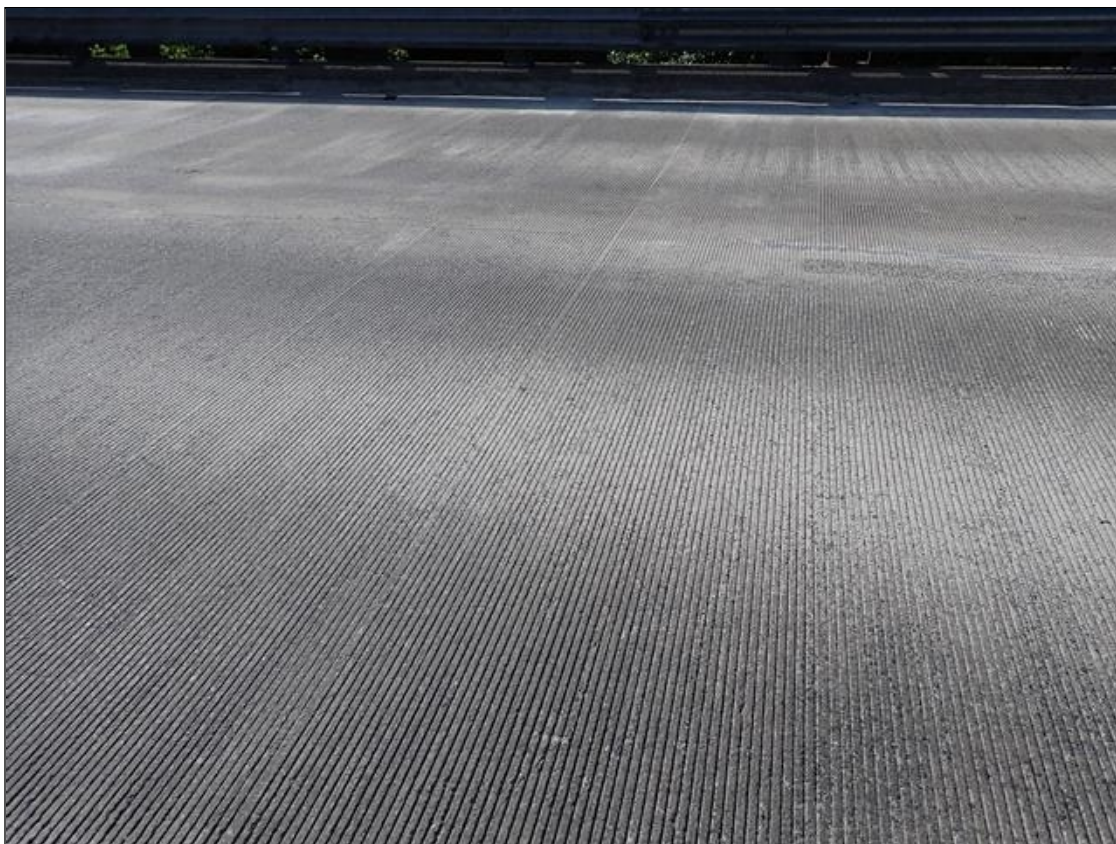
Span 1 Deck: throughout top of deck, wear with secure aggregate at random

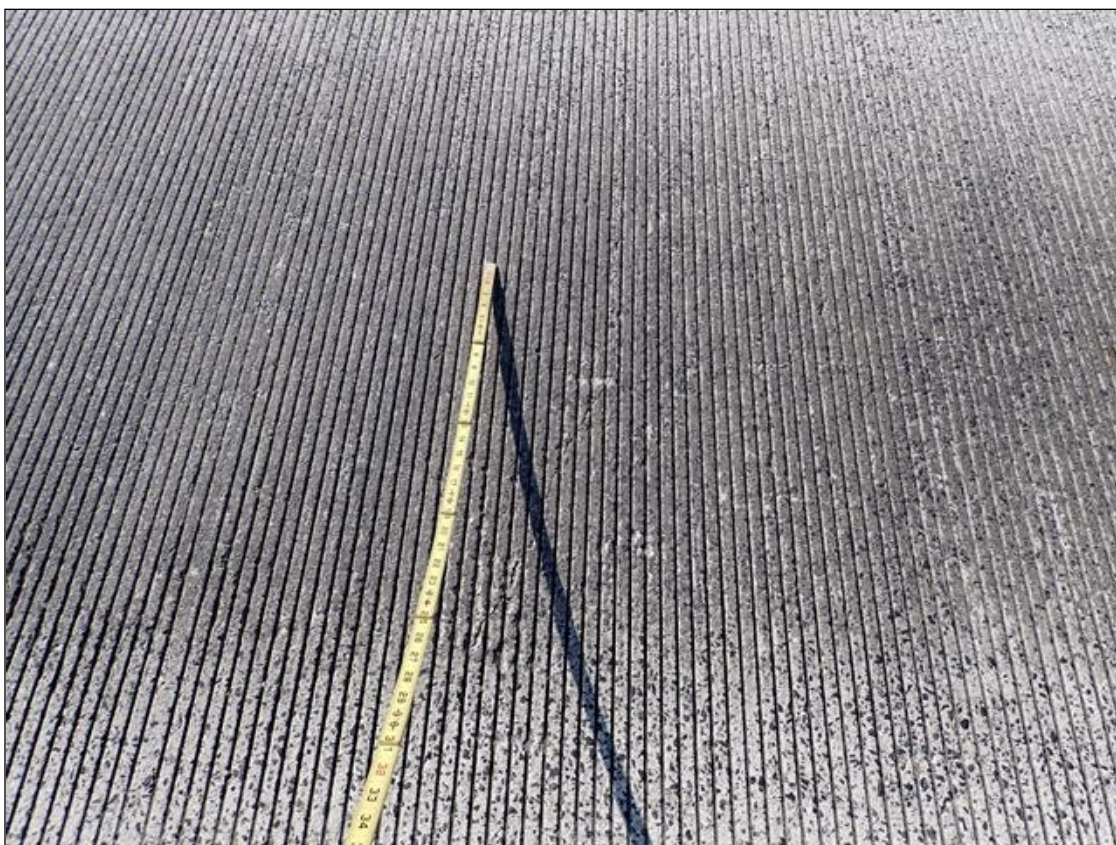
Span 1 Deck: throughout top of deck, areas of map cracks (up to 1/32 inch) at random

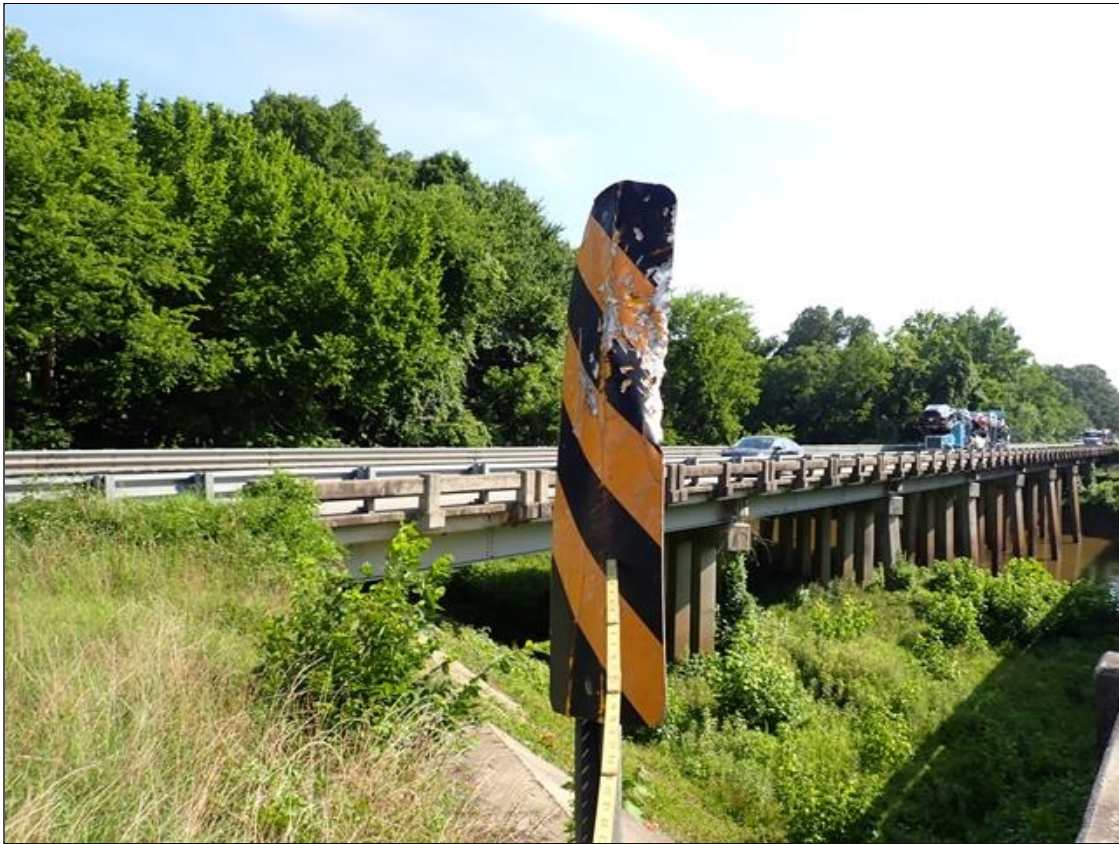
Span 1 Southwest Delineator: (PAR) IMPACT DAMAGE TO SIGN WITH SCRAPING AND DISTORTIONS.

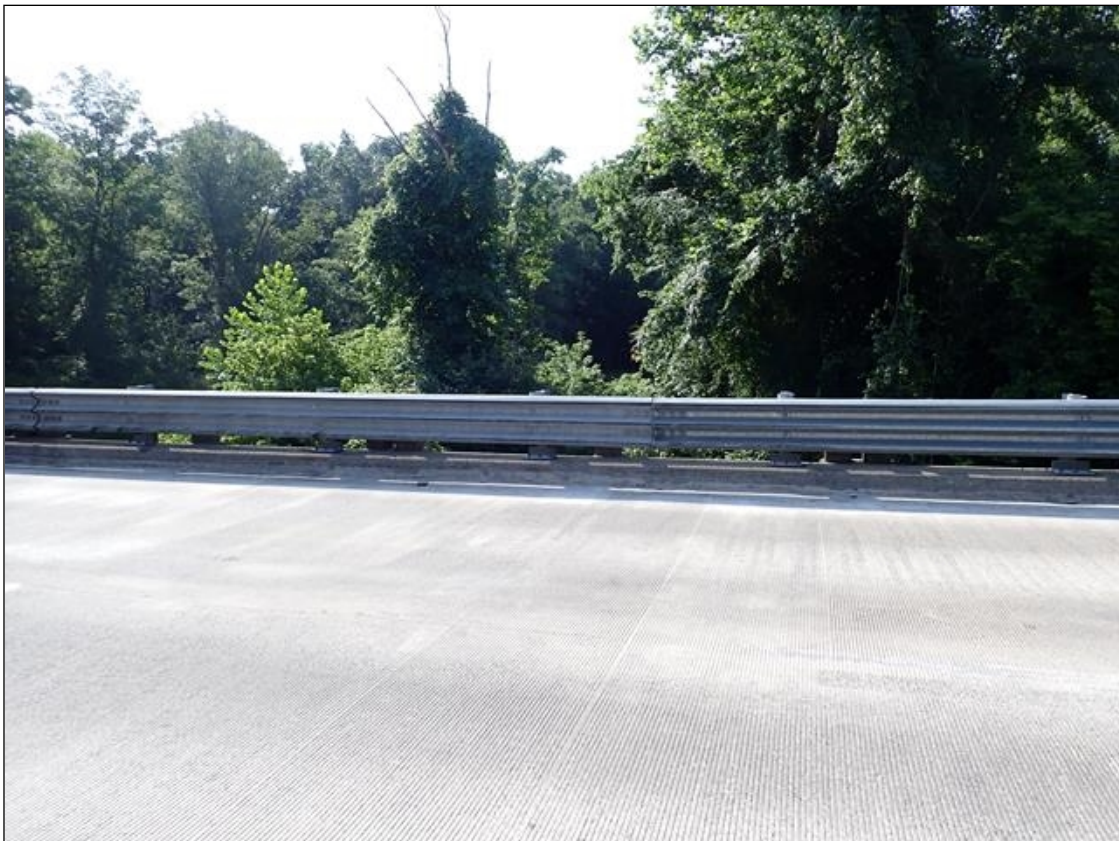
Span 1 Right Retrofit Bridge Rail: (PAR) IMPACT DAMAGE WITH SCRAPE MARKS AND THROUGH HOLES UP TO 3 INCH X 2 INCH IN RETROFIT RAIL AT SCATTERED LOCATIONS

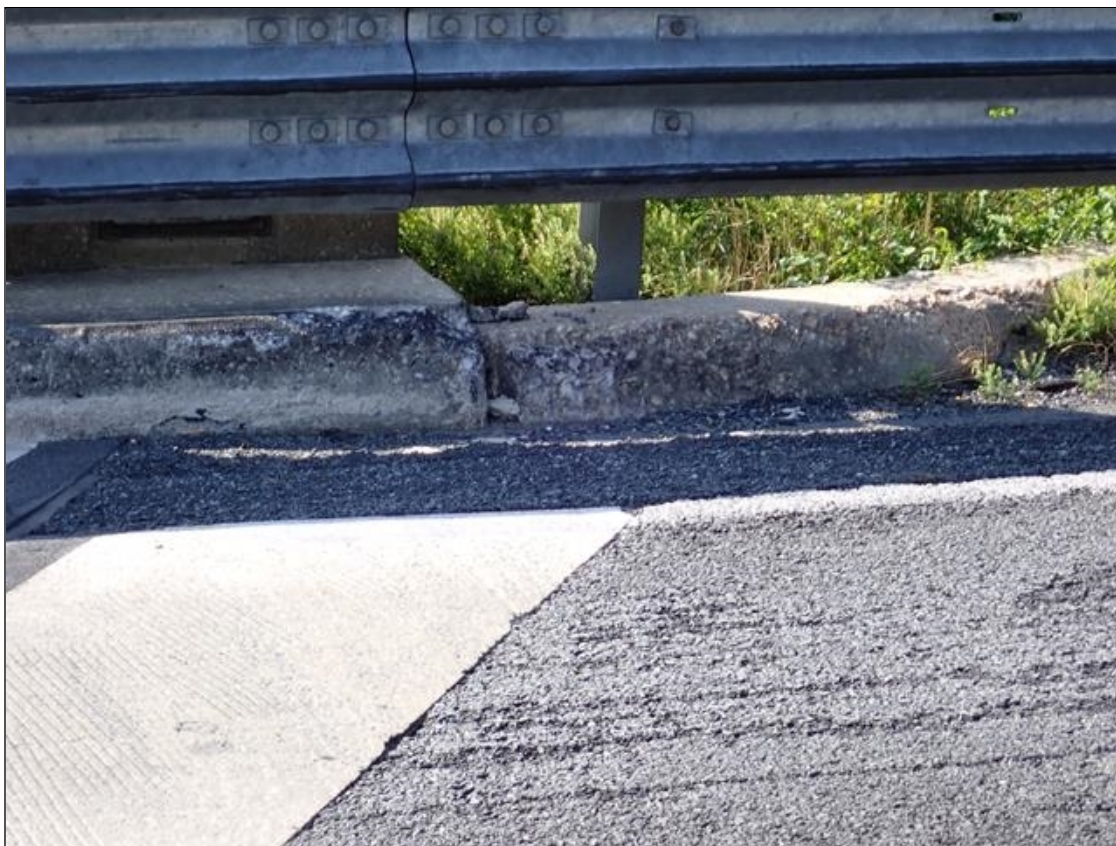
Span 1 Right Bridge Rail: AT END BENT 1, 2 SPALLS IN RAIL AND TOP OF CURB, 1 FOOT LONG X UP TO 4 INCHES X 2 INCHES DEEP

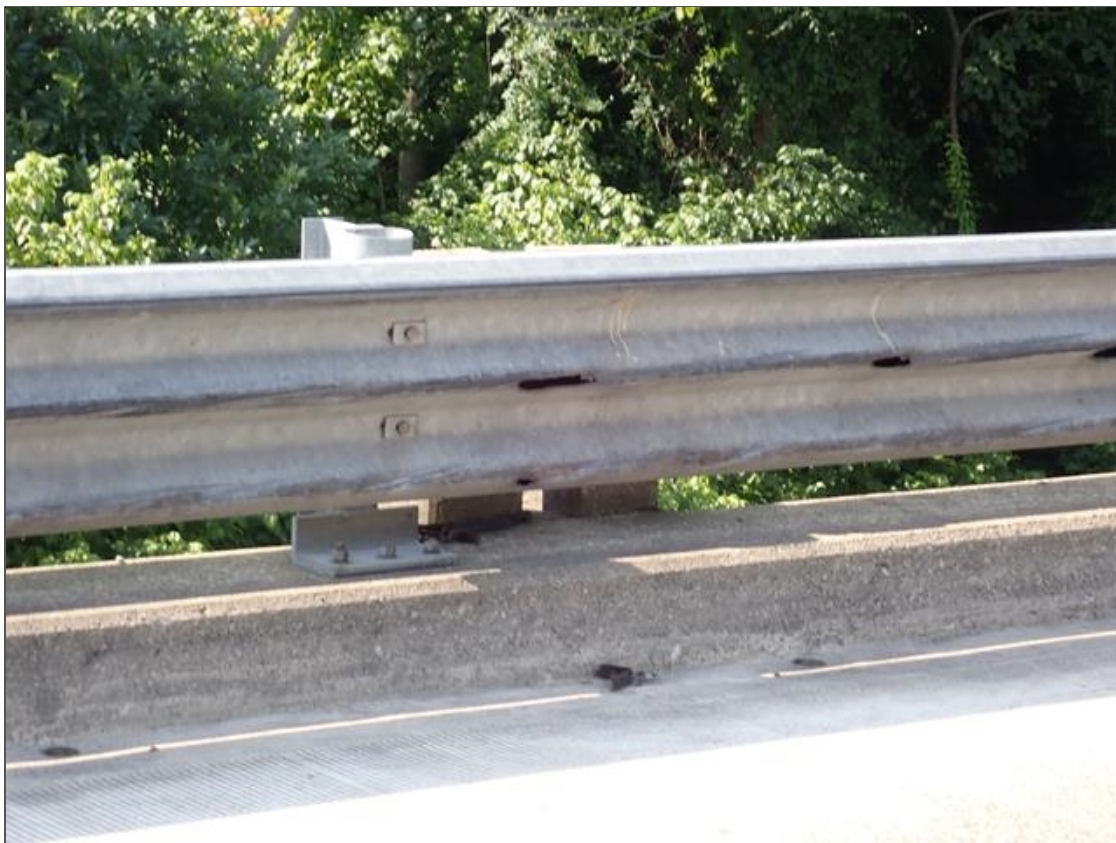
Span 2 Right Retrofit Bridge Rail: (PAR) IMPACT DAMAGE WITH SCRAPE MARKS AND THROUGH HOLES UP TO 3 INCH X 2 INCH IN RETROFIT RAIL AT SCATTERED LOCATIONS

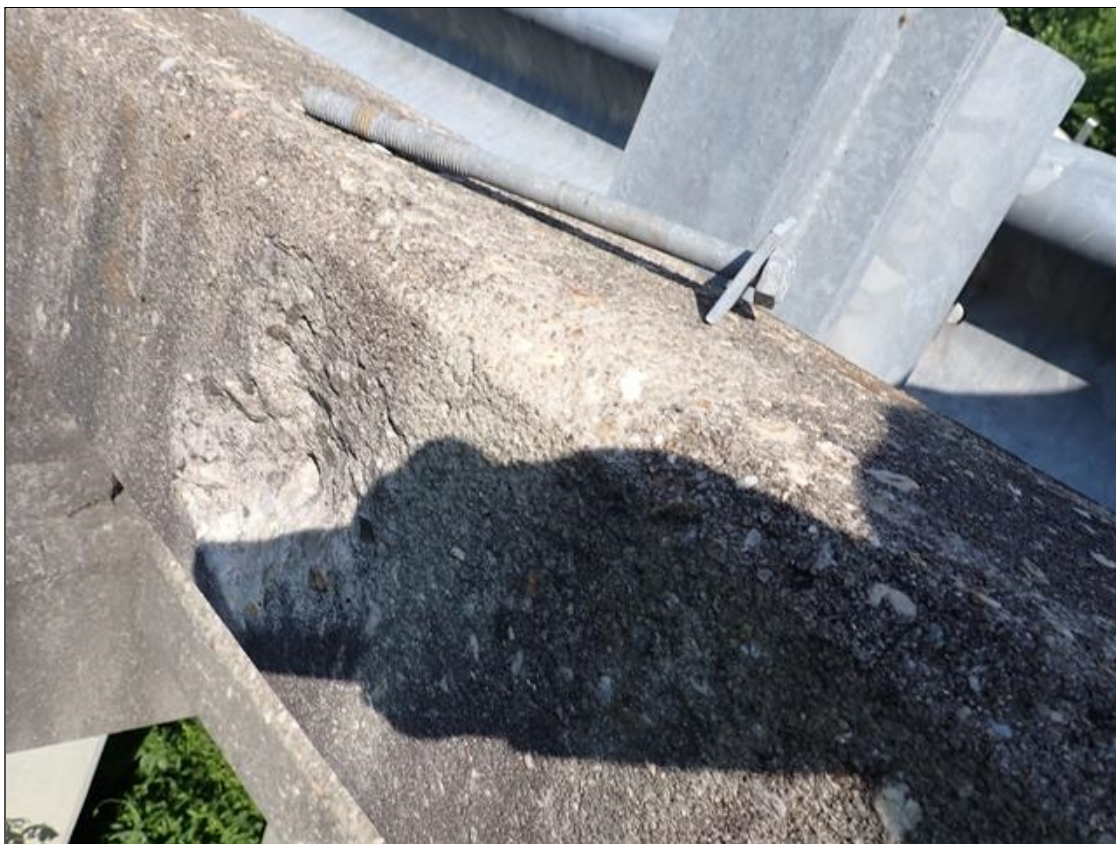
Span 2 Right Retrofit Bridge Rail: (PAR) BOLT HAS DETACHED FROM CONCRETE OUTER RAIL 10 FEET FROM BENT 1 LEAVING METAL INNER RAIL FREE

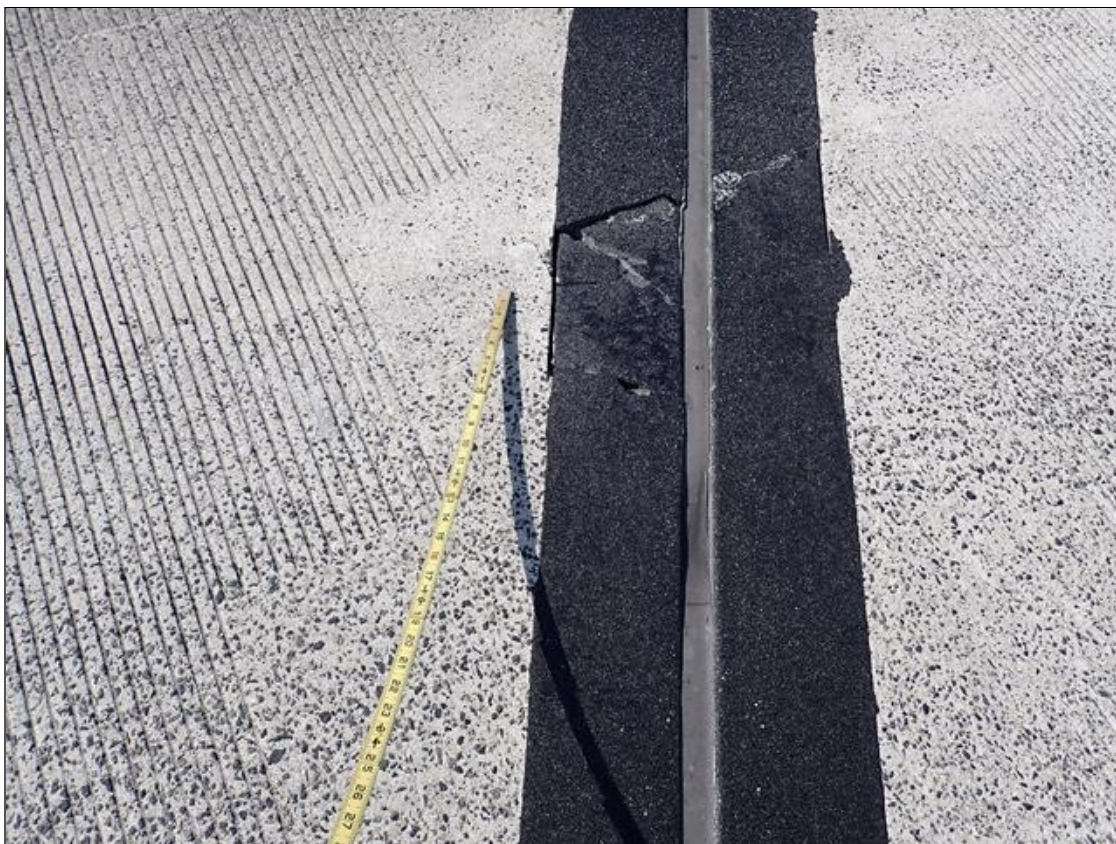
Span 3 Bent 2 Joint: span 3 side, at centerline, area of broken/cracked header with settlement (14 inch x 8 inch x 1/2 inch deep)

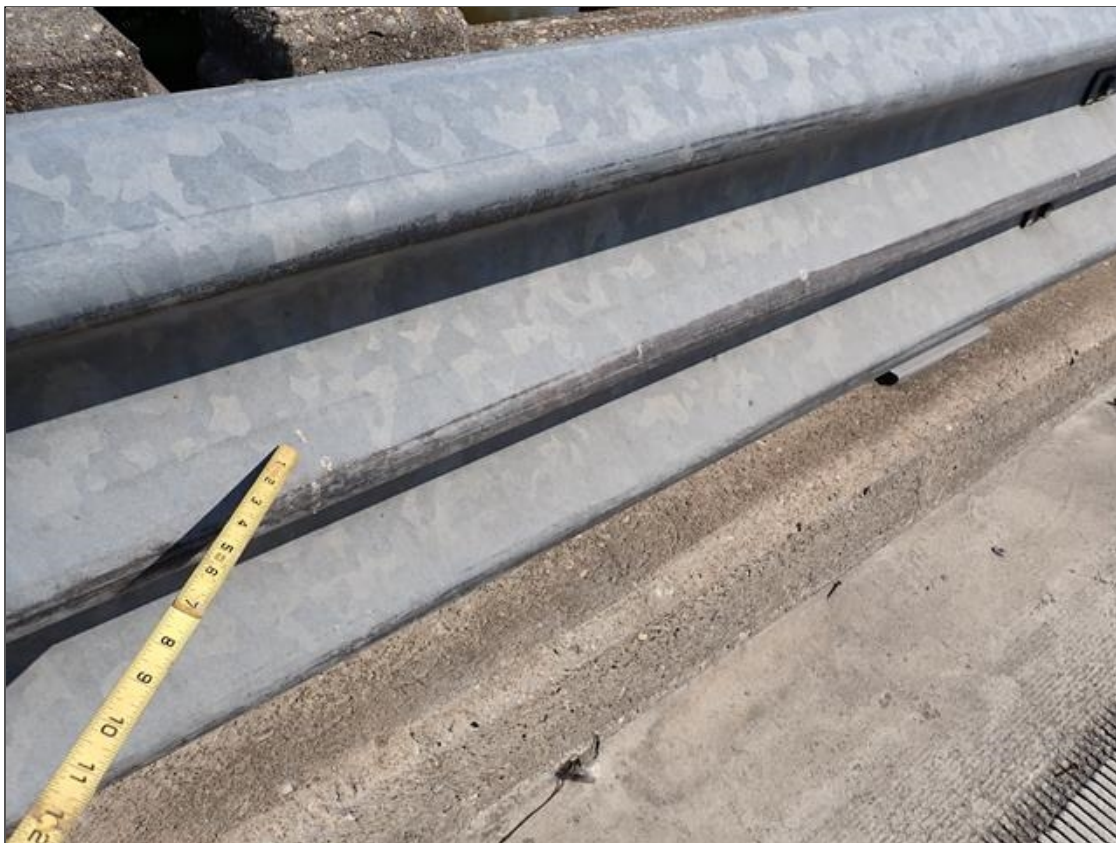
Span 3 Left Retrofit Bridge Rail: along the length of the rail, impact scrapes at random

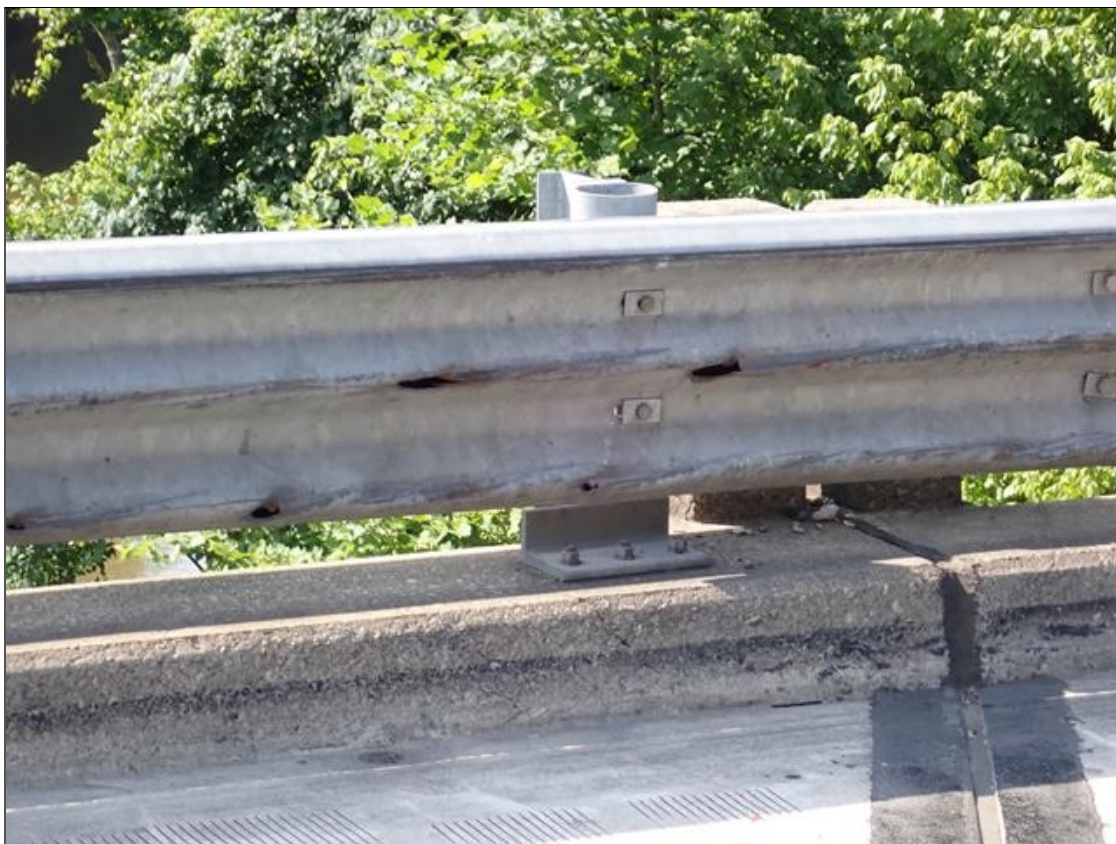
Span 3 Right Retrofit Bridge Rail: (PAR) IMPACT DAMAGE WITH SCRAPE MARKS AND THROUGH HOLES UP TO 4 INCH X 2 INCH IN RETROFIT RAIL AT SCATTERED LOCATIONS

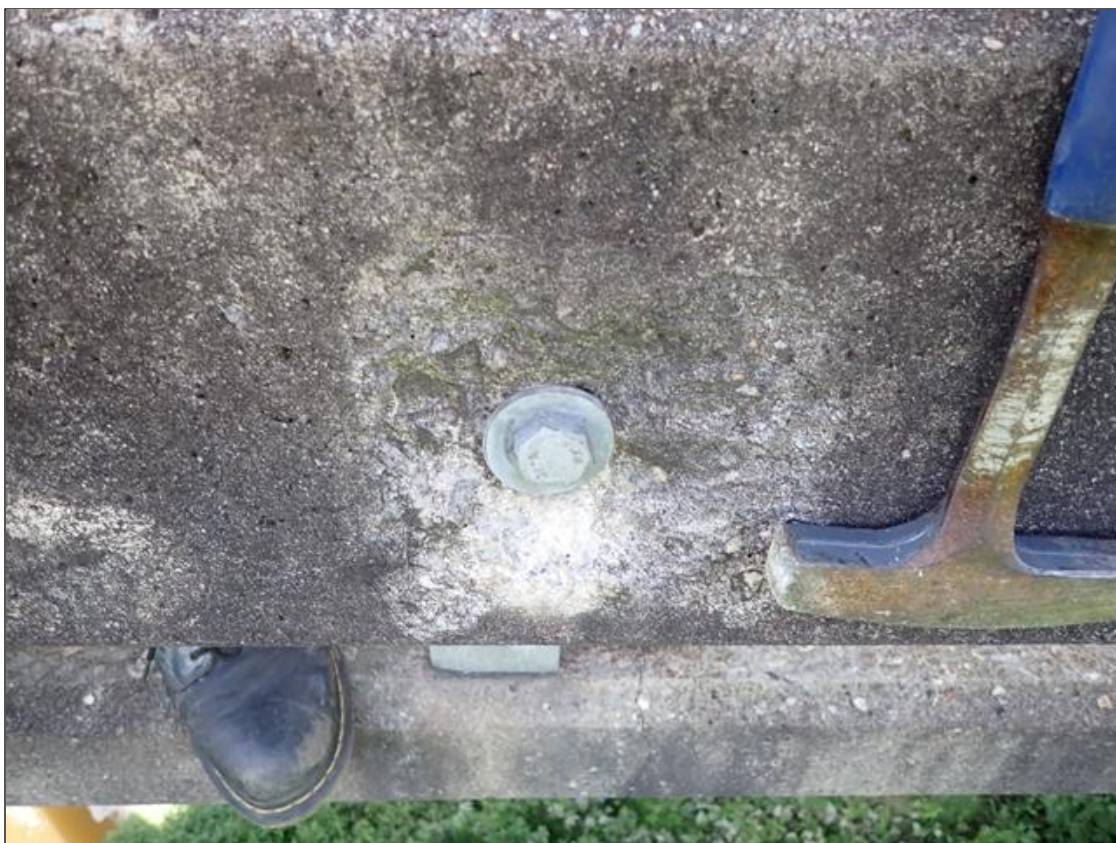
Span 3 Left Bridge Rail: UP TO 6 INCH DIAMETER X 1.5 INCH DEEP SPALL IN EXTERIOR FACE AT ANCHOR BOLT CONNECTION. TYPICAL AT SEVERAL CONNECTIONS.

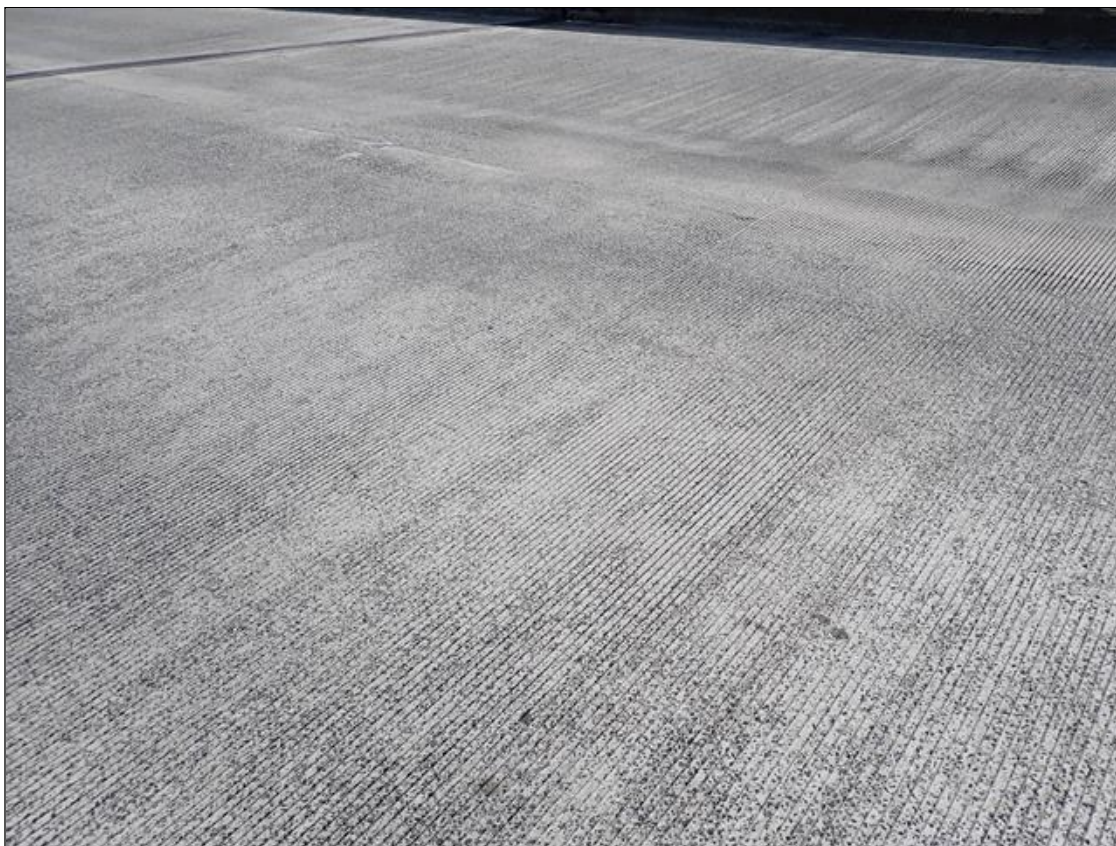
Span 4 Deck: throughout top of deck, wear with secure aggregate at random
