NC DEPARTMENT OF TRANSPORTATION  
 DIVISION OF HIGHWAYS  
 STRUCTURE MANAGEMENT UNIT  
 COUNTY: JOHNSTON DIV: 4

ATTENTION:  PARS Submitted  Sign Notice Issued  
 sketches revised; new repairs

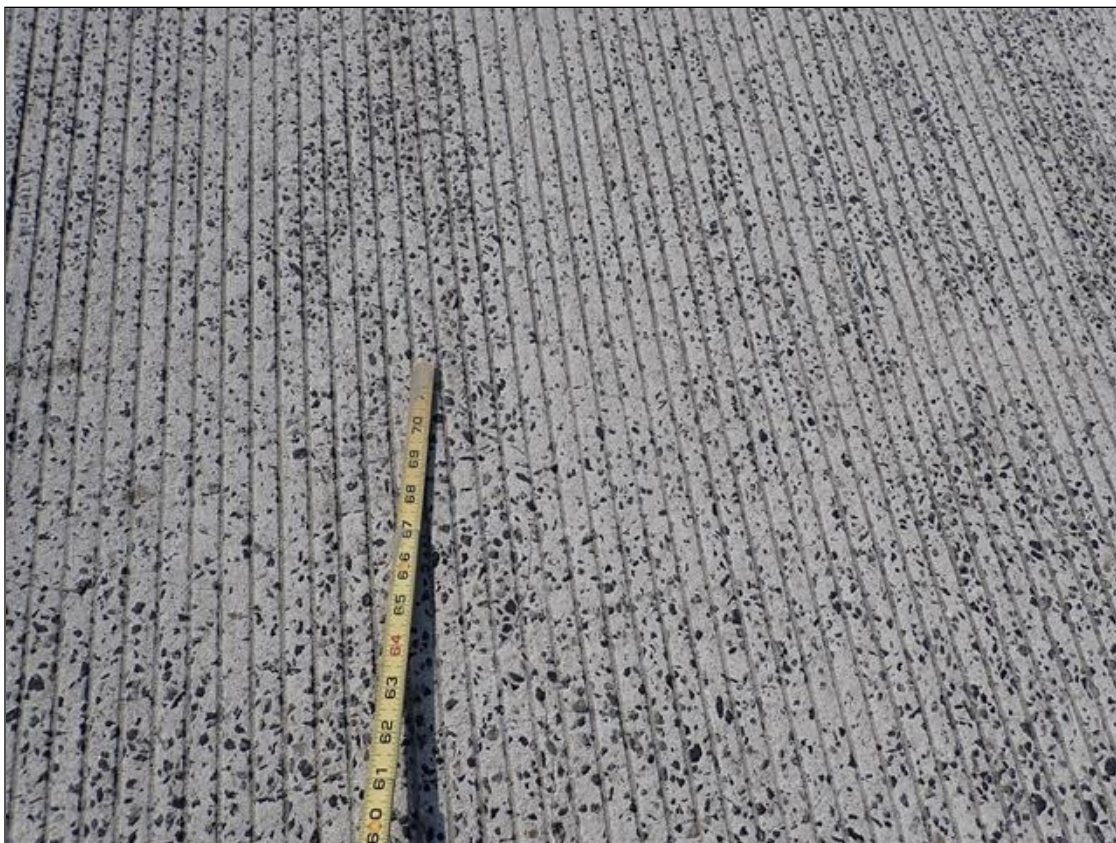
Span 4 Deck: throughout top of deck, areas of map cracks (hairline) at random

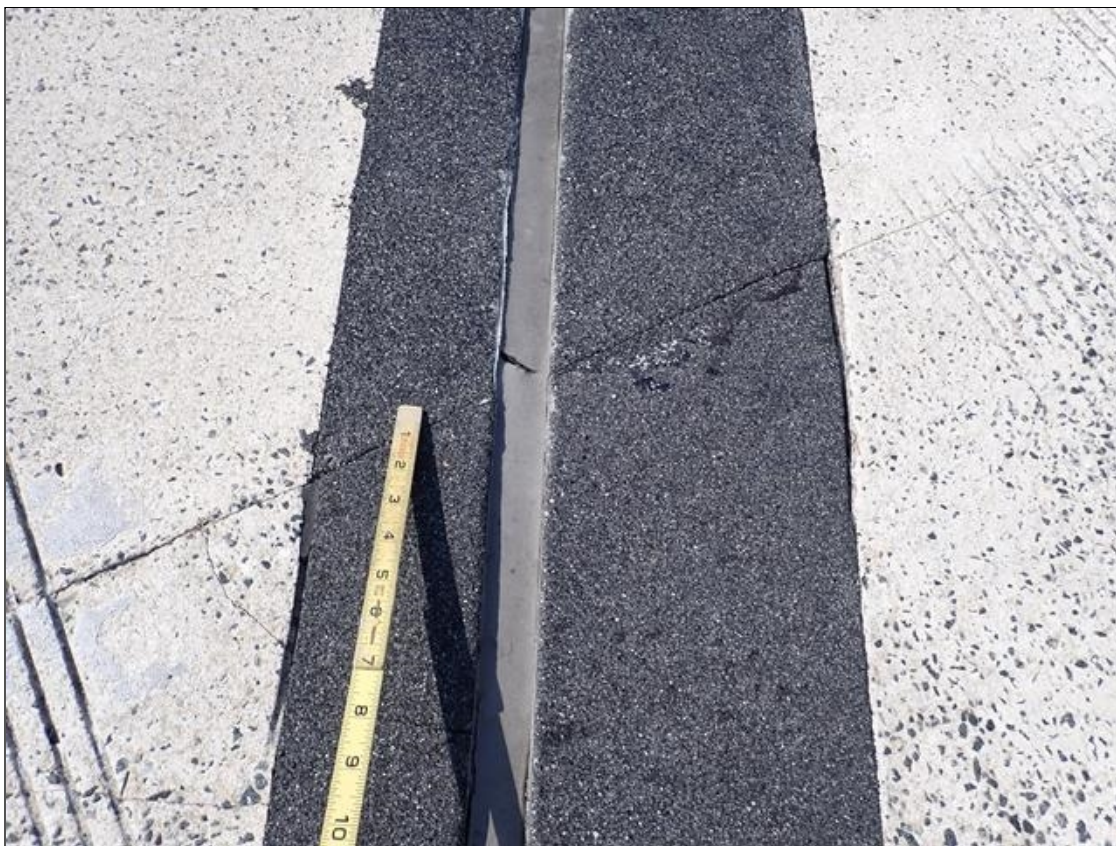
Span 5 Bent 4 Joint: at centerline of roadway, tear (1 inch long)

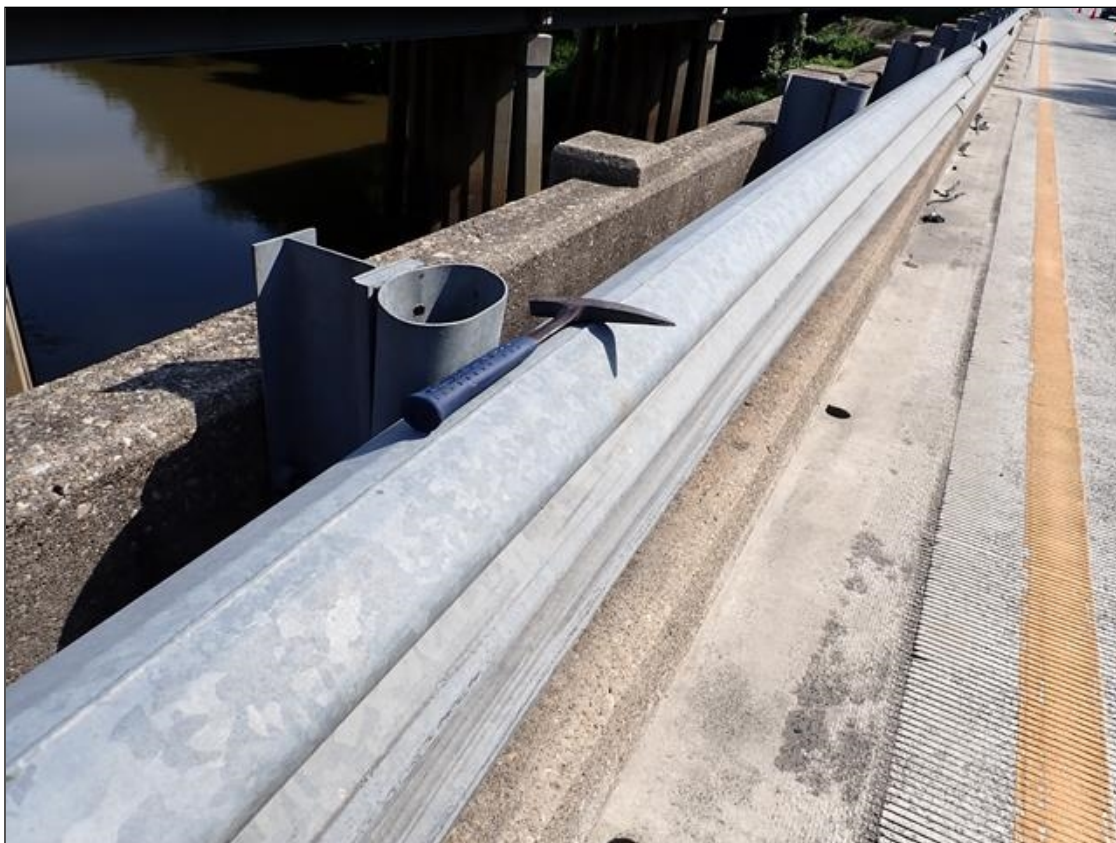
Span 5 Left Retrofit Bridge Rail: (PAR) starting at bent 4, impact damage (25 foot) with (3) partially crushed posts

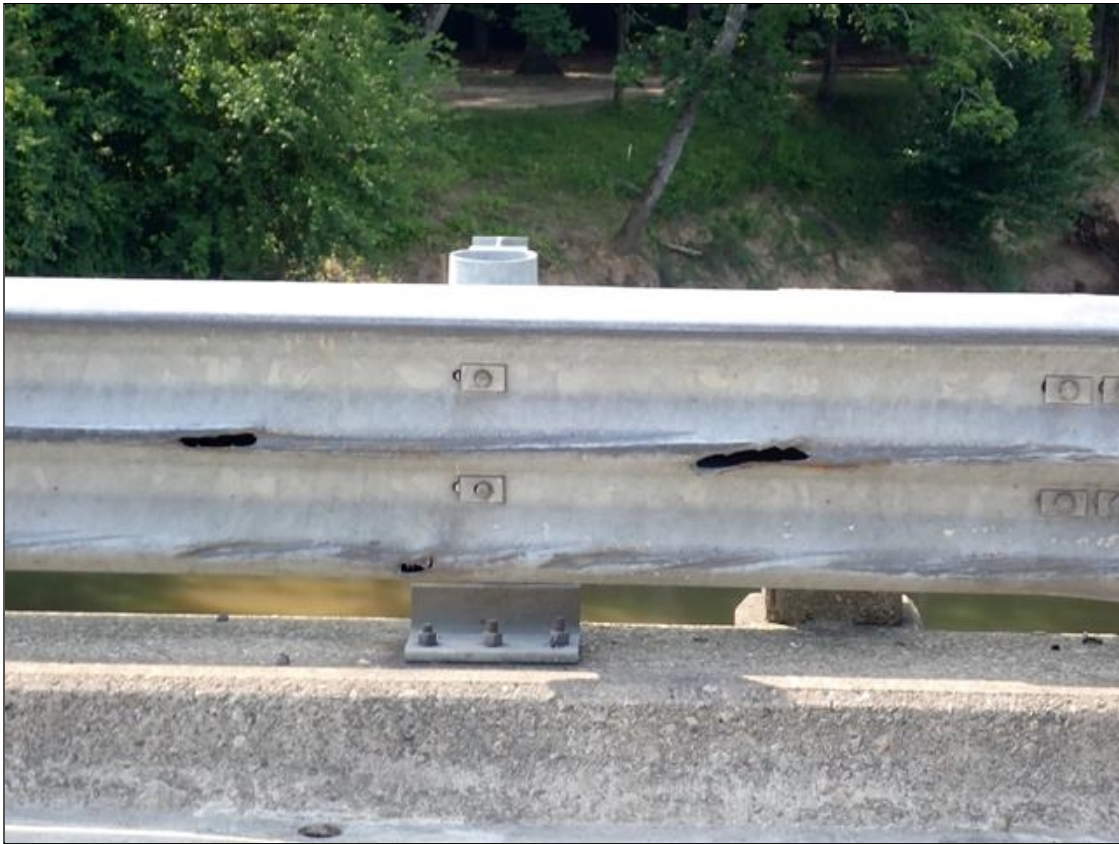
Span 4 Right Retrofit Bridge Rail: (PAR) IMPACT DAMAGE WITH SCRAPE MARKS AND THROUGH HOLES UP TO 4 INCH X 2 INCH IN RETROFIT RAIL AT SCATTERED LOCATIONS

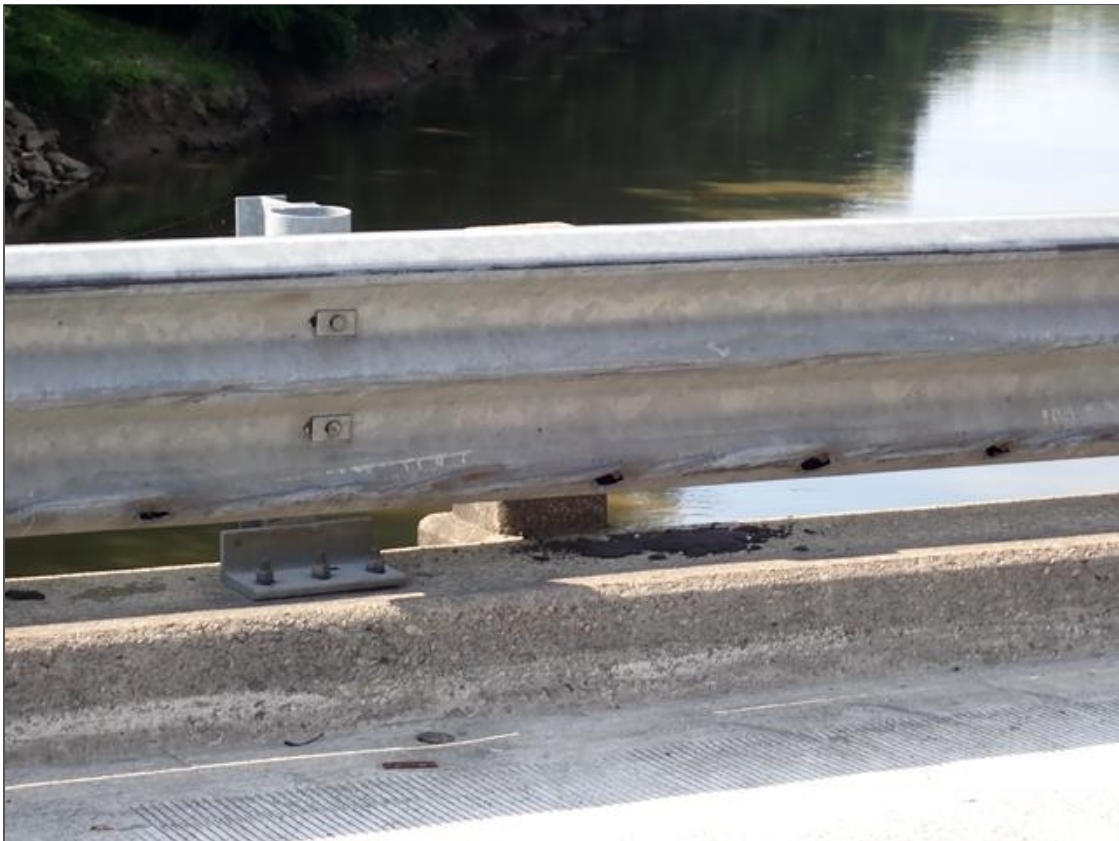
Span 5 Right Retrofit Bridge Rail: (PAR) IMPACT DAMAGE WITH SCRAPE MARKS AND THROUGH HOLES UP TO 4 INCH X 2 INCH IN RETROFIT RAIL AT SCATTERED LOCATIONS

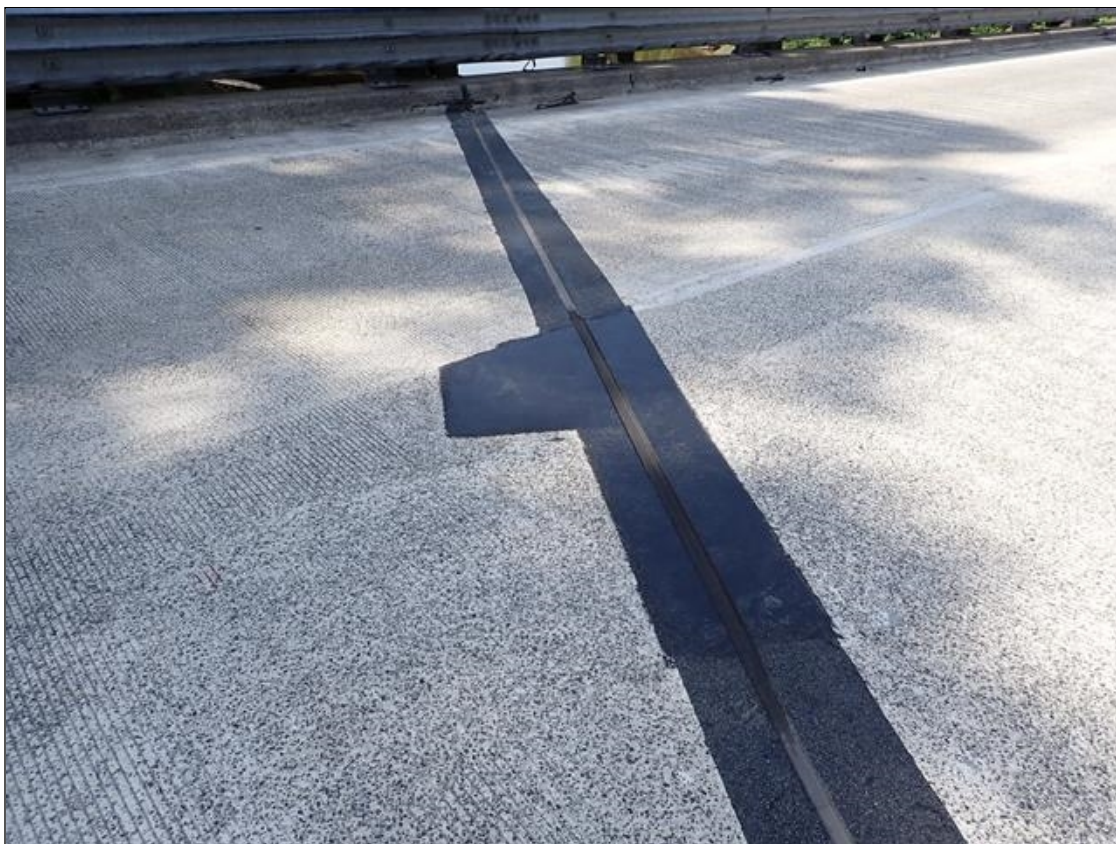
Span 6 Bent 5 Joint: 2025 new repair (29 inch x 21 inch patch), previously noted as: ADJACENT TO DECK SPALL IN SPAN 6, 8 INCHES DIAMETER AREA OF HEADER DEPRESSED BY 1 INCH.

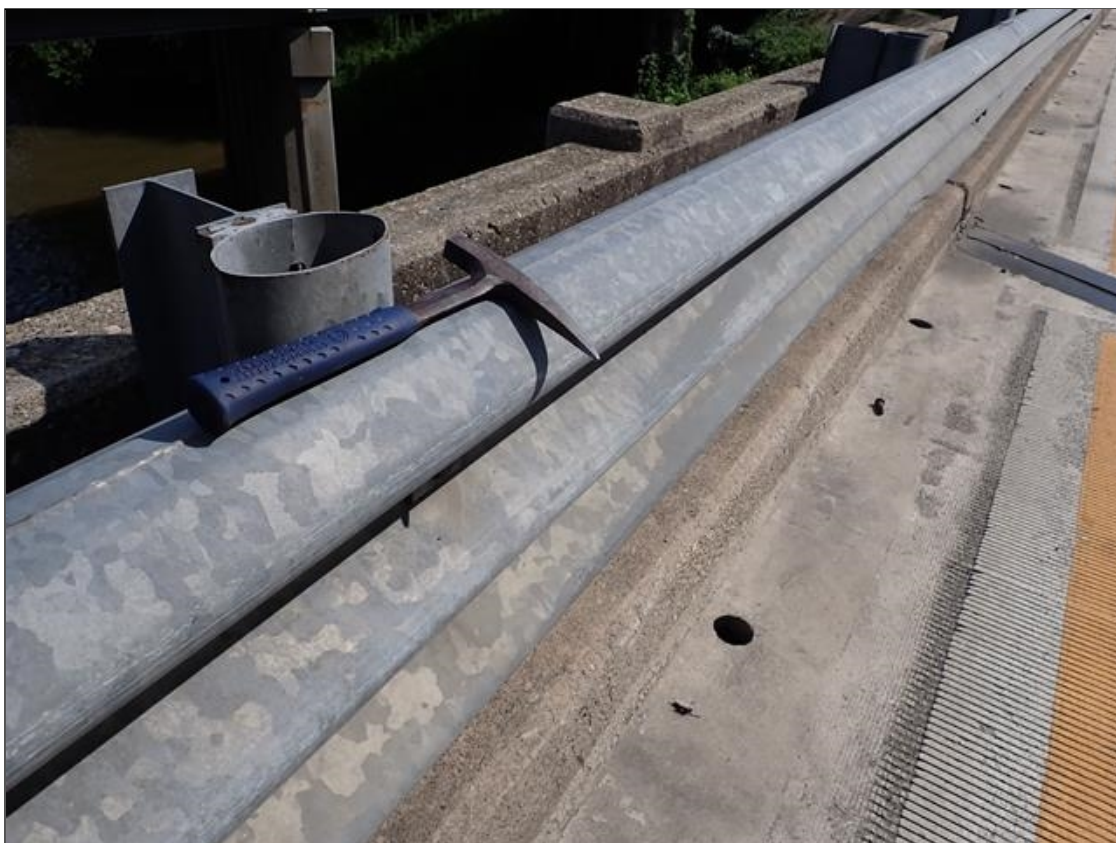
Span 6 Left Retrofit Bridge Rail: near bent 6, impact scrapes (10 foot)

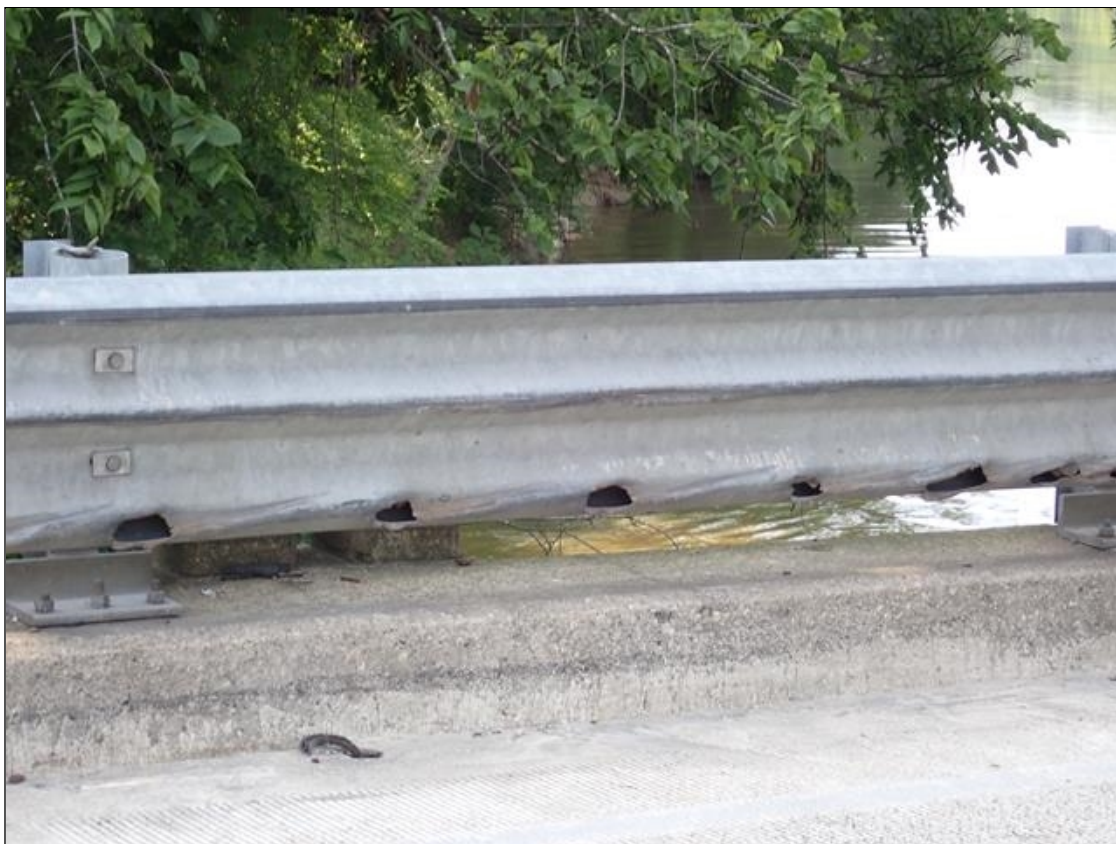
Span 6 Right Retrofit Bridge Rail: (PAR) IMPACT DAMAGE WITH SCRAPE MARKS AND THROUGH HOLES UP TO 4 INCH X 2 INCH IN RETROFIT RAIL AT SCATTERED LOCATIONS

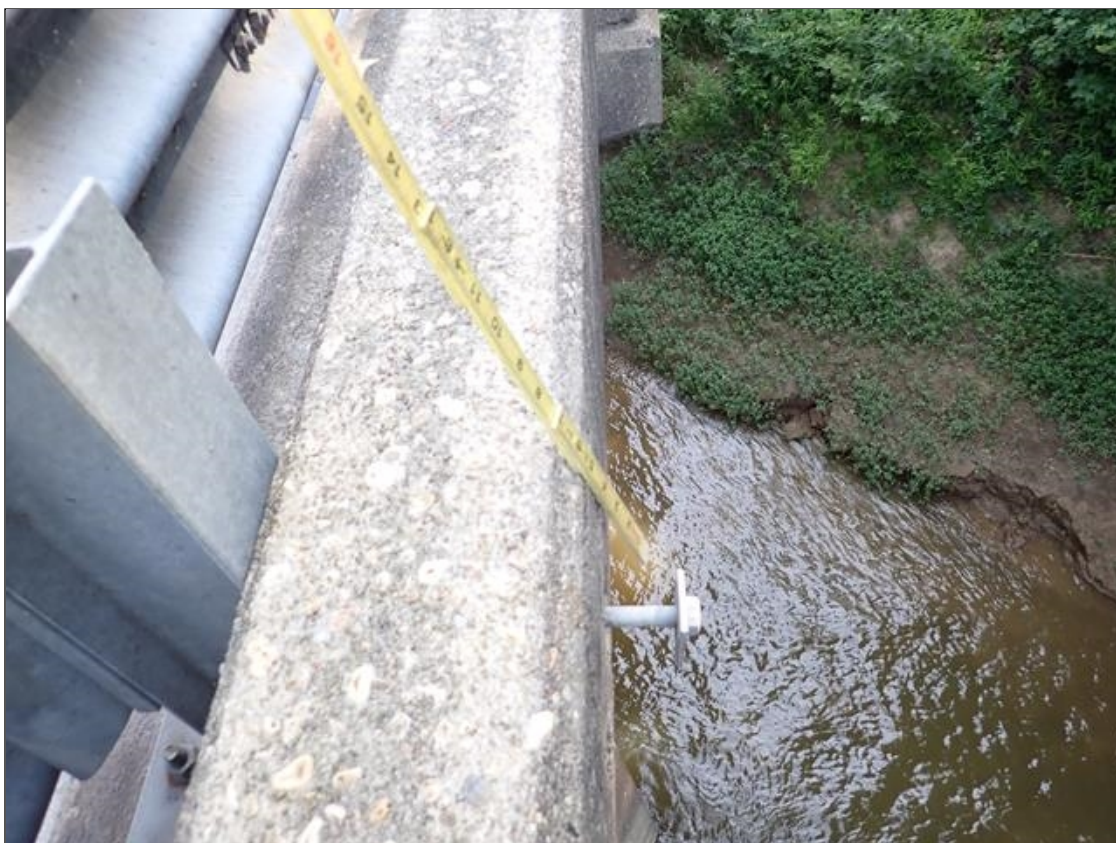
Span 6 Right Retrofit Bridge Rail: (PAR) ADJACENT TO POSTS 5 AND 8, 2 BOLTS DISCONNECTED AND PROTRUDING ON THE OUTSIDE OF RAIL

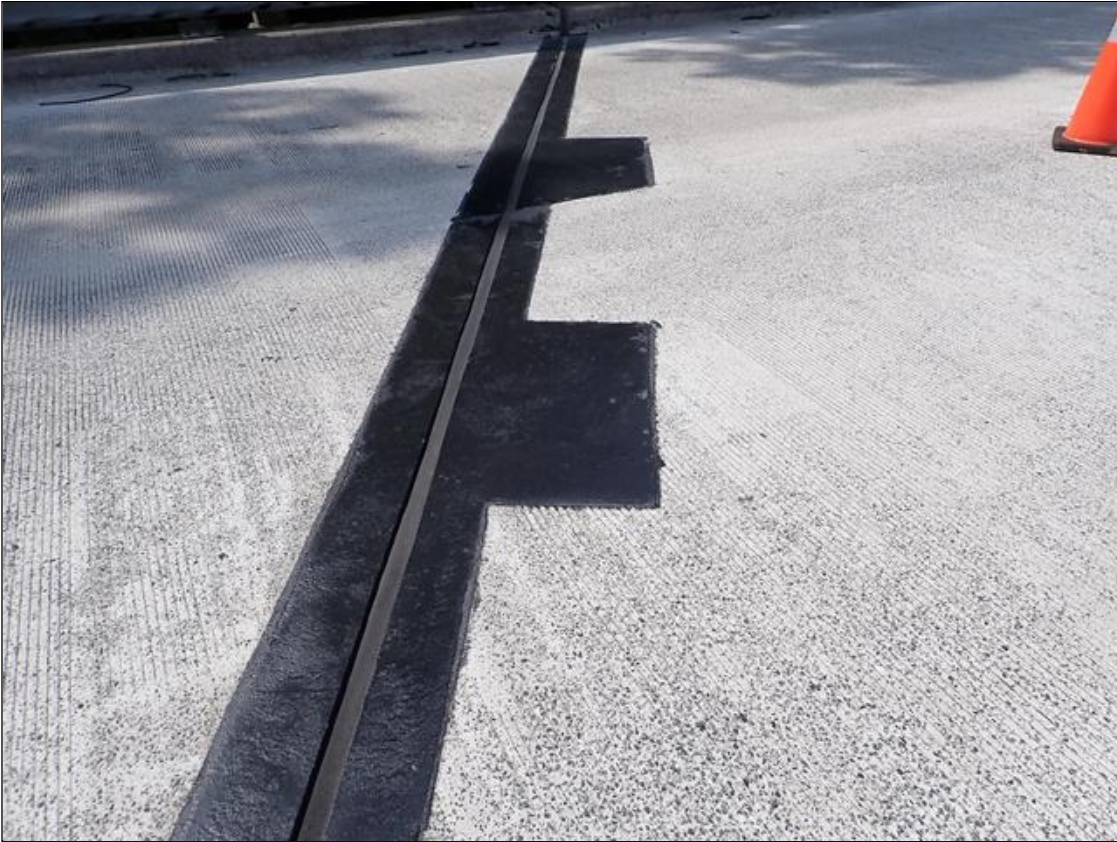
Span 7 Bent 6 Joint: 2025 NEW REPAIR (UP TO 37 INCH X 24 INCH), PREVIOUSLY NOTED AS: IN RIGHT AND LEFT LANES (2) AREAS OF MISSING HEADER AND JOINT MATERIAL UP TO 2 FEET X 8 INCHES X FULL DEPTH

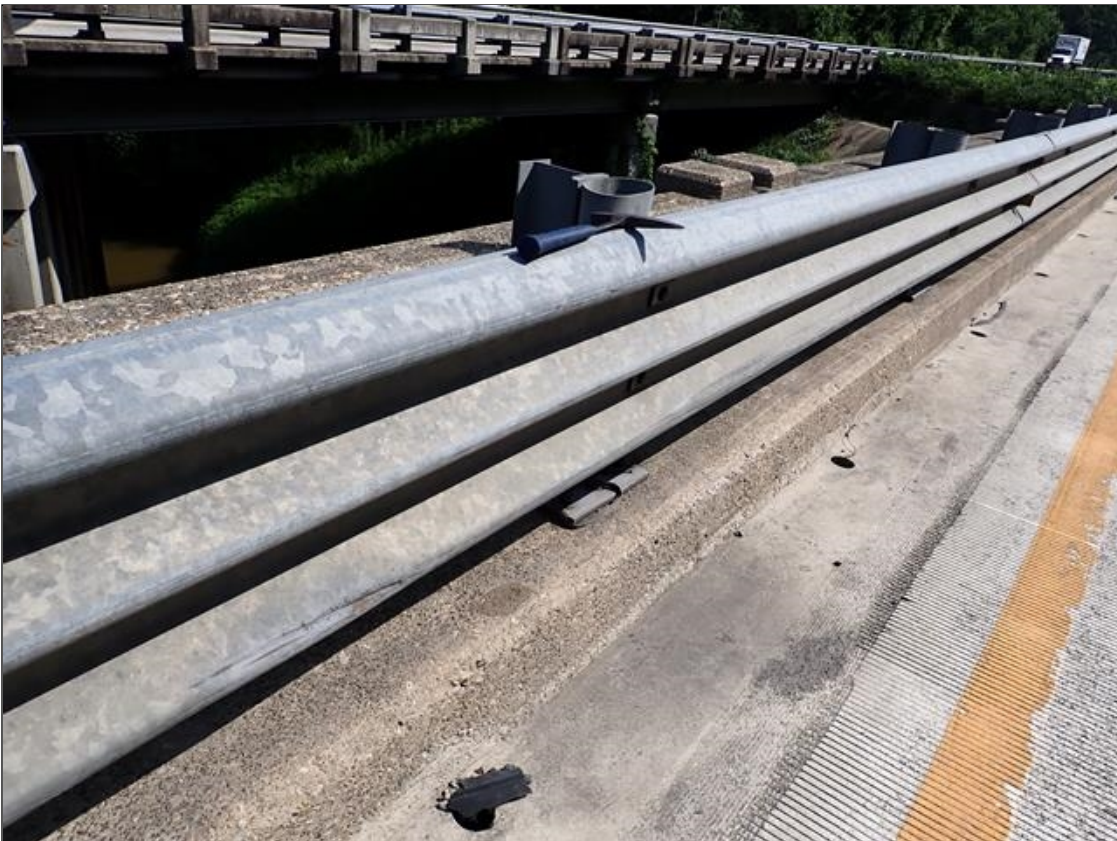
Span 7 Left Retrofit Bridge Rail: (PAR) starting at bent 6, impact scrapes (20 foot) with (2) partially crushed posts

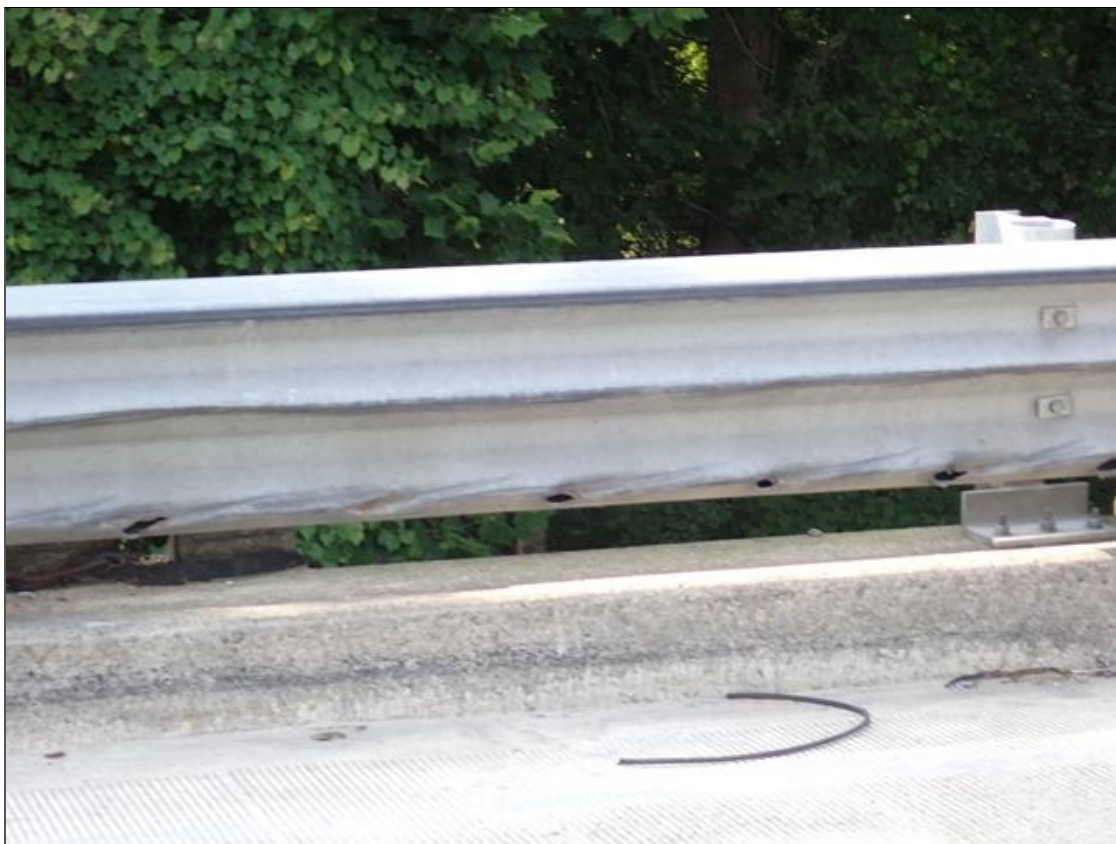
Span 7 Right Retrofit Bridge Rail: (PAR) IMPACT DAMAGE WITH SCRAPE MARKS AND THROUGH HOLES UP TO 4 INCH X 2 INCH IN RETROFIT RAIL AT SCATTERED LOCATIONS

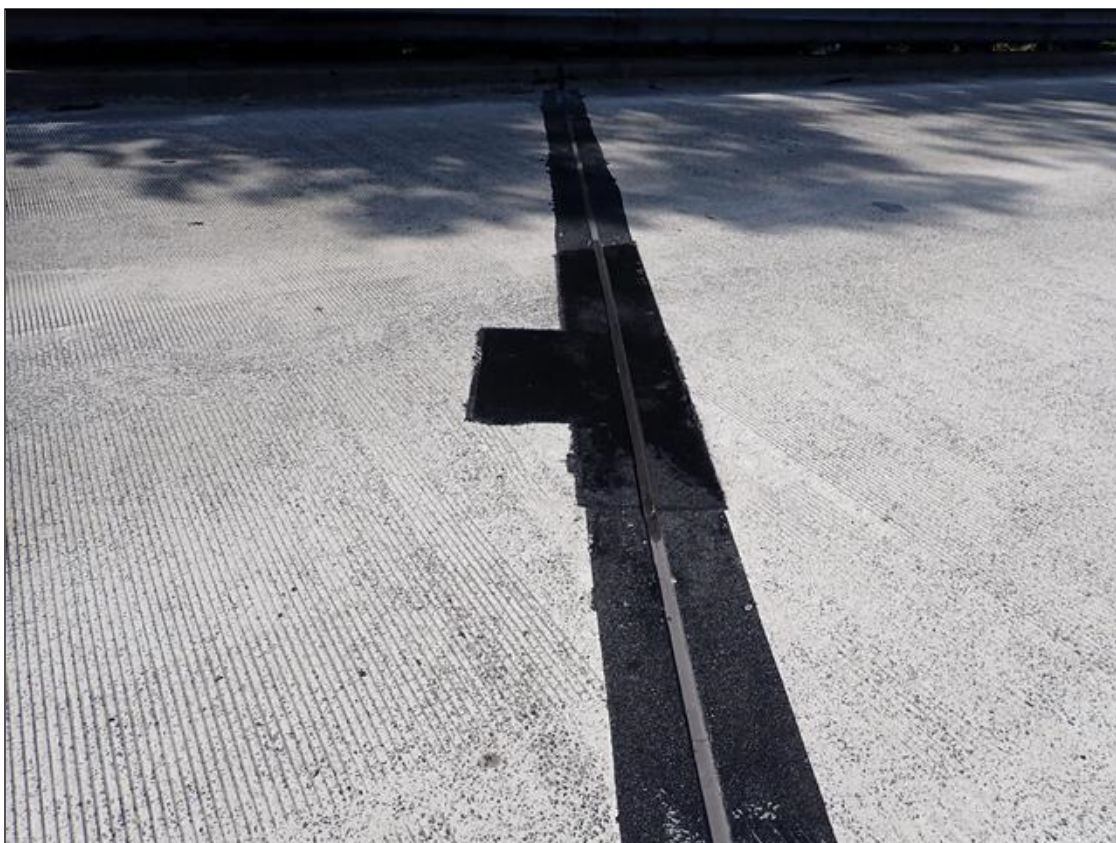
Span 8 Bent 7 Joint: in left travel lane near centerline, patch (28 inch x 18 inch)

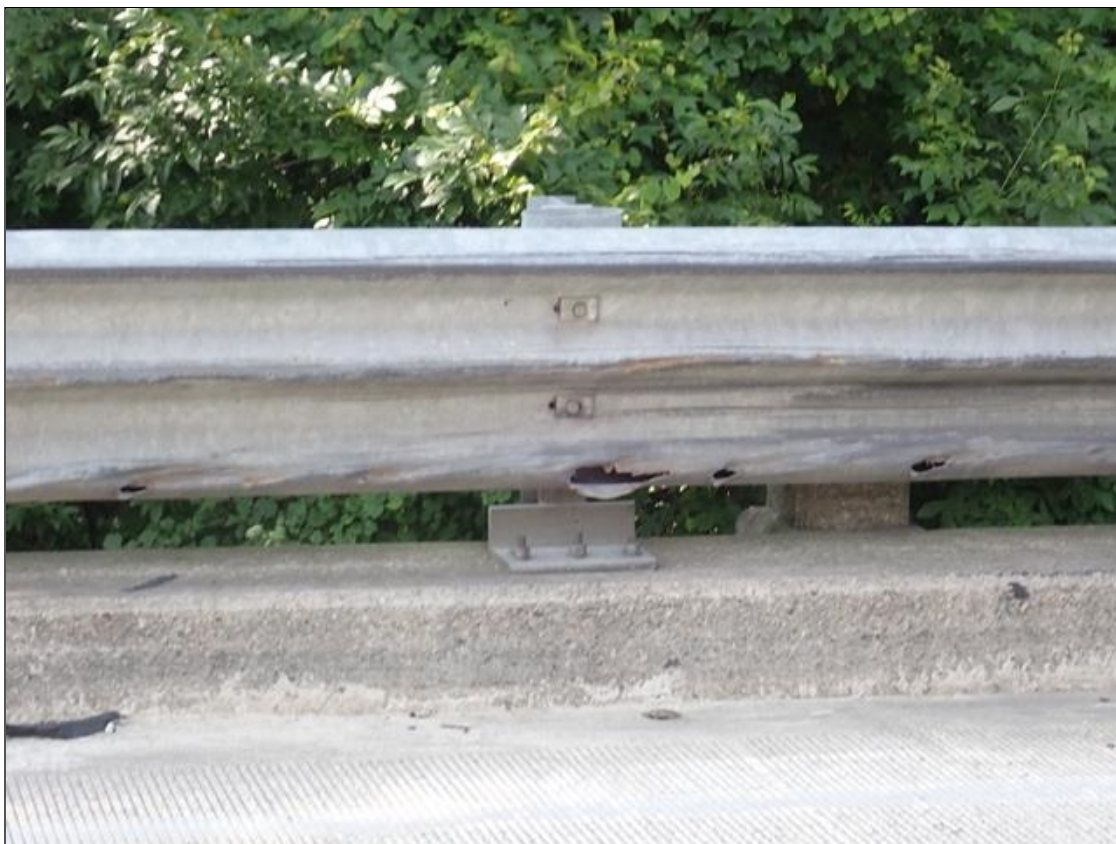
Span 8 Right Retrofit Bridge Rail: (PAR) IMPACT DAMAGE WITH SCRAPE MARKS AND THROUGH HOLES UP TO 4 INCH X 2 INCH IN RETROFIT RAIL AT SCATTERED LOCATIONS

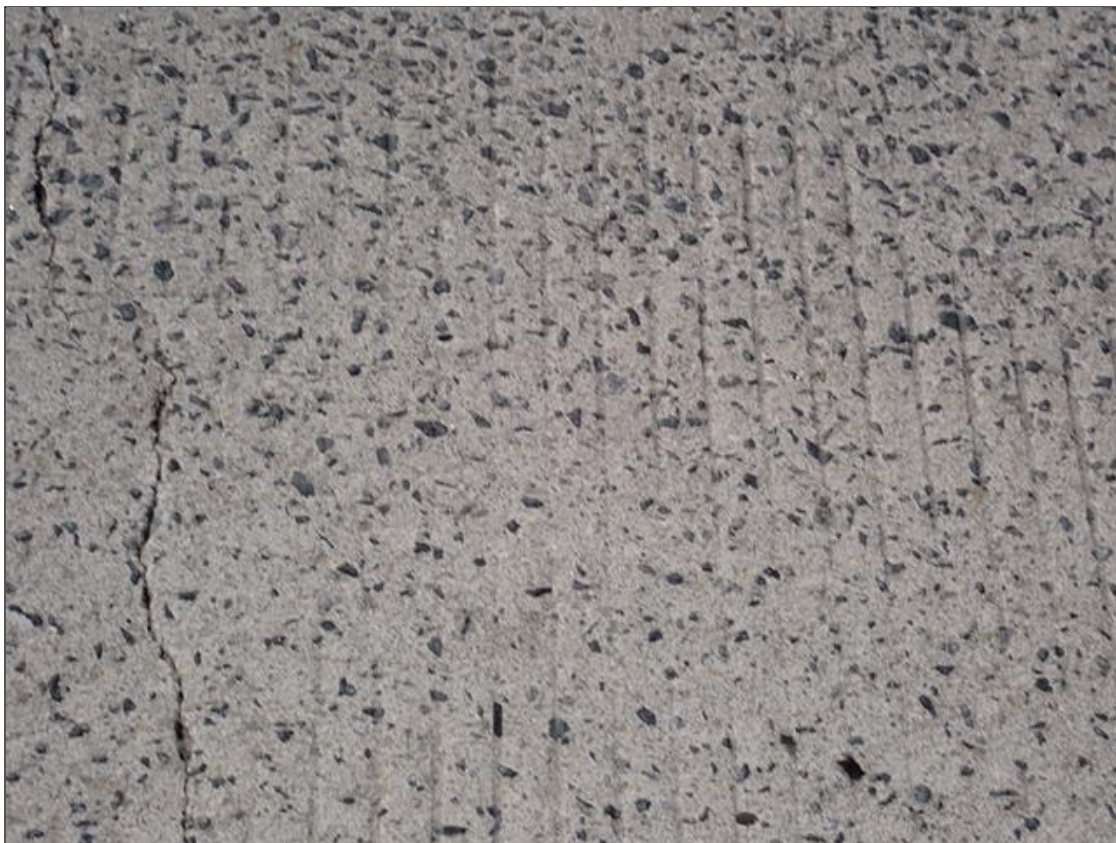
Span 8 Deck: throughout top of deck, areas of map cracks (hairline) and transverse cracks (up to 1/32 inch x 12 foot) at random

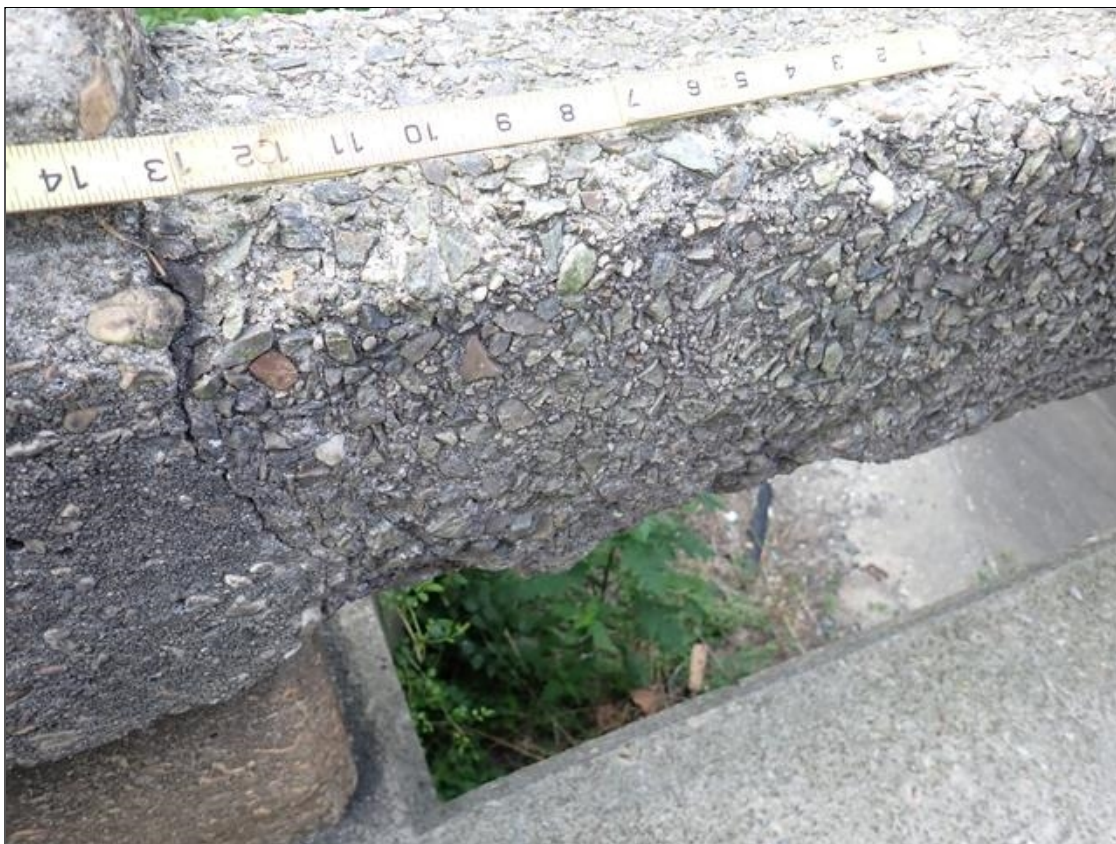
Span 8 Right Bridge Rail: AT END BENT 2, BOTTOM FACE, 1 FOOT LONG X 4 INCHES WIDE X 1 INCH DEEP SPALL

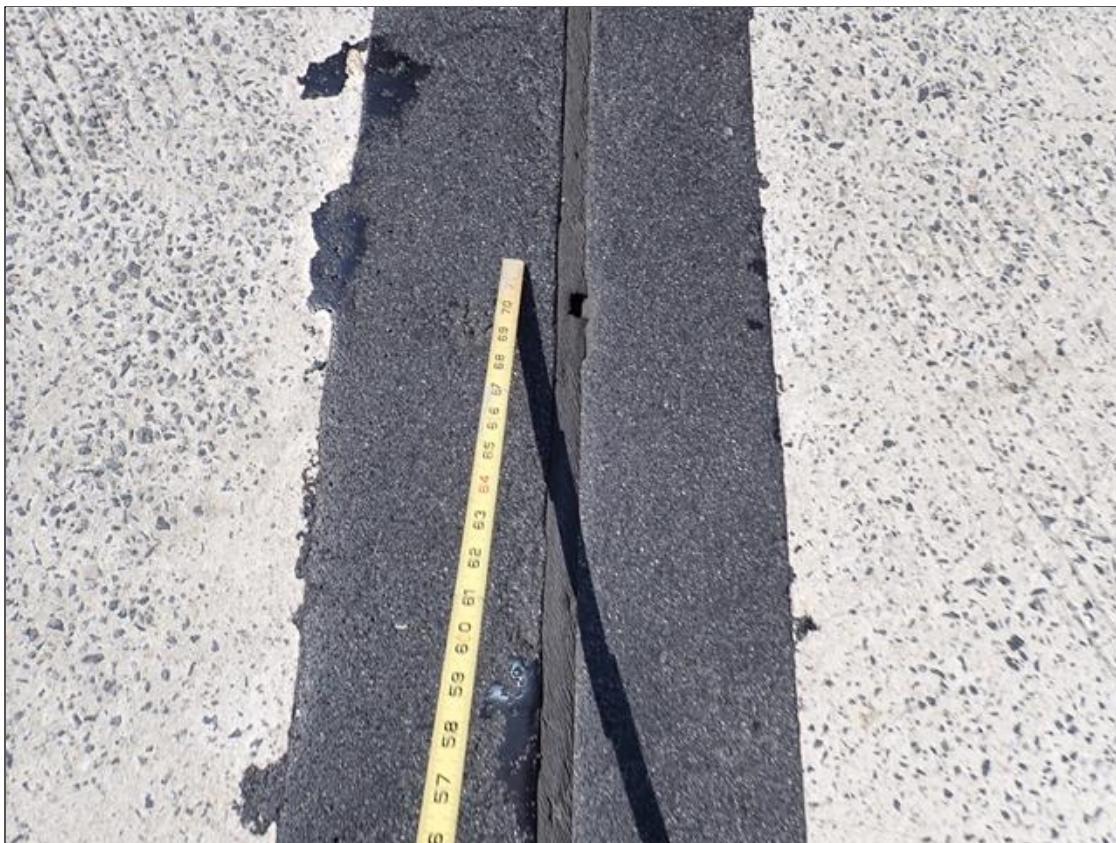
Span 8 End bent 2 Joint: in right travel lane, (2) area of missing seal (up to 1 inch diameter)

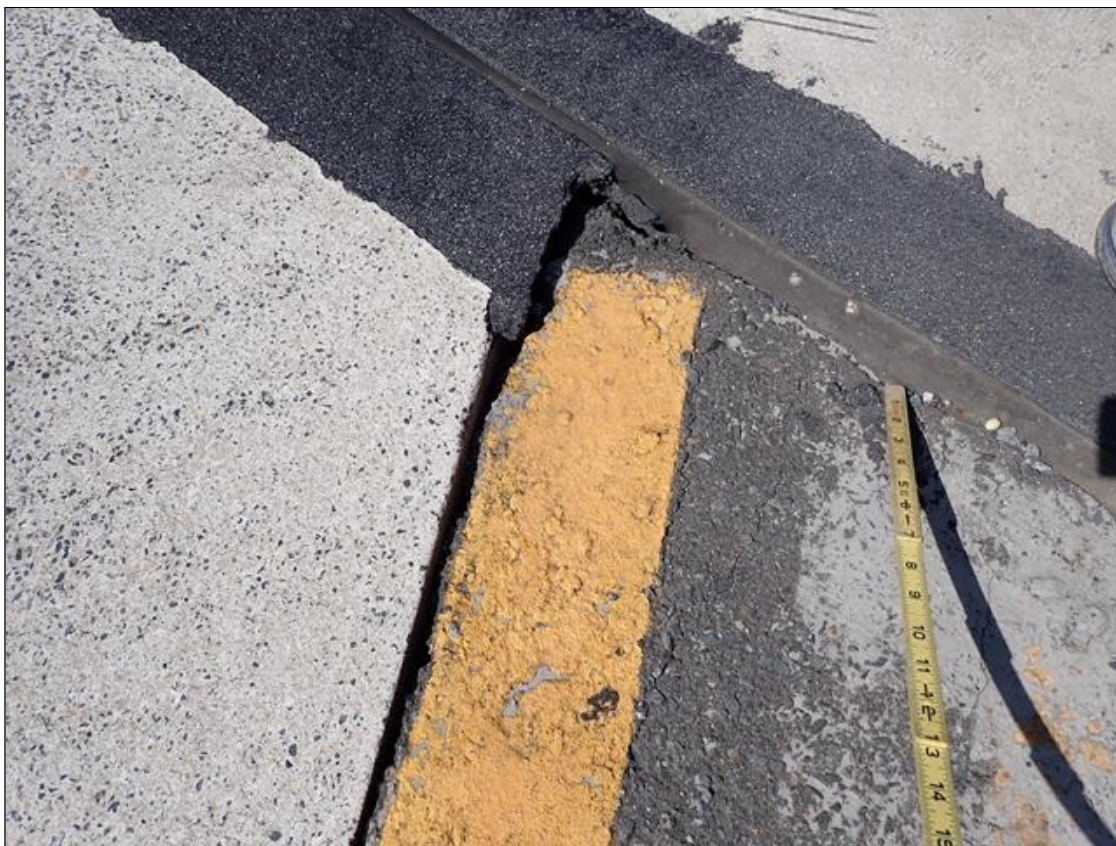
Approach 2: at west end adjacent to end bent 2 joint, settlement (12 inch x 16 inch x 1 inch deep)

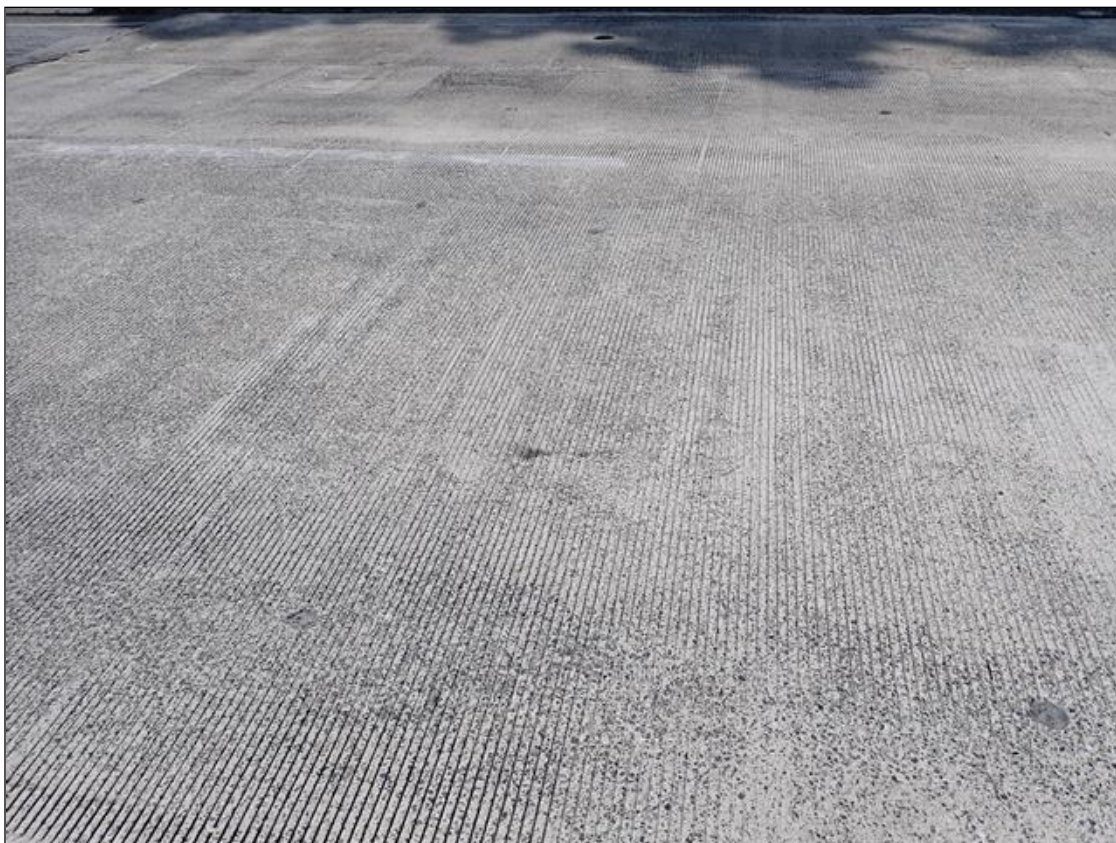
Approach 2: throughout slab, wear with secure aggregate at random

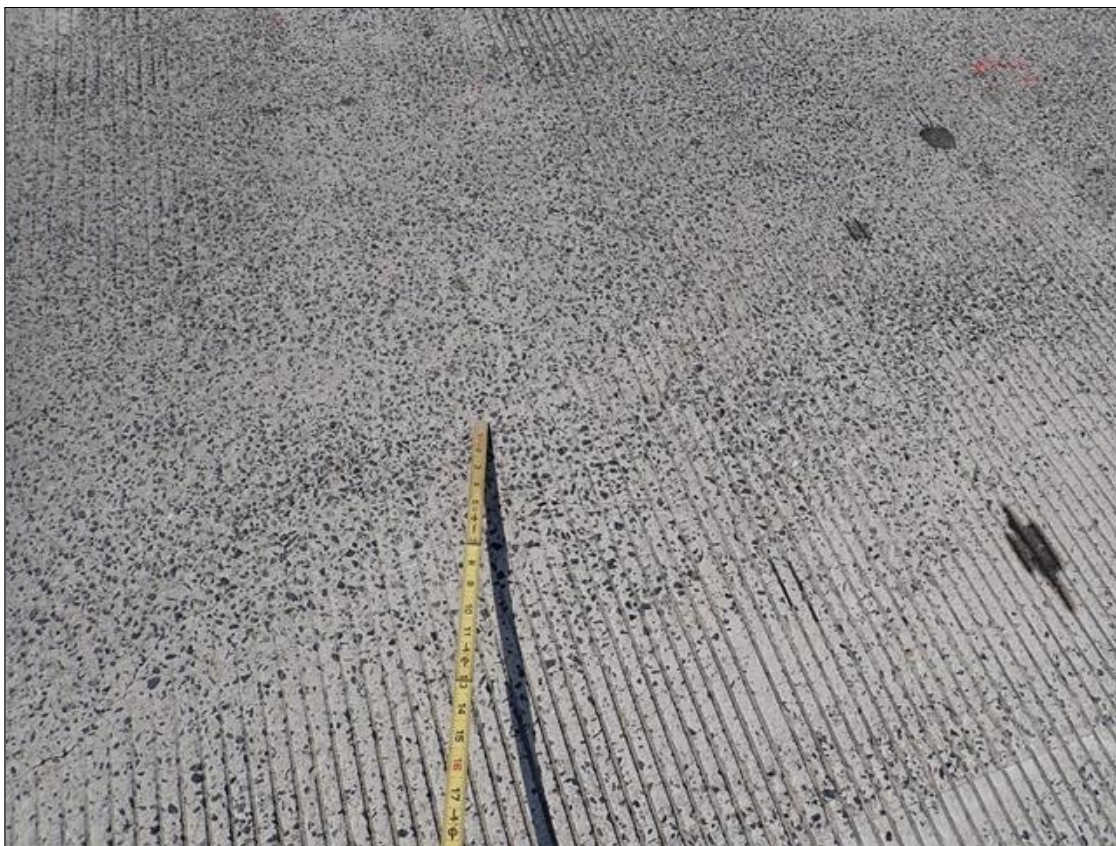
Approach 2: throughout slab, map cracks (hairline) at random

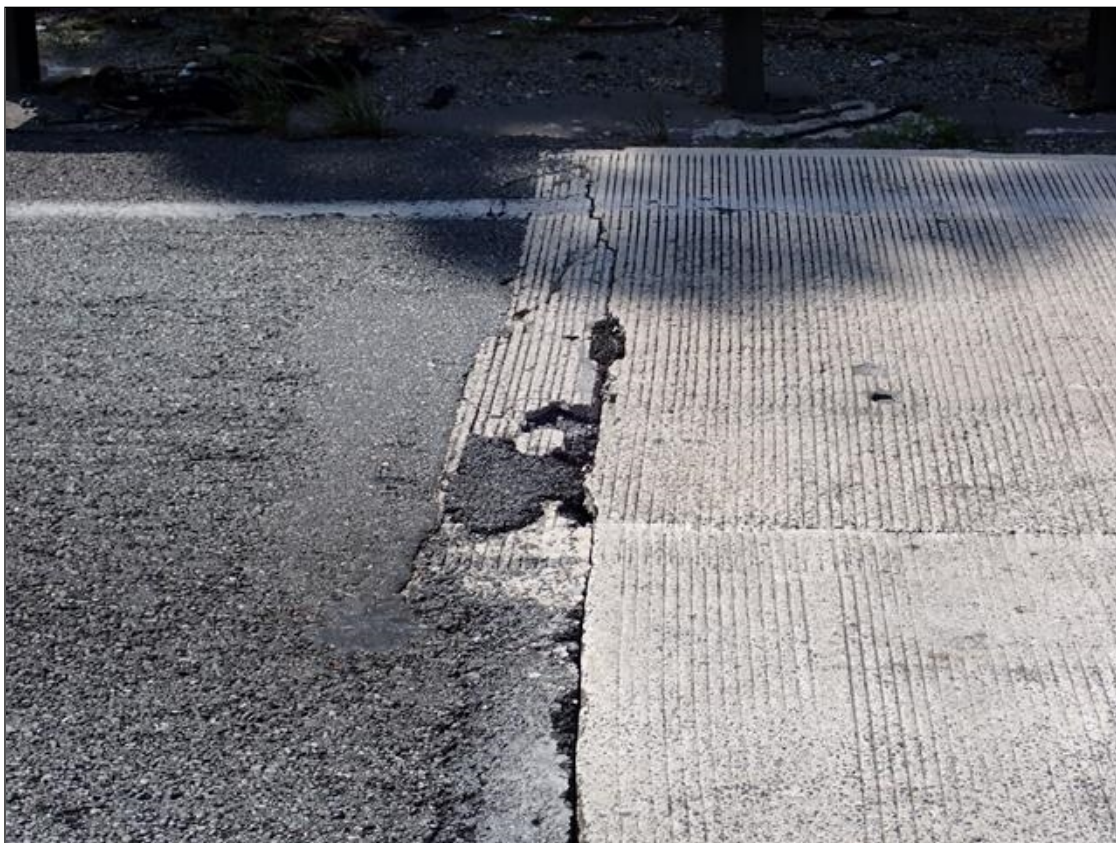
Approach 2: northeast corner, area of broken/cracked concrete (5 foot x 1 foot x 2 inch deep) with settlement (2 inch deep)

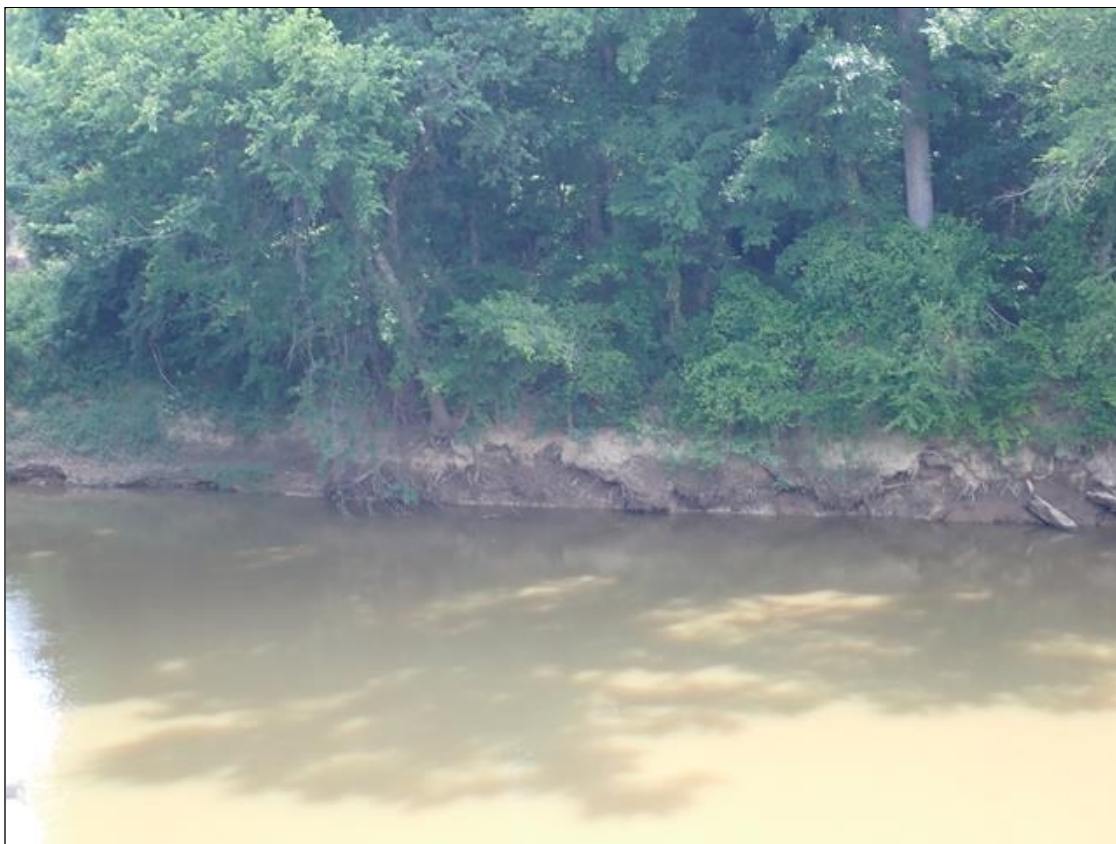
along channel embankments, vertical cuts (up to 4 foot high)

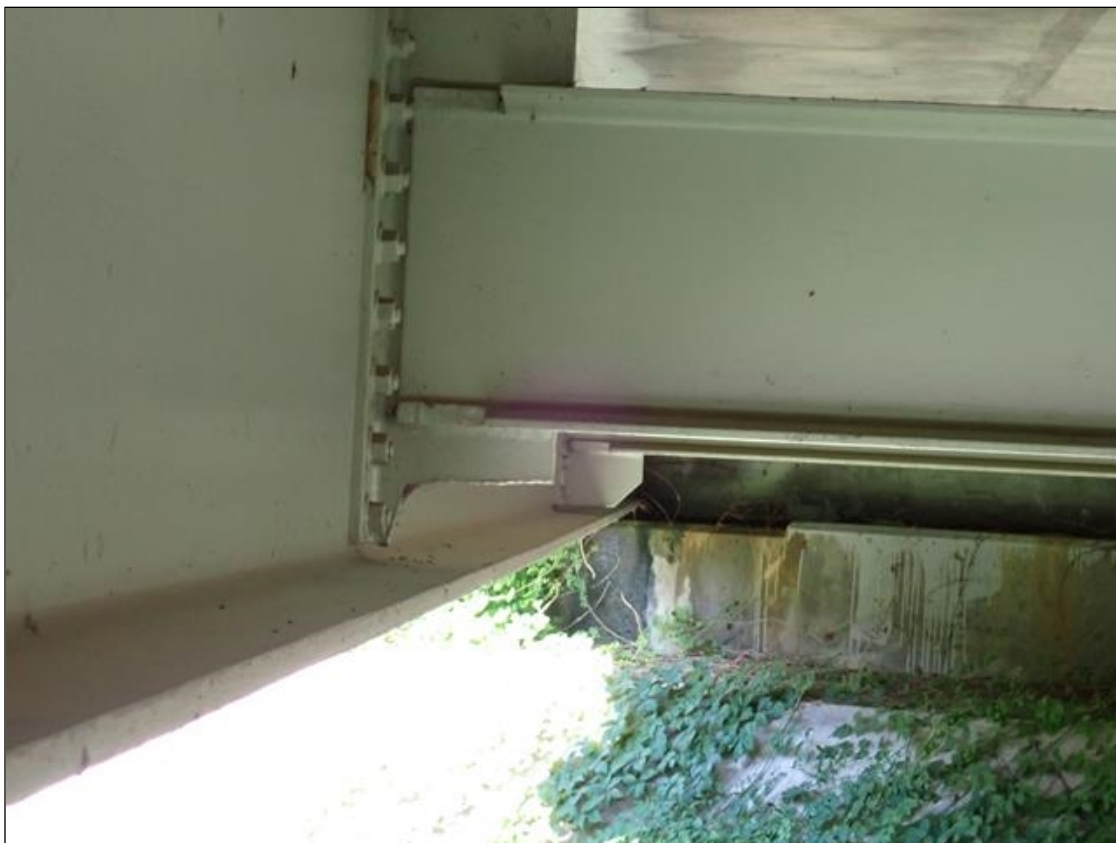
Span 1 Beam 4 : 2 INCHES HIGH OF INTERMEDIATE STIFFENER IS CUT OUT AT BOTTOM AT BOTH LOCATIONS. PAR IS NOT ISSUED AS IT APPEARS TO BE FROM PREVIOUS BRIDGE REPAIR.
