NC DEPARTMENT OF TRANSPORTATION  
 DIVISION OF HIGHWAYS  
 STRUCTURE MANAGEMENT UNIT  
 COUNTY: JOHNSTON DIV: 4

ATTENTION:  PARS Submitted  Sign Notice Issued  
 sketches revised; new repairs

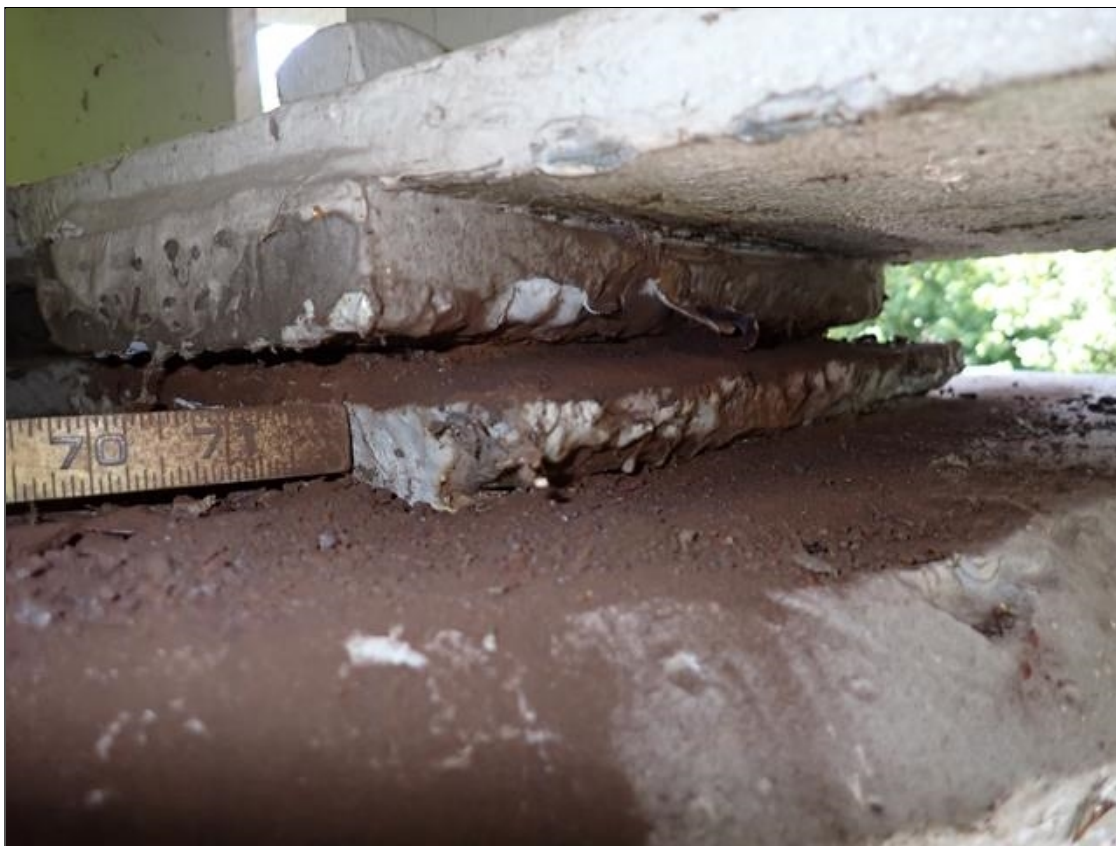
Span 1 Far Bearing 4: painted over section loss (approximately 80 percent remaining)

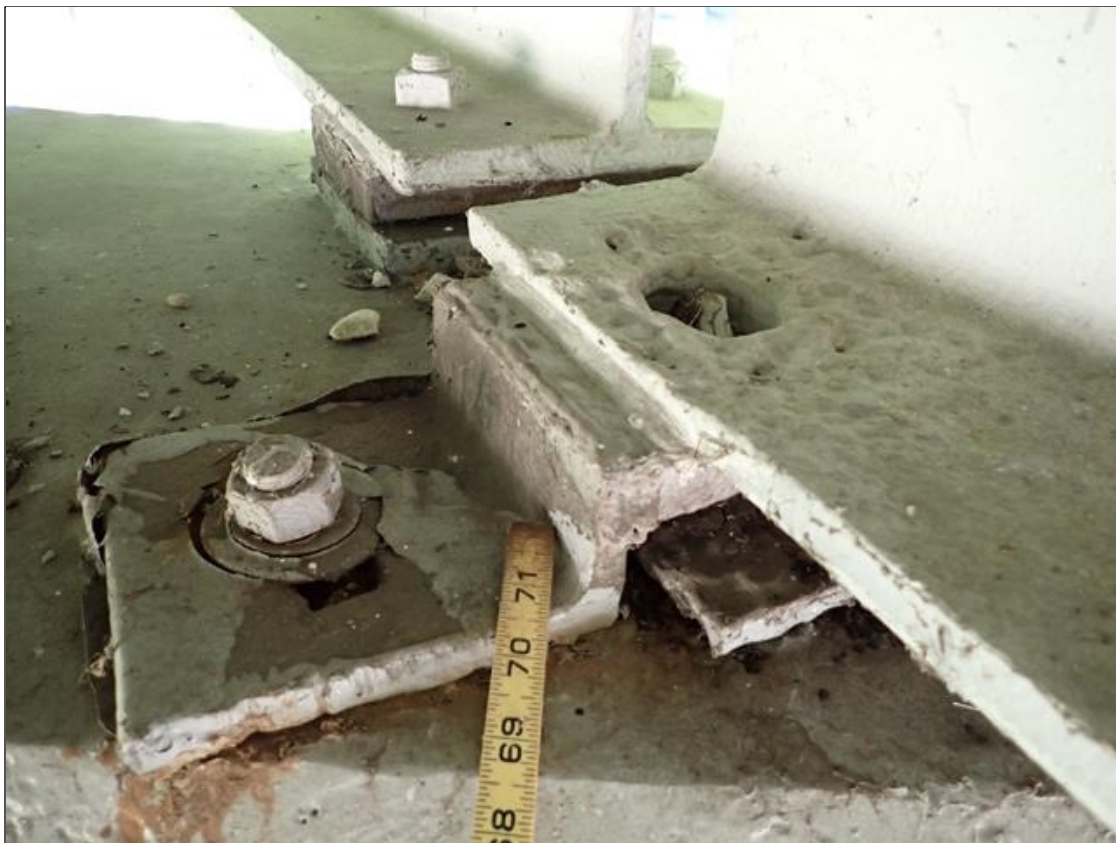
Span 1 Far Bearing 3: LEFT ANCHOR BOLT MISSING; WELDED REPAIR WITH ADDED ANCHOR BOLT.

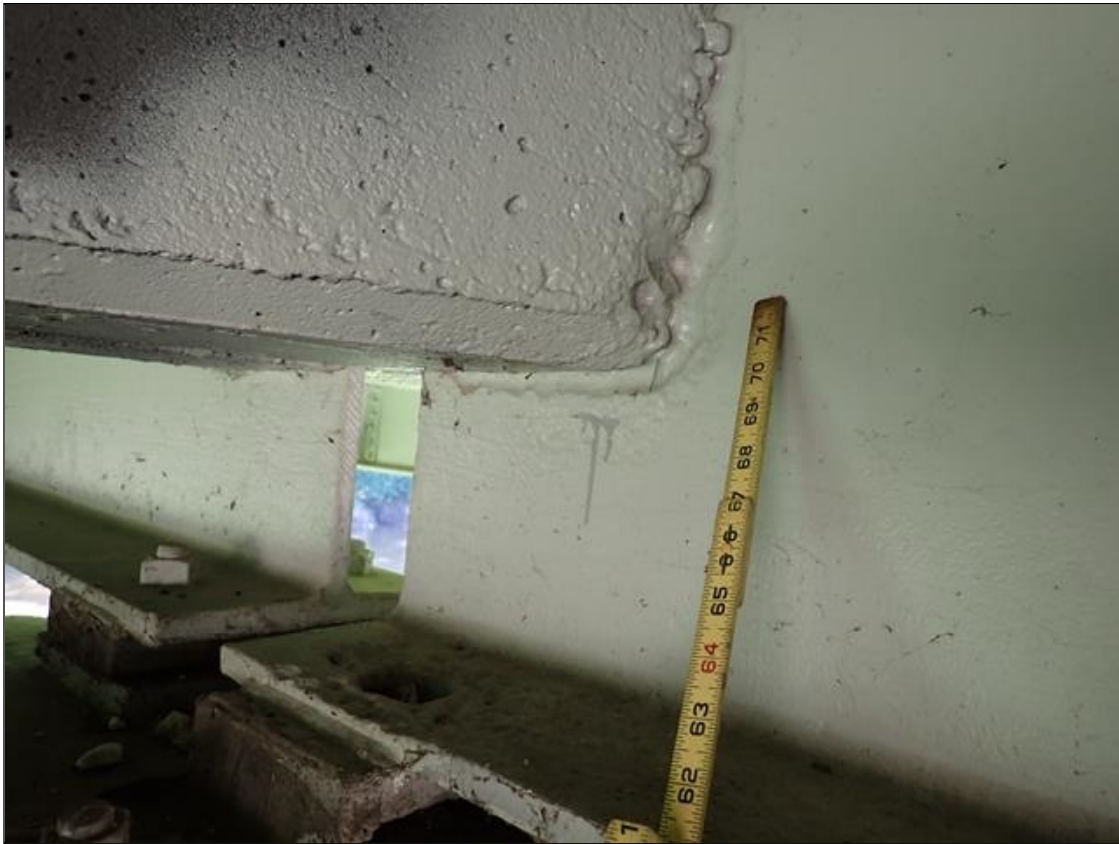
Span 1 Beam 3: (PAR) at bent 1, painted over section loss: web adjacent to end diaphragm (3/8 inch average remaining x 18 inch x 9 inch); bottom flange (0.65 inch average remaining x 8 inch)

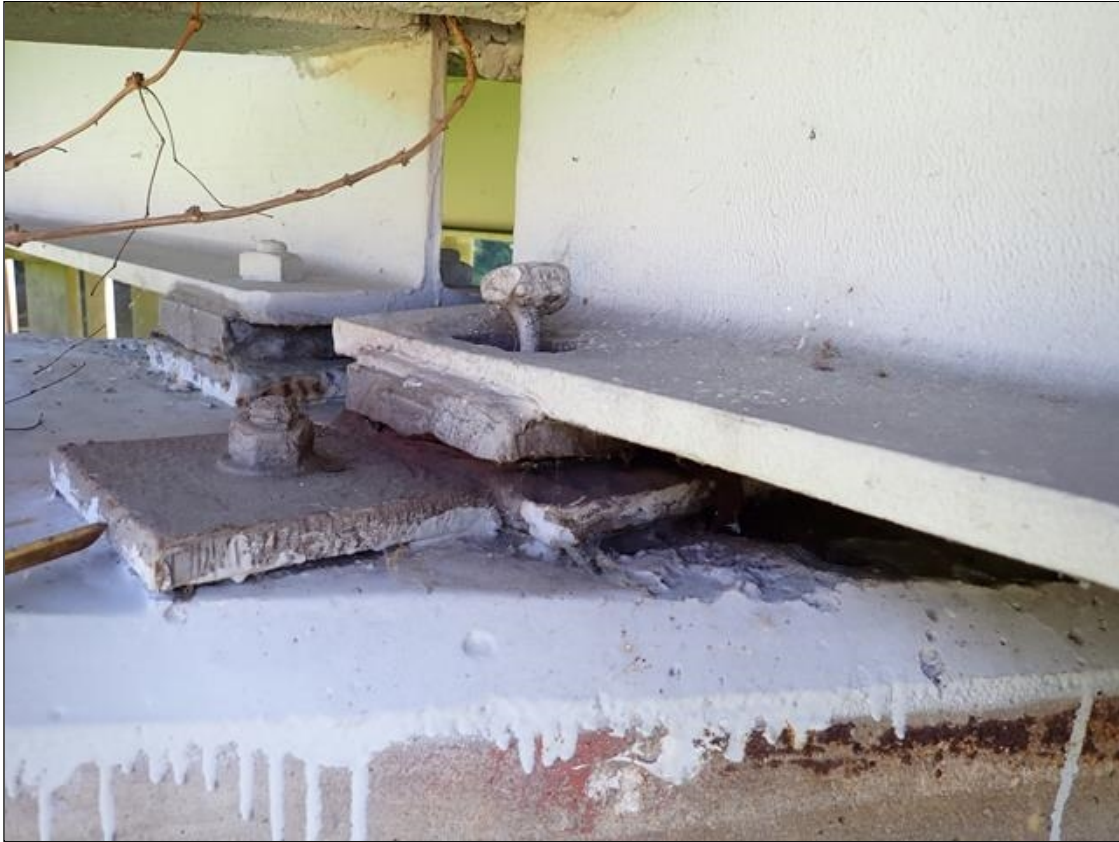
Span 1 Far Bearing 1: LEFT ANCHOR BOLT, PAINTED OVER LOSS (APPROXIMATELY 30 PERCENT REMAINING); WELDED REPAIR, WITH ADDED ANCHOR BOLT.

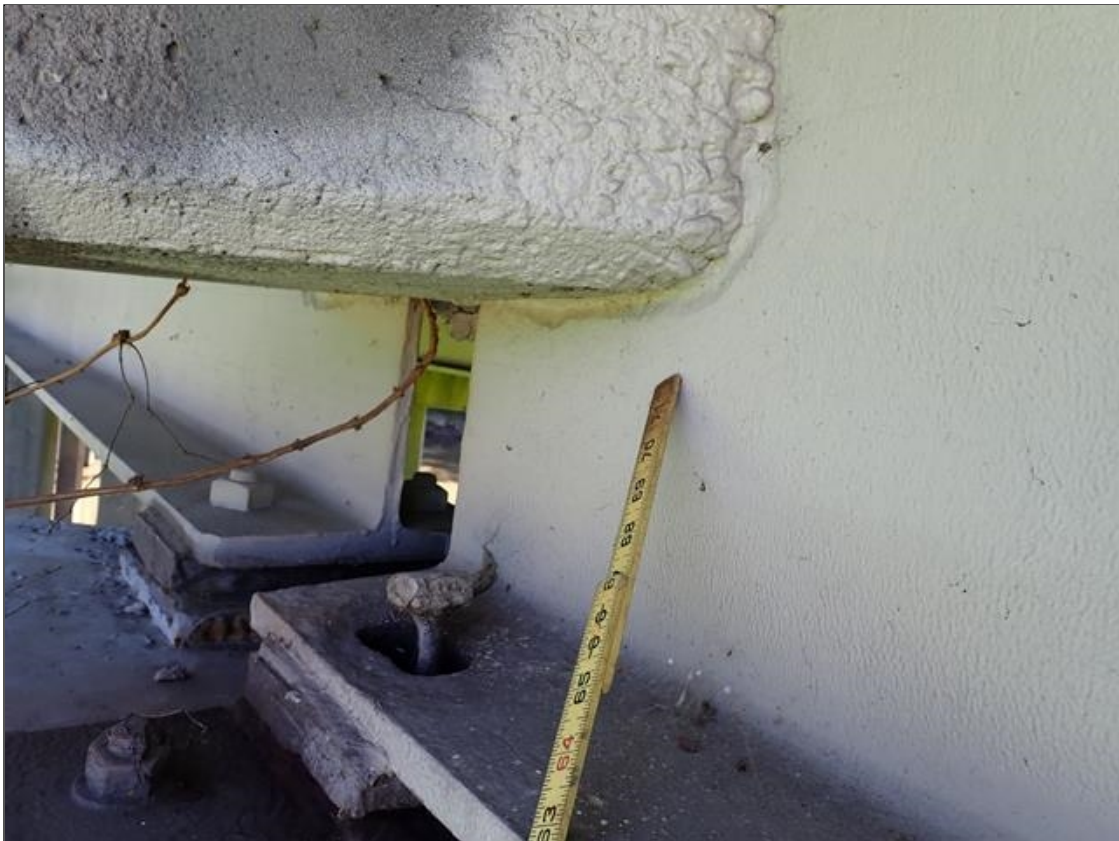
Span 1 Beam 1: (PAR) at bent 1, painted over section loss: web adjacent to end diaphragm (3/8 inch average remaining x 3 inch x 18 inch); bottom flange (less than 1/16 inch loss x 4 diameter)

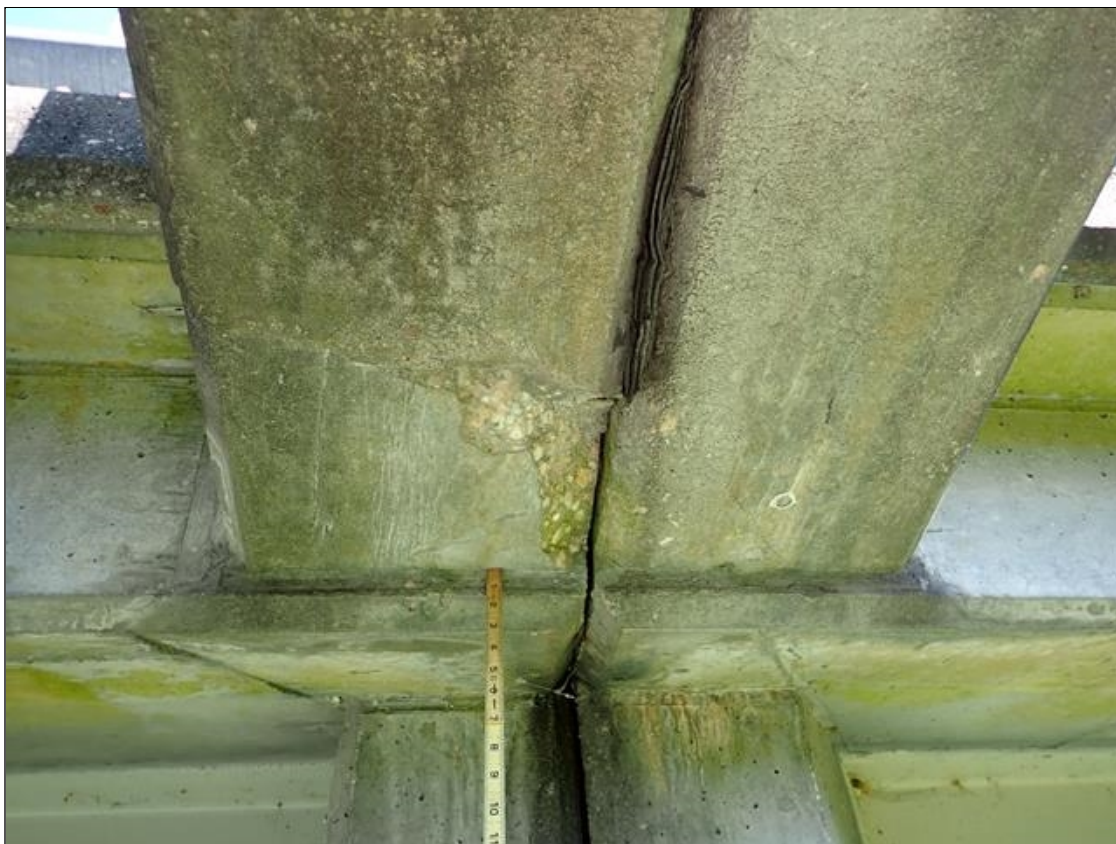
Span 1 Deck: 9 INCHES LONG X UP TO 4 INCHES WIDE X UP TO 2.5 INCHES DEEP SPALL IN RIGHT DECK OVERHANG ABOVE BENT 1.

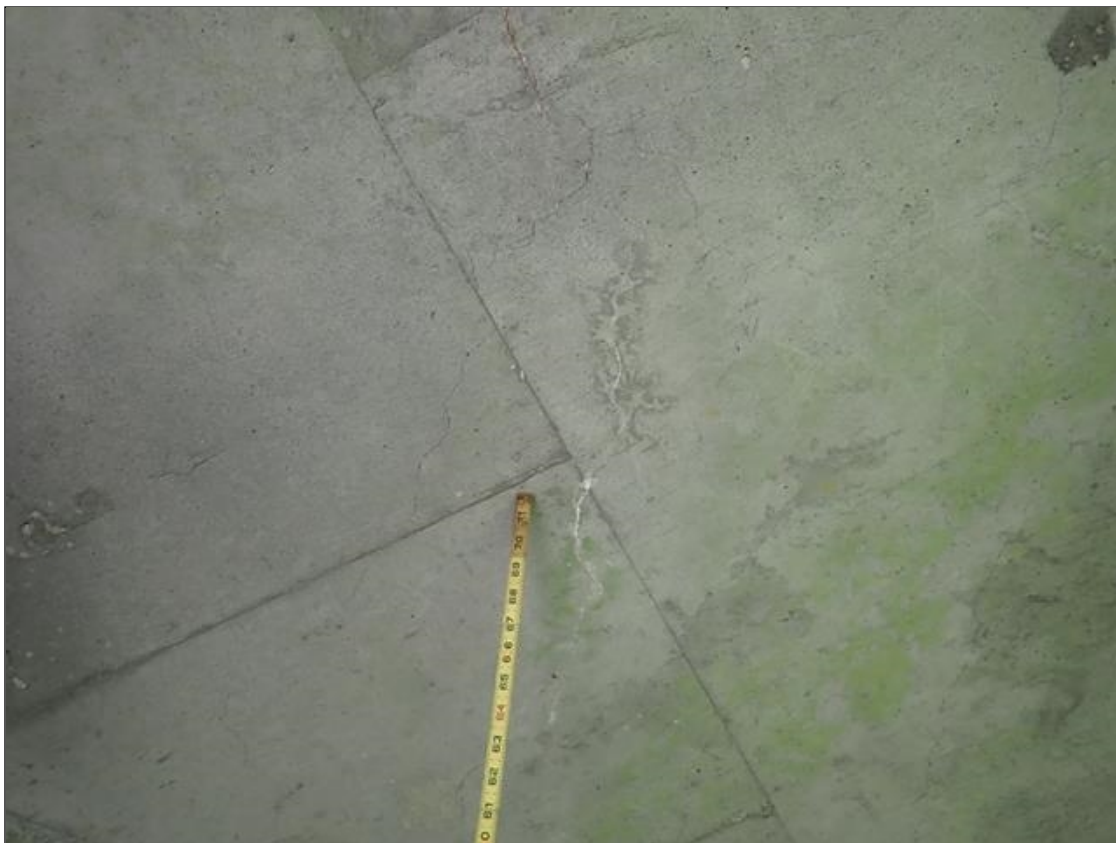
Span 2 Deck: UP TO 0.02 INCH WIDE RANDOM CRACKING SOME WITH EFFLORESCENCE IN DECK UNDERSIDE, SCATTERED THROUGHOUT.

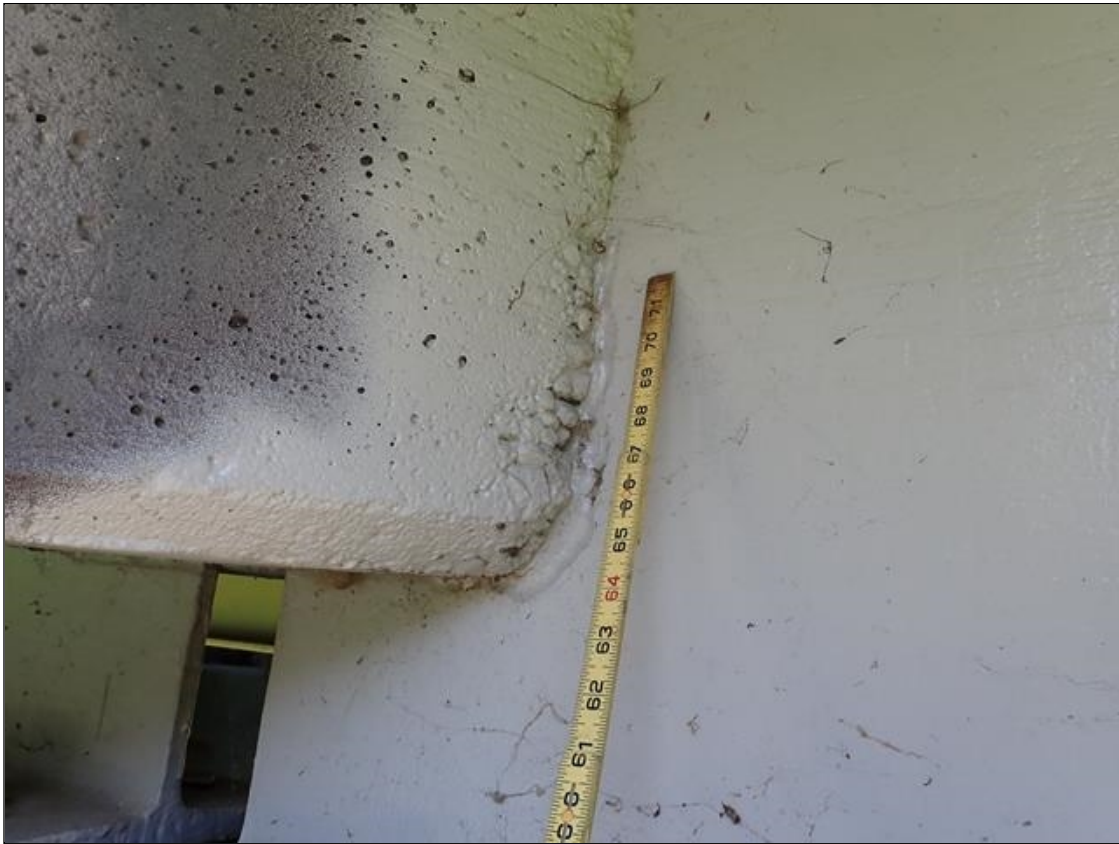
Span 2 Beam 4: (PAR) at bent 1, web adjacent to end diaphragm, painted over section loss (3/8 inch average remaining x 1 inch x 9 inch)

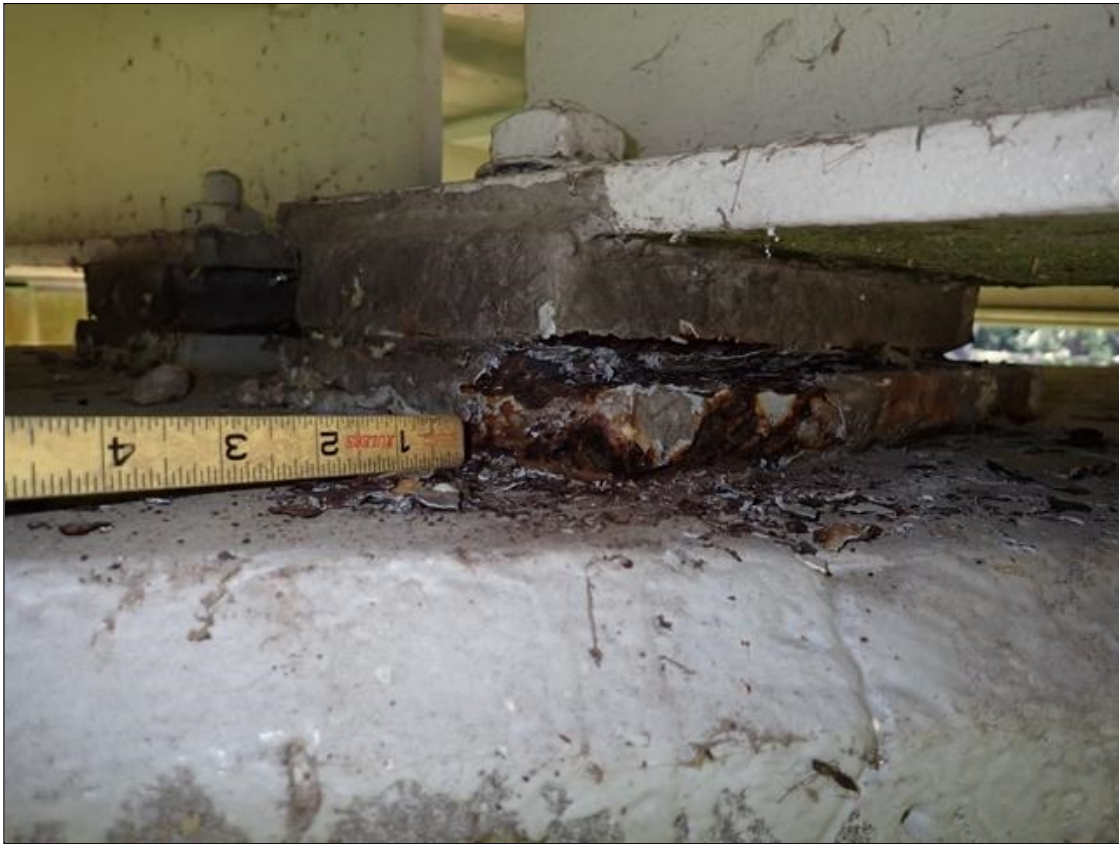
Span 2 Far Bearing 1: painted over section loss (approximately 80 percent remaining) with corrosion reactivating

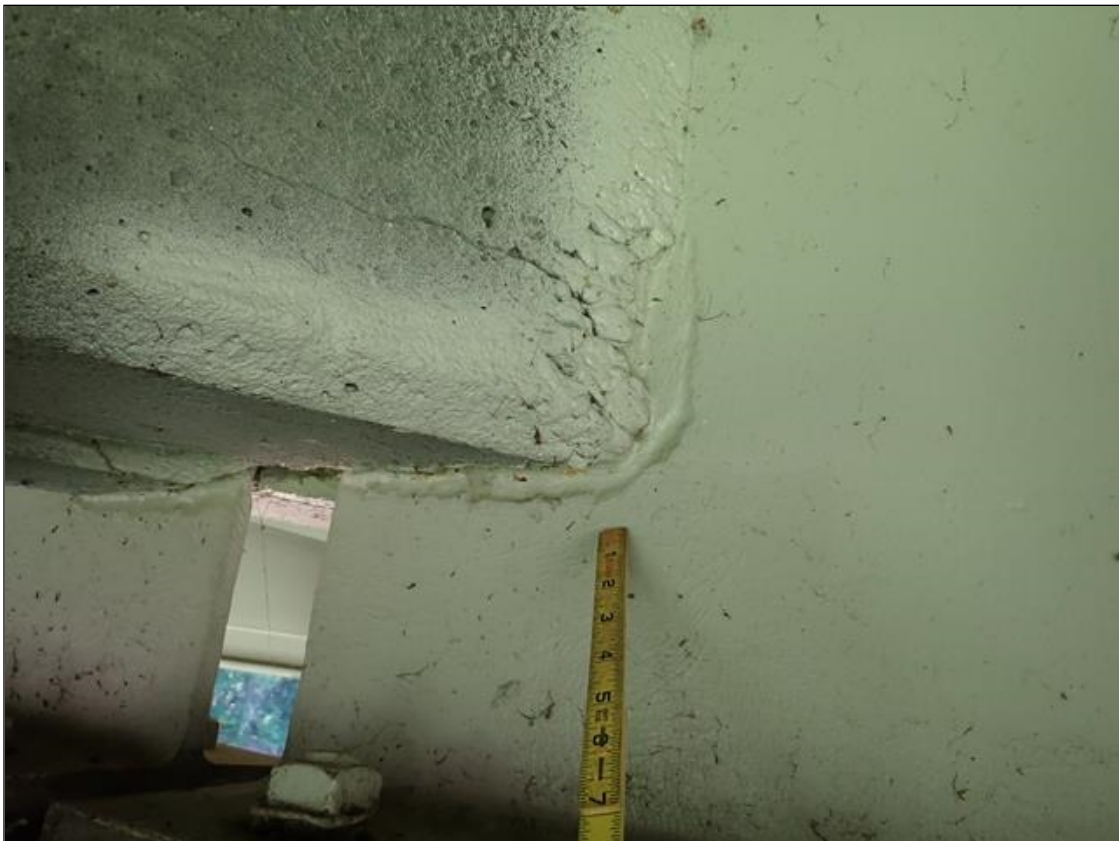
Span 2 Beam 2: (PAR) at bent 2, painted over section loss: web adjacent to end diaphragm (3/8 inch average remaining x 7 inch x 5 inch)

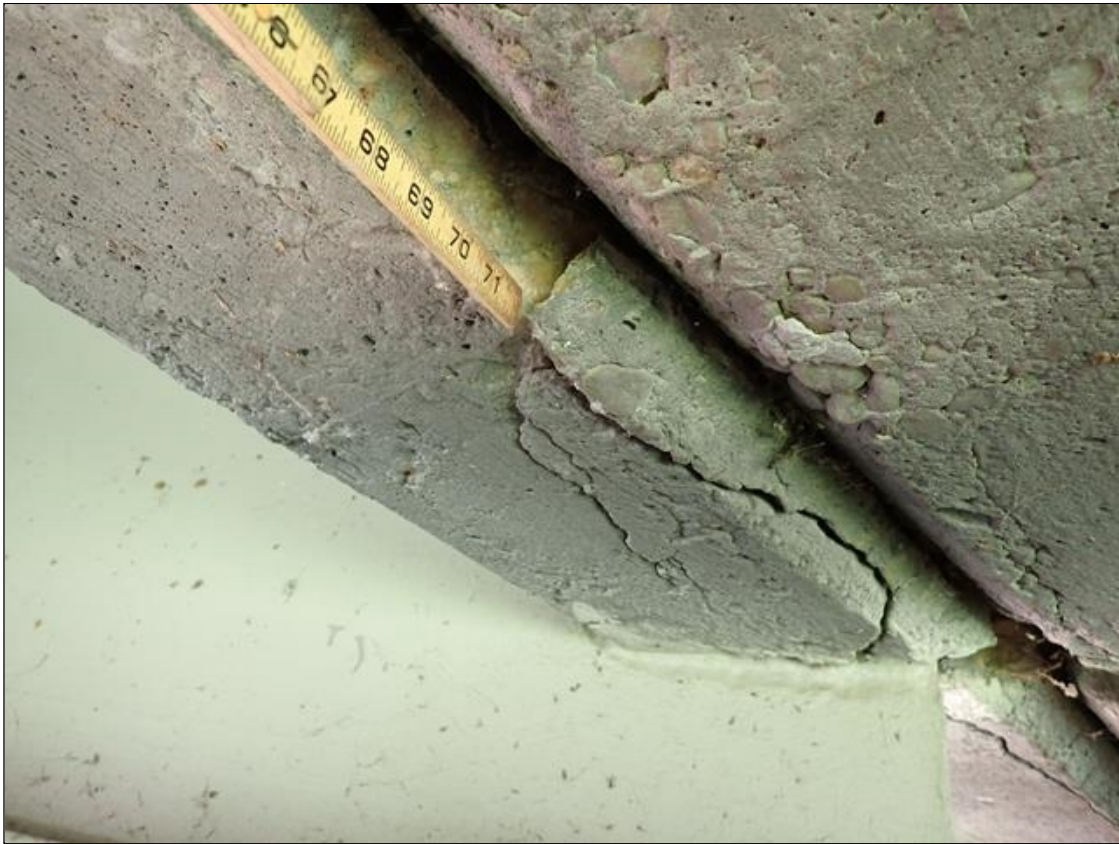
Span 3 Deck: 4 FEET LONG X 1 FOOT HIGH X 1.5 INCH DEEP FAILED PATCH IN BAY 1 DIAPHRAGM; ADJA TO BEAM 2, DELAMINATION (3 FOOT X 8 INCH) AT BENT 2.

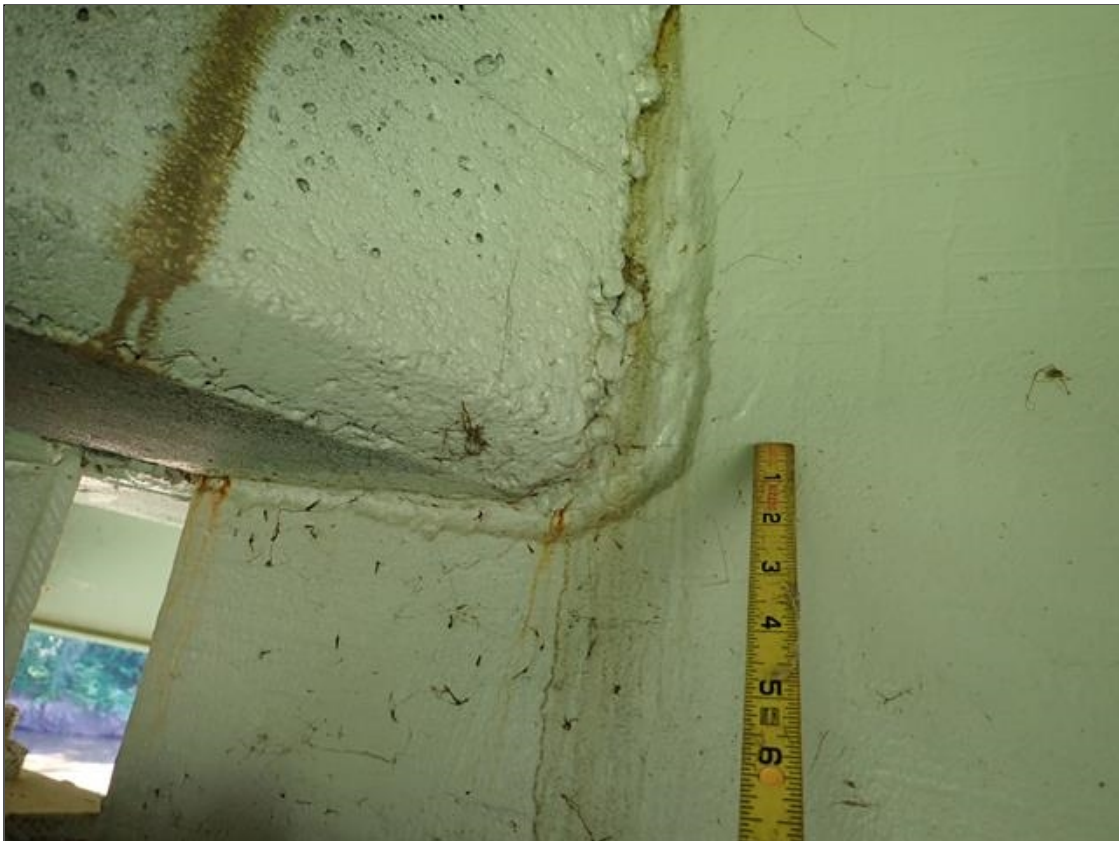
Span 2 Beam 3: (PAR) at bent 2, web adjacent to end diaphragm, painted over section loss (3/8 inch average remaining x 8 inch x 7 inch)

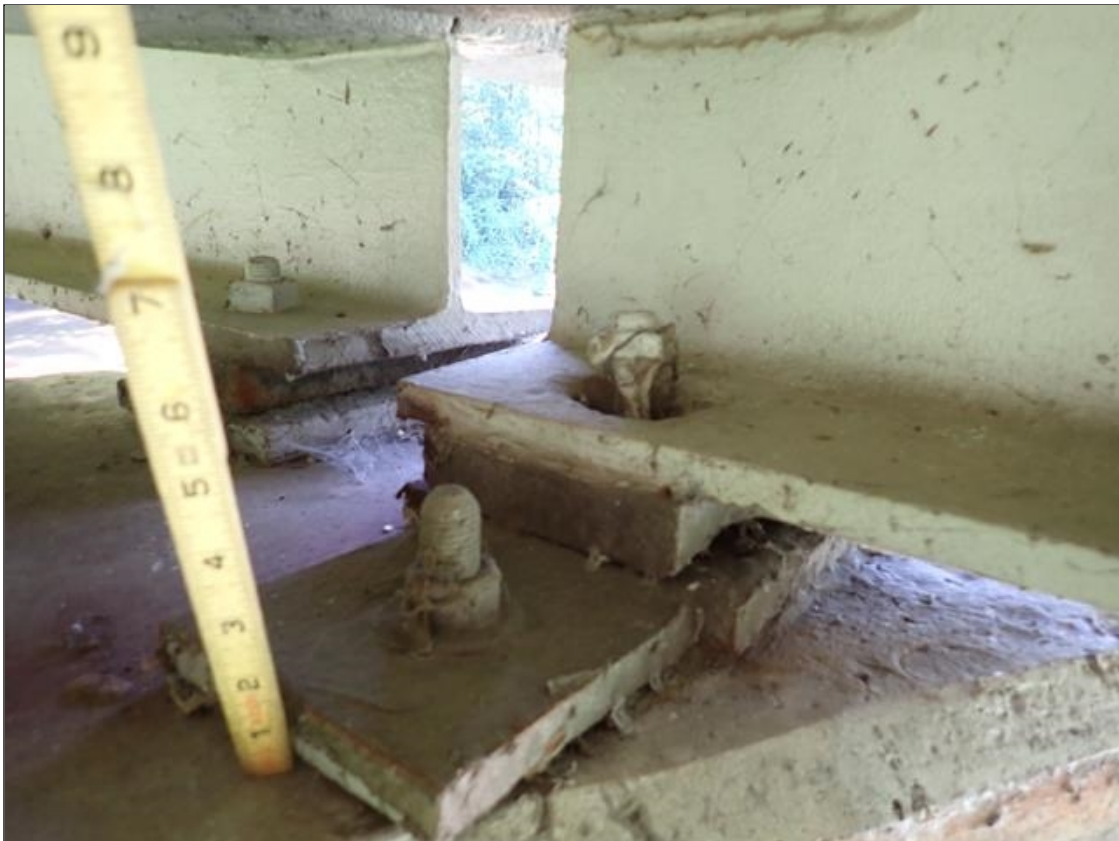
Span 2 Far Bearing 1: WELDED REPAIR WITH NEW ANCHOR BOLT. UP TO 50 PERCENT SECTION LOSS IN OLD ANCHOR BOLT. PAR NOT ISSUED DUE TO NEW ANCHOR BOLT REPAIR.

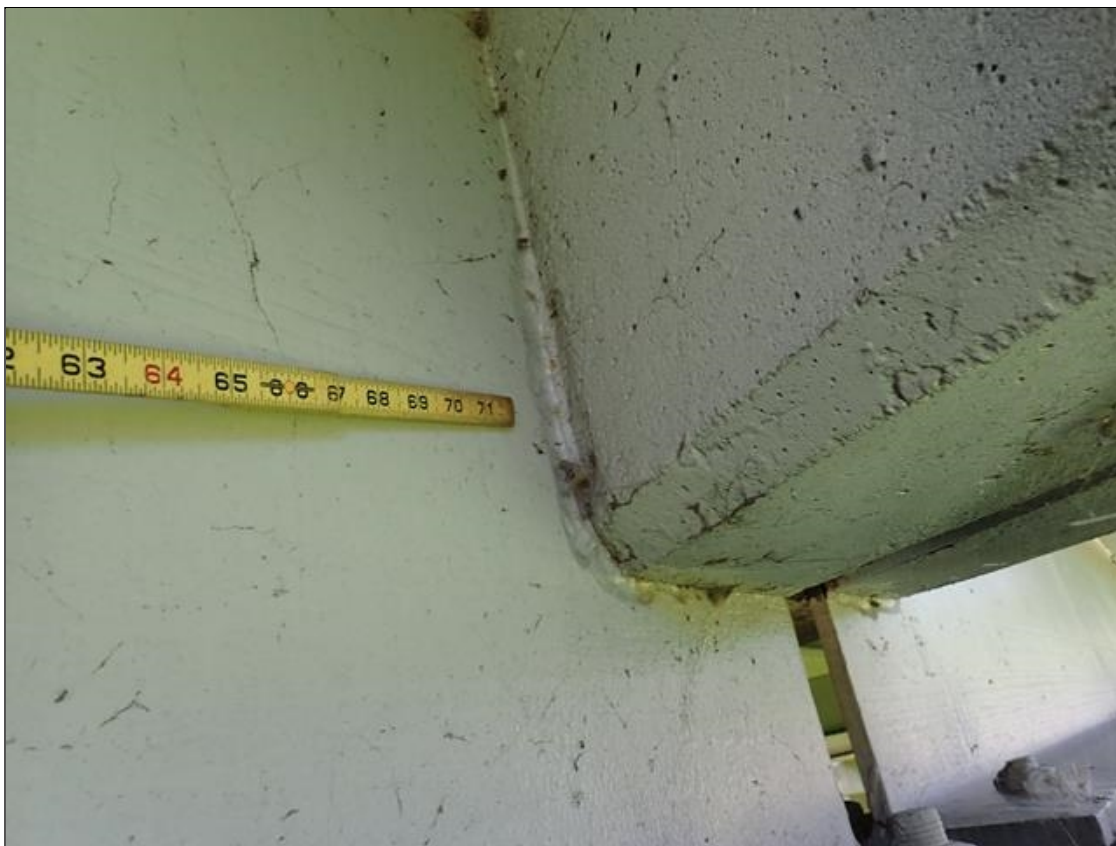
Span 3 Beam 1: at bent 2, web adjacent to end diaphragm, painted over section loss (1/2 inch average remaining x 1 inch x 8 inch)

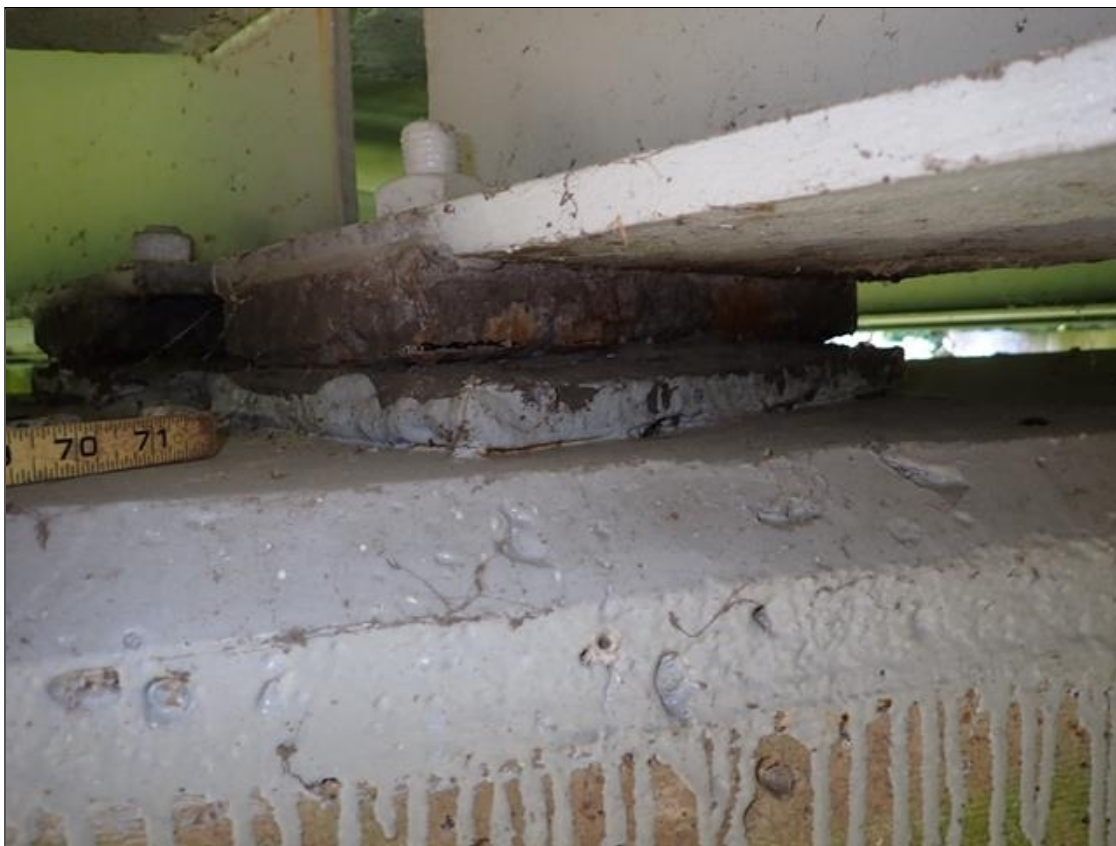
Span 3 Near Bearing 3: painted over section loss (less than 1/16 inch loss) with corrosion reactivating

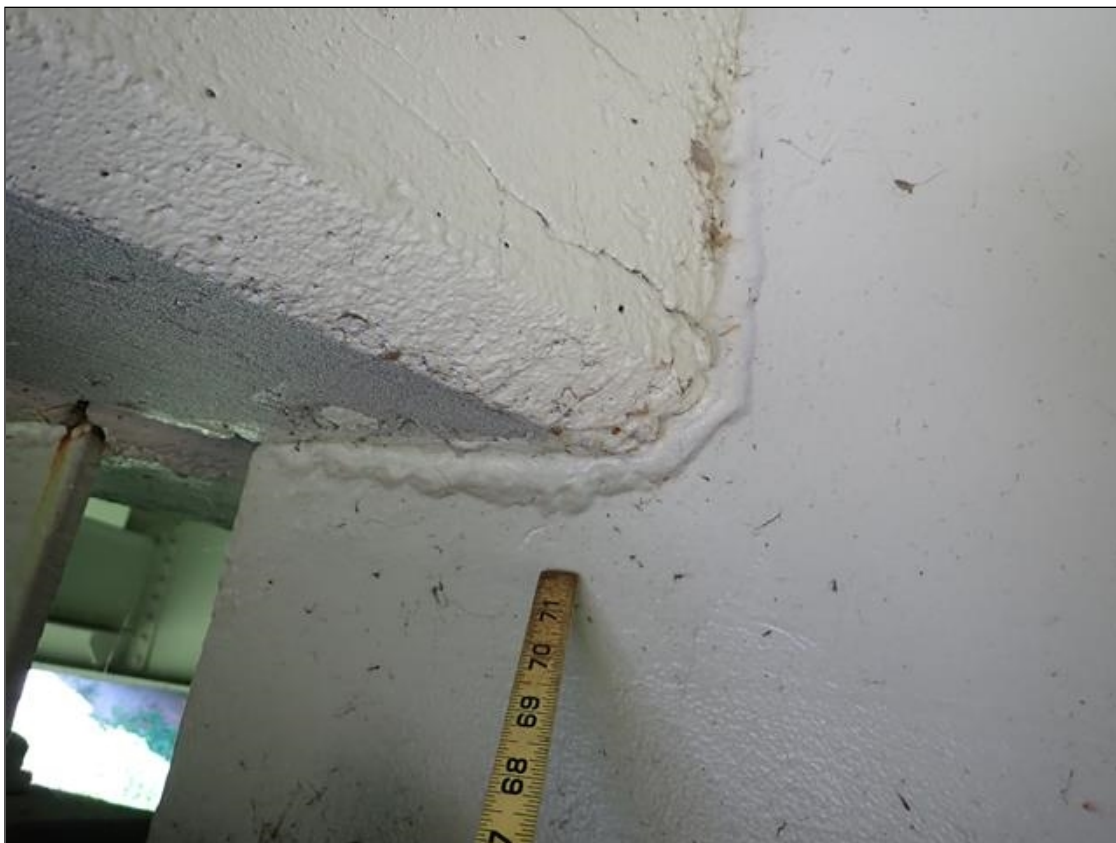
Span 3 Beam 3: (PAR) at bent 2, web adjacent to end diaphragm, painted over section loss (3/8 inch average remaining x 10 inch x 7 inch)

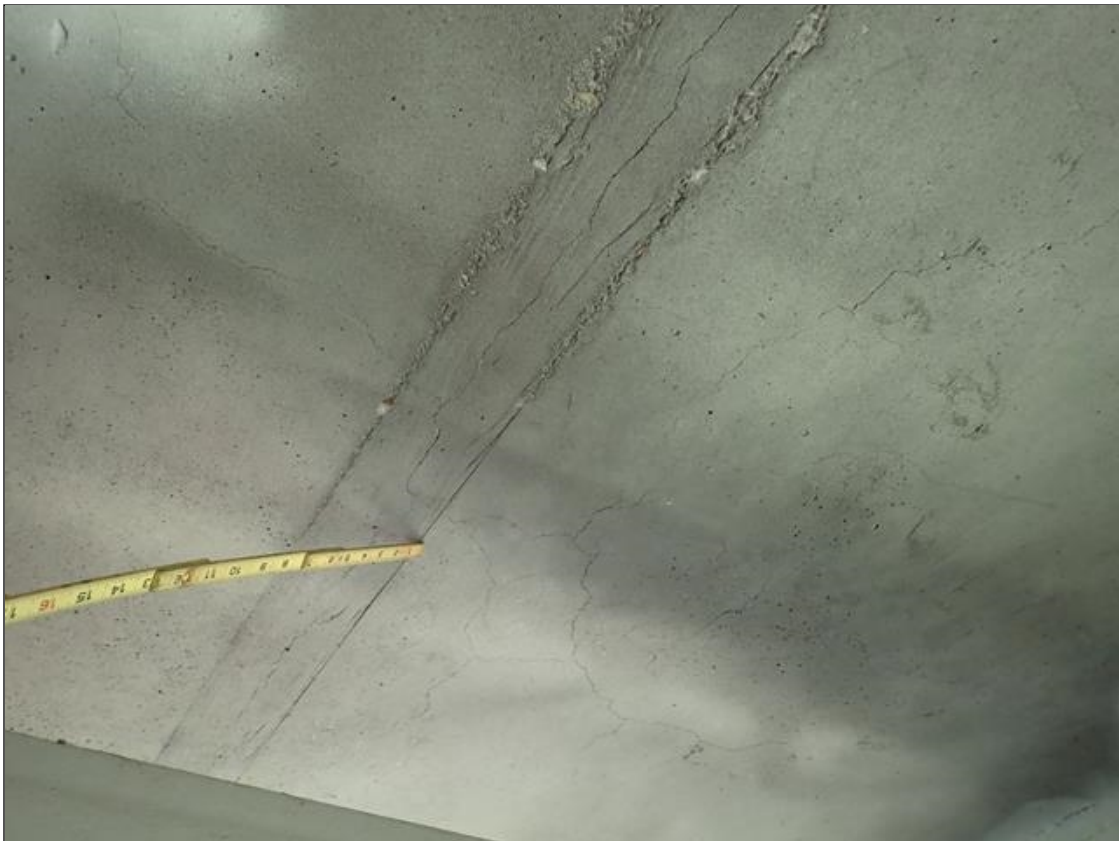
Span 3 Deck: UP TO 0.03 INCH WIDE RANDOM CRACKING IN DECK UNDERSIDE, SCATTERED THROUGHOUT.

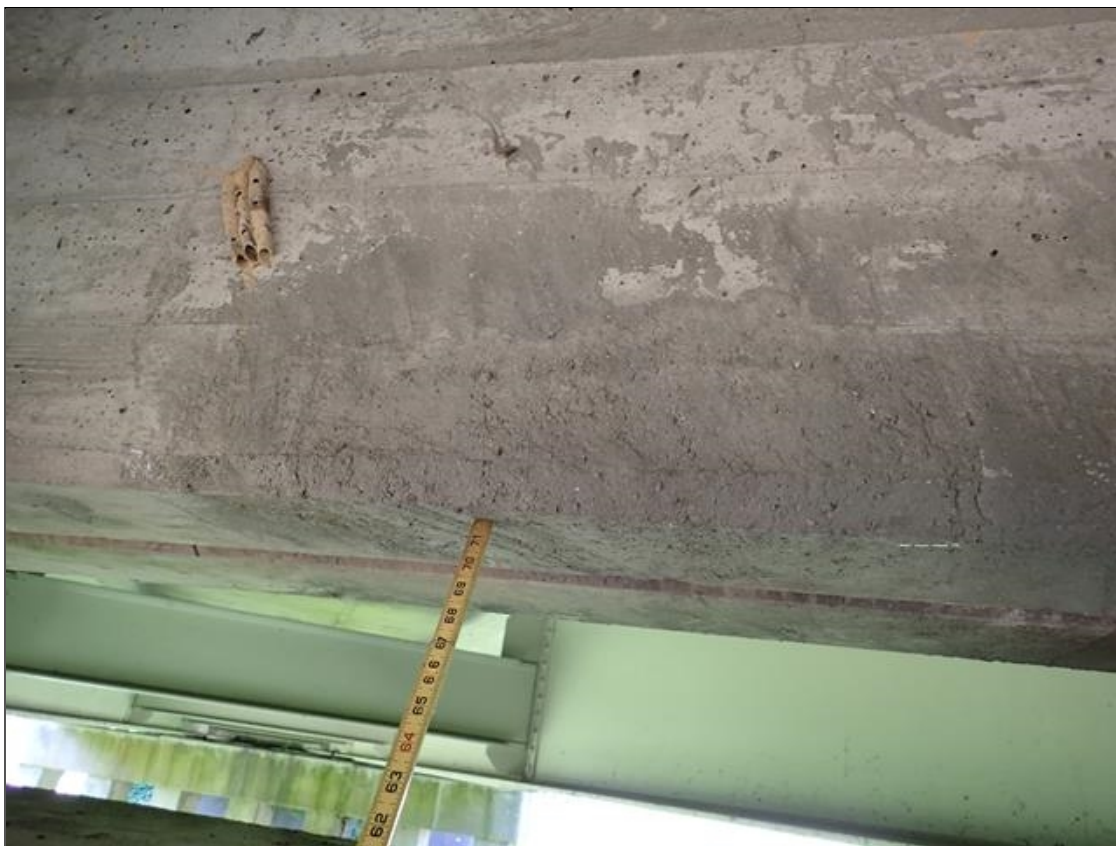
Span 3 Deck: BAY 2, END DIAPHRAGM, AT BENT 2, 2 FEET LONG X 1 FOOT HIGH SOUND PATCH.

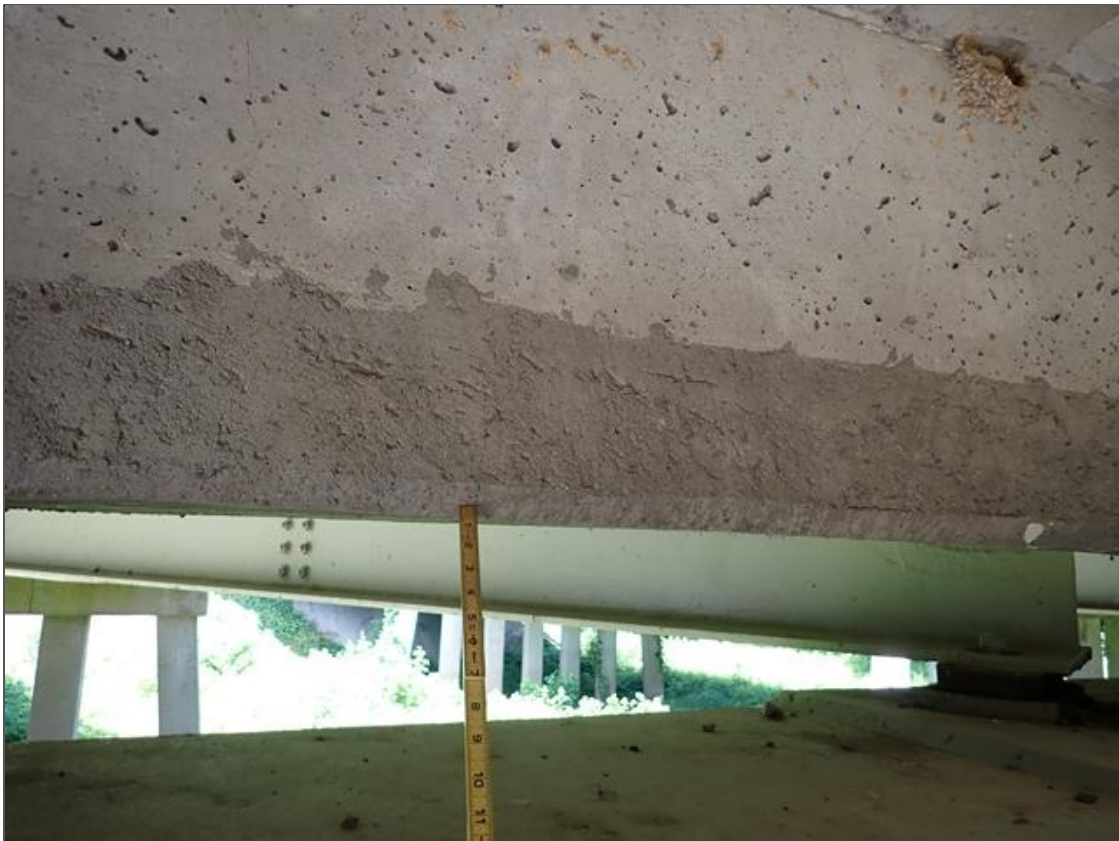
Span 4 Deck: 4 FEET LONG X 1 FOOT HIGH AREA OF UNSOUND CONCRETE PATCH WITH UP TO 1/64 INCH VERTICAL CRACKS IN BAY 3 BENT DIAPHRAGM AT BENT 3.

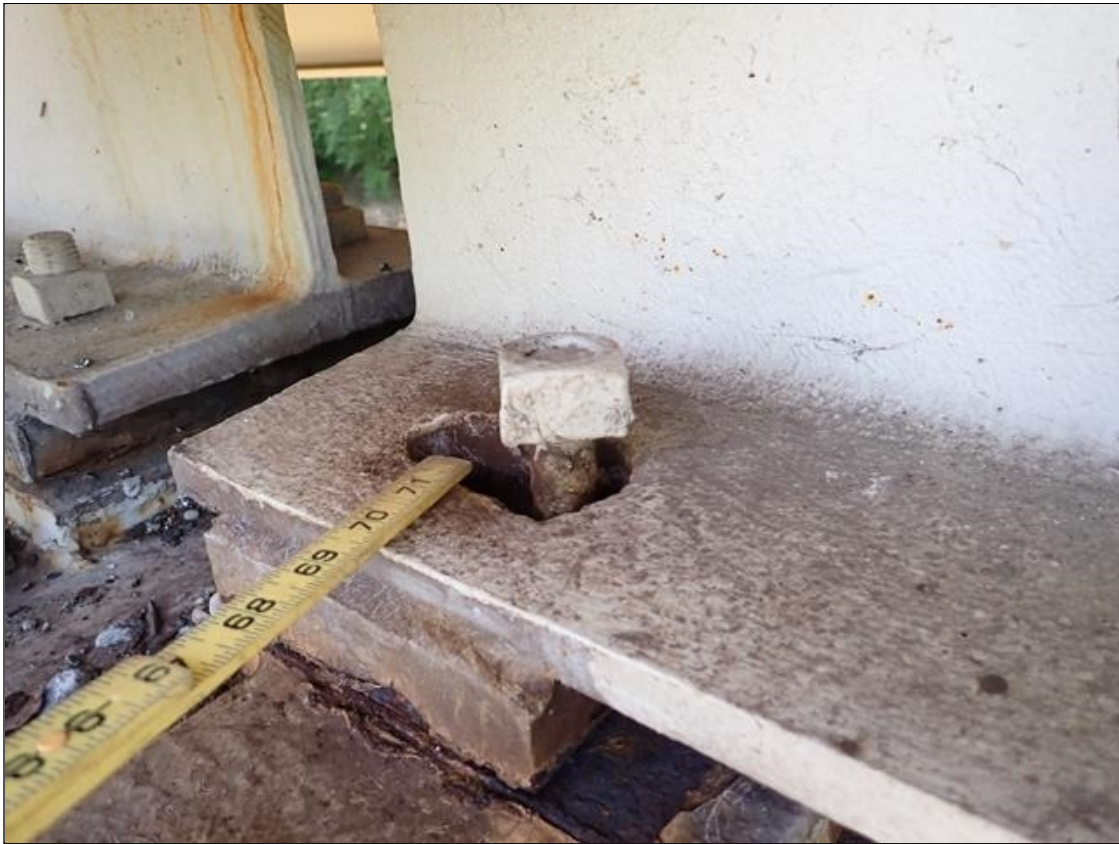
Span 4 Far Bearing 1: RIGHT ANCHOR BOLT IS MISSING; LEFT ANCHOR BOLT, PAINTED OVER SECTION LOSS (50 PERCENT REMAINING); WELDED REPAIR WITH NEW ANCHOR BOLTS.

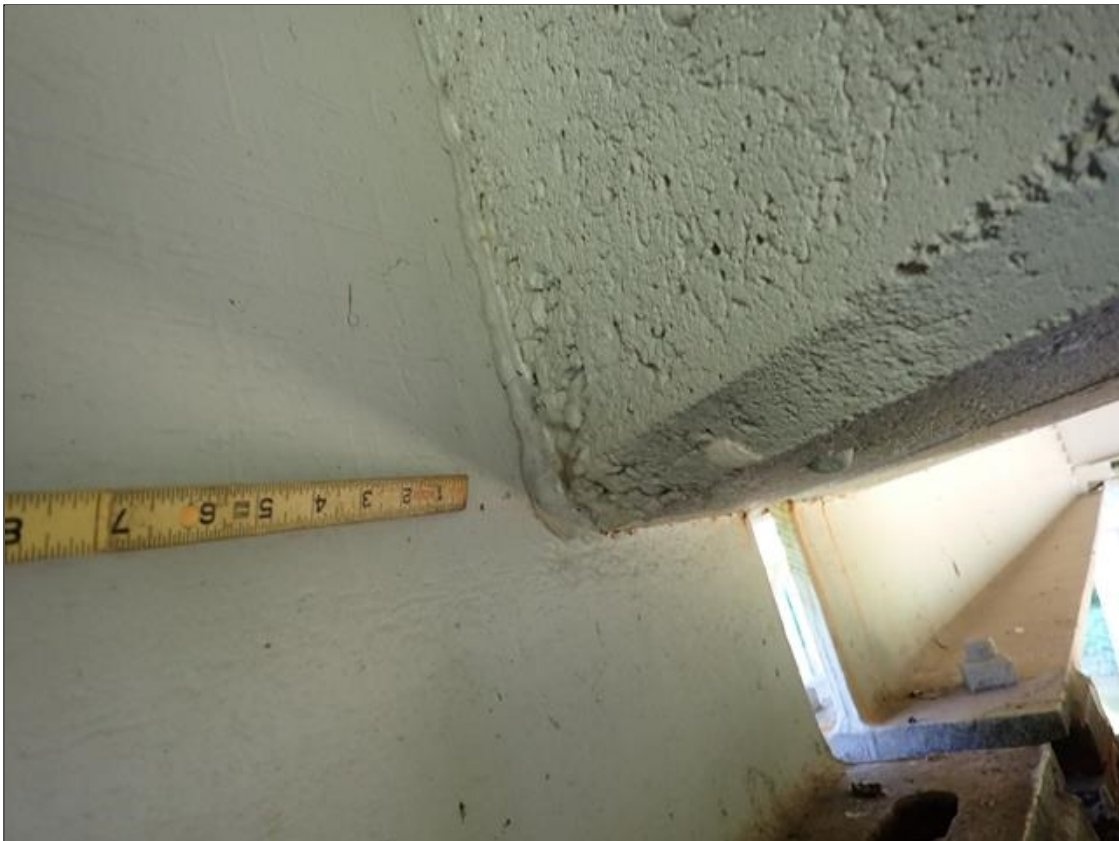
Span 4 Beam 1: (PAR) at bent 4, web adjacent to end diaphragm, painted over section loss (3/8 inch average remaining x 8 inch x 1 inch)

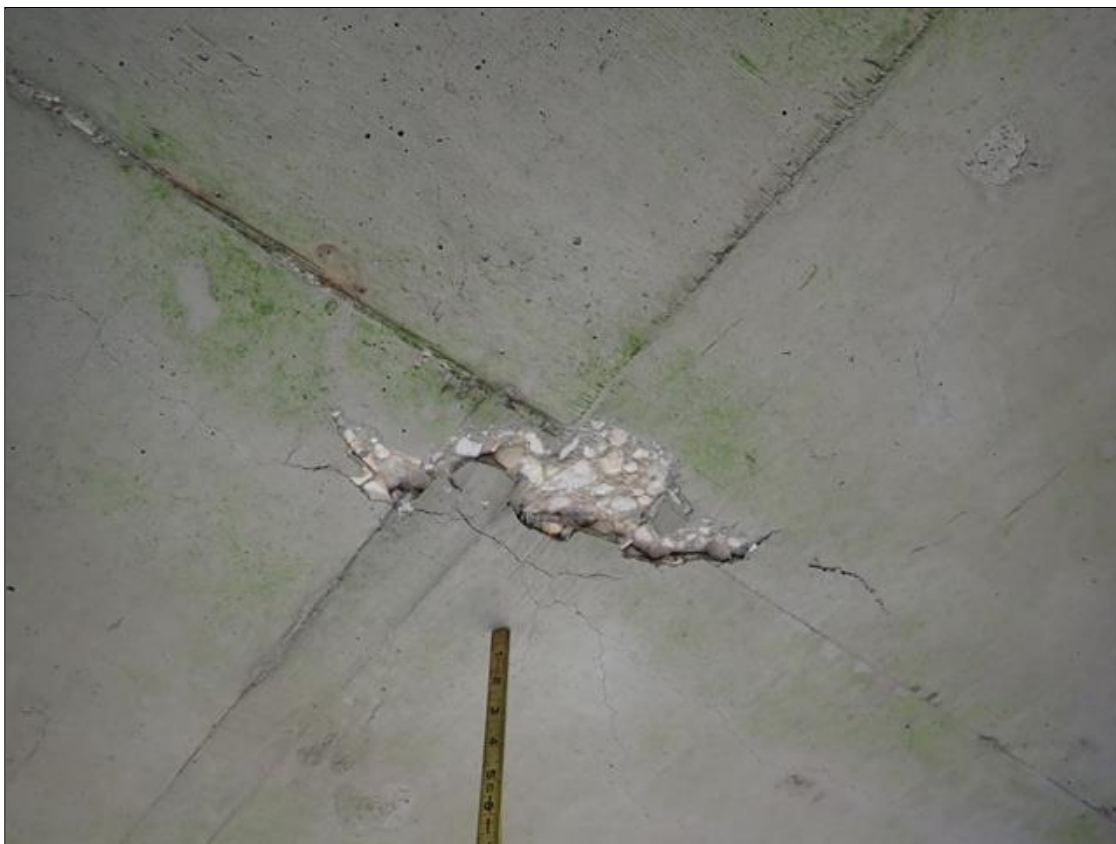
Span 4 Deck: underside of deck in bay 1, near bent 4, delamination/spall (22 inch x 7 inch x 1/2 inch deep)

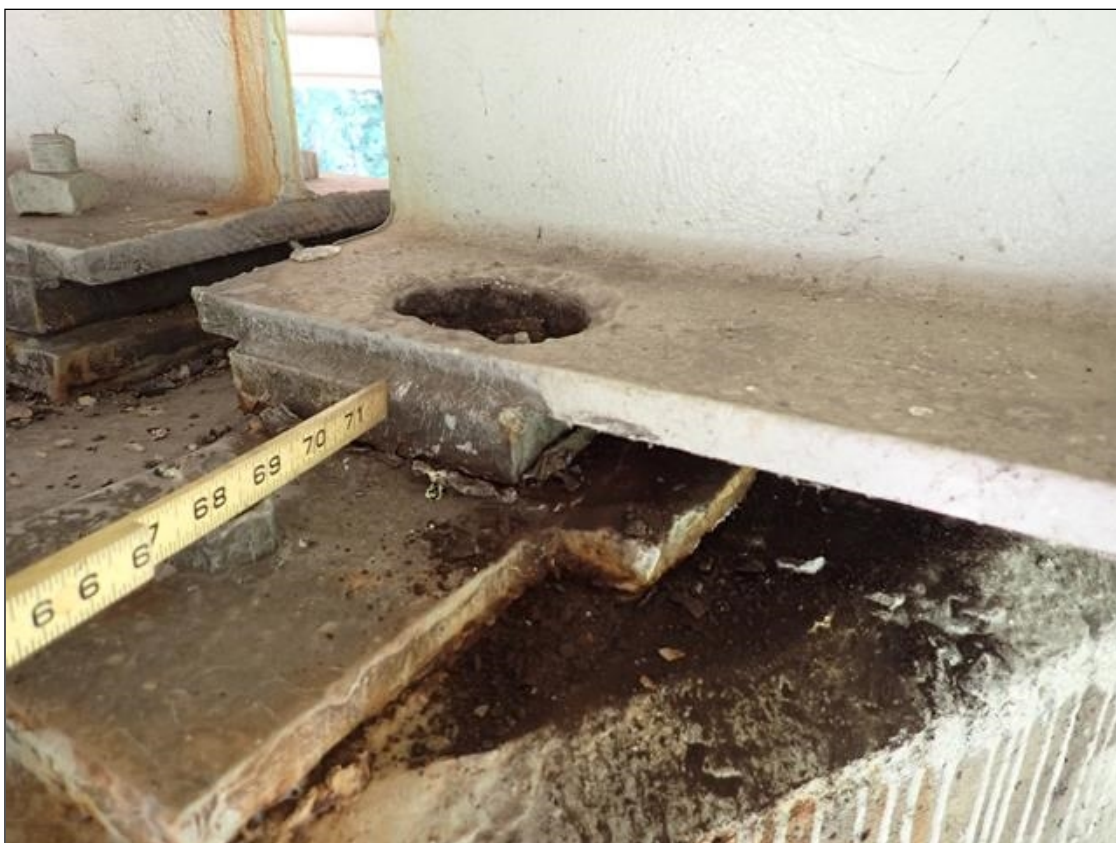
Span 4 Far Bearing 2: BOTH ANCHOR BOLTS, MISSING; WELDED REPAIR WITH ADDED ANCHOR BOLT.
