NC DEPARTMENT OF TRANSPORTATION  
 DIVISION OF HIGHWAYS  
 STRUCTURE MANAGEMENT UNIT  
 COUNTY: JOHNSTON DIV: 4

ATTENTION:  PARS Submitted  Sign Notice Issued  
 sketches revised; new repairs

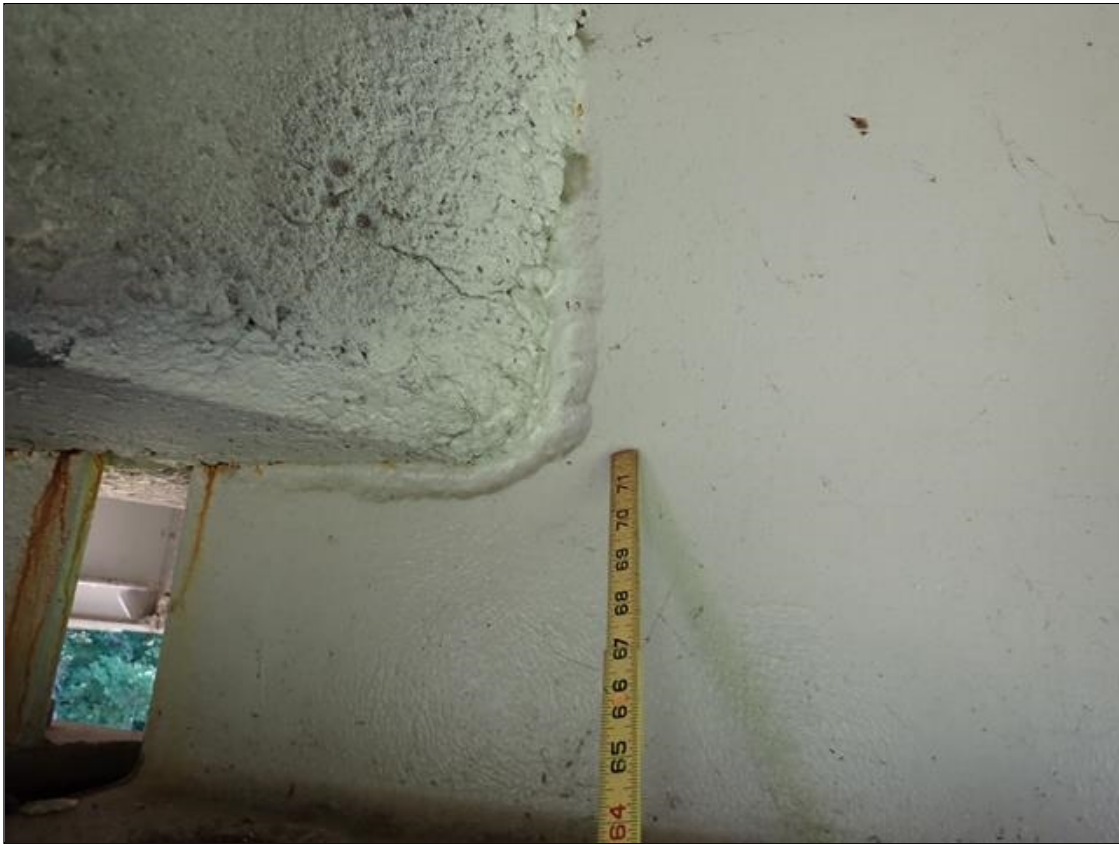
Span 4 Beam 2: (PAR) at bent 4, web adjacent to end diaphragm, painted over section loss (3/8 inch average remaining x 8 inch x 8 inch) with corrosion reactivating

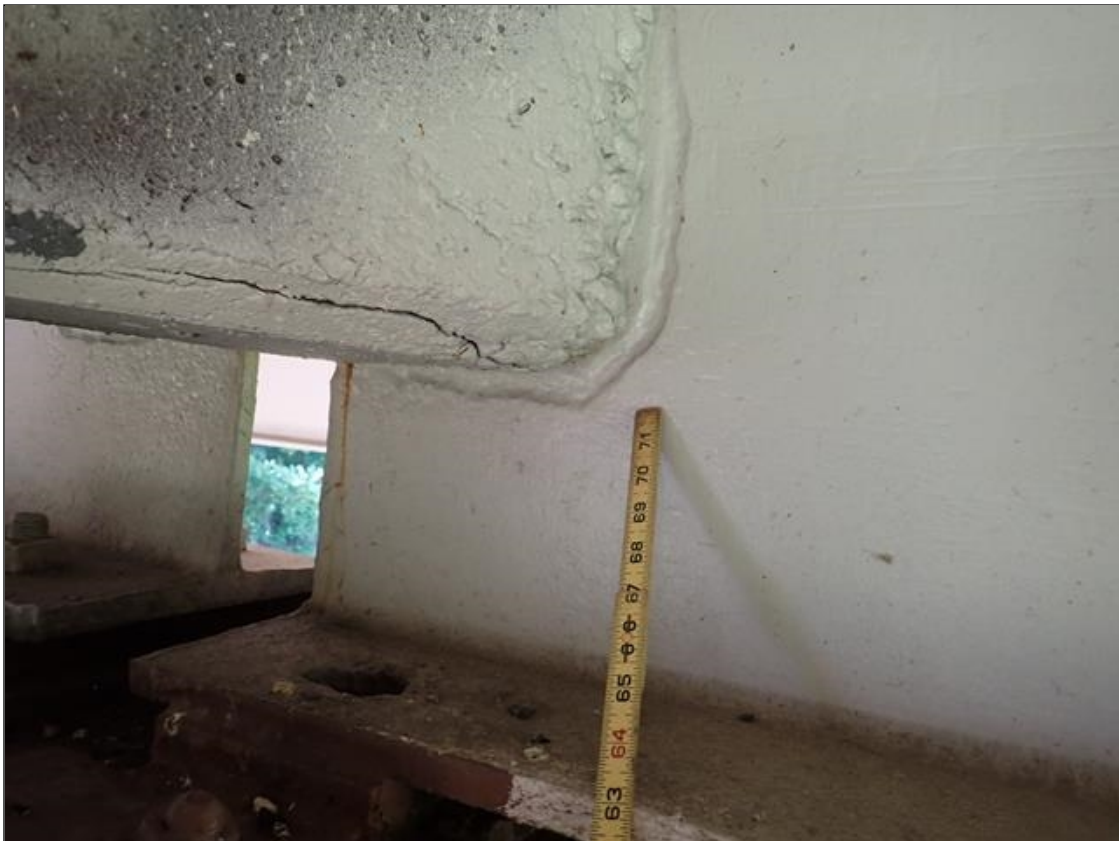
Span 4 Beam 3: (PAR) at bent 4, web adjacent to end diaphragm, painted over section loss (3/8 inch average remaining x 8 inch x 8 inch) with corrosion reactivating

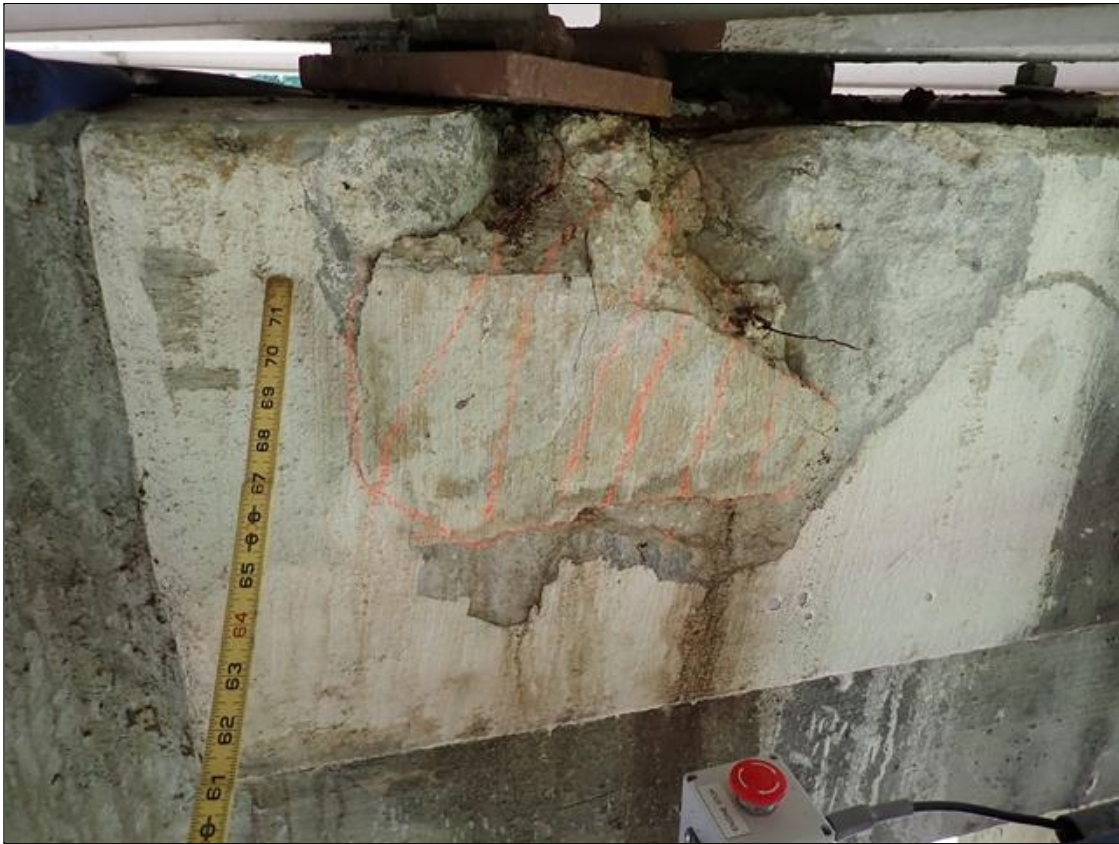
Span 4 Far Bearing 3: (PAR) ADDED BEARING HAS A LOSS OF BEARING AREA DUE TO SPALL ON CAP. AREA REPAIRED IS UNSOUND AND HAS 13 INCHES HIGH X 20 INCHES WIDE X 6 INCHES DEEP SPALL/ DELAMINATION.

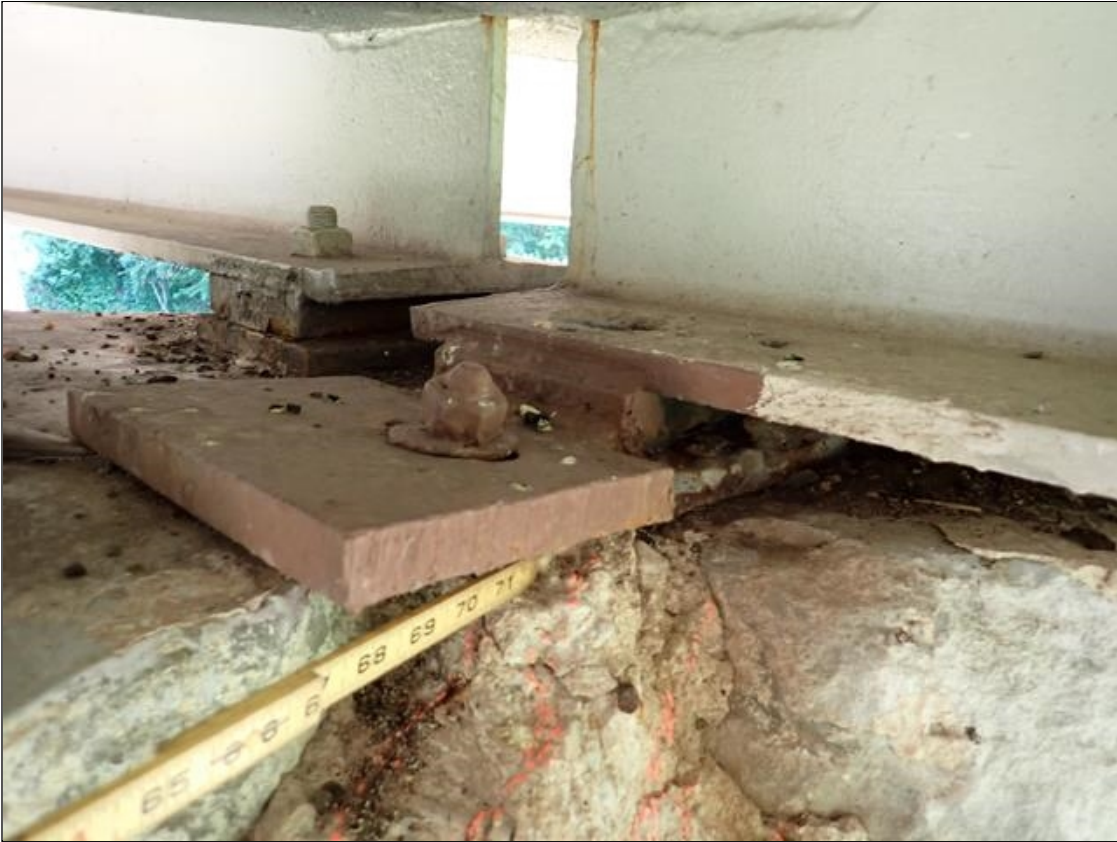
Span 4 Far Bearing 3: LEFT ANCHOR BOLT NUT, MISSING; RIGHT ANCHOR BOLT, PAINTED OVER SECTION LOSS (50 PERCENT REMAINING) BEARING HAS WELDED REPAIR WITH NEW ANCHOR BOLTS.

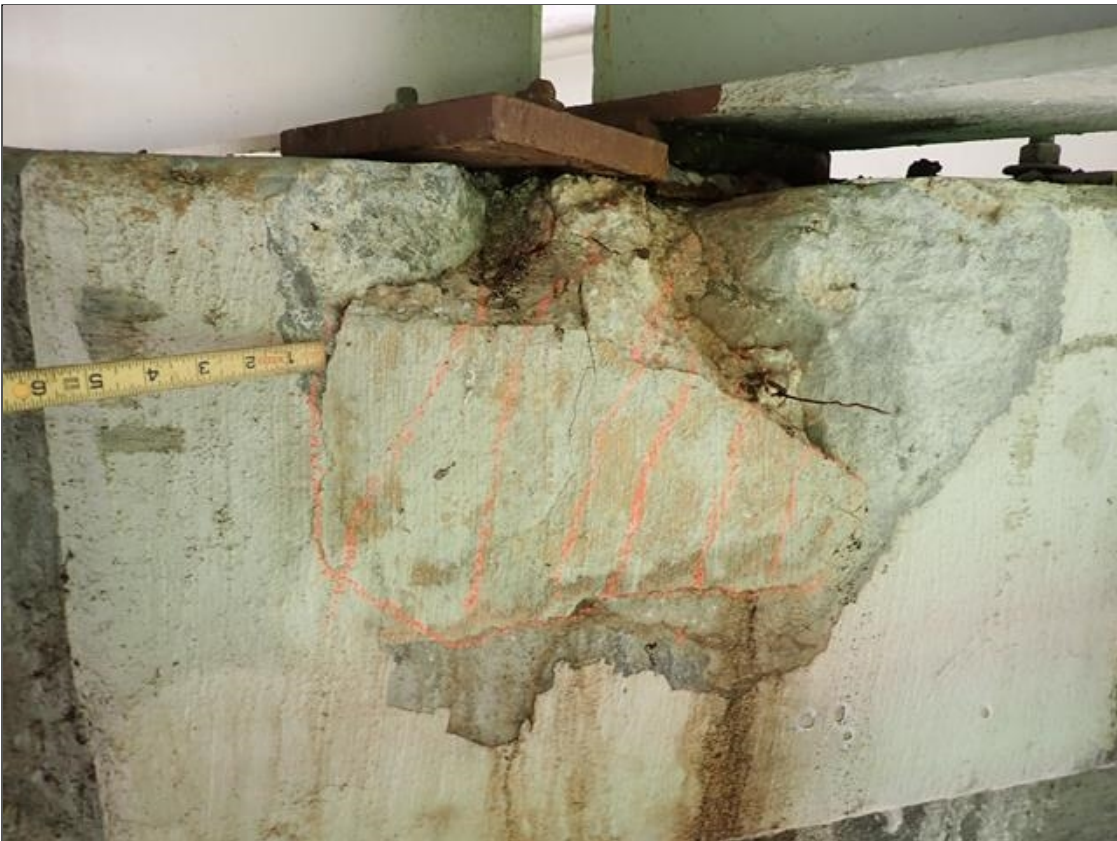
Bent 4 Cap 1: (PAR) SOUTH FACE BELOW BEAM 3 UNSOUND PATCHED AREA WITH SPALLING 4 FEET X 18 INCHES, SPALLS 20 INCHES X 13 INCHES X 6 INCHES DEEP; UNDERMINING BEARING (4 INCH DEEP)

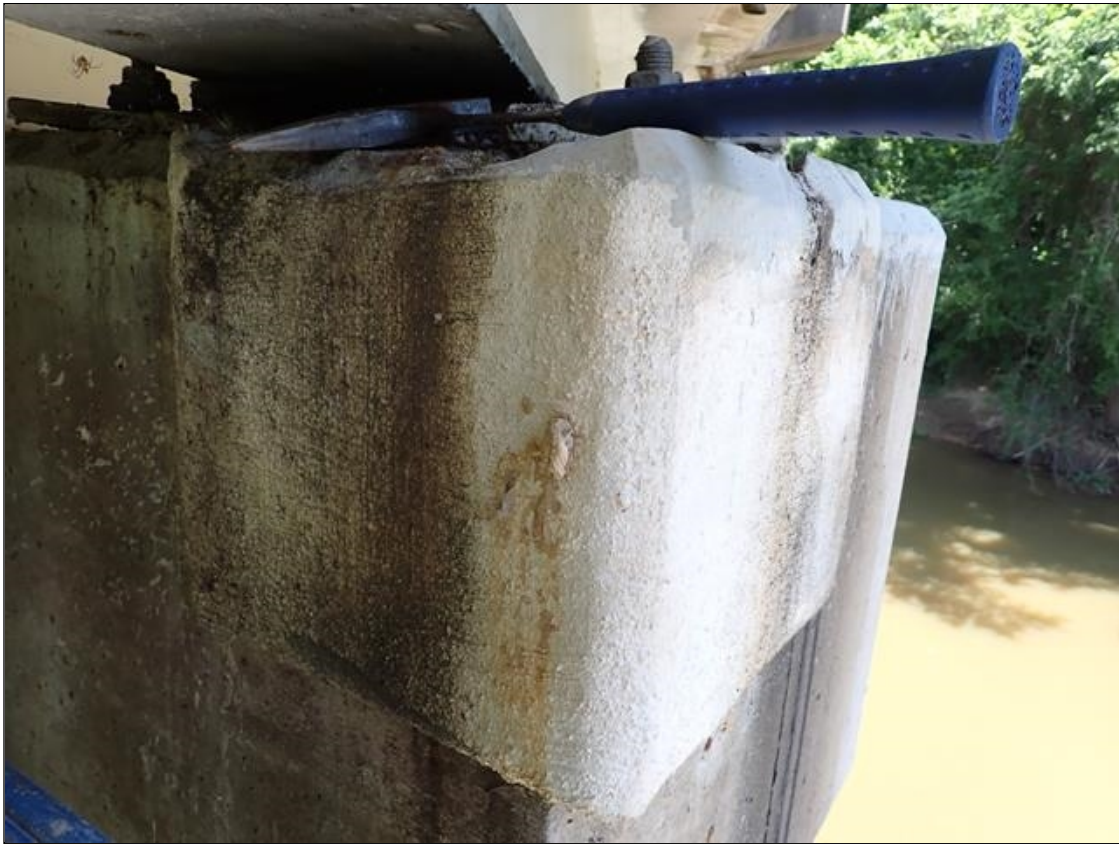
Bent 4 Cap 1: 15 INCHES HIGH X 21 INCHES WIDE SOUND CONCRETE PATCH AREA, TOP SOUTHEAST CORNER OF CAP, BELOW NEW BEARING ASSEMBLY OF BEAM 4.

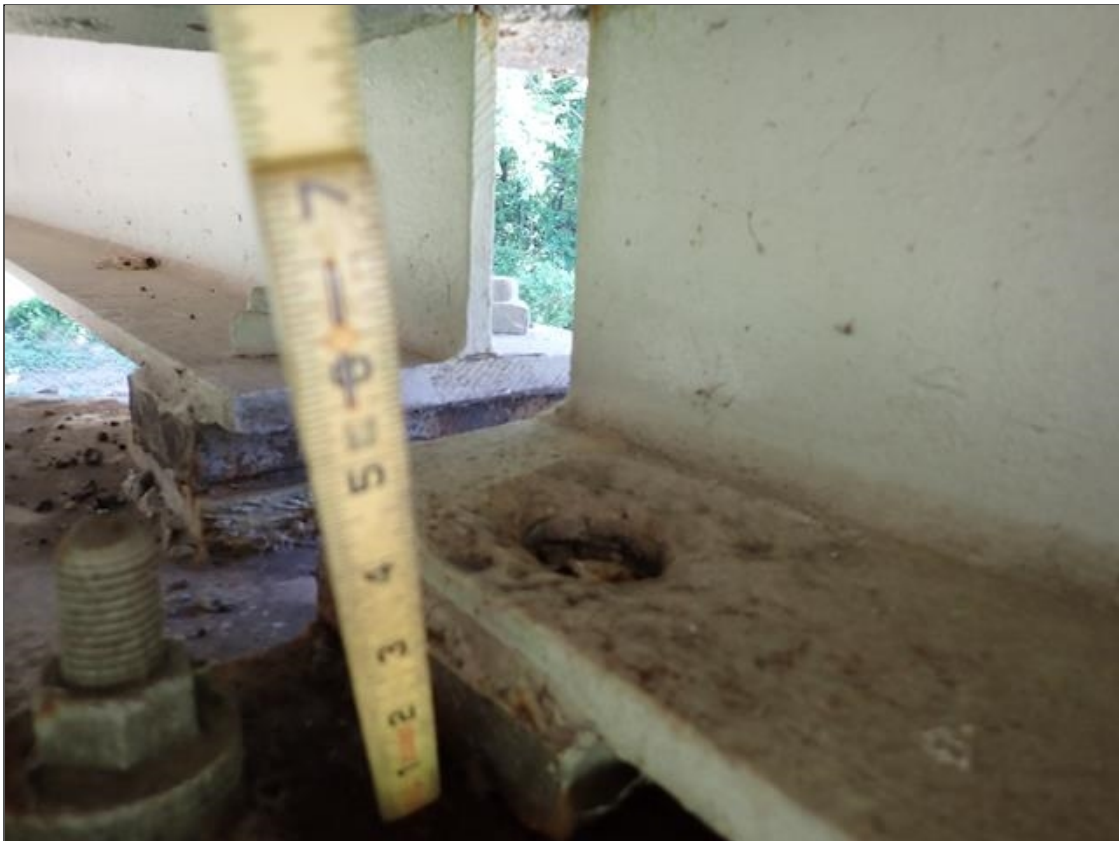
Span 4 Far Bearing 4: BOTH ANCHOR BOLTS ARE MISSING; BEARING ASSEMBLY HAS A WELDED REPAIR WITH NEW ANCHOR BOLTS.

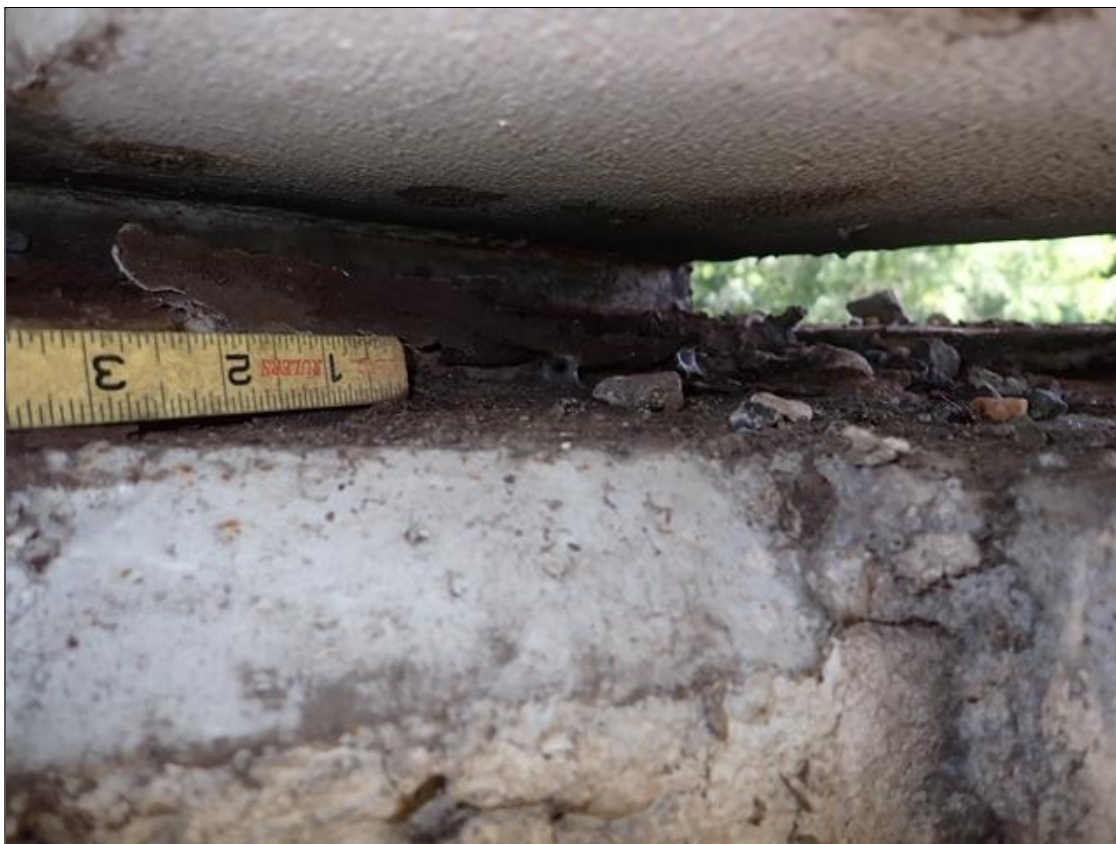
Span 4 Far Bearing 4: corrosion with section loss (approximately 80 percent remaining)

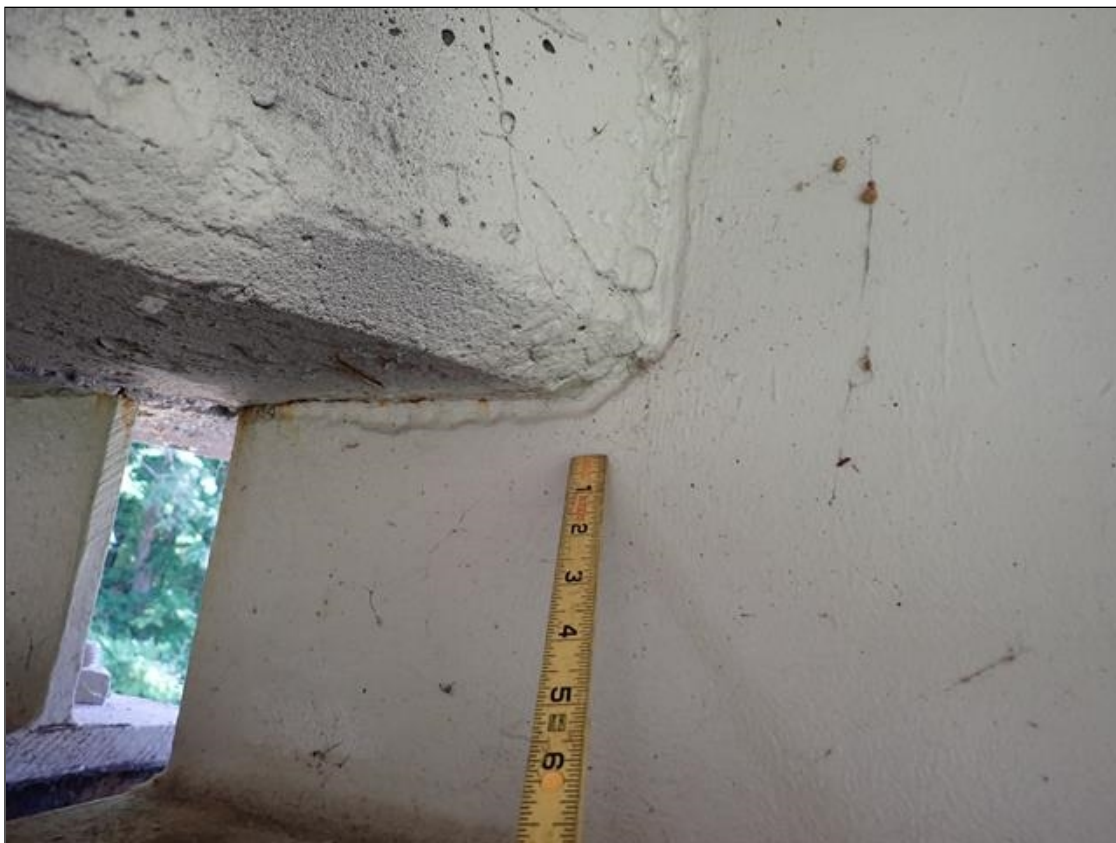
Span 4 Beam 4: (PAR) at bent 4, web adjacent to end diaphragm, painted over section loss (3/8 inch average remaining x 8 inch x 8 inch)

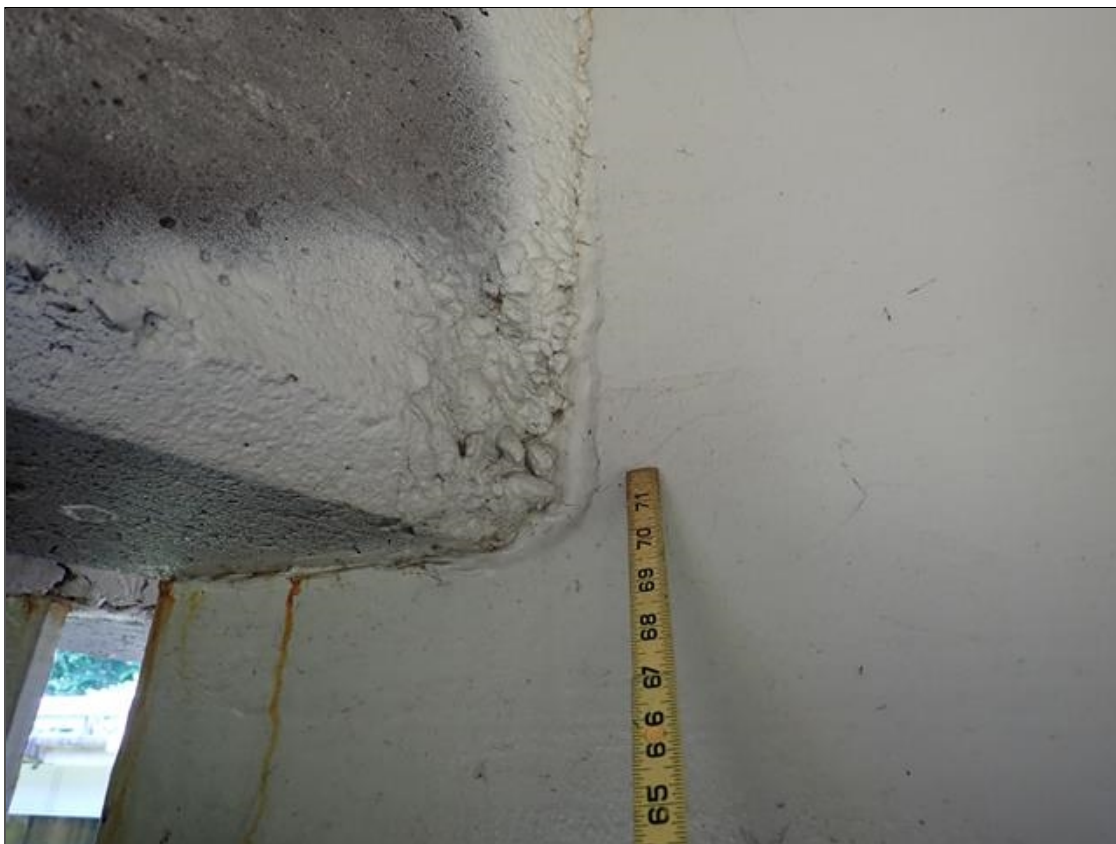
Span 5 Beam 1: (PAR) at bent 4, web adjacent to end diaphragm, painted over section loss (3/8 inch average remaining x 8 inch x 1 inch) with corrosion reactivating

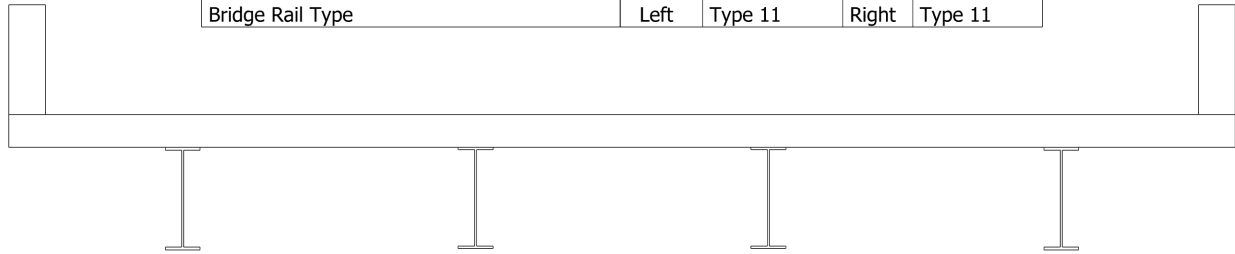
Measurements for Span #	1	ALL SPANS SIMILAR	
Deck Thickness	10.74in	Left Overhang	4.75ft
Top of Rail to Bottom of Beam (Avg)	6.697ft	Right Overhang	4.75ft
