NC DEPARTMENT OF TRANSPORTATION
 DIVISION OF HIGHWAYS
 STRUCTURE MANAGEMENT UNIT
 COUNTY: JOHNSTON DIV: 4

ATTENTION: PARS Submitted Sign Notice Issued
 sketches revised; new repairs

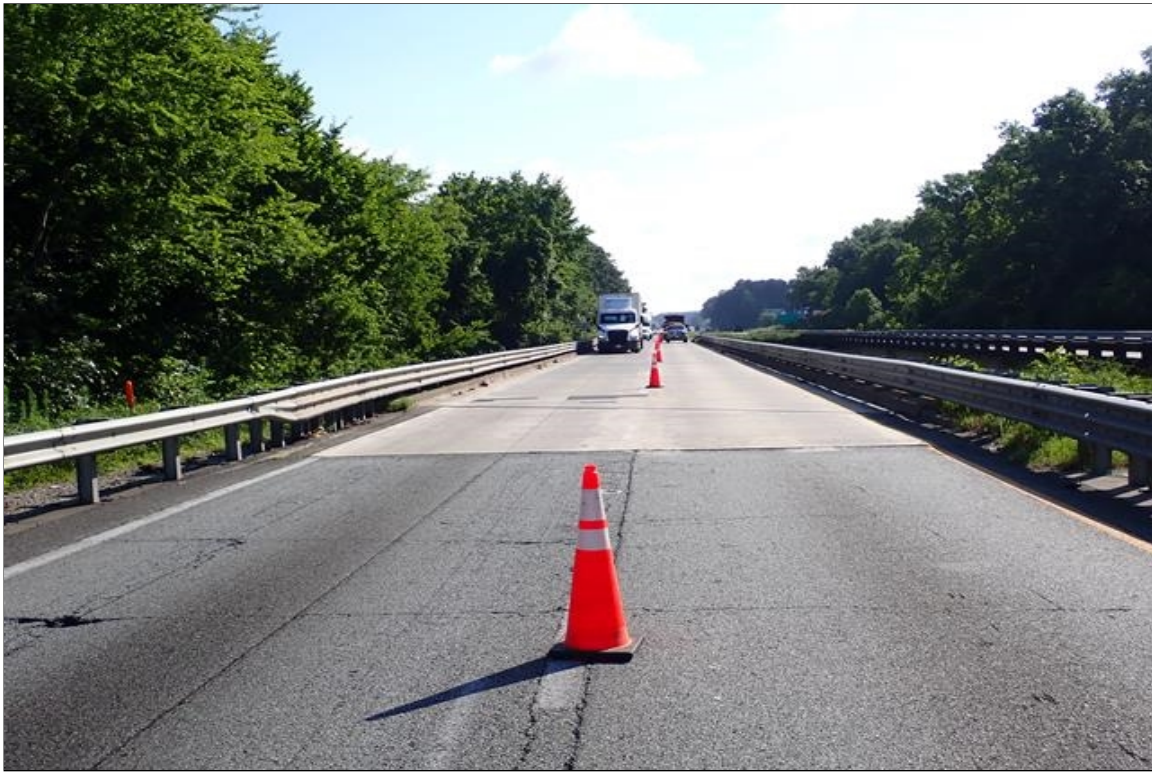
south approach looking north

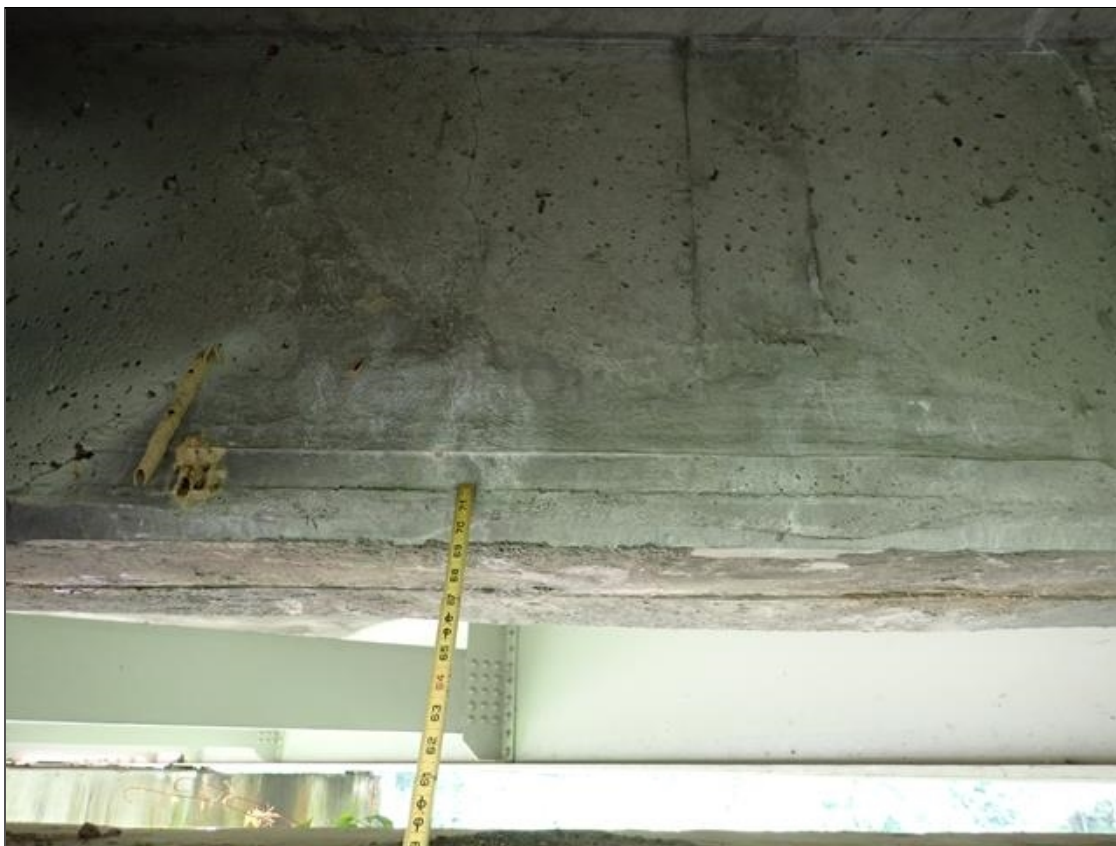
Span 8 Deck: 3 FEET LONG X 10 INCHES HIGH SOUND CONCRETE PATCHED AREA BOTTOM OF BAY 2 END DIAPHRAGM, AT BENT 7.

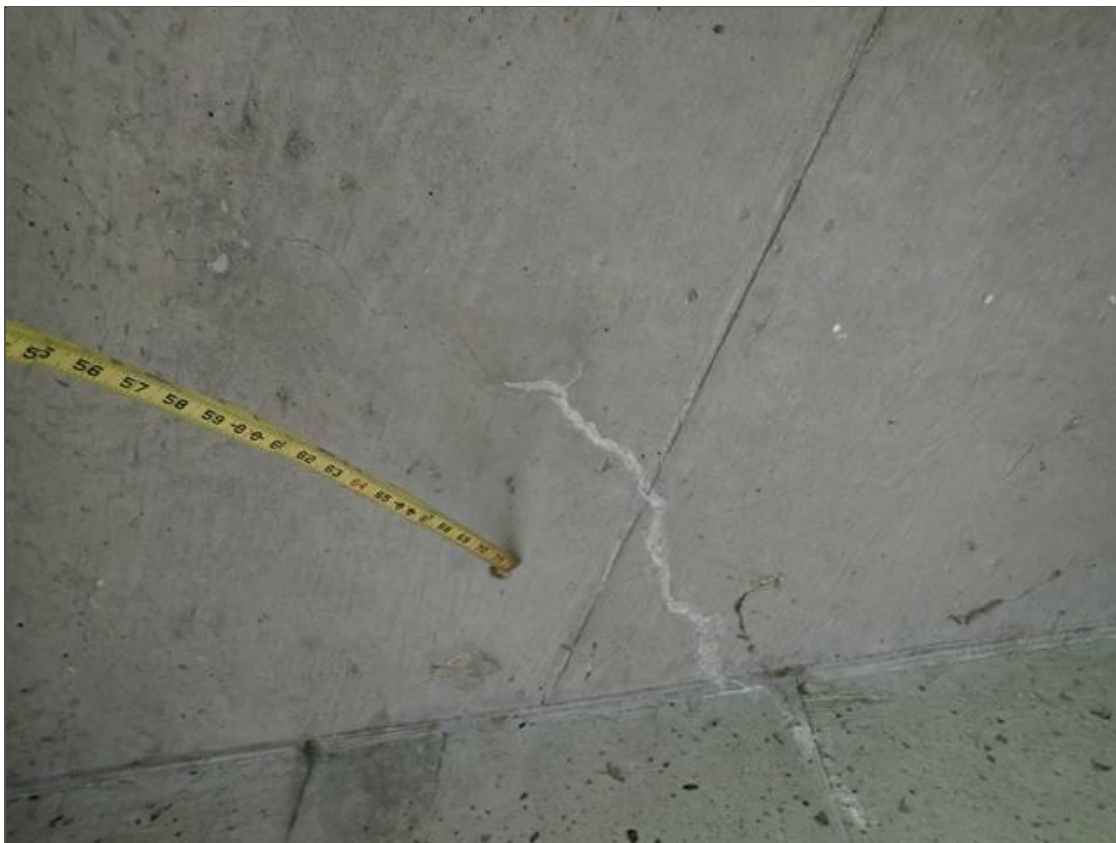
Span 8 Deck: underside of deck, map cracks (up to 1/64 inch) and transverse cracks (up to 1/32 inch x 3 foot) some with efflorescence at random

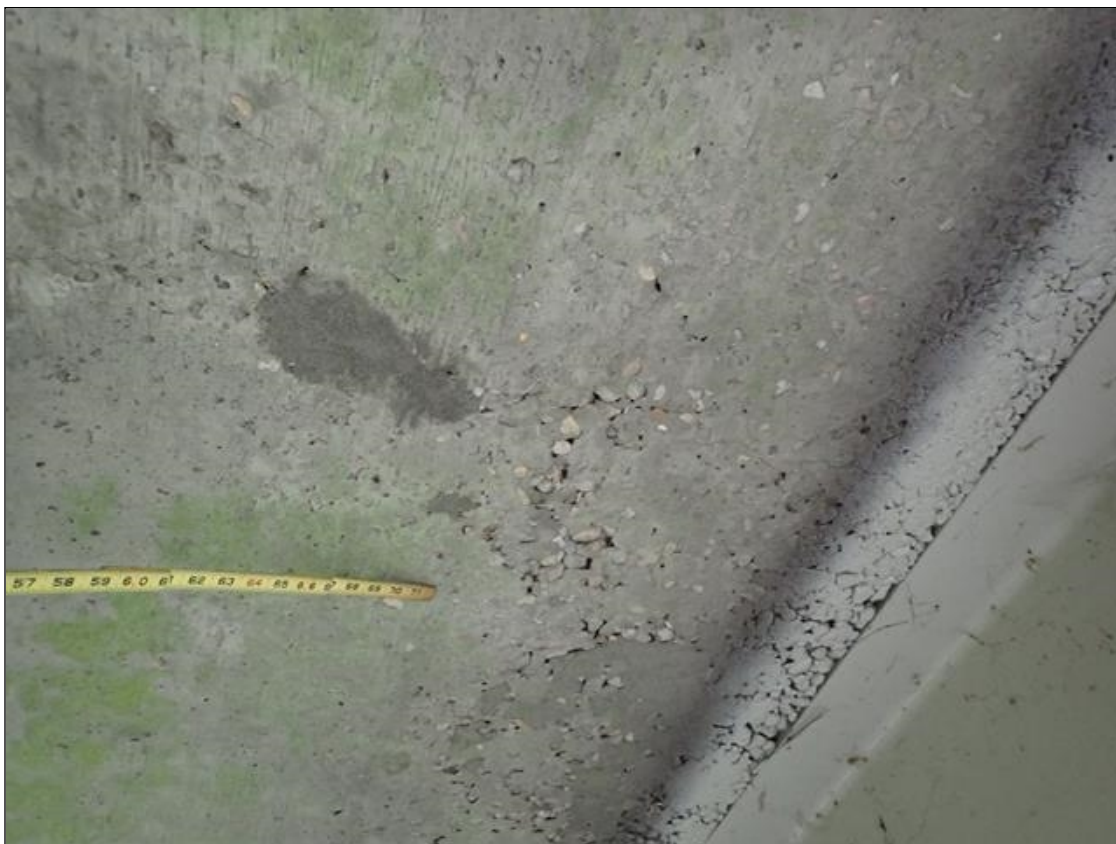
Span 8 Deck: throughout underside, areas of honeycomb (up to 7 foot x 3 foot x 1/2 inch deep)

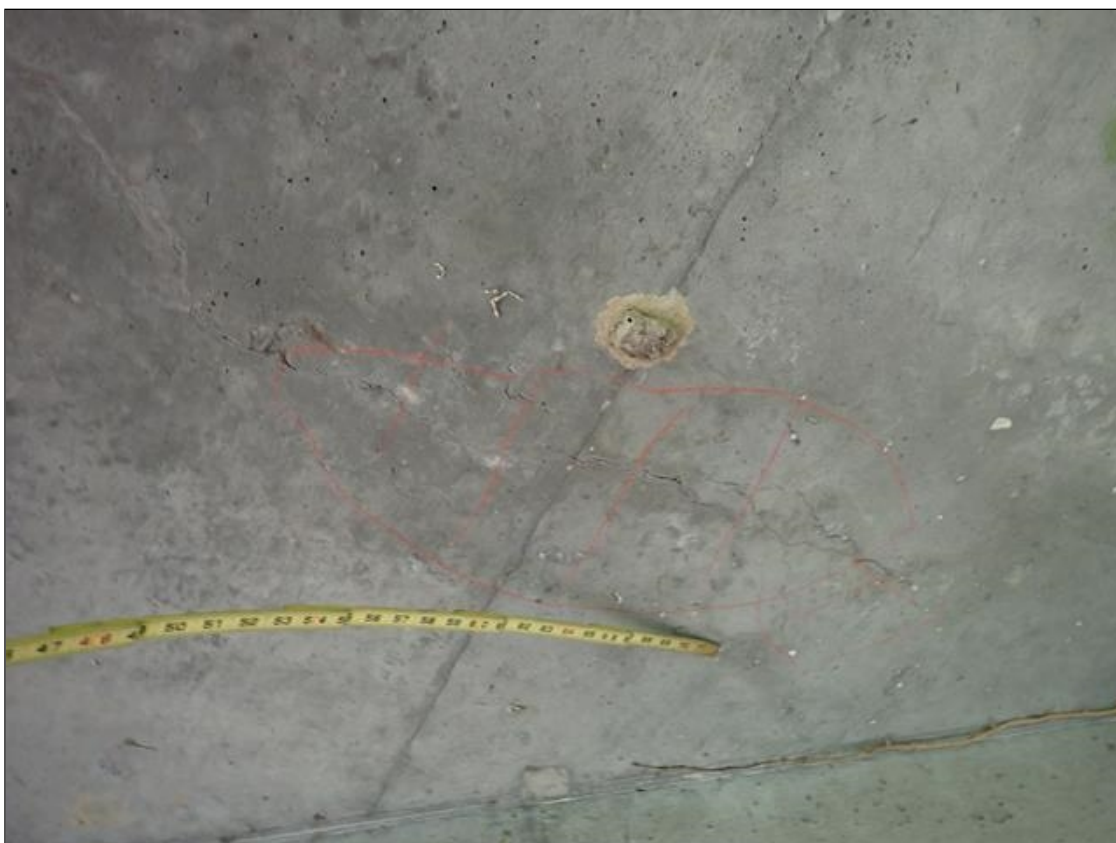
Span 8 Deck: underside in bay 3 adjacent to bent 7, delamination (30 inch x 12 inch) with cracks (up to 1/32 inch)

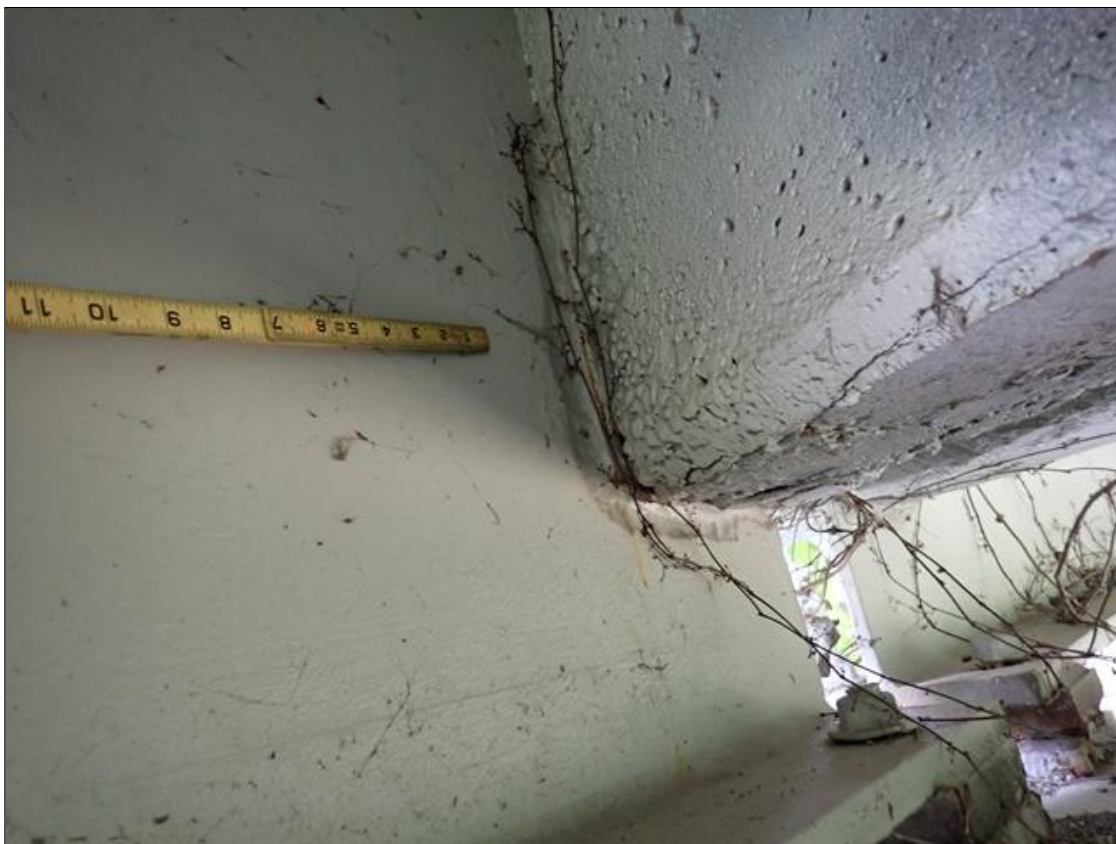
Span 8 Beam 4: (PAR) at bent 7, web adjacent to end diaphragm, painted over section loss (7/16 inch average remaining x 7 inch x 13 inch)

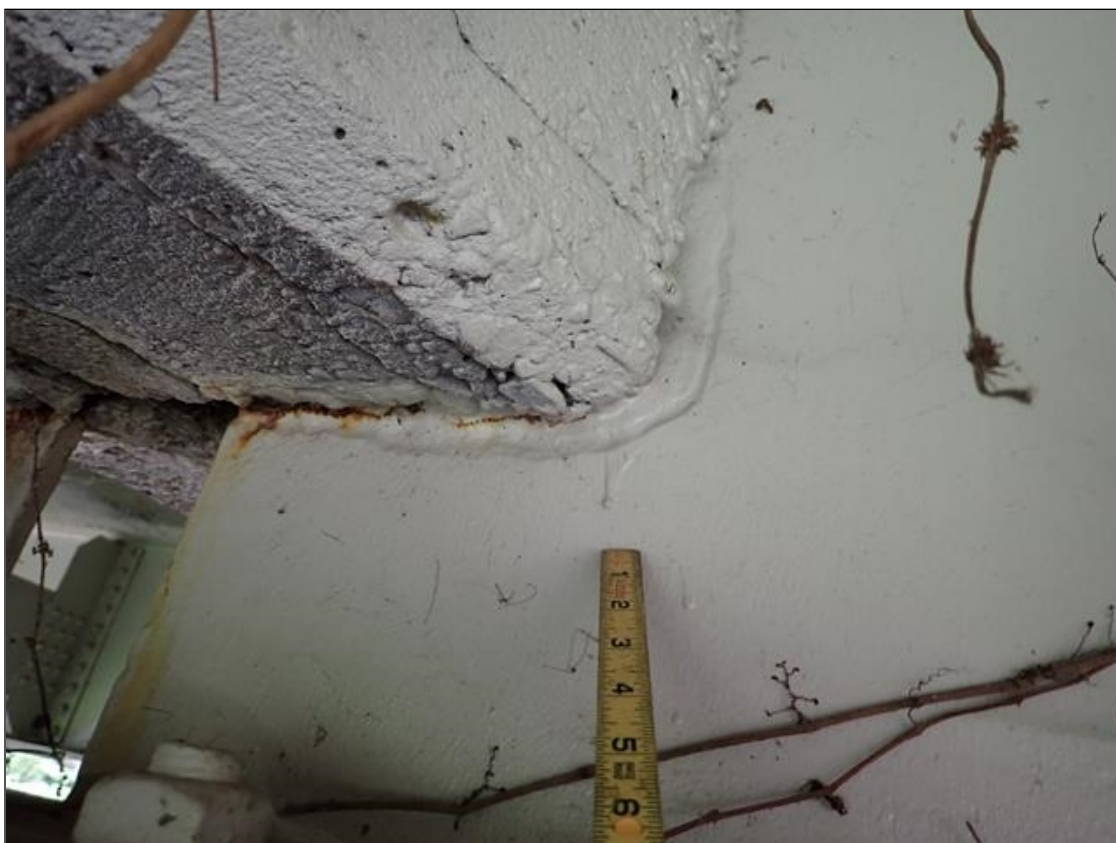
Span 8 Beam 3: (PAR) at bent 7, web adjacent to end diaphragm, painted over section loss (7/16 inch average remaining x 8 inch x 8 inch) with corrosion reactivating

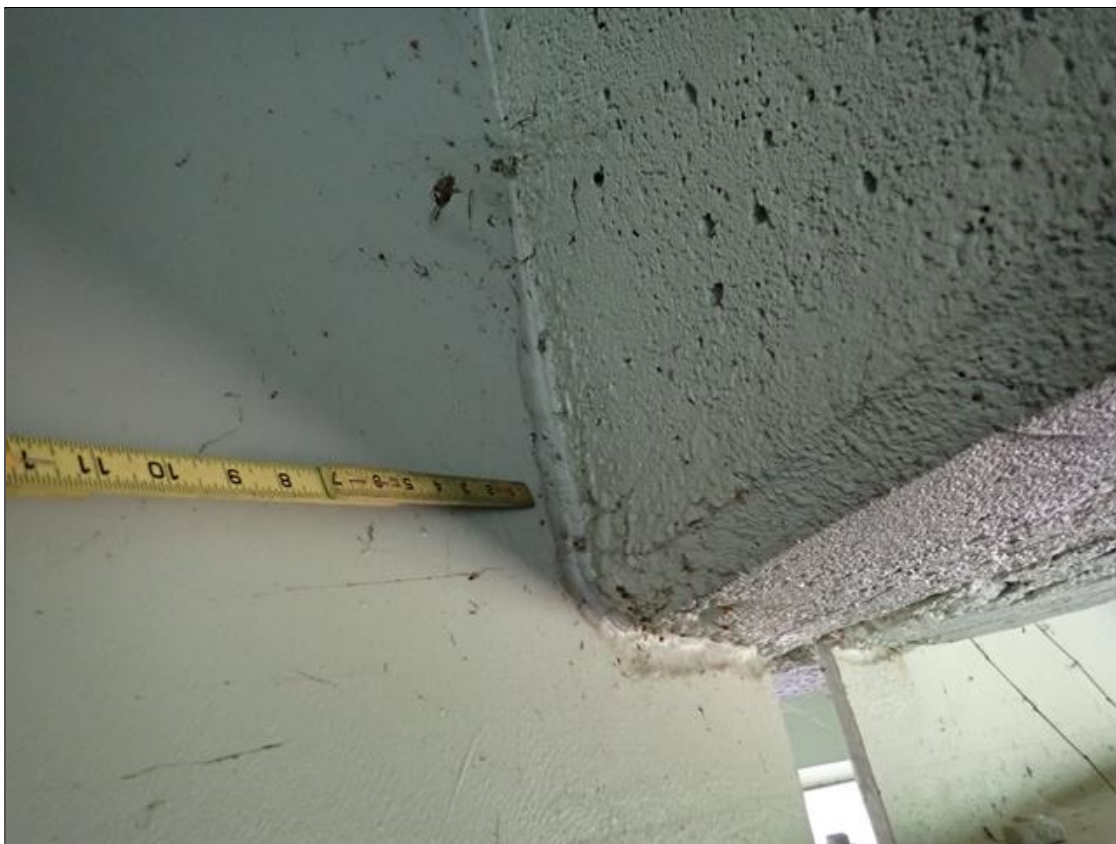
Span 8 Beam 2: (PAR) at bent 7, web adjacent to end diaphragm, painted over section loss (7/16 inch average remaining x 8 inch x 10 inch) with corrosion reactivating

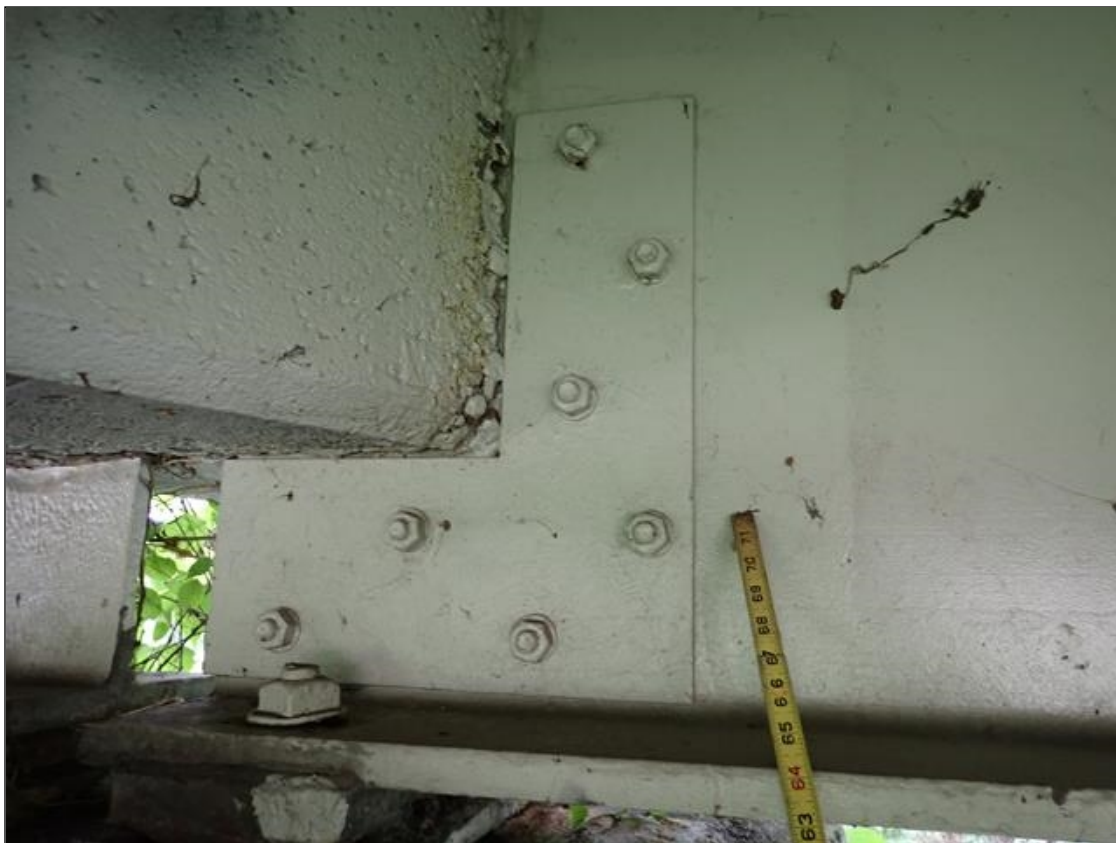
Span 8 Beam 1: at bent 7, web repair plate (1/4 inch thick x 15 inch x 18.5 inch)

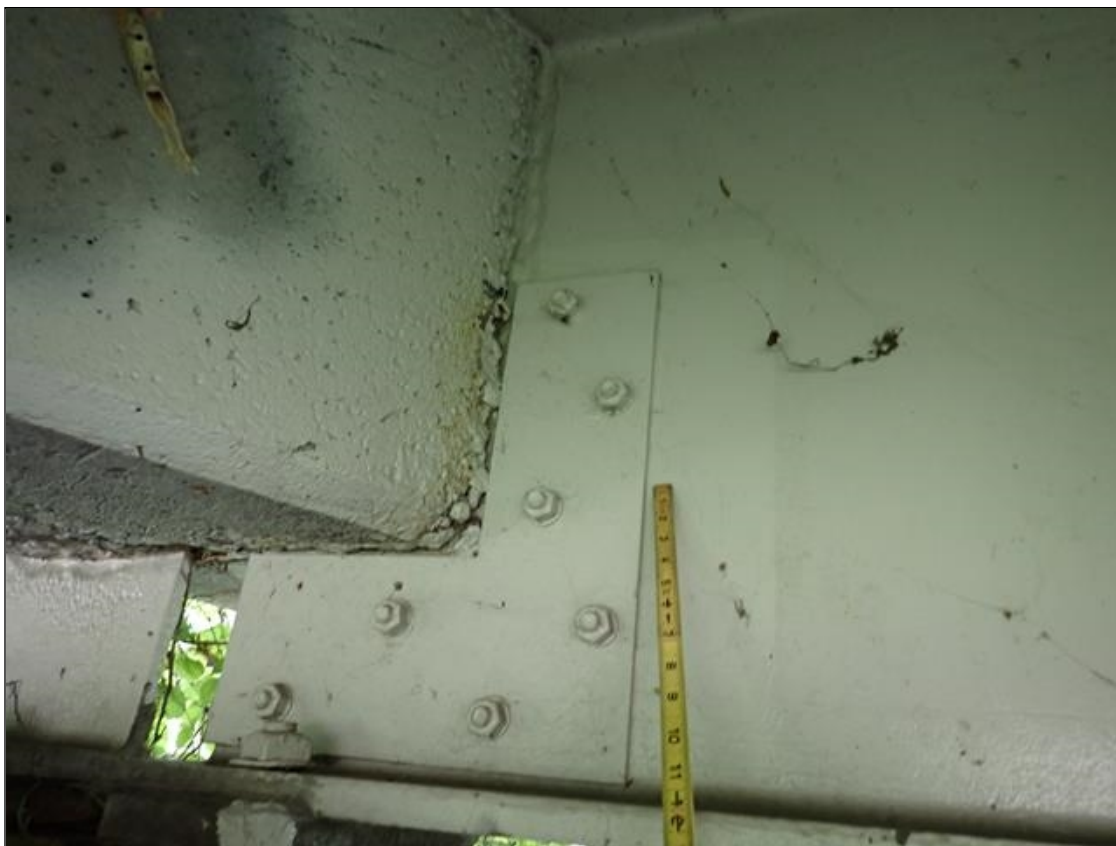
Span 8 Beam 1: (PAR) at bent 7, web adjacent to end diaphragm, painted over section loss (1/2 inch average remaining x 1 inch x 10 inch)

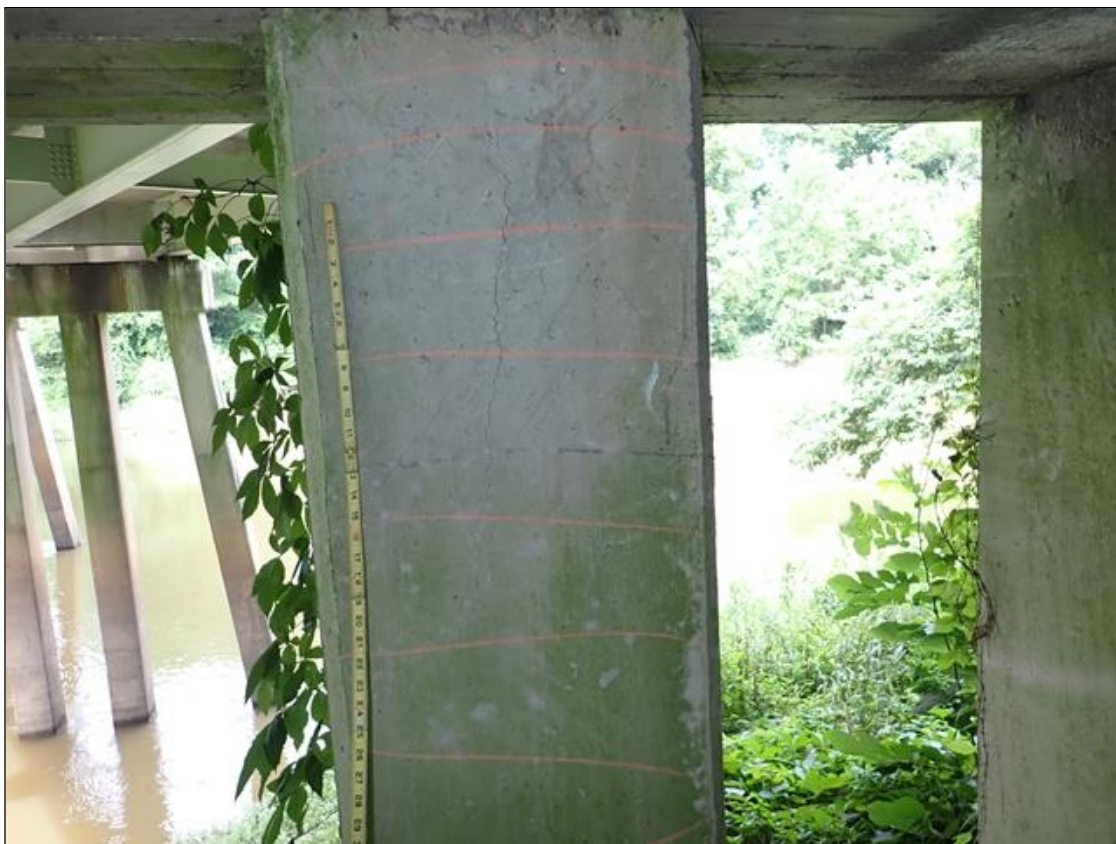
Bent 7 Pile 4: north face below cap, delamination (44 inch x 20 inch) with cracks (hairline)

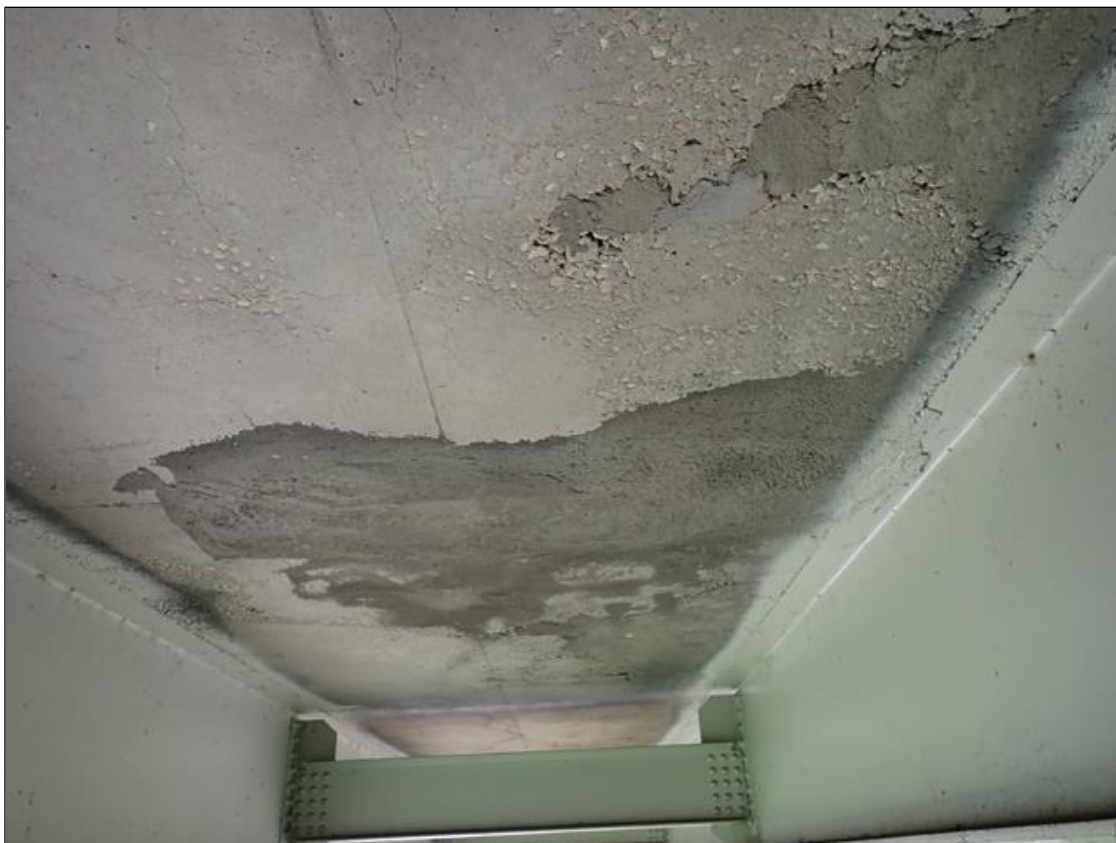
Span 7 Deck: 75 SQUARE FEET OF PATCHED AREA, UNDERSIDE OF DECK, AT RANDOM THROUGHOUT ALL BAYS.

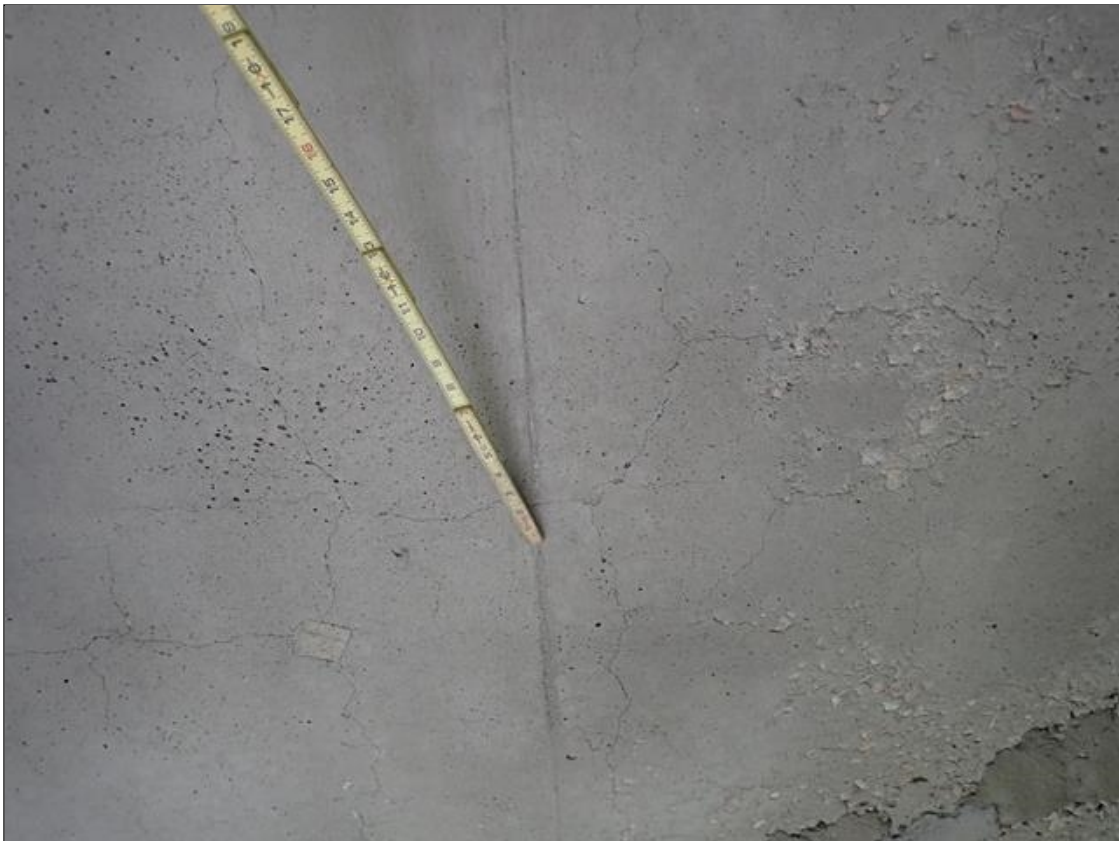
Span 7 Deck: UP TO 0.02 INCH WIDE RANDOM CRACKING IN DECK UNDERSIDE IN ALL BAYS, SCATTERED THROUGHOUT.

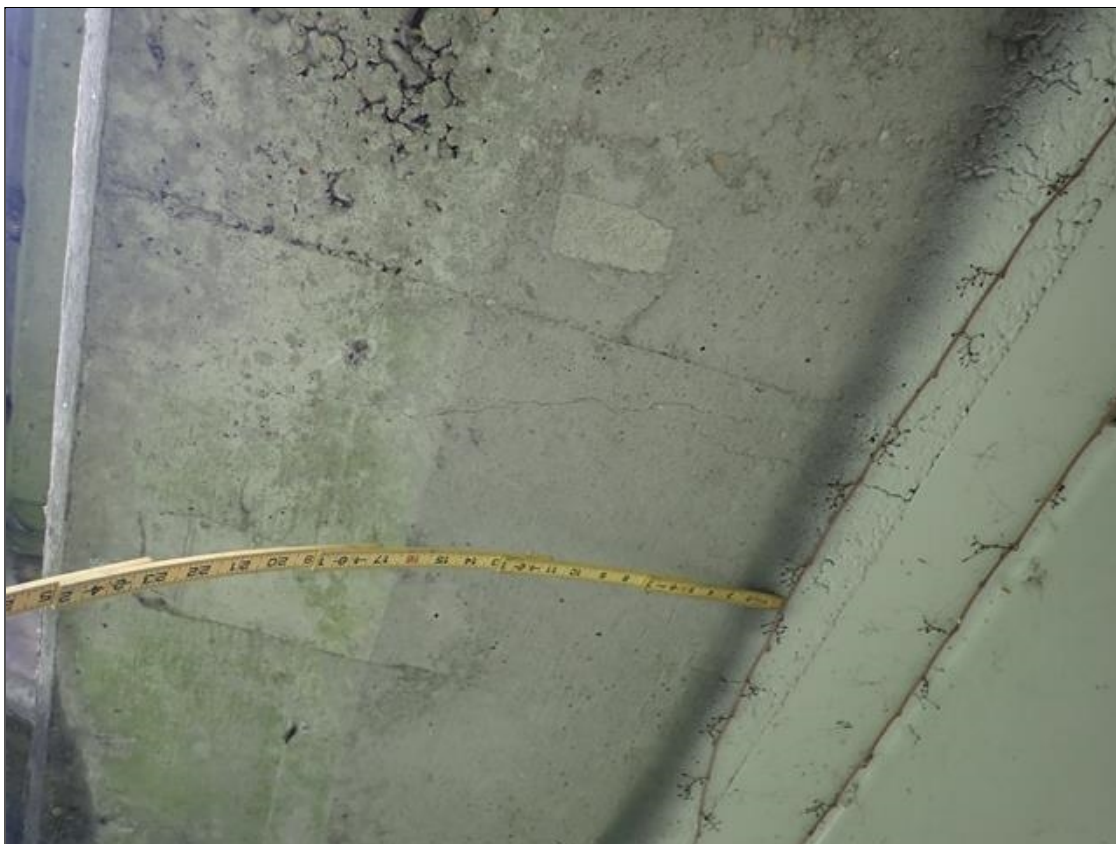
Span 7 Deck: UP TO 0.03 INCH WIDE X UP TO 3 FEET LONG TRANSVERSE CRACKS IN LEFT OVERHANG. RIGHT OVERHANG TYPICAL.

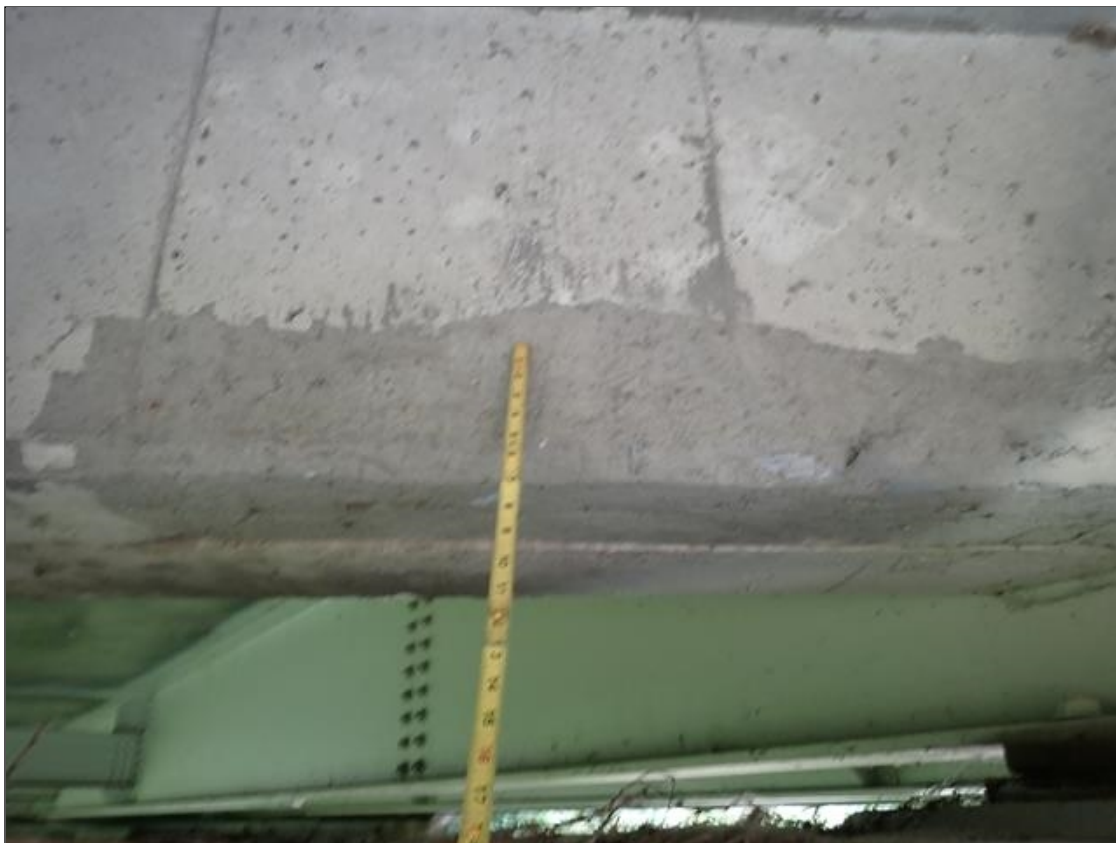
Span 7 Deck: 20 INCHES WIDE X 18 INCHES HIGH SOUND CONCRETE PATCHED AREA, BAY 1 END DIAPHRAGM, OVER BENT 7, NEXT TO BEAM 2.

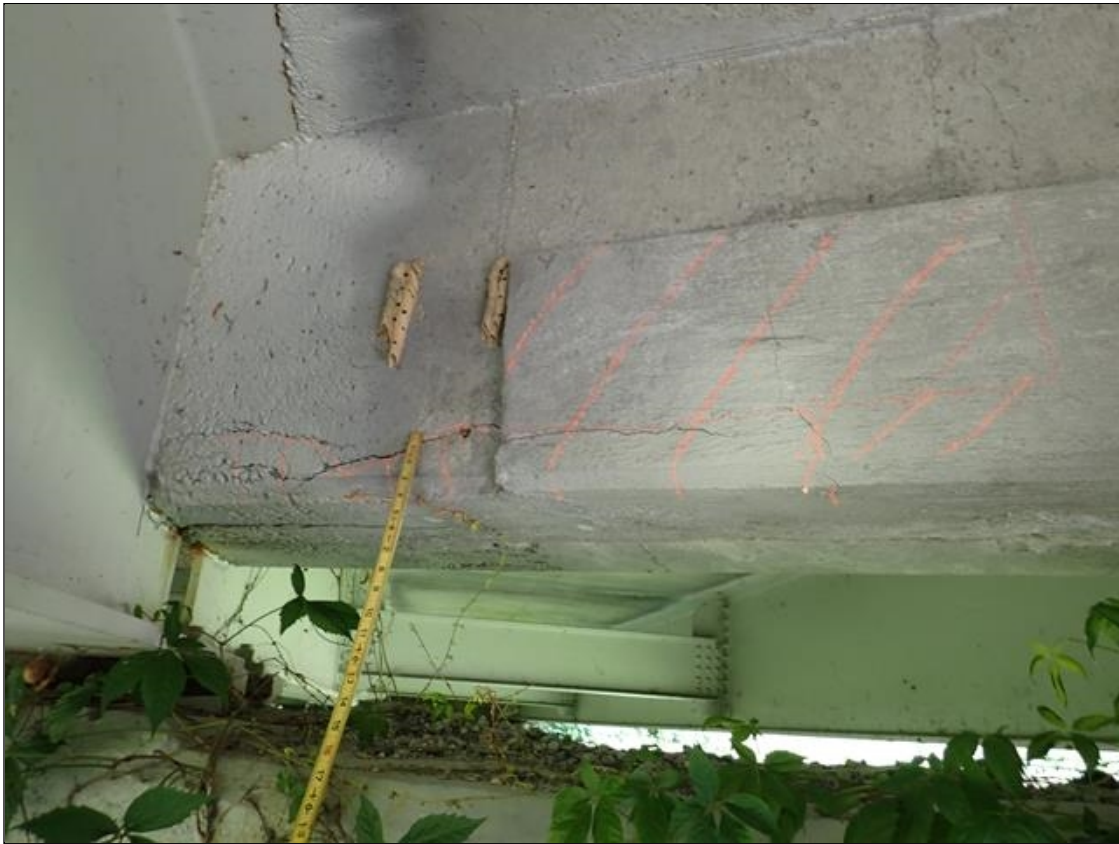
Span 7 Deck: AT BENT 7 BAY 3 DIAPHRAGM UNSOUND PATCH 7 FEET X 1 FOOT WITH 45 INCH X 18 INCH AREA OF DELAMINATION AND CRACKS UP TO 1/32 INCH

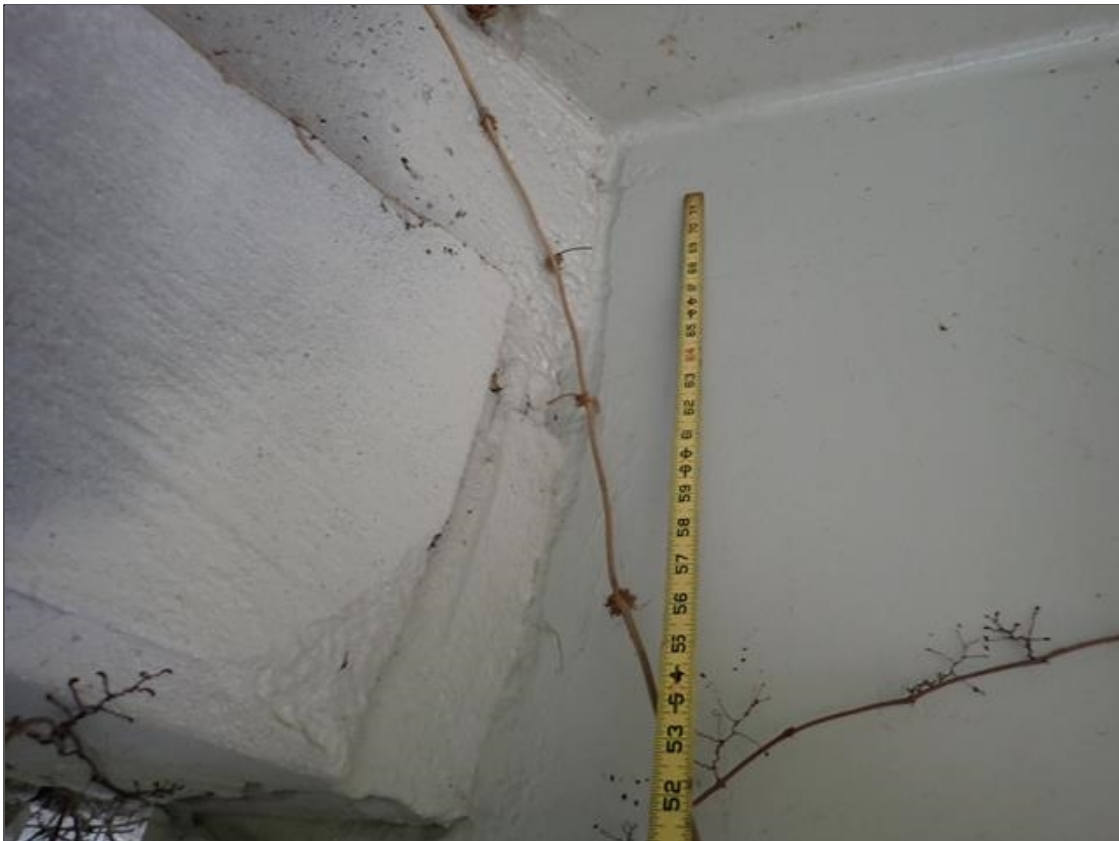
Span 7 Beam 4: (PAR) at bent 7, web adjacent to end diaphragm, painted over section loss (7/16 inch average remaining x 1 inch x 24 inch)

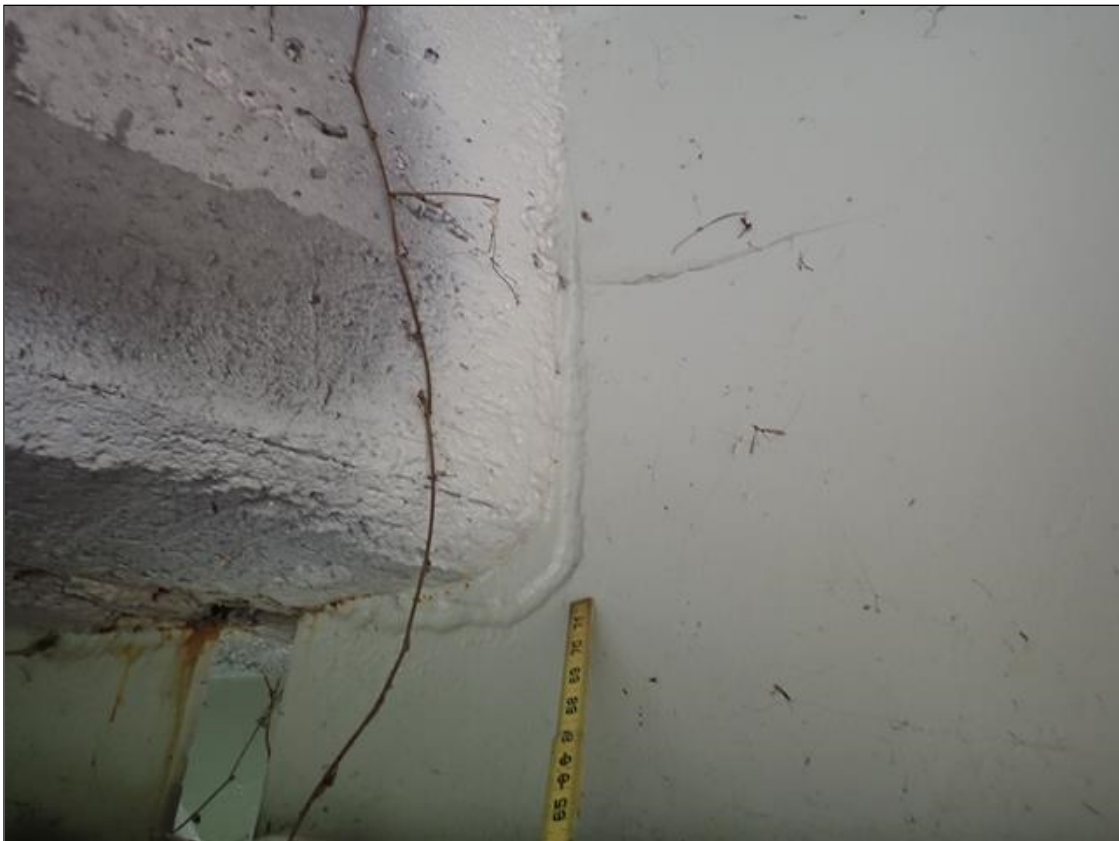
Span 7 Beam 3: (PAR) at bent 7, web adjacent to end diaphragm, painted over section loss (7/16 inch average remaining x 7 inch x 1 inch) with corrosion reactivating

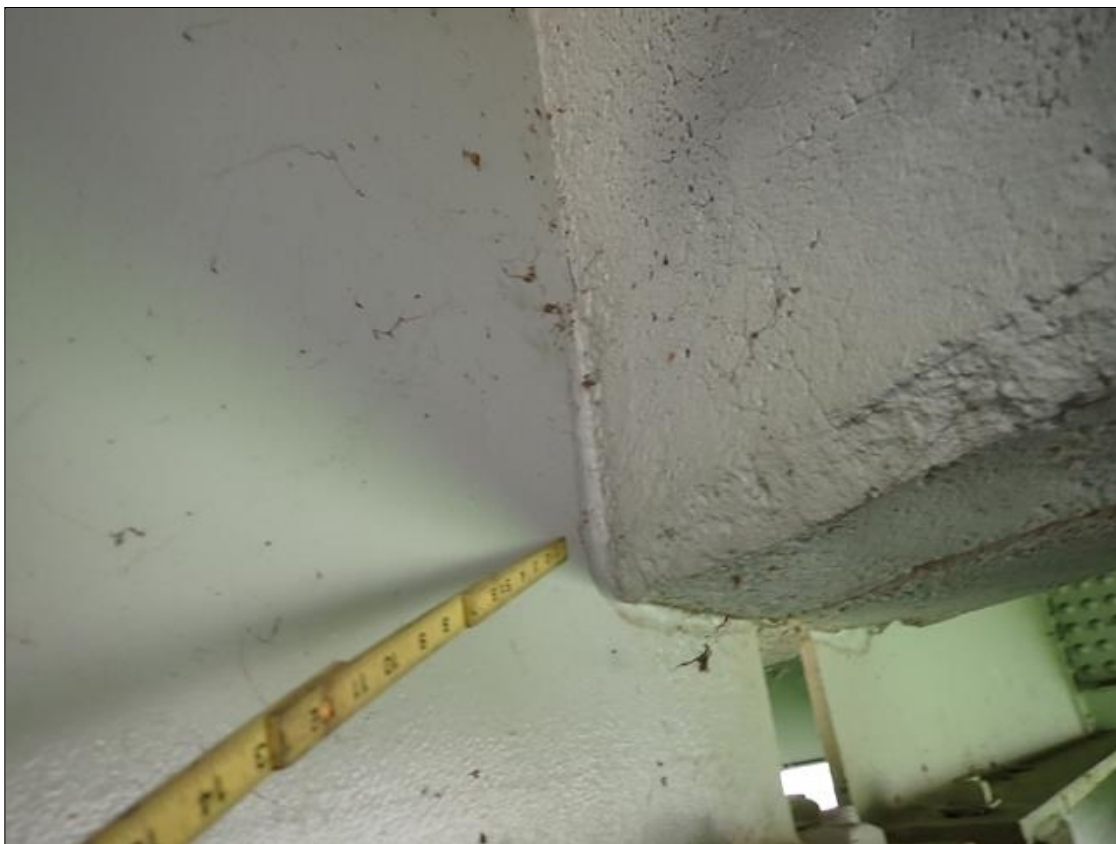
Span 7 Beam 2: (PAR) at bent 7, web adjacent to end diaphragm, painted over section loss (7/16 inch average remaining x 7 inch x 7 inch)

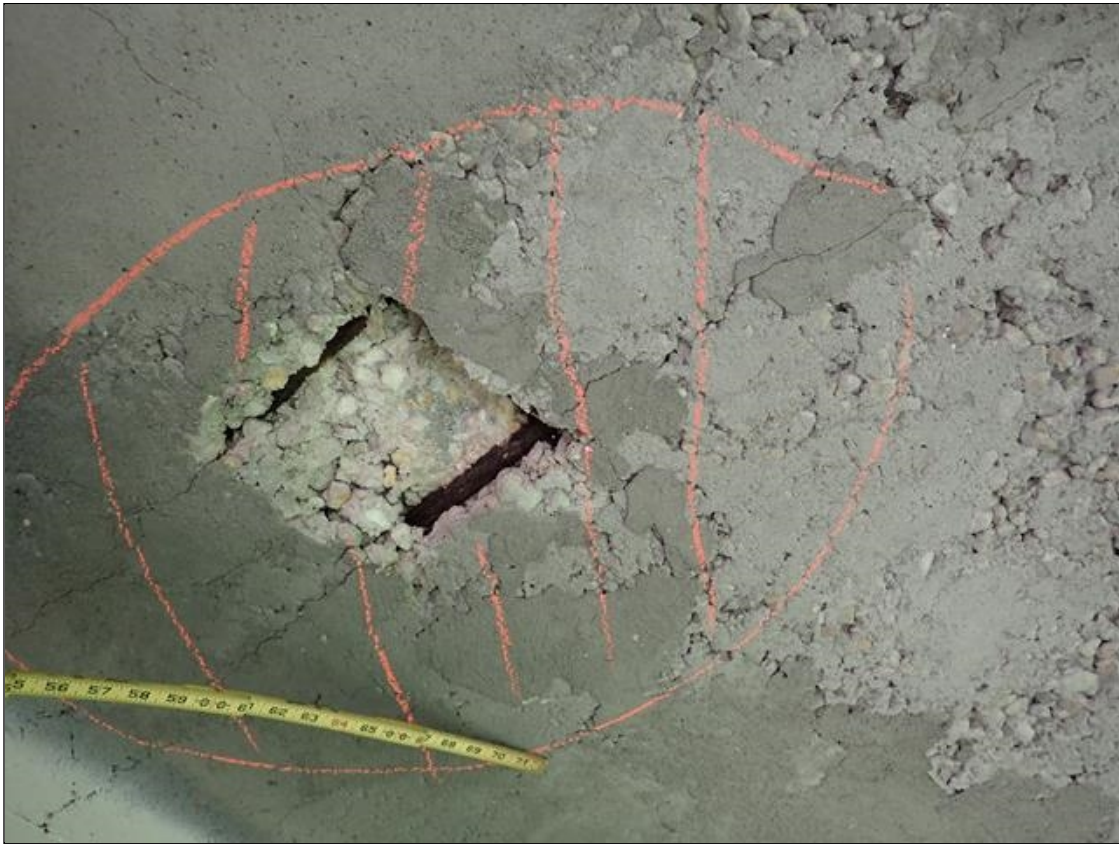
Span 7 Deck: (PAR) underside in bay 3 near midspan, spall/delamination (30 inch x 20 inch x 2 inch deep) with exposed rusted rebar (approximately 85 percent remaining)

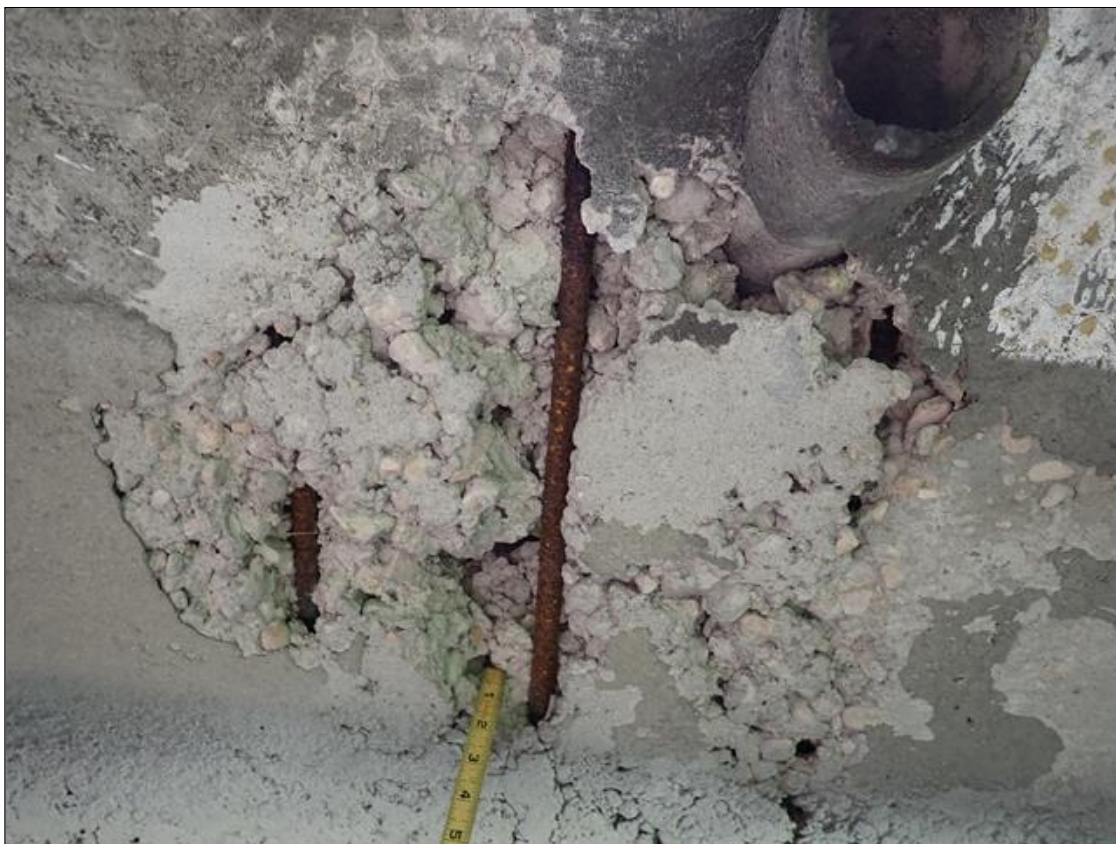
Span 7 Deck: (PAR) 24 INCHES LONG X 2 FEET WIDE X UP TO 4 INCHES DEEP DELAMINATION/SPALL WITH EXPOSED REINFORCING, UNDERSIDE OF EAST OVERHANG AT 4TH DRAIN. UP TO 5 PERCENT SECTION LOSS IN EXPOSED REINFORCEMENT.

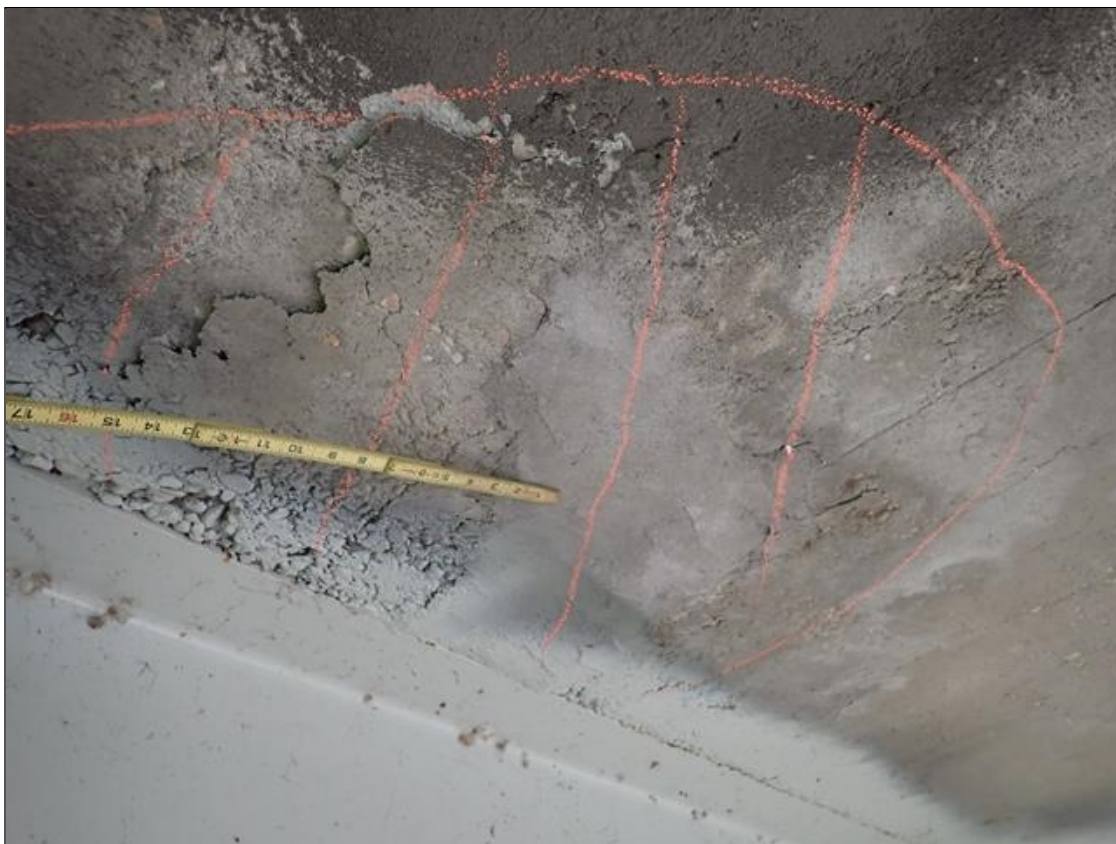
Span 7 Deck: underside in bay 2, near midspan, delamination/failed patch (3 foot x 26 inch)

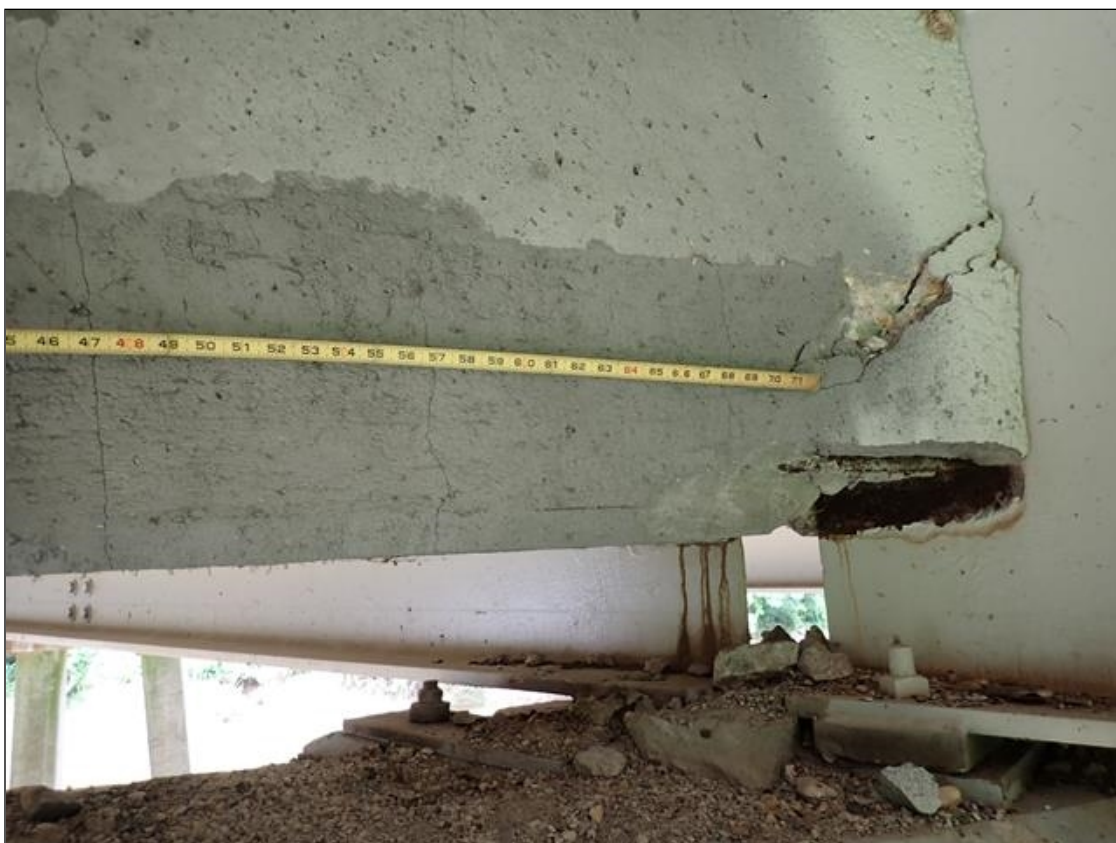
Span 7 Deck: bay 3 end diaphragm at bent 6, failed patch (5 foot x 19 inch x 4 inch deep) with exposed rusted rebar
