NC DEPARTMENT OF TRANSPORTATION
 DIVISION OF HIGHWAYS
 STRUCTURE MANAGEMENT UNIT
 COUNTY: JOHNSTON DIV: 4

ATTENTION: PARS Submitted Sign Notice Issued
 sketches revised; new repairs

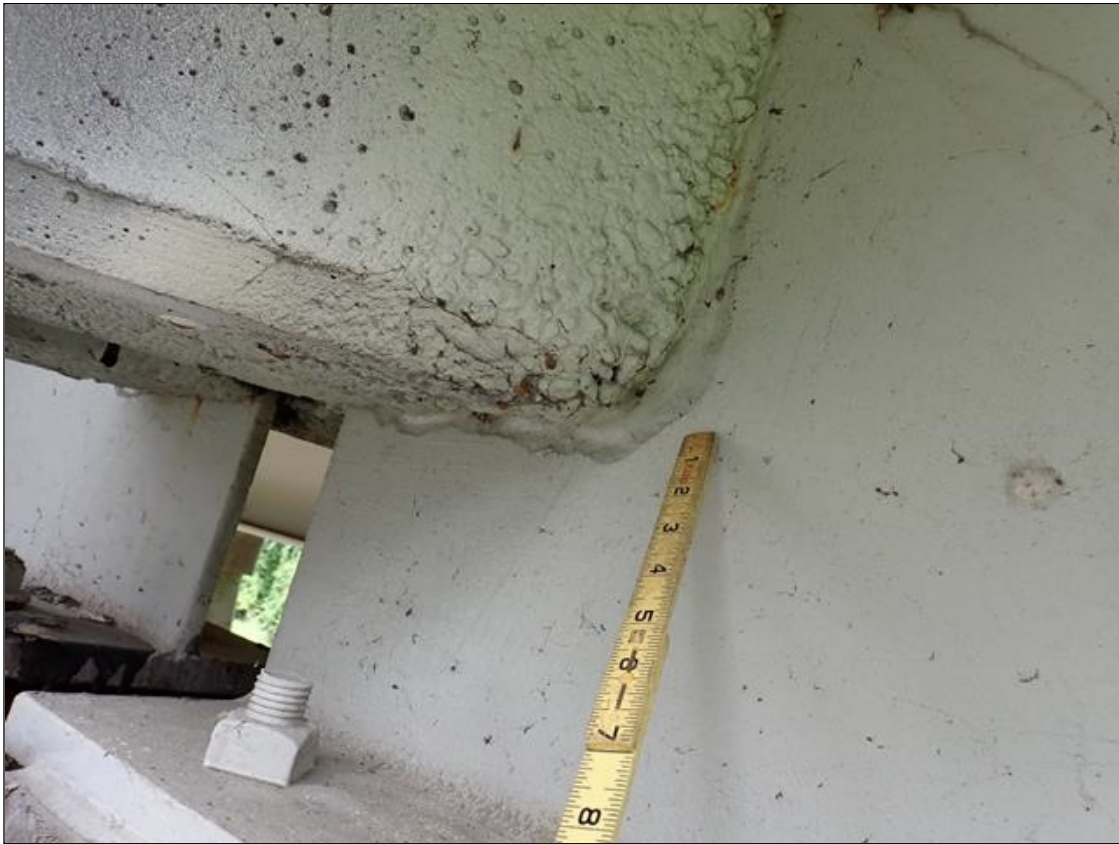
Span 7 Beam 4: (PAR) at bent 6, web adjacent to end diaphragm, painted over section loss (7/16 inch average remaining x 7 inch x 7 inch) with corrosion reactivating

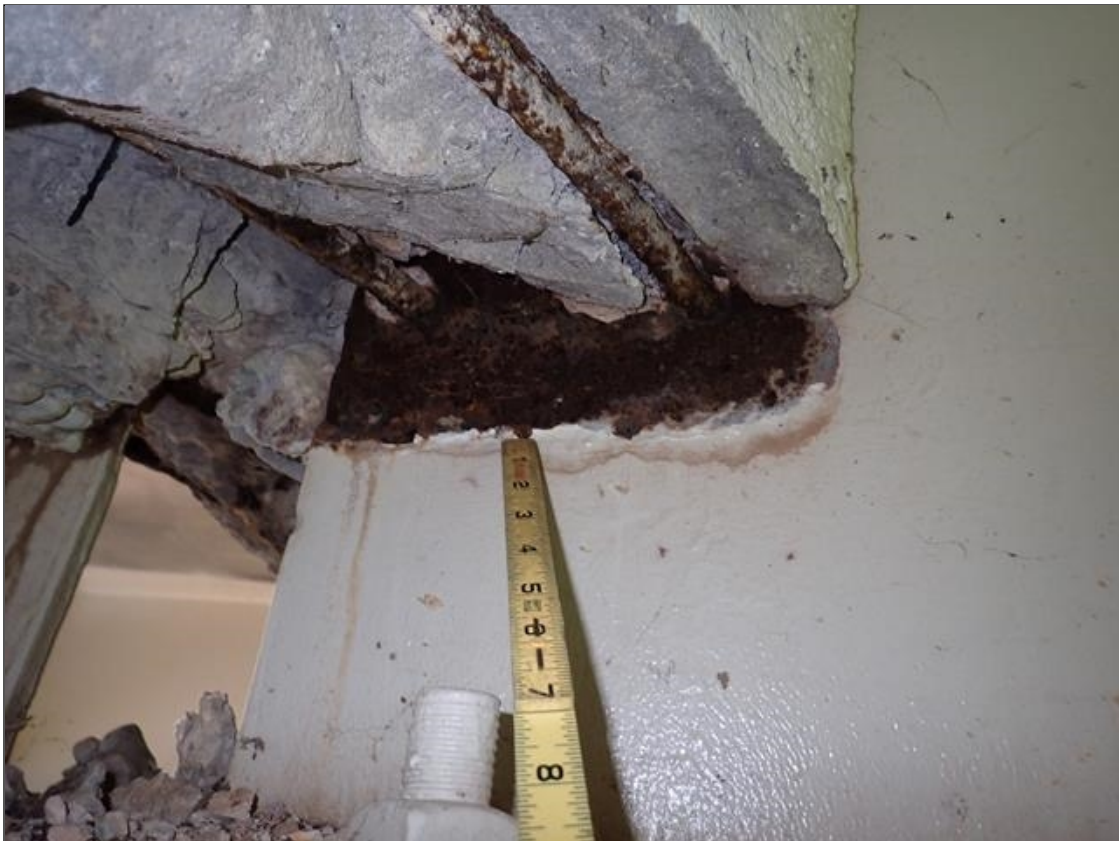
Span 7 Beam 3: (PAR) at bent 6, web adjacent to end diaphragm, corrosion with section loss (7/16 inch average remaining x 7 inch x 4 inch)

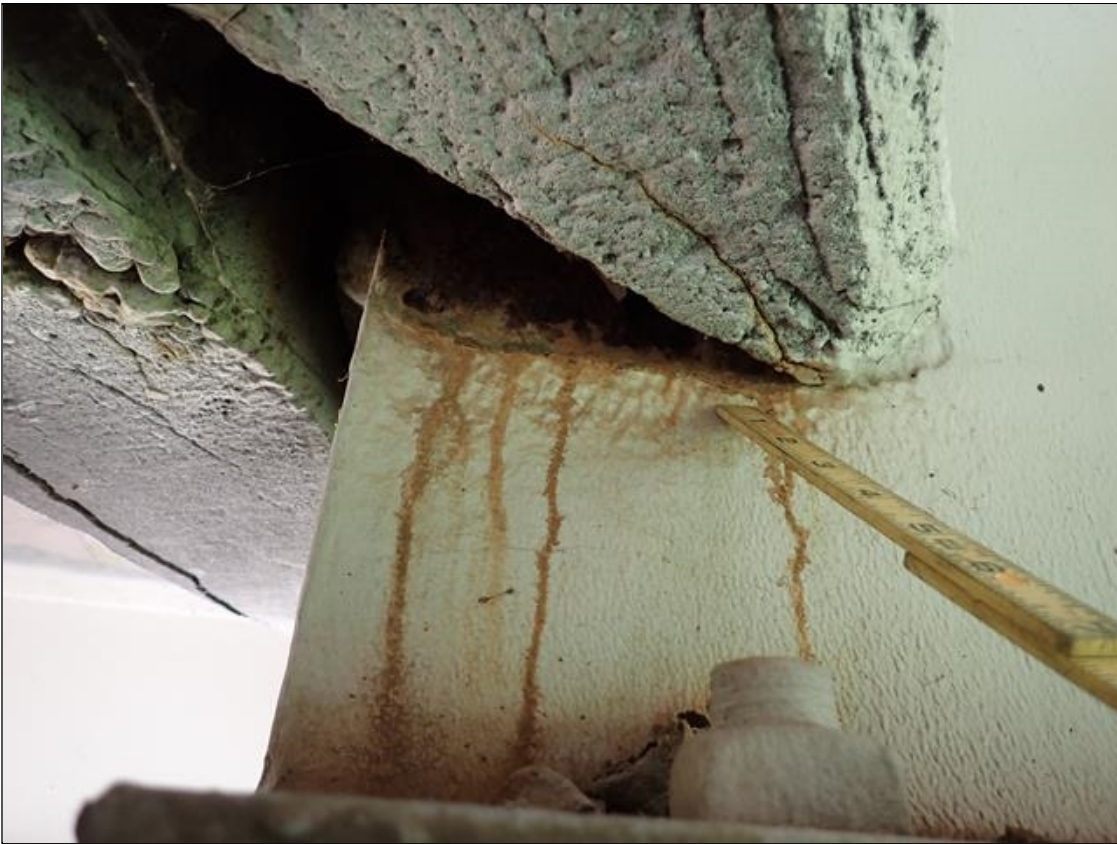
Span 7 Beam 2: (PAR) at bent 6, web adjacent to end diaphragm, corrosion with section loss (7/16 inch average remaining x 7 inch x 10 inch)

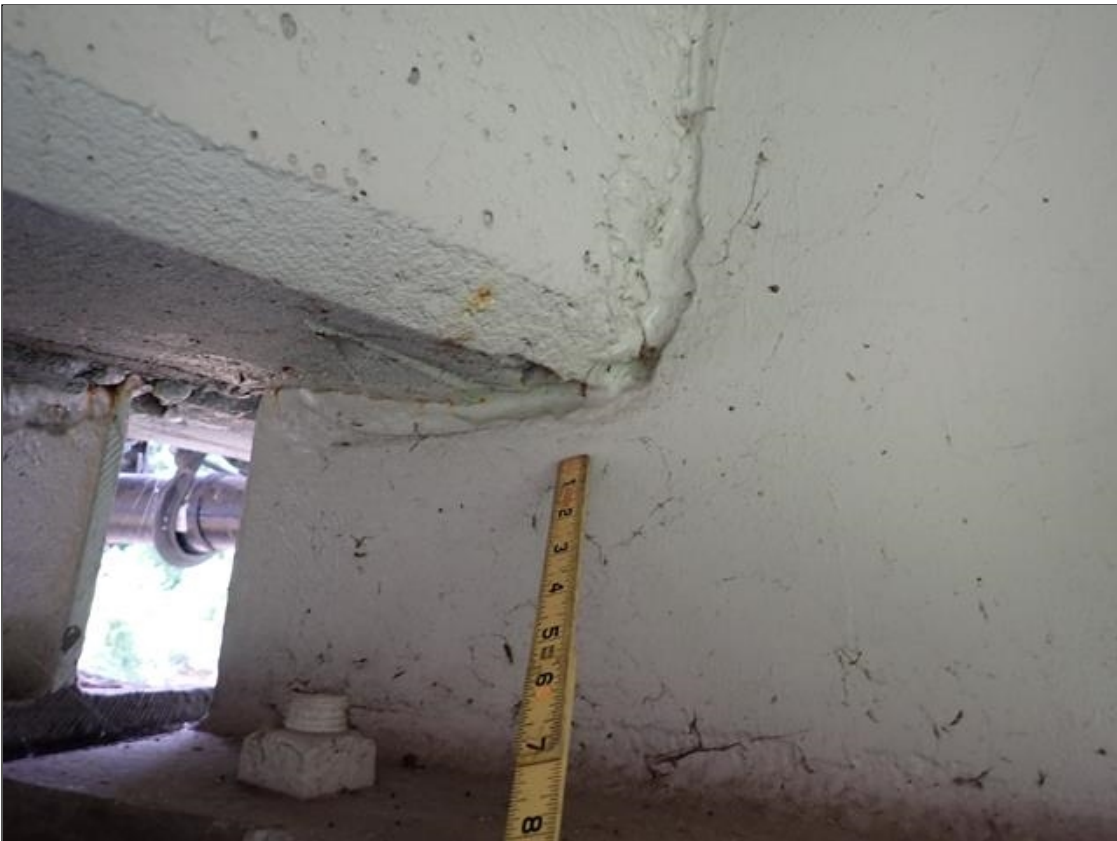
Span 7 Beam 1: (PAR) at bent 6, web adjacent to end diaphragm, painted over section loss (7/16 inch average remaining x 7 inch x 10 inch)

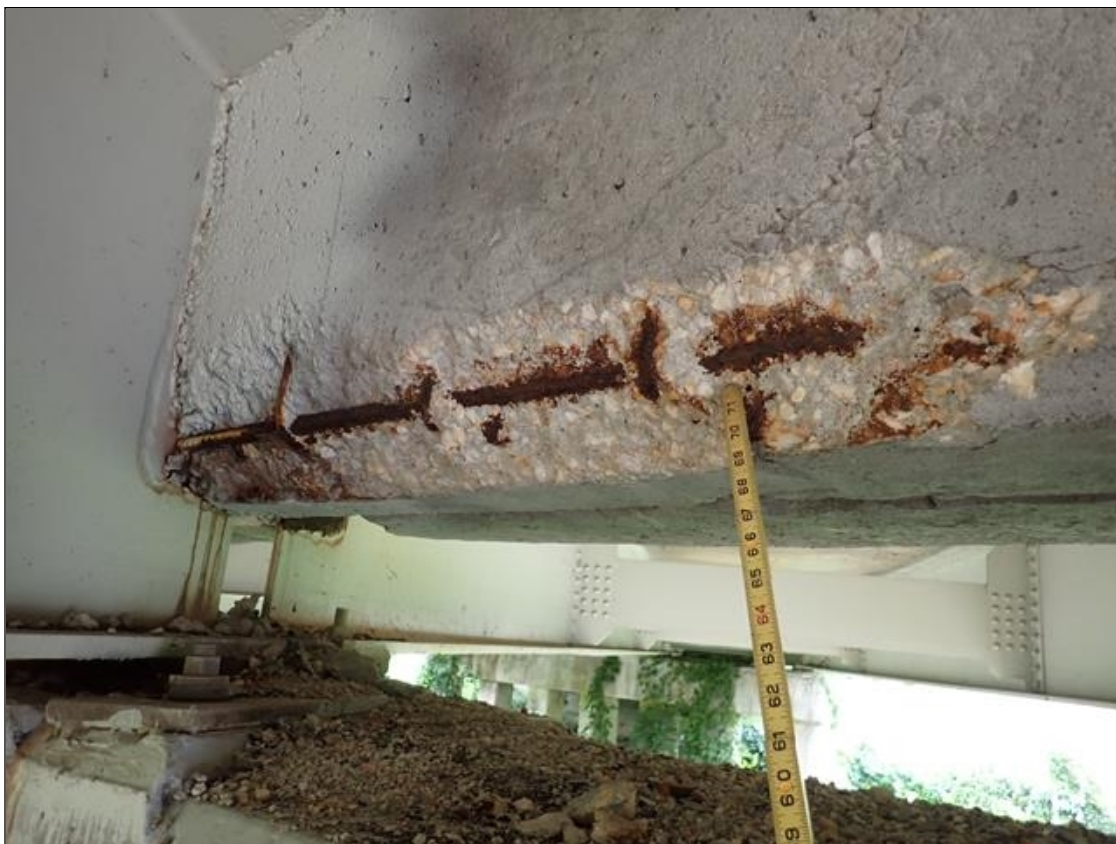
Span 6 Deck: (PAR) 4 FEET WIDE X 10 INCHES LONG X UP TO 6 INCHES HIGH AREA OF UNSOUND CONCRETE AND SPALL WITH EXPOSED REINFORCEMENT IN BAY 3 END DIAPHRAGM AT BENT 6. 10 PERCENT SECTION LOSS IN EXPOSED REBAR.

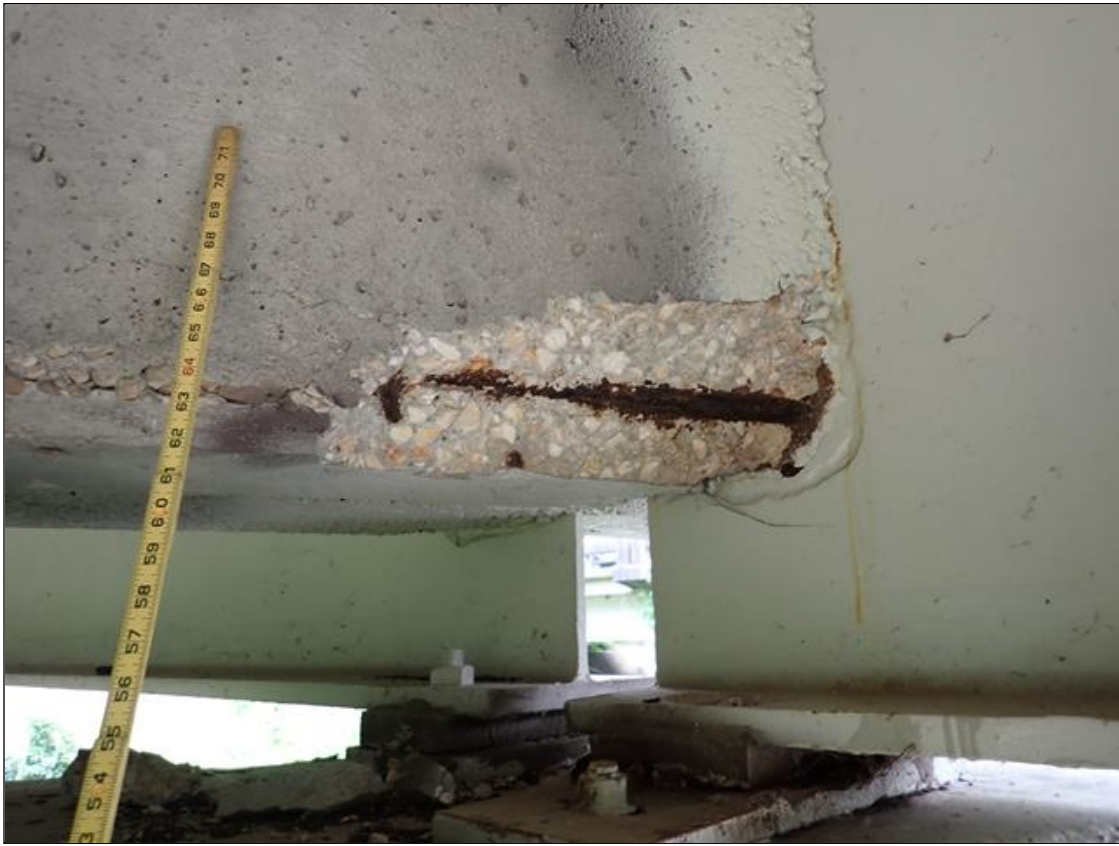
Span 6 Deck: (PAR) BAY 3 FAR DIAPHRAGM ADJACENT TO BEAM 4 SPALL WITH EXPOSED REBAR 18 INCHES X 7 INCHES X 3 INCH DEEP WITH 10 PERCENT SECTION LOSS.

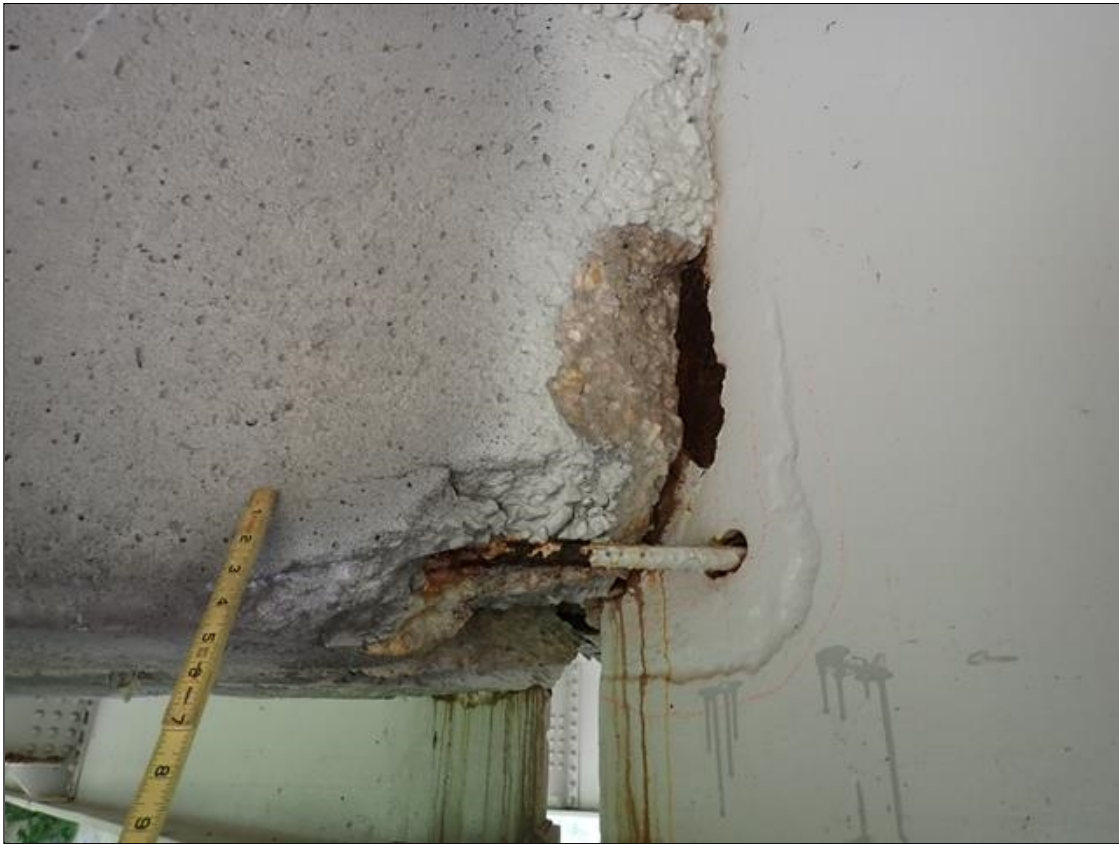
Span 6 Deck: (PAR) 12 INCHES WIDE X 9 INCHES LONG X 14 INCHES HIGH SPALL IN SOUTH FACE WITH EXPOSED REINFORCEMENT IN BAY 2 AT BENT 6. 10 PERCENT SECTION LOSS IN EXPOSED REINFORCEMENT.

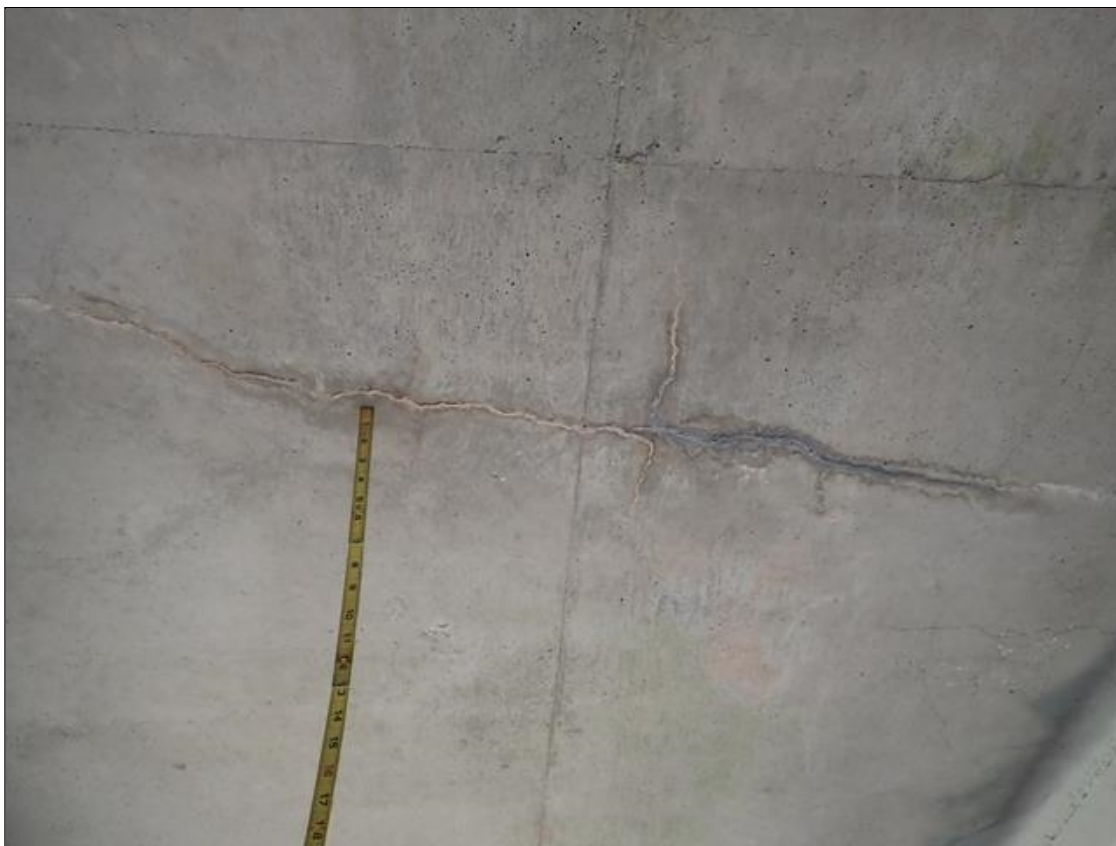
Span 6 Deck: 8 FEET LONG X HAIRLINE TRANSVERSE CRACKS WITH EFFLORESCENCE, UNDERSIDE OF DECK, AT RANDOM THROUGHOUT BAY 1. SIMILAR IN BAY 3.

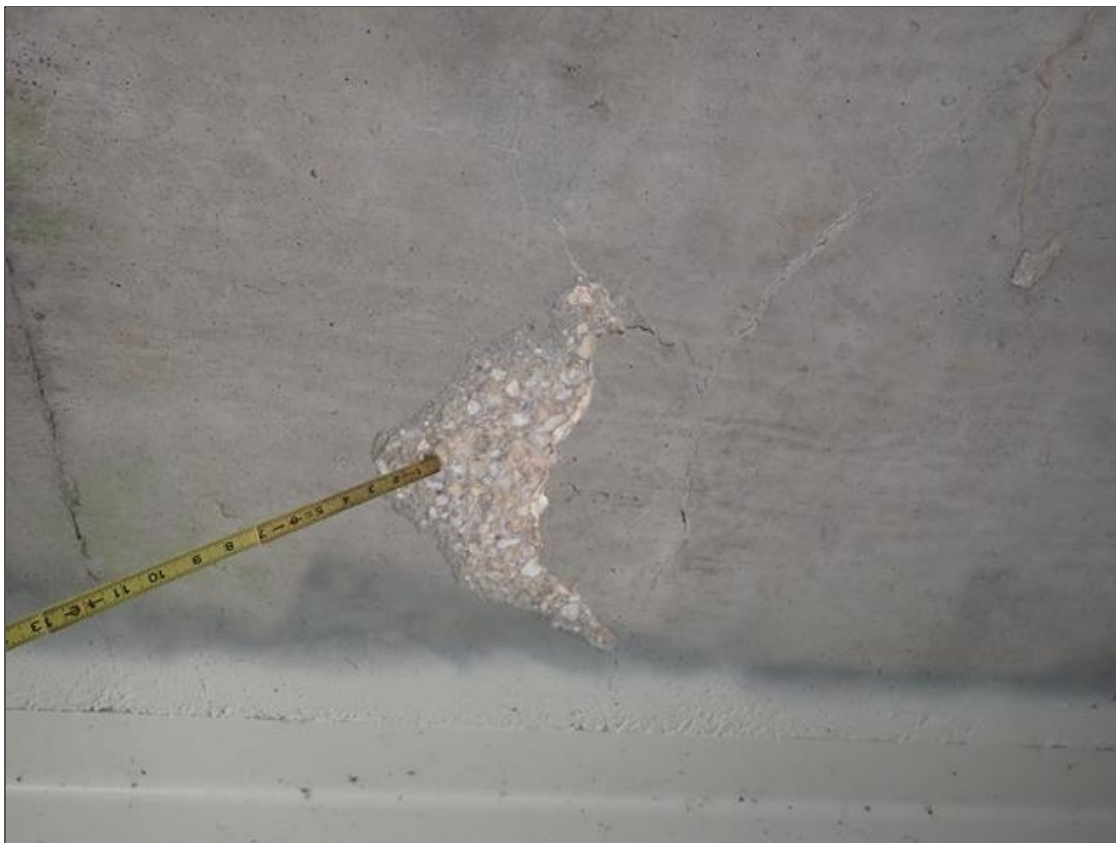
Span 6 Deck: BAY 1 NEAR BENT 6 AREA OF SPALL/DELAMINATION 18 INCHES DIAMETER X 1/2 INCH DEEP.

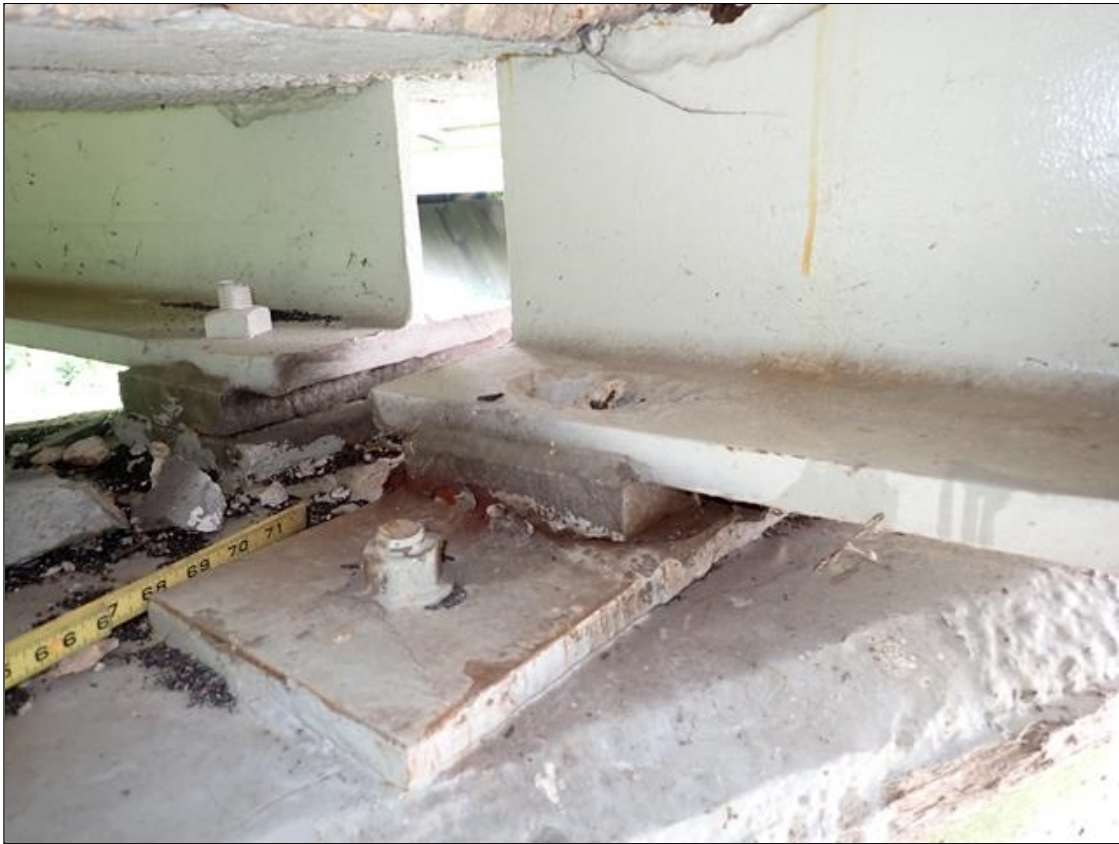
Span 6 Far Bearing 4: LEFT ANCHOR BOLT, MISSING; BEARING ASSEMBLY HAS WELDED REPAIR WITH NEW ANCHOR BOLT.

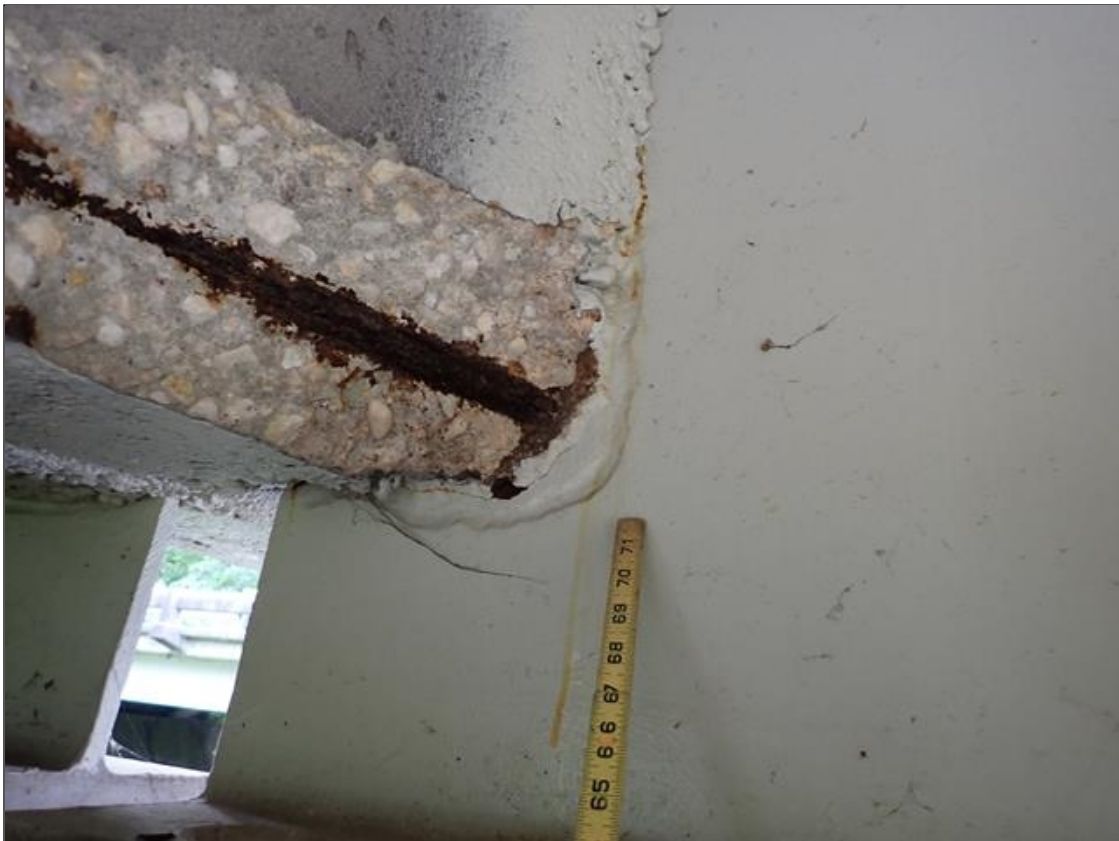
Span 6 Beam 4: (PAR) at bent 6, web adjacent to end diaphragm, corrosion with section loss (7/16 inch average remaining x 8 inch x 7 inch)

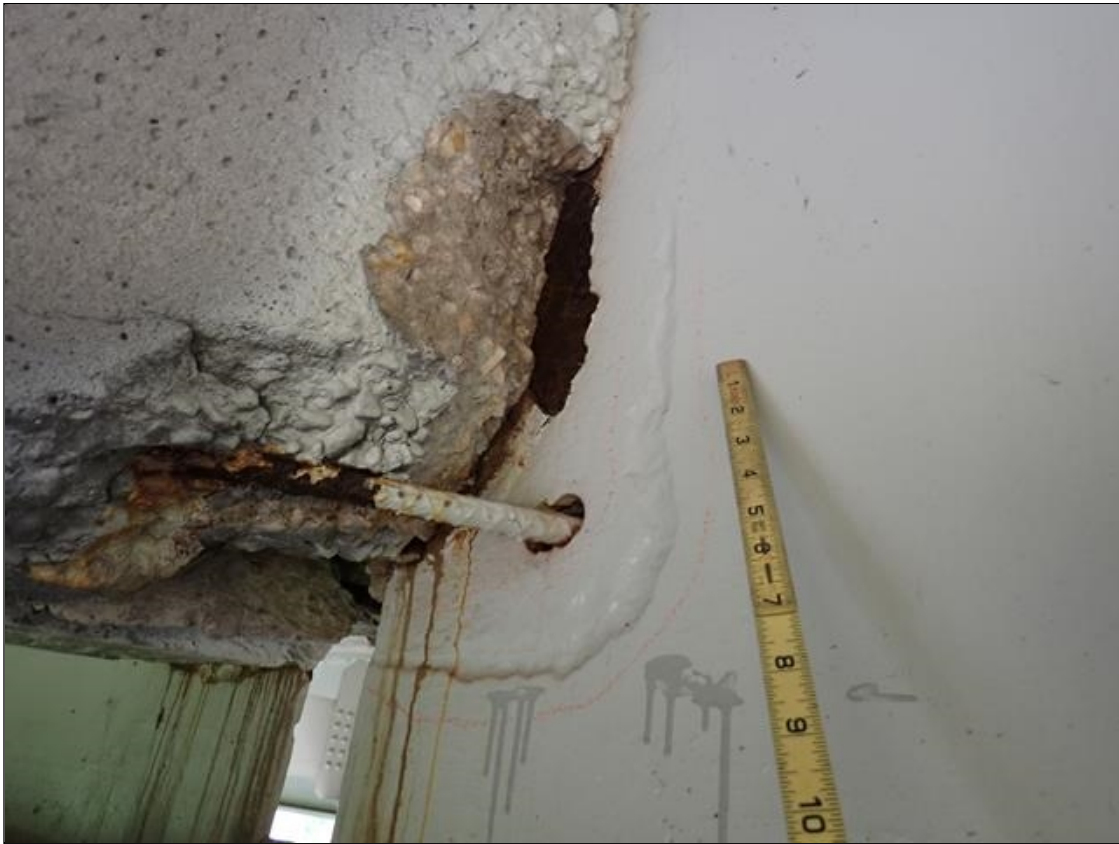
Span 6 Beam 3: (PAR) at bent 6, web adjacent to end diaphragm, corrosion with section loss (7/16 inch average remaining x 10 inch x 2 foot)

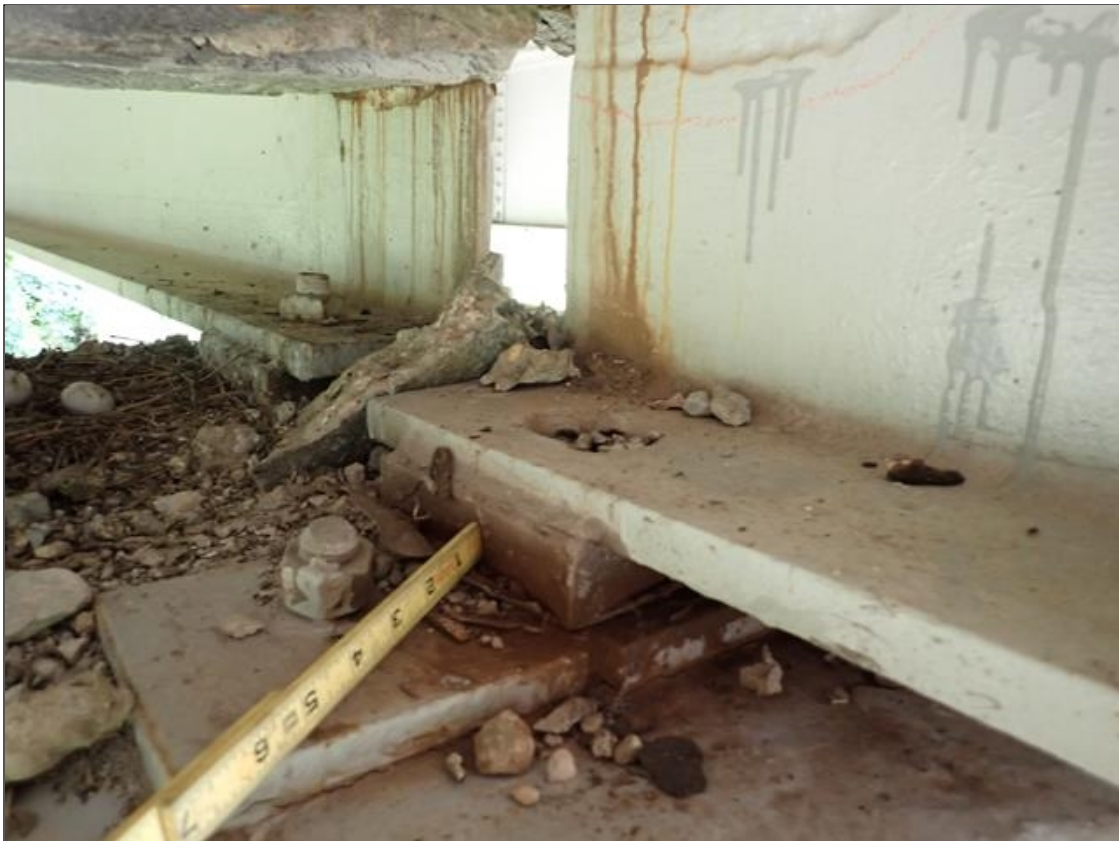
Span 6 Far Bearing 3: BOTH ANCHOR BOLTS, MISSING; BEARING ASSEMBLY HAS WELDED REPAIR WITH NEW ANCHOR BOLT.

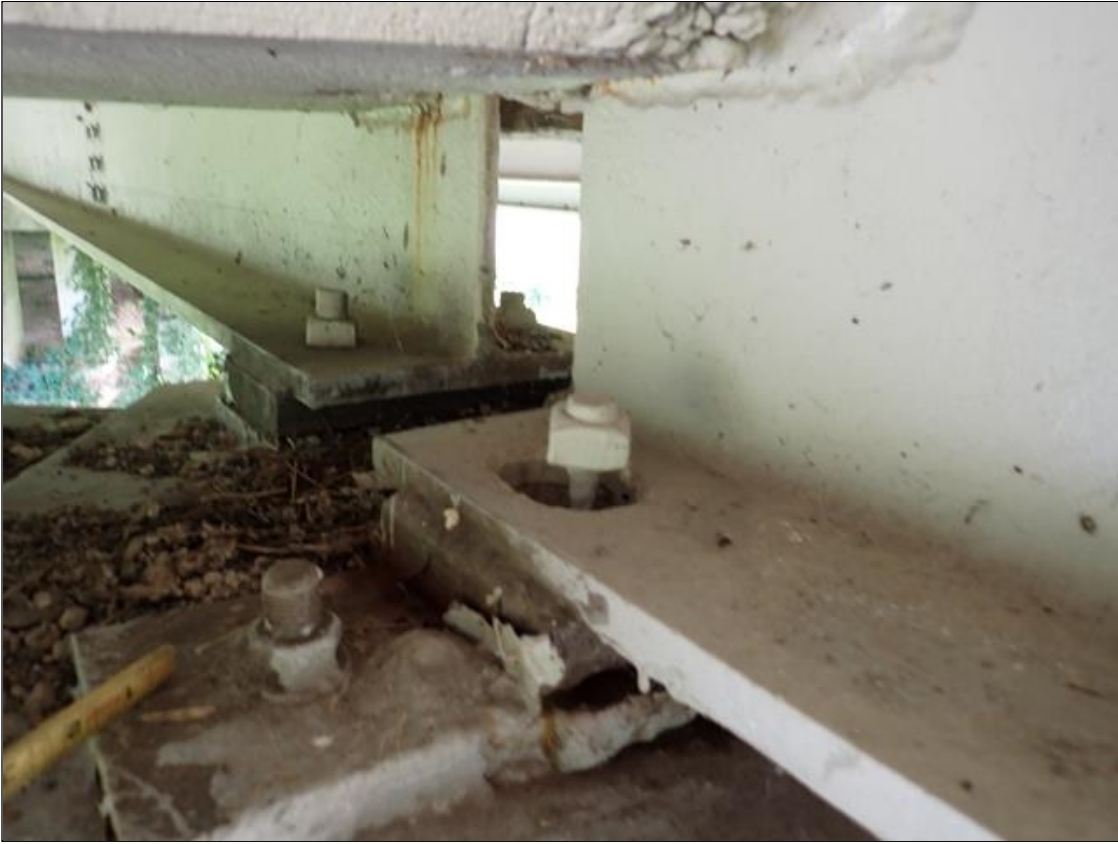
Span 6 Far Bearing 2: LEFT ANCHOR BOLT, PAINTED OVER SECTION LOSS (APPROXIMATELY 40 PERCENT REMAINING; BEARING ASSEMBLY HAS WELDED REPAIR WITH NEW ANCHOR BOLT.

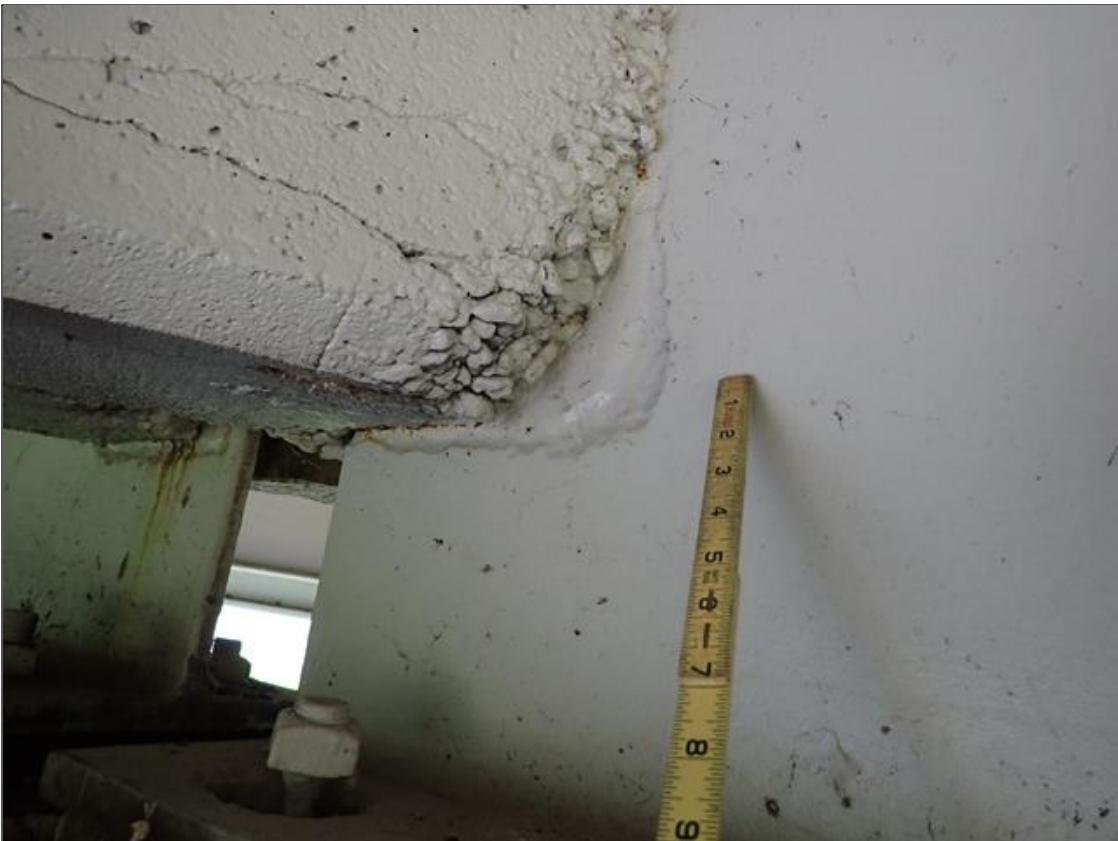
Span 6 Beam 2: (PAR) at bent 6, web adjacent to end diaphragm, painted over section loss (7/16 inch average remaining x 7 inch x 8 inch) with corrosion reactivating

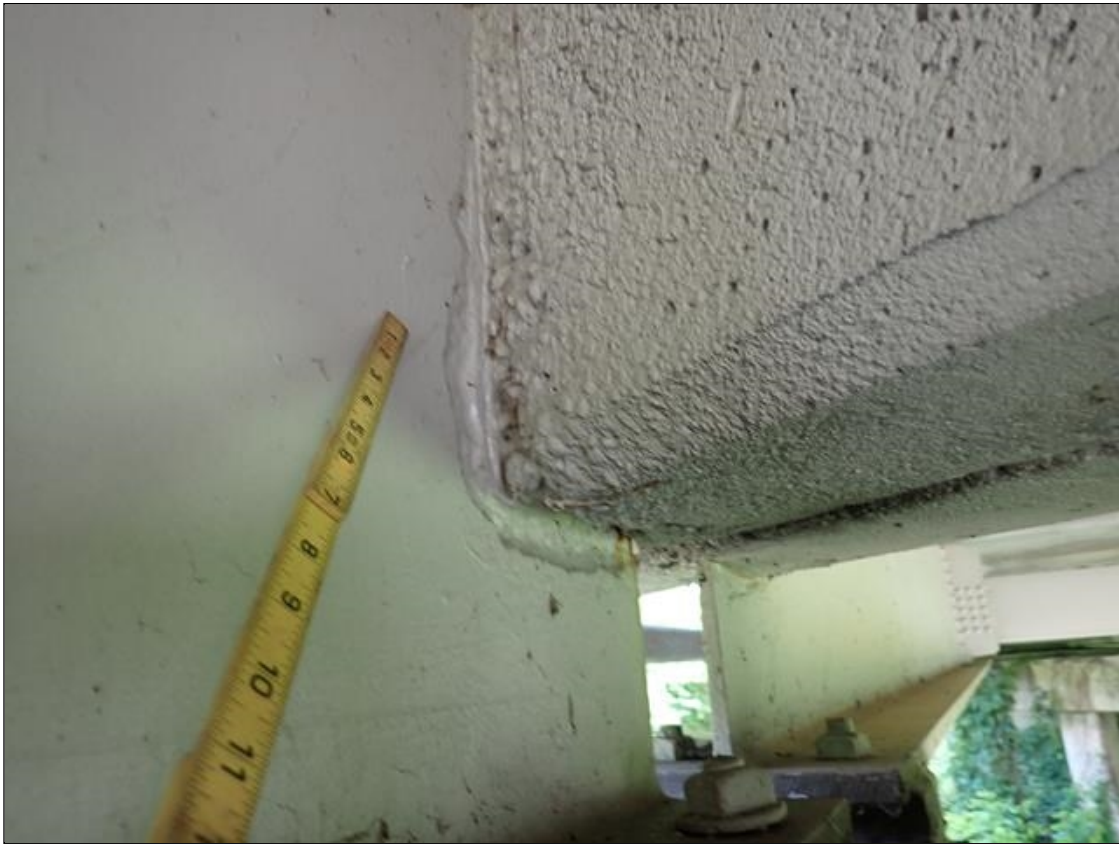
Span 6 Beam 1: (PAR) at bent 6, web adjacent to end diaphragm, painted over section loss (1/4 inch average remaining x 7 inch x 8 inch) with corrosion hole (up to 1/8 inch diameter) and corrosion reactivating

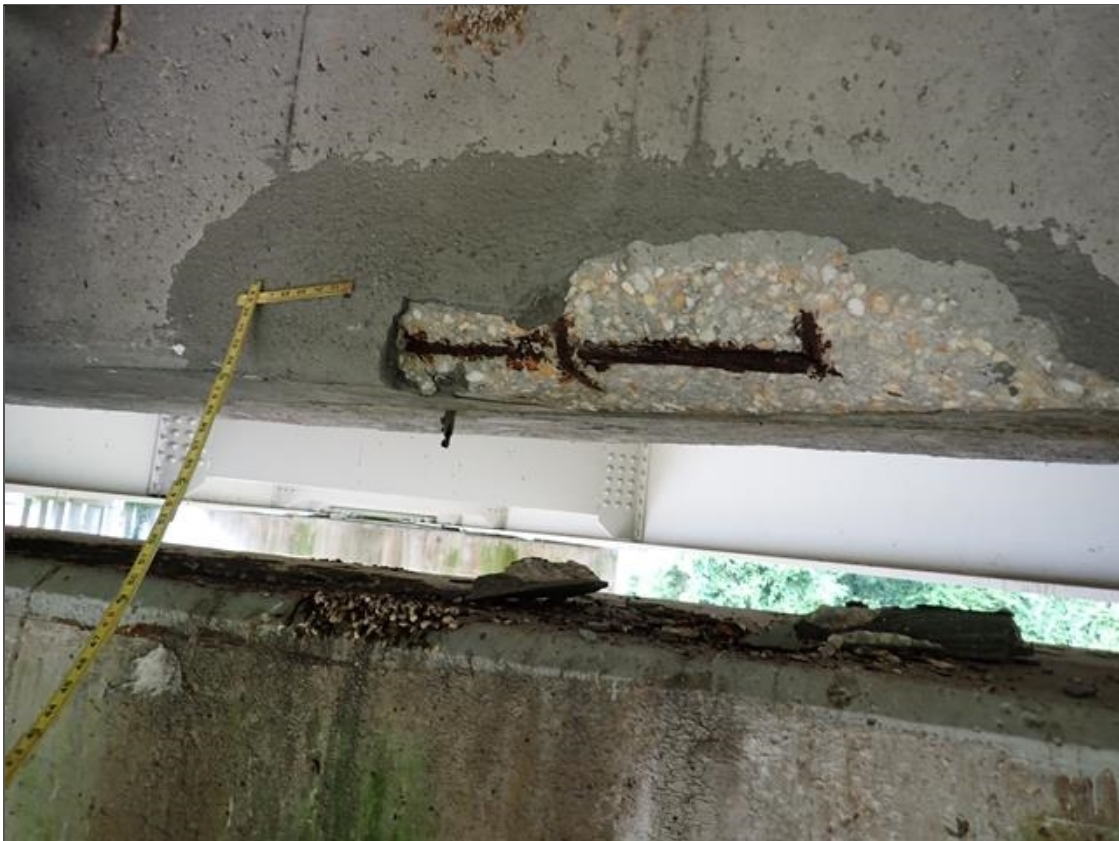
Span 6 Deck: (PAR) bay 2 end diaphragm at bent 5, failed patch/delamination (6 foot x 16 inch x 3 inch deep) with exposed rusted rebar (approximately 100 percent section loss)

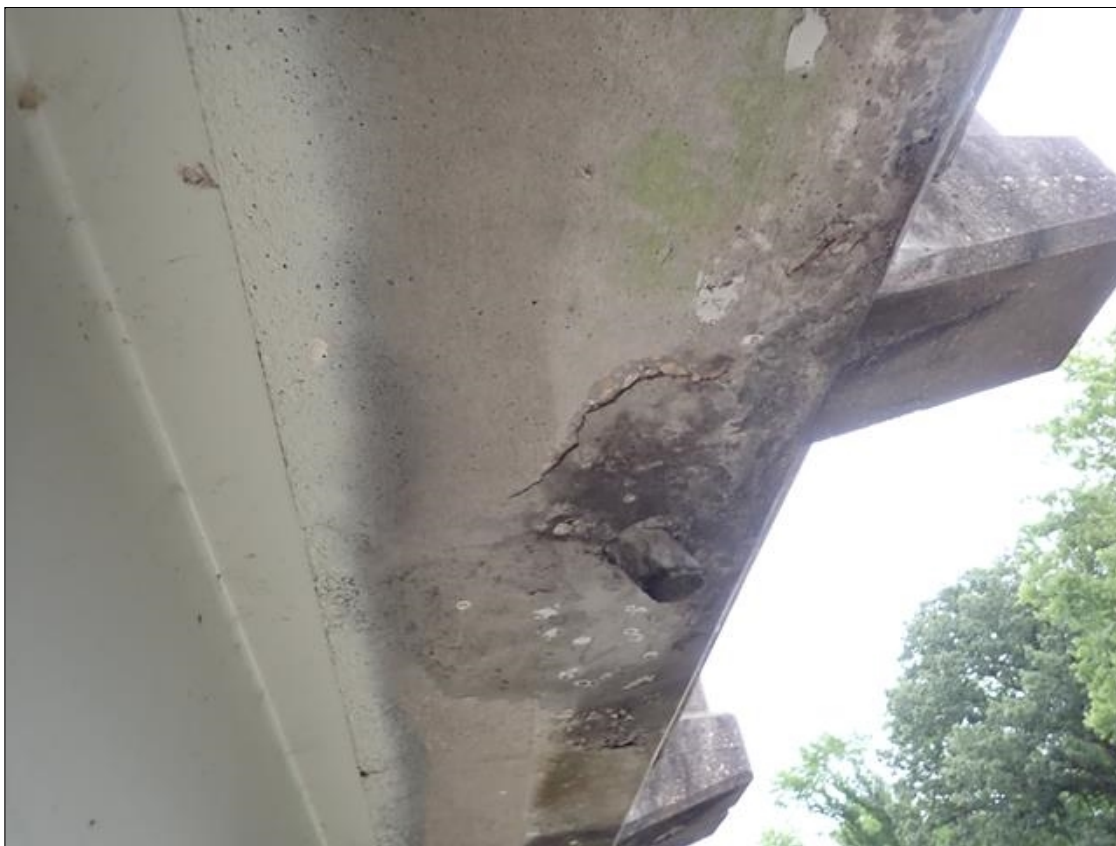
Span 6 Deck: 12 INCHES DIAMETER SOUND CONCRETE PATCH WITH ADJACENT DELAMINATION (18 INCH X 18 INCH) AT 2ND DRAIN PIPE IN EAST OVERHANG.

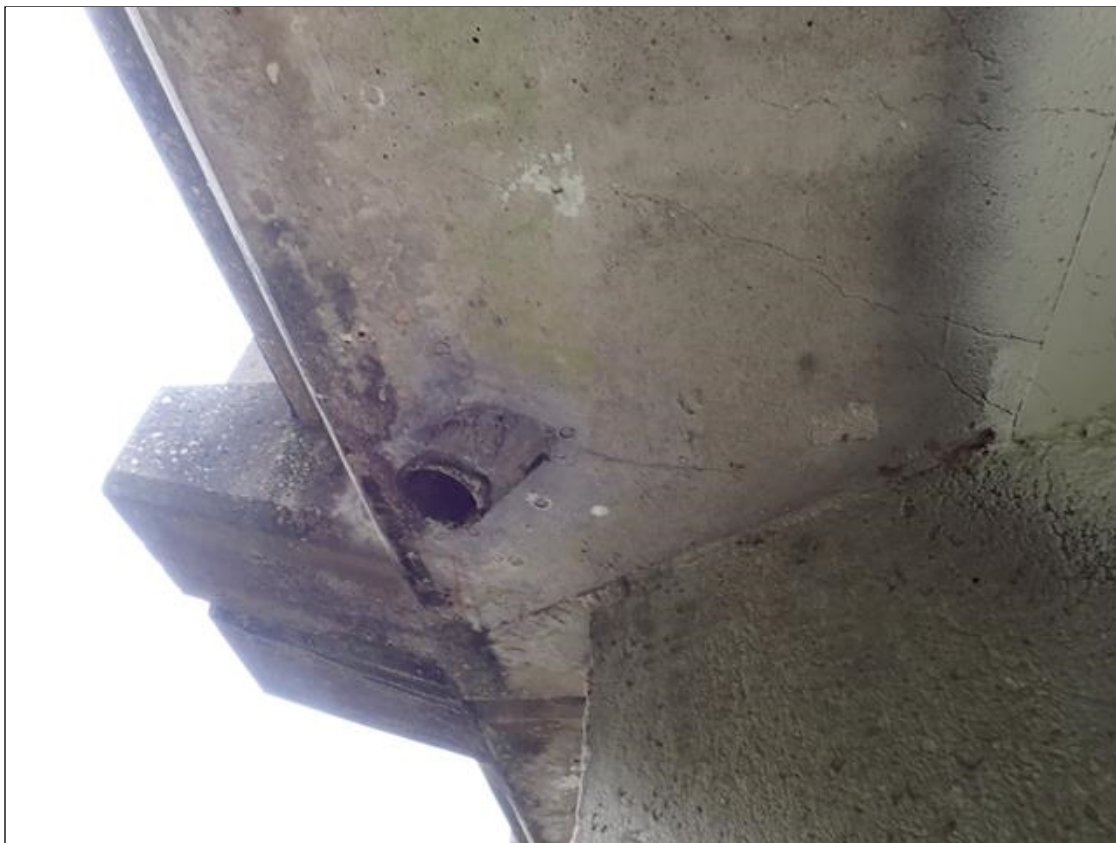
Span 6 Deck: (not found 2025) 12 INCHES DIAMETER SOUND CONCRETE PATCH IN EAST OVERHANG AT DRAIN ONE.

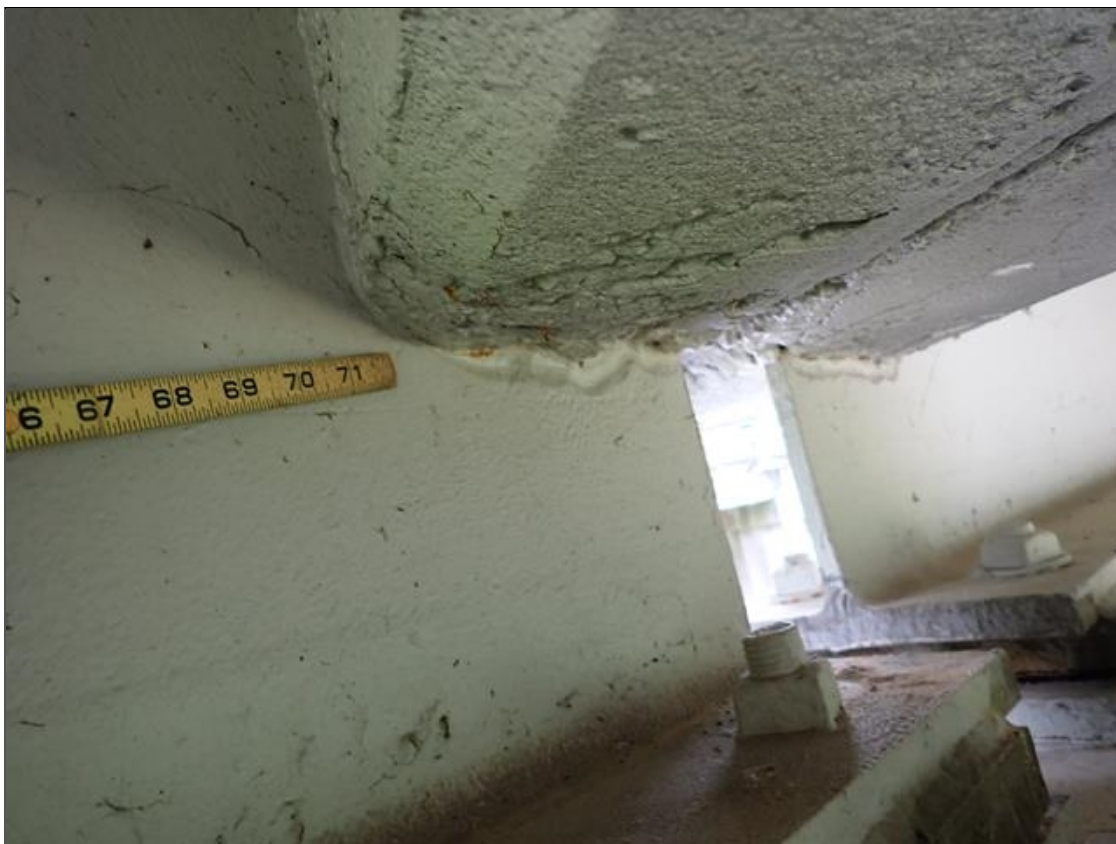
Span 6 Beam 4: (PAR) at bent 5, web adjacent to end diaphragm, painted over section loss (7/16 inch average remaining x 5 inch x 1 inch) with corrosion reactivating

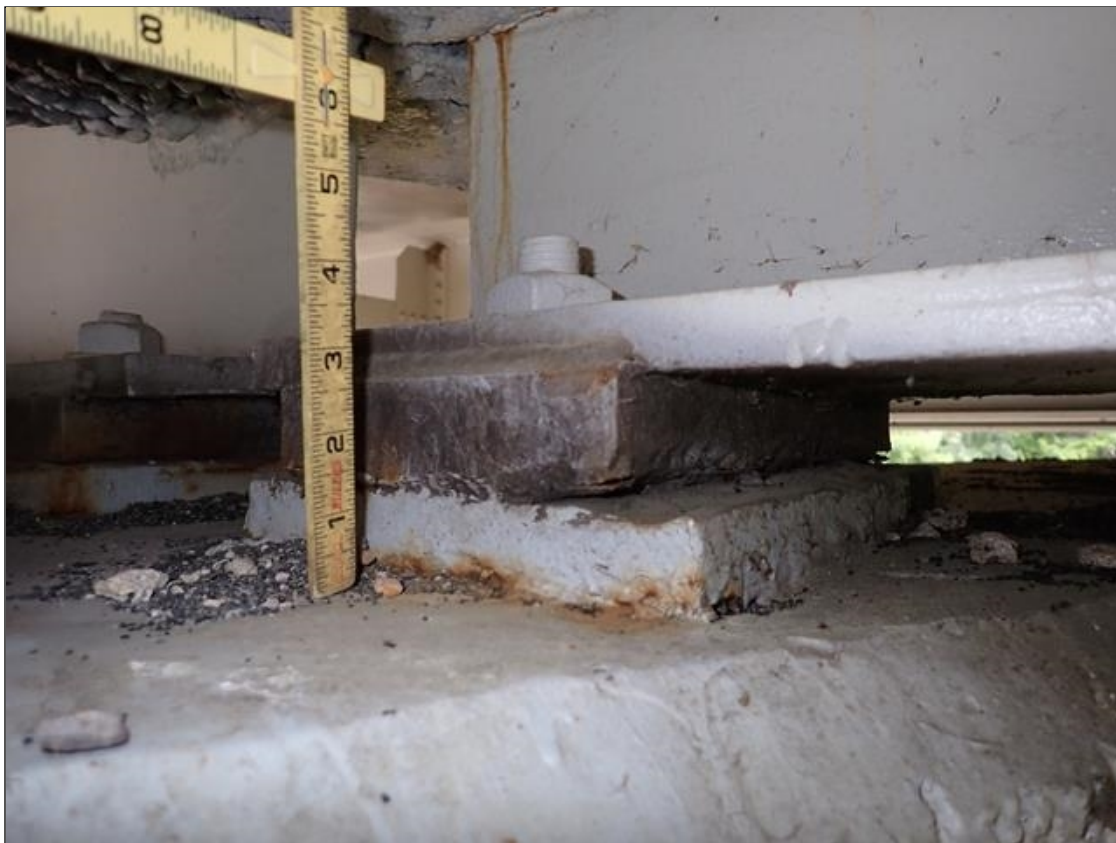
Span 6 Near Bearing 3: painted over section loss (less than 1/16 inch loss)

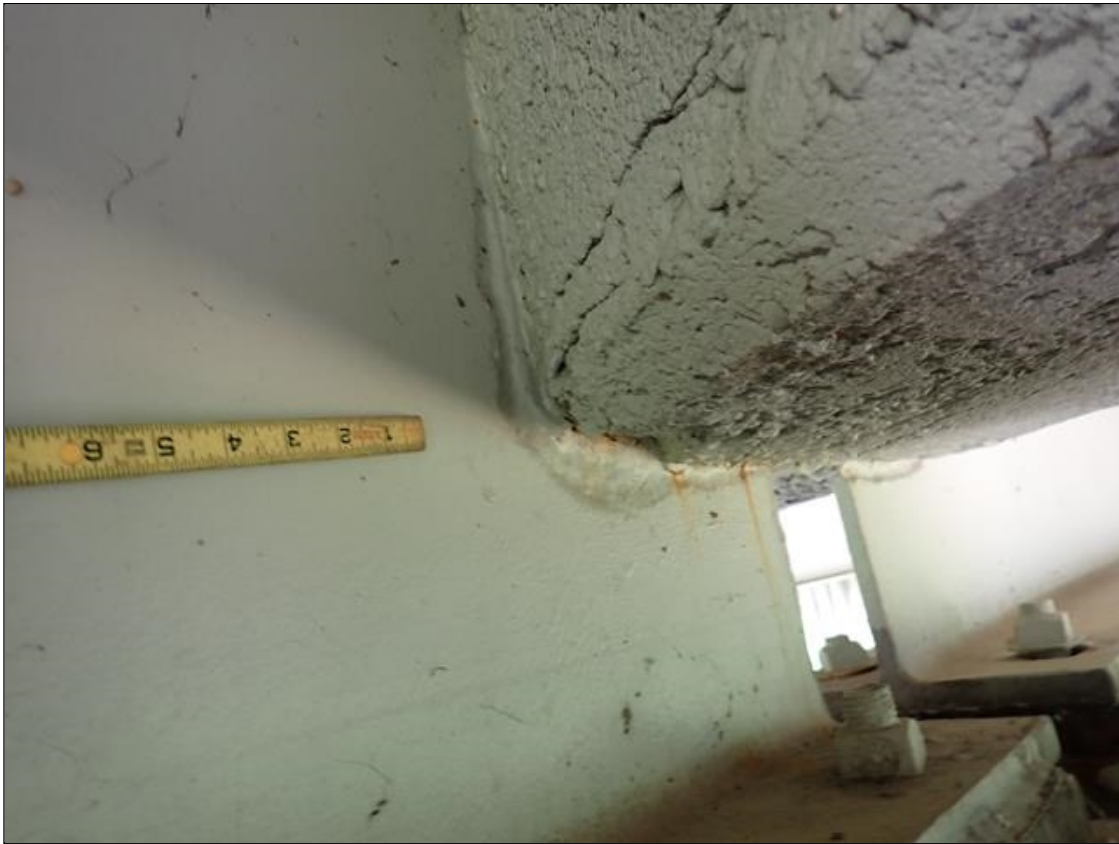
Span 6 Beam 3: (PAR) at bent 5, web adjacent to end diaphragm, painted over section loss (7/16 inch average remaining x 7 inch x 8 inch) with corrosion reactivating

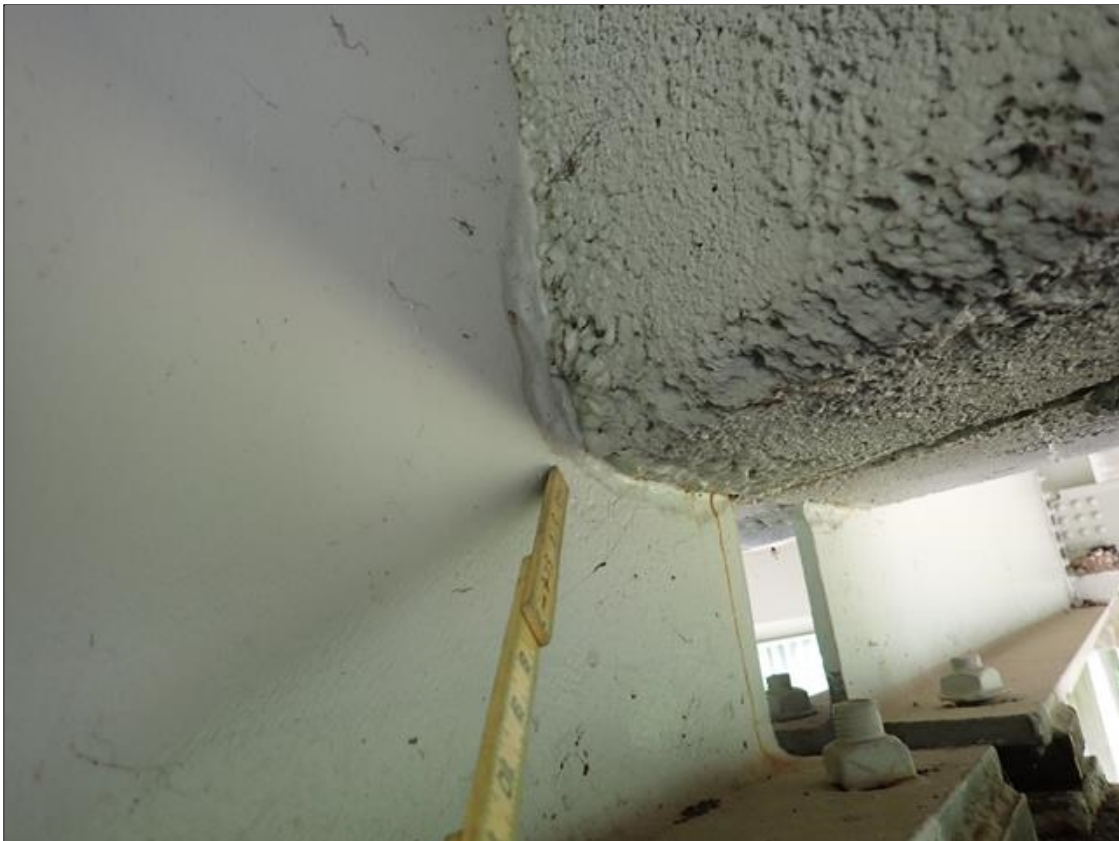
Span 6 Beam 2: (PAR) at bent 5, web adjacent to end diaphragm, painted over section loss (7/16 inch average remaining x 7 inch x 8 inch) with corrosion reactivating
