NC DEPARTMENT OF TRANSPORTATION
 DIVISION OF HIGHWAYS
 STRUCTURE MANAGEMENT UNIT
 COUNTY: JOHNSTON DIV: 4

ATTENTION: PARS Submitted Sign Notice Issued
 sketches revised; new repairs

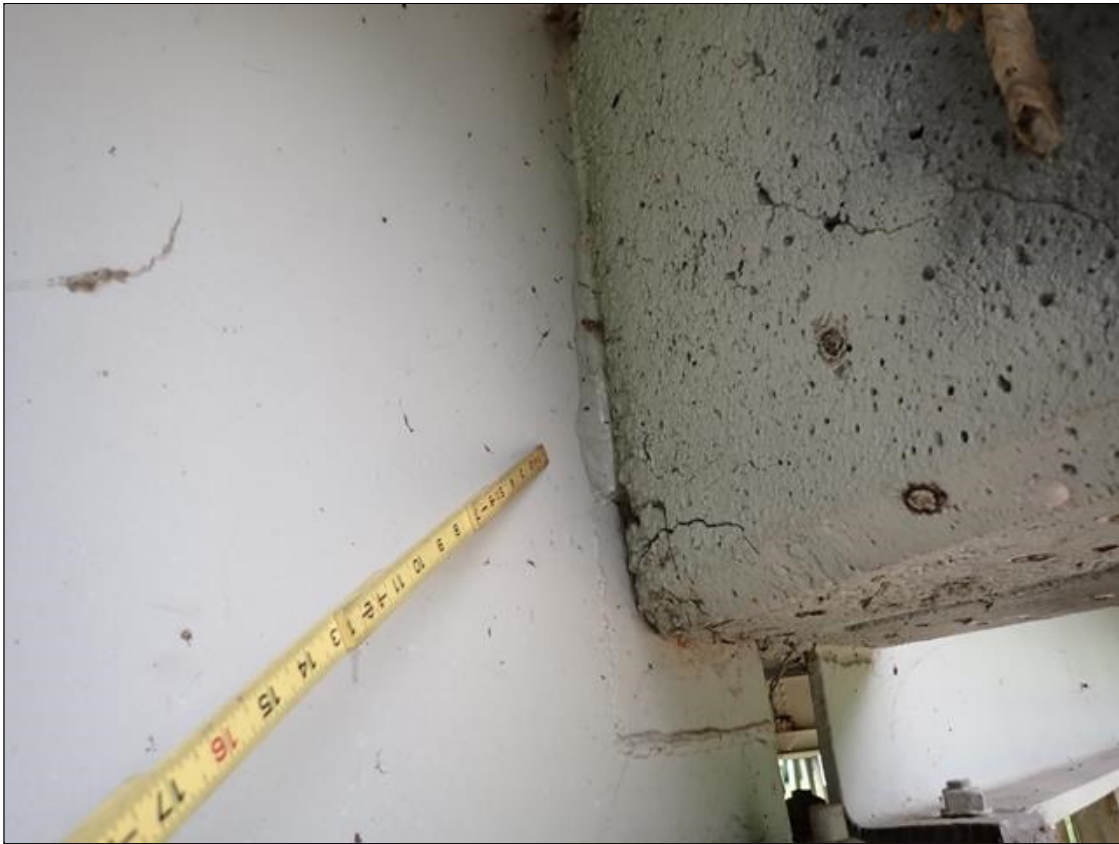
Span 6 Beam 1: (PAR) at bent 5, web adjacent to end diaphragm, painted over section loss (1/2 inch average remaining x 2 inch x 9 inch)

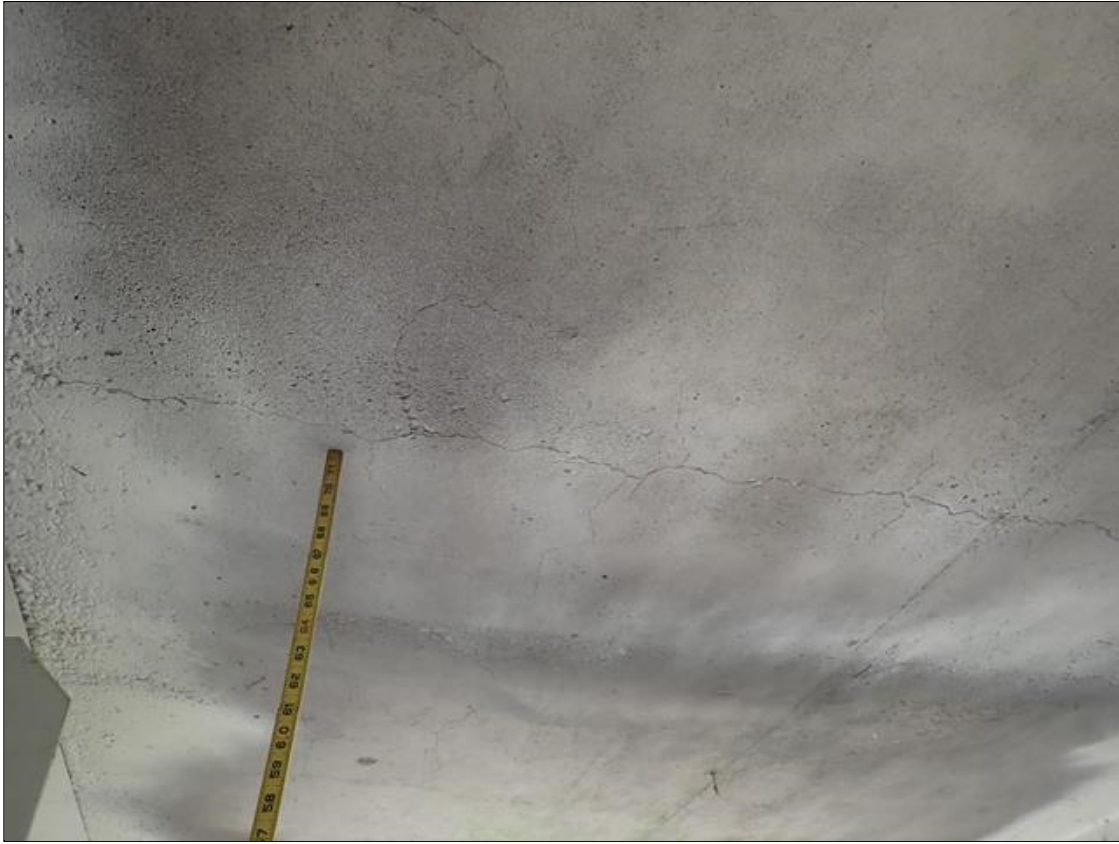
Span 5 Deck: UP TO 1/32 INCH WIDE RANDOM CRACKING IN DECK UNDERSIDE IN ALL BAYS, SOME WITH EFFLORESCENCE, SCATTERED THROUGHOUT.

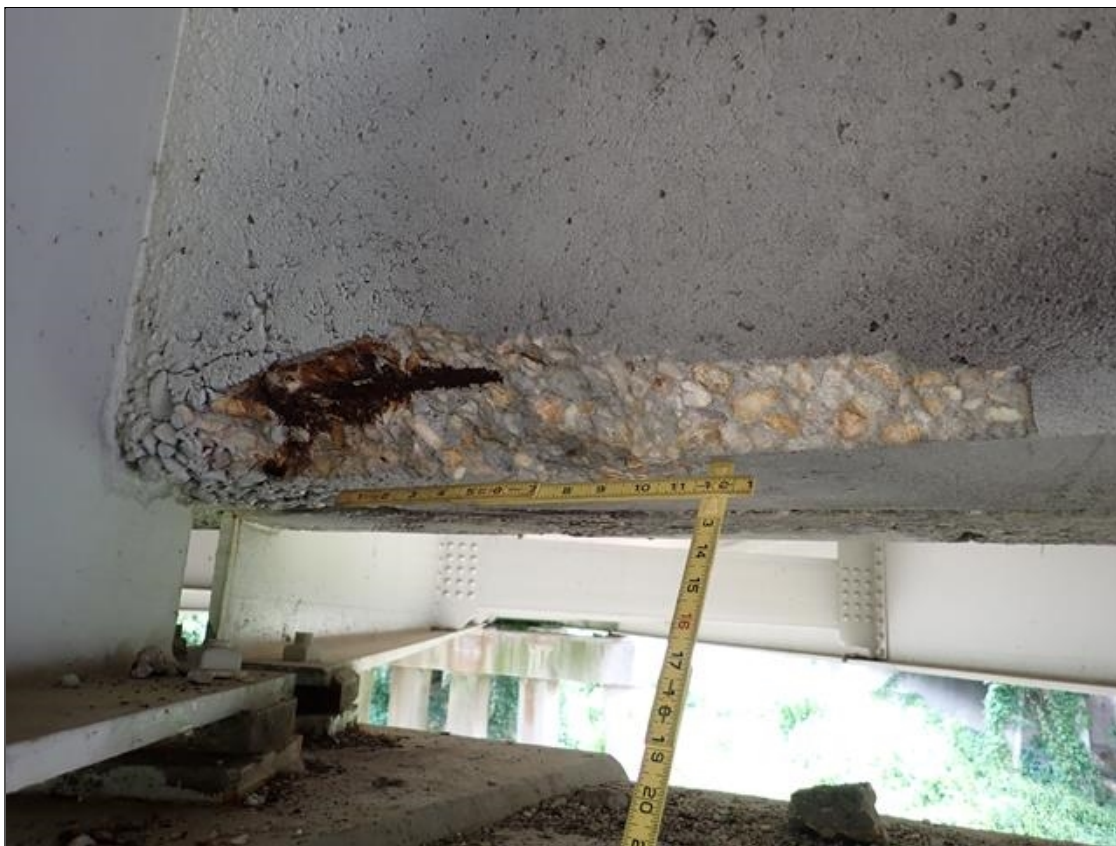
Span 5 Deck: (PAR) BAY 3 FAR DIAPHRAGM ADJACENT TO BEAM 3 AREA OF SPALLING AND DELAMINATION 2 FEET X 4 INCHES X UP TO 3 INCHES DEEP WITH EXPOSED RUSTED REBAR (APPROXIMATELY 80 PERCENT REMAINING)

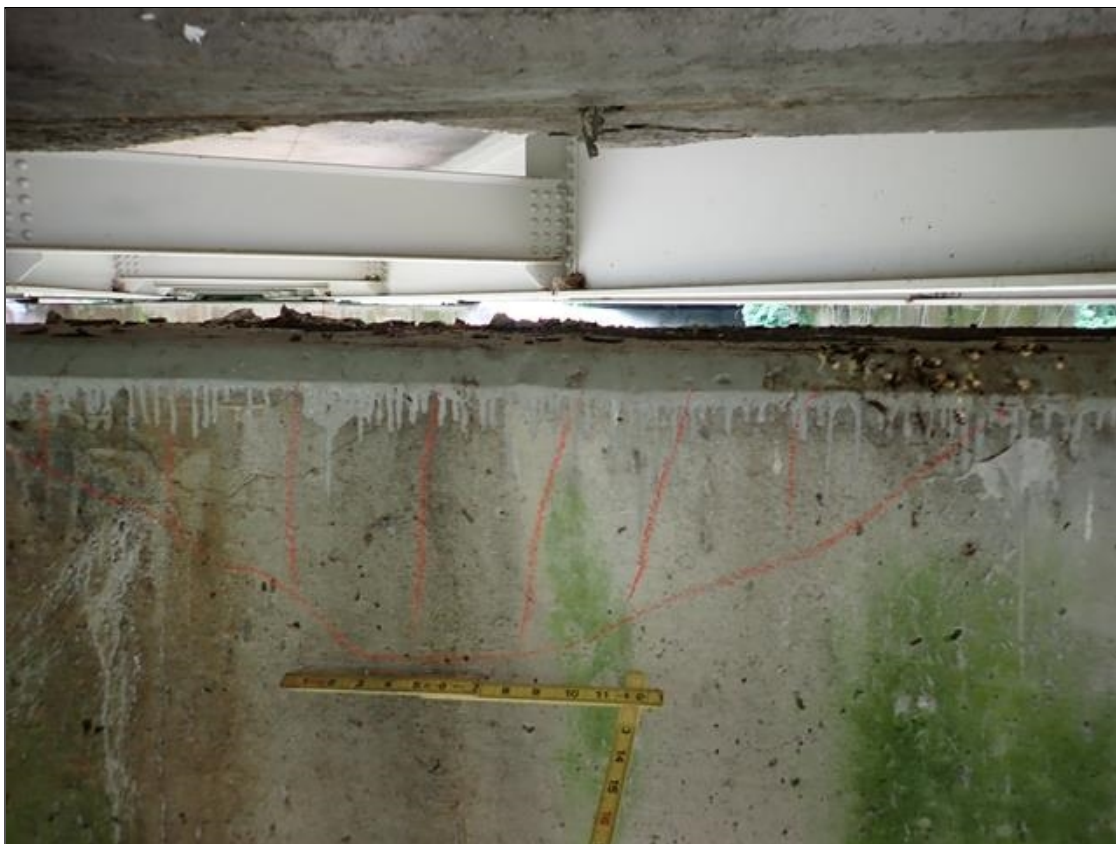
Bent 5 Cap 1: south face in bay 2, delamination (30 inch x 12 inch)

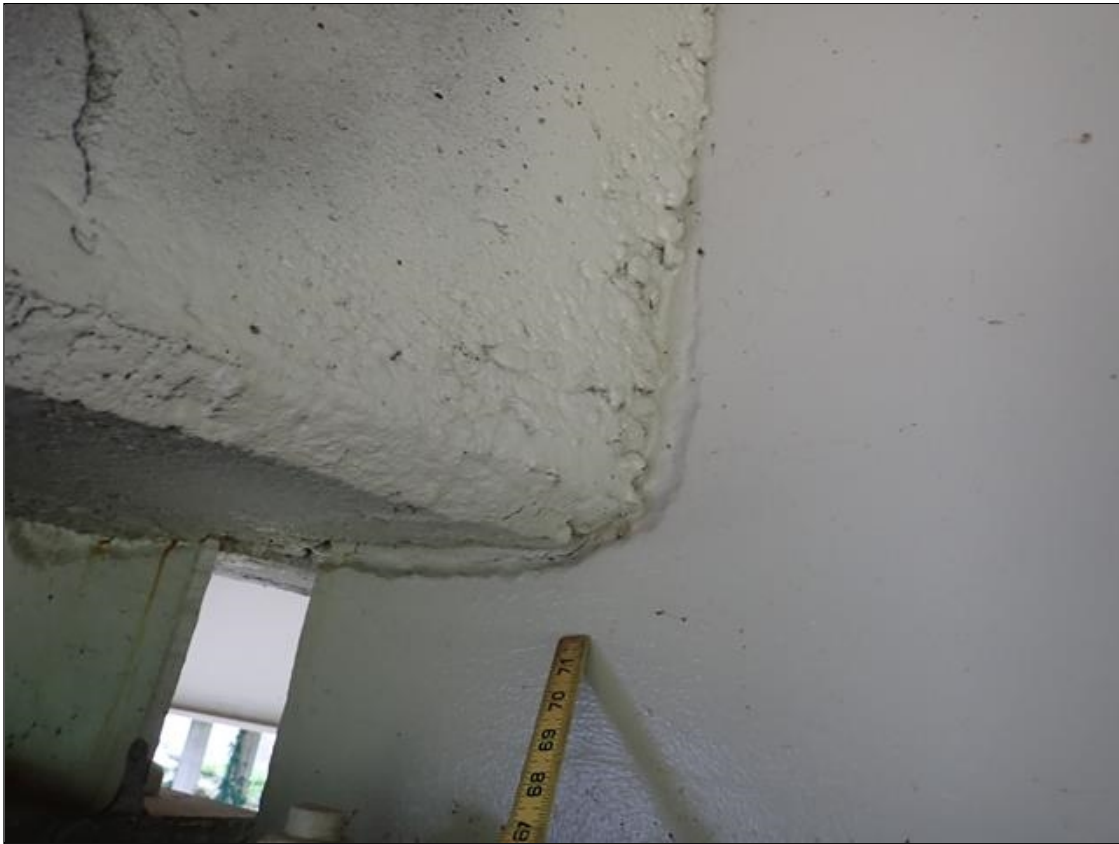
Span 5 Beam 3: (PAR) at bent 5, web adjacent to end diaphragm, painted over section loss (7/16 inch average remaining x 7 inch x 7 inch) with corrosion reactivating

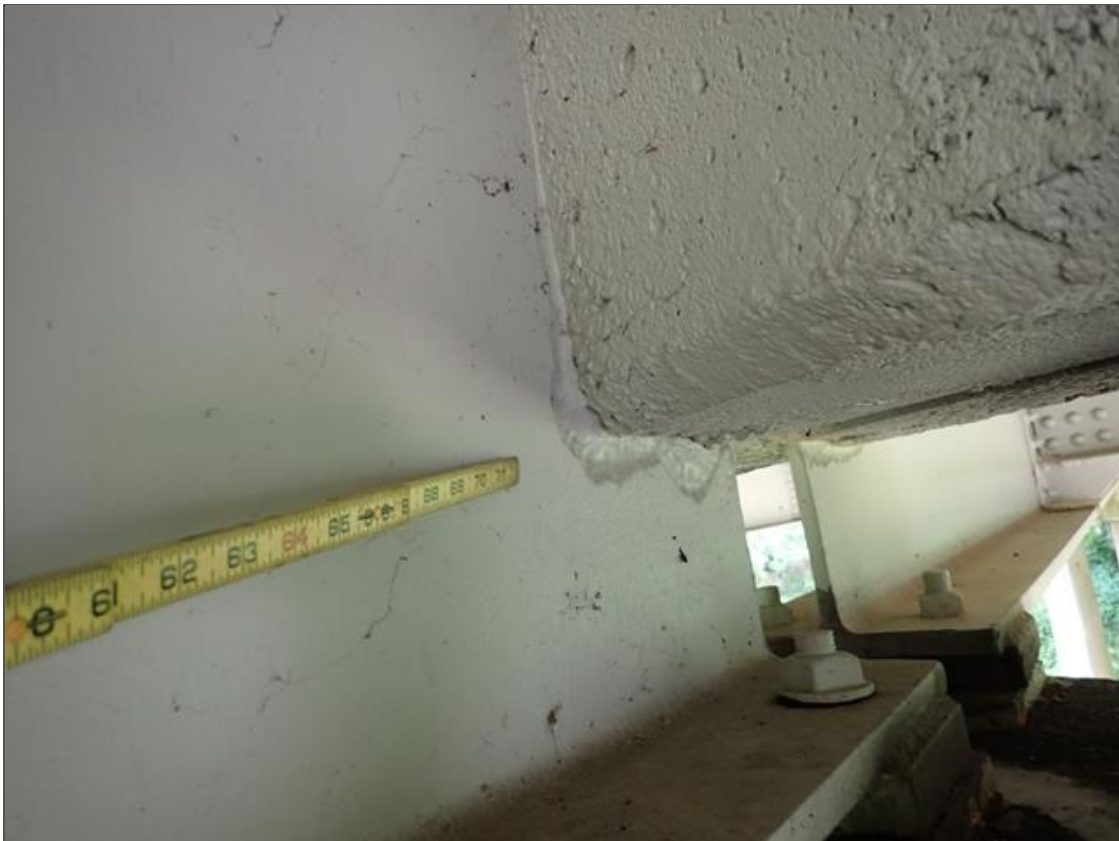
Span 5 Beam 2: (PAR) at bent 5, web adjacent to end diaphragm, painted over section loss (7/16 inch average remaining x 2.5 inch x 8 inch) with corrosion reactivating

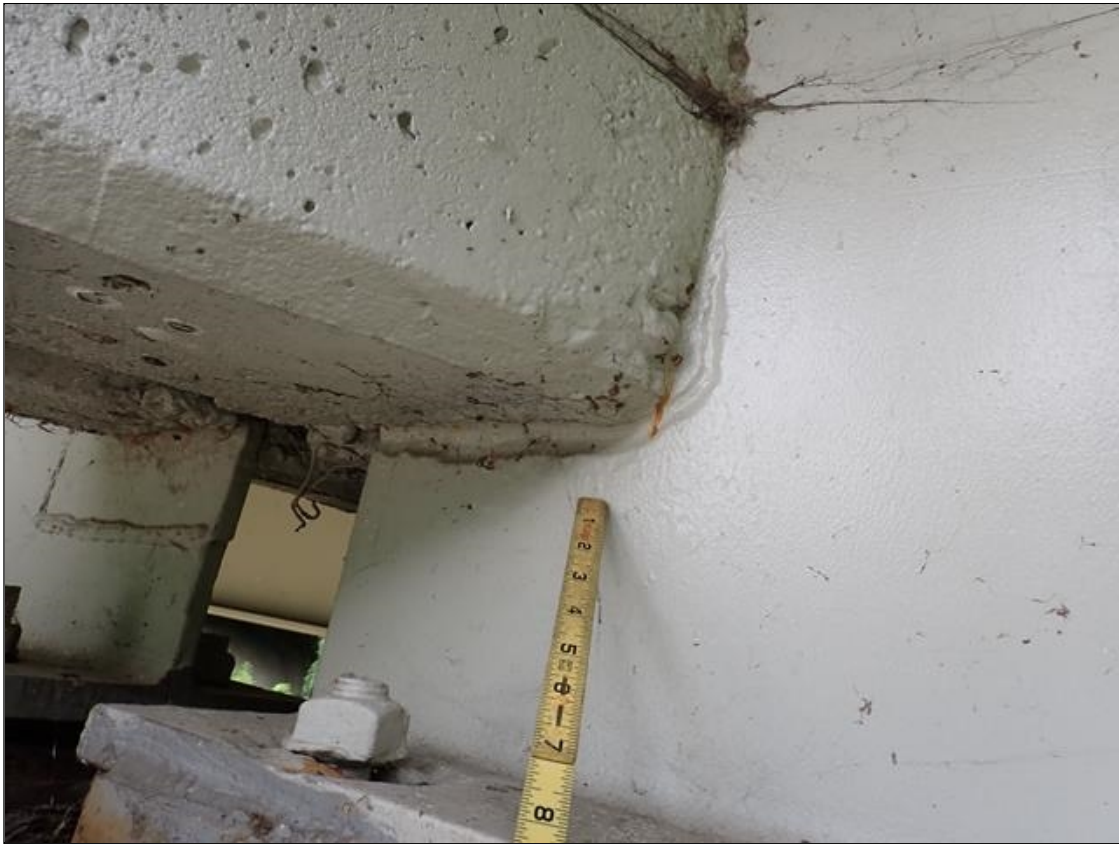
Span 5 Beam 1: (PAR) at bent 5, web adjacent to end diaphragm, painted over section loss (7/16 inch average remaining x 8 inch x 10 inch) with corrosion reactivating

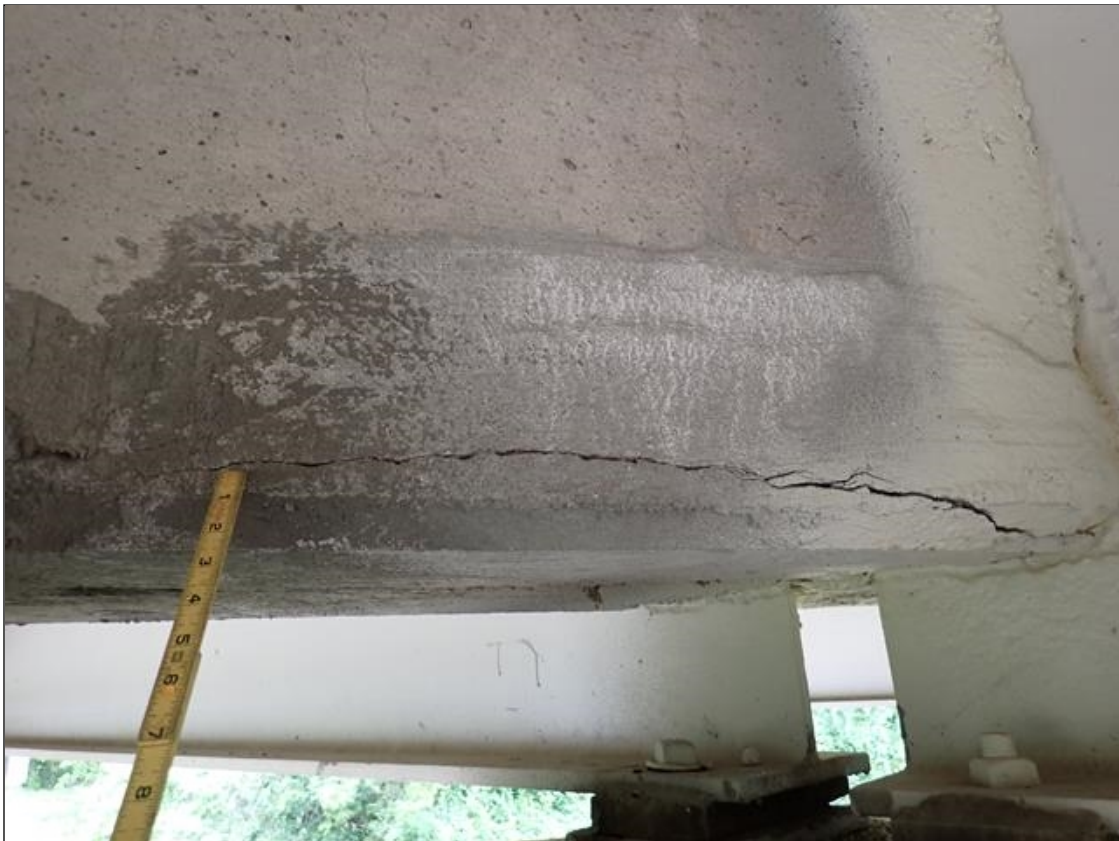
Span 5 Deck: 3 FEET LONG X 11 INCHES HIGH UNSOUND CONCRETE PATCH WITH 1/8 INCH WIDE HORIZONTAL CRACK, BAY 2 END DIAPHRAGM, NEXT TO BEAM 2, AT BENT 4.

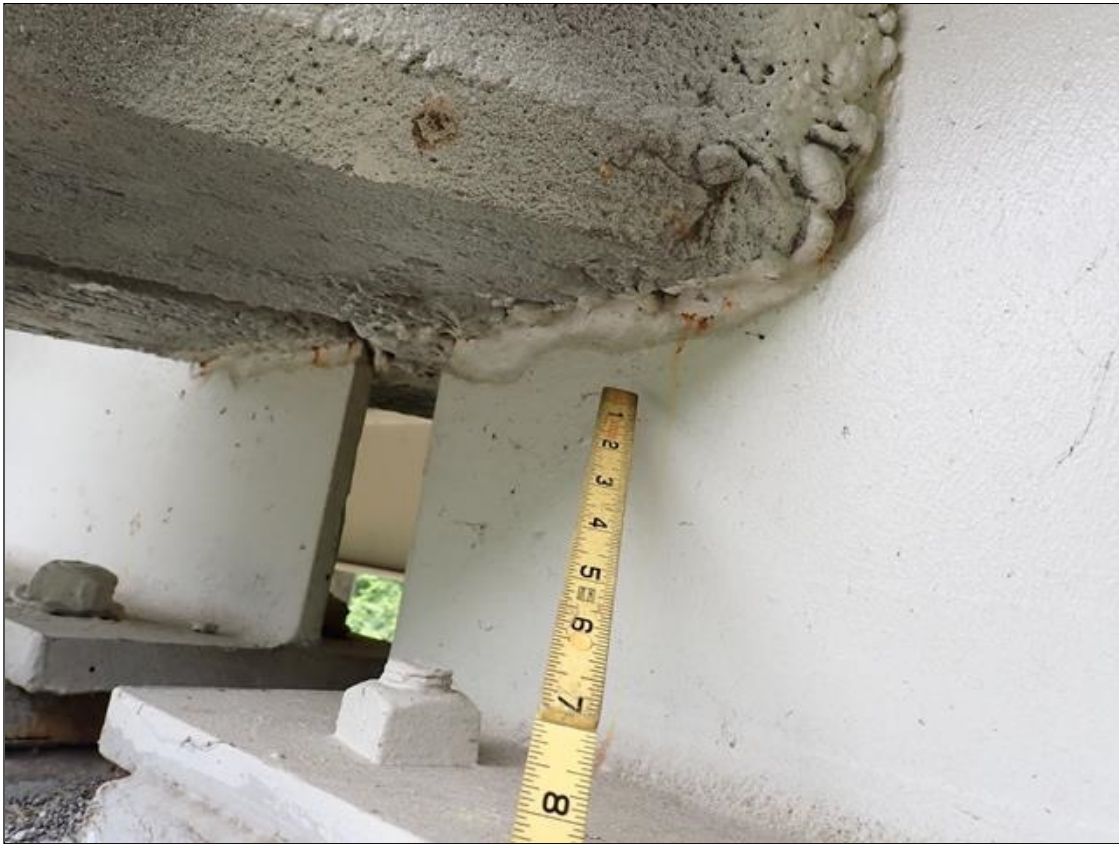
Span 5 Beam 4: (PAR) at bent 4, web adjacent to end diaphragm, painted over section loss (1/2 inch average remaining x 7 inch x 1 inch) with corrosion reactivating

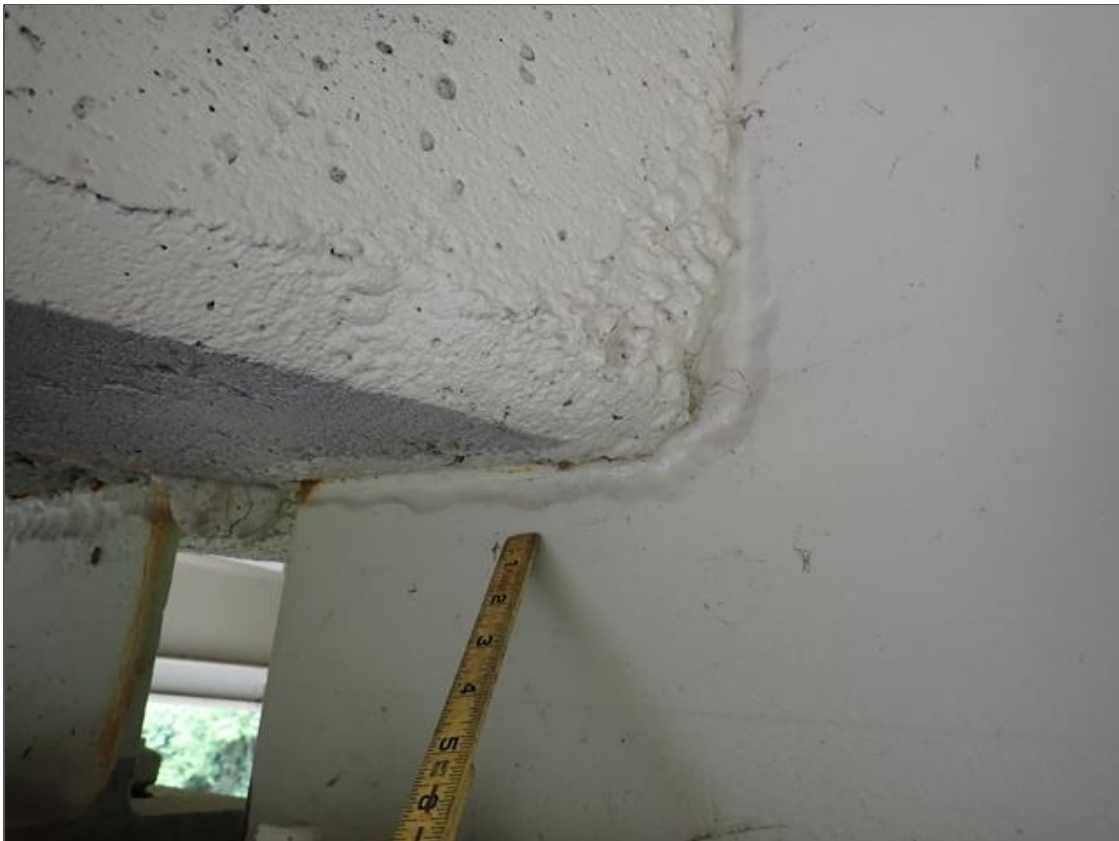
Span 5 Beam 3: (PAR) at bent 4, web adjacent to end diaphragm, painted over section loss (7/16 inch average remaining x 8 inch x 8 inch) with corrosion reactivating

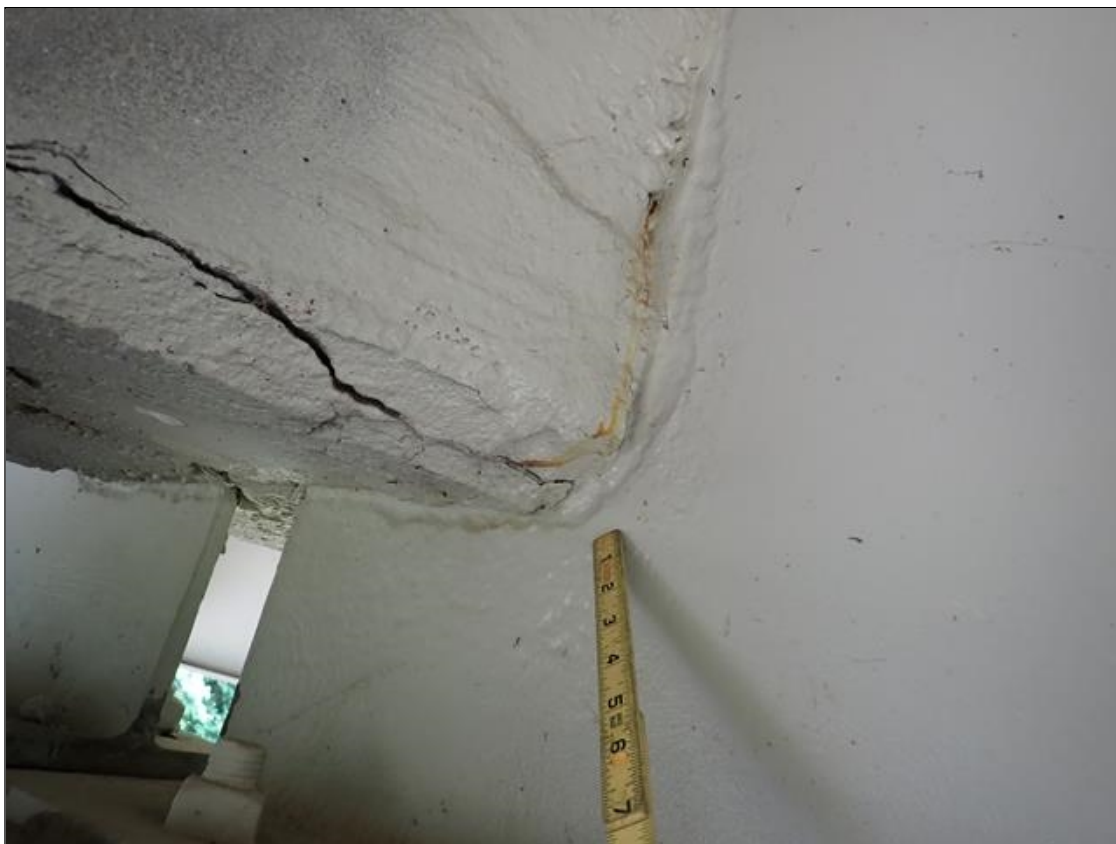
Span 5 Beam 2: (PAR) at bent 4, web adjacent to end diaphragm, painted over section loss (7/16 inch average remaining x 8 inch x 12 inch) with corrosion reactivating

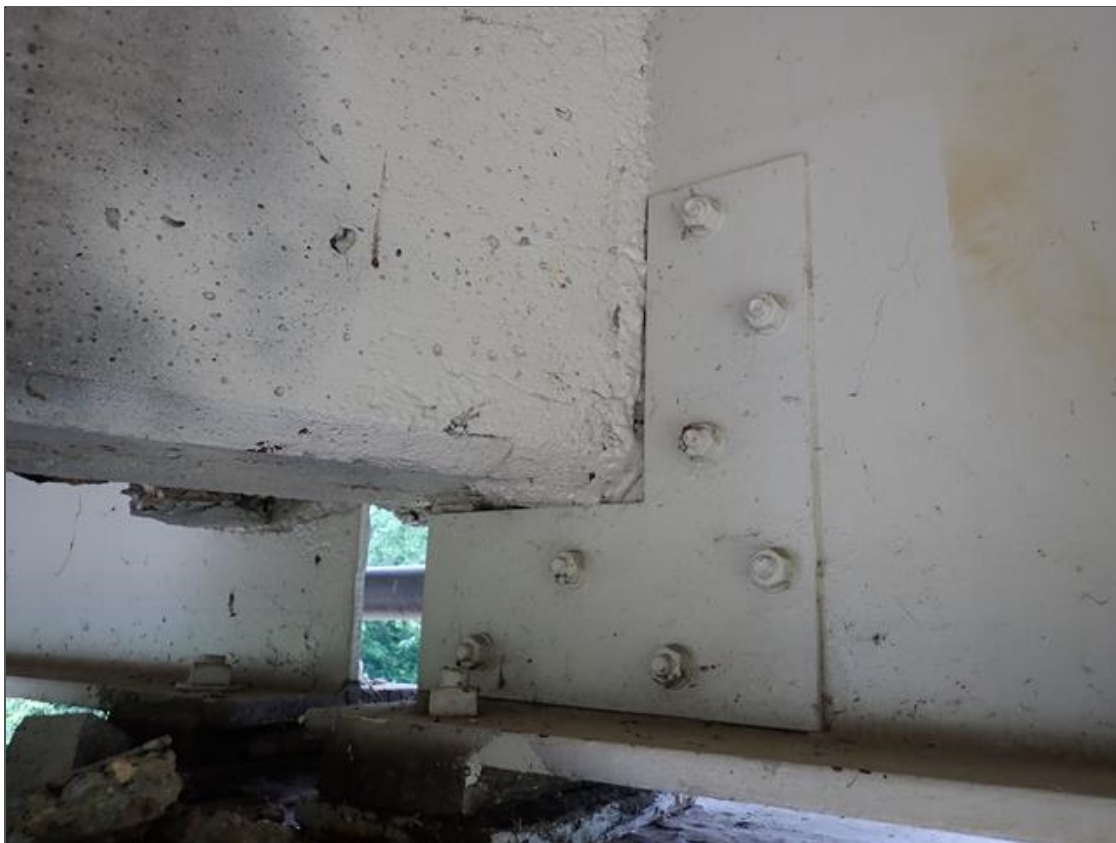
Span 5 Beam 1: at bent 4, web repair plate, (3/8 inch thick x 15.5 inch x 17 3/4 inch)

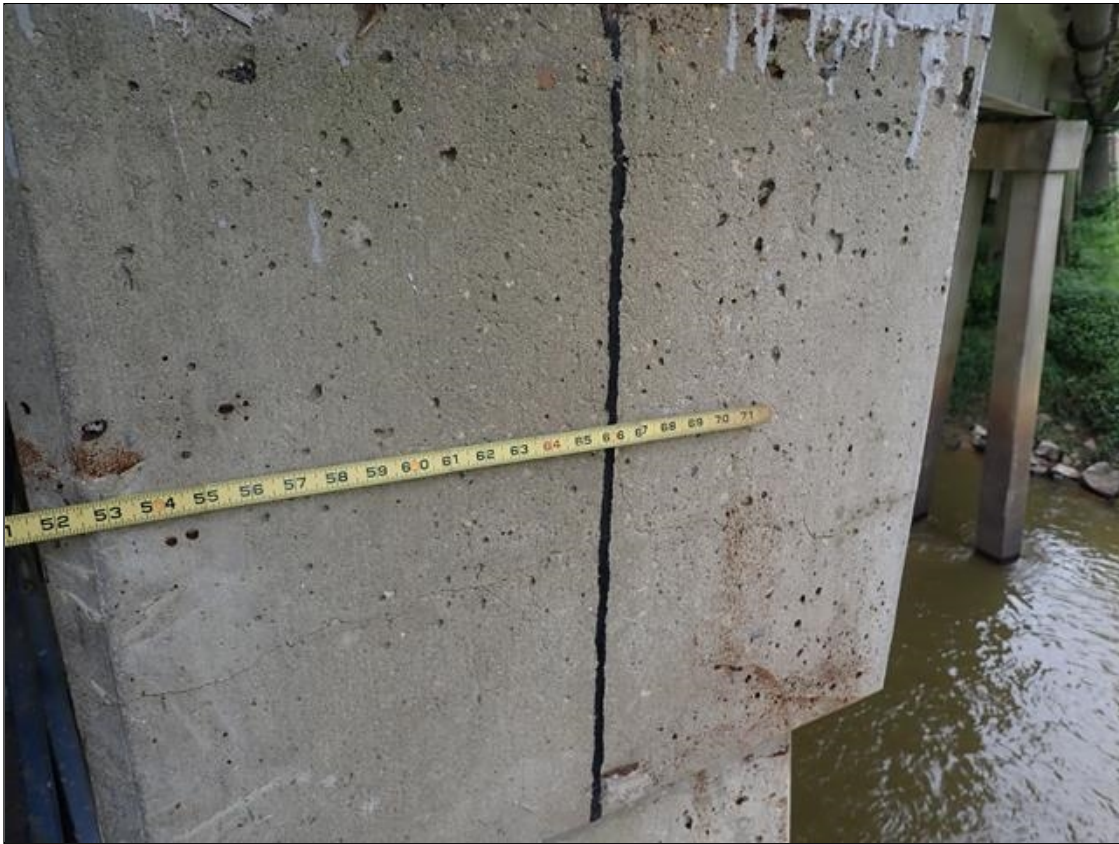
Bent 4 Cap 1: 30 INCHES LONG X 1/32 INCH WIDE HORIZONTAL CRACK, CENTER OF WEST END.

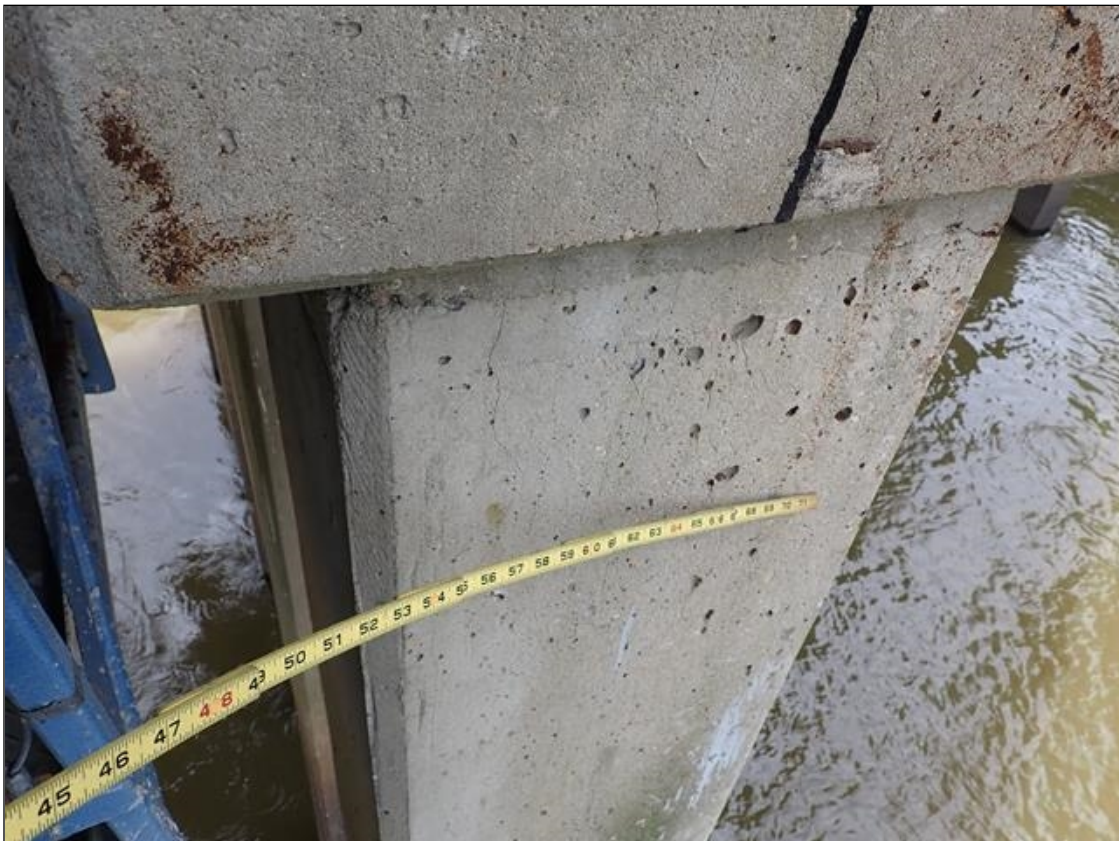
Bent 4 Pile 1: UP TO 5 FEET LONG X 0.02 INCH WIDE VERTICAL CRACKS, IN ALL FACES FACE BEGINNING AT CAP.

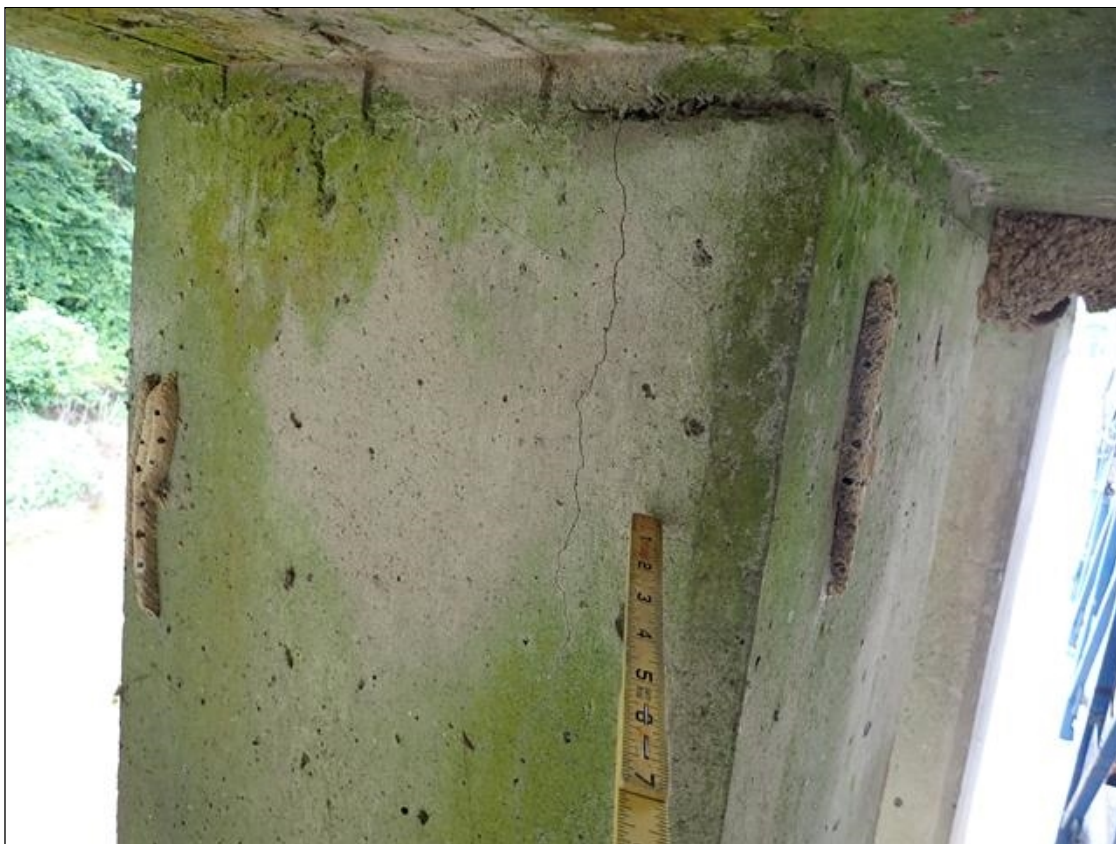
Bent 4 Pile 2: UP TO 1 FOOT LONG VERTICAL HAIRLINE CRACK, EAST AND SOUTH FACES, BEGINNING AT CAP.

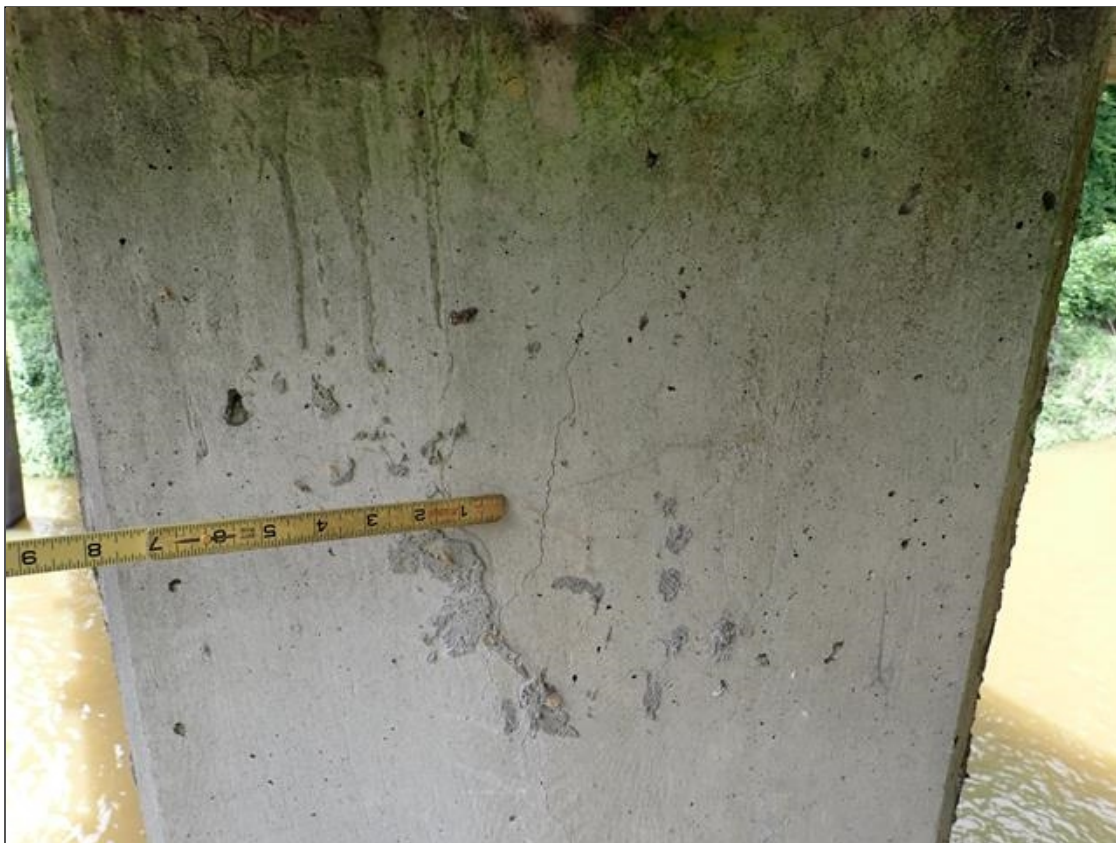
Bent 4 Pile 6: north face near cap, vertical crack (1/32 inch x 28 inch)

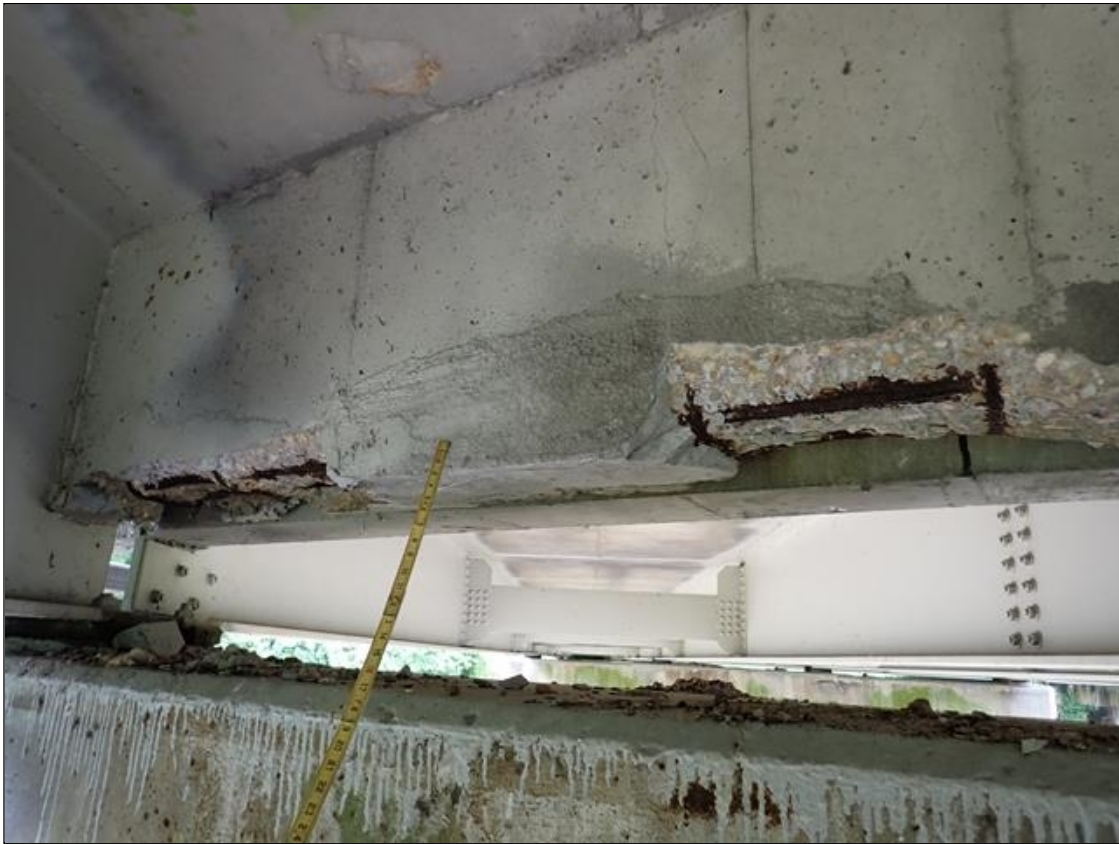
Span 4 Deck: (PAR) 5 FEET LONG X 11 INCHES HIGH UNSOUND CONCRETE PATCH WITH 1/16 INCH WIDE CRACKS AND SPALLS UP TO 3 FEET X FULL WIDTH X 5 INCHES WITH EXPOSED REBAR UP TO 100 PERCENT SECTION LOSS IN BAY 1 AND EXTERIOR END DIAPHRAGM, NEXT TO BEAM 1, AT BENT 4.

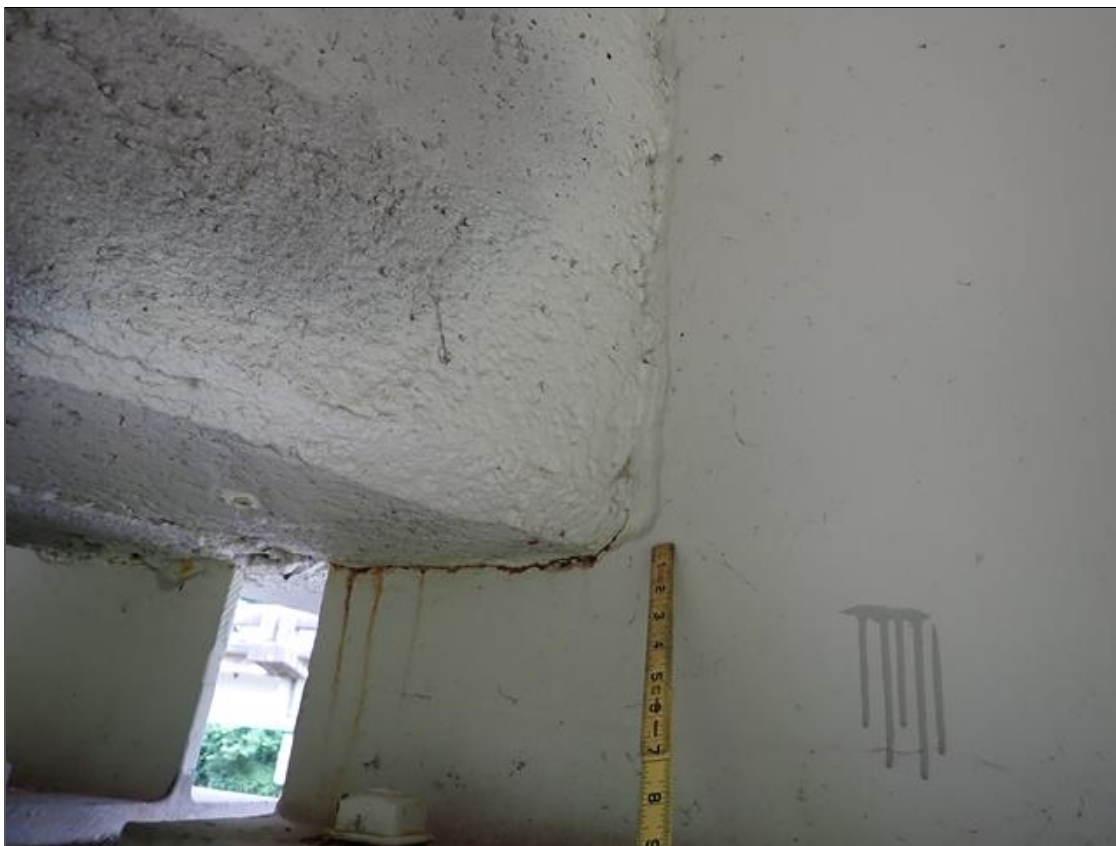
Span 4 Beam 4: (PAR) at bent 4, web adjacent to end diaphragm, painted over section loss (7/16 inch average remaining x 1 inch x 18 inch) with corrosion reactivating

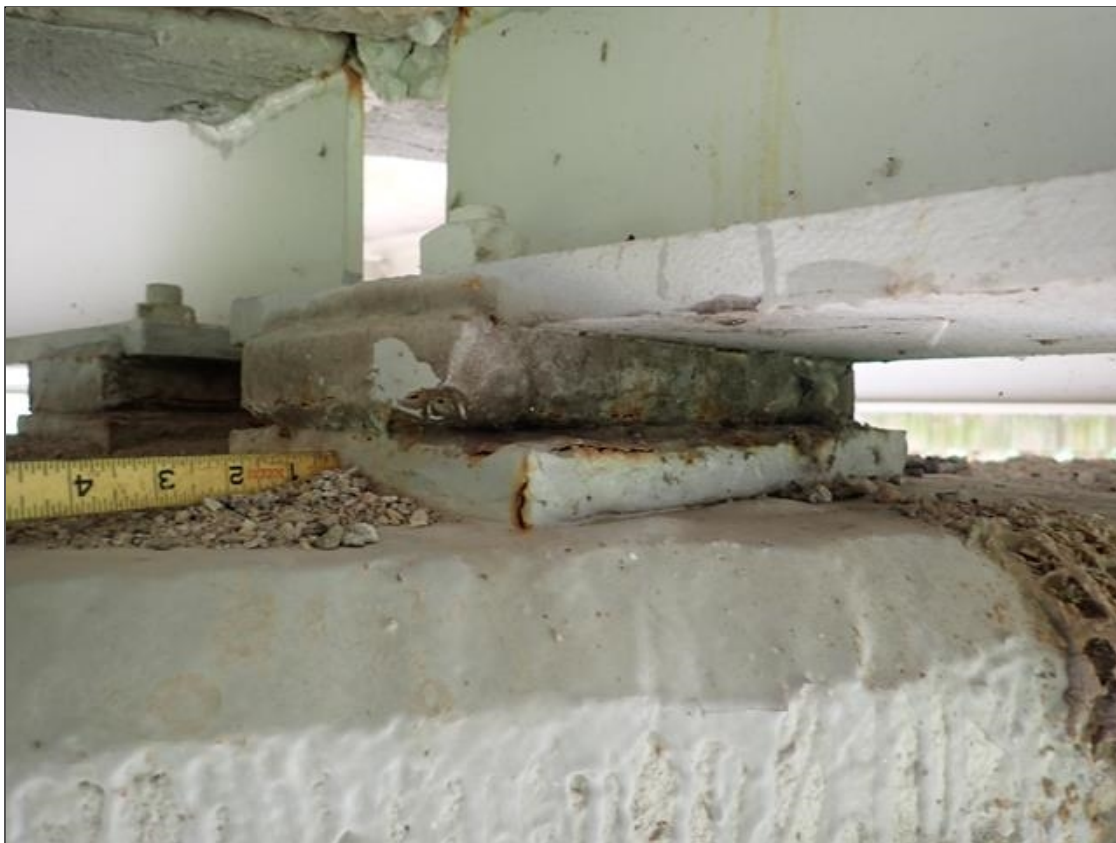
Span 4 Far Bearing 3: painted over section loss (less than 1/16 inch loss) with corrosion reactivating

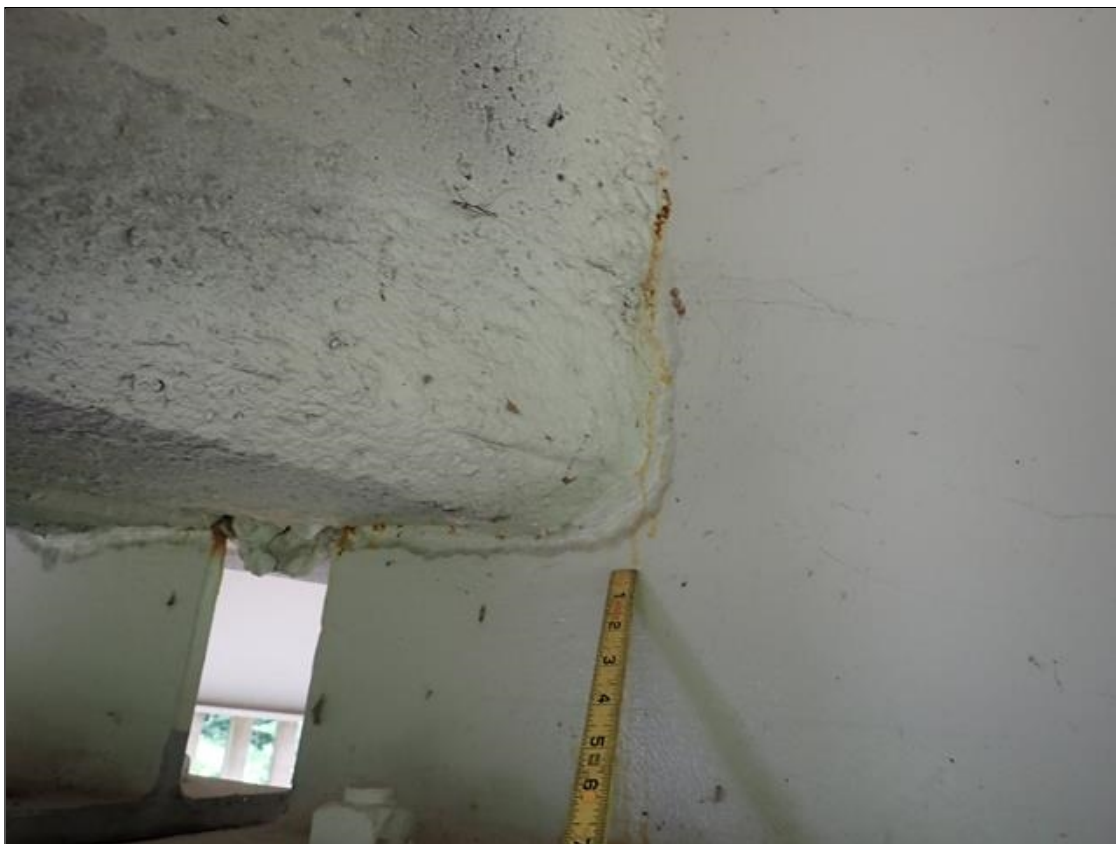
Span 4 Beam 3: (PAR) at bent 4, web adjacent to end diaphragm, painted over section loss (7/16 inch average remaining x 8 inch x 7 inch) with corrosion reactivating

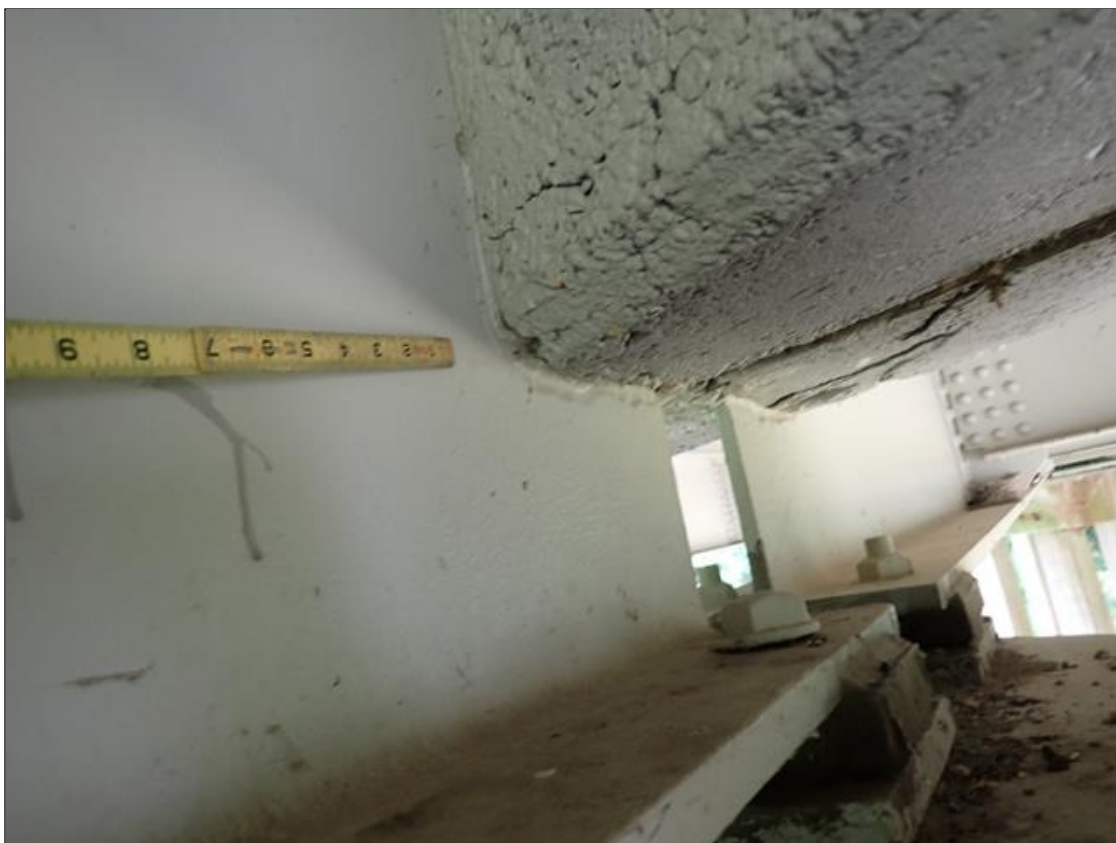
Span 4 Beam 2: at bent 4, web adjacent to end diaphragm, painted over section loss (9/16 inch average remaining x 7 inch x 1 inch)

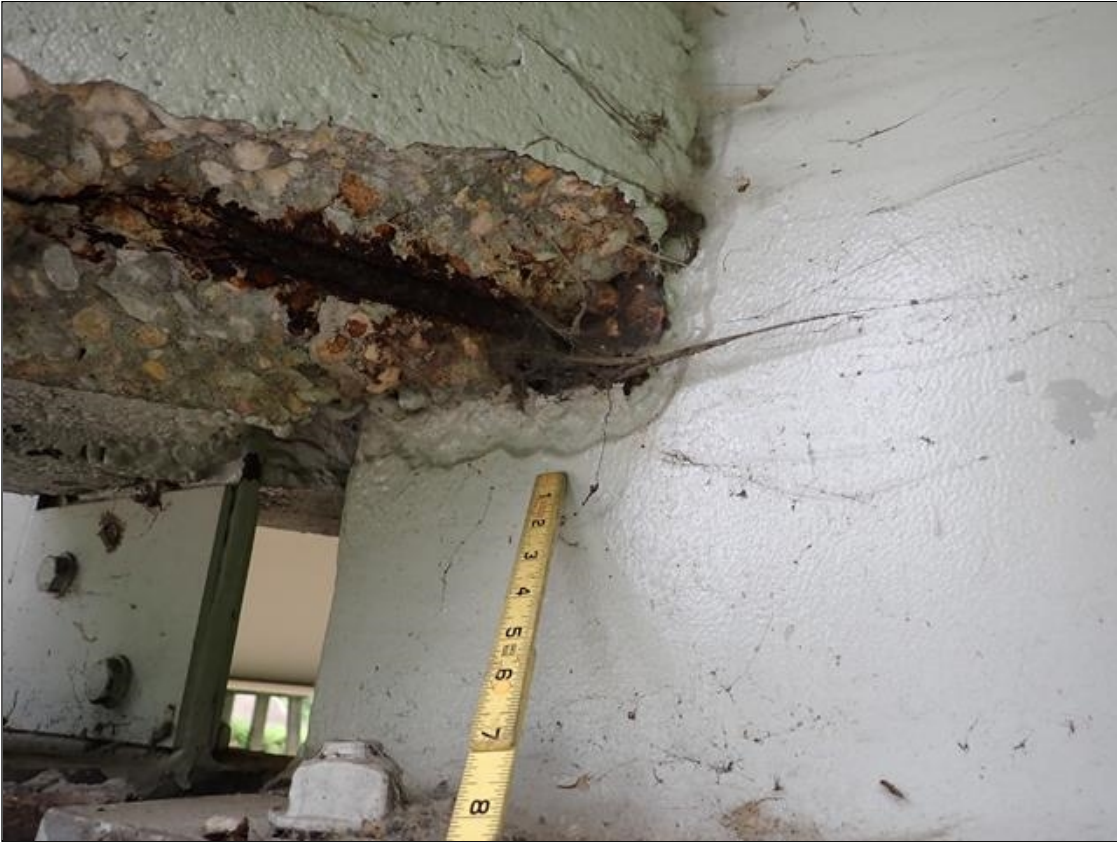
Span 4 Beam 1: (PAR) at bent 4, web adjacent to end diaphragm, painted over section loss (7/16 inch average remaining x 8 inch x 16 inch) with corrosion reactivating

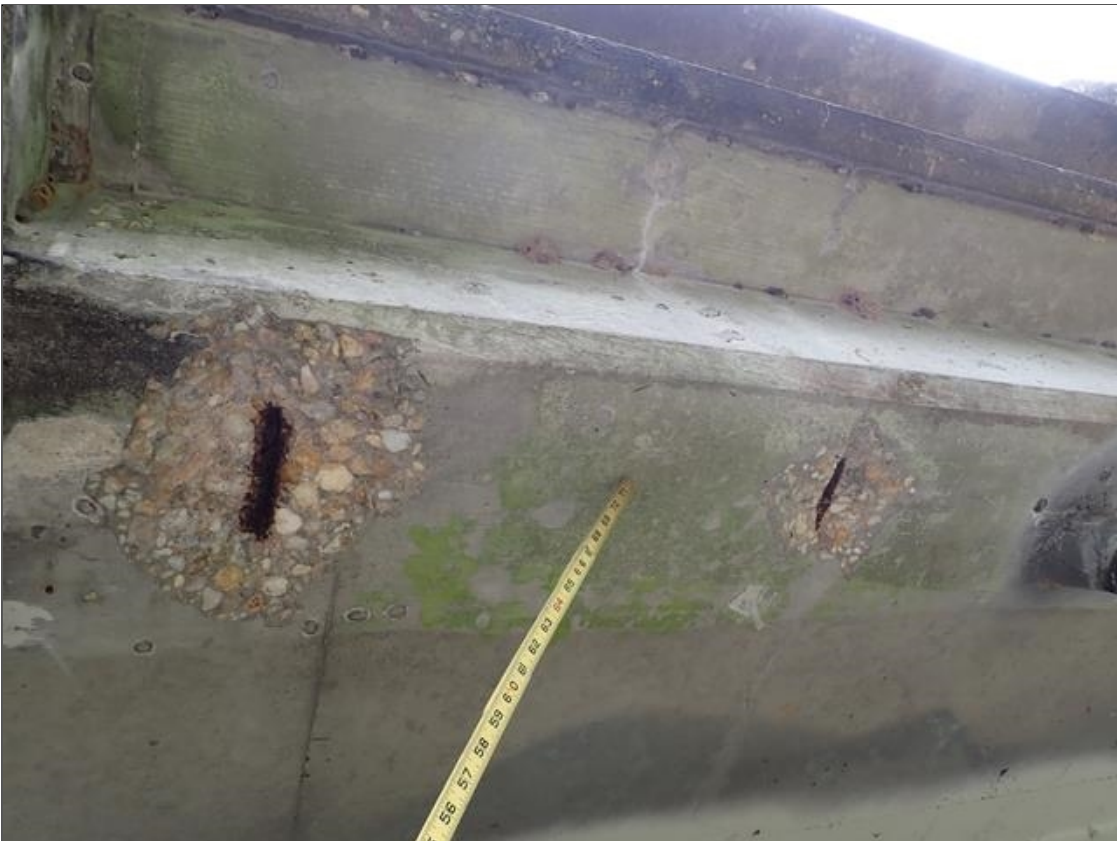
Span 4 Deck: (PAR) LEFT OVERHANG NEAR MIDSPAN 2 SPALLS WITH EXPOSED REBAR UP TO 10 INCHES DIAMETER X 1 INCH DEEP, 5 PERCENT SECTION LOSS.
