NC DEPARTMENT OF TRANSPORTATION
 DIVISION OF HIGHWAYS
 STRUCTURE MANAGEMENT UNIT
 COUNTY: JOHNSTON DIV: 4

ATTENTION: PARS Submitted Sign Notice Issued
 sketches revised; new repairs

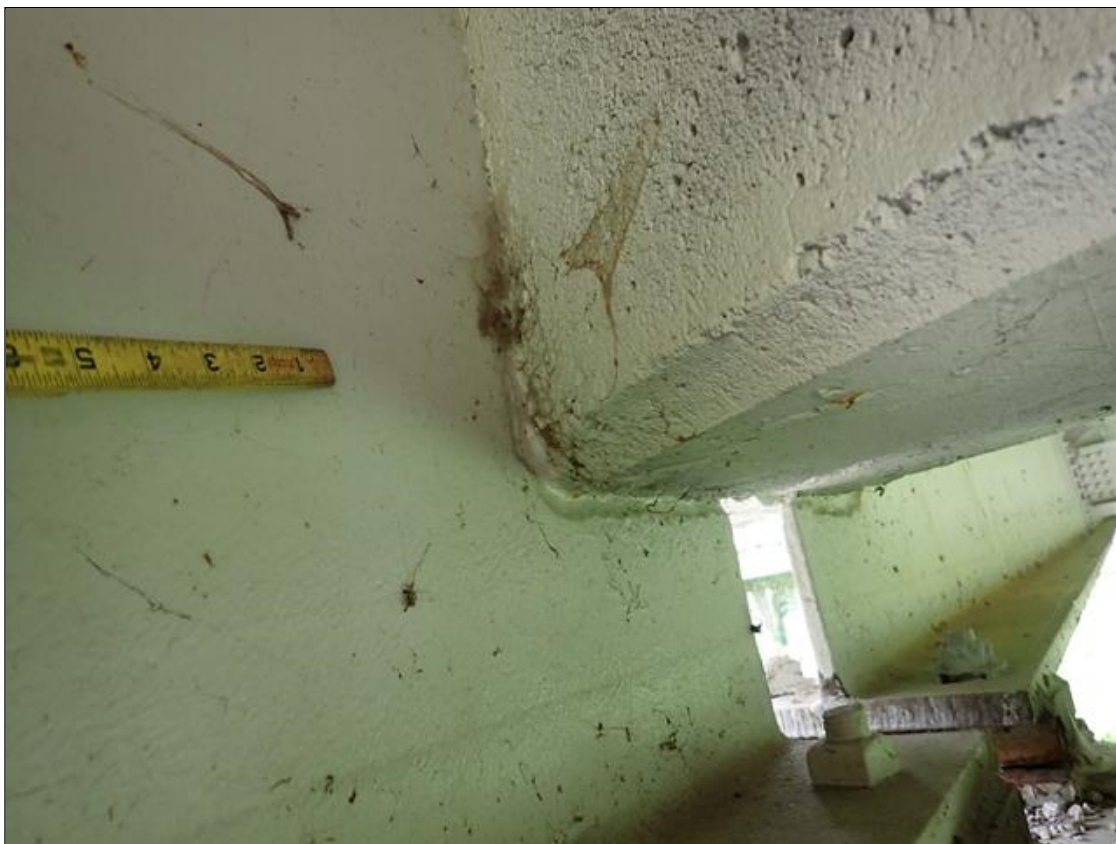
Span 4 Beam 4: (PAR) at bent 3, web adjacent to end diaphragm, painted over section loss (7/16 inch average remaining x 8 inch x 4 inch)

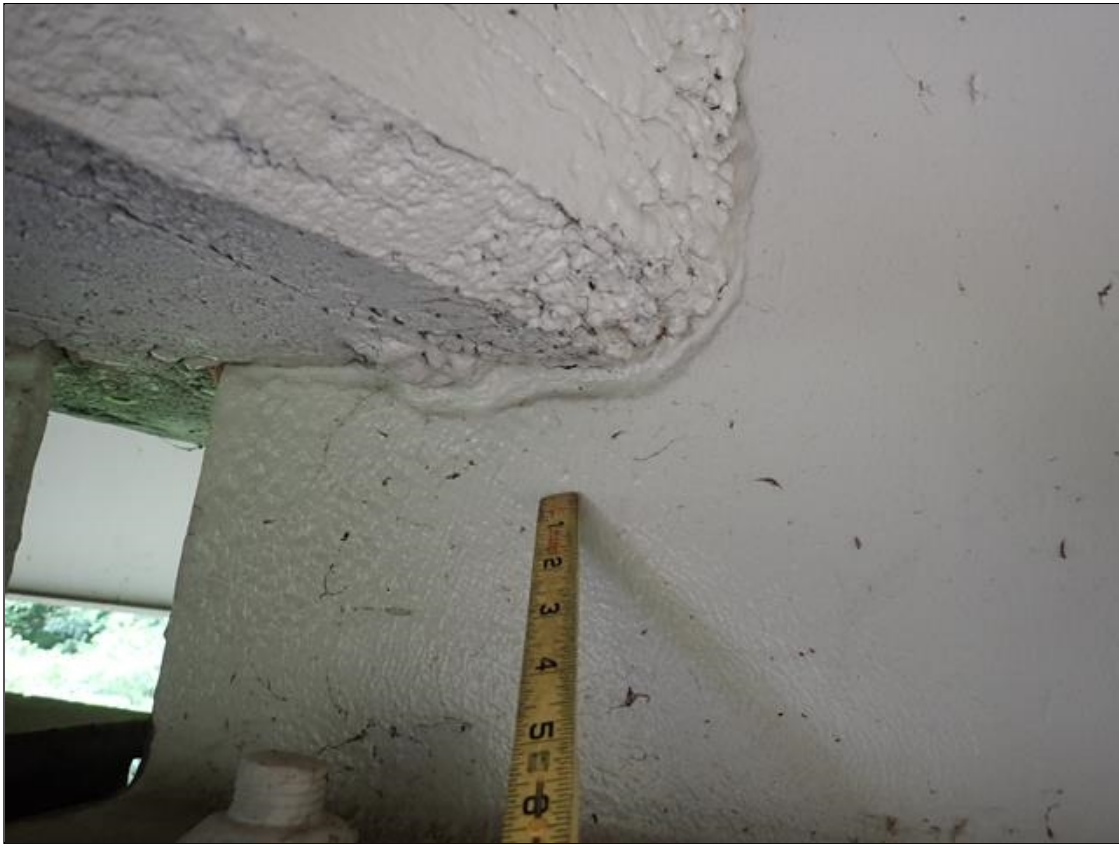
Span 4 Beam 2: (PAR) at bent 3, web adjacent to end diaphragm, painted over section loss (1/2 inch average remaining x 8 inch x 4 inch) with corrosion reactivating

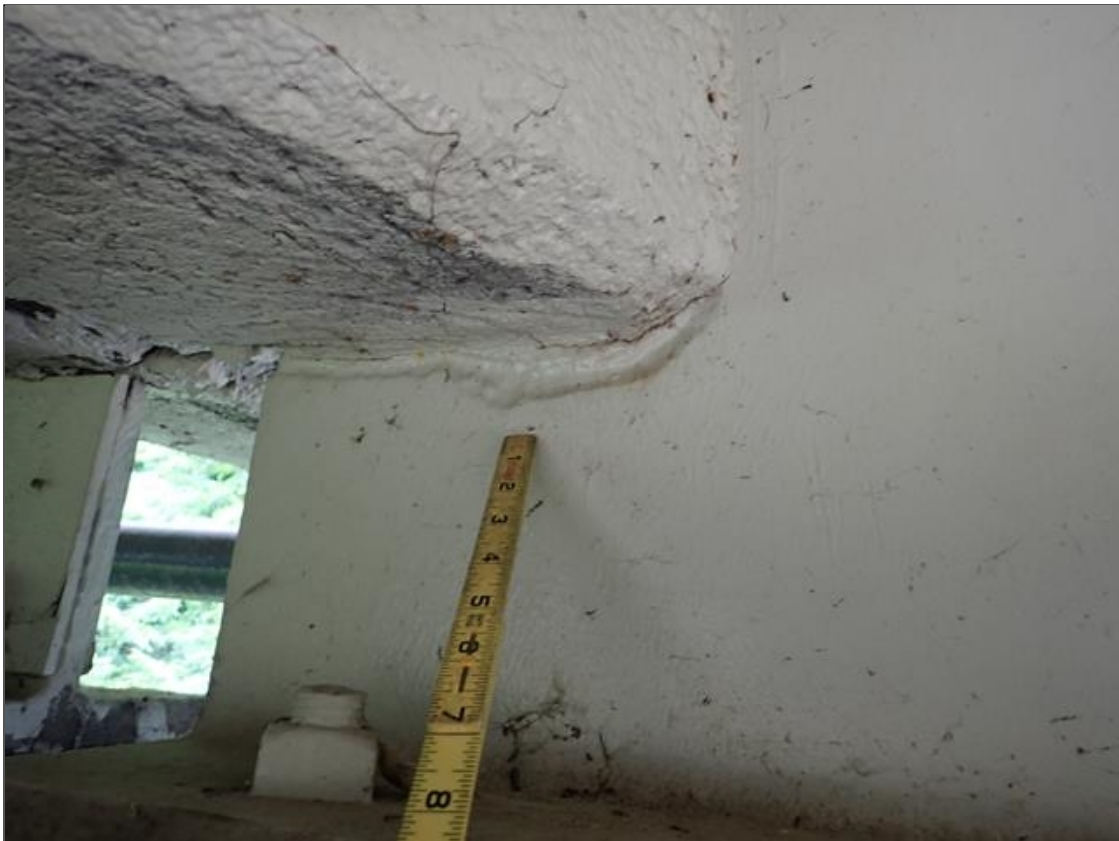
Span 4 Beam 1: (PAR) at bent 3, web adjacent to end diaphragm, painted over section loss (7/16 inch average remaining x 8 inch x 6 inch) with corrosion reactivating

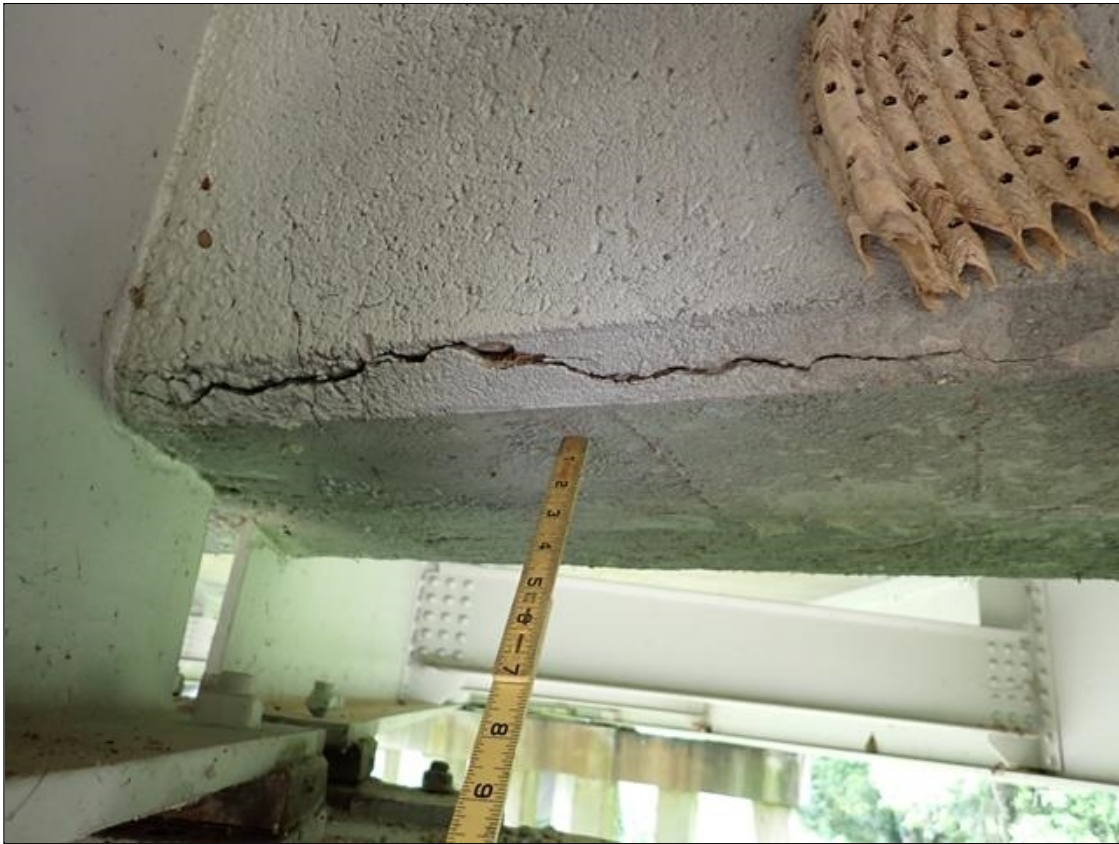
Span 4 Deck: bay 2 end diaphragm at bent 3, adjacent to beam 3, delamination (22 inch x 8) with crack (1/4 inch)

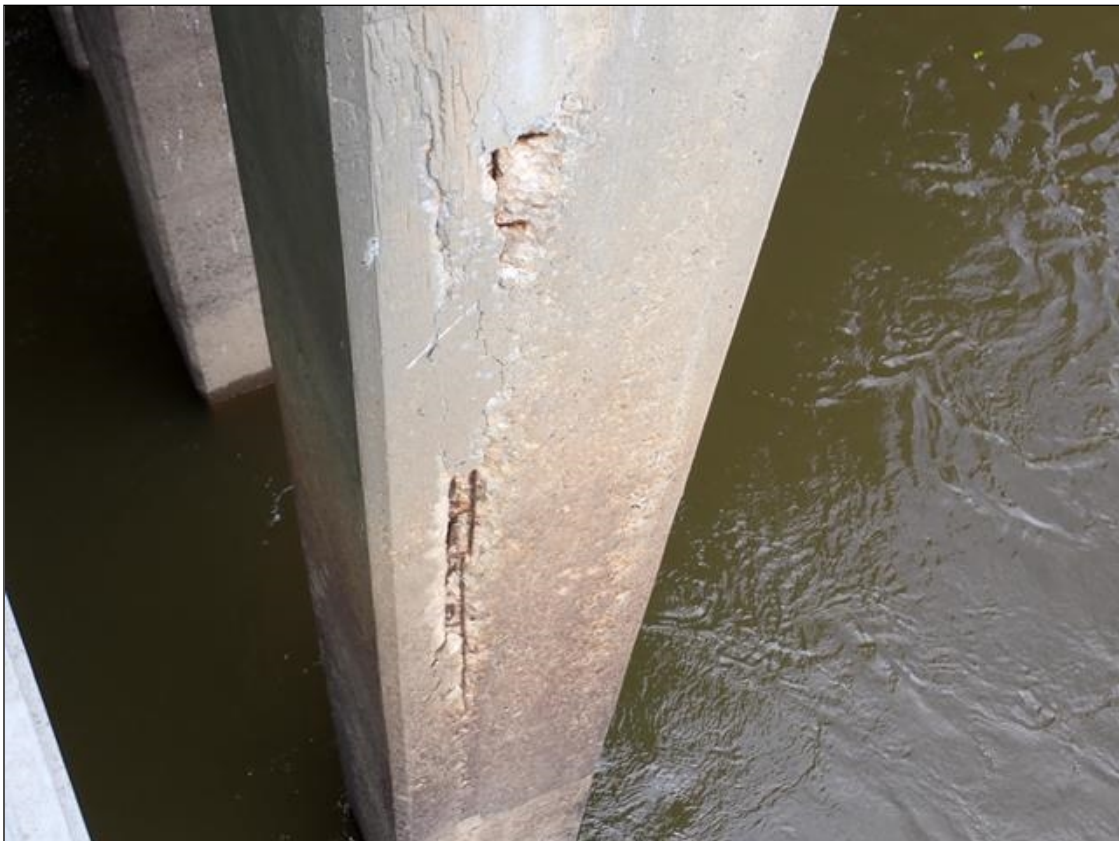
Bent 3 Pile 7: (PAR) starting at cap, east and south faces, delamination/spall (16 foot x 18 inch x 2 inch deep) with exposed rusted rebar (approximately 80 percent remaining) and cracks (up to 1/32 inch)

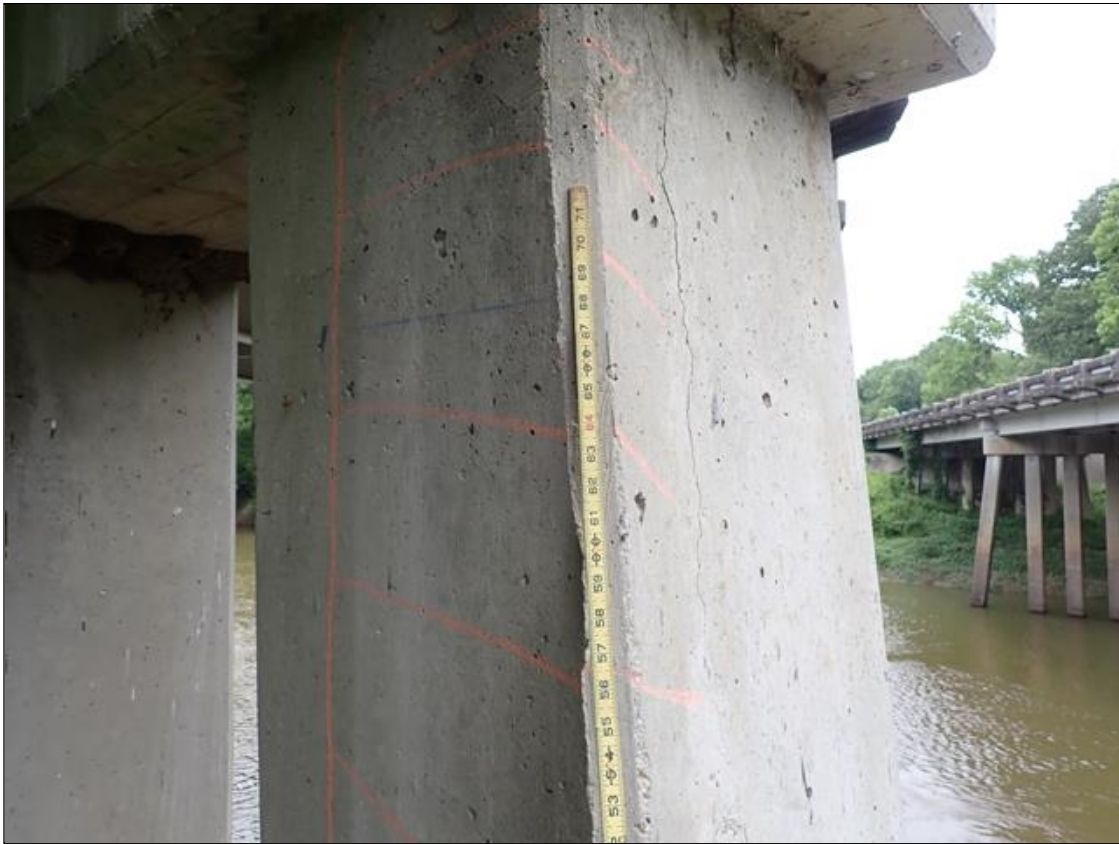
Bent 3 Pile 7: (PAR) starting at cap, east and south faces, delamination/spall (16 foot x 18 inch x 2 inch deep) with exposed rusted rebar (approximately 80 percent remaining) and cracks (up to 1/32 inch)

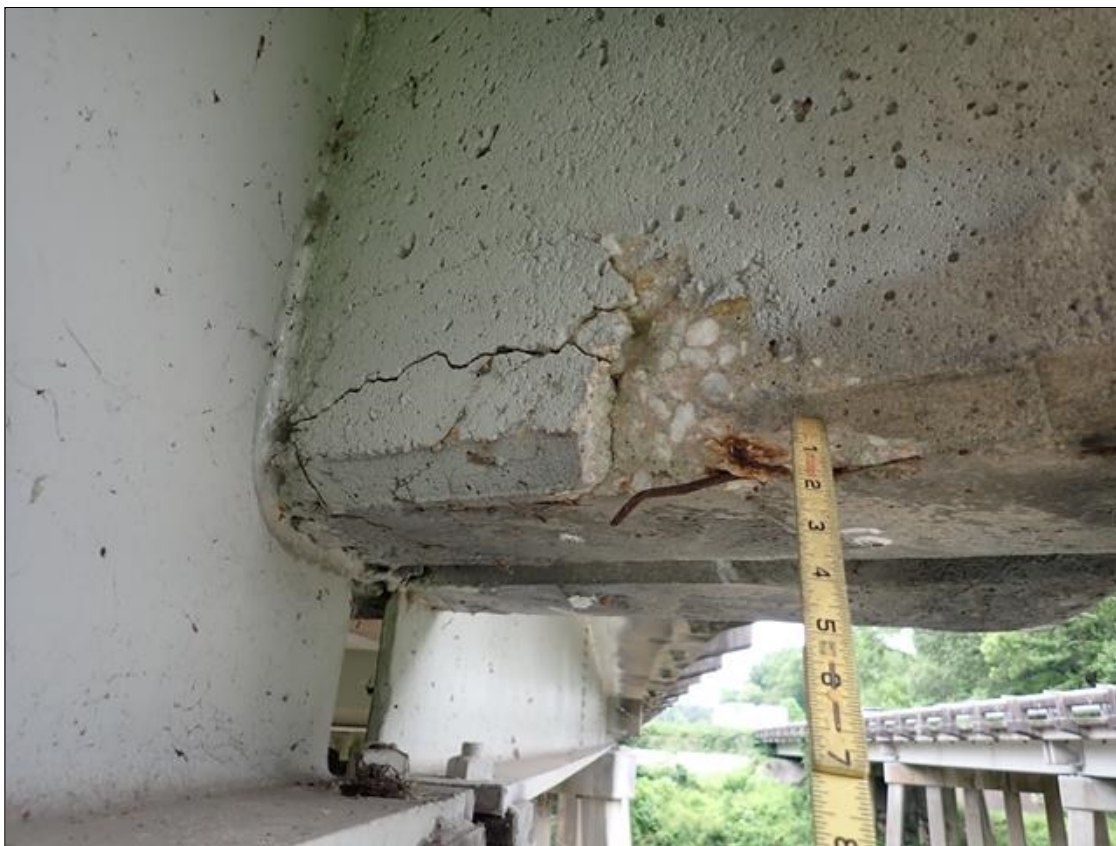
Span 3 Deck: 4 INCHES HIGH X 1 FOOT LONG AREA OF UNSOUND CONCRETE WITH SPALL 4 INCHES DIAMETER X 1 INCH DEEP WITH 1/8 INCH WIDE CRACKS AND EXPOSED STEEL IN END DIAPHRAGM AT BENT 3 UNDER RIGHT OVERHANG.

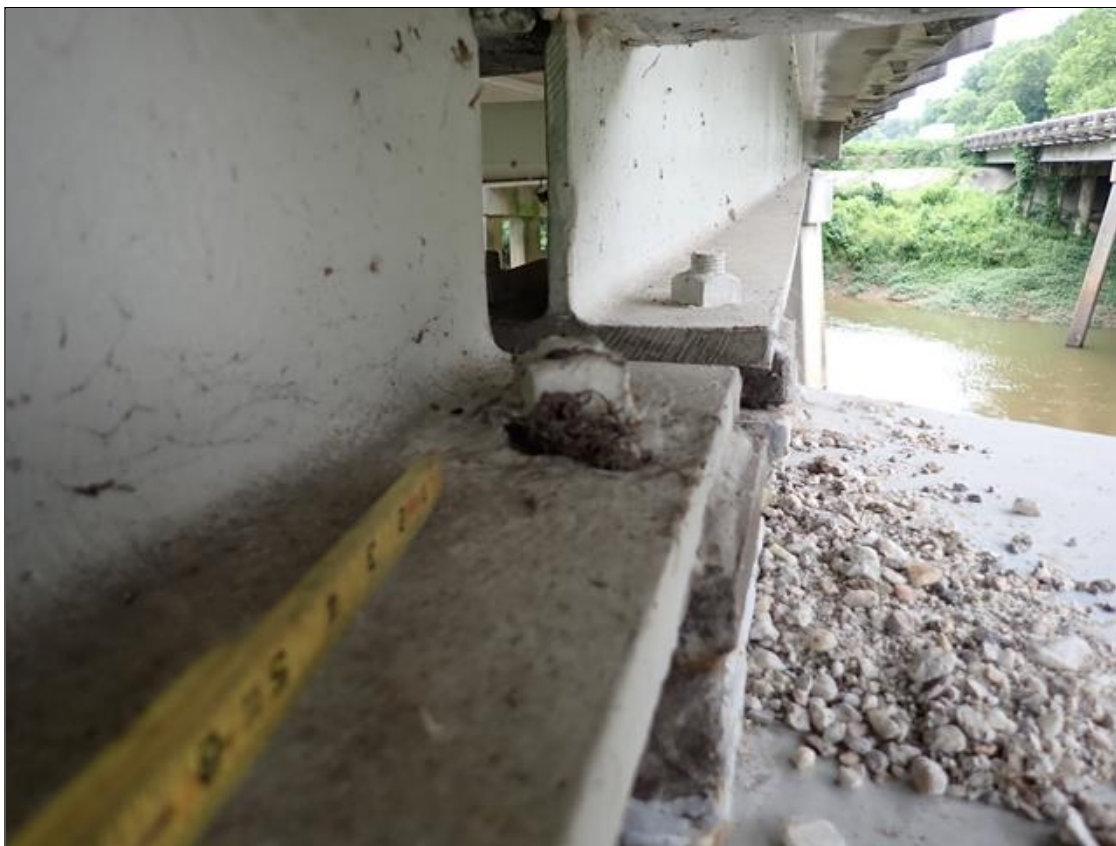
Span 3 Beam 4: (not found 2025) RIGHT ANCHOR BOLT NUT LOOSE.

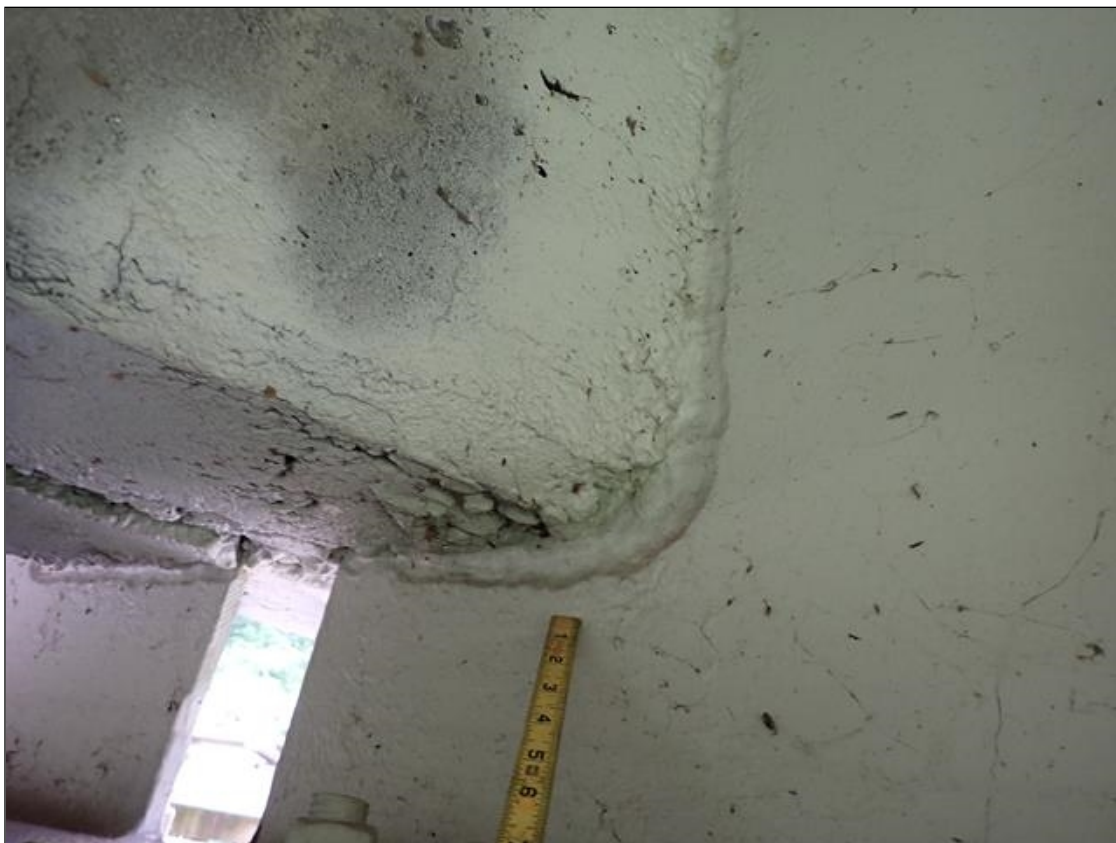
Span 3 Beam 4: (PAR) at bent 3, web adjacent to end diaphragm, painted over section loss (7/16 inch average remaining x 8 inch x 16 inch) with corrosion reactivating

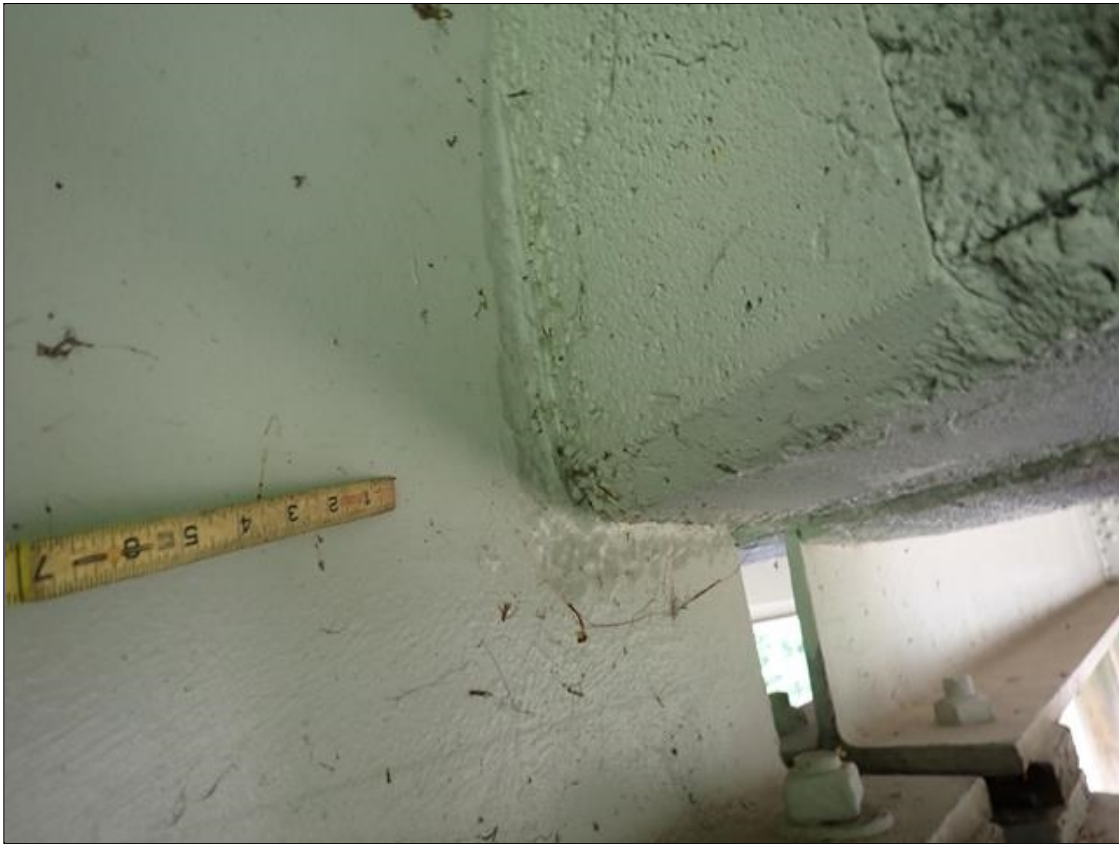
Span 3 Beam 3: (PAR) at bent 3, web adjacent to end diaphragm, painted over section loss (7/16 inch average remaining x 8 inch x 12 inch)

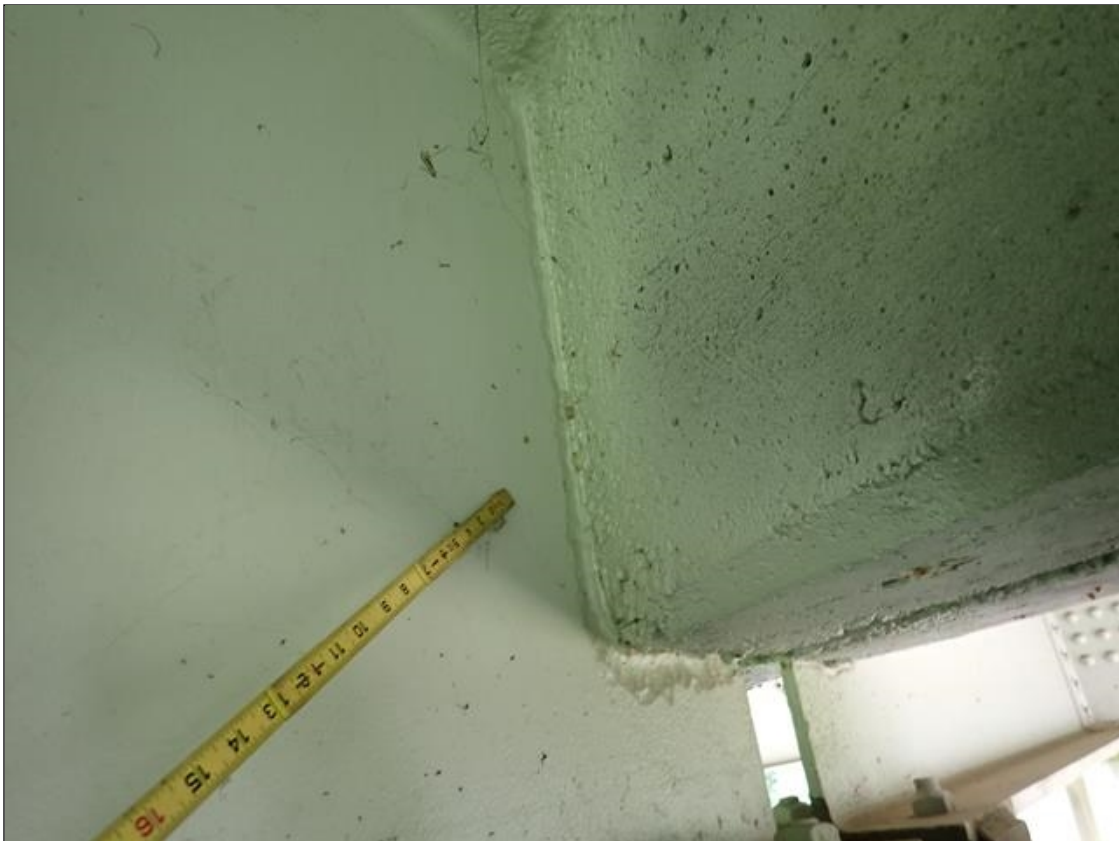
Span 3 Beam 2: (PAR) at bent 3, web adjacent to end diaphragm, painted over section loss (7/16 inch average remaining x 8 inch x 24 inch) with corrosion reactivating

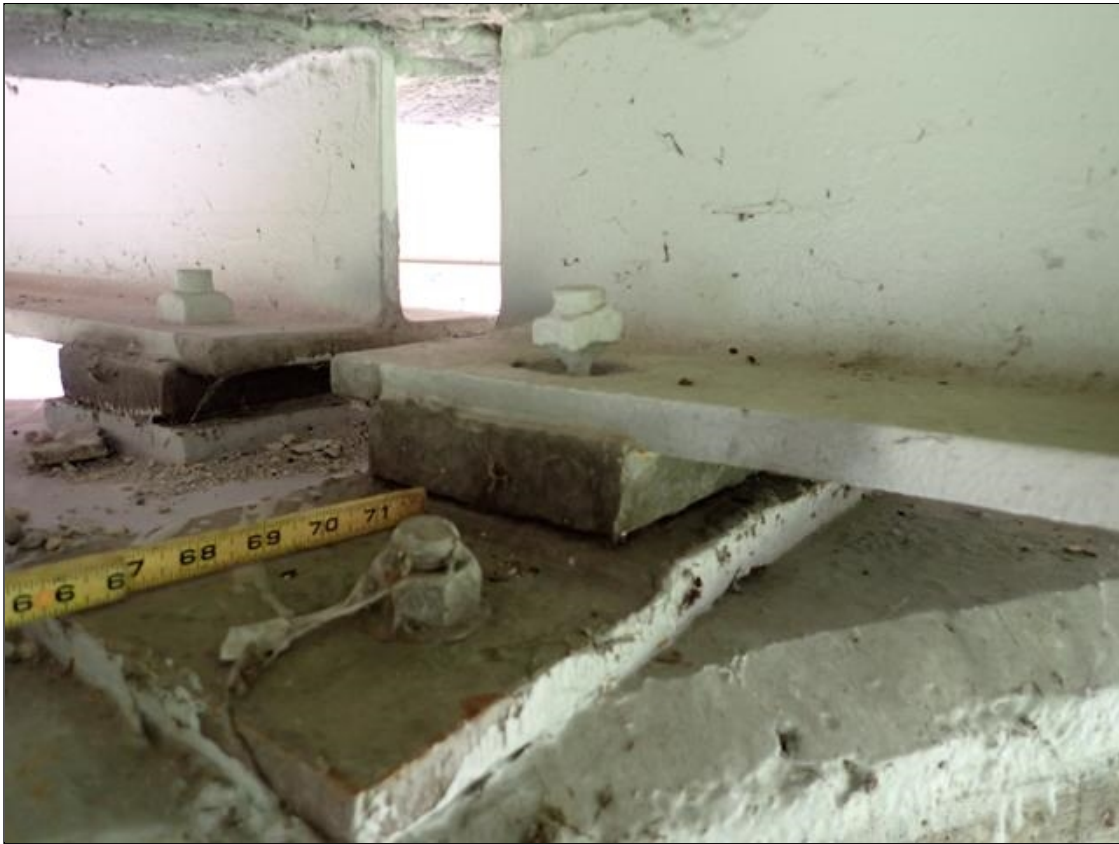
Span 3 Far Bearing 3: LEFT ANCHOR BOLT, PAINTED OVER SECTION LOSS (APPROXIMATELY 20 PERCENT REMAINING); WELDED REPAIR WITH NEW ANCHOR BOLT.

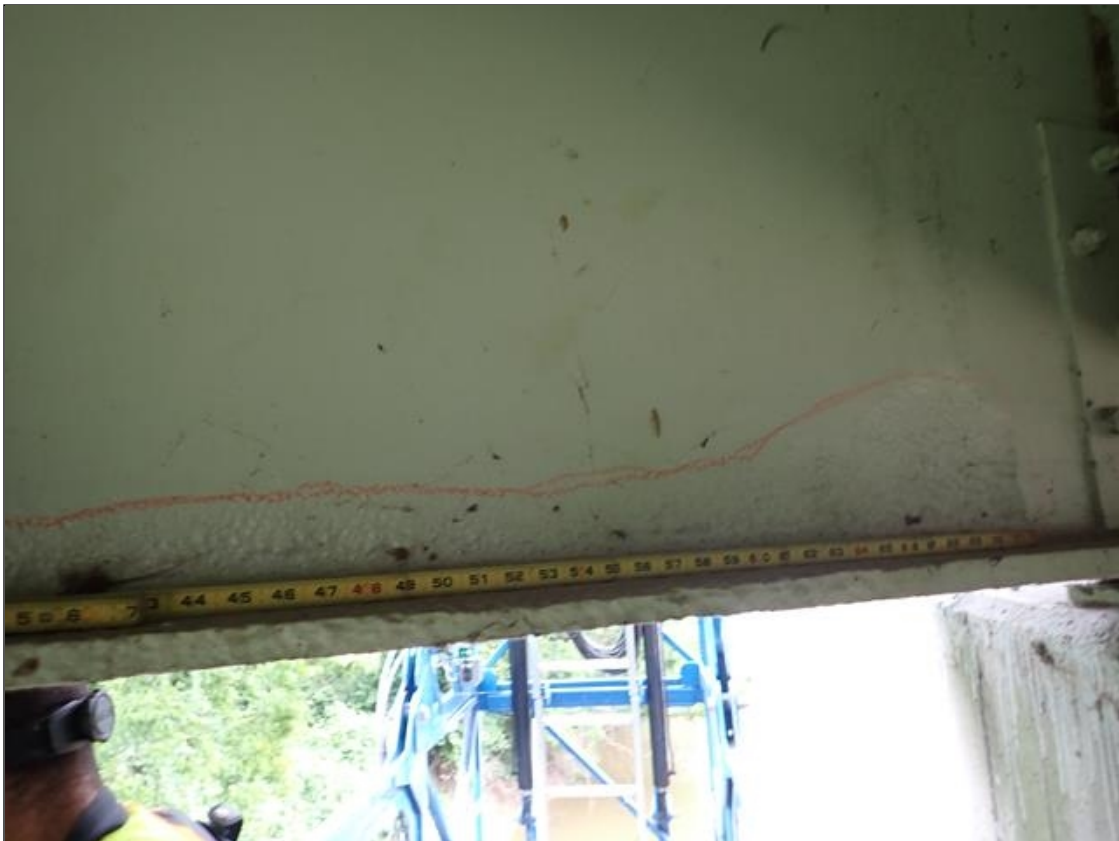
Span 3 Beam 1: (PAR) at bent 3, 2 foot from beam end, painted over section loss: lower web (1/2 inch average remaining remaining x 40 inch x 10 inch); bottom flange (0.87 inch x 40 inch)

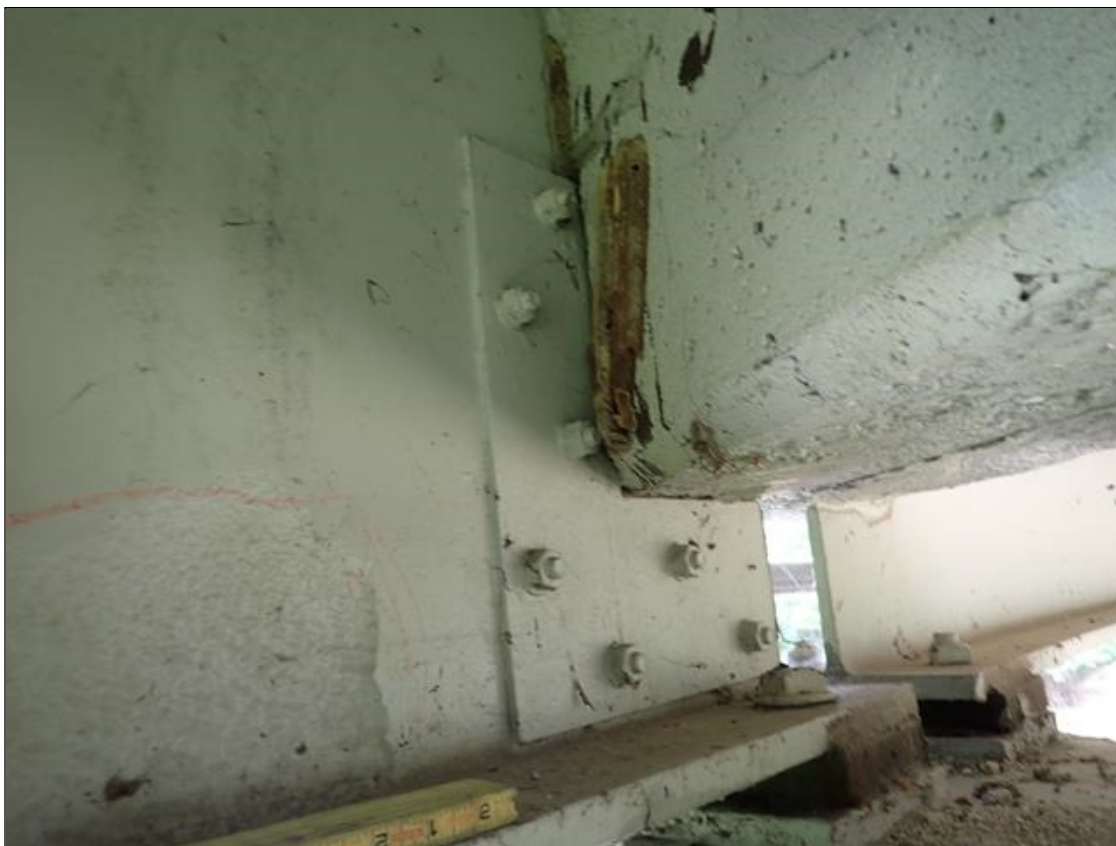
Span 3 Beam 1: at bent 3, web repair plate (3/8 inch thick x 18 inch x 15 inch)

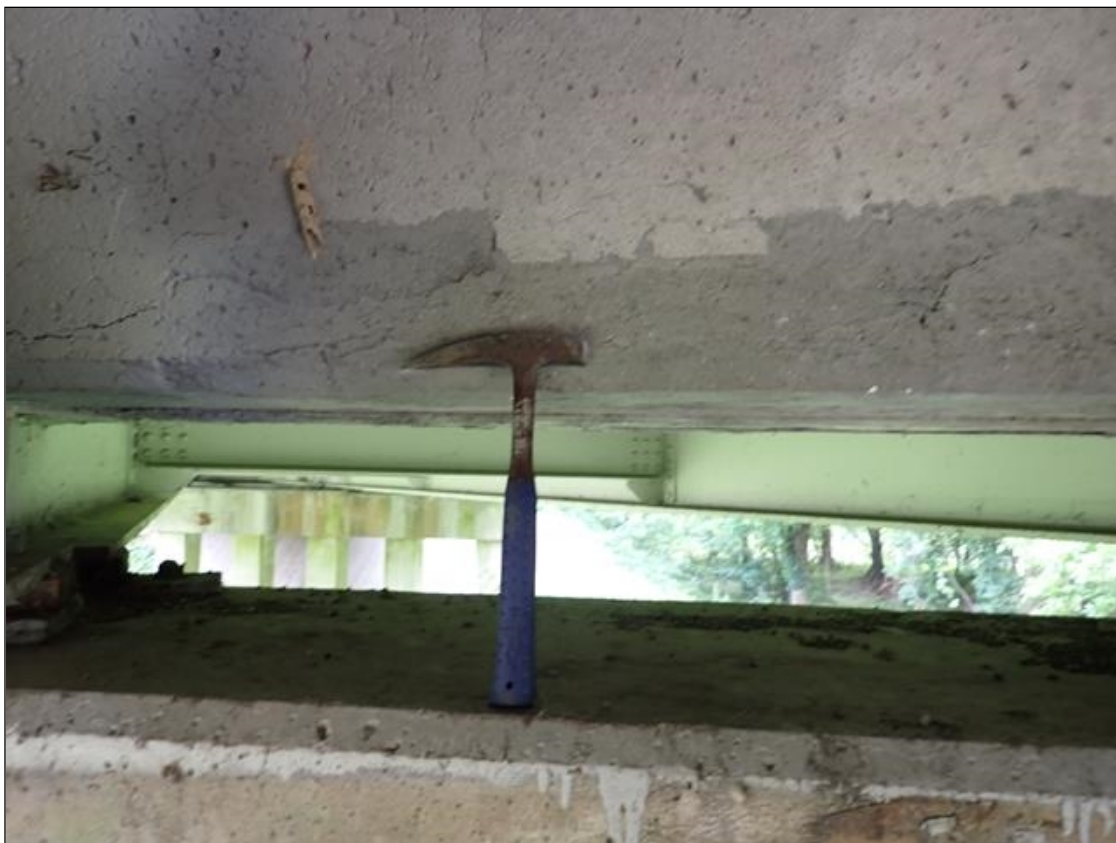
Span 3 Deck: 7 FEET LONG X 6 INCHES HIGH UNSOUND CONCRETE PATCH IN BAY 2 END DIAPHRAGM, AT BENT 2.

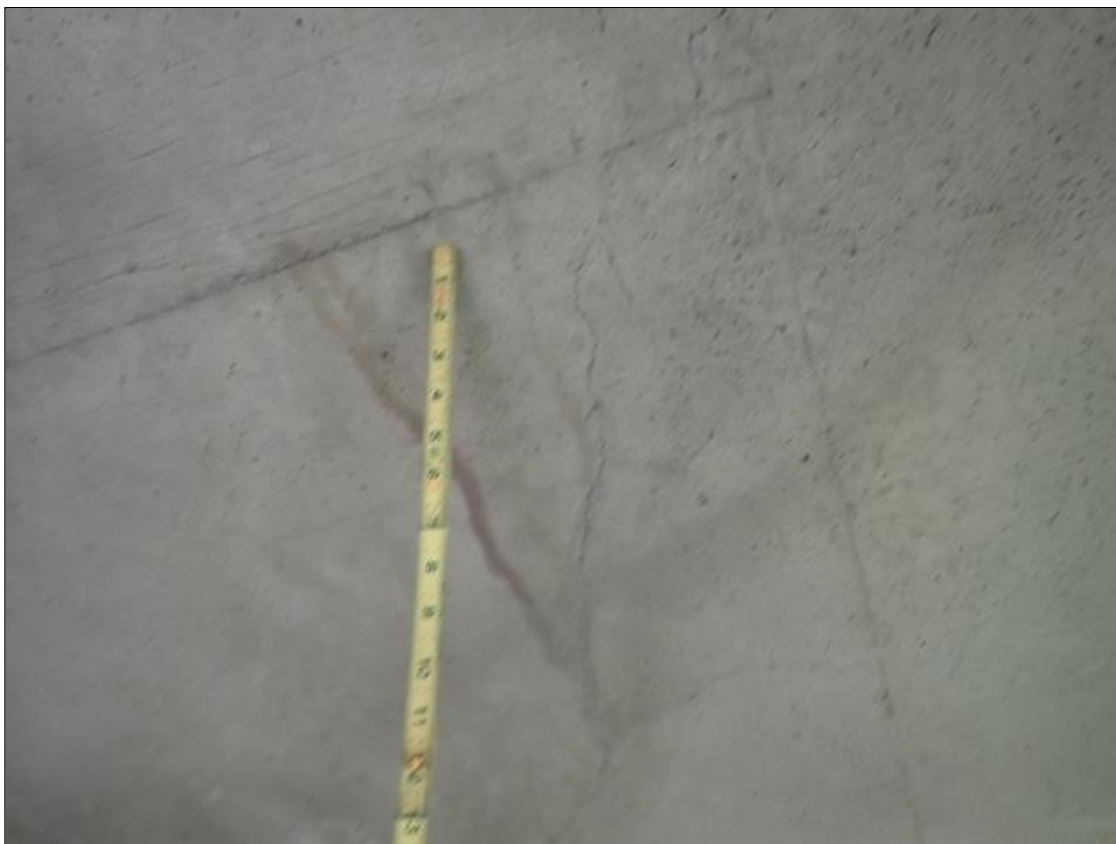
Span 3 Deck: 7 FEET LONG X 1/64 INCH WIDE DIAGONAL CRACK WITH EFFLORESCENCE IN UNDERSIDE OF DECK, BAY 3 AT BENT 2.

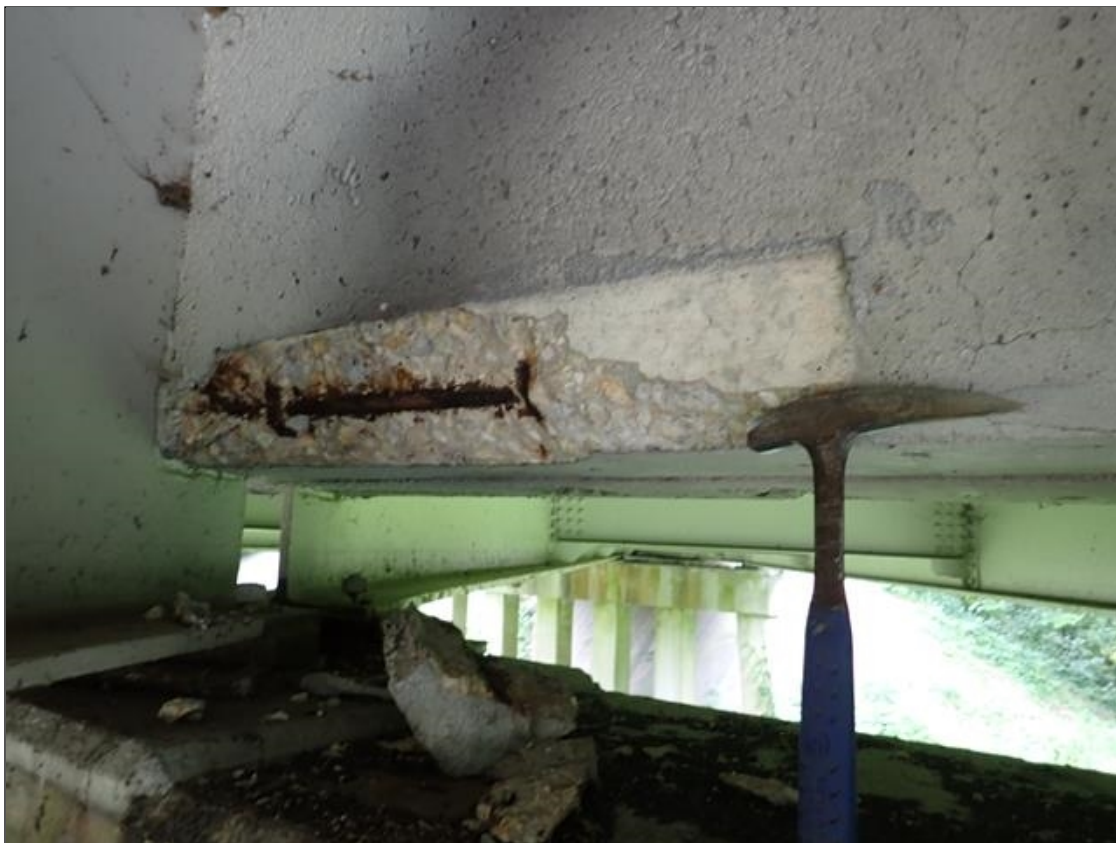
Span 3 Deck: (PAR) BAY 1 NEAR DIAPHRAGM ADJACENT TO BEAM 2, SPALL WITH EXPOSED REBAR 3 FEET X 5 INCHES X 3 INCH DEEP, 5 PERCENT SECTION LOSS.

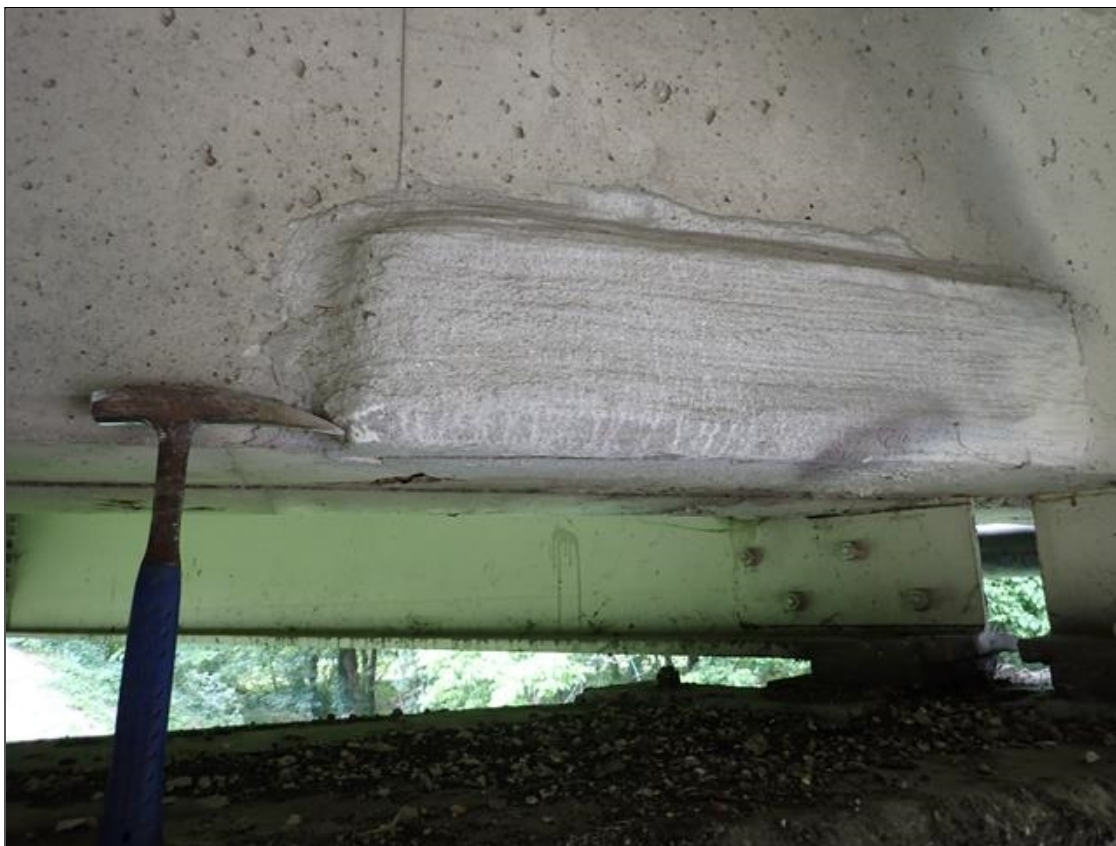
Span 3 Deck: 3 FEET LONG X 1 FOOT HIGH UNSOUND CONCRETE PATCH, BAY 1 END DIAPHRAGM, AT BENT 2.

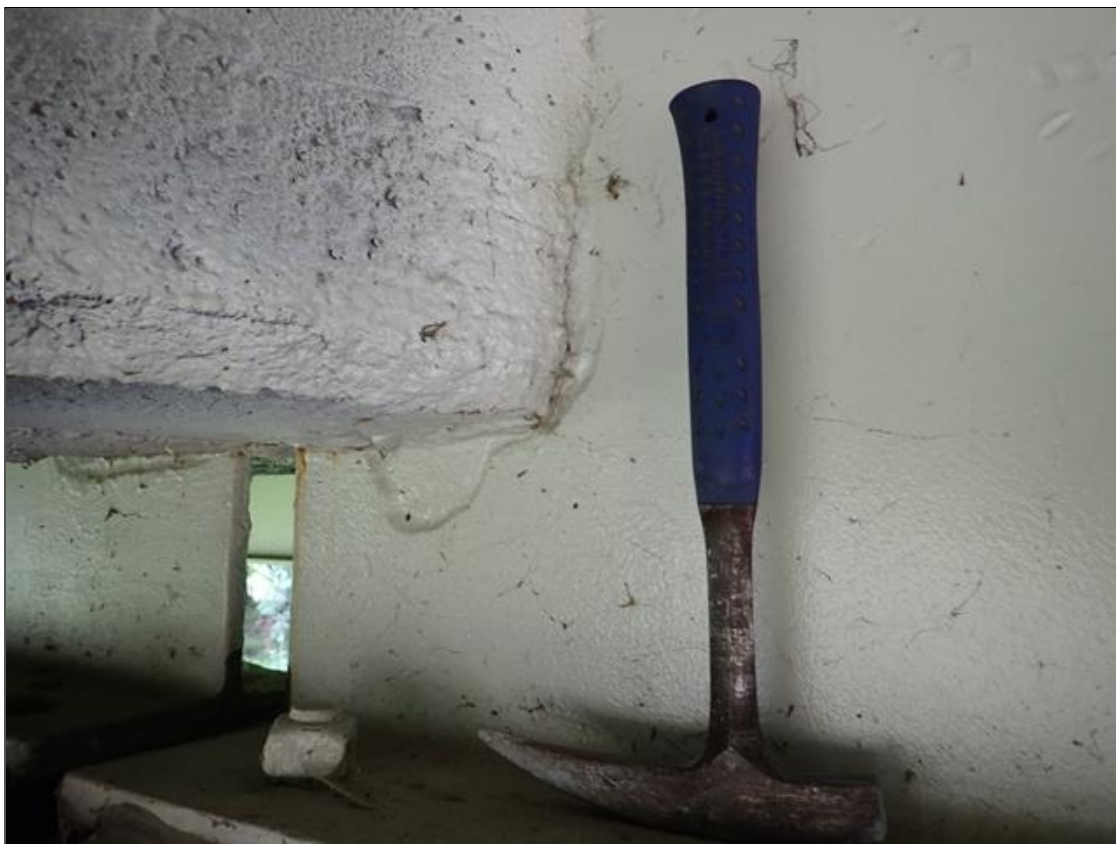
Span 3 Beam 2: (PAR) at bent 2, web adjacent to end diaphragm, painted over section loss (1/2 inch average remaining x 8 inch x 4 inch) with corrosion reactivating

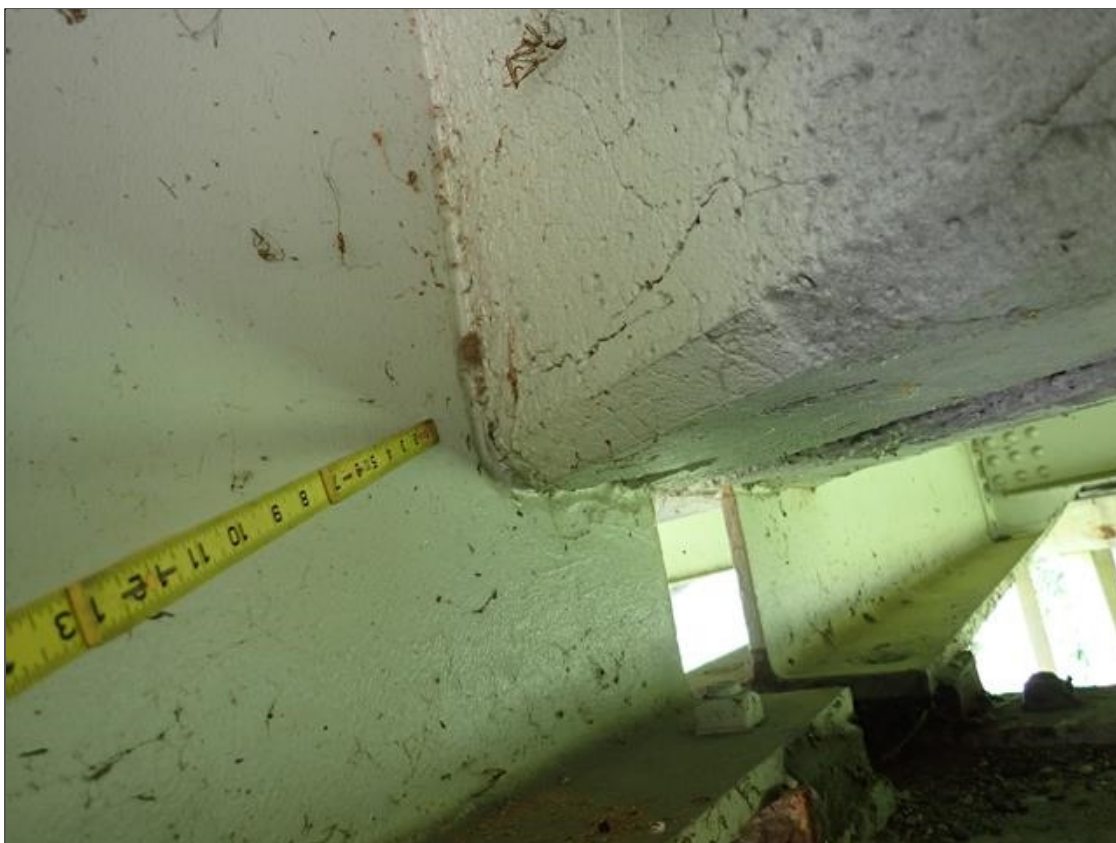
Span 3 Beam 3: (PAR) at bent 2, web adjacent to end diaphragm, painted over section loss (7/16 inch average remaining x 4 inch x 8 inch) with corrosion reactivating

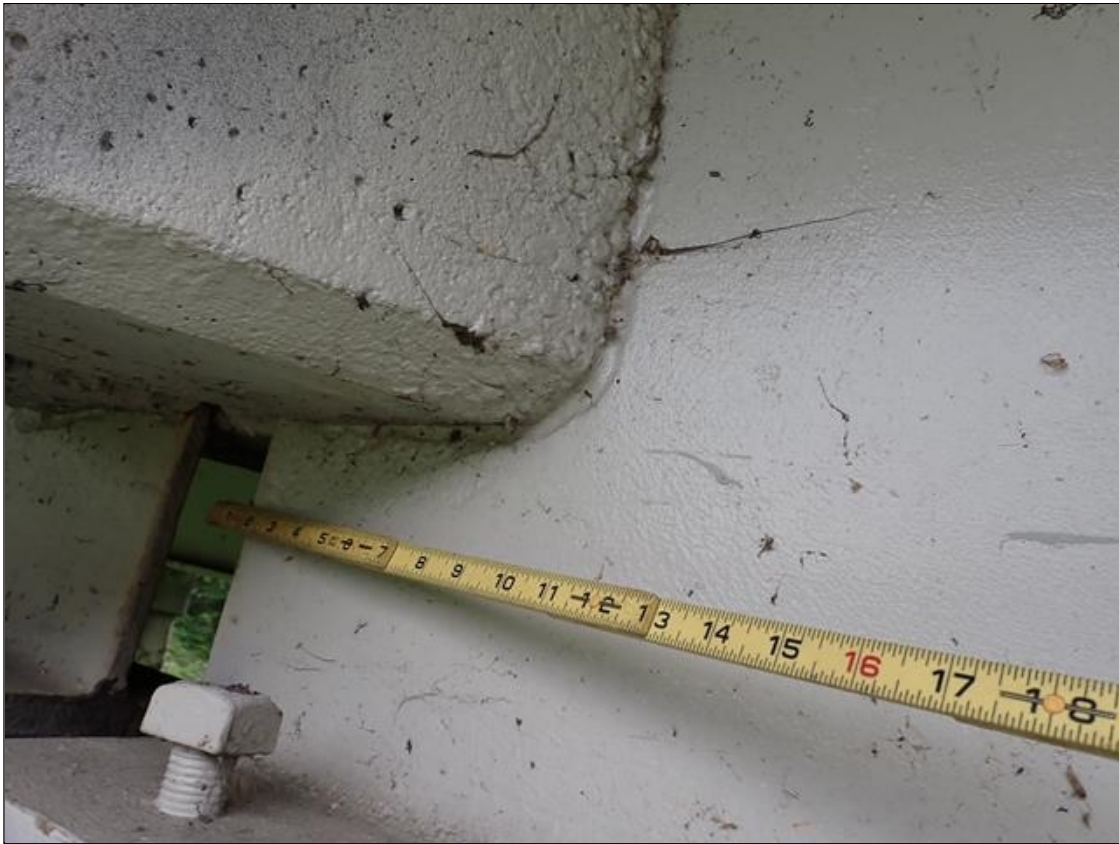
Span 3 Beam 4: (PAR) at bent 2, web adjacent to end diaphragm, painted over section loss (7/16 inch average remaining x 8 inch x 4 inch) with corrosion reactivating

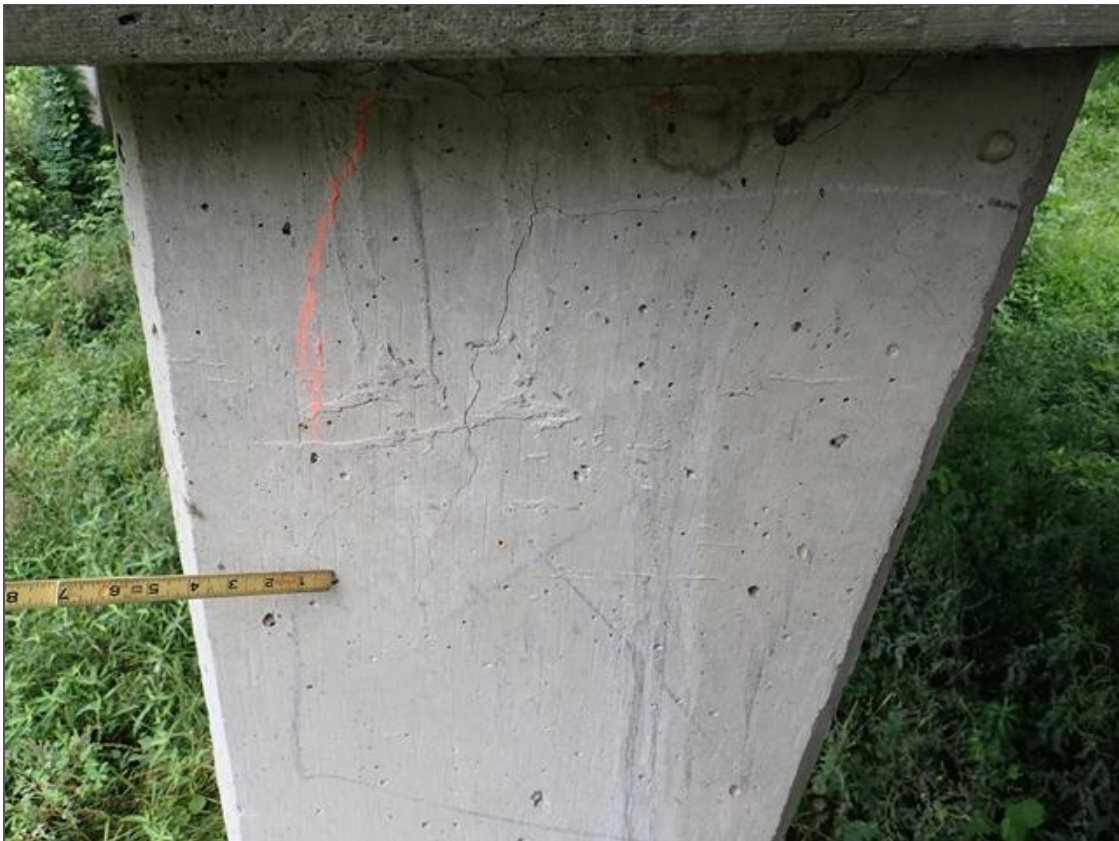
Bent 2 Pile 7: north face at top, delamination (26 inch x 18 inch) with crack (up to 1/64 inch)

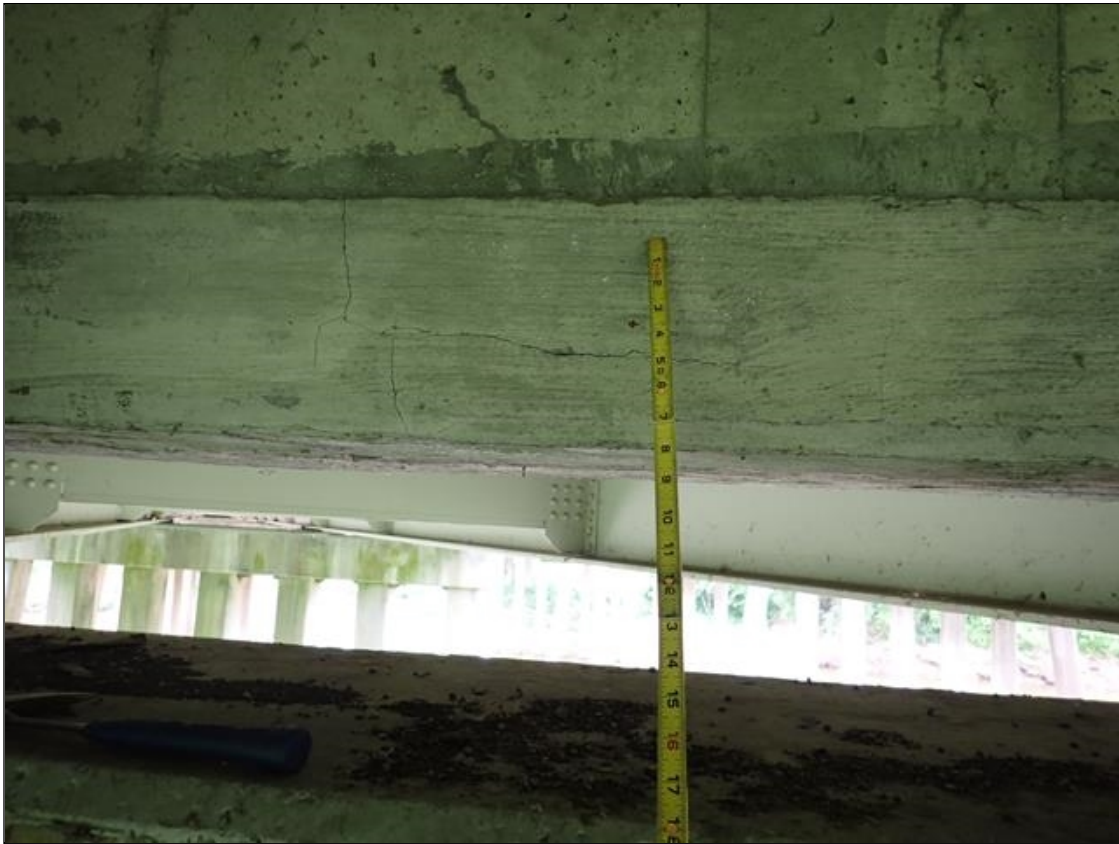
Span 2 Deck: 9 FEET LONG X 1 FOOT HIGH CONCRETE PATCH, BAY 2 END DIAPHRAGM, AT BENT 2. PATCH EXHIBITS UP TO 1/8 INCH WIDE X 5 FEET LONG CRACK IN THE BOTTOM FACE WITH A 5 FEET LONG X 5 INCHES WIDE UNSOUND CONCRETE AND UP TO 0.02 INCH WIDE VERTICAL CRACKS IN FRONT FACE, SCATTERED.
