NC DEPARTMENT OF TRANSPORTATION
 DIVISION OF HIGHWAYS
 STRUCTURE MANAGEMENT UNIT
 COUNTY: JOHNSTON DIV: 4

ATTENTION: PARS Submitted Sign Notice Issued
 sketches revised; new repairs

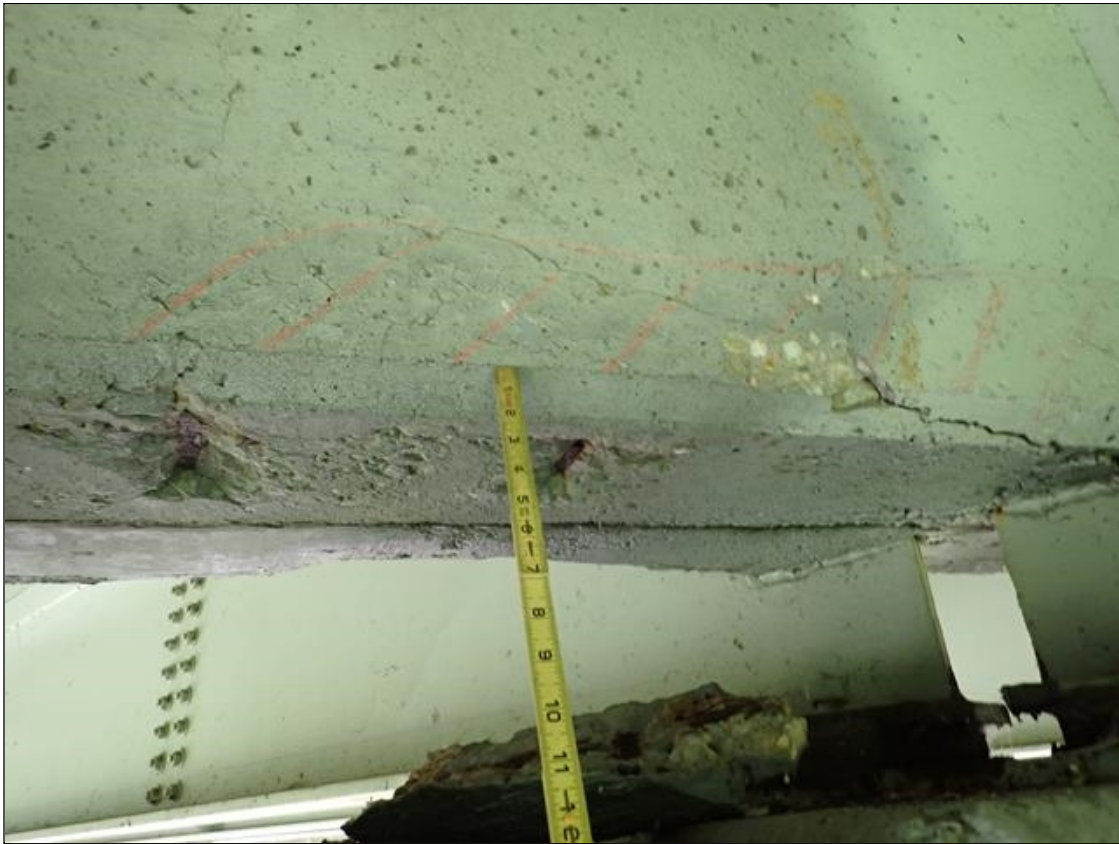
Span 2 Deck: THREE (3) 6 INCHES DIAMETER X 3/4 INCH DEEP SPALLS WITH EXPOSED REINFORCING AND AREA OF DELAMINATION 3 FEET X 7 INCHES, UNDERSIDE AND FACE OF BAY 1 END DIAPHRAGM, AT BENT 2.

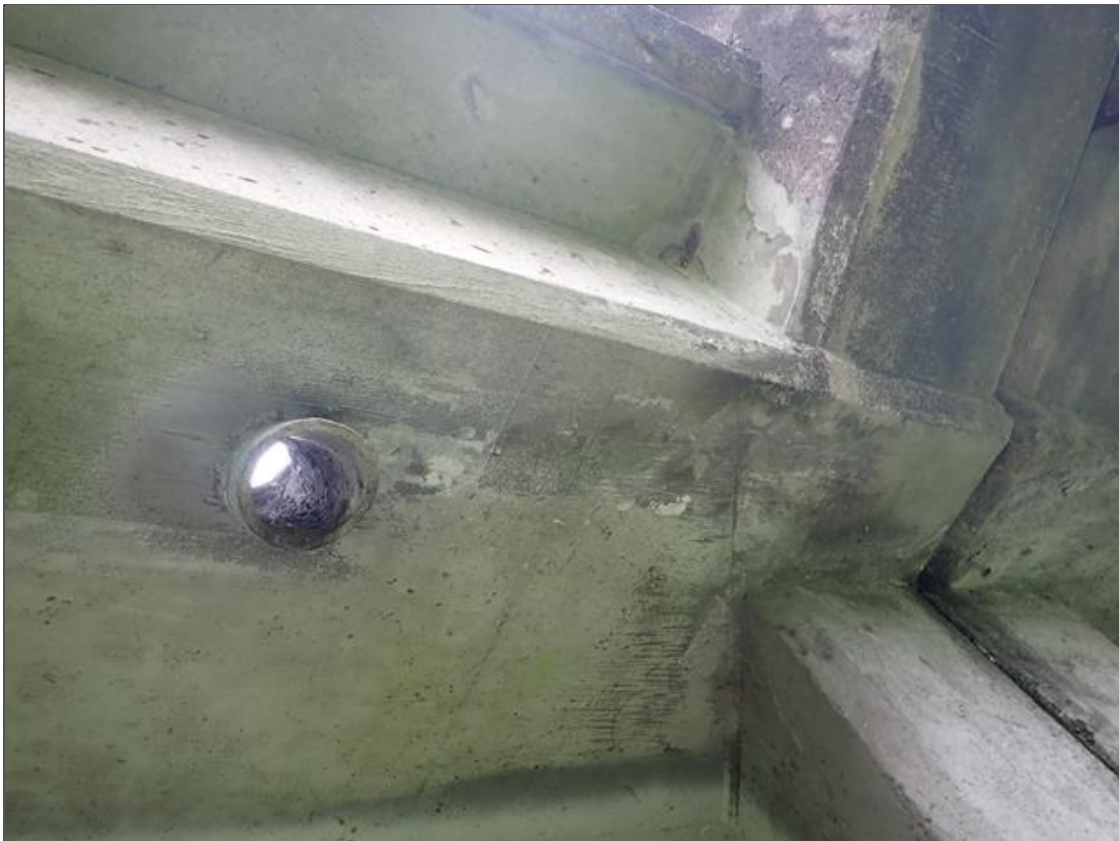
Span 2 Deck: 1 FOOT WIDE X 2 FEET HIGH SOUND CONCRETE PATCH IN DIAPHRAGM OUTSIDE OF BEAM 4 AT BENT 2.

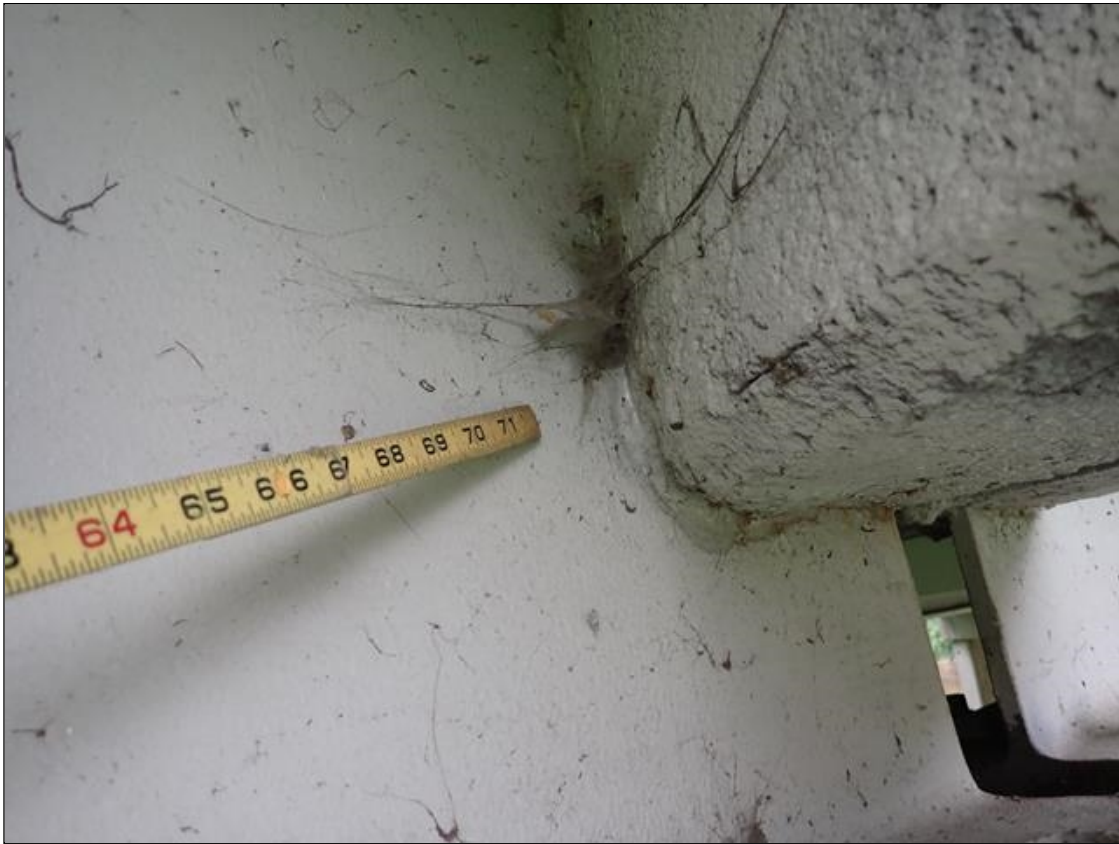
Span 2 Beam 4: (PAR) at bent 2, web adjacent to end diaphragm, painted over section loss (1/2 inch average remaining x 4 inch x 15 inch) with corrosion reactivating

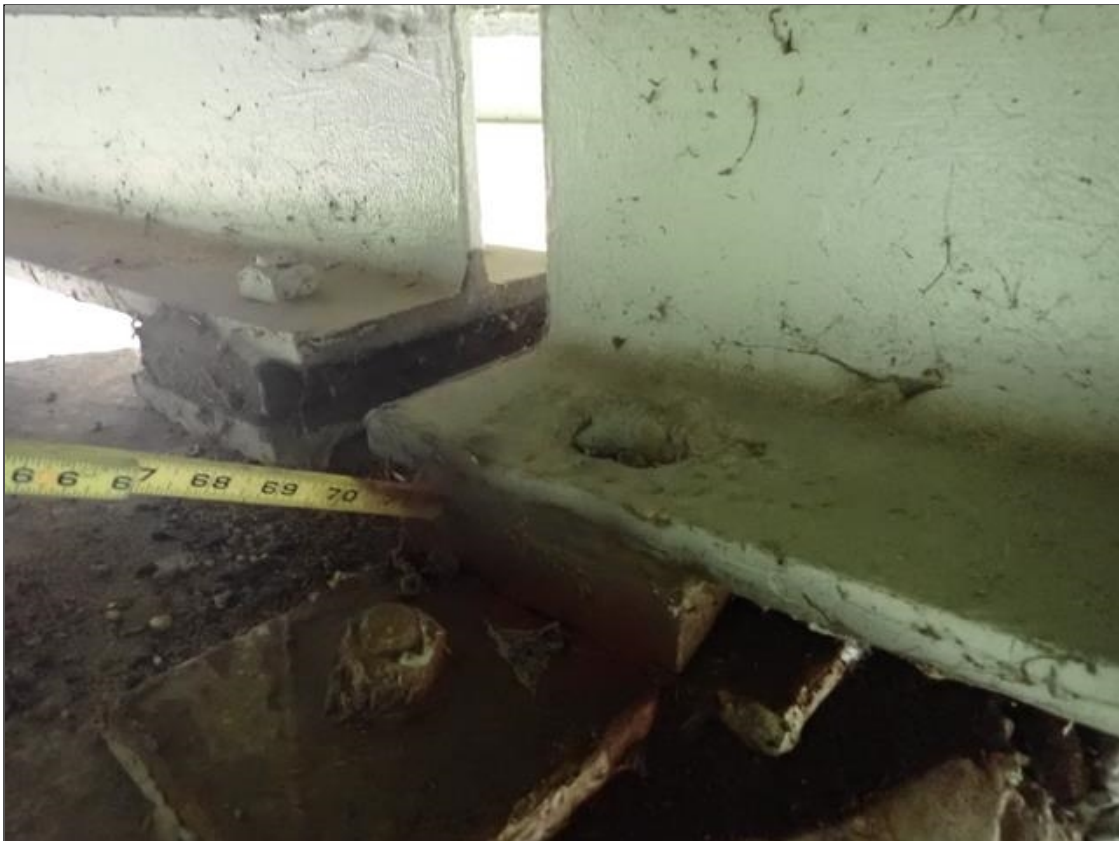
Span 2 Far Bearing 3: BOTH ANCHOR BOLTS, MISSING; WELDED BEARING REPAIR WITH ANCHOR ROD.

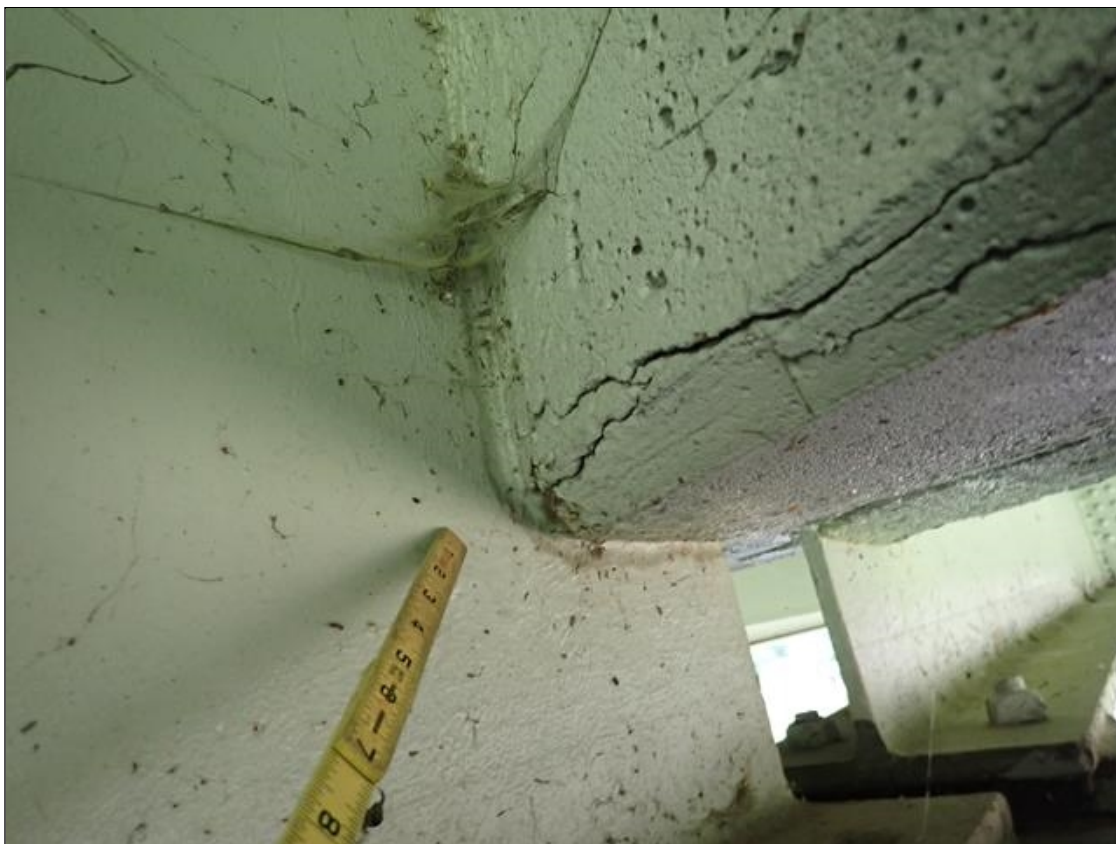
Span 2 Beam 3: (PAR) at bent 2, web adjacent to end diaphragm, painted over section loss (1/2 inch average remaining x 5 inch x 8 inch)

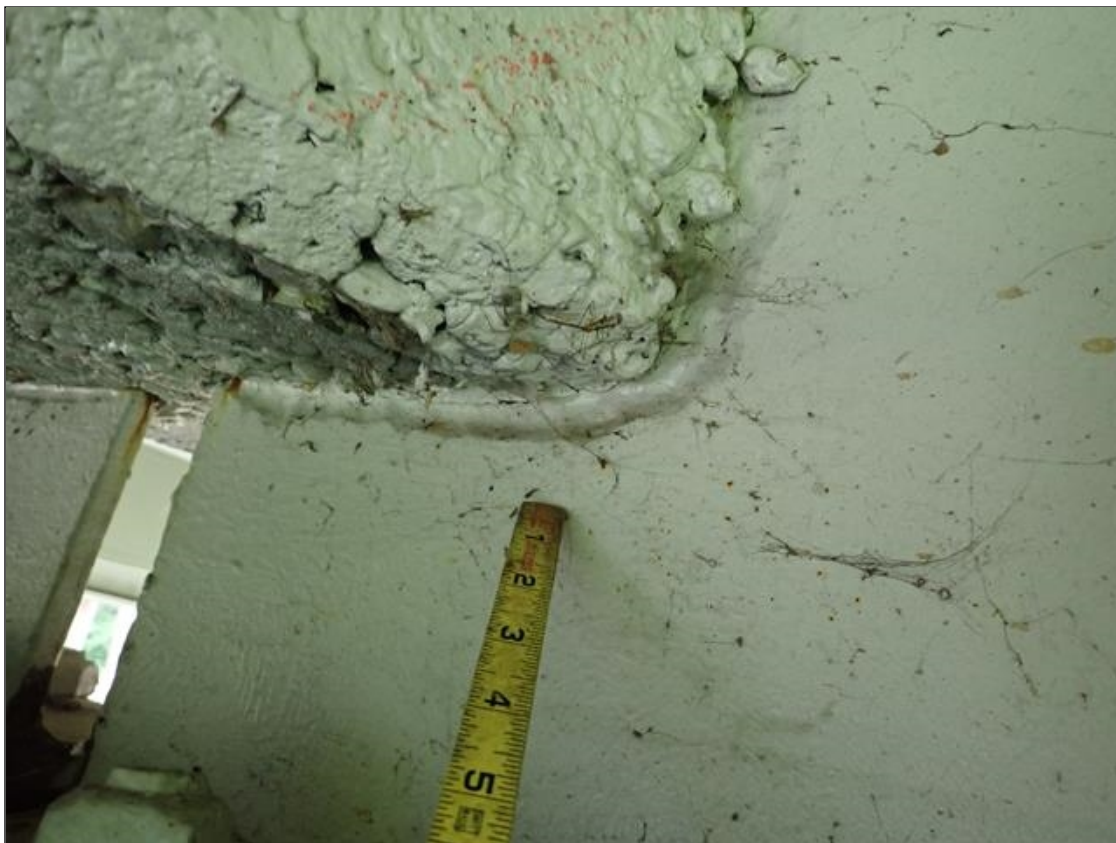
Span 2 Beam 2: (PAR) at bent 2, web adjacent to end diaphragm, painted over section loss (7/16 inch average remaining x 8 inch x 9 inch) with corrosion reactivating

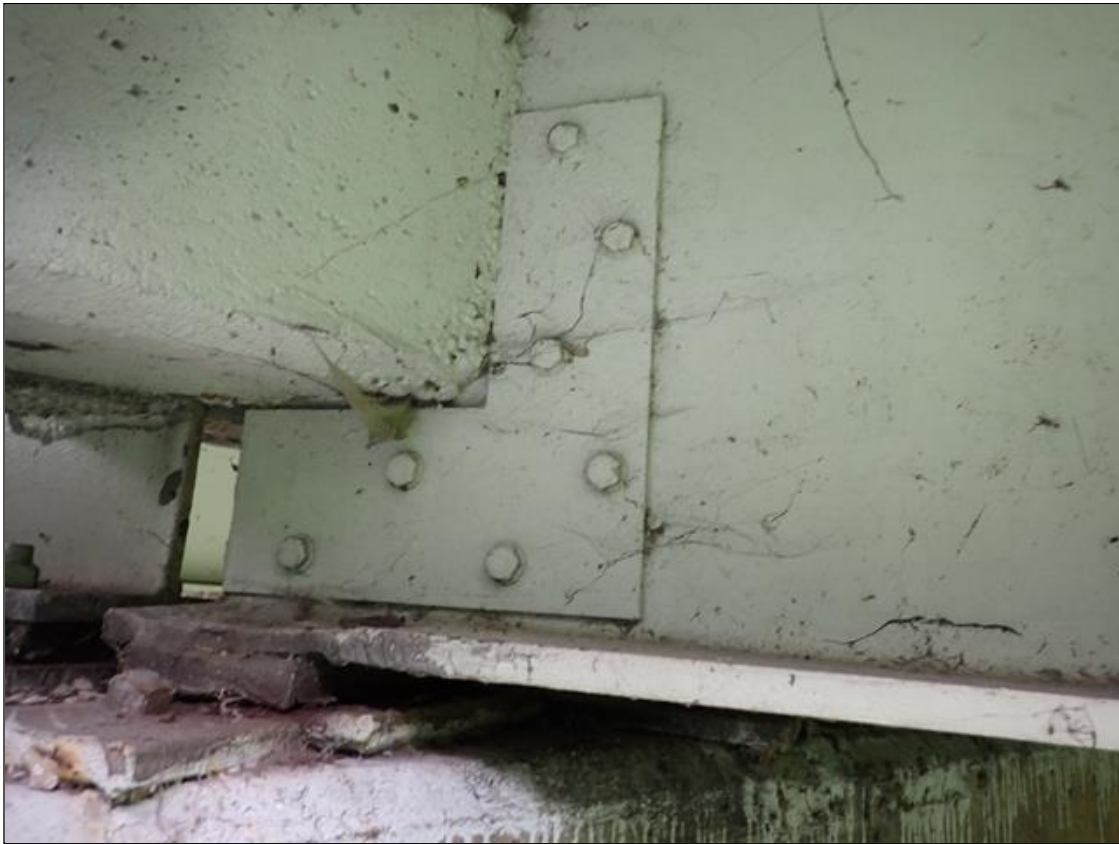
Span 2 Beam 1: 2025 new repair (3/8 inch thick x 15.5 inch x 18 inch), previously noted as: 10 INCHES LONG X 5 INCHES WIDE AREA OF SECTION LOSS BENEATH THE PAINTED SURFACE ABOVE THE BEARING AT BENT 2. 0.60 INCH SECTION REMAINING.

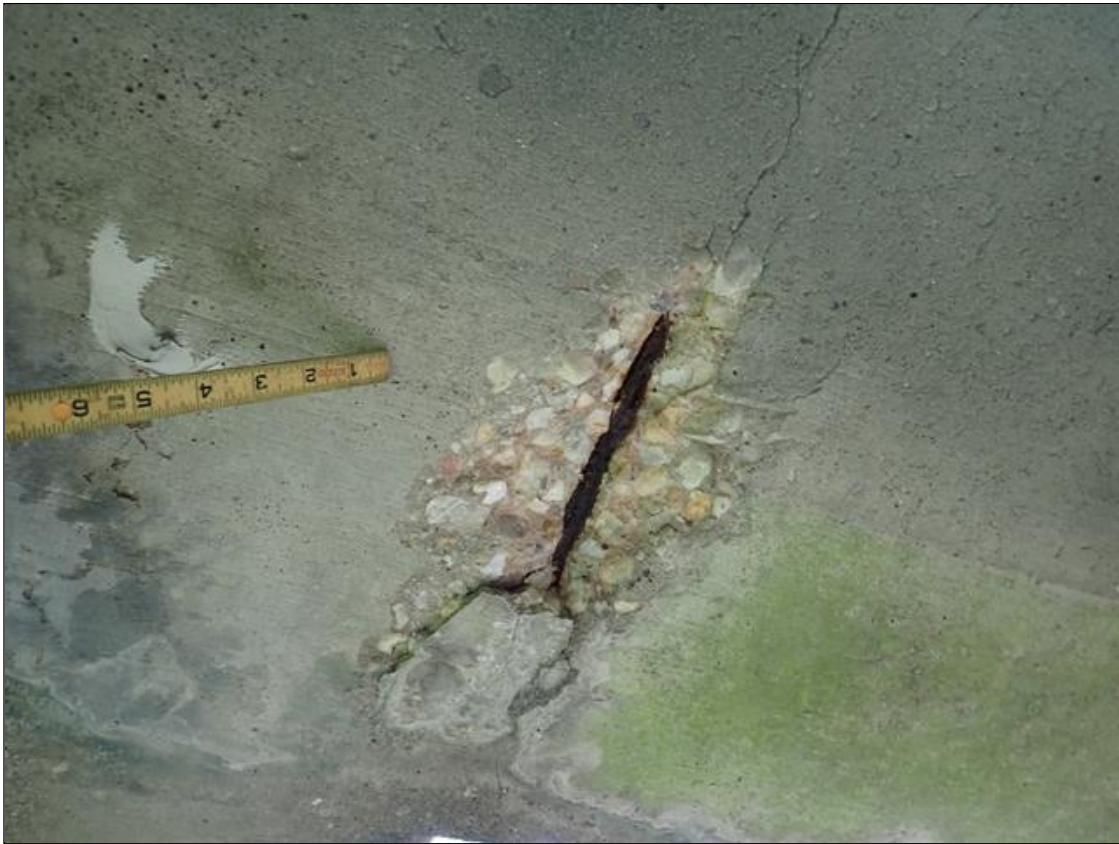
Span 2 Deck: (PAR) 15 FEET FROM BENT 2 IN LEFT OVERHANG SOFFIT SPALL WITH EXPOSED REBAR 6 INCHES X 8 INCHES X 1 INCH DEEP 5 PERCENT SECTION LOSS.

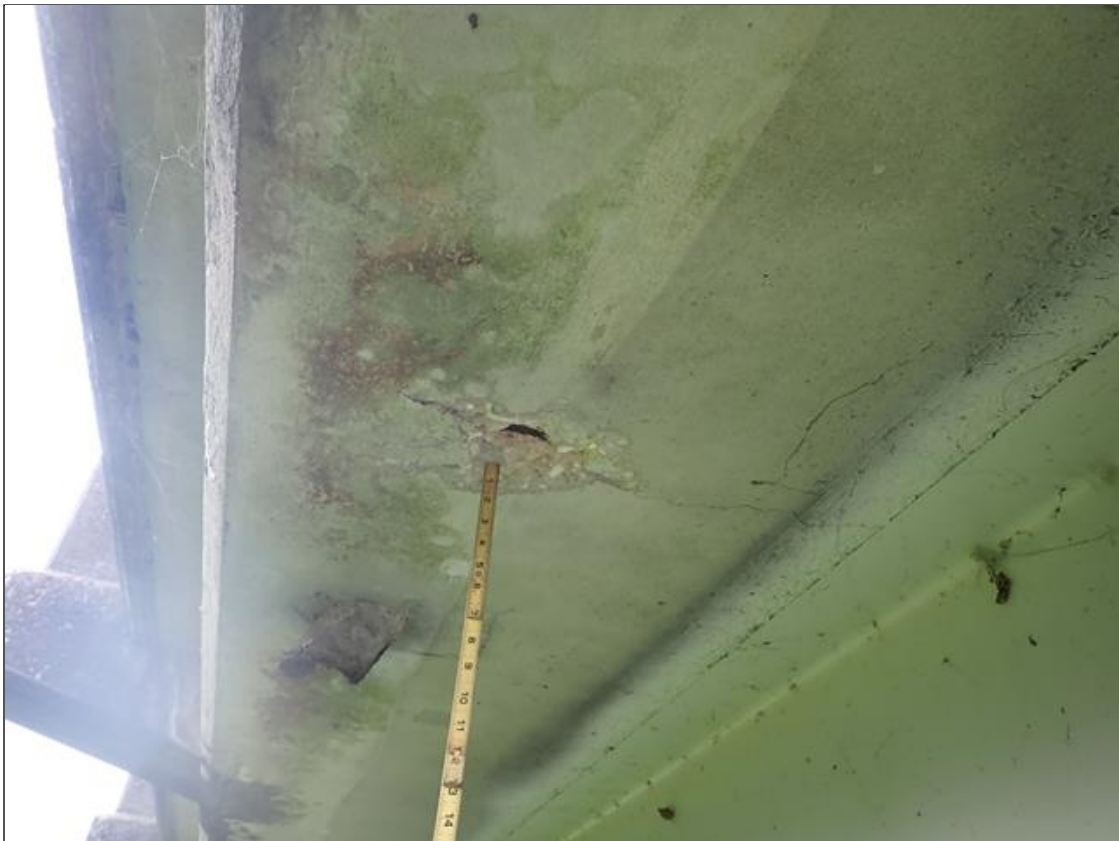
Span 2 Deck: (PAR) RIGHT OVERHANG SOFFIT NEAR MIDSPAN SPALL WITH EXPOSED REBAR 6 INCHES DIAMETER X 1 INCH DEEP, 5 PERCENT SECTION LOSS.

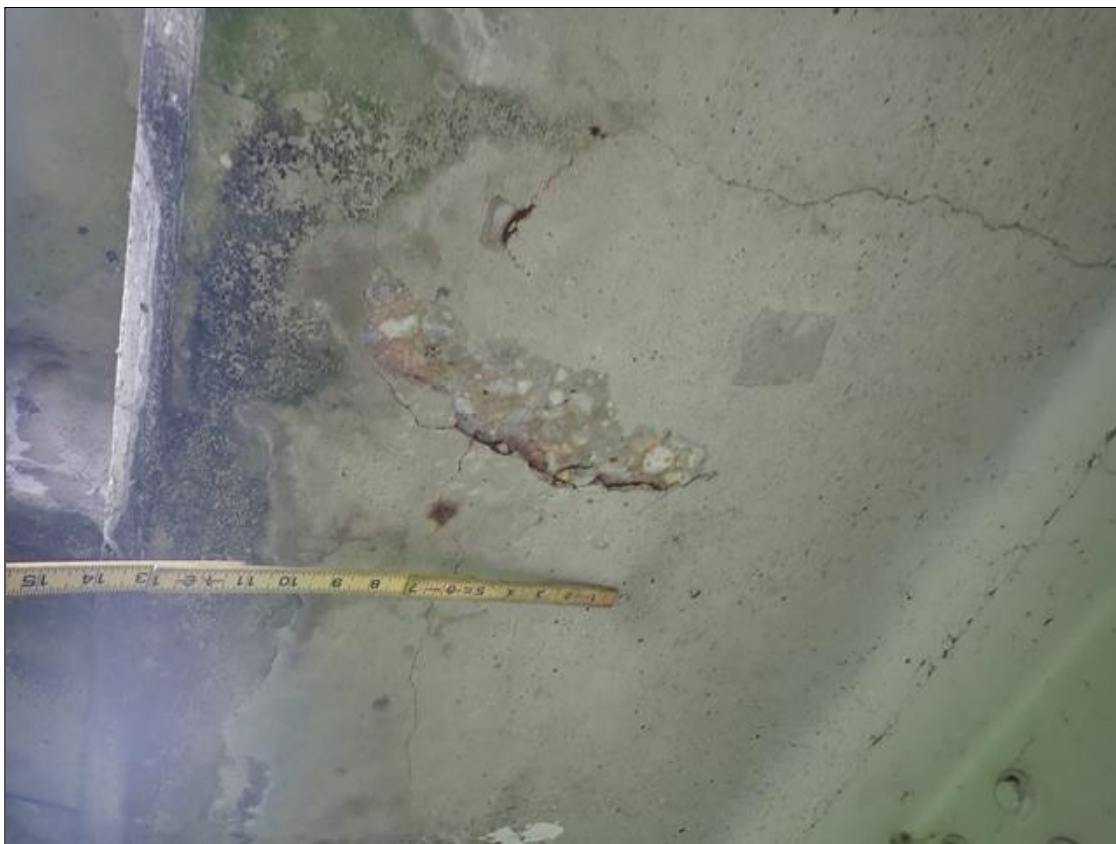
Span 2 Deck: RIGHT OVERHANG SOFFIT NEAR DRAIN 3, 4 INCHES X 8 INCHES X 1/2 INCH DEEP SPALL.

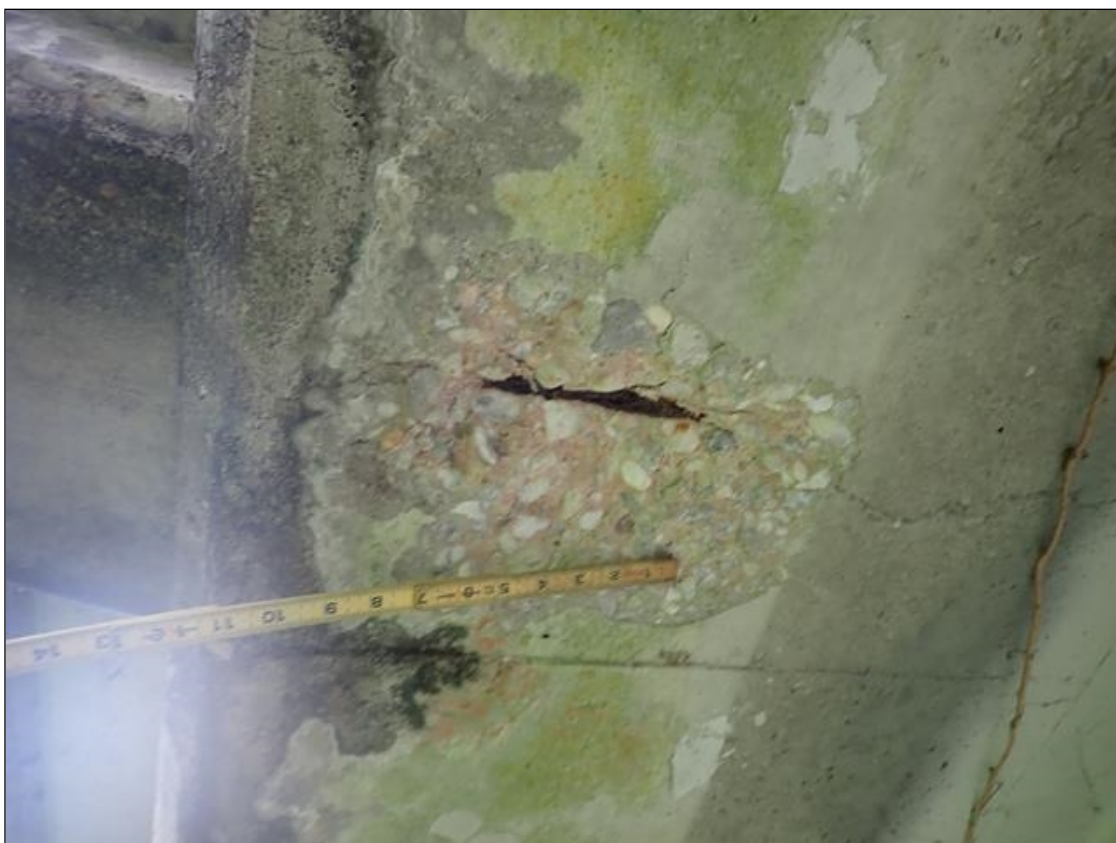
Span 2 Deck: (PAR) RIGHT OVERHANG SOFFIT AT RAIL POST 2, 1 FOOT DIAMETER X 1.5 INCHES DEEP SPALL WITH EXPOSED REBAR. 5 PERCENT SECTION LOSS.

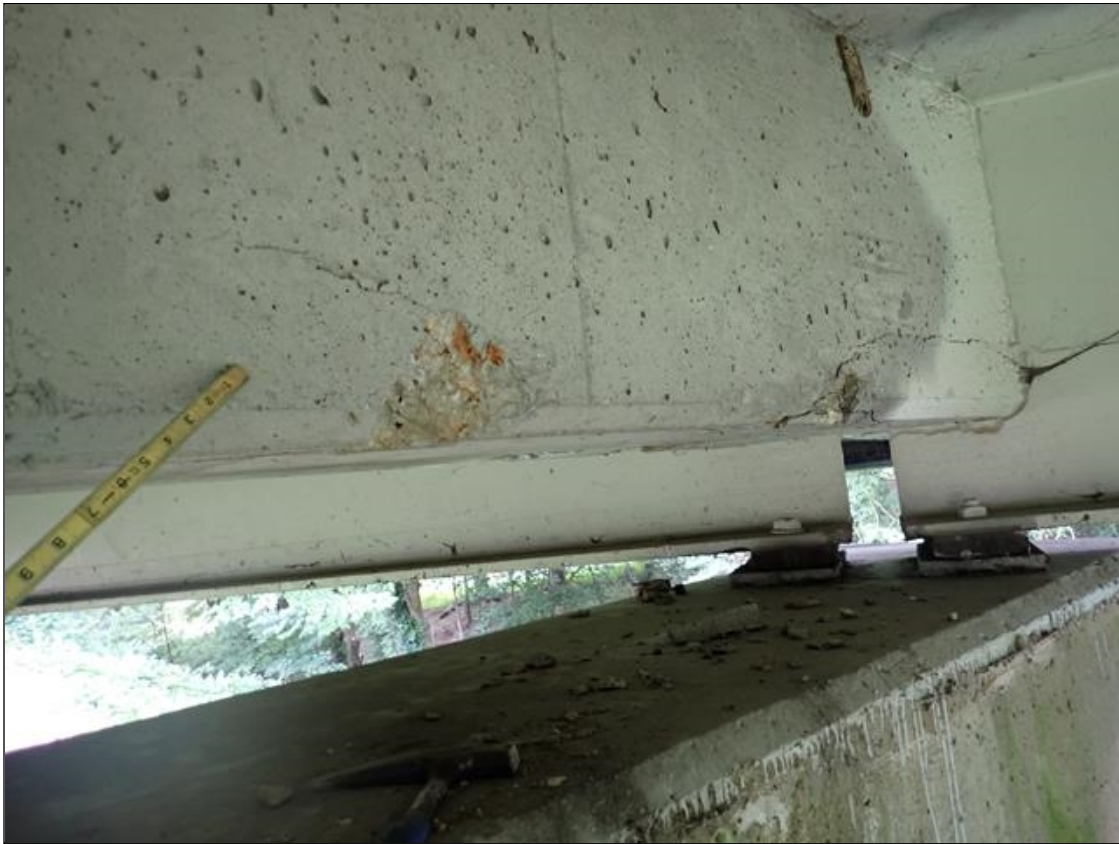
Span 2 Deck: TWO (2) AREAS OF UNSOUND CONCRETE UP TO 2.5 FEET LONG X 1 FOOT HIGH WITH SPALLING UP TO 5 INCHES DIAMETER X UP TO 4 INCHES DEEP IN END DIAPHRAGM IN BAY 1 AT BENT 1.

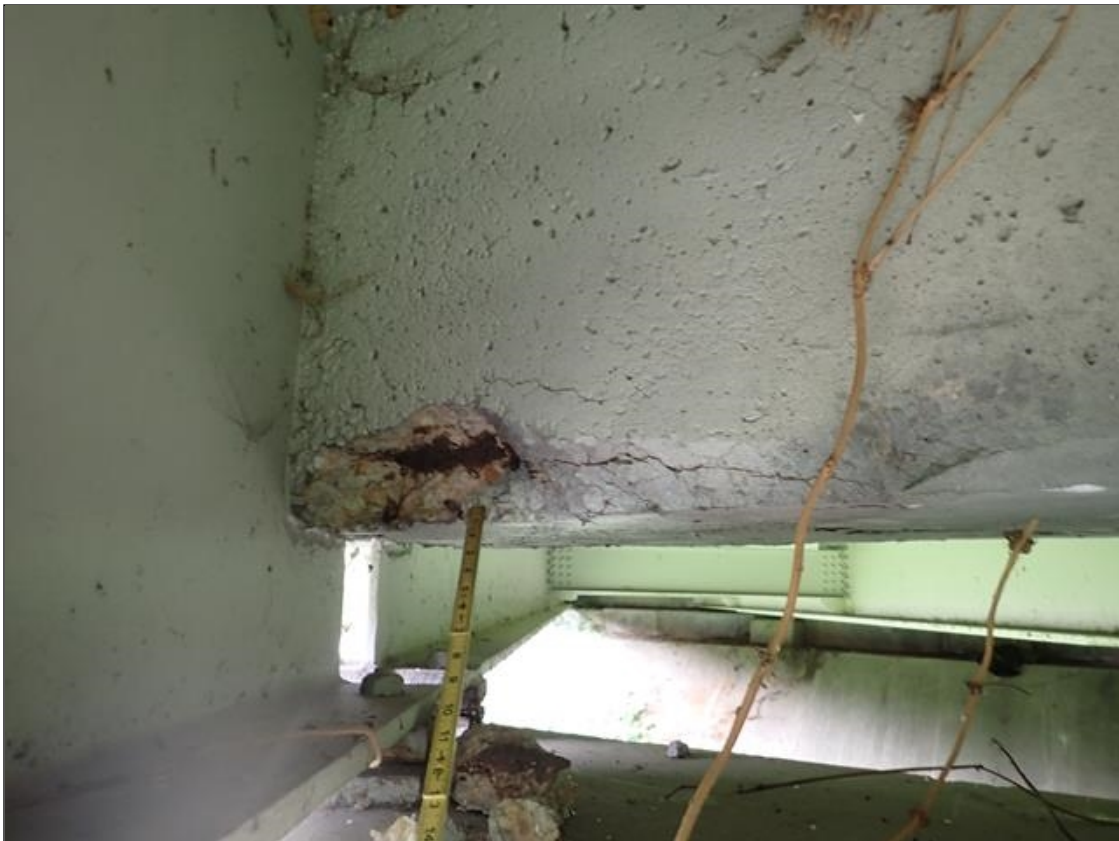
Span 2 Deck: UP TO 1.5 FEET WIDE X 4 INCHES HIGH X UP TO 4 INCHES DEEP SPALL WITH EXPOSED REBAR, 5 PERCENT SECTION LOSS IN DIAPHRAGM IN BAY 3 AT BENT 1.

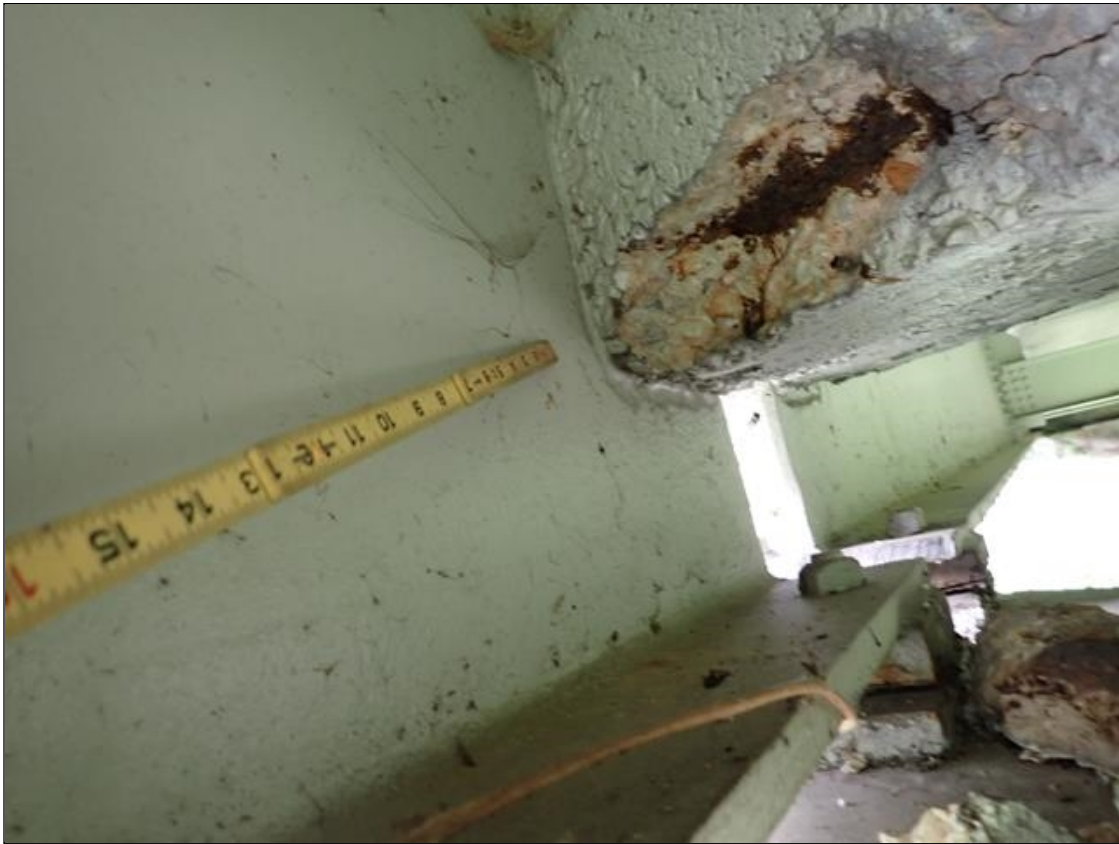
Span 2 Beam 4: (PAR) at bent 1, web adjacent to end diaphragm, painted over section loss (7/16 inch average remaining x 8 inch x 4 inch) with corrosion reactivating

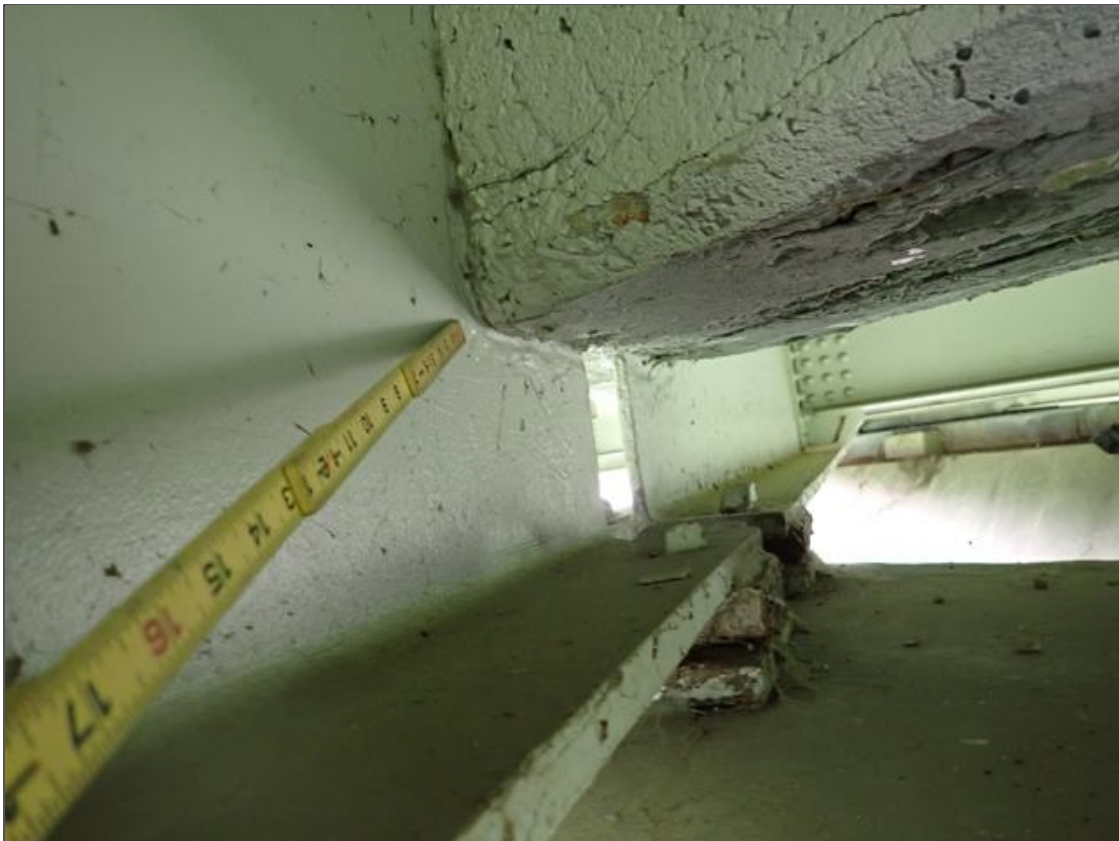
Span 2 Beam 3: (PAR) at bent 1, web adjacent to end diaphragm, painted over section loss (9/16 inch average remaining x 1 inch x 7 inch)

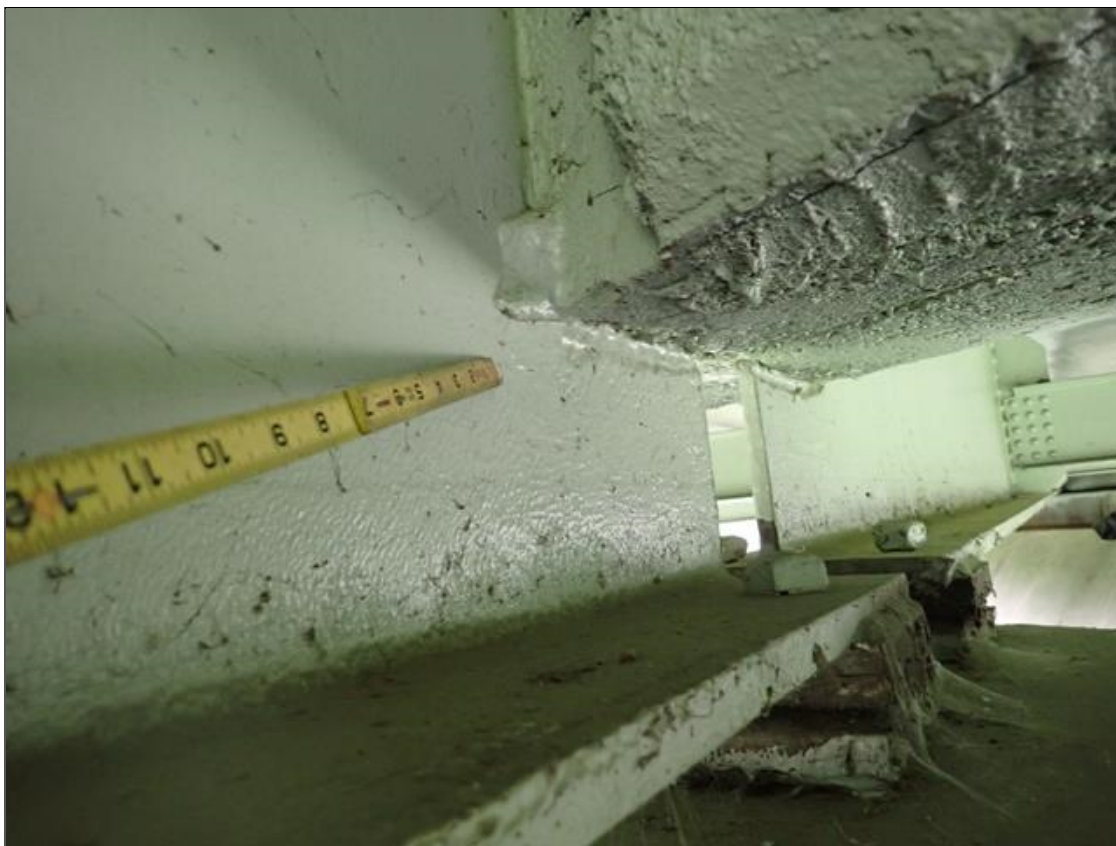
Span 2 Beam 2: (PAR) at bent 1, web adjacent to end diaphragm, painted over section loss (1/2 inch average remaining x 1 inch x 7 inch) with corrosion reactivating

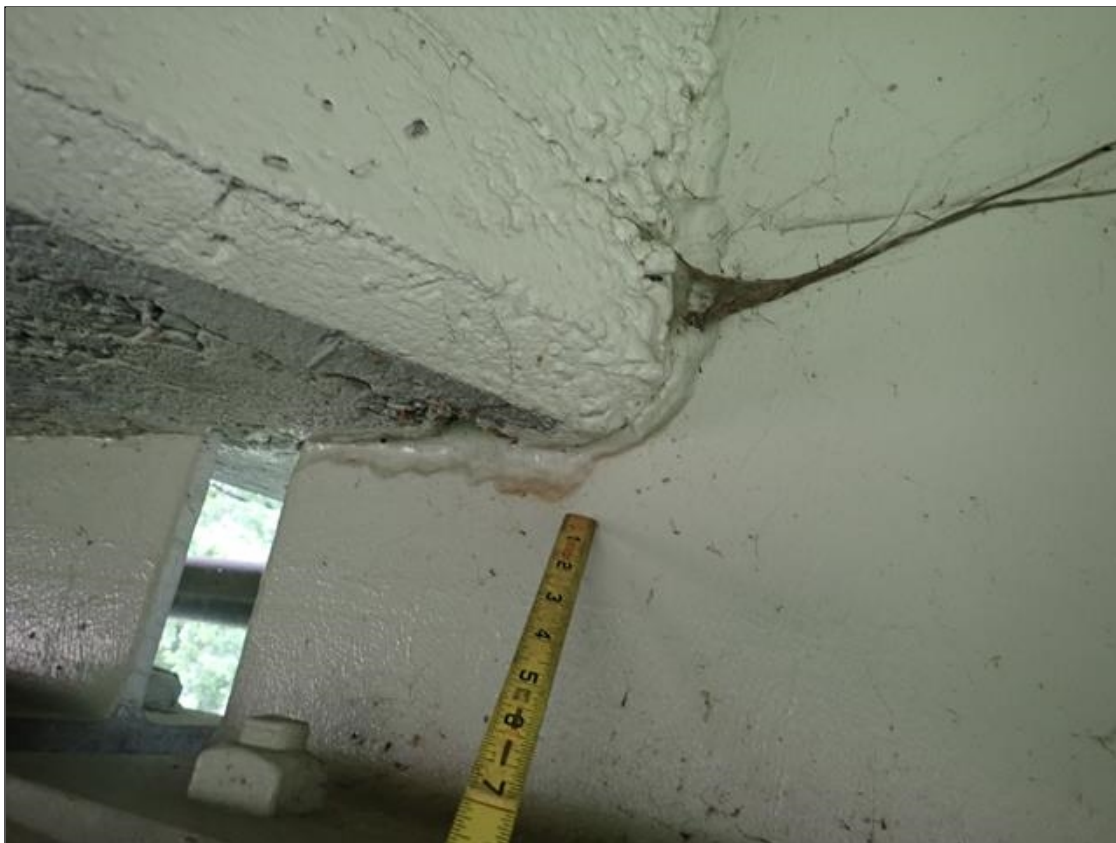
Span 2 Beam 1: (PAR) at bent 1, web adjacent to end diaphragm, painted over section loss (7/16 inch average remaining x 7 inch x 9 inch)

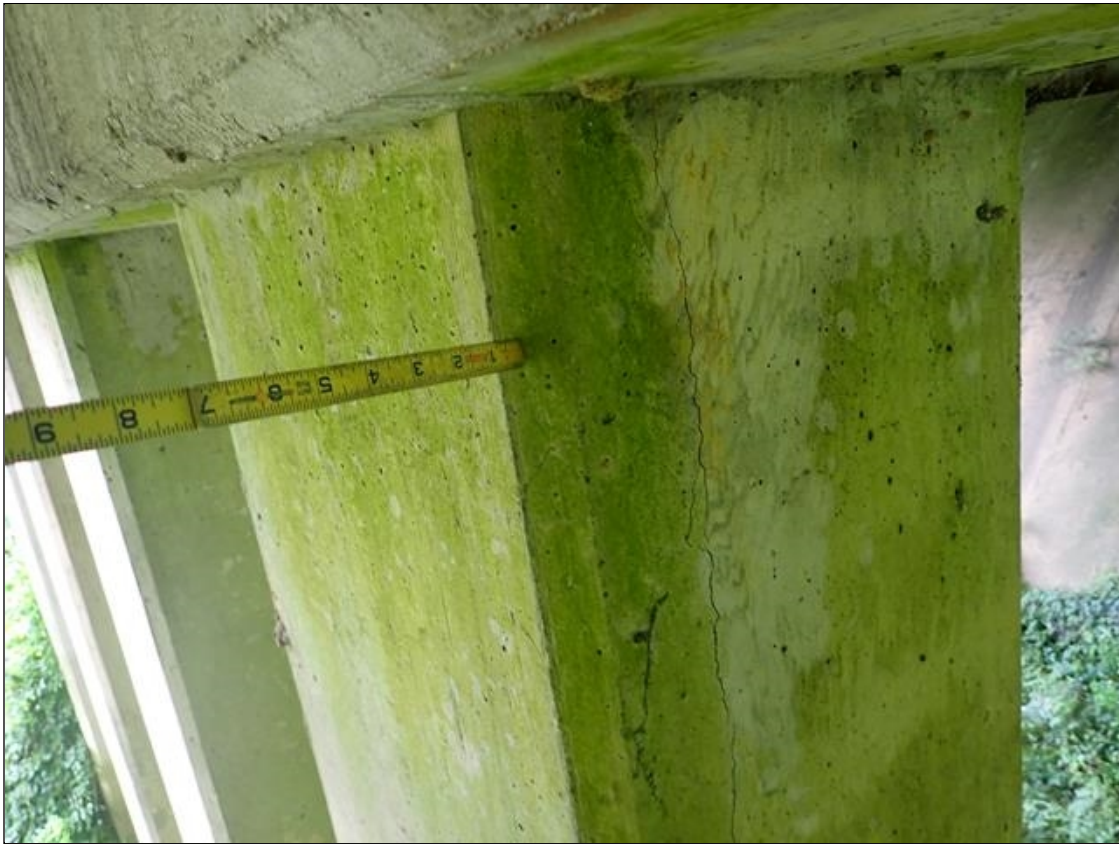
Bent 1 Pile 4: west face at cap, vertical crack (1/32 inch x 32 inch)

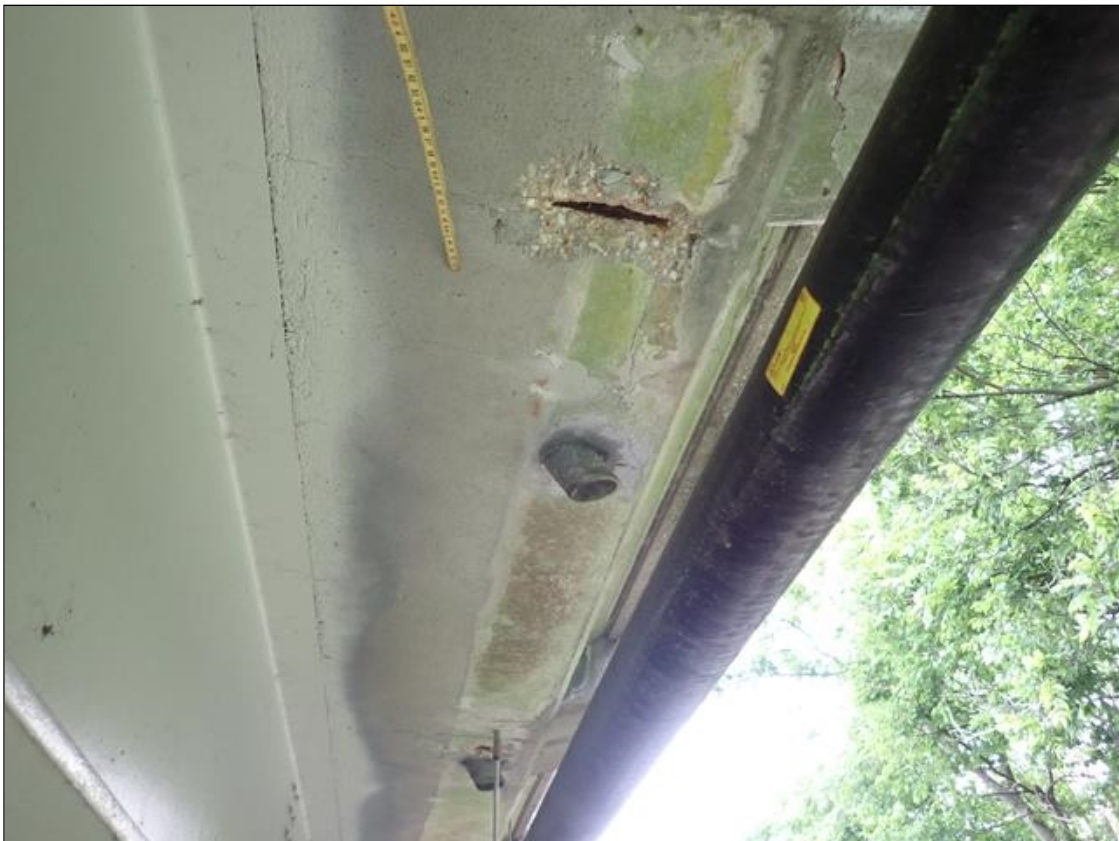
Span 1 Deck: (PAR) UP TO 12 INCHES DIAMETER X 1.5 INCHES DEEP SPALLS WITH EXPOSED REBAR WITH 5 PERCENT SECTION LOSS AT DRAINS 3 AND 4 IN LEFT OVERHANG.

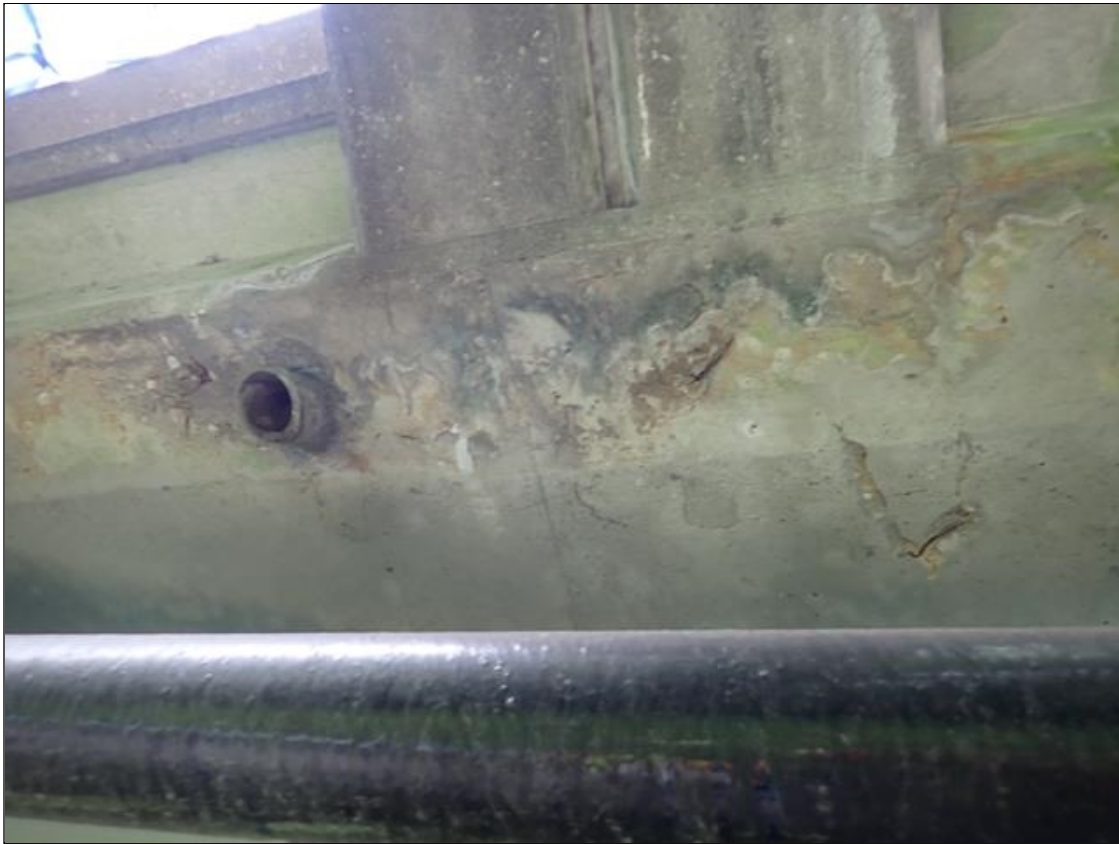
Span 1 Deck: TWO (2) 12 INCHES DIAMETER X 1/2 INCH DEEP DELAMINATIONS/SPALLS, UNDERSIDE OF WEST OVERHANG, AT DRAIN 6.

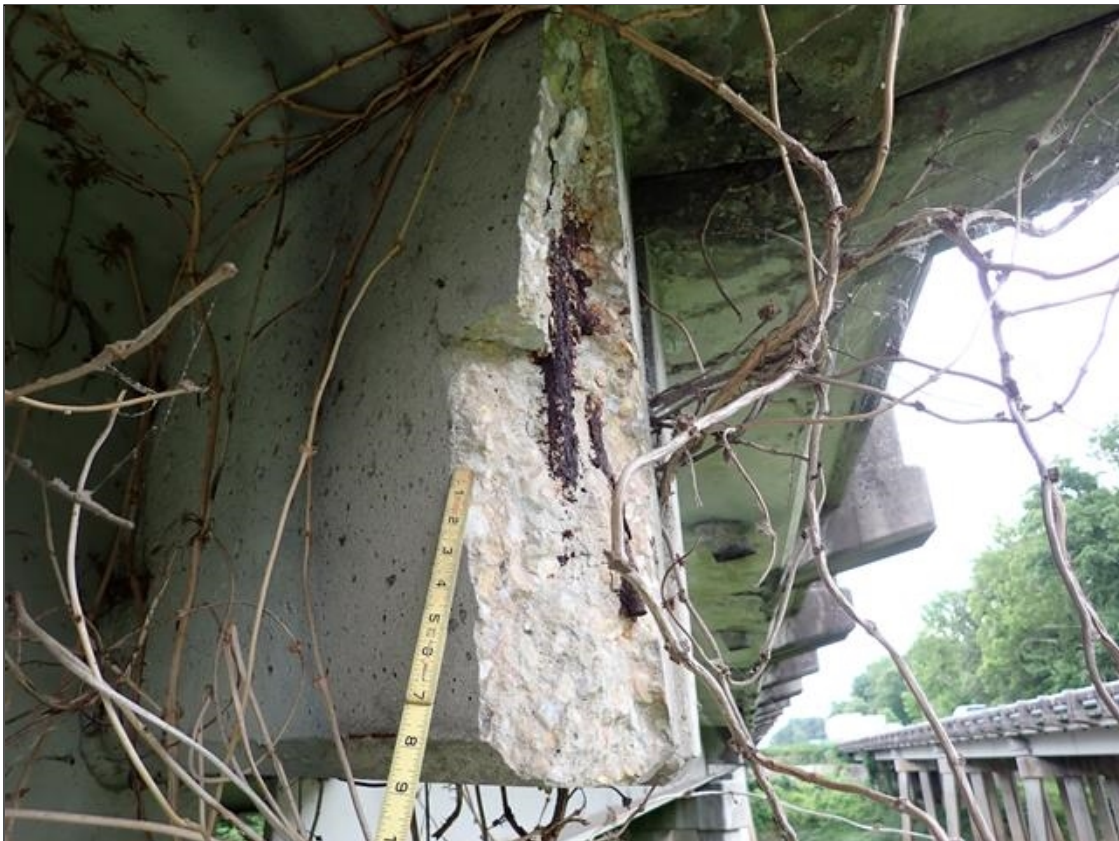
Span 1 Deck: (PAR) FAR END DIAPHRAGM AT RIGHT OVERHANG SPALL WITH EXPOSED REBAR 6 INCHES X 2 FEET X 4 INCH DEEP, 5 PERCENT SECTION LOSS.

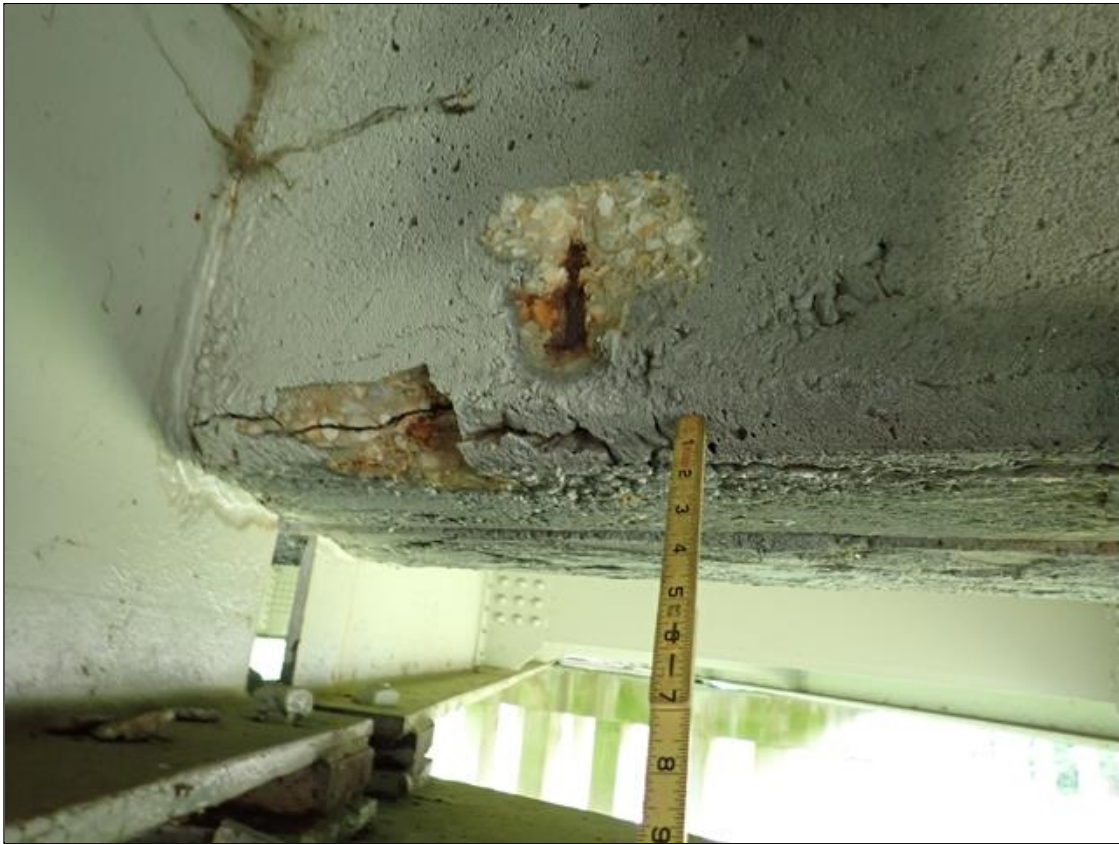
Span 1 Deck: (PAR) BAY 2 FAR DIAPHRAGM ADJACENT TO BEAM 2 AREA OF DELAMINATION AND SPALLING WITH EXPOSED REBAR 1.5 FEET X 8 INCHES X UP TO 3 INCHES DEEP, 5 PERCENT SECTION LOSS.

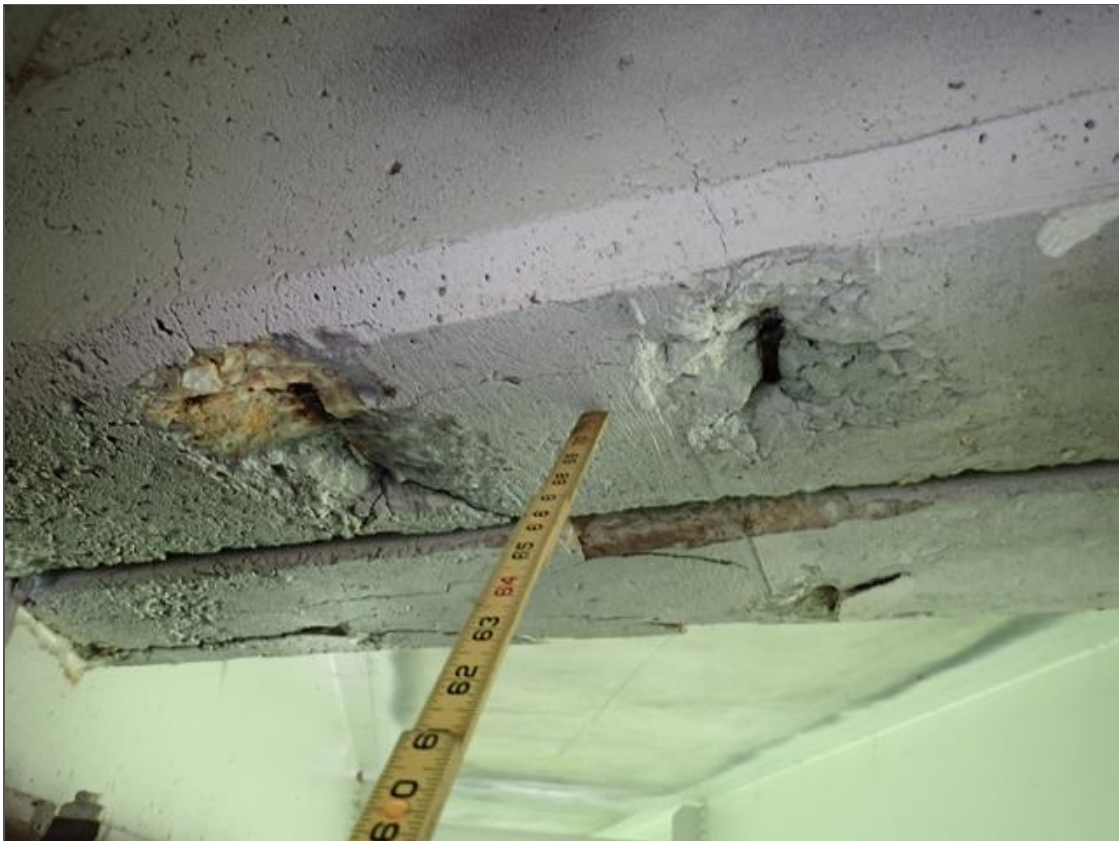
Span 1 Deck: (PAR) TWO (2) UP TO 8 INCHES DIAMETER X 3/4 INCH DEEP SPALLS WITH EXPOSED REBAR, 5 PERCENT SECTION LOSS, UNDERSIDE OF BAY 1 END DIAPHRAGM, AT BENT 1.
