NC DEPARTMENT OF TRANSPORTATION
 DIVISION OF HIGHWAYS
 STRUCTURE MANAGEMENT UNIT
 COUNTY: JOHNSTON DIV: 4

ATTENTION: PARS Submitted Sign Notice Issued
 sketches revised; new repairs

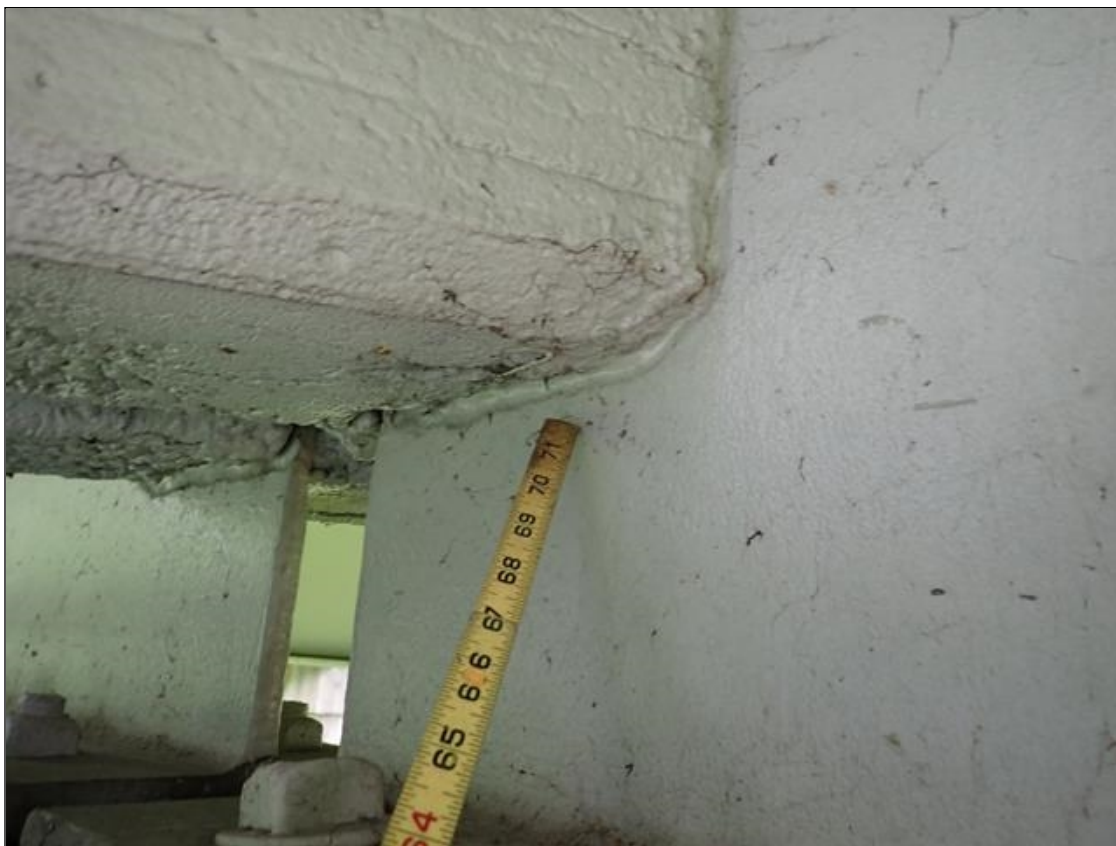
Span 1 Beam 1: at bent 1, web adjacent to end diaphragm, painted over section loss (9/16 inch average remaining x 7 inch x 16 inch) with corrosion reactivating

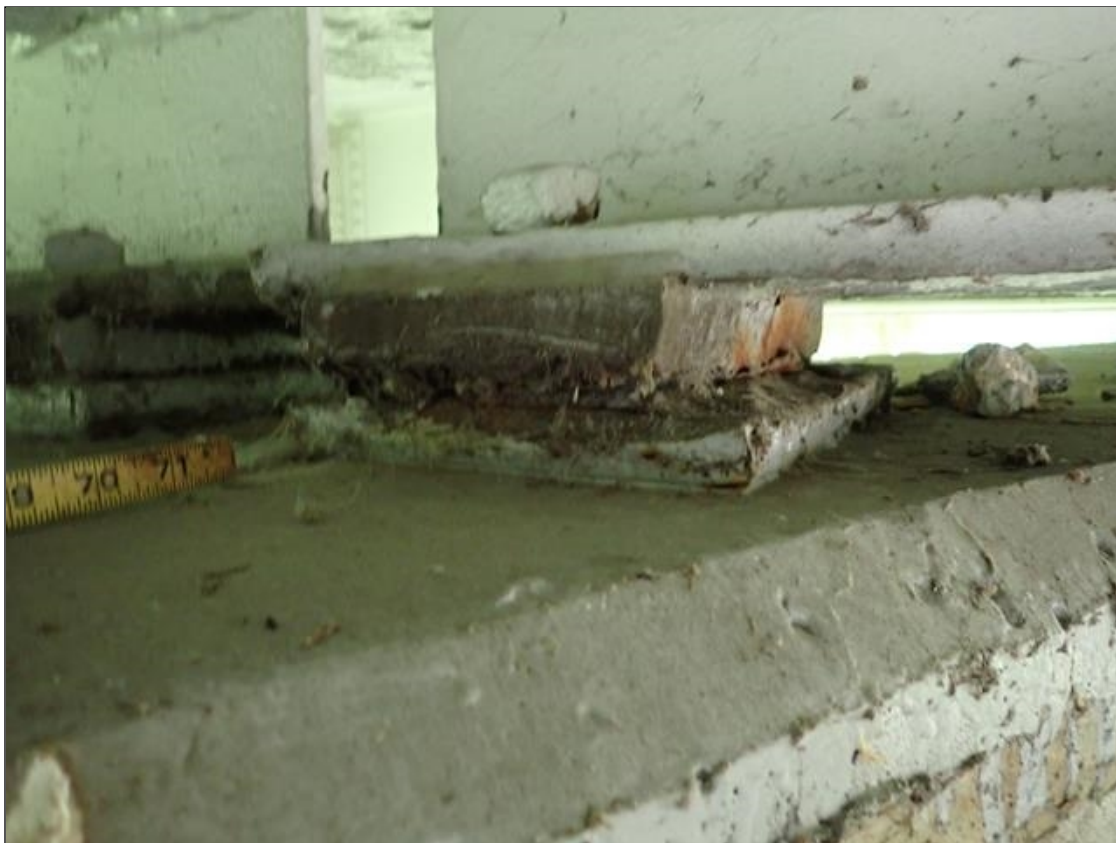
Span 1 Far Bearing 2: painted over section loss (approximately 85 percent remaining) with corrosion reactivating

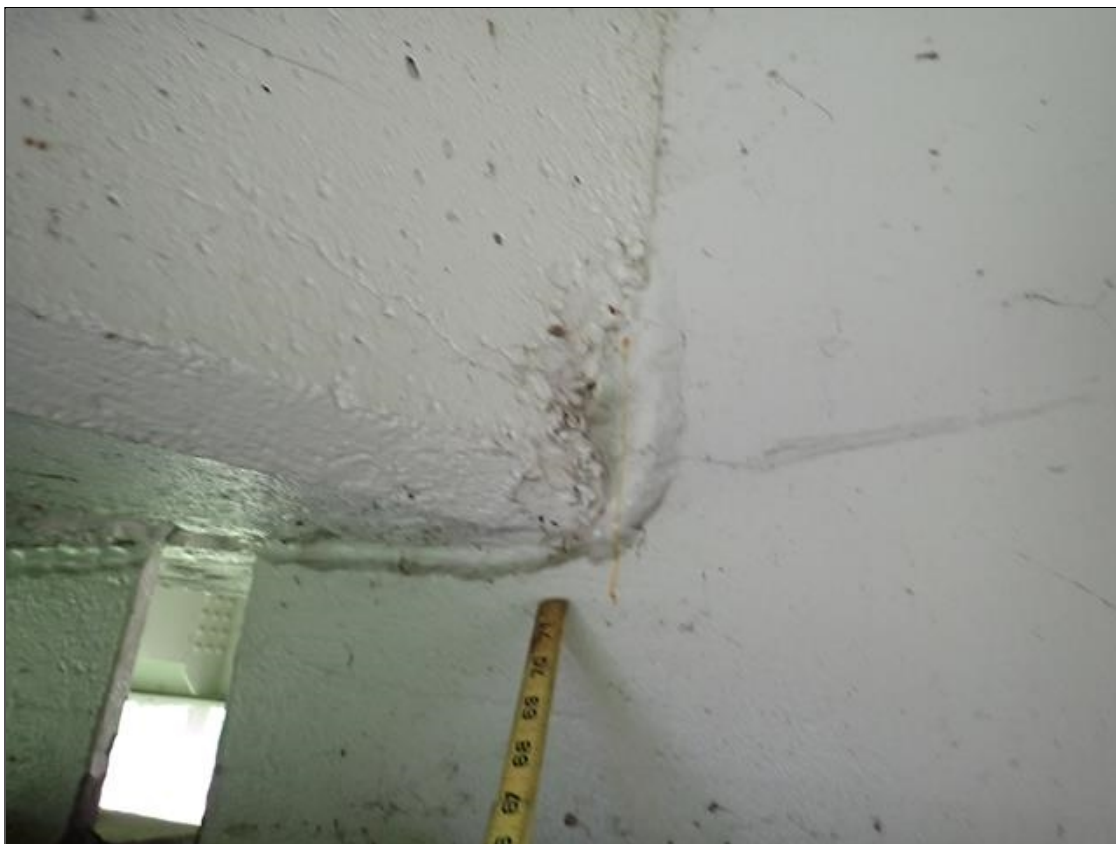
Span 1 Beam 2: (PAR) at bent 1, web adjacent to end diaphragm, painted over section loss (7/16 inch average remaining x 8 inch x 12 inch)

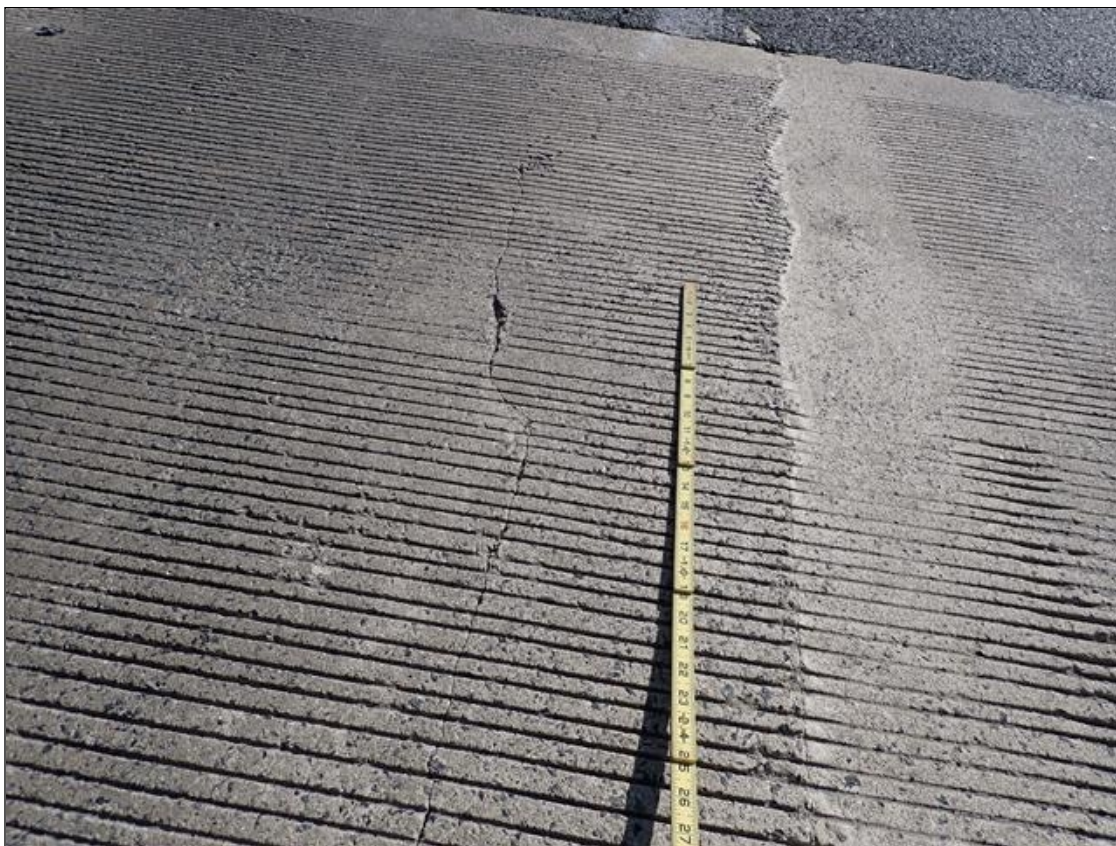
Approach 2: UP TO 0.05 INCH WIDE DIAGONAL AND LONGITUDINAL CRACKS IN BOTH TRAVEL LANES.

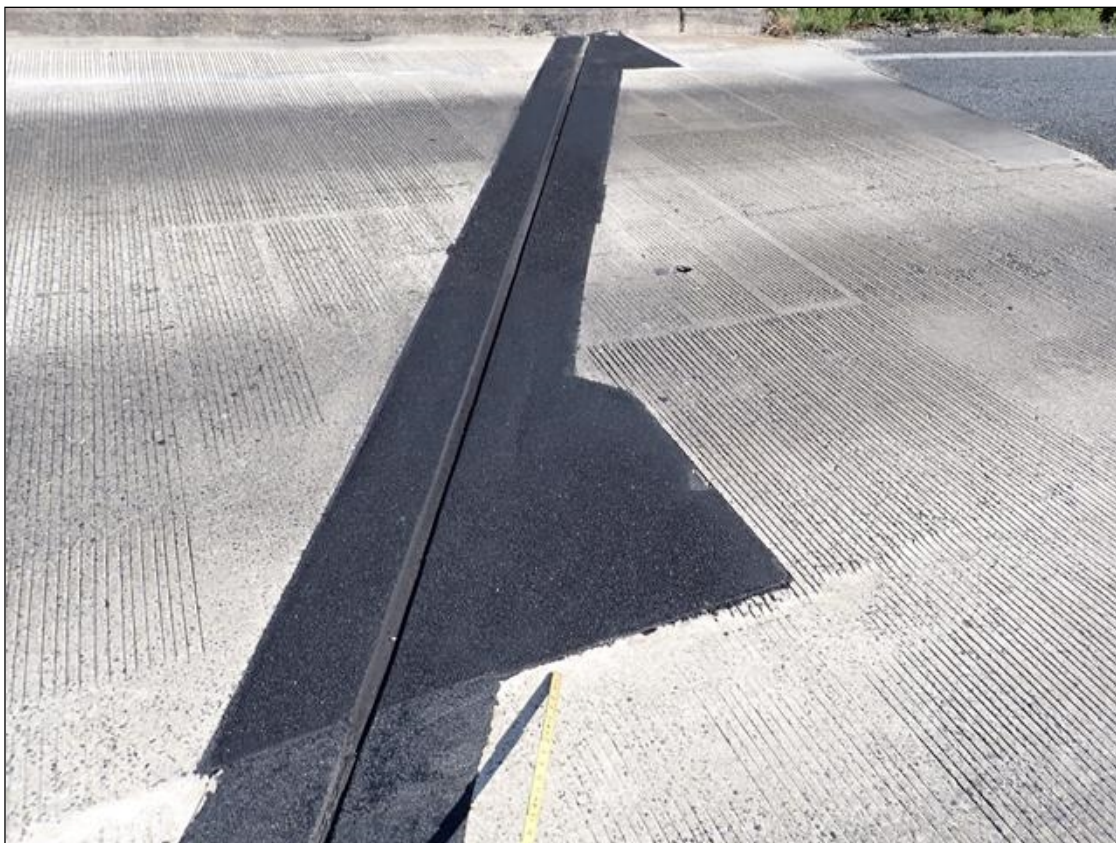
Approach 2: AT SOUTH END BETWEEN LANES AND RIGHT SHOULDER (2) SOUND PATCHES UP TO 2 FEET X 2 FEET.

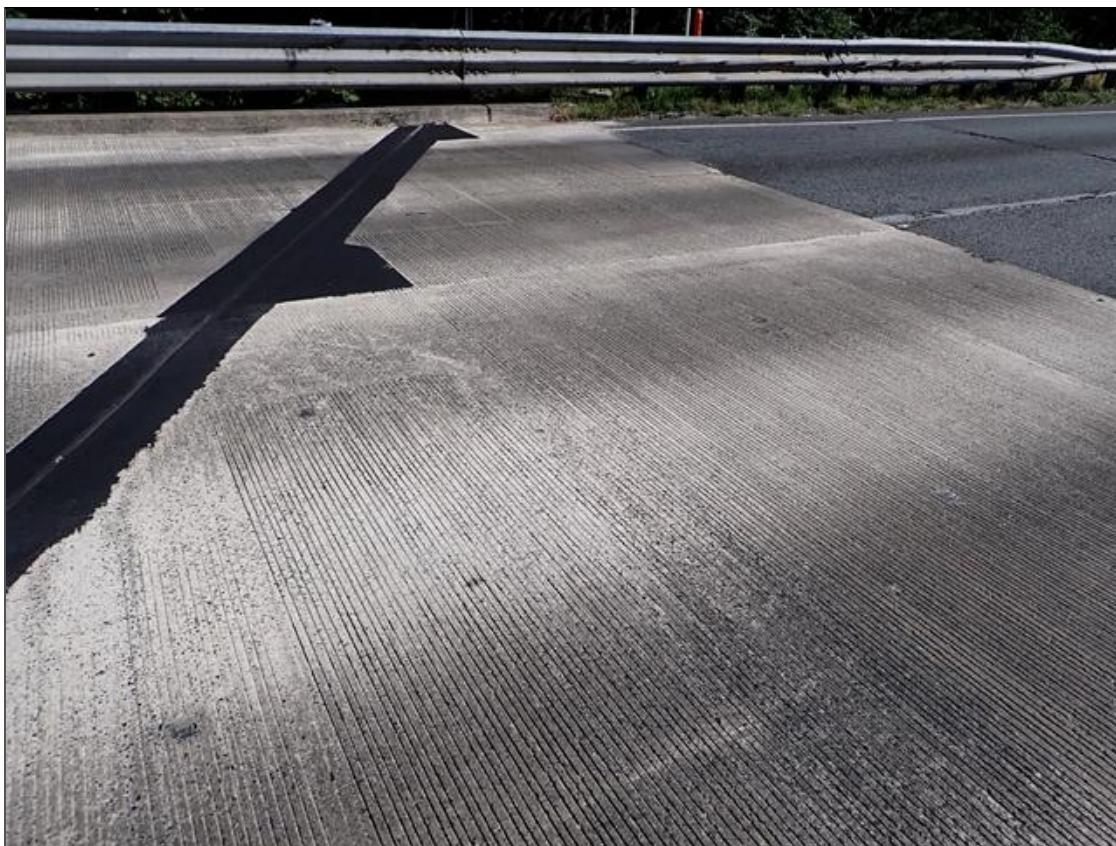
Approach 2: throughout slab, wear with secure aggregate at random

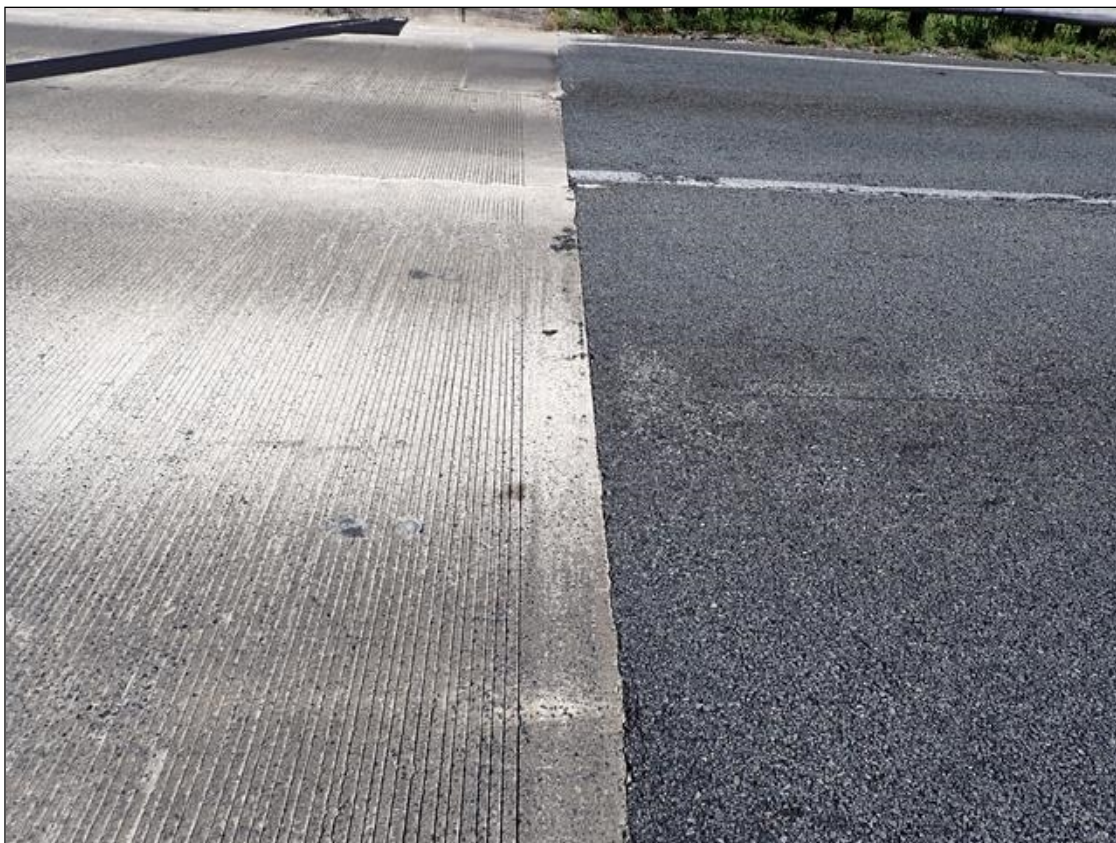
Approach 2: (not found 2025) ASPHALT AT SOUTH END SETTLED FULL WIDTH X UP TO 1 1/2 INCH.

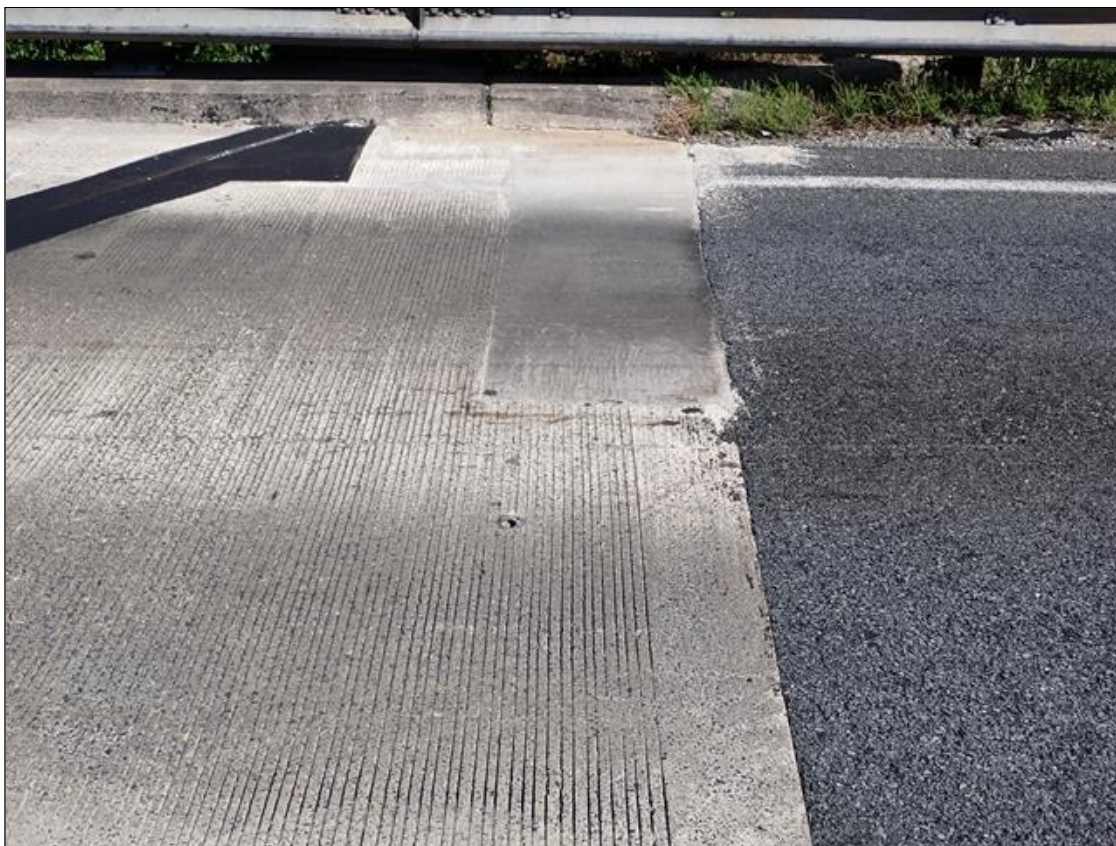
Approach 2: in right travel lane at north end, patch (2 foot x 8 foot)

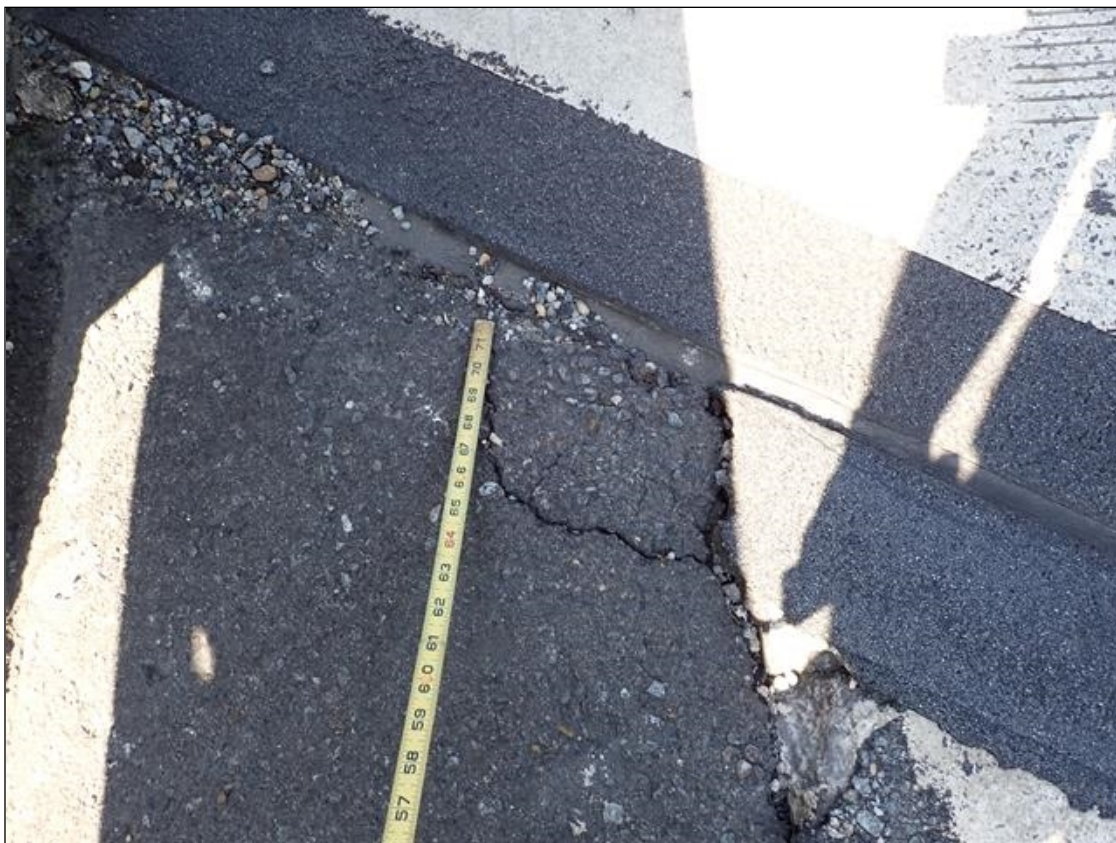
Span 8 End Bent 2 Joint : near right bridge rail, area of broken/cracked/settled header (1 inch deep)

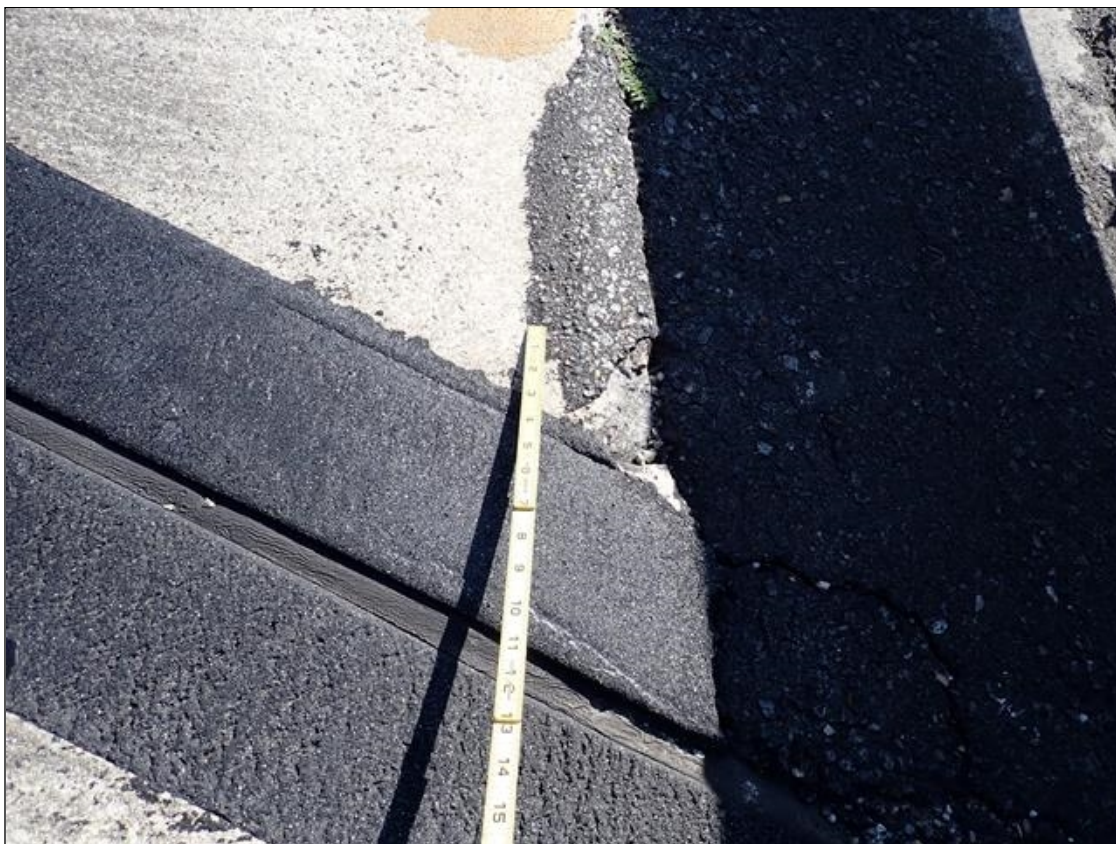
Approach 2: at southeast corner, spall (6 inch x 4 inch x 1.5 inch deep)

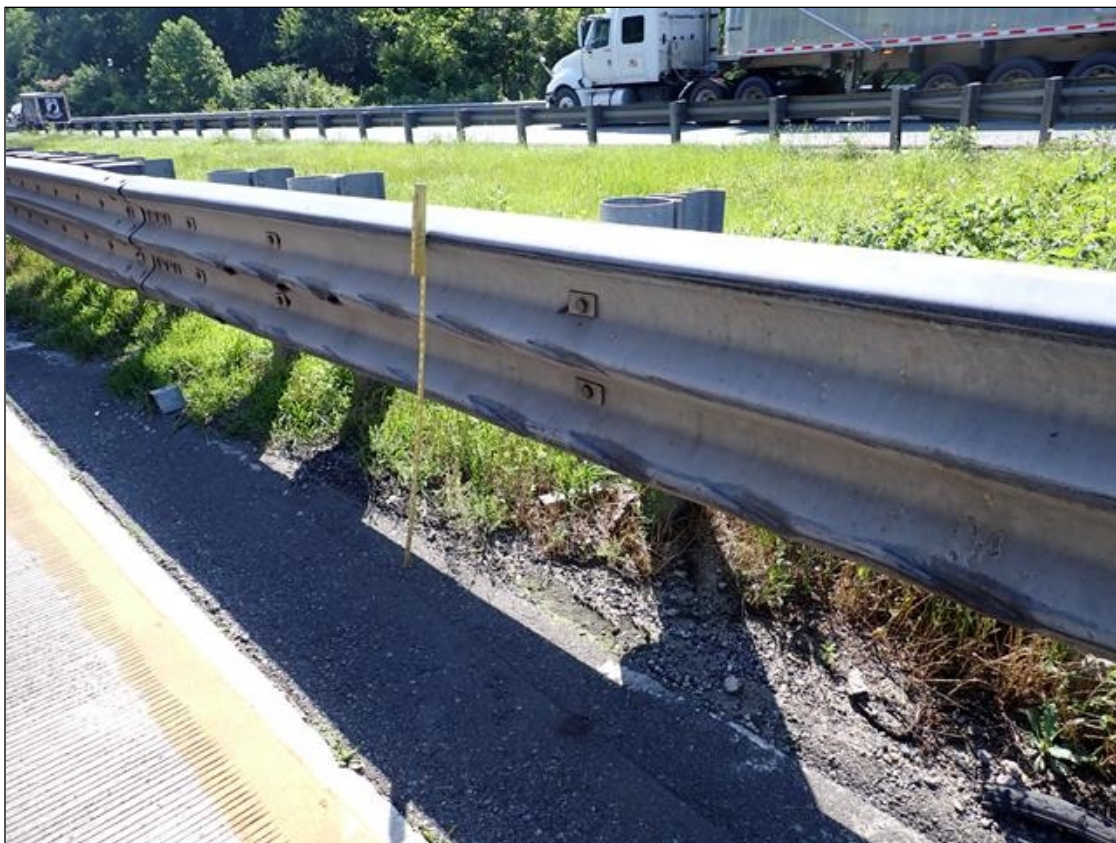
(PAR) northeast guardrail near bridge, impact damage (23 foot) with holes (up to 4 inch x 3 inch)

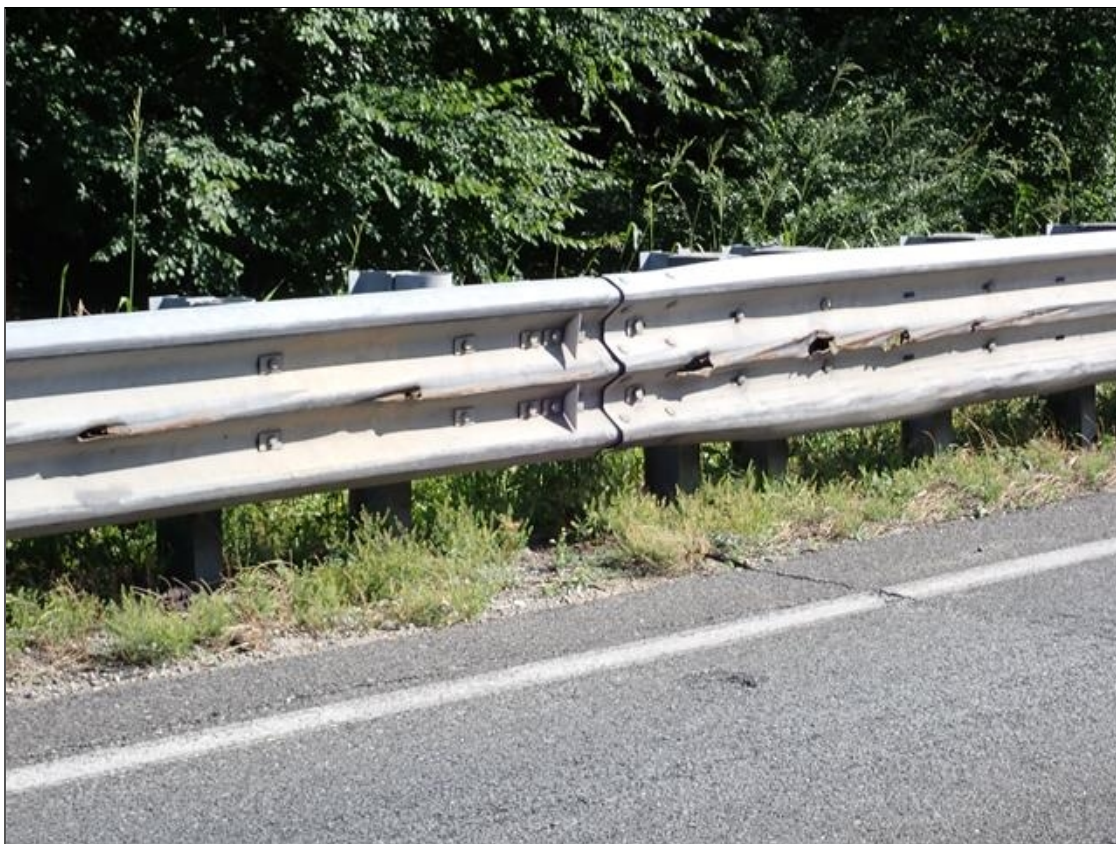
(PAR) northwest guardrail near bridge, impact damage (25 foot) with holes (up to 4 inch x 3 inch)

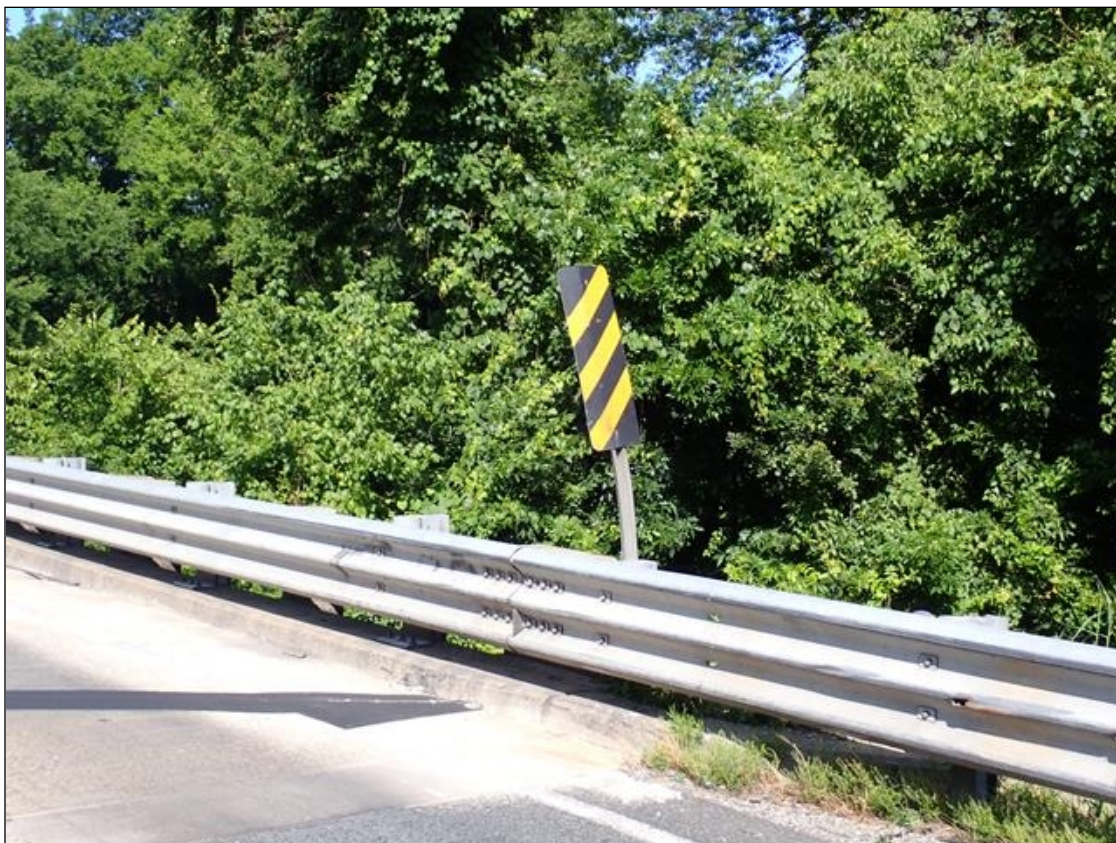
Span 8 Northwest delineator: bent/leaning to the south

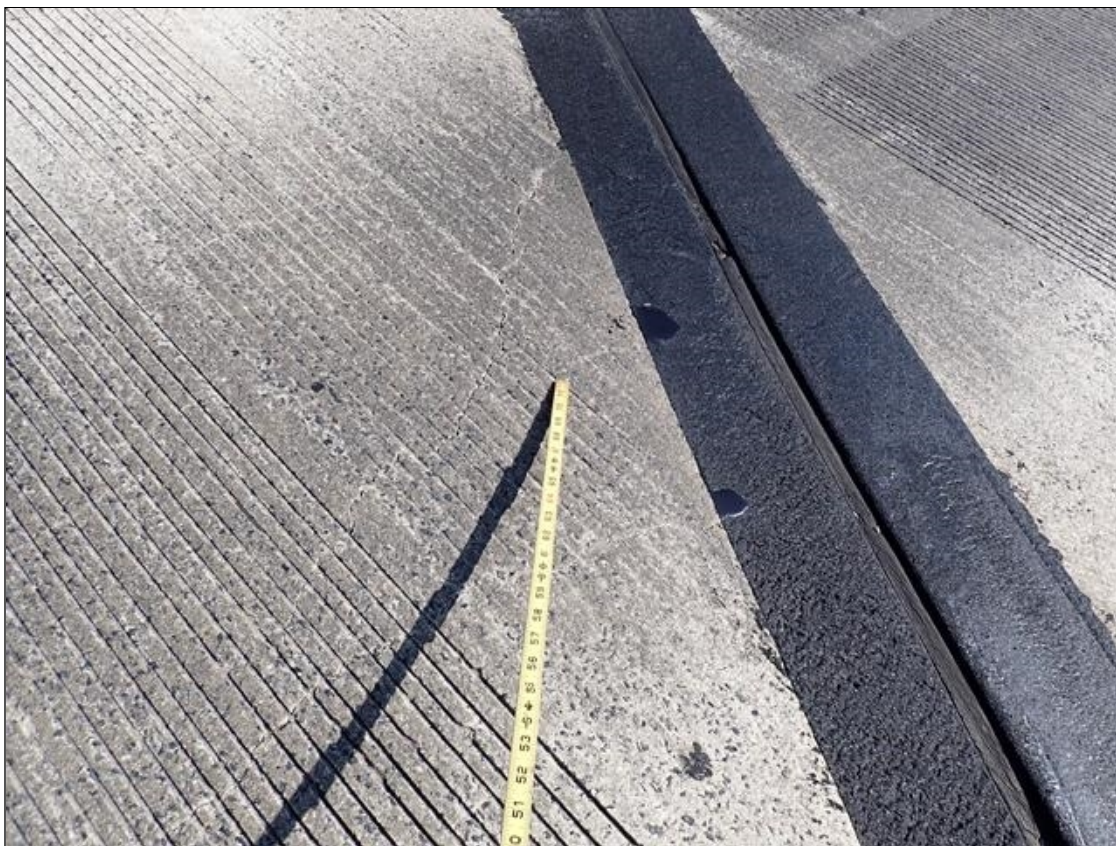
Span 8 Deck: UP TO 0.05 INCH WIDE X 8 FEET LONG DIAGONAL CRACKS EXTENDING FROM EXPANSION JOINT AT END BENT 2.

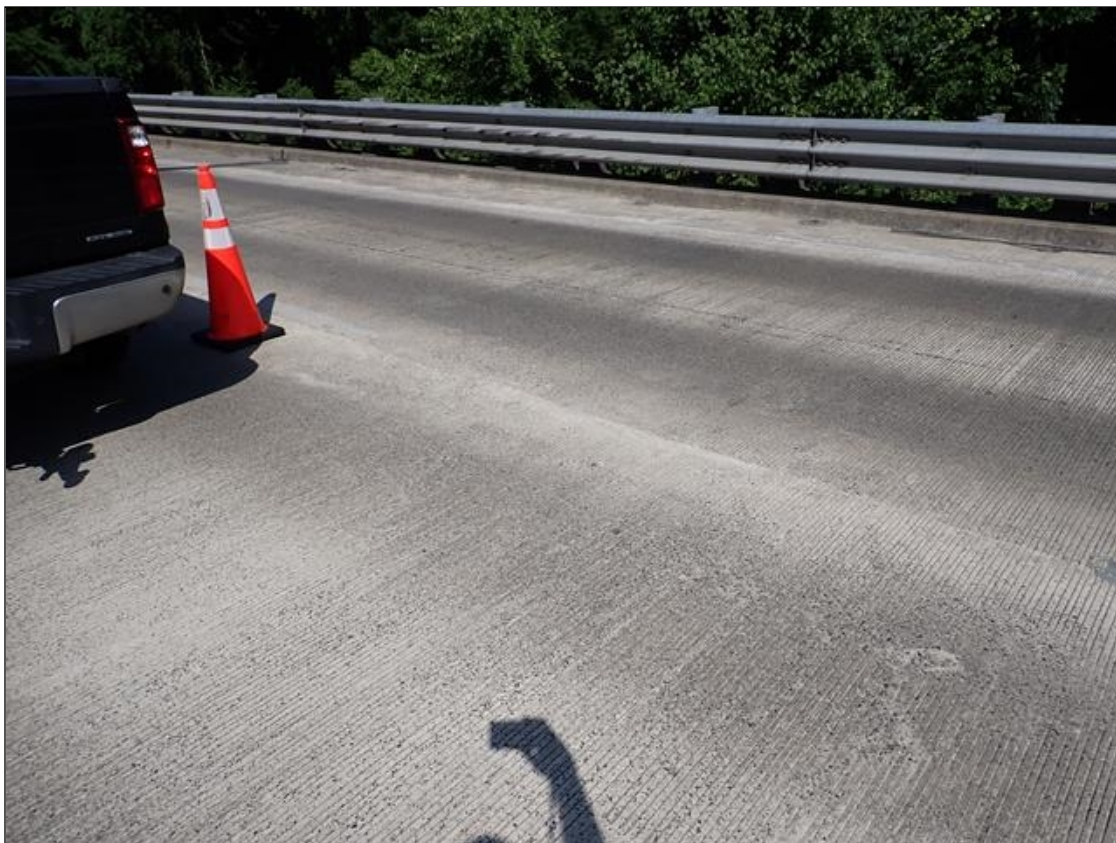
Span 8 Deck: throughout top of deck, wear with secure aggregate at random

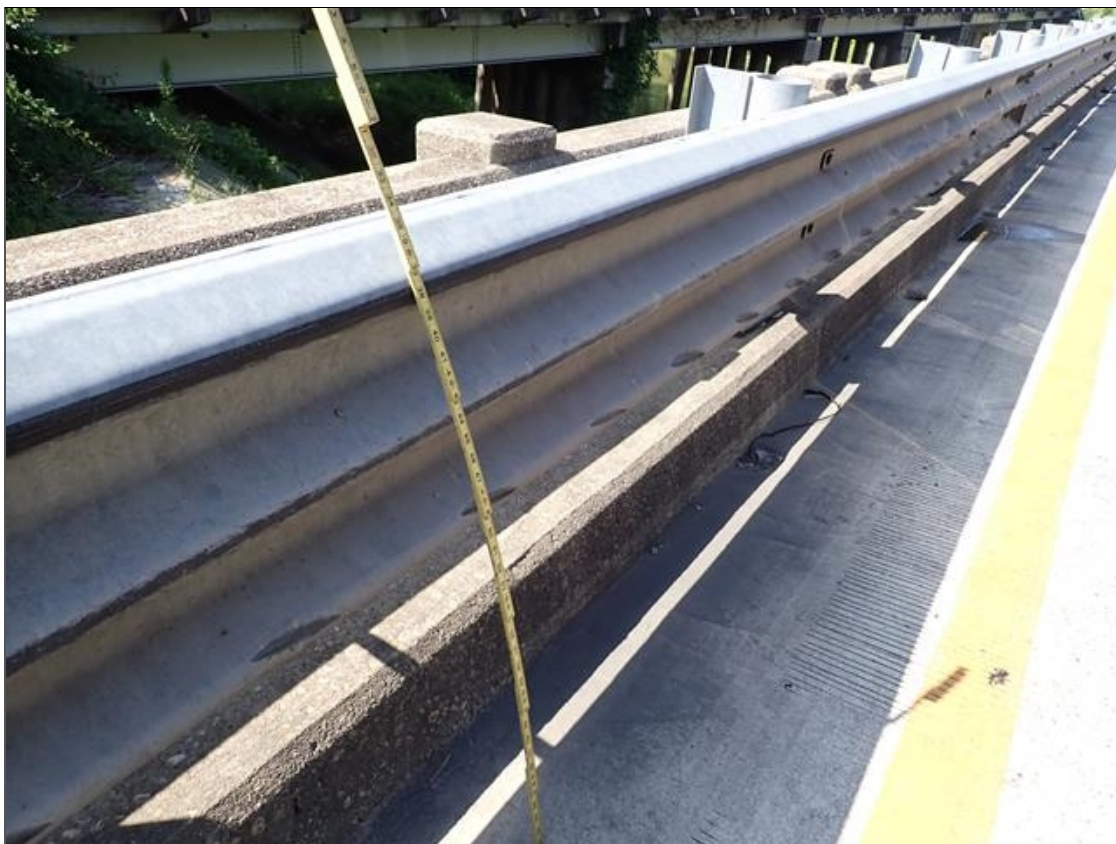
Span 8 Right Retrofit Bridge Rail: (PAR) IMPACT DAMAGE WITH SCRAPE MARKS AND THROUGH HOLES UP TO 4 INCH X 2 INCH IN RETROFIT RAIL AT SCATTERED LOCATIONS

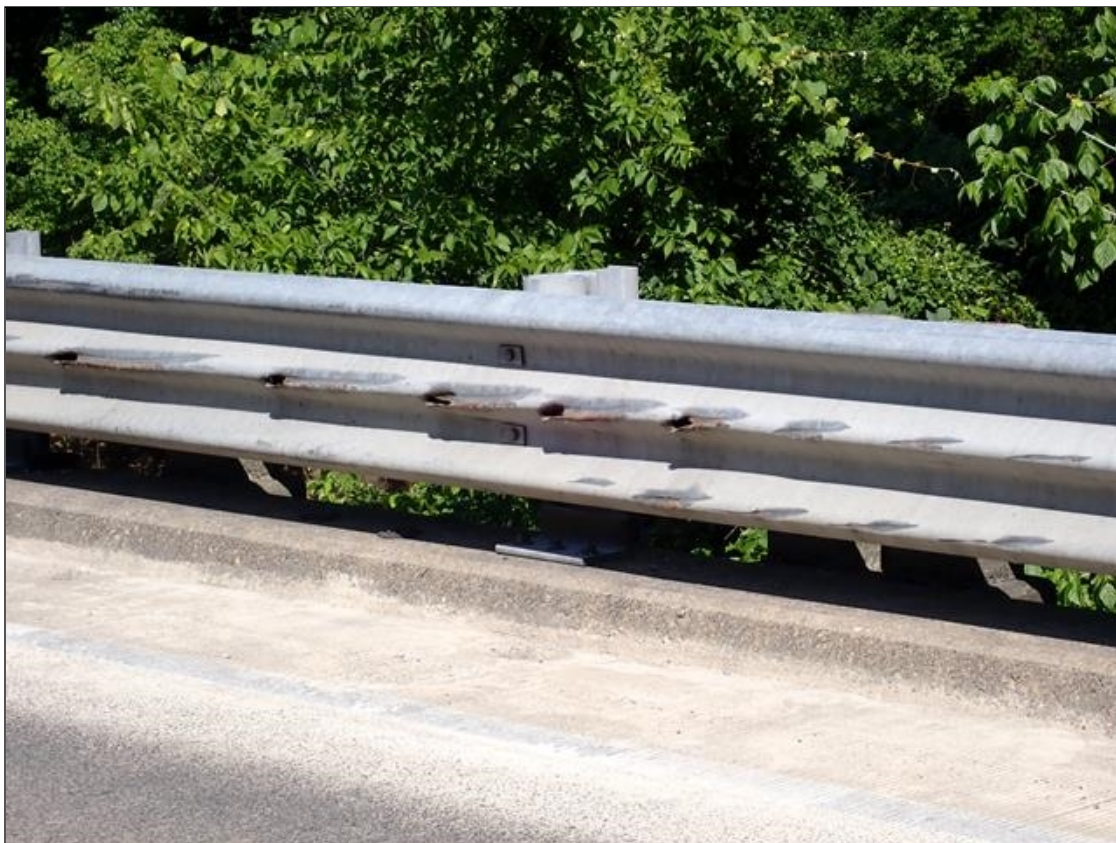
Span 8 Left Retrofit Bridge Rail: (PAR) IMPACT DAMAGE WITH SCRAPE MARKS AND THROUGH HOLES IN RETROFIT RAIL AT SCATTERED LOCATIONS

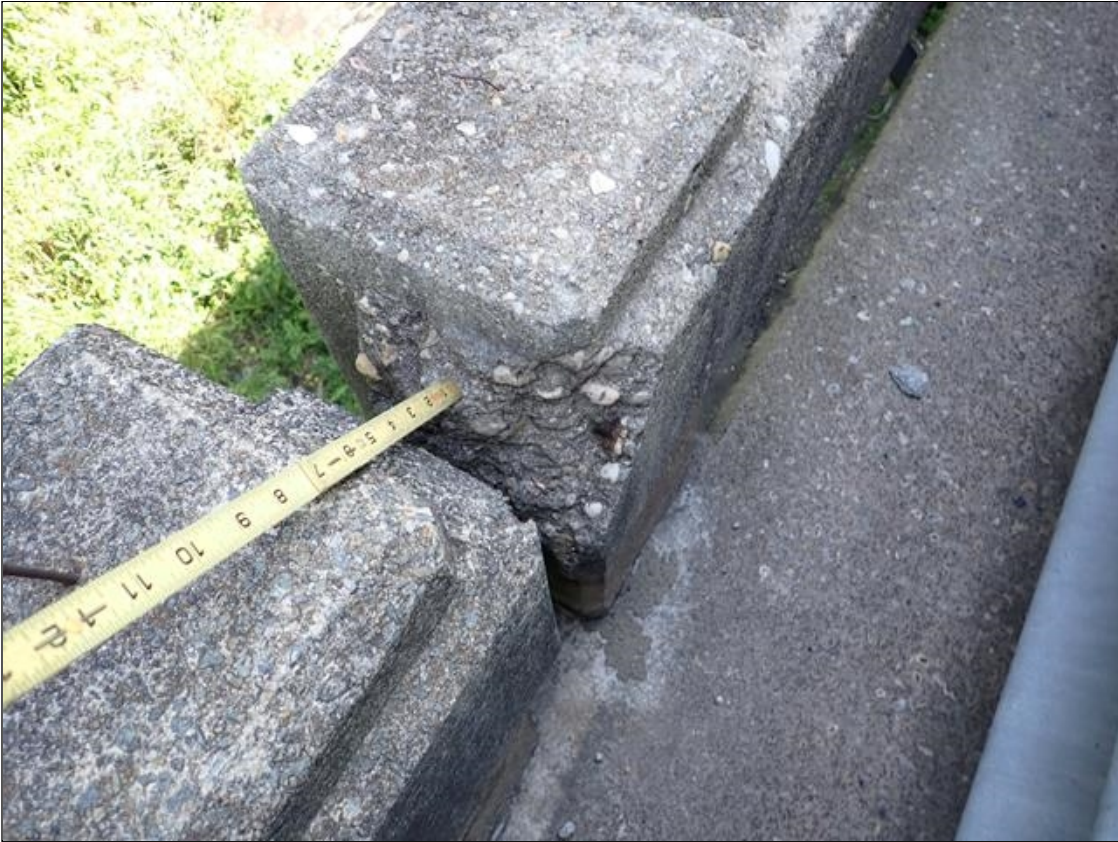
Span 8 Left Bridge Rail: TOP OF RAIL AT FIRST RAIL JOINT FROM END BENT 2, 8 INCHES WIDE X 8 INCHES HIGH X UP TO 3 INCHES DEEP SPALL WITH EXPOSED REINFORCEMENT

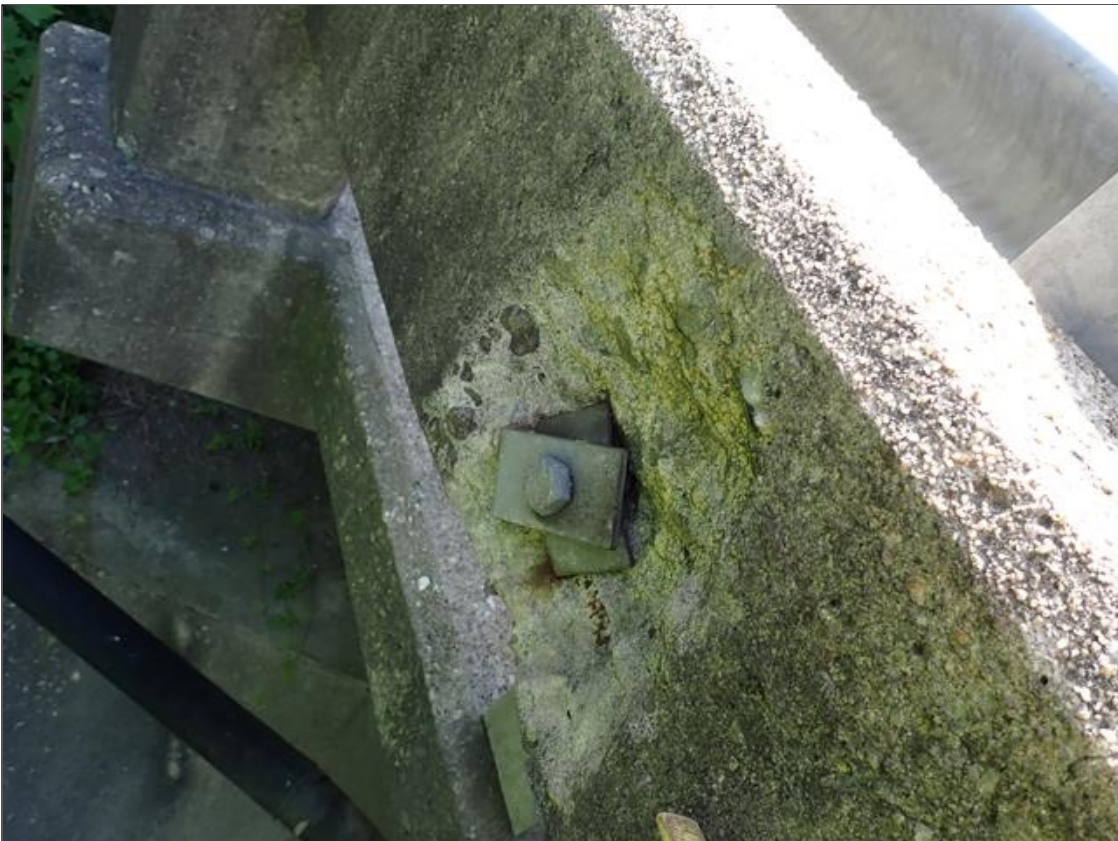
Span 8 Left Bridge Rail: BETWEEN POSTS 7 AND 8 FROM BENT 7, 6 INCH DIAMETER X 1.5 INCH DEEP SPALLS IN EXTERIOR FACE AT ANCHOR BOLT CONNECTION TO RETROFIT RAIL

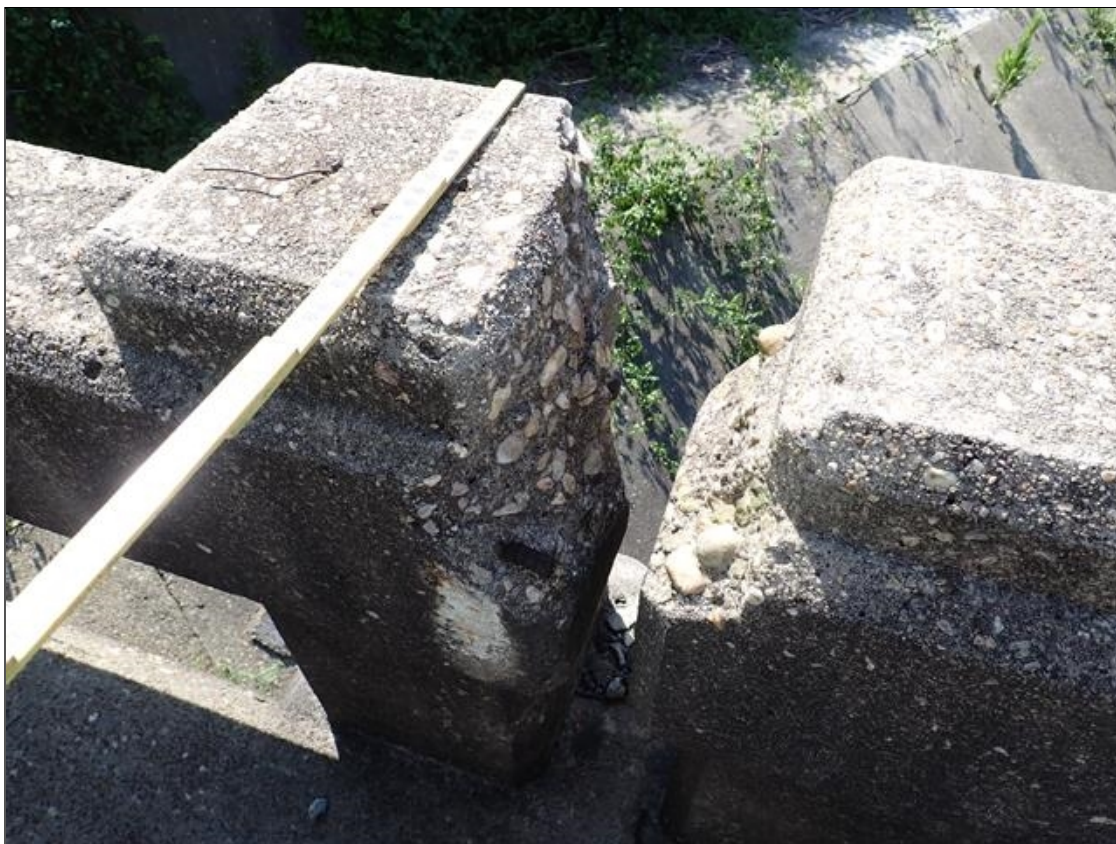
Span 8 Right Bridge Rail: at posts 6 and 7 from bent 7, spalls (up to 16 inch x 12 inch x 2 inch deep) with exposed rusted rebar

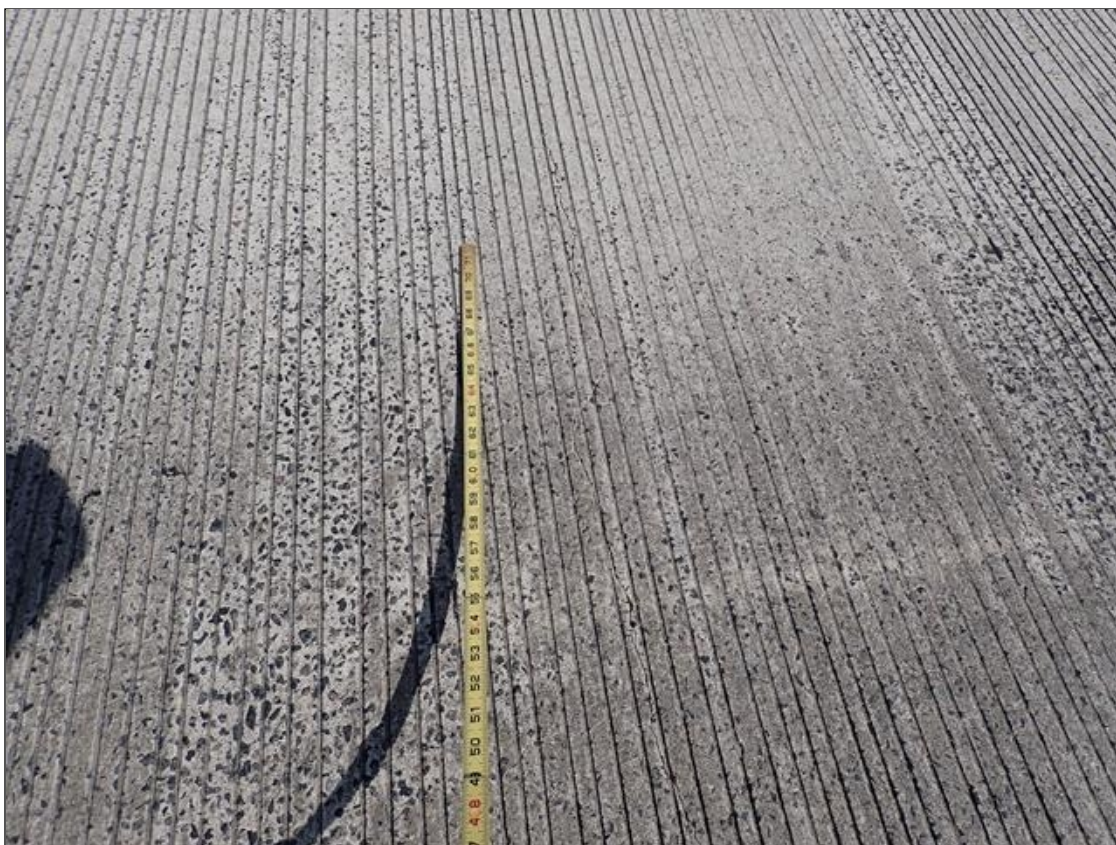
Span 7 Deck: throughout top of deck, longitudinal and transverse cracks (up to 1/32 inch x 16 foot) at random

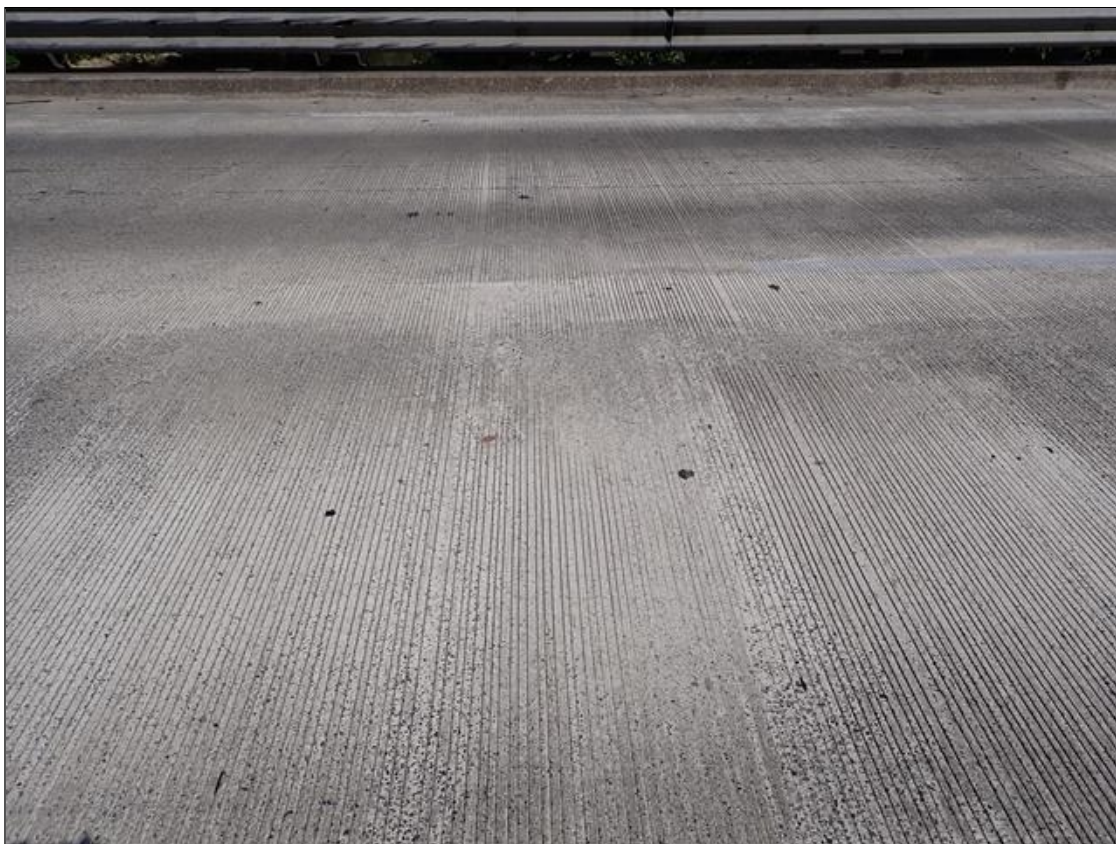
Span 7 Deck: throughout top of deck, wear with secure aggregate at random

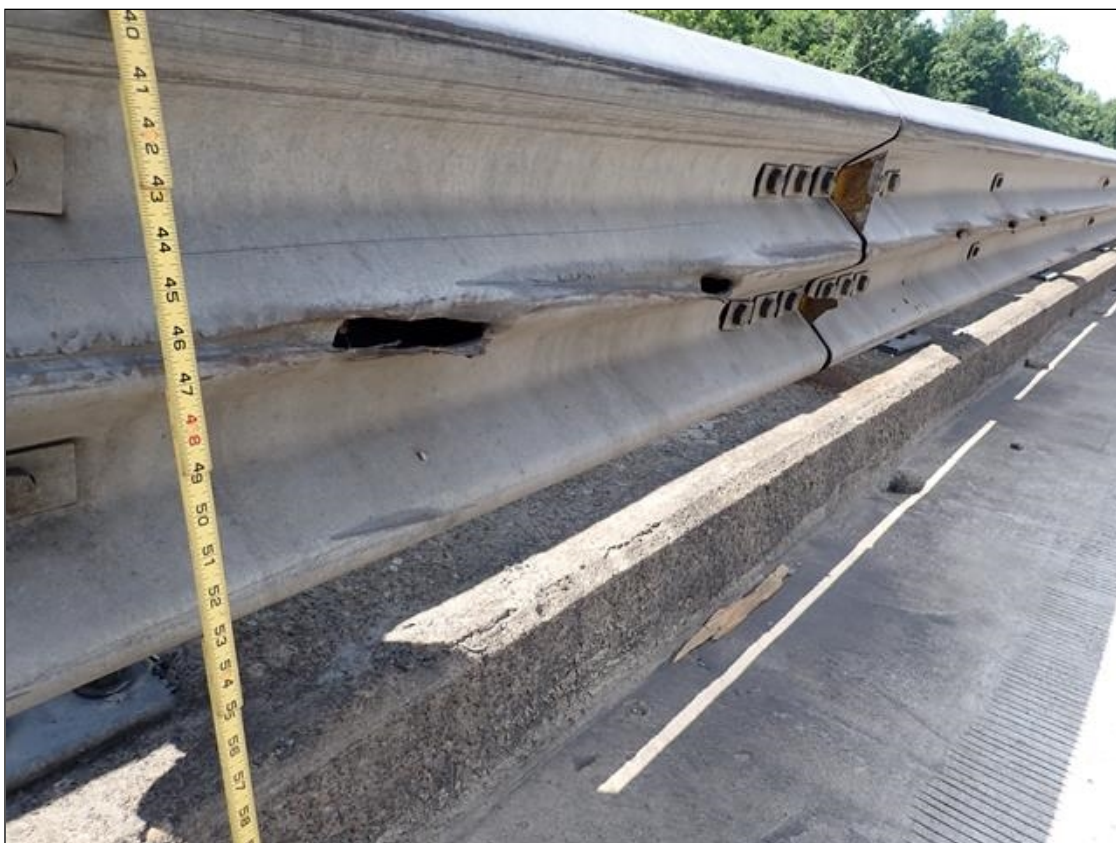
Span 7 Right Retrofit Bridge Rail: (PAR) IMPACT DAMAGE WITH SCRAPE MARKS AND THROUGH HOLES UP TO 4 INCH X 2 INCH IN RETROFIT RAIL AT SCATTERED LOCATIONS

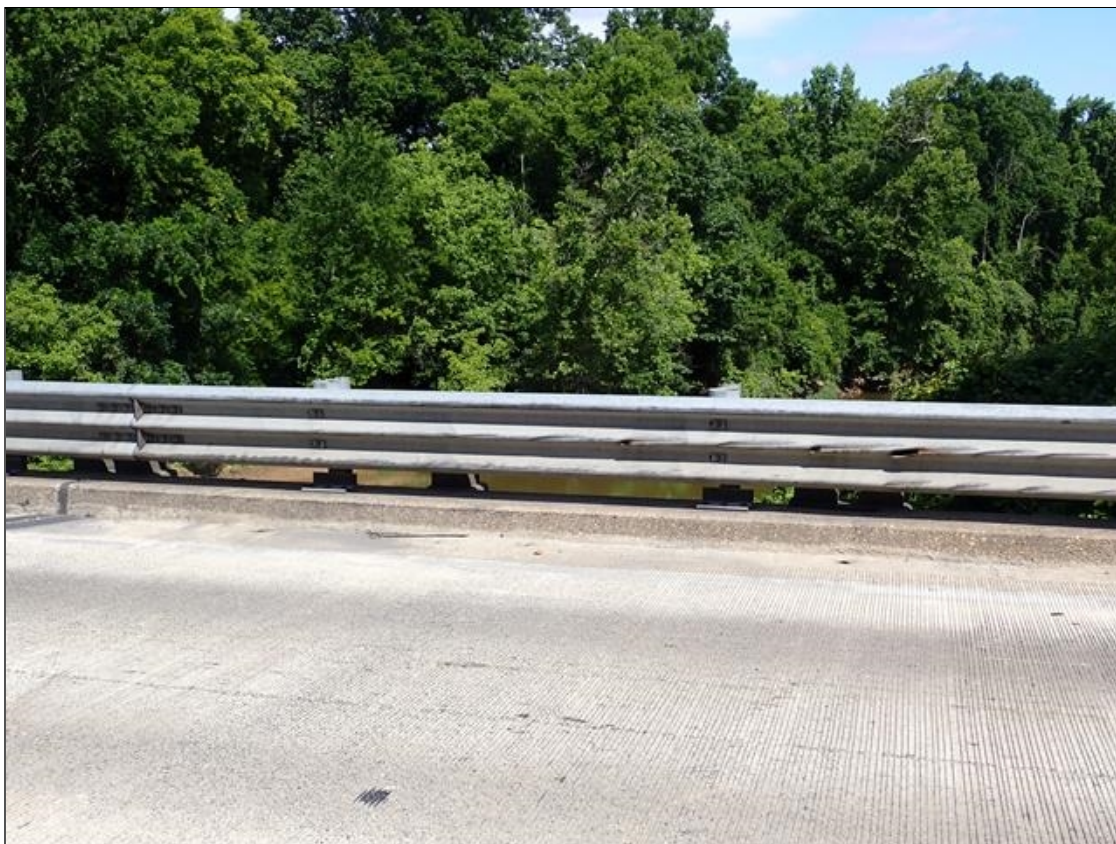
Span 7 Left Retrofit Bridge Rail: (PAR) IMPACT DAMAGE WITH SCRAPE MARKS AND THROUGH HOLES UP TO 4 INCH X 2 INCH IN RETROFIT RAIL AT SCATTERED LOCATIONS
