NC DEPARTMENT OF TRANSPORTATION
 DIVISION OF HIGHWAYS
 STRUCTURE MANAGEMENT UNIT
 COUNTY: JOHNSTON DIV: 4

ATTENTION: PARS Submitted Sign Notice Issued
 sketches revised; new repairs

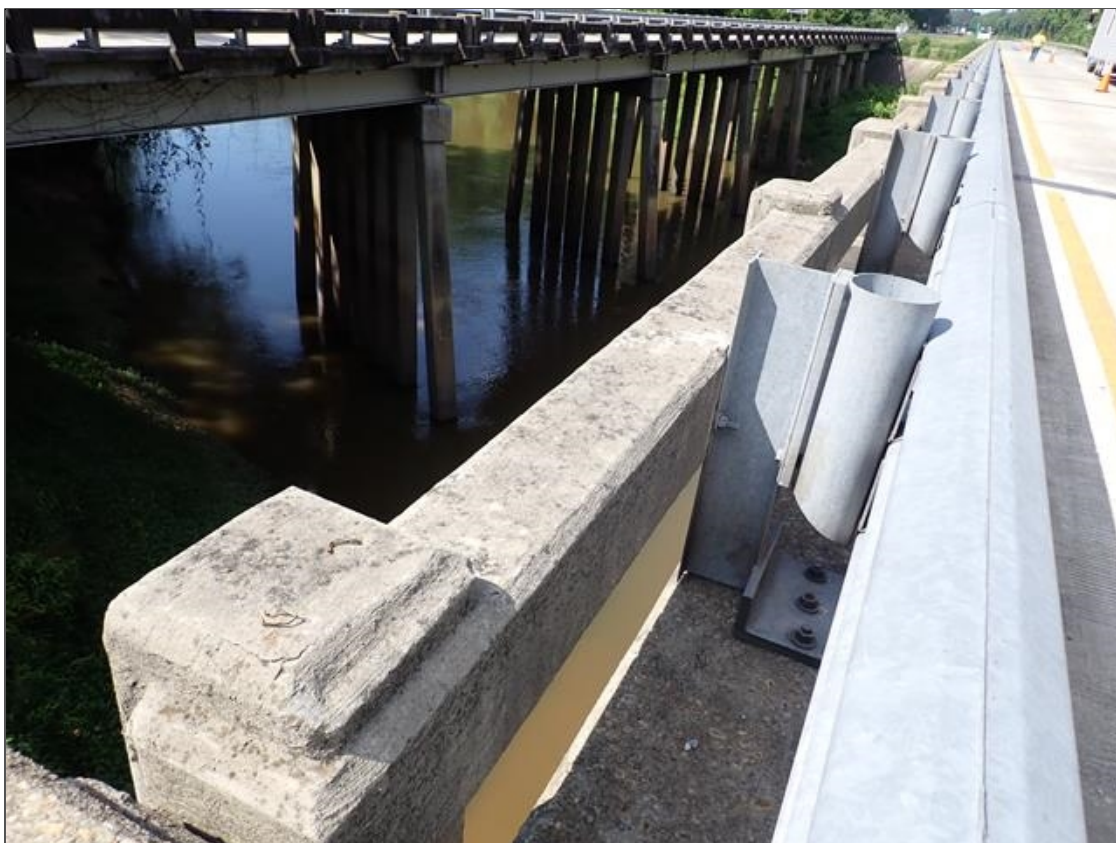
Span 7 Right Bridge Rail: AT MIDSPAN, 15 FEET LONG SECTION OF CONCRETE RAIL HAS BEEN REPLACED

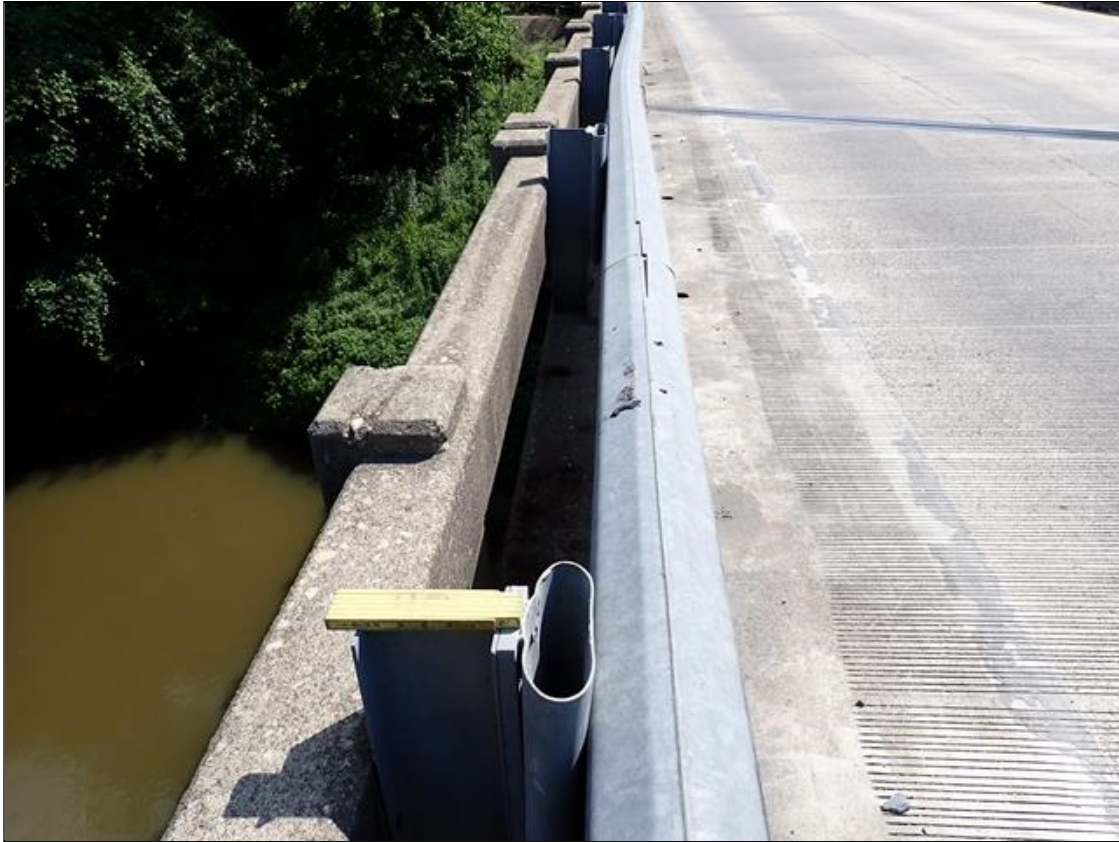
Span 6 Left Retrofit Bridge Rail: (PAR) IMPACT DAMAGE WITH AND THROUGH HOLES UP TO 4 INCH X 2 INCH AND UP TO 5 INCHES DEFLECTION TOWARDS WEST TO THE SUPPLEMENTAL BRIDGE RAIL FOR 20 FEET LONG STARTING AT BENT 6. TWO (2) SPACER BLOCKS CONNECTING THE GUARDRAIL TO POSTS ARE PARTIALLY CRUSHED.

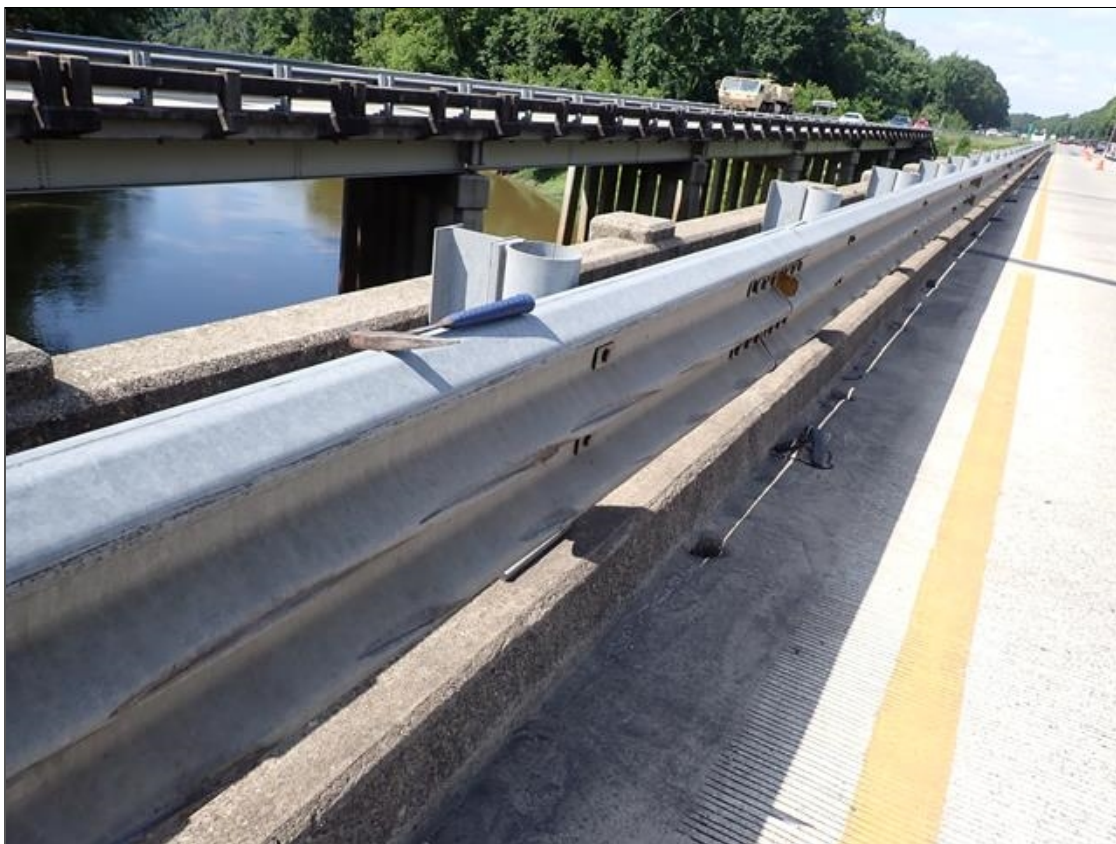
Span 6 Right Retrofit Bridge Rail: (PAR) IMPACT DAMAGE WITH SCRAPE MARKS AND THROUGH HOLES UP TO 4 INCH X 2 INCH IN RETROFIT RAIL AT SCATTERED LOCATIONS

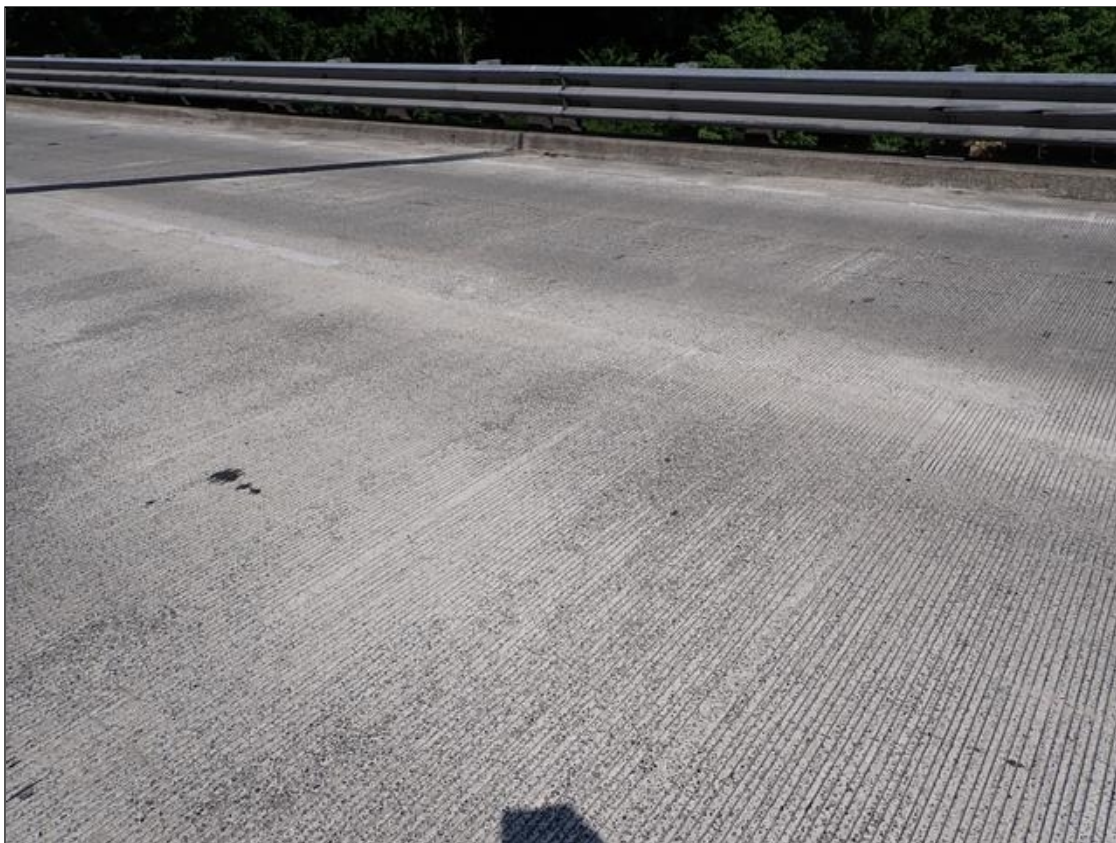
Span 6 Deck: throughout top of deck, wear with secure aggregate at random

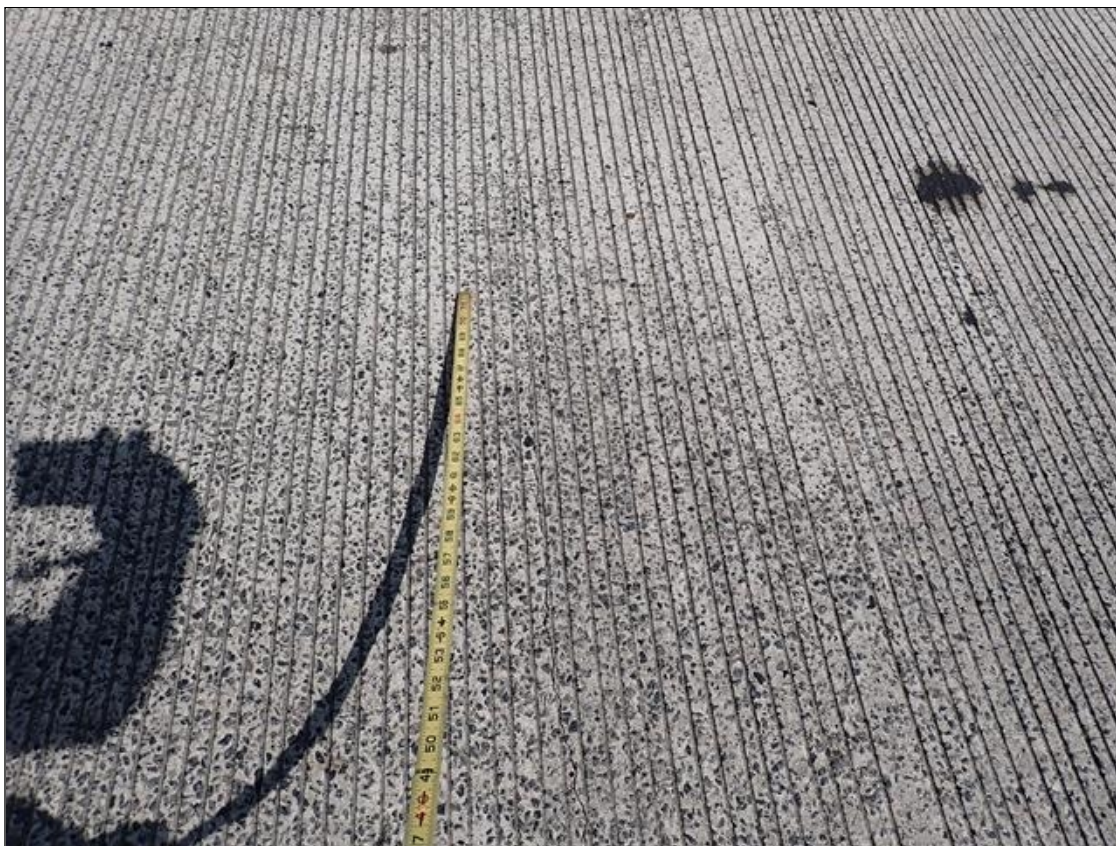
Span 6 Deck: throughout top of deck, longitudinal and transverse cracks (up to 1/32 inch x 16 foot) at random

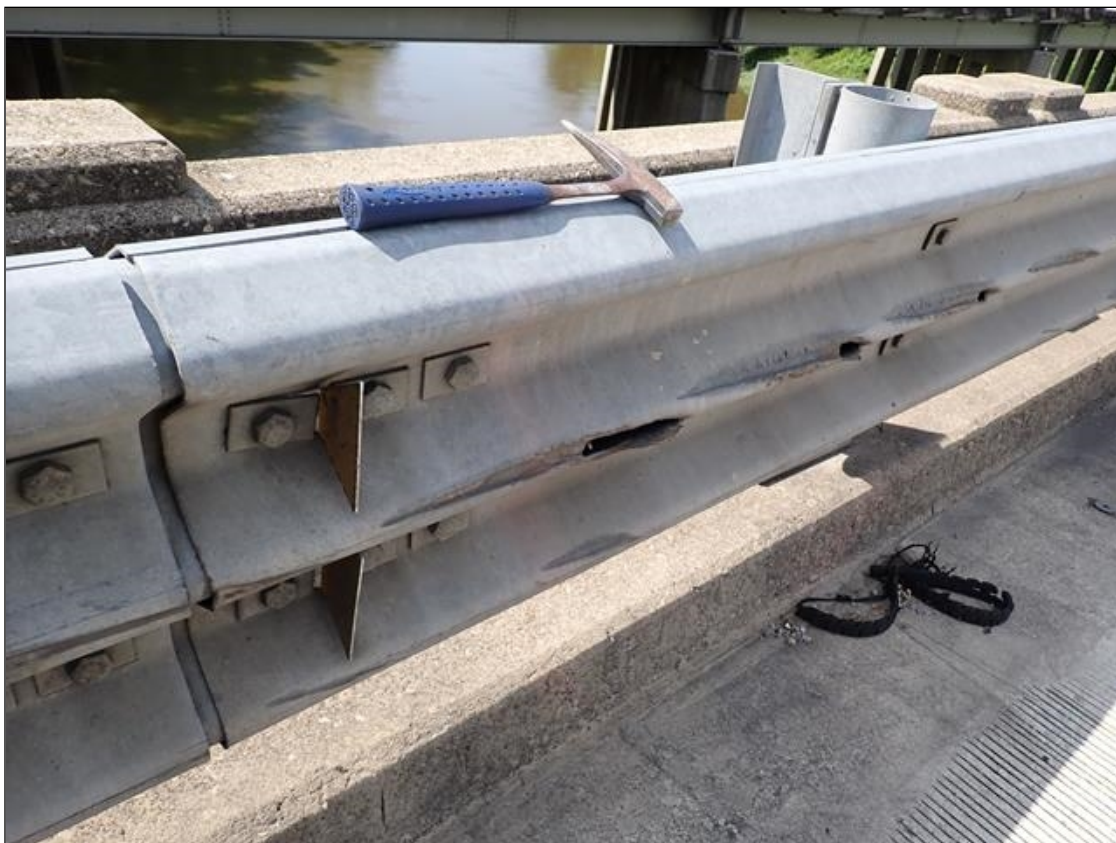
Span 5 Right Retrofit Bridge Rail: (PAR) IMPACT DAMAGE WITH SCRAPE MARKS AND THROUGH HOLES UP TO 4 INCH X 2 INCH IN RETROFIT RAIL AT SCATTERED LOCATIONS

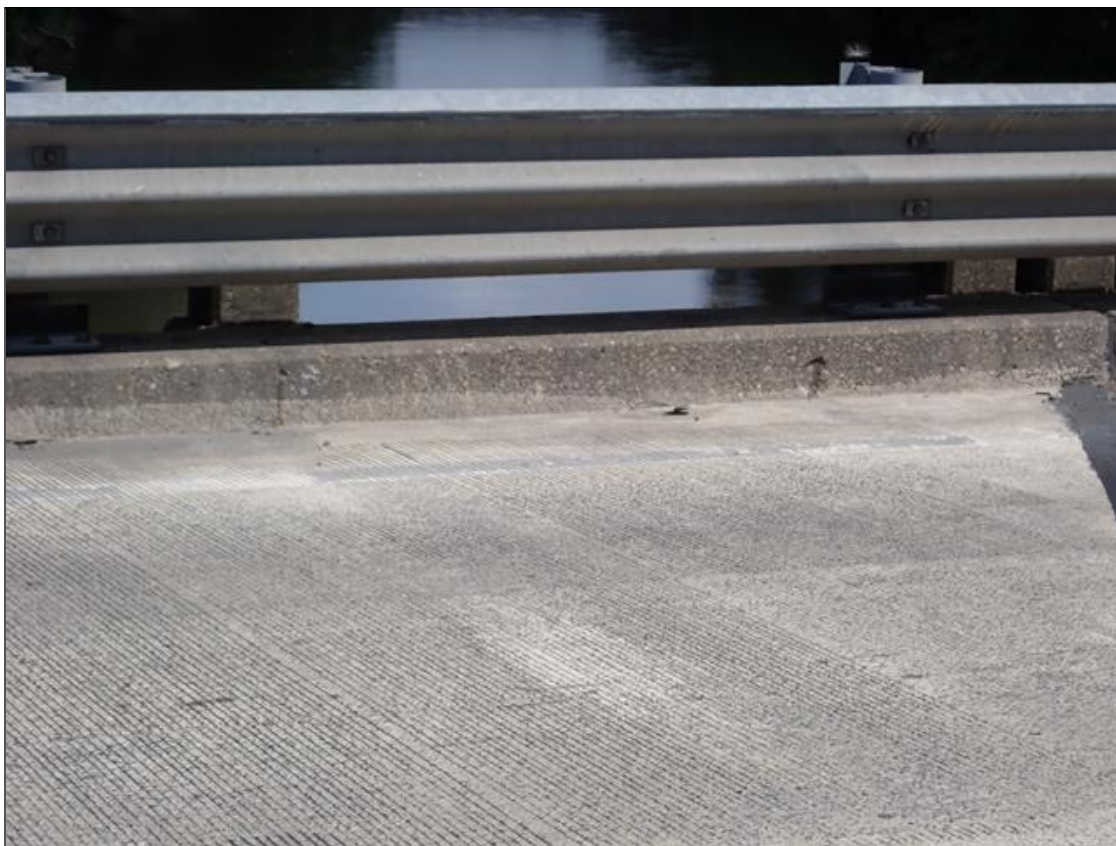
Span 5 Left Bridge Rail: BOTTOM OF CURB NEAR BENT 5 JOINT, (2) UP TO 6 INCH DIAMETER X 1 INCH DEEP SPALLS WITH EXPOSED PAINTED REBAR

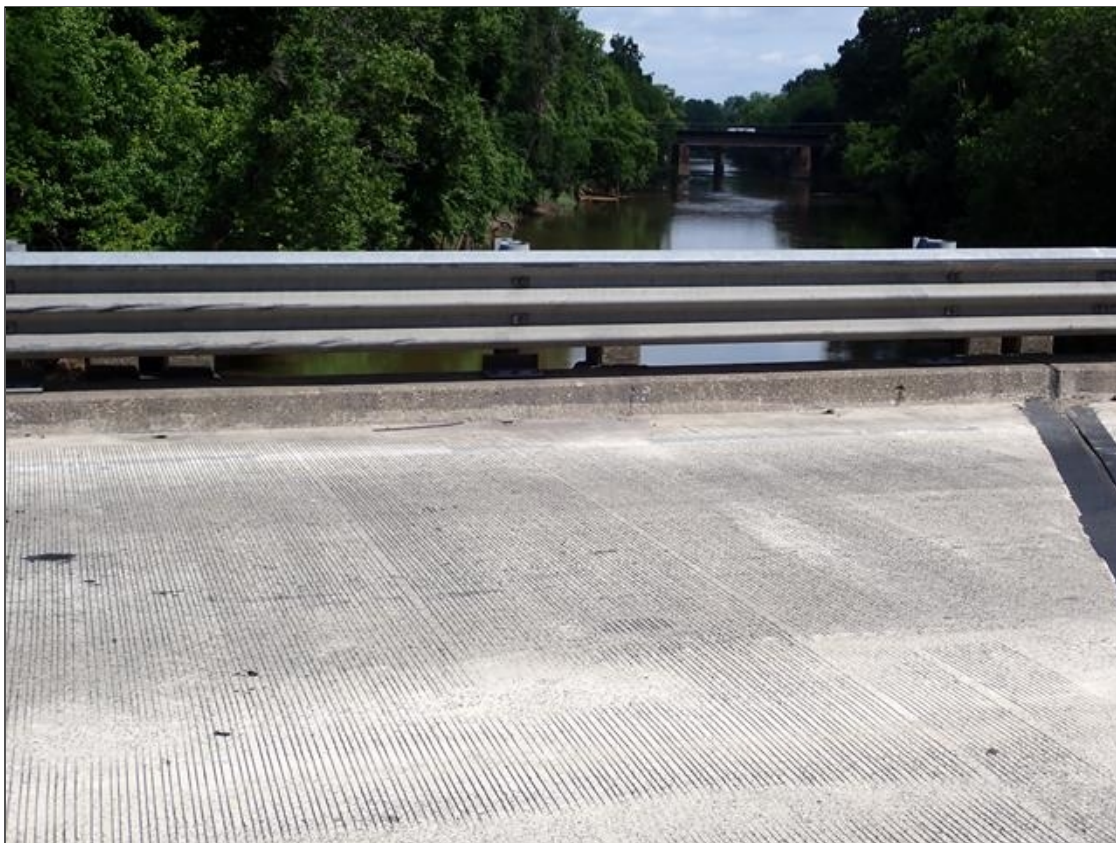
Span 5 Left Bridge Rail: (not found 2025) BOTTOM OF CURB 10 FEET FROM BENT 5, 6 INCH DIAMETER SOUND PATCH

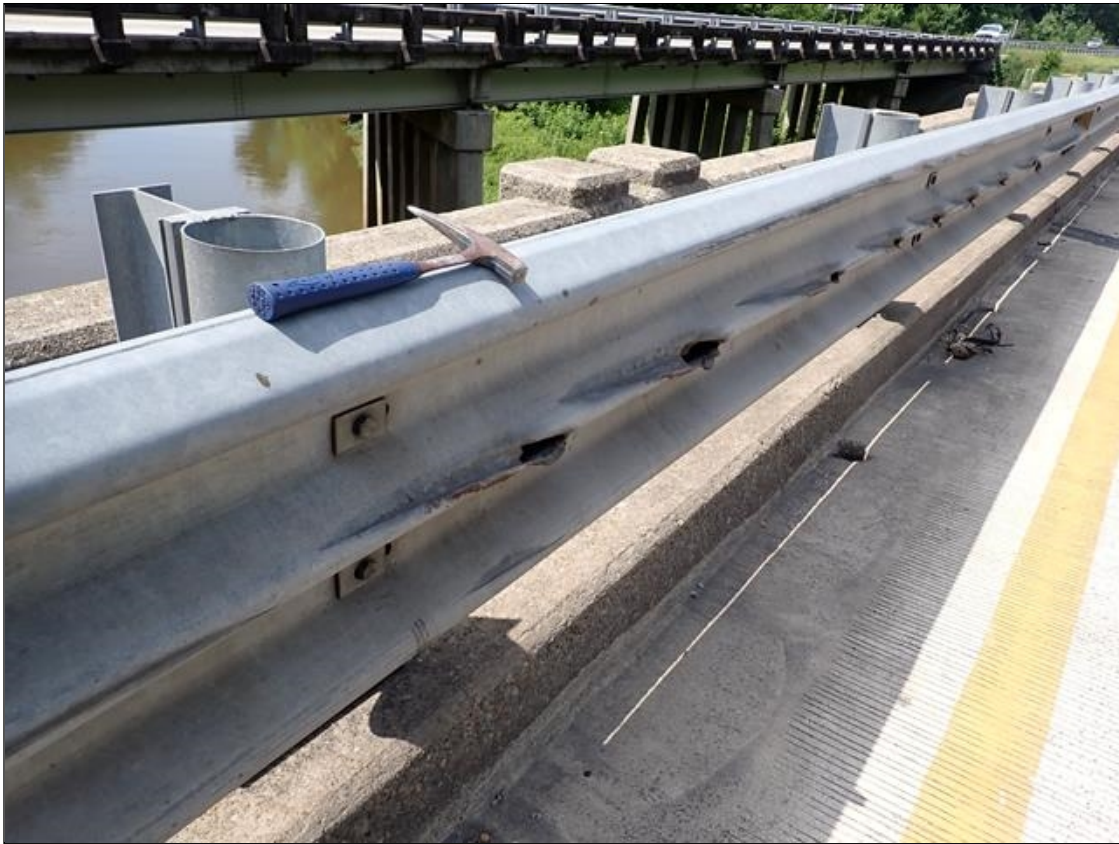
Span 4 Right Retrofit Bridge Rail: (PAR) IMPACT DAMAGE WITH SCRAPE MARKS AND THROUGH HOLES UP TO 4 INCH X 2 INCH IN RETROFIT RAIL AT SCATTERED LOCATIONS

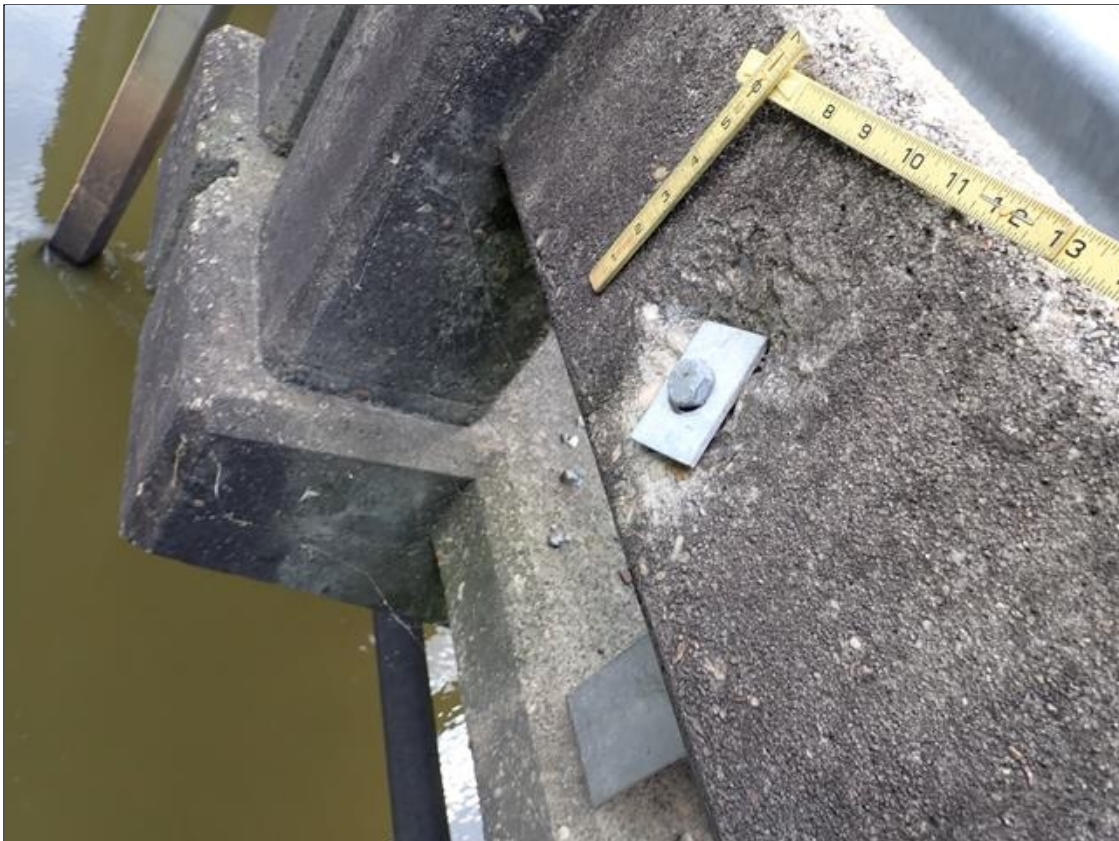
Span 4 Left Bridge Rail: AT 3RD POST FROM BENT 3, 6 INCH DIAMETER X 1 INCH DEEP SPALL IN EXTERIOR FACE AT ANCHOR BOLT CONNECTION TO RETROFIT RAIL

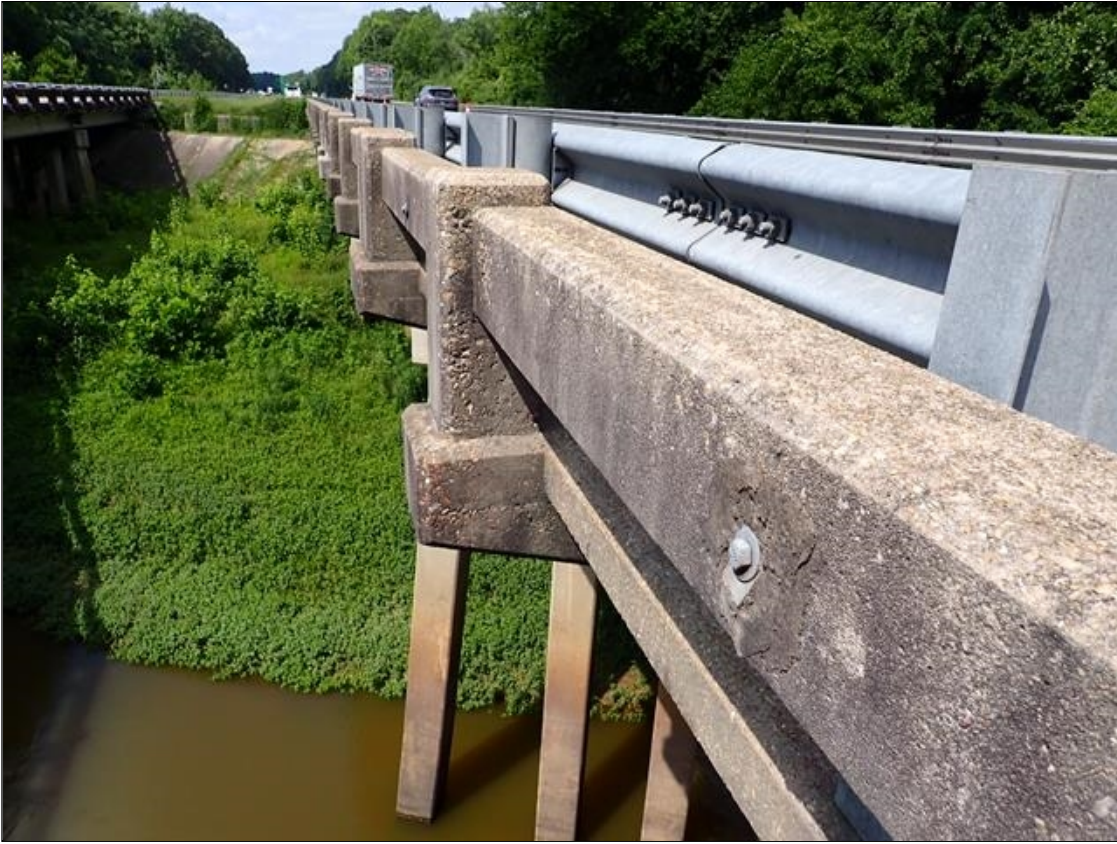
Span 4 Right Bridge Rail: (not found 2025) AT MIDSPAN EXTERIOR FACE, 1.5 FEET LONG X 9 INCHES HIGH X UP TO 1.5 INCHES DEEP SPALL

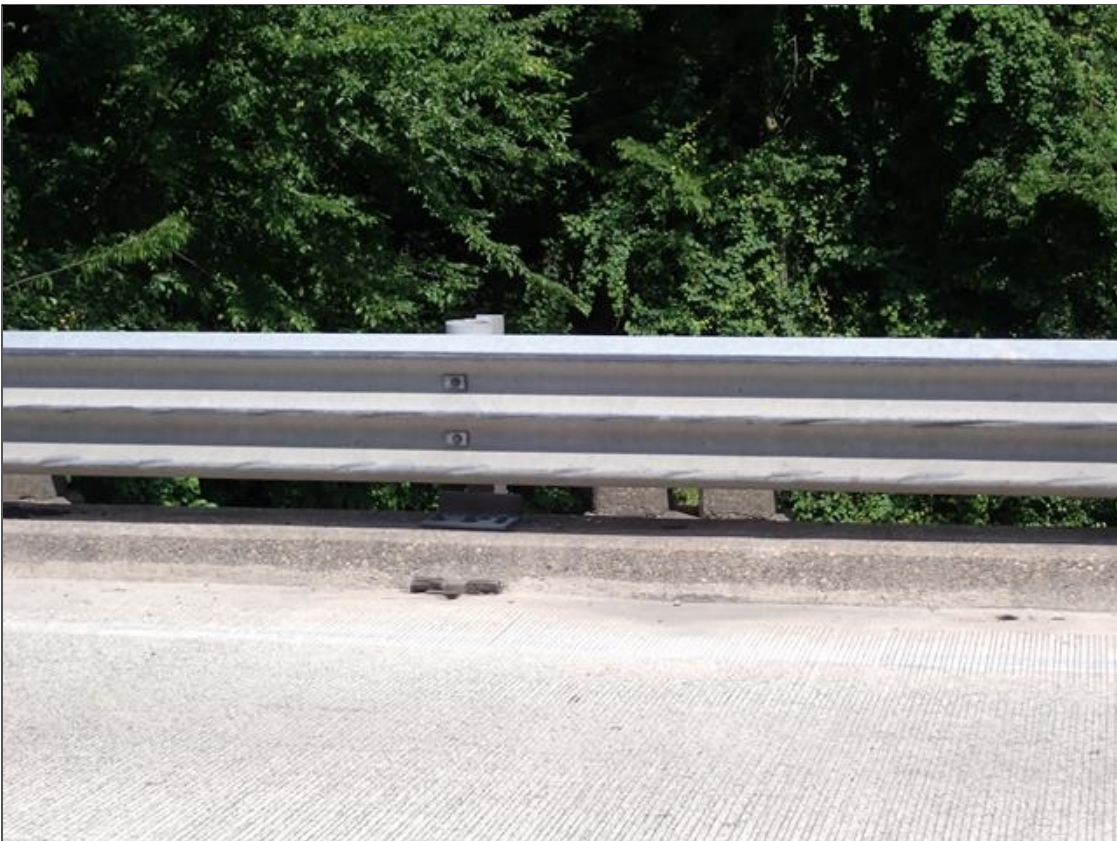
Span 4 Left Retrofit Bridge Rail: (PAR) IMPACT DAMAGE WITH SCRAPE MARKS AND DENTS UP TO 1 INCH DEEP IN RETROFIT RAIL AT SCATTERED LOCATIONS

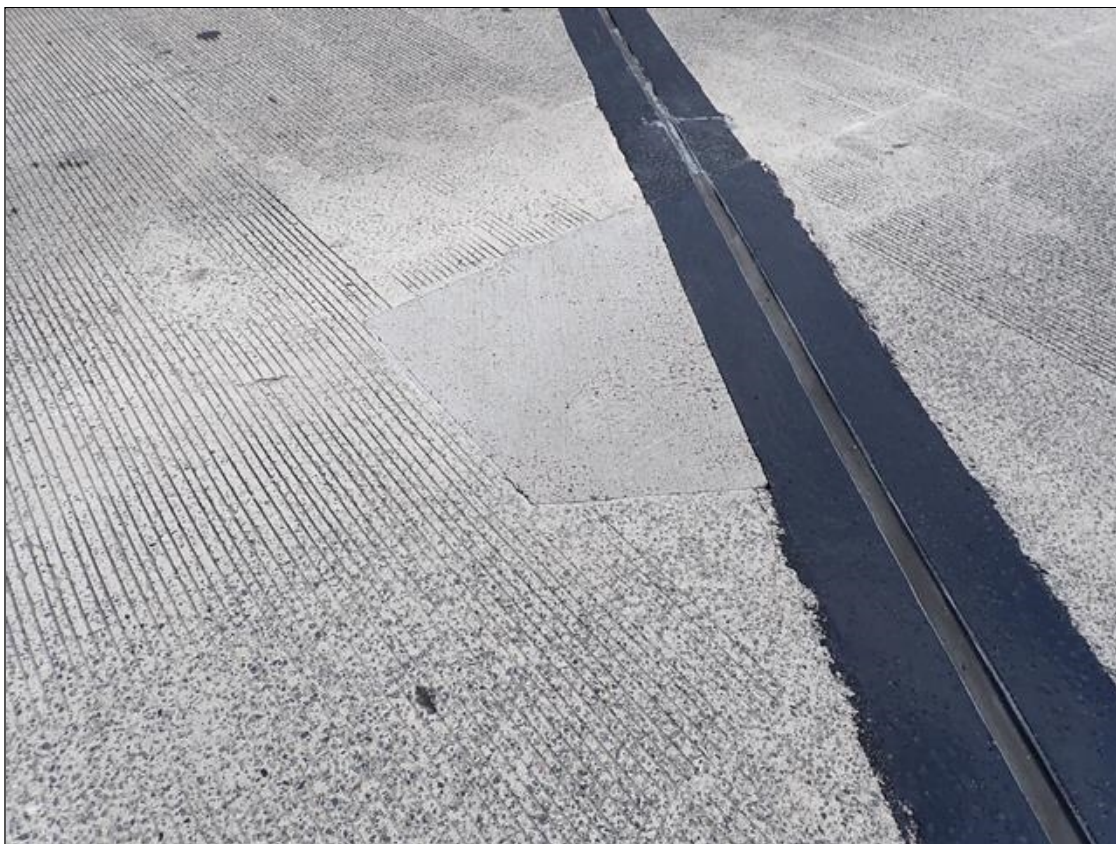
Span 4 Deck: 3 FEET LONG X 2 FEET WIDE SOUND CONCRETE PATCH IN LEFT TRAVEL LANE AT BENT 4.

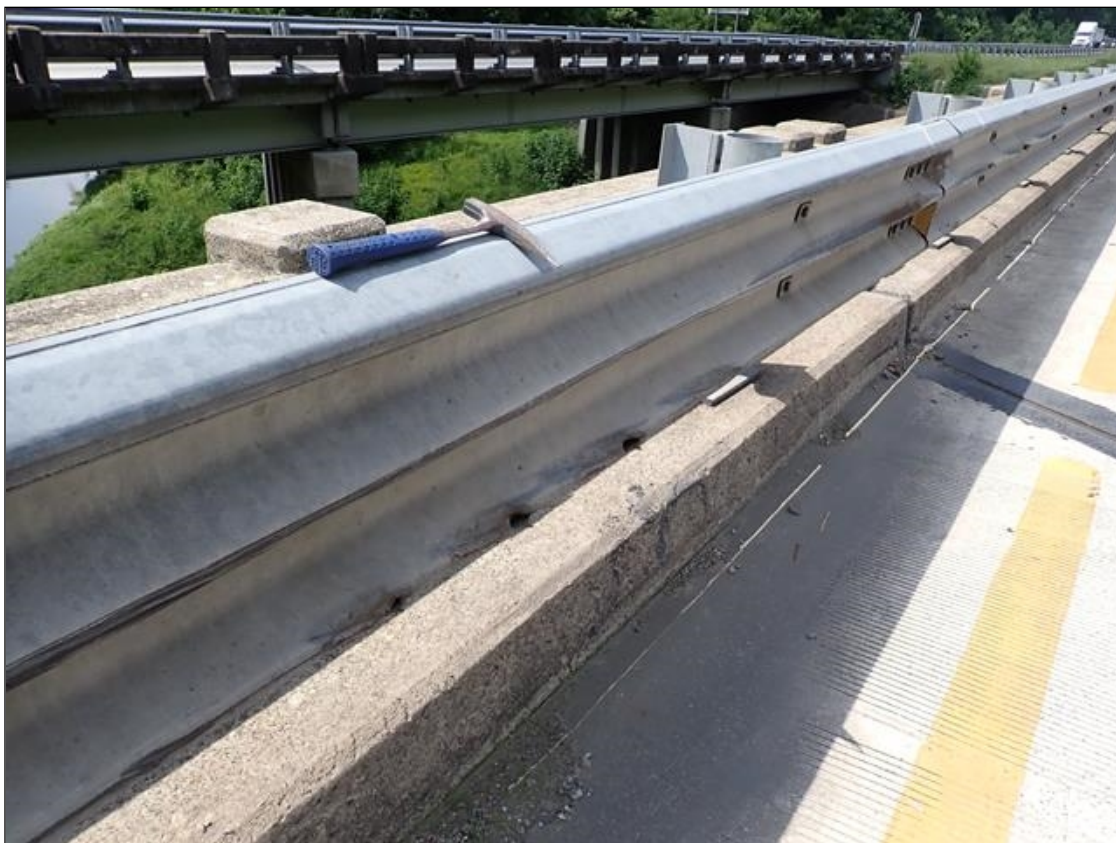
Span 3 Right Retrofit Bridge Rail: (PAR) IMPACT DAMAGE WITH SCRAPE MARKS AND THROUGH HOLES UP TO 4 INCH X 2 INCH IN RETROFIT RAIL AT SCATTERED LOCATIONS

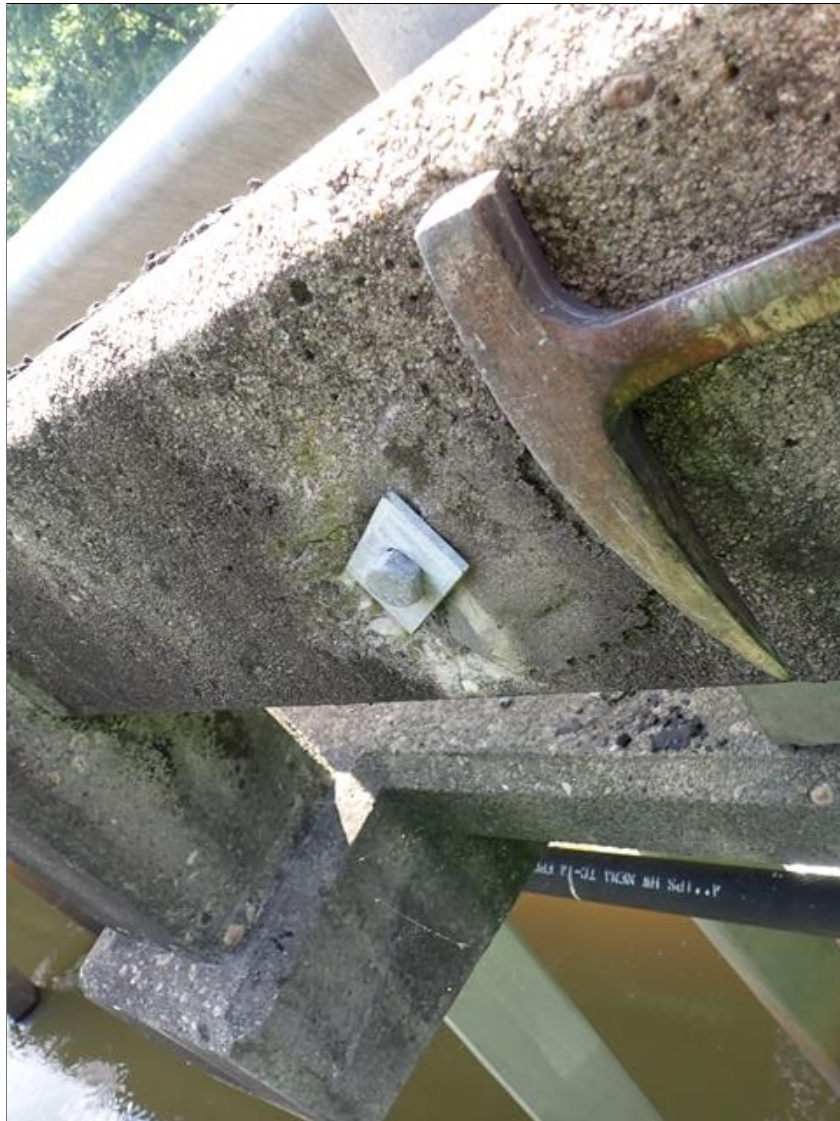
Span 3 Left Bridge Rail: between posts 7 and 8, outside face, spall (6 inch diameter x 1 inch deep)

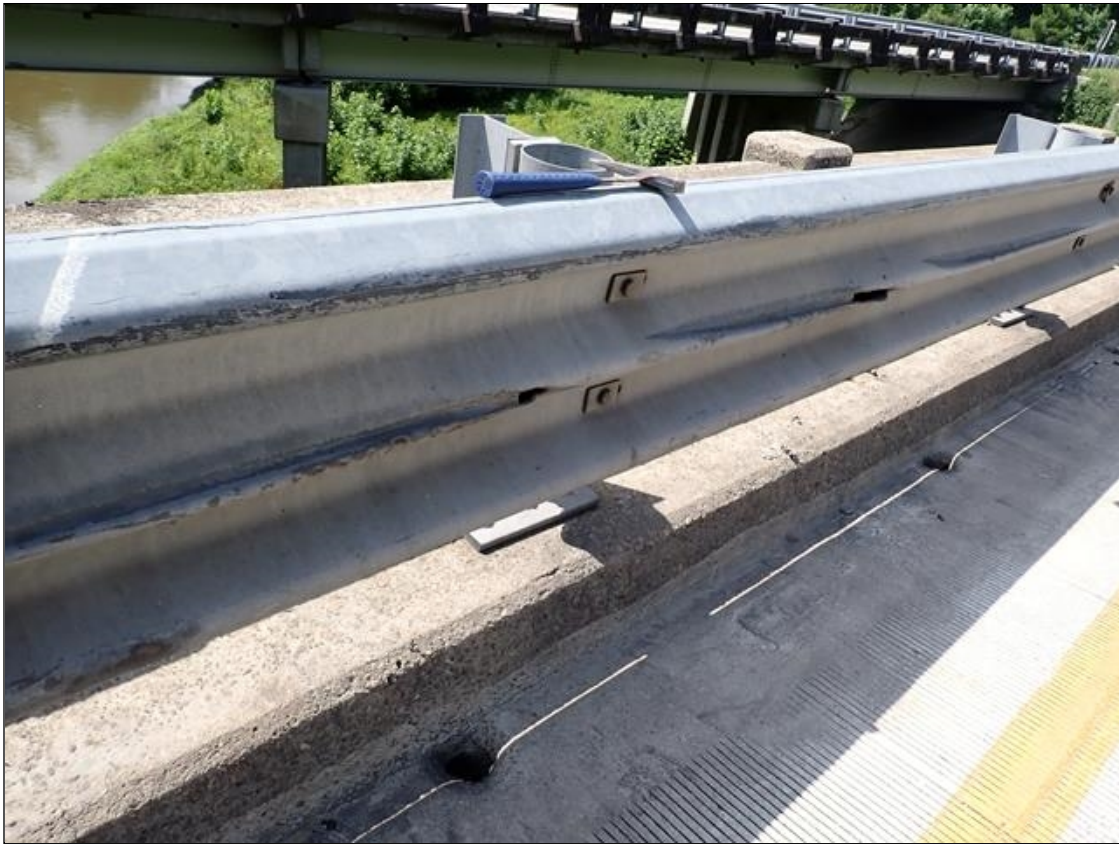
Span 2 Right Retrofit Bridge Rail: (PAR) IMPACT DAMAGE WITH SCRAPE MARKS AND THROUGH HOLES UP TO 4 INCH X 2 INCH IN RETROFIT RAIL AT SCATTERED LOCATIONS

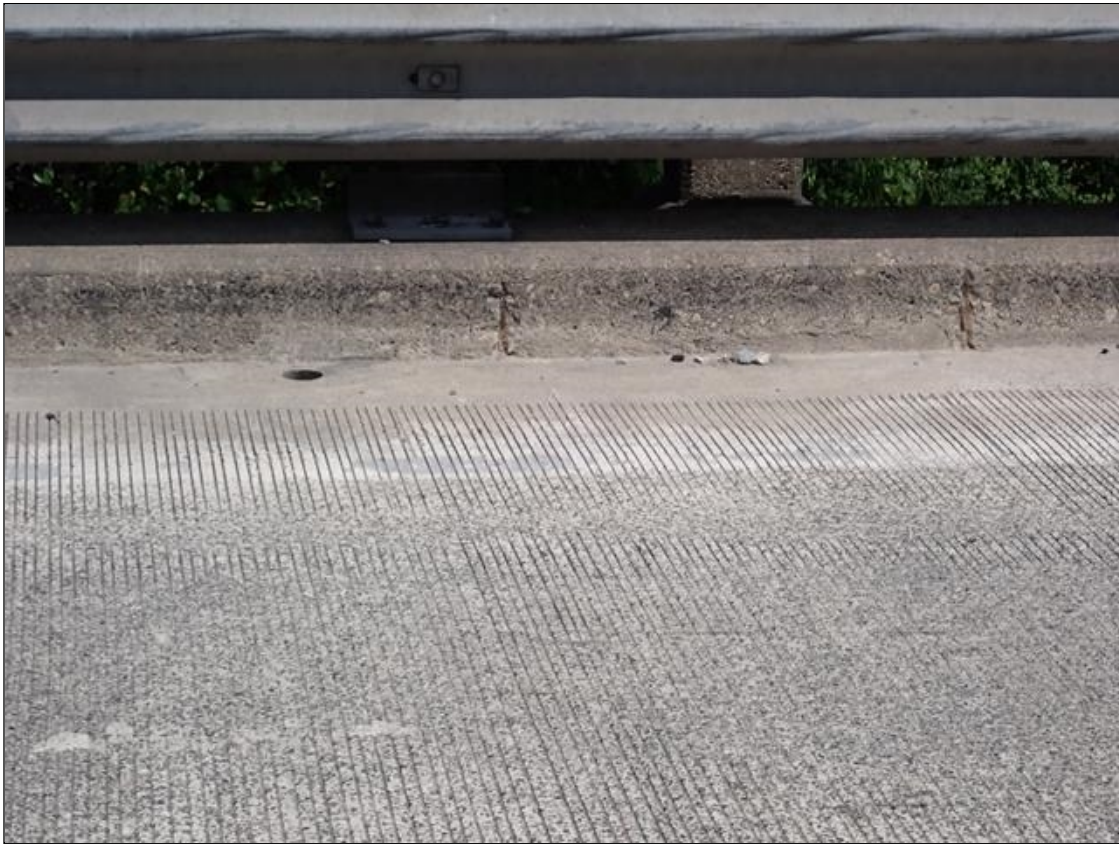
Span 3 Left Bridge Rail: 6 FEET AND 10 FEET FROM BENT 3 JOINT, BOTTOM OF CURB, TWO (2) SPALLS UP TO 8 INCHES DIAMETER X 1 INCH DEEP WITH EXPOSED REINFORCEMENT. NO MEASUREABLE SECTION LOSS IN EXPOSED REINFORCEMENT.

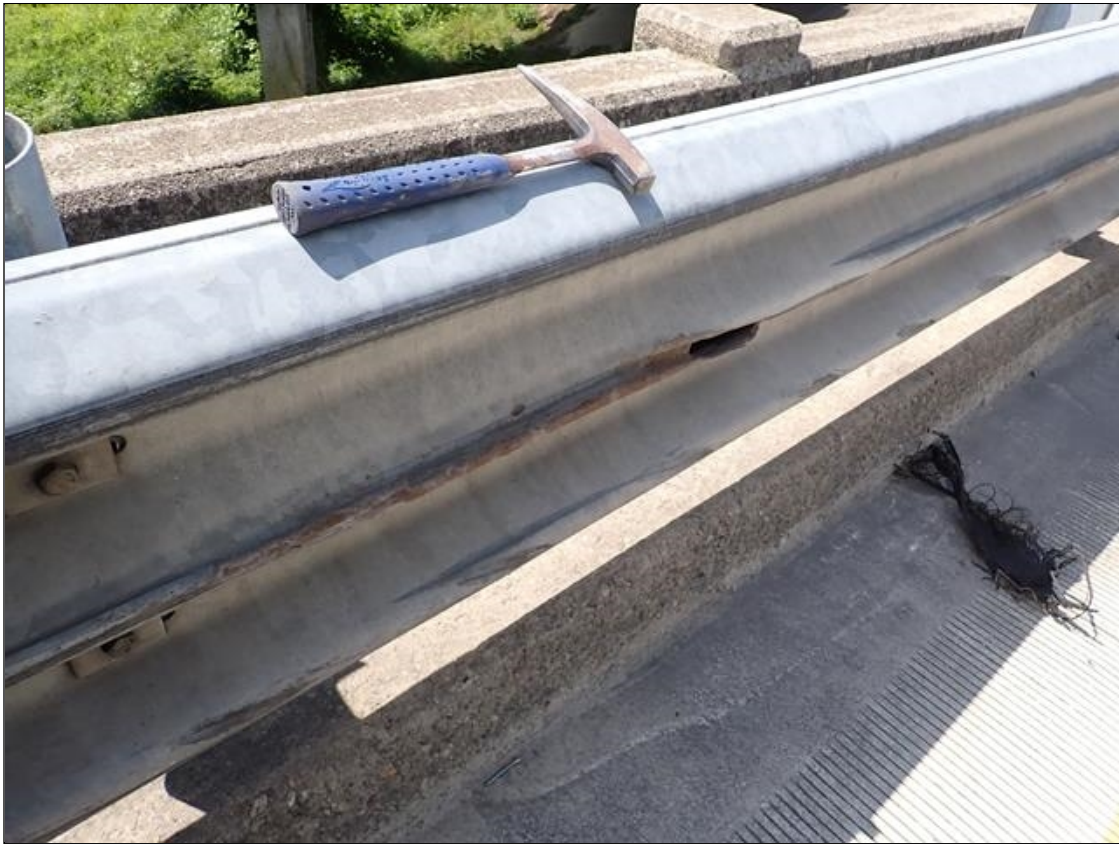
Span 1 Right Retrofit Bridge Rail: (PAR) IMPACT DAMAGE WITH SCRAPE MARKS AND THROUGH HOLES UP TO 4 INCH X 2 INCH IN RETROFIT RAIL AT SCATTERED LOCATIONS

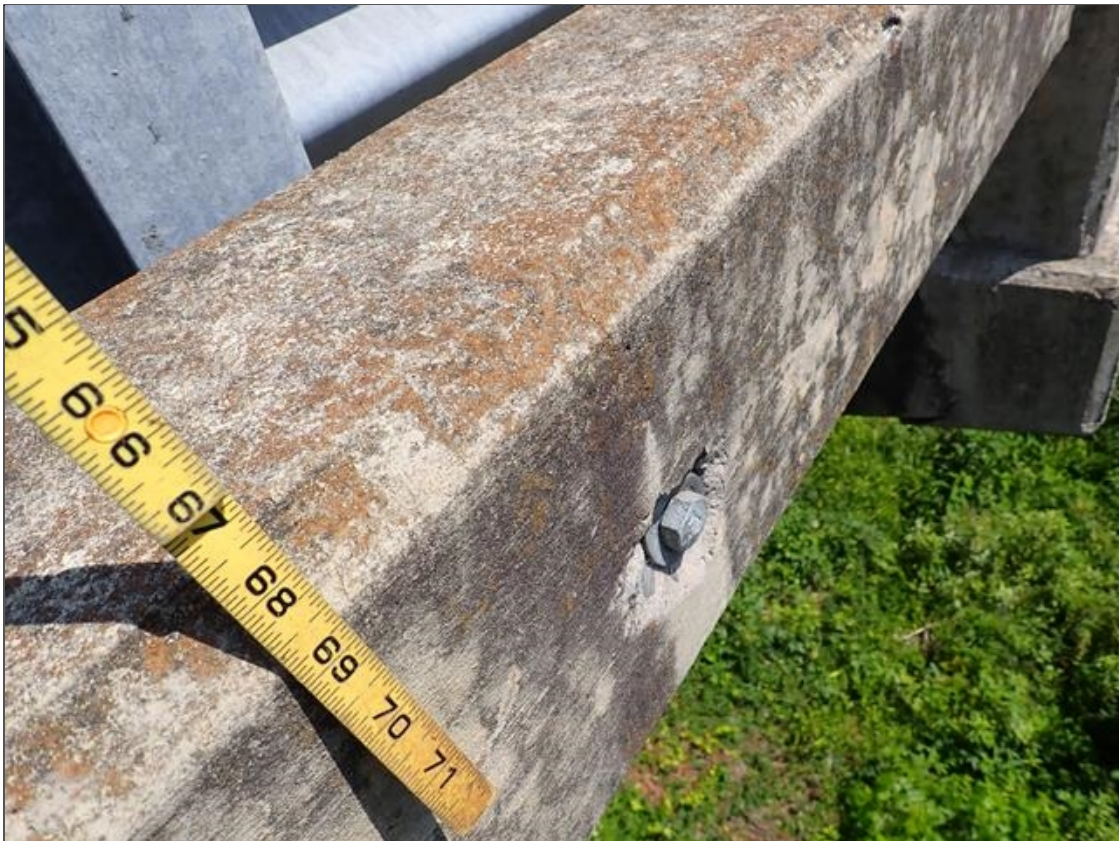
Span 1 Right Bridge Rail: 4 INCH X 3 INCH X 1 INCH DEEP SPALLS IN EXTERIOR FACE AT ANCHOR BOLT CONNECTION TO RETROFIT RAIL AT ISOLATED LOCATIONS

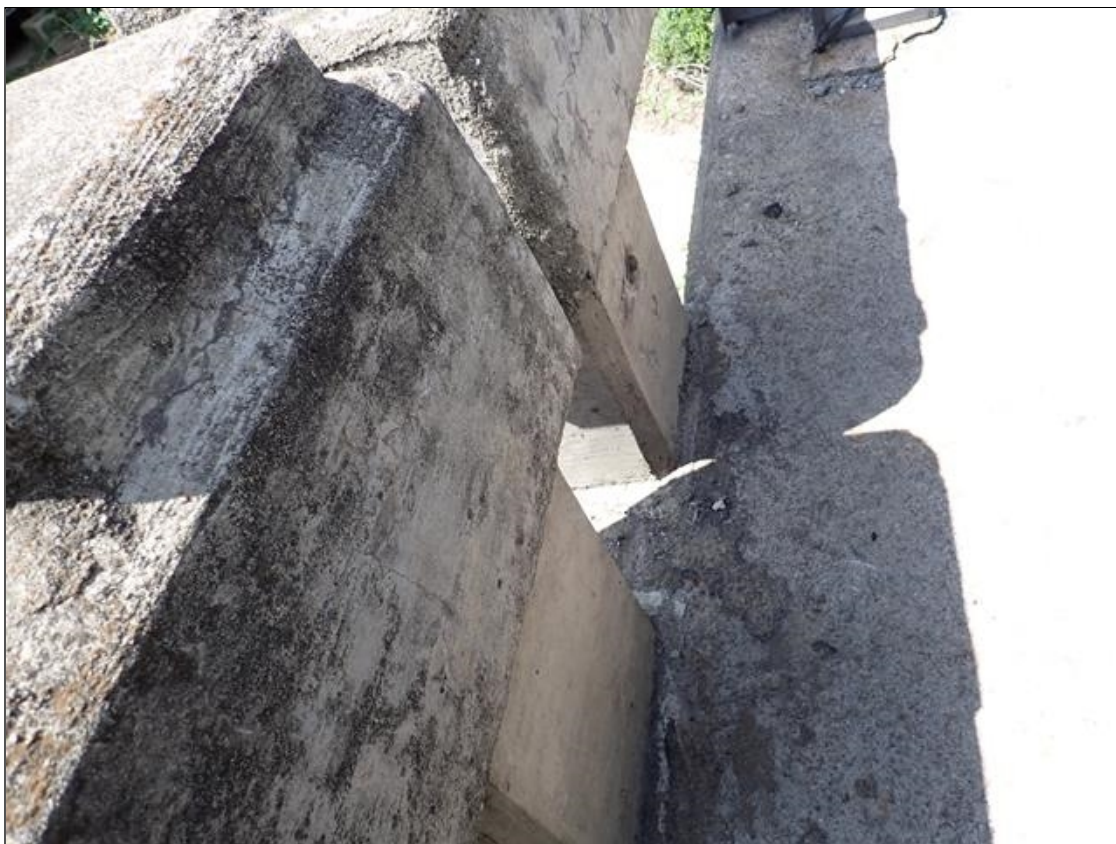
Span 1 Right Bridge Rail: BEGINNING 8 FEET FROM END BENT 1, 20 FEET OF SOUND PATCHING WITH CRACKS (HAIRLINE) AND EFFLORESCENCE

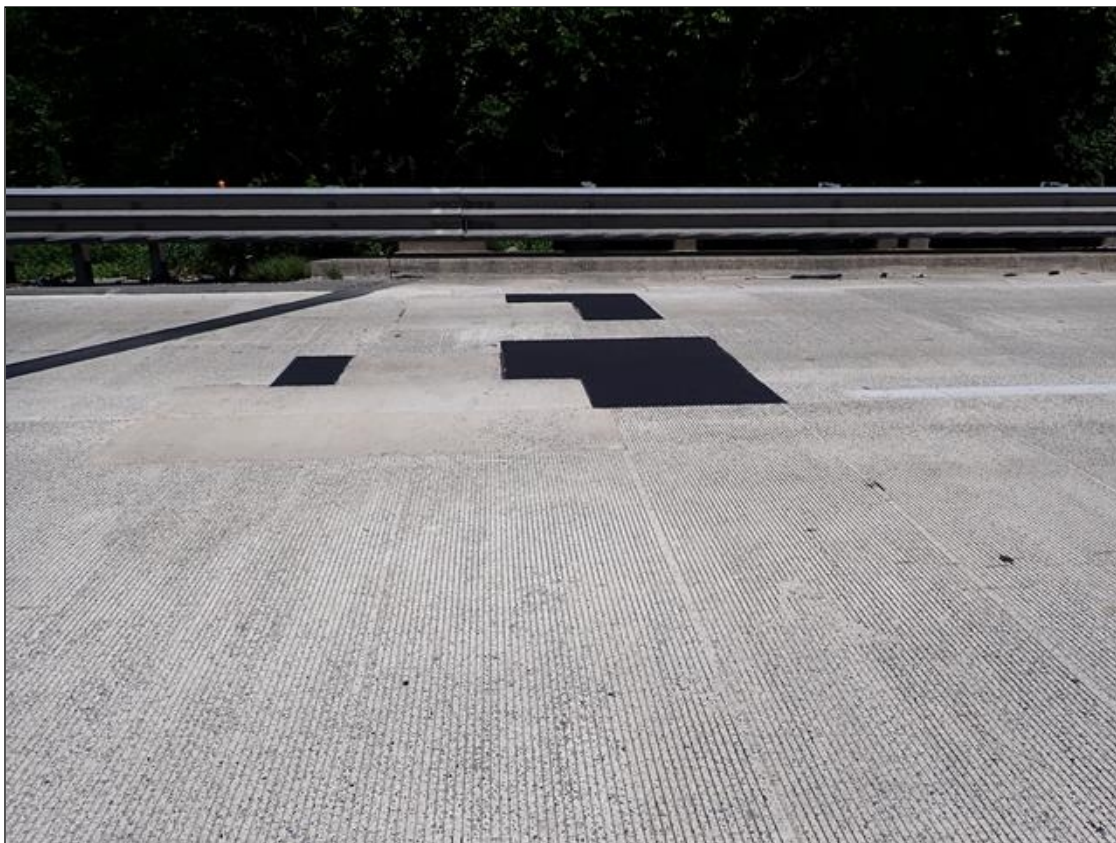
Span 1 Deck: NEAR END BENT 1 IN BOTH LANES PATCHES UP TO 6 FEET X 6 FEET WITH CRACKS (HAIRLINE)

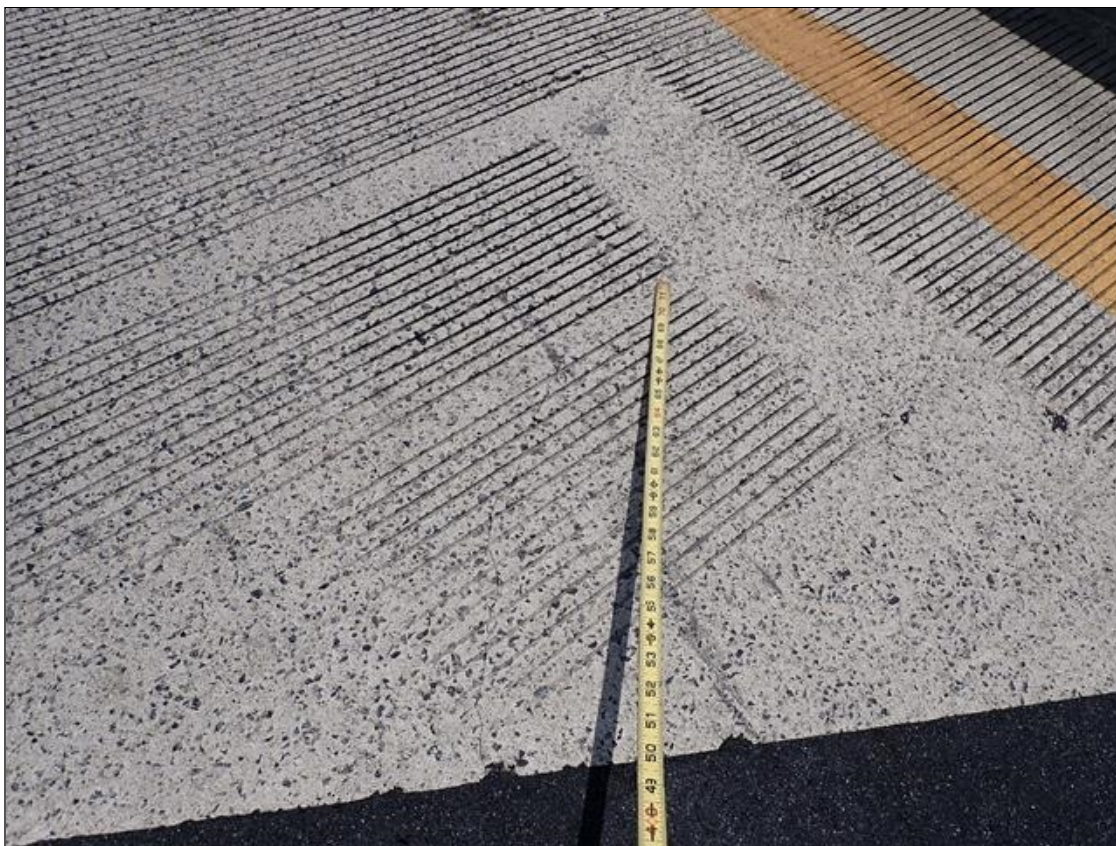
Span 1 Deck: UP TO 5 FEET LONG X 1/32 INCH WIDE LONGITUDINAL AND DIAGONAL CRACKS IN BOTH TRAVEL LANES, SCATTERED.

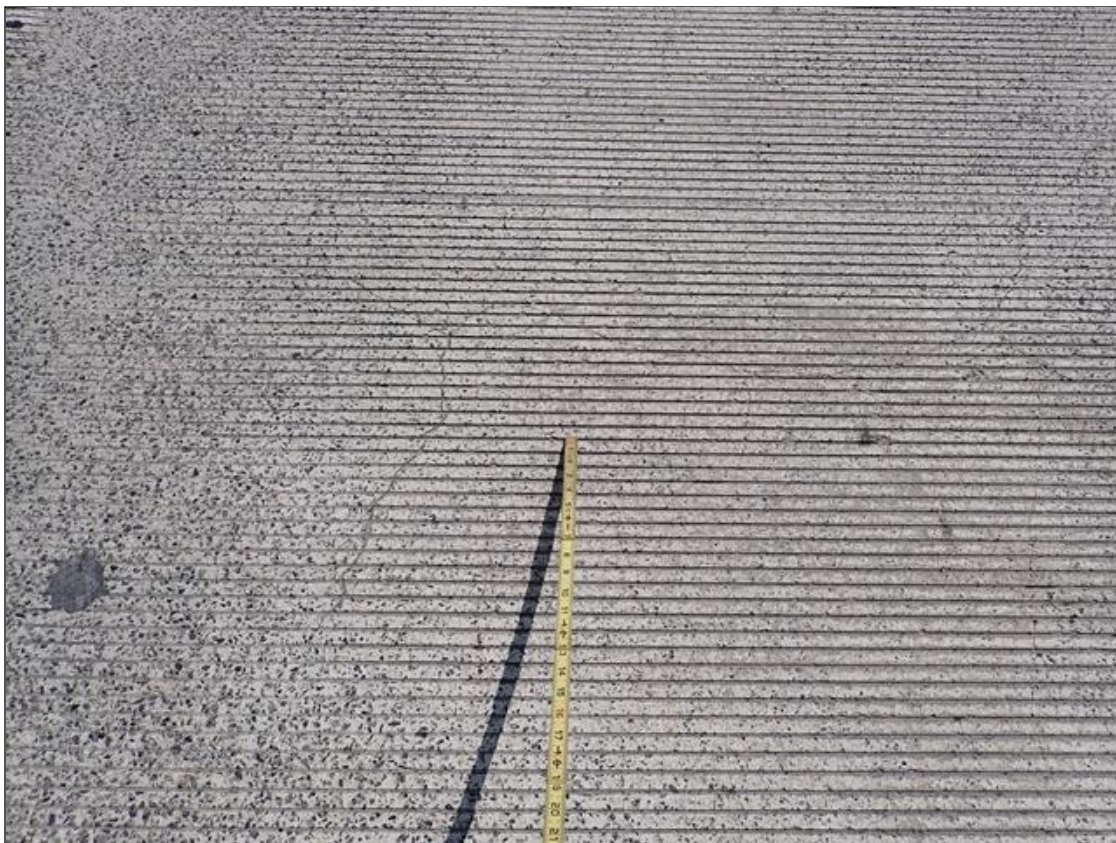
Approach 1: throughout slab, longitudinal/diagonal/transverse cracks (up to 1/32 inch x 10 foot) at random
