NC DEPARTMENT OF TRANSPORTATION
 DIVISION OF HIGHWAYS
 STRUCTURE MANAGEMENT UNIT
 COUNTY: JOHNSTON DIV: 4

ATTENTION: PARS Submitted Sign Notice Issued
 sketches revised; new repairs

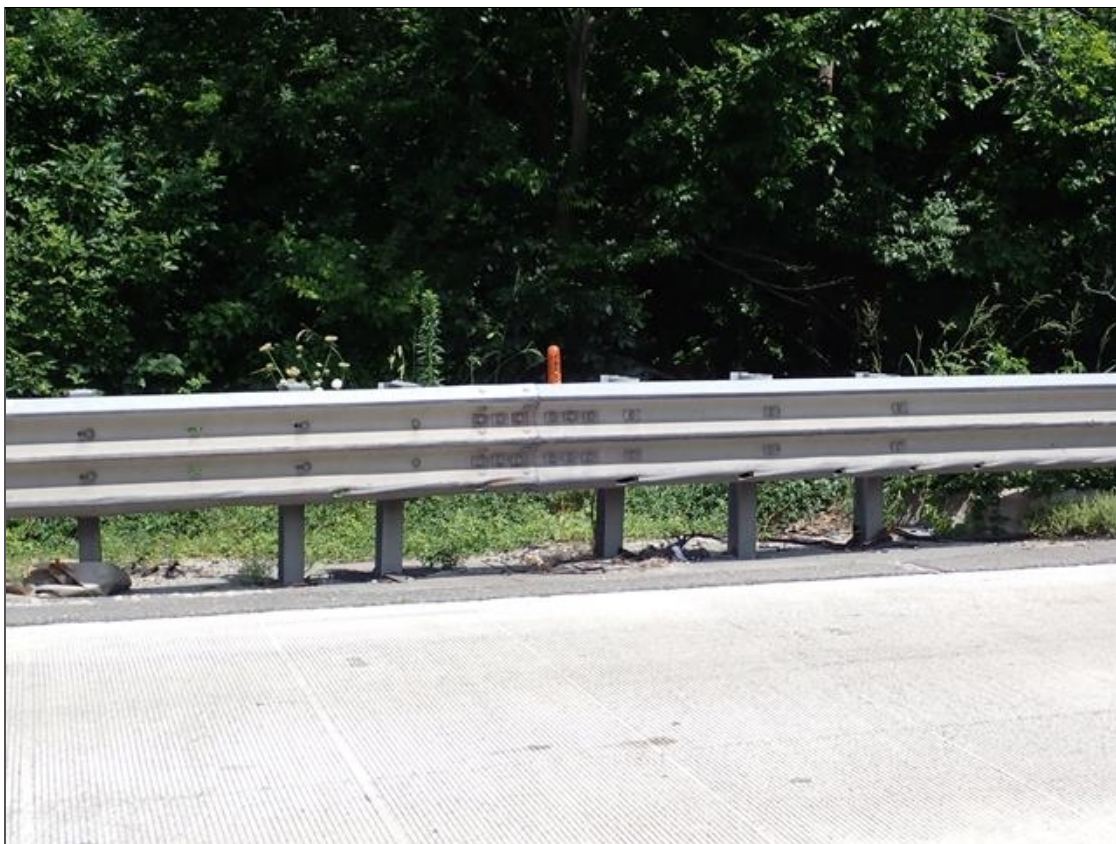
(PAR) southwest guardrail starting at bridge, impact damage (25 foot) with holes (up to 4 inch x 3 inch)

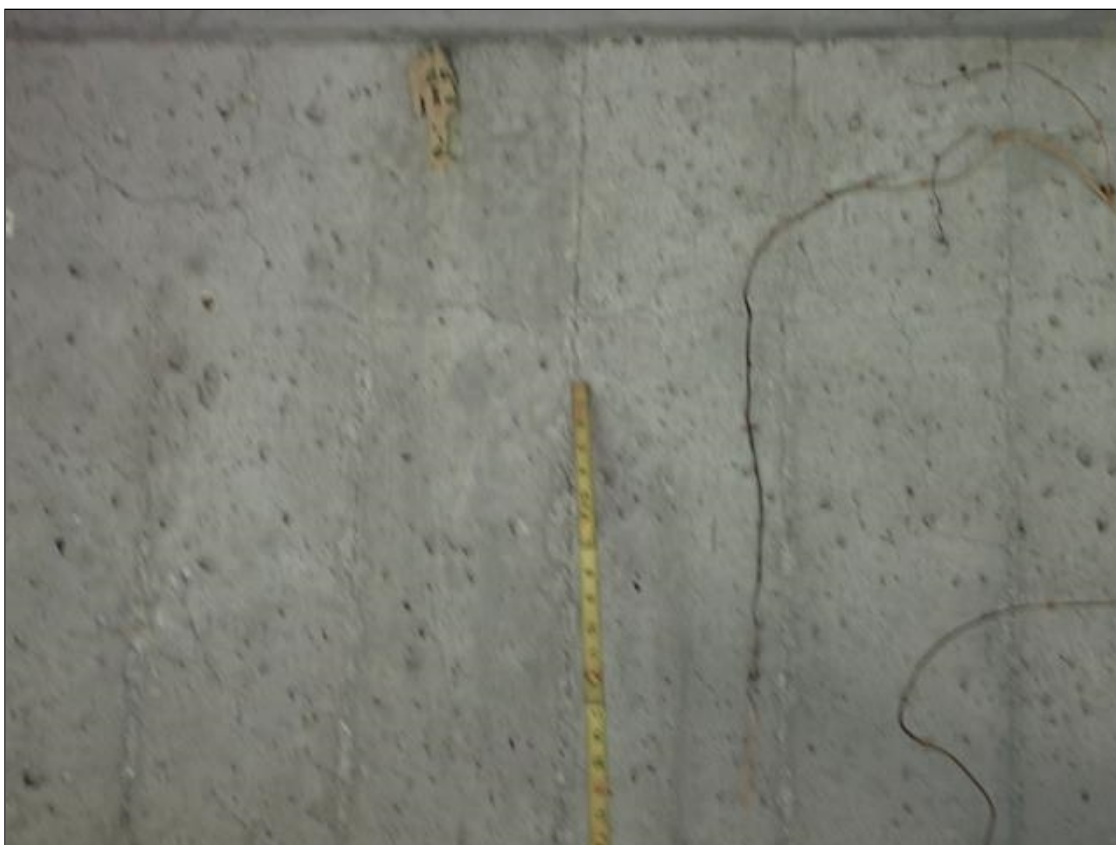
End Bent 1 Abutment: UP TO 0.03 INCH WIDE RANDOM CRACKING IN BACKWALL FOR FULL LENGTH.

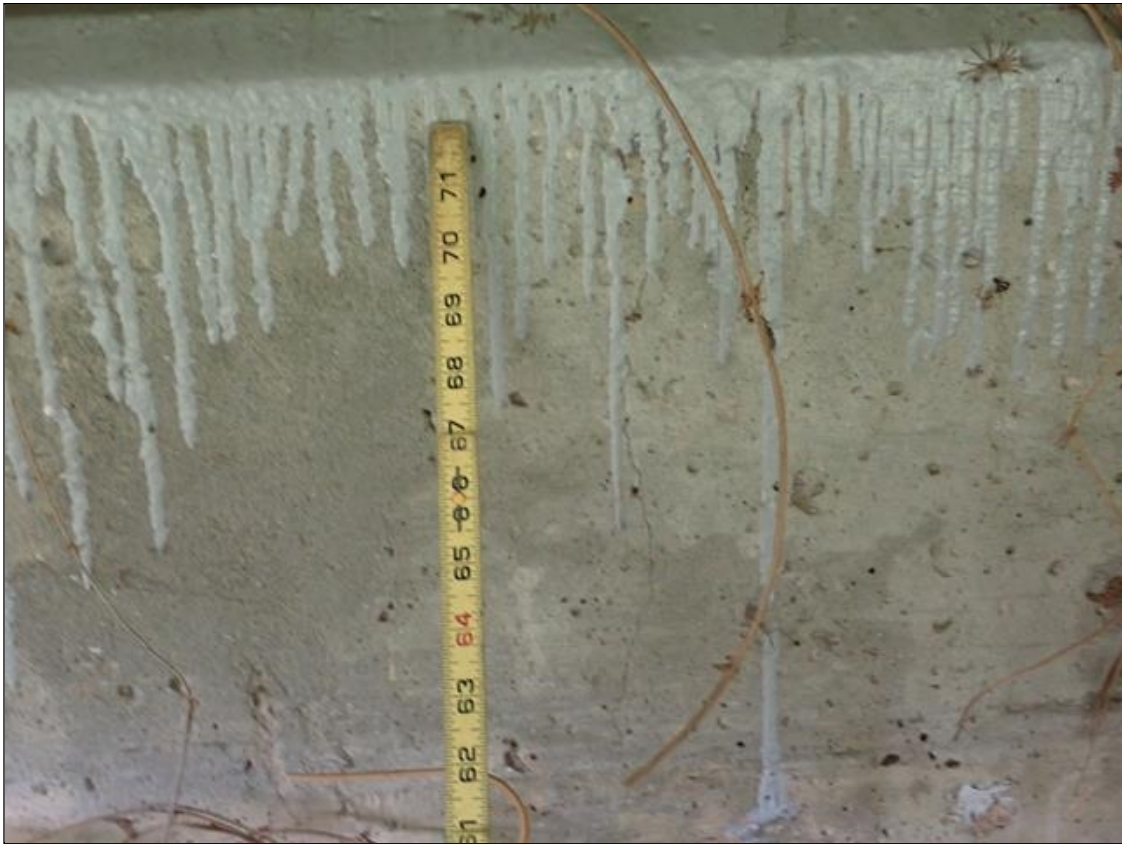
End Bent 1 Cap 1: along the length of the cap, vertical cracks (up to 1/32 inch x full height) at random

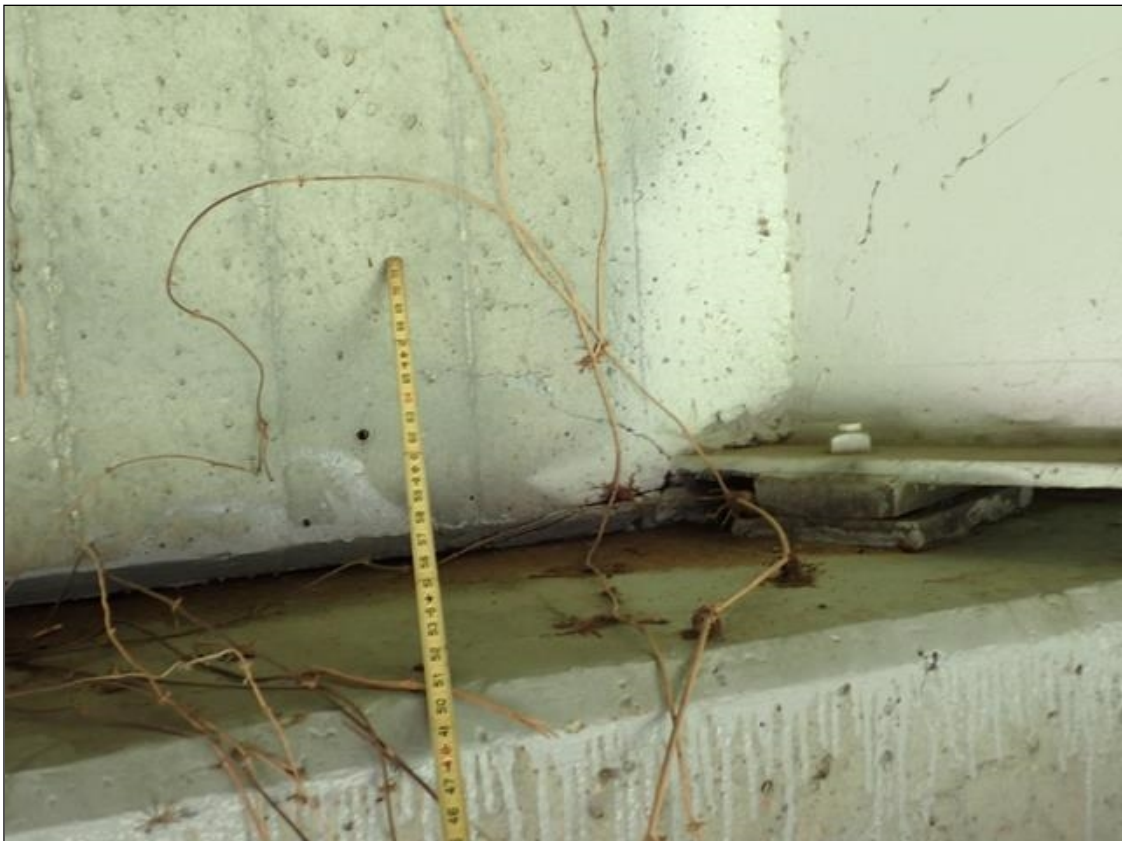
End Bent 1 Abutment: UP TO 1/16 INCH WIDE X 2 FEET LONG DIAGONAL CRACKS EXTENDING FROM BEARING AT ALL BEAMS.

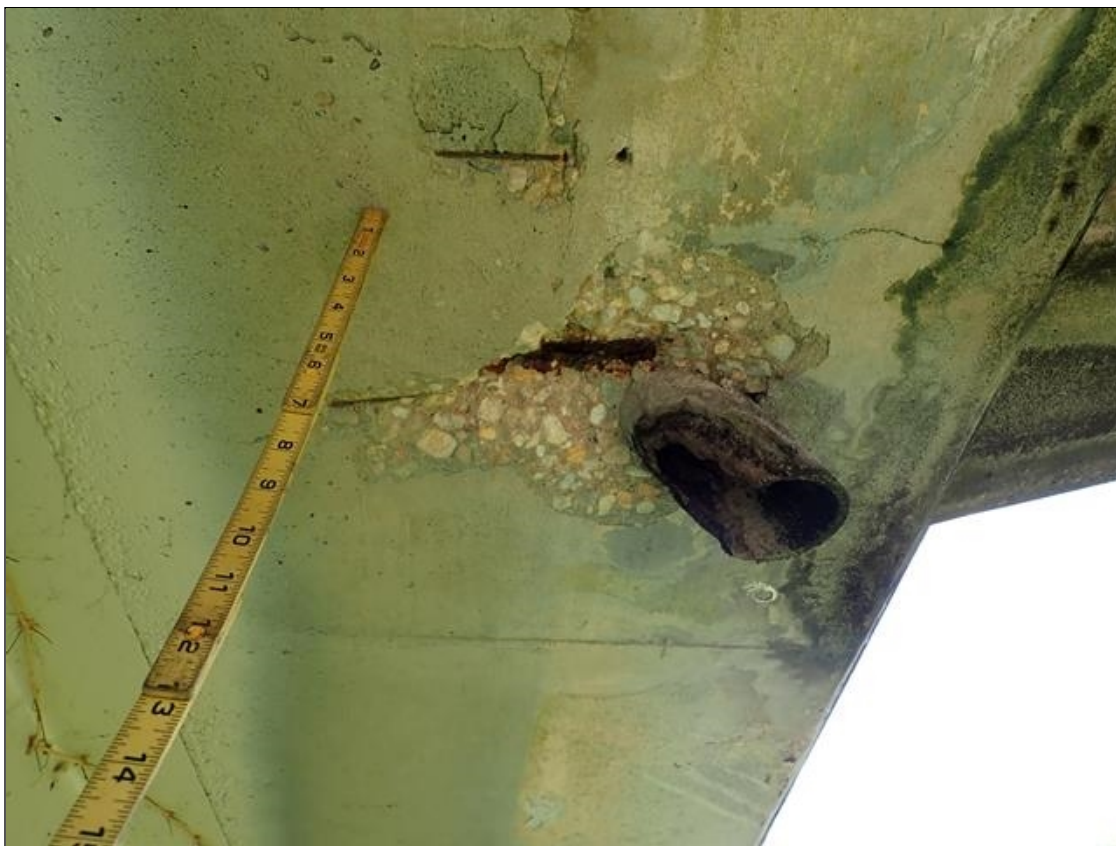
Span 1 Deck: (PAR) UP TO 1 FOOT WIDE X 9 INCHES LONG X UP TO 1 INCH DEEP SPALL WITH EXPOSED REINFORCEMENT IN RIGHT OVERHANG, LOCATED AT THIRD DRAIN PIPE. 15 PERCENT SECTION LOSS IN EXPOSED REINFORCEMENT.

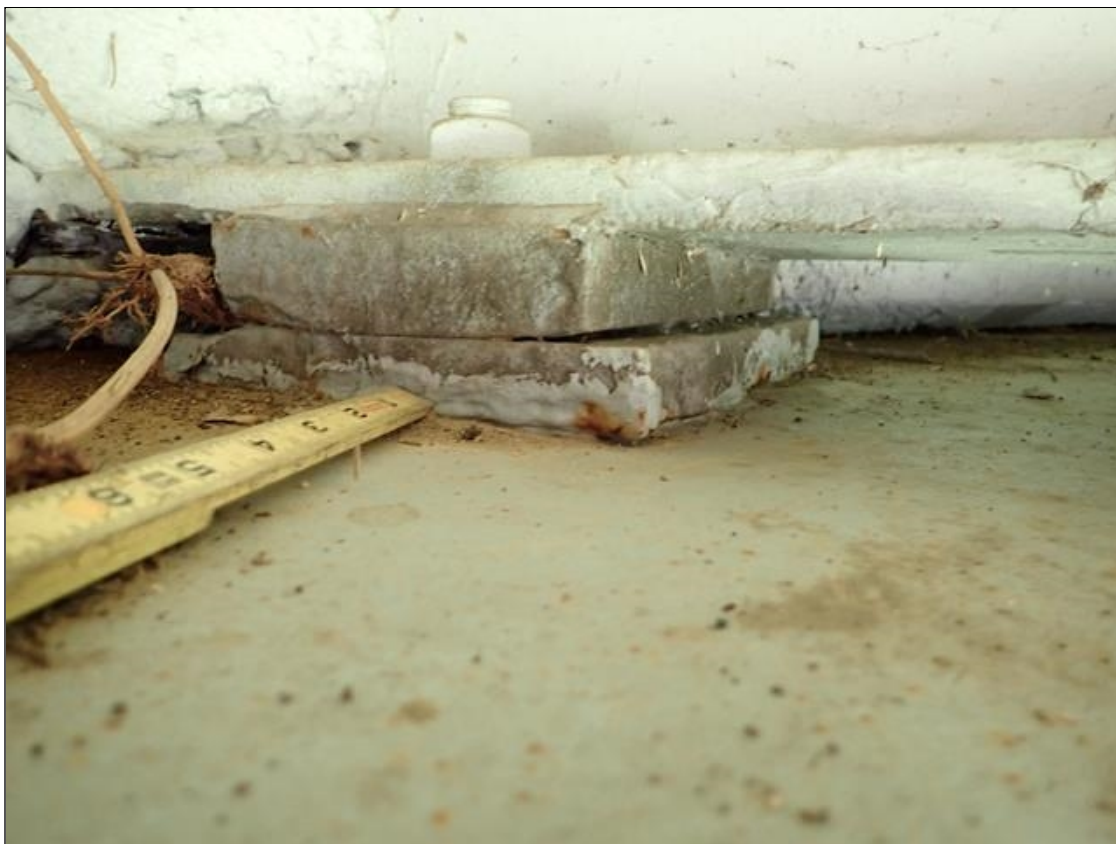
Span 1 Near Bearing 3: painted over section loss (less than 1/16 inch loss) with corrosion reactivating

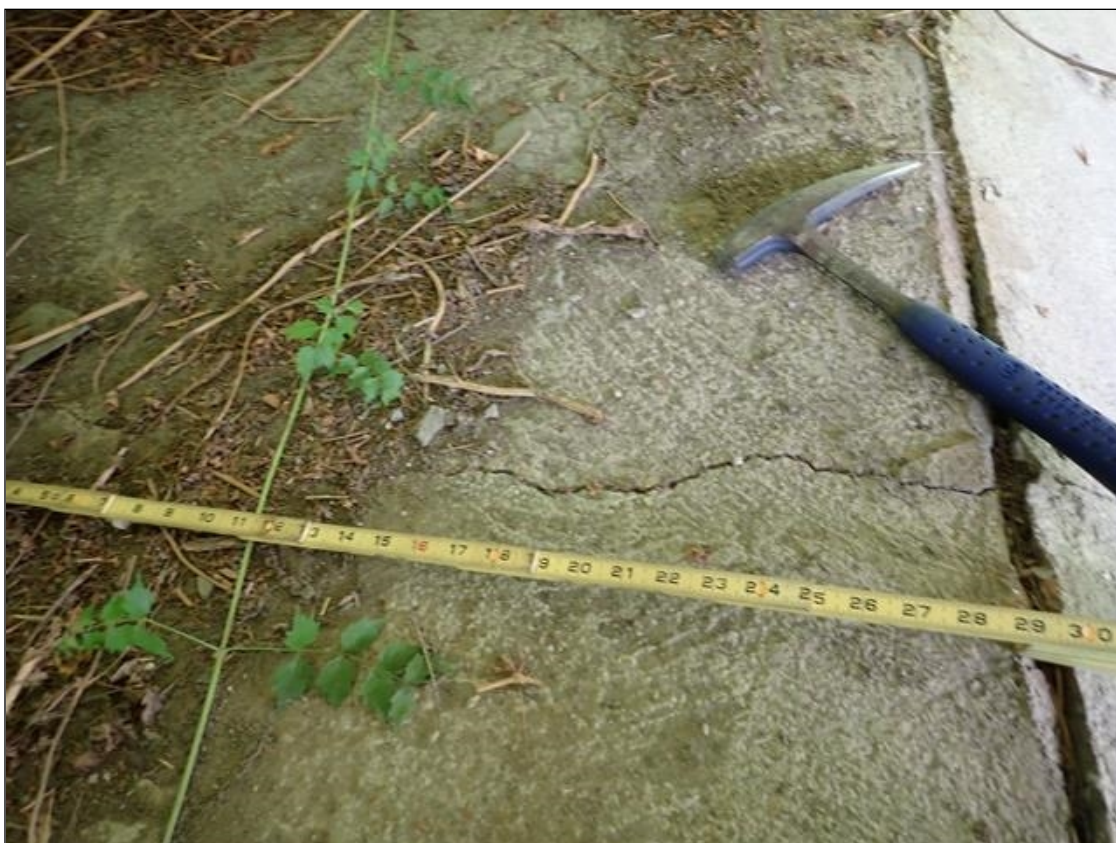
end bent 1 slope protection, below bay 3, transverse cracks (up to 1/16 inch x 4 foot)

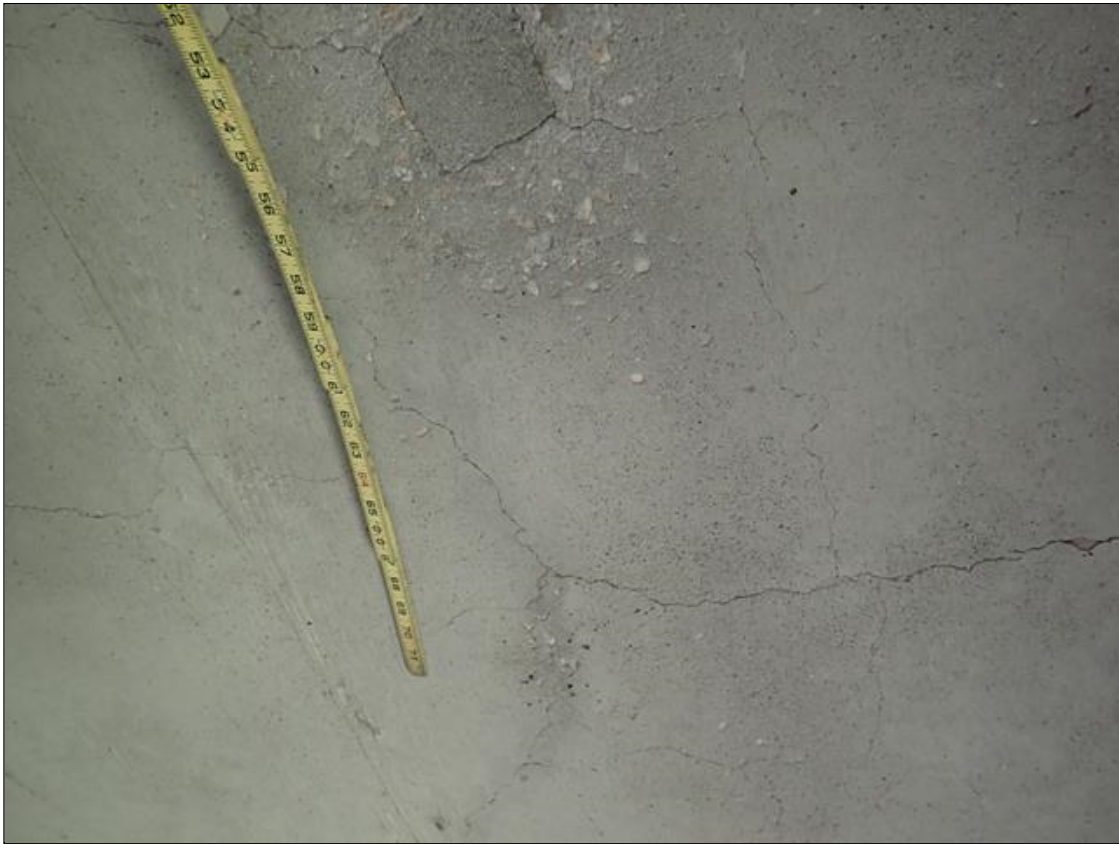
Span 1 Deck: UP TO 0.02 INCH WIDE RANDOM CRACKING SOME WITH EFFLORESCENCE IN DECK UNDERSIDE IN ALL BAYS, SCATTERED THROUGHOUT.

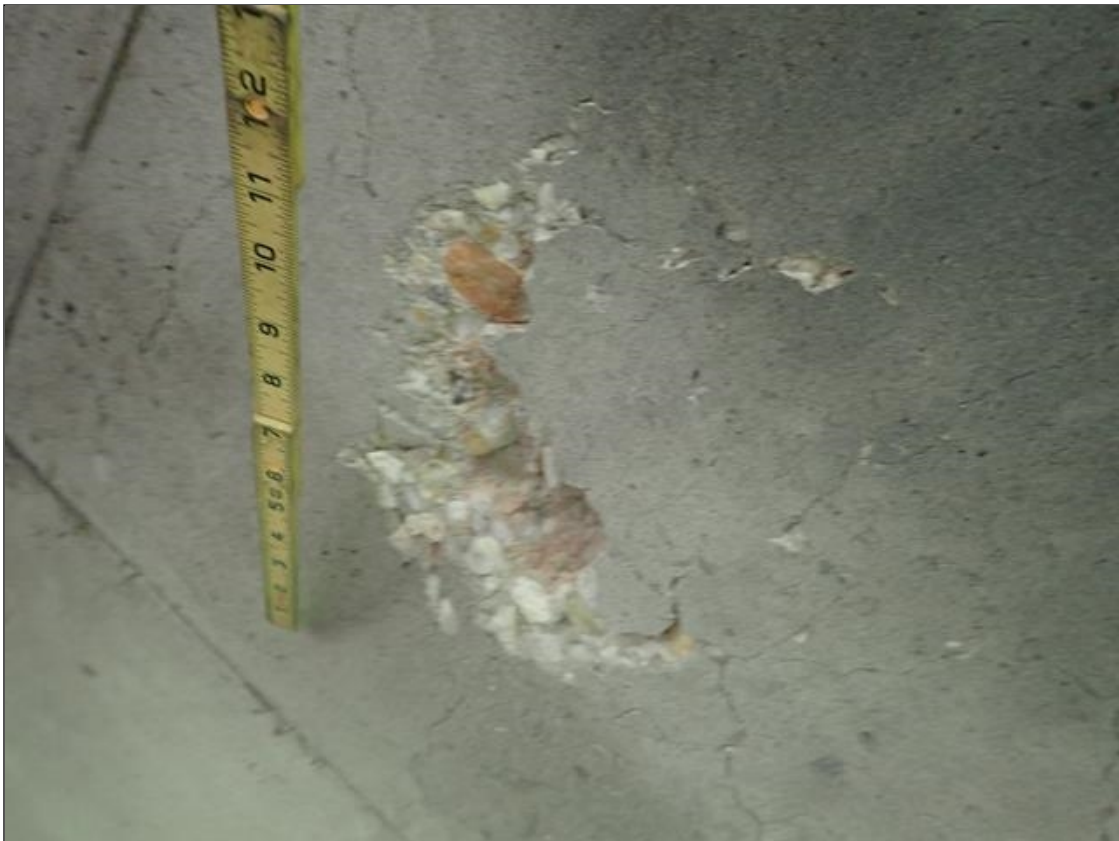
Span 1 Deck: underside of deck in bay 2, adjacent to 1st intermediate diaphragm from end bent 1, spall/delamination (8 inch diameter x 1 inch deep)

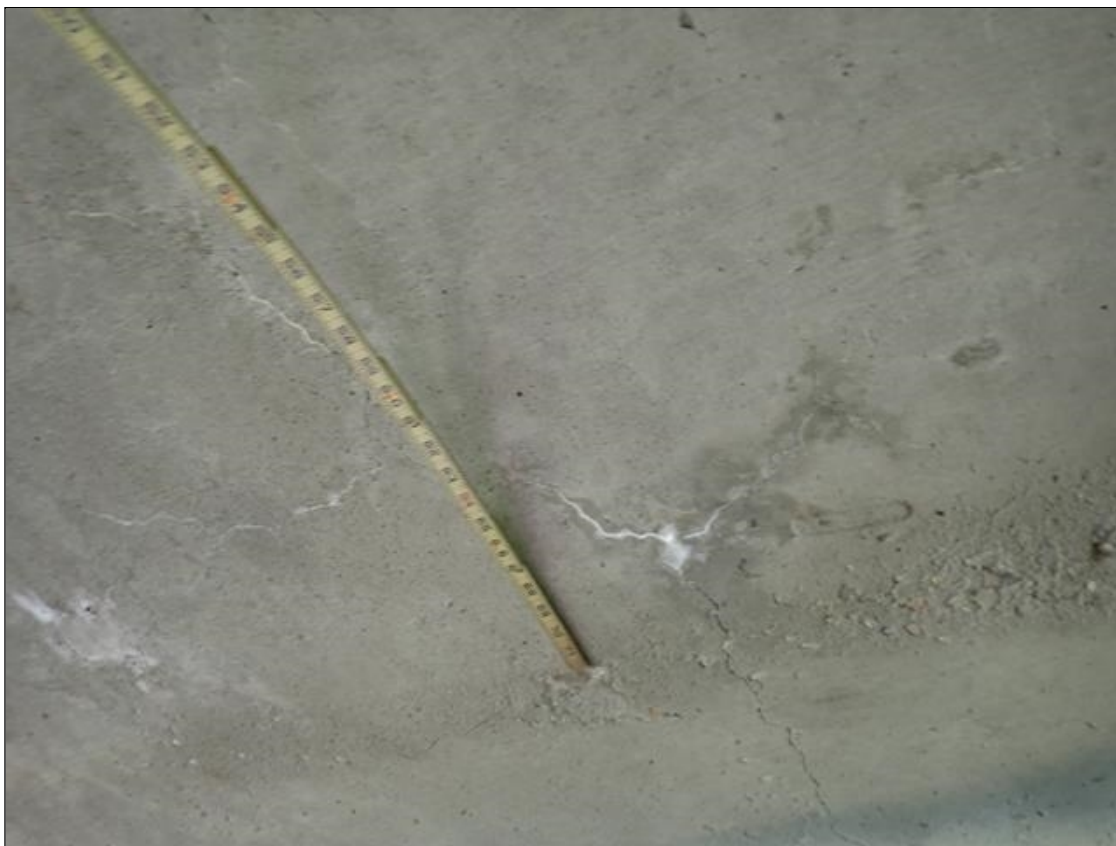
Span 1 Deck: UP TO 0.02 INCH WIDE RANDOM CRACKING SOME WITH EFFLORESCENCE IN DECK UNDERSIDE IN ALL BAYS, SCATTERED THROUGHOUT.

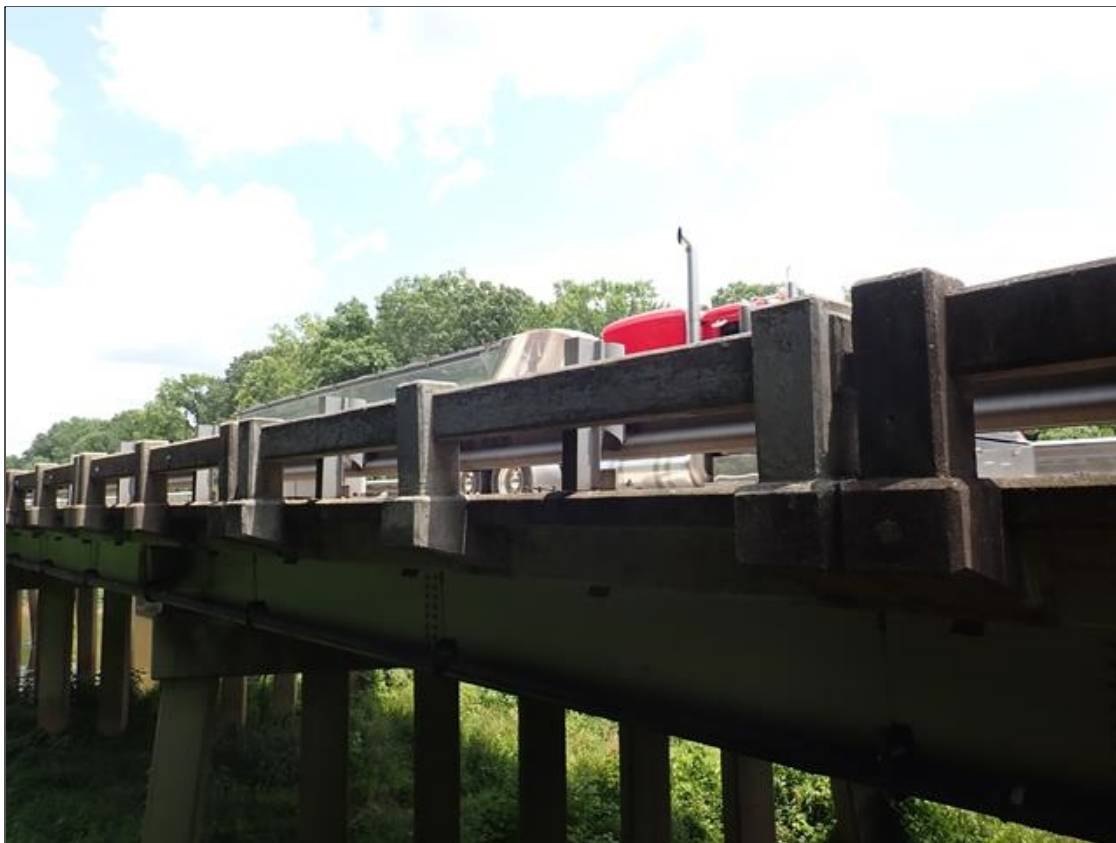
Span 1 Left Bridge Rail: BEGINNING 15 FEET FROM END BENT 1, 15 FEET LONG AREA OF SOUND PATCHING TO RAIL

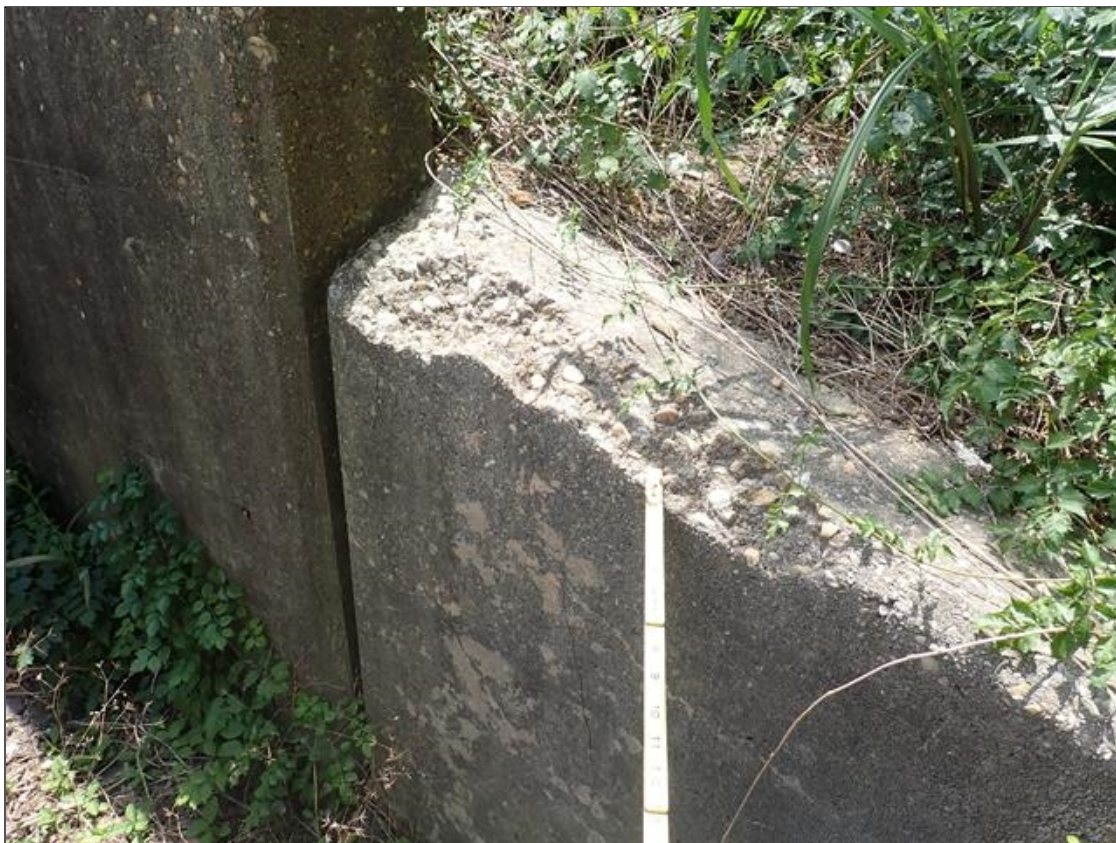
southwest wingwall extension, spall (28 inch x 10 inch x 2 inch deep)

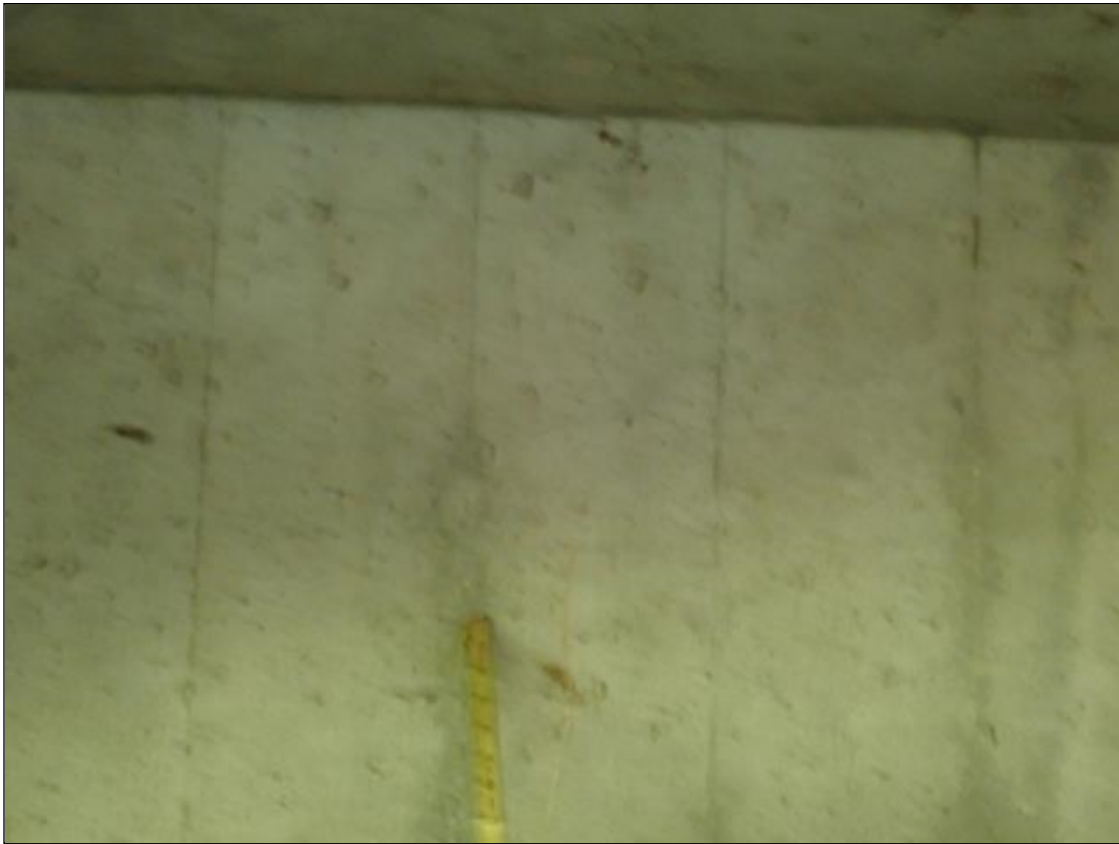
End Bent 2 Cap 1: along abutment, vertical and horizontal cracks (up to 1/32 inch x 4 foot) at random

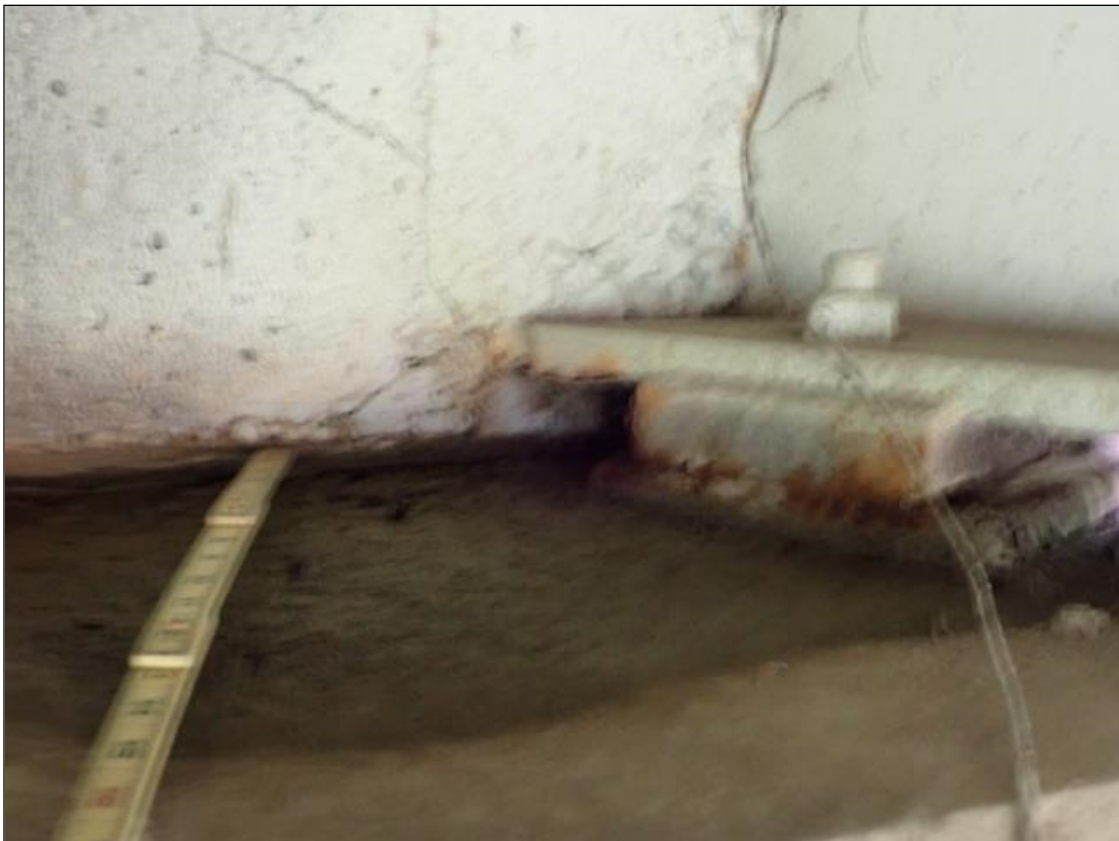
End Bent 2 Abutment: UP TO 1/16 INCH WIDE X 2 FEET LONG DIAGONAL CRACKS EXTENDING FROM BEARING AT ALL BEAMS

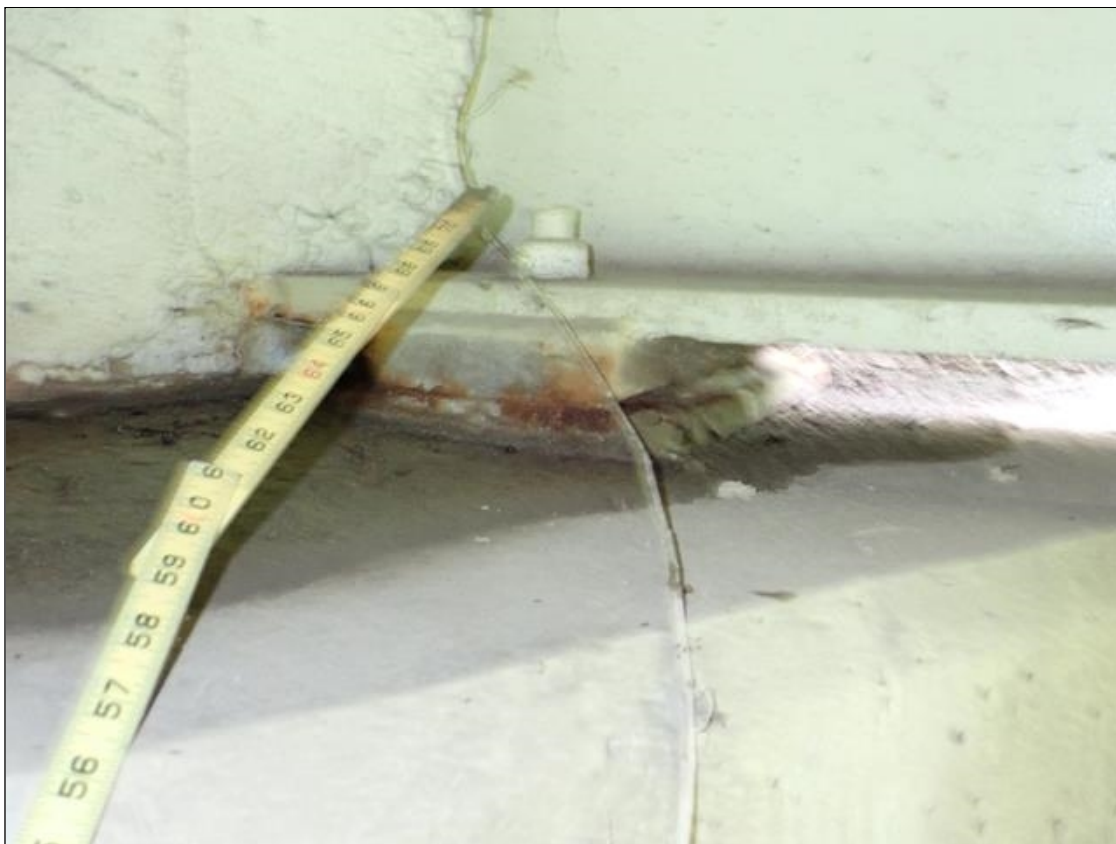
Span 8 Far Bearing 4: painted over section loss (approximately 80 percent remaining) with corrosion reactivating

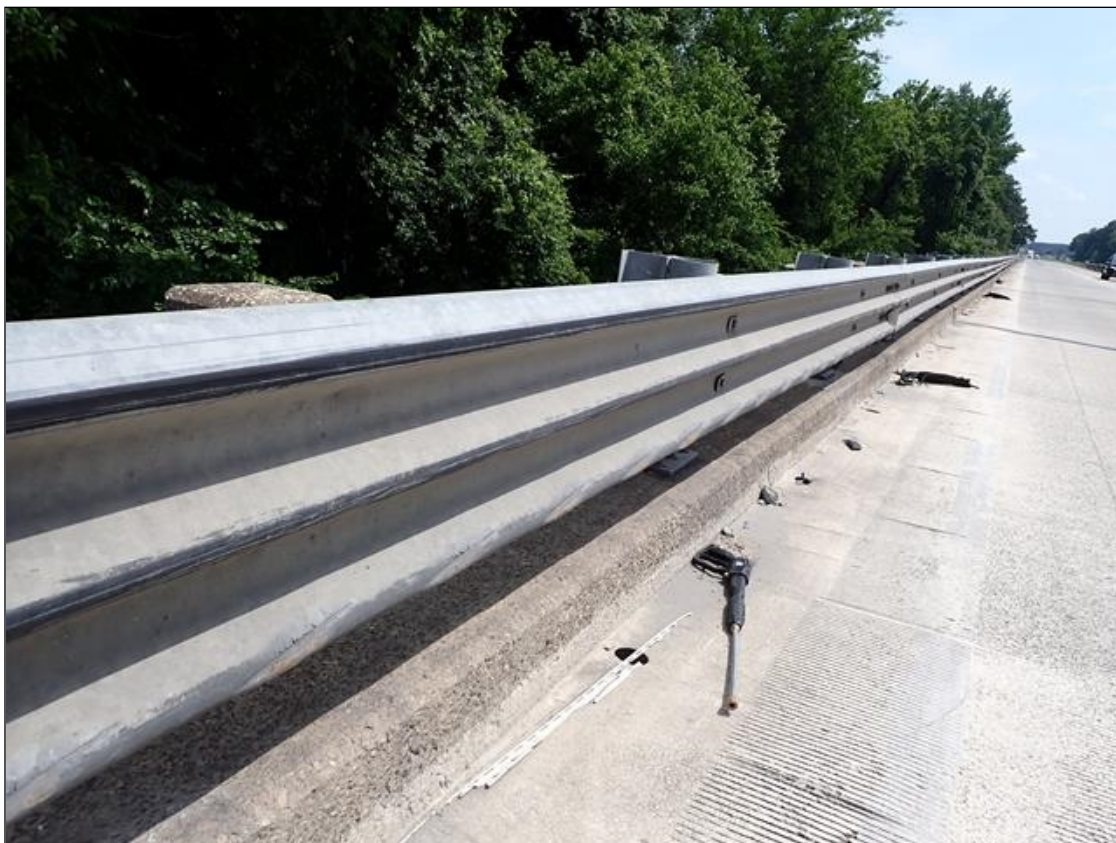
Span 1 Left Retrofit Bridge Rail: (PAR) IMPACT DAMAGE WITH SCRAPE MARKS AND DENTS UP TO 1 INCH DEEP IN RETROFIT RAIL AT SCATTERED LOCATIONS

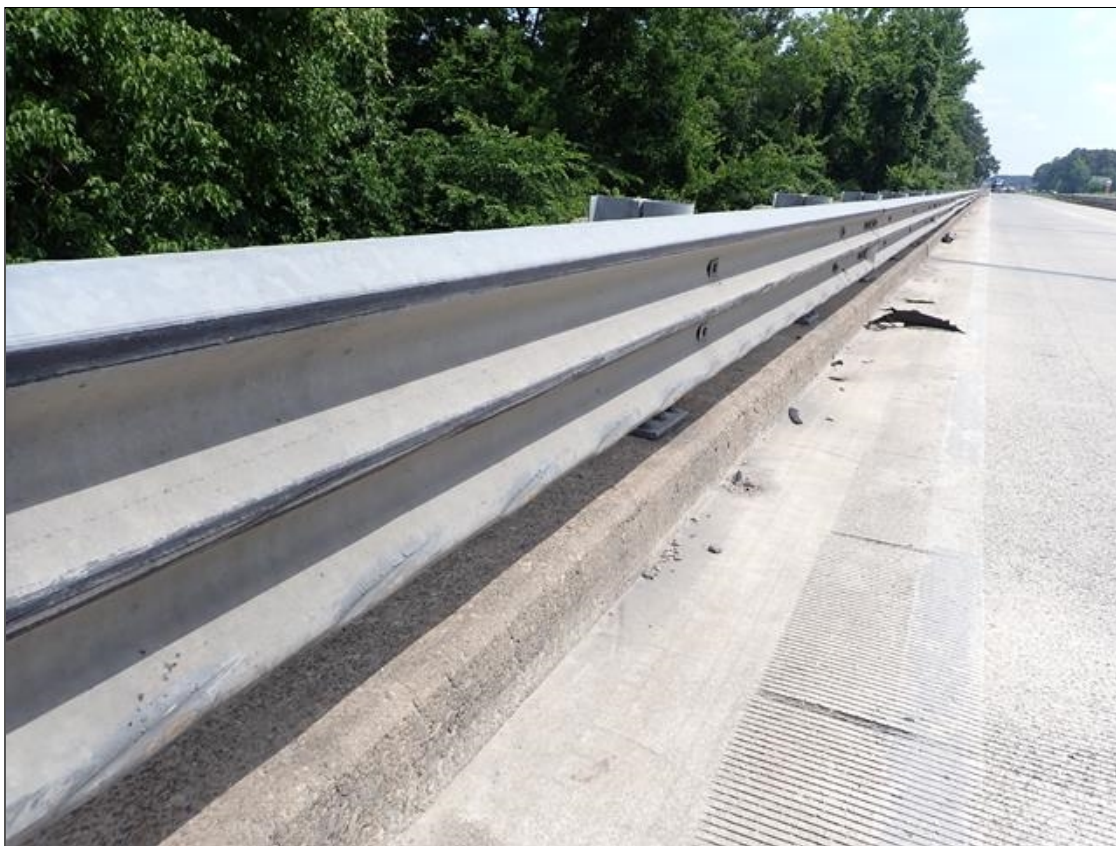
Span 2 Left Retrofit Bridge Rail: (PAR) IMPACT DAMAGE WITH SCRAPE MARKS AND DENTS UP TO 1 INCH DEEP IN RETROFIT RAIL AT SCATTERED LOCATIONS

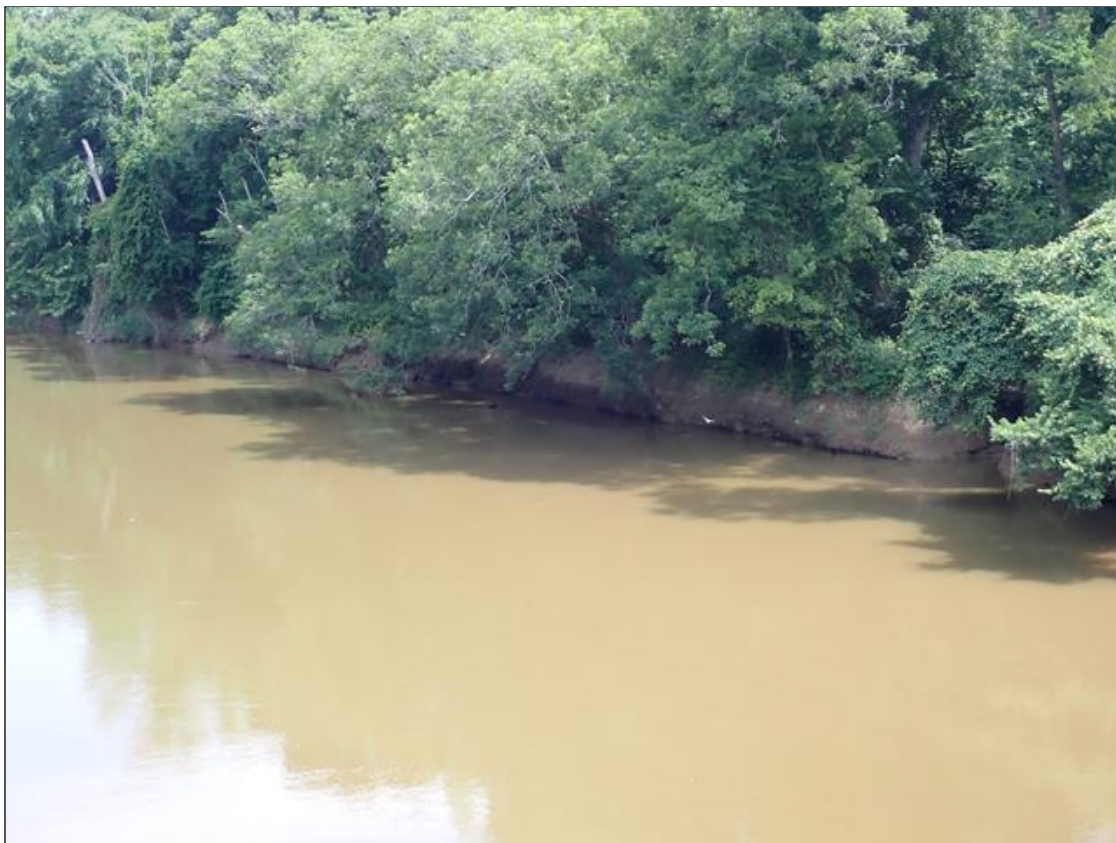
along channel embankments, cutbank erosion (up to 4 foot x 2 foot deep)

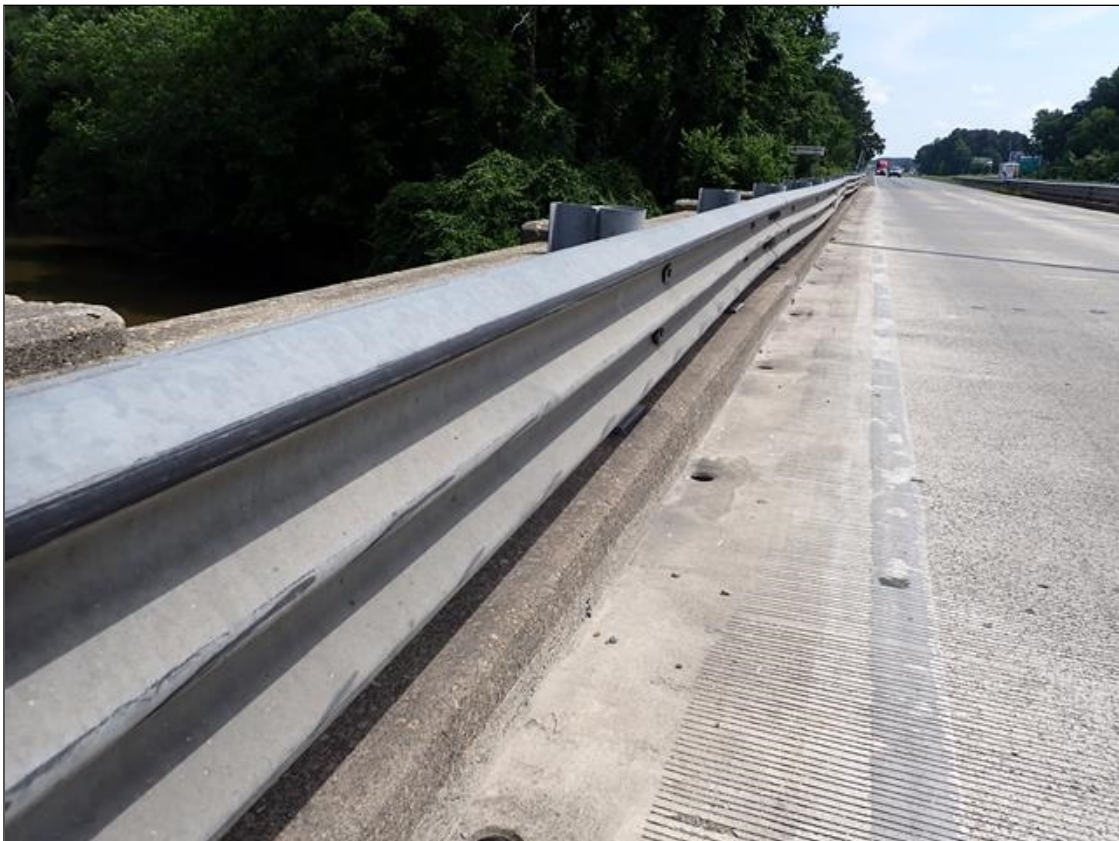
Span 5 Left Retrofit Bridge Rail: (PAR) IMPACT DAMAGE WITH SCRAPE MARKS AND DENTS UP TO 1 INCH DEEP IN RETROFIT RAIL AT SCATTERED LOCATIONS

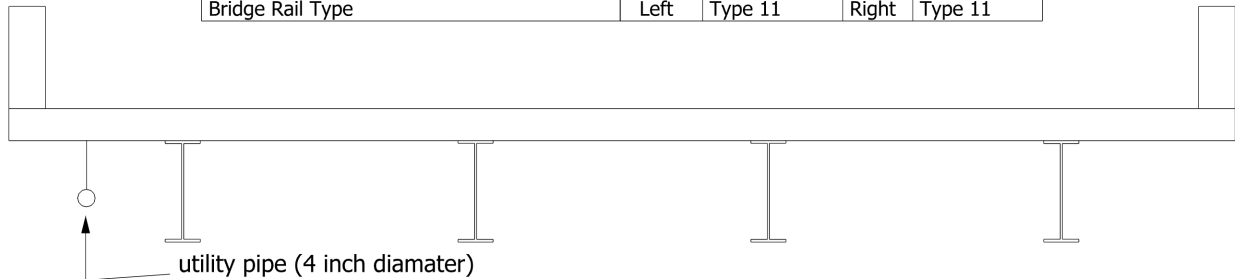
Measurements for Span #	1	ALL SPANS SIMILAR	
Deck Thickness	10.5in	Left Overhang	4.75ft
Top of Rail to Bottom of Beam (Avg)	6.438ft	Right Overhang	4.75ft
