NC DEPARTMENT OF TRANSPORTATION
 DIVISION OF HIGHWAYS
 STRUCTURE MANAGEMENT UNIT

ATTENTION: **prompt action request, sketches revised, horizontal clearances revised**

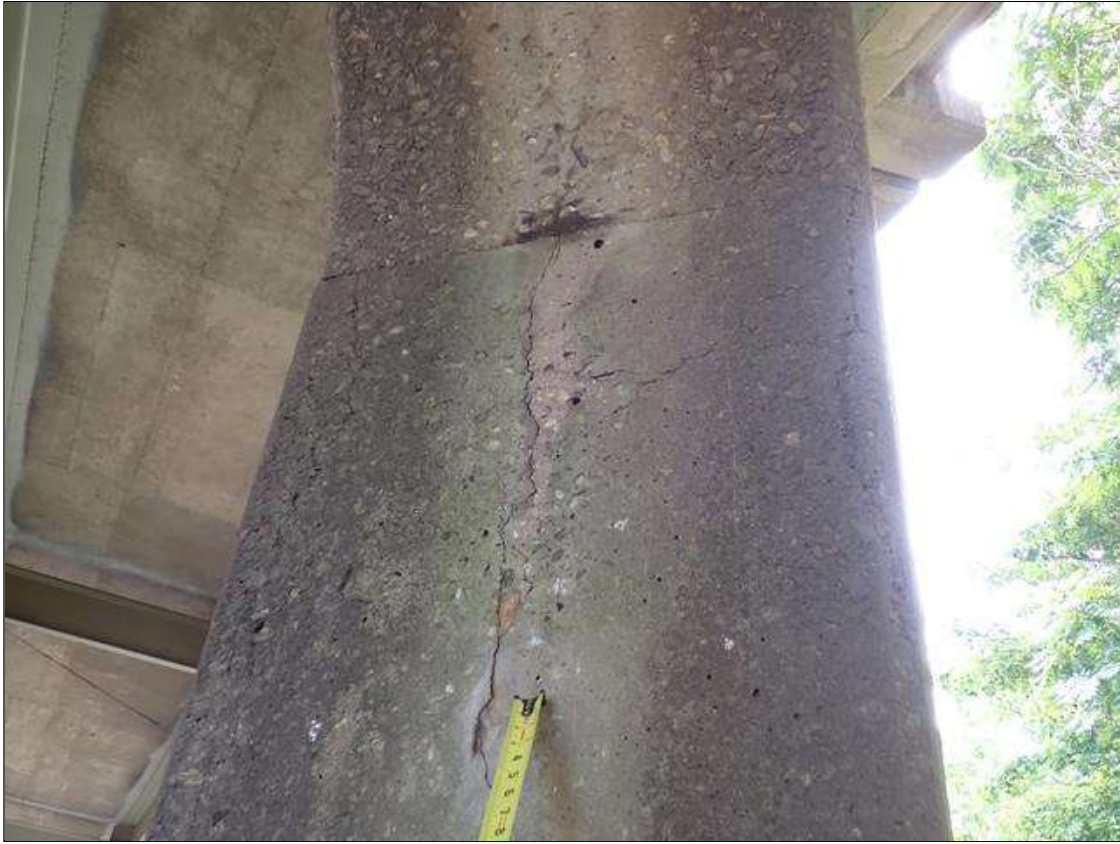
Bent 3 Pile 1: UP TO 1/8 INCH x 6 FOOT VERTICAL CRACKS AND UP TO 1/32 INCH MAP CRACKS AT RANDOM THROUGHOUT, some with efflorescence, some with adjacent delamination, up to 4 foot x 1 foot

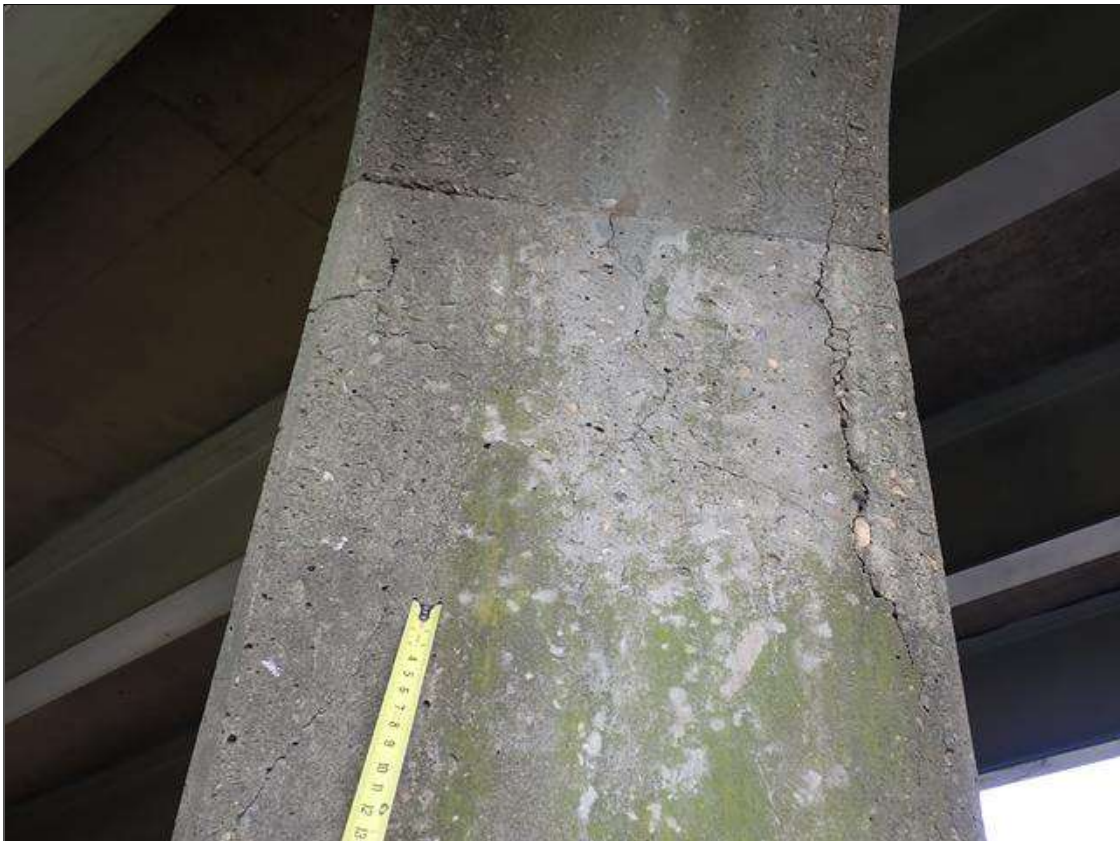
Bent 3 Pile 1: UP TO 1/8 INCH x 6 FOOT VERTICAL CRACKS AND UP TO 1/32 INCH MAP CRACKS AT RANDOM THROUGHOUT, some with efflorescence, some with adjacent delamination, up to 4 foot x 1 foot

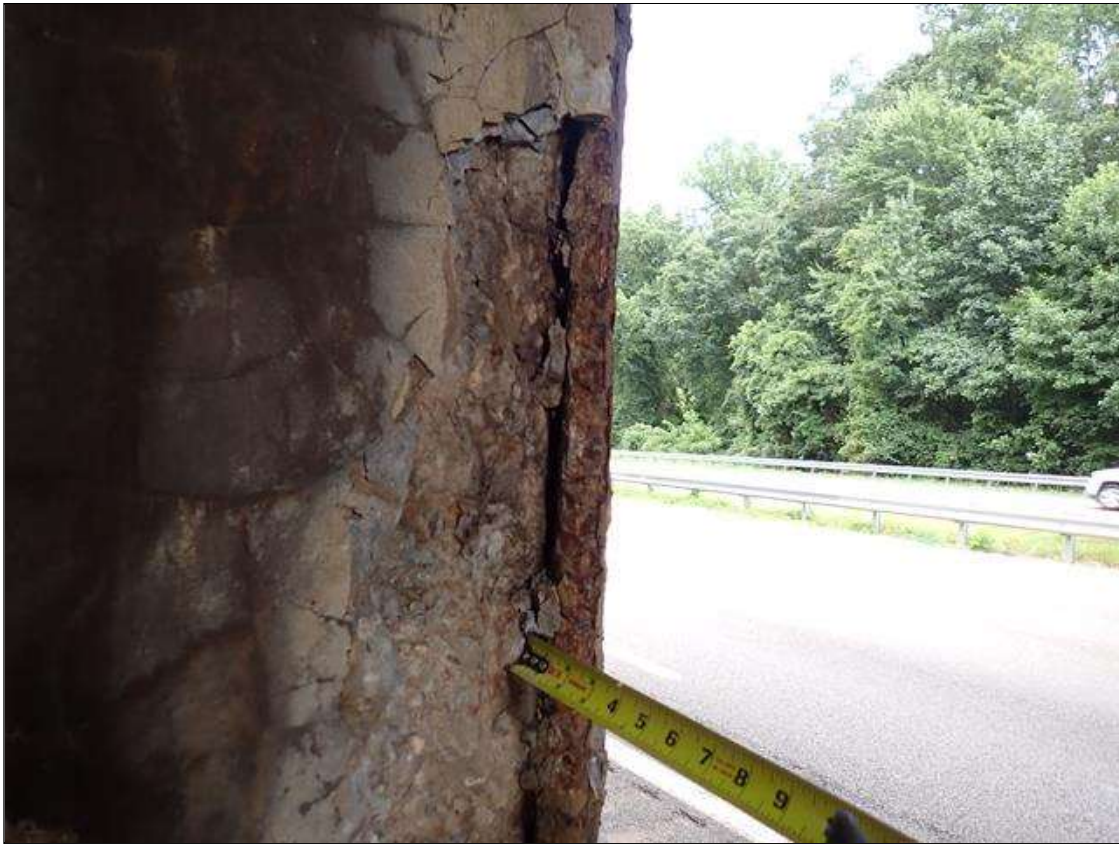
Bent 3 Pile 2: (PAR) at Southwest corner, failed patch, 7 feet high x 22 inches wide x up to 3.5 inches deep with exposed rusted and debonded primary reinforcing

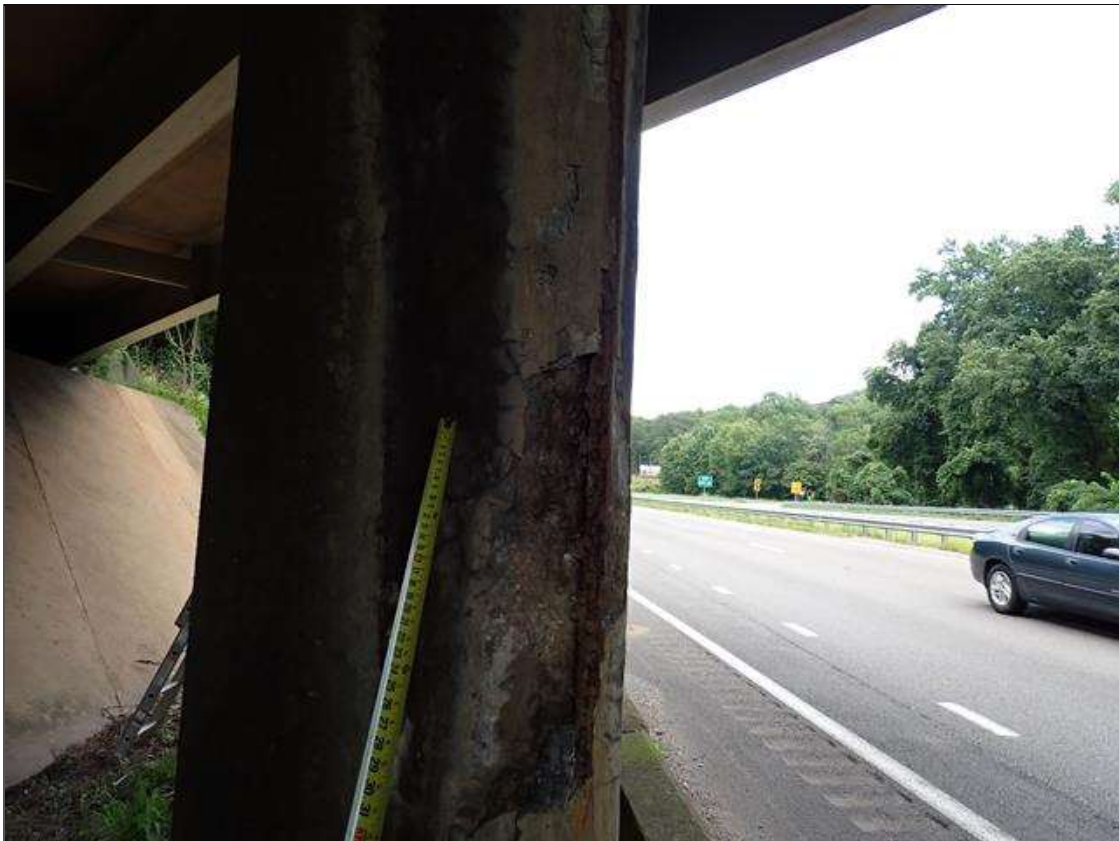
Bent 3 Pile 2: (PAR) at Southwest corner, failed patch, 7 feet high x 22 inches wide x up to 3.5 inches deep with exposed rusted and debonded primary reinforcing

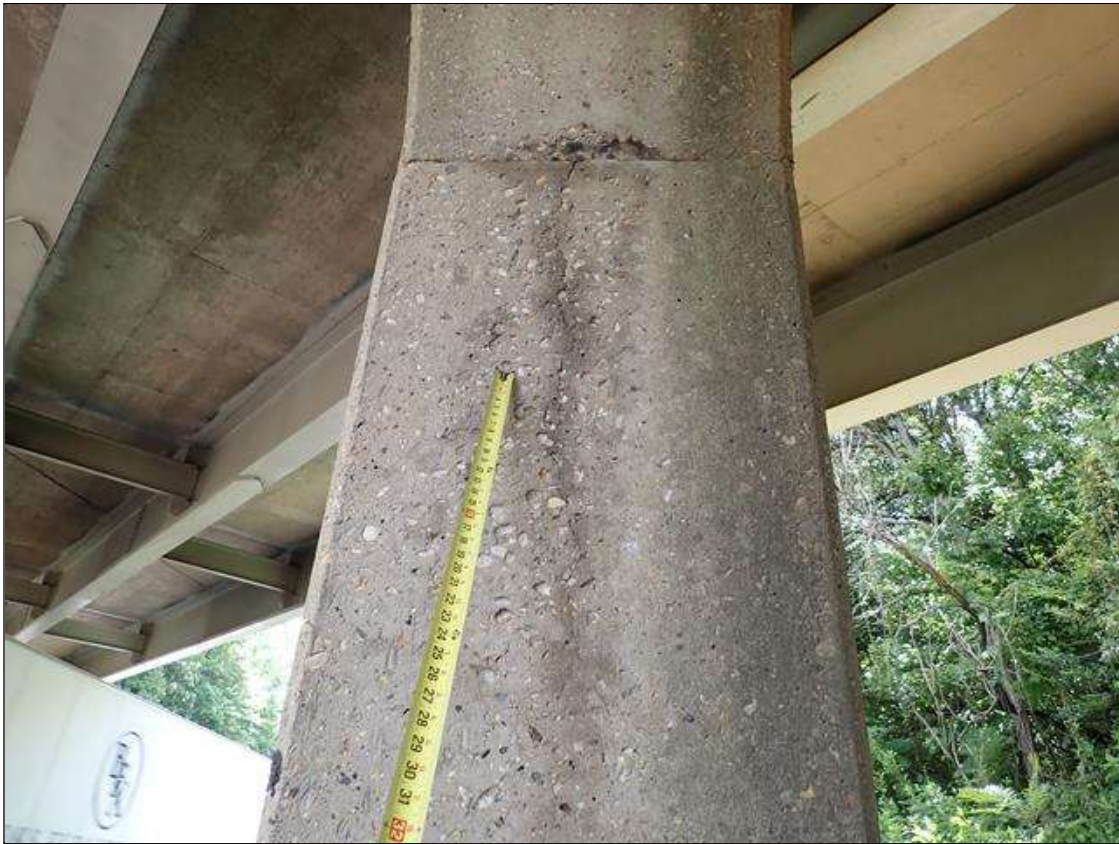
Bent 3 Pile 2: south, north and east faces, multiple vertical cracks, up to 4 feet x 1/16 inch wide with adjacent delaminations (4 feet x 10 inch)

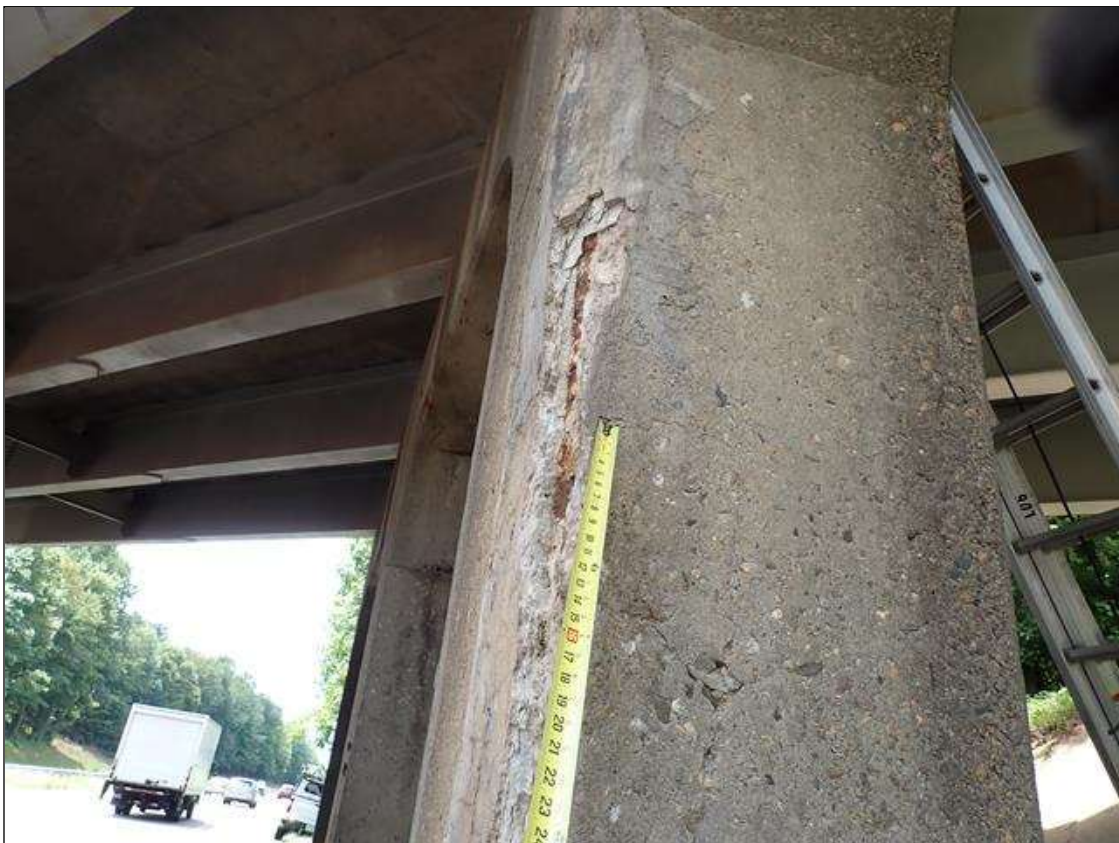
Bent 3 Pile 3: (PAR) at Southeast corner, failed patch/delamination/spall, 8 feet x up to 2 feet x 2.5 inches deep, with exposed rusted primary reinforcing

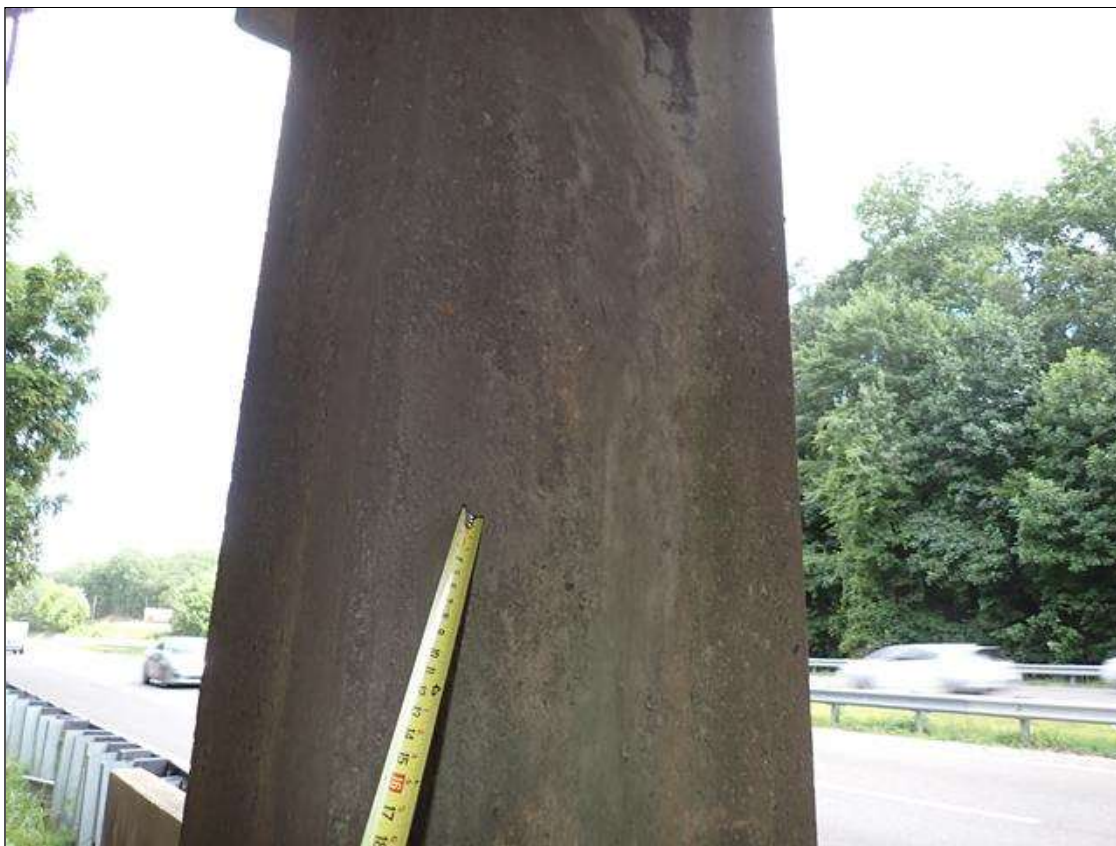
Bent 3 Pile 3: WEST FACE AND SOUTHWEST AND NORTHWEST CORNERS HAVE PATCHED AREAS UP TO 8.5 FEET X 1 FOOT WITH SCATTERED MAP CRACKING UP TO 1/32 INCH.

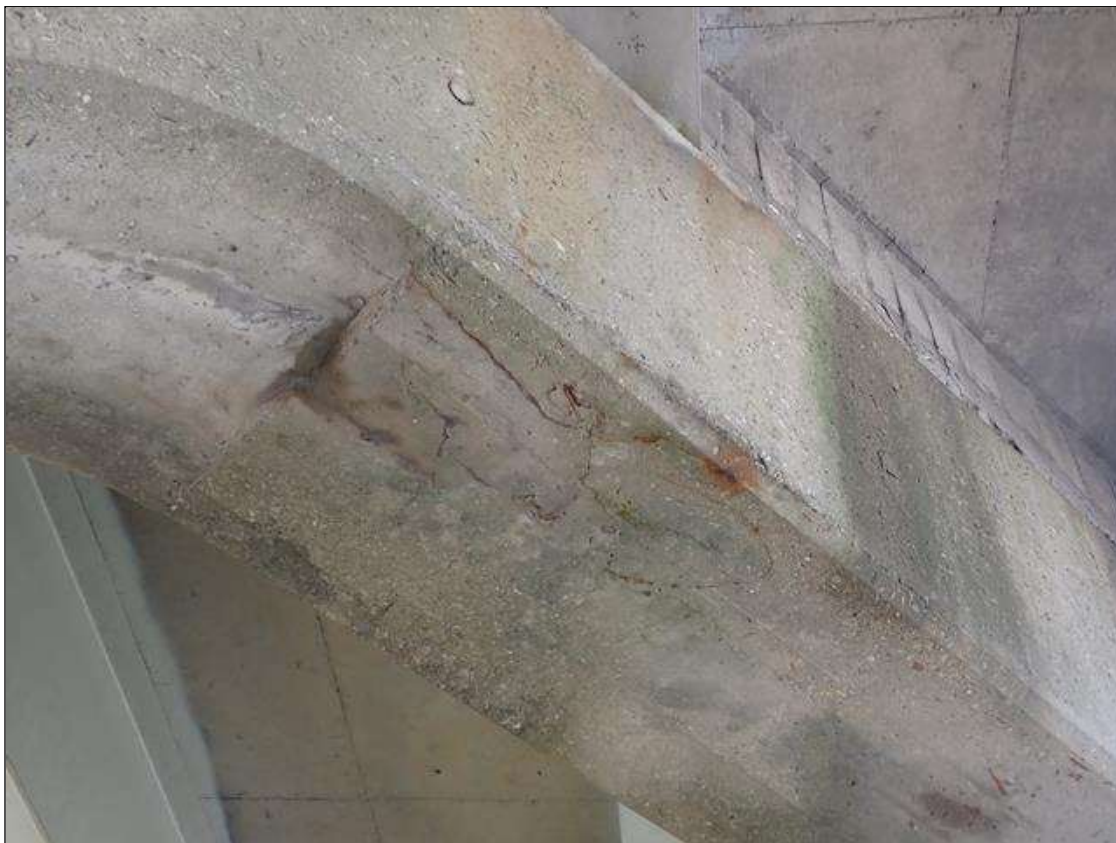
Bent 3 Cap 1: (PAR) UP TO 1/32 INCH MAP CRACKING, SOME WITH EFFLORESCENCE AND RUST STAINS, AT RANDOM THROUGHOUT

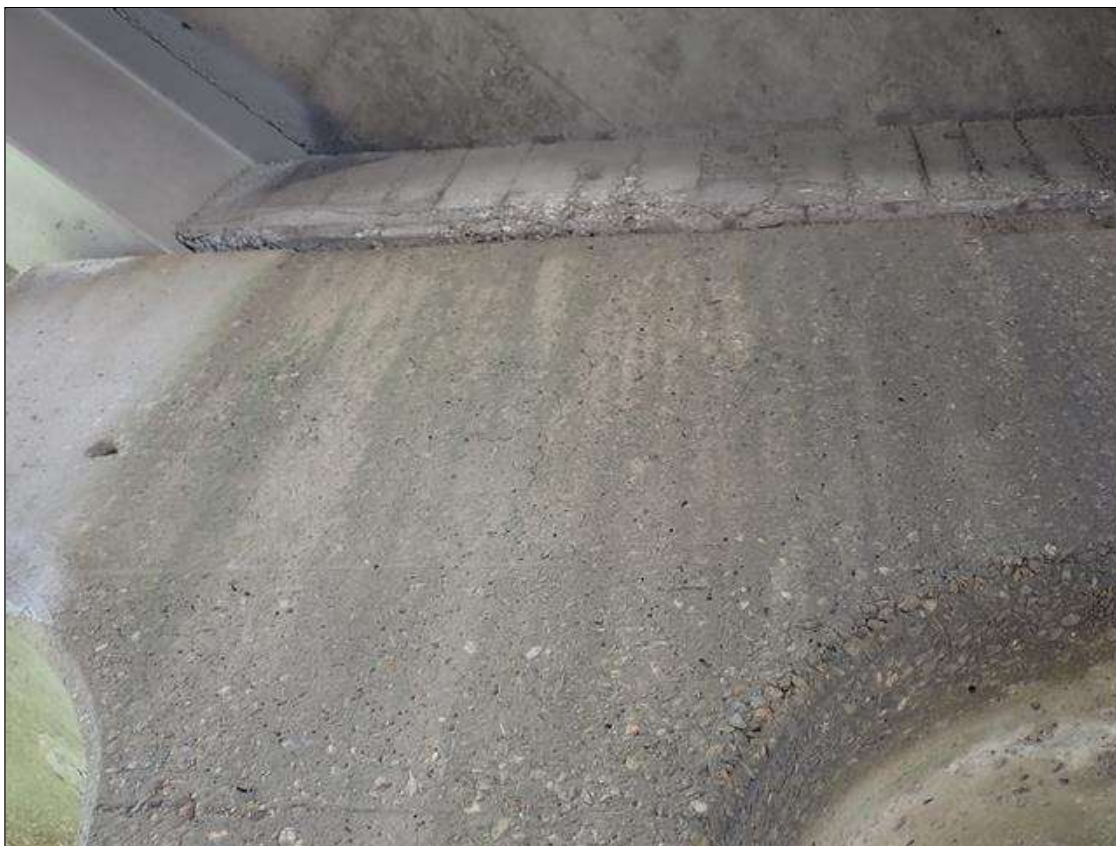
Bent 3 Cap 1: (PAR) UP TO 1/32 INCH MAP CRACKING, SOME WITH EFFLORESCENCE AND RUST STAINS, AT RANDOM THROUGHOUT

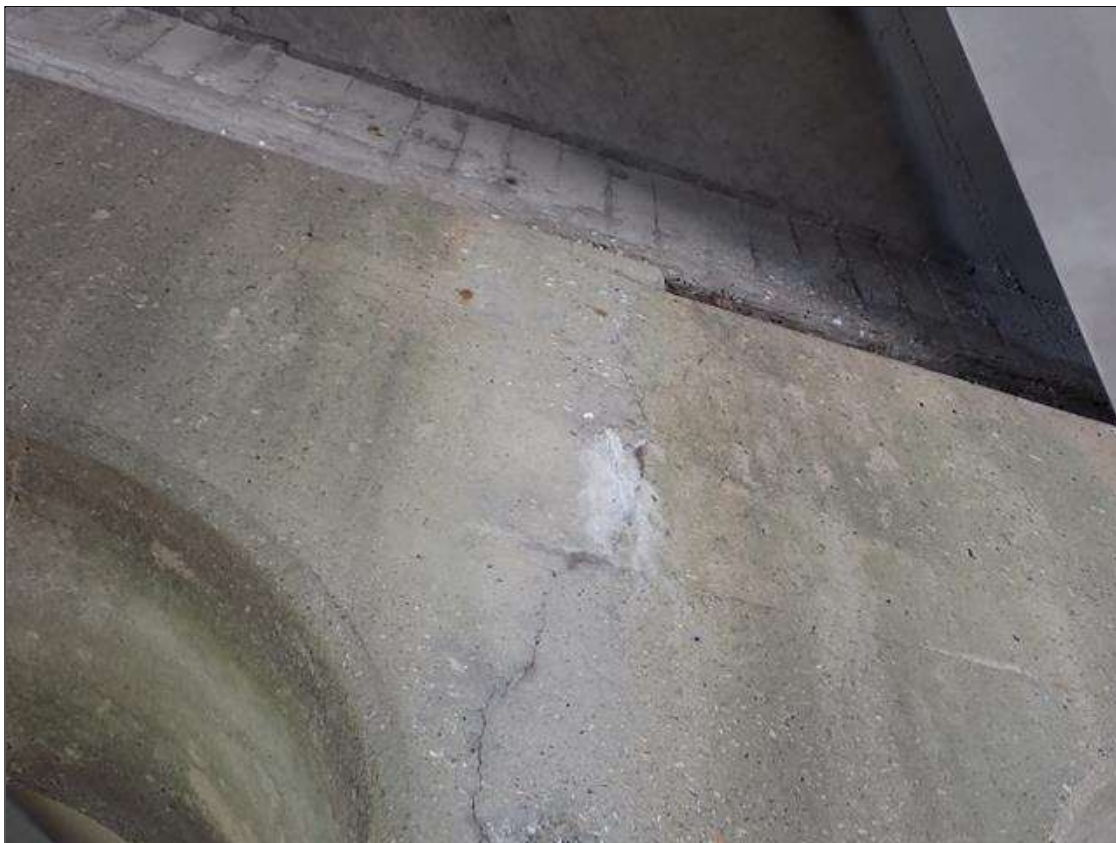
Bent 3 Cap 1: (PAR) UP TO 1/32 INCH MAP CRACKING, SOME WITH EFFLORESCENCE AND RUST STAINS, AT RANDOM THROUGHOUT

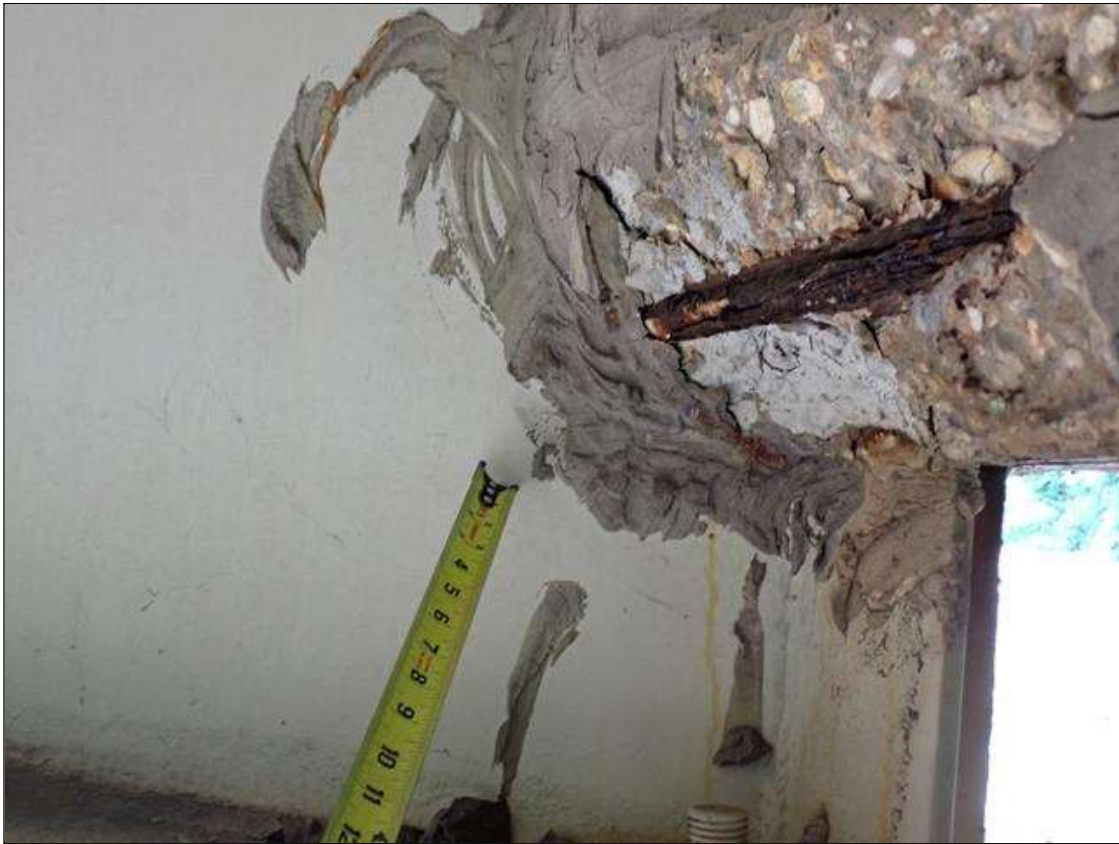
Span 4 Beam 4: at bent 3, web adjacent to diaphragm, painted over section loss (1/2 inch average remaining x 6 inch x 6 inch), partially covered with epoxy

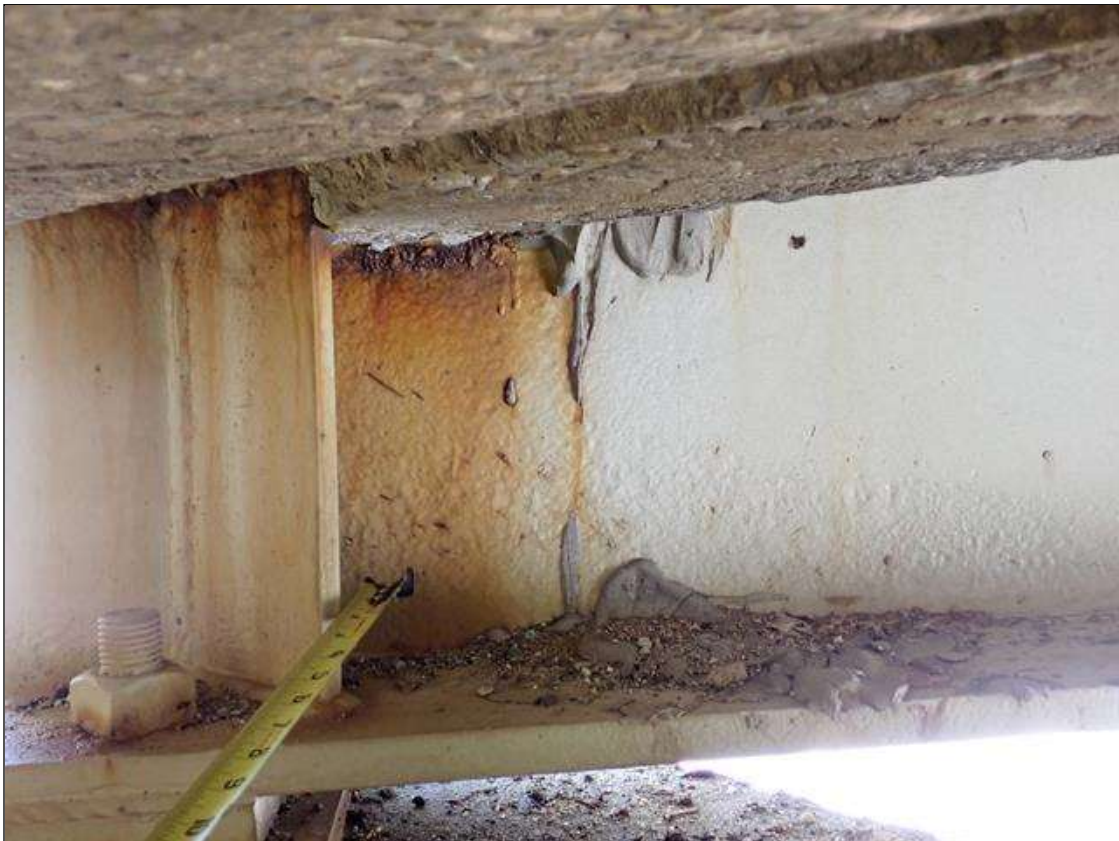
Span 3 Beam 4: at bent 3, web adjacent to diaphragm and lower web, painted over pitting (up to 1/8 inch deep x 2 feet x 9 inches) with corrosion reinitiated

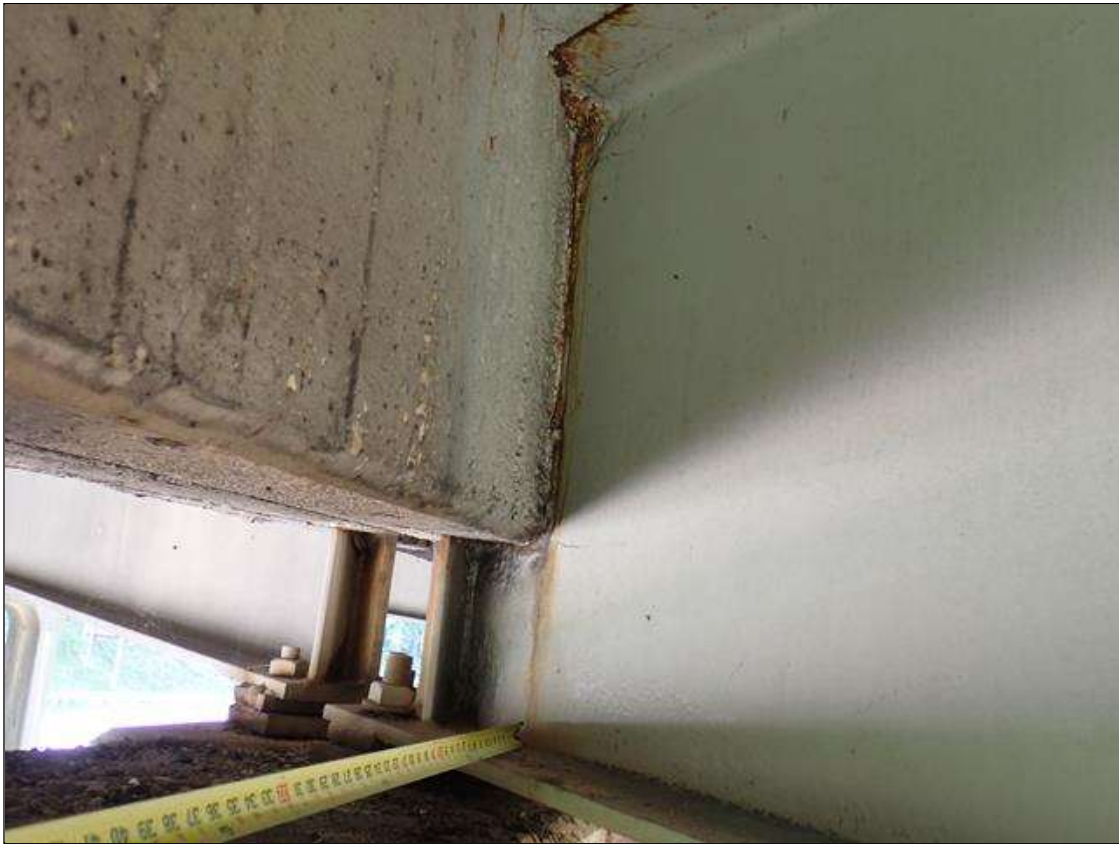
Span 4 Beam 3: (PAR) at bent 3, painted over section loss: web adjacent to diaphragm and upper web (7/16 inch average remaining x 6 inch x 2 foot); lower web (1/2 average remaining x up to 2.5 feet long x 6 inches high); bottom flange (0.77 inch average remaining x 8 inches); top flange, painted over pitting (up to 1/8 inch deep) with corrosion reinitiated

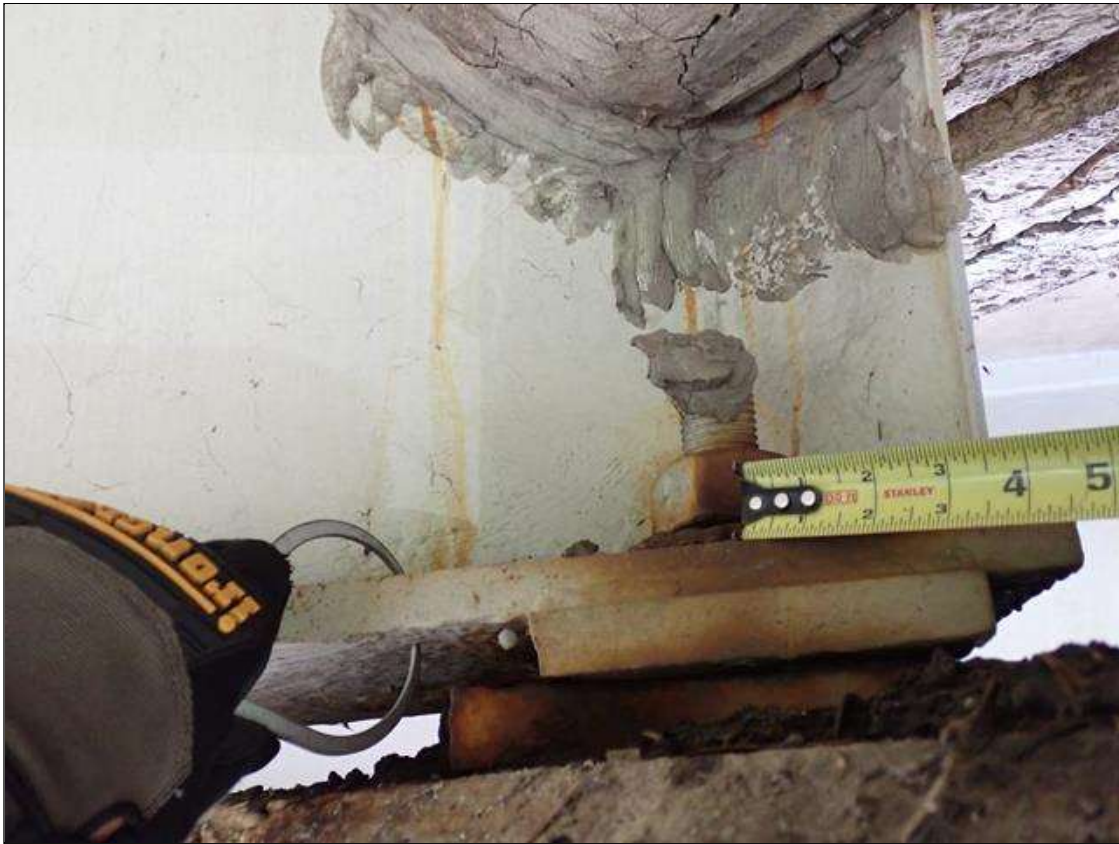
Span 4 Beam 3: (PAR) at bent 3, painted over section loss: web adjacent to diaphragm and upper web (7/16 inch average remaining x 6 inch x 2 foot); lower web (1/2 average remaining x up to 2.5 feet long x 6 inches high); bottom flange (0.77 inch average remaining x 8 inches); top flange, painted over pitting (up to 1/8 inch deep) with corrosion reinitiated

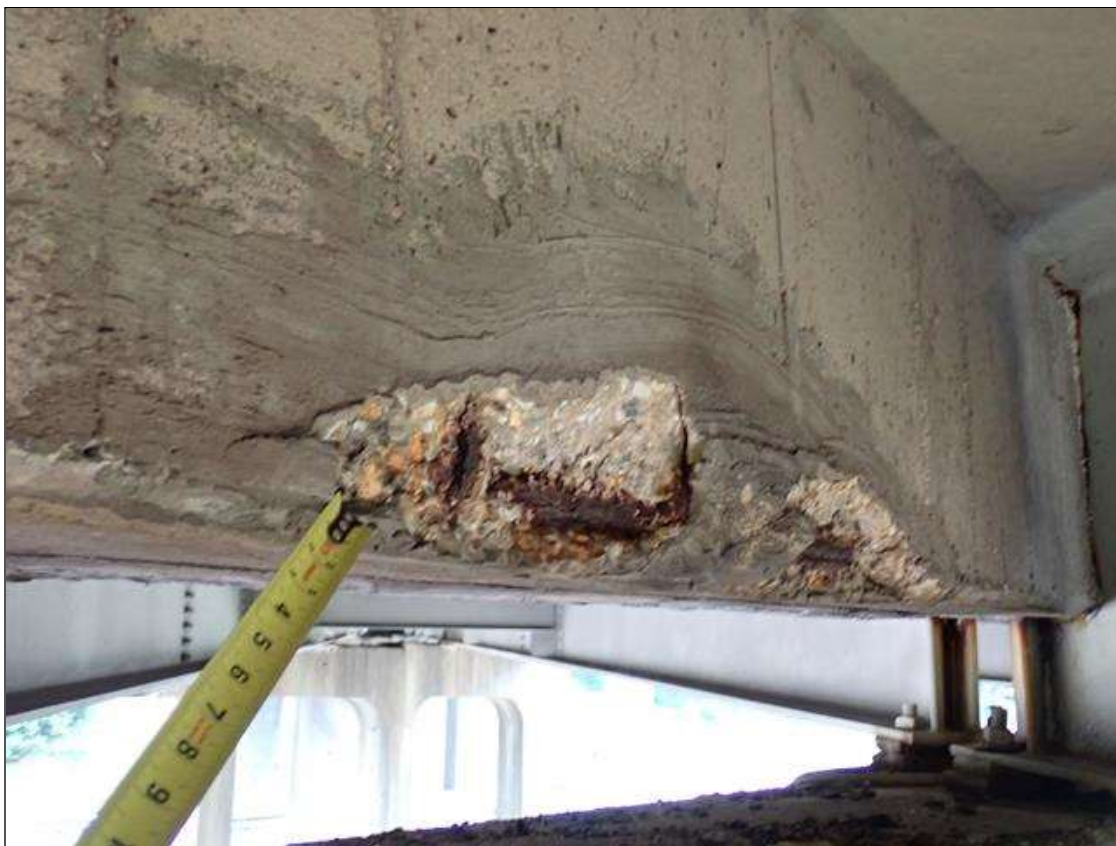
Span 4 Deck: at bent 3, end diaphragms in all bays, failed patches/delaminations/spalls (3.5 feet x 10 inch x 2 inches deep) with exposed rusted rebar

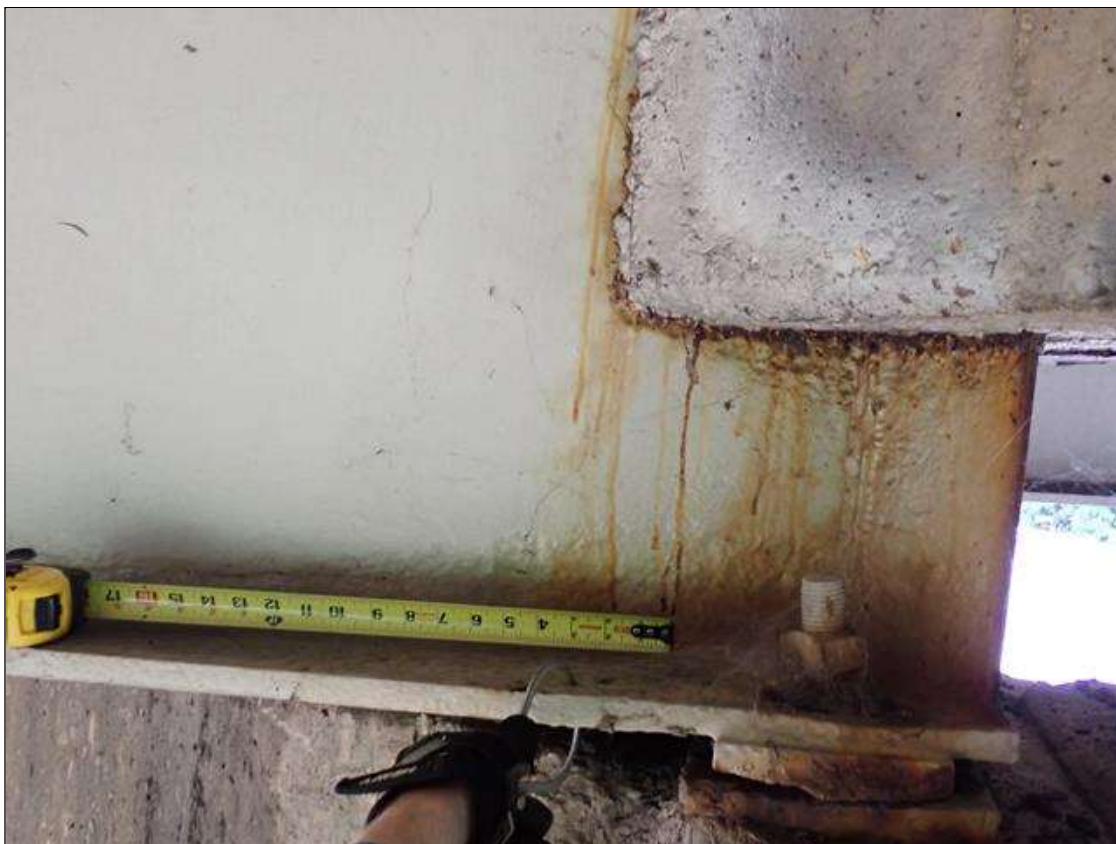
Span 4 Beam 2: (PAR) at bent 3, painted over section loss: web adjacent to diaphragm (7/16 inch average remaining x 7 inch x 2 inch); lower web (1/2 inch average remaining x 4.5 feet x 4 inches); bottom flange (0.71 inch average remaining x 6 inches) with corrosion reinitiated

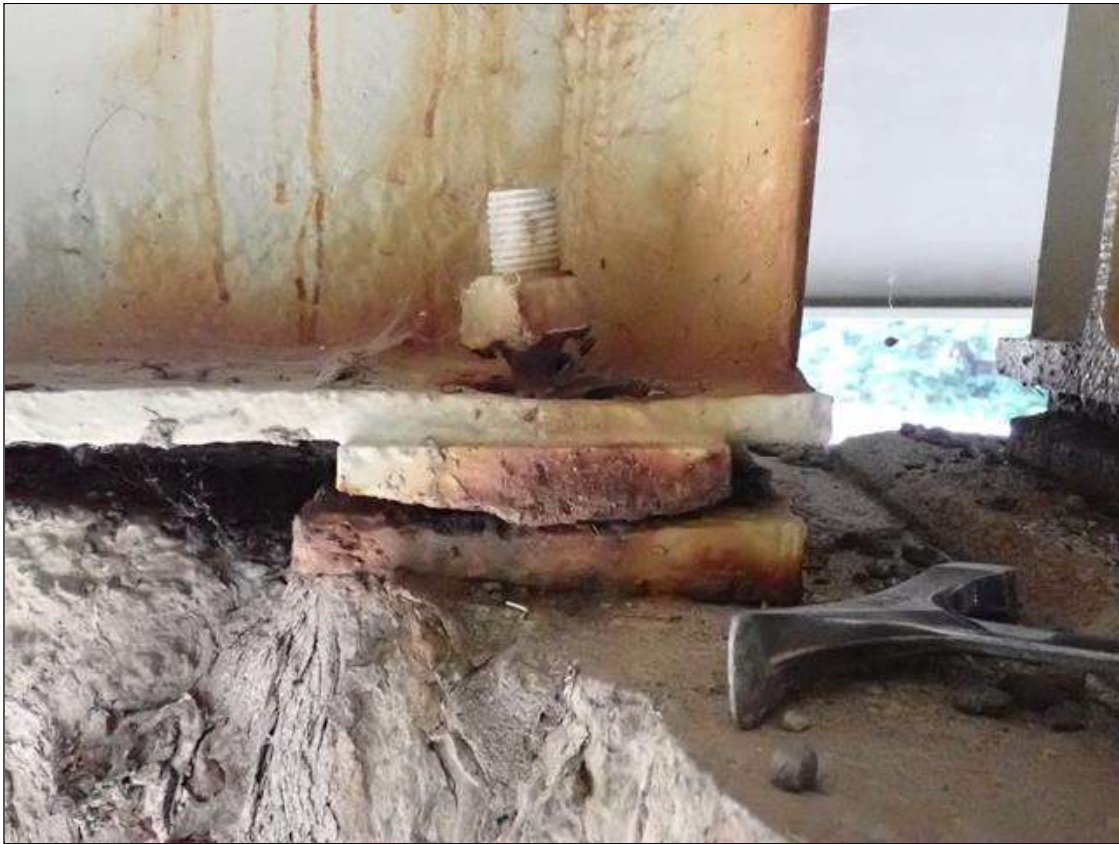
Span 4 Beam 2 - Near Bearing 2: (PAR) painted over section loss (up to 1/8 inch deep); left anchor bolt, approximately 50 percent section loss; pack rust

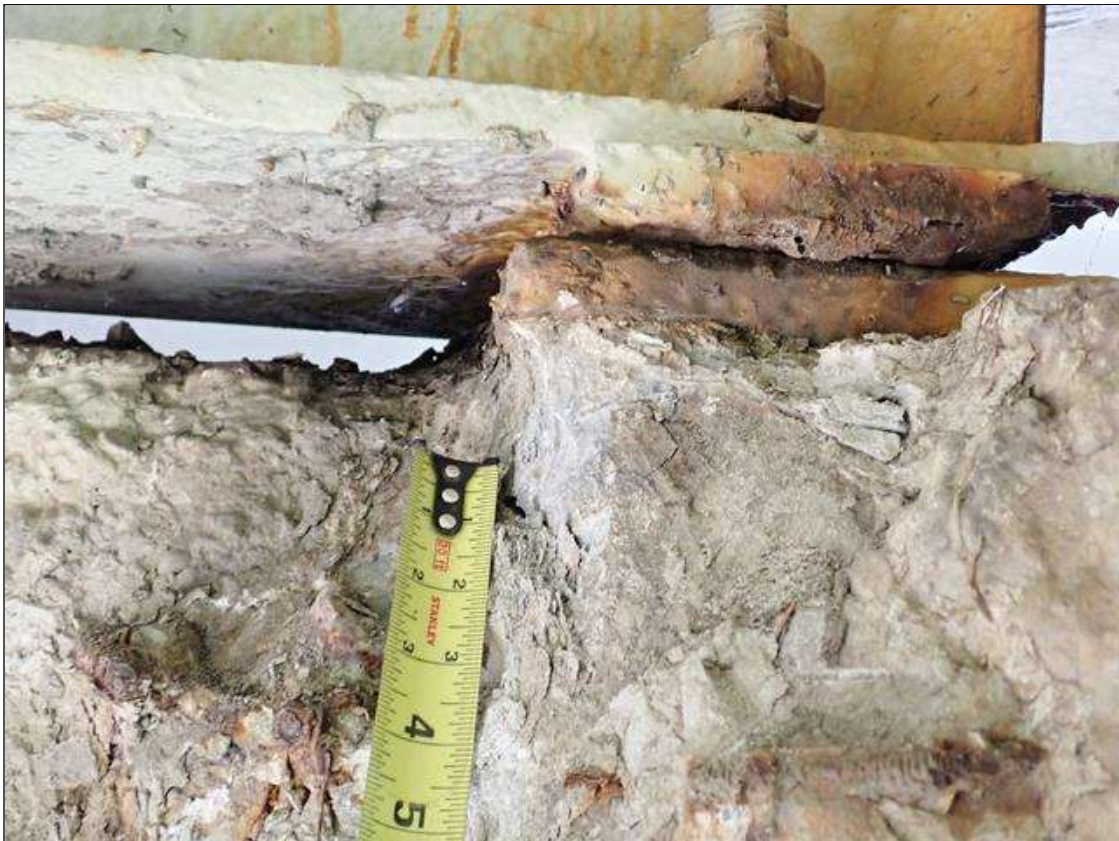
Span 4 Beam 2 - Near Bearing 2: (PAR) northwest corner, loss of bearing (4 inch x 3 inch x up to 1/2 inch deep) due to cap spall

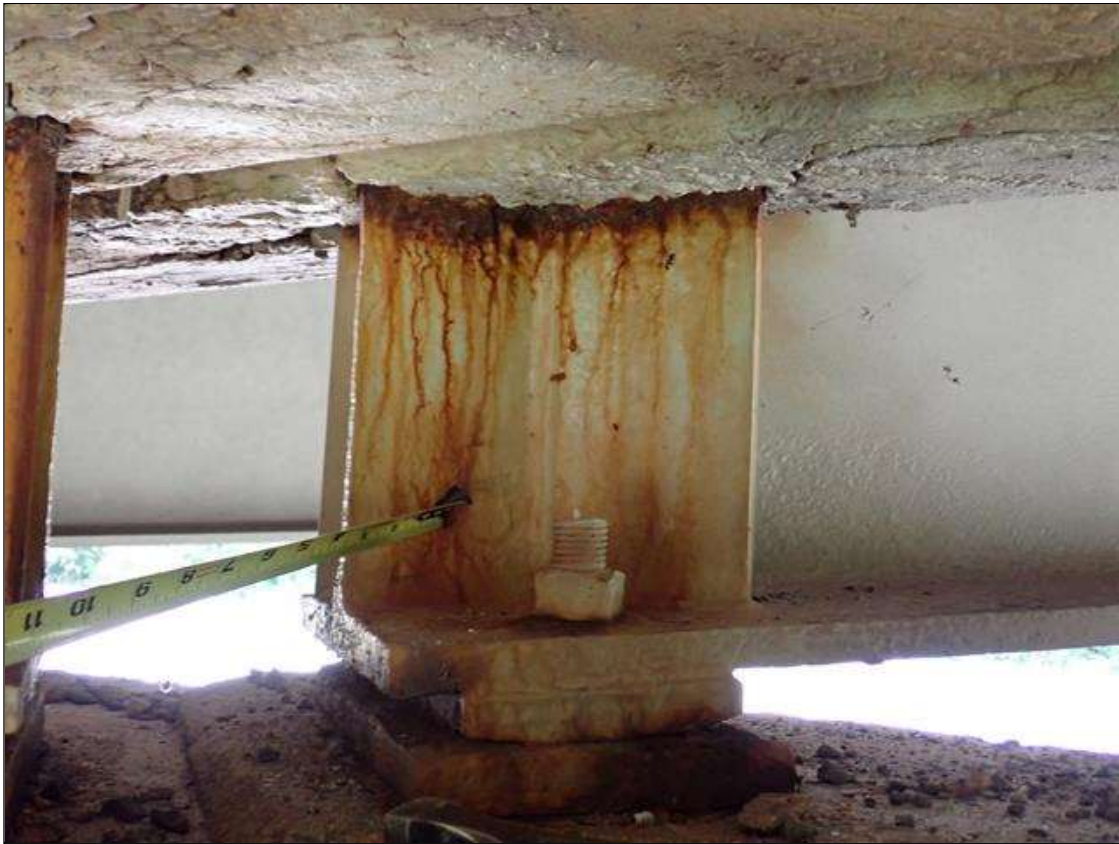
Span 3 Beam 2: at bent 3, painted over section loss: web adjacent to diaphragm and upper web (9/16 inch average remaining x 5 inch x 1 inch); lower web (9/16 average remaining x 5 inch x 3 inch) with adjacent pitting (up to 1/8 inch deep) with corrosion reinitiated

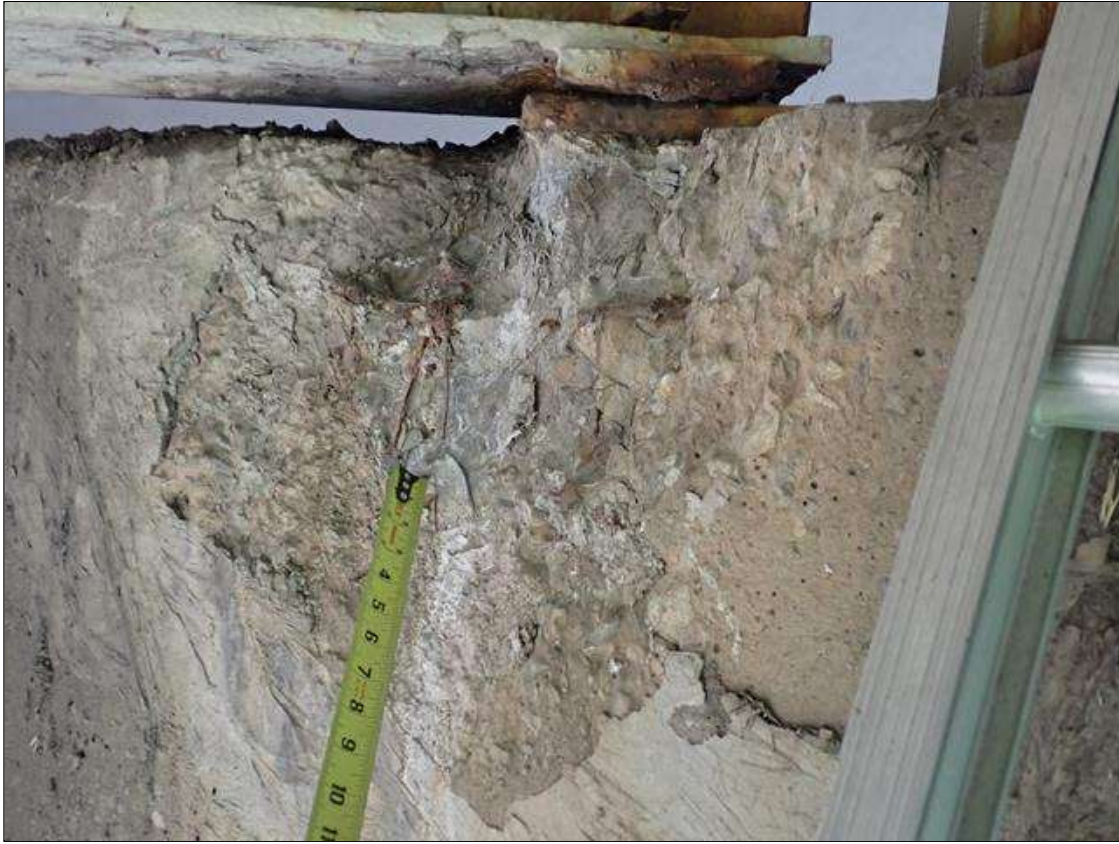
Bent 3 Cap 1: (PAR) 3 FOOT X 18 INCH X 4 INCH DEEP FAILED PATCH/SPALL WITH EXPOSED REINFORCING, CAUSING LOSS OF BEARING, AT PREVIOUSLY PATCHED AREA NORTH FACE BELOW BEAM 2.

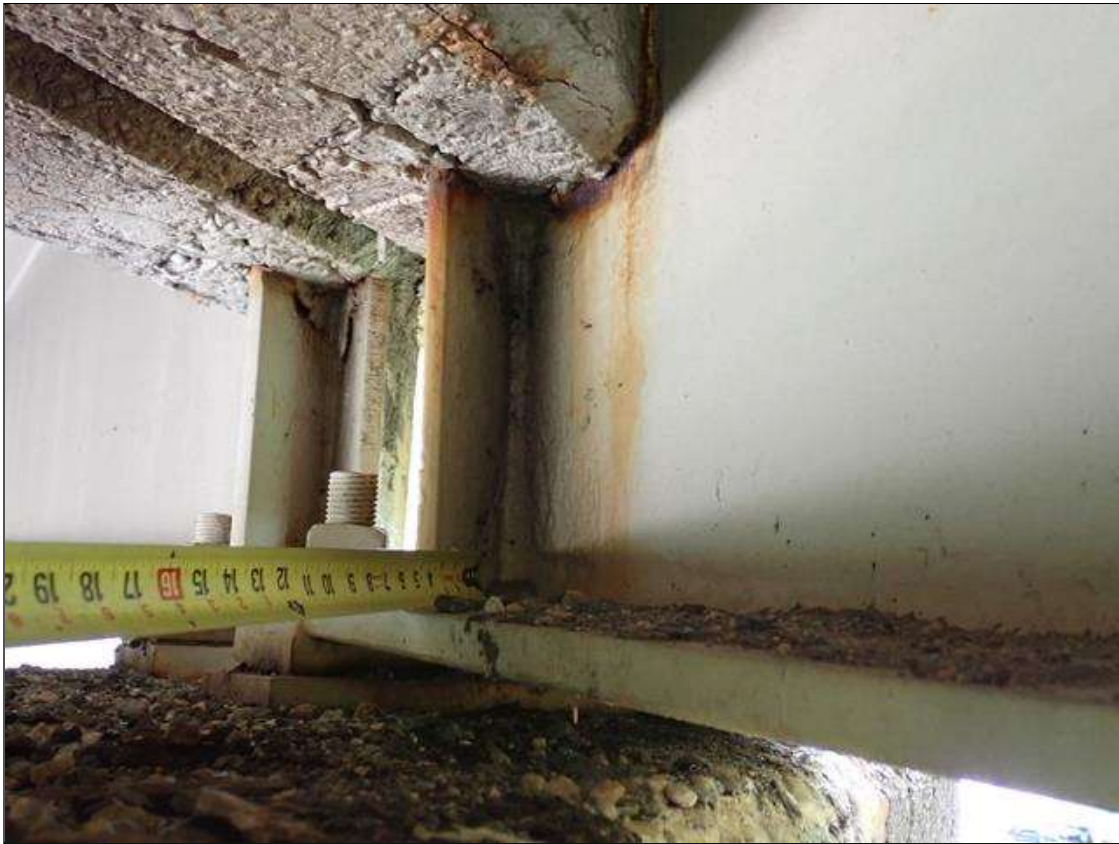
Span 4 Beam 1: at bent 3, painted over section loss: web adjacent to diaphragm (1/2 inch average remaining x 7 inch x 2 inch); lower web (1/2 inch average remaining x 5 inch x 5 inch); bottom flange (0.86 inch average remaining x 1 foot) with corrosion reinitiated

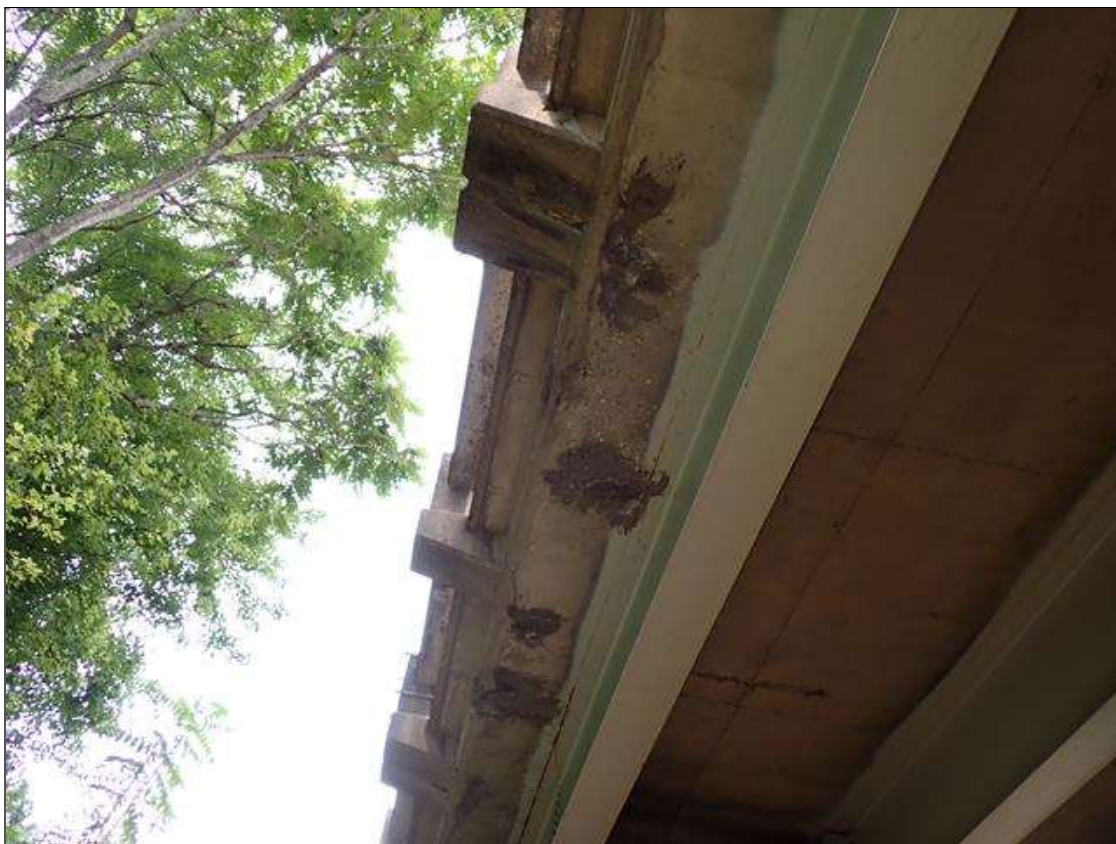
Span 4 Deck: MULTIPLE SOUND PATCHES UP TO 2.5 FEET x 2 FEET IN UNDERSIDE OF WEST OVERHANG AT RANDOM THROUGHOUT.

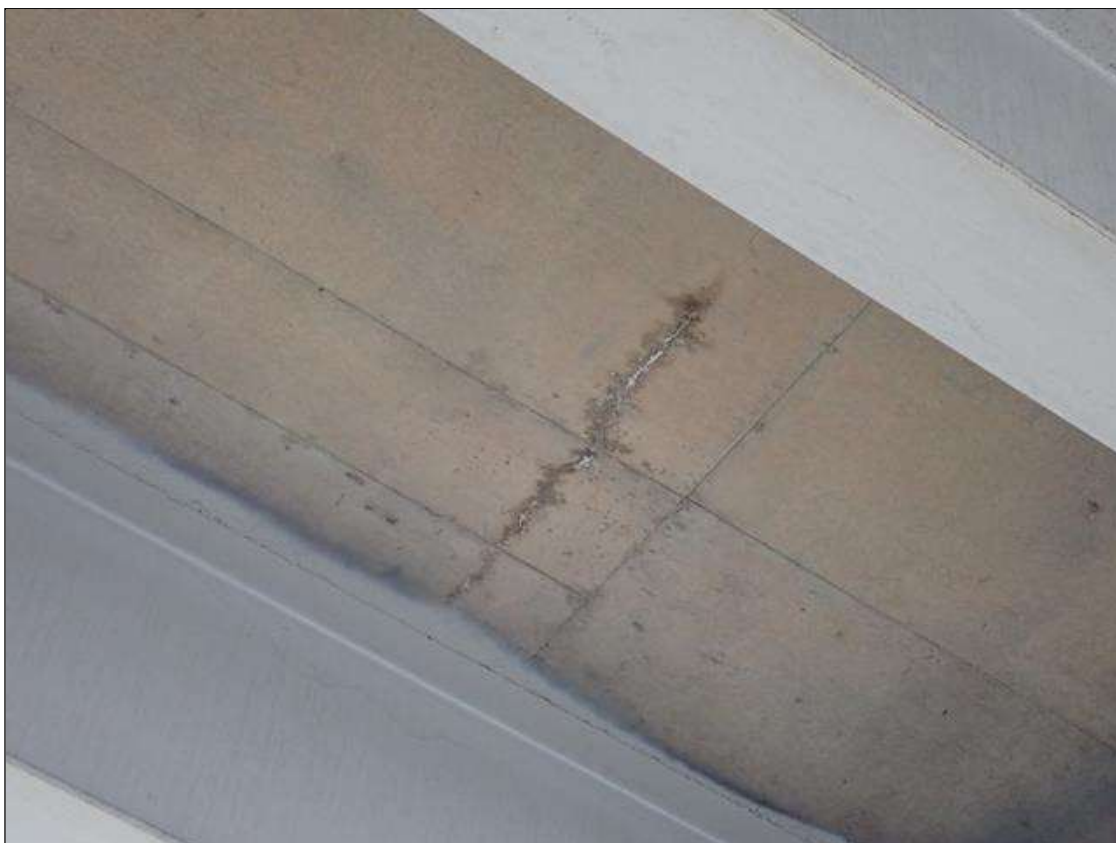
Span 4 Deck: (PAR) throughout underside of deck, transverse cracks (up to 1/32 inch x full bay width) and map cracks (hairline), some with efflorescence buildup and rust stains at random
